EVALUATION OF THE RELIABILITY AND SENSITIVITY OF  
NDT METHODS FOR TITANIUM ALLOYS

McDONNELL AIRCRAFT COMPANY

PREPARED FOR  
AIR FORCE MATERIALS LABORATORY

JUNE 1974

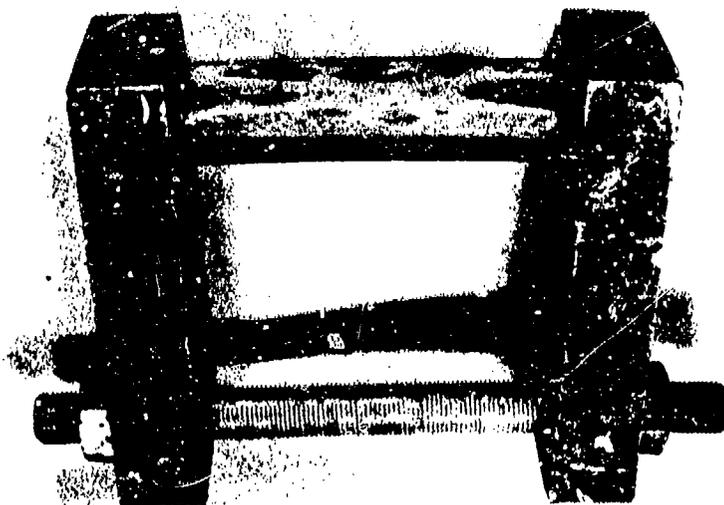
FIGURE 1  
FIXTURE FOR STRESSING SPECIMENS

Ti-6Al-4V blanks,  $1/4 \times 2 \times 5$  inches, were cut to size and ground on one side. The blanks were ground to approximately 32 rms using a 60 grit wheel (12 inch diameter x 1 inch wide), 2,000 rpm wheel speed, .002 to .003 inch downfeed, and approximately .100 inch crossfeed per pass. The workpiece was flooded with coolant during the process. After grinding, the specimens were bent in a fixture, as shown in Figure 1, to approximately 25% yield strength. The bent specimens were wetted with methanol and NaCl was applied such that NaCl adhered to the specimen surface. The stressed specimens were lowered into an anhydrous methanol-NaCl solution and remained immersed until cracking occurred in a few hours.

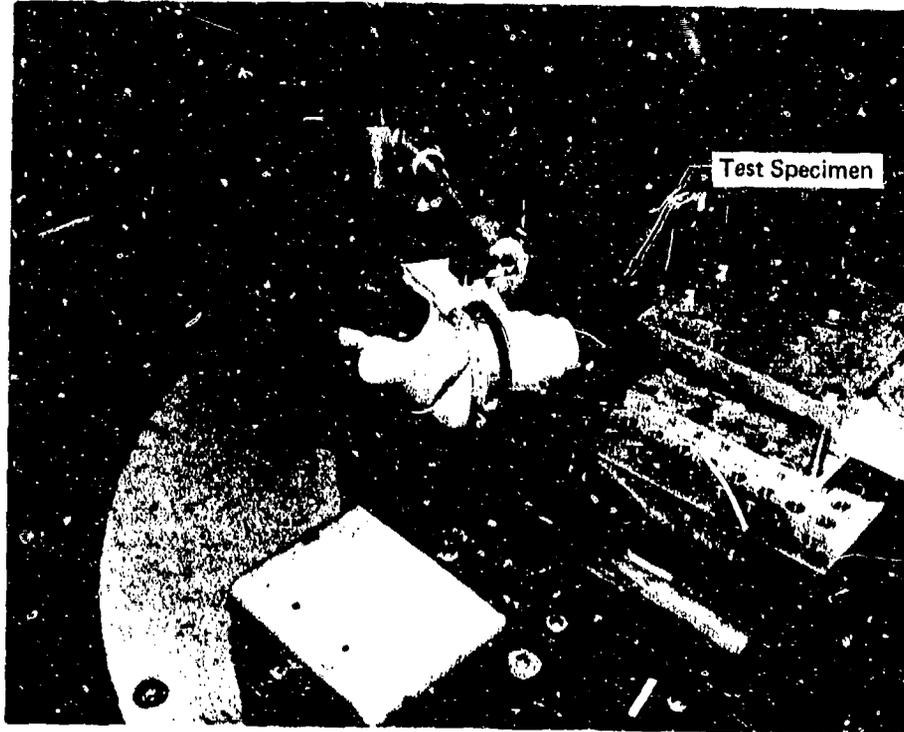
**FIGURE 2**  
**SHAKER TABLE TEST SET-UP**

Blanks,  $1/4 \times 1 \times 6$  inches, were cut from Ti-6Al-4V and a saw-cut notch was put into the  $1/4 \times 6$  inch face to serve as a crack initiation site. Each specimen was cantilevered in a shaker table with a mass of 239 grams added near the free end and was vibrated at its resonant frequency (approximately 550 Hz). The crack growth was monitored optically until the desired crack length ( $1/4$  to  $1/2$  inch) was obtained. The test set-up is shown in Figure 2. The resulting cracks were propagated through the  $1/4$  inch thickness and  $1/4$  to  $1/2$  inch into the  $1 \times 6$  face (see Figure 2). The surface finish on the specimens was approximately 32 rms.

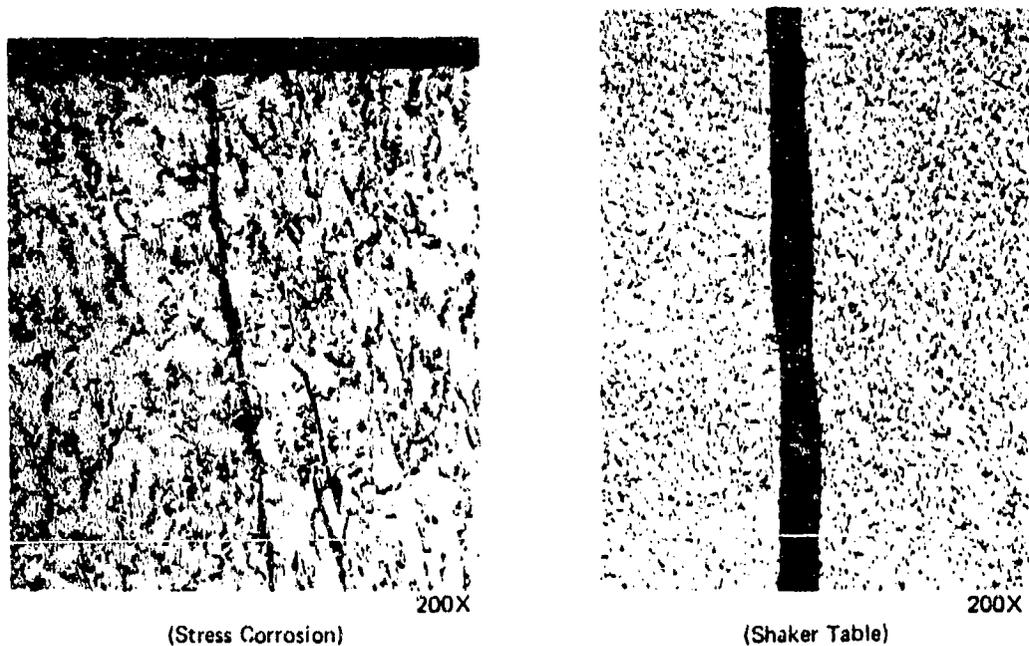
**FIGURE 4**  
**PHOTOMICROGRAPHS OF STRESS CORROSION CRACKS AND**  
**SHAKER TABLE PRODUCED CRACKS**

Photomicrographs of typical tight cracks, gross cracks, and porosity are shown in Figures 4 and 5. As can be seen in Figure 4, a wide range of crack sizes are represented by the tight cracks and gross cracks. The gross cracks had widths at the surface of approximately .001 inch and depths of 0.25 and 0.50 inch. Cracks of this size are among those which have been encountered in production processes. For example, rolling cracks have been encountered with widths of approximately .001 inch. The width of the tight cracks (at the surface) varied from .00016 to .0002 inch and the crack depth varied from .007 to .060 inch. Cracks this size have also been encountered in production processes such as forming. As shown in Figure 5, the porosity size varied considerably. The diameter of several pores was measured at high magnification and found to vary from .0005 to .0075 inch; the depths varied from .002 to .015 inch.

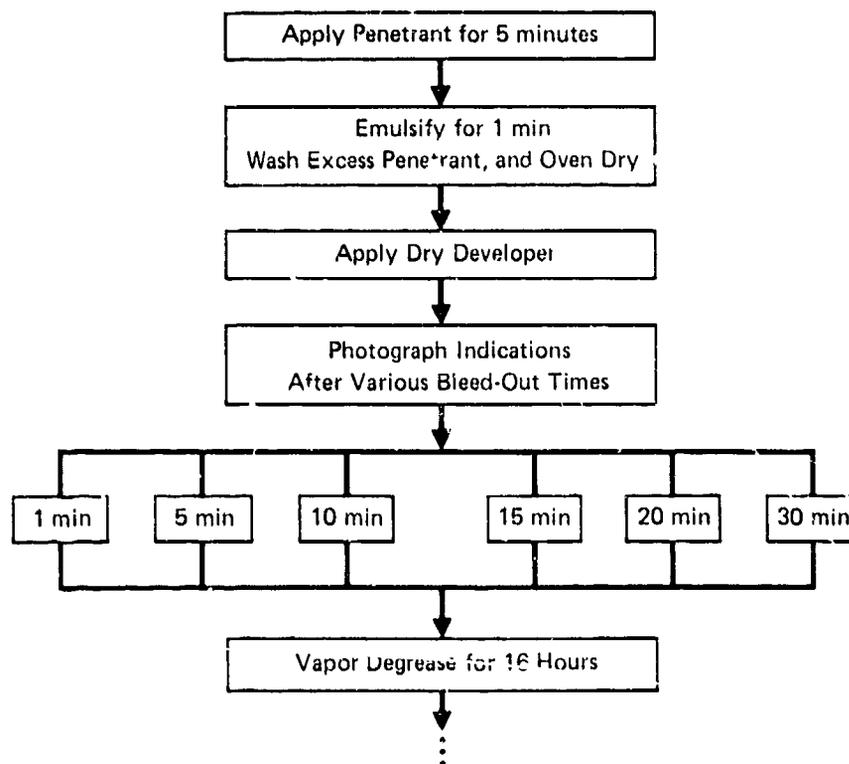
Note: This process was repeated for penetrant dwell times of 10, 20, and 30 minutes and for nonaqueous wet developer, aqueous developer, and no developer

**FIGURE 7**  
**TEST PLAN FOR PENETRANT BLEED-OUT TIME STUDY**

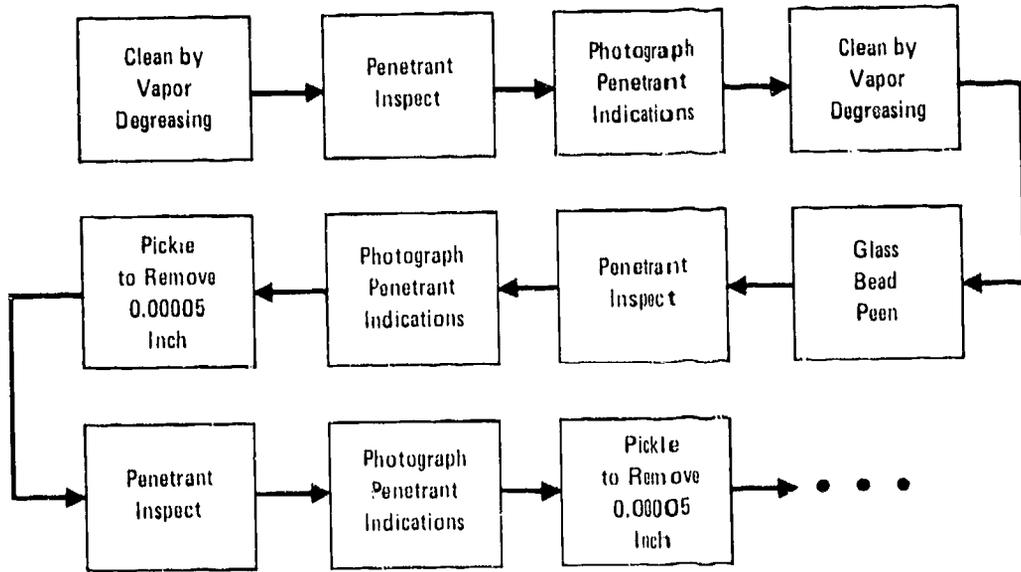
**FIGURE 25**  
**REPRESENTATIVE TEST PROCEDURE**

The schematic shown in Figure 25 is representative of the test procedure used to investigate the effect of each process. The photographs of the penetrant indications were compared both before and after the mechanical process. If the strength of the penetrant indications were reduced by the particular mechanical process, the specimens were pickled to remove surface metal and re-penetrant inspected. This was repeated until the penetrant indications returned to full strength.

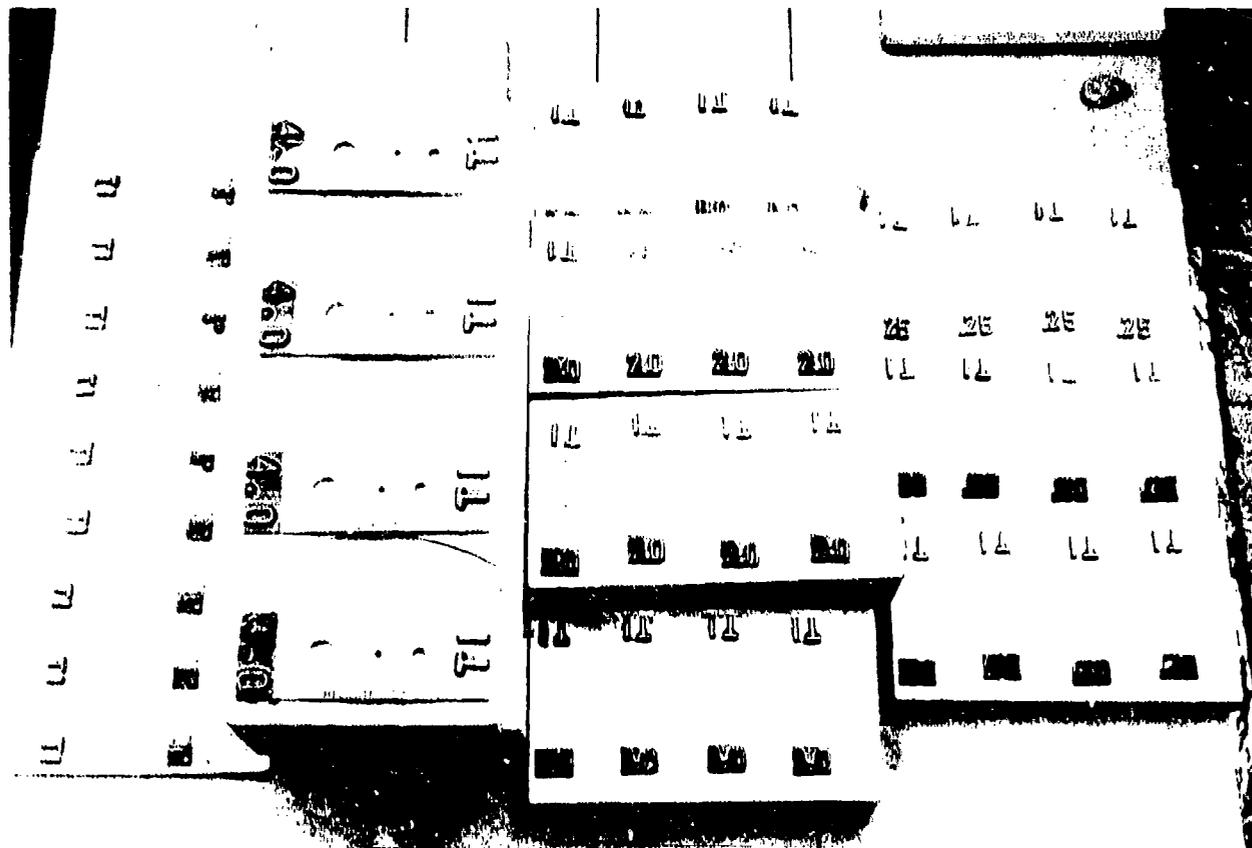
**FIGURE 30**  
**STEP WEDGES WITH MIL-STD-453 PENETRAMEters**

These screen combinations are typical for a production radiographic inspection. Prior to exposure, titanium 2% penetrameters (MIL-STD-453) were placed on each step of the test specimens (Figure 30). A focal spot-to-film distance of 72 inches was used for each exposure. This resulted in a geometric unsharpness of .005 inch or less for all the radiographs except at the 4 inch step wedge for exposures made with the Isovolt 400 where the geometric unsharpness is .0088 inch. Exposures were made using the kilovoltage/milliamp-minute combinations shown in Table 17. Exposures of 16 and 64 milliamp-minutes were chosen in order to yield a sufficient number of section thicknesses with film density between 0.5 and 3.5 H&D for evaluation. For the lower kilovoltages, longer exposures (96 and 240 milliamp-minutes) were also investigated to help determine if the increase in contrast warrants the longer exposure times and to determine the upper titanium thickness limits which exist for each kilovoltage. To ensure reproducibility, the chosen exposure time was never less than 1 minute. One minute exposures compensated for transient line voltage fluctuations as well as variations in the rate of increase of the X-ray beam to full power from one exposure to the next. Each exposed film was processed automatically in a Kodak Model B X-OMAT using Gevaert G135N developer and G334N fixer.

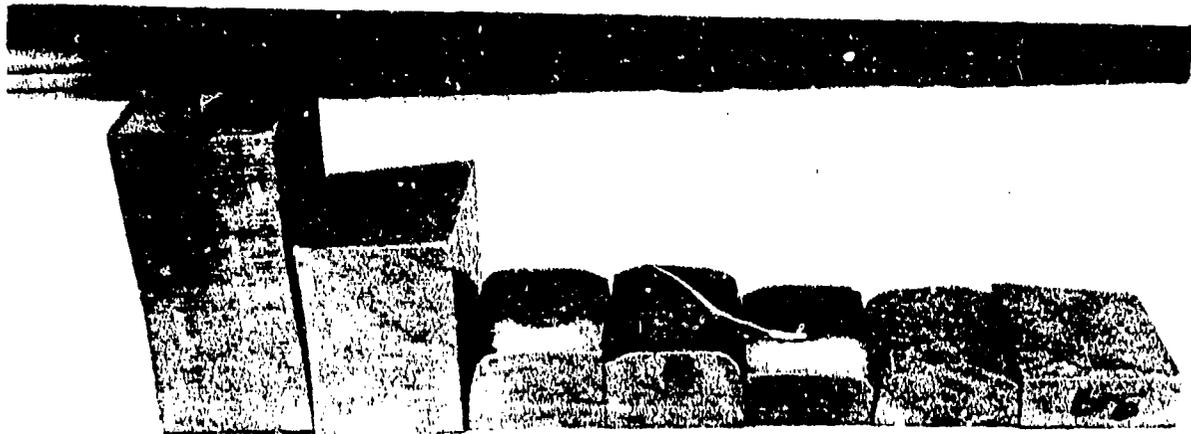
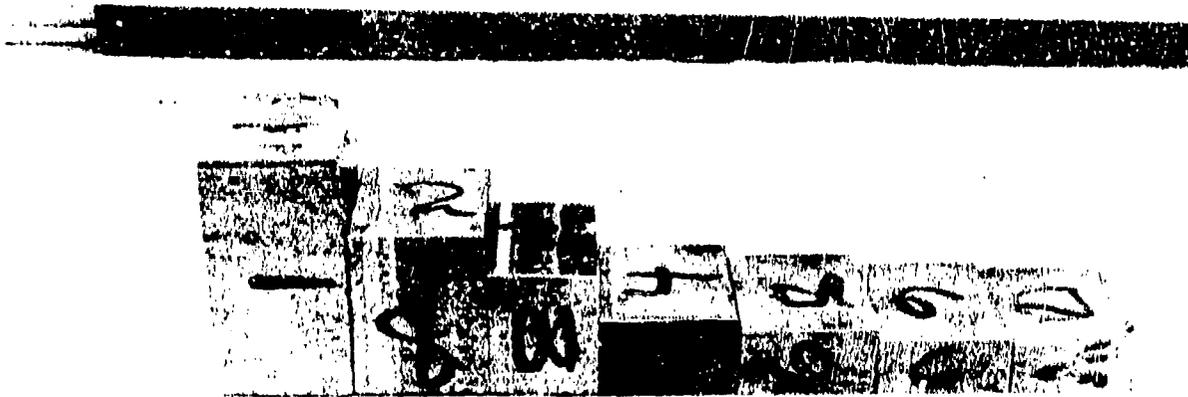
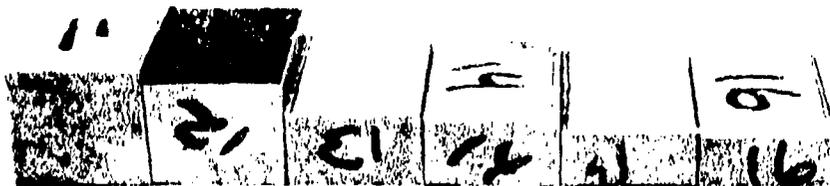
Die Forging

4 Inch Plate

2 Inch Plate

FIGURE 44  
NEAR SURFACE RESOLUTION SPECIMENS

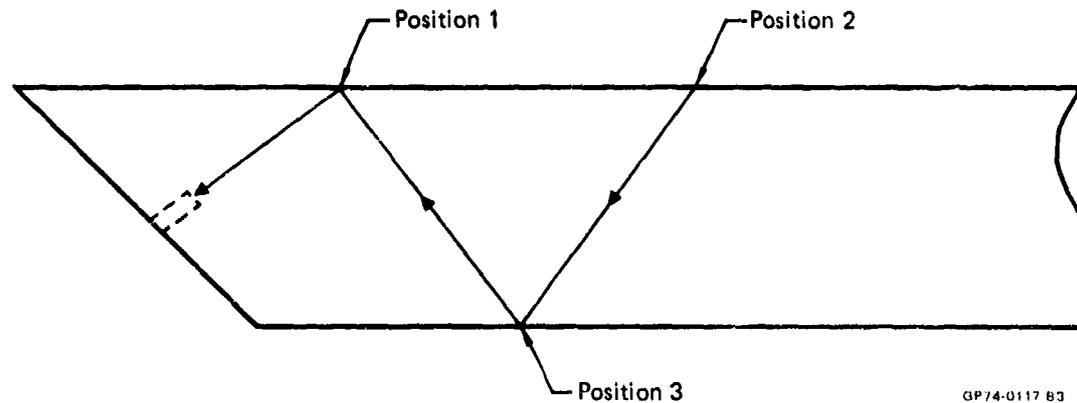
**FIGURE 56**  
**SOUND ENTRY POSITIONS**

A Branson 600 ultrasonic instrument was used along with a 622T pulser/receiver for each test. Each search unit was adjusted for a 3 inch water path and a refracted sound beam angle in the specimen of 45 degrees  $\pm$  5 degrees for the 1-1/2 and 2 inch thick specimens and 60 degrees  $\pm$  5 degrees for the 1 inch thick specimen. The sound entry point was adjusted to Position 1 (see Figure 56) and the flat bottom hole response was adjusted to 80 percent of saturation. The response-to-noise ratio was measured off the cathode ray tube. Next, the search unit was moved to Position 2 and the testing was repeated. A few selected tests were performed from Position 3.

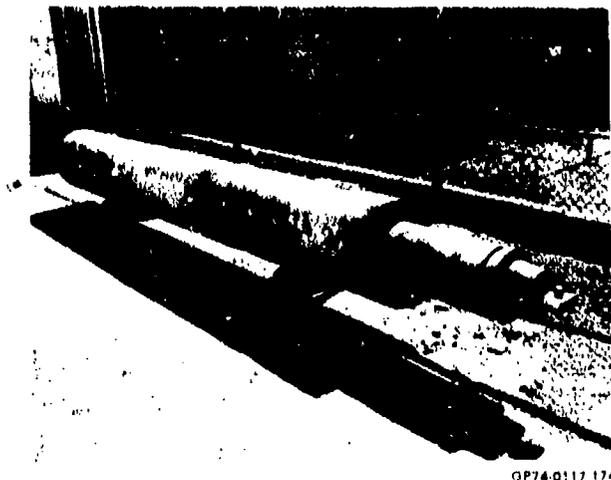
**FIGURE 57**  
**FIRST MELT INGOT**

A full size double vacuum melted production Ti-6Al-4V ingot (24 inch diameter, 7,500 pounds) was produced for the program by Oregon Metallurgical Company (Oremet) in Albany, Oregon. The ingot raw material components were sponge, alloy, and revert chip. A photograph of the first melt ingot is shown in Figure 57.

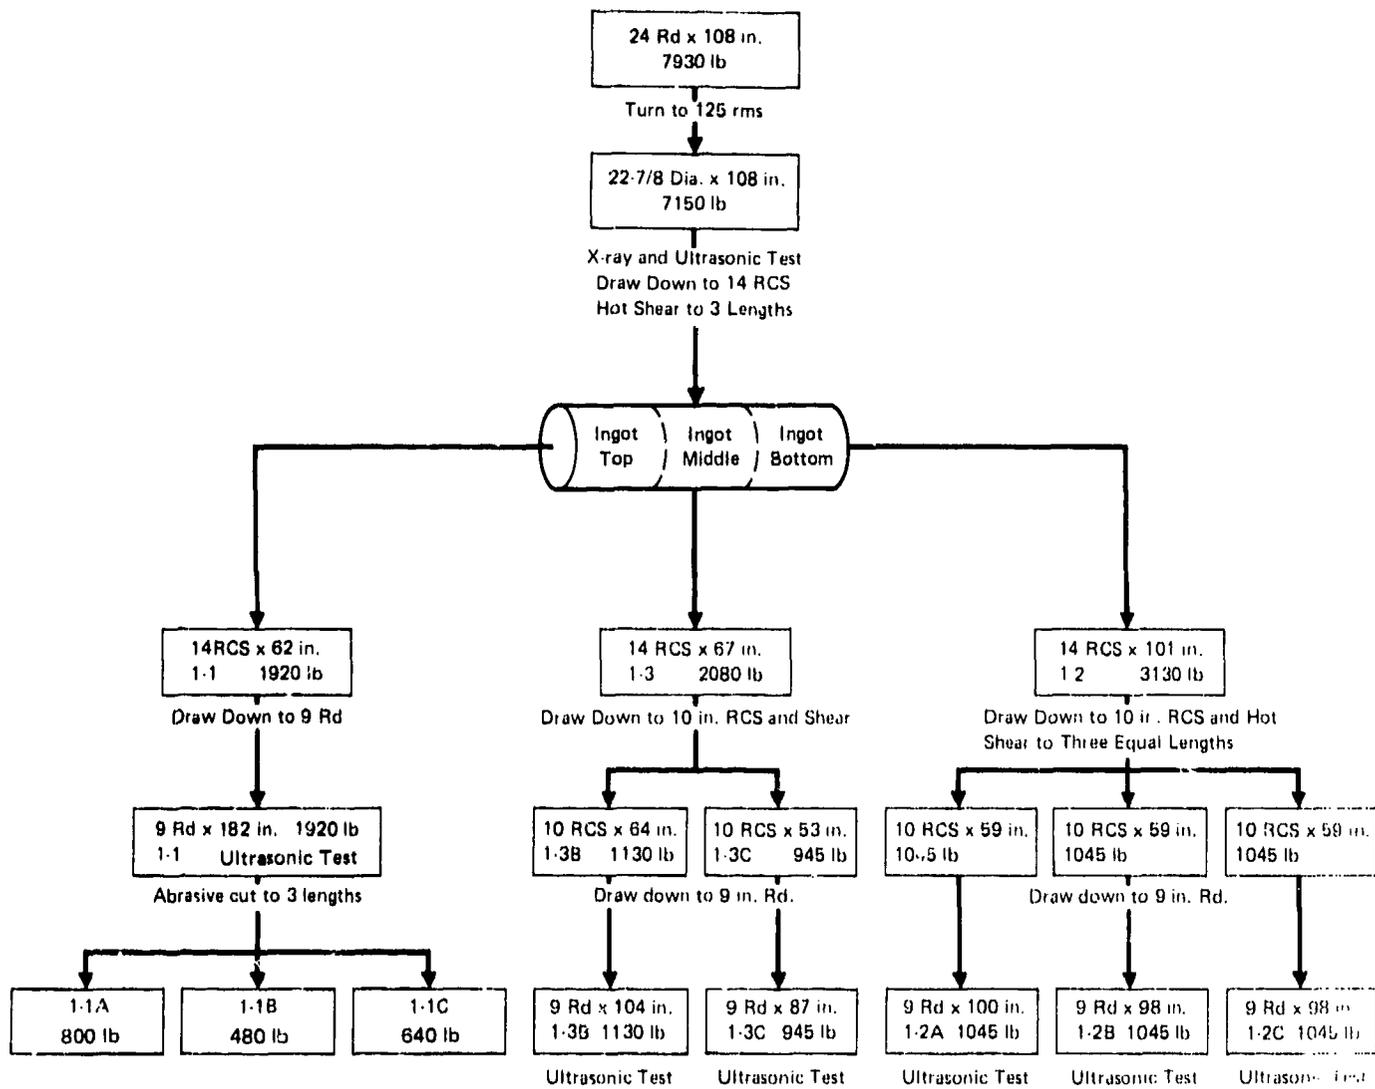
**FIGURE 62  
CONVERSION OF INGOT TO 9 INCH ROUND BILLET**

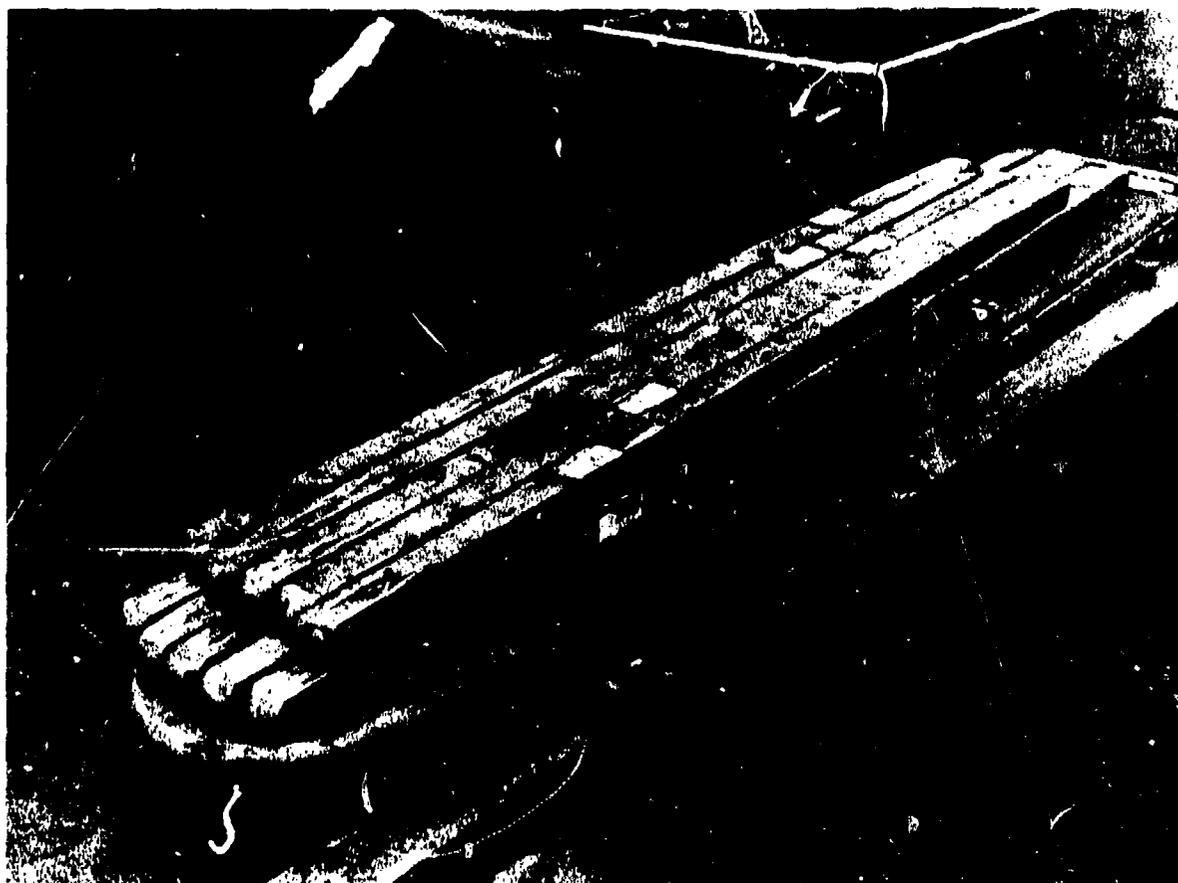
FIGURE 67  
TWO-INCH SQUARE BAR

Two inch square bar was produced from each of the three ingot sections. Six inch diameter billet was press forged at 1750°F - 1800°F to 4 inch square bar and then hammer forged at 1750°F - 1800°F to 2 inch square bars. Next, the 2 inch bars were annealed at 1300°F for 2 hours and air cooled. Processing was completed by grit blasting. A photograph of the 2 inch square bar is shown in Figure 67.

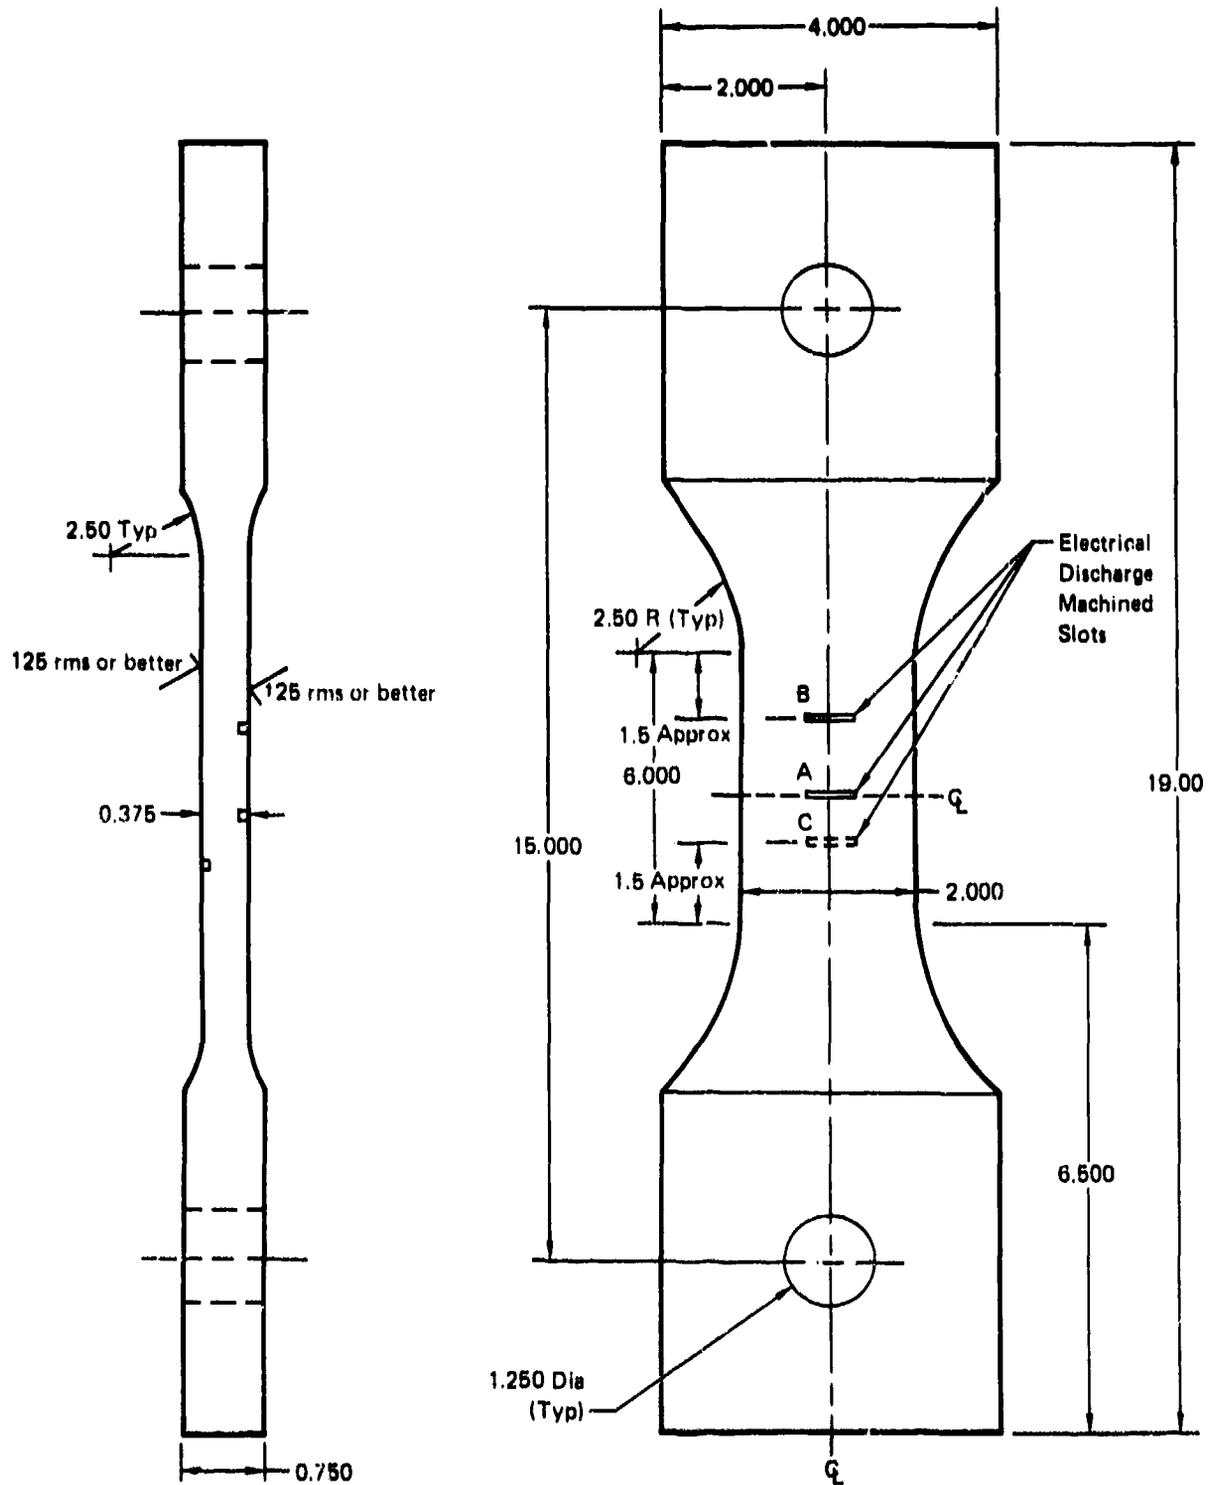
FIGURE 90  
FATIGUE SPECIMEN

Specimens containing surface connected cracks were produced by subjecting fatigue specimens (see Figure 90) to tension-tension fatigue using a 50,000 pound Sonntag fatigue machine. Electrical discharge machined (EDM) slots were incorporated at various locations to serve as

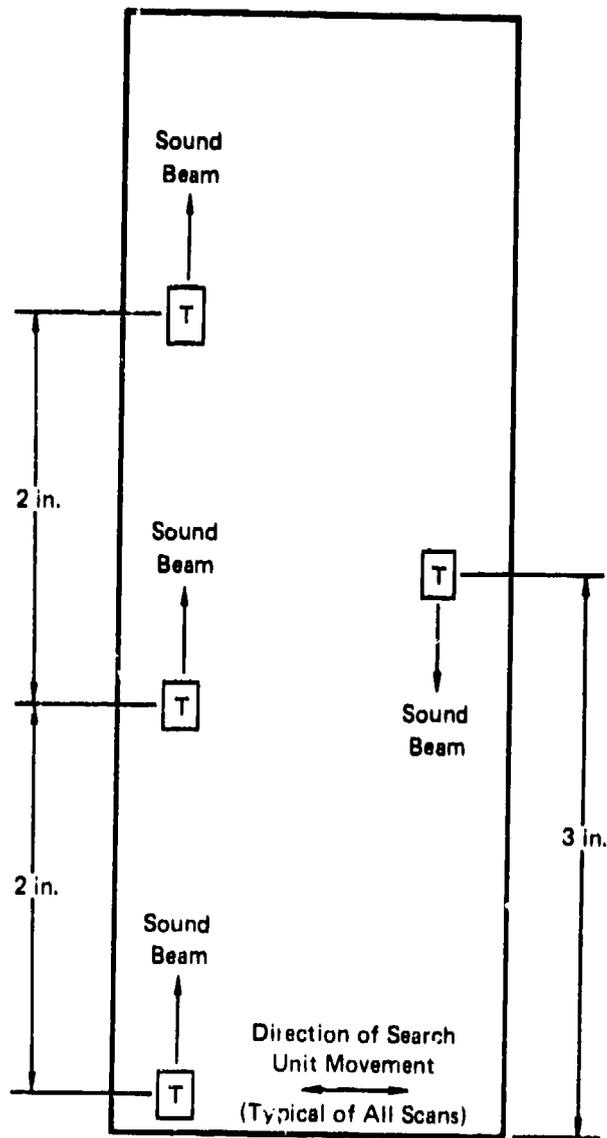
**FIGURE 91**  
**SURFACE WAVE SCANNING**

Considerable difficulty was encountered in establishing a reproducible distance-amplitude curve during the surface wave testing. The amplitude of the response was very sensitive to variations in hand pressure on the search unit. In order to demonstrate this effect, 4 DAC

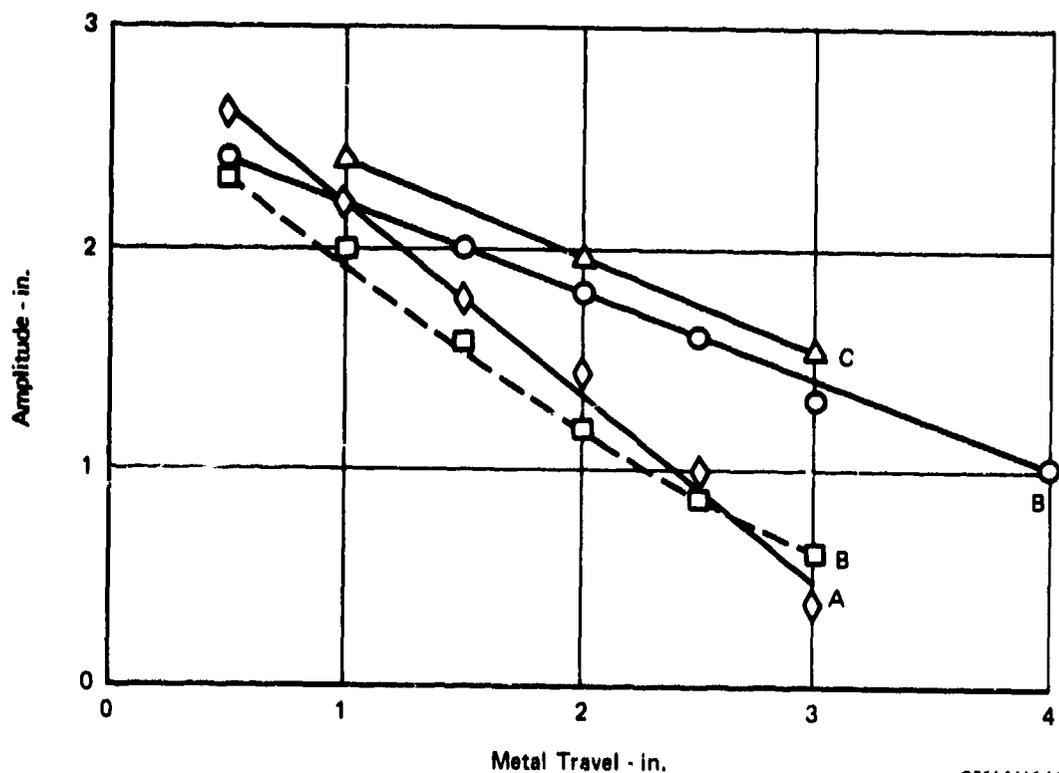
**FIGURE 92**  
**DISTANCE AMPLITUDE CORRECTION (DAC) CURVES FOR THREE REPRESENTATIVE TECHNICIANS**

The results of the production surface wave testing are shown in Table 63. A notation such as 3/3 indicates that 3 cracks were detected

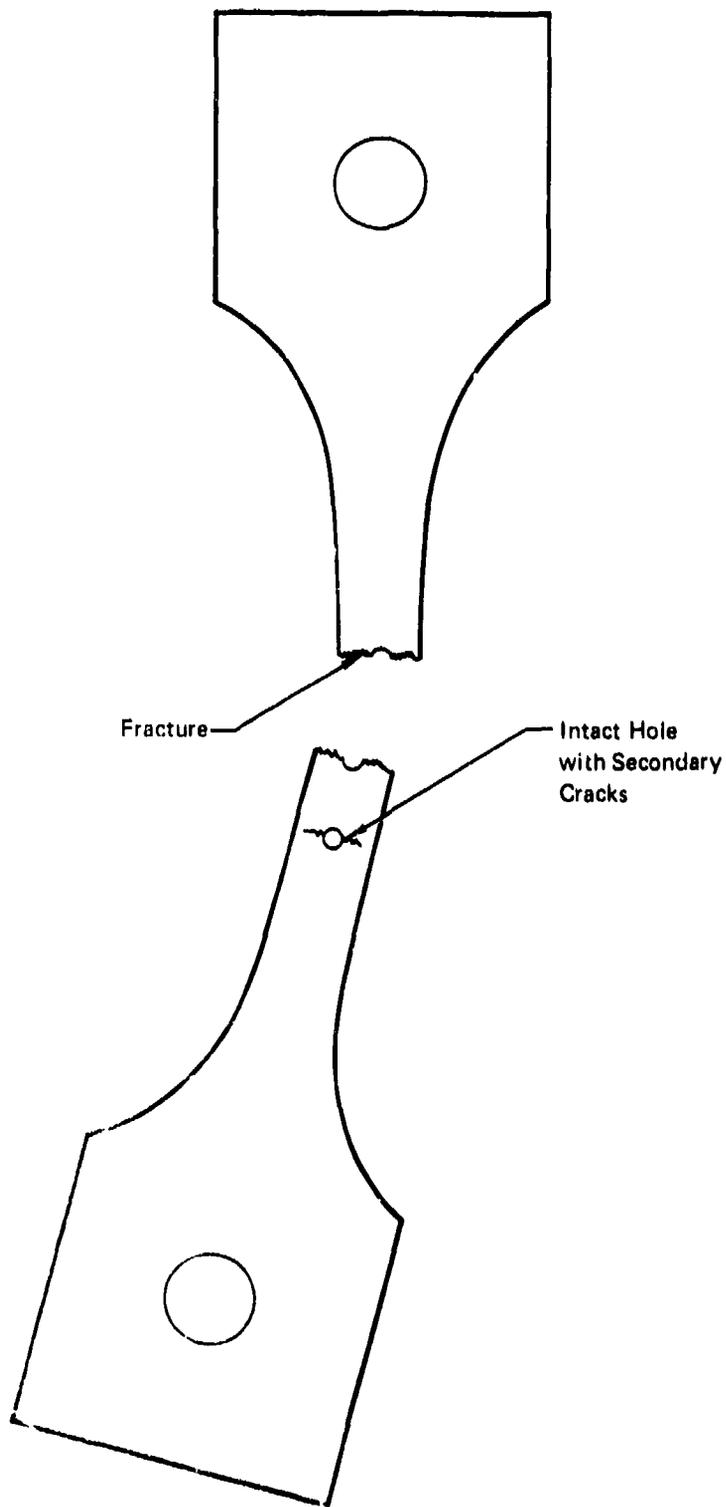
**FIGURE 101**  
**SECONDARY CRACKS IN FASTENER HOLE**

A total of 230 fractured specimens were initially eddy current tested to select holes containing secondary cracks (see Figure 101). The intact hole in each specimen was scanned with a Nortec NDT-3 eddy current instrument capable of several discrete frequencies between 10 KHz and 2 MHz. The instrument features an adjustable operating point within the complex impedance plane for each of the 7 available frequencies. Ideal Specialty Co. absolute type hole probes of the appropriate size were used. These probes were a single coil and used a ferrite core of .050 inch nominal diameter from .130 to .160 inch long wound with 150 turns of #40 wire.

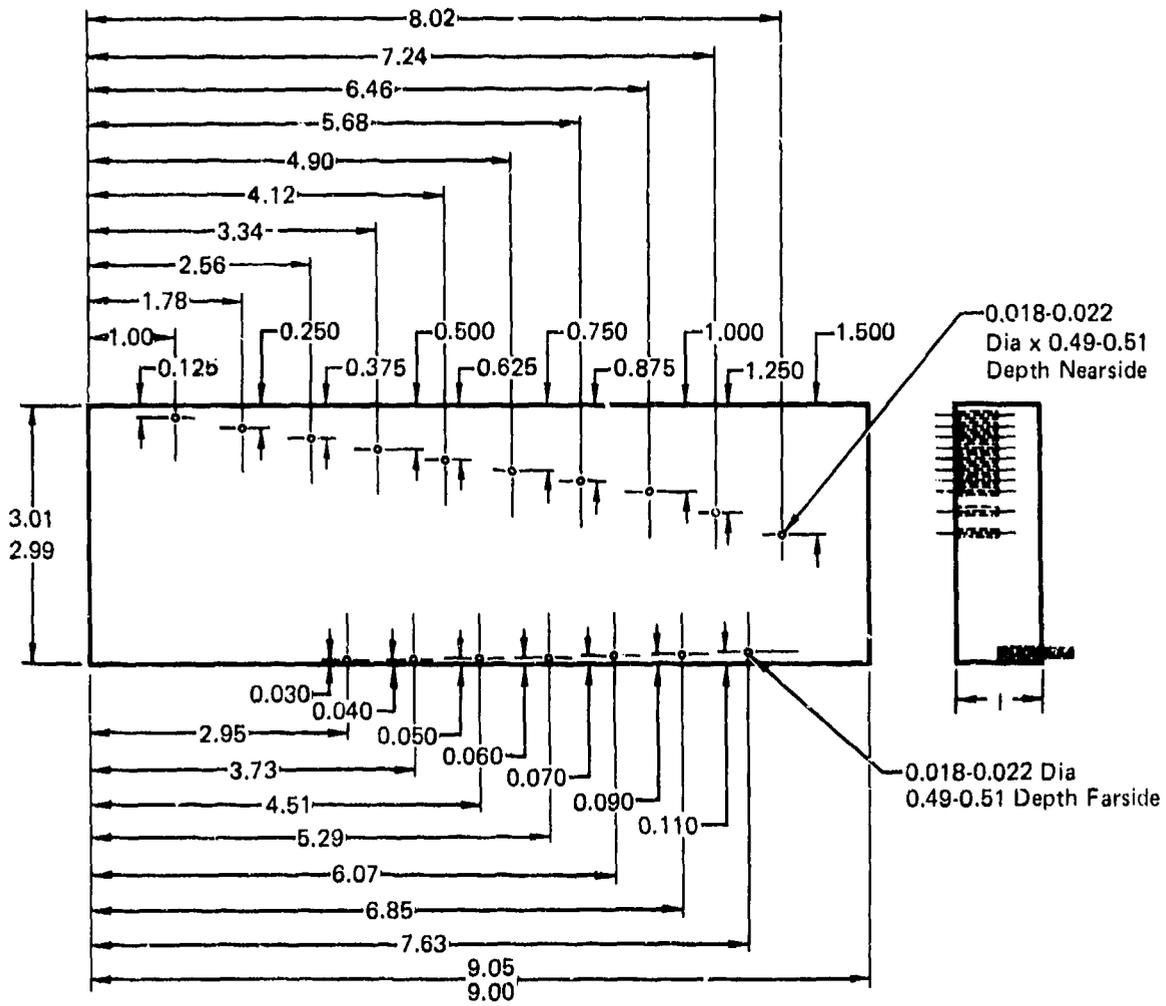
FIGURE 110  
REFERENCE STANDARD

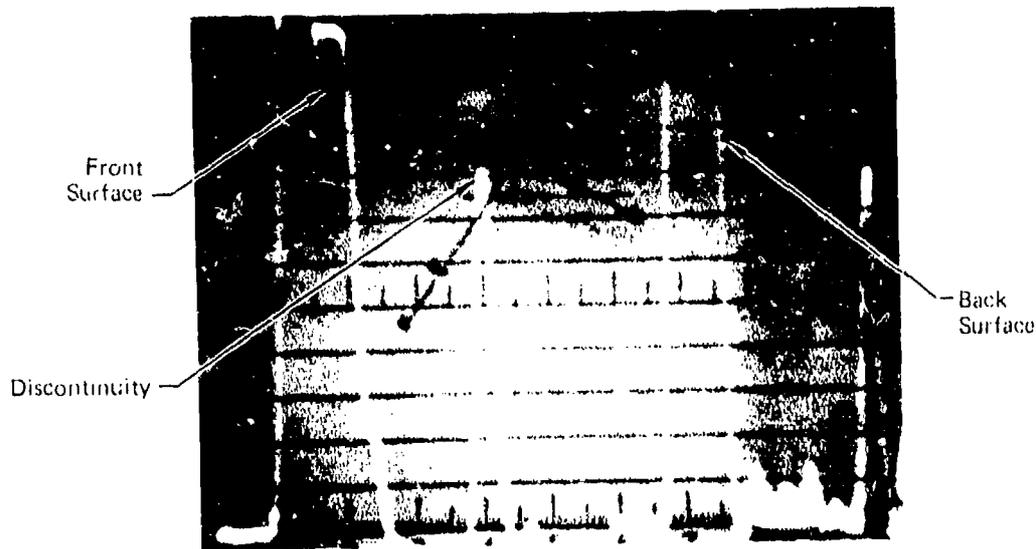
FIGURE 126  
TYPICAL RESPONSE FROM DISCONTINUITY IN PLATE

A typical CRT photograph of a discontinuity in the plate is shown in Figure 126.

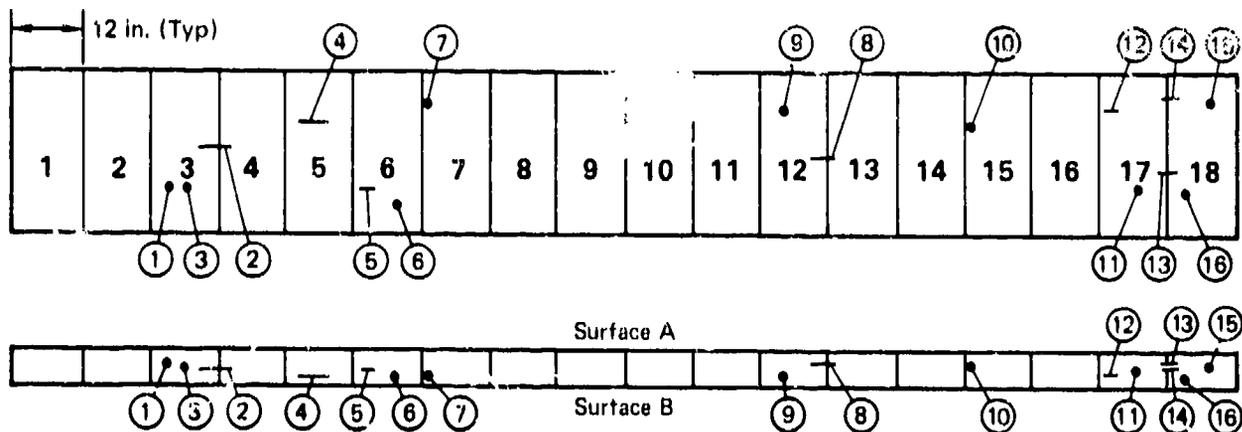
**FIGURE 127**  
**LOCATION OF DEFECTS IN PLATE A**

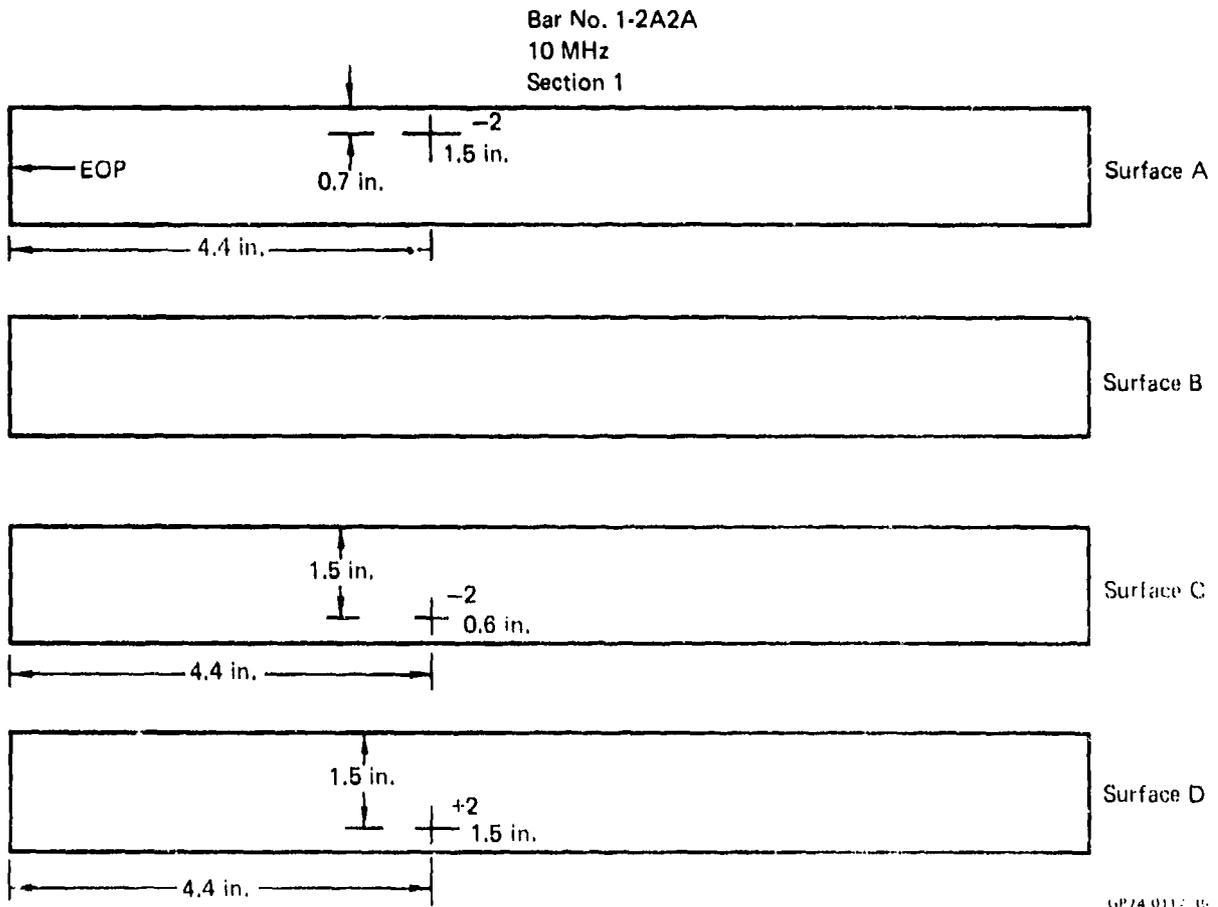
**FIGURE 132**  
**LOCATION OF DEFECTS IN BAR**

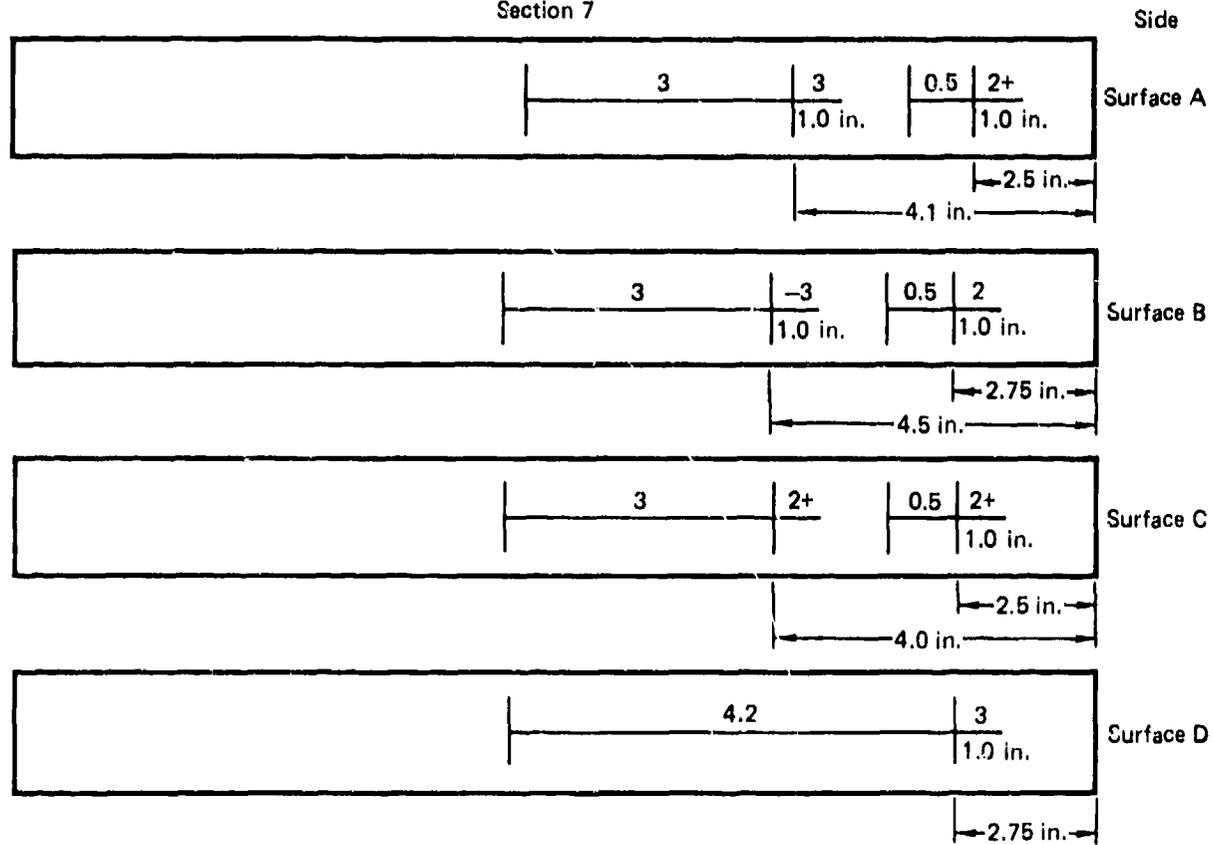
Bar No. 1-2A2A  
 5 MHz  
 Section 7

FIGURE 132 (Continued)  
 LOCATION OF DEFECTS IN BAR

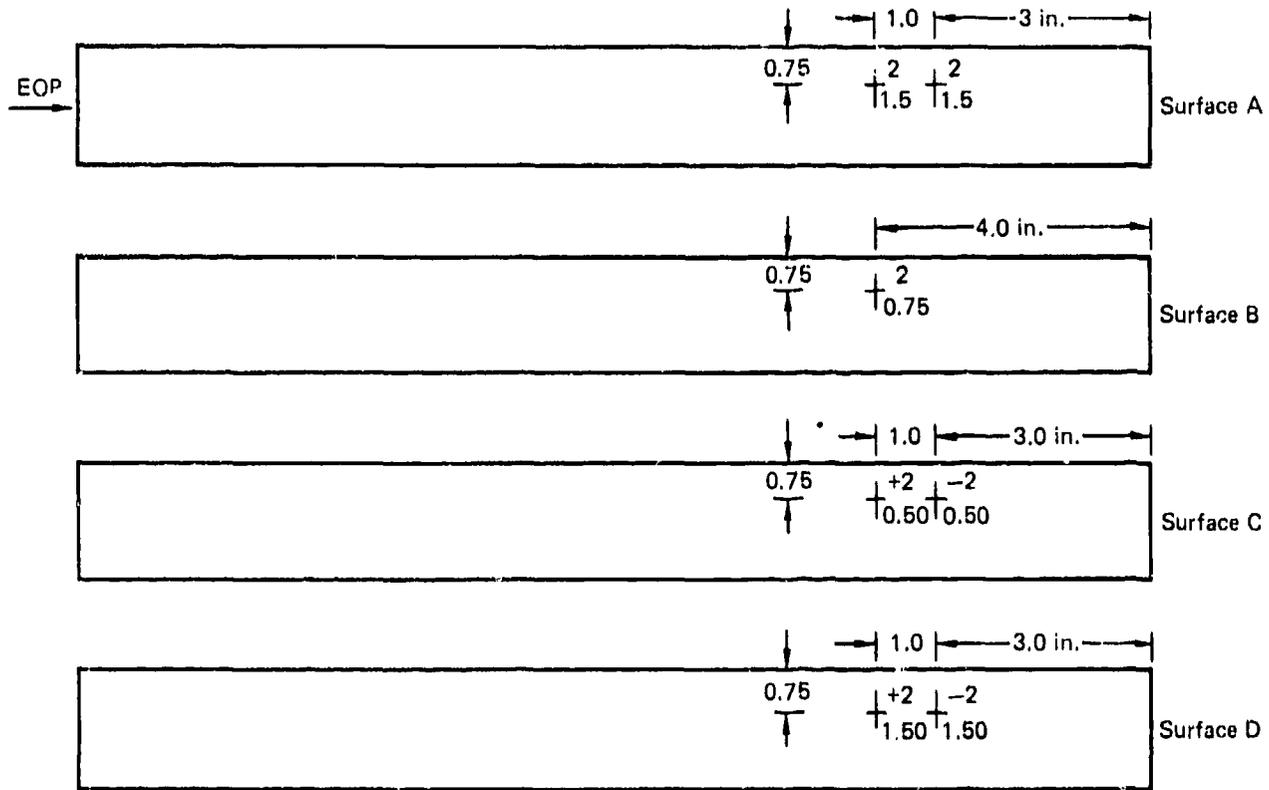
Bar No. 1-2A2B  
 5 MHz  
 Section 1

FIGURE 132 (Continued)  
 LOCATION OF DEFECTS IN BAR

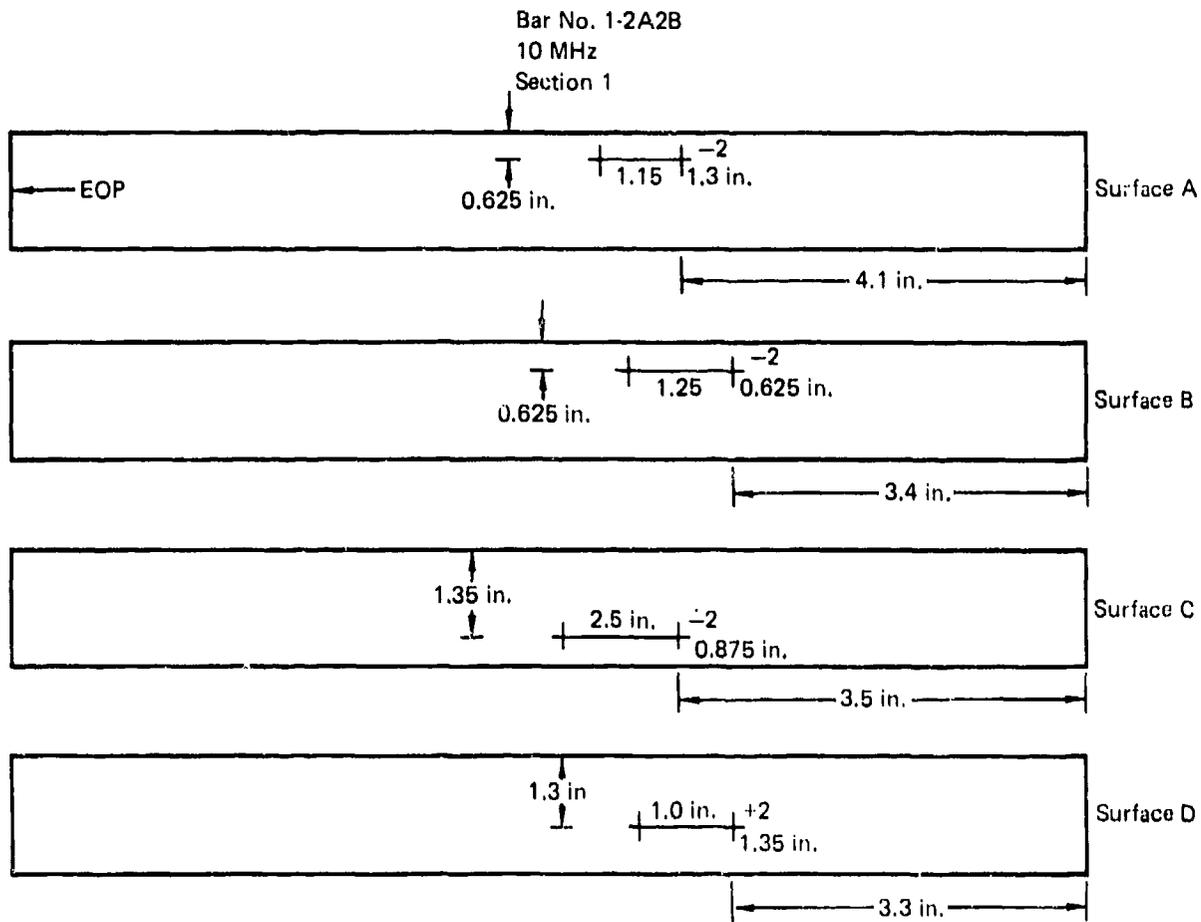
**FIGURE 132 (Continued)**  
**LOCATION OF DEFECTS IN BAR**

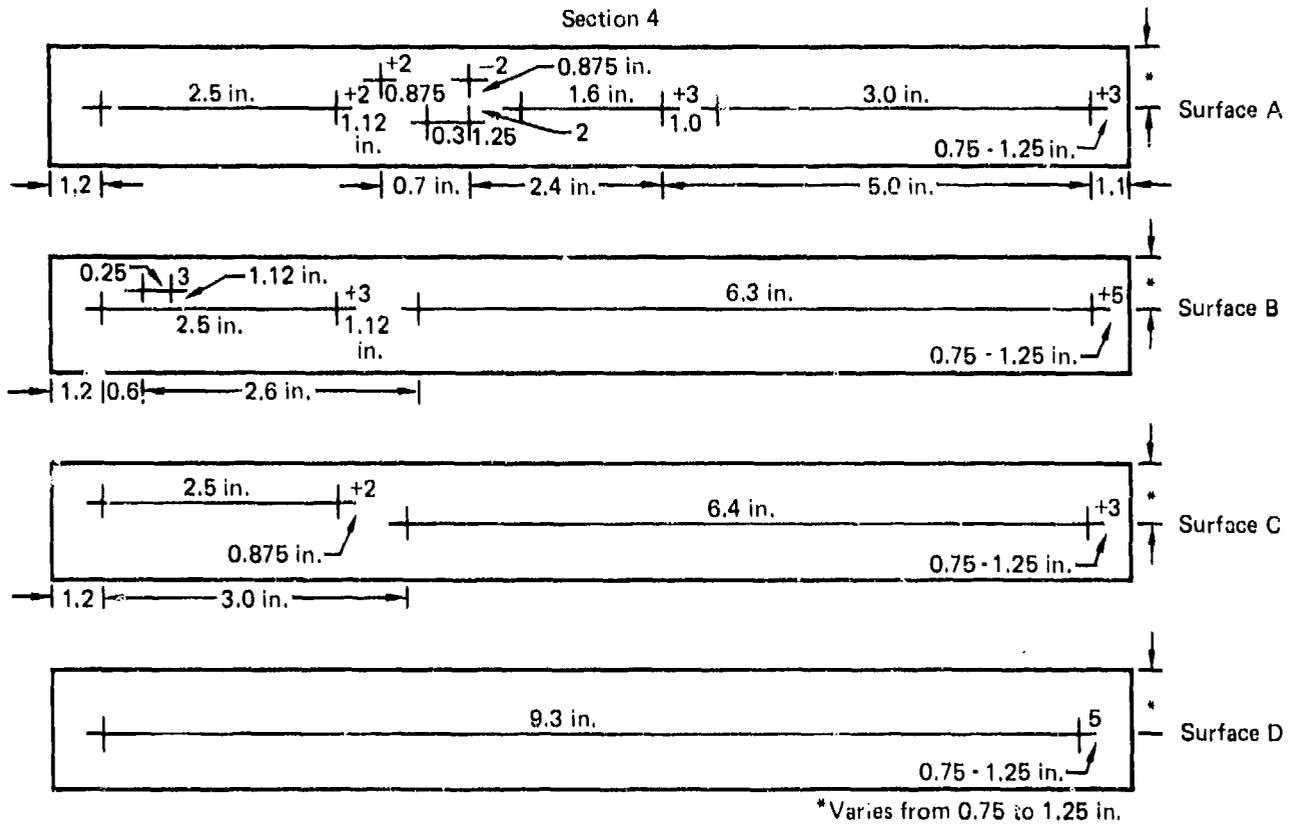
Bar No. 1-2A2E  
 10 MHz  
 Section 4

FIGURE 132 (Continued)  
 LOCATION OF DEFECTS IN BAR
