EVALUATION OF THE RELIABILITY AND SENSITIVITY OF  
NDT METHODS FOR TITANIUM ALLOYS

McDONNELL AIRCRAFT COMPANY

PREPARED FOR  
AIR FORCE MATERIALS LABORATORY

JUNE 1974

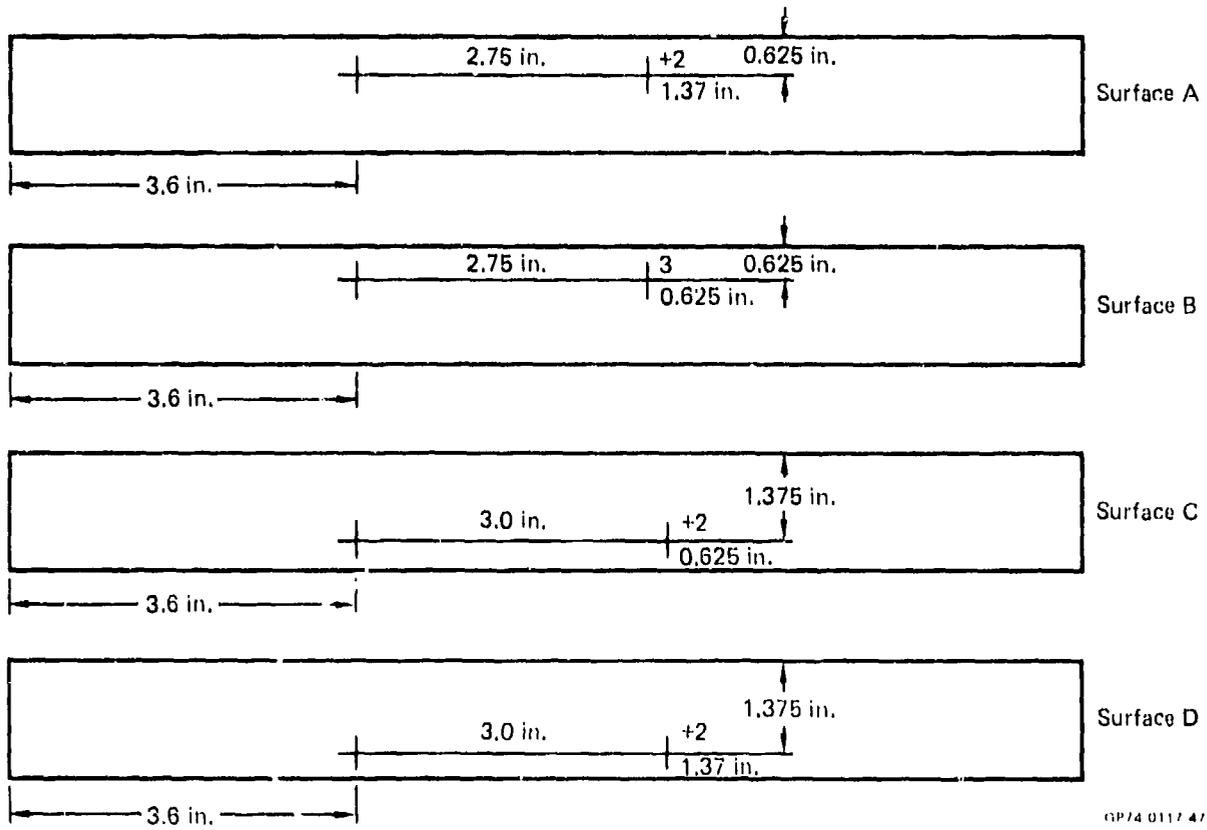
Bar No. 1-2A2E  
10 MHz  
Section 5

FIGURE 132 (Continued)  
LOCATION OF DEFECTS IN BAR

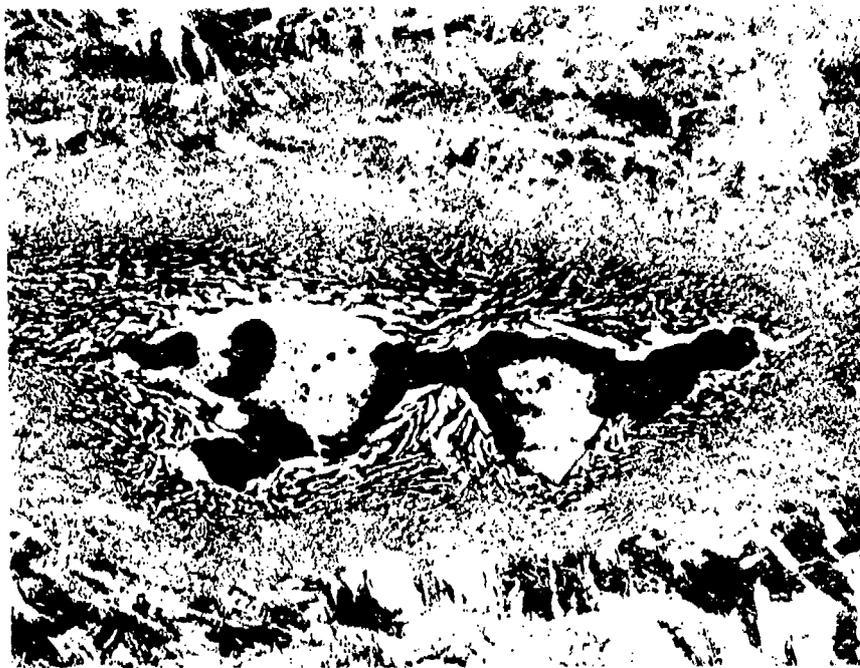
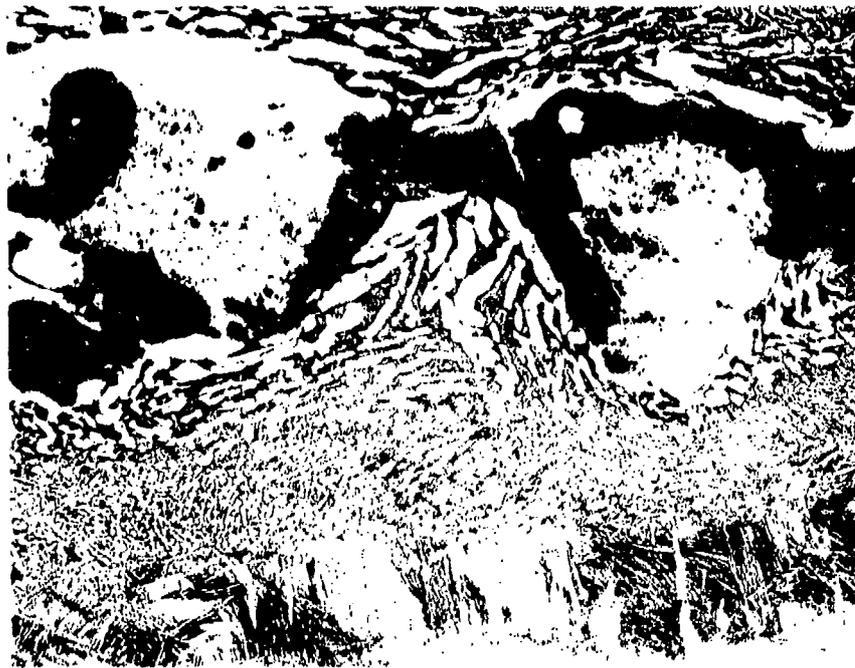
**FIGURE 136 (Continued)**  
**PHOTOMICROGRAPHS OF SEGREGATE IN PLATE A, SECTION 3 (RESPONSE WAS**  
**GREATER THAN NO. 5 FLAT BOTTOM HOLE)**

50X

100X

Photomicrographs of the discontinuities found metallographically in the bar and plate are shown in Figures 136 through 142. A summary of the size of each is documented in Table 97.
