WATER ELECTROLYSIS PROPULSION SYS-
TEM TESTING

John G. Campbell, et al

Marquardt Company

REPORT DOCUMENTATION PAGE		READ INSTRUCTIONS BEFORE COMPLETING FORM
1. REPORT NUMBER AFRPL-TR-74-72	2. GOVT ACCESSION NO.	3. RECIPIENT'S CATALOG NUMBER
4. TITLE (and Subtitle) Water Electrolysis Propulsion System Testing		5. TYPE OF REPORT & PERIOD COVERED Final Report October 72 - July 74

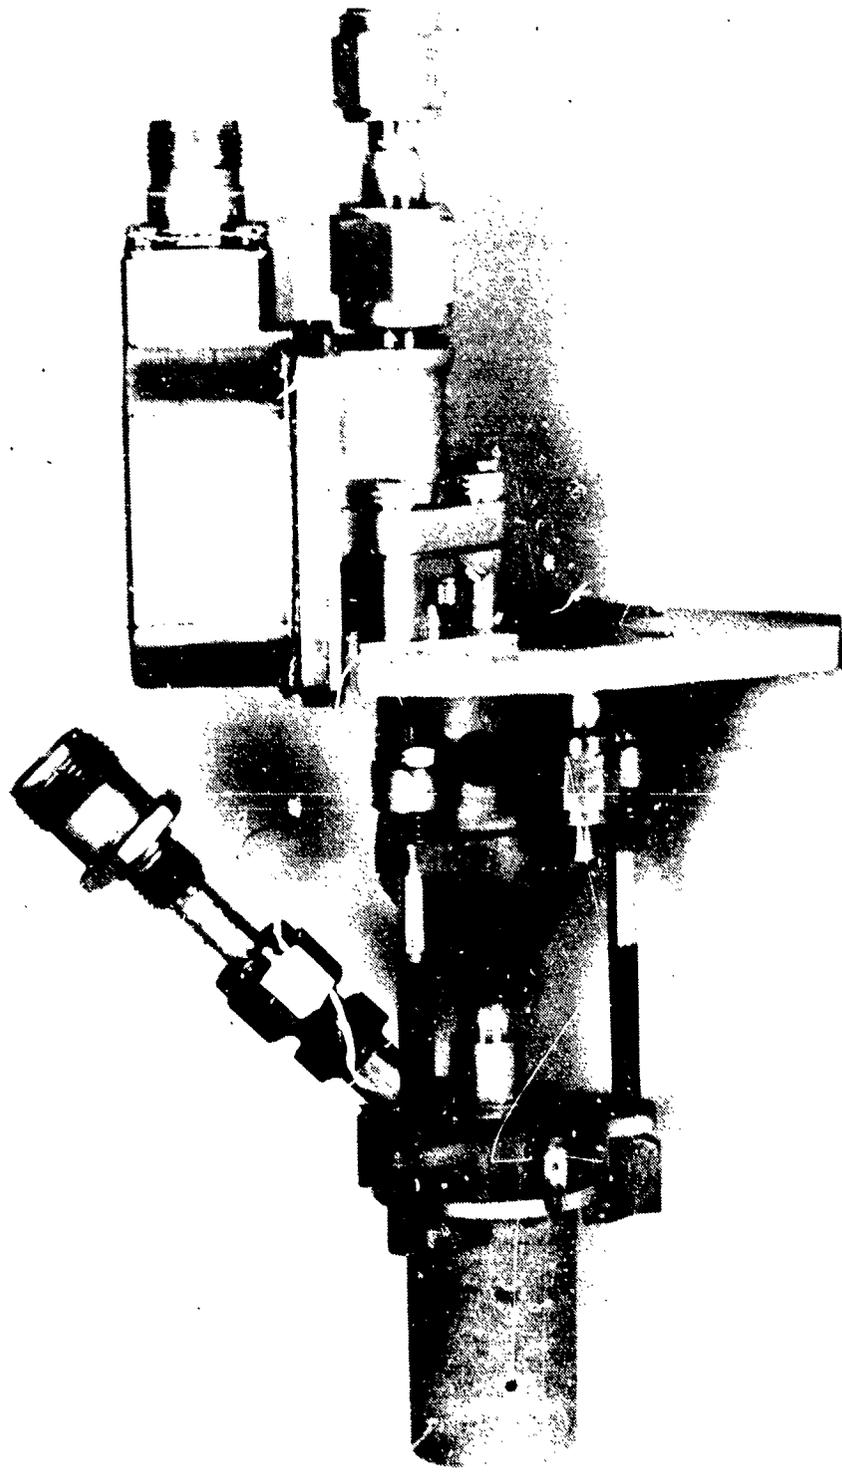
Figure 1. Flightweight 0.1 Lbf. Engine After Test Firings

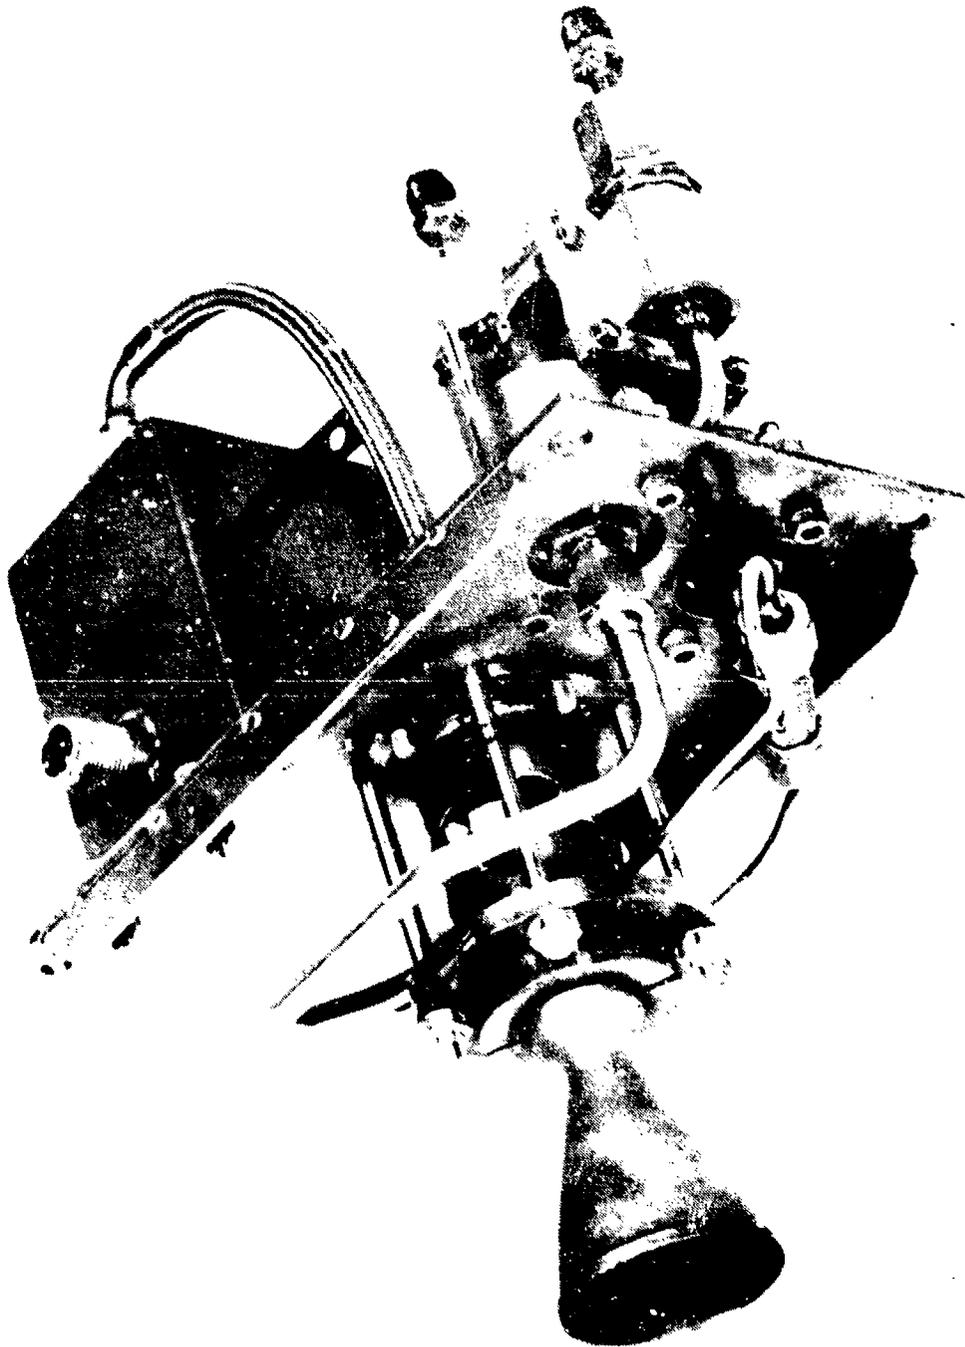
Figure 2. Flightweight 5 Lbf. Engine and Igniter

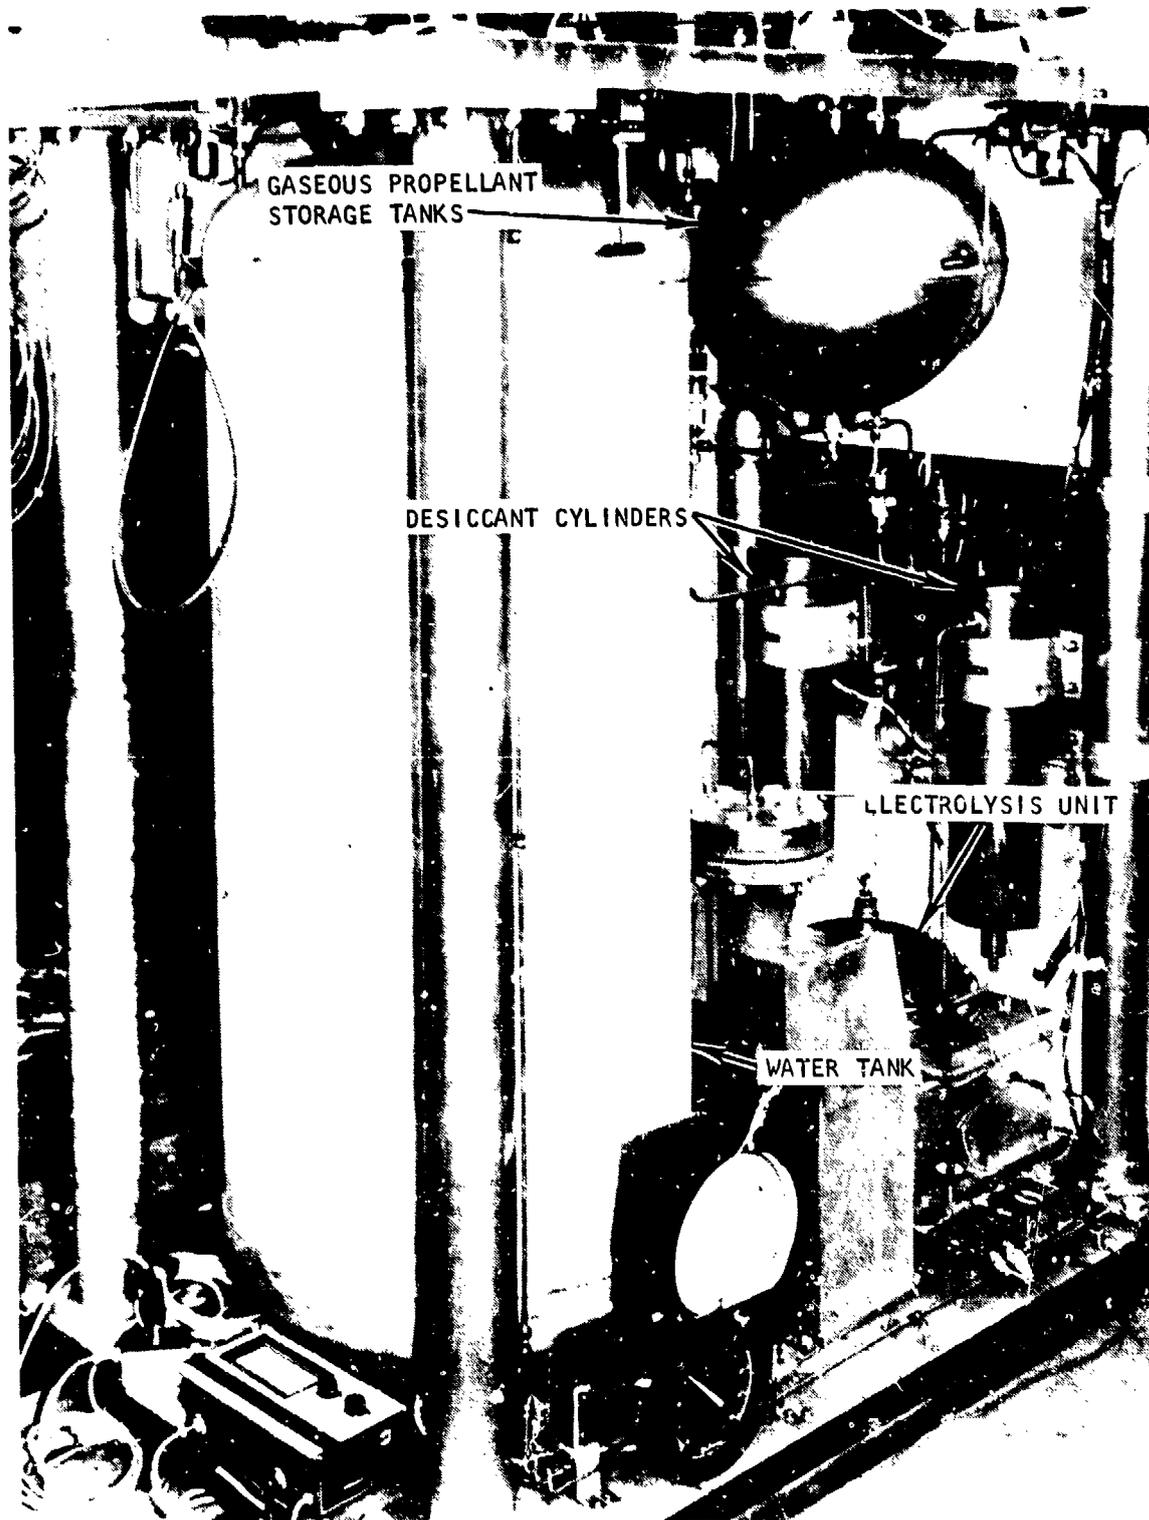
Figure 3. Water Electrolysis Propellant Supply System

The water tank, shown in Figure 13, is made of 321 stainless steel. It has an inside diameter of 24 inches, a height of 65 inches, and a volume of 15 ft³. Ultra pure water supplied by Arrowhead Puritas with a resistance above 10 megohms was loaded into the tank. The ultra pure water is deionized, sterilized by ultraviolet light and filtered through a 0.45 micron filter. The tank and all other parts of the water system were cleaned thoroughly before using. The design goal was to maintain 2 megohm resistance of the water without particulate or ionic contamination.

The electrolysis unit which separates the water into hydrogen and oxygen is shown in Figure 13. The electrolysis unit was made by General Electric Company. A number of design changes (described on page 50), were made by General Electric Company to correct deficiencies in the original design described in Reference 1.

The two hydrogen tanks and one oxygen tank, shown in Figure 13, were spherical and had a volume of 1 ft³. The tanks were made of 321 stainless steel.

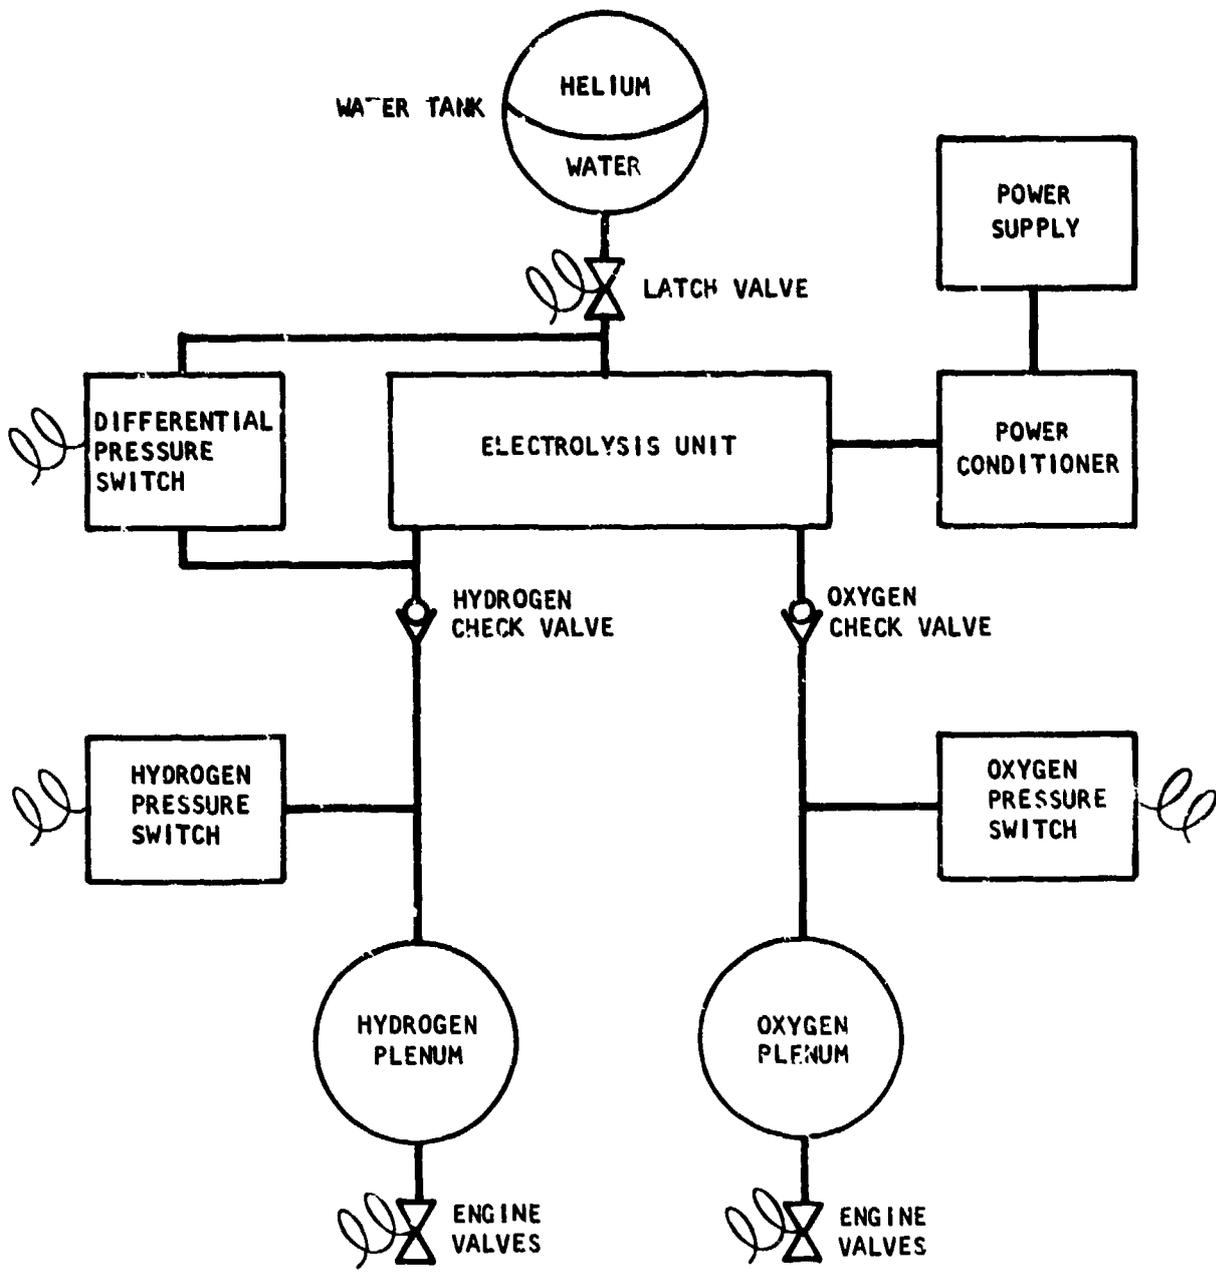
Figure 11. Simple Blowdown System

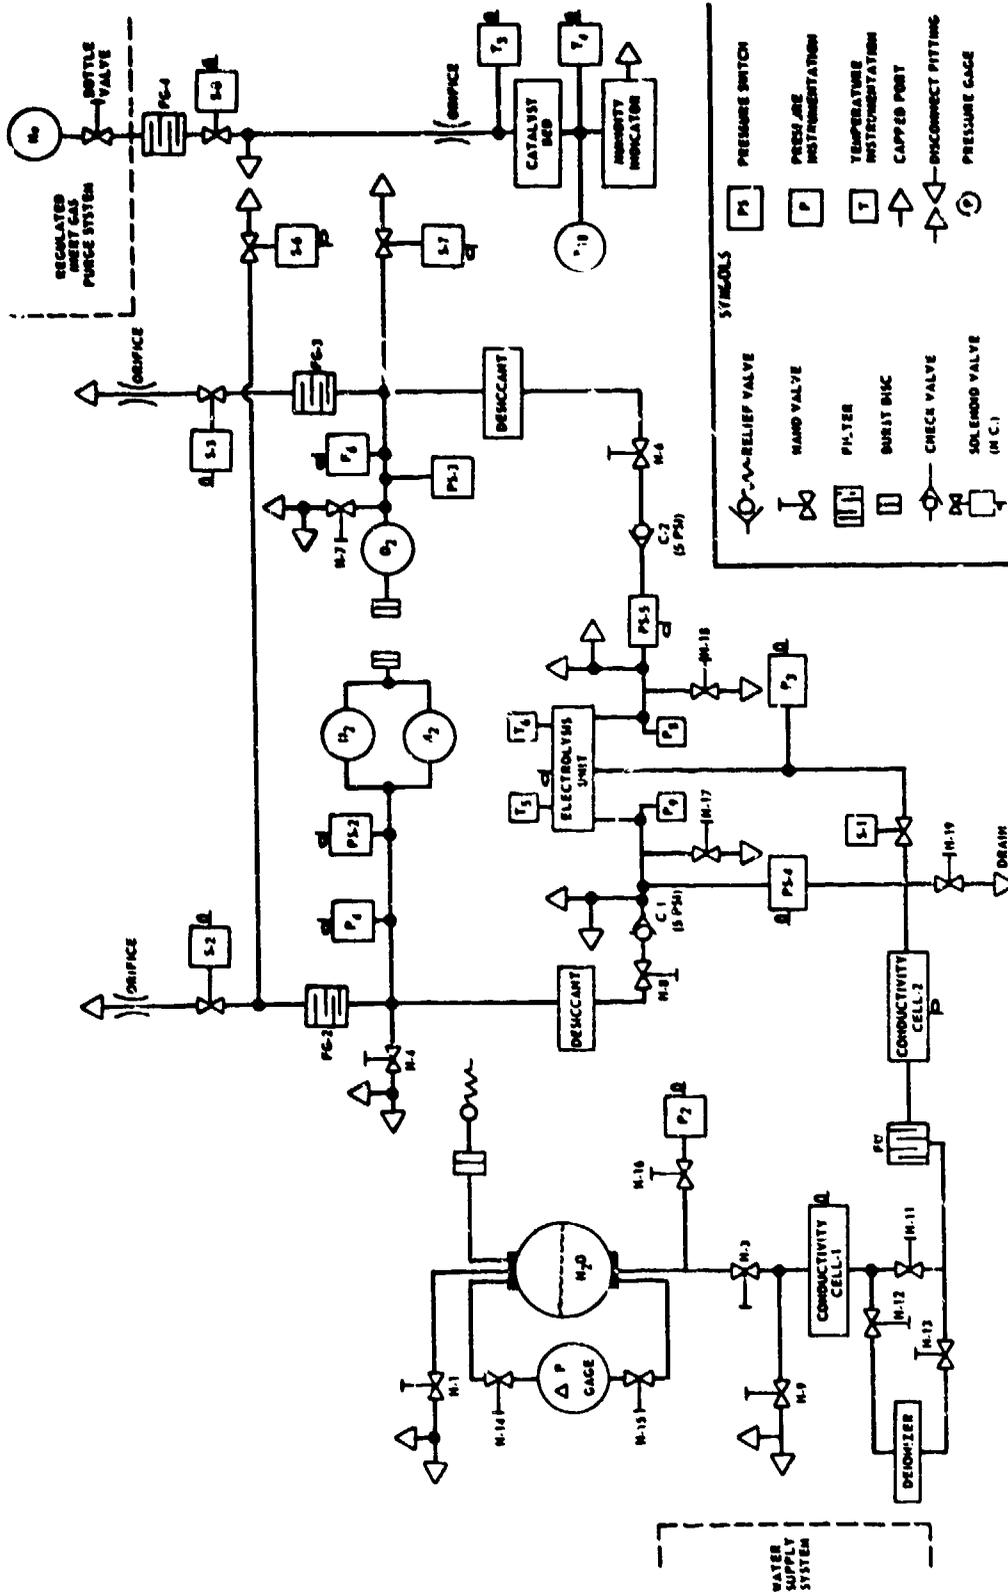
Figure 12. Water Electrolysis Ground Test System Schematic

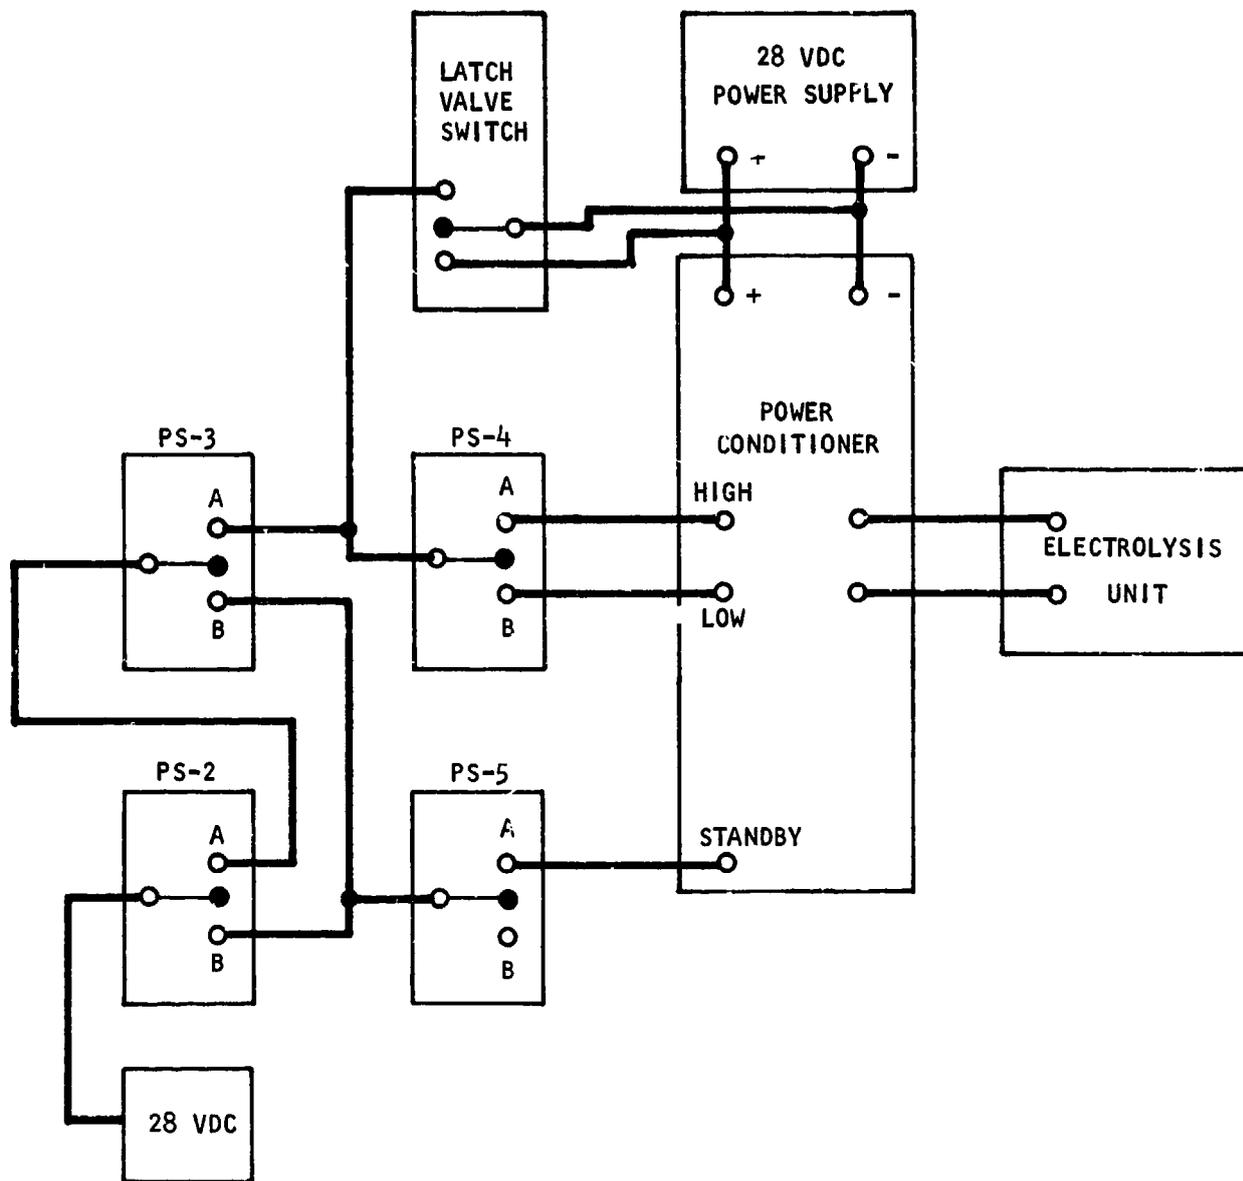
COMPONENT	SENSES	CONTINUITY WHEN	
		(A)	(B)
PS - 2	H ₂ TANK PRESSURE	$P_{H_2} \leq 180 \text{ PSIA}$	$P_{H_2} \geq 200 \text{ PSIA}$
PS - 3	O ₂ TANK PRESSURE	$P_{O_2} \leq 180 \text{ PSIA}$	$P_{O_2} \geq 200 \text{ PSIA}$
PS - 4	$P_{H_2O} - P_{H_2}$	$P_{H_2O} - P_{H_2} \geq 70 \text{ PSIA}$	$P_{H_2O} - P_{H_2} \leq 70 \text{ PSIA}$
PS - 5	O ₂ CELL PRESSURE	$P_{O_2} \leq 145 \text{ PSIA}$	$P_{O_2} \geq 180 \text{ PSIA}$

If either the hydrogen or oxygen tank pressure exceeds 200 psia, PS-5, a pressure switch on the oxygen cell (outlet) pressure, is activated. If the oxygen cell pressure drops below 145 psia, PS-5 is in position "A" and transmits a signal to the standby terminal of the power conditioner. In this case, a current of one amp will be transmitted to the electrolysis unit. If the oxygen cell pressure is above 180 psia, PS-5 is in position "B", and current to the electrolysis unit is turned off.

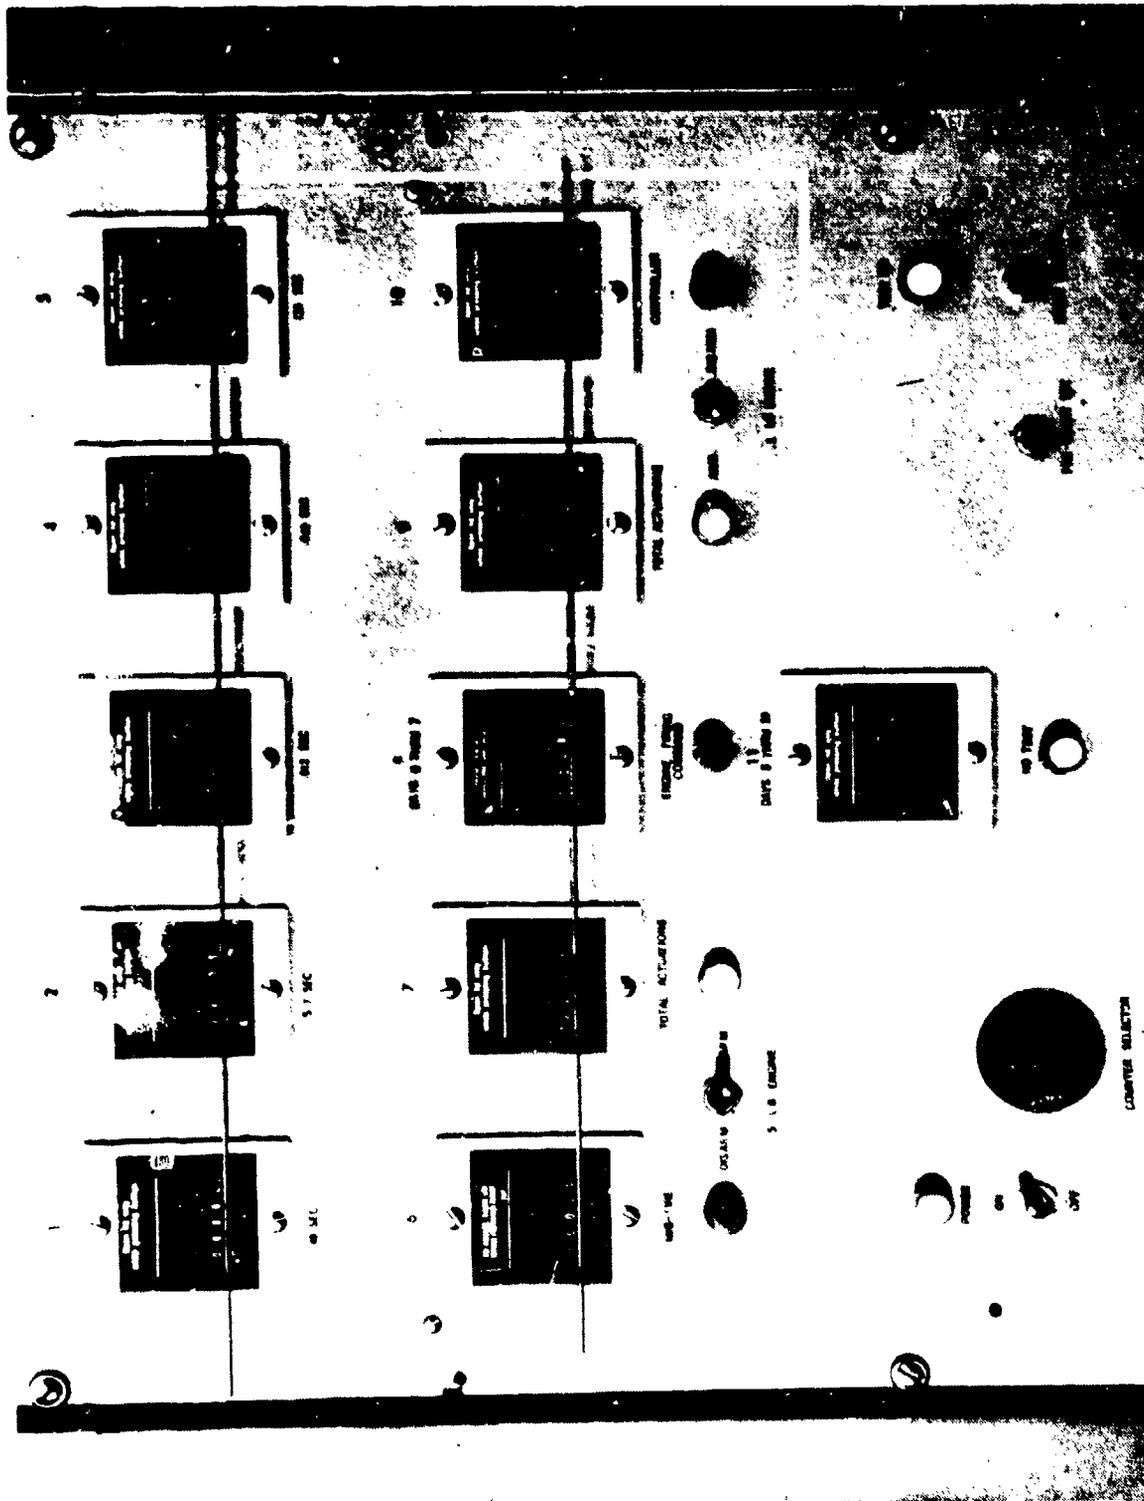
Figure 18. Engine Firing Timer

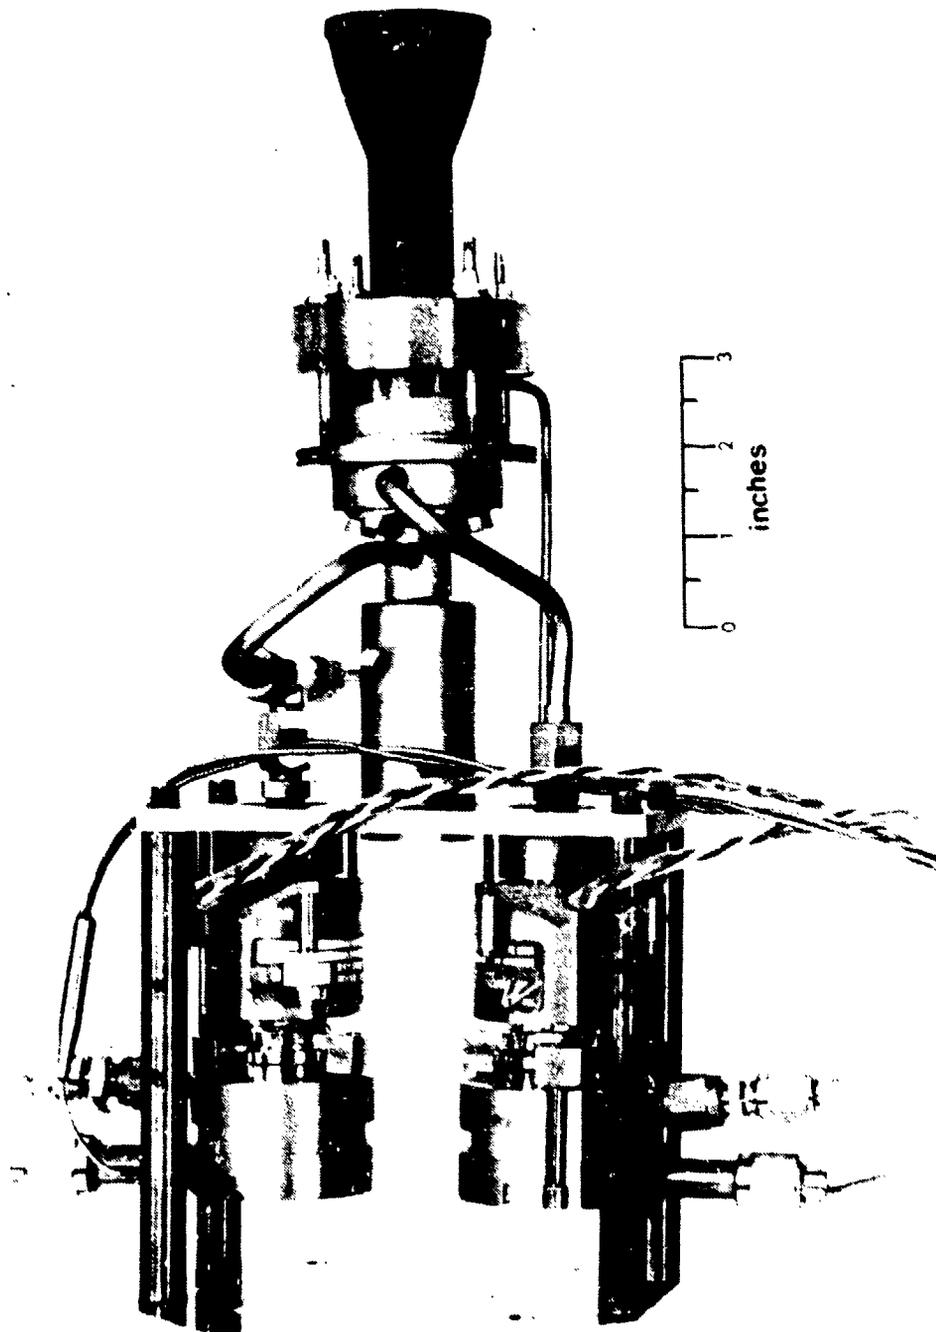
Figure 19. 5 Lbf. Workhorse Engine

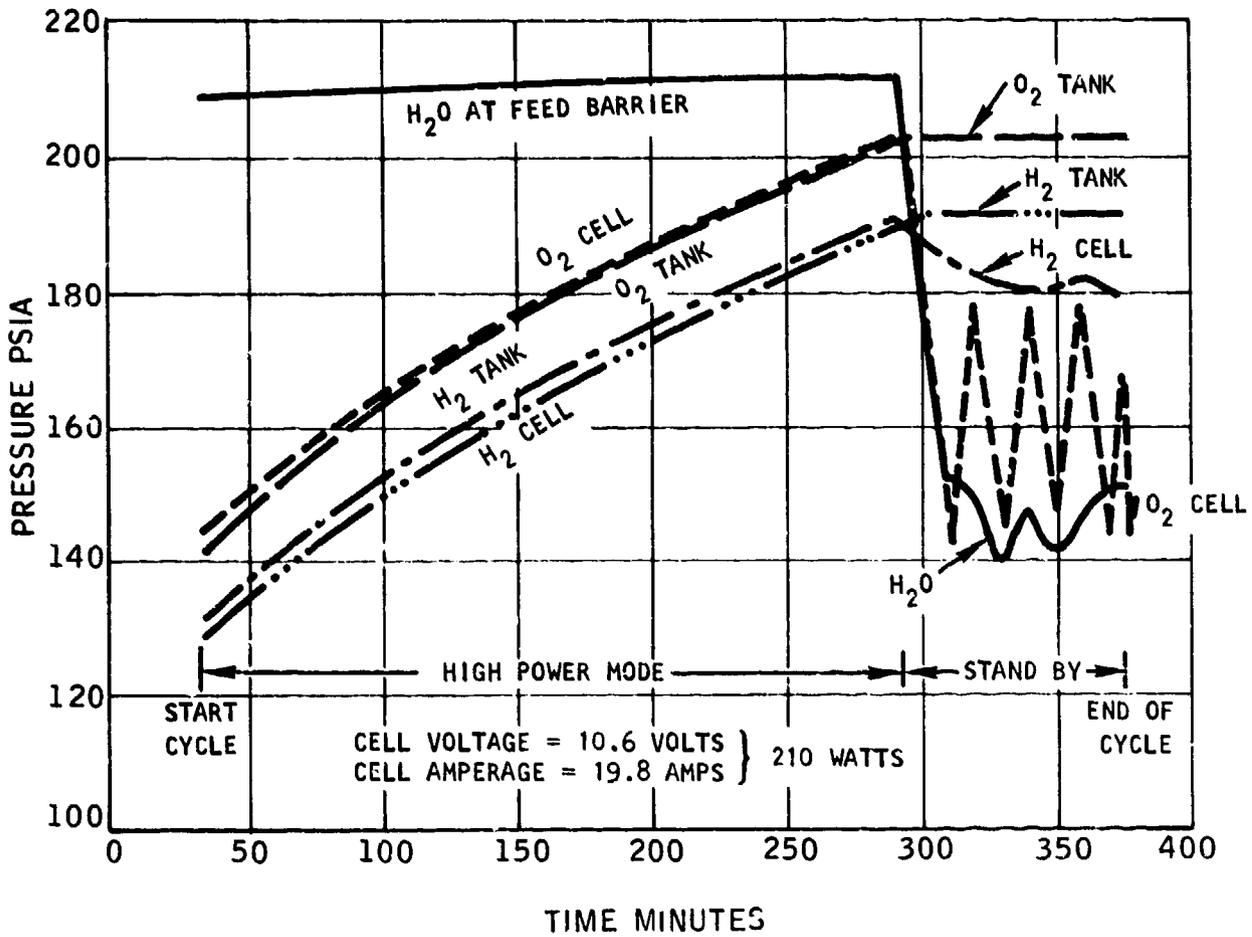
Figure 21. Typical Pressure Cycle

A typical history of electrolysis system pressures is shown in Figure 21. This data, taken July 11, 1973, shows buildup of pressures due to operation of the electrolysis unit in the high power mode. After 290 minutes, the oxygen tank reaches the maximum pressure and the electrolysis unit is shut off by the pressure switch PS-3. The electrolysis unit operates in the standby

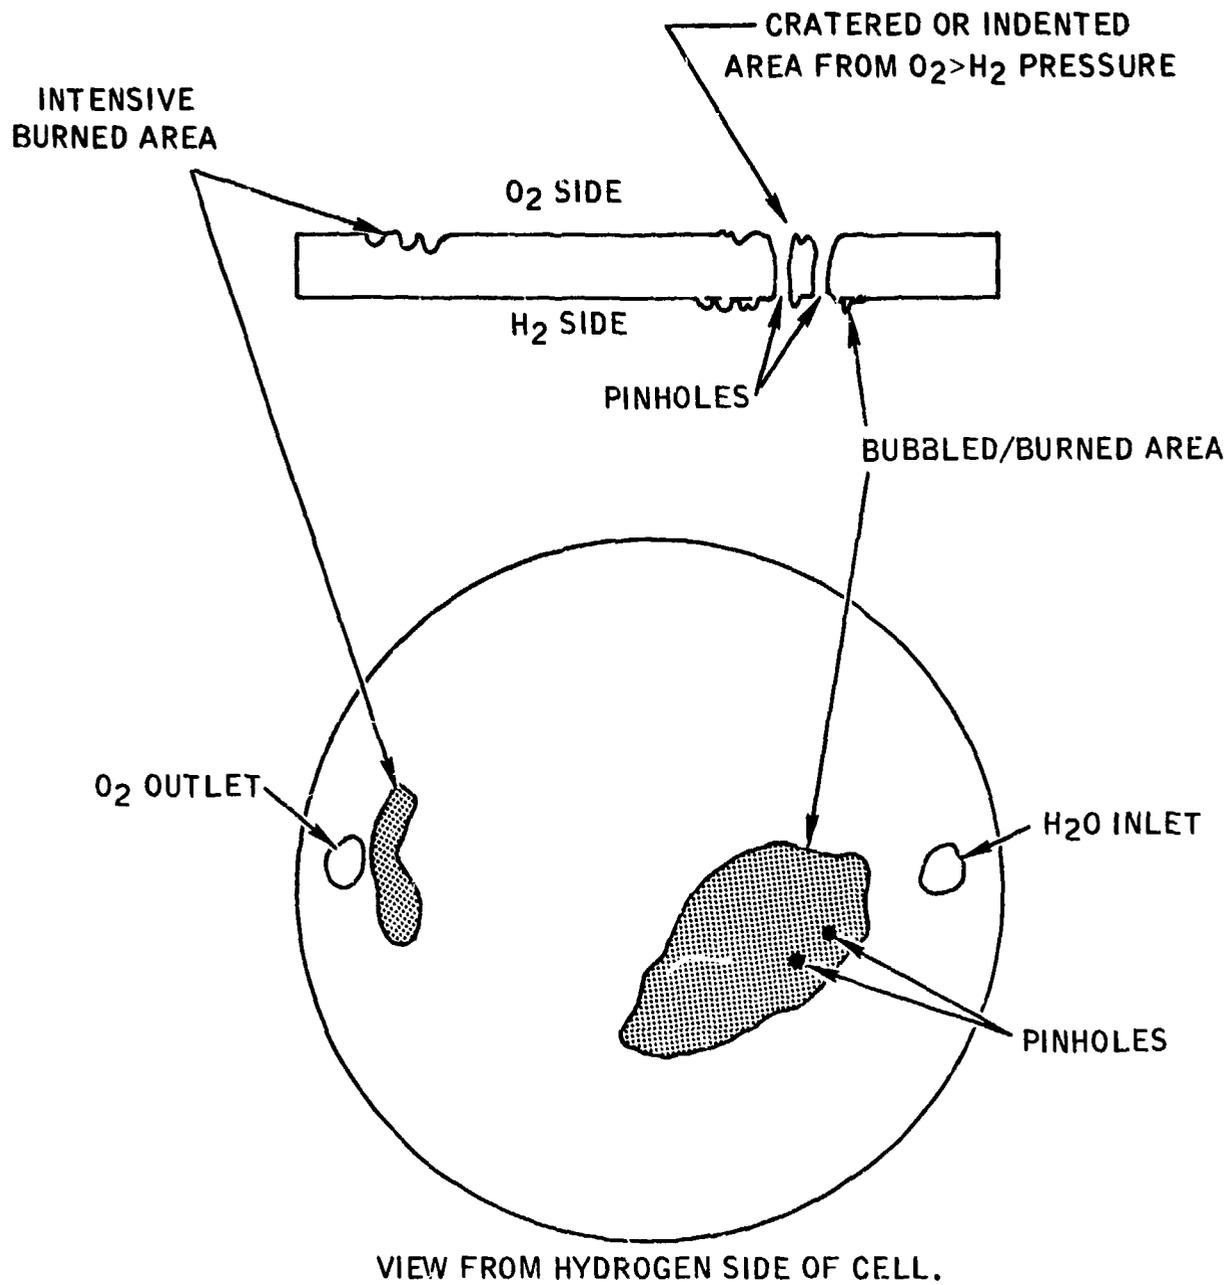
Figure 26. Failure Pattern on Cell No. 4

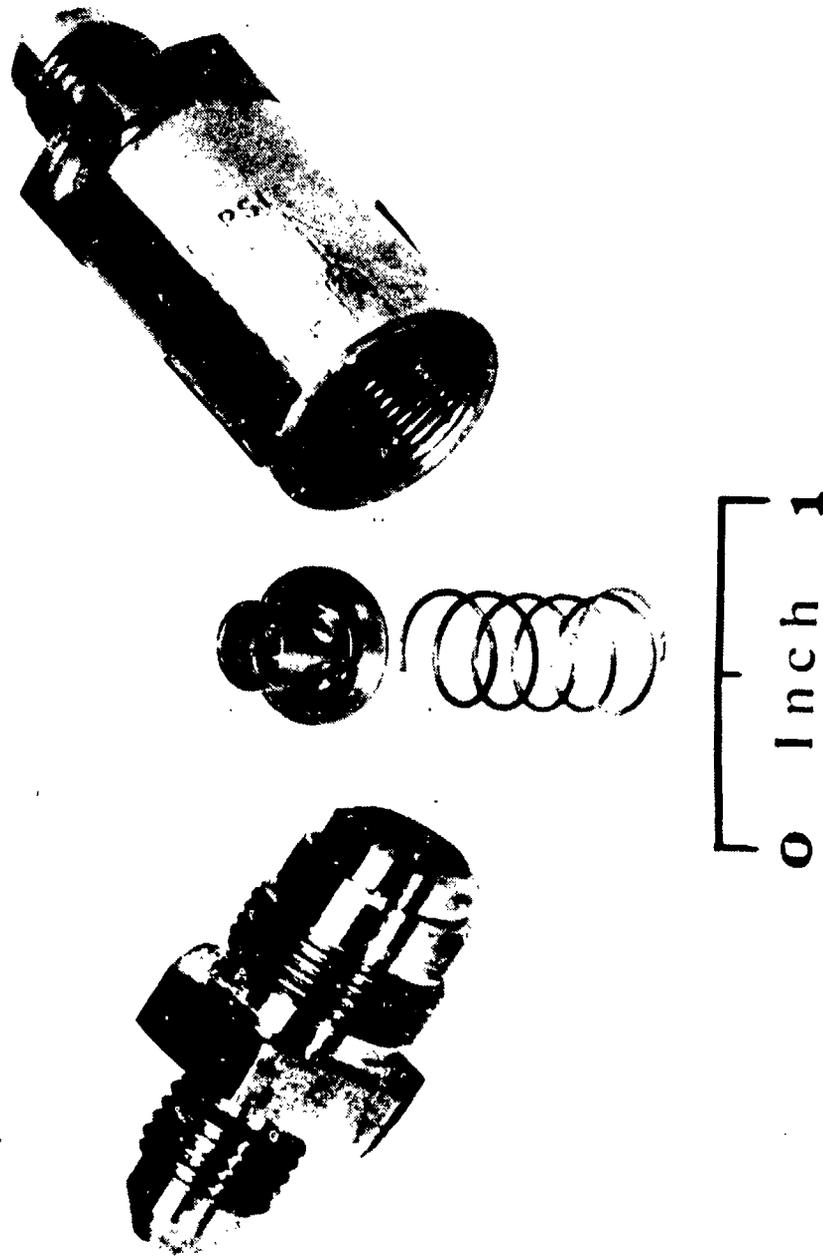
Figure 27. Disassembled Carpenter 20 Check Valve After 14 Week Life Test

The check valve on the oxygen cell outlet was found to be stuck open on July 18. The 316 stainless steel check valve was removed from the system and found to be badly rusted. It was replaced by a clean valve.

The oxygen outlet check valve was again found to be rusty at this time and was replaced.

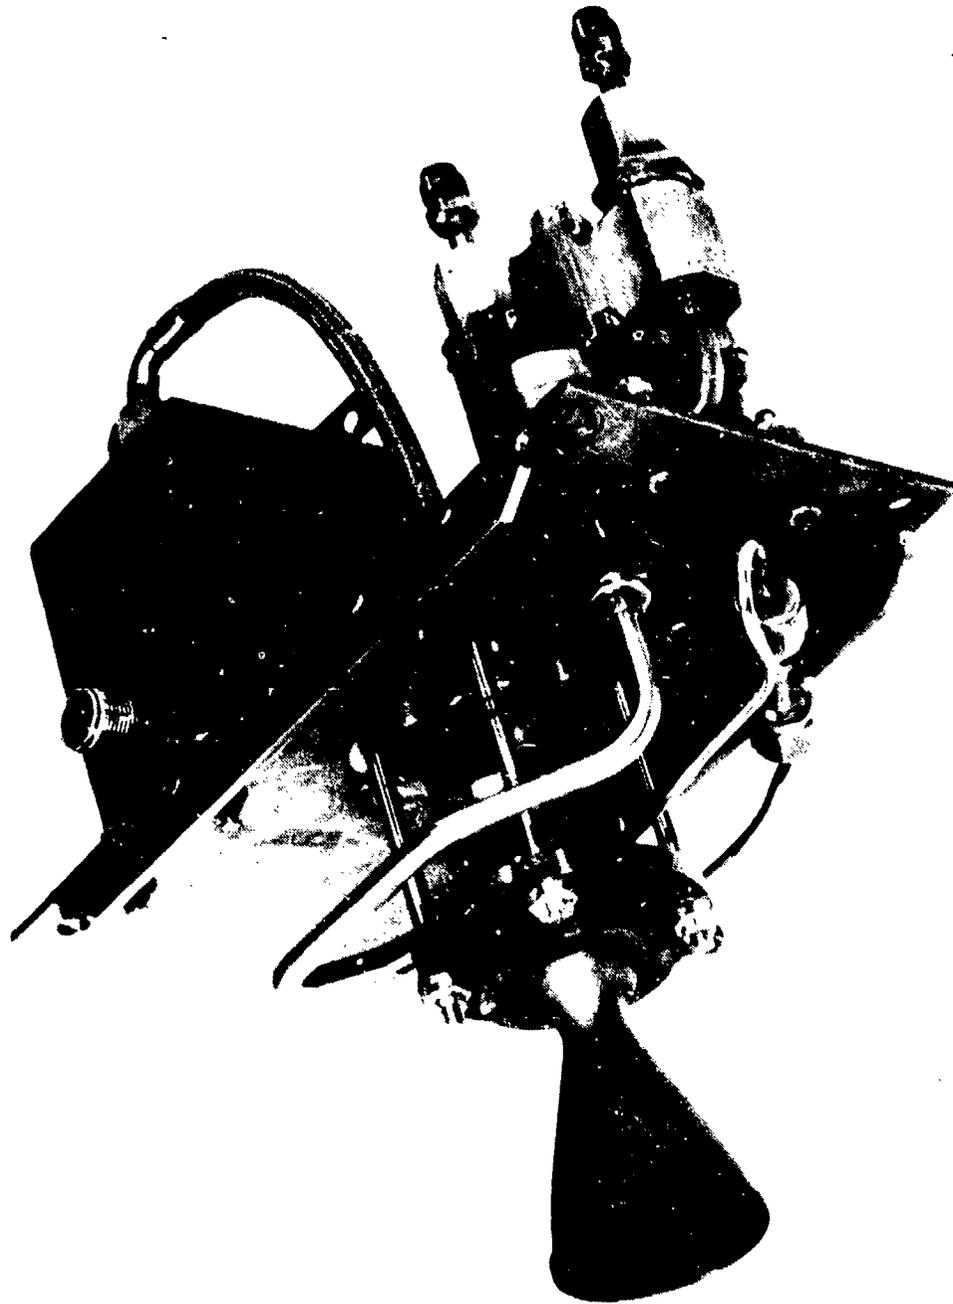
Figure 30. 5 Lbf. Thruster No. 3 After Test Program

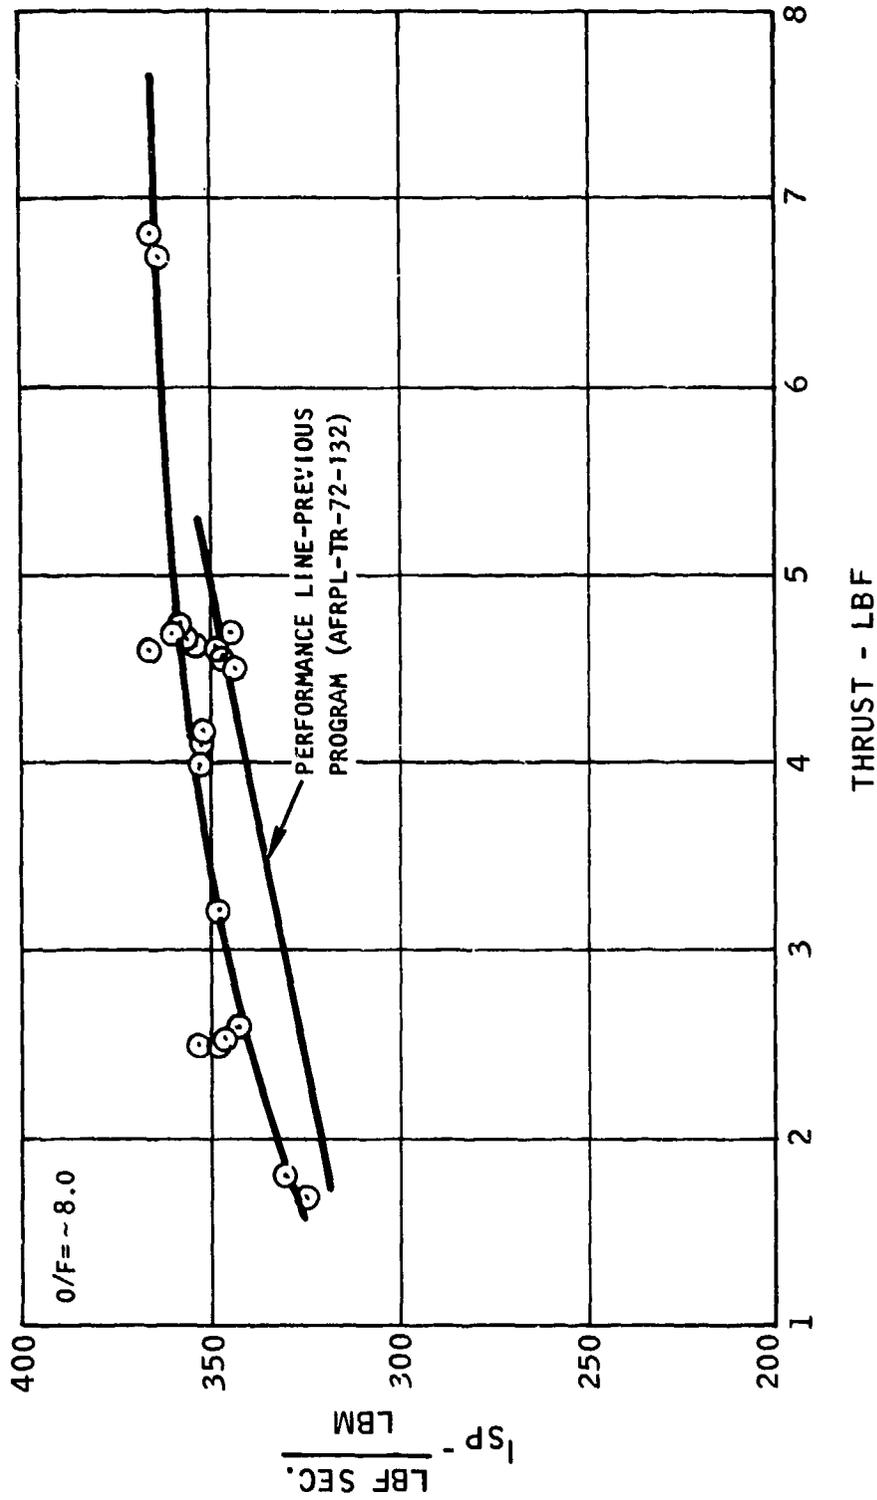
Figure 31. Performance of 5 Lbf. Engine

A lightweight five-pound thrust engine was developed and life tested for 152,015 pulses and a total firing time of 4.16 hours. A test summary is given in Table 2. The engine was in excellent condition after completion of the life test program. Design changes made in the heavyweight five-pound engine developed on the previous contract resulted in an improvement of specific impulse from 345 seconds to 355 seconds. The engine performance is shown in Figure 4.

Figure 53, specific impulse versus mixture ratio, indicates a specific impulse of 355 seconds at the stoichiometric mixture ratio of 7.934. Performance increases as thrust is increased and mixture ratio is decreased due to the change in reaction kinetics (as it affects thrust) and a change in theoretical performance. The maximum heat release increases as the mixture ratio decreases. The performance of the thruster as a function of thrust is shown on Figure 31. Performance

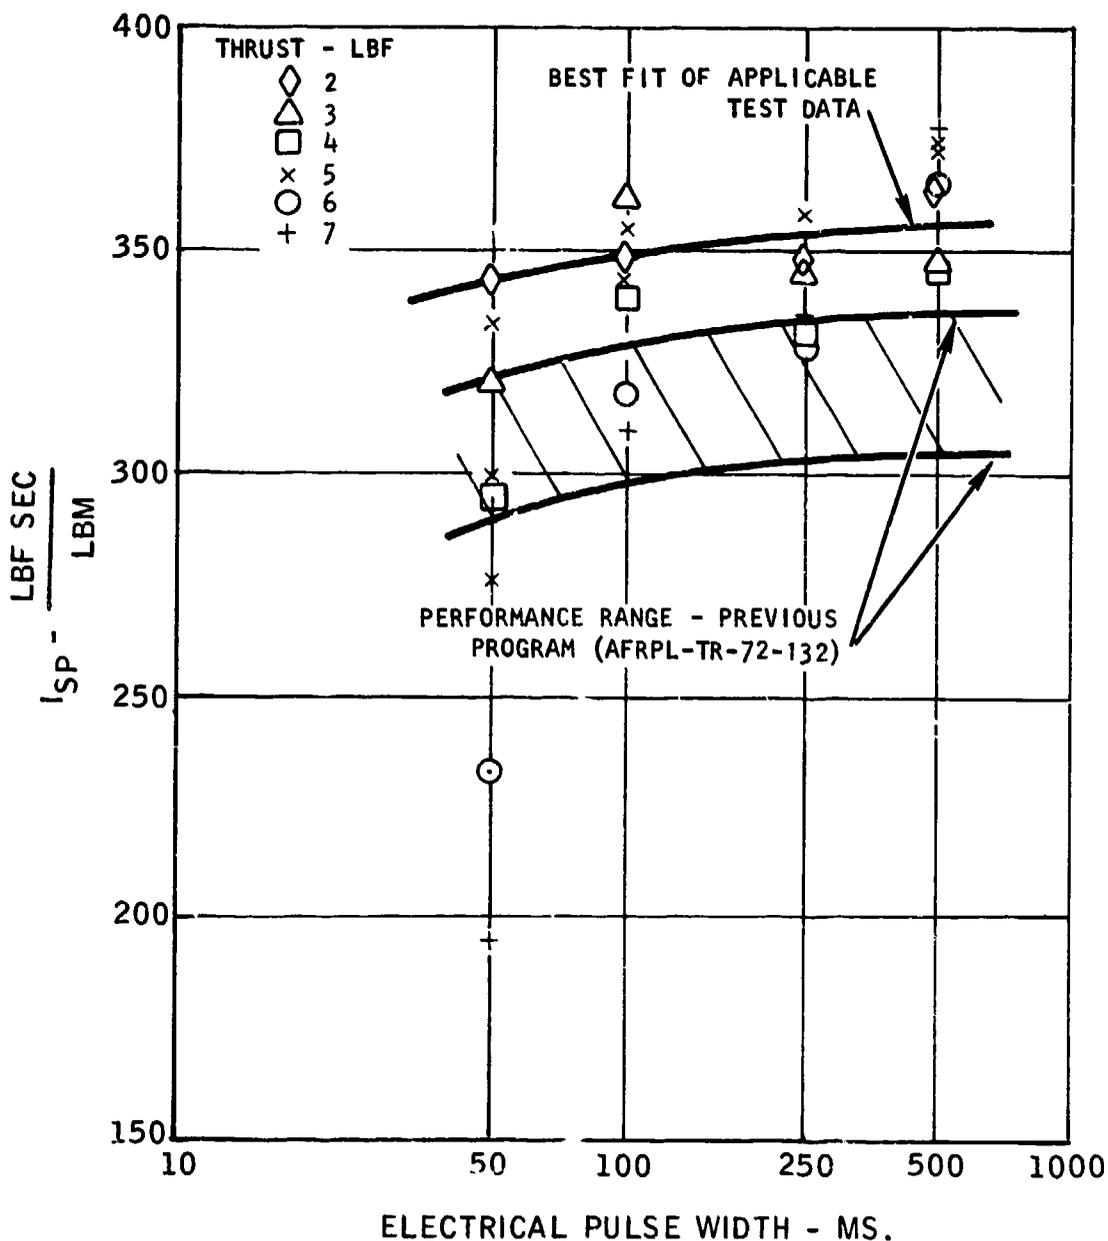
Figure 32. 5 Lbf. Engine ISP Vs. Electrical Pulse Width

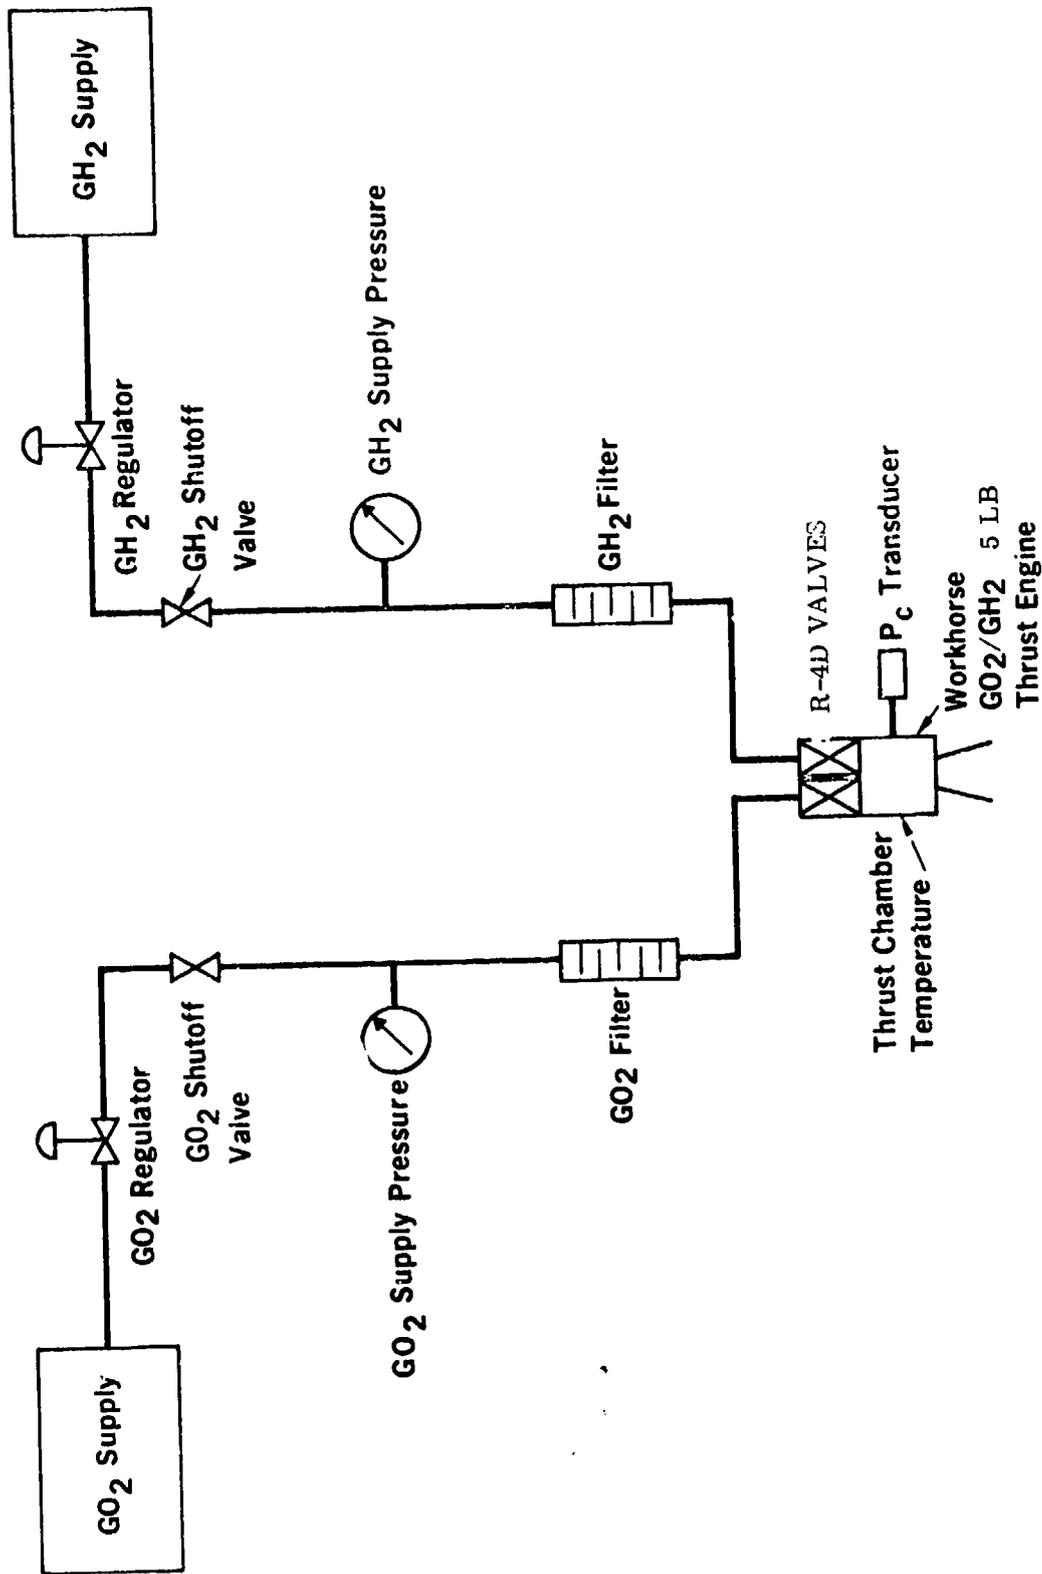
Figure 34. Cell 9 Schematic

Marquardt's Test Cell 9 was used for all hot firing tests conducted on the three thrusters. The test cell is a 4,000 cubic foot steel sphere, 20 feet in diameter, rated for pressures from 0.0009 to 160 psia. Vacuum capability is provided by a 5-stage steam ejector system. The feed system and engine flow schematic for the thruster is shown on Figure 34.
