WATER ELECTROLYSIS PROPULSION SYS-
TEM TESTING

John G. Campbell, et al

Marquardt Company

REPORT DOCUMENTATION PAGE		READ INSTRUCTIONS BEFORE COMPLETING FORM
1. REPORT NUMBER AFRPL-TR-74-72	2. GOVT ACCESSION NO.	3. RECIPIENT'S CATALOG NUMBER
4. TITLE (and Subtitle) Water Electrolysis Propulsion System Testing		5. TYPE OF REPORT & PERIOD COVERED Final Report October 72 - July 74

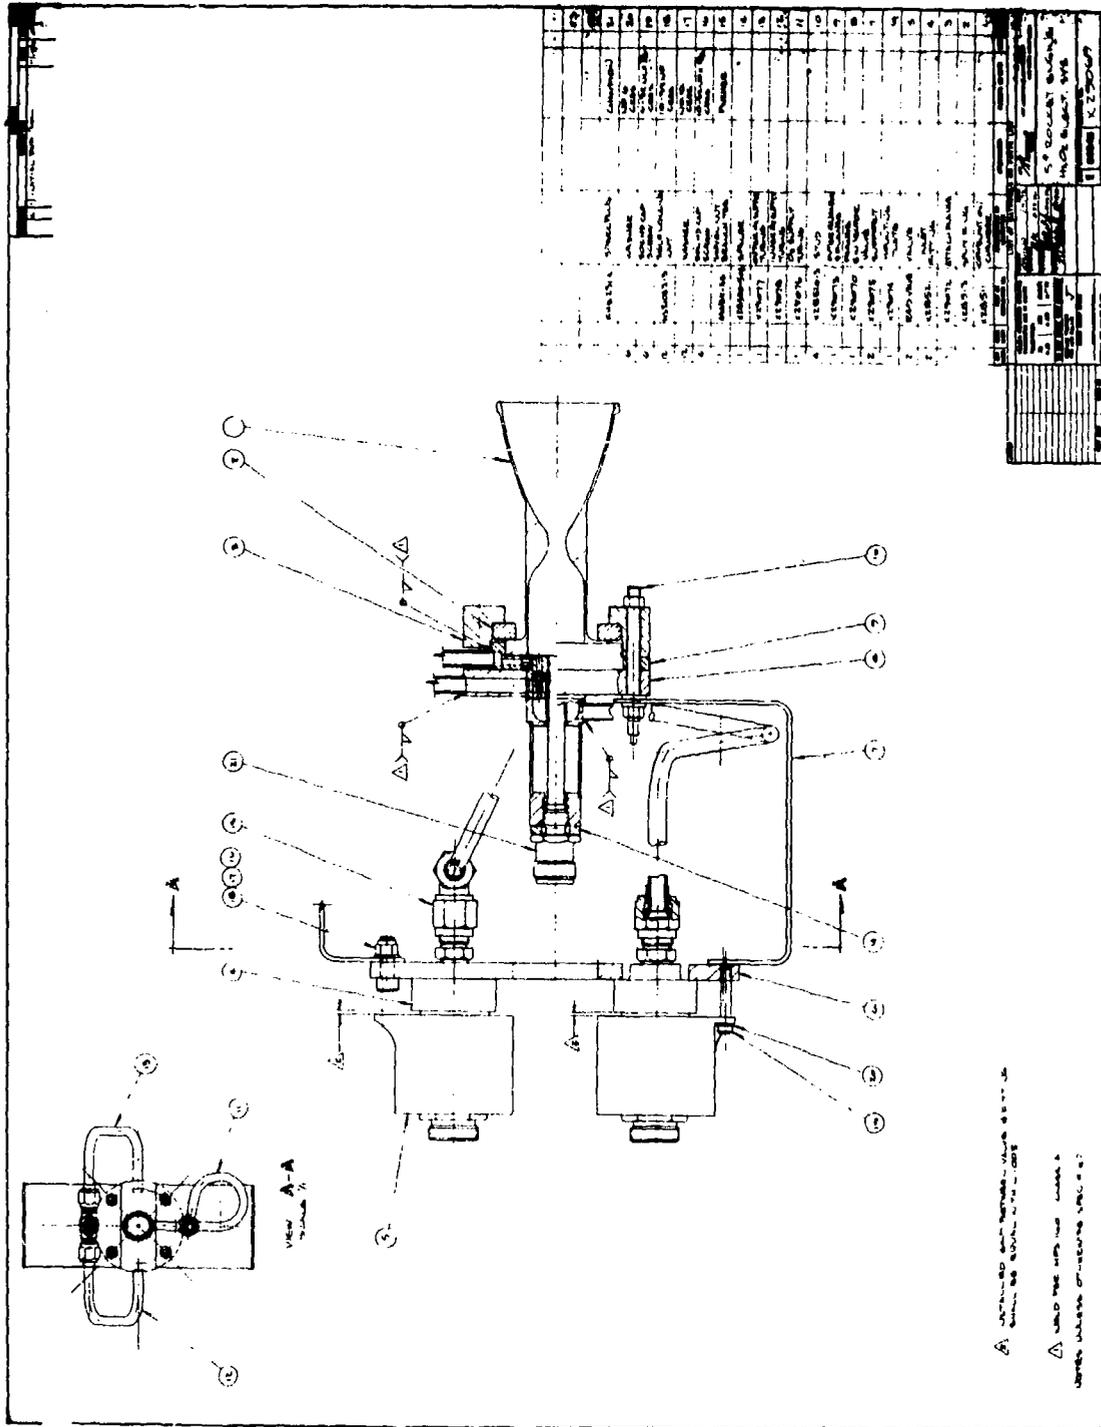
Figure 35. 5 Lbf. Thruster, Configuration No. 1 (X29069).

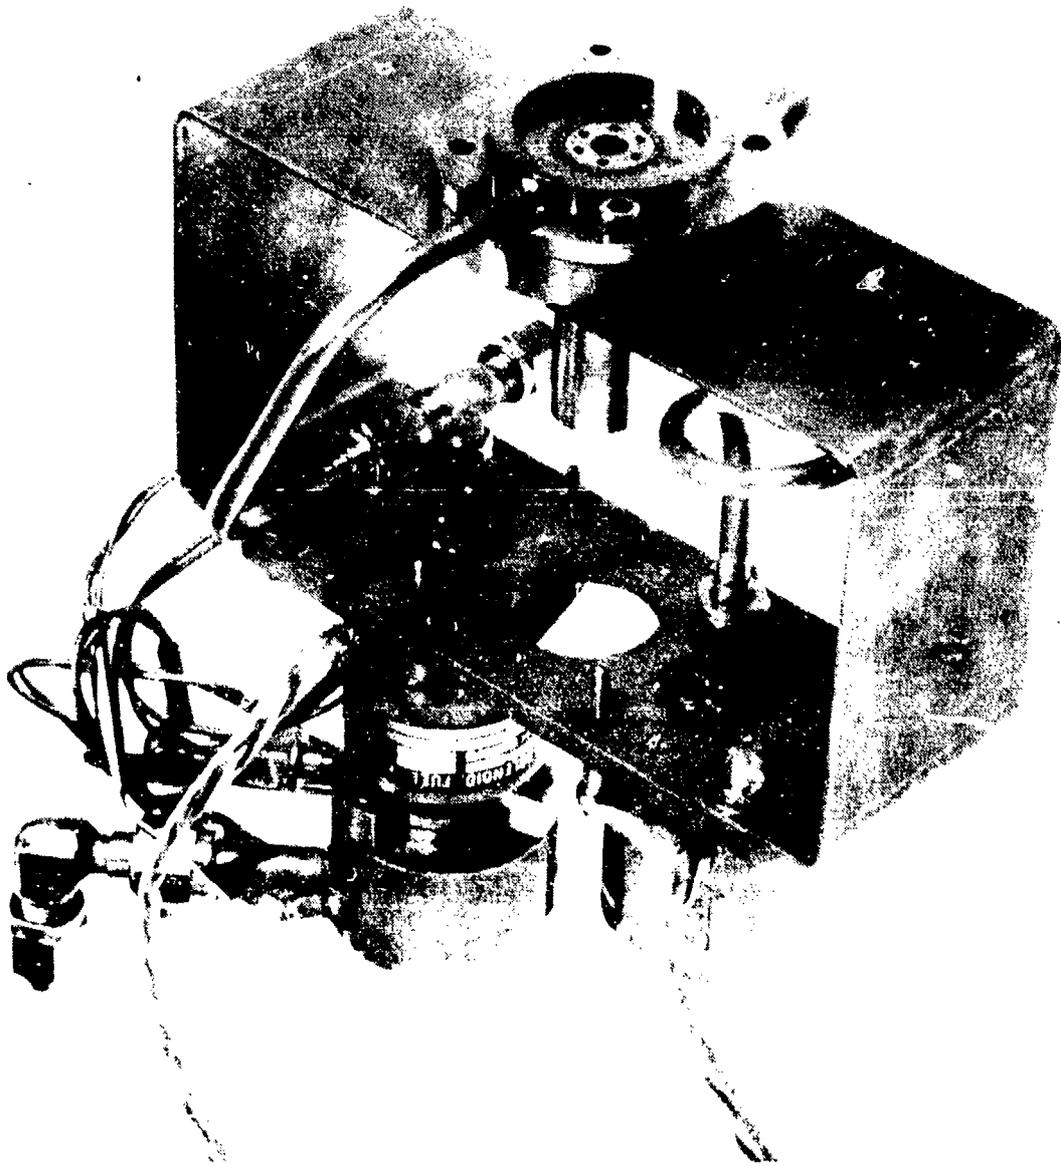
Figure 38. 5 lbf. Thruster Injector, Configuration No. 1

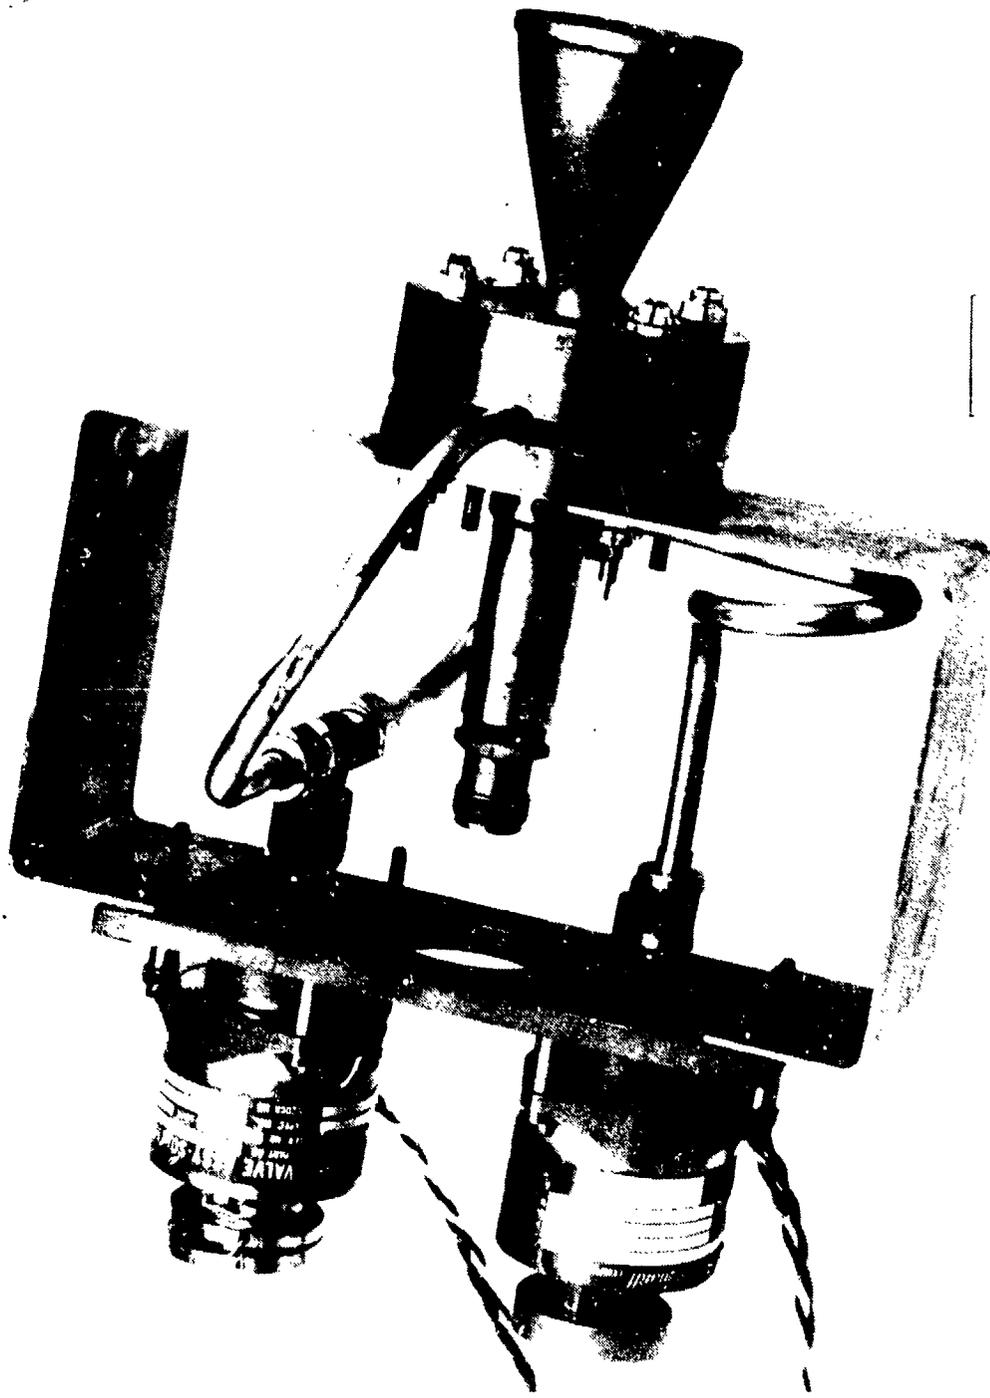
Figure 39. 5 Lbf. Thruster Assembly, Configuration No. 1

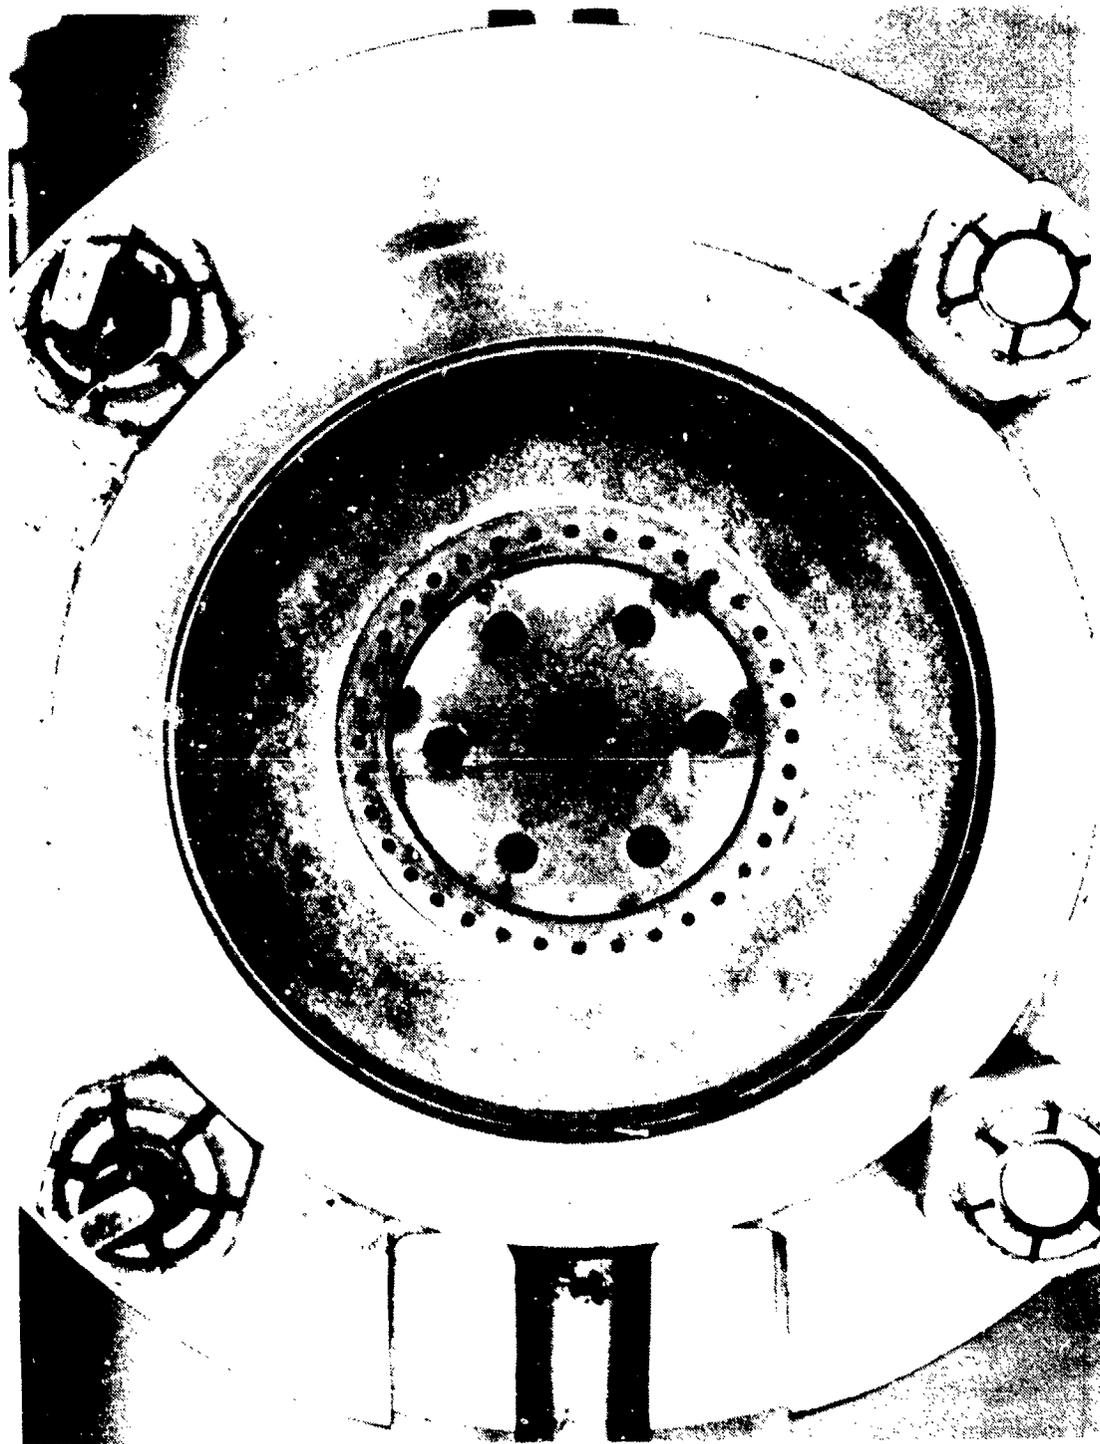
Figure 40. 5 Lbf. Injector, Configuration No. 1, After Test

At the completion of the test program, the engine was removed from the system and examined. Figures 40, 41, and 42 show the injector and combustor. The nickel injector shows a slight erosion around the spark plug hole and one crack is evident on a premix orifice at the 9 o'clock position. The spark plug tip was apparently corroded or galled within the injector and could not be removed. This was probably caused by the small clearance. The clearance was increased on the final design and the spark plug did not stick in the injector. The throat section of the combustor was not eroded, but as shown in Figure 42, a significant amount of "pockmarks" are evident on the outside and some were also on the inside. Although a significant amount of testing was accomplished at sea level,

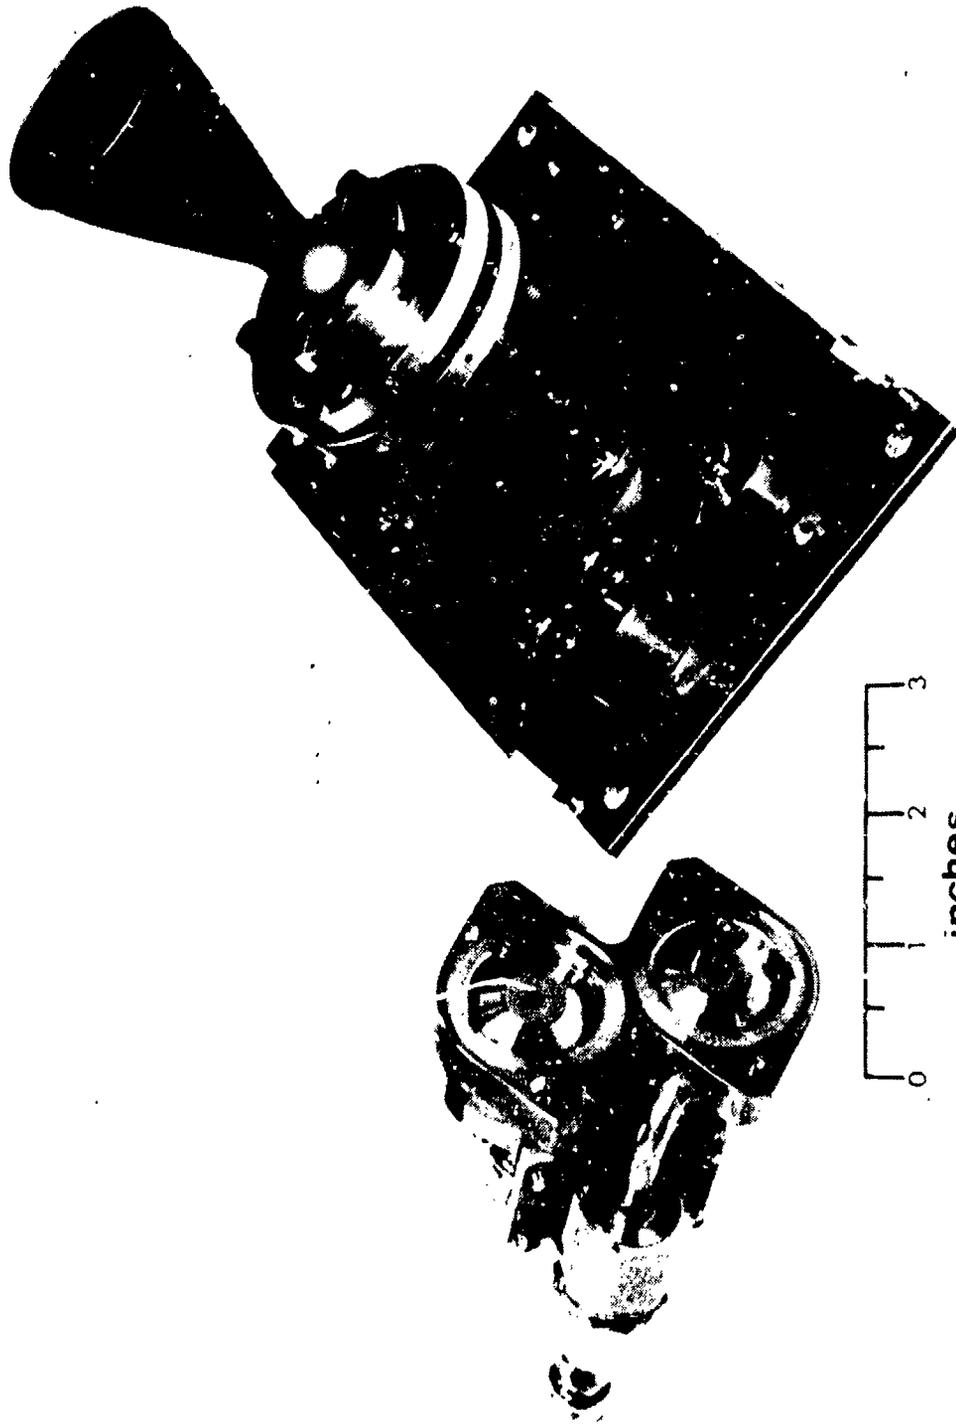
Figure 46. Partially Assembled 5 Lbf. Thruster, Configuration No. 2

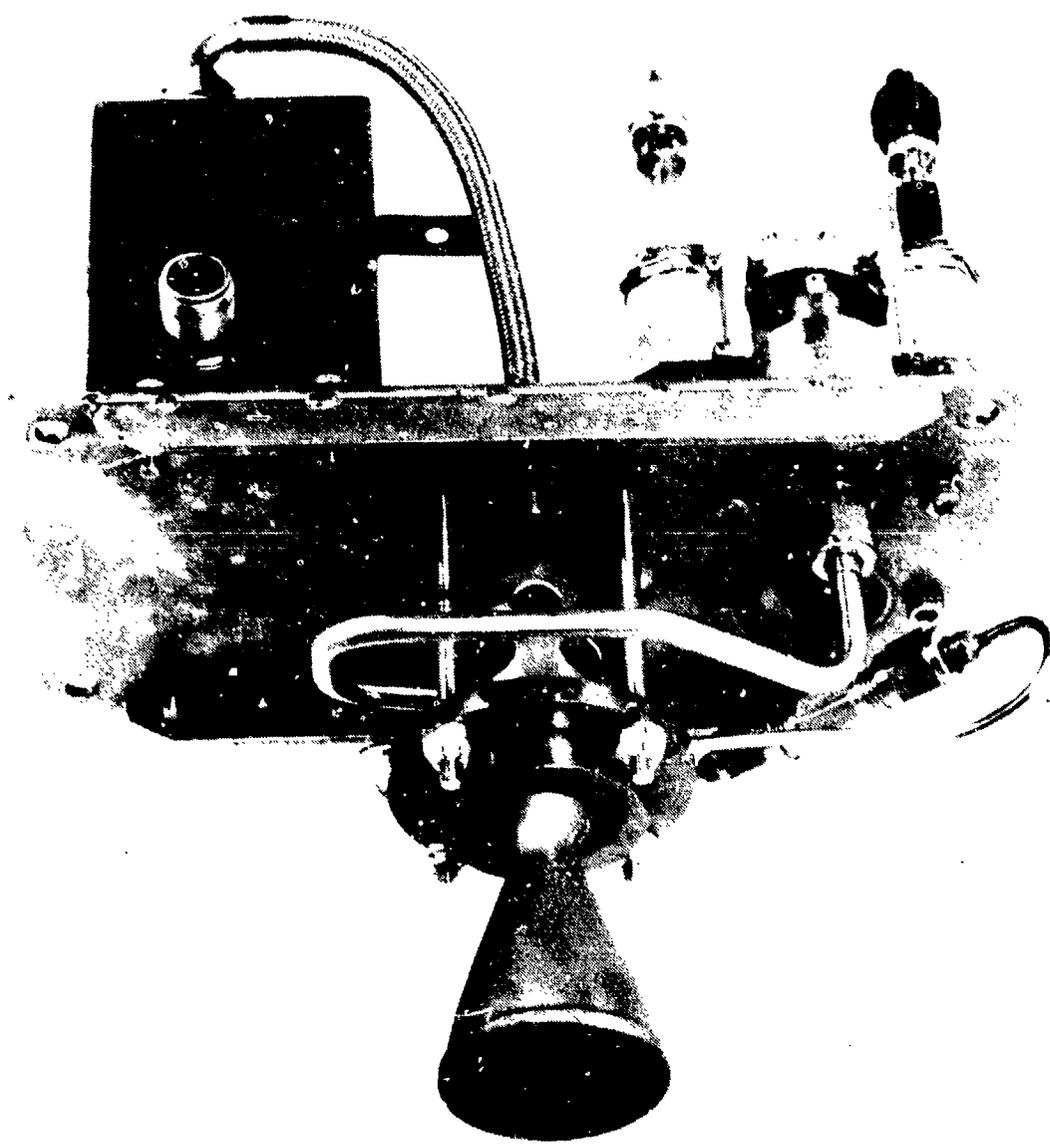
Figure 51. Assembled 5 Lbf. Thruster, Configuration No. 3

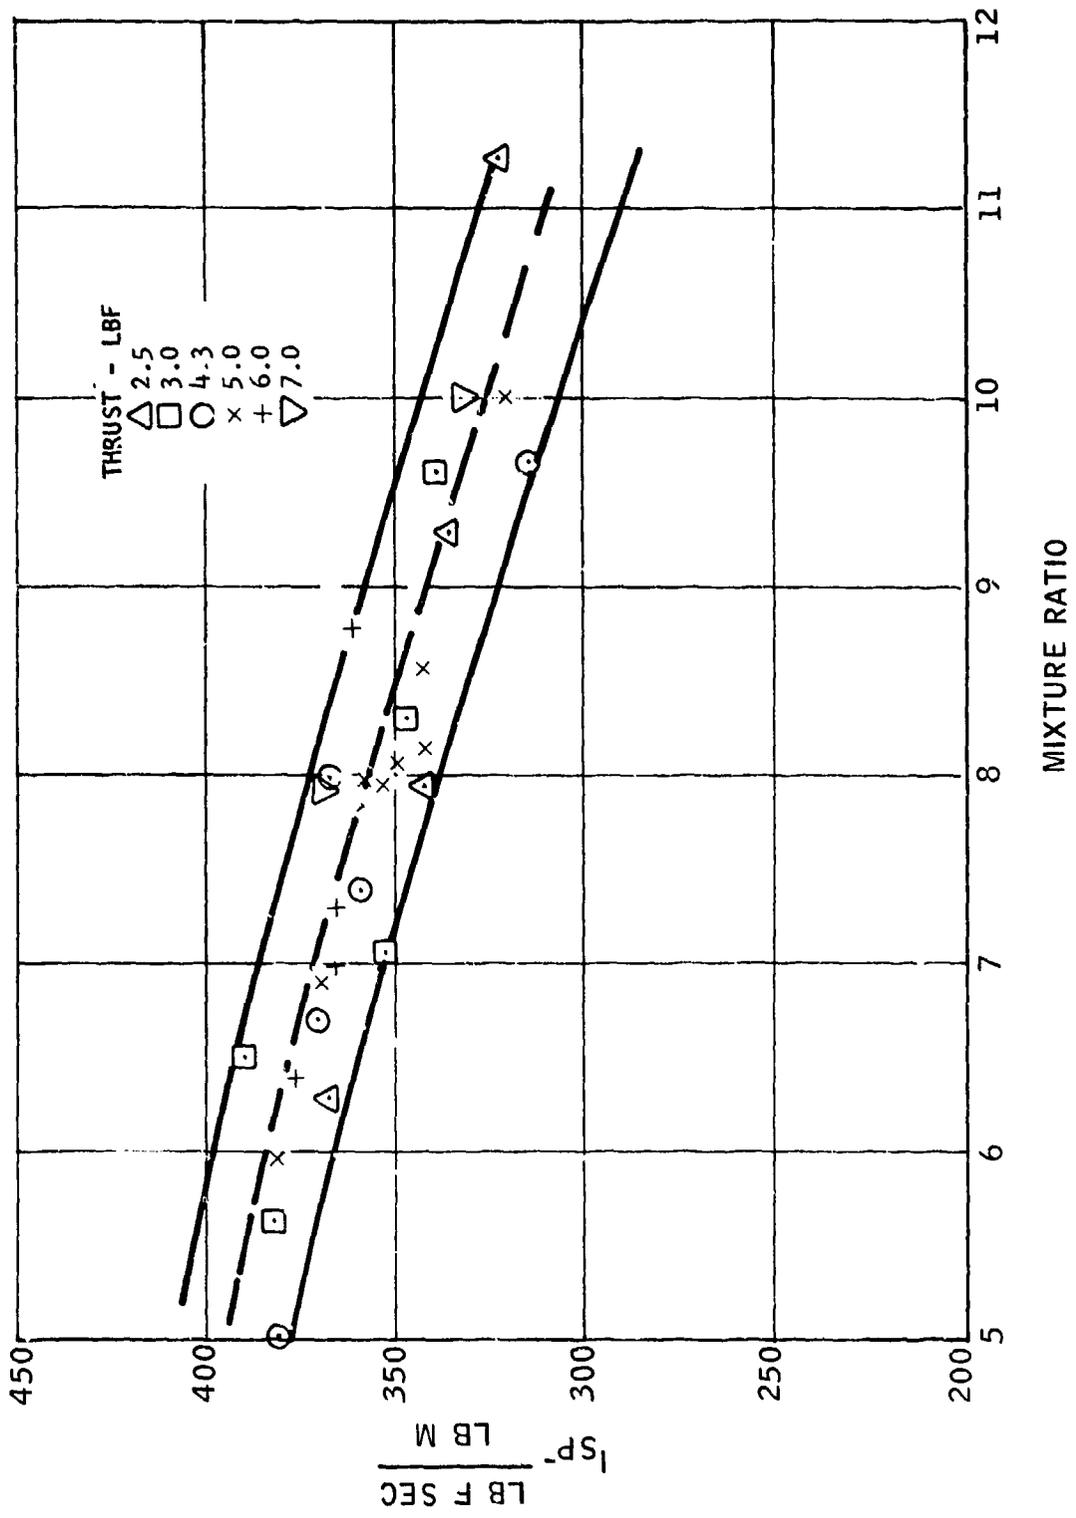
Figure 53. Performance of 5 Lbf. Thruster, Configuration No. 3

Figure 53, specific impulse versus mixture ratio, indicates a specific impulse of 355 seconds at the stoichiometric mixture ratio of 7.934. Performance increases as thrust is increased and mixture ratio is decreased due to the change in reaction kinetics (as it affects thrust) and a change in theoretical performance. The maximum heat release increases as the mixture ratio decreases. The performance of the thruster as a function of thrust is shown on Figure 31. Performance

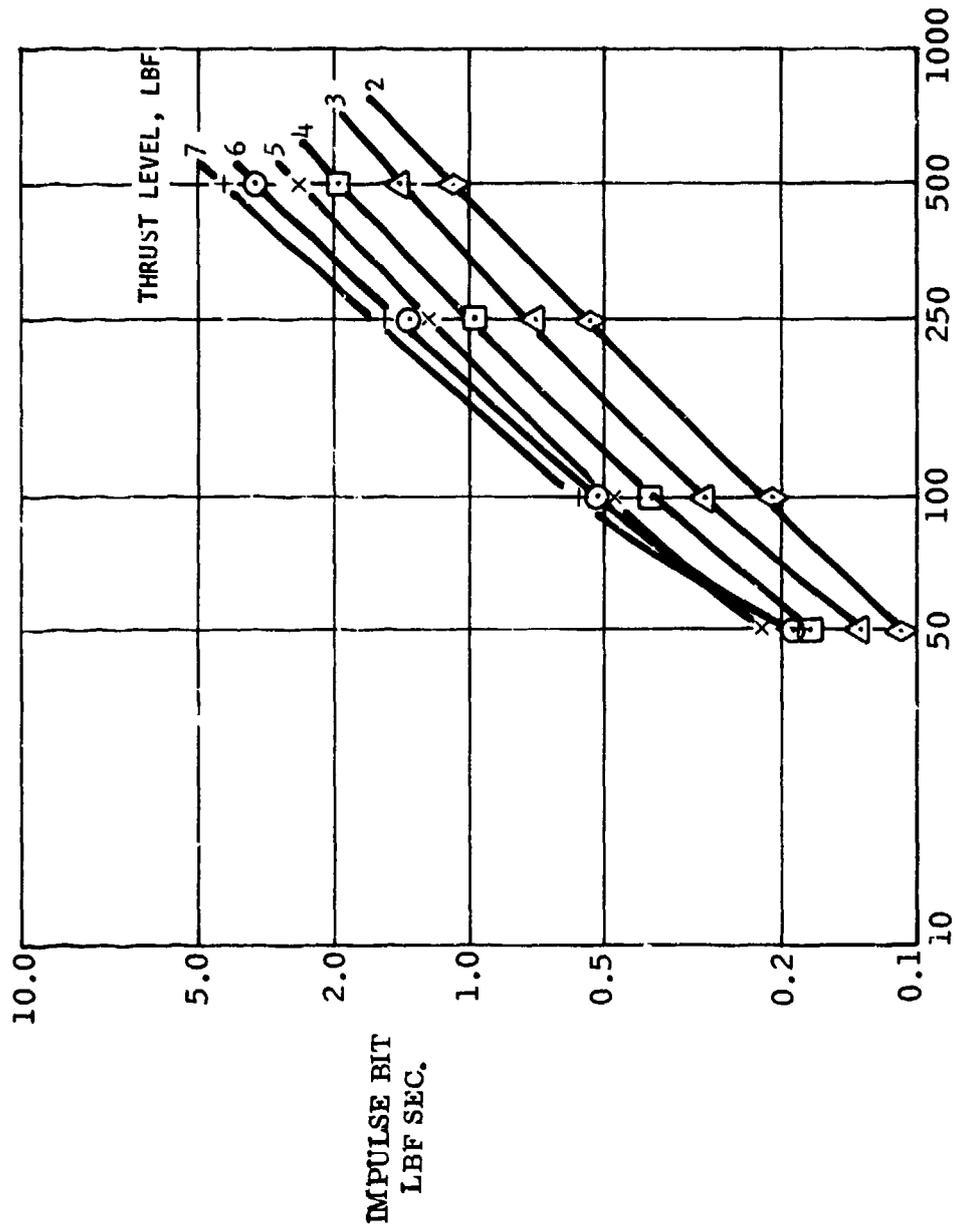
Figure 54. Impulse Bit of 5 Lbf. Thruster, Configuration No. 3

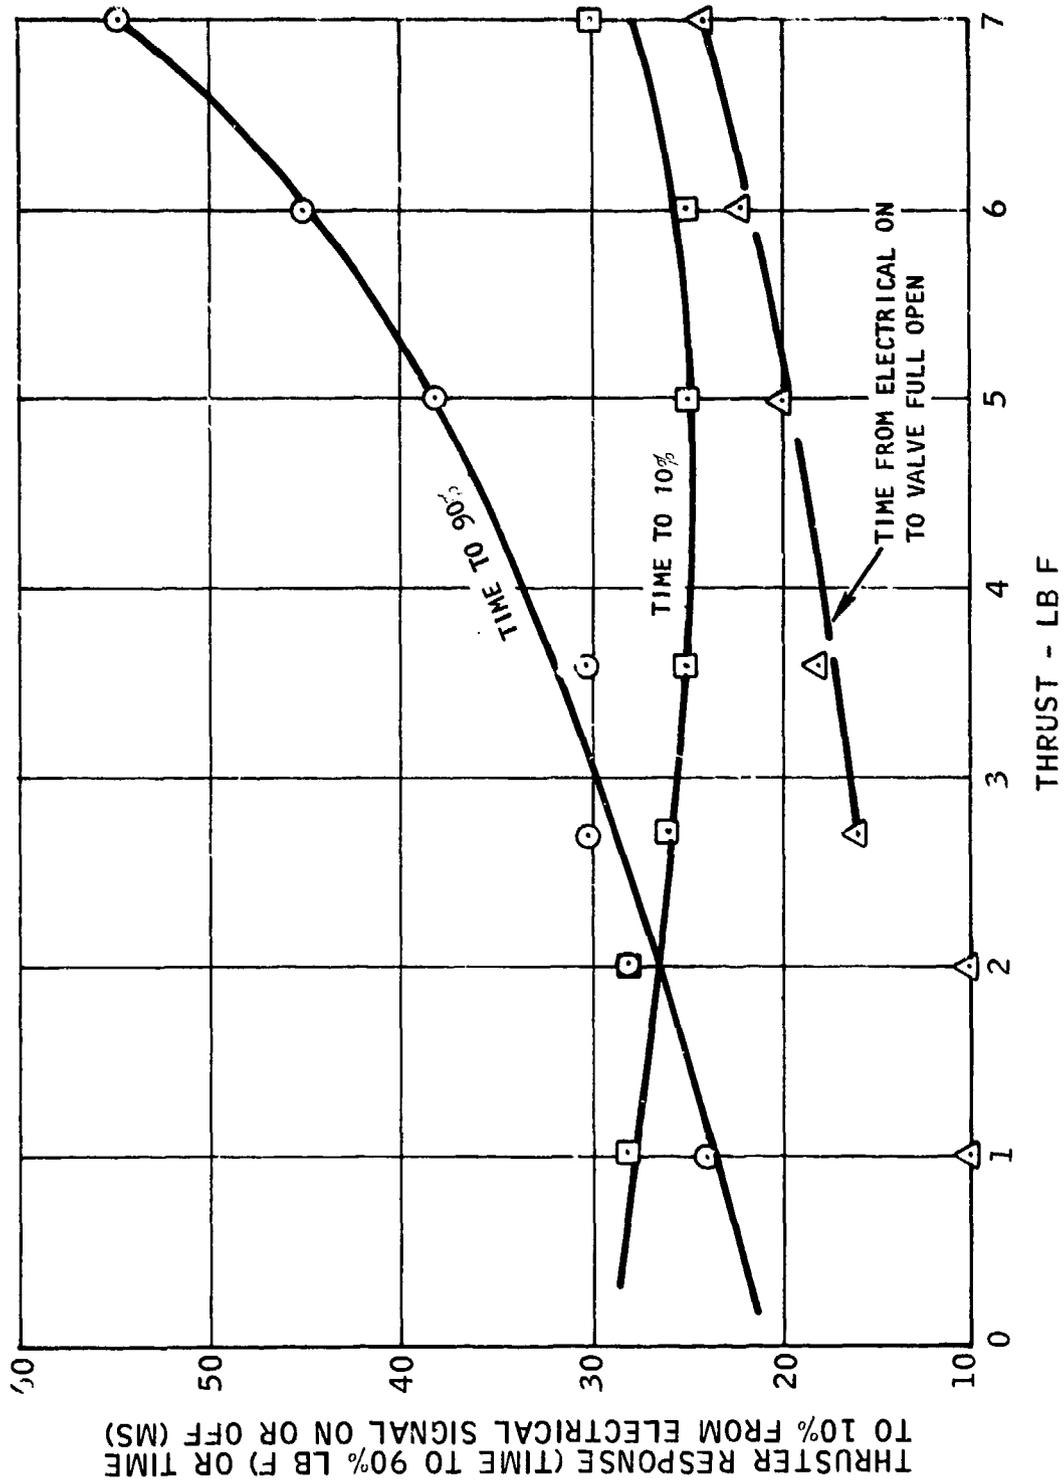
Figure 55. Valve Response Vs. Thrust Level

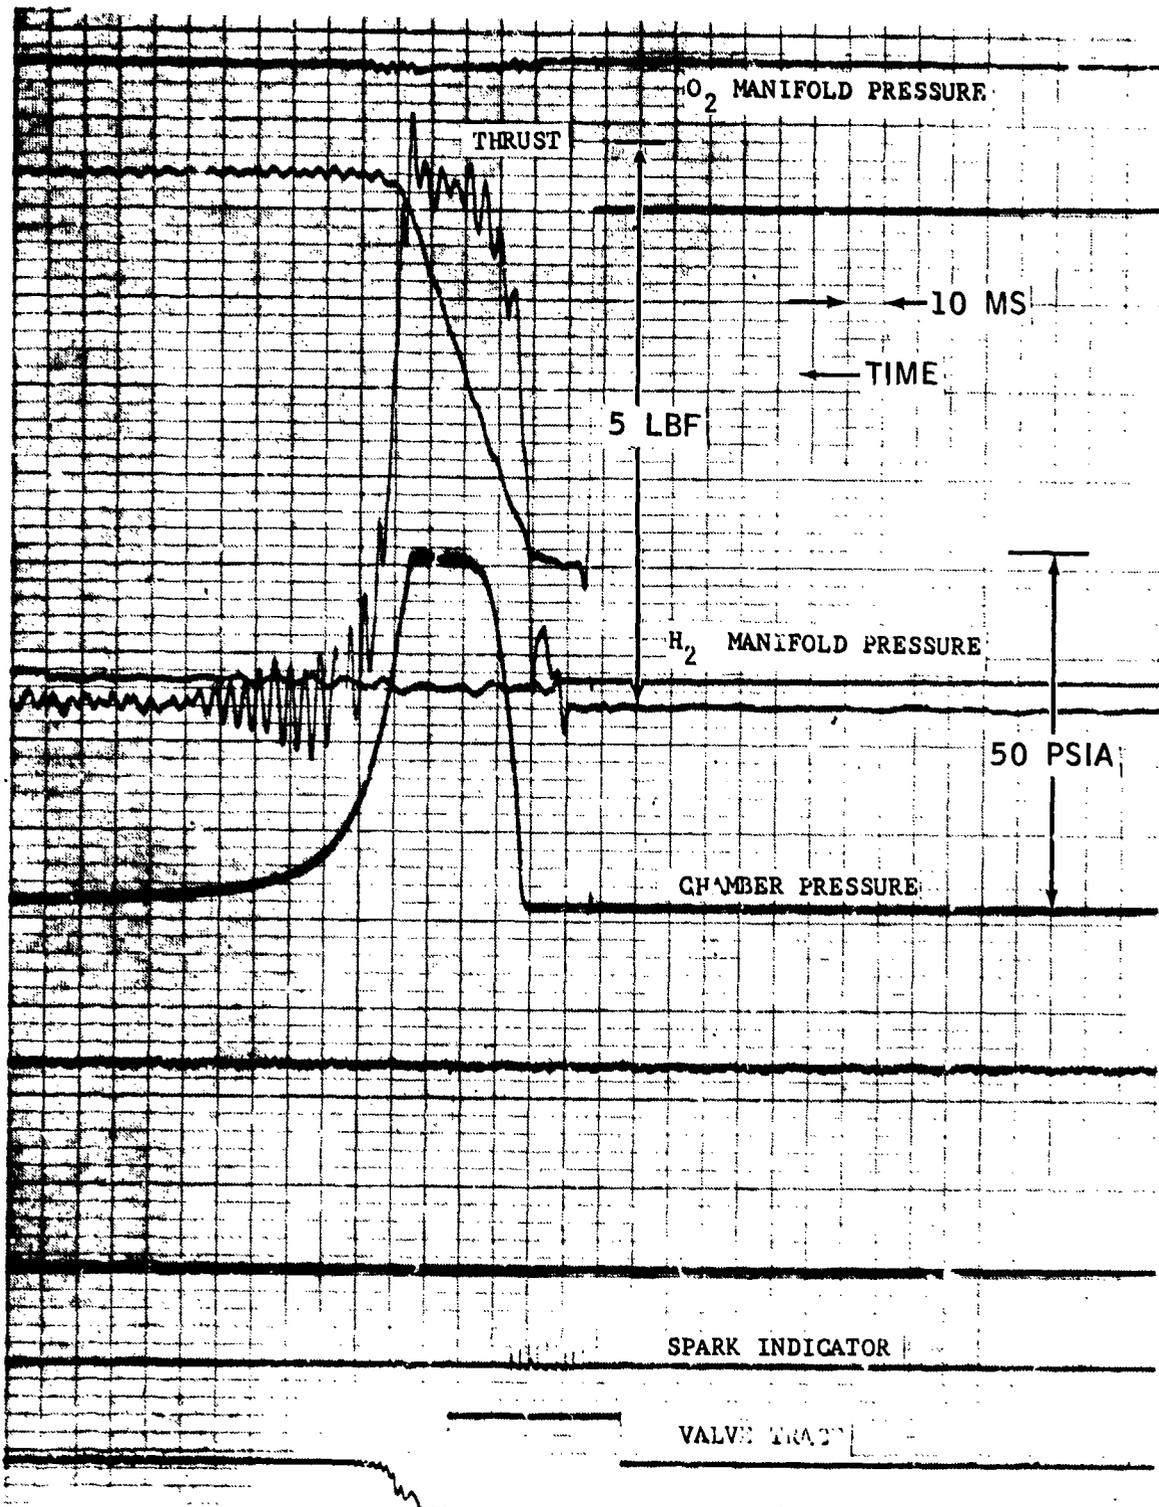
Figure 56. 5 Lbf. GO₂/GH₂ Rocket Engine Firing Record - 50 Ms Firing

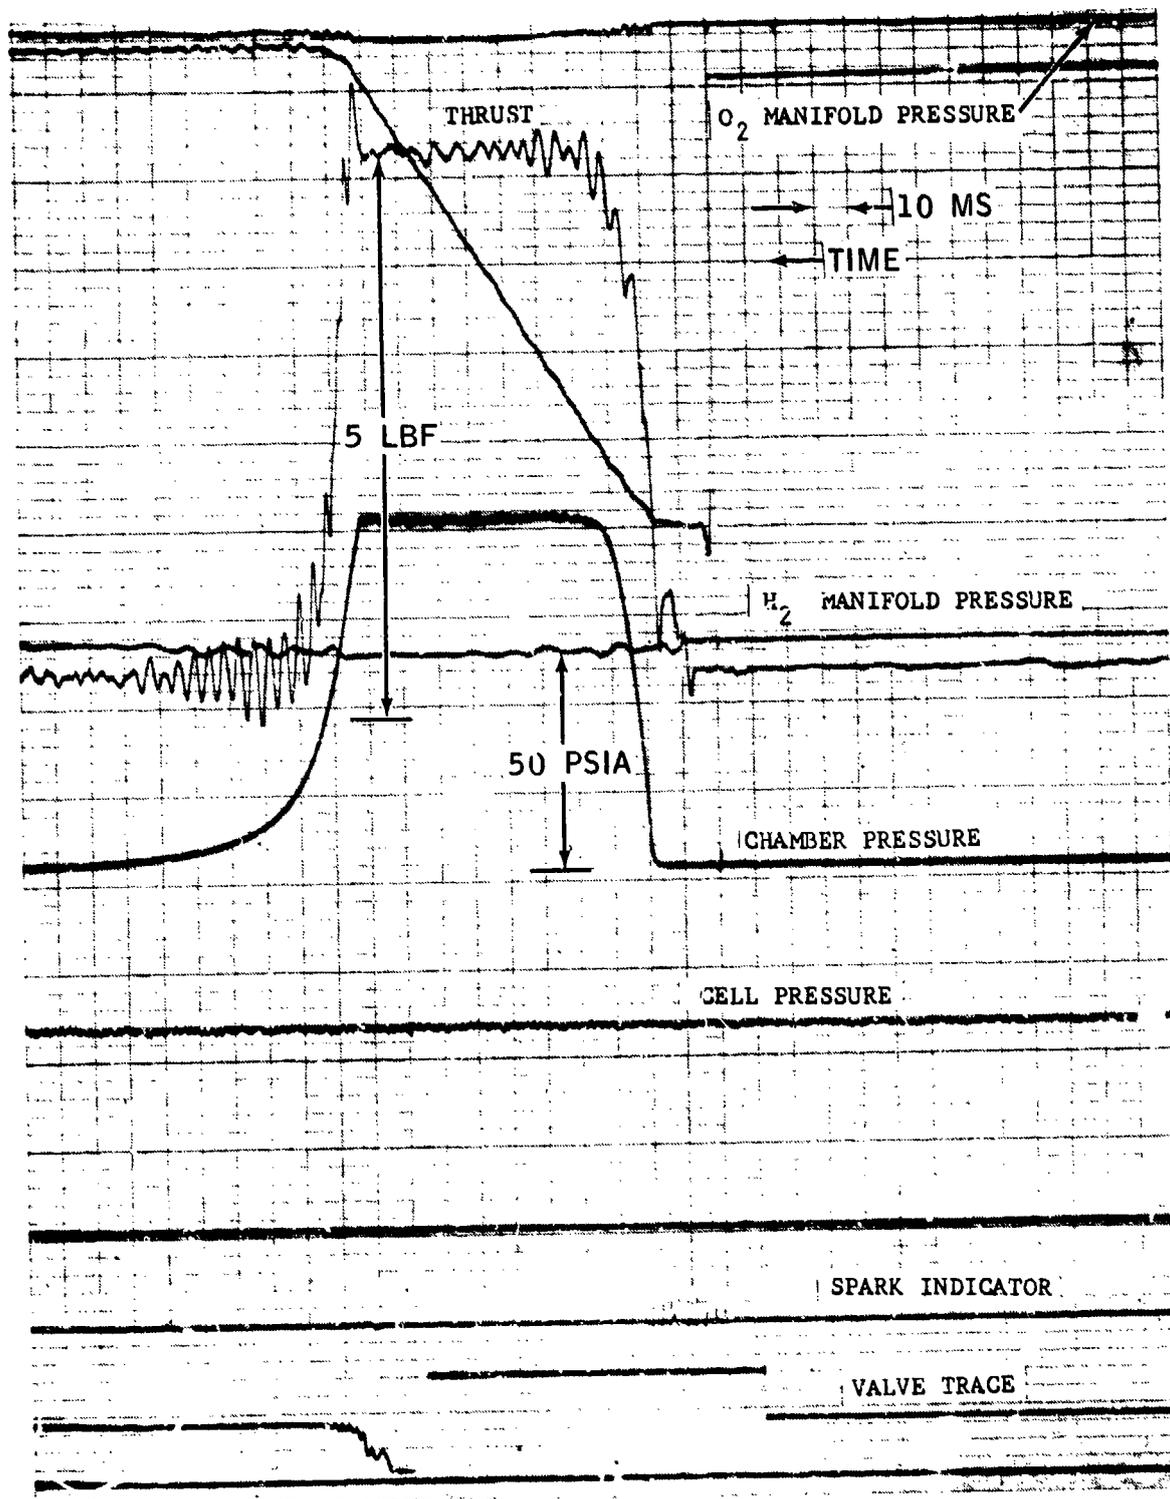
Figure 57. 5 Lbf. GO₂/GH₂ Rocket Engine Firing Record - 100 Ms Firing

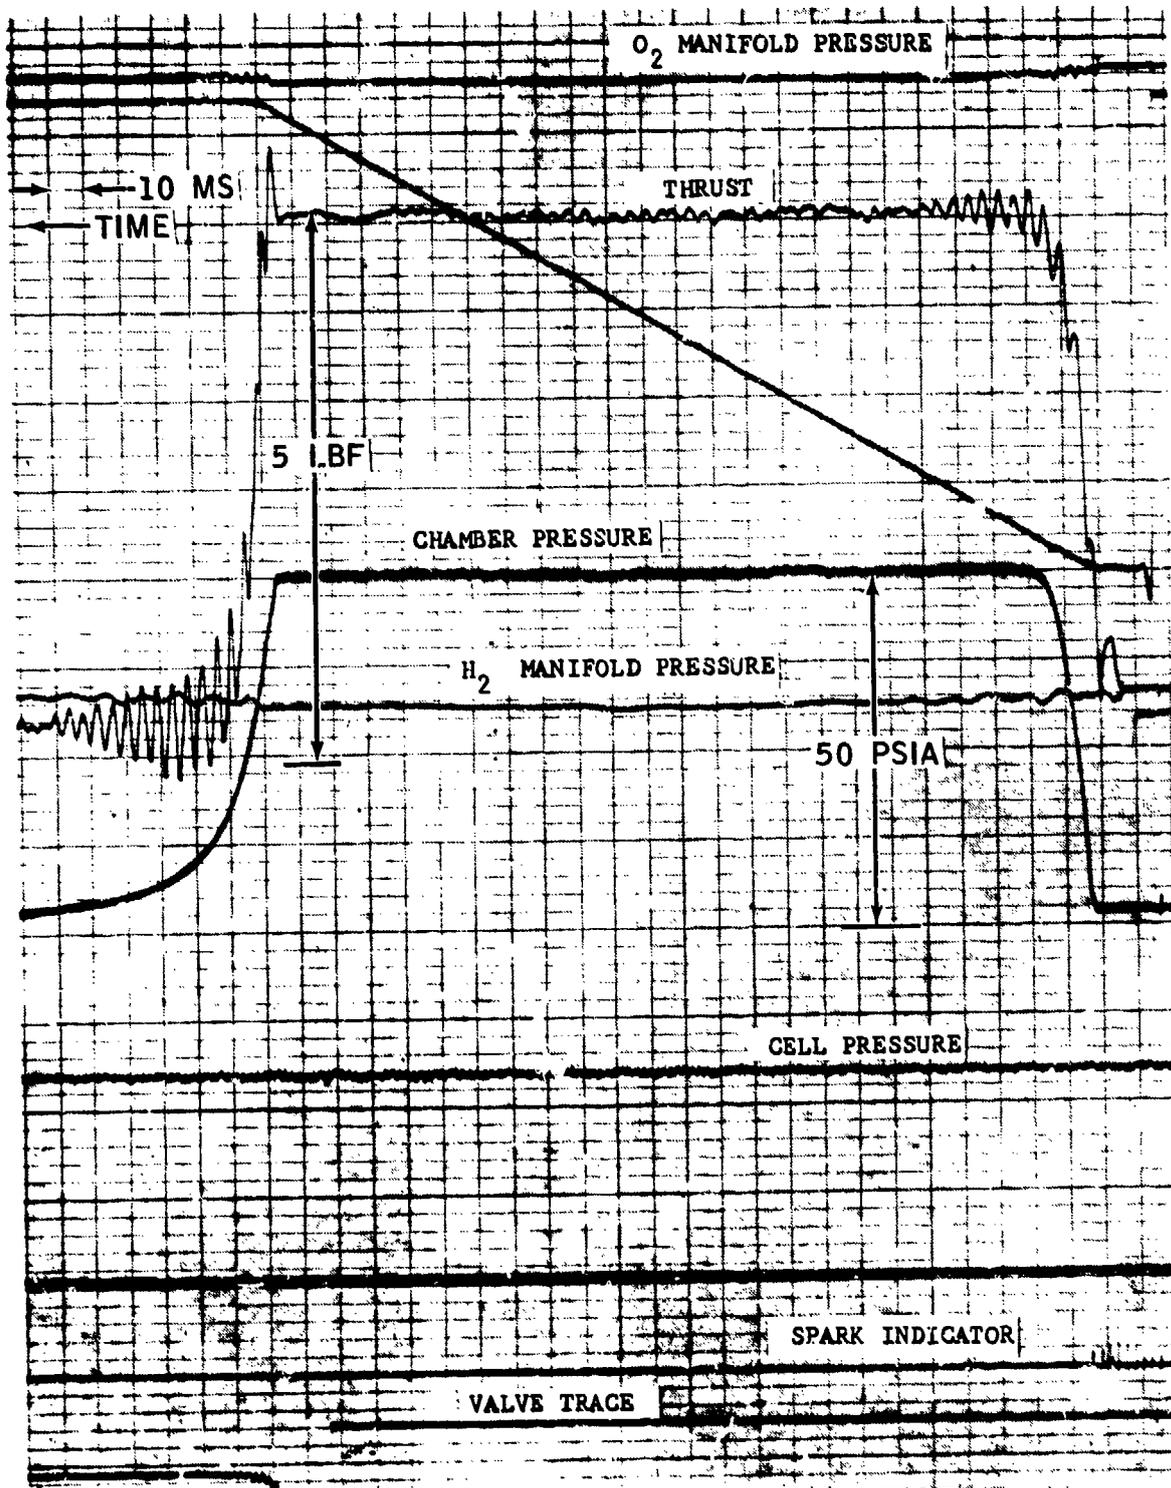
Figure 58. 5 Lbf. GO₂/GH₂ Rocket Engine Firing Record - 250 Ms Firing

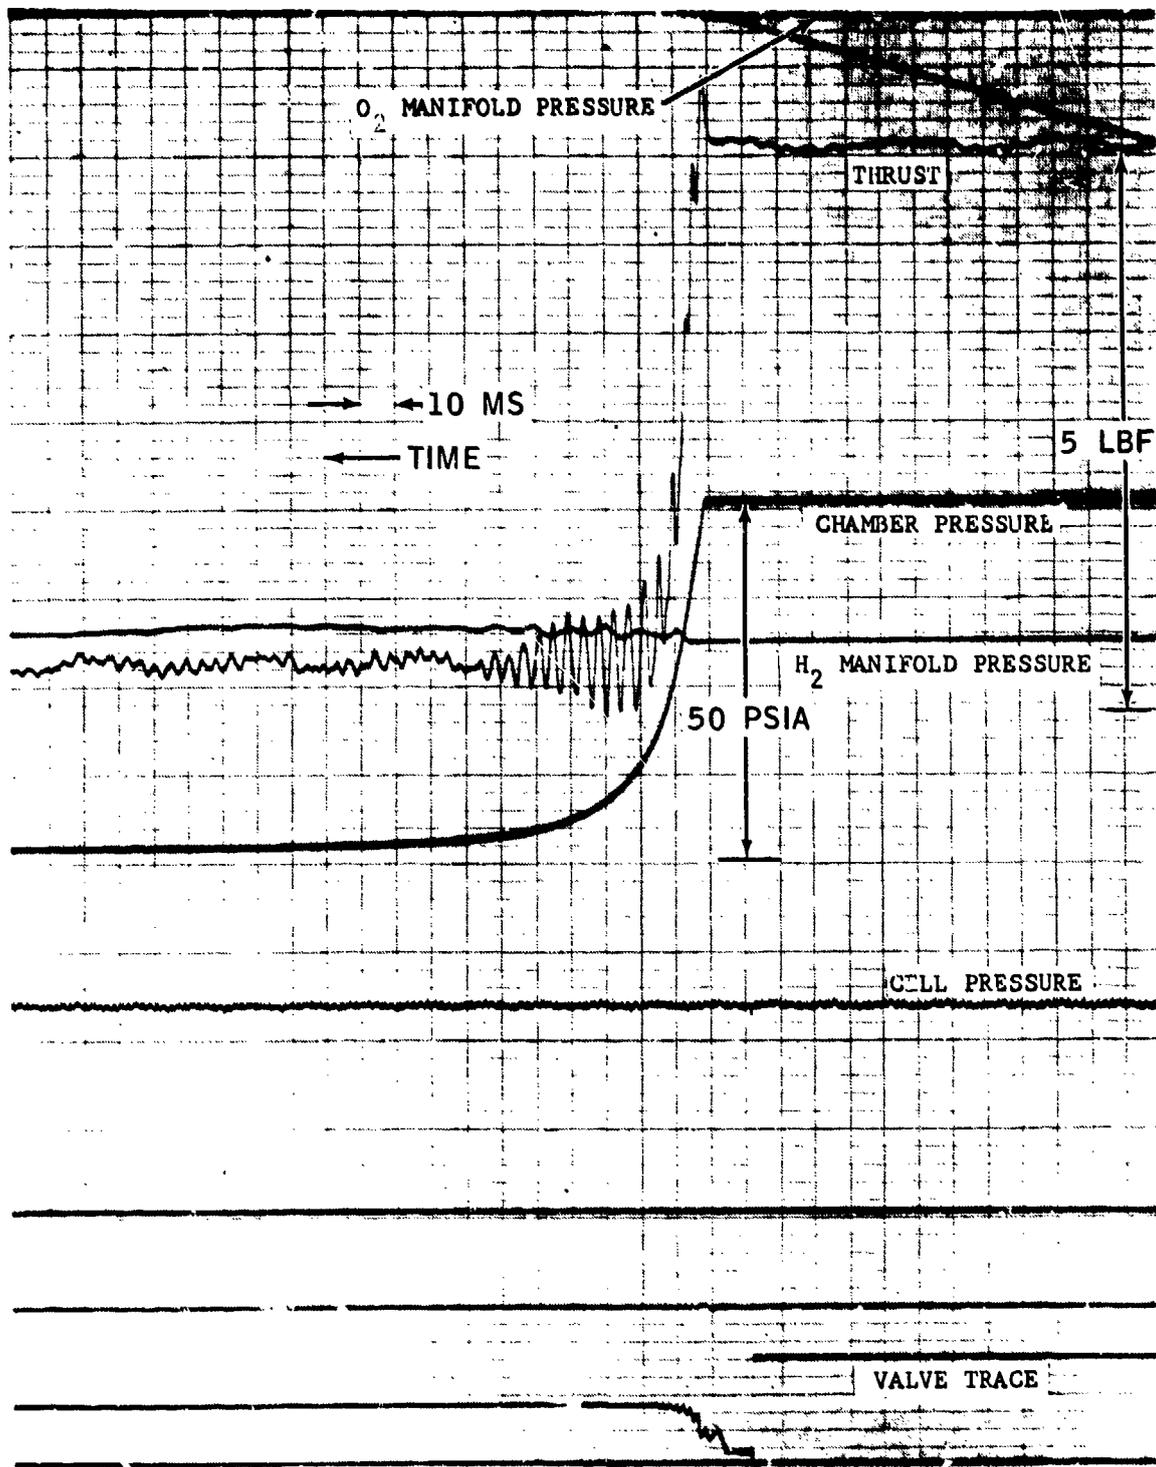
Figure 59. 5 Lbf. GO₂/GH₂ Rocket Engine Firing Record - End of Steady State Firing

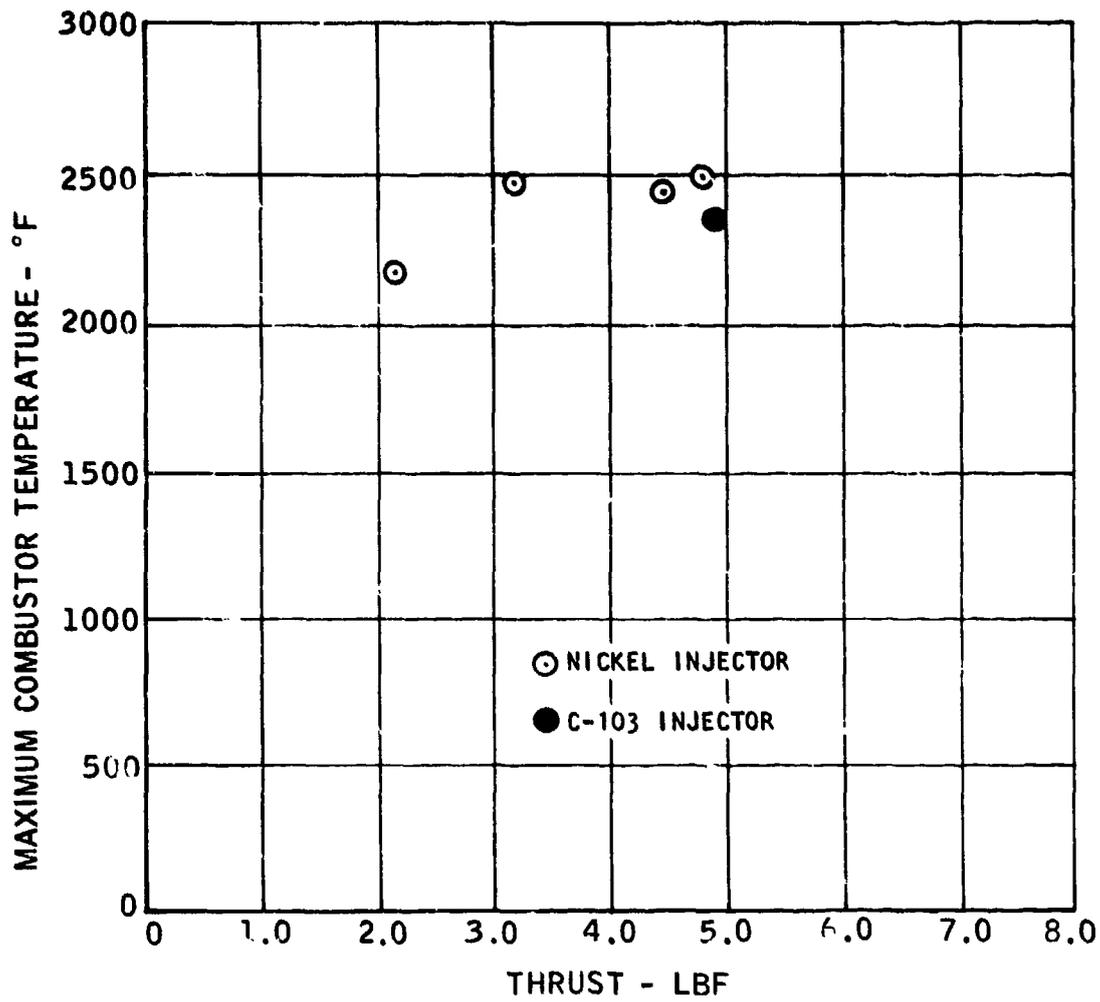
Figure 60. Maximum Combustor Temperature of 5 Lbf, Thruster

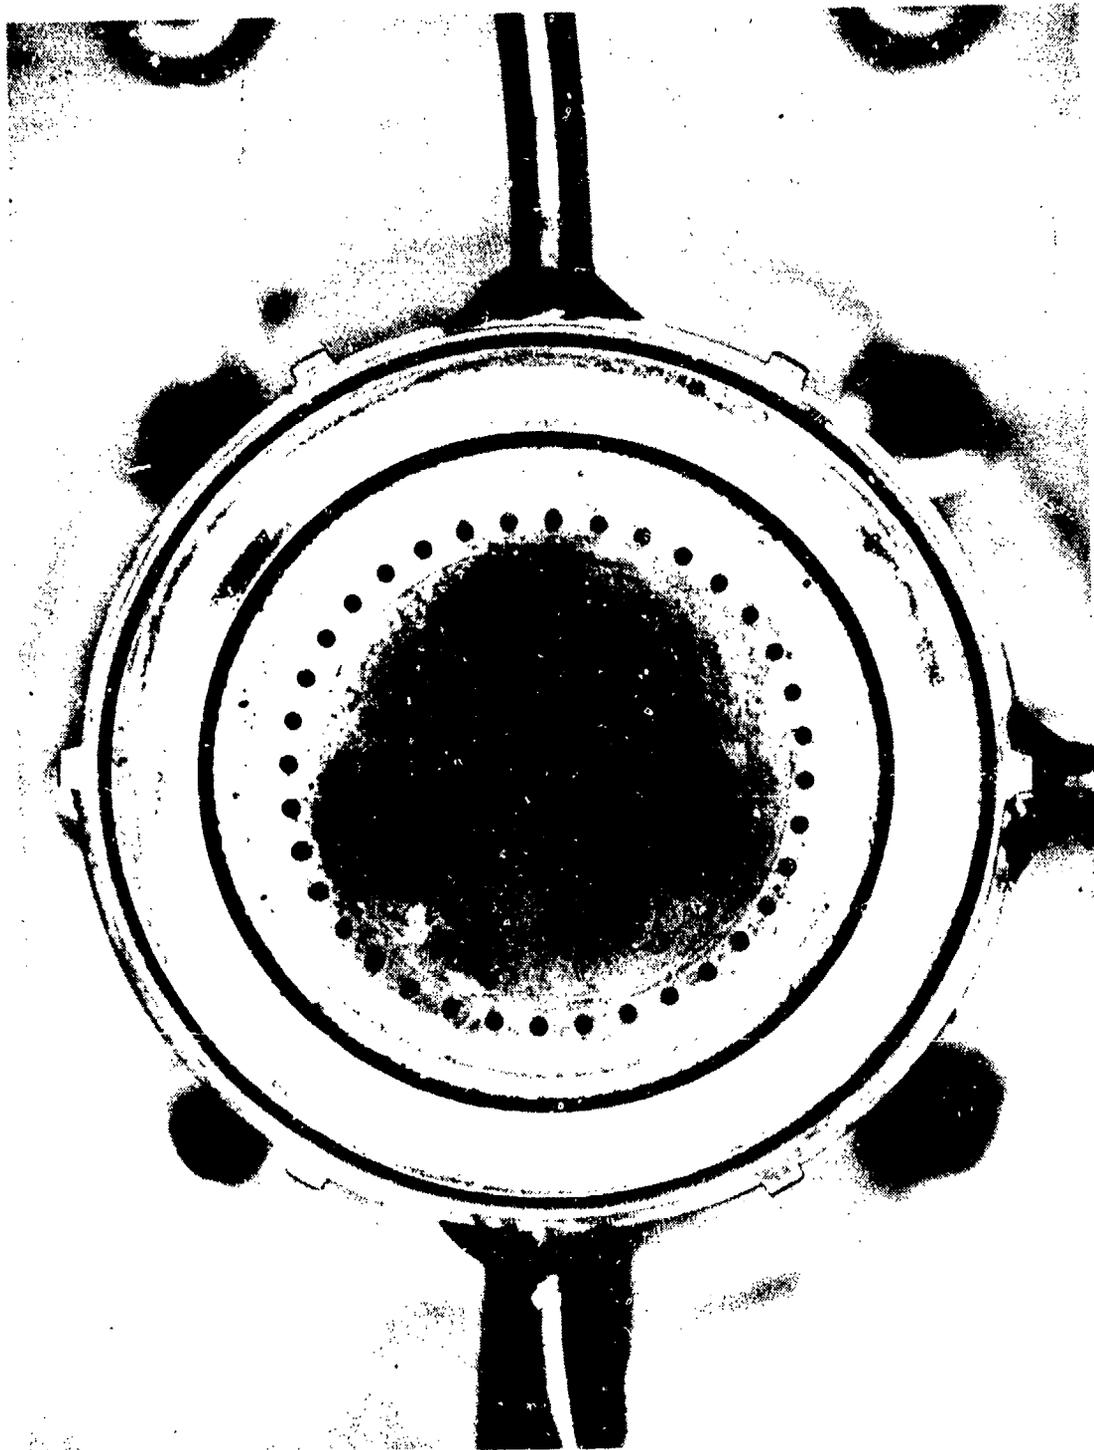
Figure 62. 5 Lbf. Injector Face, Configuration No. 3, After Test

Figure 61 shows the disassembled thruster at the end of the program, while Figures 62, 63, and 64 show the injector face, the spark plug, and the chamber, respectively. No cracks are visible on the face of the injector, and the combustion chamber shows only some heat stains. The white spots are columbium oxide which was the result of tests on Configuration 2. Figure 64 shows the tip of the spark plug after 150,000 cycles. The anode (inside portion of the plug) has miniscule globules of material deposited on it. The deposits are due to erosion of the cathode and redeposition on the anode. No degradation of spark efficiency was noted visually. The thruster ignition was also 100% reliable at the end of the 150,000 firings.
