WATER ELECTROLYSIS PROPULSION SYS-
TEM TESTING

John G. Campbell, et al

Marquardt Company

REPORT DOCUMENTATION PAGE		READ INSTRUCTIONS BEFORE COMPLETING FORM
1. REPORT NUMBER AFRPL-TR-74-72	2. GOVT ACCESSION NO.	3. RECIPIENT'S CATALOG NUMBER
4. TITLE (and Subtitle) Water Electrolysis Propulsion System Testing		5. TYPE OF REPORT & PERIOD COVERED Final Report October 72 - July 74

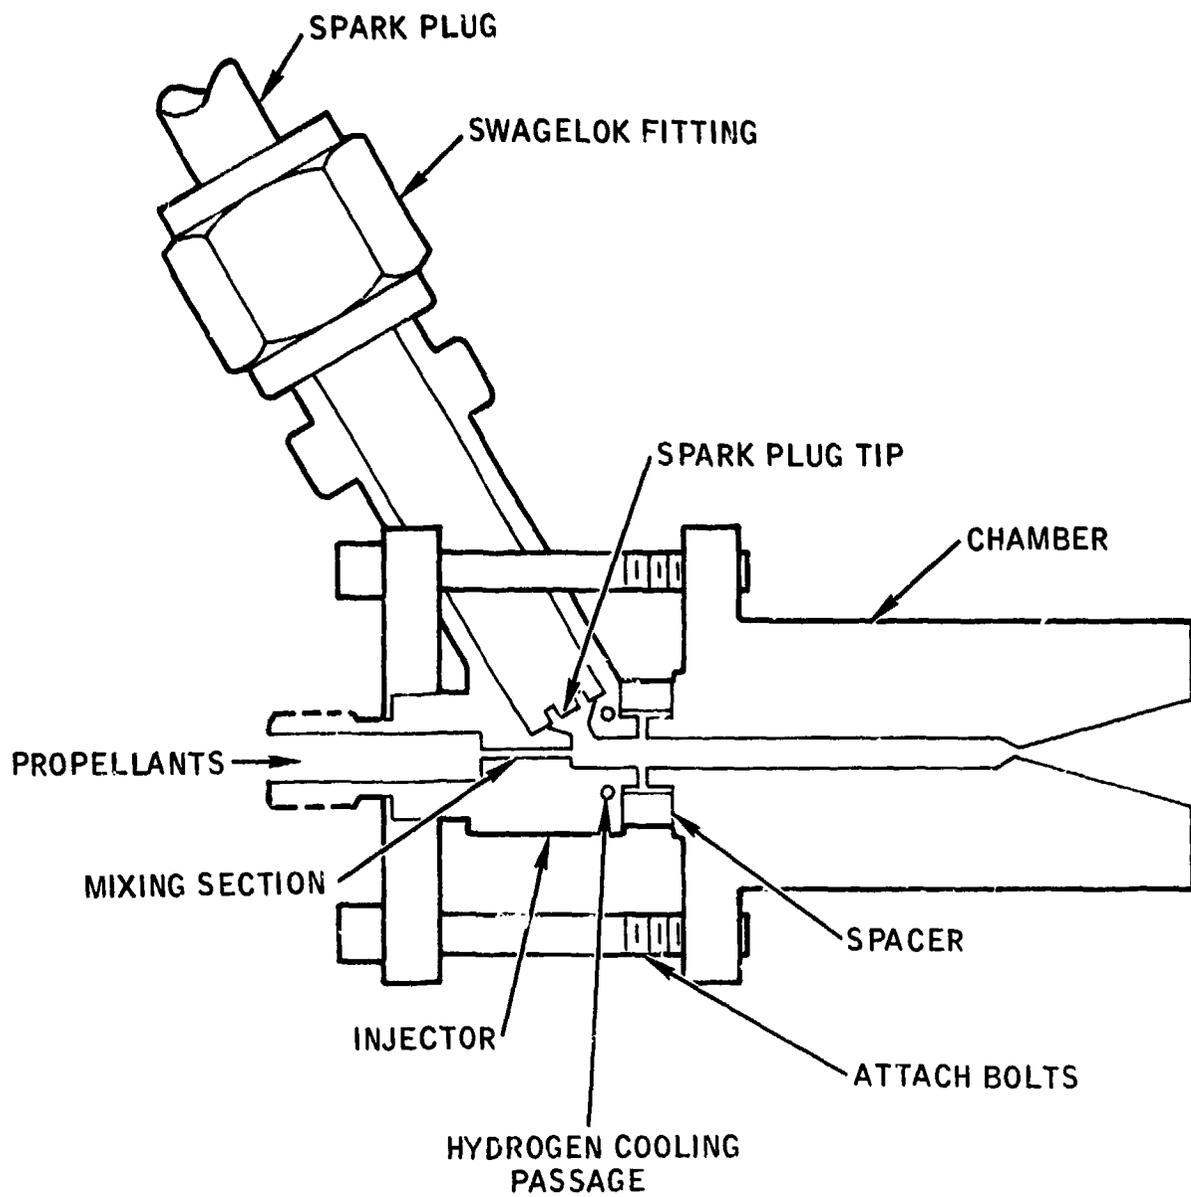
Figure 65. Flightweight 0.1 Lbf. Engine No. 1 Design

Chamber Pressure (Maximum)	75 psia @ 0.1 Lb. Thrust
Chamber Pressure (Minimum)	25 psia @ 0.03 Lb. Thrust
Contraction Area Ratio	8:1
Expansion Area Ratio	100:1
L*	9 Inches
L/D Premix	8
Cooling	Radiation/Regenerative
Injector	Single Element Coaxial Premix
Valves	Moog Bipropellant
Spark Plug	Champion FHE 231A (Modified)
Injector	Radial Hydrogen Injection Into Oxygen Stream

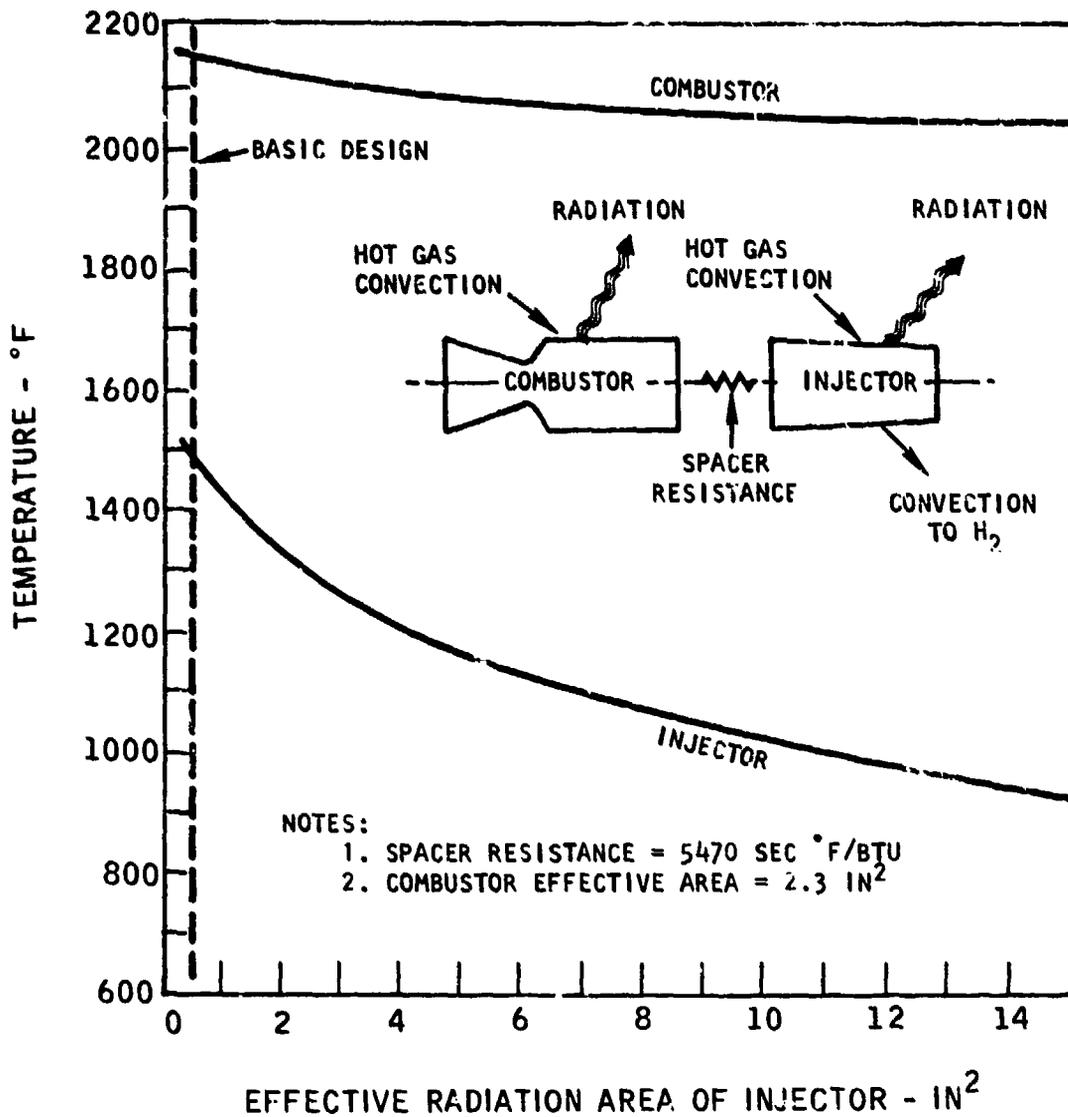
FLIGHTWEIGHT 0.1 LB ENGINE NO. 1

Figure 67. 0.1 Lbl. Engine Temperatures Vs. Injector Effective Radiation Area

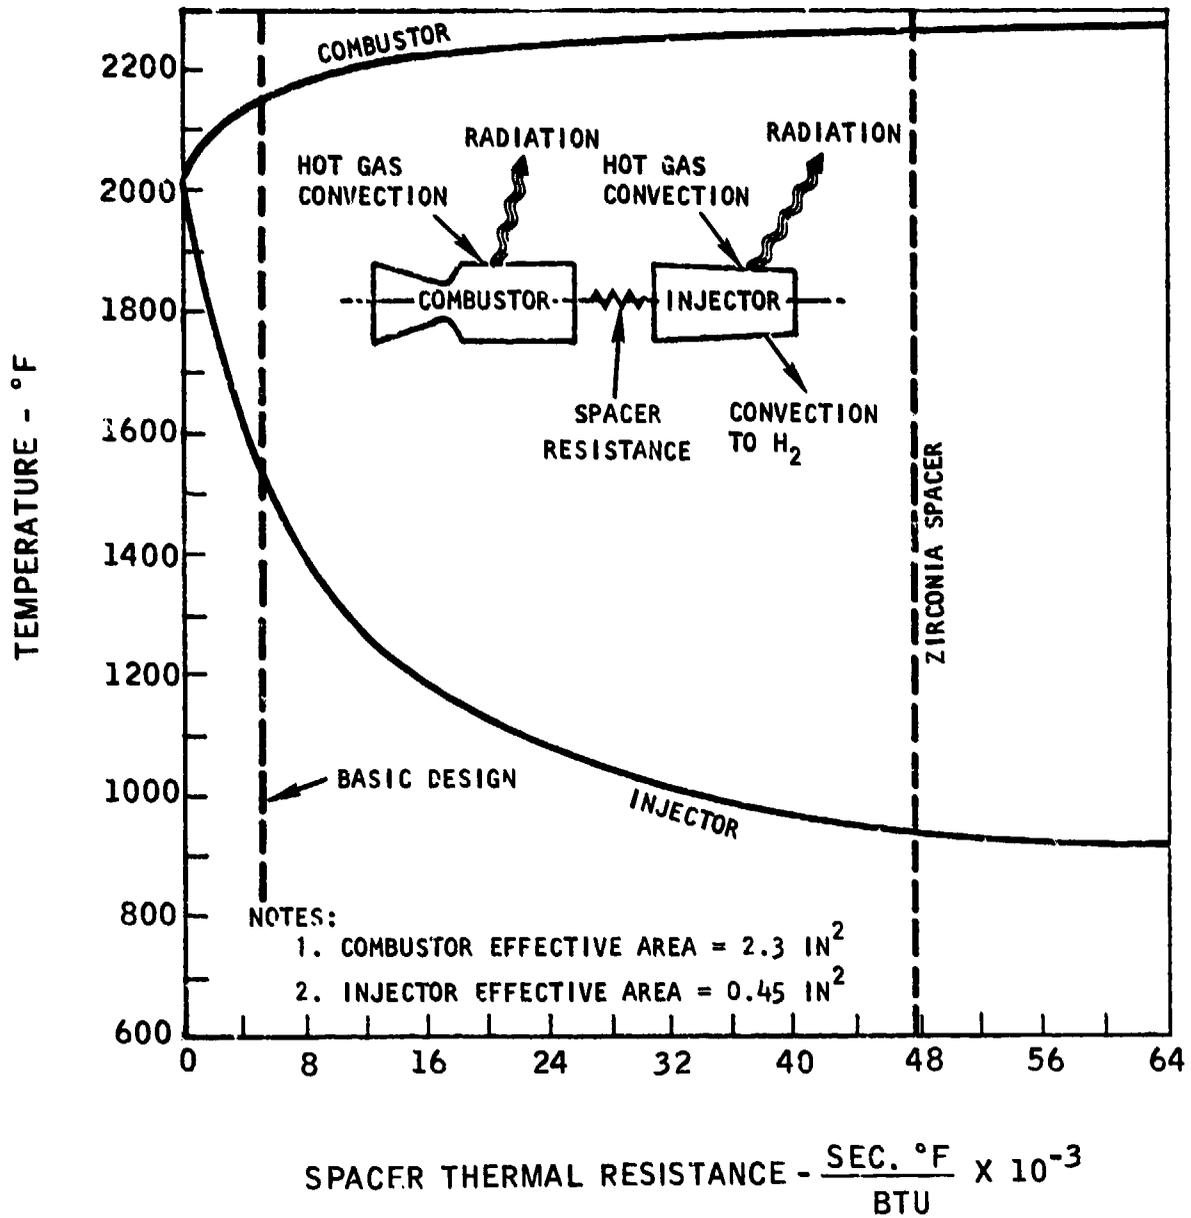
FLIGHTWEIGHT 0.1 LB. ENGINE NO 1

Figure 68. 0.1 Lbf. Engine Temperatures Vs. Spacer Thermal Resistance

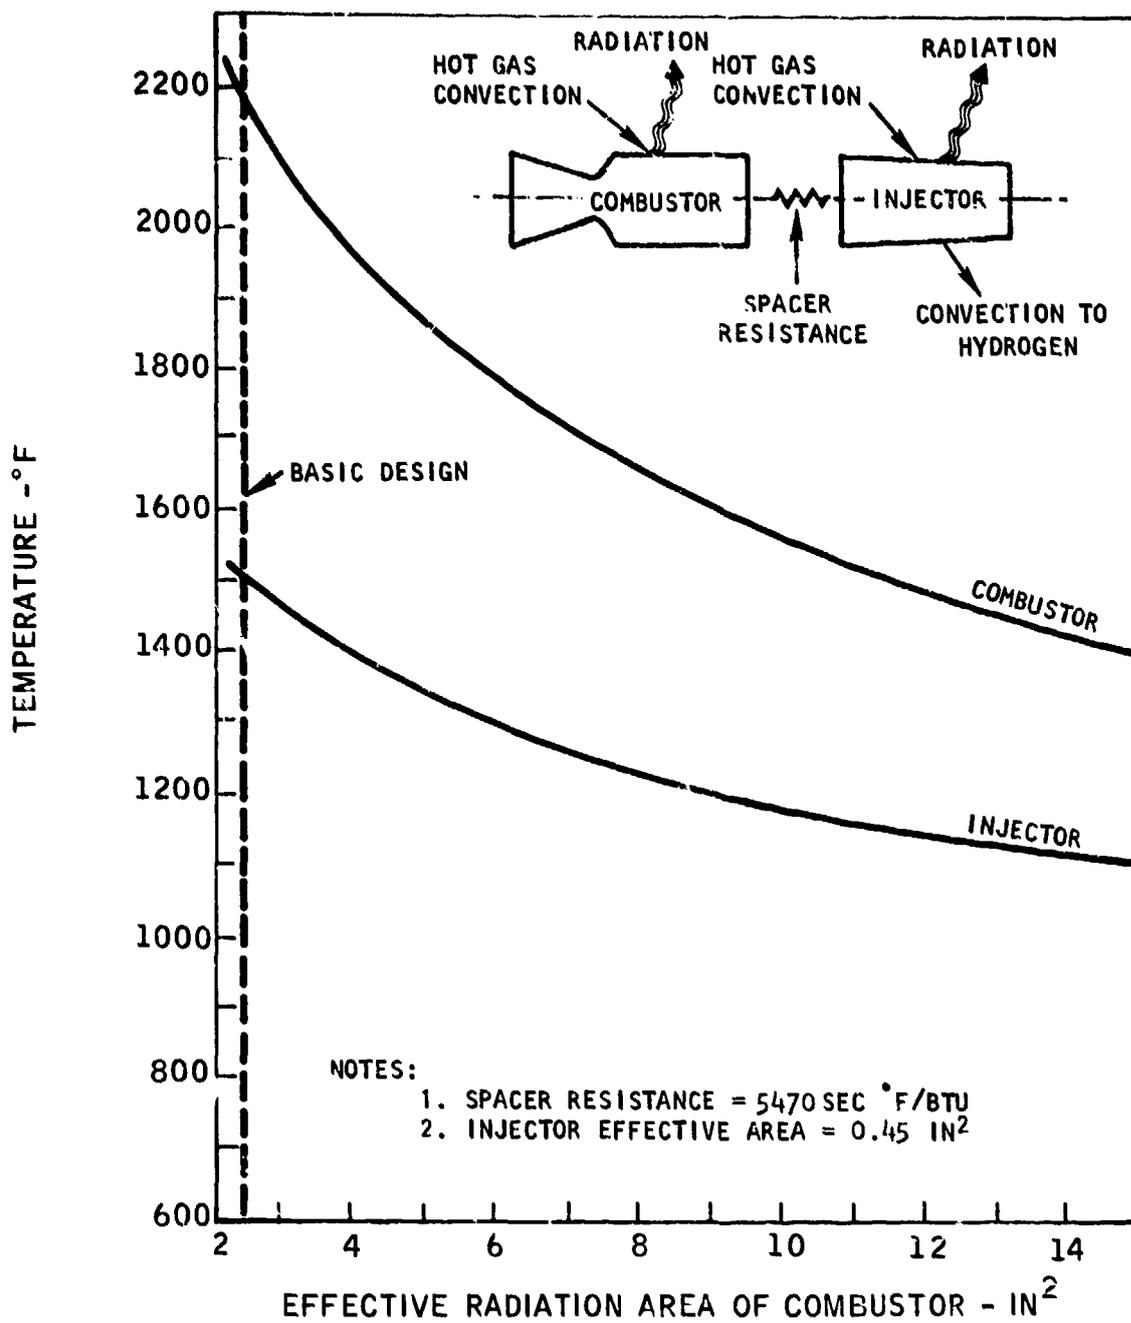
FLIGHT WEIGHT 0.1 LB. ENGINE NO. 1

Figure 69. 0.1 Lbf, Engine Temperatures Vs. Combustor Effective Radiation Area

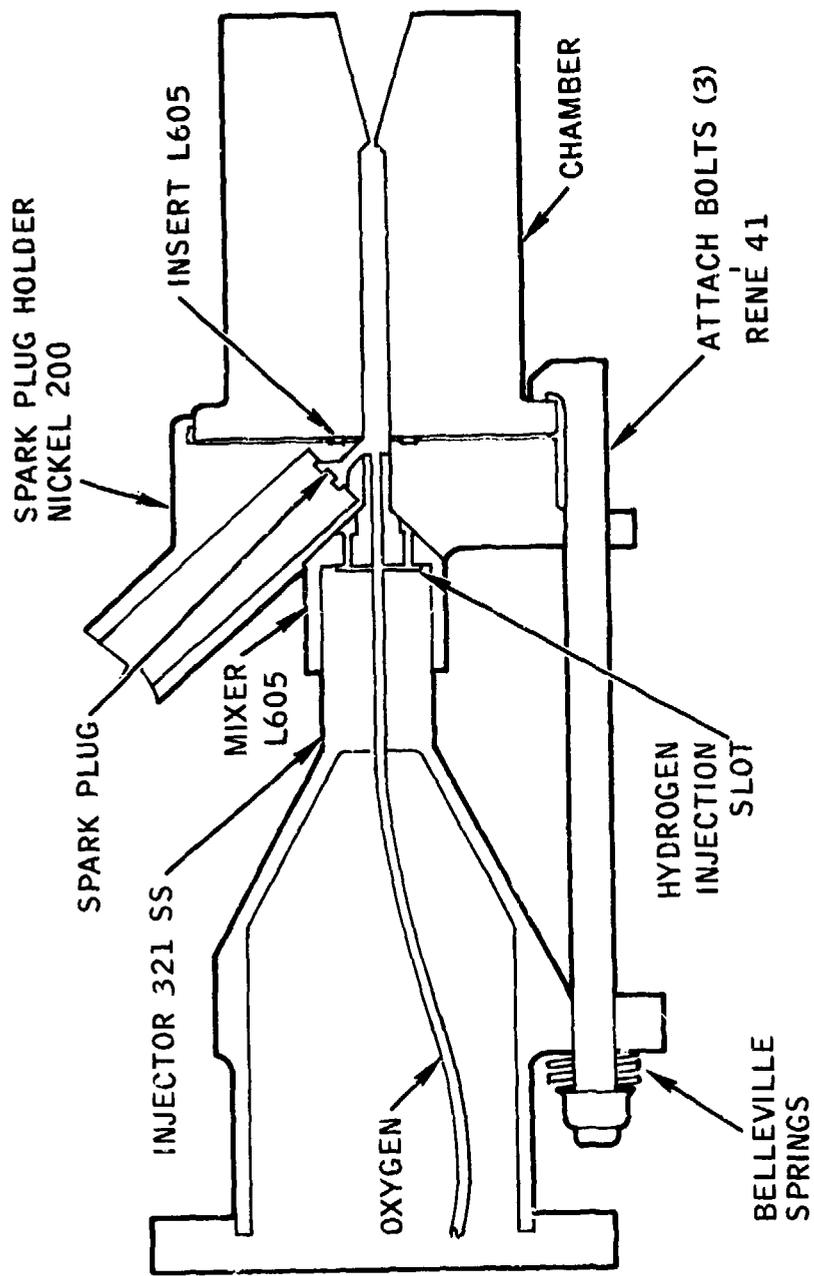
Figure 71. Flightweight 0.1 Lbf. Engine No. 2 Design

Two combustion chambers were made, one using C-103 columbium alloy with a R512E silicide coating, and the other using unalloyed molybdenum with a Durak B silicide coating. Initial life testing was performed with the molybdenum chamber, which originally provided a better sealing surface when lapped than the columbium. The columbium silicide coating exhibited a more granular structure, which appeared to provide very small leak paths over the short distance (about 0.030 inch) across the sealing surface against the L-605 insert. The final life testing was performed with the columbium chamber and was very successful after the columbium chamber was carefully lapped.

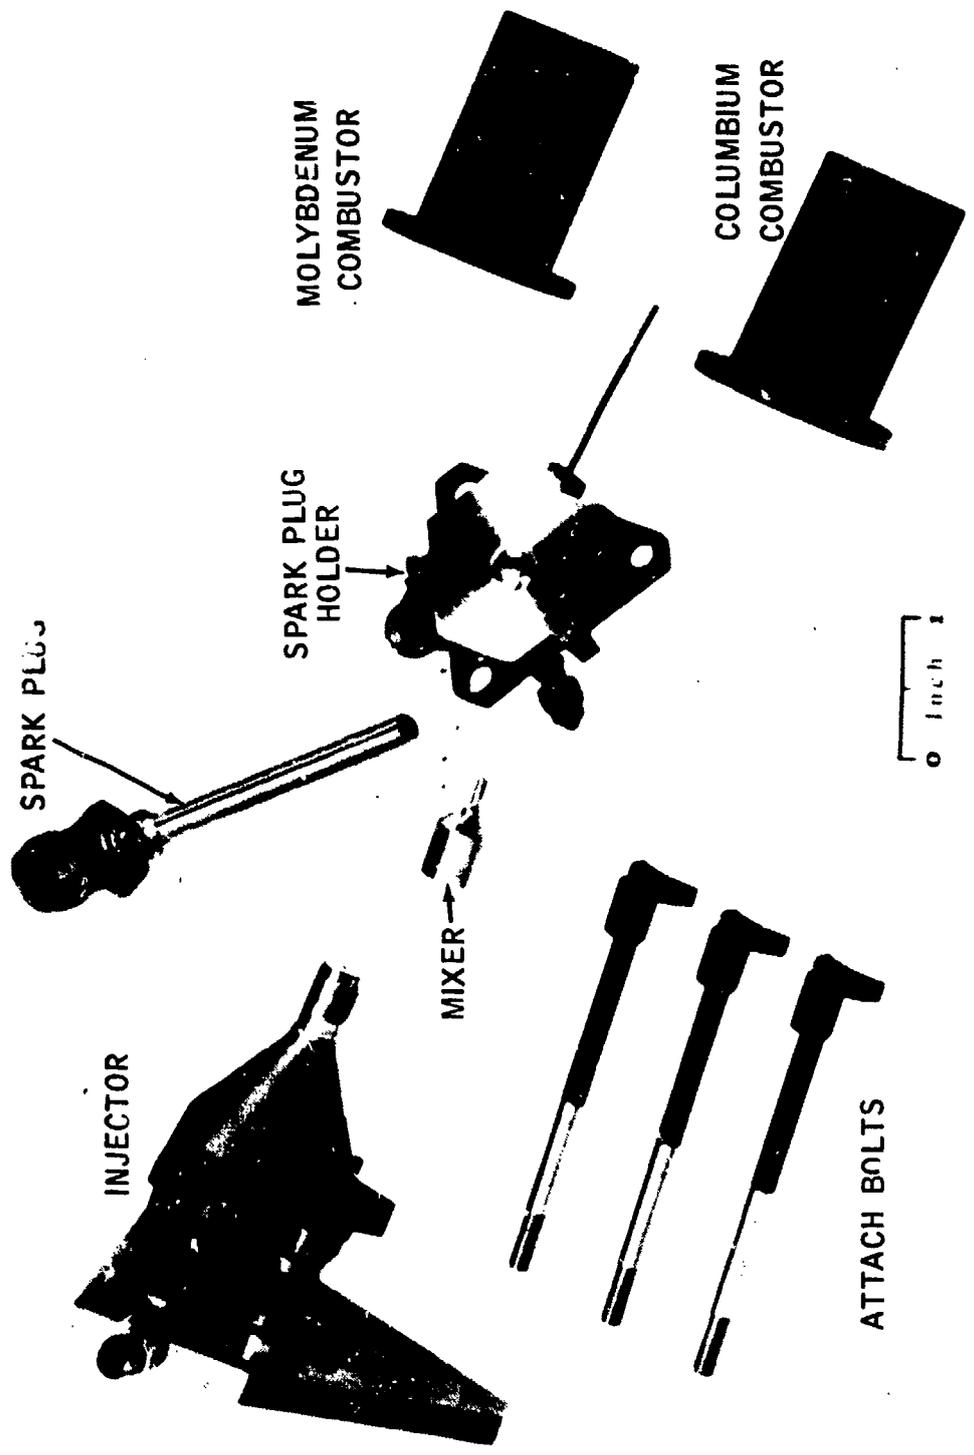
Figure 72. Components of Flightweight 0.1 Lbf. Engine No. 2

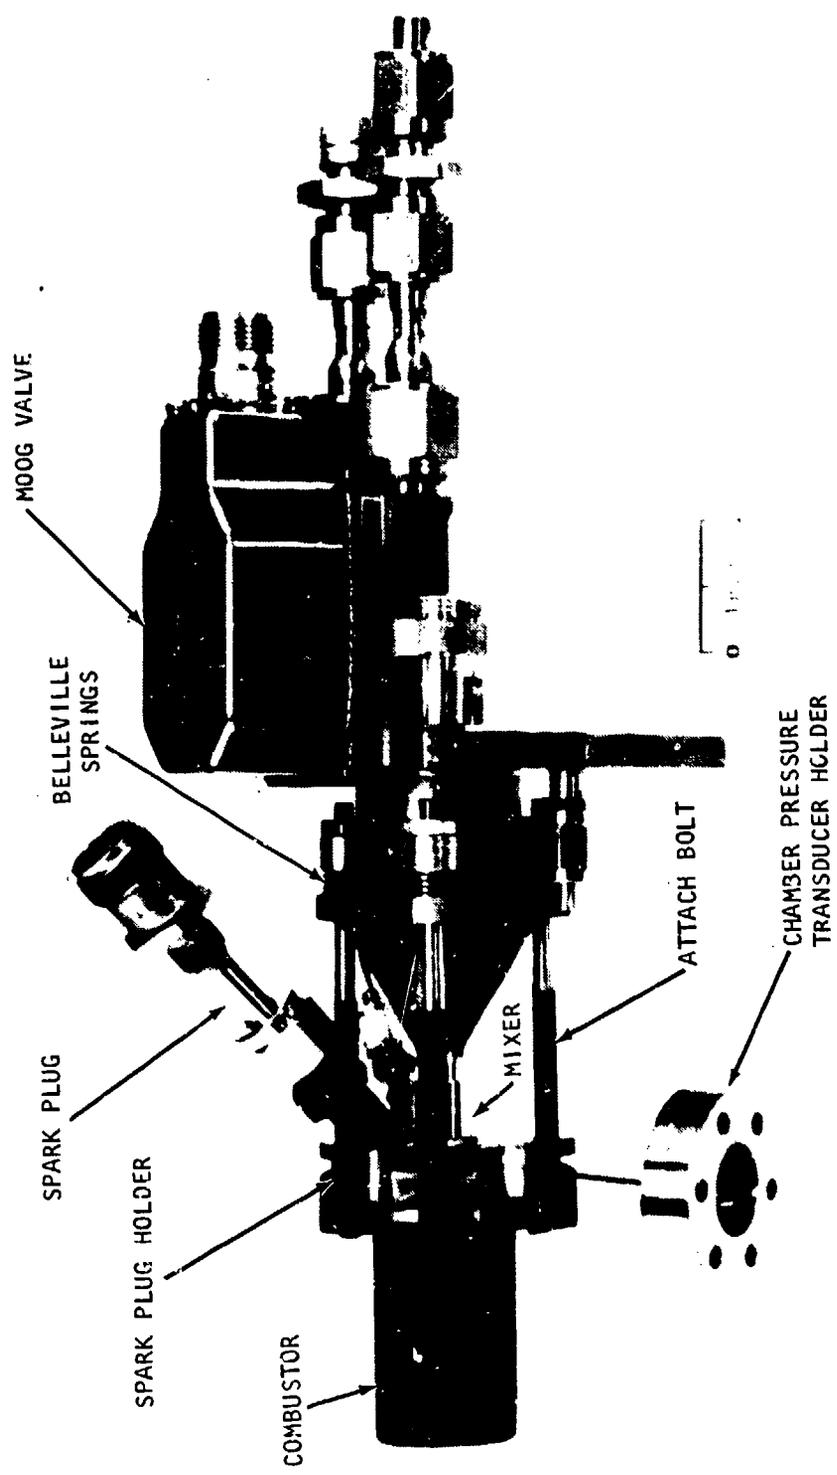
Figure 73. Flightweight 0.1 Lbf. Engine No. 2 Assembly

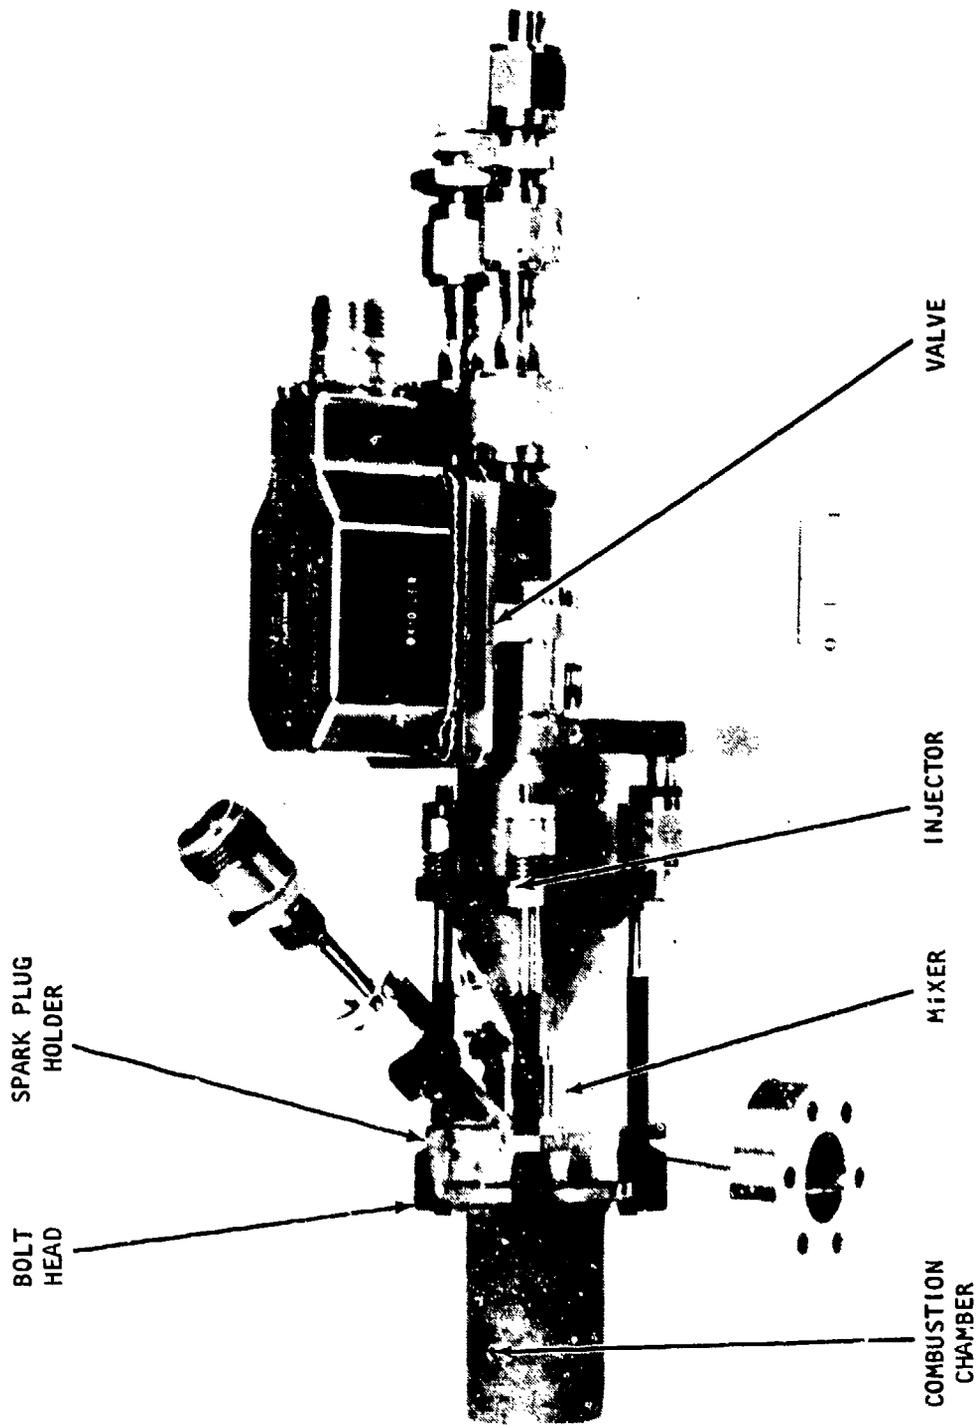
Figure 74. Location of Thermocouples on Flightweight Engine No. 2

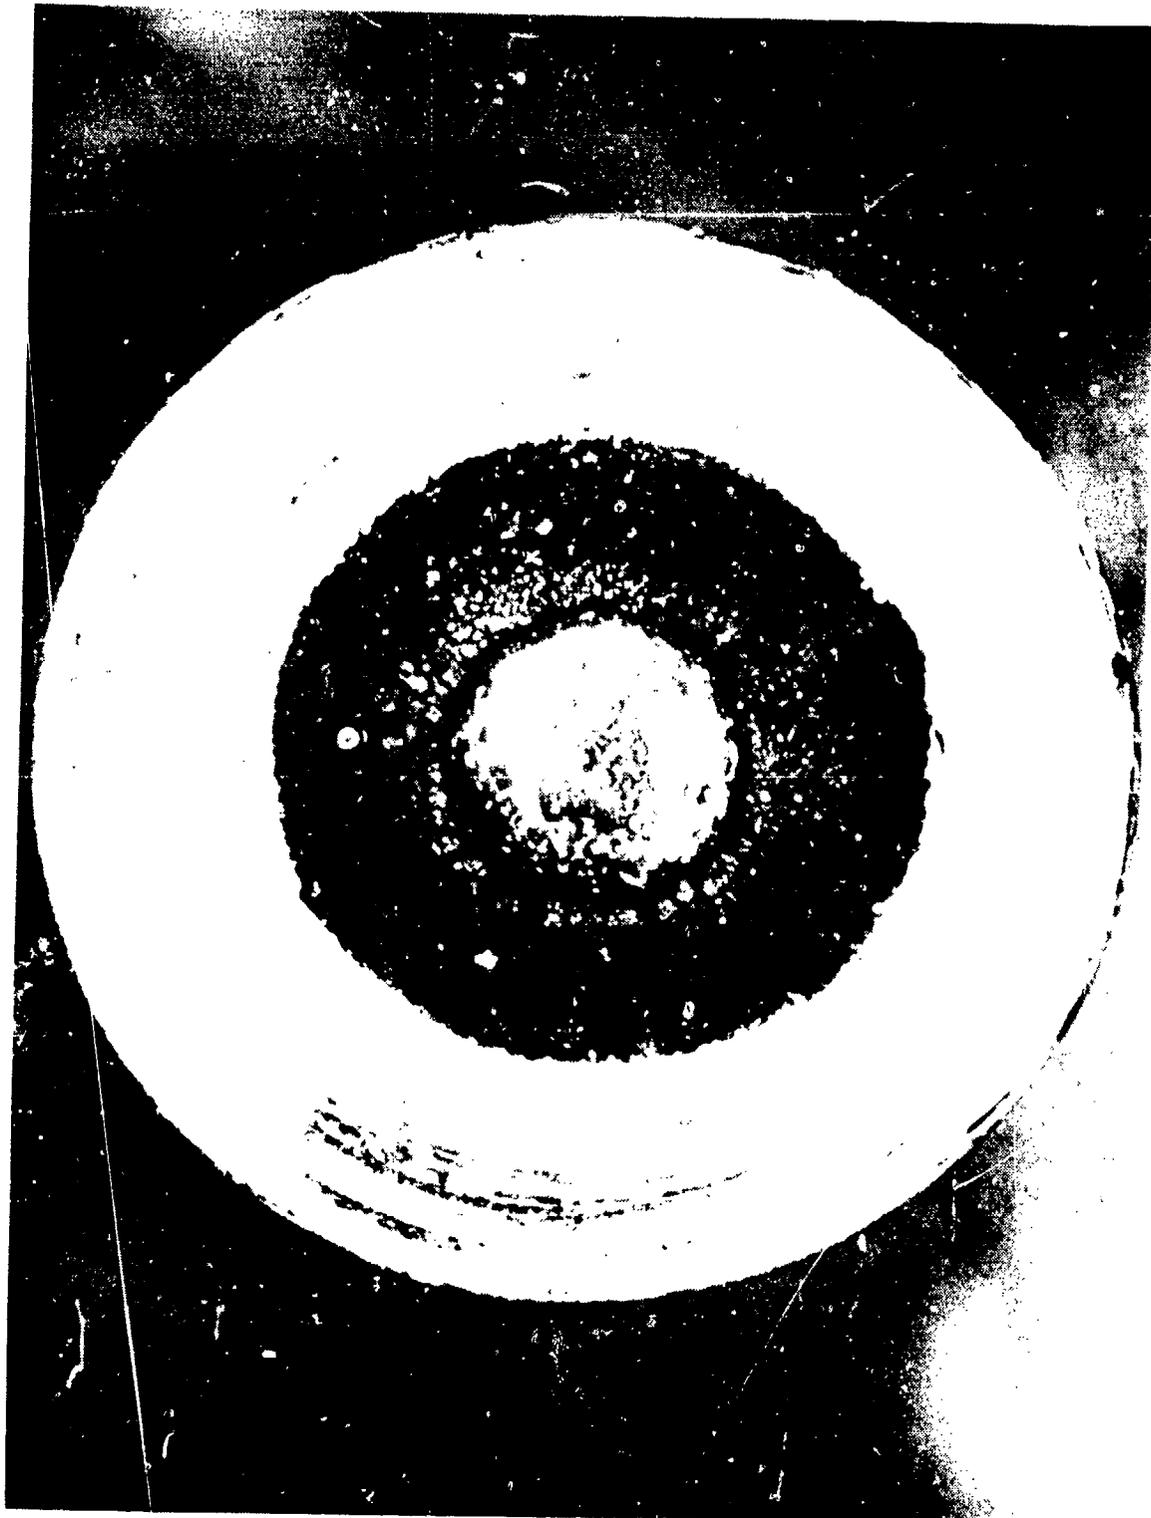
Figure 82. Spark Plug After Run 255 (301,728 Accumulated Pulses)

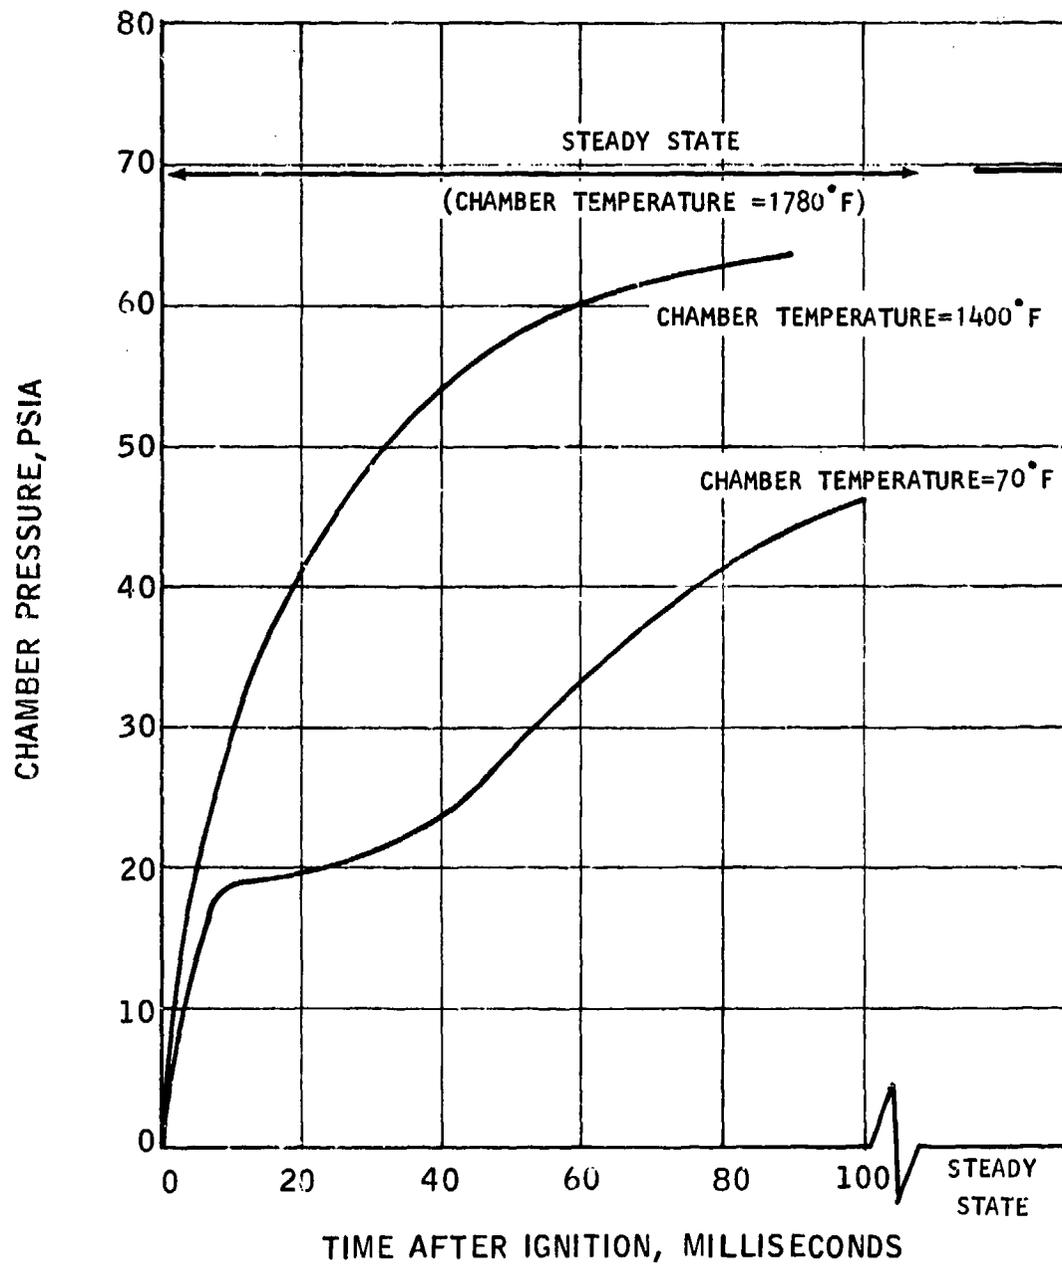
Figure 83. 0, 1 Lbf. Engine Chamber Pressure Rise

A low volume holder for the chamber pressure transducer was connected to the spark plug holder through a 0.026 inch ID tube. The volume in the chamber pressure transducer on the heavyweight engine had been 10.6 times as large as the combustion chamber volume. The time to reach 90% of chamber pressure had been observed to be as much as 500 milliseconds for a cold heavyweight combustor. Pressure rise was faster with a hotter combustor. It was surmised that the combustion gas entering the pressure transducer line was being quenched, causing a slow chamber pressure rise.

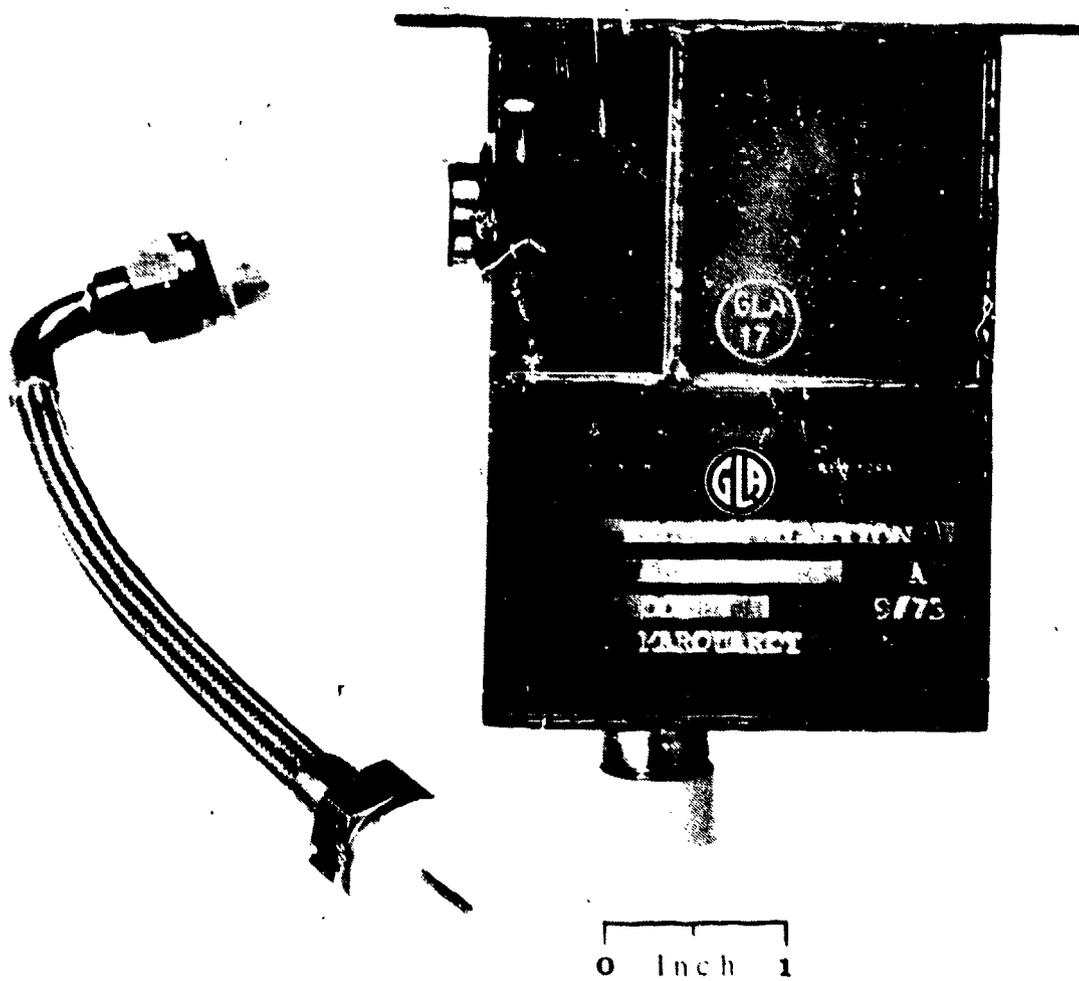
Figure A1. Flight Type Exciter

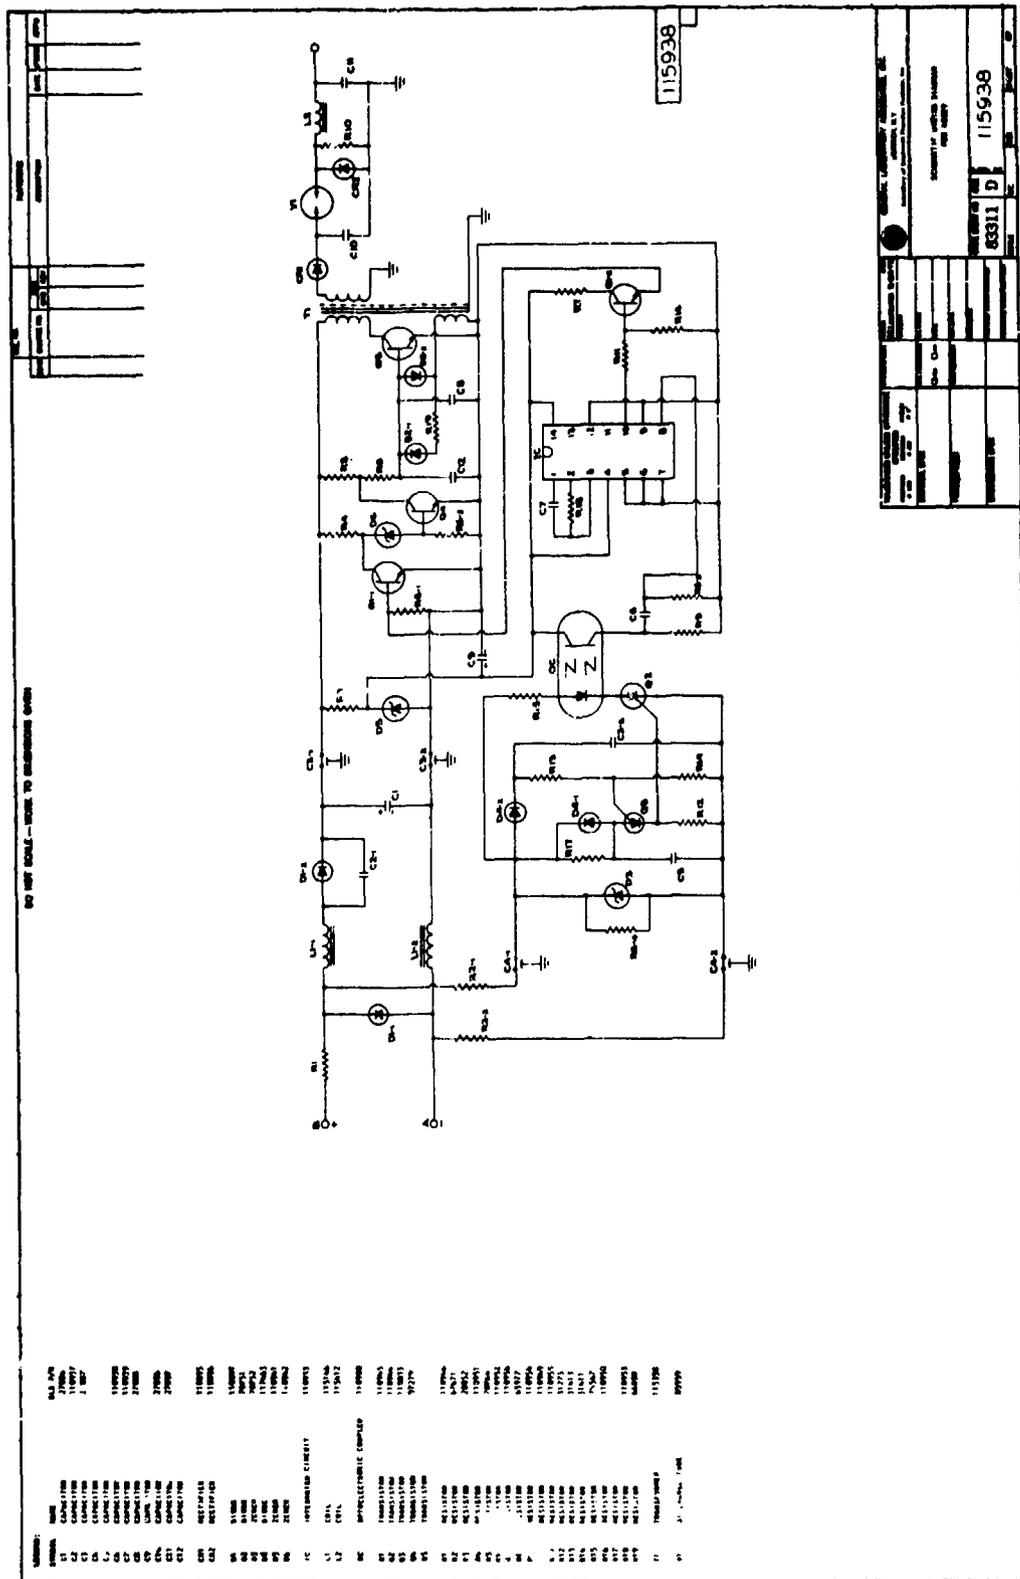
Figure A2. Schematic Wiring Diagram for Flightweight Igniter

The Delay Circuit is basically a programmable Unijunction Oscillator (Q3). Its standoff ratio is set by the ratio of R13/R14. The delay is set by the RC network R17, C5. When the charge on C5 reaches the firing point, Q3 conducts.

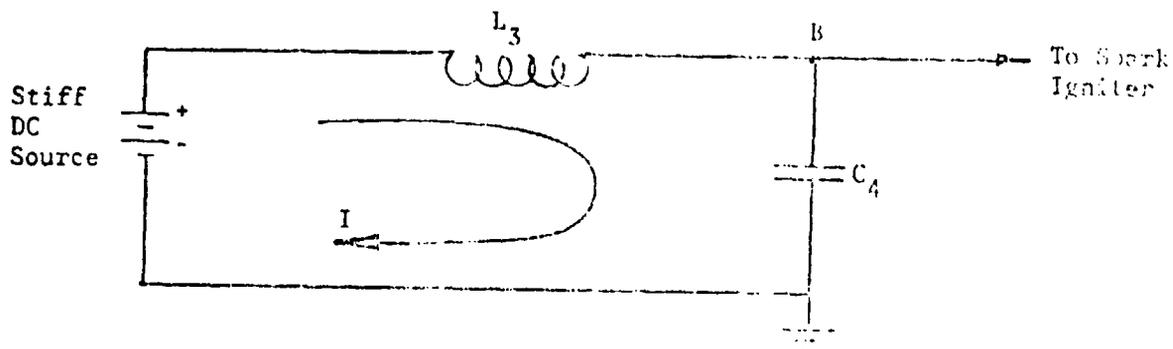
Figure A6. Resonant Charging Circuit

The circuit of Figure A5 can be simplified for analysis as follows (see Figure A6). When the Gap V_1 fires, it is a short circuit and can be eliminated from the circuit. Capacitor C_3 has a much larger capacity than C_4 and can be considered a stiff DC source during the period of time we are considering (time from Gap firing to Plug firing). What remains is the resonant charging circuit of Figure A6.

If the circuit of Figure A-6 were allowed to continue undisturbed, C4 would discharge back to the source voltage with the discharge current again building up a magnetic field about L3. This field would begin to collapse when $V_B = V_A$ and cause the discharge current to continue flowing in the same direction. V_B is less than V_A when the field is completely collapsed, and C4 will again start to charge to the source voltage. This process would continue with energy being gradually lost until the condition is reached where $V_B = V_A$, and there is no energy stored in the magnetic field. The spark ignitor will fire somewhere between O and X on the V_B curve (see Figure A7).

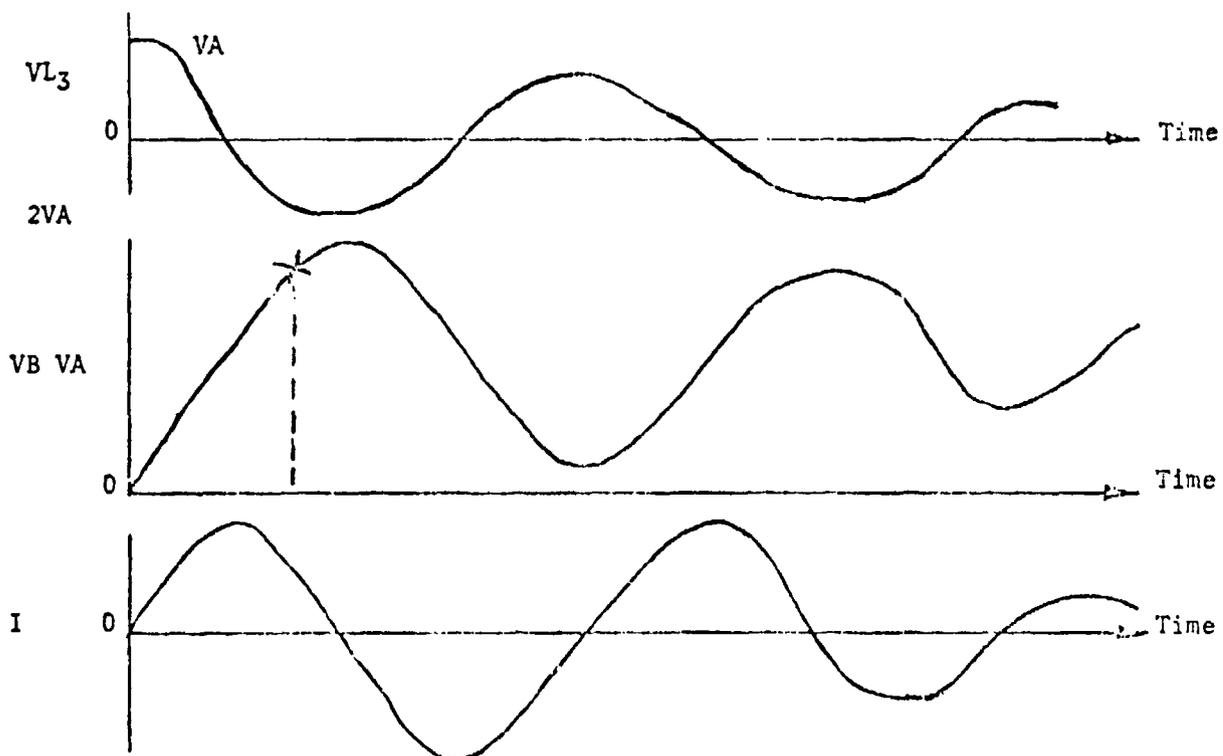
Figure A7. Voltage and Current Transients

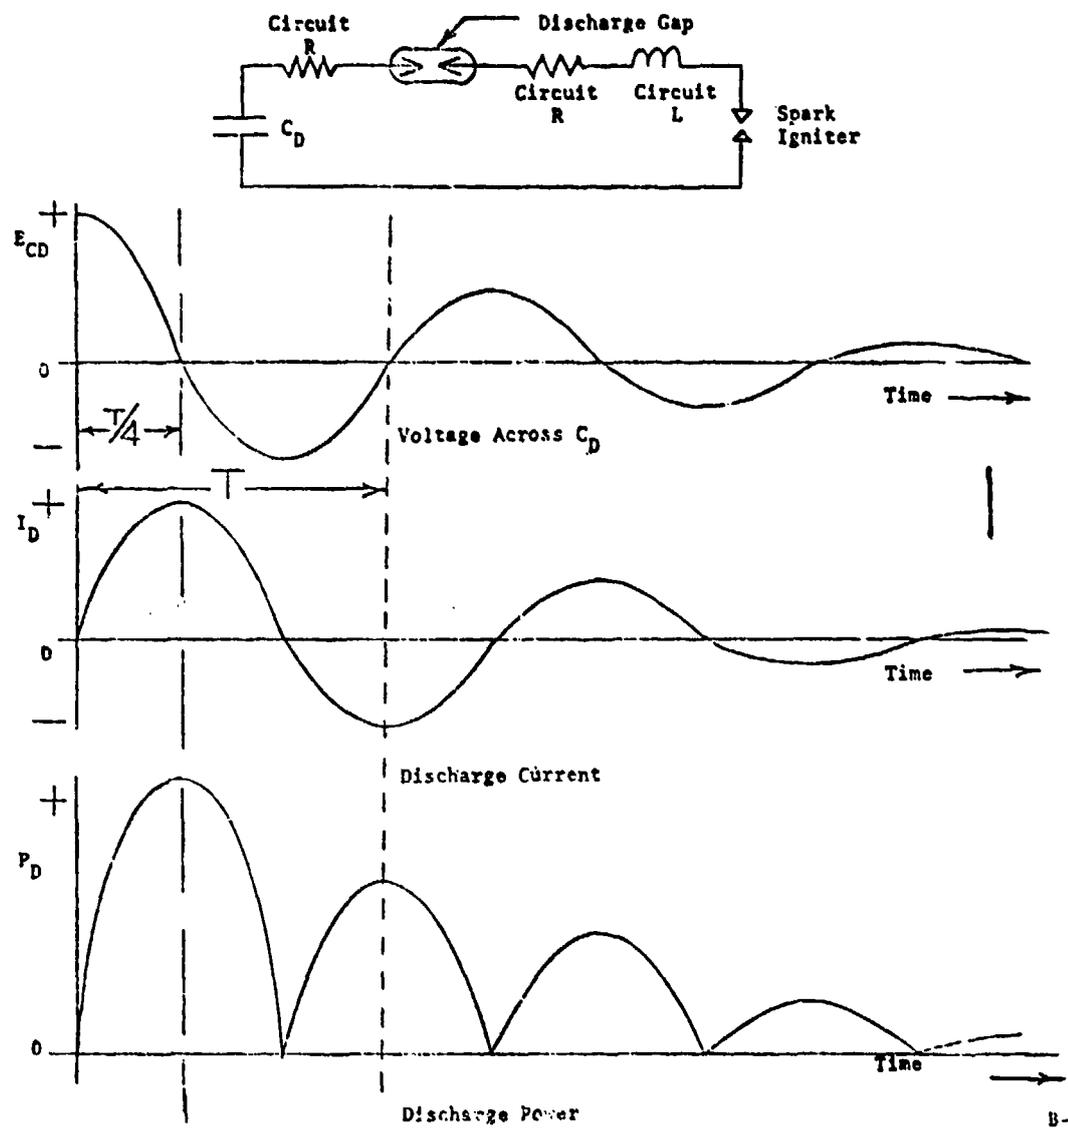
Figure A9. Characteristics of Oscillatory Discharge Circuit

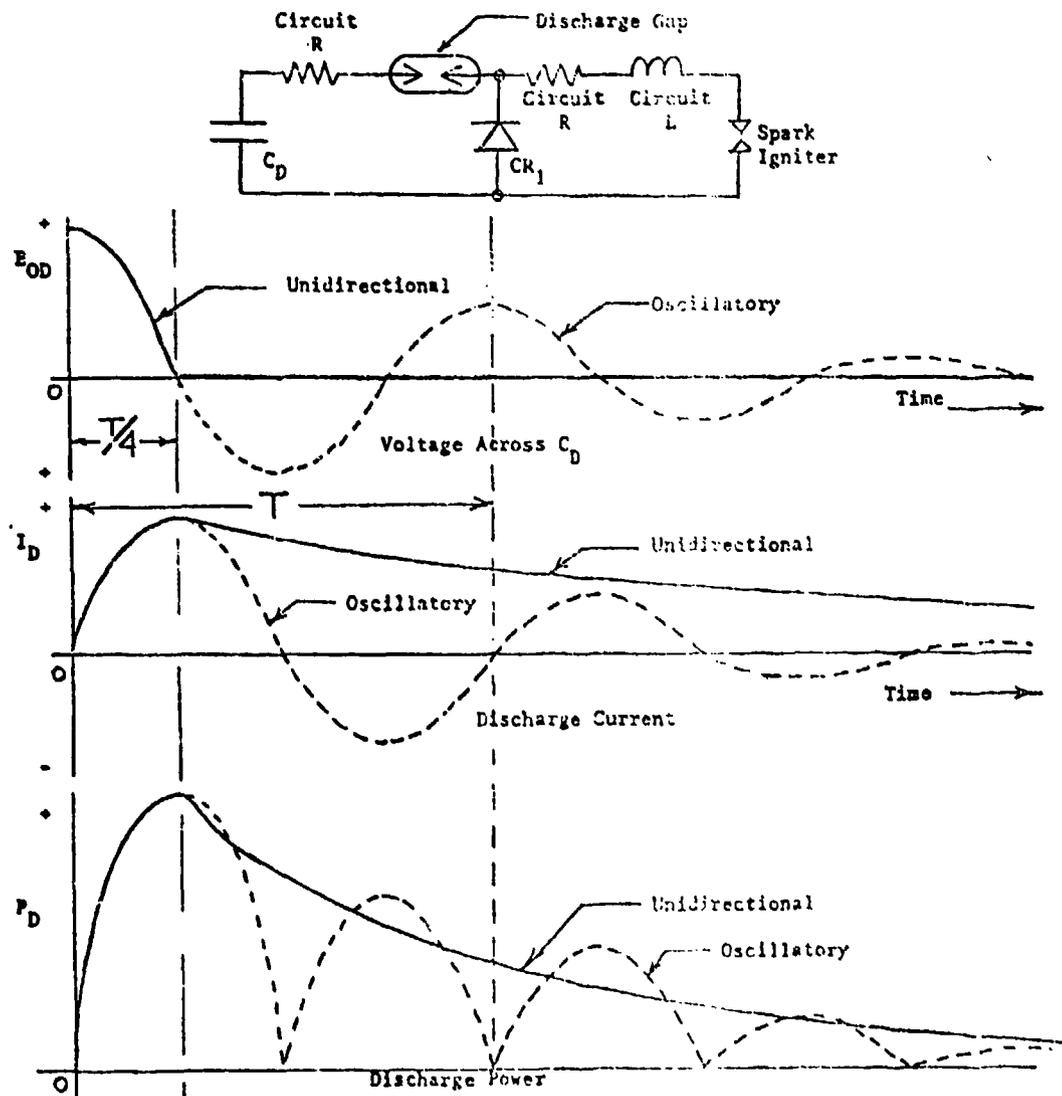
Figure A11. Characteristics of Unidirectional Discharge Circuit

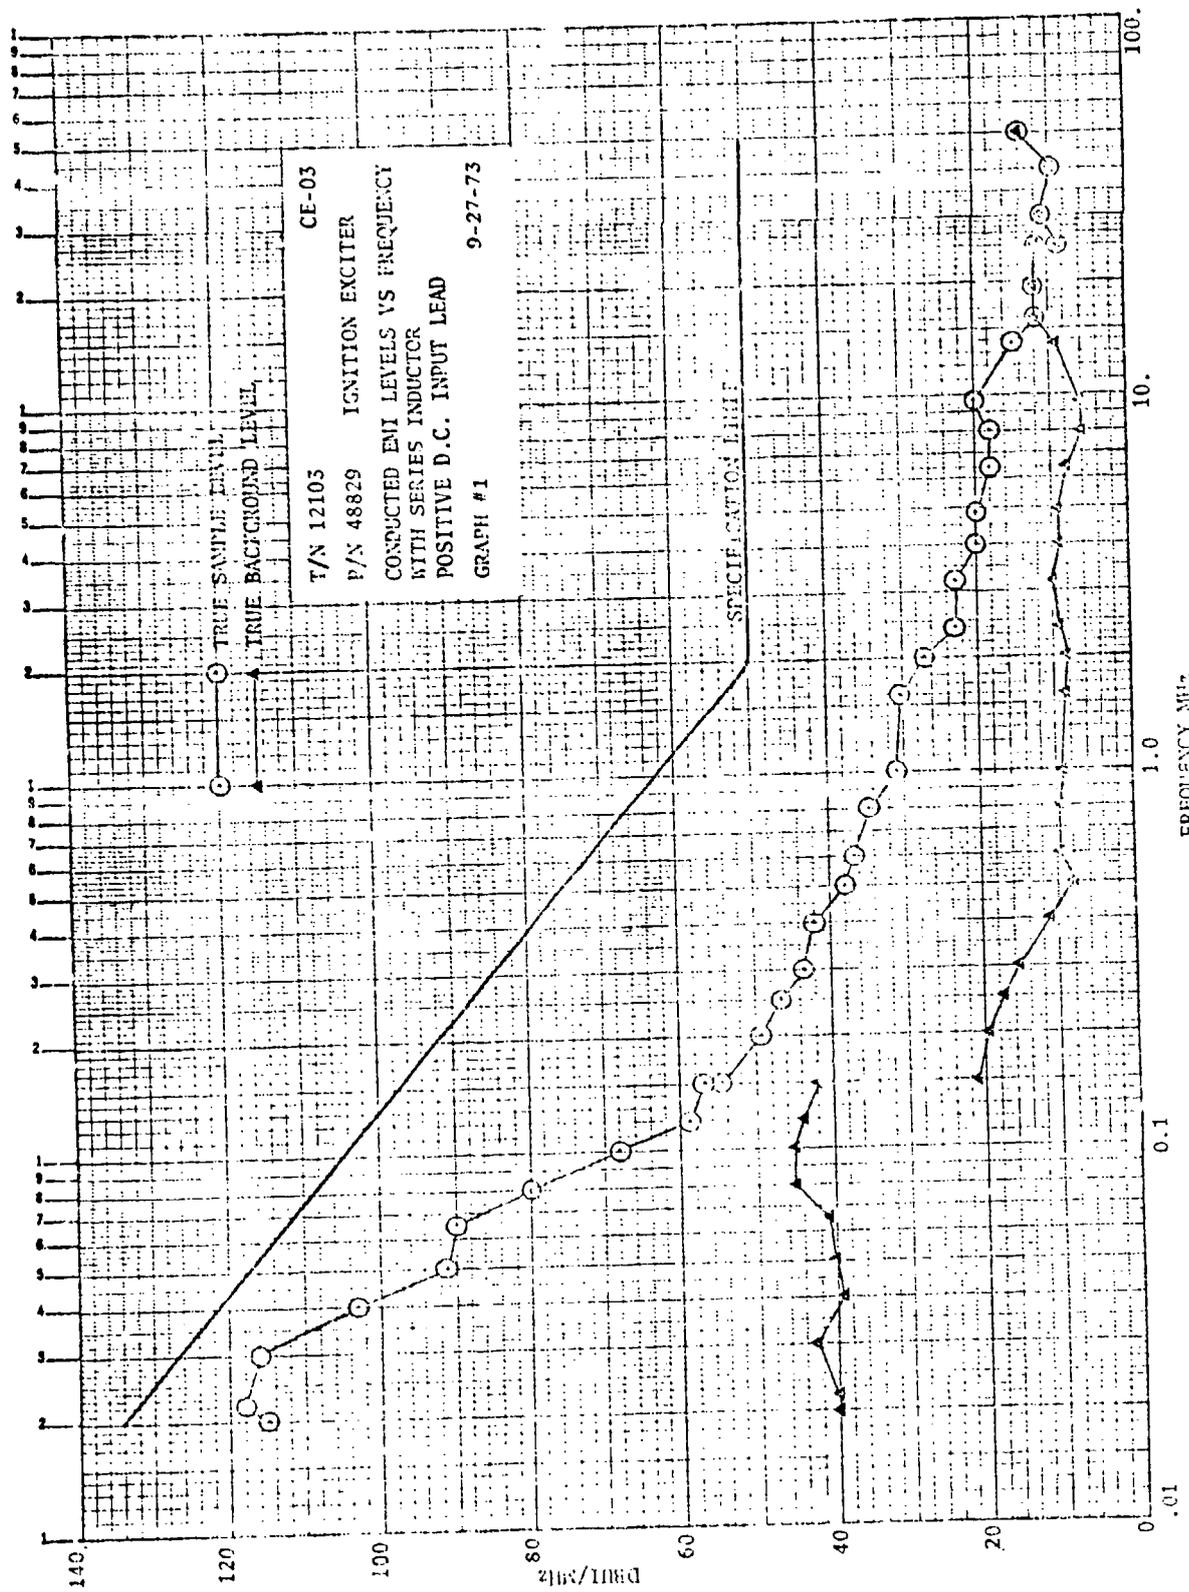
Figure B3. EMI Levels Vs. Frequency, Positive D.C. Input
