WATER ELECTROLYSIS PROPULSION SYS-
TEM TESTING

John G. Campbell, et al

Marquardt Company

REPORT DOCUMENTATION PAGE		READ INSTRUCTIONS BEFORE COMPLETING FORM
1. REPORT NUMBER AFRPL-TR-74-72	2. GOVT ACCESSION NO.	3. RECIPIENT'S CATALOG NUMBER
4. TITLE (and Subtitle) Water Electrolysis Propulsion System Testing		5. TYPE OF REPORT & PERIOD COVERED Final Report October 72 - July 74

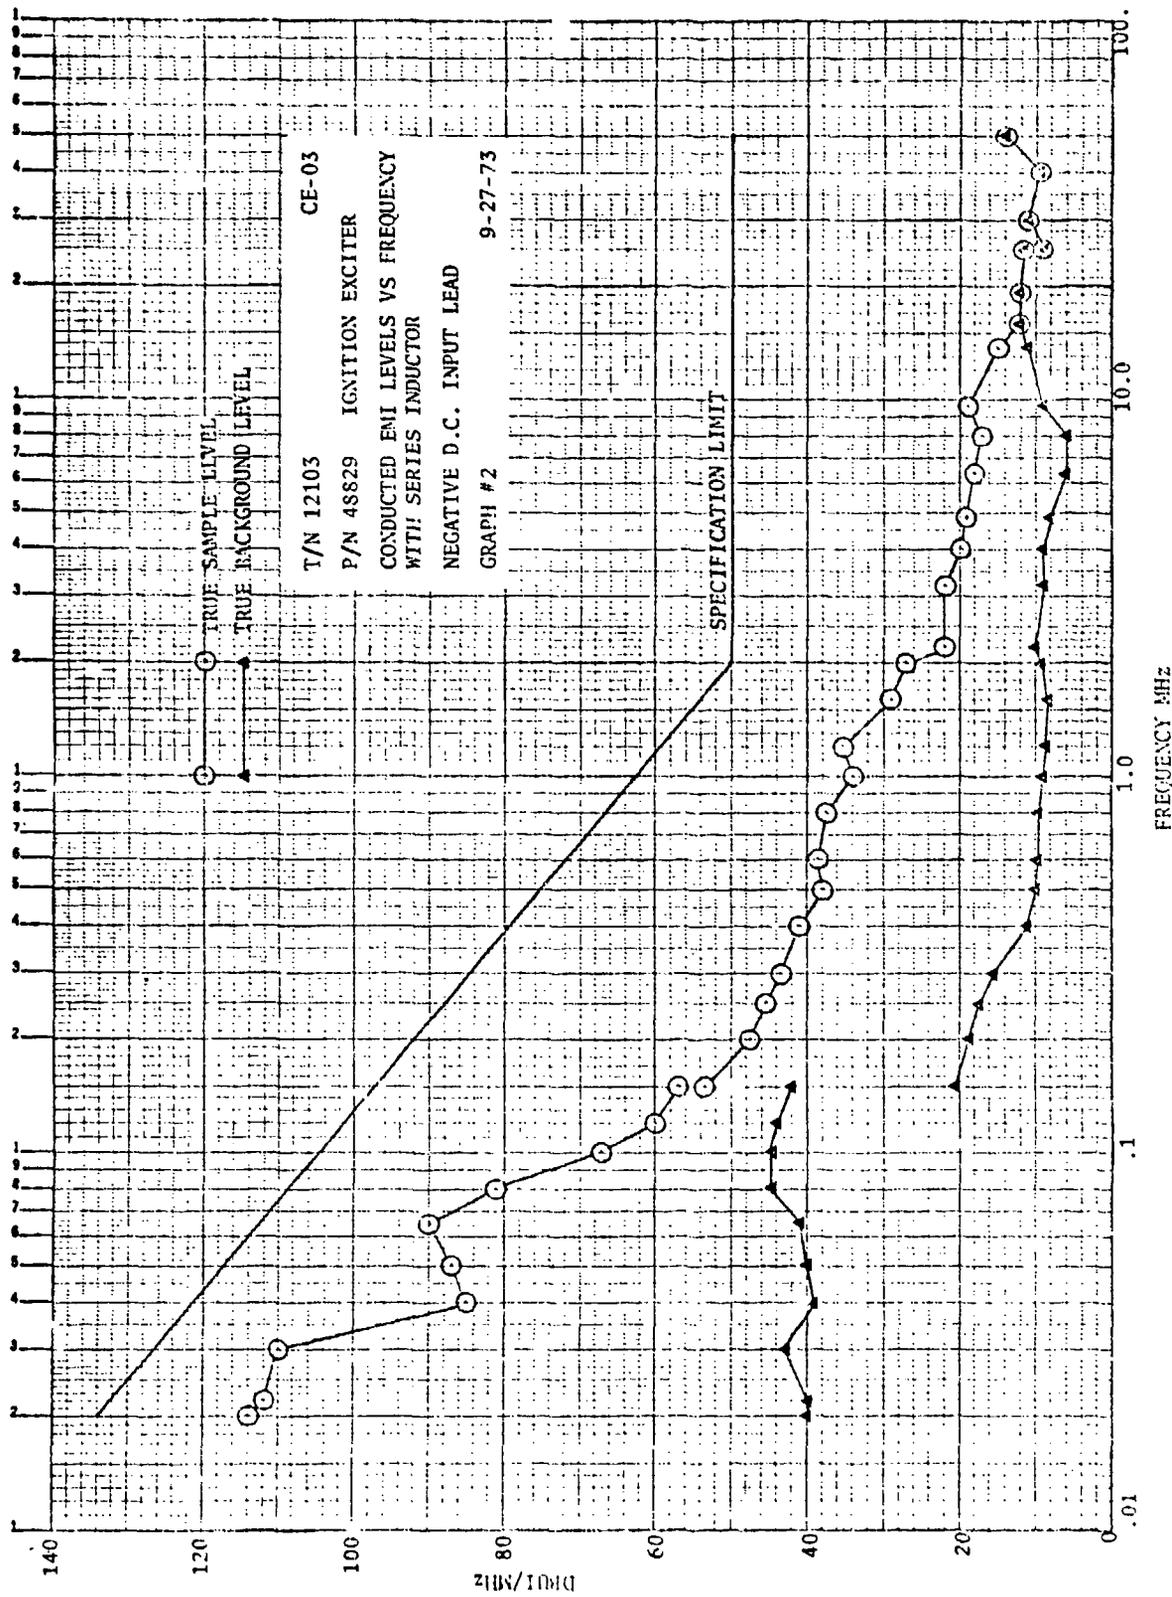
Figure B4. EMI Levels Vs. Frequency, Negative D.C. Input

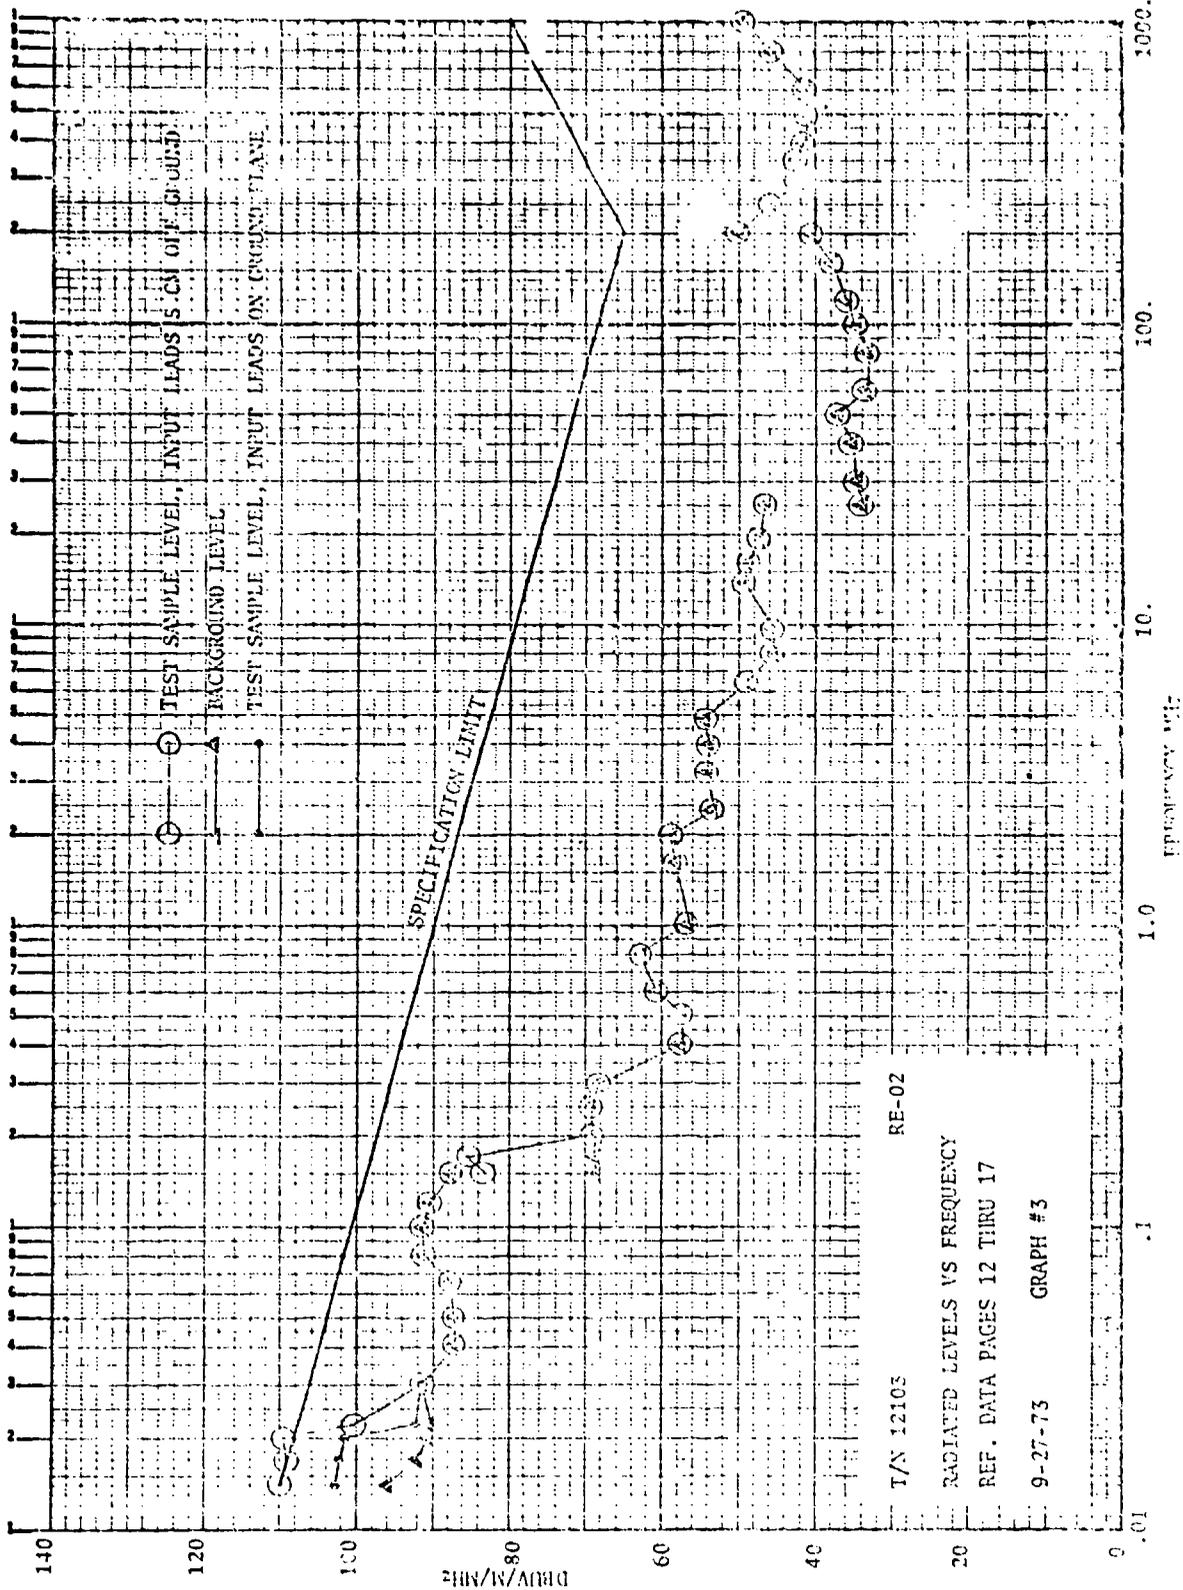
TEST NO. 12103

Figure B5. Radiated Levels Vs. Frequency
