A-7 ALOFT HARDWARE REQUIREMENTS ENVIRONMENTAL
ANALYSIS

G. Holma

Naval Electronics Laboratory
San Diego, California

20. ABSTRACT (Continue on reverse side if necessary and identify by block number) Environmental and operational testing of a fiber-optic interface was conducted to determine suitability of fiber-optic cables, connectors, and LED module for use aboard the A-7 aircraft.

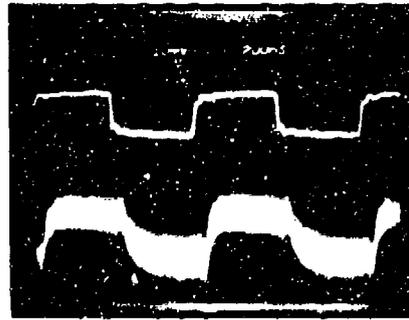
Figure D-2. System output at 85°C at sea level.

Photographs were taken of the light output of System 1 at frequencies of 100 KHz, 1 MHz, and 10 MHz. The LED module power supply was 5.0 volts. The input voltage was 0.8 volts for "0" and 2.0 volts for "1" logic levels. Inputs at 1 MHz are shown in the top trace of each figure. The output of the system is shown in the bottom trace of each figure as it was detected by a silicon avalanche photo-diode (TIXL55) operated at 180 volts.

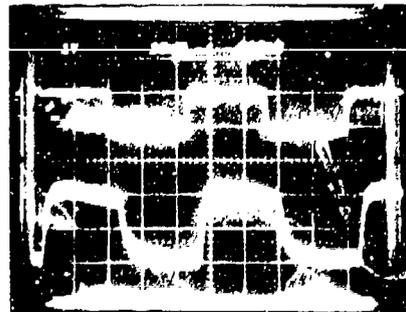
Figure D-5. System output at -54°C at 70,000 feet.
