ARMY PRELIMINARY EVALUATION YAH-1Q HELICOPTER WITH
A FLAT-PLATE CANOPY

USAAEFA PROJECT NO. 75-18

FINAL REPORT

AUGUST 1975

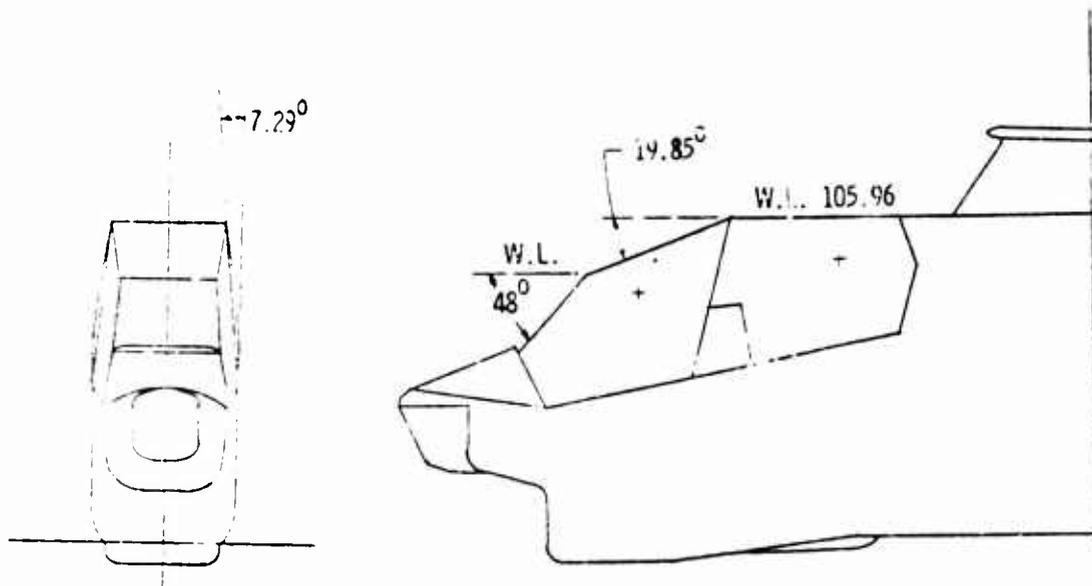
Figure 1. YAH-1Q with Seven-Plane Geometry (Flat-Plate) Canopy.

The test helicopter, serial number 70-16019, was a production AH-1G helicopter that was modified with an ICAS and redesignated a YAH-1Q. A detailed description of the AH-1Q is included in references 3 and 4, appendix A. The YAH-1Q was further modified by the installation of a seven-plane geometry (flat-plate) canopy. The flat-plate canopy is shown in the following figure and photographs.

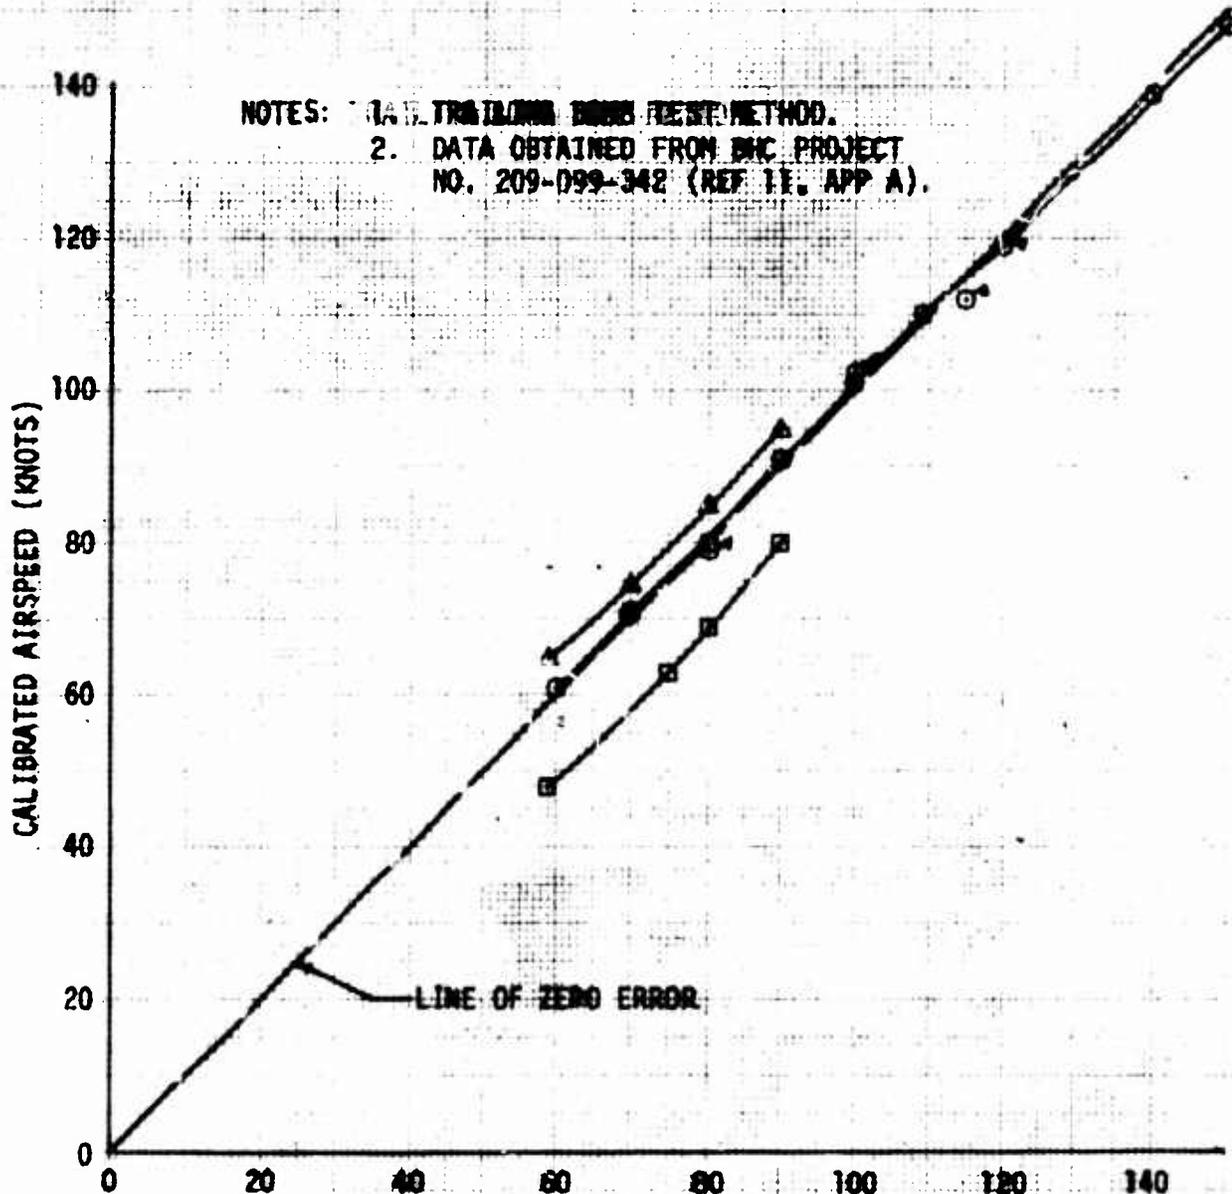
FIGURE 1
AIRSPEED CALIBRATION
MM-18 USA S/N 70-10019
(FLAT-PLATE CROFT)
WEP'S STANDING SYSTEM

SYMBOL	AVG GROSS WEIGHT (LB)	AVG CG LOCATION (IN.)	AVG DENSITY ALTITUDE (FT)	AVG OAT (°C)	AVG MOTOR SPEED (RPM)	AVG CT	FLIGHT COND	CONFIGURATION
○	8000	201.5(AFT)	5500	18	324	0.004681	LEVEL	CLEAN
○	9500	192.5(FWD)	3000	20	324	0.004788	LEVEL	HOG
□	8000	201.5(AFT)	5500	18	324	0.004681	CLIMB	CLEAN
▲	8000	201.5(AFT)	5500	18	324	0.004681	AUTO	CLEAN

NOTES: 1. TRAILING WIRE METHOD.
 2. DATA OBTAINED FROM DMC PROJECT NO. 209-099-342 (REF 11, APP A).

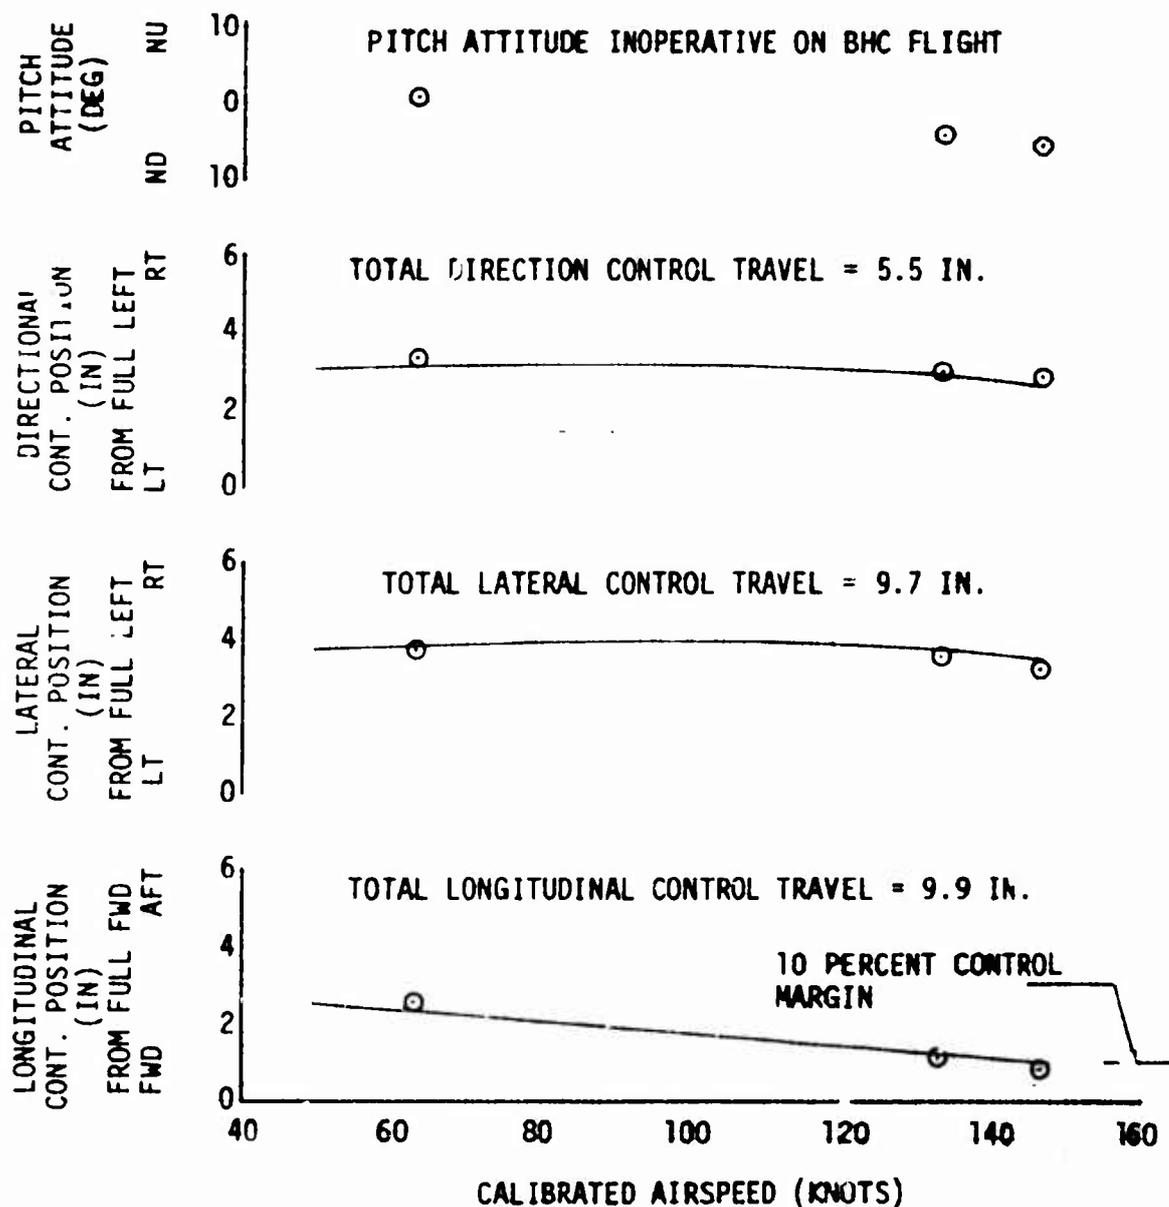
AVG. GROSS WEIGHT (LB)	AVG. C.G. LOCATION (IN)	AVG. DENSITY ALTITUDE (FT)	AVG. OAT (°C)	AVG. ROTOR SPEED (RPM)	AVG. C_T	CONFIGURATION
7720	201.5(AFT)	5250	21.5	324	0.004483	CLEAN

NOTE: Curves obtained from Bell Helicopter Project No. 209-099-342 (ref 11, app A)

8. Control positions in trimmed forward flight were investigated in conjunction with level flight performance testing. The results are presented in figures 1 and 2, appendix E, in conjunction with data obtained by BHC. In the clean configuration (fig. 1) the forward longitudinal control margin was less than 10 percent at V_H . This is a reduction of approximately 0.8 inch longitudinal control margin from the AH-1G at similar test conditions. The lack of sufficient longitudinal control margin was also evidenced during the static longitudinal and maneuvering stability tests (paras 9 and 14, respectively). The insufficient forward longitudinal control margin in the clean configuration (aft cg) at V_H is a shortcoming. The lack of

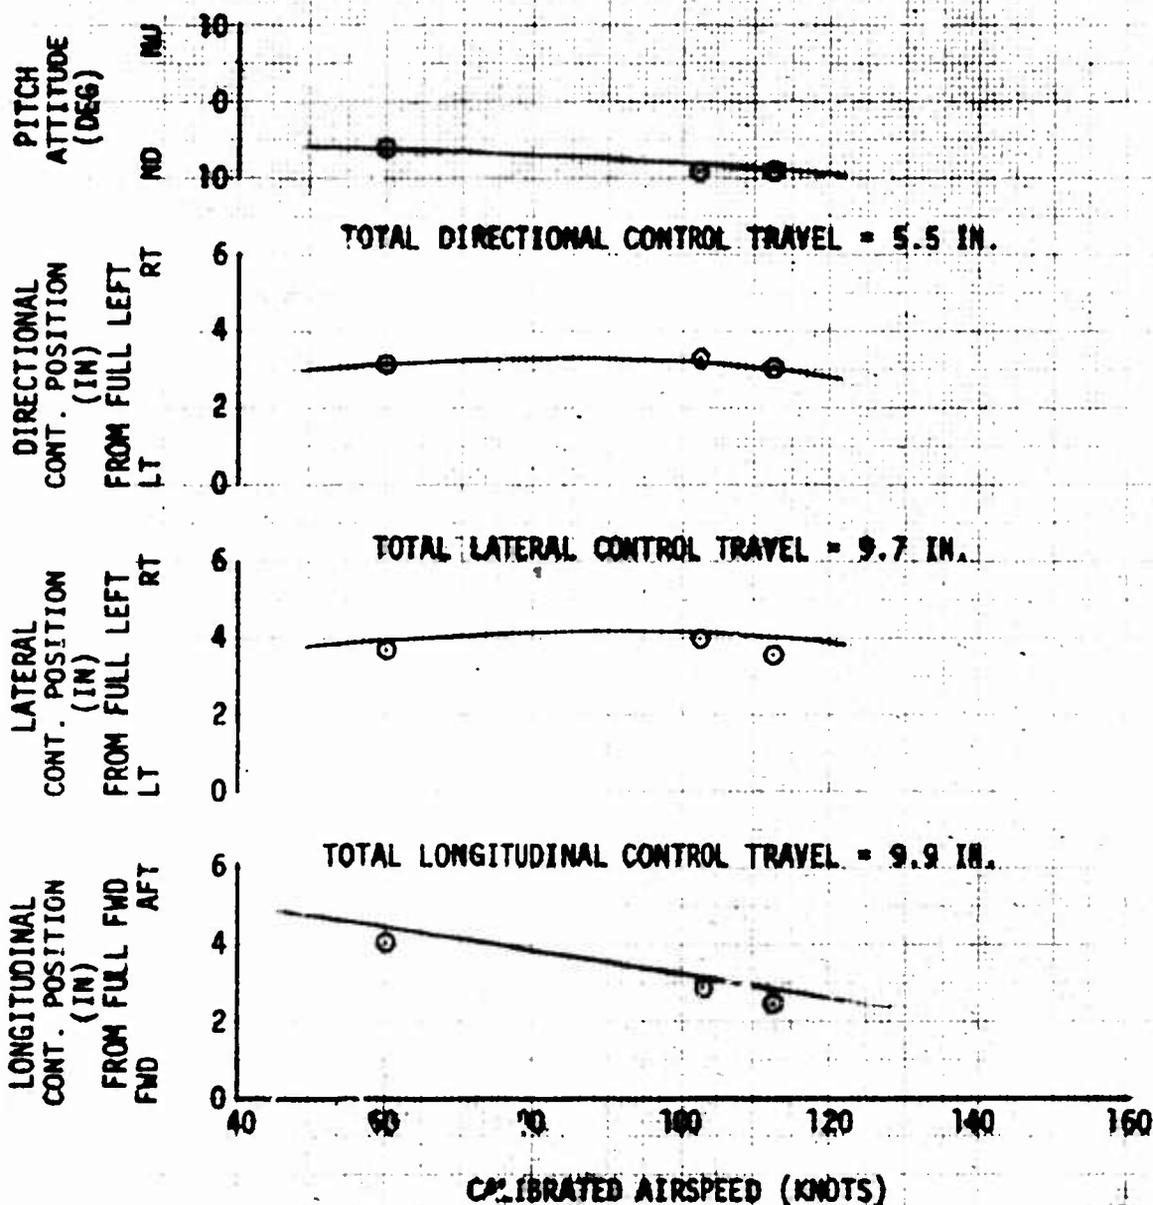
FIGURE 2
CONTROL POSITIONS IN TRAINED FORWARD FLIGHT
500-1000 RPM (100-120 KTS)
(FULL-PLANE CONTROL)

WEIGHT (LB)	AVG. C.G. LOCATION (IN)	AVG. DENSITY ALTITUDE (FT)	AVG. OAT (°C)	AVG. ROTOR SPEED (RPM)	AVG. C_T	CONFIGURATION
95	192.8 (FWD)	4600	21.5	324	0.005886	MOS

NOTE: Curves obtained from Bell Helicopter
 Project No. 209-099-302 (ref TT, app A)

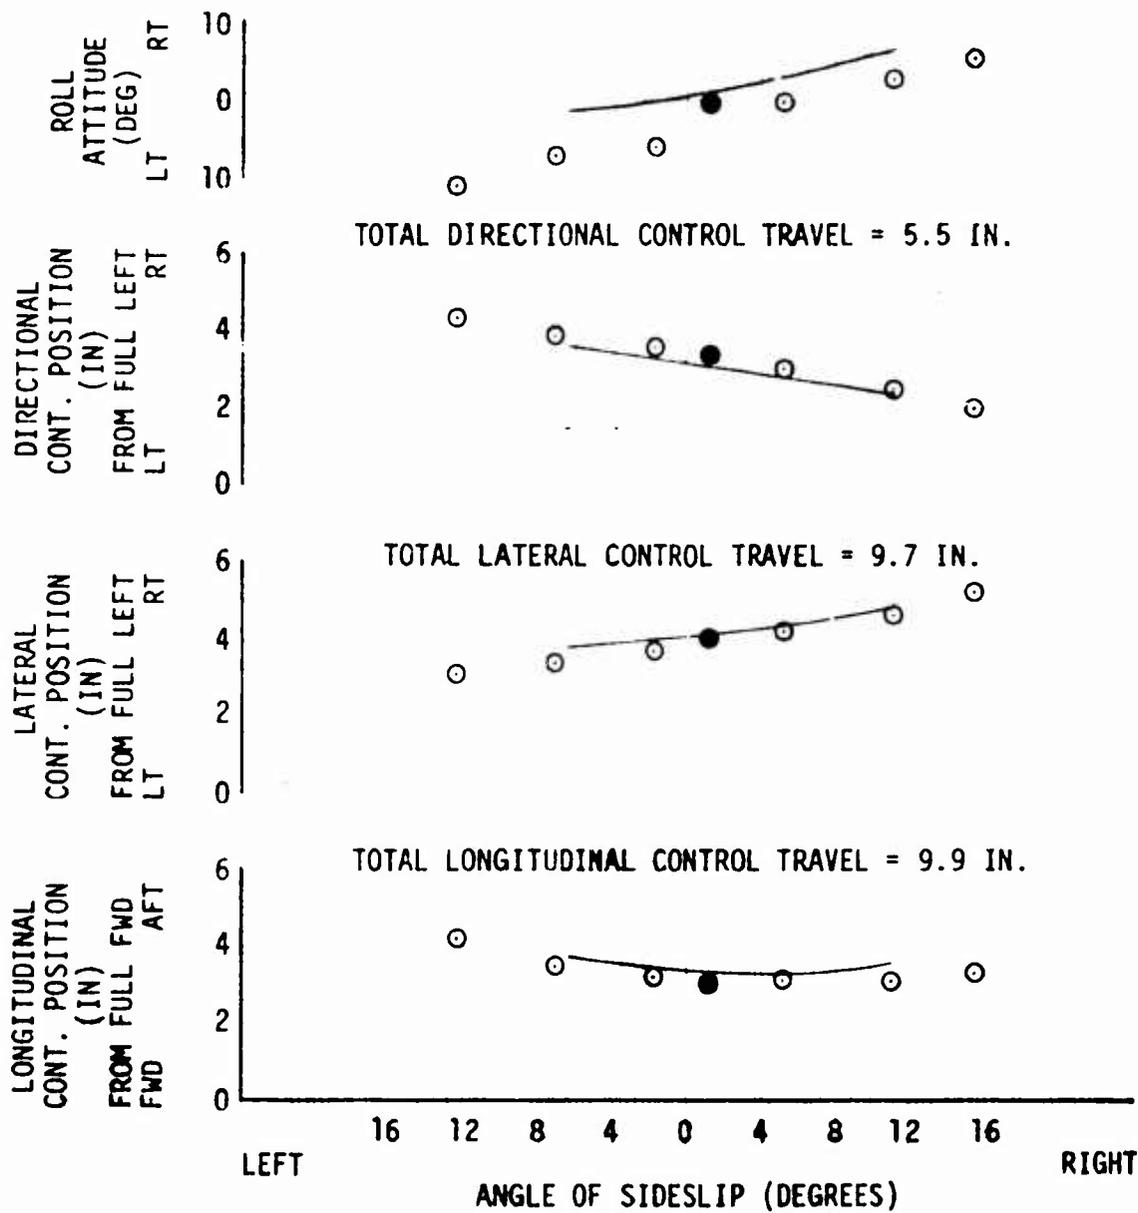
STATIC LATERAL - DIRECTION STABILITY
 YAH-1Q USA S/N 70-16019
 (FLAT-PLATE CANOPY)

AVG. GROSS WEIGHT (LB)	AVG. C.G. LOCATION (IN)	AVG. DENSITY ALTITUDE (FT)	AVG. OAT (°C)	AVG. ROTOR SPEED (RPM)	TRIM CALIB. A/S (KTS)	FLIGHT CONDITION	CONFIGURATION
9500	192.5(FWD)	4620	21.5	324	102	LEVEL	HOG

NOTE: 1) Shaded symbols denote trim
 2) Curves obtained from Bell Helicopter Project No. 209-099-342

10. Static lateral-directional stability characteristics were evaluated at the conditions listed in table 1. The tests were conducted by tracking a straight-line ground reference while stabilized at incremental sideslip angles. Control positions were recorded with the aircraft stabilized in steady-heading sideslips at the trim airspeed with the collective control fixed. Test results are presented in figures 5 and 6, appendix E.

11. For both configurations the helicopter exhibited positive directional stability (left pedal required during right sideslip). However, when the directional stability gradient of the YAH-1Q with a flat-plate canopy was compared to the AH-1G at similar test conditions, a significant loss in directional stability was evidenced (table 2). Both the flat-plate canopy and the TSU could contribute to the loss in directional stability but individual contributions cannot be determined from this test. The reduction in directional stability was qualitatively noted throughout the test, but was most noticeable in the clean configuration. During simulated attack dives in both configurations, considerable pilot compensation was required to maintain coordinated (ball-centered) flight, which is necessary for accurate delivery of 2.75-inch rockets (HQRS 5). The weak static directional stability is a shortcoming. Further testing should be conducted to determine the effect of the decreased directional stability on the accuracy of rocket fire.

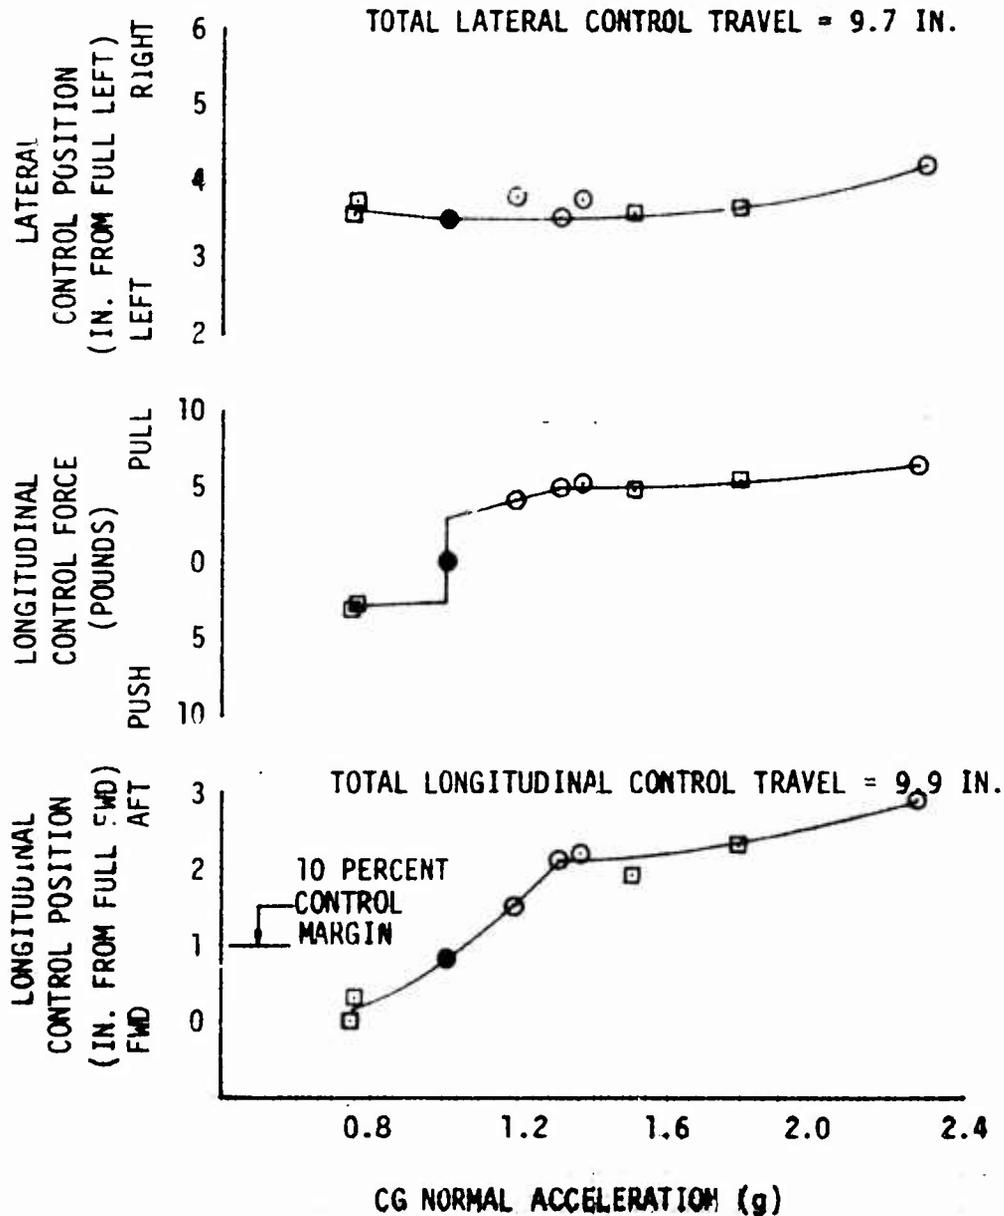
MANEUVERING STABILITY
YAH-1Q USA S/N 70-16019
(FLAT-PLATE CANOPY)

AVG GROSS WEIGHT (LB)	AVG CG LOCATION (IN.)	AVG DENSITY ALTITUDE (FT)	AVG OAT (°C)	ROTOR SPEED (RPM)	TRIM CALIB. A/S (KTS)	FLIGHT CONDITION	CONFIGURATION
7720	201.5(AFT)	5060	21.0	324	133.0	LEFT TURN	CLEAN

- NOTES: 1. SHADED SYMBOLS DENOTE TRIM
 2. LONGITUDINAL CONTROL FORCE DATA OBTAINED FROM FIGURE 9
 3. SQUARE SYMBOLS DENOTE SYMMETRICAL PUSH-OVER/PULL-UP

14. Maneuvering stability characteristics were evaluated at the conditions listed in table 1. Steady turns (left and right), pushovers, and pull-ups were used to determine the variation of longitudinal control position and force with normal acceleration. The results are presented in figures 7 and 8, appendix E. The longitudinal control force characteristics were determined on the ground with rotors stopped and hydraulic and electrical power supplied by external sources. The longitudinal control force versus position characteristics about trim (fig. 9) were used in conjunction with in-flight measurement of longitudinal control positions to determine the longitudinal control forces during maneuvering stability tests. The

variation of longitudinal control position and control force with normal acceleration in the clean configuration was positive (aft control movement and pull force with increasing load factor) and essentially unchanged from the AH-1G. The change in the maneuvering stability gradient at 1.3g represents the limit of the longitudinal SCAS authority and normal accelerations above that load factor represent the basic helicopter (SCAS OFF) maneuvering stability. During pushover maneuvers to obtain normal accelerations less than 1.0g, the forward longitudinal control limit was reached. In the test configuration, insufficient forward longitudinal control margin was available to develop normal accelerations less than 0.75g. This characteristic amplifies the shortcoming discussed in paragraph 8.

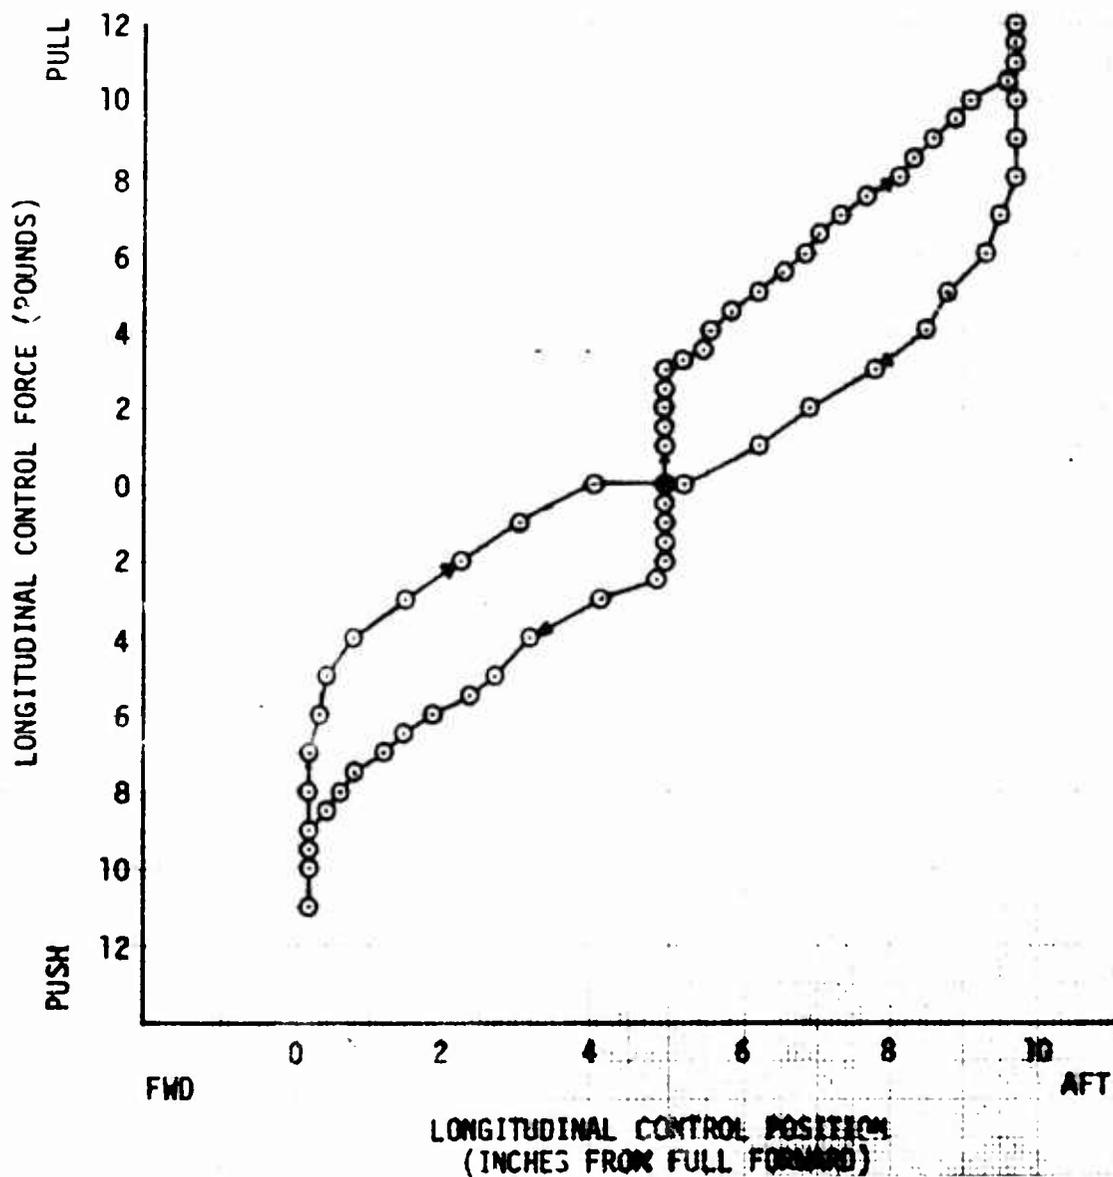
FIGURE 9
LONGITUDINAL CONTROL SYSTEM CHARACTERISTICS
YAN-10 USA S/N 70-16019
(FLAT-PLATE CANOPY)

- NOTES: 1. ROTOR STATIC
 2. FORCES MEASURED AT CENTER OF GRIP
 3. HYDRAULIC AND ELECTRICAL POWER PROVIDED BY GROUND POWER UNITS
 4. NO. 1 and NO. 2 BOOST SYSTEMS ON
 5. SOLID SYMBOL DENOTES TRIM POINT
 6. LATERAL CONTROL POSITION 4.85 INCHES FROM FULL LEFT
 7. TOTAL LONGITUDINAL CONTROL DISPLACEMENT = 9.9 INCHES
 8. FORCE TRIM ON
 9. HAND RECORDED DATA
