DEVELOPMENT OF A BACKUP COVER FOR THE AH-1 CANOPY  
REMOVAL SYSTEM

Teledyne McCormick Selph

REPORT USA AVSCOM TR-75-49

FINAL REPORT

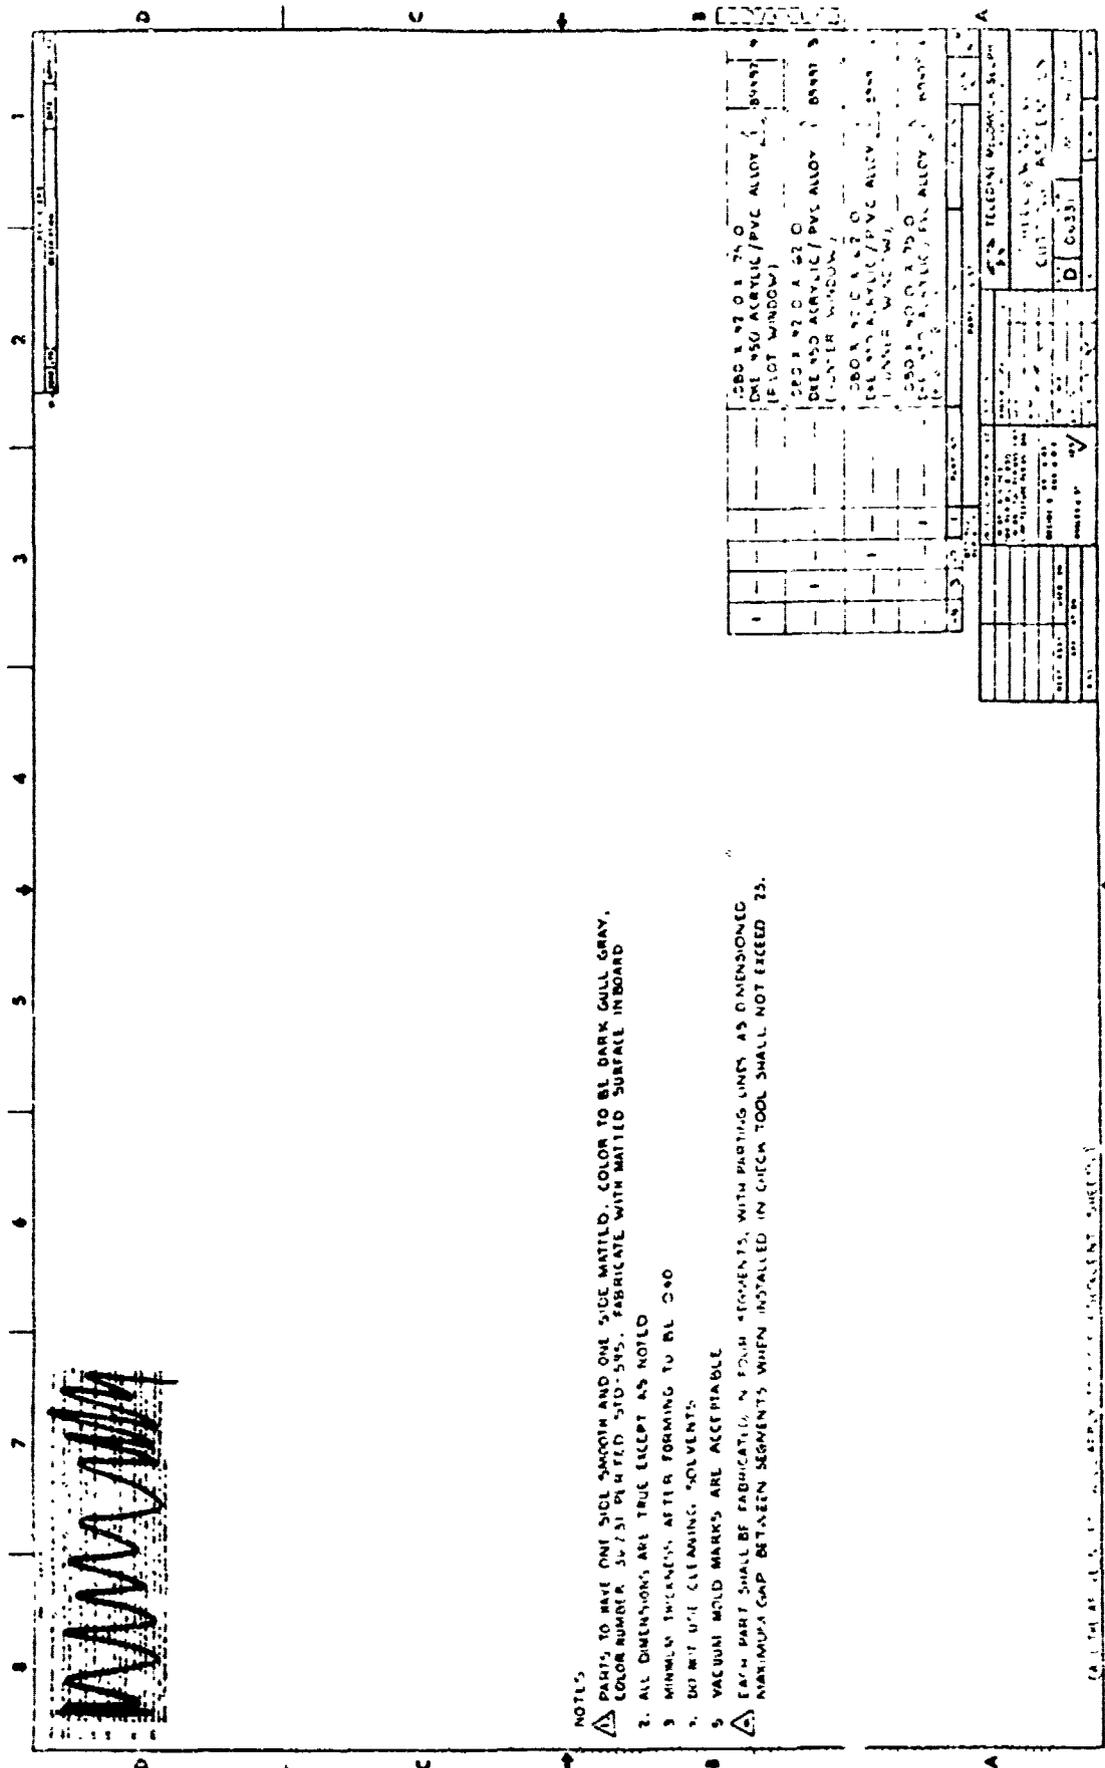
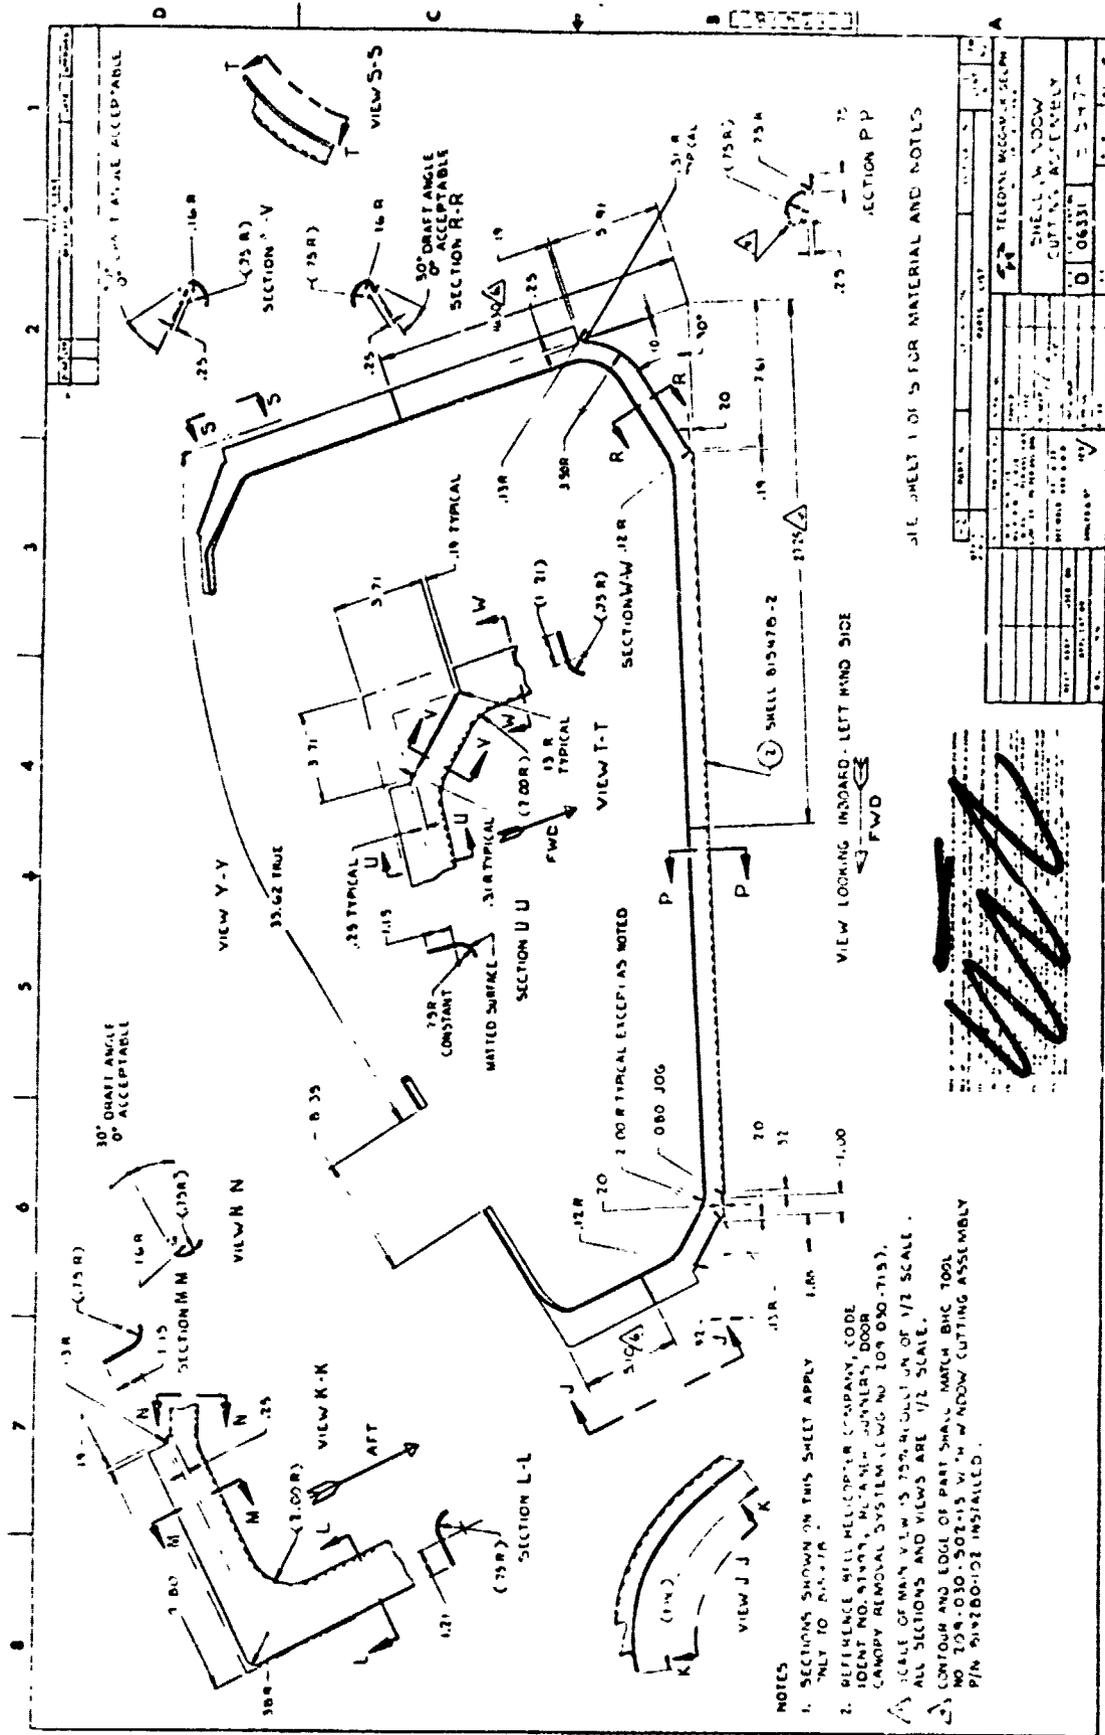
The TMc/S fabrication drawing for the shells is included as Drawing Number 815478.

Shells were formed from flat sheets of 0.062 thick DKE-450 and trimmed to fit the appropriate WCA and associated canopy support structure. Each shell consists of four segments which, when fitted to the WCA, provide complete coverage of the WCA with the exception of the doubler area and a maximum gap of 0.25 inch between segments.
