Technical Note N-1422

GROUND TRANSPORTATION FOR POLAR OPERATIONS - 16-WHEEL
LOW-GROUND-PRESSURE VEHICLE (LGPV-16)

January 1976

CIVIL ENGINEERING LABORATORY
Naval Construction Battalion Center
Port Hueneme, California 93043

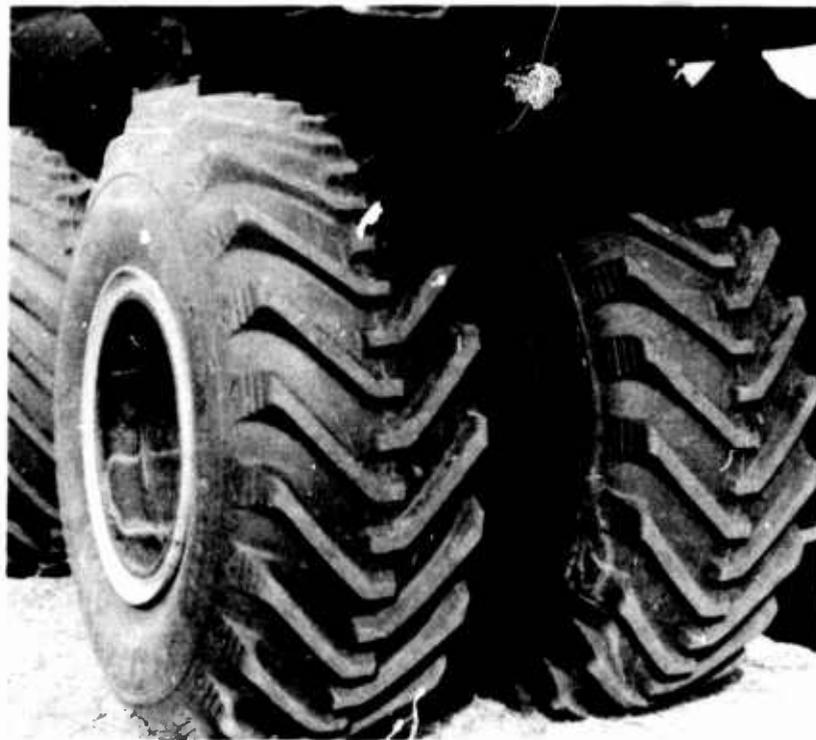
Figure 6. Goodyear 48 x 20.00 x 20 Super Terra-Grip tire, replacement tire.

psi. According to manufacturer's specifications, ground contact area is 280 square inches at no penetration and 590 square inches at 4-inch penetration. The new tires also required new wheels with lockbead rims to eliminate tire-rim slippage at the low inflation pressures. To use the tire also required reversing the wheel drive chains to eliminate the chain link pin ends' rubbing against the tire sidewall. Figures 5 and 6 show the difference in tread design between the original and replacement tires.

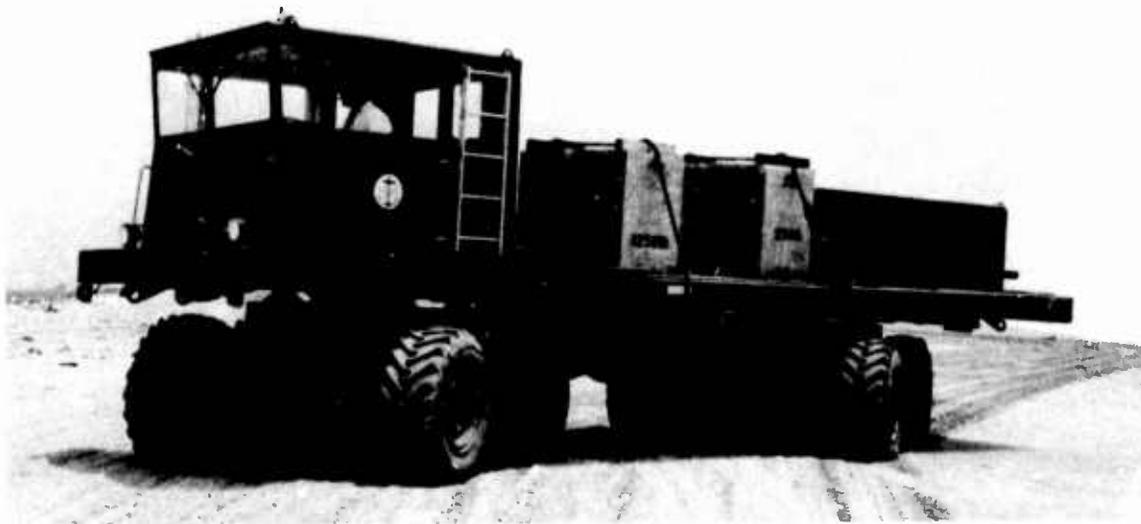
Figure 7. Operating vehicle on beach sand for Terra-Grip tire performance and frame modification tests.

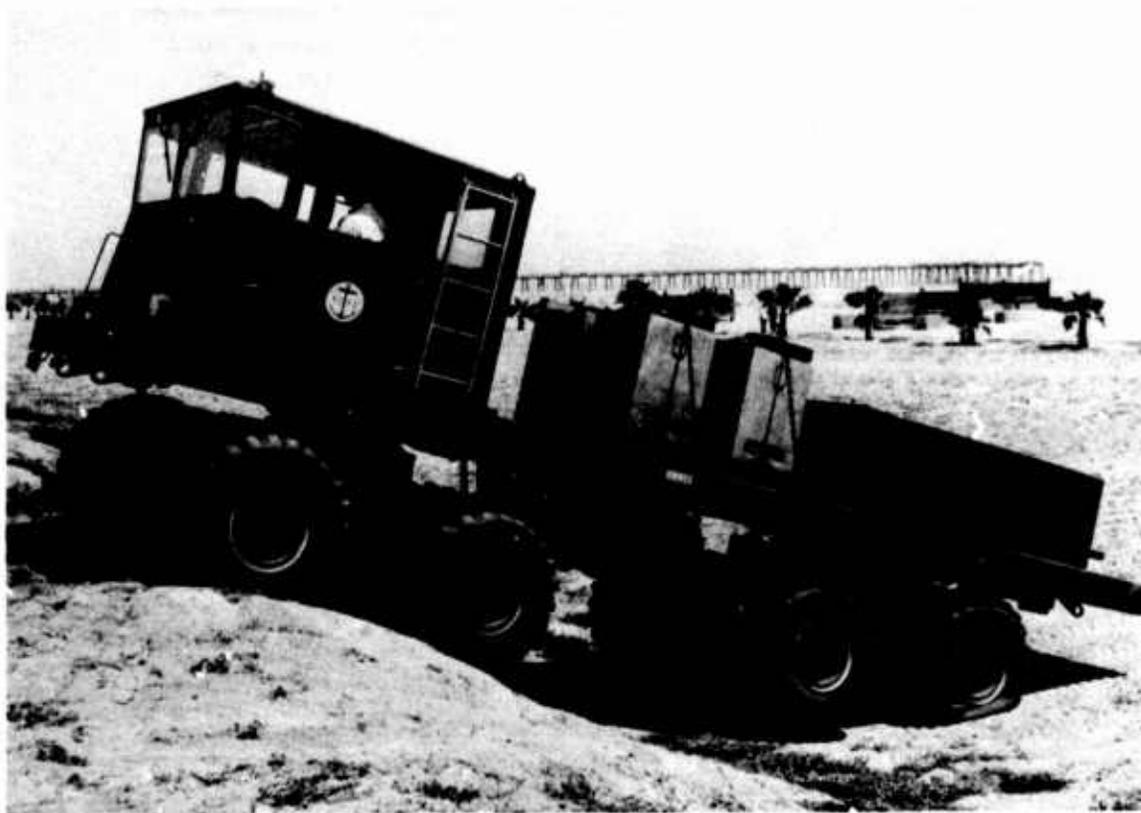
Figure 8. Operating vehicle over sand dune area to observe rough-terrain performance.

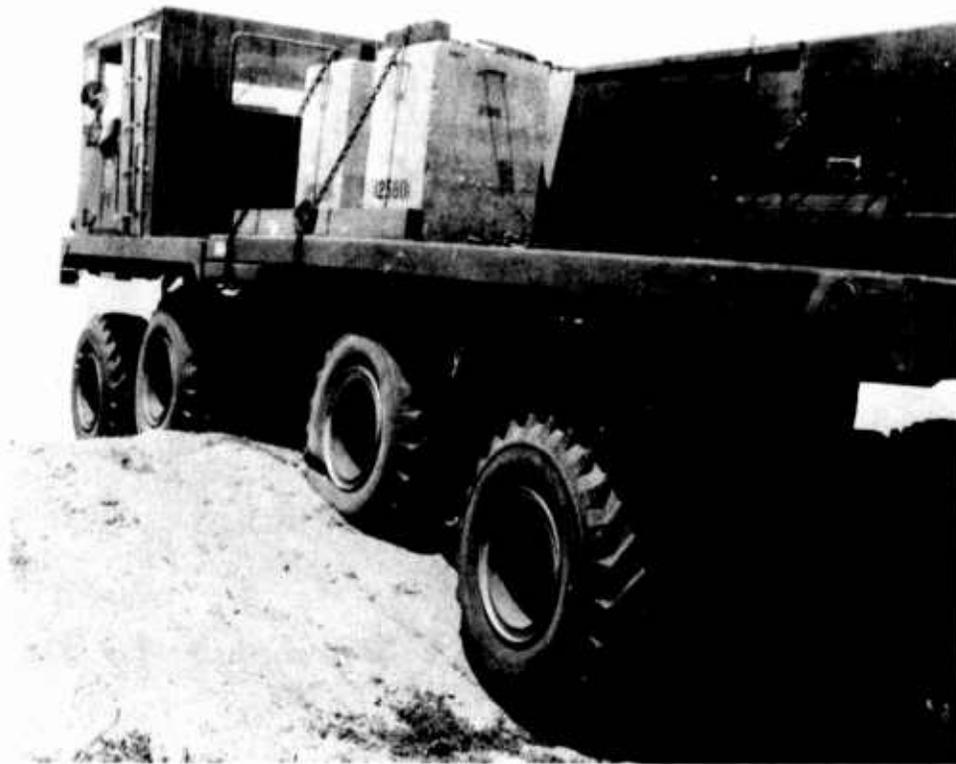
Figure 9. Sequence view of Figure 8, showing severe loading of tire as vehicle progressed over slope.

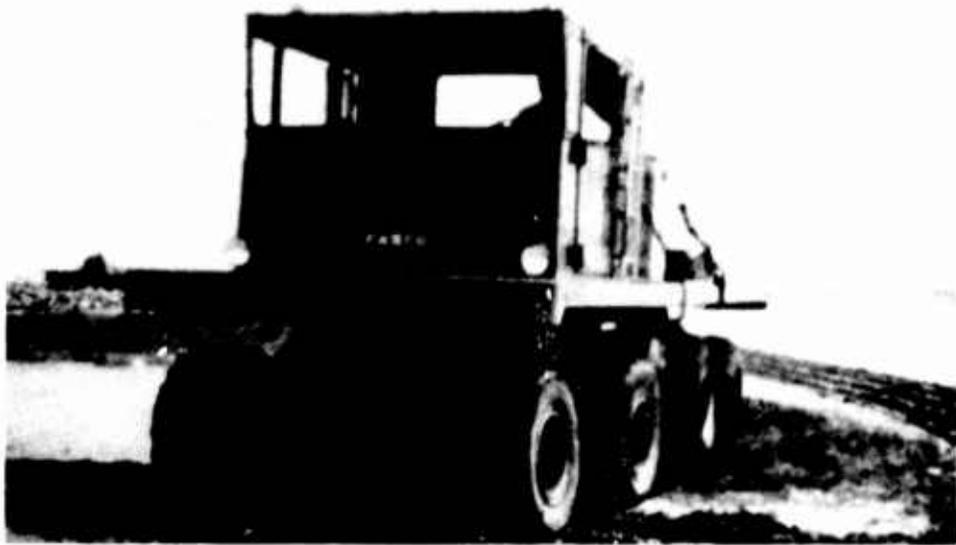
Figure 10. Vehicle making an initial pass over Point Mugu test area.

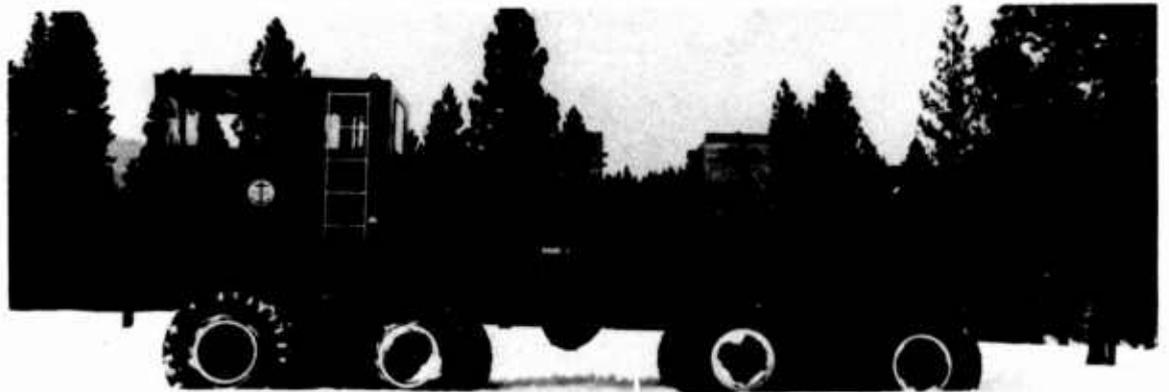
Figure 12. Vehicle operating on level terrain at Truckee test site.

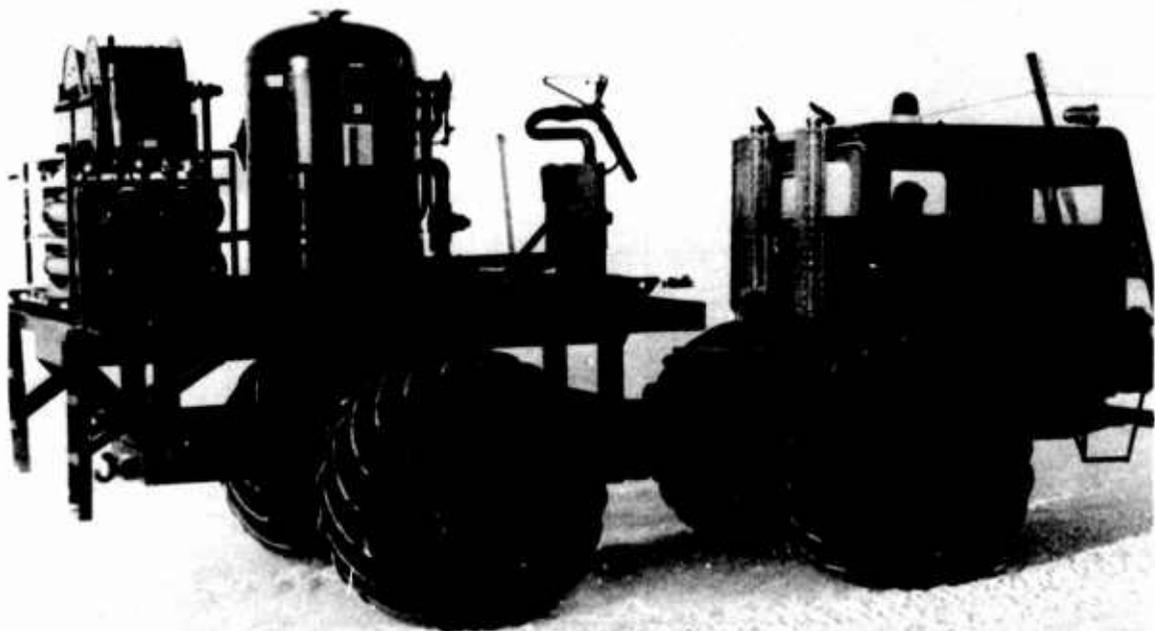
Figure 16. Nodwell Water Trotter vehicle used for aircraft crash/rescue service at McMurdo, Antarctica.
