INHIBITION OF CORROSION IN CATAPULT WATER BRAKE TANKS

Naval Air Engineering Center  
Lakehurst, New Jersey

28 January 1976

NAEC-ENG-7878

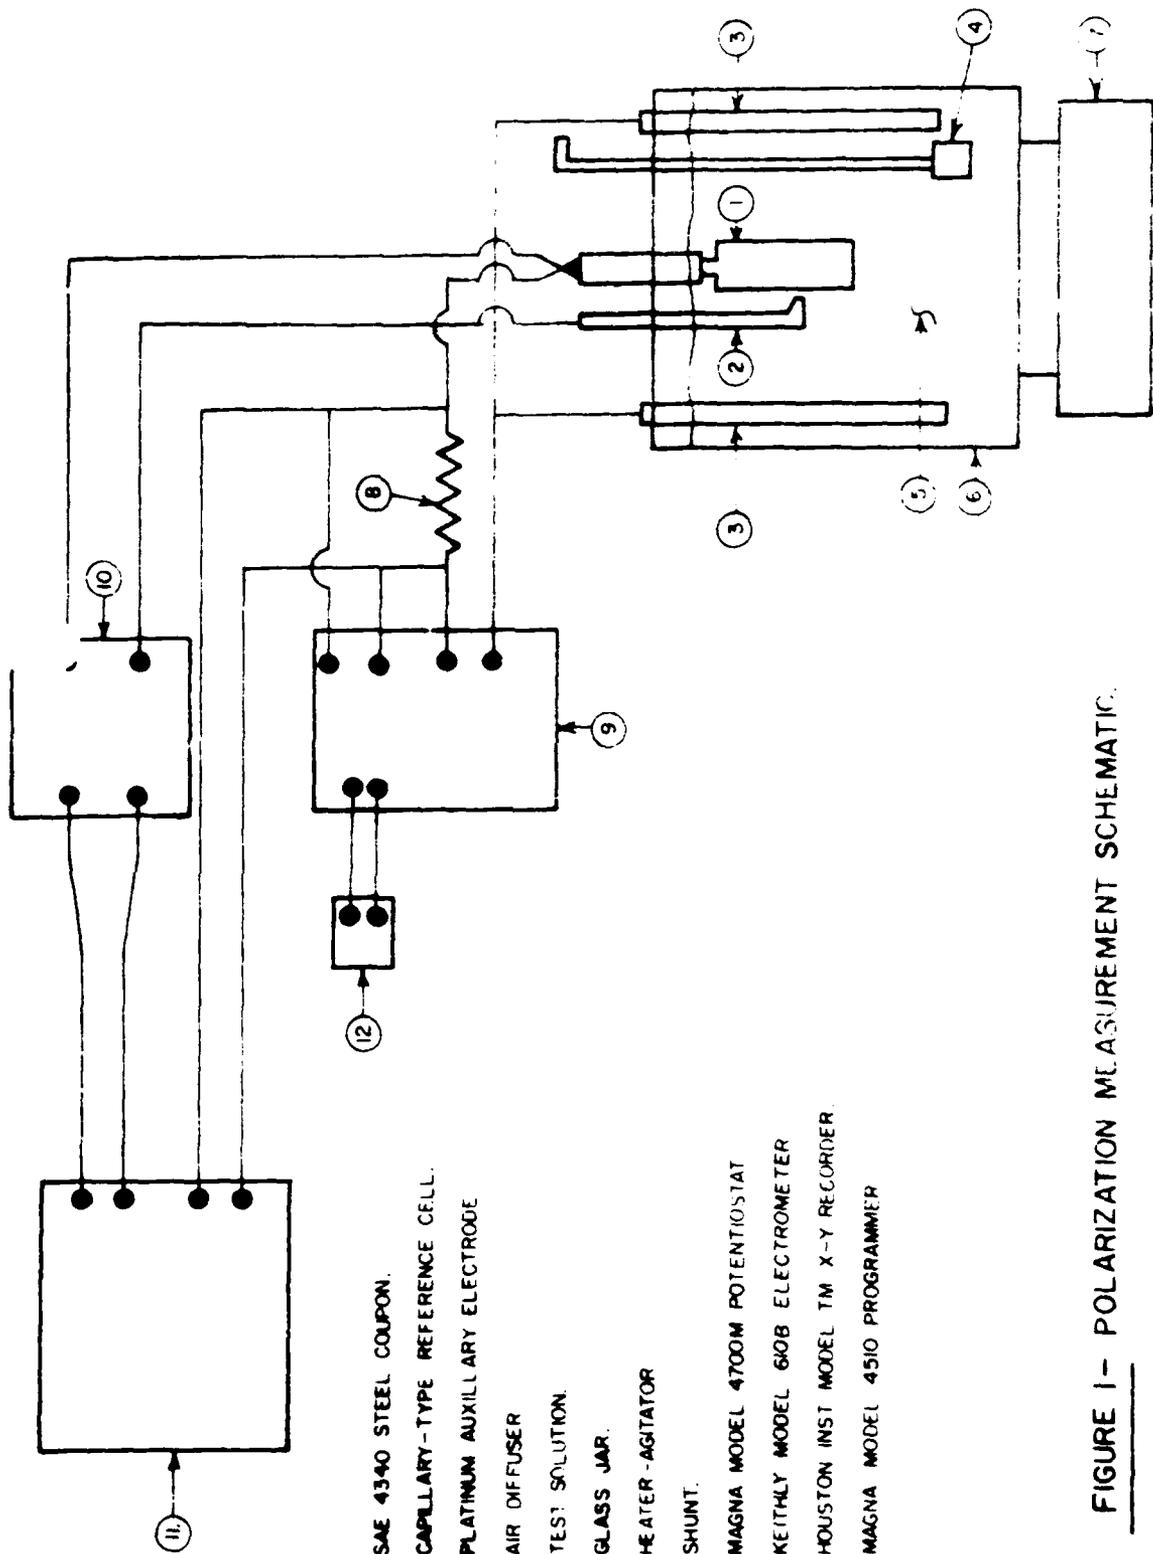
FIGURE 1- POLARIZATION MEASUREMENT SCHEMATIC.

- 1. SAE 4340 STEEL COUPON.
- 2. CAPILLARY-TYPE REFERENCE CELL.
- 3. PLATINUM AUXILIARY ELECTRODE
- 4. AIR DIFFUSER
- 5. TEST SOLUTION.
- 6. GLASS JAR.
- 7. HEATER -AGITATOR
- 8. SHUNT.
- 9. MAGNA MODEL 4700M POTENTIOSTAT
- 10. KEITHLY MODEL 610B ELECTROMETER
- 11. HOUSTON INST MODEL TM X-Y RECORDER.
- 12. MAGNA MODEL 4510 PROGRAMMER

A polished (600 silicon carbide grit finish), degreased steel (SAE 4340) coupon was immersed under each of the experimental conditions listed. After a 24-hour stabilization period, potential and polarization measurements were made. Figure 1 shows a schematic of the instrumentation used to gather the data. Intersection of the cathodic polarization curve for the solution condition outside the crevice and the anodic polarization curve for the solution condition inside the crevice determines the galvanic corrosion current that would flow in the hypothetical cell. Polarization resistance measurements determine the local-action corrosion that would occur within the crevice. Appendix A describes the calculation of local-action corrosion rates from polarization resistance measurements. The total corrosion rate within the crevice is the sum of the galvanic corrosion rate and the local-action corrosion rate.

Simulation of the environment and determination of the potential and polarization characteristics for each alloy in the environment provided data for estimating the effect of pH treatment on bi-metallic corrosion. Electrochemical measurements were made on the other alloys used for hardware in the water brake system. Table 1 lists these alloys. The measurements were made with the instrumentation setup shown in Figure 1 under the following solution conditions:

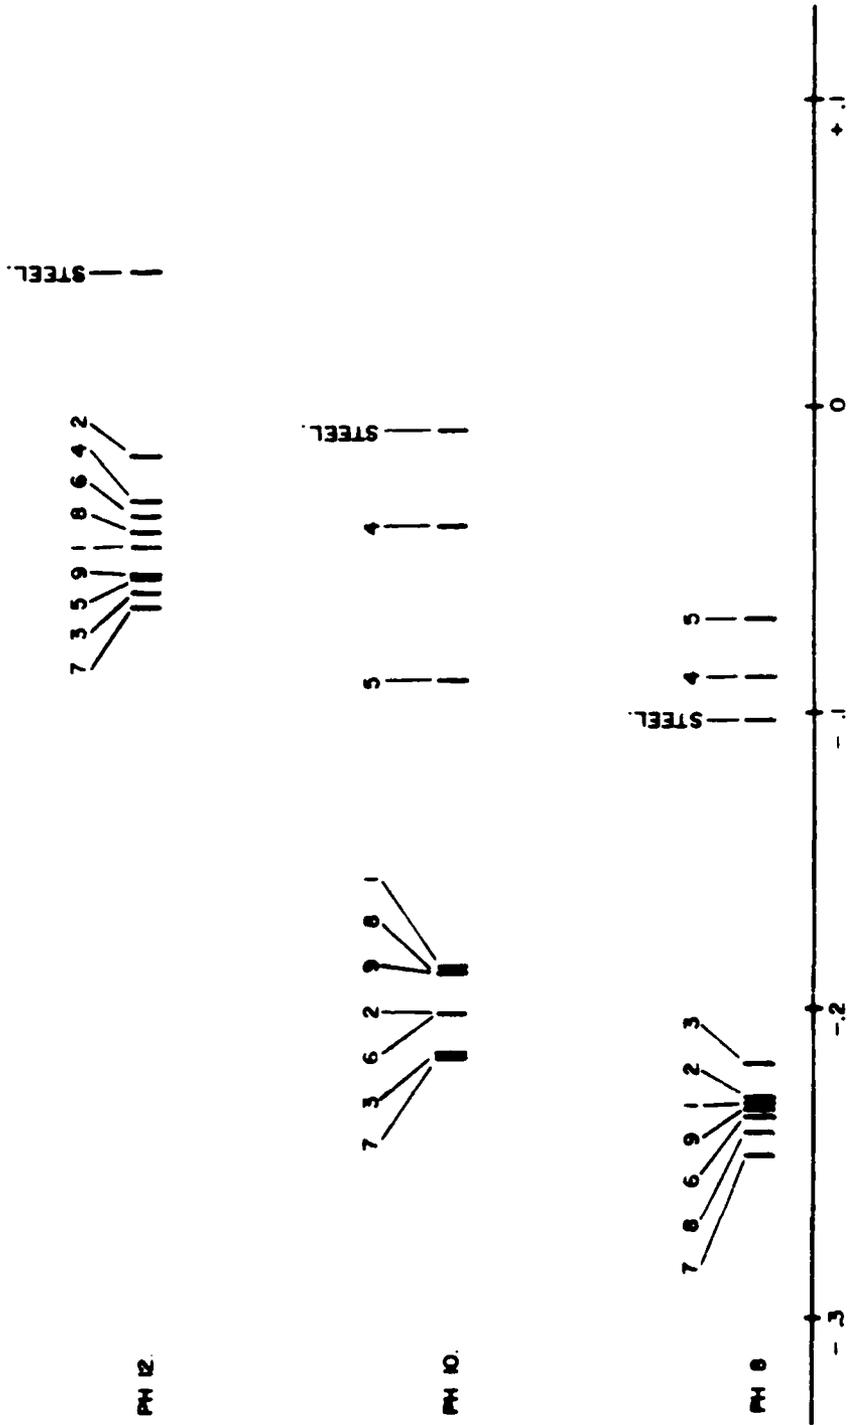
FIGURE 13. - CORROSION POTENTIAL, VOLTS, SHE., 180°F., 0.2% SALINITY, 1.25% NaNO<sub>2</sub>, OXYGEN SATURATED.

(3) BI-METALLIC CORROSION. Laboratory tests indicate that pH treatment in a water brake system will not significantly affect bi-metallic corrosion. Figure 13 and Table V present the results of these tests. Figure 13 shows the effect of pH treatment on the corrosion potential of the different copper-bearing alloys in the water brake system as well as SAE 4340 steel. The effect of increasing pH in almost all cases is to shift the corrosion potential to more active (negative) values. The most significant observation regarding the effect of pH treatment on bi-metallic corrosion is that the relative differences in potential between alloys do not significantly change. This indicates that the thermodynamic driving force for the bi-metallic corrosion reaction has not been appreciably altered. There is a shift in the relative position for some alloys, however, this is still considered to be insignificant.

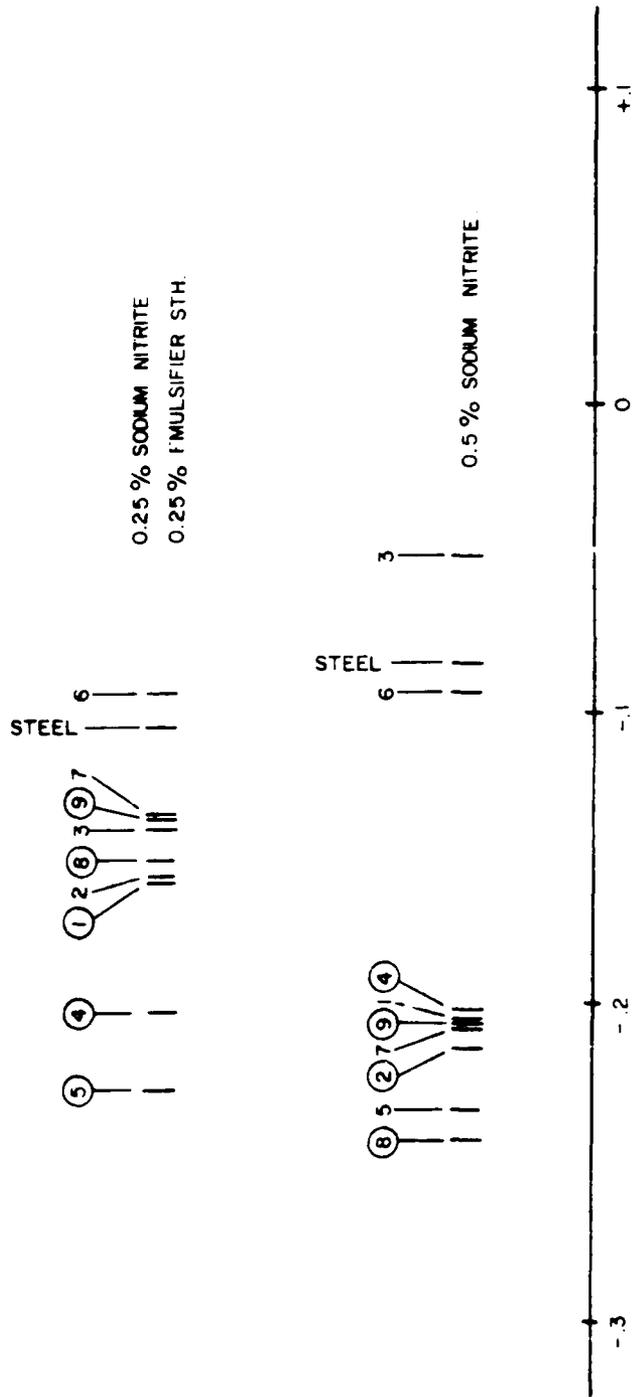
FIGURE 20 - CORROSION POTENTIAL, VOLTS, SHE., 180° F., 0.2 % SALINITY, AIR SATURATED.

The effect of Emulsifier STH addition on bi-metallic corrosion in a nitrite-inhibited system was investigated utilizing techniques similar to those described in B.1.a. Figure 20 shows the effect of Emulsifier STH addition on the corrosion potential of the other alloys in the system. Table IX presents a comparison of the local-action corrosion rates in the nitrite-STH system with those that occur in a solution treated only with sodium nitrite. From the data, it appears that addition of Emulsifier STH neither significantly accelerates corrosion of other alloys in the system nor increases the susceptibility towards bi-metallic corrosion.

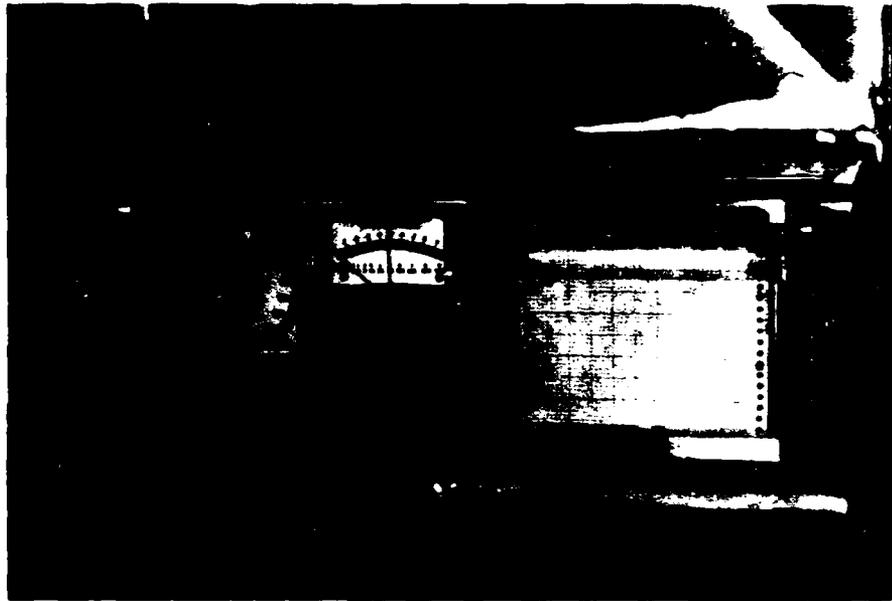
FIGURE 21 - CORROSION RATE MONITORING  
INSTRUMENT

FIGURE 22 - SHIPBOARD INSTALLATION OF  
INSTRUMENT

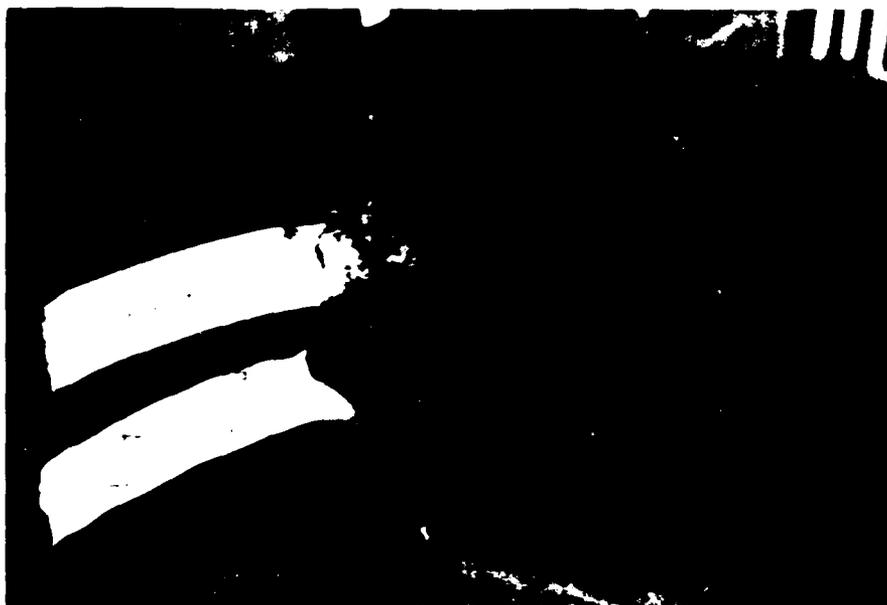
Figure 28 - Annulus Rings From Water Brakes  
Nos. 3 & 4 on the CVA-64 After  
12 Months Operation

Figure 29 - Striker Rings From Water Brakes  
Nos. 3 & 4 on the CVA-64 After  
12 Months Operation
