## FATIGUE INVESTIGATION OF THE E-2B/C NOSE LANDING GEAR

H. D. Lystad  
Air Vehicle Technology Department  
NAVAL AIR DEVELOPMENT CENTER  
Warminster, Pennsylvania 18974

31 December 1975

FINAL REPORT  
AIRTASK No. A510-5103/001-4/4510-000-002  
AIRTASK No. A510-5102/001-2/4231-000-356  
Work Unit No. PE701

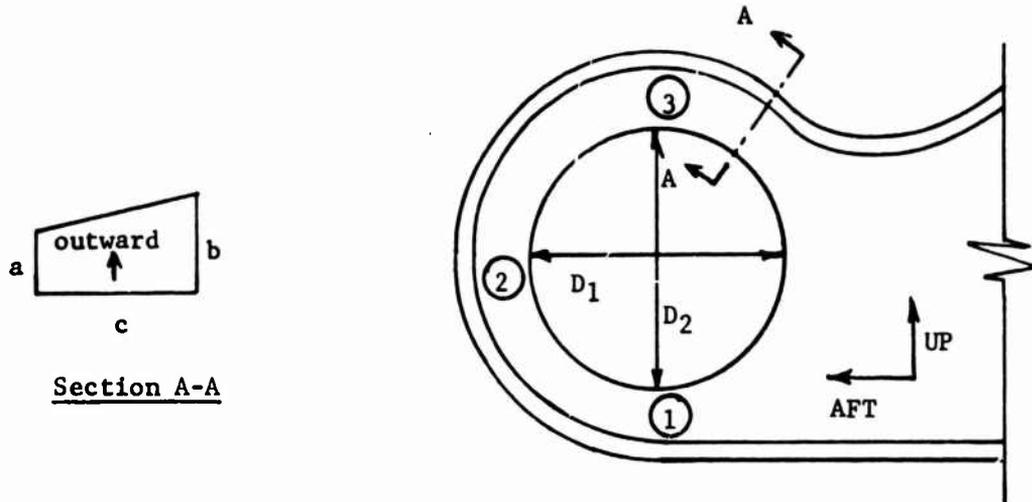
DRAG BRACE ATTACHMENT LUG

As recommended by Grumman Aerospace Corp. (GAC), references (b) and (c), the attachment lugs were modified by boring the lug inner diameter 0.050 inches oversize on the radius, thus opening the lug inner diameter to a maximum of 2.3505 inches. While enlarging the inner diameter the cross sectional area was not allowed to decrease below 0.415 square inches. Figure 4 shows the modified test specimen dimensions. After modification of the lugs, oversize bushings were fabricated to fit with an interference of .0010 to .0015 inches.

Since cracks smaller than 0.040 inches cannot be detected by nondestructive testing techniques and since inspection prior to modification of the lug surfaces revealed no cracks, this modification procedure assumes the removal of any minute fatigue cracks that may have been present.

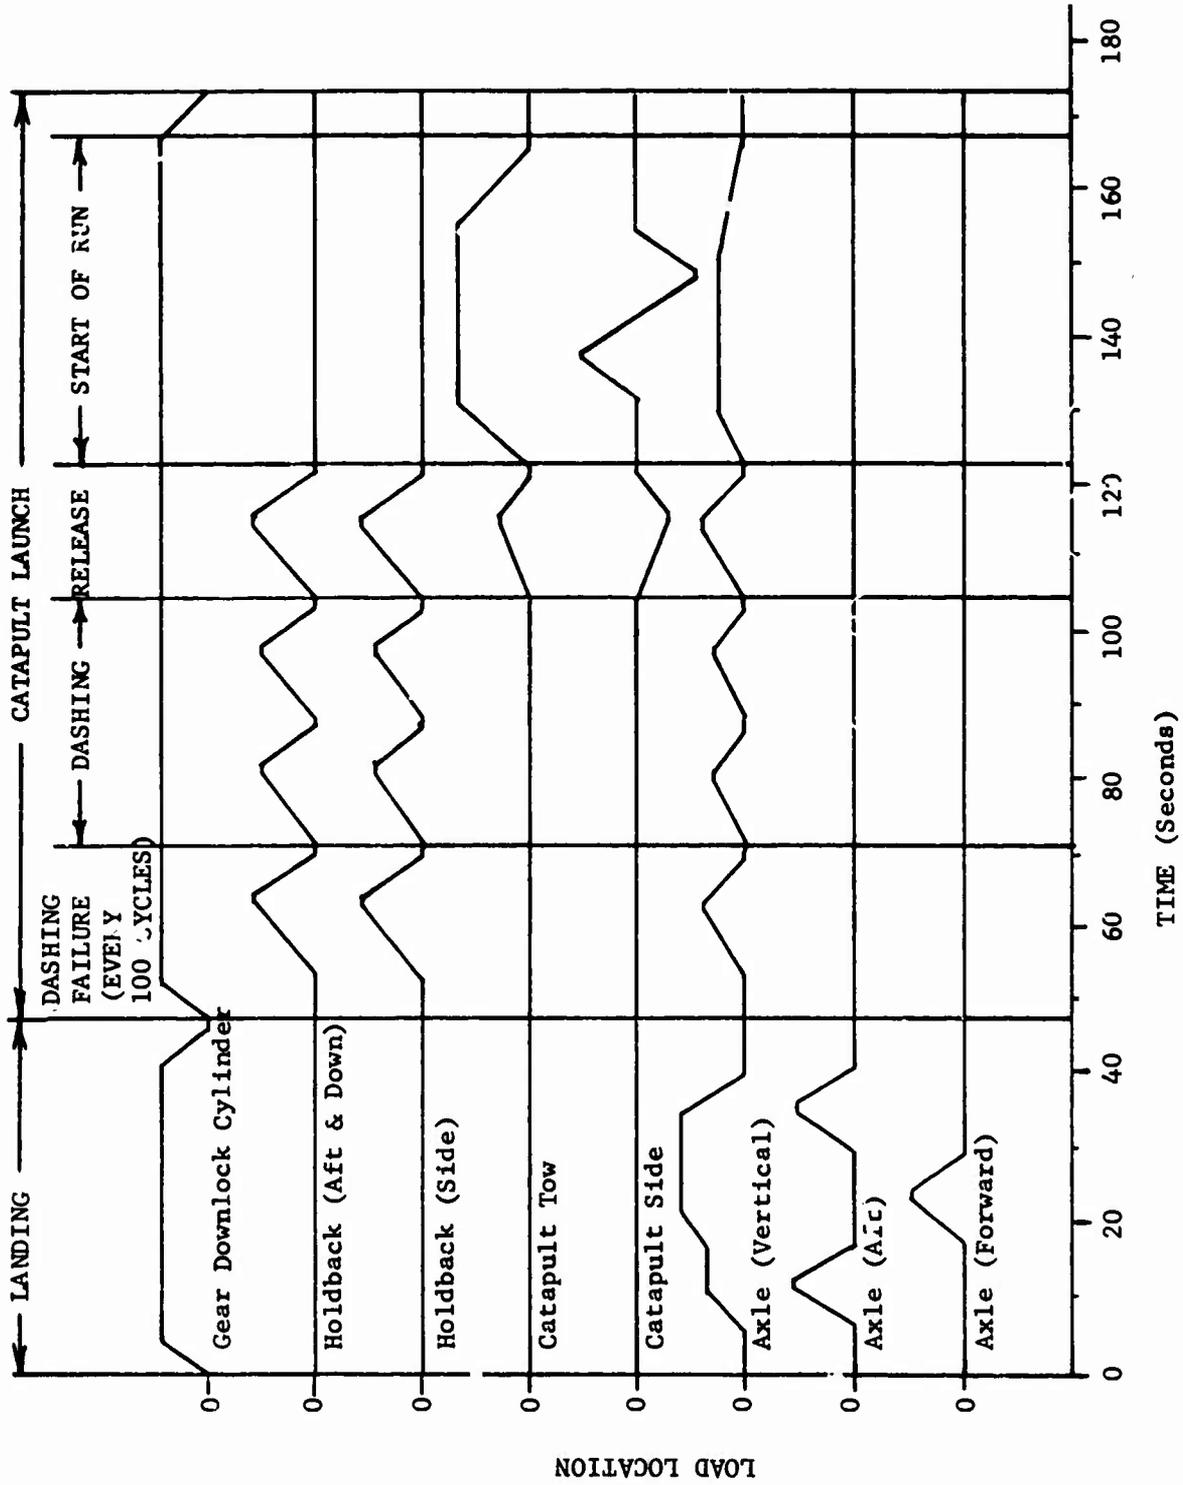
Figure 5. Typical Loading Cycle

Two applications of condition 11D and one application of condition 11A were applied for each holdback cycle. Holdback cycles were applied until specimen failure occurred. A typical holdback cycle is shown below.

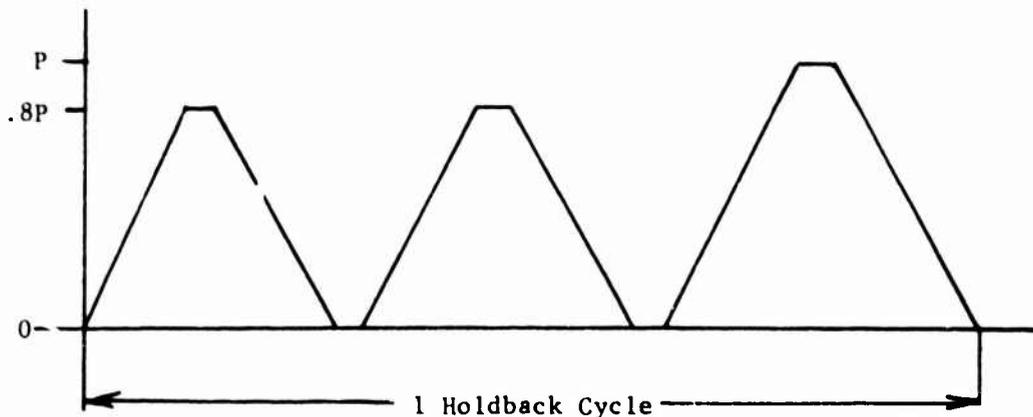
A typical loading cycle of one carrier landing followed by one catapult launch is shown in Figure 5.

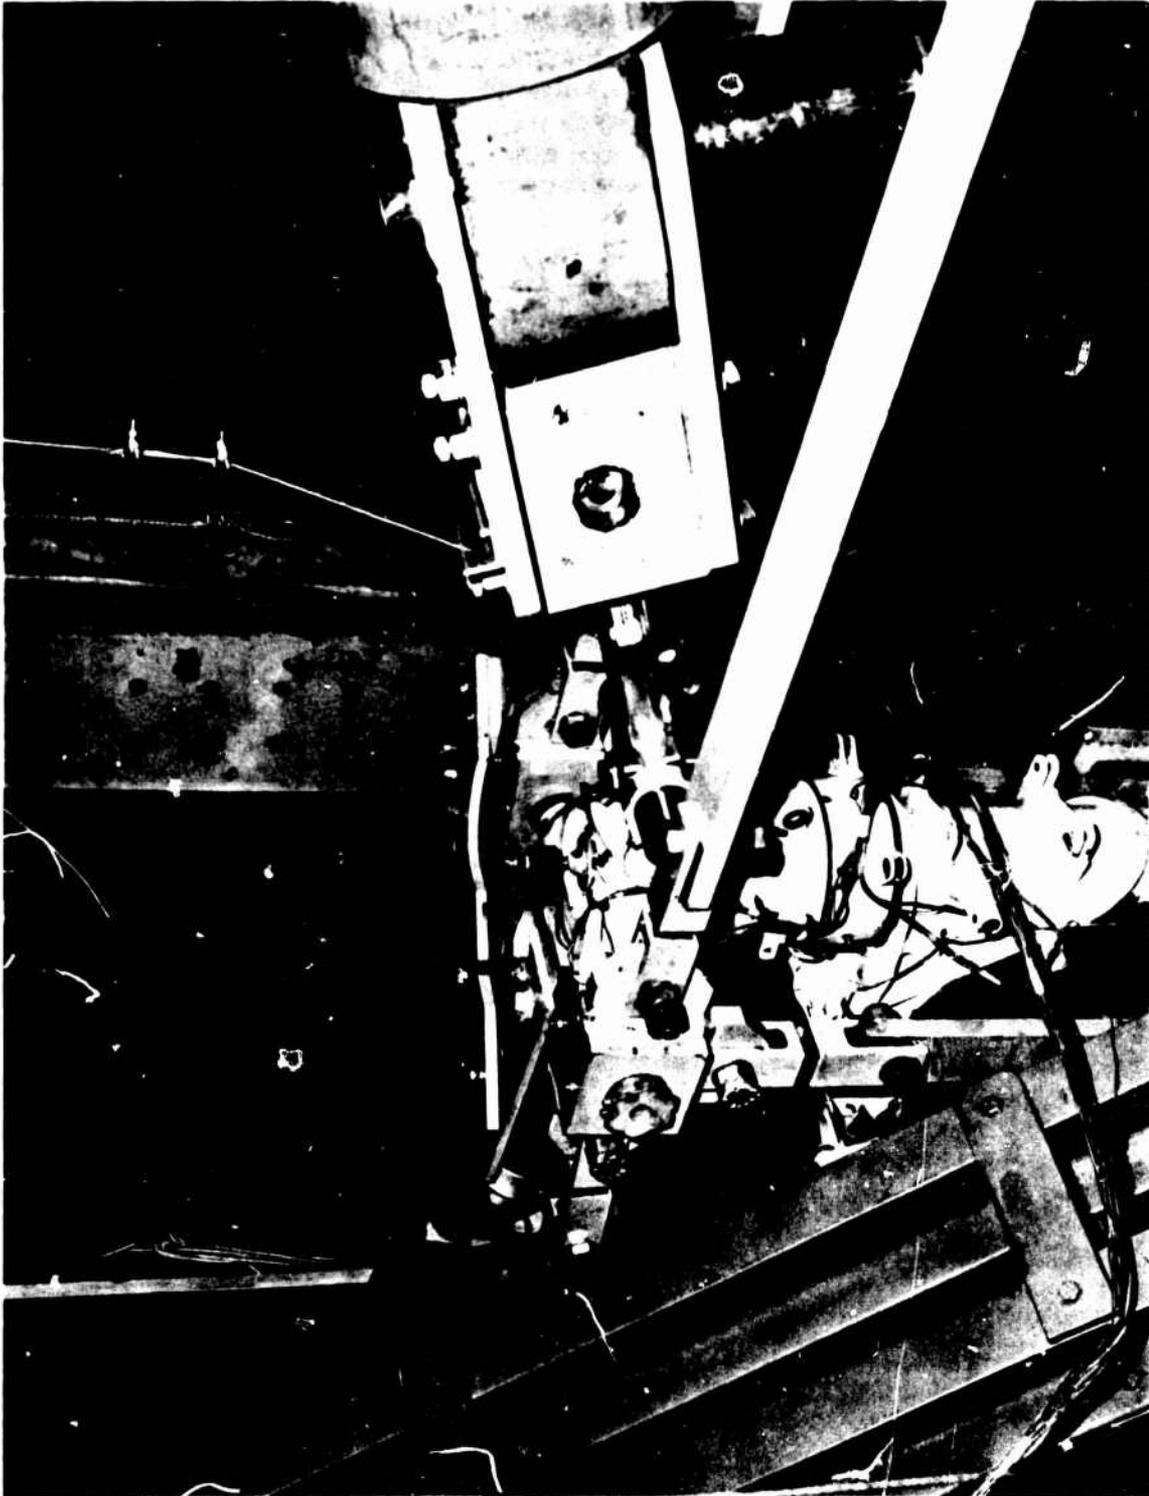
Each test specimen was mounted in an inverted position, in a loading frame. Test loads were reacted at the shock strut upper trunnions and the drag brace trunnions. Steel fixtures were fabricated to simulate the E-2 airplane fuselage fittings for the shock strut and drag brace supports. Adapter fittings were fabricated to apply loads to test specimens at the catapult tow link, holdback lugs and wheel axles. The metering pin was removed from the oleo shock strut and replaced with a plug. The shock strut was then filled with hydraulic fluid to fix the gear in the fully extended static position throughout the test.

Figures 6, 7 and 8 show the final test set-up.

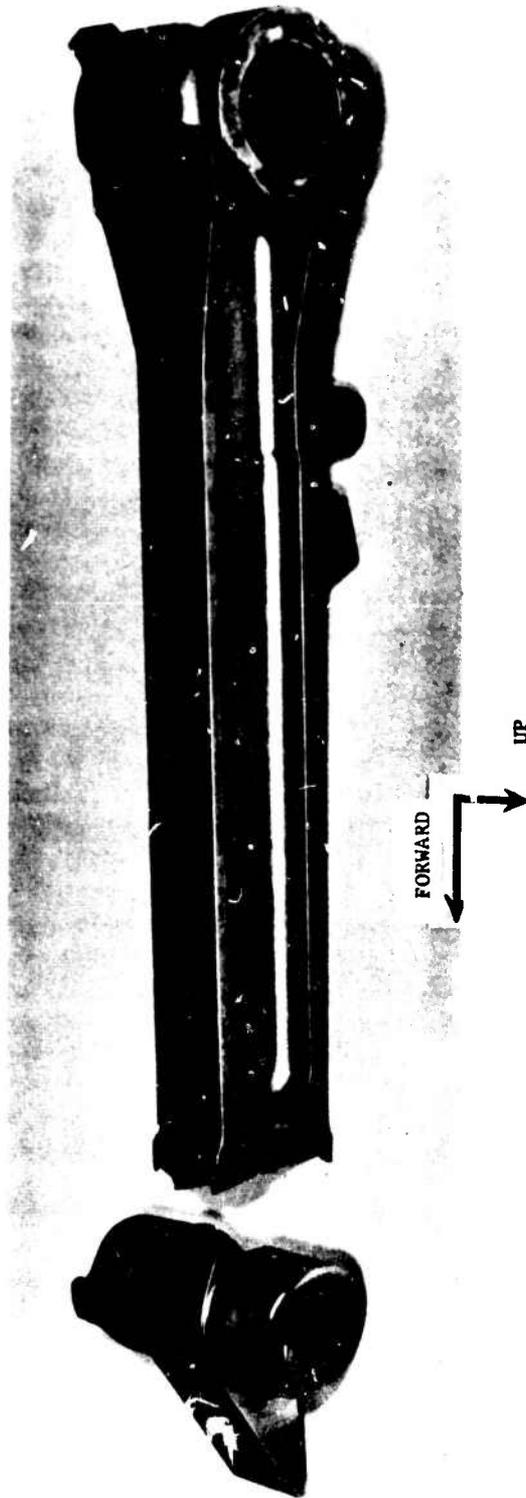
Figure 9. Tow Link #1 Failure

During the application of cycle 3200, the catapult tow link #1 failed. This tow link, P/N 123LM10189-1, which had no previous usage, was inspected at cycle 2,920 using dye penetrant and found to be crack free. Figures 9 and 10 show the failure. Visual examination of the fracture surfaces indicated two regions of small crack growth prior to failure. One region was approximately 0.1 inches deep and 0.6 inches long. The second region was approximately 0.1

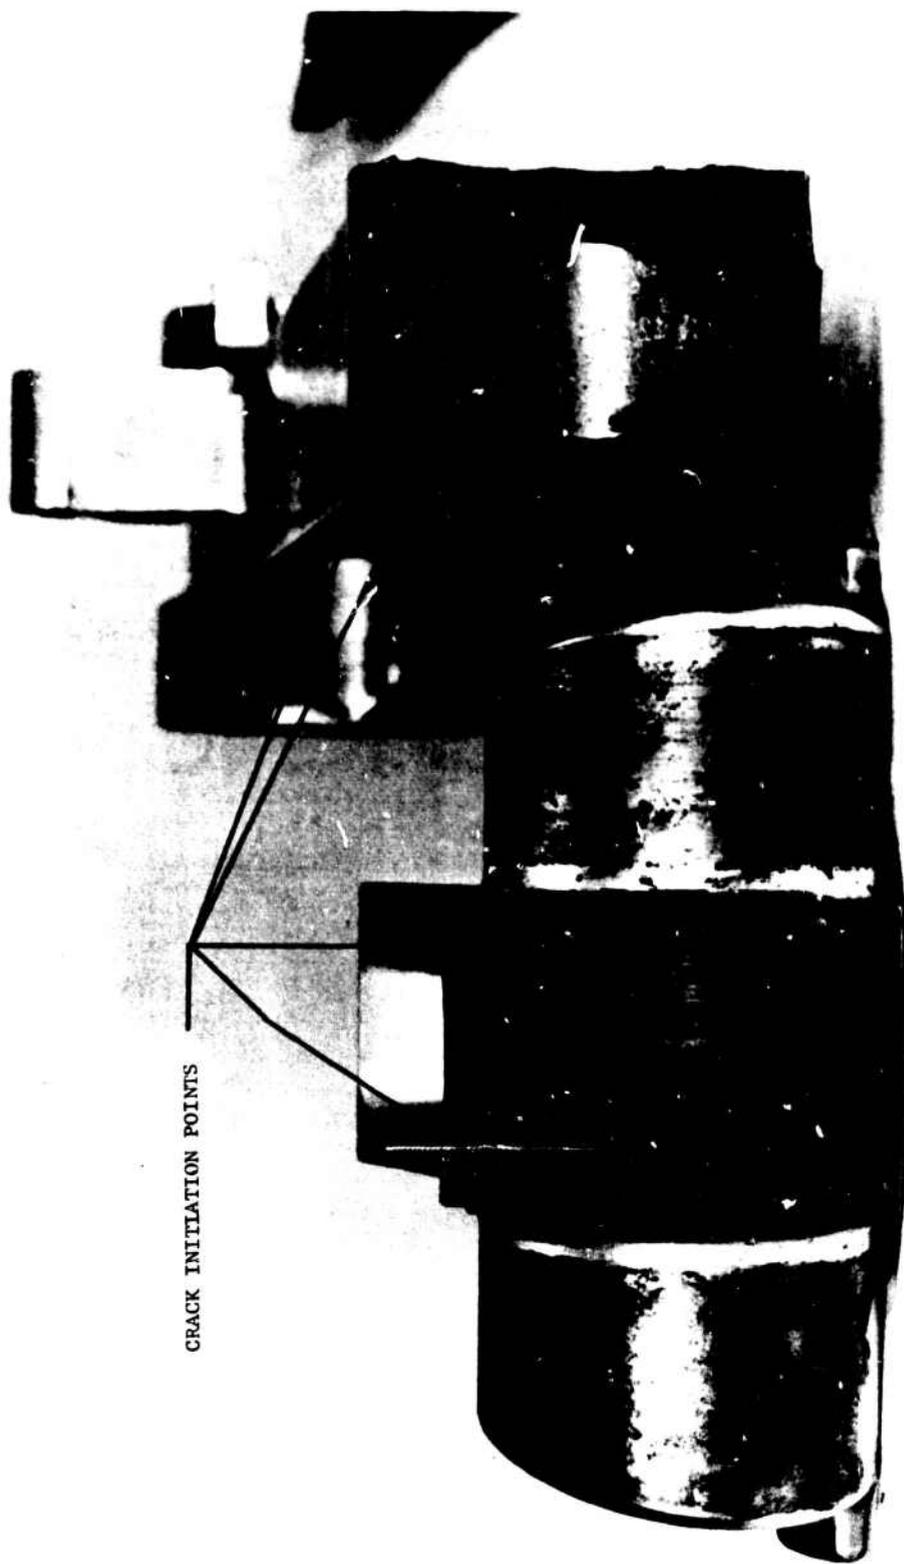
Figure 10. Tow Link #1 Fracture Face

inches deep and 0.2 inches long. A metallurgical examination of the fracture surfaces revealed fatigue striations with transgranular secondary cracks running perpendicular to the striations in the crack growth regions.

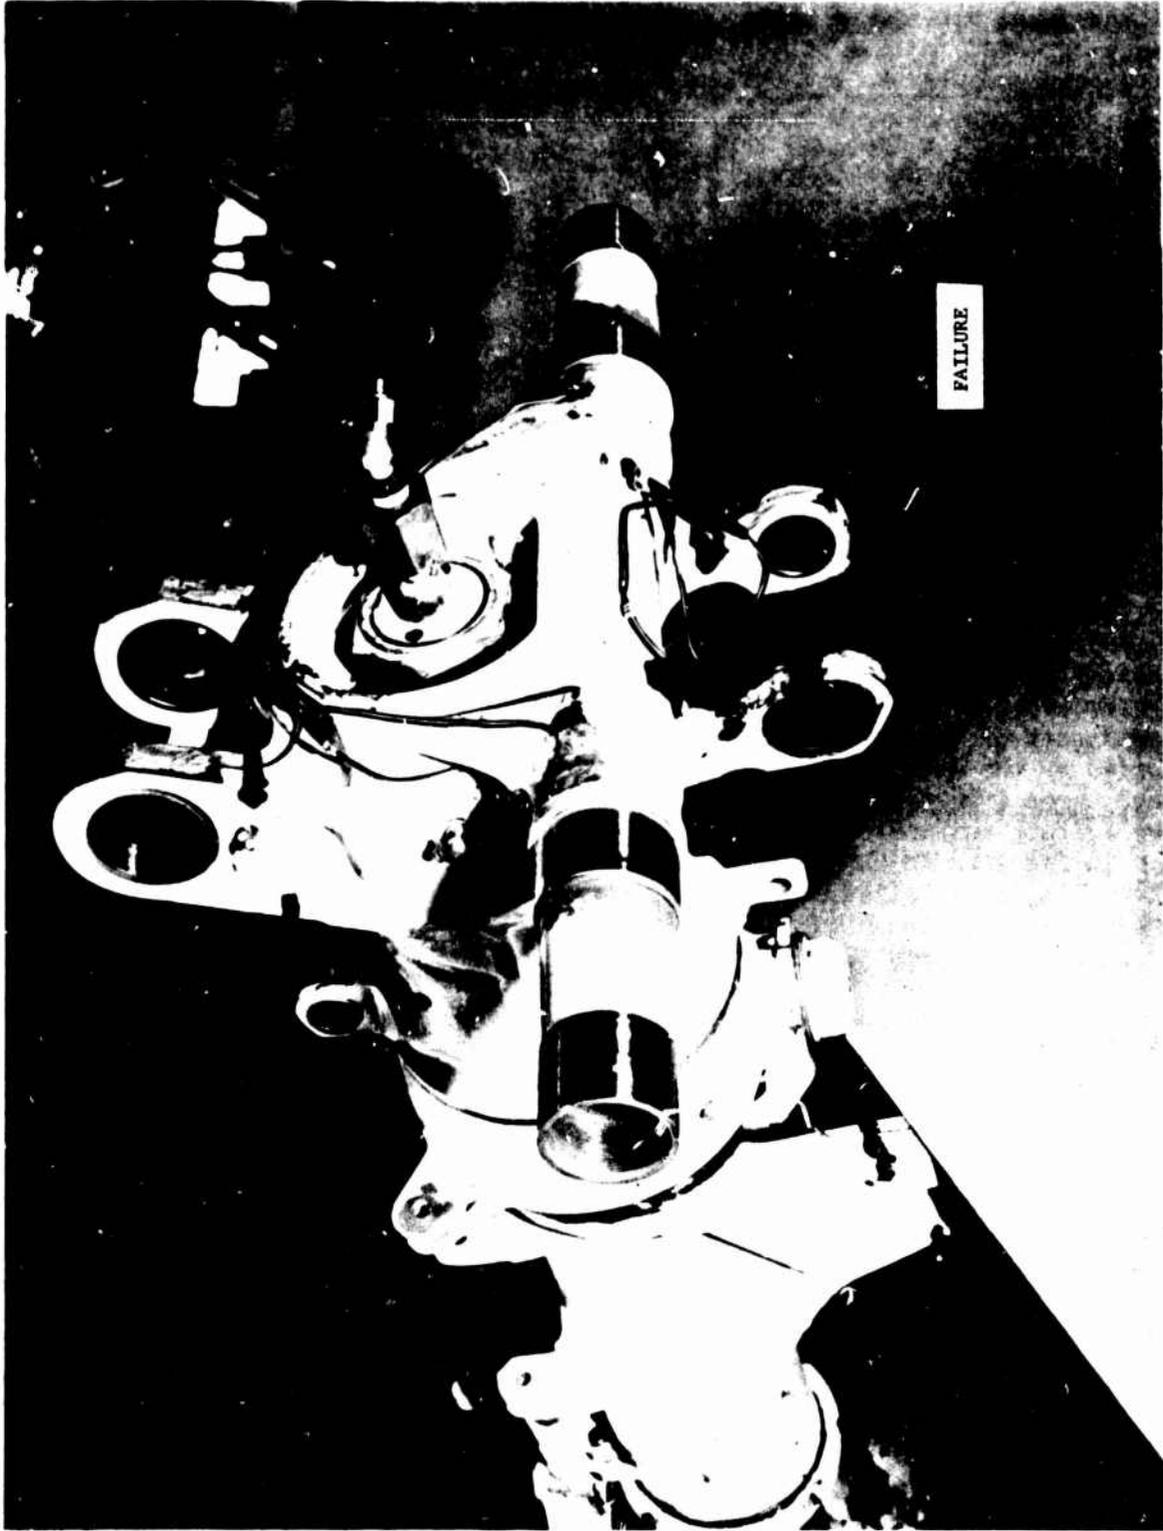
Figure 11. E-2B Holdback Lug Failure

The failed tow link was replaced by tow link #2, P/N 123LM10080-3, having an unknown service history. The NLG was disassembled for a detailed inspection, found to be crack free and testing was continued. During the application of cycle 3336 the right hand holdback lug of the shock strut failed. Figures 11 and 12 show the failure.

As of 1 May 1974, all E-2B NLG were assumed to have 650 launches. It is recommended that the drag brace attachment lugs of the E-2B NLG shock struts be modified within 100 launches of this date. Therefore, after modification, the E-2B NLG will have achieved no more than 750 launches. Based on the test results, it is recommended that an additional 1000 launches be permitted after modification, which extends the original 650 catapult launch limit of the E-2B NLG shock strut to 1750 launches.

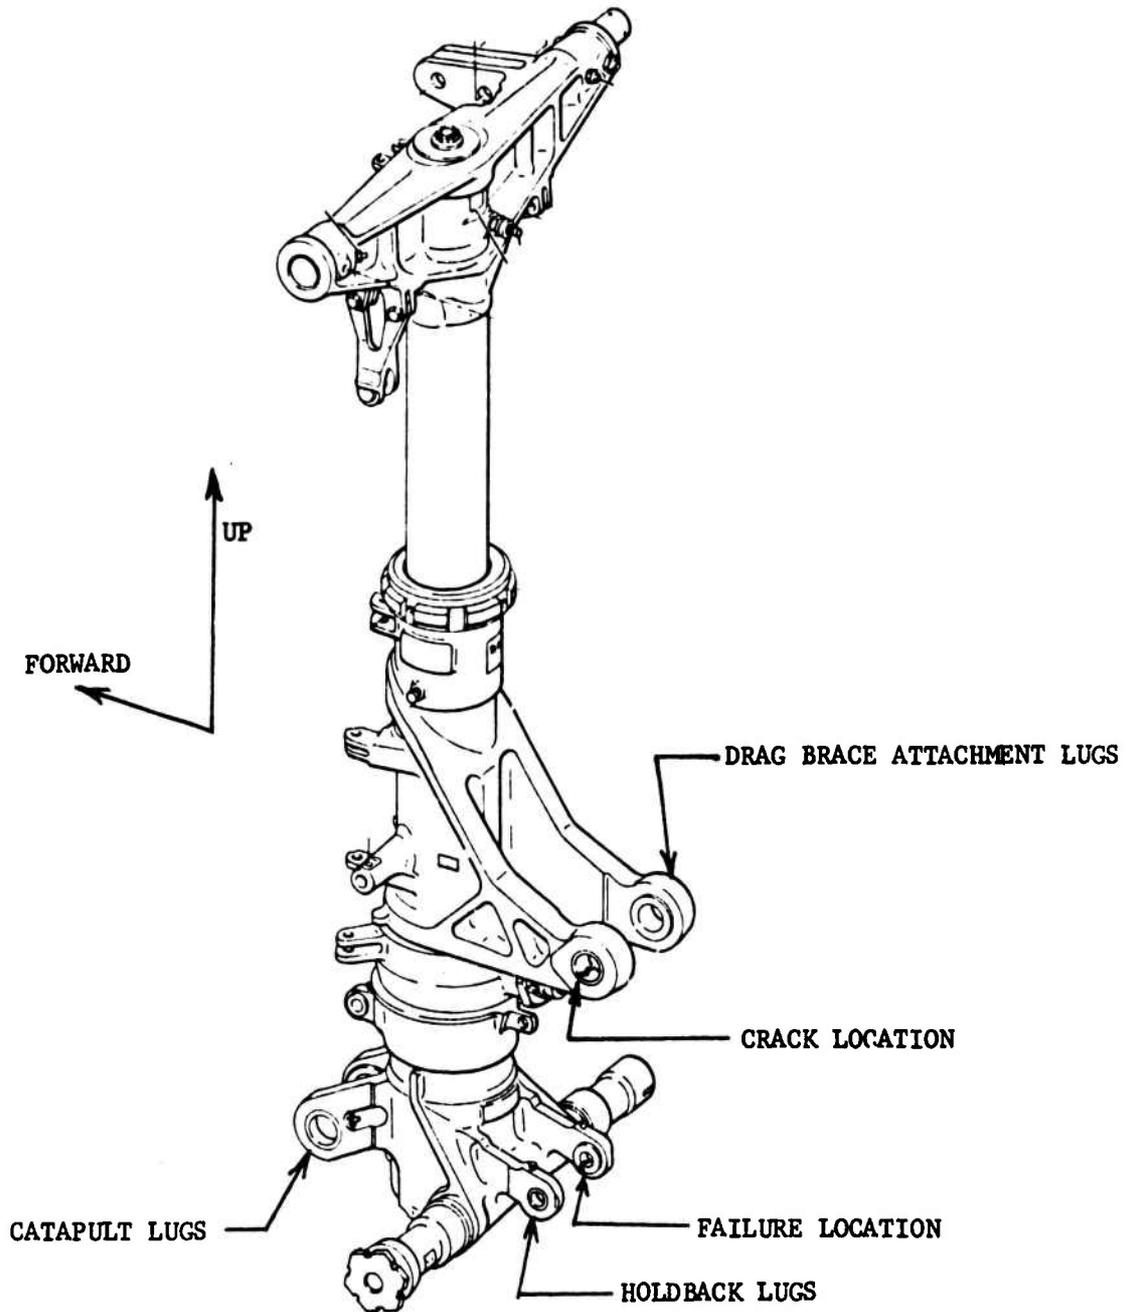
Figure 13. Location of Holdback Lug Failure and Drag Brace Attachment Lug Crack

Upon inspection of the specimen after the holdback lug failure, a hair-line crack was found in the left hand drag brace attachment lug. The crack extended across the entire thickness of the lug. A section of the lug encompassing the crack was removed from the specimen and subjected to a slow, continuous load in a testing machine to break open the section, thereby exposing the fracture surface for metallurgical examination. The relative locations of the holdback lug failure and the drag brace attachment lug crack are shown in Figure 13.

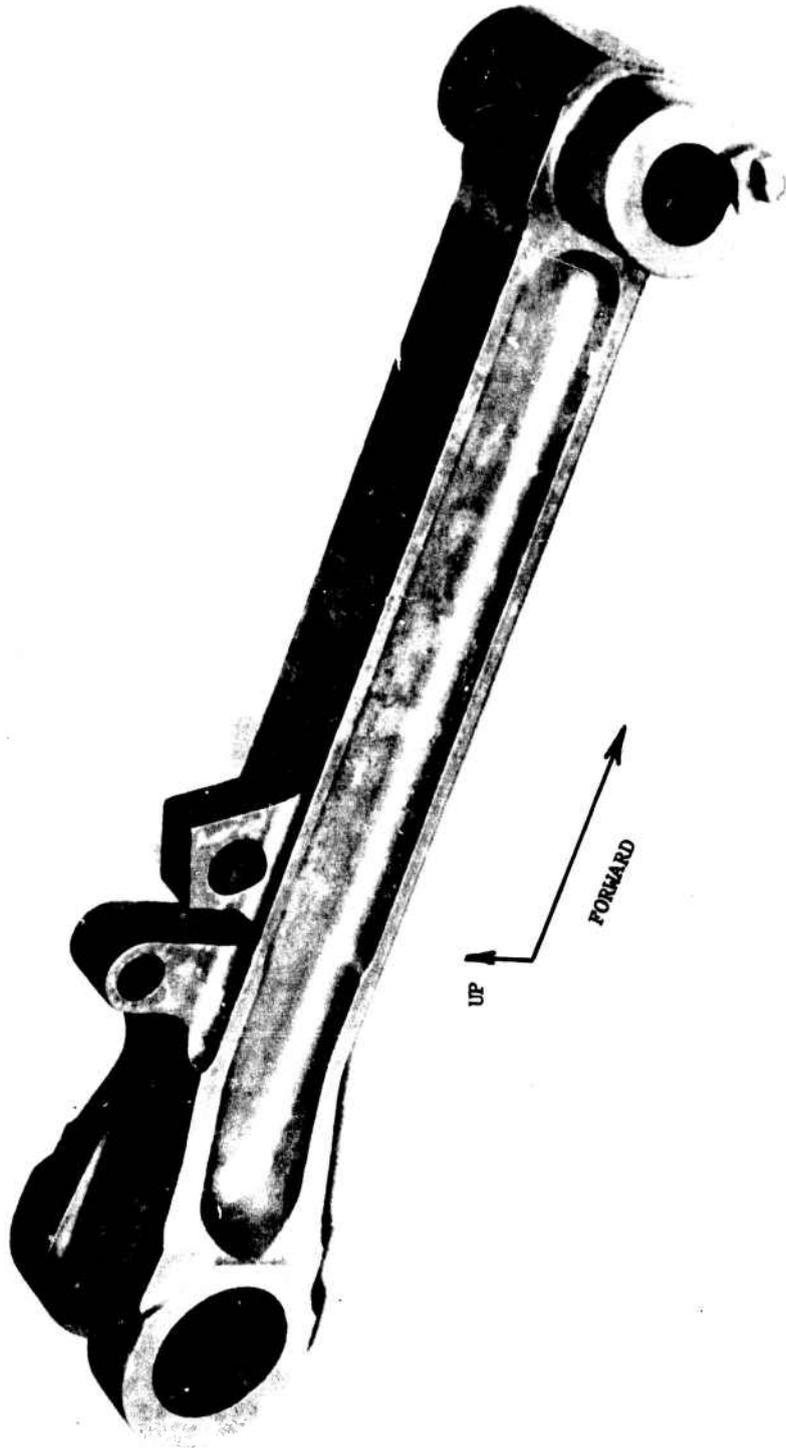
Figure 16. Tow Link Modification

During the application of cycle 2270, catapult tow link #3 failed. This tow link was a new part in which the toe had been removed to conform to the new flush deck catapult shuttles. Figure 16 shows the tow link modification. The mode of failure was identical to tow link #1 and is shown in Figures 17 and 18. The failed tow link was replaced with tow link #2, which was used to complete the E-2B NLG test.

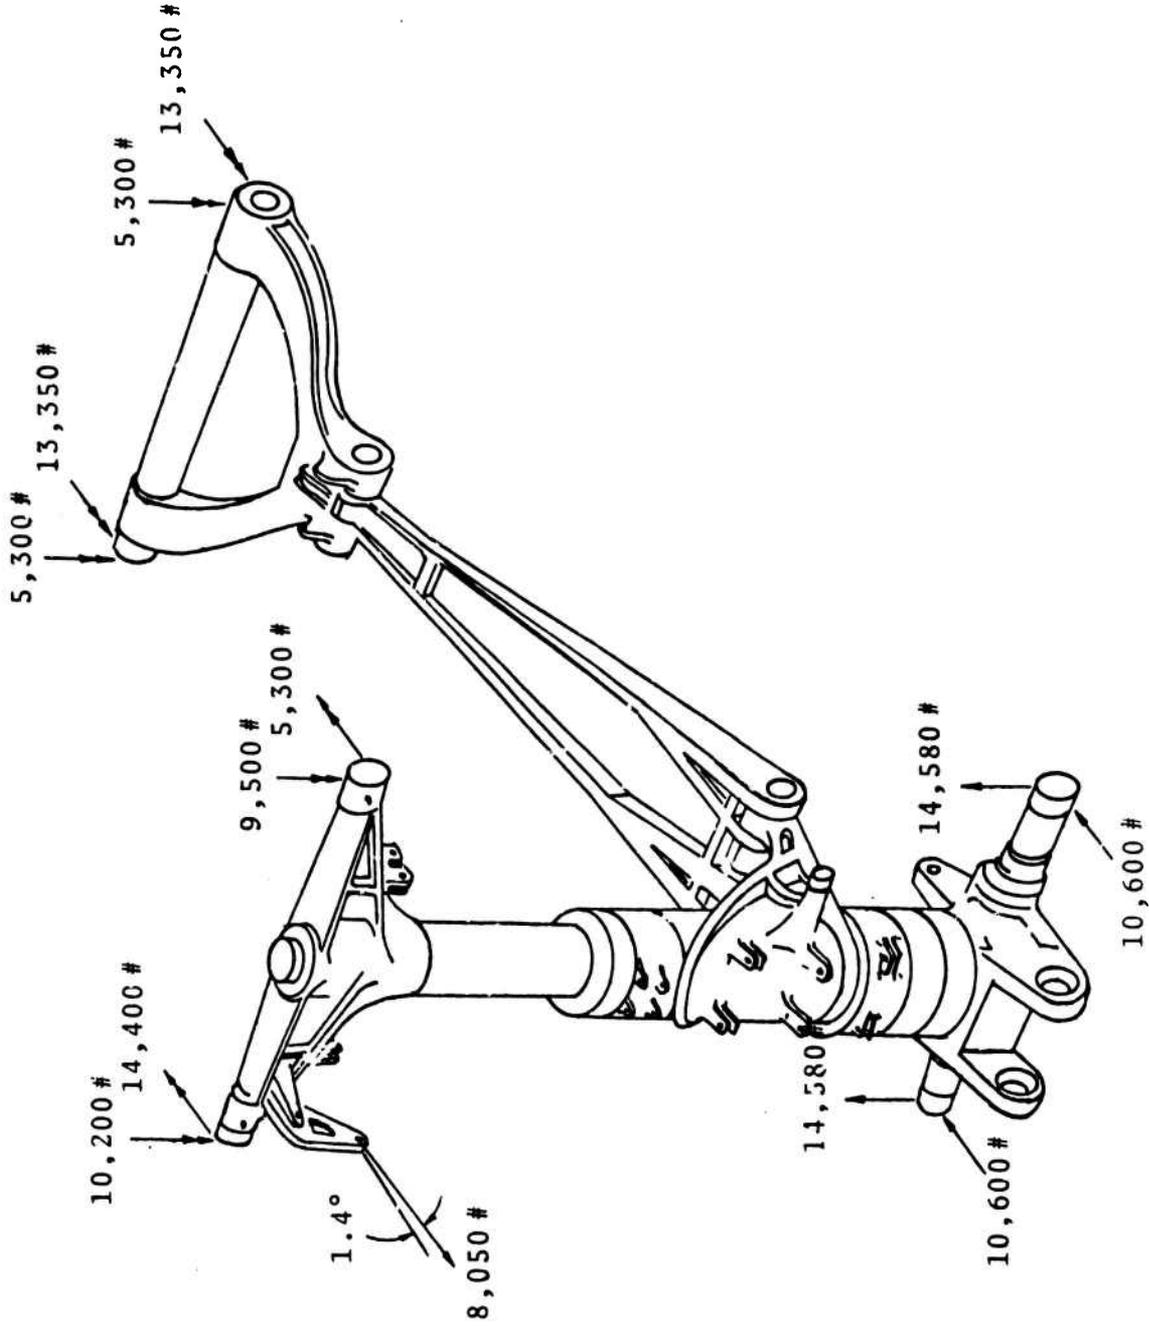
Figure A-2. Condition 1 SU, 3 Point Landing - Maximum Spin Up

The load distribution of this condition, direction and magnitude, is given in Figure A-2.

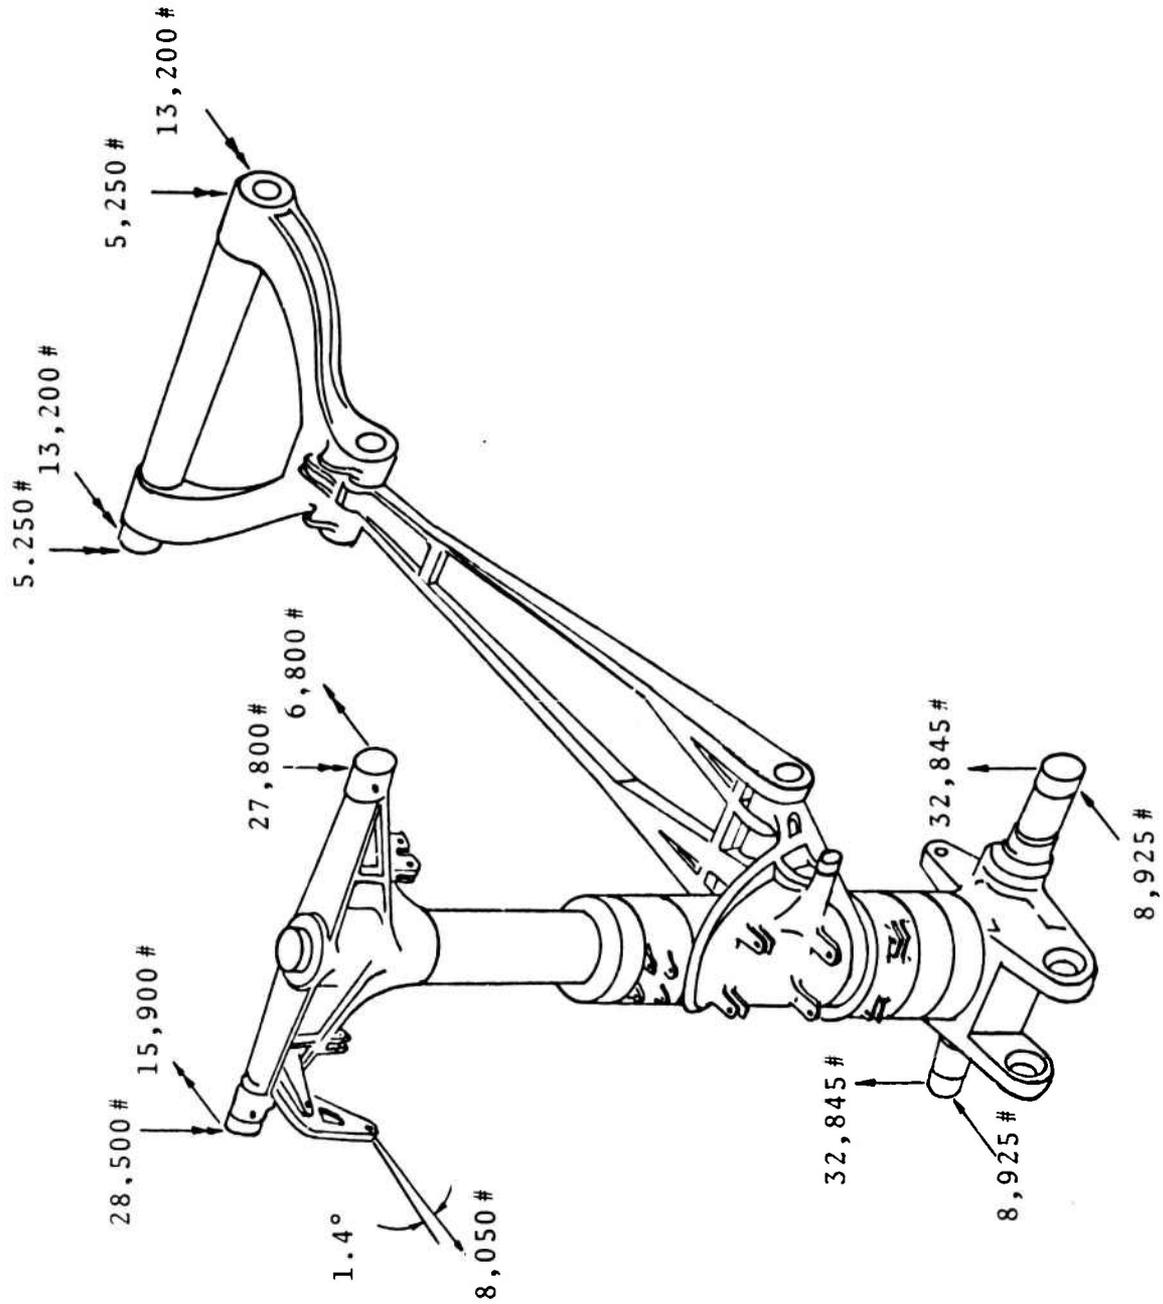
Figure A-4. Condition 1 SU<sub>2</sub>, 3 Point Landing - Second Cycle Spin Up

The load distribution for this condition, direction and magnitude is given in Figure A-4.

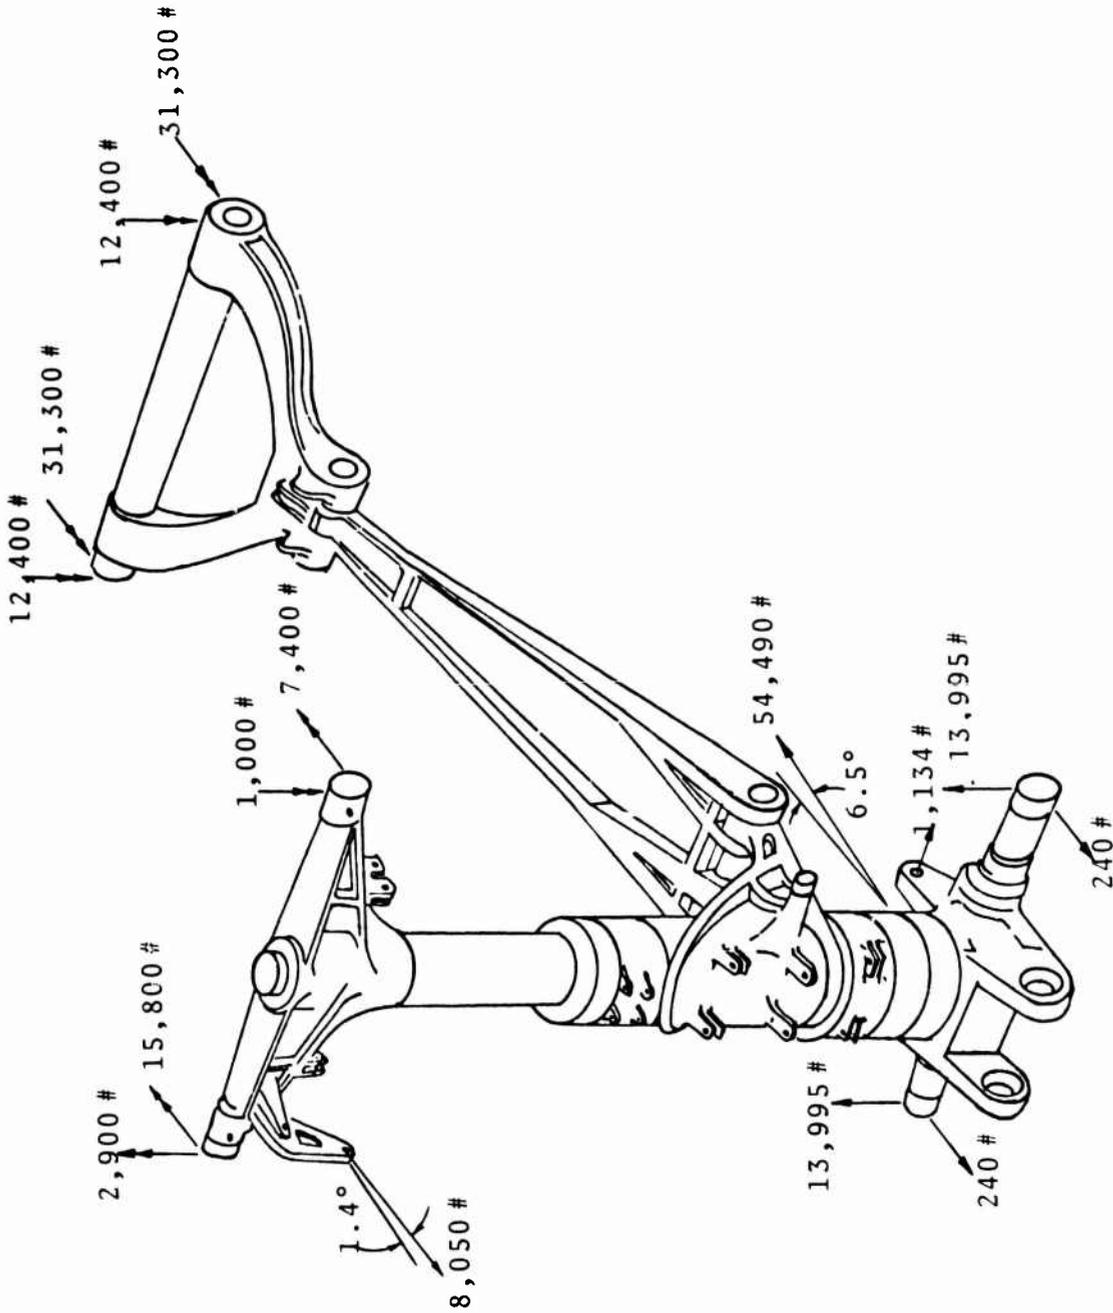
Figure A-5. Condition 11 D<sub>F</sub>,

The loads for this condition were derived using the holdback release element failure load of 54,500 lbs. The components of the holdback and nose wheel axle loads are as follows:

The resultant nose wheel axle load act normal to the ground with the FRL inclined nose-up at  $0.972^\circ$ . The loading distribution for this condition, direction and magnitude, is given in Figure A-5.

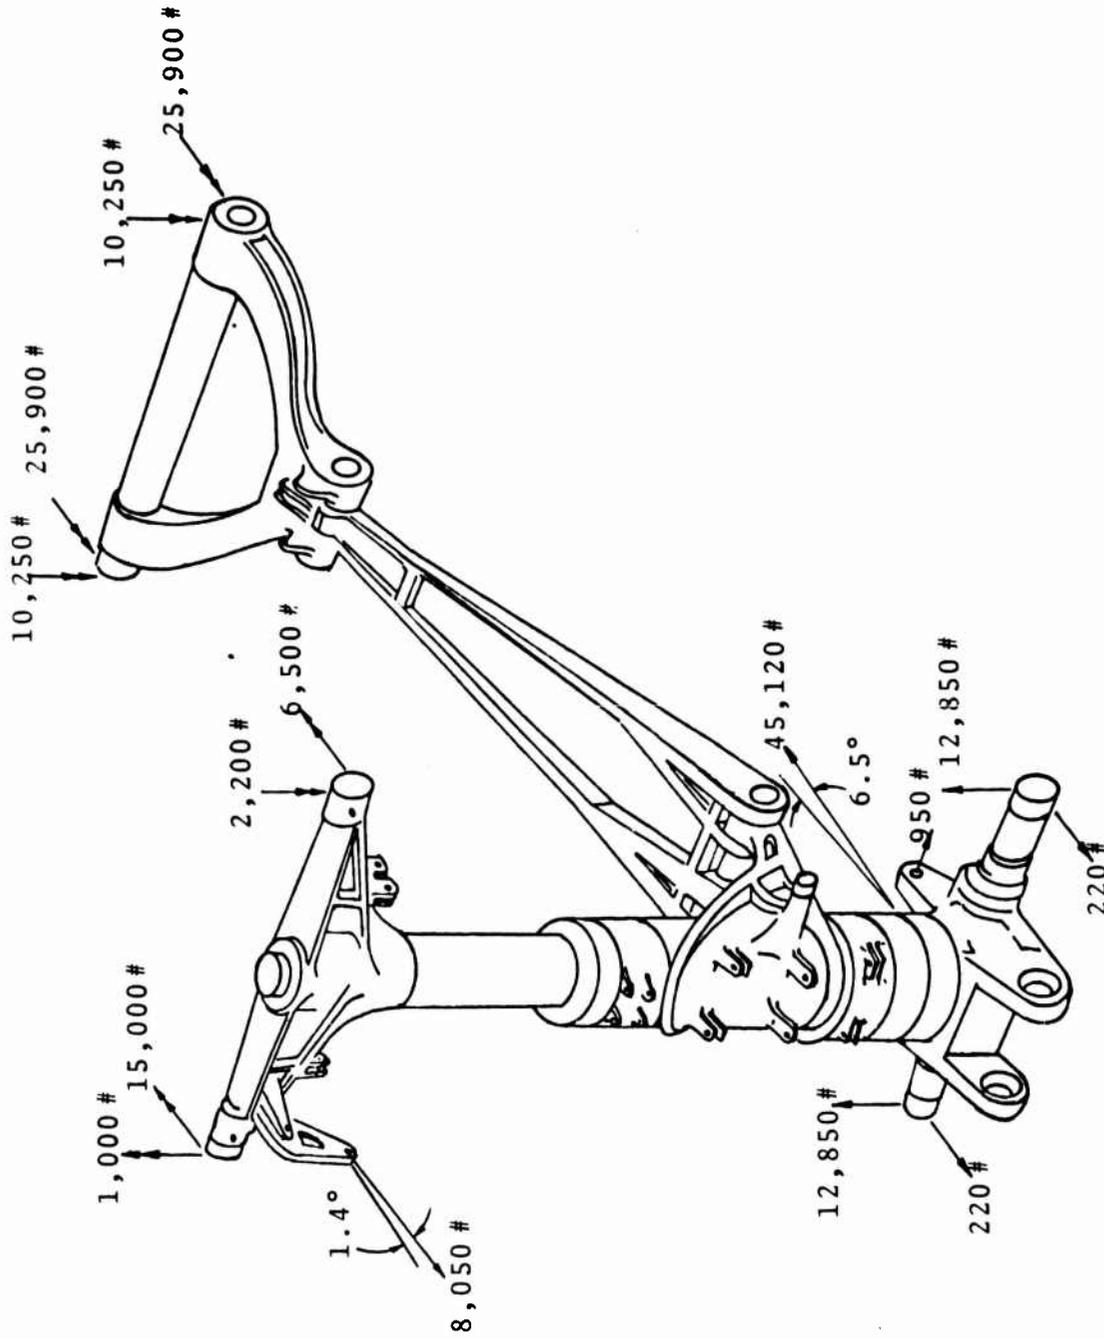
Figure A-6. Condition 11D, Catapult Approach Dashing

The loads for this condition were derived to produce a design limit compression load of 60,000 lb. in the nose gear drag brace, which was measured during the airplane catapult trials at Patuxent in February 1962. For taxi speeds of 2 to 4 mph and no wheel braking, a holdback trial bar axial load of 45,124 lbs. is required to produce 60,000 lbs. compression in the drag brace. The components of the holdback and nose wheel axle loads are as follows:

The resultant nose wheel load acts normal to the ground with the FRL inclined nose up at 0.97°. The loading distribution for this condition, direction and magnitude is given in Figure A-6.

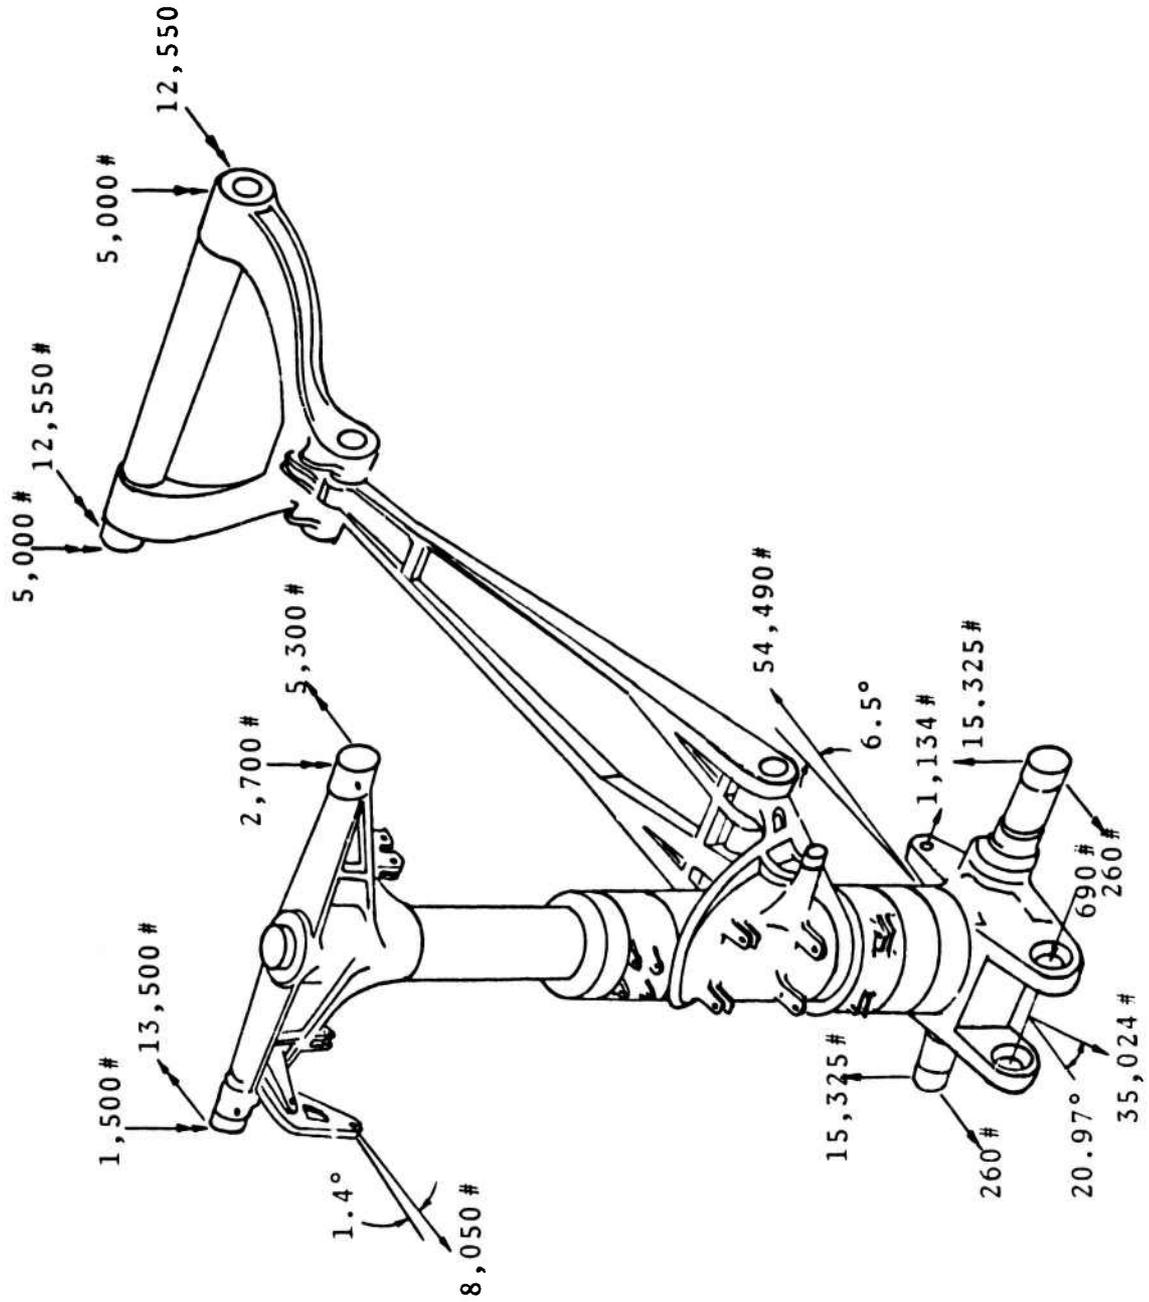
Figure A-7. Condition 11A, Catapult Release

The loads for this condition were derived using the holdback release element failure load of 54,500 lbs. and a simultaneously applied tow link load of 35,470 lbs. The components of the holdback, tow link and nose wheel axle loads are as follows:

The resultant tow link load acts at an angle of 20.97° down and 1.2° to the right or left of the fuselage reference axes.

The resultant nose wheel load acts normal to the ground with the FRL inclined nose-up at  $0.97^\circ$ . The loading distribution for this condition, direction and magnitude is given in Figure A-7.

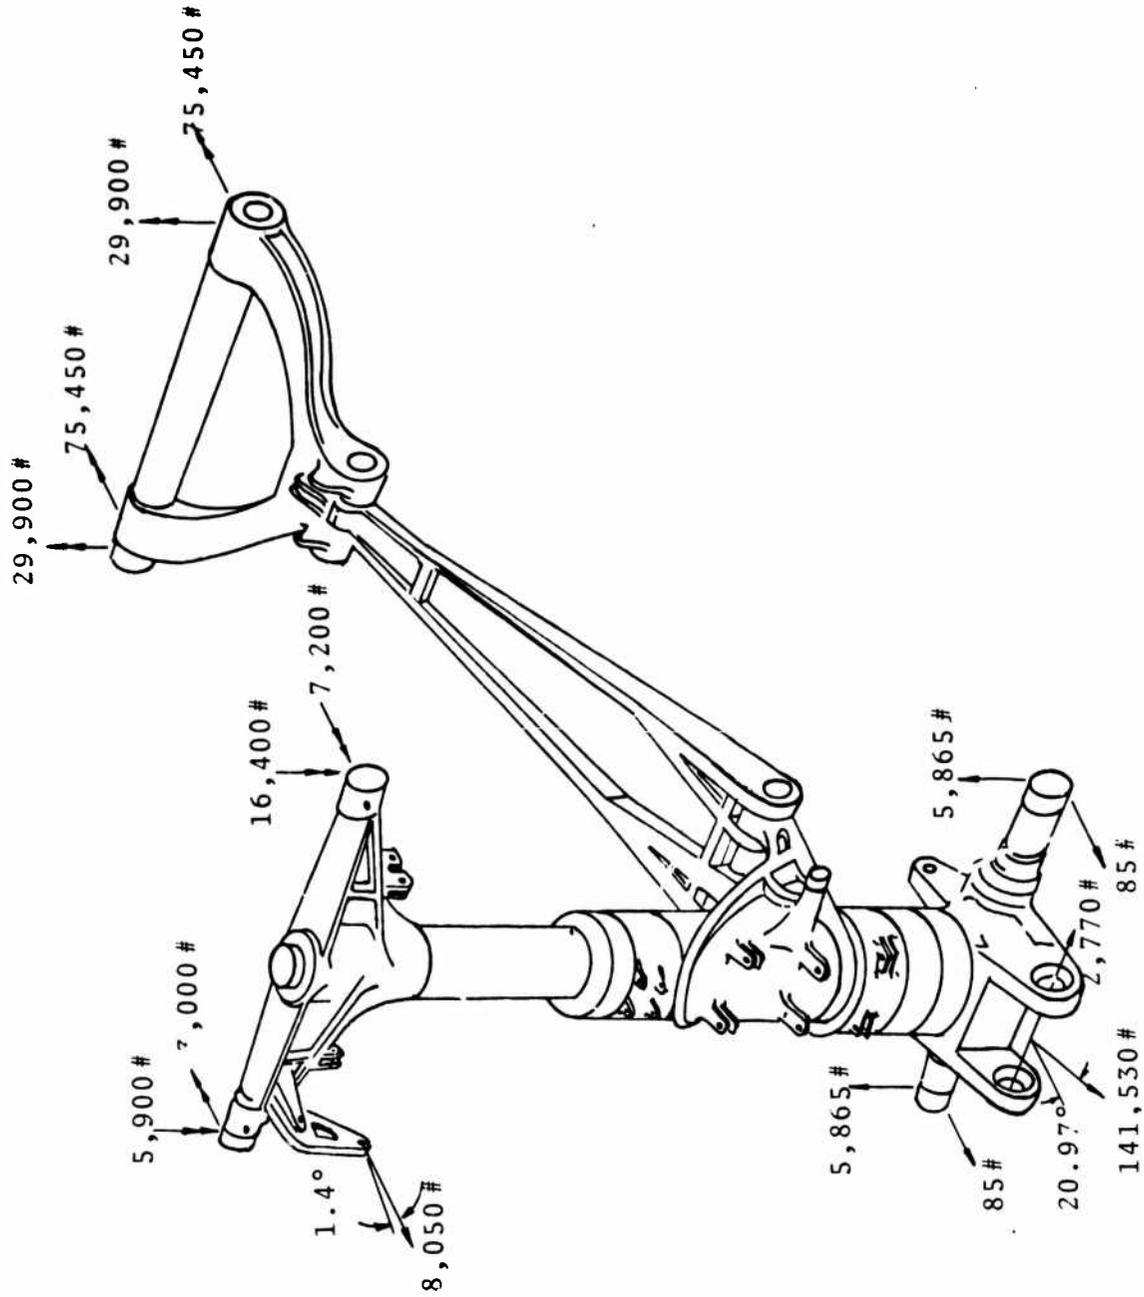
Figure A-8. Condition 11C, Catapult Start-of-Run Maximum Tow Load

The loads for this condition were derived using a maximum tow force equal to 133,000 lbs. and a mean tow force of 120,000 lbs., applied at the minimum tow link angle of  $20^\circ$  relative to the ground. The components of the maximum tow link and nose wheel axle loads are as follows:

The resultant nose wheel axle loads acts normal to the ground with the FRL inclined nose-up at  $0.97^\circ$ . The loading distribution for this condition is given in Figure A-8.
