AMMRC CTR 76-5

FINISHING TECHNIQUES FOR SILICON NITRIDE BEARINGS

FINAL REPORT - CONTRACT DAAG46-74-C-0055

ARMY MATERIALS AND MECHANICS RESEARCH CENTER  
Watertown, Massachusetts 02172

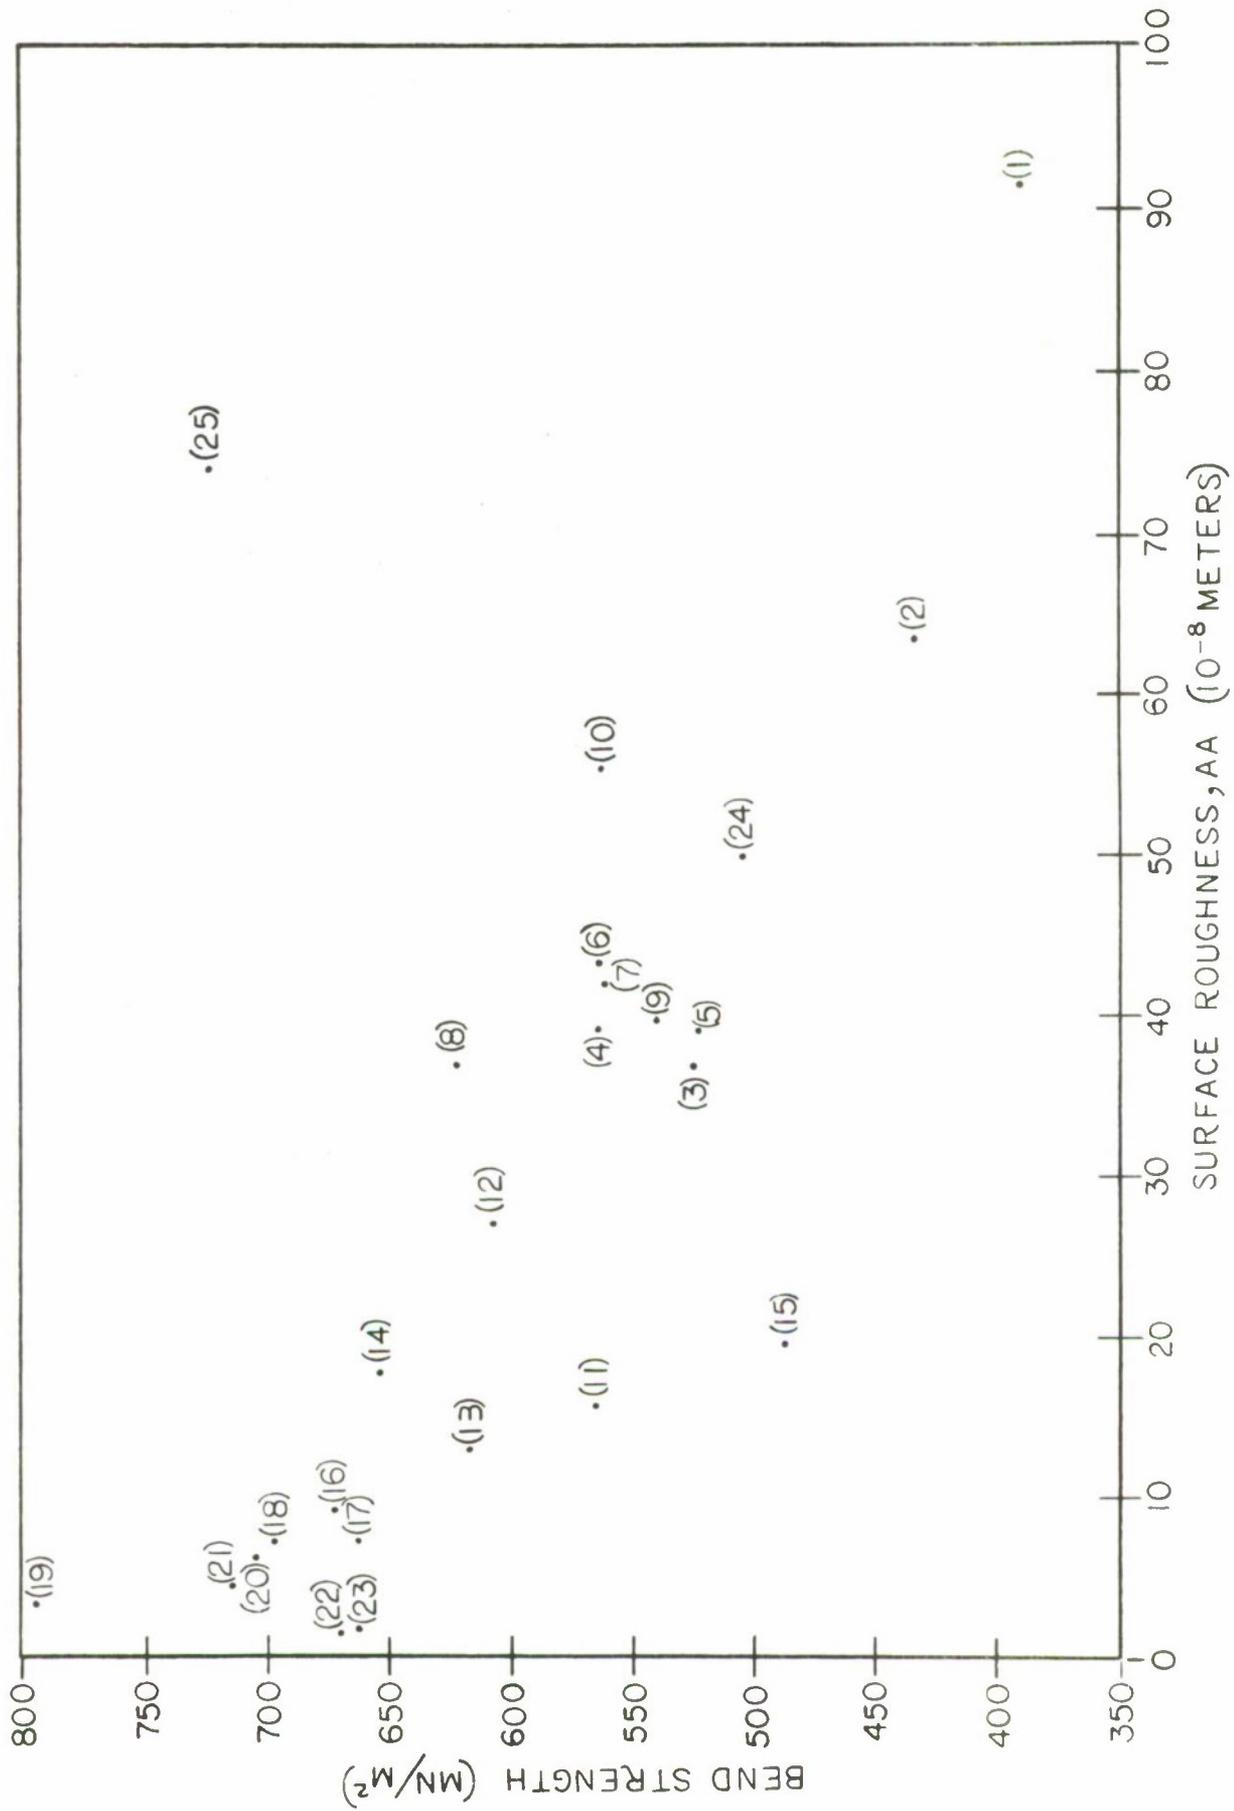
FIGURE 1 - Strength vs. Roughness for finishing variations

It had been anticipated that the stress intensity factor for the surface flaws associated with the smoother surfaces would eventually fall below that for inherent internal flaws, at which point the strength would plateau at a constant value. Furthermore, because of the smoother finishes and the smaller stressed volume of the three-point versus the four-point bend test, it was expected that the highest strengths of the round rods would be in excess of the 931 MN/m<sup>2</sup> (135 ksi) strength obtained for billet qualification. Neither expectation was realized.

The absence of the expected behavior can be explained on the basis of retained grinding damage from previous finishing steps. Repeated diameter measurements on ground specimens revealed that the rods were frequently out of round by about 1-2 x 10<sup>-3</sup> cm (0.0005 inch), a significant amount because stock removal steps subsequent to grinding were of this magnitude and the lapping and honing operations could not be expected to remove a uniform layer of material from a non-uniform cross section. Microscopic examination of lapped or honed specimens revealed traces of grinding scratches. Retained grinding damage is also reflected in the relatively higher coefficients of variation for the strengths and range of roughnesses for the smoother finishes. It is concluded that the strengths of all of the honed and lapped finishes are below their potential strengths.

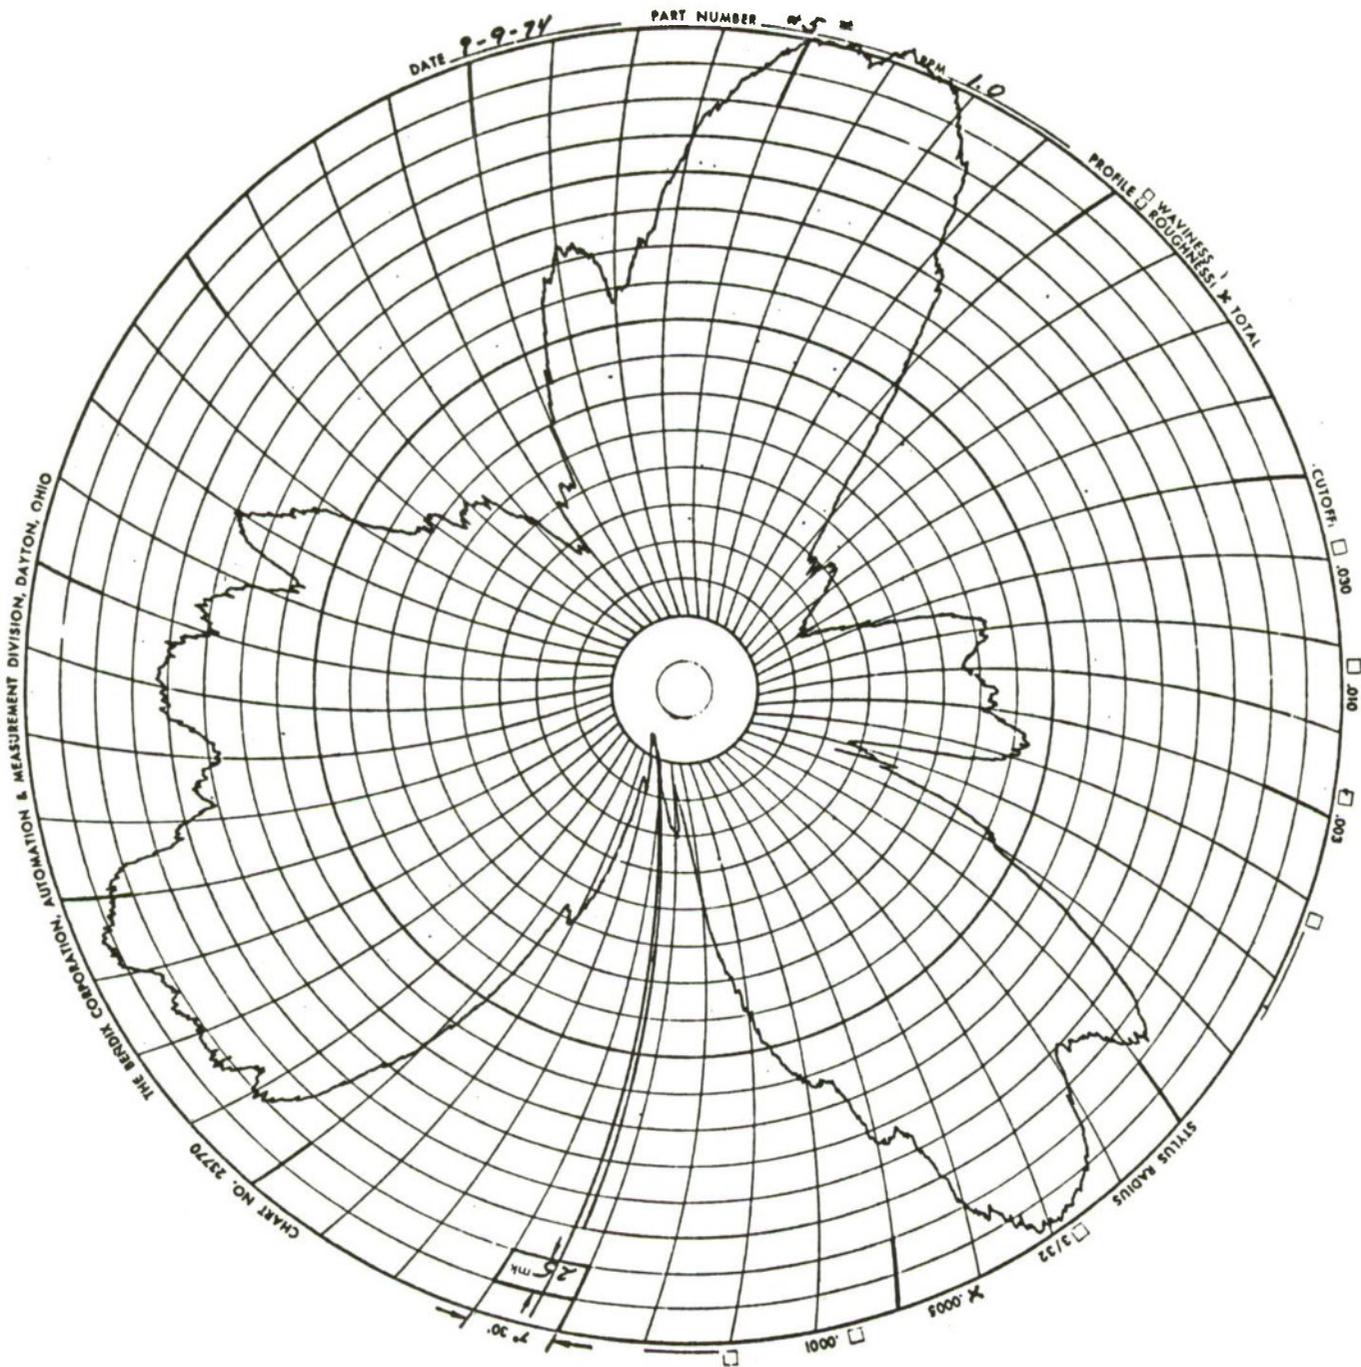
FIGURE 2 - Polar chart of reject RCF rod

To overcome the out-of-roundness problem, the method of specimen fabrication was altered. Specimen rod blanks were prepared by rough grinding to a 0.025 cm oversized diameter. Steel dead centers were epoxied to ends of the 7.6 cm blanks for subsequent grinding on a standard cylindrical grinder. The preparation of all finishes required additional grinding, the conditions of which are listed in Table VII. The switch in the grinding machine type (from centerless to cylindrical) necessitated some changes in machining parameters of the RCF specimens, as compared to those of the strength rod specimens. The most notable example of this was the change in infeeds during final diamond grinding to ensure specimen roundness.

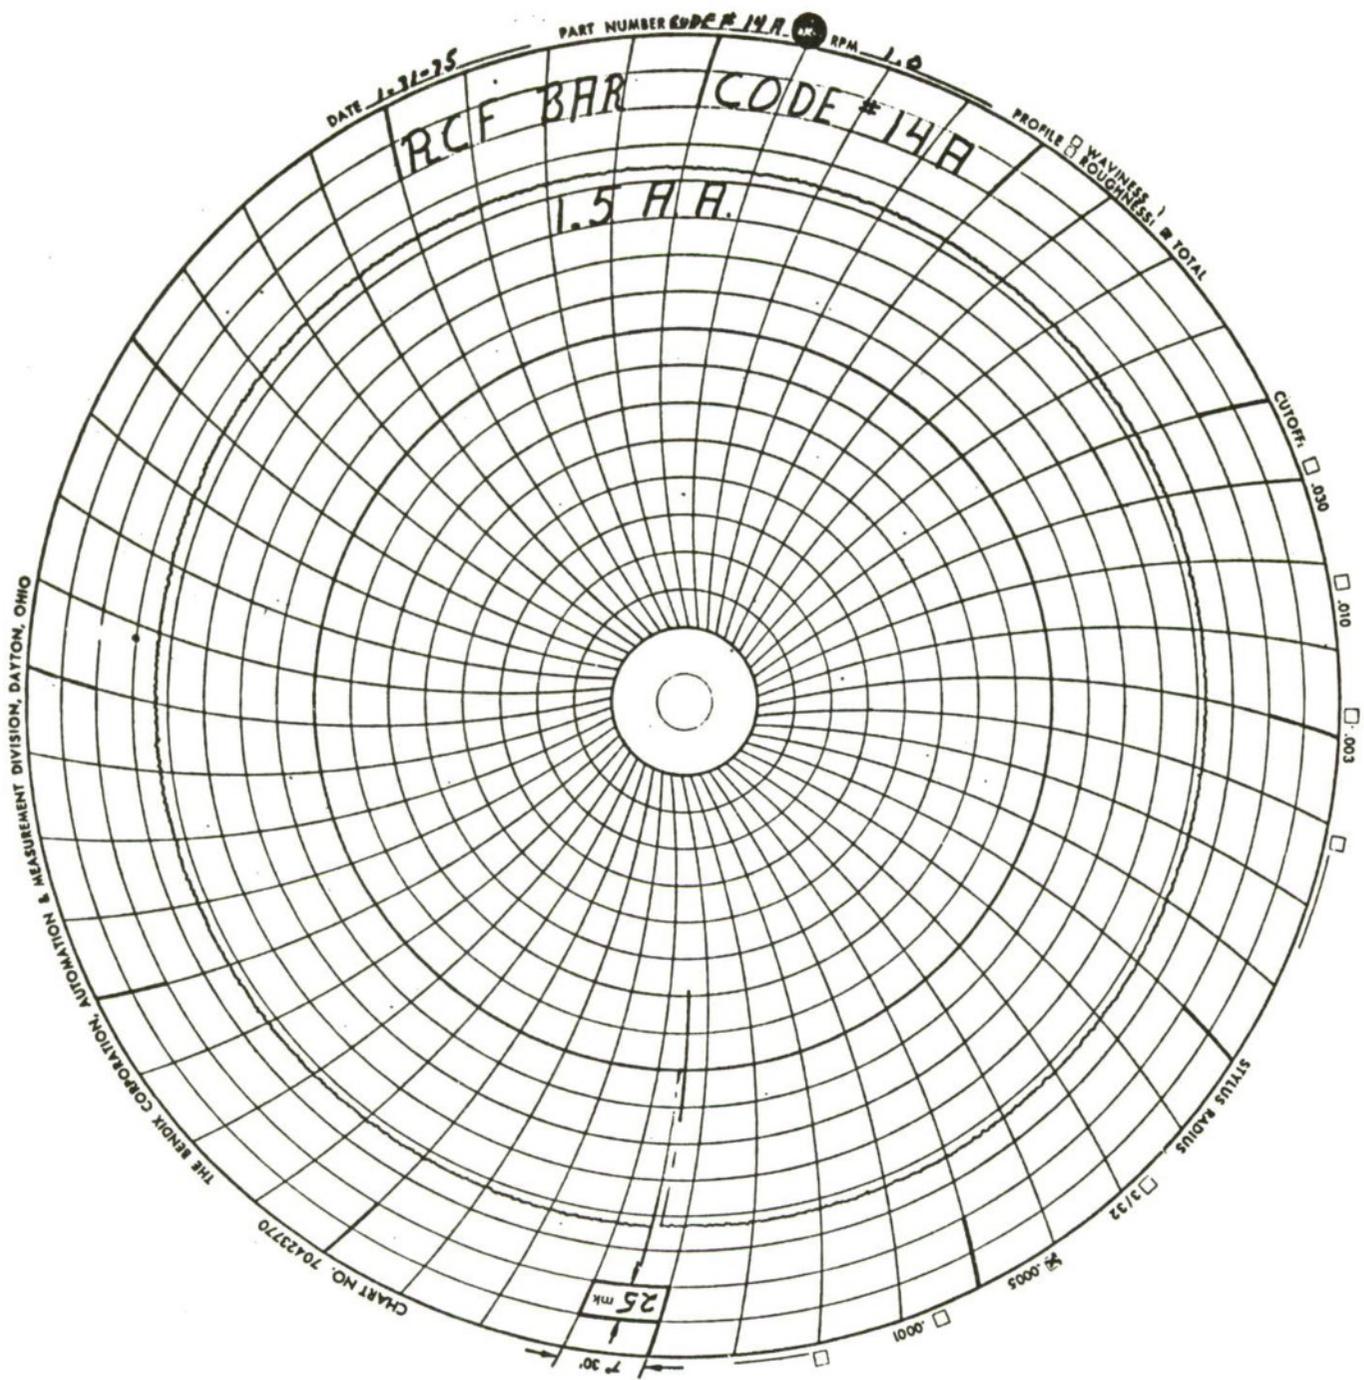
FIGURE 3 Excellent RCF rod roundness

specimen out-of-roundness was typically 1.3 microns ( $50 \times 10^{-6}$  inches). The improved roundness may be attributed to higher grinding machine stiffness and the lower infeed during final grinding.

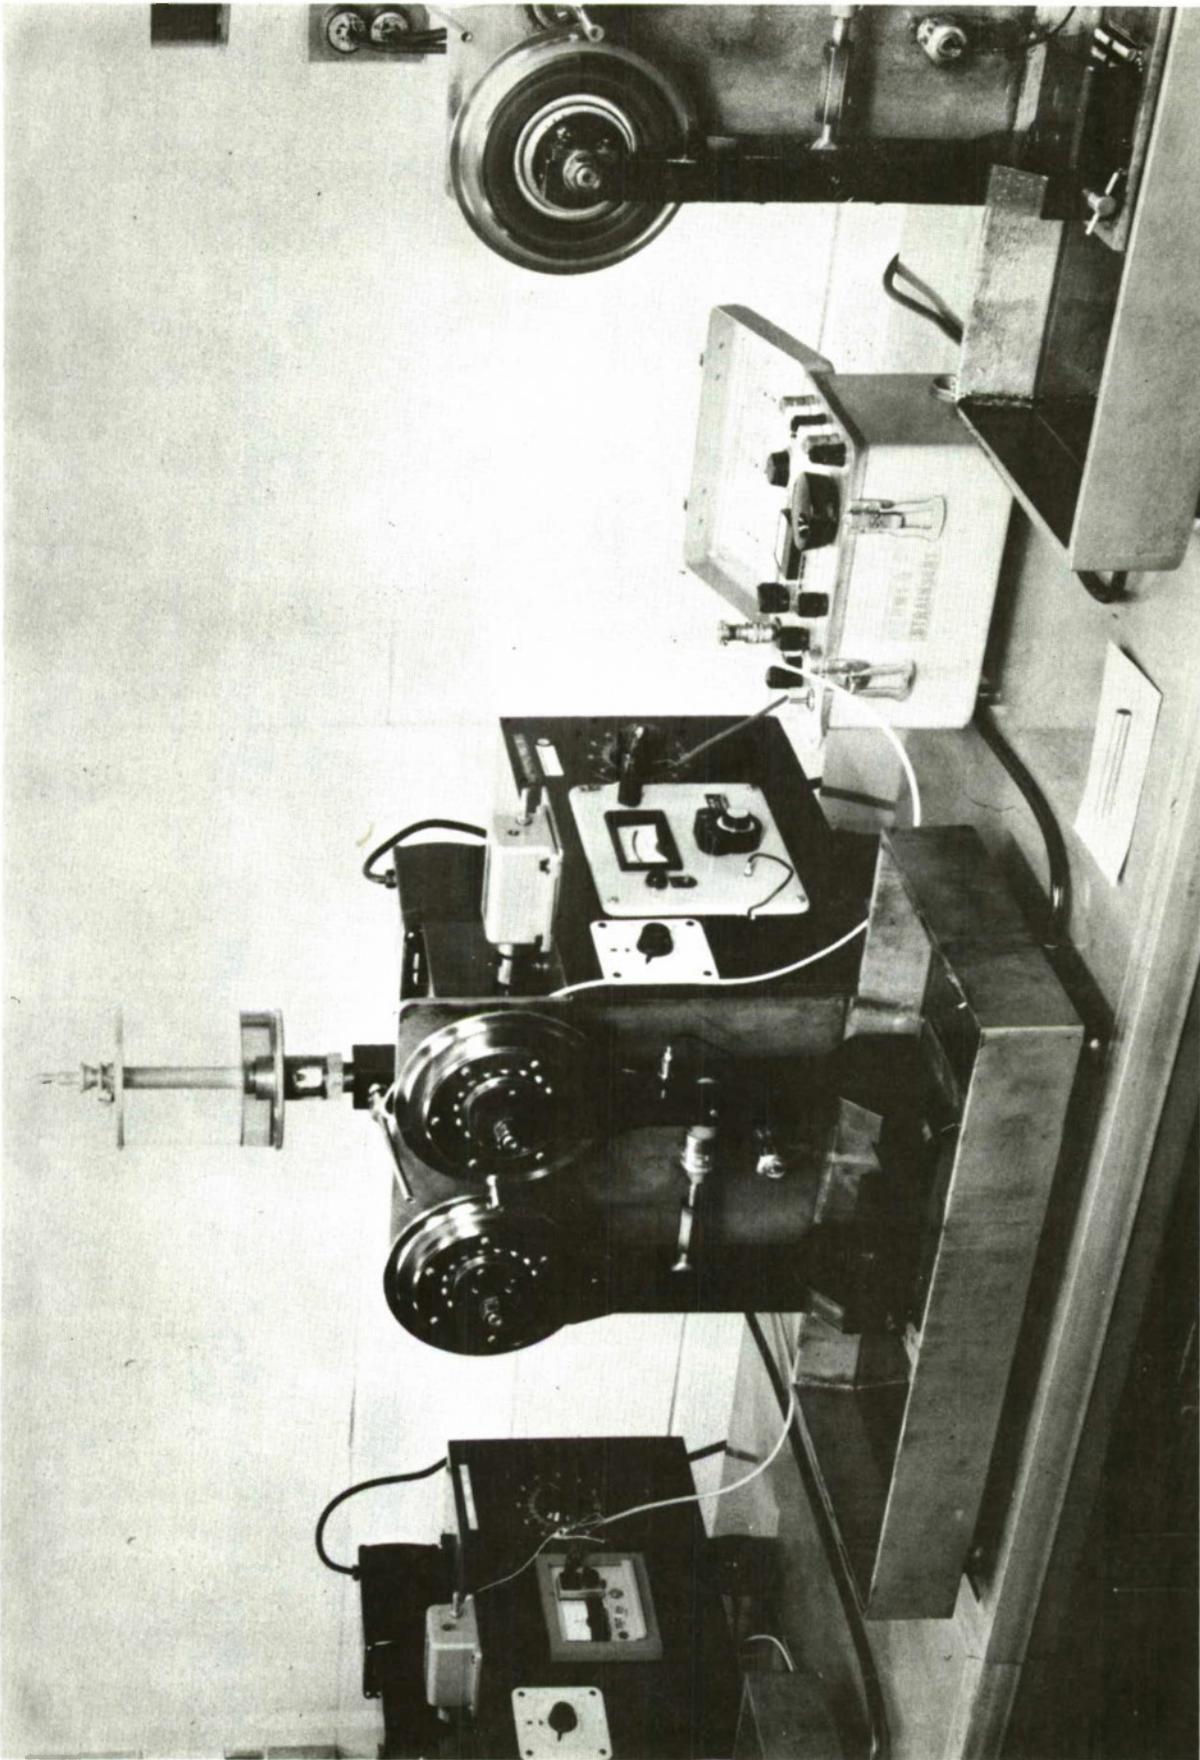
FIGURE 4 - Rolling contact fatigue test machines

The RCF machine provides a rapid method for testing of bearing material under load in nearly pure rolling contact. The specimen is driven at 10,000 rpm and, since it receives two stress cycles per revolution, one hour produces  $1.2 \times 10^6$  cycles. The fatigue life of a test is defined either by the number of cycles incurred before spall formation, which produces rig vibrations that cause automatic test termination, or by the number of cycles sustained before test suspension at an arbitrarily high number of cycles. The average test for M-50 steel, at 700 ksi Hertz stress, is about  $2.5 \times 10^6$  cycles, or two hours. By comparison, an average "accelerated" full scale bearing test may run hundreds of hours.

The loading discs see the same maximum stress as the test specimen, but their relatively large diameter normally provides them a longer life than the specimens. However, they require refinishing when they spall, normally after 20-30 tests on steel, or when they flatten after extended use. The discs are requalified after refinishing and between silicon nitride tests, with a controlled group of M-50 steel specimens (Q-bars). The RCF test conditions used in the program are shown in Table X.

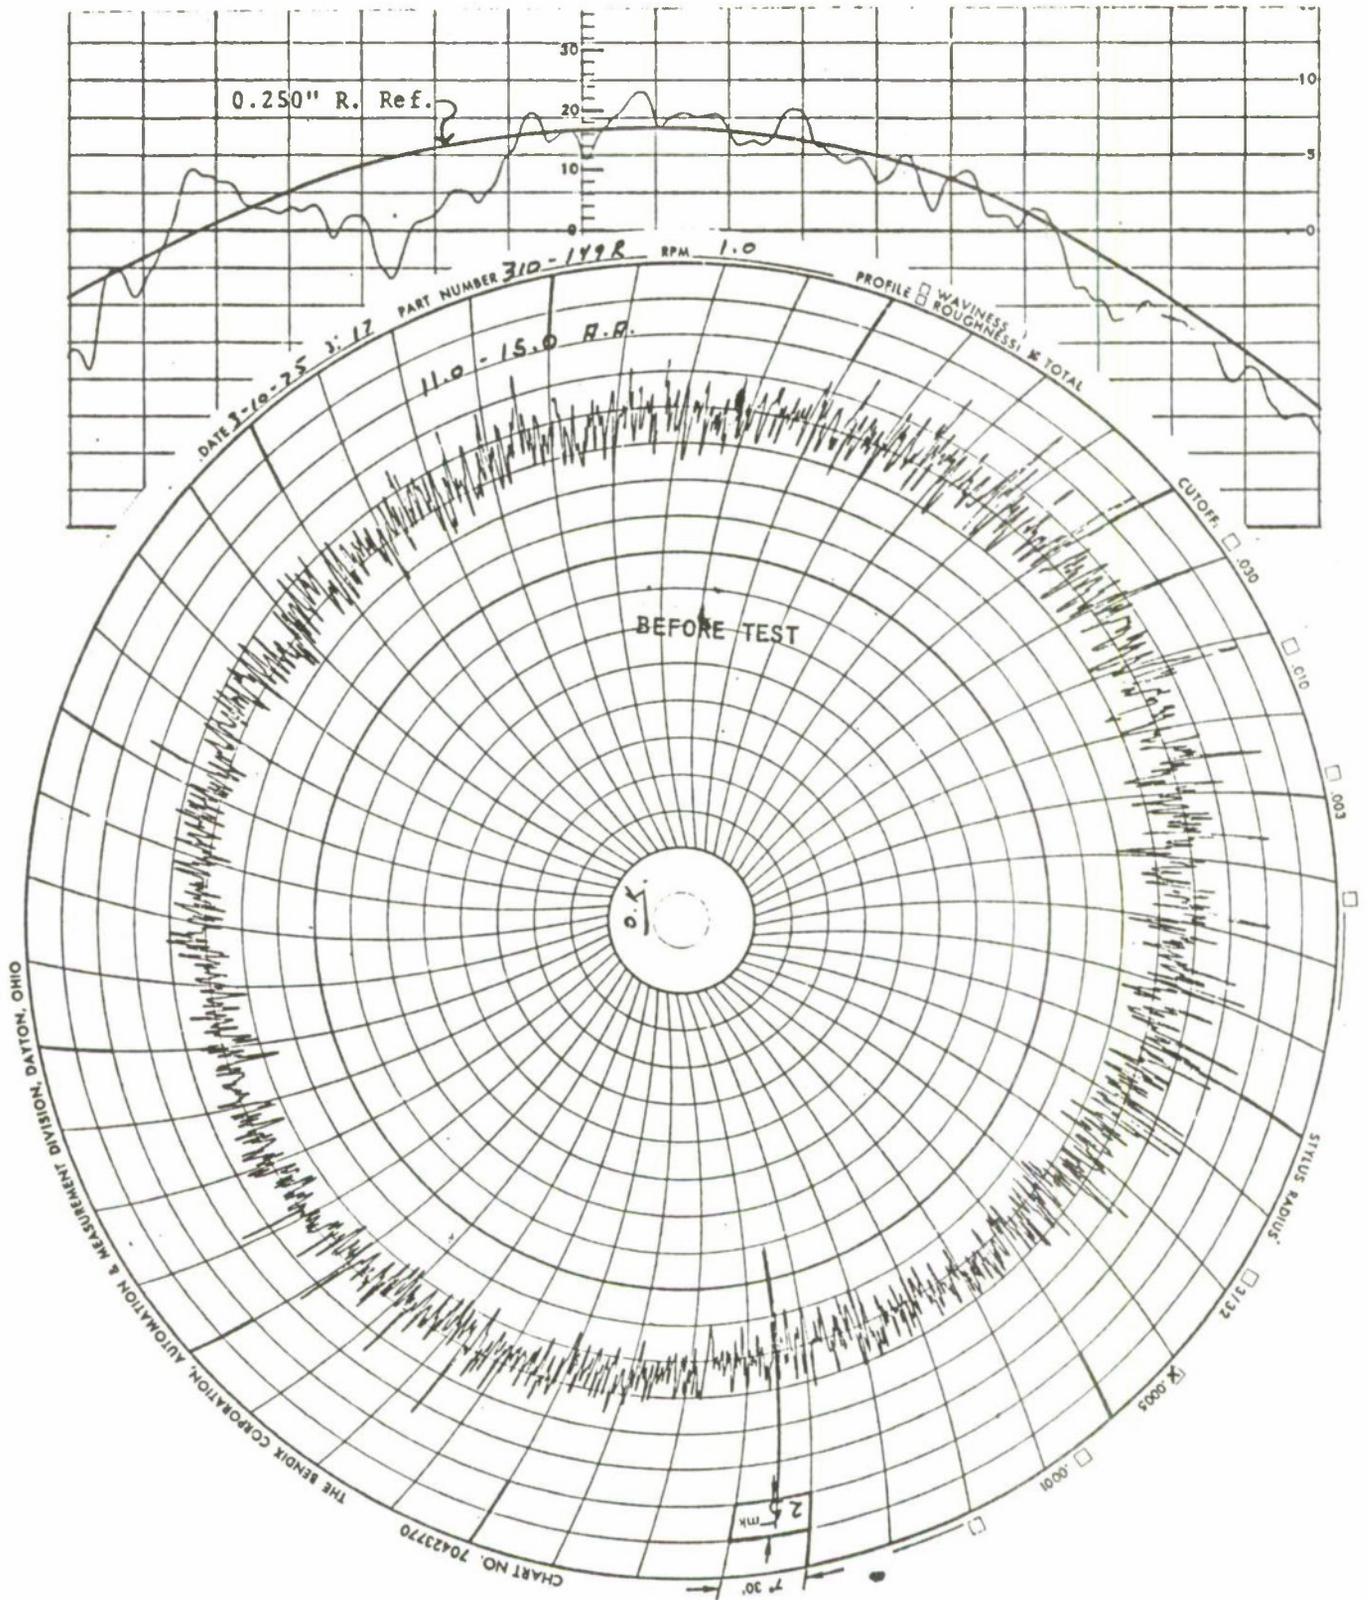
FIGURE 5 - Axial (top) and circumferential (bottom) profiles of load disc A, set 1 before silicon nitride test.

In addition, long fatigue tests were found to be self perpetuating as a result of load disc smoothing during test. This behavior was discovered by measuring fatigue lives on M-50 steel reference specimens during the use of the loading discs. Four pairs of load discs were involved in the study and each set was run against Q-bars before and after a long time silicon nitride suspended test. The fatigue comparisons are shown in Table XI.

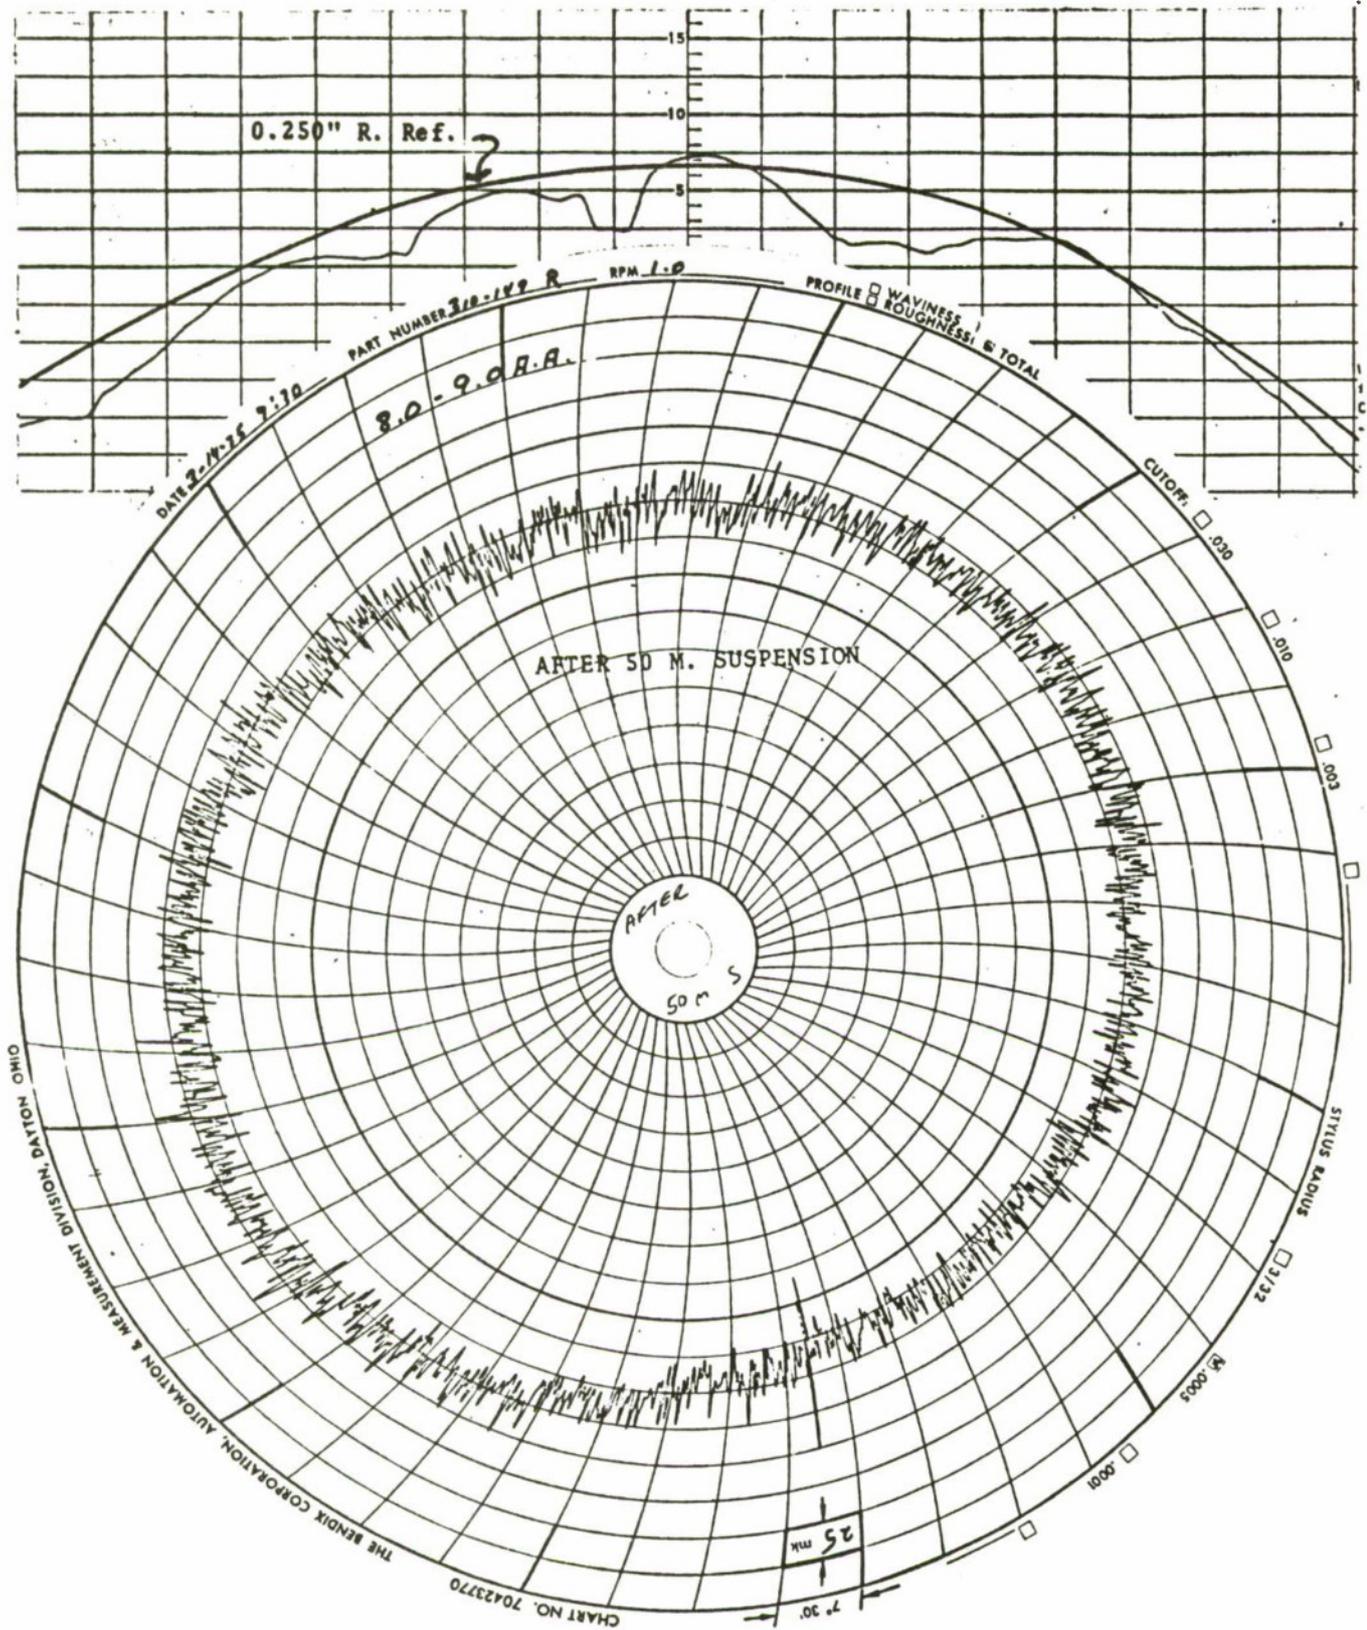
FIGURE 6 - Axial (top) and circumferential (bottom) profiles of load Disc A after 50 million cycles on silicon nitride

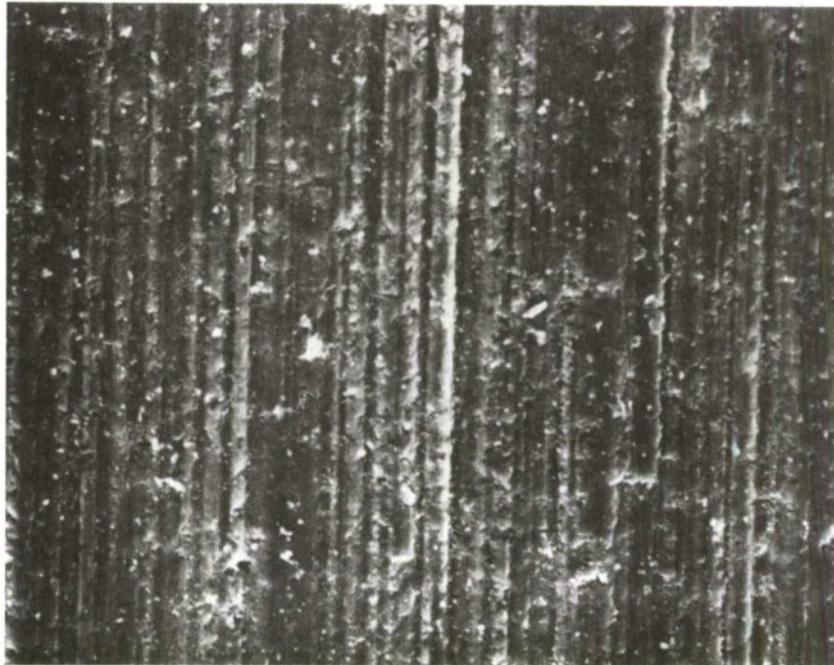
FIGURE 7 - Finish Variation #5 (320 grit diamond grind)  
on HS-110  $\text{Si}_3\text{N}_4$ , 1000X.

Figure 7 is of Finish Variation #5, that of a 320 grit diamond wheel grind. The surface is furrowed and plastically deformed by the grinding scratches. With a single exception to be shown, a given finish on HS-110 material was indistinguishable from the same finish on NC-132 material, and, therefore, only one material finish is shown. Figure 8 shows Finish Variation #14 produced by the

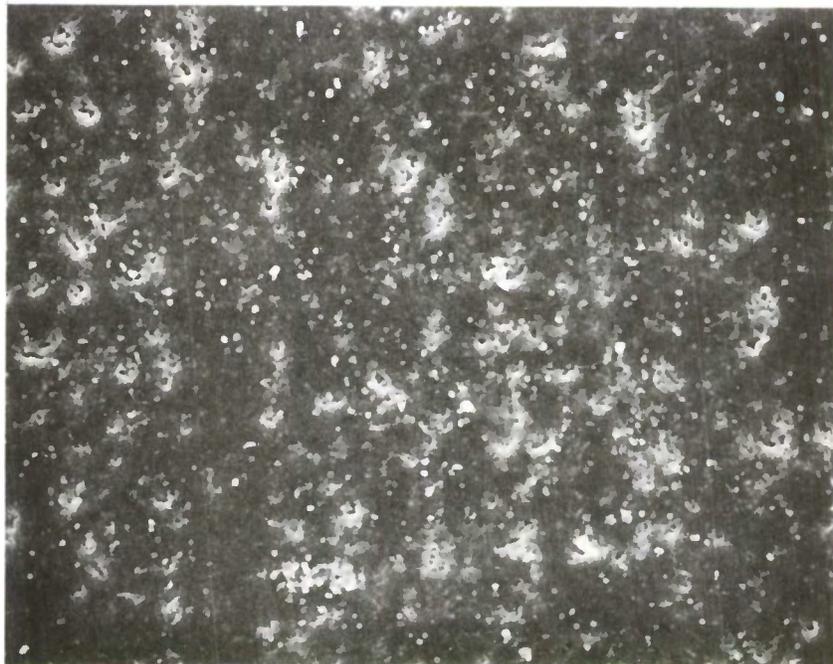
FIGURE 8 - Finish Variation #14 (150 grit SiC grind)  
on HS-110  $\text{Si}_3\text{N}_4$ , 1000X.

150 grit silicon carbide wheel. Grinding furrows are absent due to the small grit penetration of the large worn grits. Considerable pitting is evident and which resulted from grain pull-out at regions of grain boundary damage. Figure 9 and 10 are of Finish Variation #19 (diamond paste lapping) on HS-110 and NC-132 silicon nitride, respectively. Microstructural details are apparent. The grains in the NC-132 silicon nitride show more background relief, while, in the HS-110, fine needle crystals ( $\sim 2\mu$  long) are present along with the more typical blocky crystals.

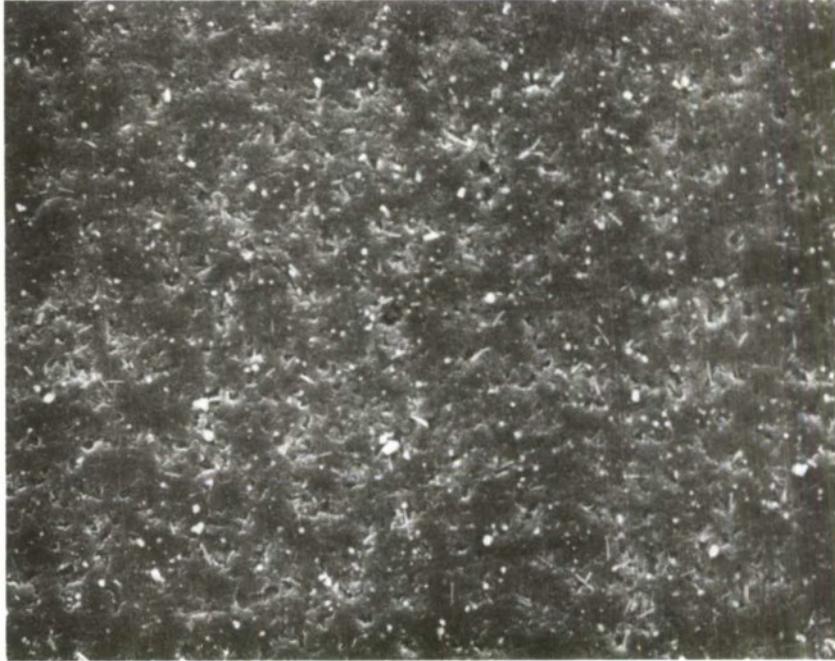
FIGURE 9 - Finish Variation #19 (diamond grit lap)  
on HS-110  $\text{Si}_3\text{N}_4$ , 1000X.

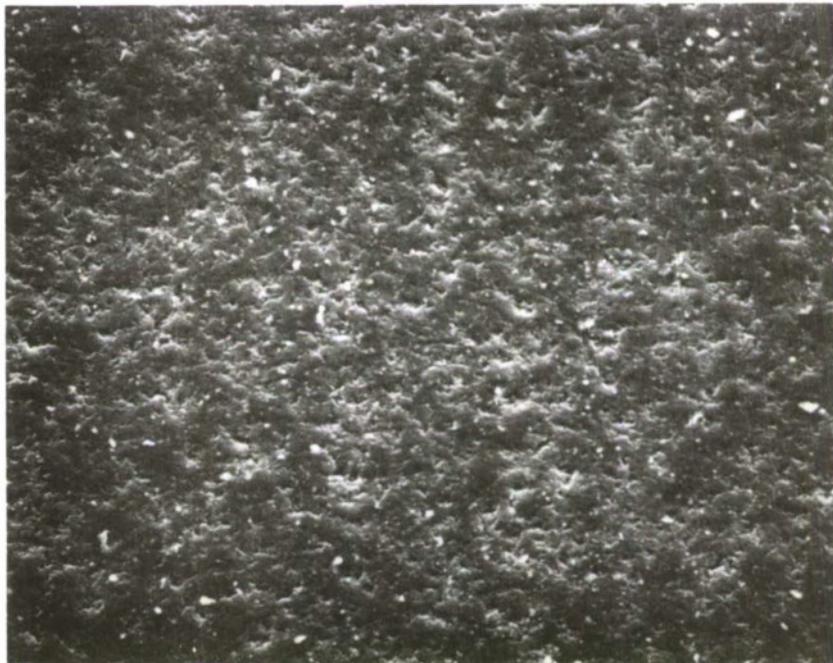
FIGURE 10 - Finish Variation #19 (diamond grit lap)  
on NC-132  $\text{Si}_3\text{N}_4$ , 1000X.

Figure 20 shows that the impacted  $\text{SnO}_2$  polishing compound is removed from the pull-outs within the load track. The appearance of the diamond lapped surface after RCF testing is relatively unchanged, as may be seen by comparing Figure 21 with Figure 10.

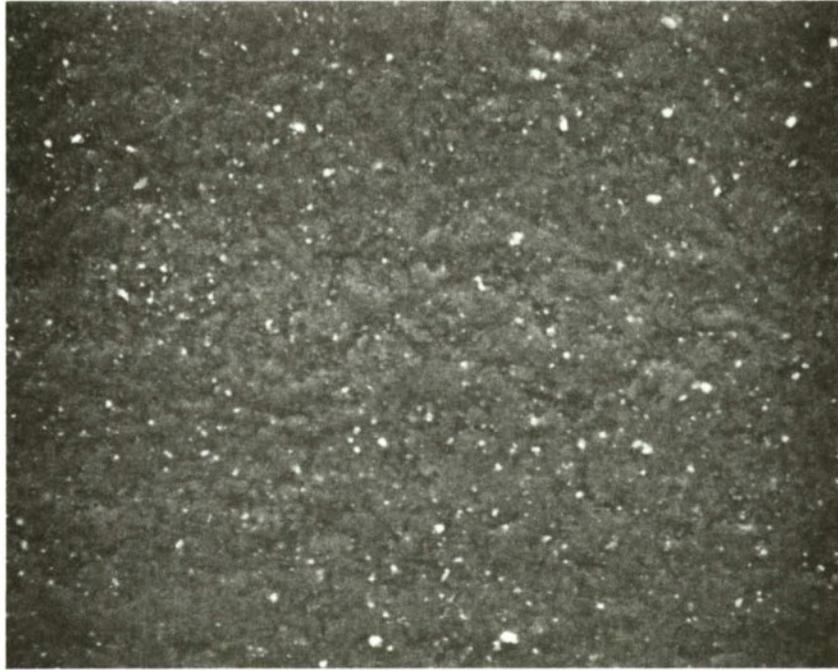
FIGURE 11 - Finish Variation #20 (B<sub>4</sub>C grit lap)  
on NC-132 Si<sub>3</sub>N<sub>4</sub>, 1000X

Figure 11 and 12 show finishing Variations #24 and #25 obtained by lapping with boron carbide and silicon carbide grits, respectively. The lack of sharp detail in both micrographs is believed due to the formation of a thin oxidation layer during lapping. The pits from grain pull-outs in Figure 12 appear to be filled with fine wear debris. The oxidation of the boron carbide abrasive is believed to contribute to the glass formation in Figure 11. The white specks in both micrographs are particles of tungsten carbide, which produce a greater yield of secondary electrons than the matrix. This is a typical appearance of NC-132 containing 2-4 percent WC.

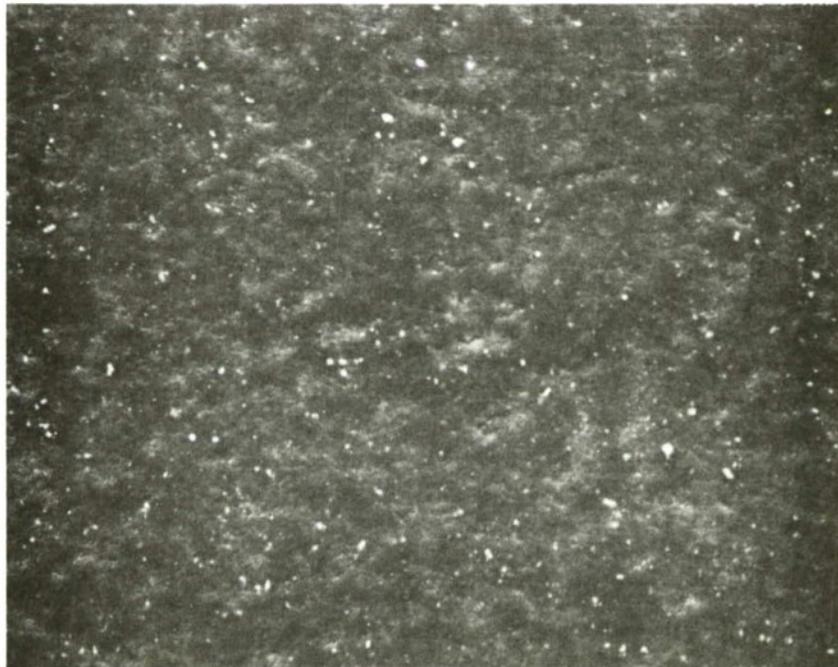
FIGURE 12 - Finish Variation #21 (SiC grit lap)  
on NC-132 Si<sub>3</sub>N<sub>4</sub>, 1000X.

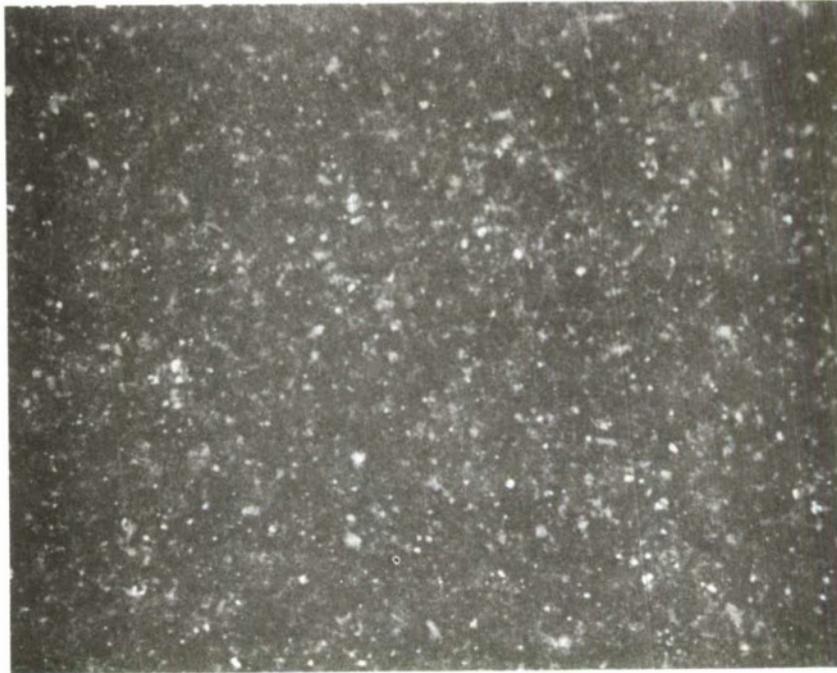
FIGURE 13 - Finish Variation #22 ( $\text{SnO}_2$  polish lap)  
on NC-132  $\text{Si}_3\text{N}_4$ , 1000X.

Figure 13 and 14 show Finish Variations #22 and #23, obtained by polishing with  $\text{SnO}_2$  and  $\text{CeO}$ , respectively. In both cases, the soft oxides have been packed into pull-outs, which contributes to the low surface roughnesses of these finishes. As in Figure 11, a residual loose abrasive scratch is visible in Figure 14.

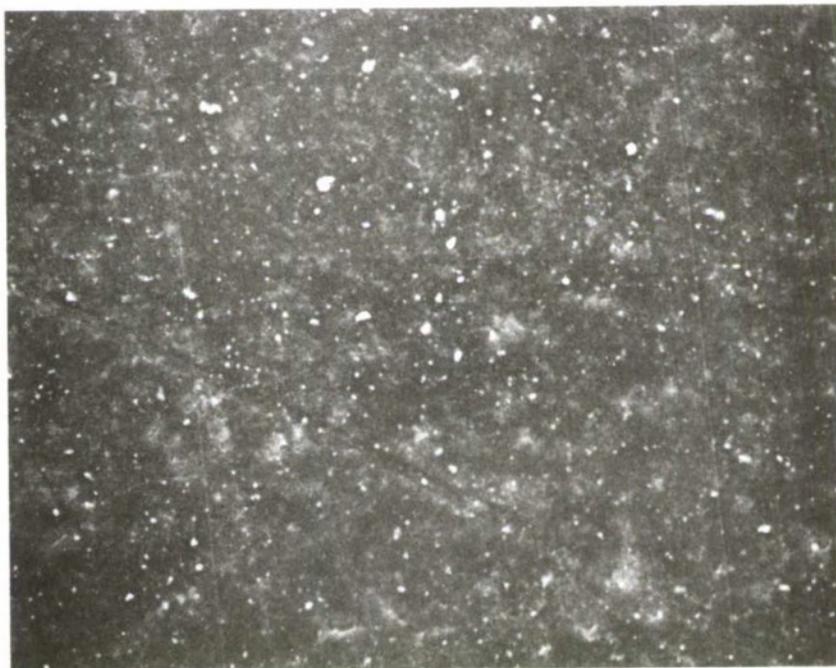
FIGURE 14 - Finish Variation #23 ( $\text{CeO}$  polish lap)  
on HS-110  $\text{Si}_3\text{N}_4$ , 1000X.

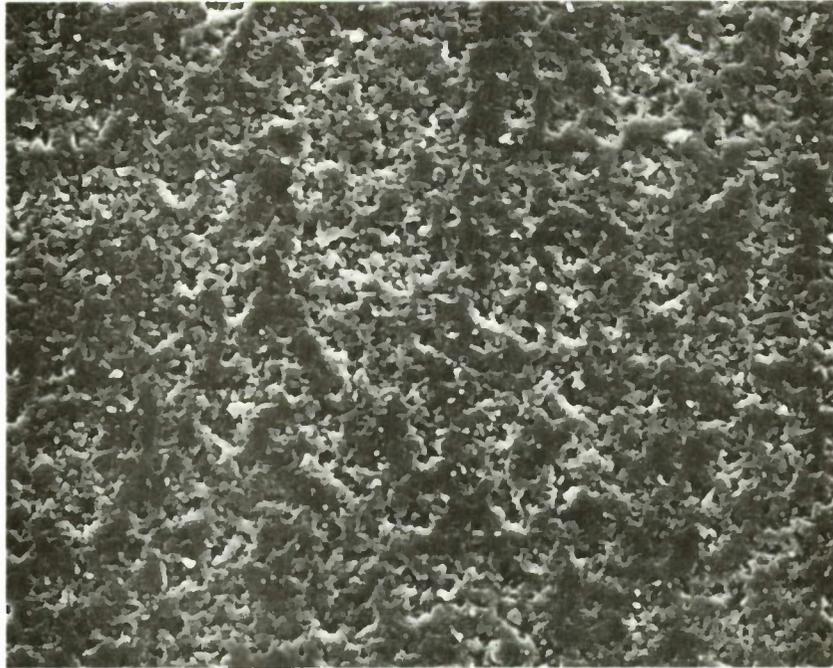
FIGURE 15 - Finish Variation #15 (400 grit hone) on  
NC-132  $\text{Si}_3\text{N}_4$ , 1000X

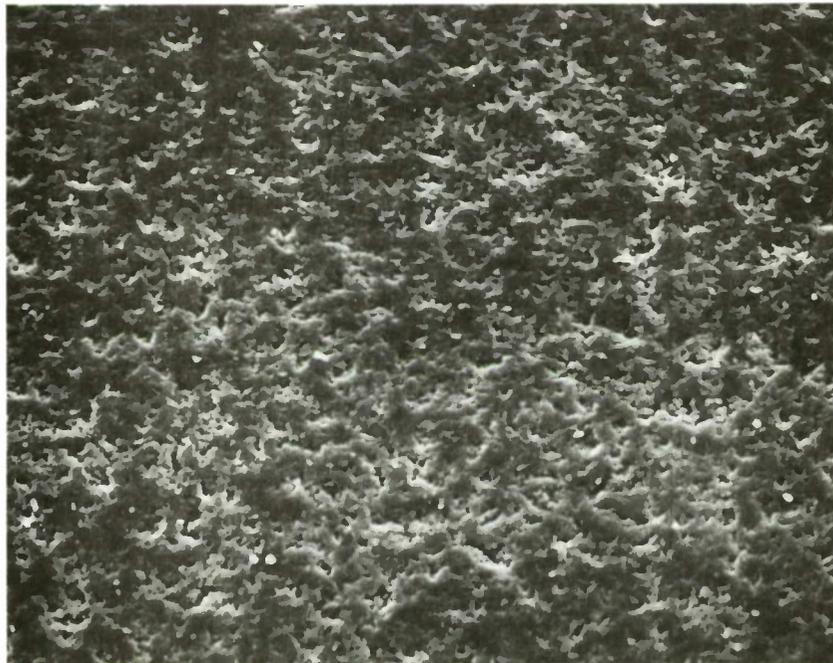
FIGURE 16 - Finish Variation #17 (600 grit hone)  
on NC-132  $\text{Si}_3\text{N}_4$ , 1000X

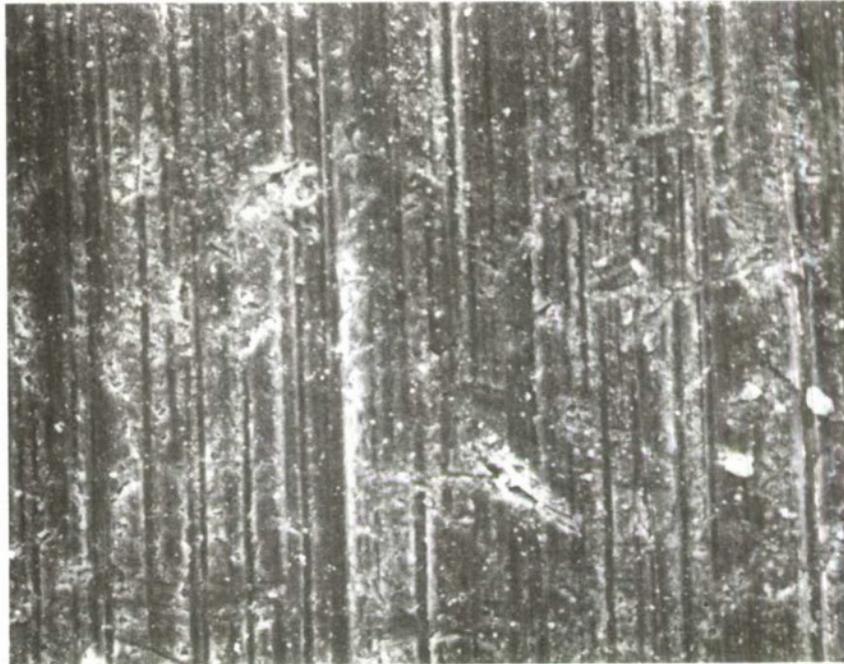
FIGURE 17 - Finish Variation #24 (tumbling in  $B_4C$  grit after 320 grit diamond grind) on strength rod, 500X.

Figure 17 and 18 show two finishes which were applied to strength rods, but not to the RCF specimens. The former is of Finish Variation #24 (tumbling in  $\text{B}_4\text{C}$  grit after grinding). While the tumbling procedure did not remove the grinding scratch topography, impact pits were formed on the surface. Figure 18 shows the strong chemical attack of the hot fluorine etch (Variation #25).

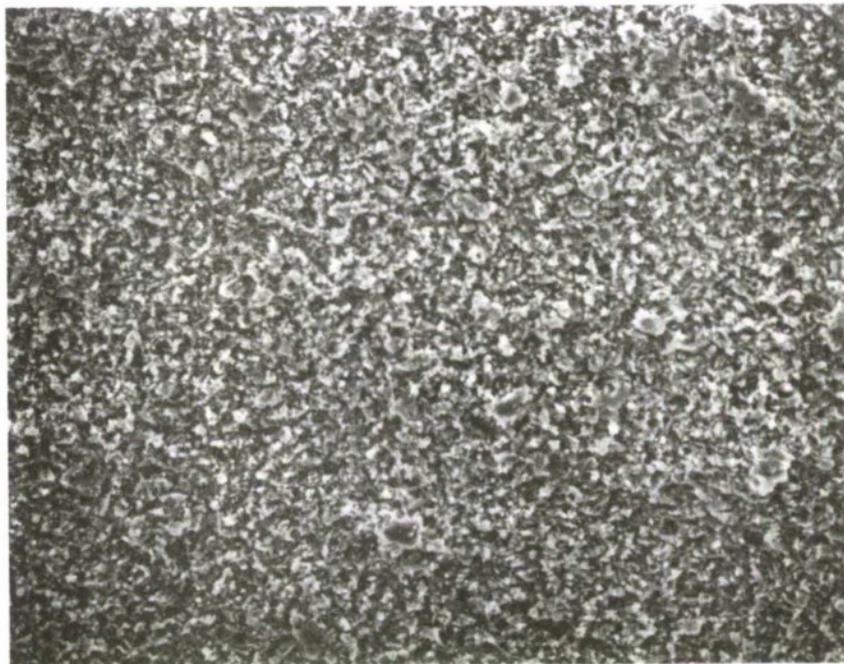
FIGURE 18 - Finish Variation #25 (gas etch) on strength rod, 500X.

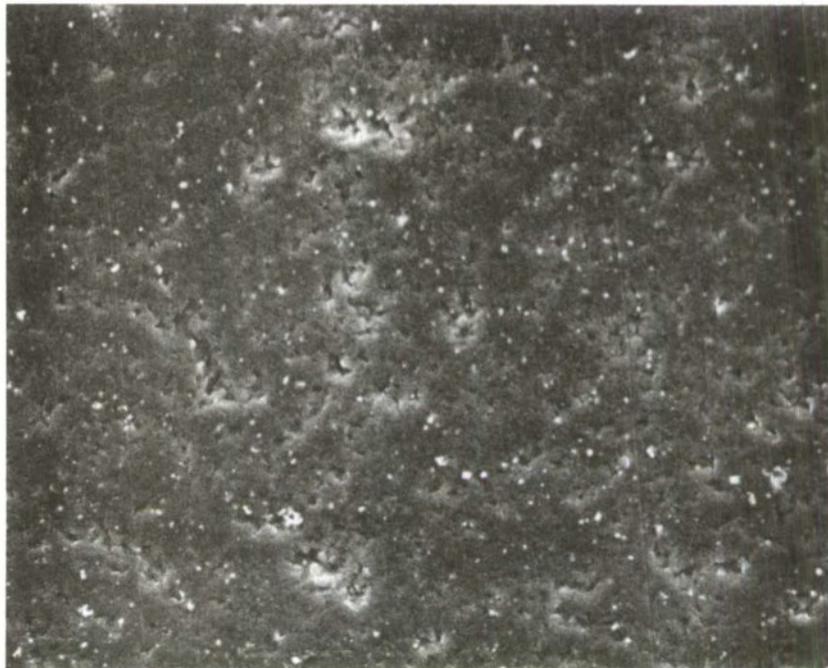
FIGURE 20 - Appearance of SnO<sub>2</sub> polished surface after RCF test, 1000X.

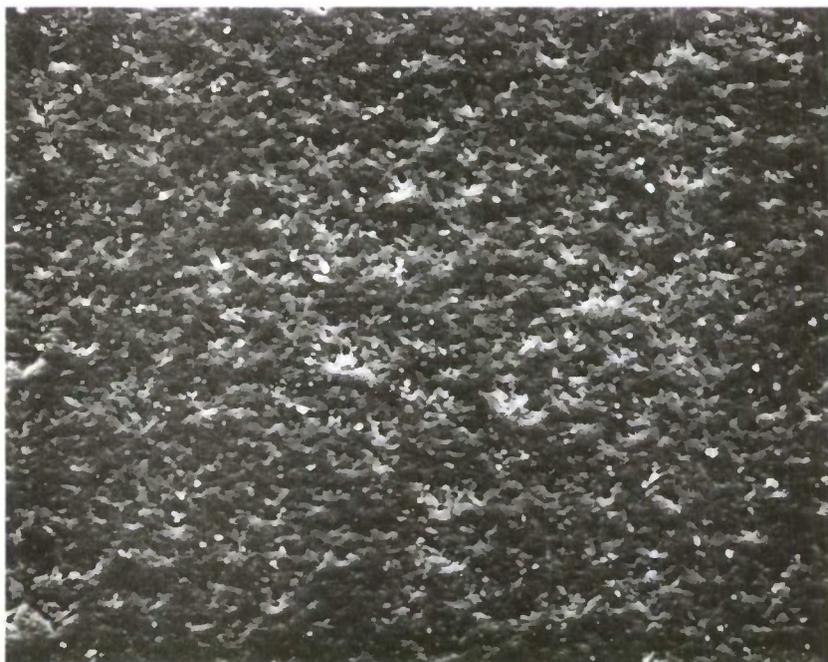
FIGURE 21 - Appearance of diamond grit lapped surface after RCF test, 1000X.
