AMMRC CTR 76-5

FINISHING TECHNIQUES FOR SILICON NITRIDE BEARINGS

FINAL REPORT - CONTRACT DAAG46-74-C-0055

ARMY MATERIALS AND MECHANICS RESEARCH CENTER  
Watertown, Massachusetts 02172

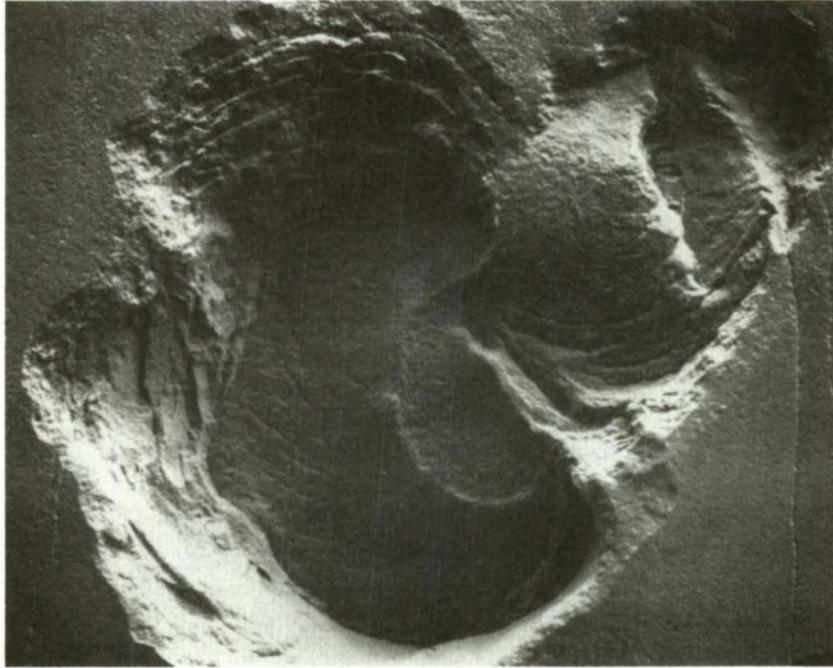
FIGURE 22 - Fatigue spall on RCF Rod #11 after 76.3 million cycles, 100X.

Typical examples of fatigue spalls formed on RCF specimens are shown in Figures 22 through 25. The load track is vertical and the specimen axis is horizontal in all photographs. As found in previous RCF testing on silicon nitride, the majority of spalls originate from a Hertz crack at the edge of the load track. The Hertz cracks border the contact zone around the circumference of the rod, although these cracks may be intermittent and only on one side of the contact zone. These cracks are analogous to cone cracks, which form when plates of brittle material are pressed with a spherical indenter, and arise from the large tensile contact stresses. However, in the RCF case, the cracks are not cones but slope down into the material on either side of the load track. Only infrequently do these cracks curl into the track.

is most clearly seen in the extreme right hand side of Figure 22. The contact stress cracks are true fatigue cracks in that numerous fatigue cycles are required for them to form. Subsequent to the border crack formation, a spall may form as the result of the propagation of a second crack beneath the contact zone. The origin of the second crack appears to be located at the point of slope change of the precedent cone crack analog.

The above spalling mechanism was responsible for most of the spalls. Of all the spalls, only three are believed to have initiated within the load track. There was no difference in spall appearance that could be attributed to material or finish type. Likewise, long lived spalls (Figures 22 and 23) were indistinguishable from short lived ones (Figures 24 and 25).

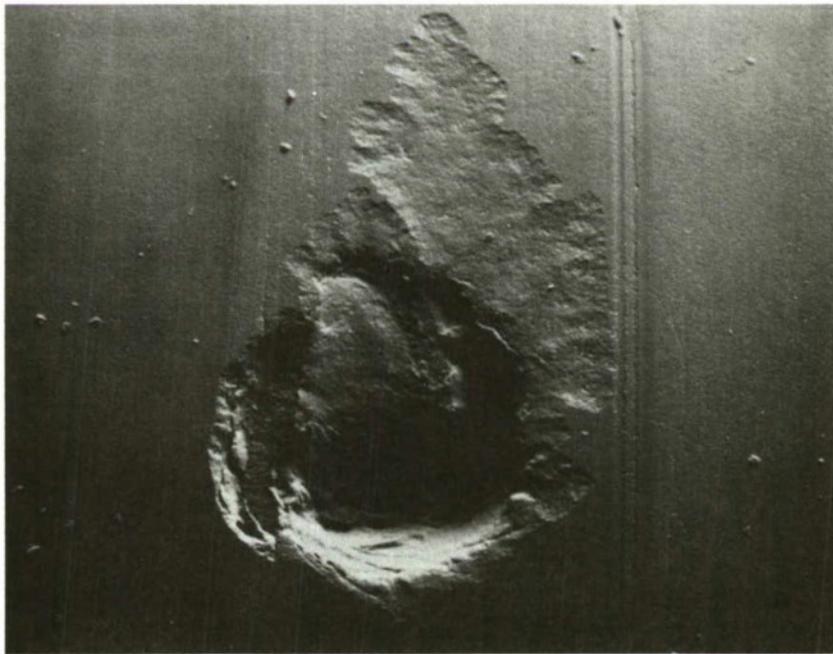
FIGURE 23 - Fatigue spall on RCF Rod #22 after 39.7 million cycles, 50X.

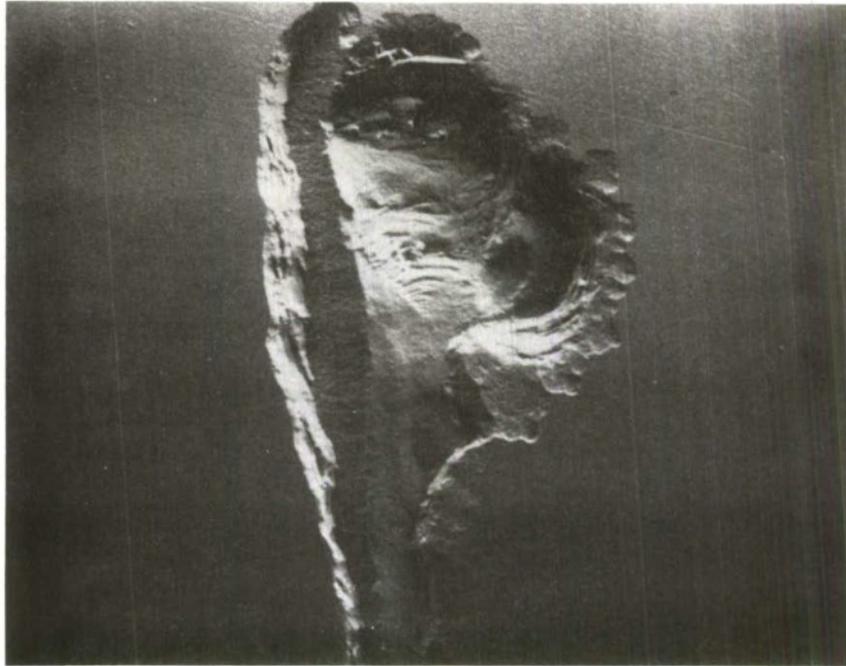
FIGURE 24 - Fatigue spall on RCF Rod #15 after 0.92 million cycles, 50X.

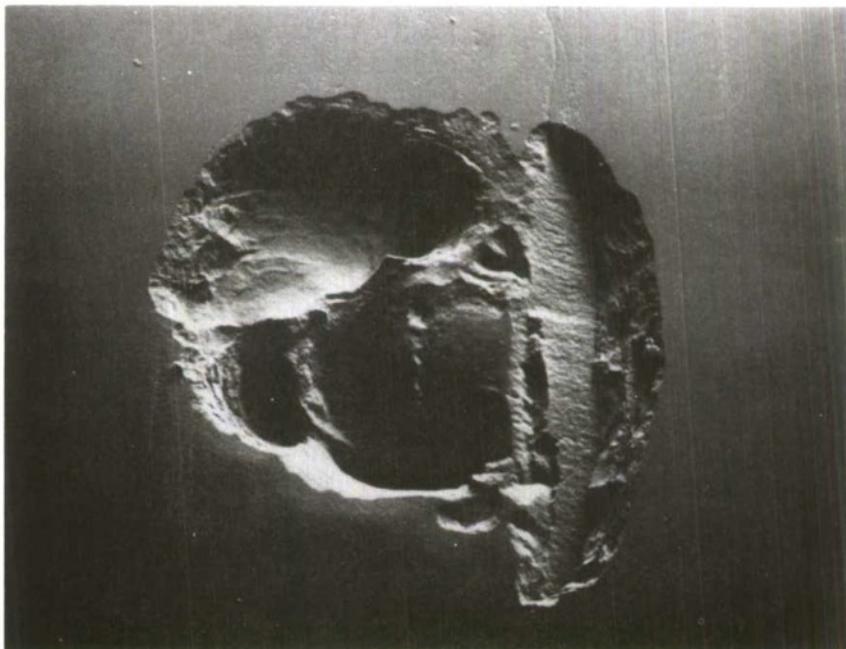
FIGURE 25 - Fatigue spall on RCF Rod #17 after 0.62 million cycles, 50X.

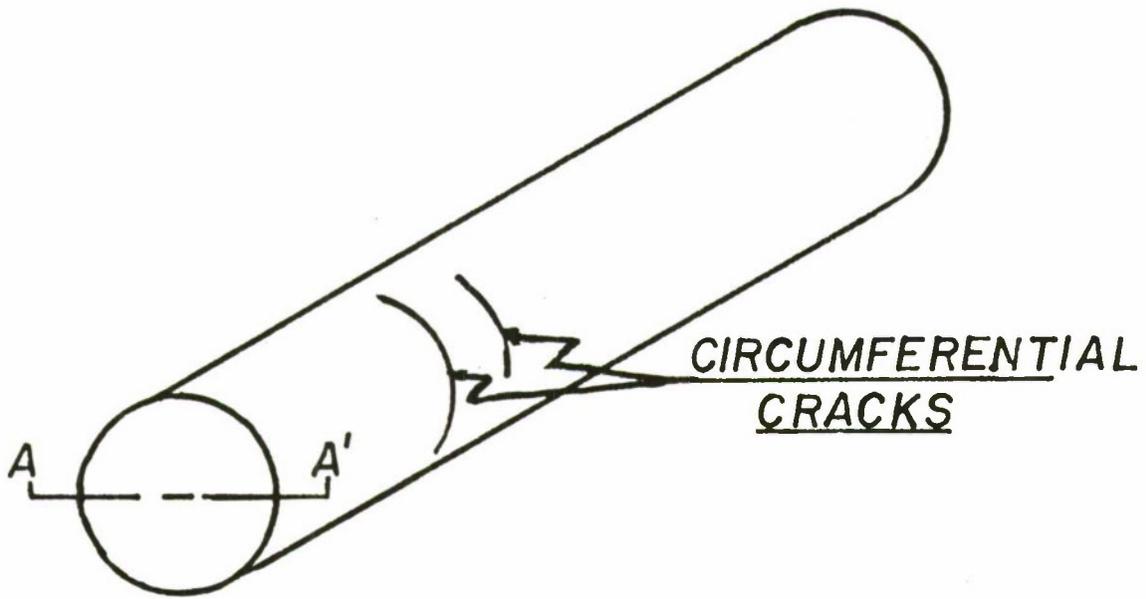
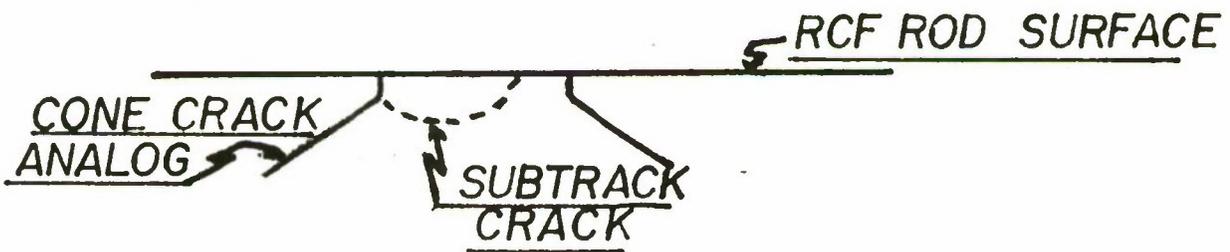
FIGURE 26 SCHEMATIC OF RCF ROD CRACKS

(A) SURFACE APPEARANCE OF CRACKS ON RCF ROD

(B) AXIAL SECTION THROUGH A A'

The geometry of these contact stress cracks is drawn in Figure 26. The intersection of border cracks with the external surface
