NONDESTRUCTIVE EVALUATION OF CERAMICS

TRW, Inc.
Cleveland, OH. 44117

July 1976

Final Technical Report
Contract No. N00019-75-C-0238

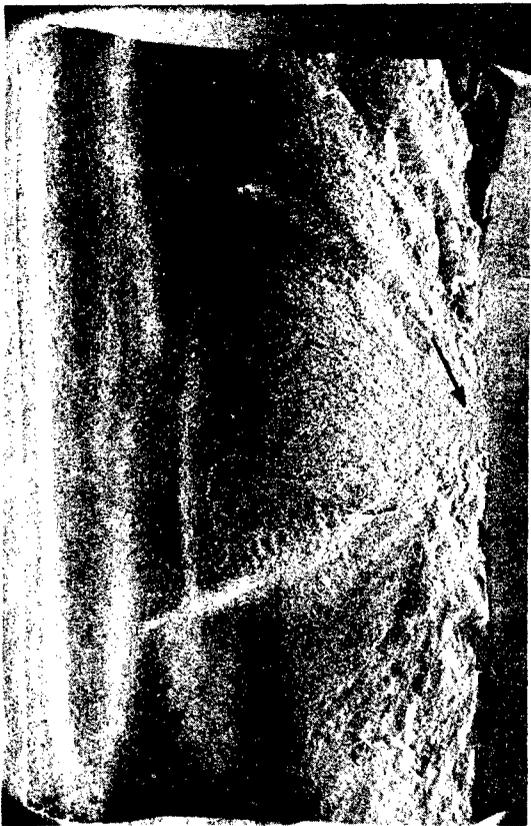
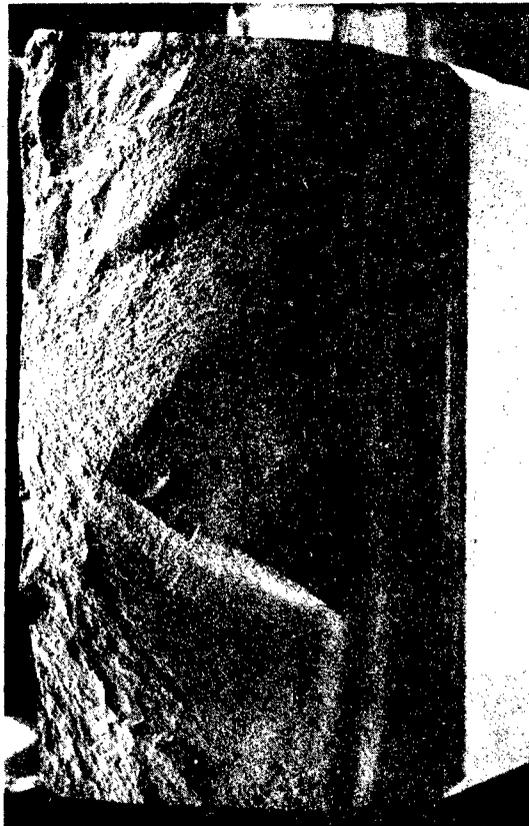
Figure 35. Fracture Surface of Hot Pressed Silicon Nitride Specimen X-4, Showing Unidentified Sub-Surface Flaw at Fracture Initiation Site.

Figure 35 shows the mating fracture surfaces of one of the control specimens (X-4) with an obvious fracture initiation site just below the tensile surface and a fairly well defined "mirror" region. At higher magnifications this defect took on the appearance of a smooth amorphous looking area. A specimen tilt of about 23° was used so that there is some image foreshortening in the vertical sense. The defect shown in Figure 36 would therefore have a width dimension of about 25 μm and a length dimension somewhat greater than 60 μm . Since the hot pressing direction for the material was in the specimen width direction, it would be anticipated that the defects would be elongated in the specimen thickness direction.

of the appearance of the smaller area in Figures 35 and 36 and, in fact, was also observed in other samples. In addition to the amorphous looking area, approximately 100 μm diameter, there was a groove with a crack at the base terminating in a "penetration flaw" referred to by Gruver et al (27). Figure 45 is included to show a frequently observed fracture behavior where initiation from one corner was evident. This type of failure would indicate the presence of surface damage from machining. In this case, however, closer examination (Figure 46) indicated the presence of a 10-20 μm diameter void close to the edge.

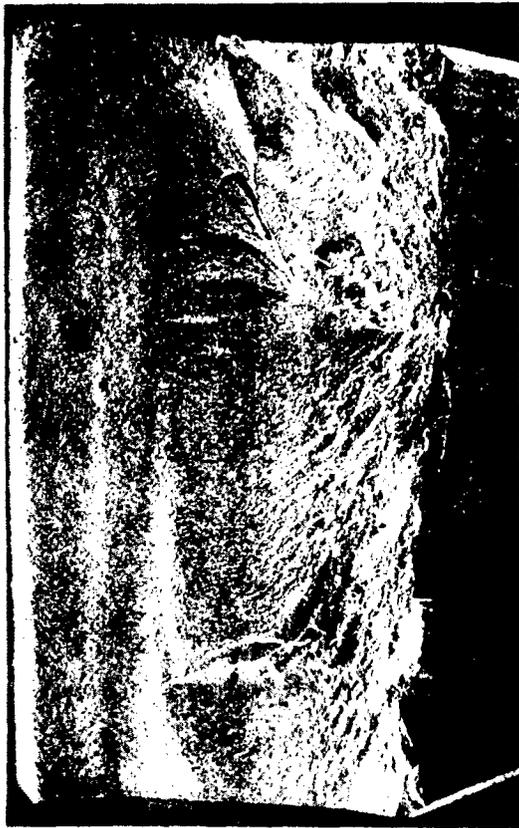
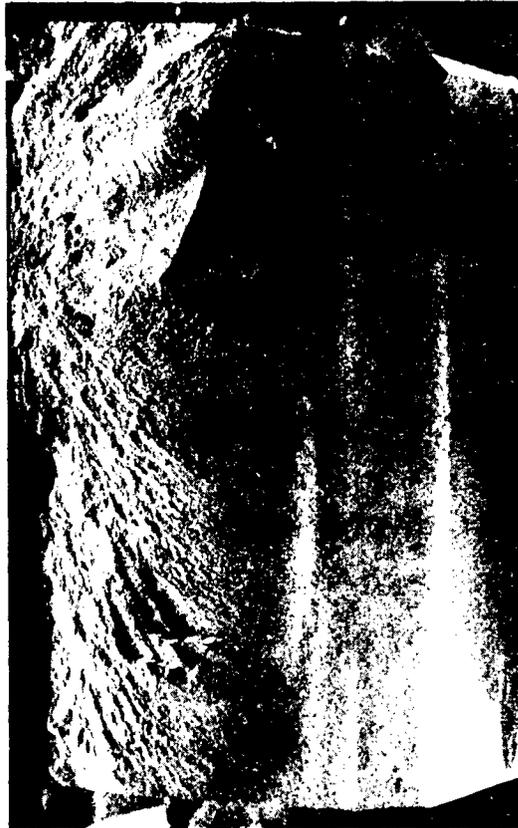
Figure 39. Fracture Surfaces of Hot Pressed Silicon Nitride Specimen 1-4, Showing Fracture Initiation Site at 25 μm Void.

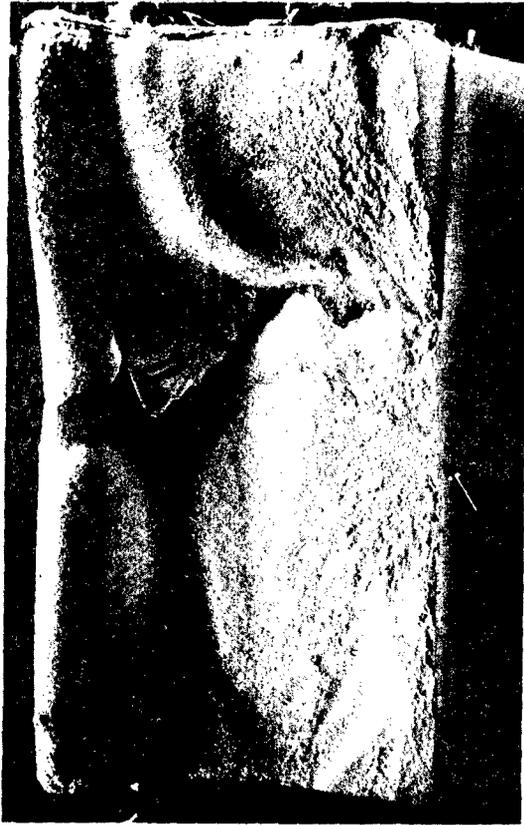
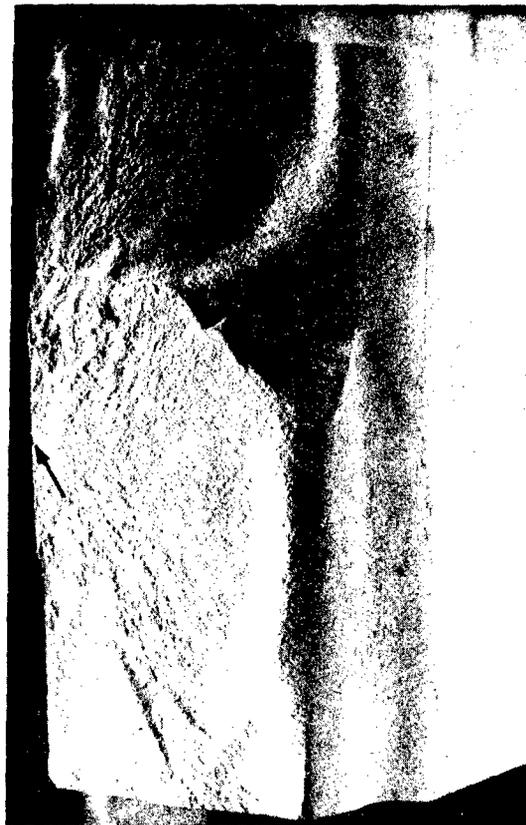
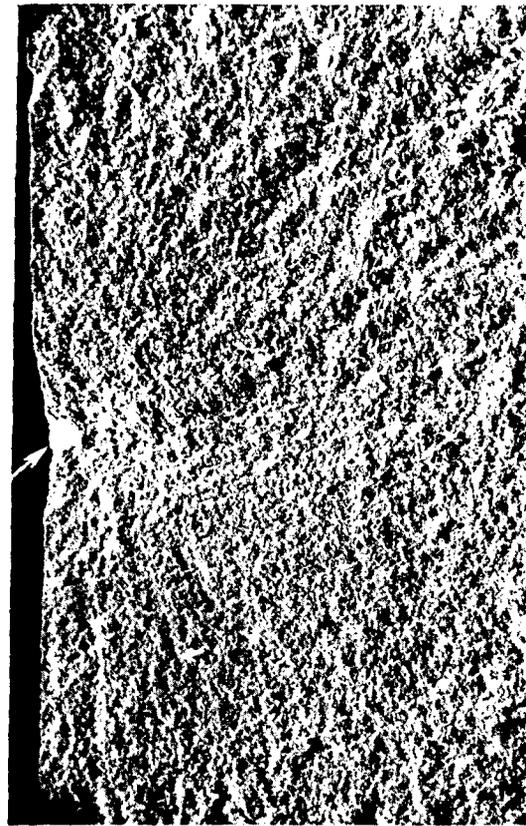
WC Seeded Defect

Figure 40. Fracture Surfaces of Hot Pressed Silicon Nitride Specimen 3-3, Showing Fracture Initiation Site at Seeded High Density Inclusion.

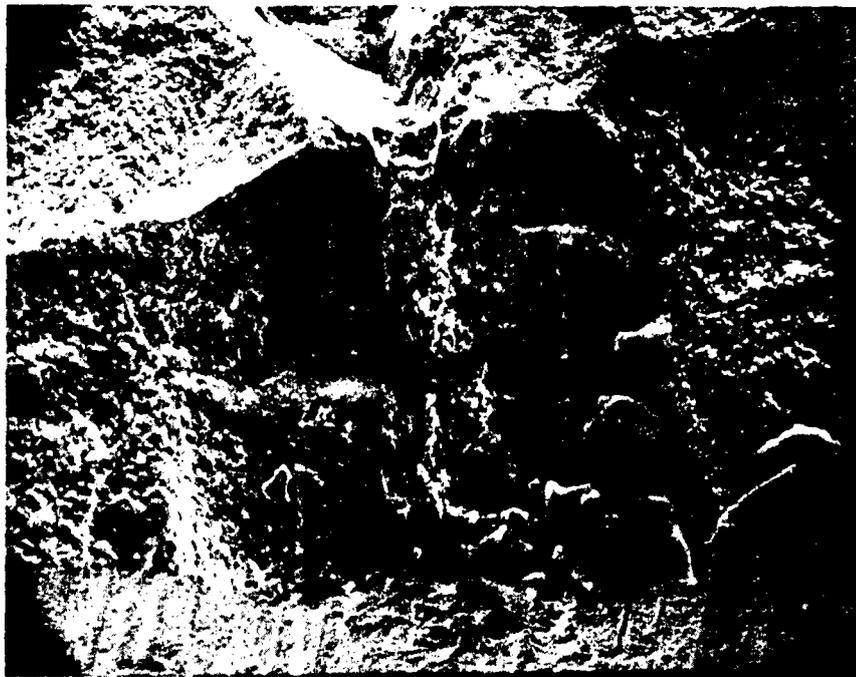
Figure 43. Seeded Defect in Specimen 3-5 at High Magnification.

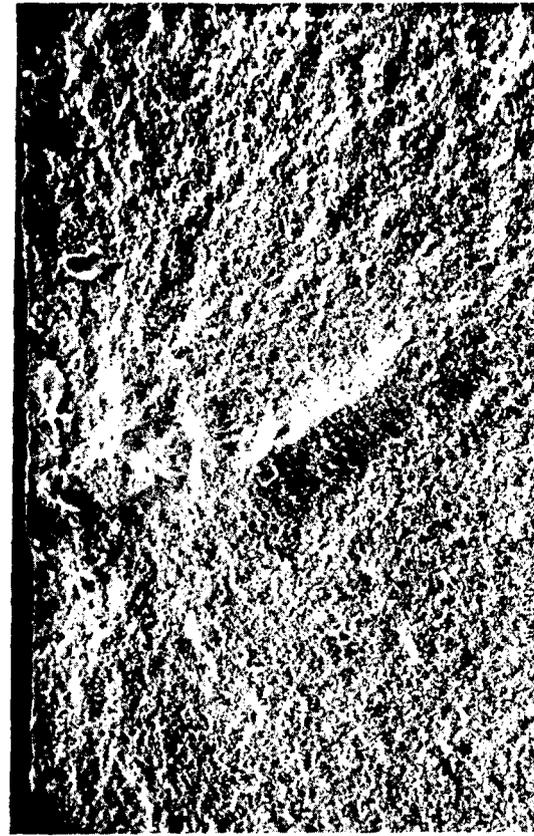
Figure 44. Fracture Surfaces of Hot Pressed Silicon Nitride Specimen 4-4, Showing Fracture Initiation Site at Unidentified Internal Flaw.

The remaining specimen with a well defined fracture origin was 4-4 (Figure 44). This specimen broke off center near one of the loading pins, however, indicating that the ultrasonically identified defect was misplaced or lost during machining, or that the defect in the fracture surface was a more potent crack initiator. Because of the high signal strength (large defect), it is likely that the former was done. The fracture origin had some

It is likely that more meaningful data would have been obtained on specimen 1-3 if the specimen had been sectioned across the defect and polished. These additional evaluations were not possible within the program schedule, however. The results obtained on specimens X-4 and 4-4 indicate that refinements in the microprobe analysis technique will be required in order to obtain useful analytical data on the type of defect shown in Figures 35 and 44.

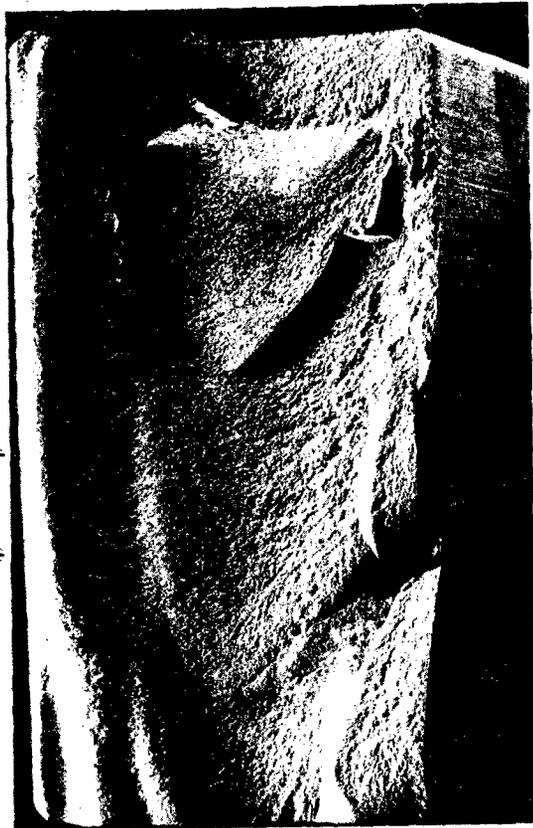
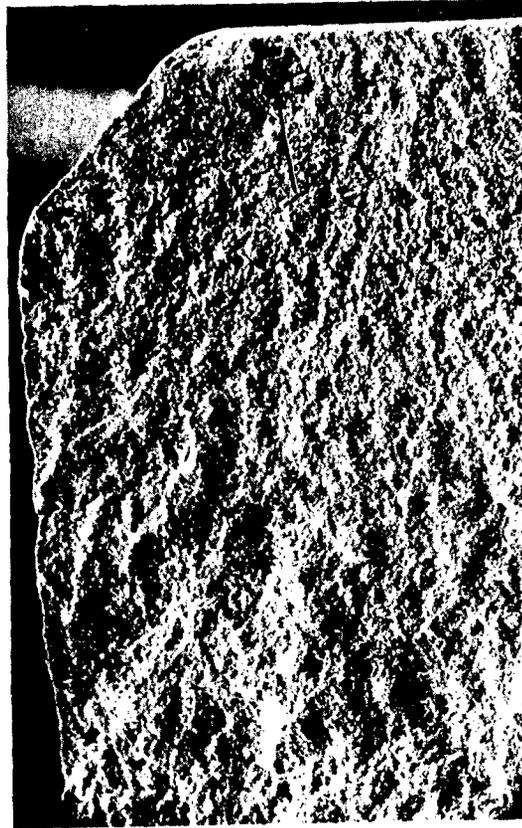
Figure 45. Fracture Surfaces of Hot Pressed Silicon Nitride Specimen 4-6, Showing Corner Fracture Initiation Site.

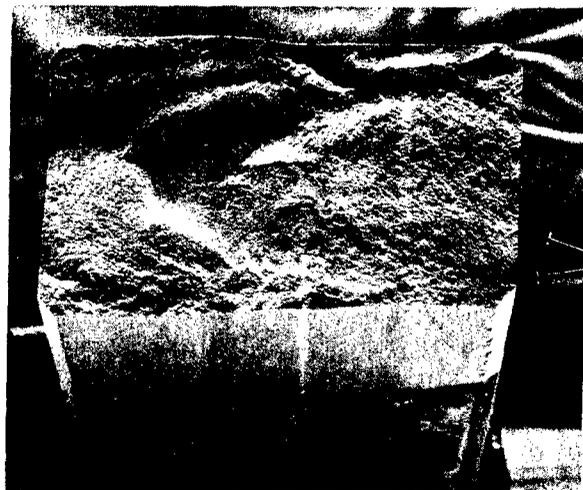
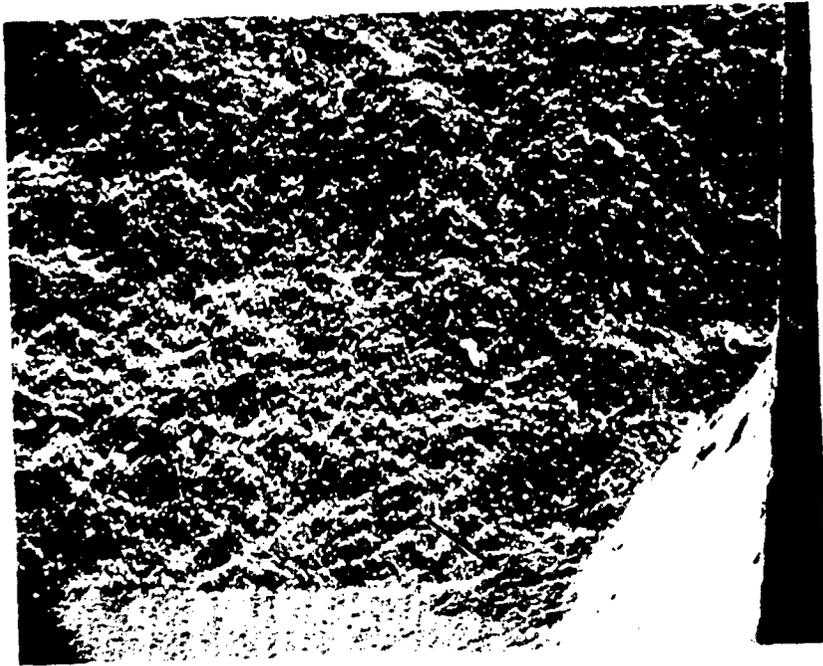
A. Corner and Edge Possible Initiation Sites Indicated.

B. Chipped Corner Indicated.

C. Internal Line Defect. 50X

Same Area as Above Rotated 180° 200X

D. Line Defect and Void Indicated.

Secondary Cracks and Microporosity. 1000X

Figure 50 is a series of SEM fractographs of Specimen 1-1 illustrating typical "flaws" found in most of these specimens. As before, the photographs are presented with the tensile surfaces, of the mating fracture surfaces, closest together. The markings visible on the compression surface in the low magnification photographs are due to residual wax pencil traces used to identify the desired load direction. In this specimen fracture appeared to

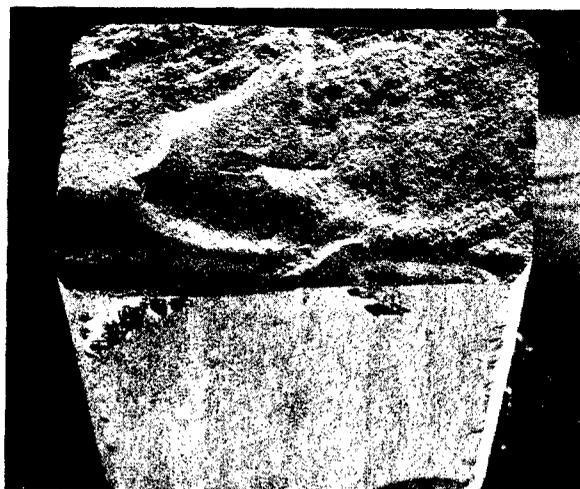
Figure 50. Fracture Surfaces of Sintered Silicon Carbide Specimen 1-1.

have initiated at the right hand corner or edge (Figure 50-A), but there was not the well defined mirror area observed in many of the silicon nitride specimens. There was also a line defect visible running horizontally and close to the neutral stress axis. The micrographs in Figures 50-B to 50-E show representative "defects" which were typical of many of these specimens at higher magnifications. Figure 50-B shows the corner of Specimen 1-1 where fracture could have initiated. The apparent remains of a large chip is visible (top photograph) at the tensile surface which may have created sufficiently high stress concentrations to initial failure. The general area near the corner location however appeared to contain several larger-than-average pores of the order of $10 \mu\text{m}$ diameter, and a large void ($\sim 40 \mu\text{m}$) is indicated in the lower photograph in a region roughly corresponding to the center of the mirror region. The horizontal line defect visible in the low magnification fractographs is shown in Figure 50-C. This has some of the appearance of the "stepped flaw" defect referred to by Gruver et al (Ref. 27) in hot pressed silicon nitride. A crack was visible at the end of this "defect" which may be just part of a multiple crack system in the fracture surface. Figure 50-D shows a region near the tensile surface and close to the center of the specimen which may have been a secondary fracture nucleation site. The only obvious structural details were the presence of a small trench with a crack running vertically (top picture) and a secondary crack system running parallel to the fracture surface. There is also a larger-than-average sized void indicated by the arrow, close to the specimen surface. Figure 50-E shows more secondary fragmentation regions and the high magnification photograph indicates an average pore size of about $1\text{-}1/2 \mu\text{m}$.

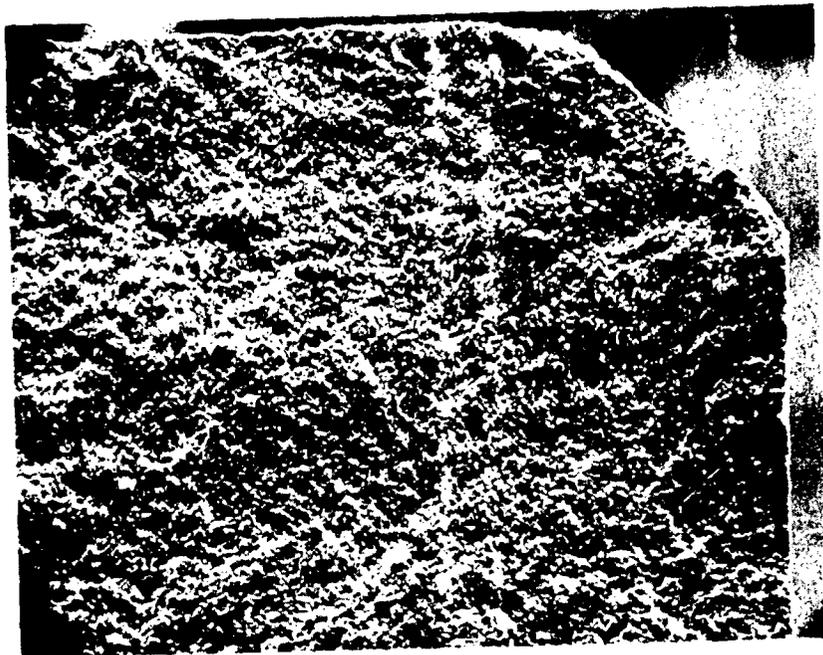
Large Void Indicated

Figure 50.
(cont.)

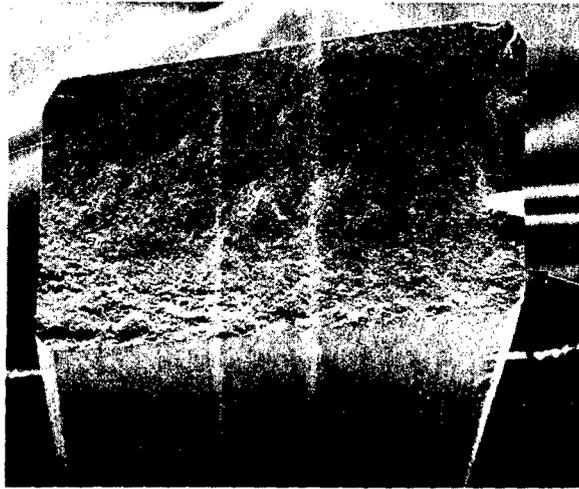
Possible Edge Initiation Site Indicated. 16X

Figure 52. Fracture Surfaces of Sintered Silicon Carbide Specimen 2-4.

In examining the fracture surfaces of the sintered silicon carbide specimens, it is evident that the ultrasonic defect patterns are associated with the areas of secondary fragmentation, such as the one located about one-third of the specimen thickness from the left side in Figure 52. Areas of this type are typical of Specimens 2-1 through 2-4 and in each case the area is about one-third through the specimen and favorably located for ultrasonic detection. Areas of this type also show up in some of the specimens in the other group, such as Specimen 1-1 (Figure 50A). However, they tend to be oriented at a steep angle to the inspection direction which was unfavorable for defect detection. The nature of these flaws could not be determined by fractography. The only explanation observed for the general background of

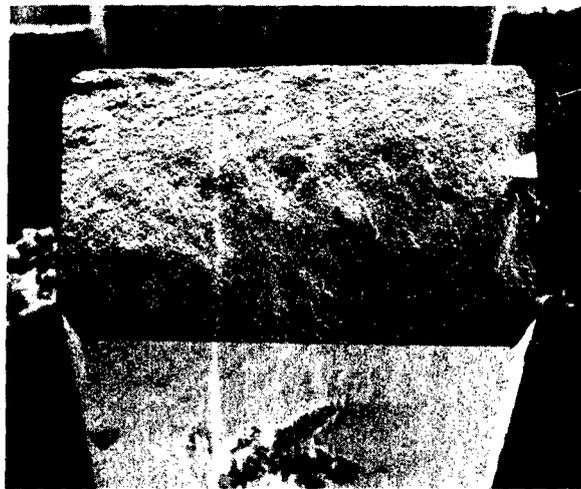
Figure 51. Fracture Surfaces of Sintered Silicon Carbide Specimen 1-3.

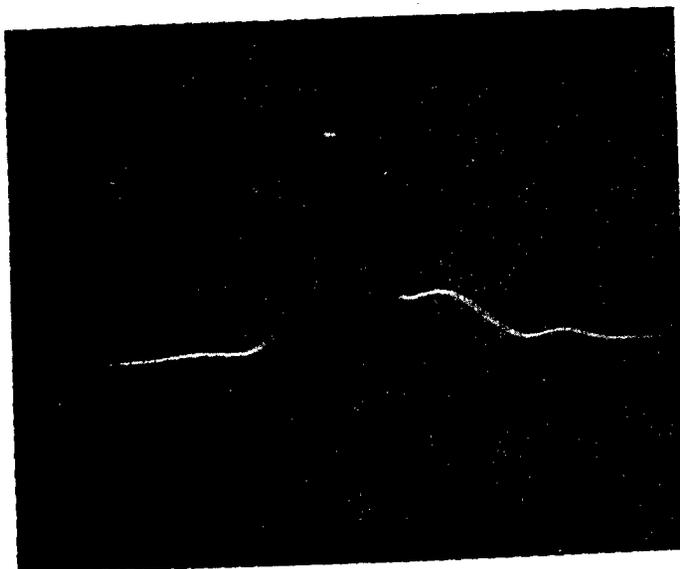
Figure 58. Unloaded Output of TRW Pulser.
50 V/cm vertical; 10 ns/cm horizontal.

Figure 58 shows the output of the pulser with no transducer. Figure 59 shows the same output with the 25 MHz transducer loading the pulser. The vertical scales of both figures are 50 V/cm and the horizontal scales are 10 ns/cm. The transducer pulse risetime (from 10% to 90% of pulse height) shown on Figure 59 is 0.8 cm or 8 ns. The risetime is 80% of a quarter wave or 20% of a full wave, so that the period of the pulse is 40 ns, corresponding to a transducer frequency of 25 MHz. Figure 60 shows the pulse reflected back to this transducer off the surface of a flat ceramic plate located at the focal point in water which was found to be 1.8 inches. Figure 61 shows the pulse from the same target at a water path of only 0.50 inches. The vertical scales are 0.05 V/cm and 0.01 V/cm, respectively. The horizontal scales are both 100 ns/cm. These photographs were taken to determine the extent of frequency degradation due to selective attenuation in the water. In both cases the frequency is degraded to about 12.5 MHz. However, the difference in water path makes no significant difference. Figure 62 shows the unloaded pulse reduced to 100 volts in order to avoid overloading the 45 MHz transducer. The vertical scale is 20 V/cm and the horizontal scale 10 ns/cm. Figure 63 shows the same output with the 45 MHz transducer loading the pulser. The scales are the same as for Figure 62. In this case the pulse risetime is 4.25 ns, which corresponds to a frequency of 47 MHz. Figures 64 and 65, respectively, show the reflected pulse off a ceramic plate at the focal point in water, which was determined to be 2.0 inches, and at a water path of 0.5 inches. In both figures the vertical scale is 0.005 V/cm and the
