**PROCEEDINGS OF THE 1974 TRISERVICE
CORROSION OF MILITARY EQUIPMENT
CONFERENCE, 29-31 OCTOBER 1974
Volume II. Sessions IV through VII**

TECHNICAL REPORT AFML-TR-75-42, Volume II
FINAL REPORT FOR PERIOD 31 OCTOBER 1974 - 1 FEBRUARY 1975

AIR FORCE MATERIALS LABORATORY
AIR FORCE WRIGHT AERONAUTICAL LABORATORIES
Air Force Systems Command
Wright-Patterson Air Force Base, Ohio 45433

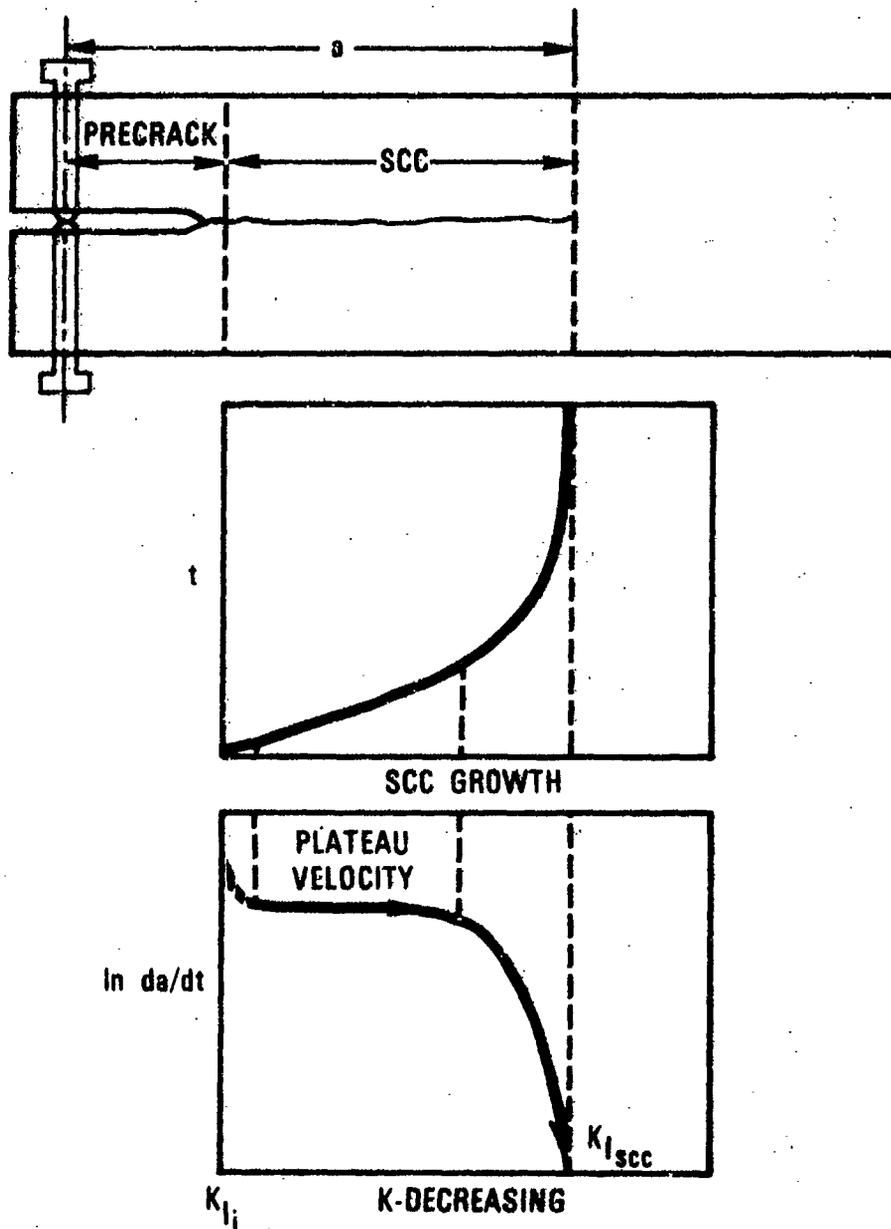
Fig. 1

SCHEMATIC ILLUSTRATION OF SCC GROWTH AND THE RELATIONSHIP BETWEEN THE SCC PROPAGATION RATE AND THE DECREASING STRESS INTENSITY IN A BOLT LOADED DCB SPECIMEN

A convenient type of specimen for determining SCC propagation rates is a double cantilever beam (DCB) loaded by constant displacement to a stress-intensity at or just below the critical stress-intensity required for mechanical fracture. With such extremely high stress-intensity SCC will start quickly in highly susceptible materials and proceed for a time at a fairly constant rate before it slows down to approach an arrest as the crack lengthens and K_I decreases. When (and if) the crack growth comes to an "arrest", the stress-intensity can be said to be at the threshold for SCC (K_{Isc}). A typical SCC crack growth curve and the relationship of the SCC propagation rate with the decreasing stress-intensity is shown for a relatively susceptible material in Figure 1. (Note that the graphs are plotted in a rather unorthodox manner in order to relate the performance with the crack growth shown in the specimen.) The purpose of the present paper is to consider the use of SCC "plateau velocities", as illustrated in Figure 1, for comparing the resistance to SCC of aluminum alloys and to describe a simple test procedure for obtaining such data. The significance of the "plateau velocity" is that it is the highest SCC propagation rate that a material will sustain for an appreciable crack extension under the controlled test conditions.

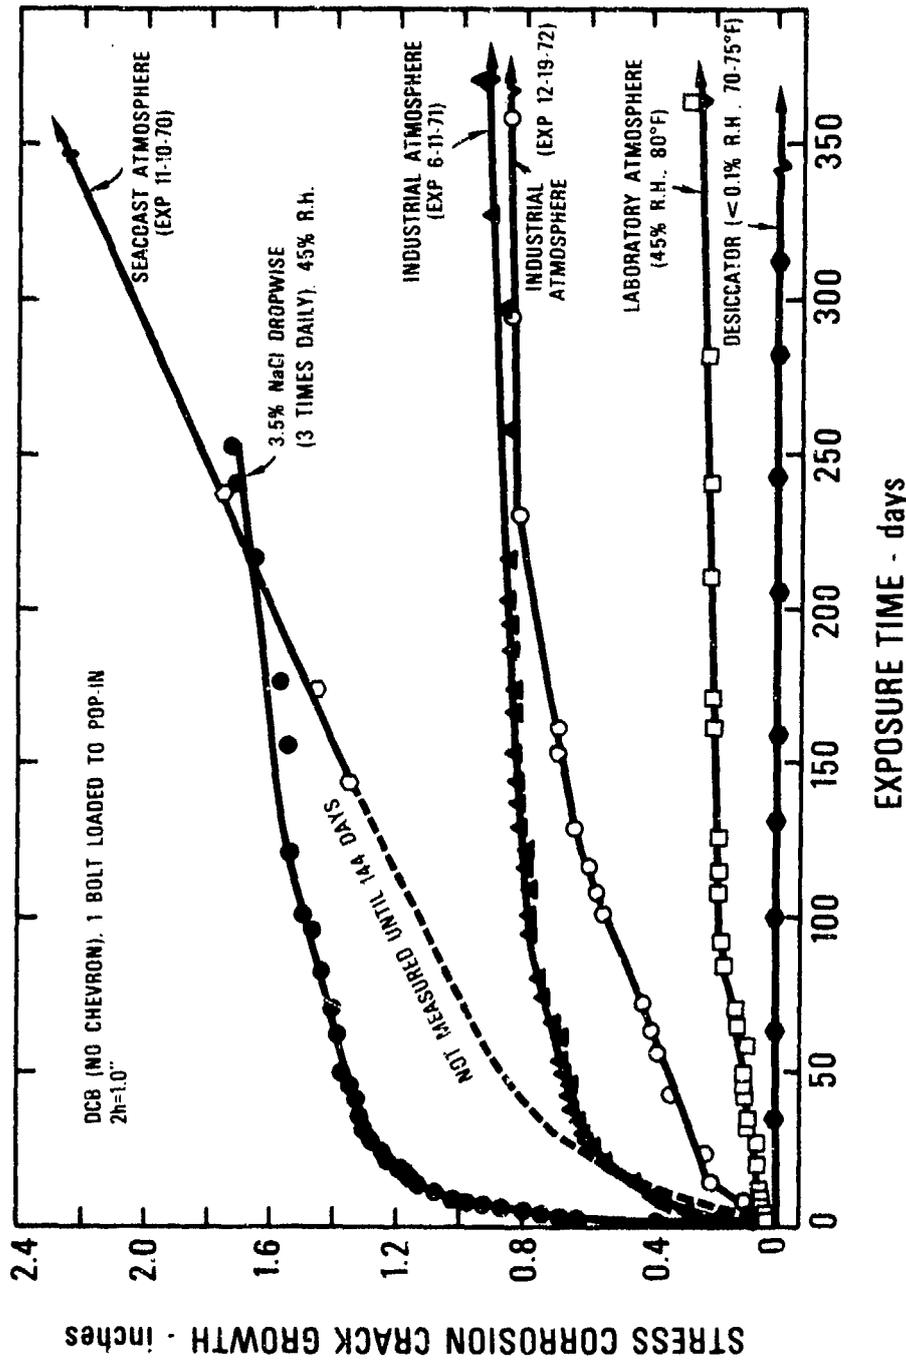
Fig. 3

EFFECT OF CORROSIVE ENVIRONMENT ON S.C.C. PROPAGATION
IN 7079-T651 ALUMINUM ALLOY PLATE (2.5 in. THICK)

SCC propagation rates, like the threshold stress or stress-intensity, depend upon the conditions of test. The effect of the corrosive environment is illustrated by the test results shown in Figures 3 and 4 for specimens of alloy 7079-T651 exposed to the atmosphere under various conditions. The SCC growth curves in Figure 3 show that the crack growth was relatively rapid at first; but in the laboratory and the outdoor industrial atmosphere, the crack growth increased only very slightly after about 250 days. Although these curves were plotted only to 365 days, the exposures were continued for at least another year and the extended curves were used for the derivations of K_I and da/dt in Figure 4. Wide variations both in the plateau velocities and the apparent K_{Isc} values were observed, depending upon the atmospheric conditions. Corrosion of the crack faces with the formation of wedges of corrosion product prevented crack arrest and the estimation of K_{Isc} values for the seacoast atmosphere and the 3.5% NaCl solution tests. It is noteworthy, also, that in the dry air in the desiccator no SCC growth occurred in a period of 39 months; this was confirmed for the interior of the specimen by breaking the specimen open and examining the fracture surface.

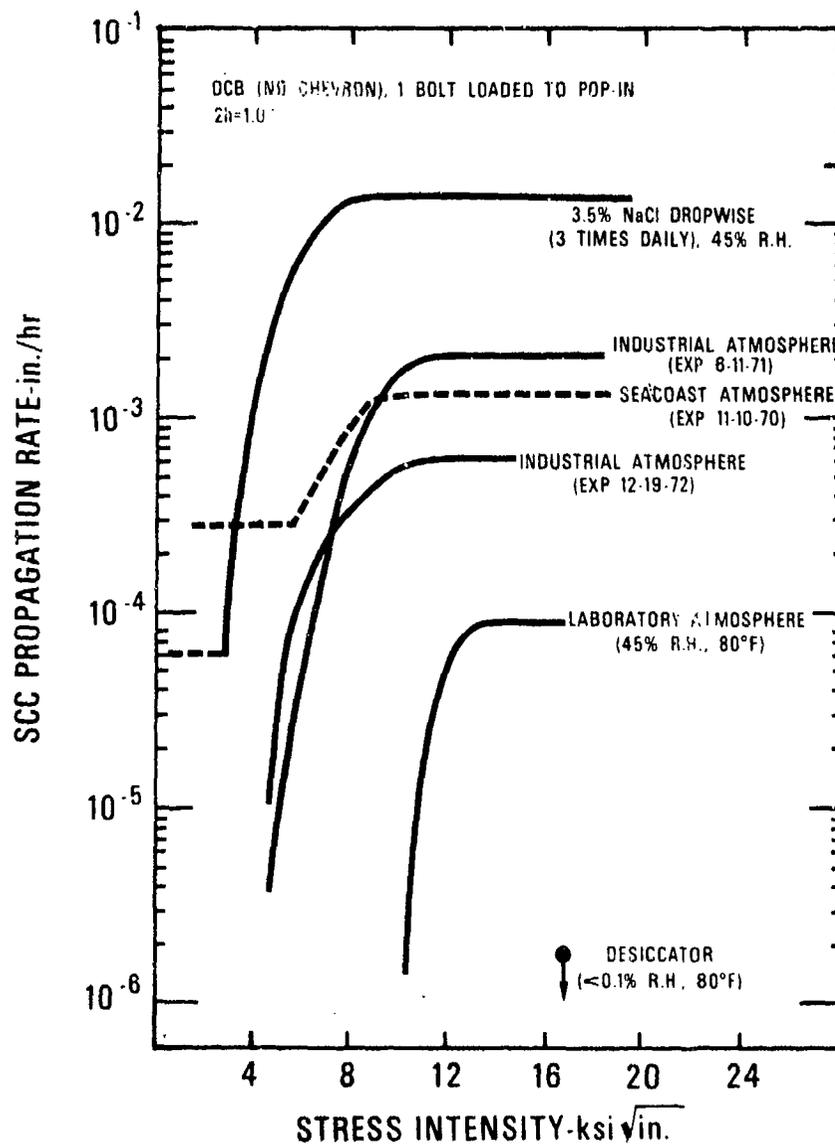
Fig. 4

EFFECT OF CORROSIVE ENVIRONMENT ON SCC PROPAGATION RATE IN 7079-T651 ALLOY PLATE (2.5-in. THICK)

In conducting the SCC test, it is not advisable to unload and reload the test specimen. Therefore, if it is desired to calculate stress-intensities, it is proposed that a pop-in test as described in the footnotes in Table V be performed on a duplicate specimen to estimate the elastic component of V to be used in the calculations of K_I for the SCC test specimen. Also, the SCC test specimen should be broken open at the end of the test to obtain a more realistic measurement of the total crack length. This procedure was used for the $K_I - da/dt$ curves in Figure 4.

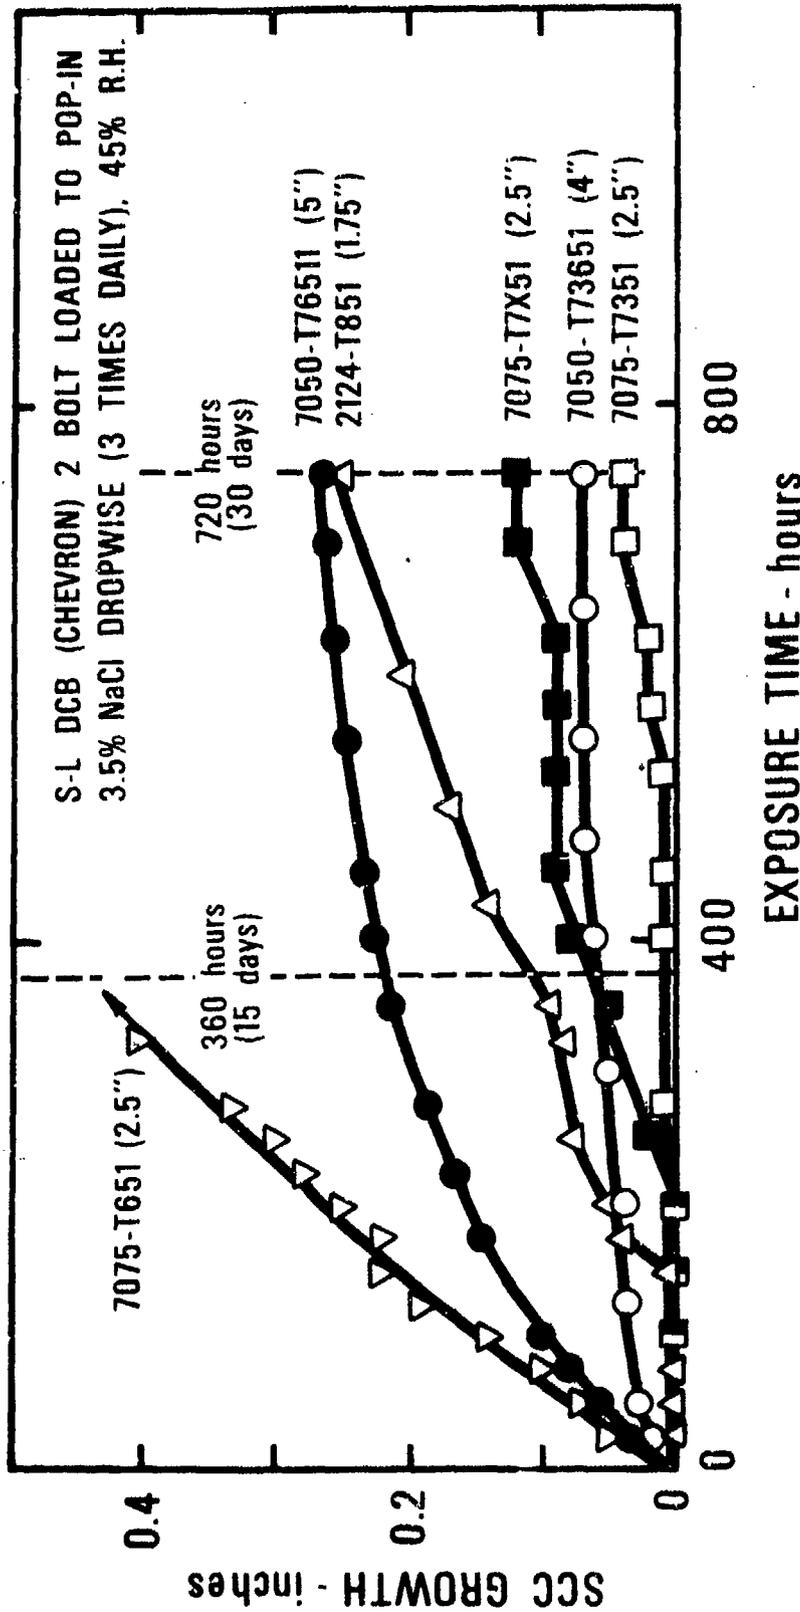
Fig. 5

**EXAMPLES OF SCC CRACK GROWTH IN VARIOUS MATERIALS
WITH RELATIVELY HIGH RESISTANCE TO SCC**

Examples of the variation encountered in the environmental crack growth curves of materials with relatively high resistance to SCC are shown in Figure 5. Various approaches were tried for determining realistic plateau velocities, and it was concluded that the simplest procedure that is subject to the least error in interpretation is to divide the total crack growth by the total exposure time for some arbitrary period. The period should be long enough to ensure an opportunity for SCC to initiate and to include the initial sustained crack growth, yet not long enough to include excessive crack growth caused by corrosion product wedging. This method will not only identify the materials with relatively low resistance to SCC (such as the 7075-T651) but will also provide a useful measure for the highly resistant materials that may not develop a K_I vs da/dt curve with a definite plateau.

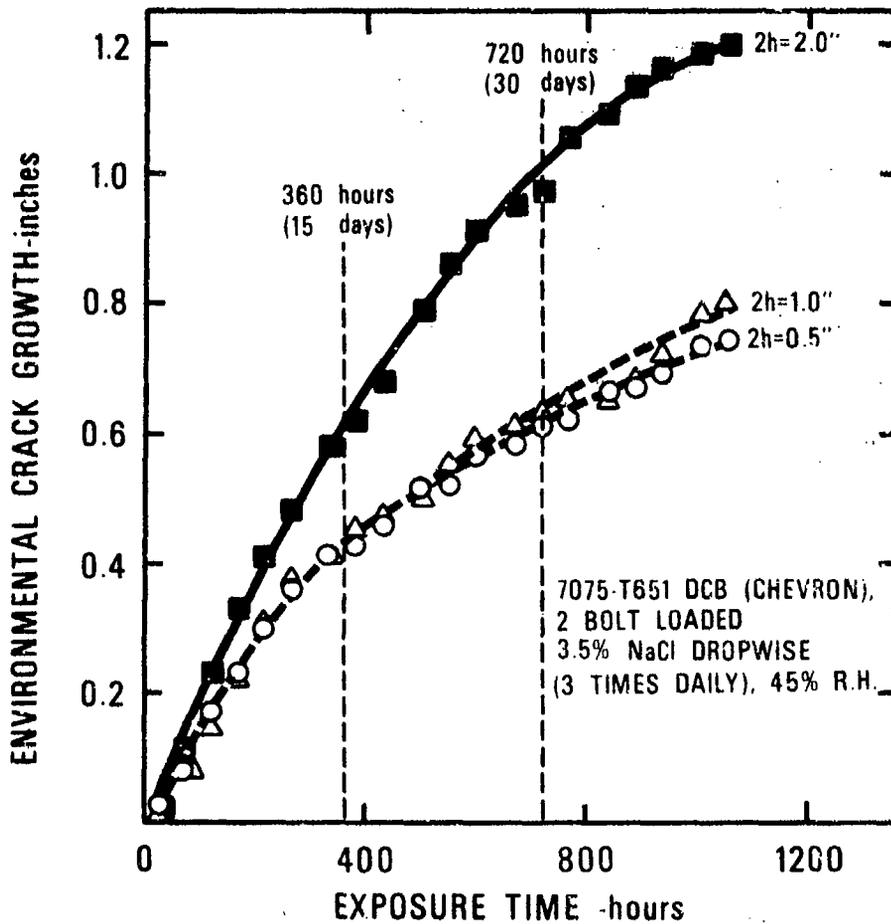
Fig. 6

EFFECT OF BEAM HEIGHT (2h) ON ENVIRONMENTAL
CRACK GROWTH IN S-L SPECIMENS FROM
7075-T651 ALLOY PLATE

The plateau velocities based on 15-day exposures are summarized in Table II, and certain comparisons are illustrated graphically in Figures 6-8. Varying the beam height did not appreciably affect the average SCC plateau velocities for any of the three tempers. However, the other variations in specimen configuration (straight notch or increased notch depth) and the reduced frequency of wetting with 3.5% NaCl solution did reduce the SCC propagation rates for 7075-T7X51 and T7351--although not for the T651 temper. The relative extent of SCC crack growth in the three different tempers is shown in the photograph of fracture surfaces in Figure 9.

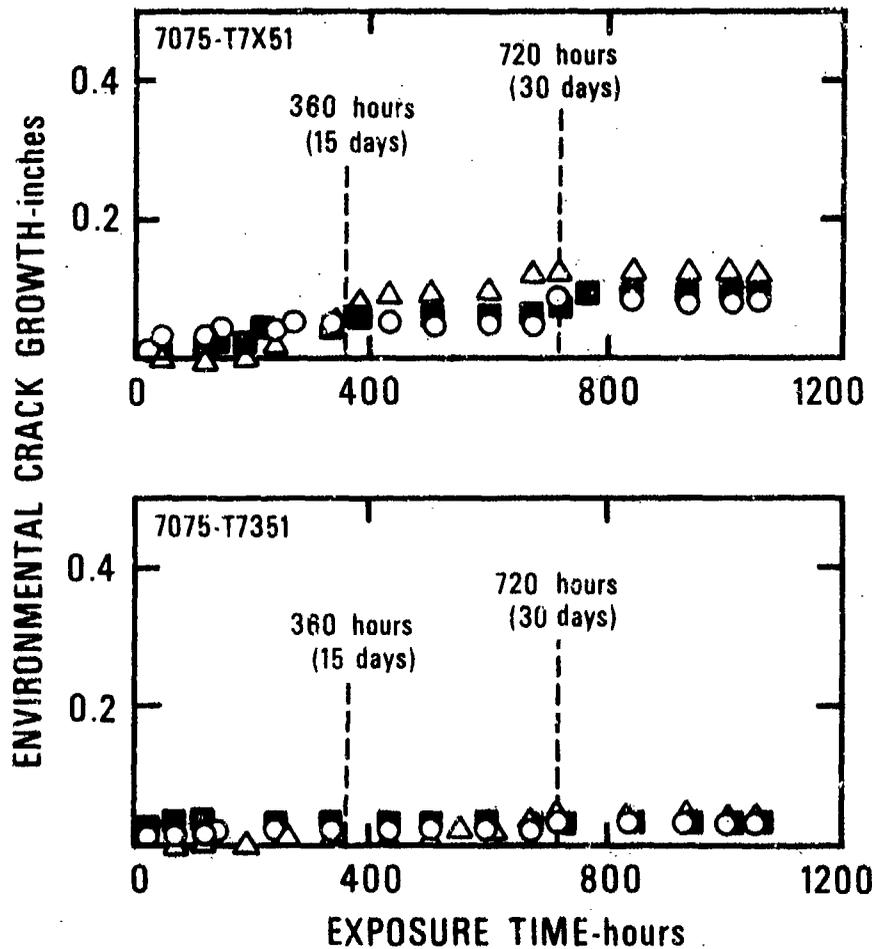
Fig. 7

EFFECT OF BEAM HEIGHT (2h) ON ENVIRONMENTAL CRACK GROWTH IN S-L SPECIMENS FROM 7075-T7X51 AND 7075-T7351 ALLOY PLATE

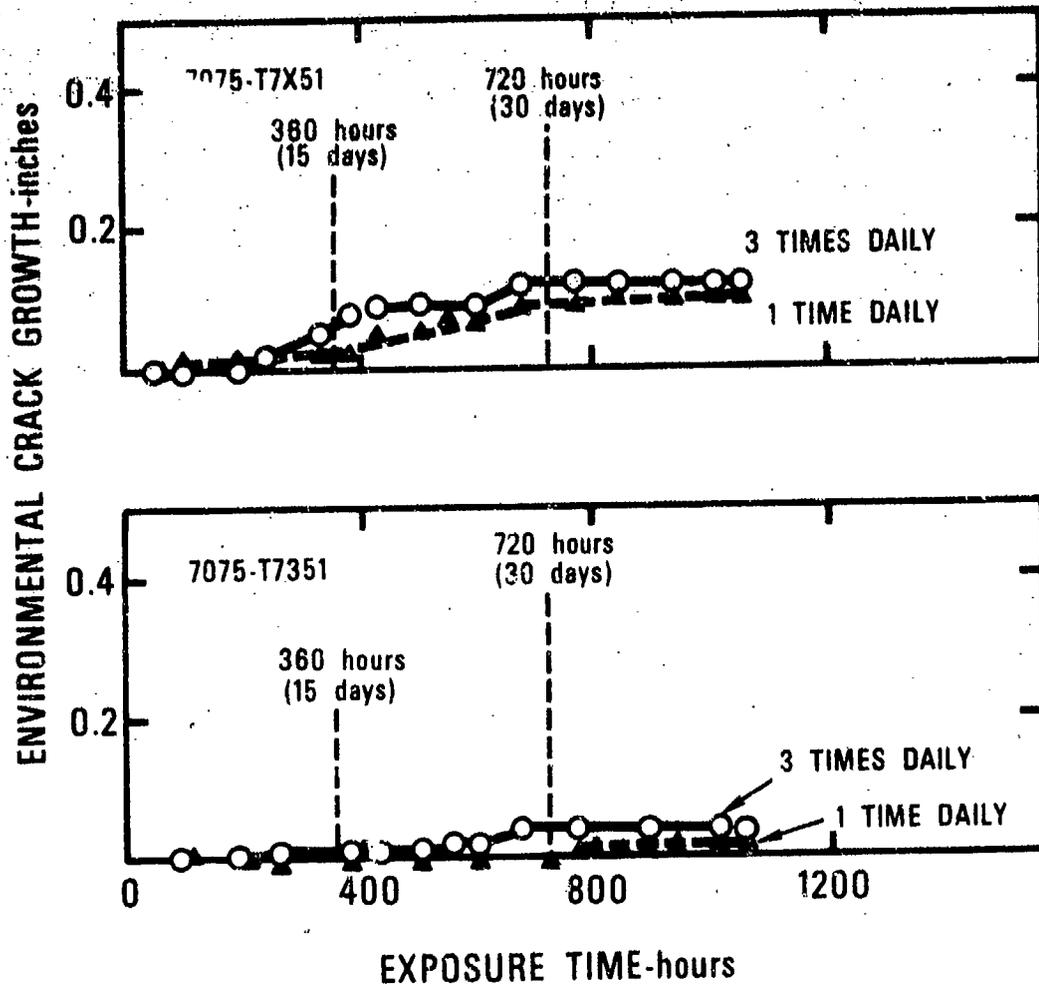
Fig. 8

DCB (CHEVRON), 2 BOLT LOADED
2h=1.0"
3.5% NaCl DROPWISE
45% R.H.

EFFECT OF DAILY WETTING FREQUENCY ON THE ENVIRONMENTAL CRACK GROWTH IN S-L SPECIMENS FROM 7075-T7X51 AND 7075-T7351 ALLOY PLATE

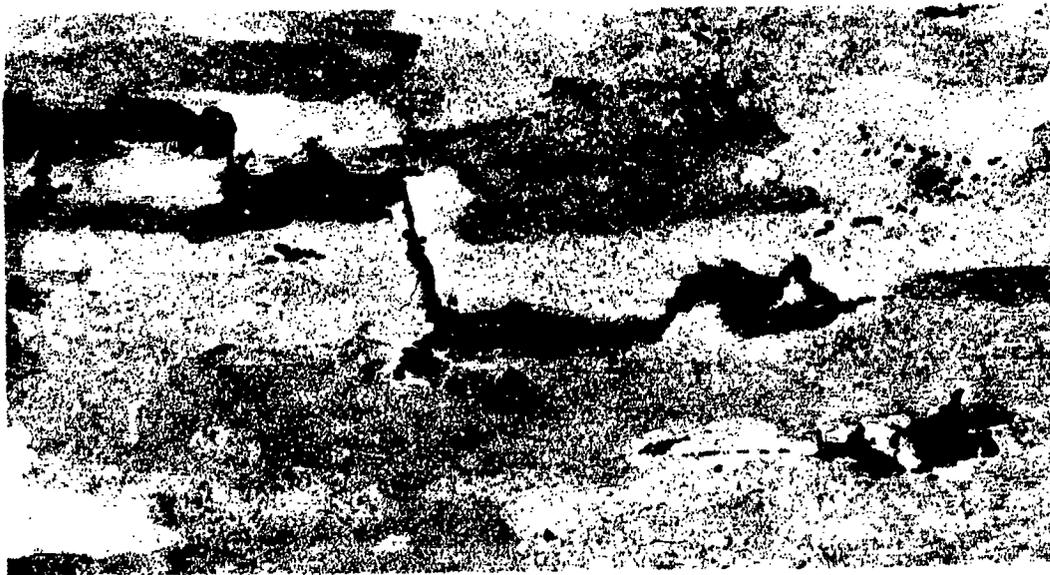
MICROGRAPHS (100X) OF TIP OF ENVIRONMENTAL CRACK
GROWTH IN DCB SPECIMENS OF 2124-T851 ALLOY PLATE

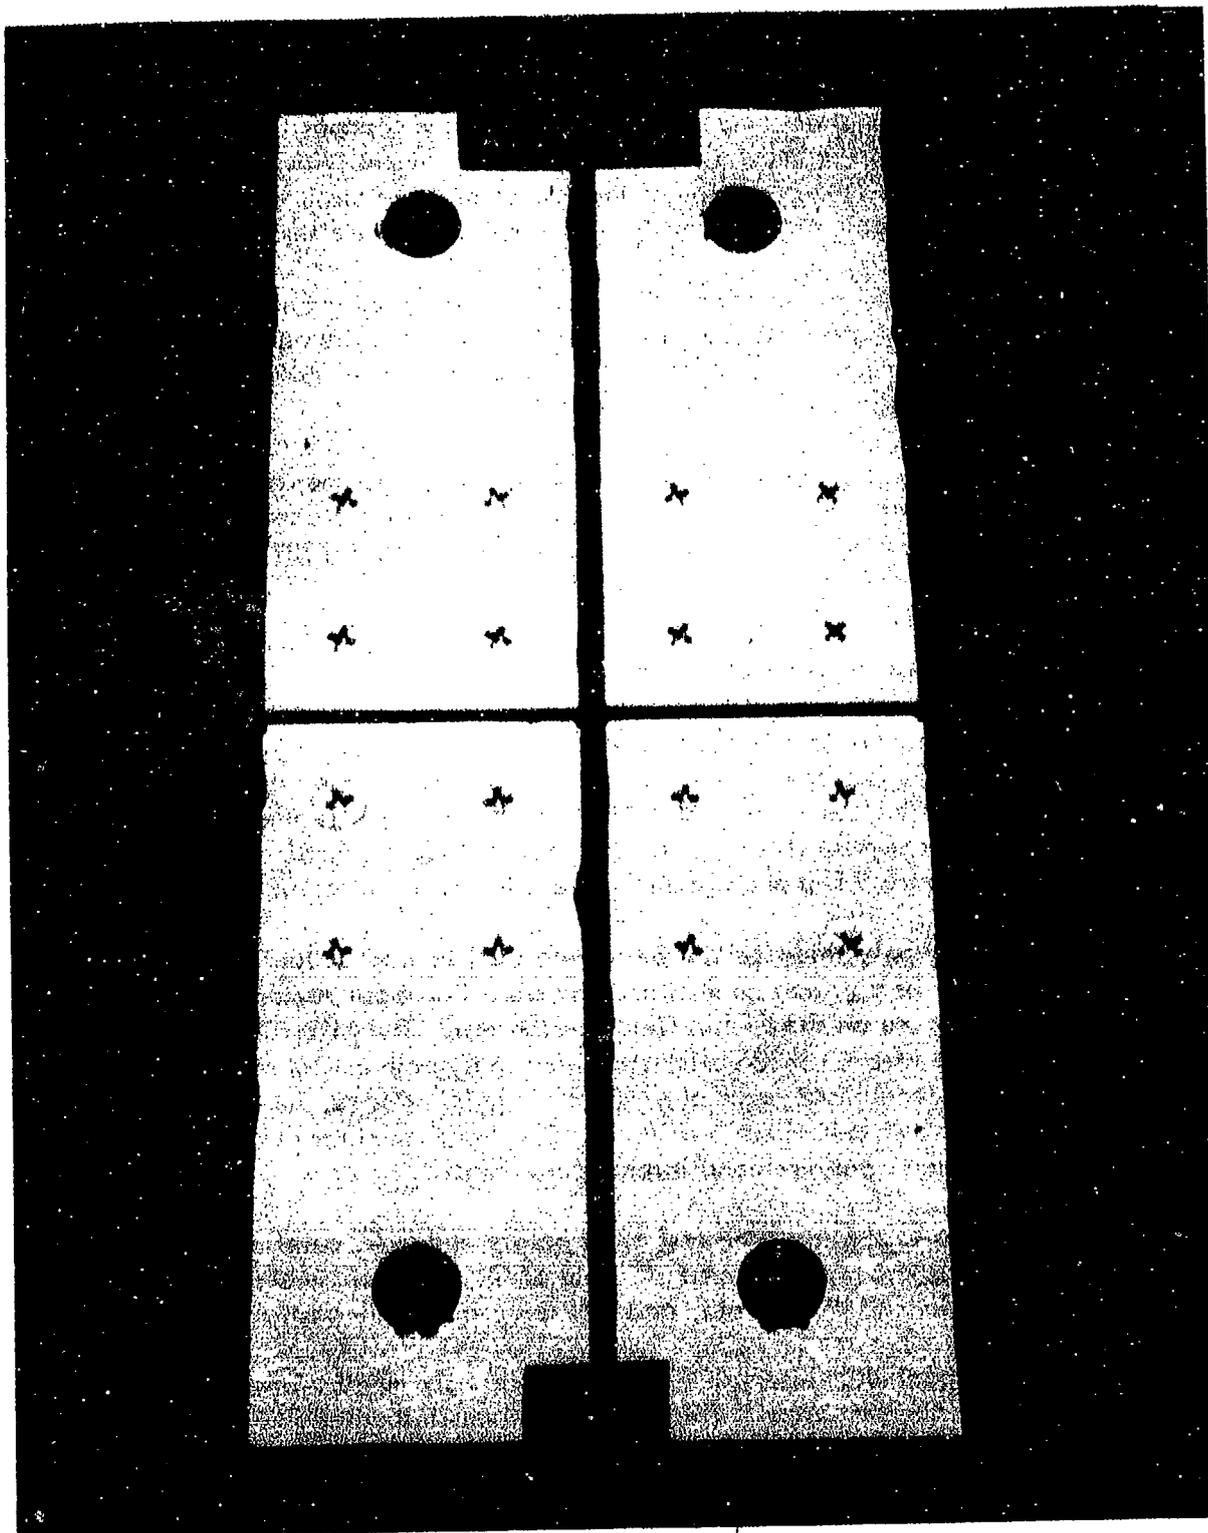
FIGURE 8. FATIGUE SPECIMENS WITH THREE-COMPONENT COATINGS AFTER ENVIRONMENTAL EXPOSURE TESTS

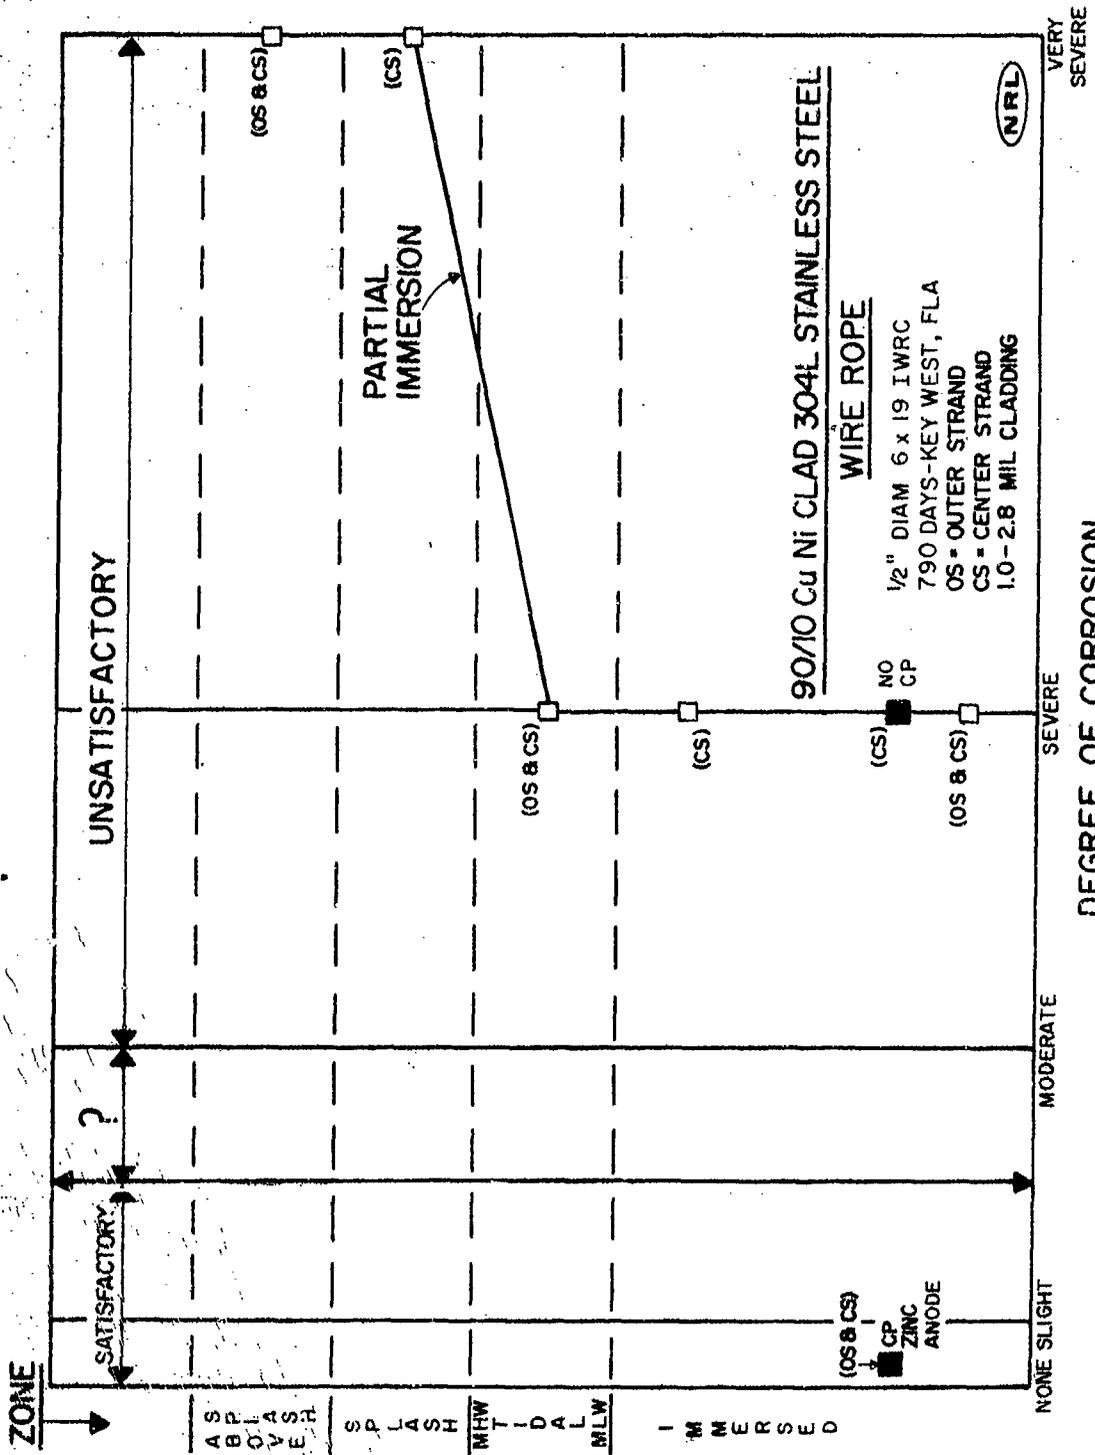
Fig. 4 - Degree of corrosion and cathodic-protection response for 90/10 copper-nickel clad Type 304L stainless steel wire rope

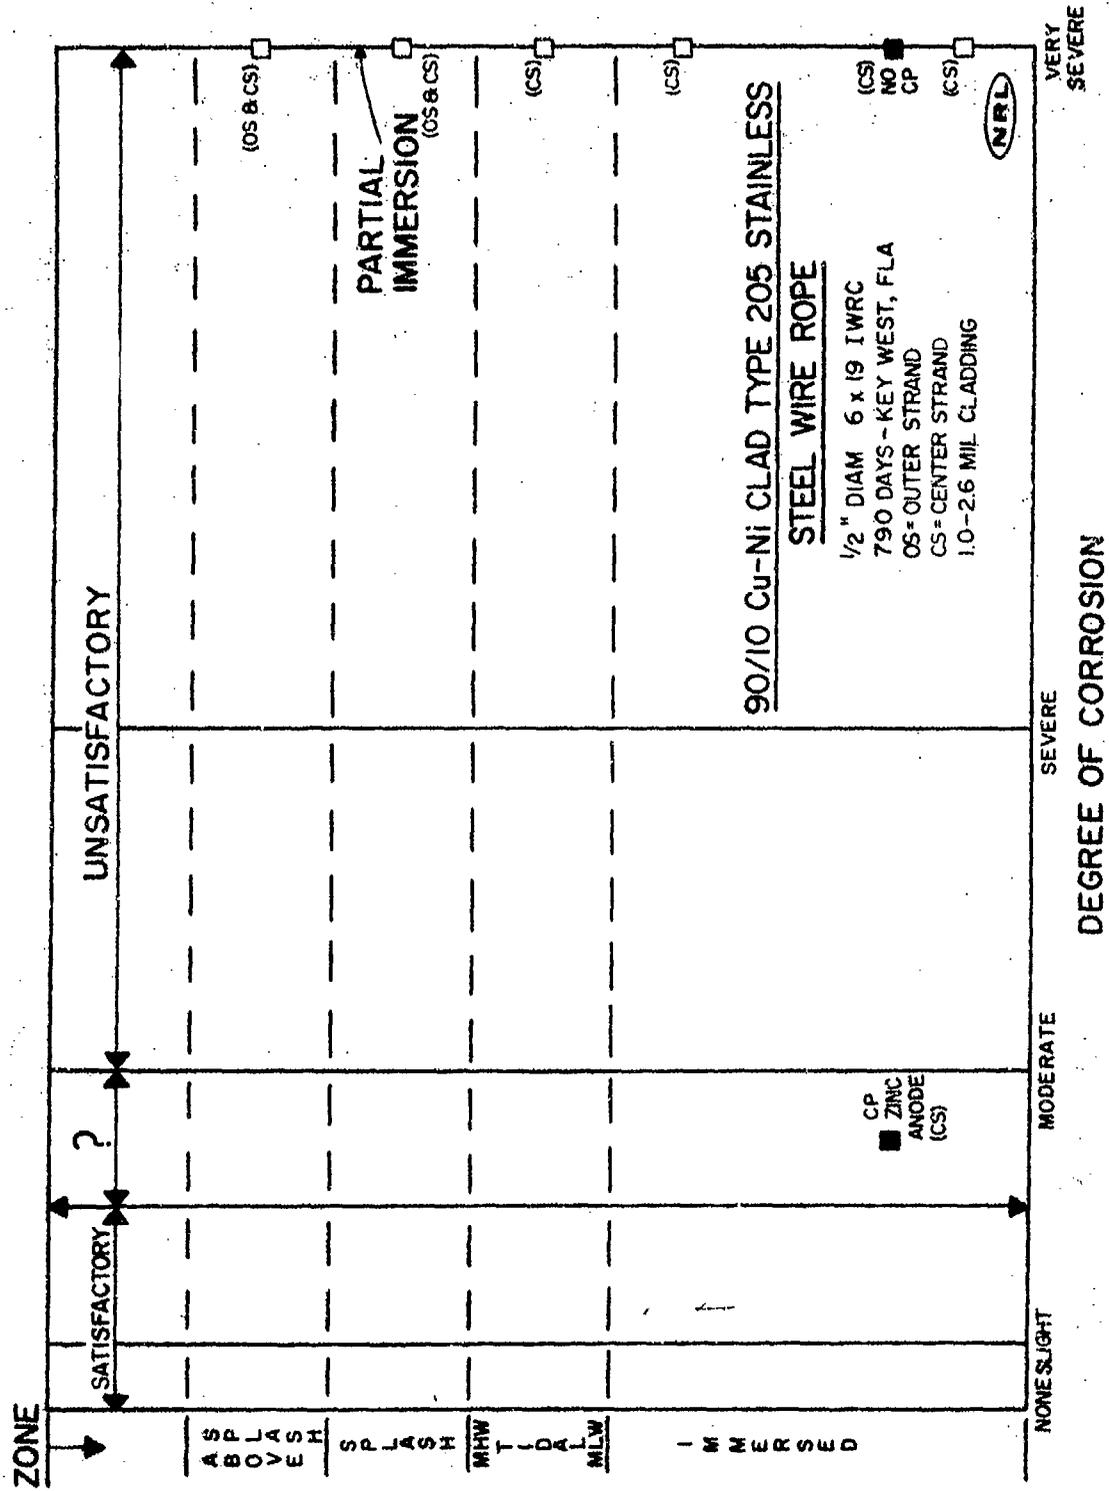
Fig. 5 - Degree of corrosion and cathodic-protection response for 90/10 copper-nickel clad Type 205 stainless steel wire rope

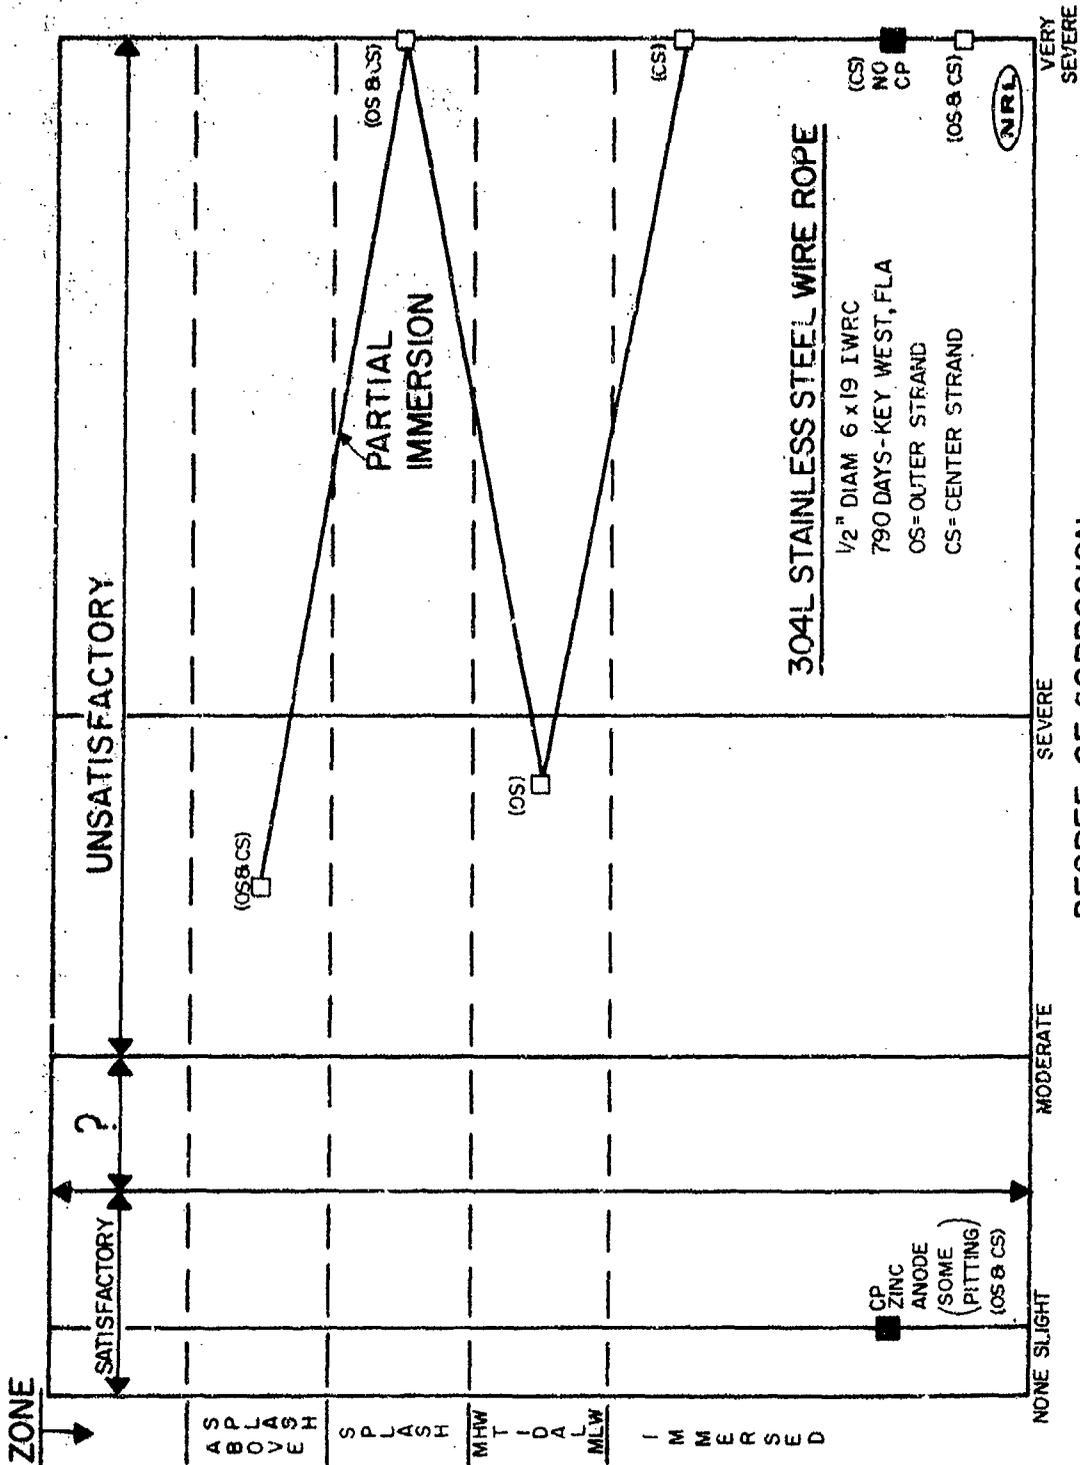
Fig. 6 - Degree of corrosion and cathodic-protection response for Type 304L unclad stainless steel wire rope

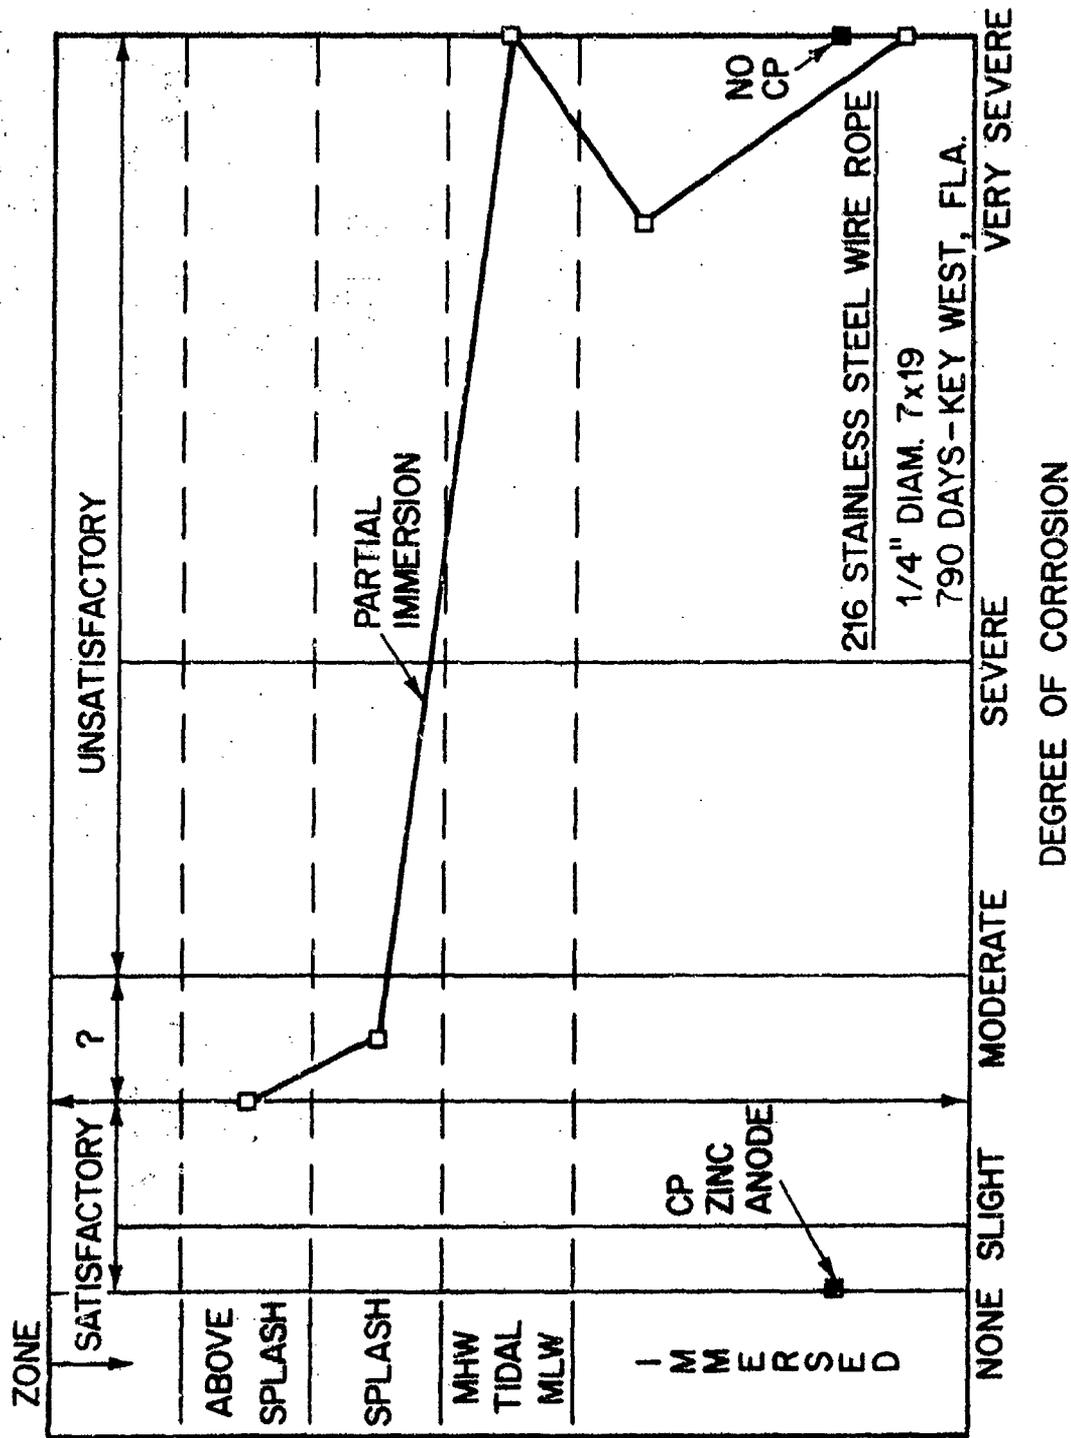
Fig. 7 - Degree of corrosion and cathodic-protection response for 216 stainless steel wire rope

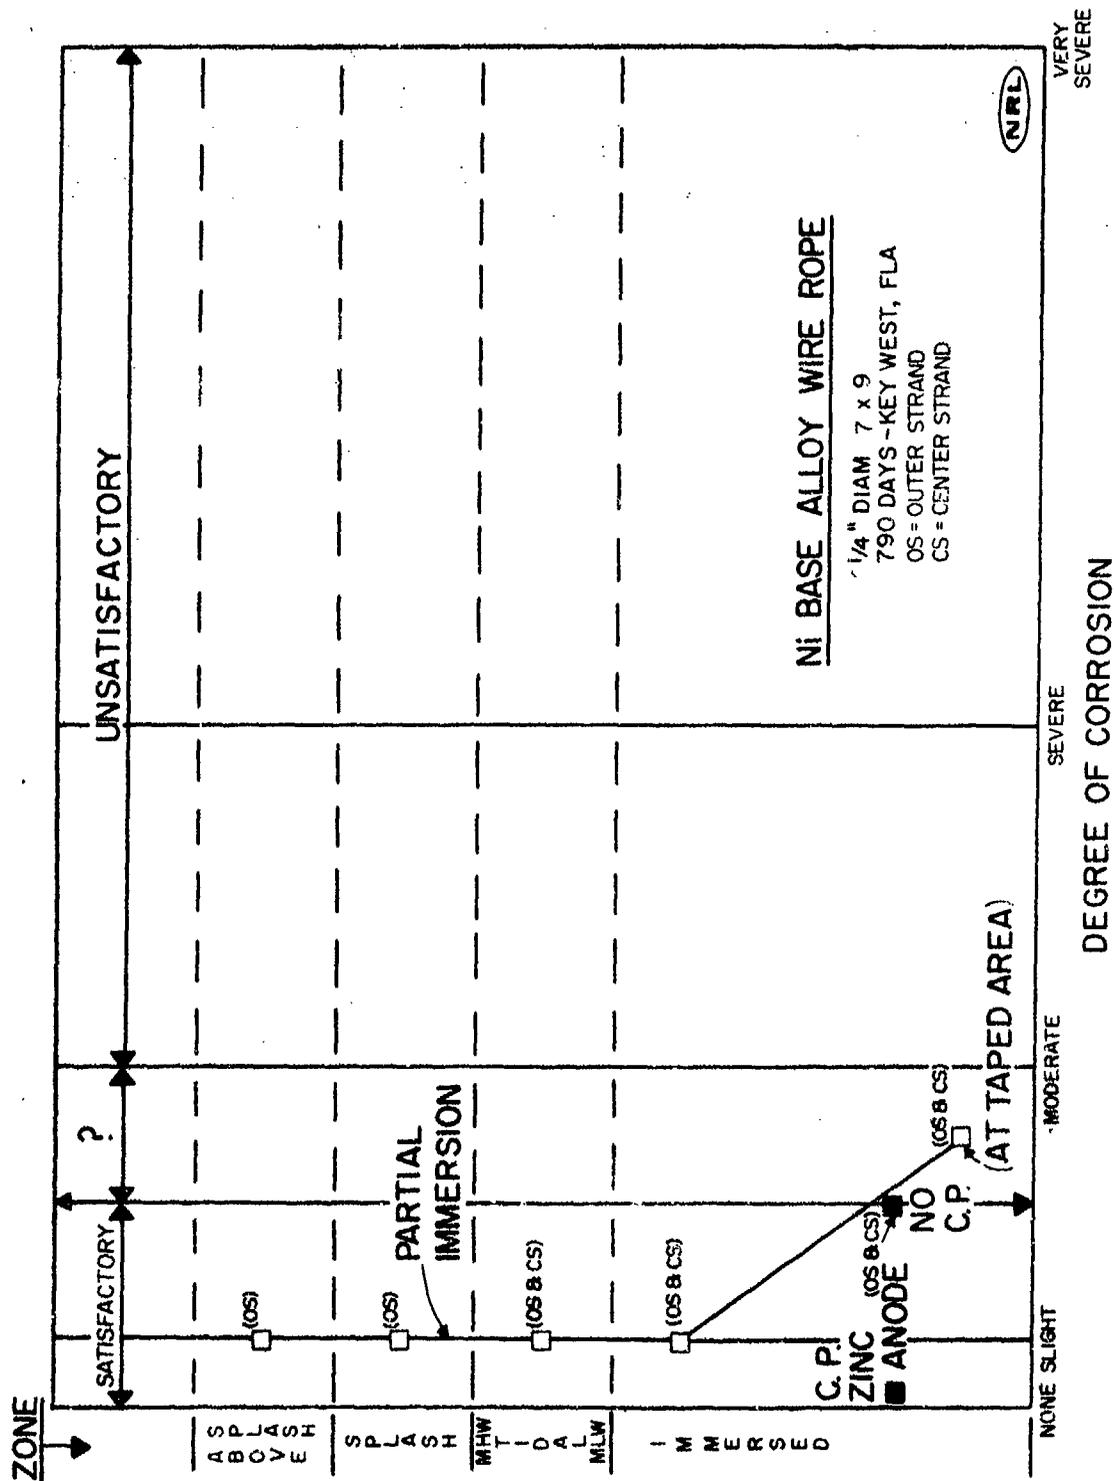
Fig. 8 - Degree of corrosion and cathodic-protection response for nickel-base-alloy wire rope

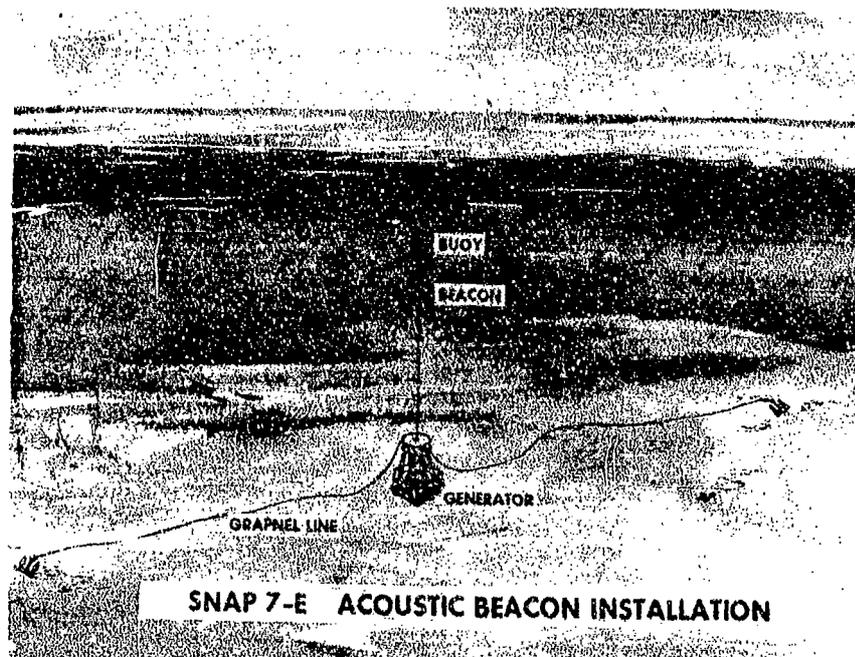
Figure 1. SNAP 7-E acoustic beacon installation.

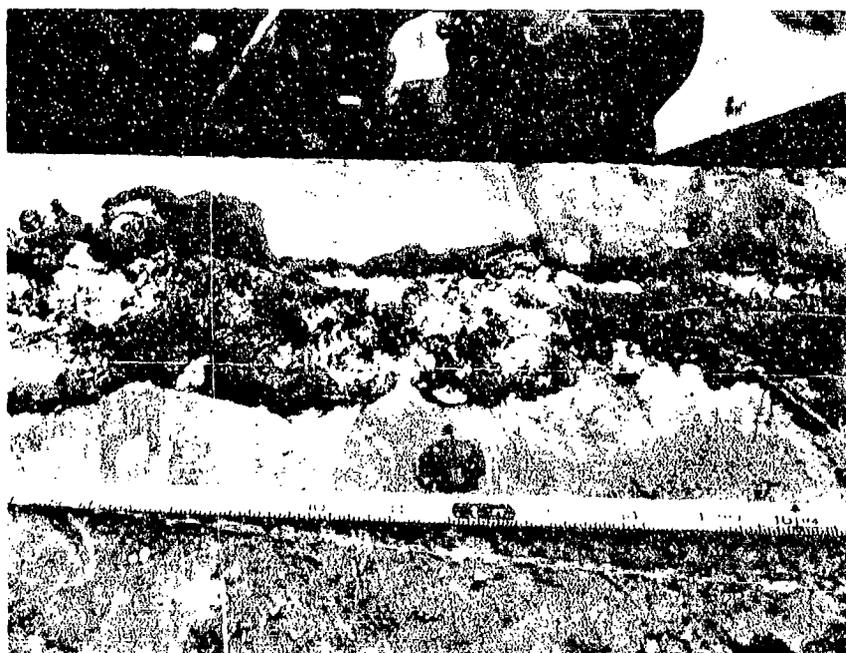
Figure 14. Crevice corrosion at main wing spar.

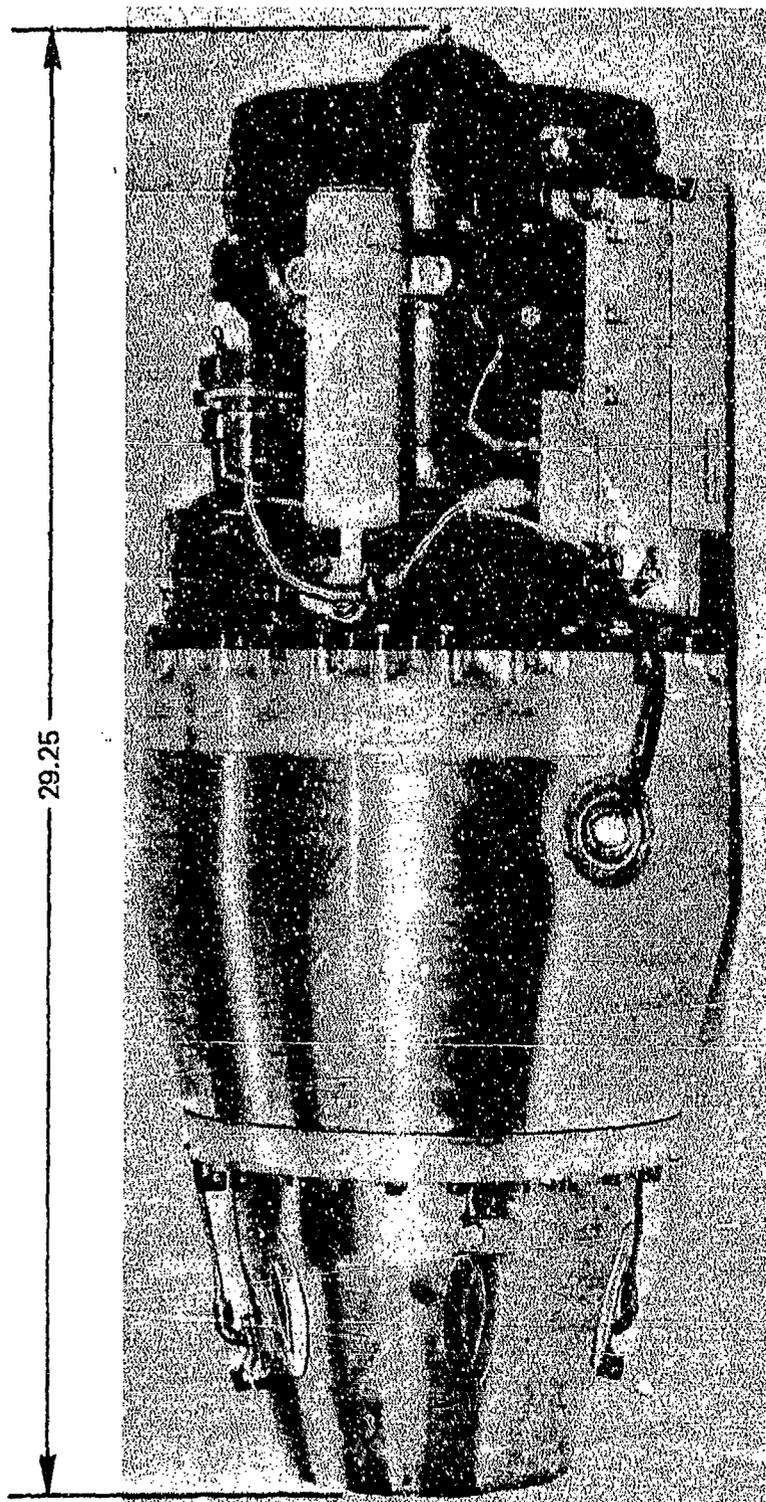
T-20108

Figure 1. Teledyne CAE J402-CA-400 Turbojet Used to Propel the Navy Harpoon Missile.

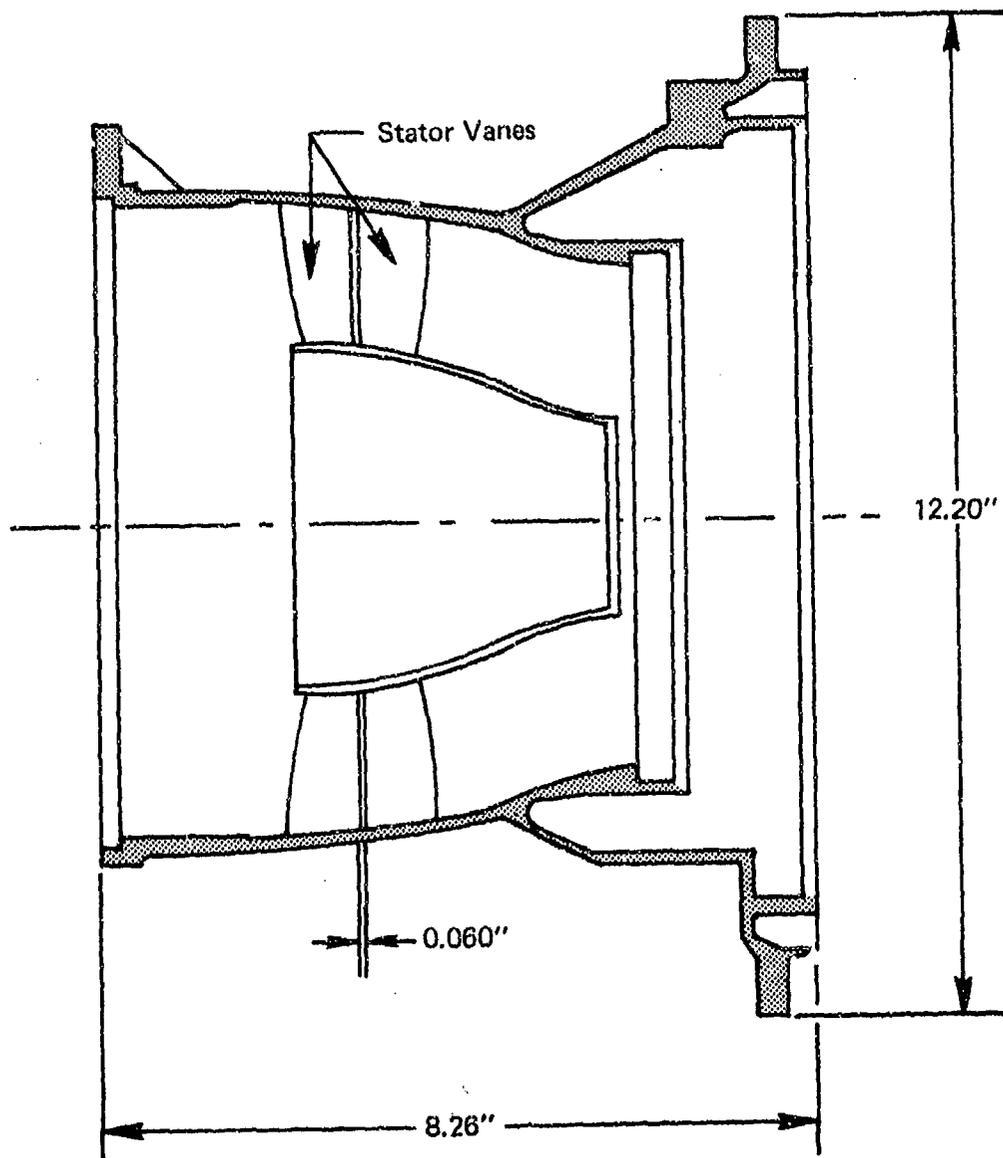
14119

Figure 4. Cross Section of Stator Housing Showing the Position of the Two Rows of Stator Vanes.
