**PROCEEDINGS OF THE 1974 TRISERVICE
CORROSION OF MILITARY EQUIPMENT
CONFERENCE, 29-31 OCTOBER 1974
Volume II. Sessions IV through VII**

TECHNICAL REPORT AFML-TR-75-42, Volume II
FINAL REPORT FOR PERIOD 31 OCTOBER 1974 - 1 FEBRUARY 1975

AIR FORCE MATERIALS LABORATORY
AIR FORCE WRIGHT AERONAUTICAL LABORATORIES
Air Force Systems Command
Wright-Patterson Air Force Base, Ohio 45433

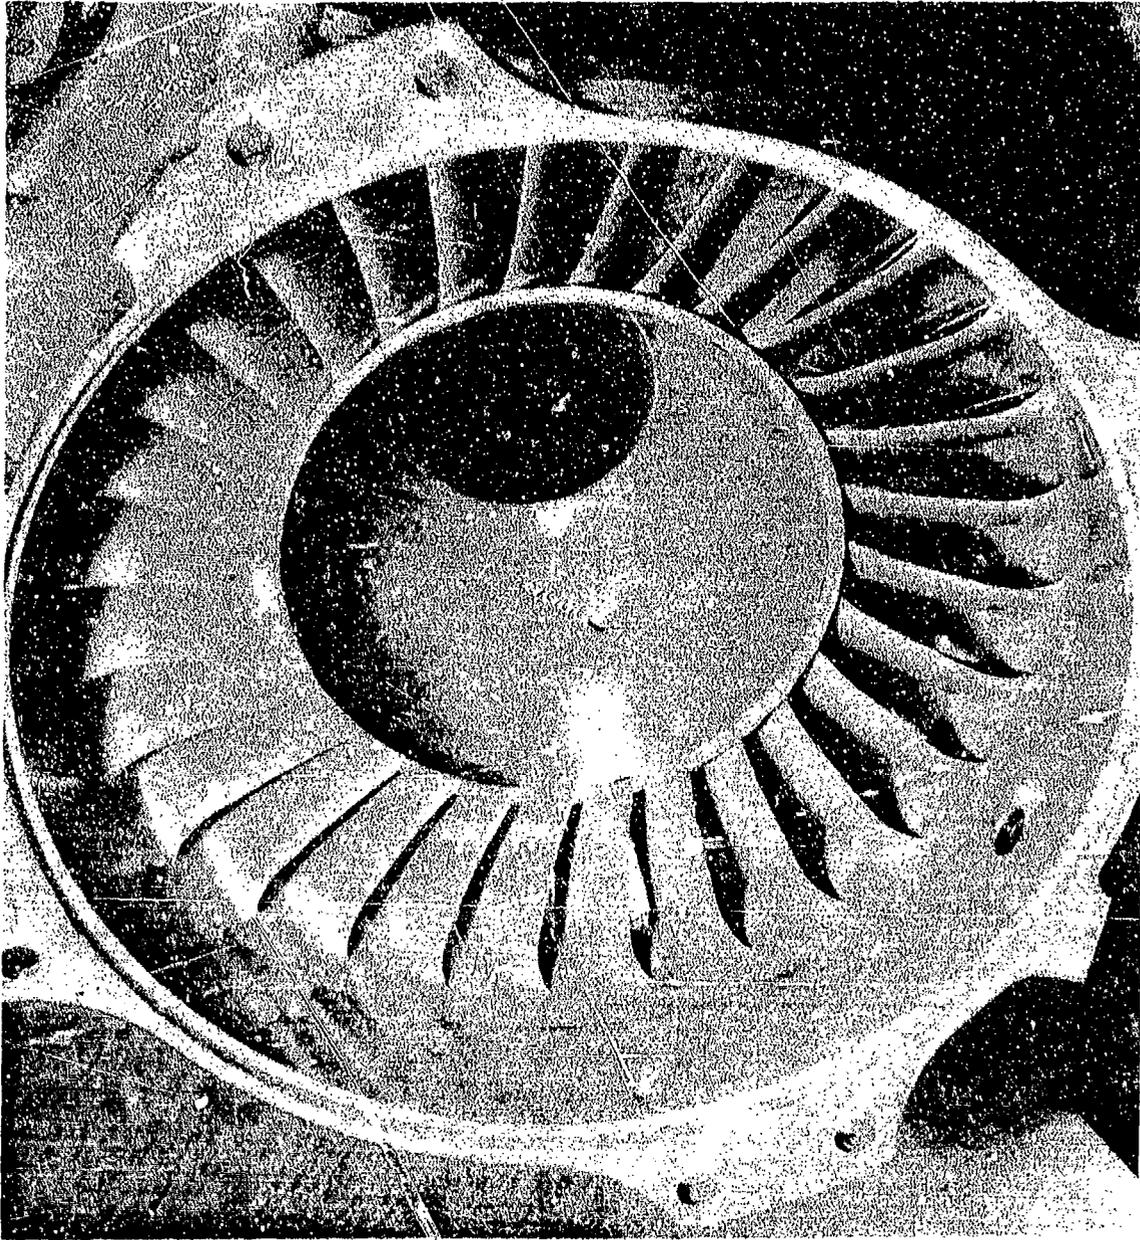
T-20874

Figure 12. Polyester Electrocoated Stator Housing Showing Excellent Condition of the Stator Vanes and Airflow Path After Exposure Aboard a Destroyer Deck for Seven Months.

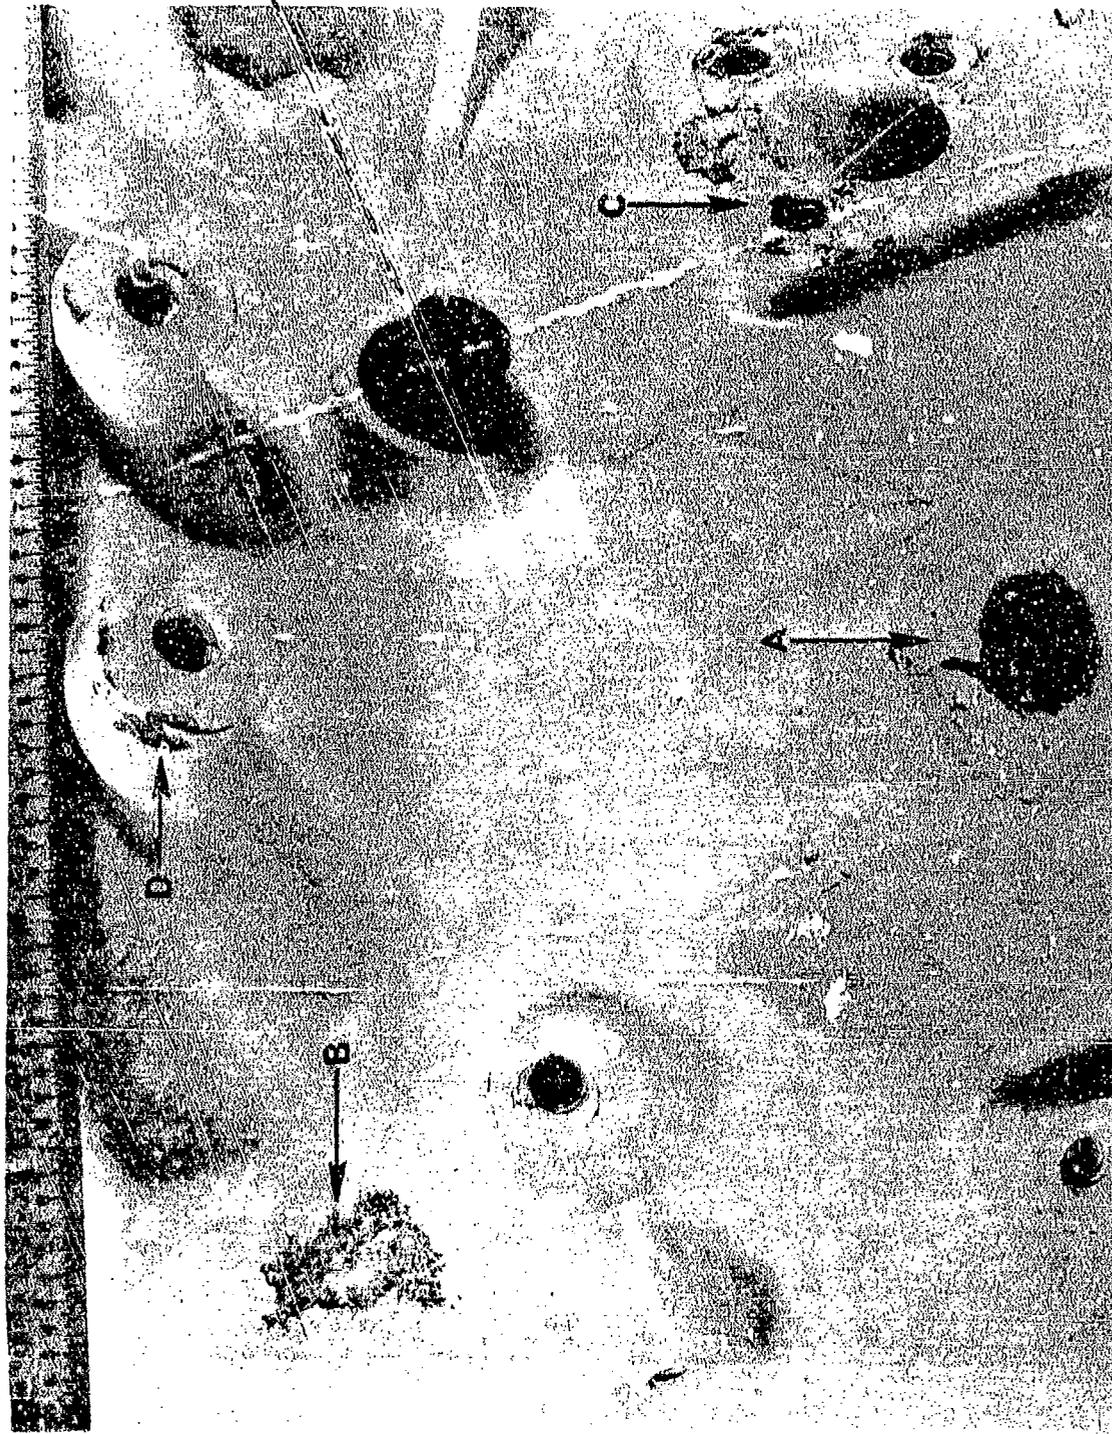
T-20873
Figure 13. Polyester Electrocoated Stator Housing Showing Some Minor Exterior Deterioration After Seven Months Exposure Aboard a Destroyer. "A" is Mounting Boss Holes; "B" is the Location Under the Fuel Line; "C", Starter Cartridge Gasket Location; and "D" is the Fuel Line Attachment Boss.

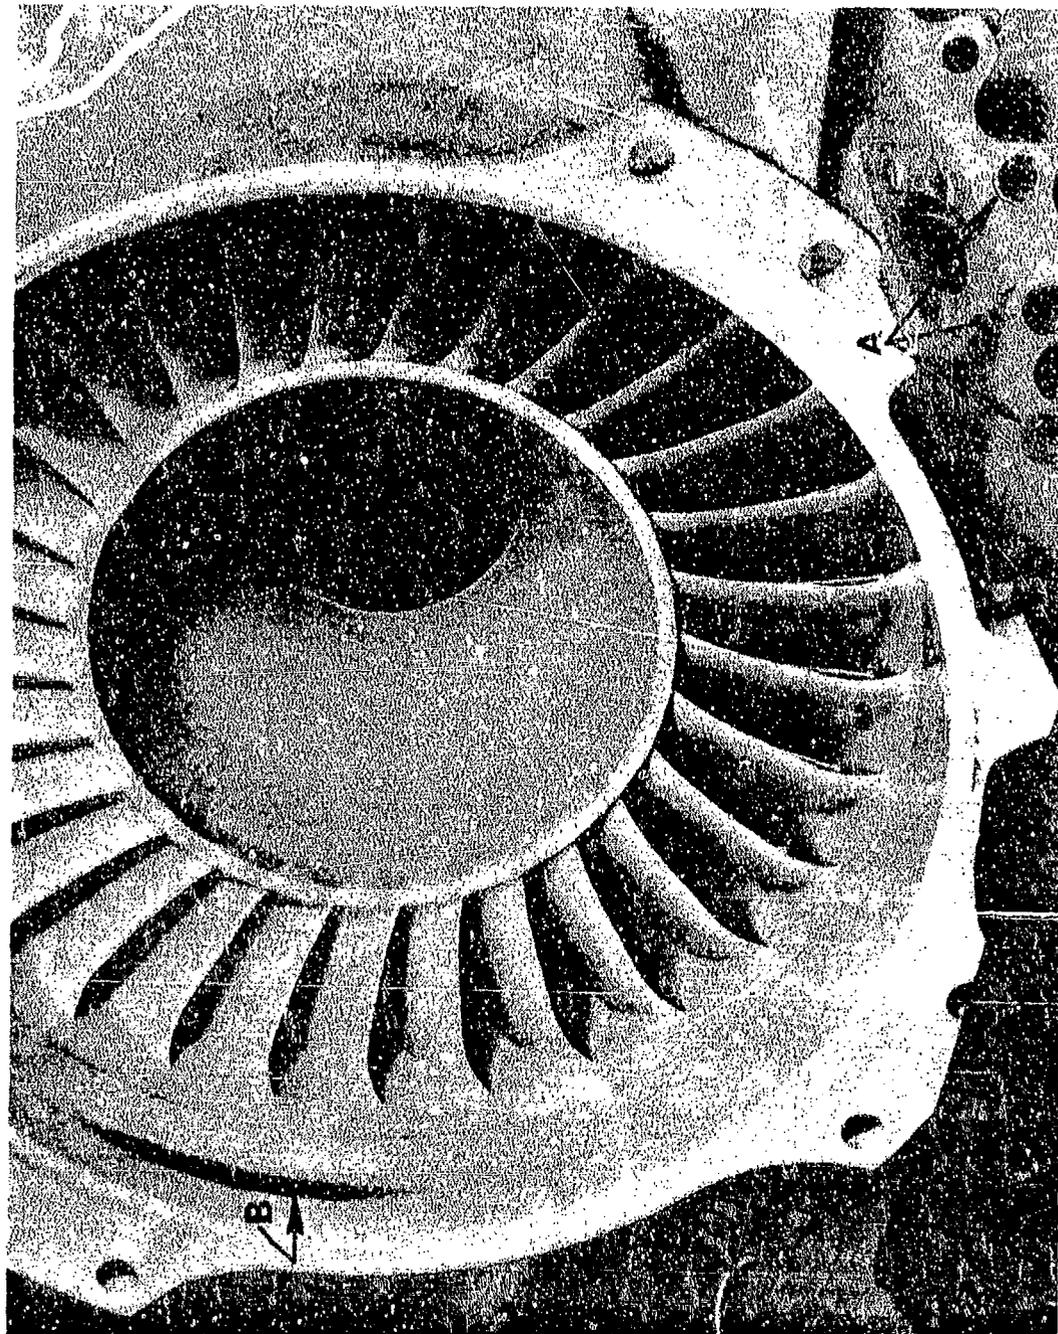
T-20875

Figure 14. Polyester Electrocoated Stator Housing Showing Excellent Condition of Stator Vanes and Air-flow Path After 12 Months Exposure Under an Aircraft Wing. "A" is Damage Caused by Lock-washers Cutting into the Aluminum. "B" is a Light Rub on Axial Compressor Shroud Which Occurred During the Initial Acceptance Test. This Area was Touched up with an Epoxy Paint and was in Excellent Condition.

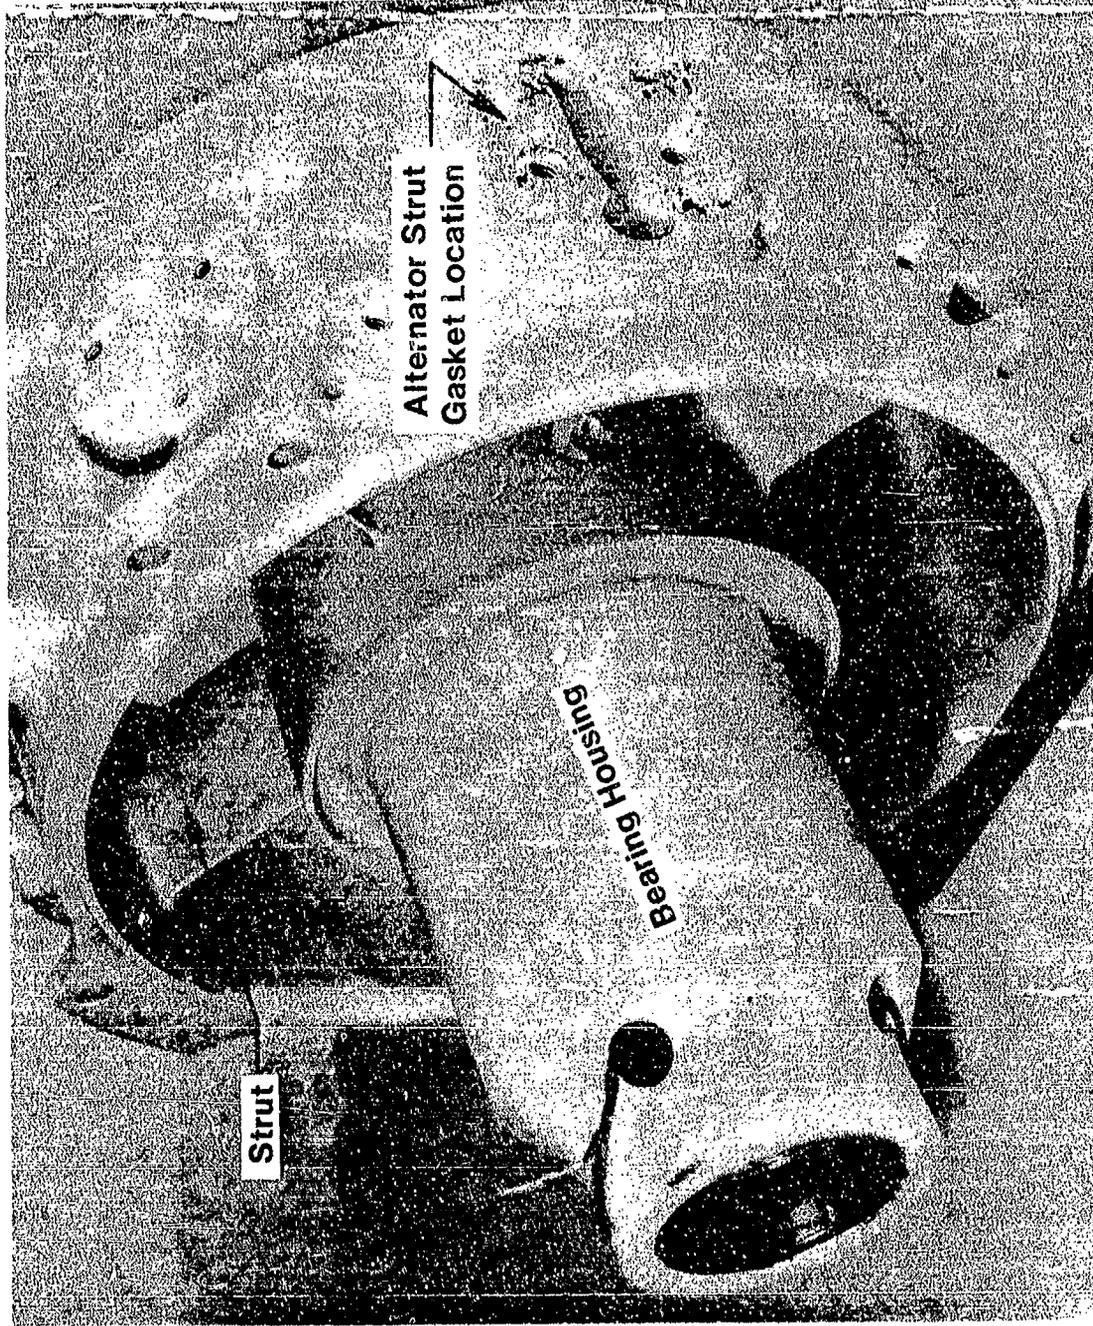
T-20876

Figure 15. Polyester Coated Air Inlet Duct Showing Excellent Condition of Air Passage Struts and Bearing Housing After 12 Months Under an Aircraft Wing. Some Minor Creepage had Occurred Under Alternator Strut Gasket.

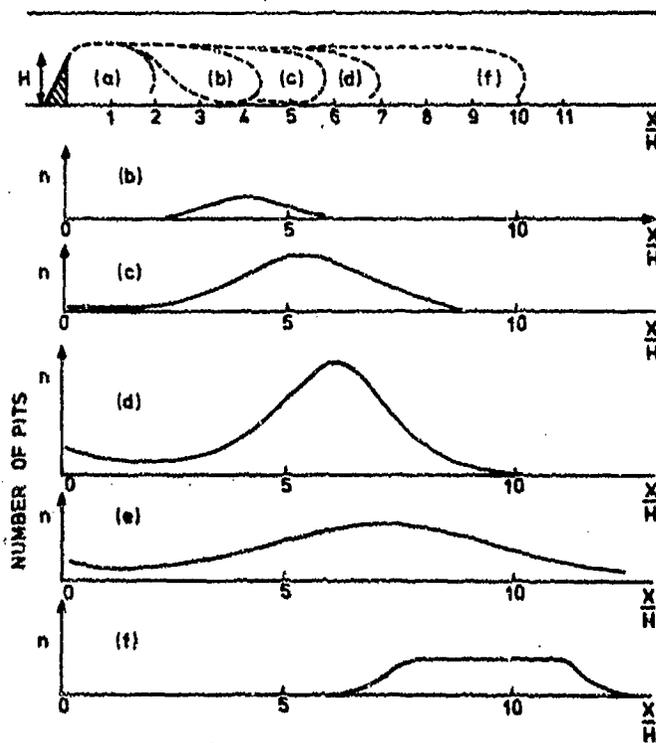
FIGURE 2. DAMAGE DISTRIBUTION BEHIND A CAVITATING ORIFICE PLATE

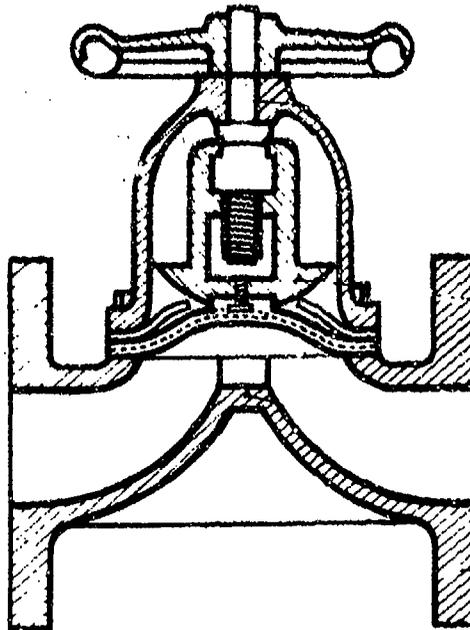
FIGURE 3. SECTIONED VIEW OF DIAPHRAGM VALVE

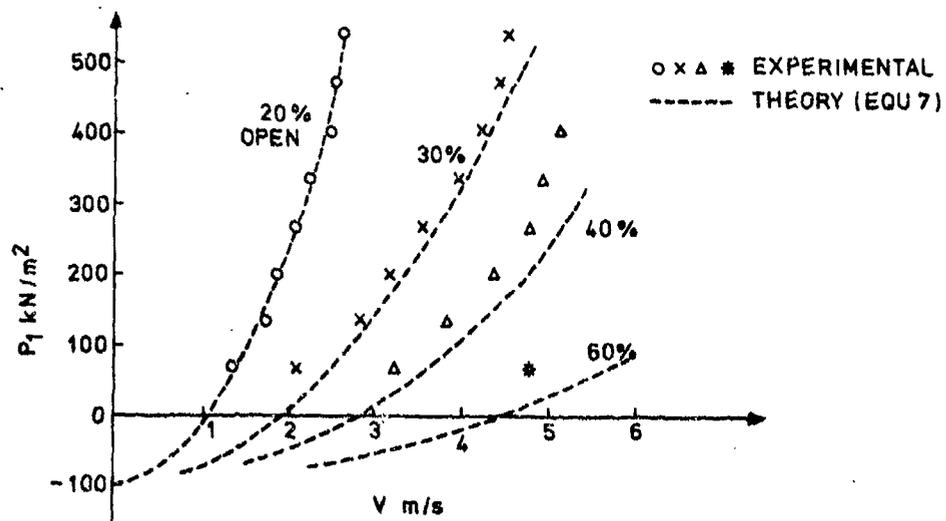
FIGURE 6. EXPERIMENTAL RESULTS FOR CAVITATION INCEPTION COMPARED WITH THEORY FOR A 38 mm DIAPHRAGM VALVE

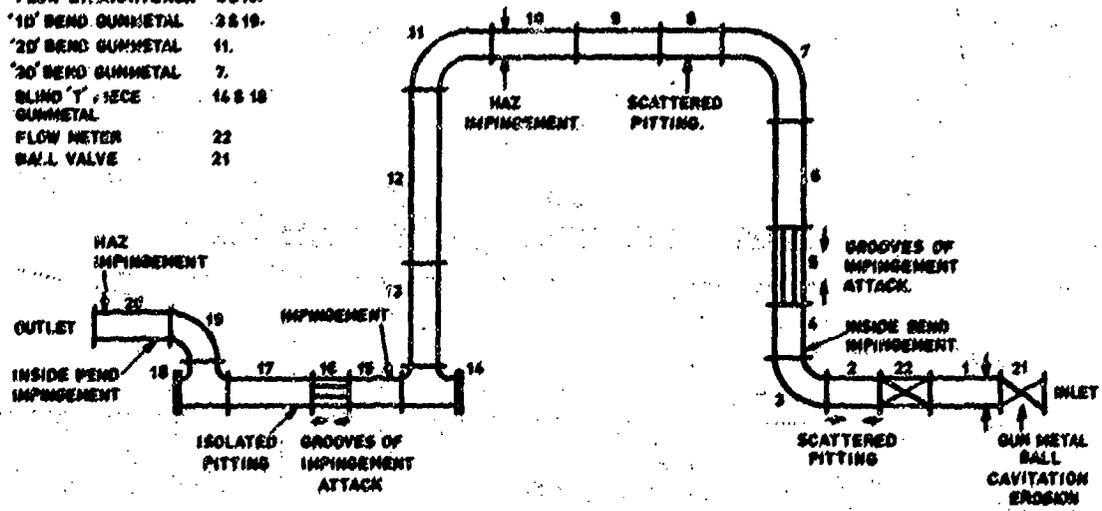
- CG/18 CUNI PIPE 1, 2, 4, 5, 6, 8, 9, 10, 12, 13, 15, 16, 17 & 20.
- FLOW STRAIGHTENER 5 & 18.
- '10' BEND GUNMETAL 2 & 19.
- '20' BEND GUNMETAL 11.
- '30' BEND GUNMETAL 7.
- BLIND 'Y' PIECE GUNMETAL 14 & 18.
- FLOW METER 22.
- BALL VALVE 21.

FIG.1 LOCALISED CORROSION SITES IN AN EXPERIMENTAL SEA WATER SYSTEM.

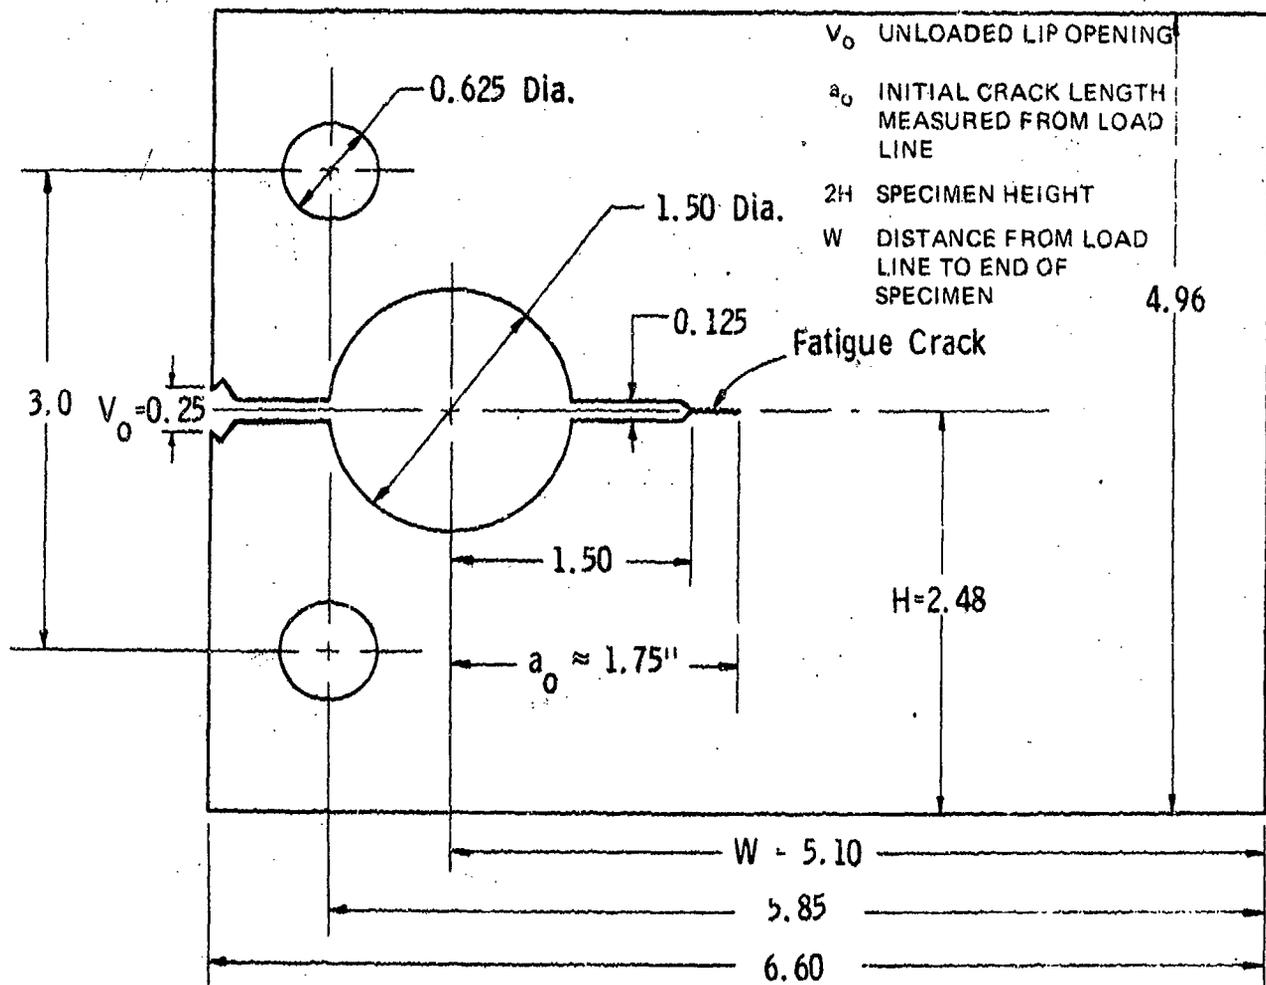
Figure 1. MODIFIED WOL-2T STRESS CORROSION SPECIMEN

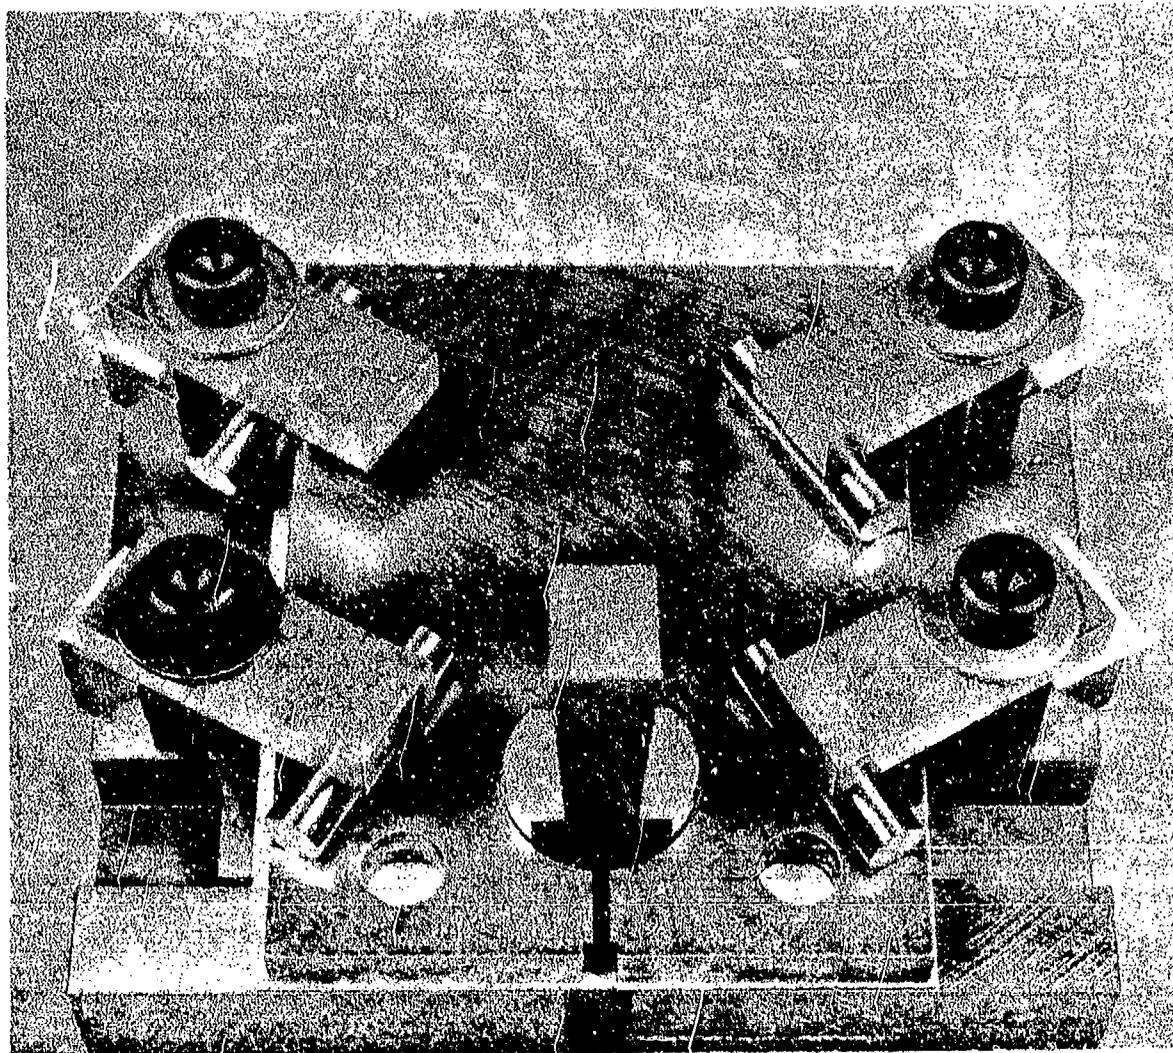
Figure 2. LOADING FIXTURE FOR WEDGE-LOADED TYPE SPECIMENS

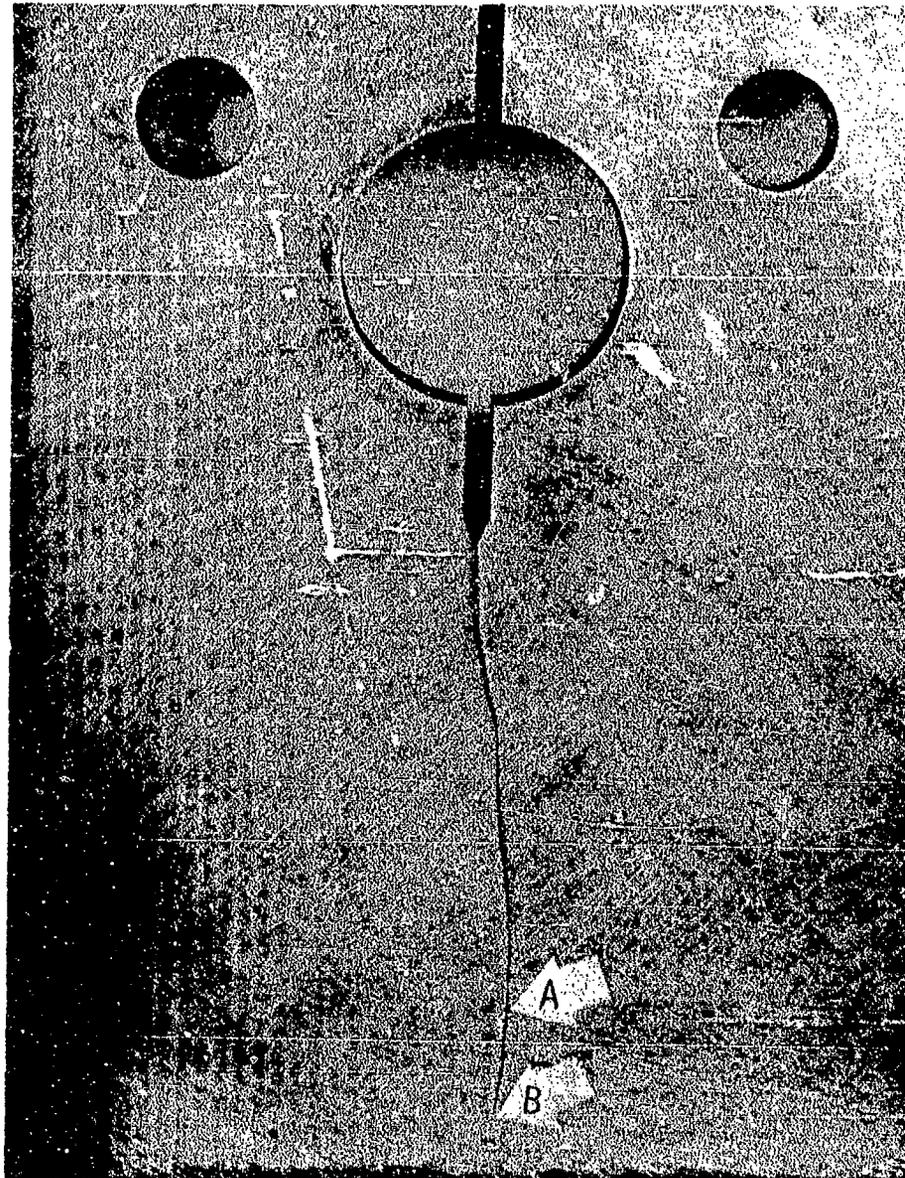
Figure 5. STRESS CORROSION CRACK IN WOL-2T SPECIMEN J13-1WR
(A. LIMIT FOR VALID MEASUREMENT OF STRESS INTENSITY
 $\left(\frac{a}{W} = 0.08\right)$ B. CRACK TIP)

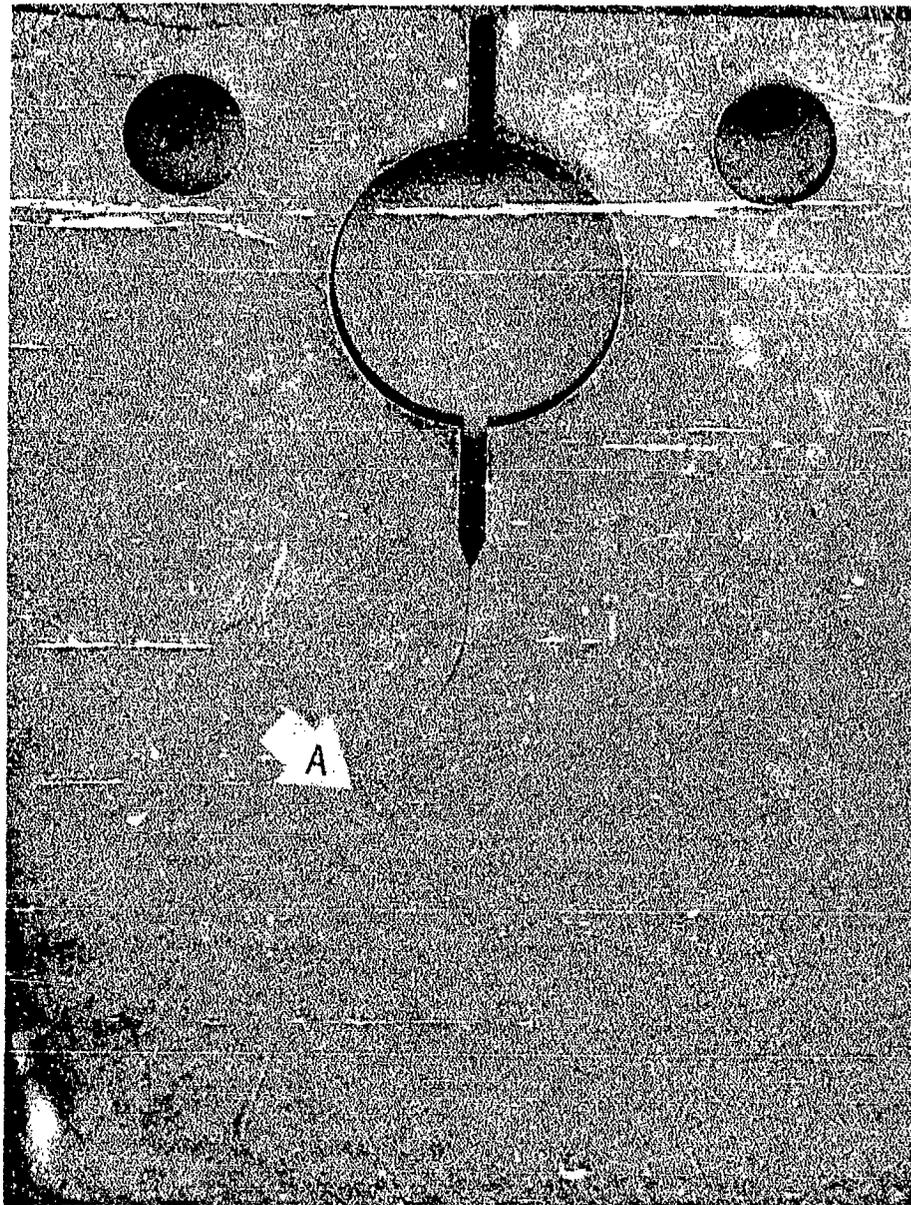
Figure 6. STRESS CORROSION CRACK IN WOL-2T SPECIMEN J13-4WR
(A. CRACK TIP)

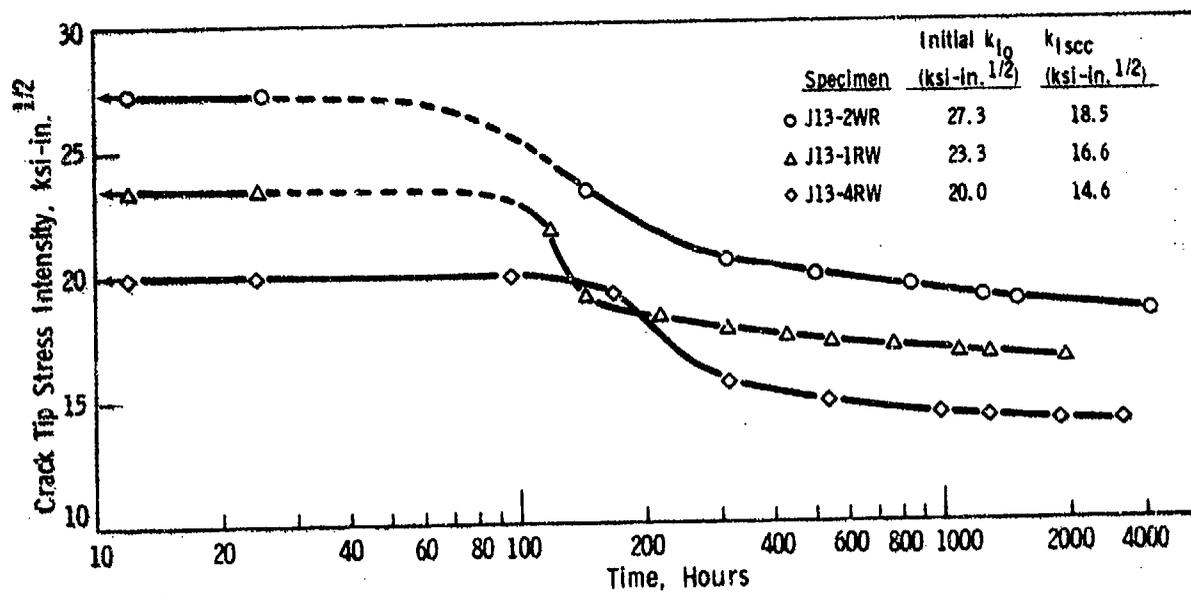
Figure 7. TYPICAL STRESS INTENSITY VERSUS TIME FOR STRESS CORROSION CRACKING OF WOL-2T SPECIMENS FROM PLATE J13

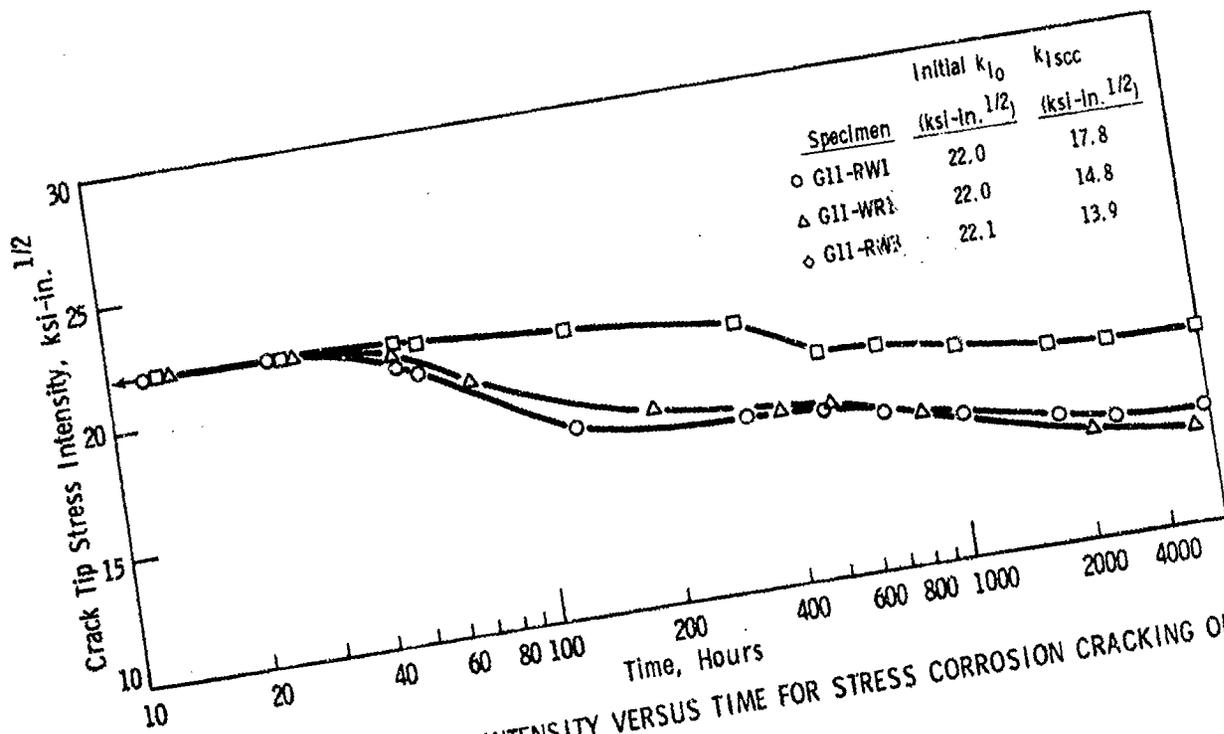
Figure 8. TYPICAL STRESS INTENSITY VERSUS TIME FOR STRESS CORROSION CRACKING OF CT2 SPECIMENS FROM PLATE G11

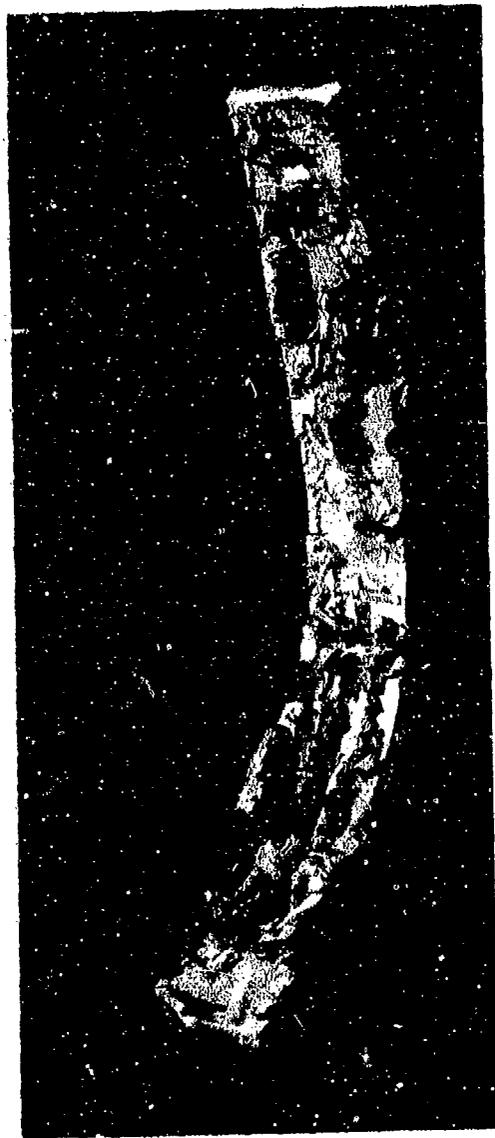
Figure 1 (68-1457)
Exfoliation Corrosion - 5456-H321

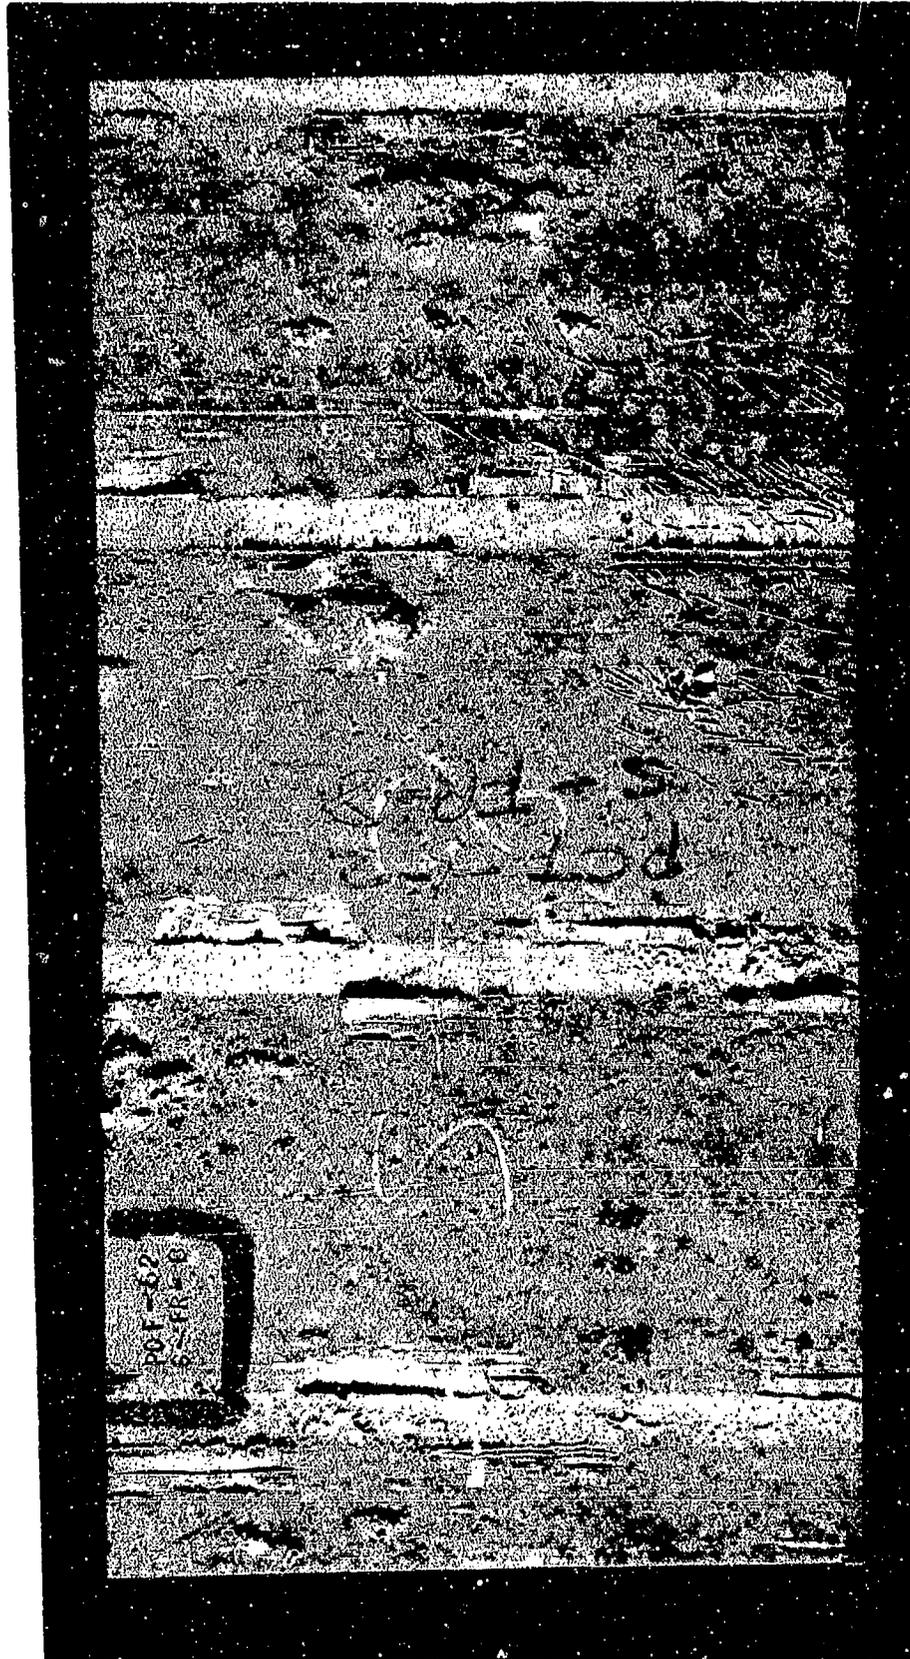
Figure 2 (68-1455)
Exfoliation Corrosion of 5456-H321
Hull Plate in Bilge Area

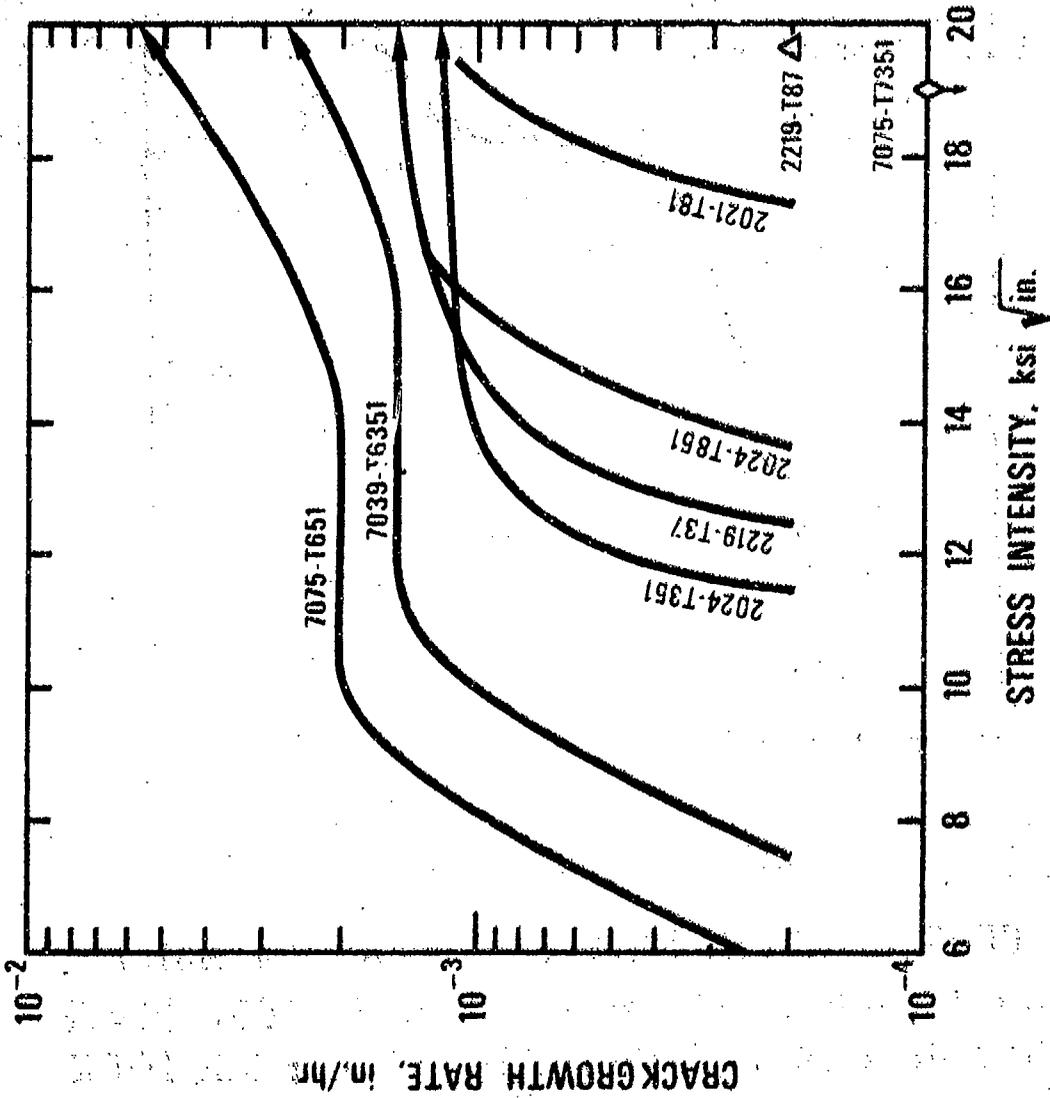
FIG. 7

CRACK GROWTH RATE VS STRESS INTENSITY FOR
S-L COMPACT SPECIMENS OF SOME ALUMINUM ALLOYS
EXPOSED IN A SALT-DICHROMATE-ACETATE SOLUTION

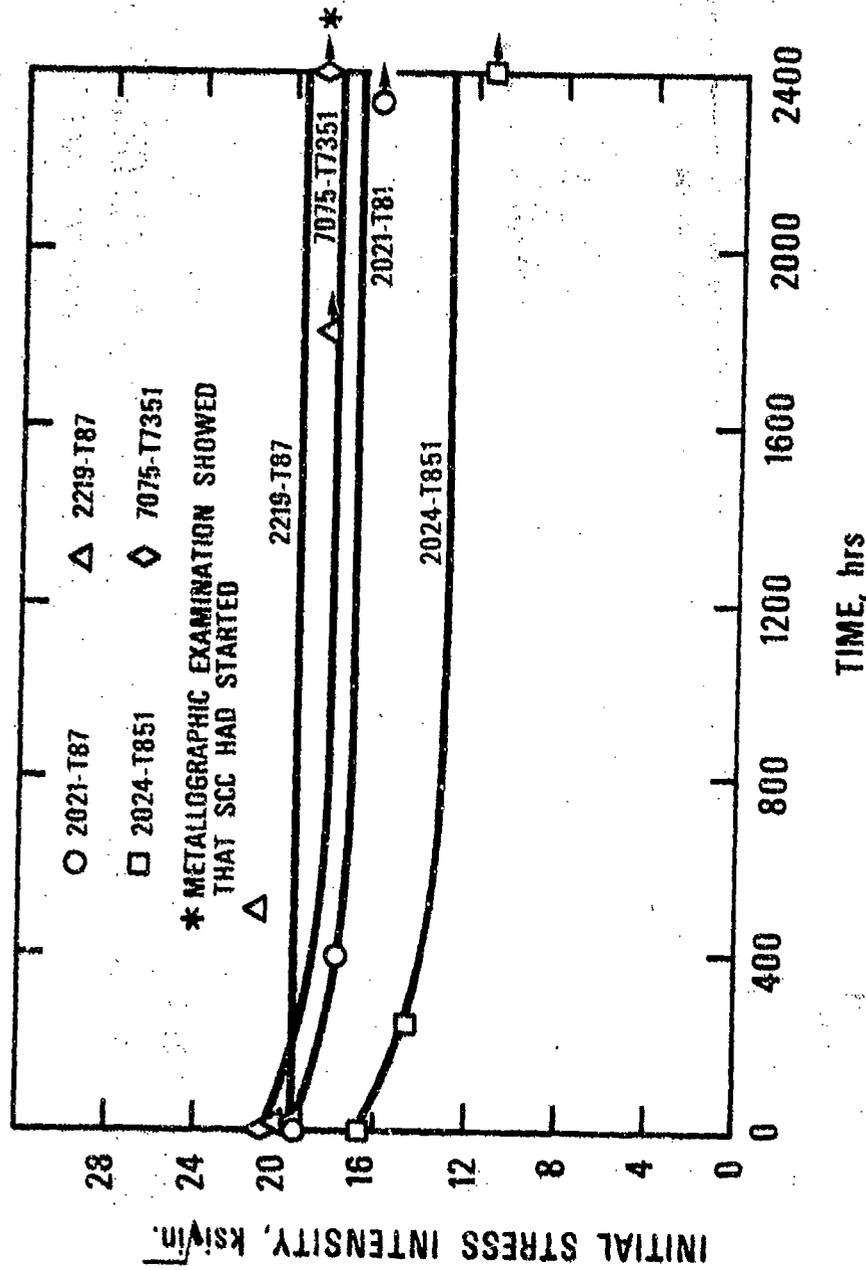
FIG 8

INITIAL STRESS INTENSITY VS TIME TO FAILURE FOR SOME S-L
COMPACT SPECIMENS OF RESISTANT ALUMINUM ALLOYS EXPOSED
IN A SALT-DICHROMATE-ACETATE SOLUTION

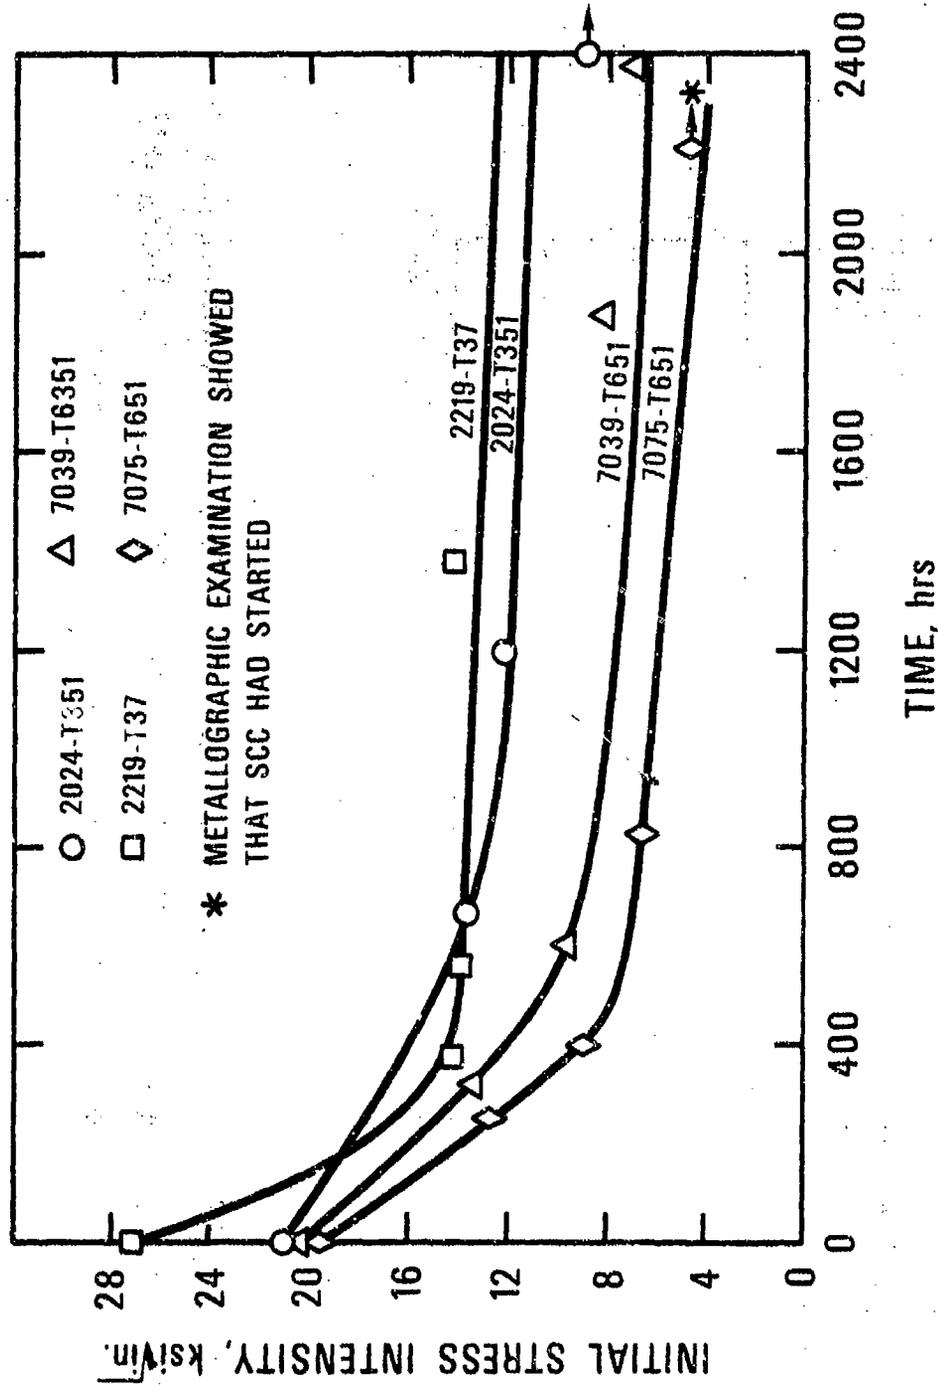
FIG 9

INITIAL STRESS INTENSITY VS TIME TO FAILURE FOR SOME S-L COMPACT SPECIMENS OF LOW RESISTANCE ALUMINUM ALLOYS EXPOSED IN A SALT-DICHROMATE-ACETATE SOLUTION

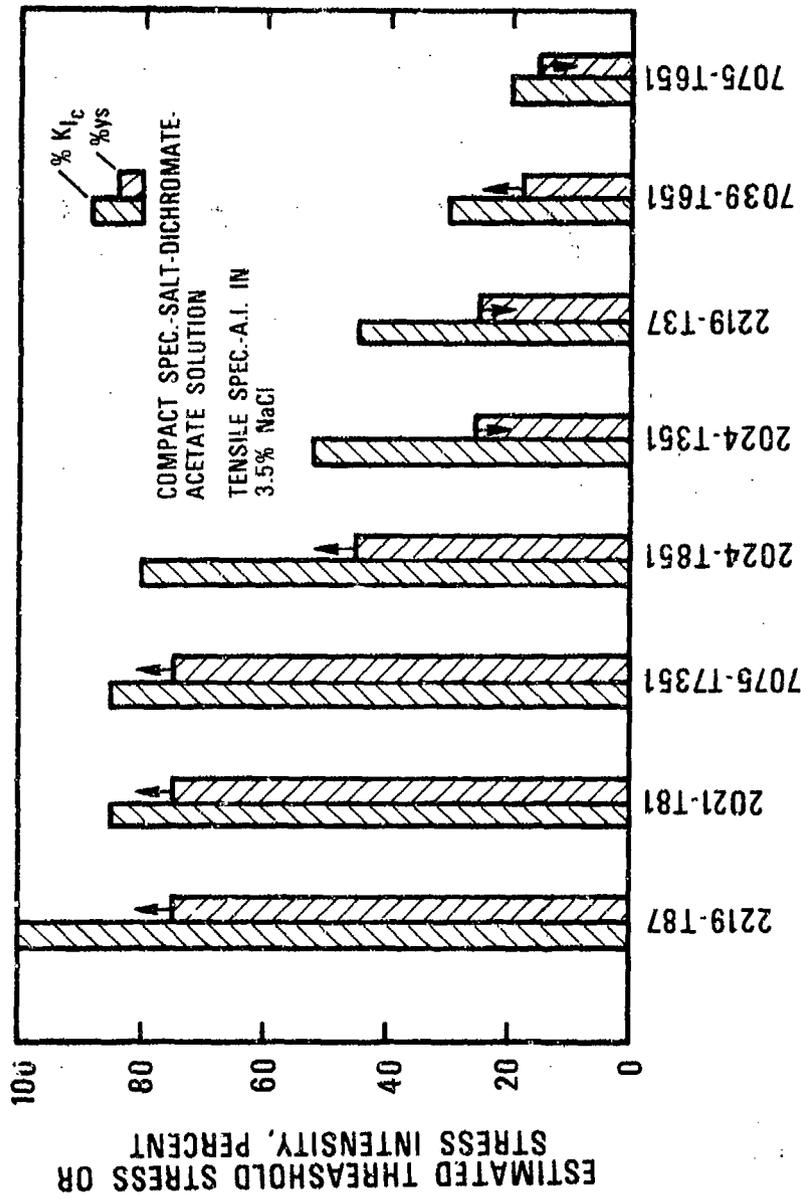
FIG. 10

COMPARISON OF SCC RANKINGS OF SOME ALUMINUM ALLOYS DETERMINED WITH RING LOADED COMPACT SPECIMENS AND SMOOTH TENSILE SPECIMENS

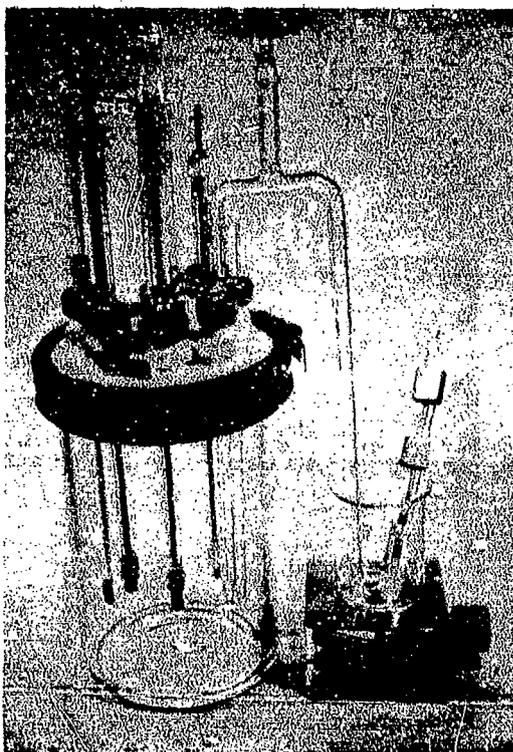
Figure 1 Polarization Cell, Basic Design with Salt Bridge to separate Beaker

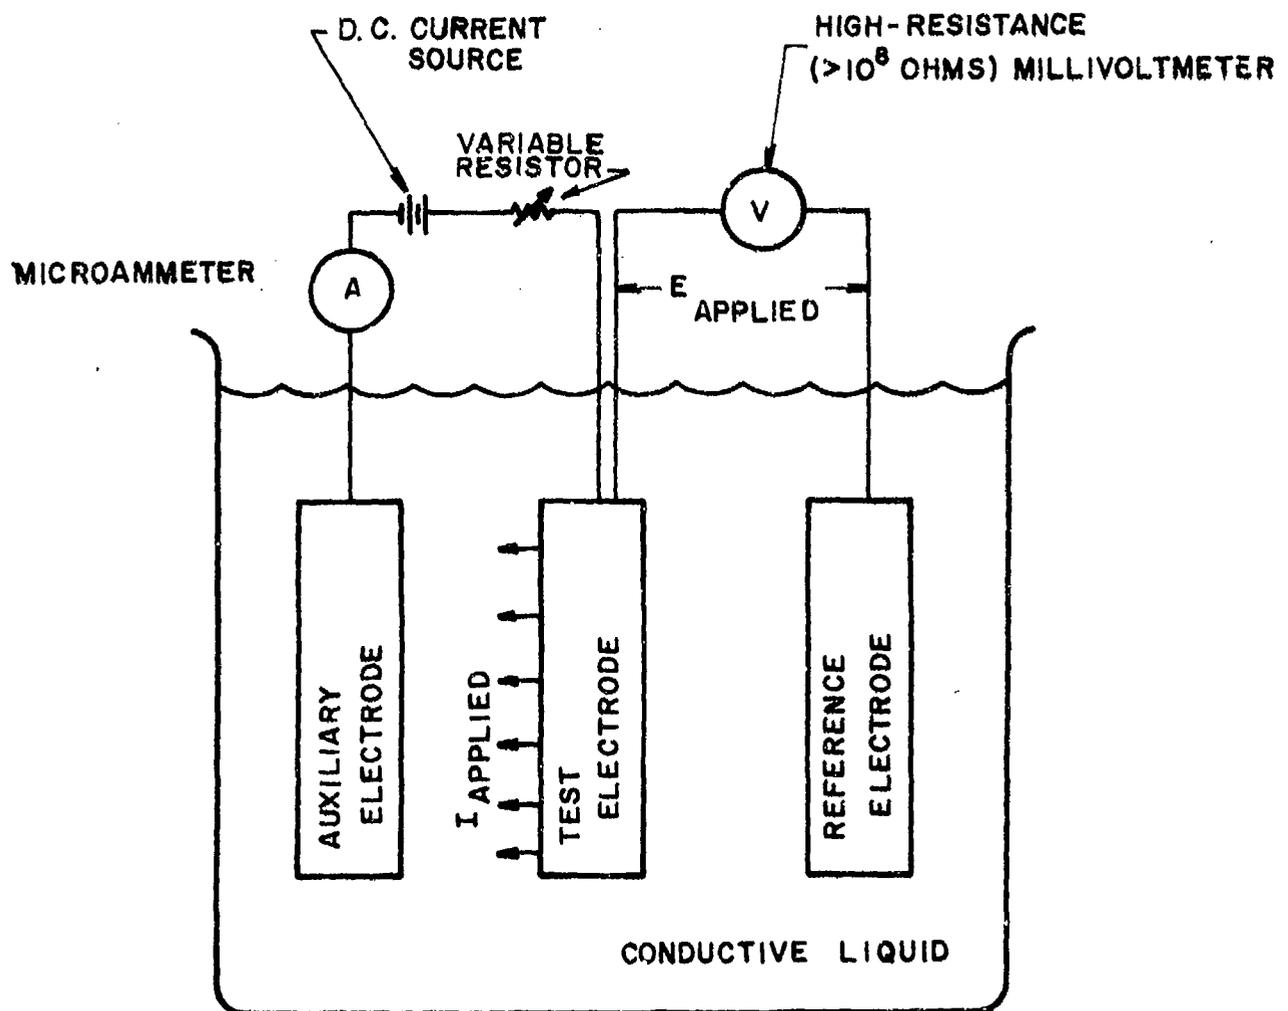
FIGURE 1. BASIC 3-ELECTRODE LINEAR POLARIZATION TEST CIRCUIT.
