**PROCEEDINGS OF THE 1974 TRISERVICE
CORROSION OF MILITARY EQUIPMENT
CONFERENCE, 29-31 OCTOBER 1974
Volume II. Sessions IV through VII**

TECHNICAL REPORT AFML-TR-75-42, Volume II
FINAL REPORT FOR PERIOD 31 OCTOBER 1974 - 1 FEBRUARY 1975

AIR FORCE MATERIALS LABORATORY
AIR FORCE WRIGHT AERONAUTICAL LABORATORIES
Air Force Systems Command
Wright-Patterson Air Force Base, Ohio 45433

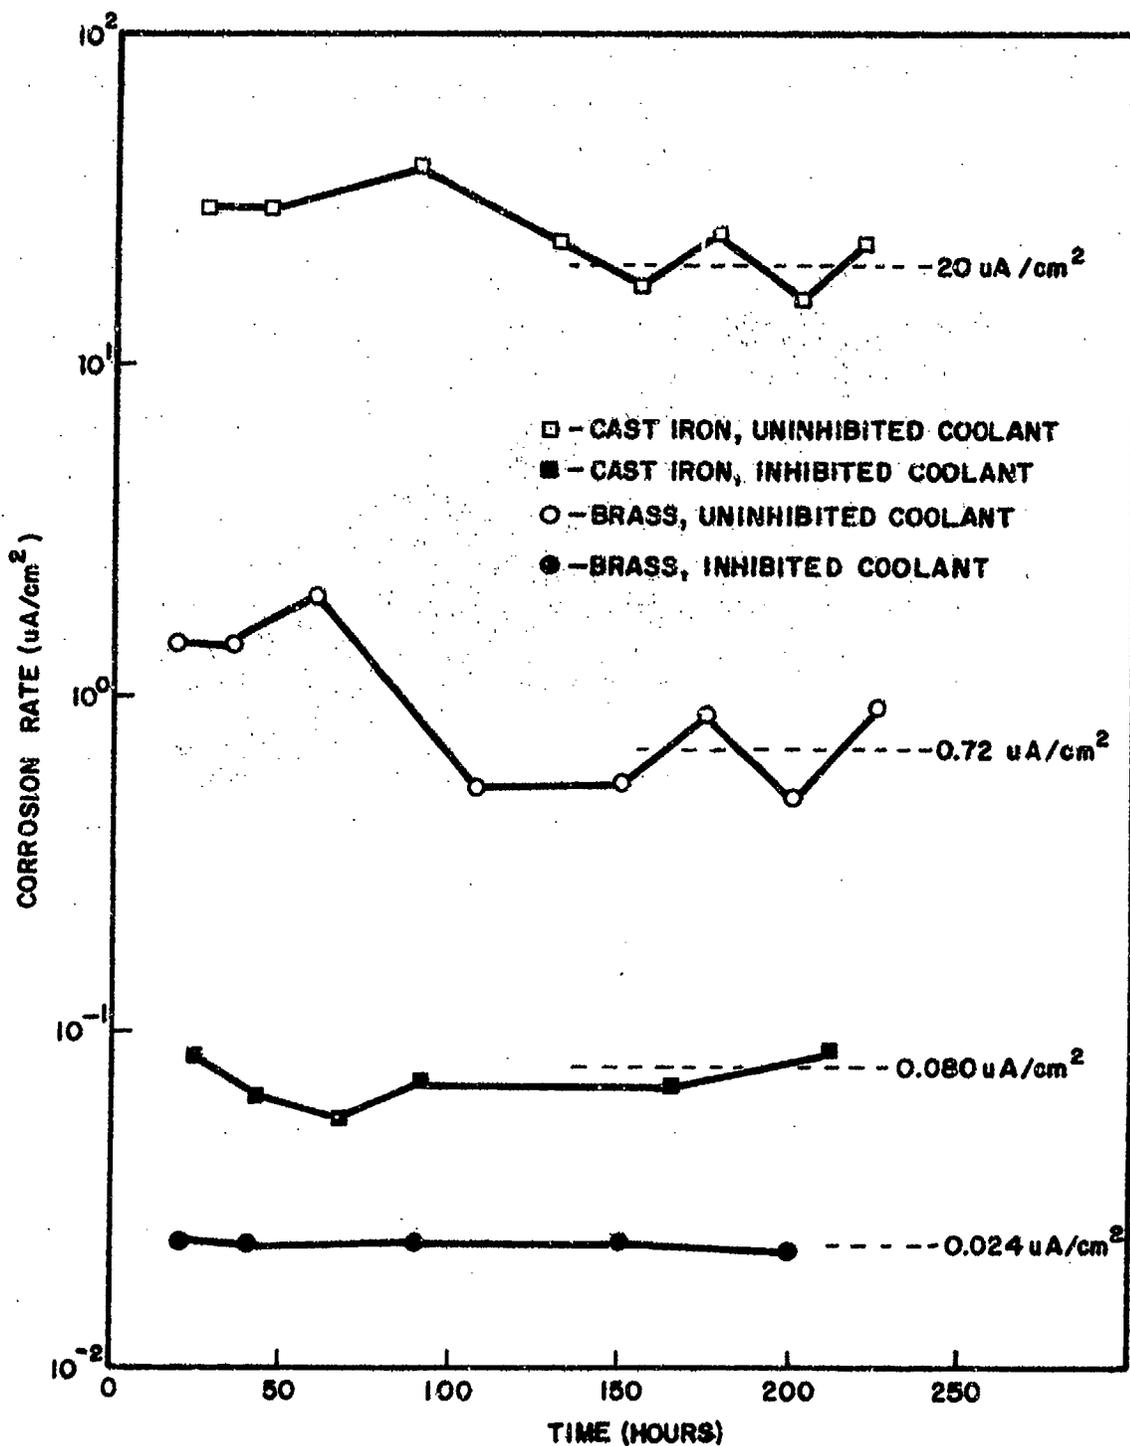
FIGURE 5. CORROSION RATES VS TIME FOR CAST IRON AND BRASS IN INHIBITED AND UNINHIBITED COOLANT. Dashed lines indicate steady-state rates.

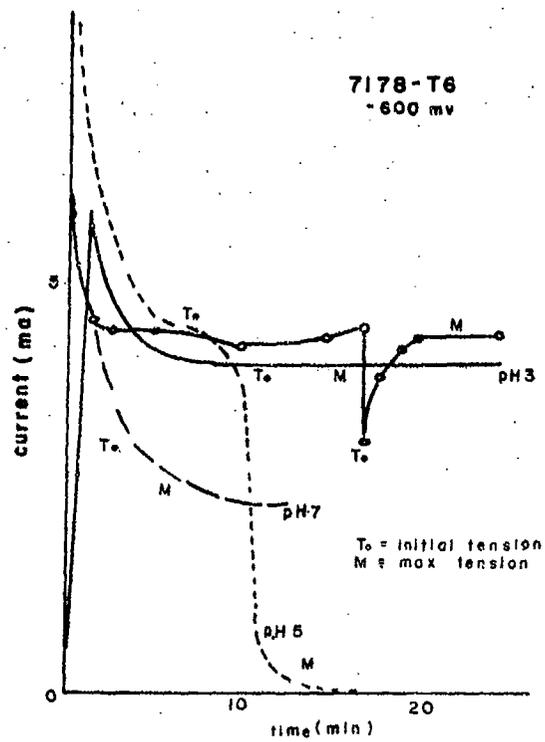
FIGURE 1. The effect of pH and variable load on current flow at fixed applied potential in alloy 7178 T6.

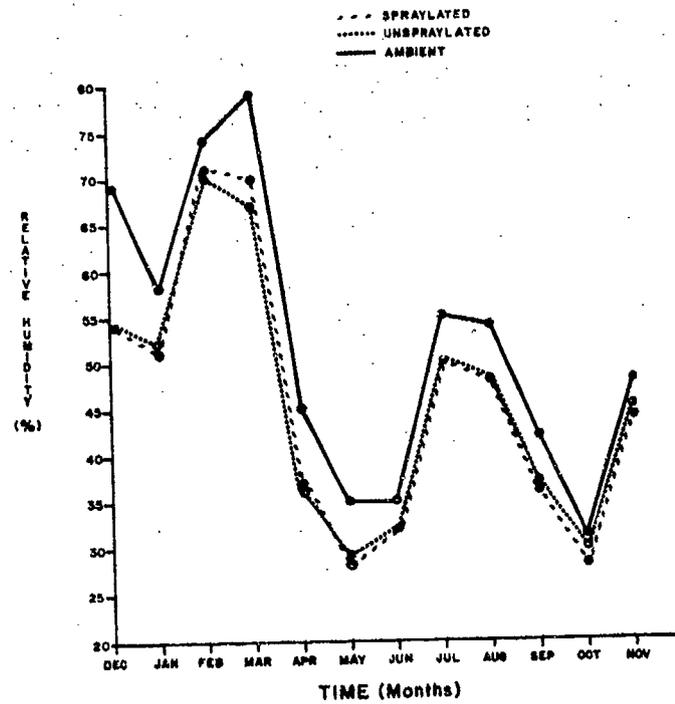
FIGURE 7. C-119J FUSELAGE RELATIVE HUMIDITY VS. AMBIENT RELATIVE HUMIDITY

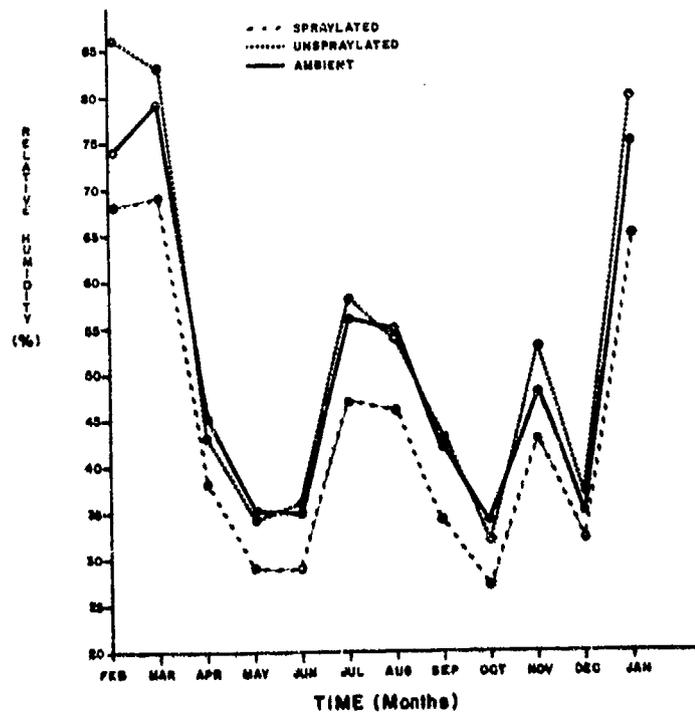
FIGURE 8. F-4B ENGINE RELATIVE HUMIDITY VS. AMBIENT RELATIVE HUMIDITY

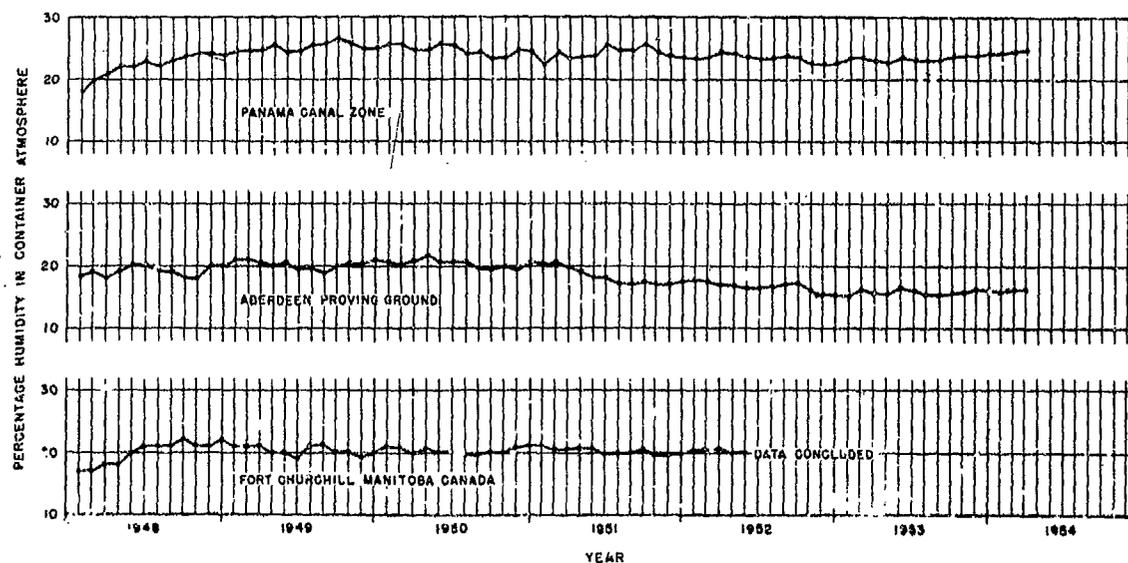
Figure 24. Relative humidity in container with solar radiation breather
