TECHNICAL REPORT H-76-15

PROTOTYPE TESTS, OLD RIVER LOW-SILL CONTROL STRUCTURE, APRIL 1973-JUNE 1975

Frank M. Neilson, Allen R. Tool

Hydraulics Laboratory
U. S. Army Engineer Waterways Experiment Station
P. O. Box 631, Vicksburg, Miss. 39180

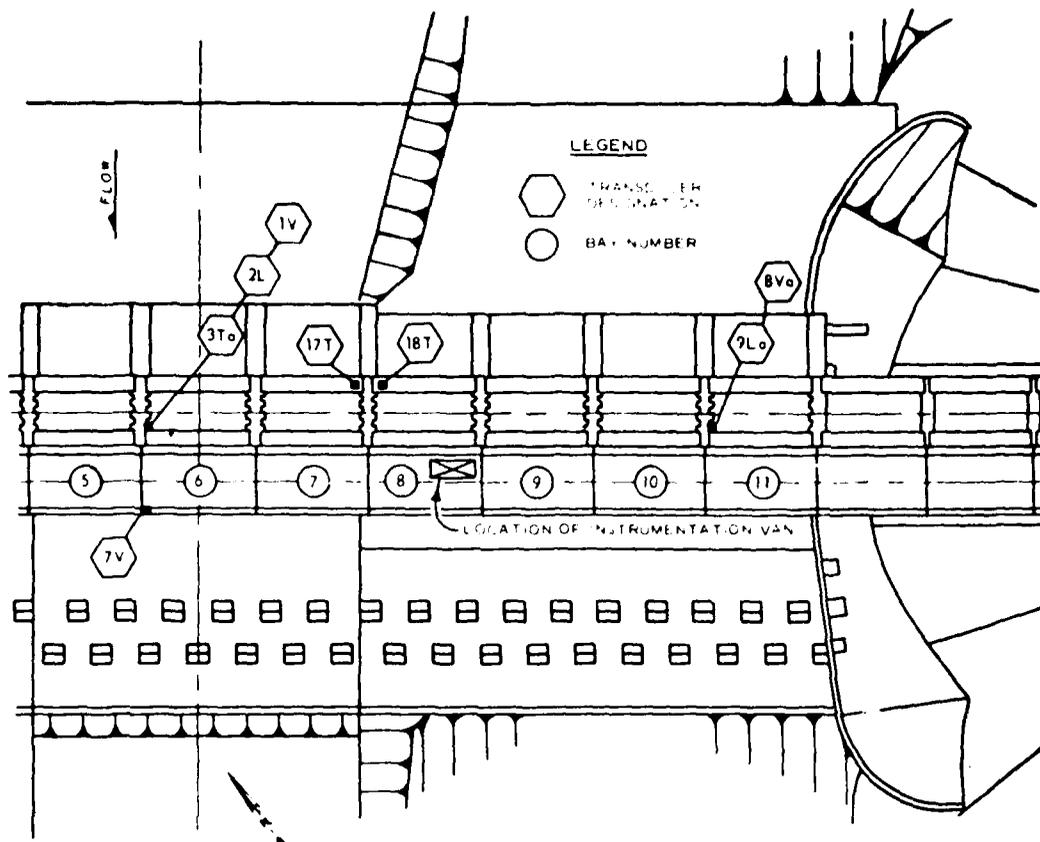
Figure 3. Transducer locations, 4-5 April 1973

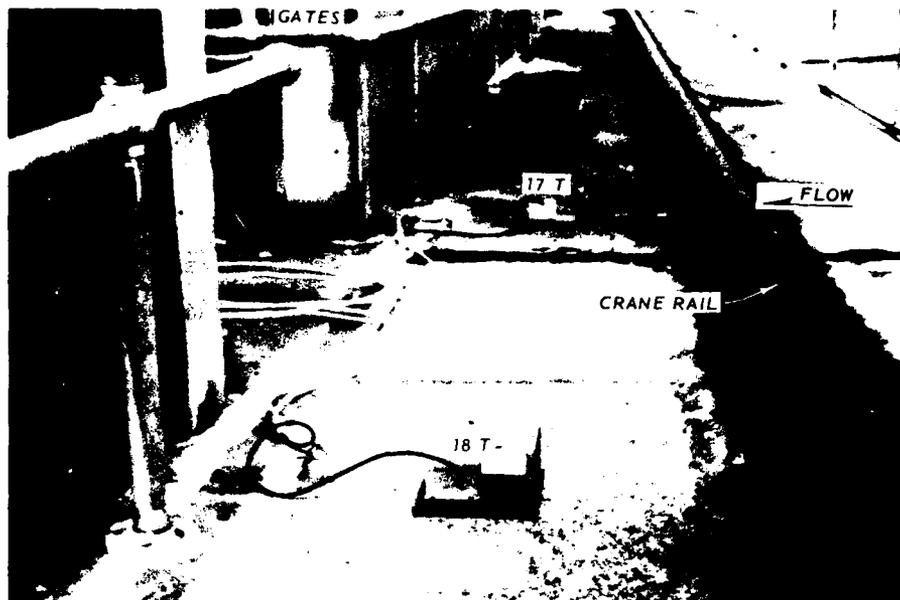
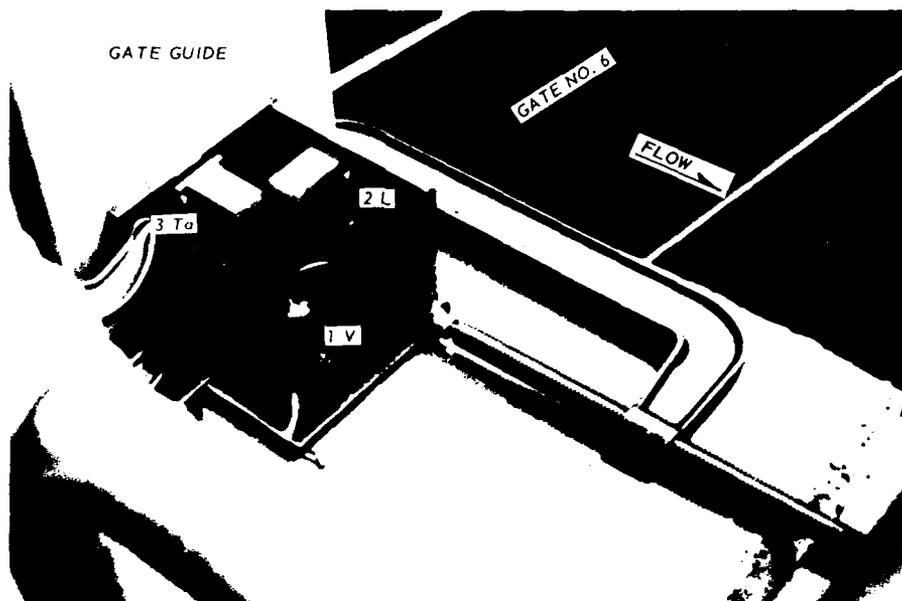
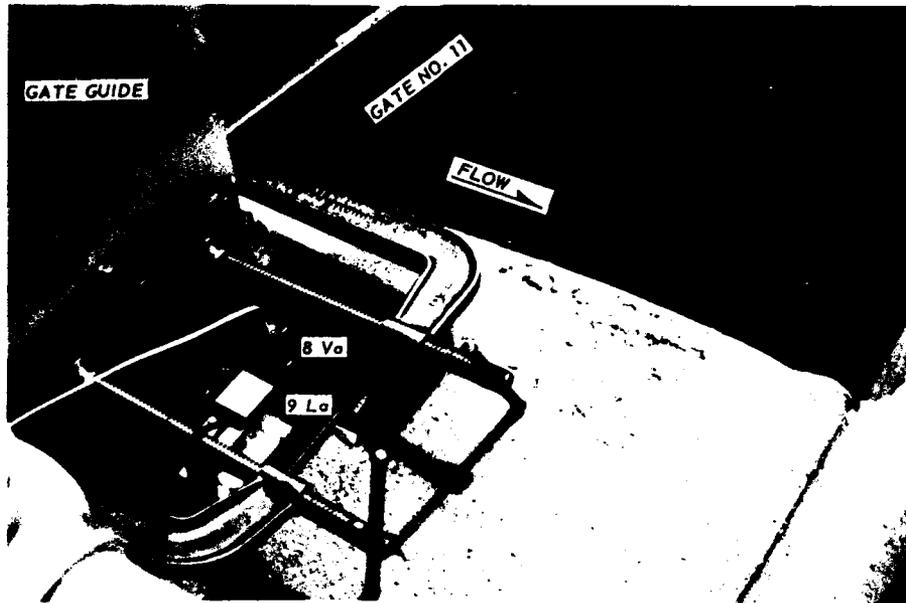
Figure 4. Transducers in place on structure,
4-5 April 1973 (sheet 1 of 2)

a. Transducers 17T and 18T on ends of bridge beams between bays 7 and 8 on the upstream side of the gates

b. Transducers 1V, 2L, and 3Ta on right, downstream gate guide of bay 6 for vibration of pier between bays 5 and 6

c. Transducers 8Va and 9La on right downstream gate guide of bay 11 for vibration of top of pier between bays 10 and 11

d. Transducer 7V on downstream handrail above the pier between bays 5 and 6 for vibration of cantilevered bridge support

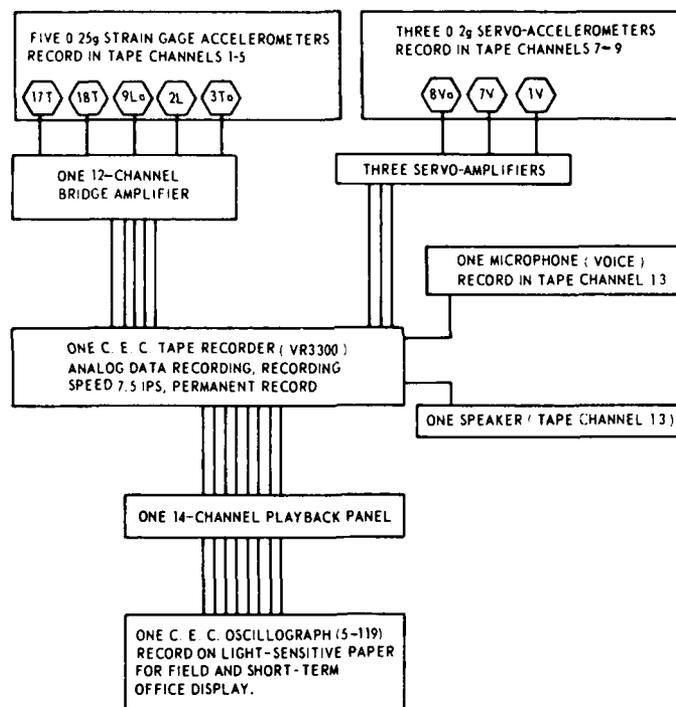
Figure 5. Schematic of data recording system,
4-5 April 1973

11. A schematic showing the main components of the data recording system is shown in Figure 5. The primary recording apparatus was the

analog (FM) magnetic-tape recorder; an oscillograph was used for short-term field and office display. Location of the instrumentation van and the 110-v power supply is shown in Figure 6a; recording equipment and interior of the van are shown in Figure 6b.

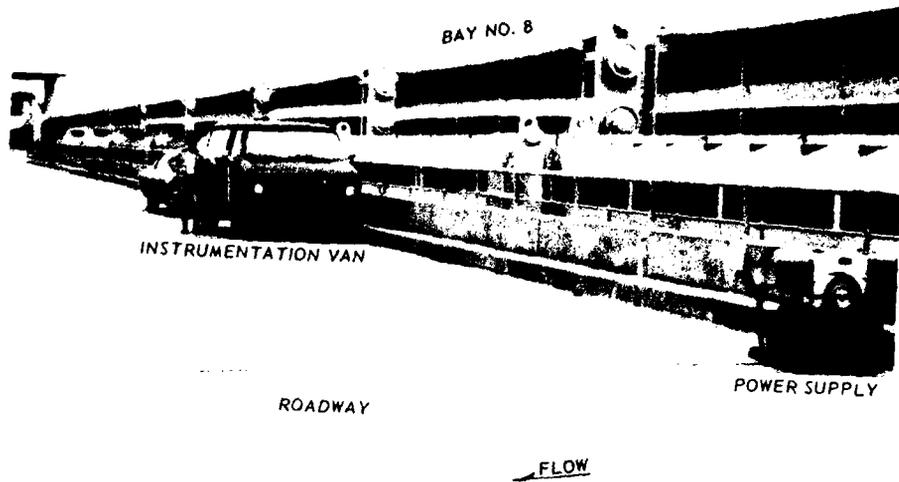
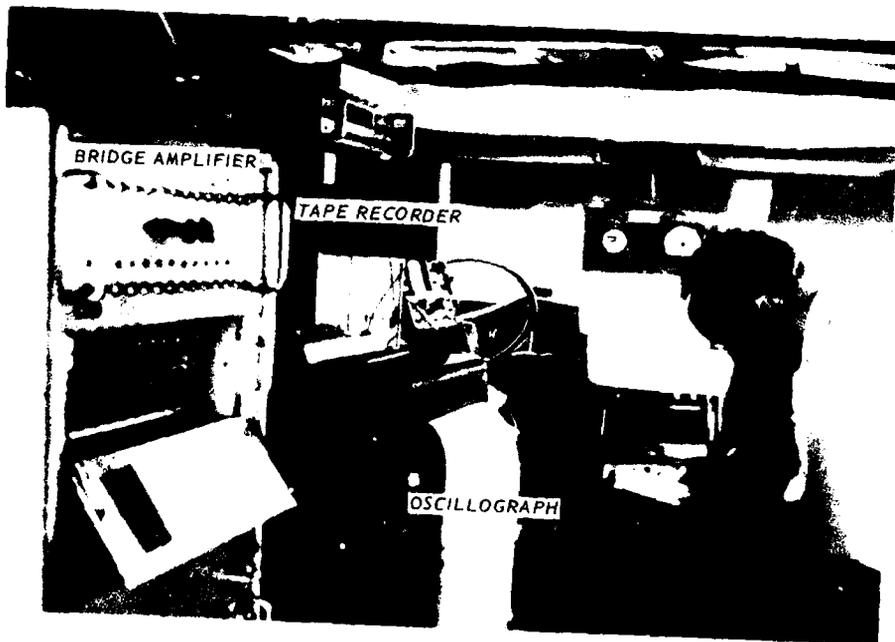
Figure 6. Recording equipment, 4-5 April 1973

a. Van location on the bridge (looking northward)

b. Interior of the van

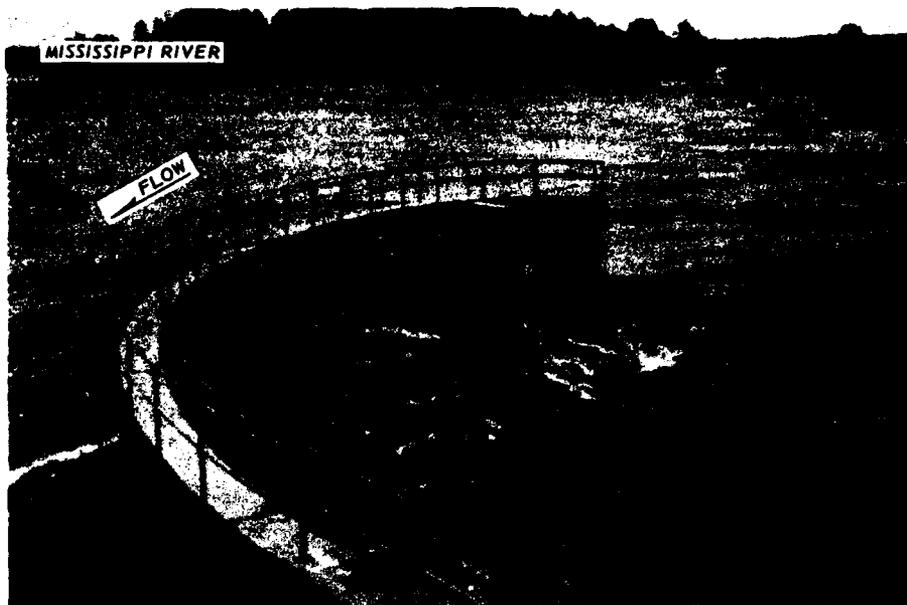
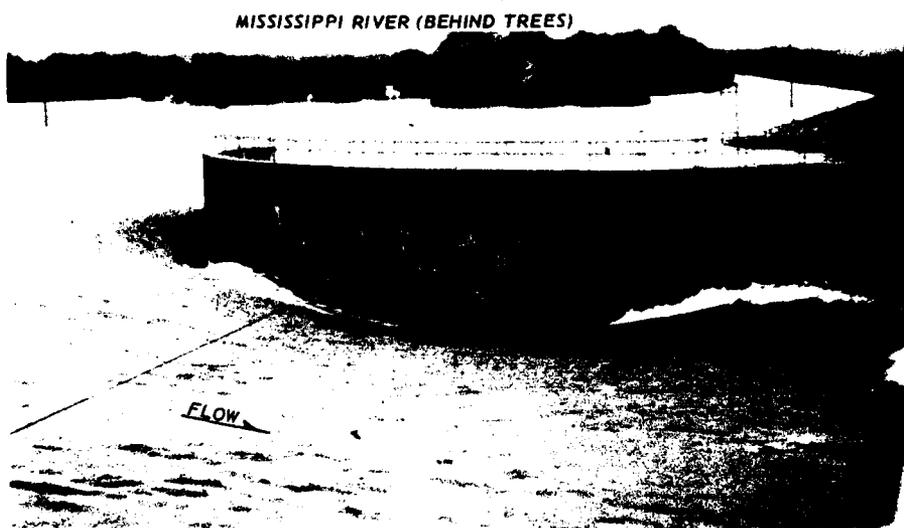
Figure 7. Flow conditions, 4-5 April 1973 (sheet 1 of 2)

a. South upstream wing wall (note the large vortices in the lee of the wall)

b. South upstream wing wall (note large standing wave along the wall)

15. Figures 7a and 7b indicate that undesirable flow conditions occurred along the south upstream wing wall; 7c shows that smooth flow occurred along the north upstream wall; and 7d shows the turbulent surface conditions that existed along the south downstream (stilling basin) guide wall. The extent to which the surface wave and eddy along the south upstream wall contributed to the subsequent failure of the wall cannot be determined from the subject test data. In fact, inspection of the data in the field indicated extremely small structural vibration, and none was felt when standing on the wall.

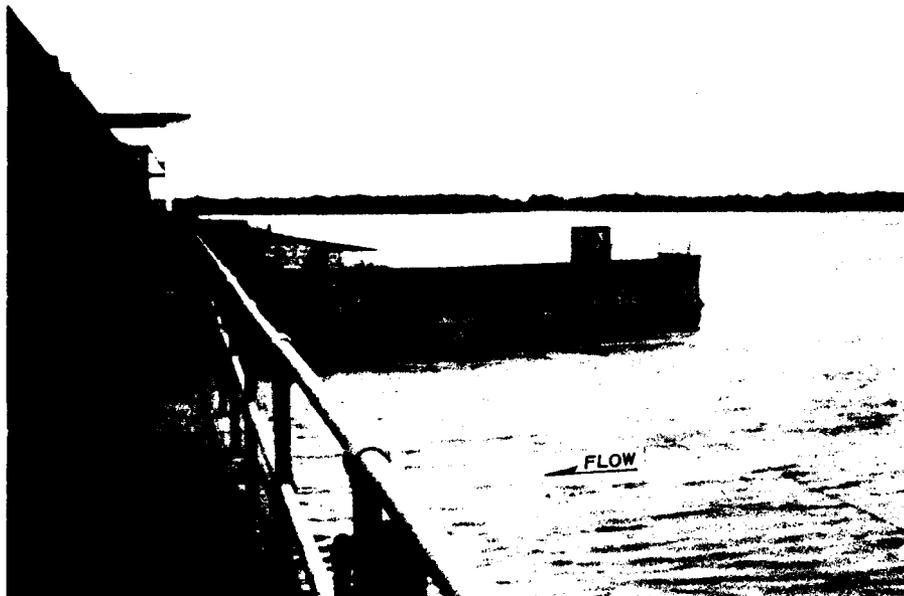
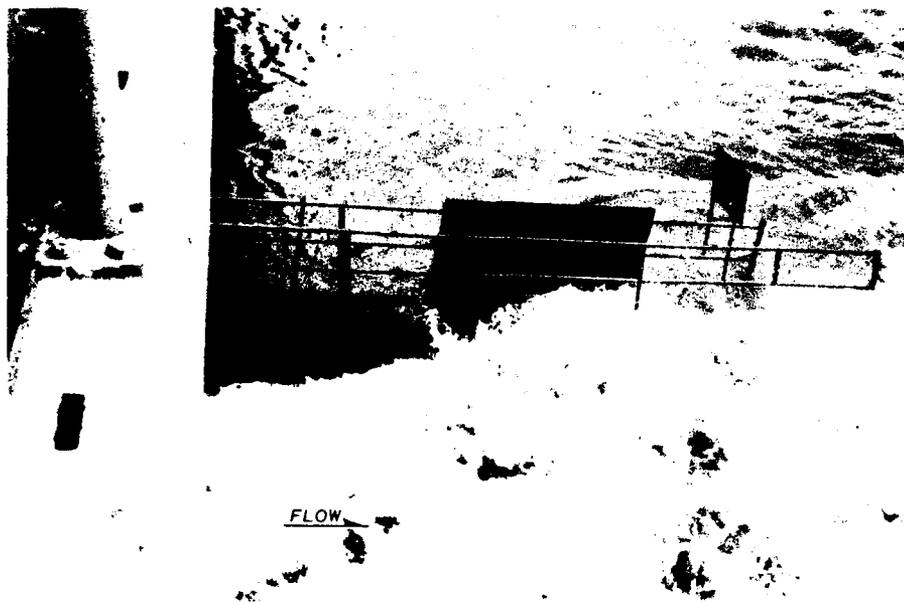
Figure 7. (sheet 2 of 2)

c. North upstream wing wall

d. South downstream guide wall

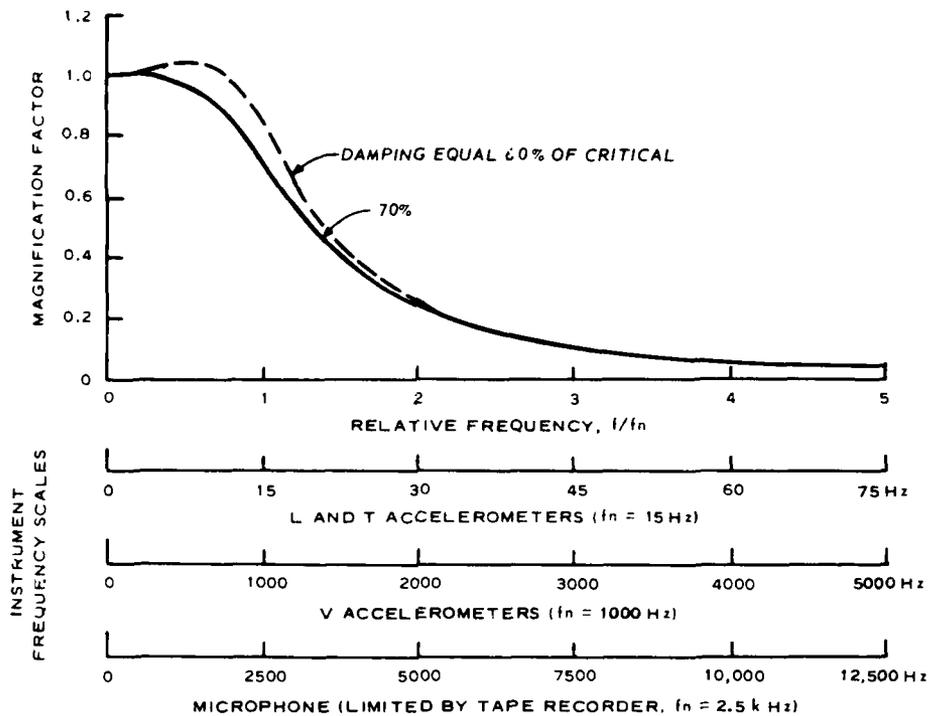
Figure 8. Frequency response, 4-5 April 1973

instruments; consequently, the L and T data are low frequencies ($f_n = 15$ Hz); V data are intermediate frequencies ($f_n = 1000$ Hz); and the audio records are high frequencies ($f_n = 2500$ Hz).

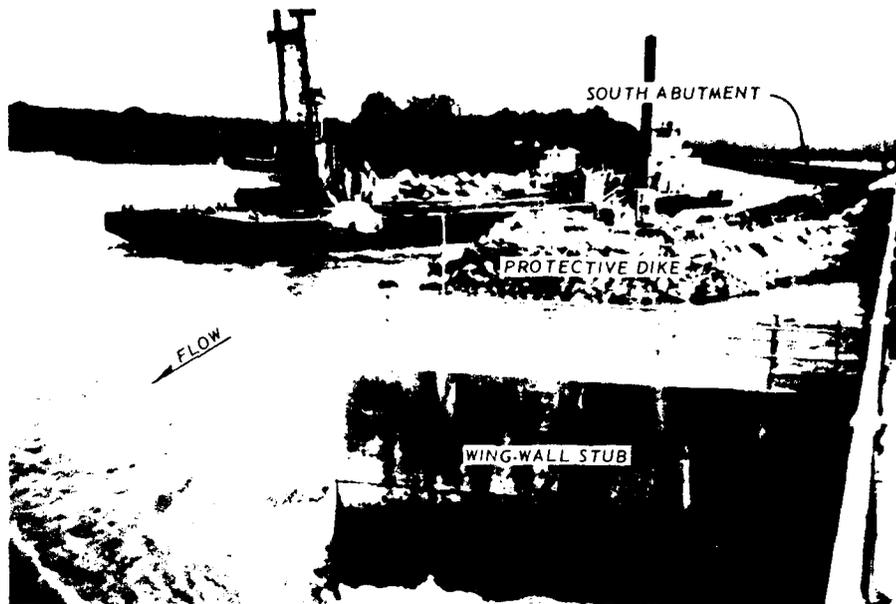
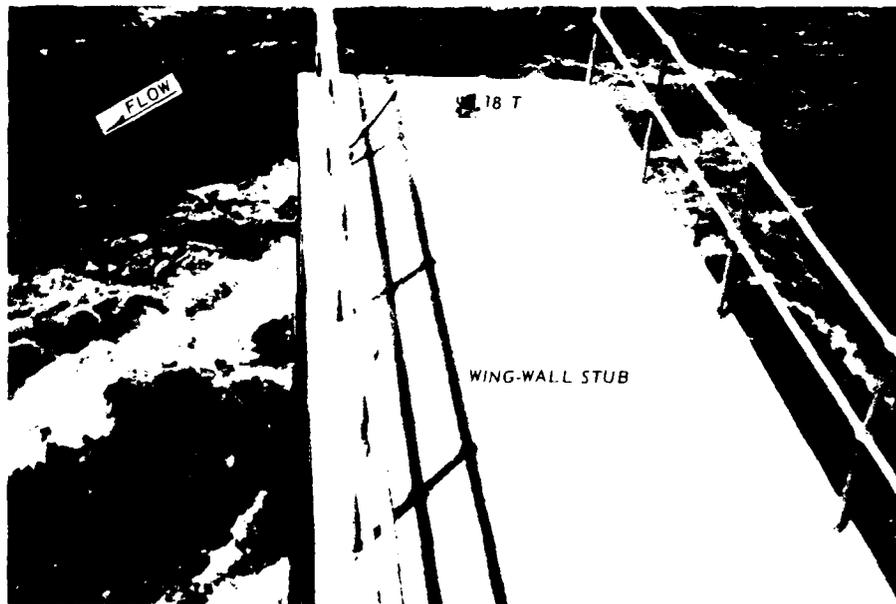
Figure 9. Wing-wall stub, 19 April 1973

a. Construction in progress on protective dike

b. Transducer 18T; the mount is epoxied to the top of the upstream end of the wing-wall stub

- b. Extension of the protective dike above the wing-wall stub--this structure, which affects the flow pattern along the south abutment, is shown under construction in Figure 9a. The progression of the dike is illustrated in Figure 13; the outline shown for 4 May existed with only minor changes for the duration of the monitoring program.

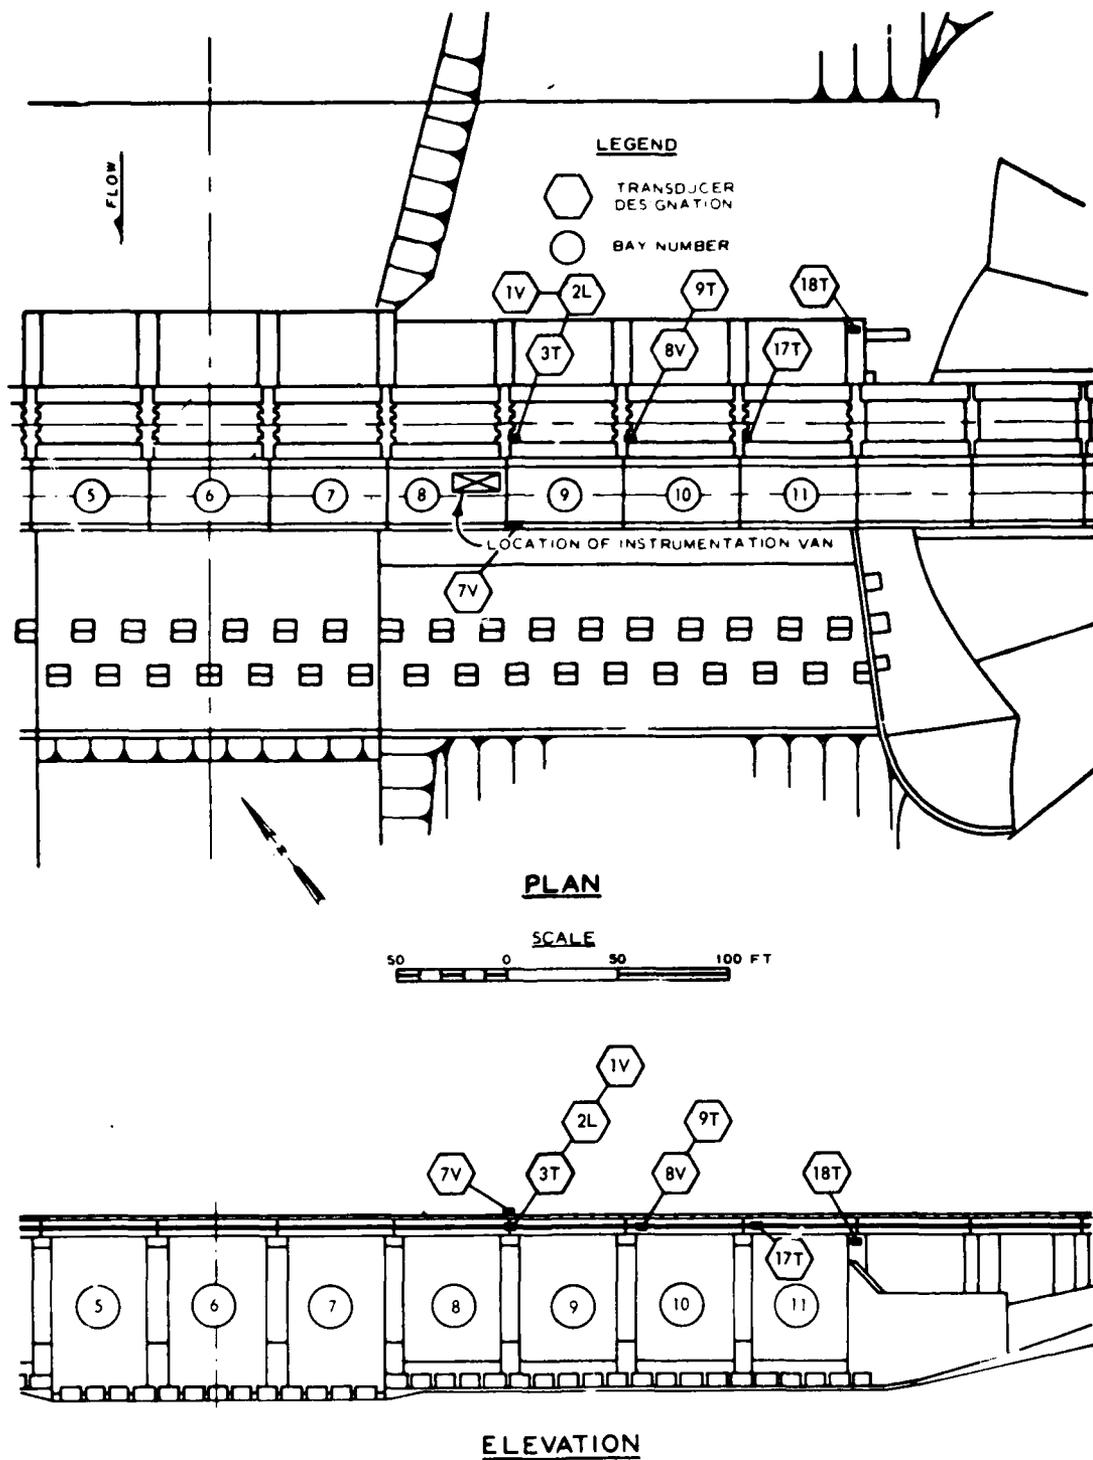
Figure 10. Transducer locations, 16 April-1 June 1973

the field. These occasions, not listed herein, are noted on the tape voice channel. The three transducers in brackets (9La, 3Ta, and 8Va) were moved to new locations for the high-flow vibration tests and were renamed 9T, 3T, and 8V; note that five new locations are denoted by symbols used in the 4-5 April tests and should not be identified as being at the same location.

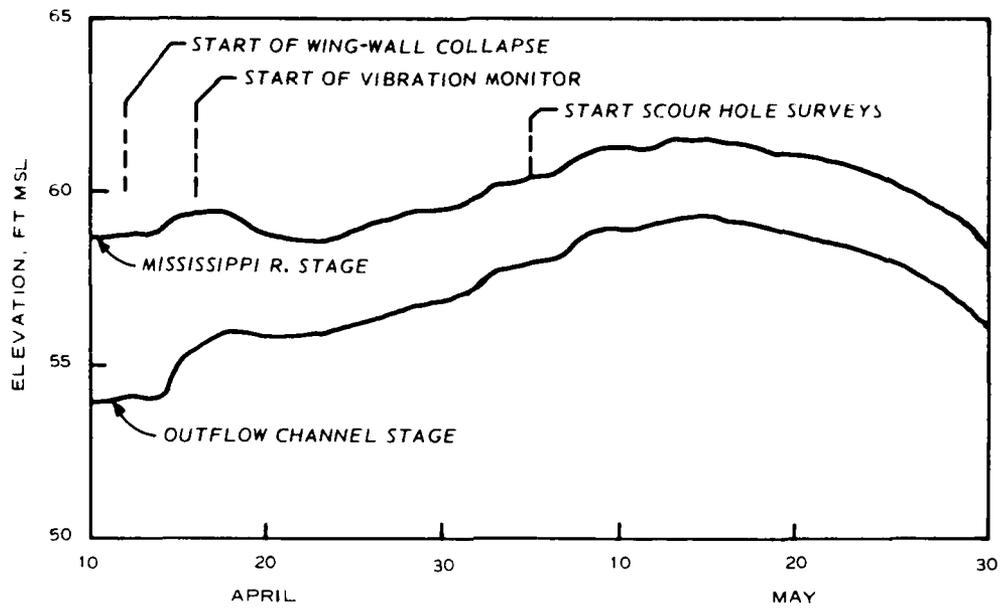
Figure 11. Hydraulic conditions during vibration monitoring (1973)

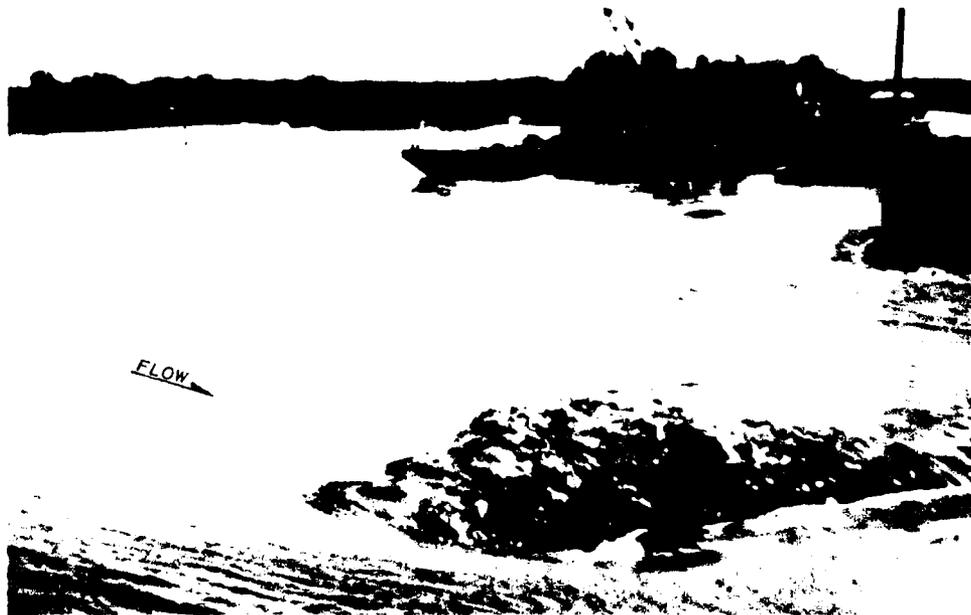
Figure 12. "Boil" in front of bay 10, 19 April 1973

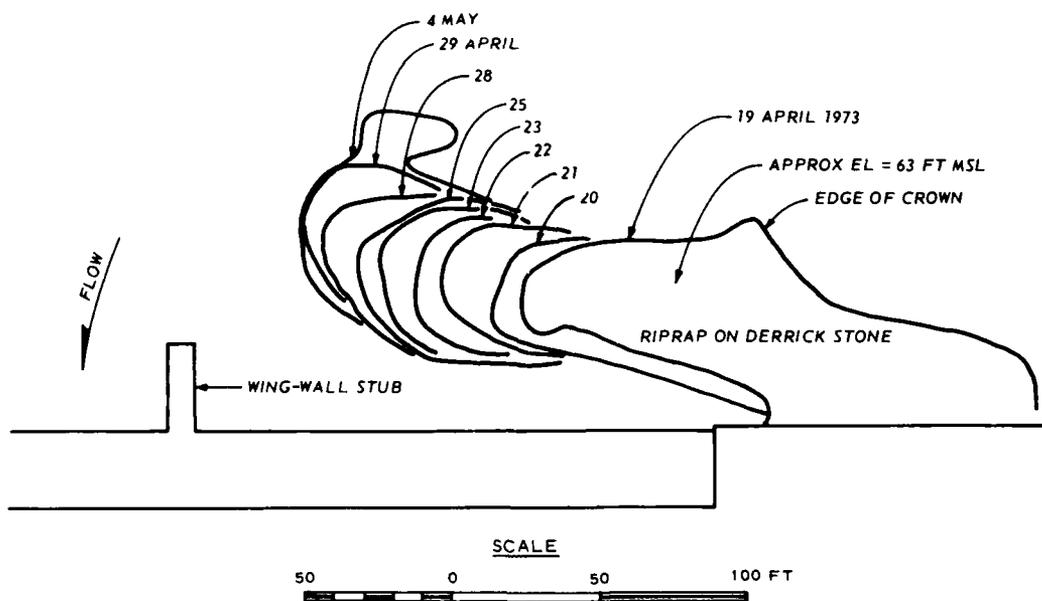
Figure 13. Progression of protective dike

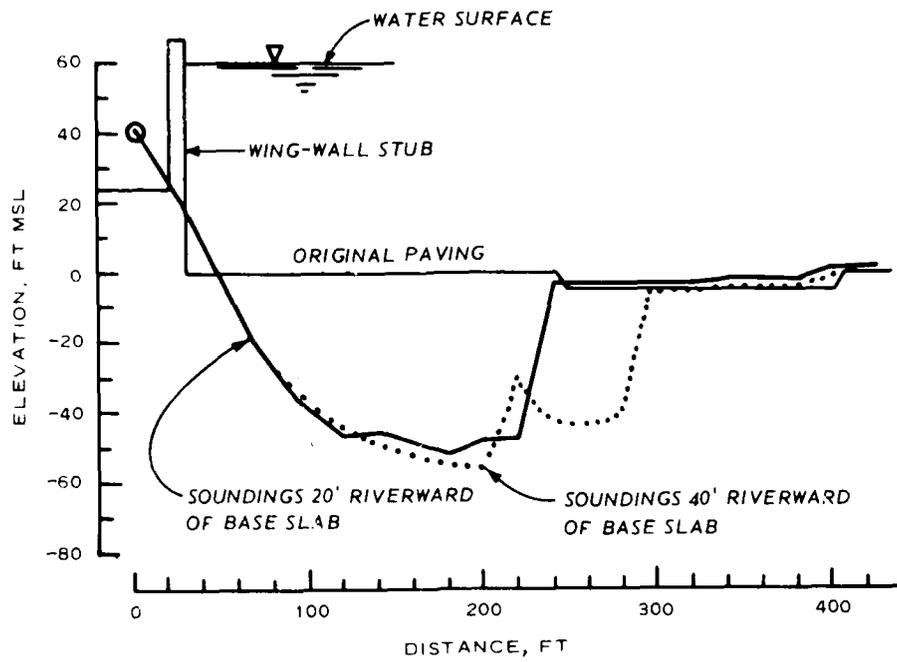
Figure 14. Scour hole geometry, 5 May 1973

* Subsequent field observations showed that the scour hole actually extended a significant distance under the base slab.

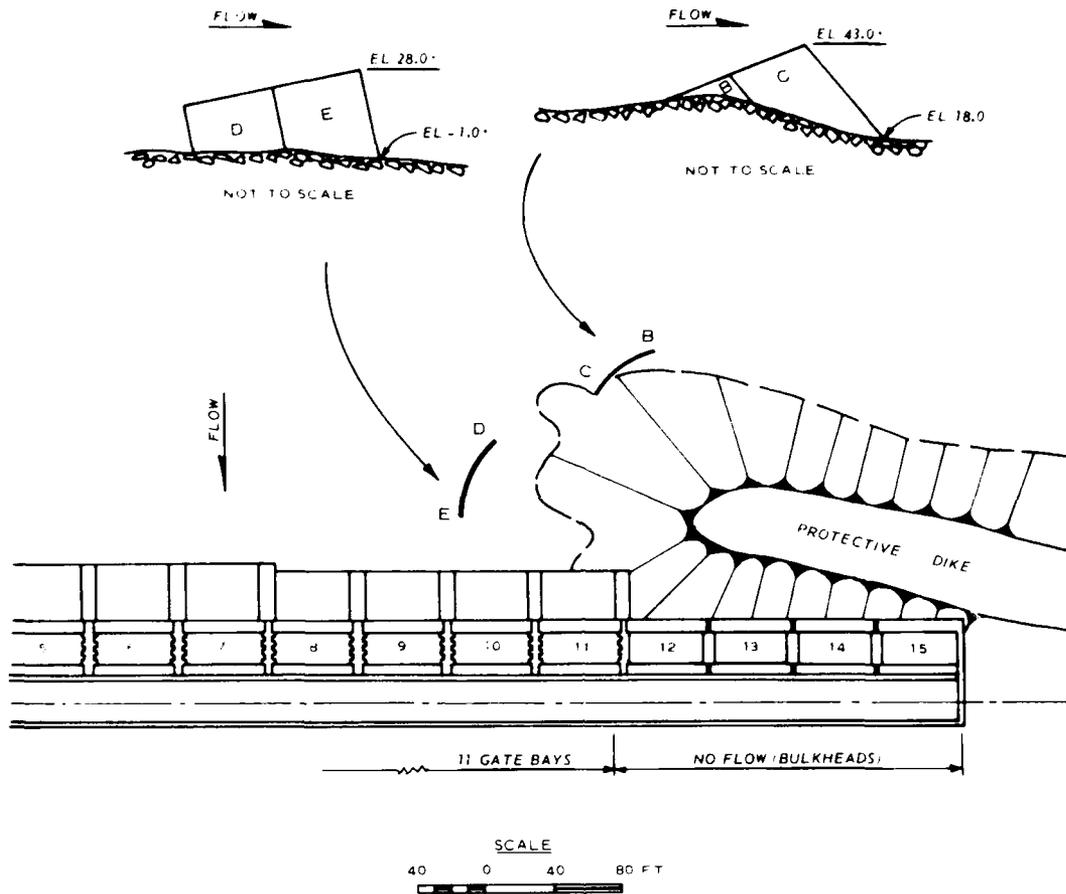
Figure 16. Location of the wing-wall segments

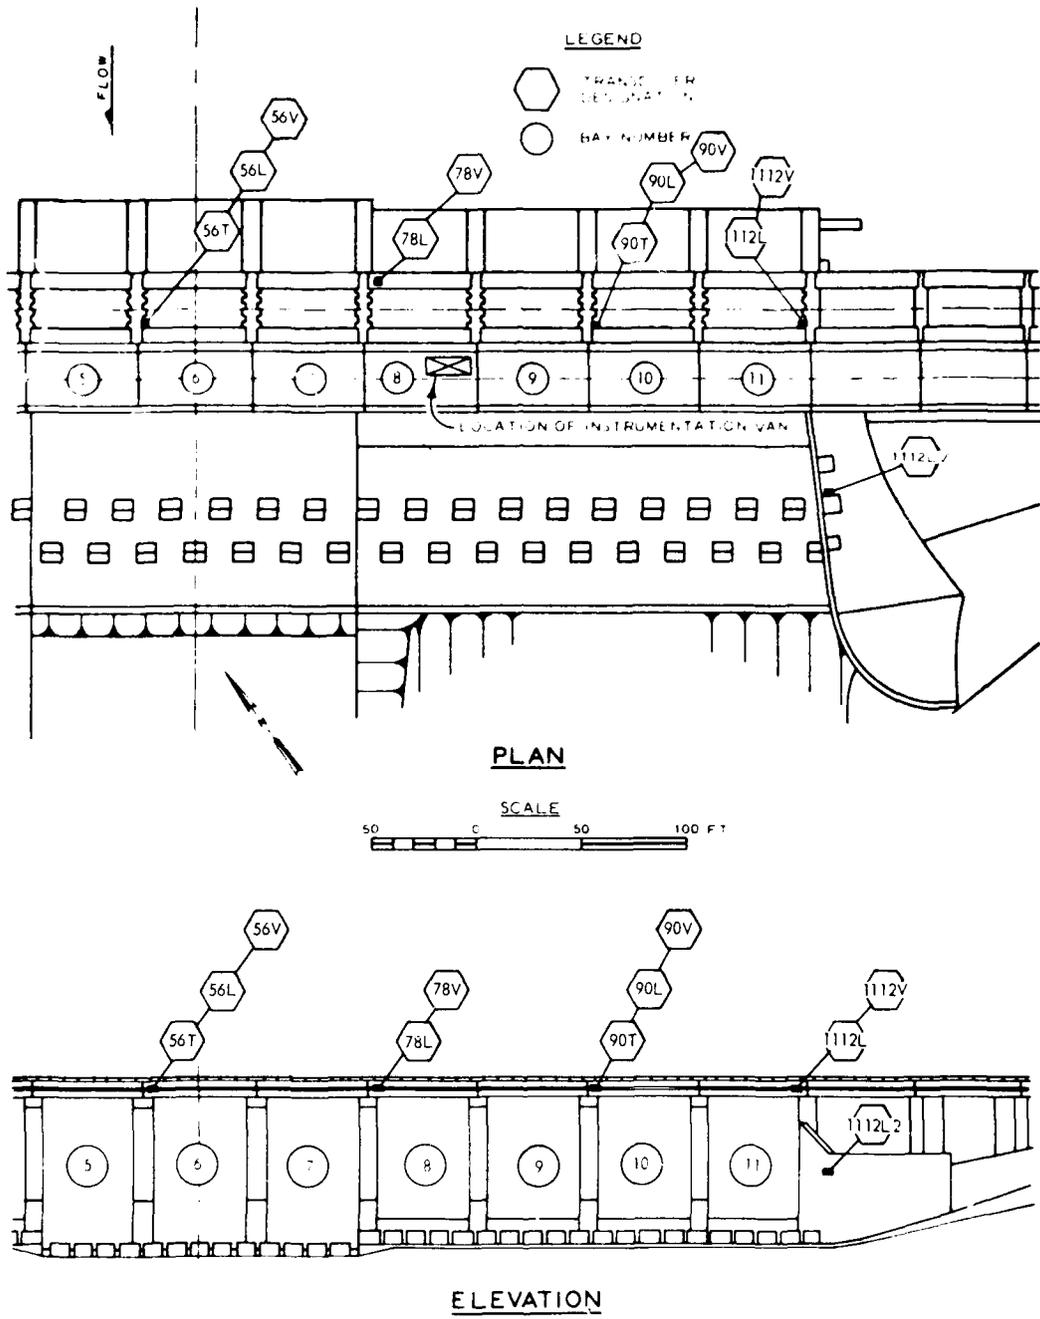
Figure 18. Accelerometer locations, test B10, 22 October 1973

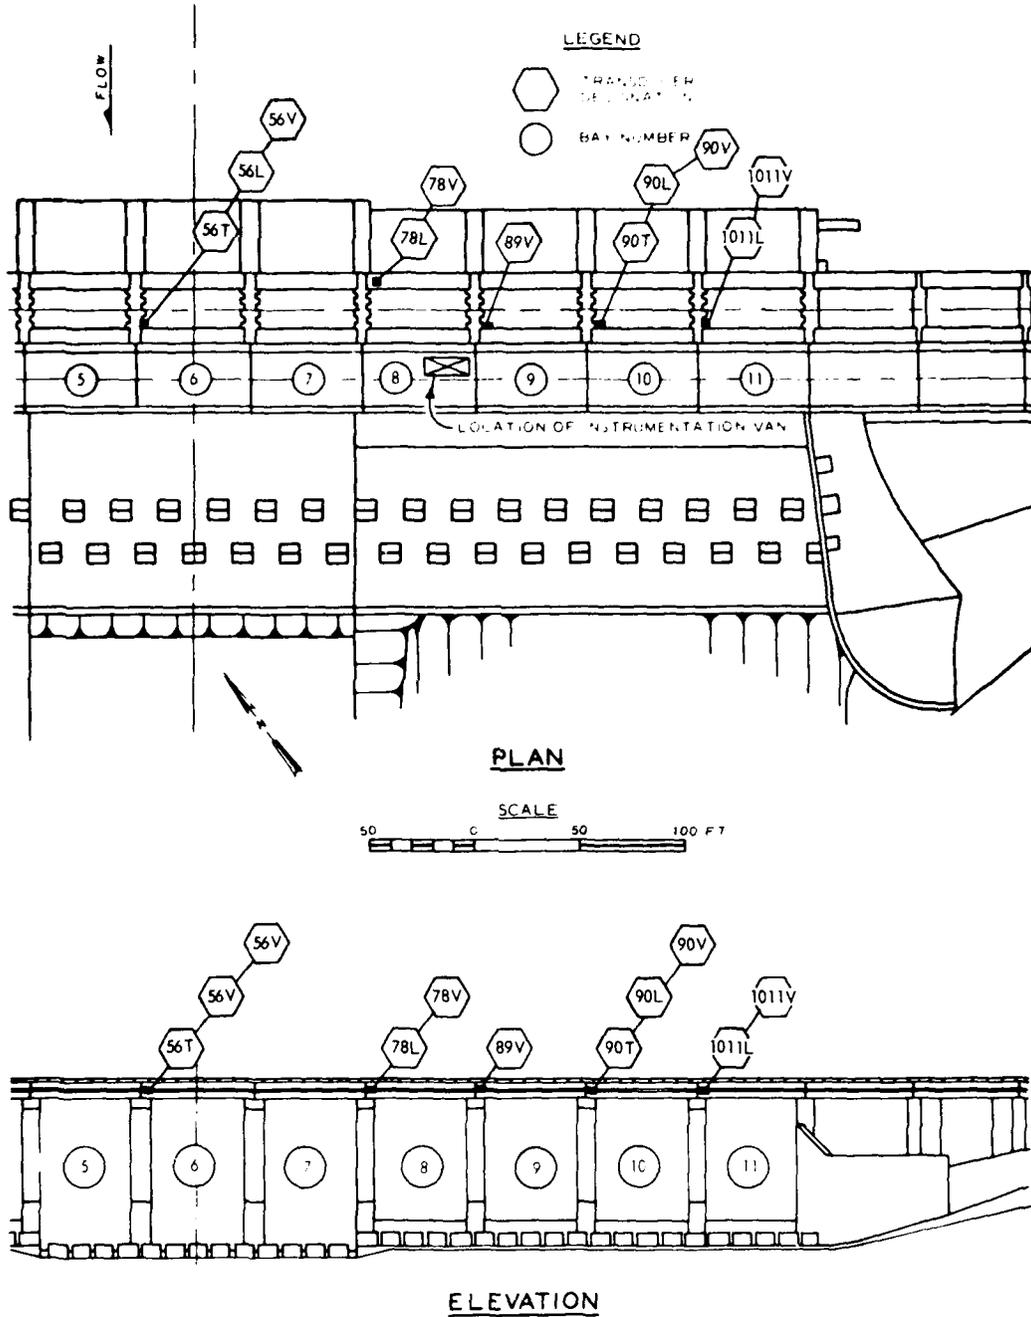
Figure 19. Accelerometer locations, test B60, 12 November 1974

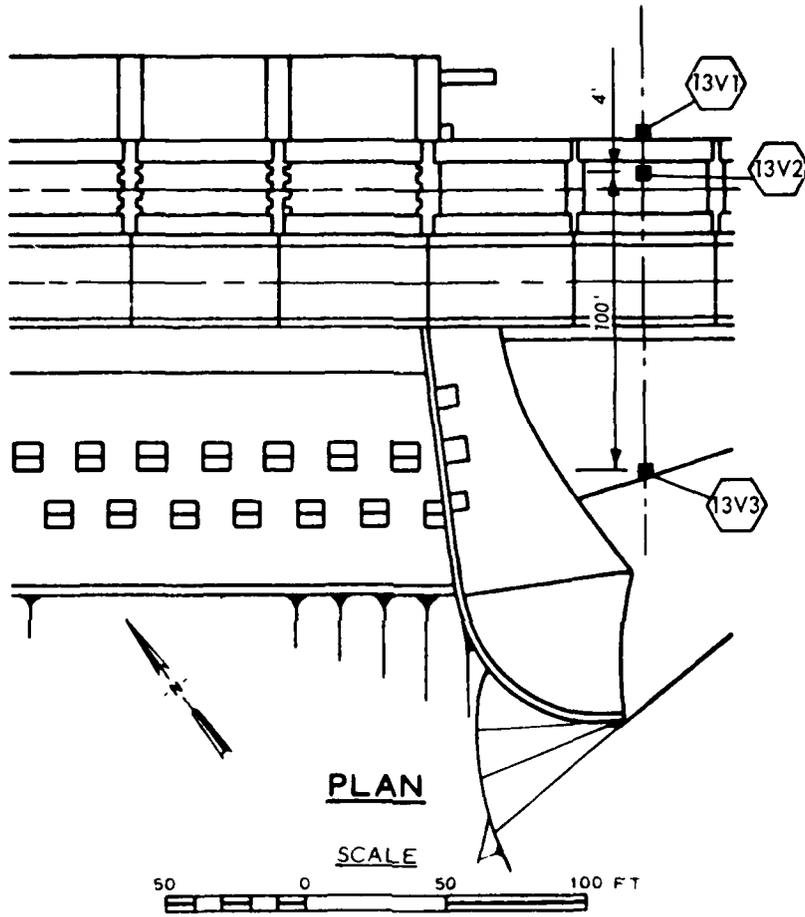
Figure 20. Location of geophones, Test B10, 22 October 1973

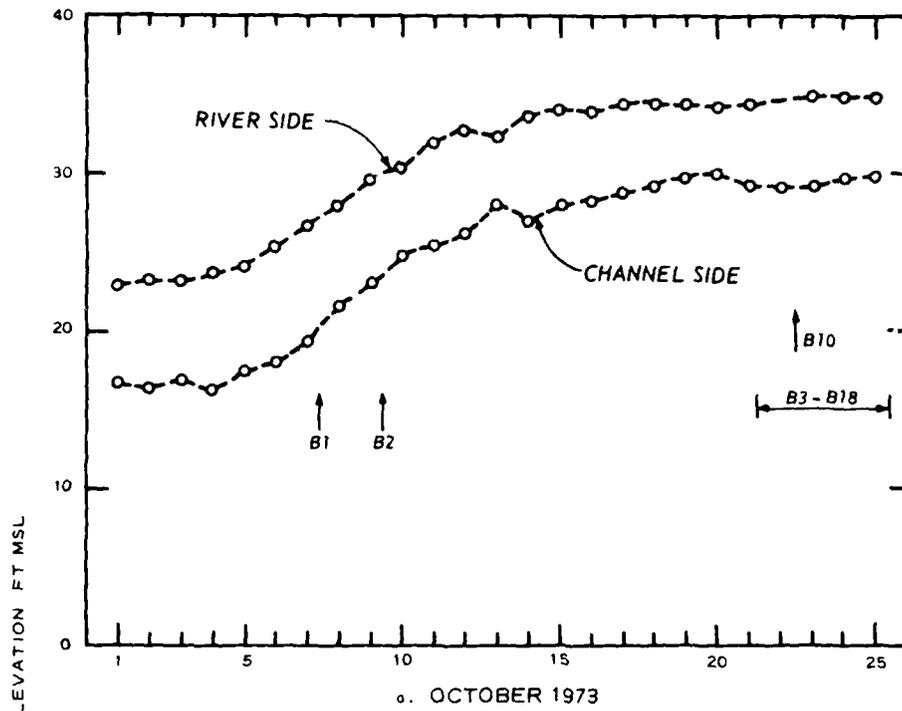
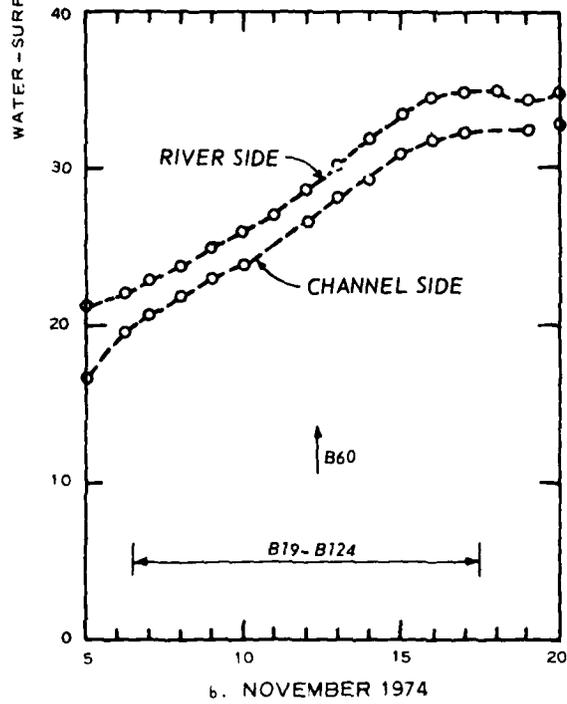
Figure 21. Stages at Old River Low-Sill Structure, October 1973 and November 1974

39. The river and outflow channel stages are presented in Figure 21a during tests B1-B18 and in Figure 21b during tests B19-B124. Other pertinent test conditions are as given previously in Tables 1 and 2. New Orleans District personnel periodically made surveys along the top of the structure; measured elevations at five points along the top of the structure are shown in Figure 22a over the period in which tests B1-B18 were made. These data indicate no significant trend of movement during the demolition of segments B and C. Prior to tests B19-B124, the foundation of the structure had been reinforced with a grouting compound and any settlement during these tests was also not of an amount measurable by standard survey technique.

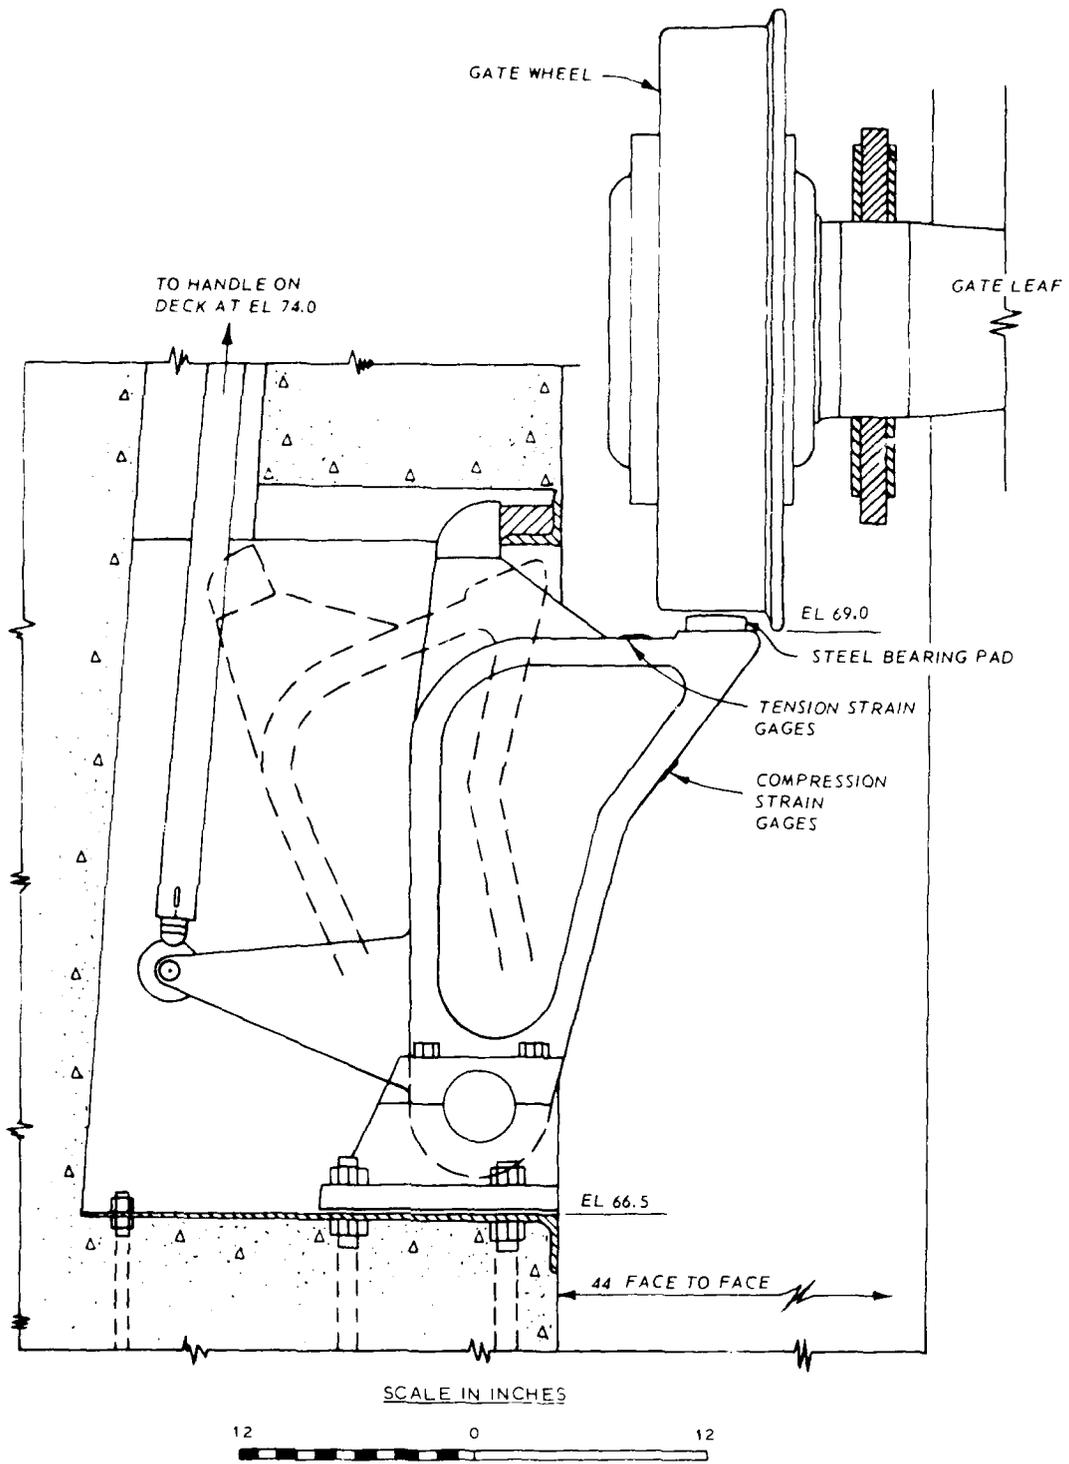
Figure 23. Gate dogging device

Name	Instrument		Purpose
	Quantity	Location	
Foil strain gage	8	(a) Crane equalizer bar (Figures 26 and 27) and (b) gate dogging device (Figure 23)	(a) Evaluate total gate loads and (b) measure strain at key locations in the gate support mechanism
Load cell	2	Crane lifting blocks (Figure 29)	Measure weight of individual gate leaves
Accelerometer arrangement (3 strain gage accelerometers)	1	Piers on north sides of bays 3, 5, 6, 7, and 8 and on Gates 5, 6, and 7 (Figure 30)	Measure vibration of gates and piers
Thermistor	2	Top gate leaf in bay 6 (Figure 31)	Measure gate leaf temperature
Direct-print oscillograph recorder	1	Instrument trailer (north end of structure)	Record acceleration data
2-Channel, electric stylus, strip chart recorder	2	Instrument trailer (north end of structure)	Record strain gage and temperature data

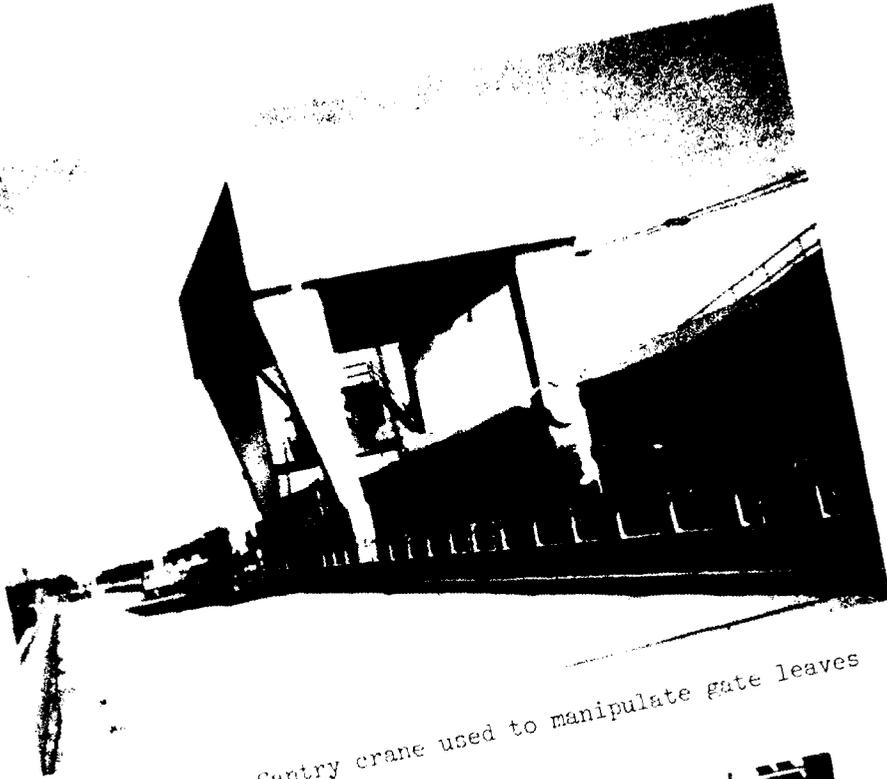
Figure 24. Gantry crane used to manipulate gate leaves

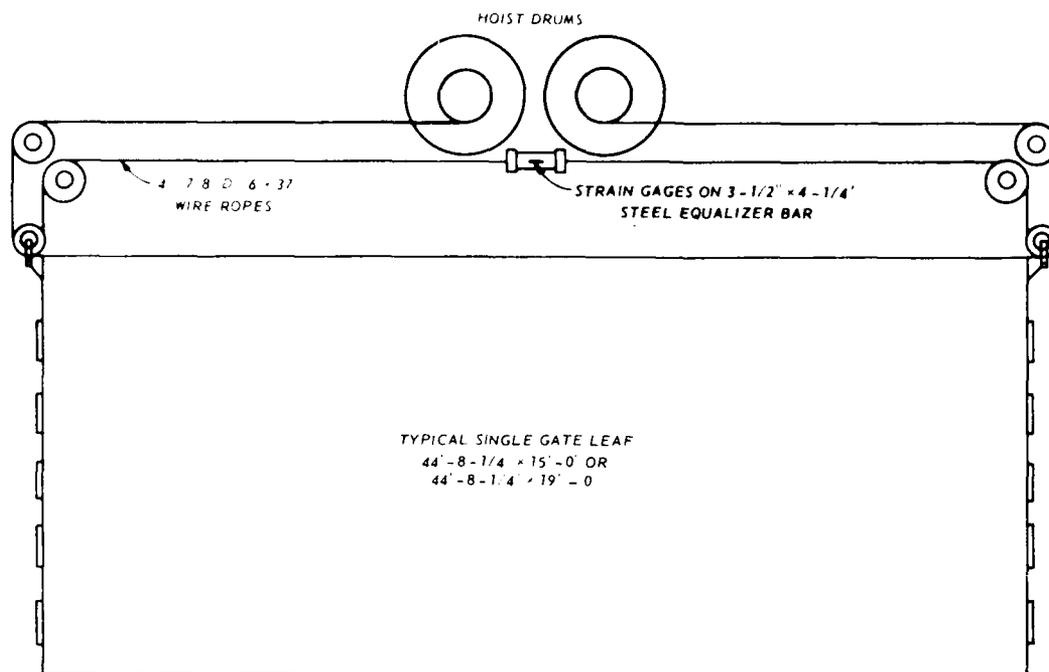
Figure 26. Gate hoist schematic

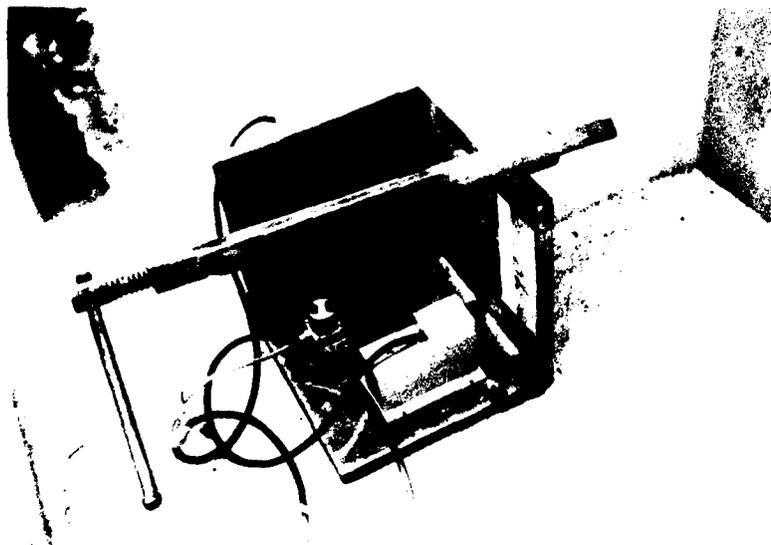
Figure 30. Portable accelerometer group
