TECHNICAL REPORT H-76-15

PROTOTYPE TESTS, OLD RIVER LOW-SILL CONTROL STRUCTURE, APRIL 1973-JUNE 1975

Frank M. Neilson, Allen R. Tool

Hydraulics Laboratory
U. S. Army Engineer Waterways Experiment Station
P. O. Box 631, Vicksburg, Miss. 39180

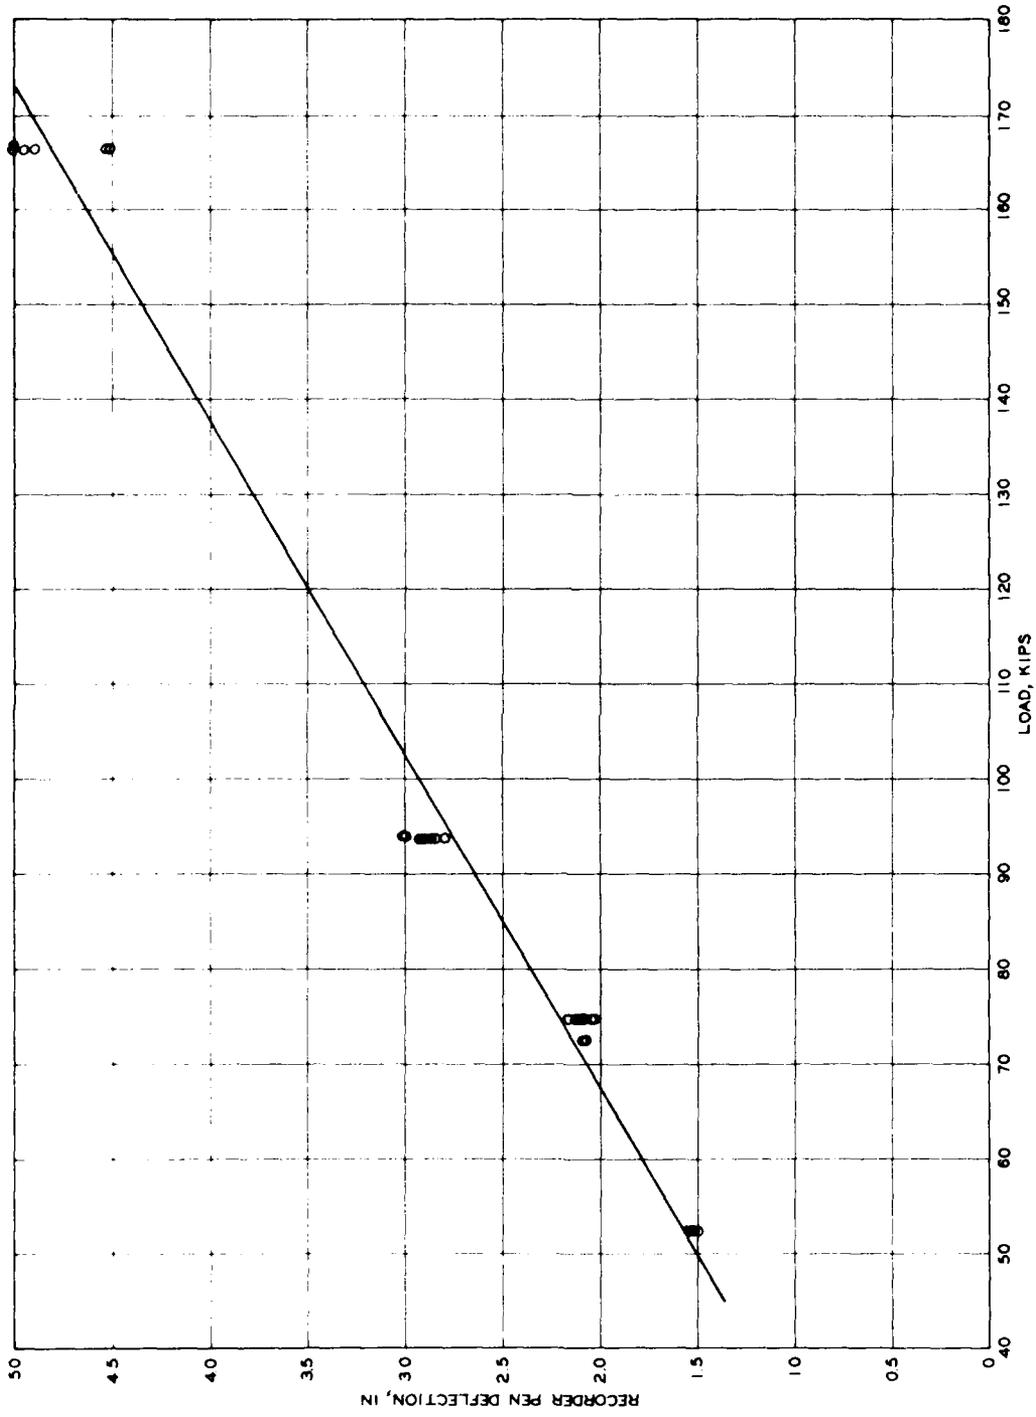
Figure 33. Crane equalizer bar calibration curve

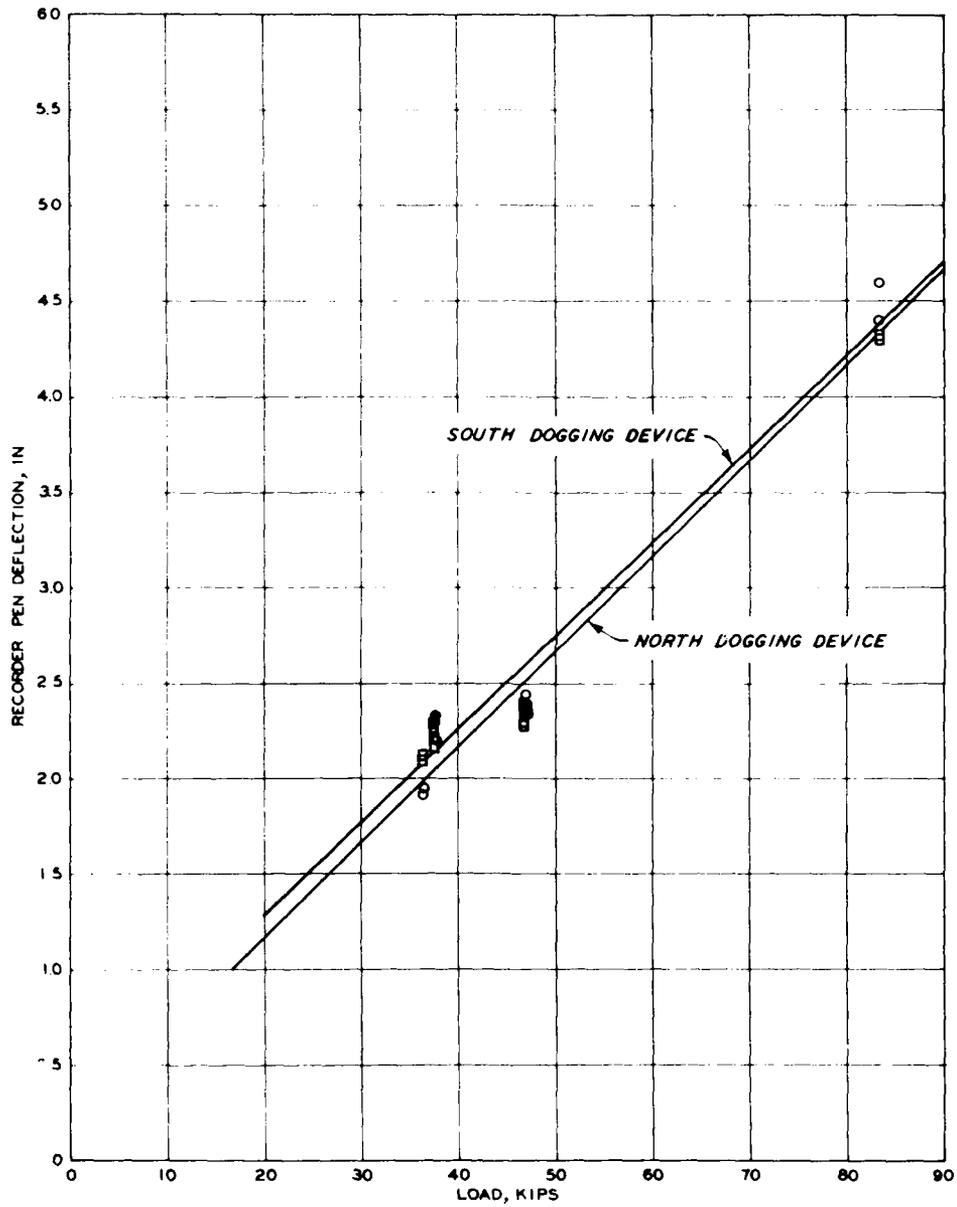
Figure 34. Dogging device calibration curves

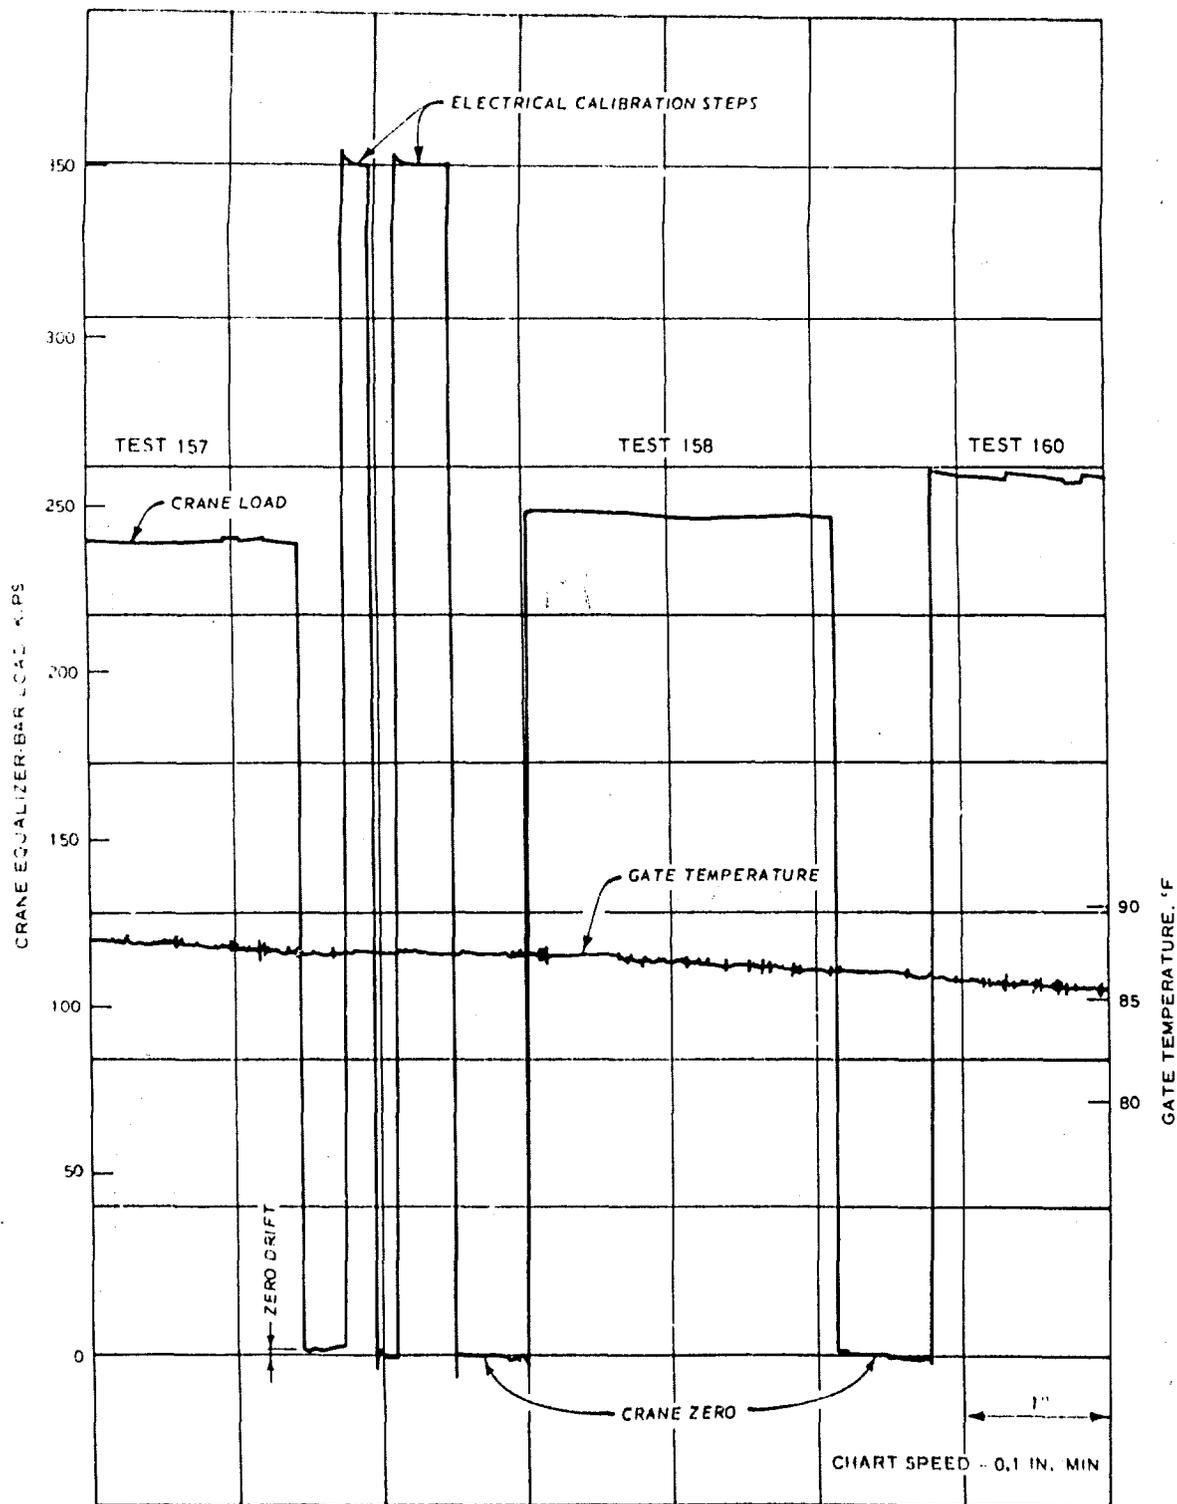
Figure 35. Typical crane equalizer-bar load and gate temperature record

58. Prior to each test, the crane was positioned so that the lifting blocks and cable were suspended in air with no load attached. This condition established the "crane zero" record on the strip chart as shown in Figure 35. When the test was completed, the apparatus was returned to the crane zero position to determine if a "zero drift" had occurred. Such drifts were small, as shown in Figure 35, and were taken into consideration during data reduction.

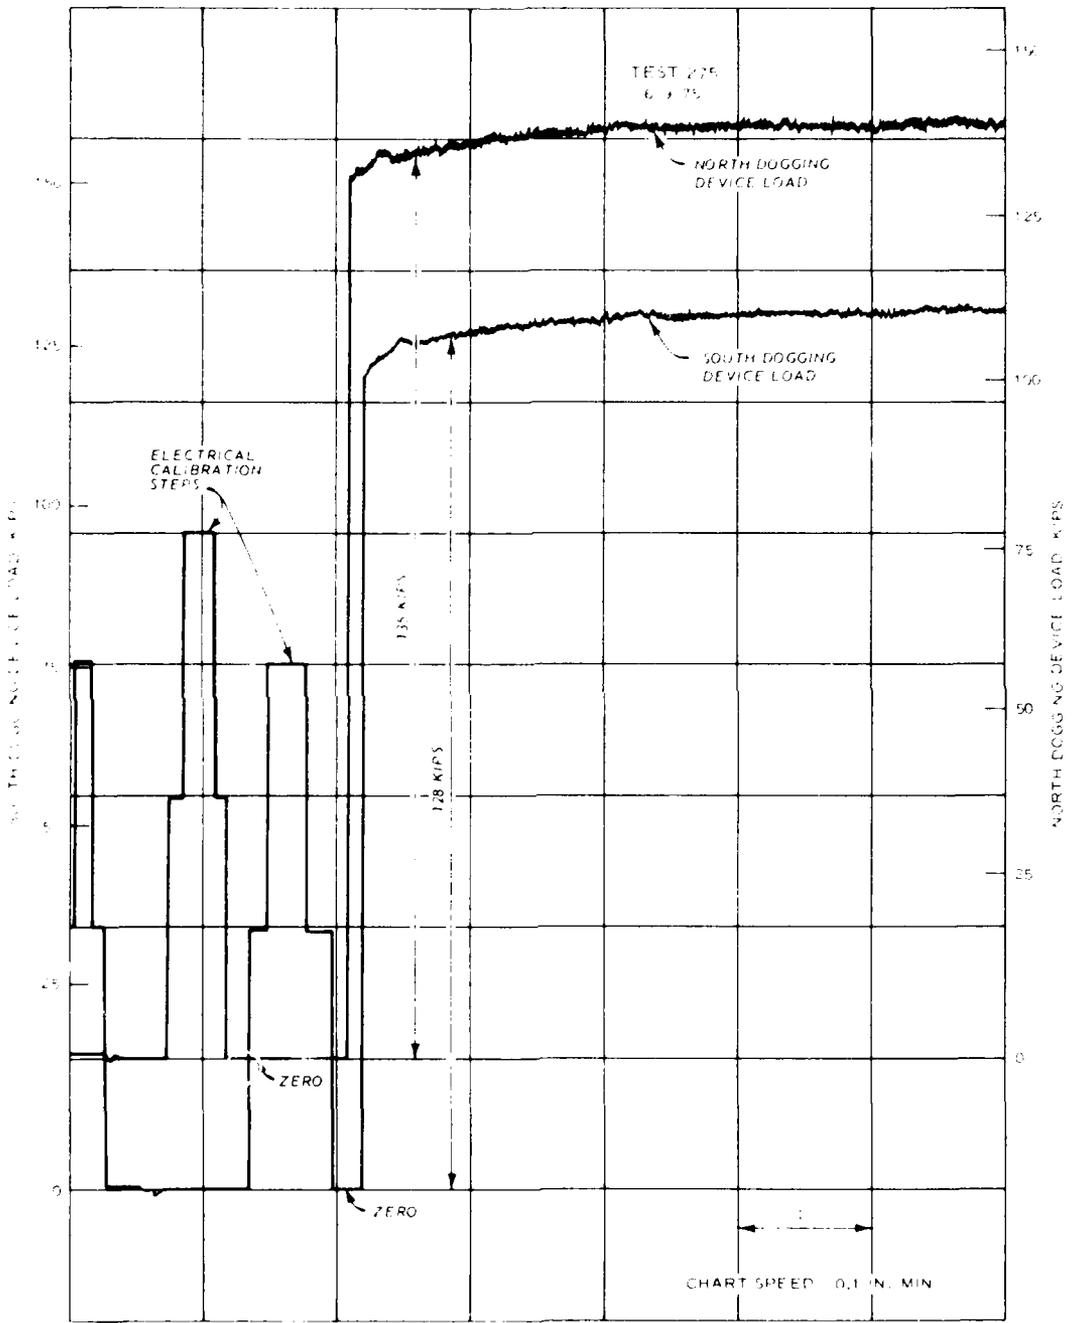
Figure 36. Typical dogging device test record

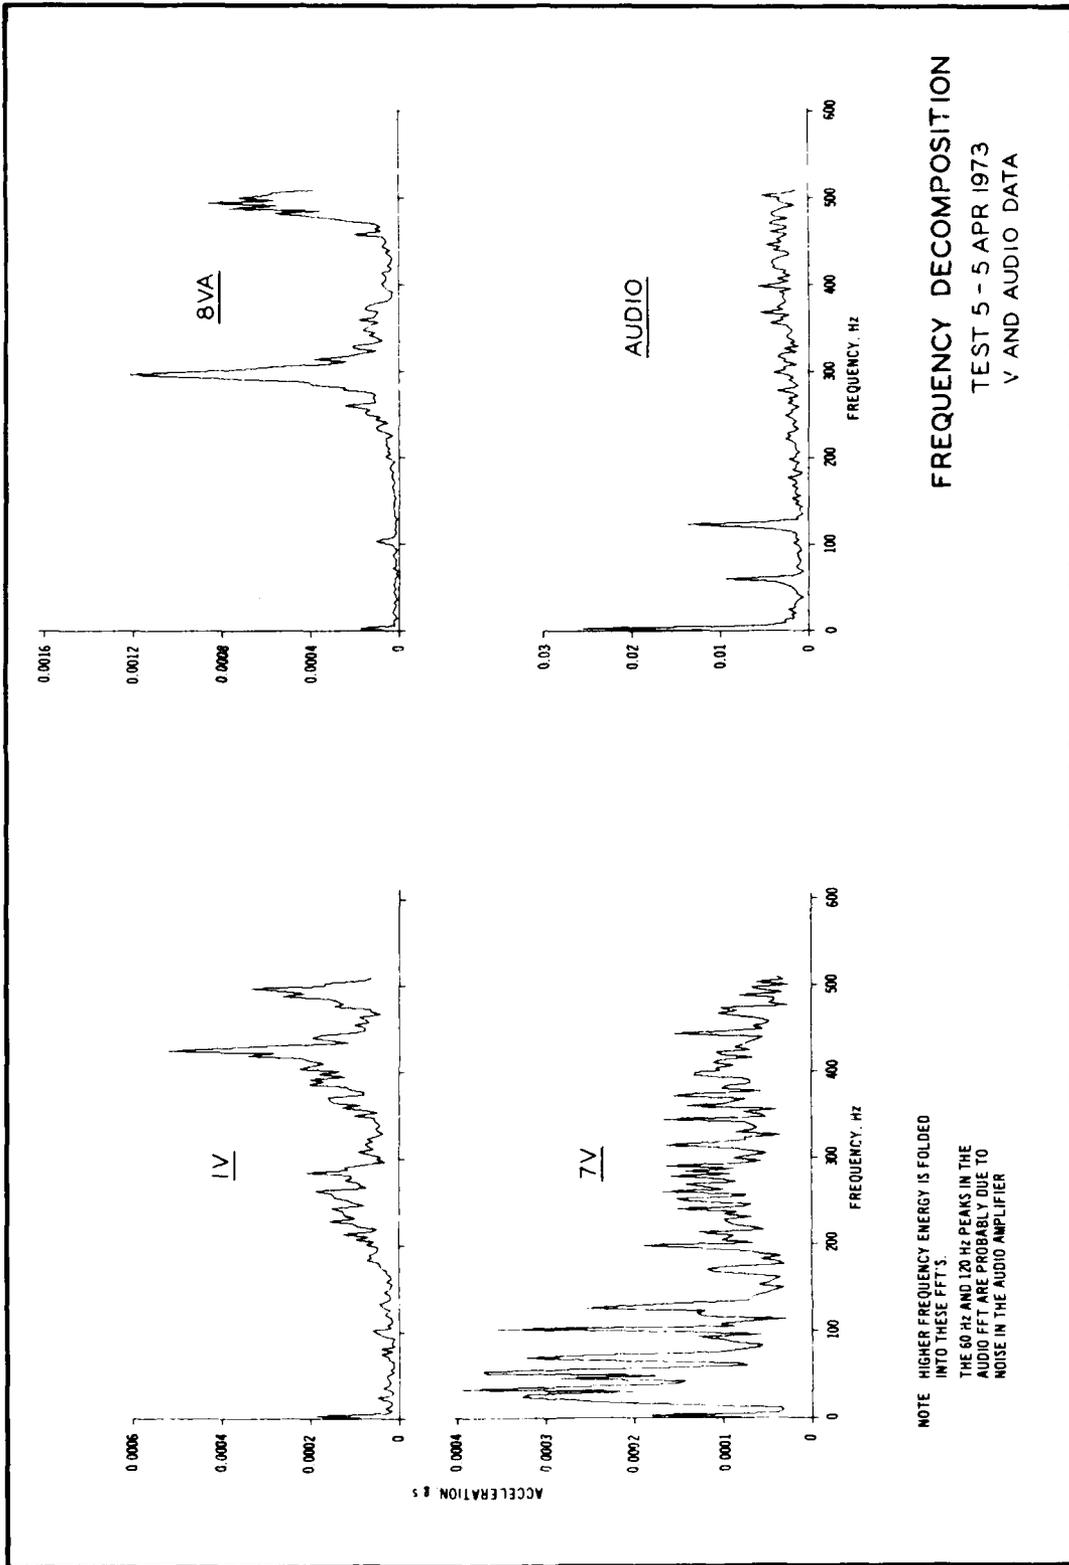
FREQUENCY DECOMPOSITION
 TEST 5 - 5 APR 1973
 V AND AUDIO DATA

NOTE HIGHER FREQUENCY ENERGY IS FOLDED
 INTO THESE FFT'S.
 THE 60 Hz AND 120 Hz PEAKS IN THE
 AUDIO FFT ARE PROBABLY DUE TO
 NOISE IN THE AUDIO AMPLIFIER

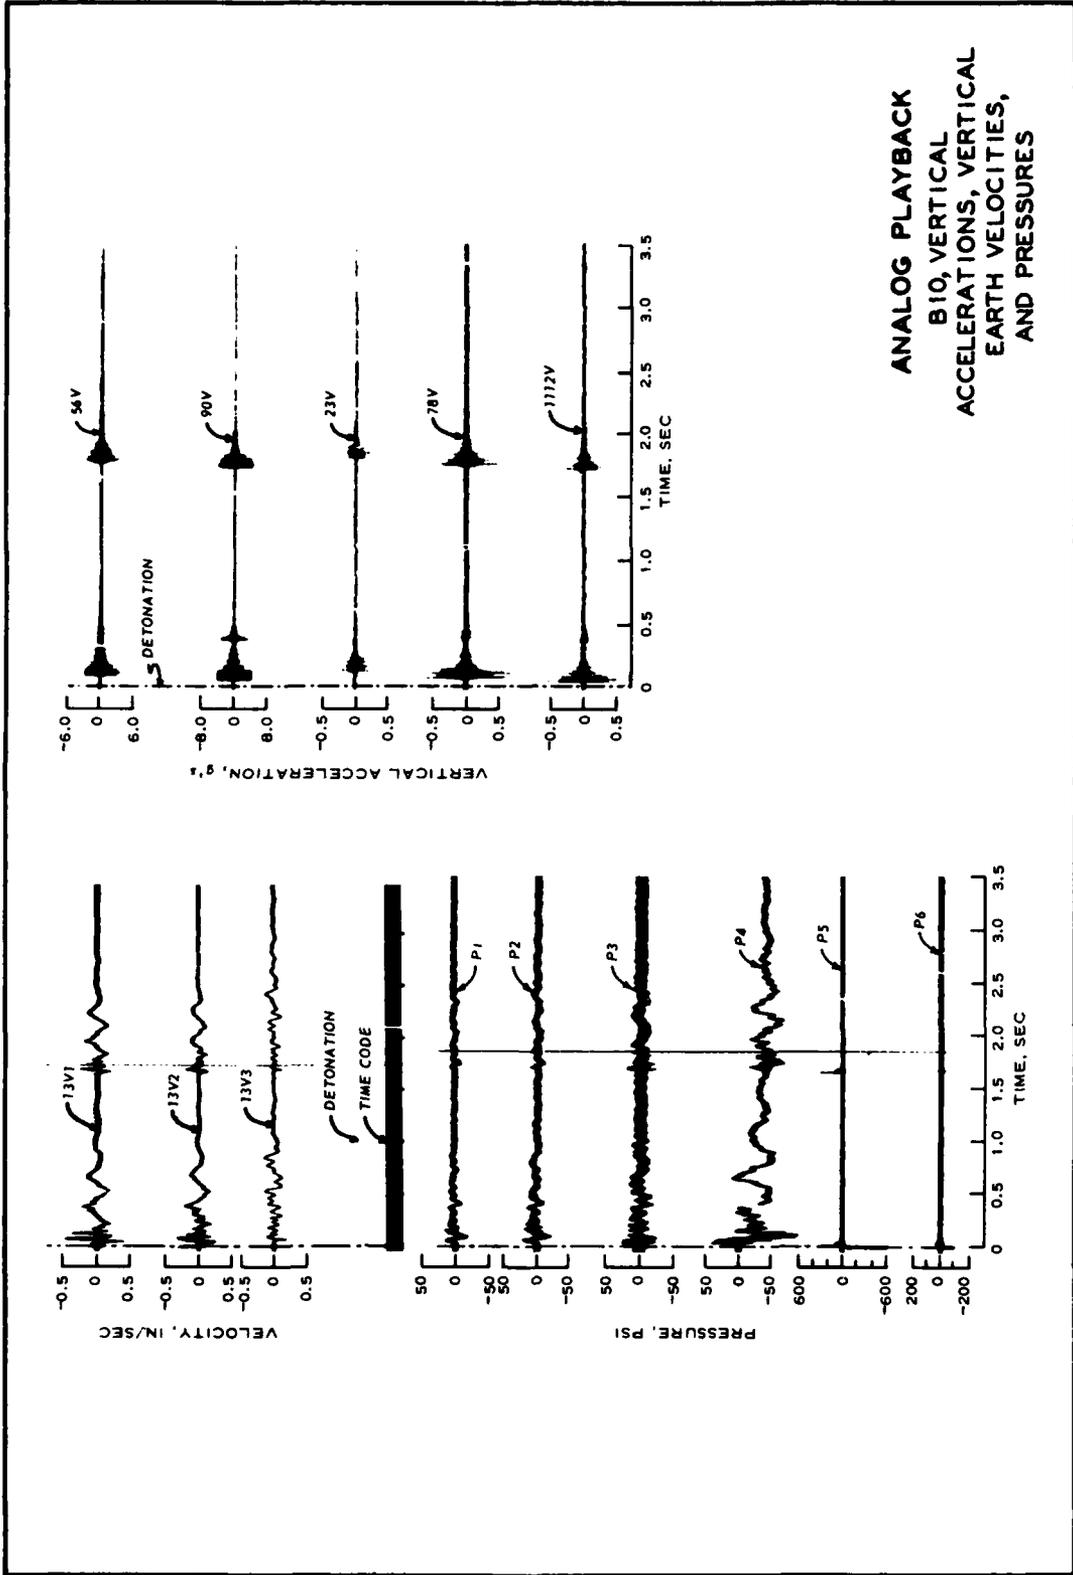
PLATE 14

**ANALOG PLAYBACK
B10, VERTICAL
ACCELERATIONS, VERTICAL
EARTH VELOCITIES,
AND PRESSURES**

The amplitude of the low-frequency oscillation is reduced at location 13V2 and is not discernible at 13V3. The time of travel between 13V2 and 13V3 of the initial shock is about 0.031 sec (Plate 14); the velocity of the shock wave through the embankment between the transducers is therefore 100 ft/0.031 sec = 3230 fps. As viewed in the field, these data indicated that (a) the low-frequency motion (3.4 Hz) corresponds to a vibration of the structure and foundation, and (b) the damping is high enough so that this motion decays rapidly.

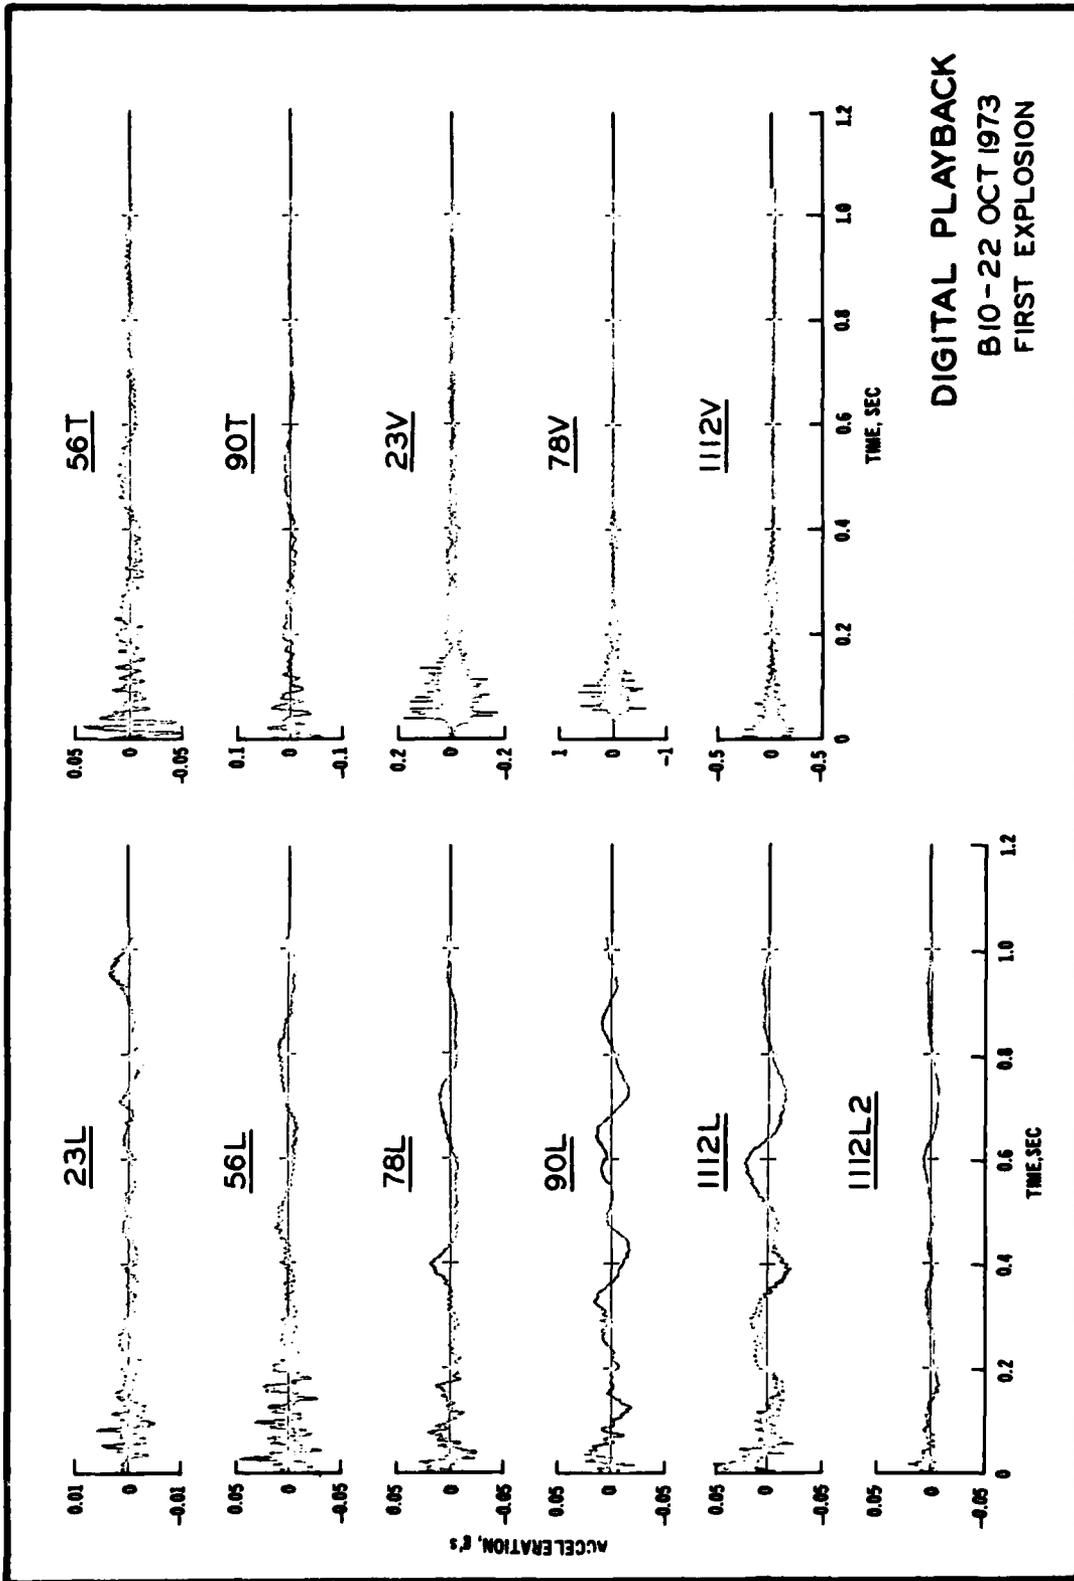
DIGITAL PLAYBACK

B10-22 OCT 1973

FIRST EXPLOSION

41. Two sets of 1-sec digital playbacks are shown in Plates 15 and 16 for the first explosion in test B10, and the single explosion in test B60, respectively. The data are digitized at 1000 samples per second and fold at 500 Hz. The corresponding FFT's, evaluated as noted in Part II, are presented in Plates 17 and 18 (longitudinal data and transverse and vertical data, respectively, for test B10) and in Plates 19 and 20 (longitudinal and transverse data and vertical data, respectively, for test B60). The FFT's are evaluated in steps of 1 Hz and extend to 500 Hz; the logarithmic frequency scale, rather than the linear scale used previously, is required so that frequencies corresponding to the initial transient movement (high frequency) as well as the subsequent rocking motion of the structure (low frequency) are shown. A summary of the significant frequency components from Plates 17-20 and the corresponding extreme accelerations from Plates 15 and 16 are listed below. Also listed are the peak-to-peak displacements of a comparable simple sinusoidal motion (Equation 1).

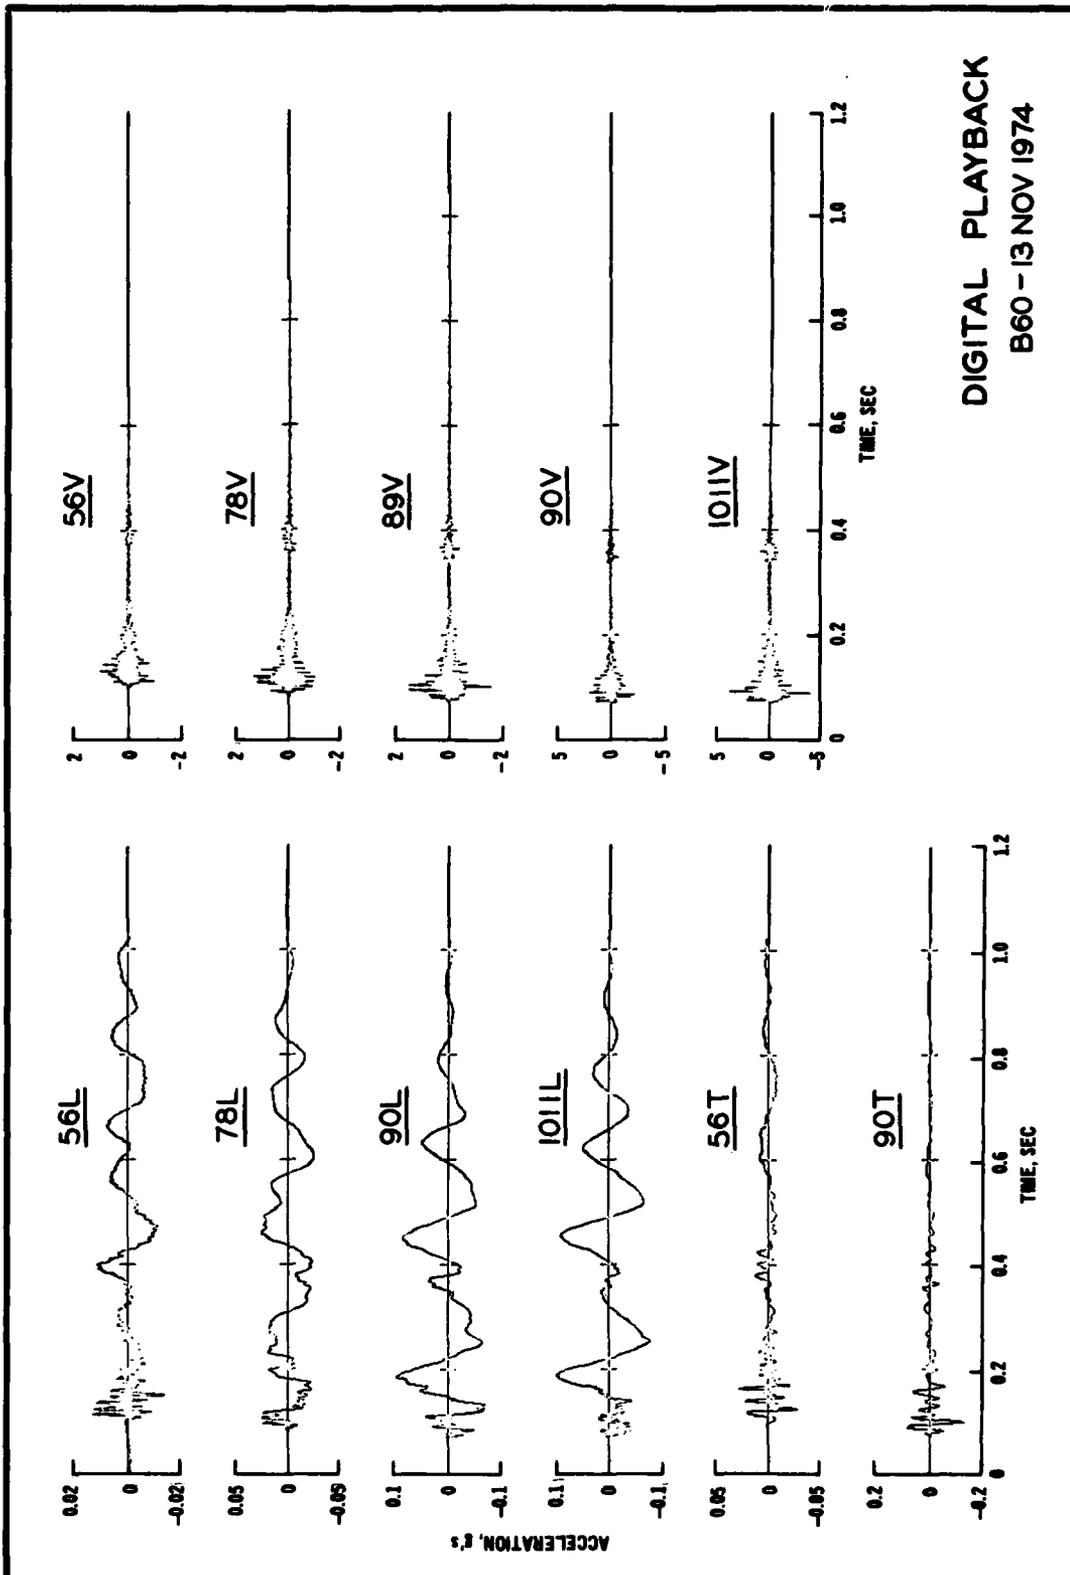
PLATE 16

DIGITAL PLAYBACK
 B60-13 NOV 1974
