Subject: Subsurface Defects in Wrought Titanium Alloy -  
Third Semi-Annual Report

INFLUENCE OF SUBSURFACE DEFECTS  
ON FATIGUE PROPERTIES OF TITANIUM ALLOYS

Covering Period April 1976 - October 1976

C.C. Law M.J. Blackburn  
Materials Engineering and Research Laboratory  
East Hartford, Connecticut

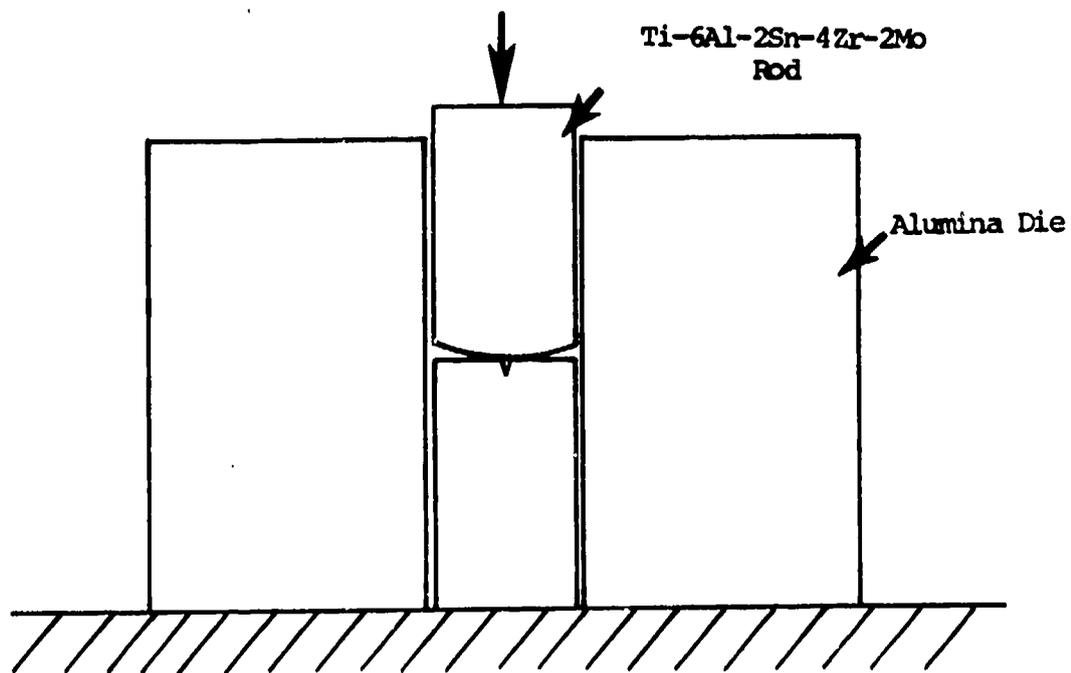
Figure 1

1. Experimental setup for seeding an argon pore in two rods which were subsequently diffusion bonded together and machined into a LCF specimen.
2. S-N curves of defect-free IMI 685 specimens tested at either  $R = 0-0.3$ , 20 cpm or  $R = 0.3$ , 12 cph.

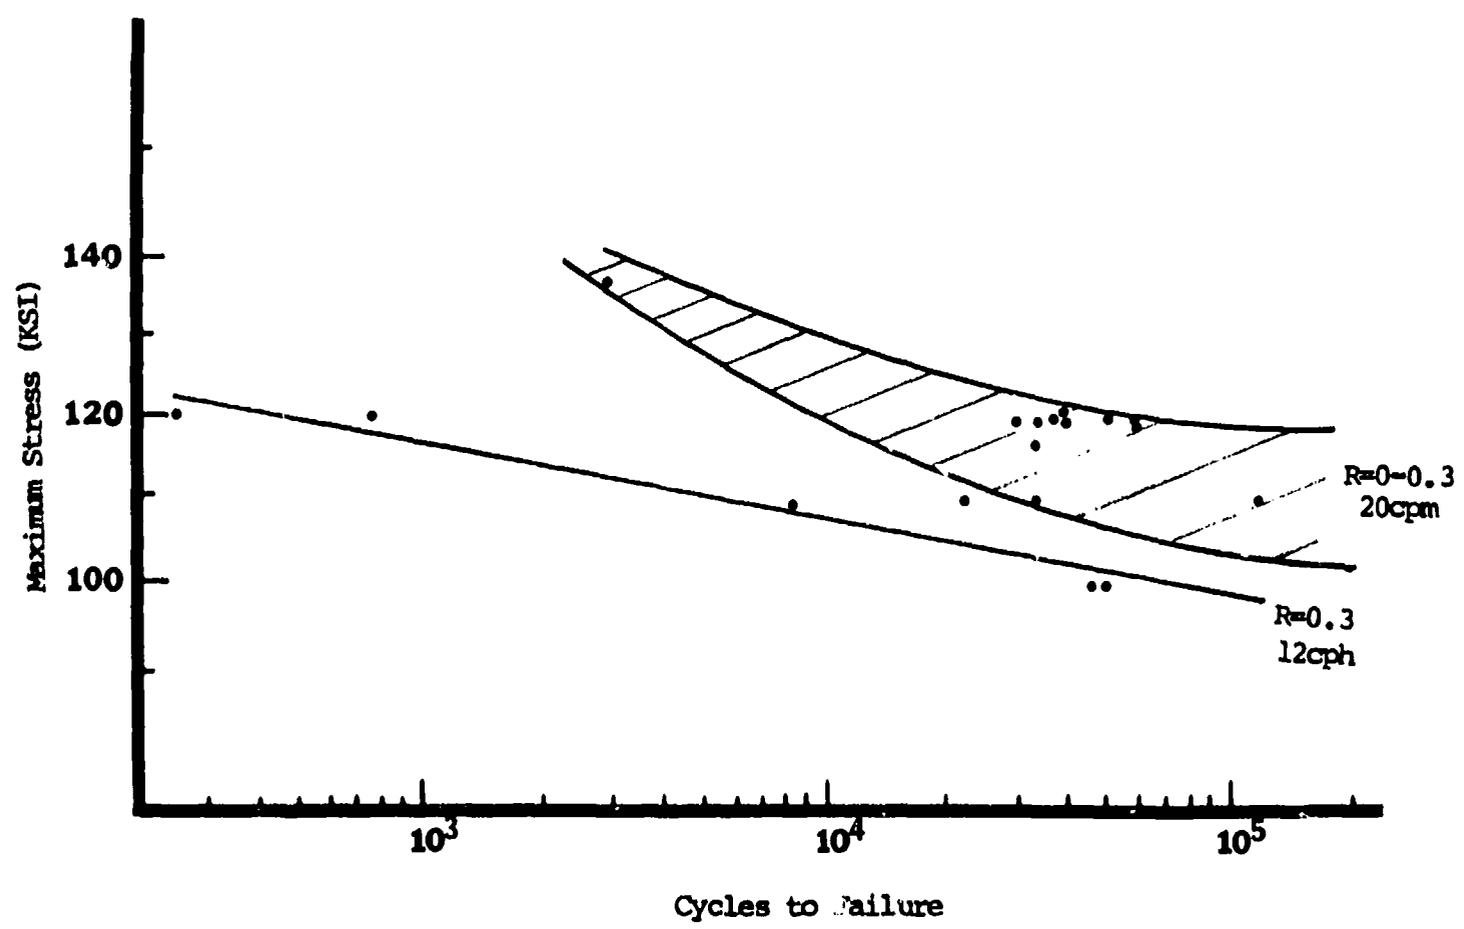
Figure 2

The room temperature S-N curves of defect-free IMI 685 specimens are shown in Figure 2. Most of these data have been generated by the AF/Metcut. Fatigue behavior is clearly frequency dependent; lower fatigue lives are associated with the lower frequency (12 cph). The frequency effect is especially pronounced at higher stresses. These data will be used as a basis of comparison for specimens failed with rosette-type of fracture.

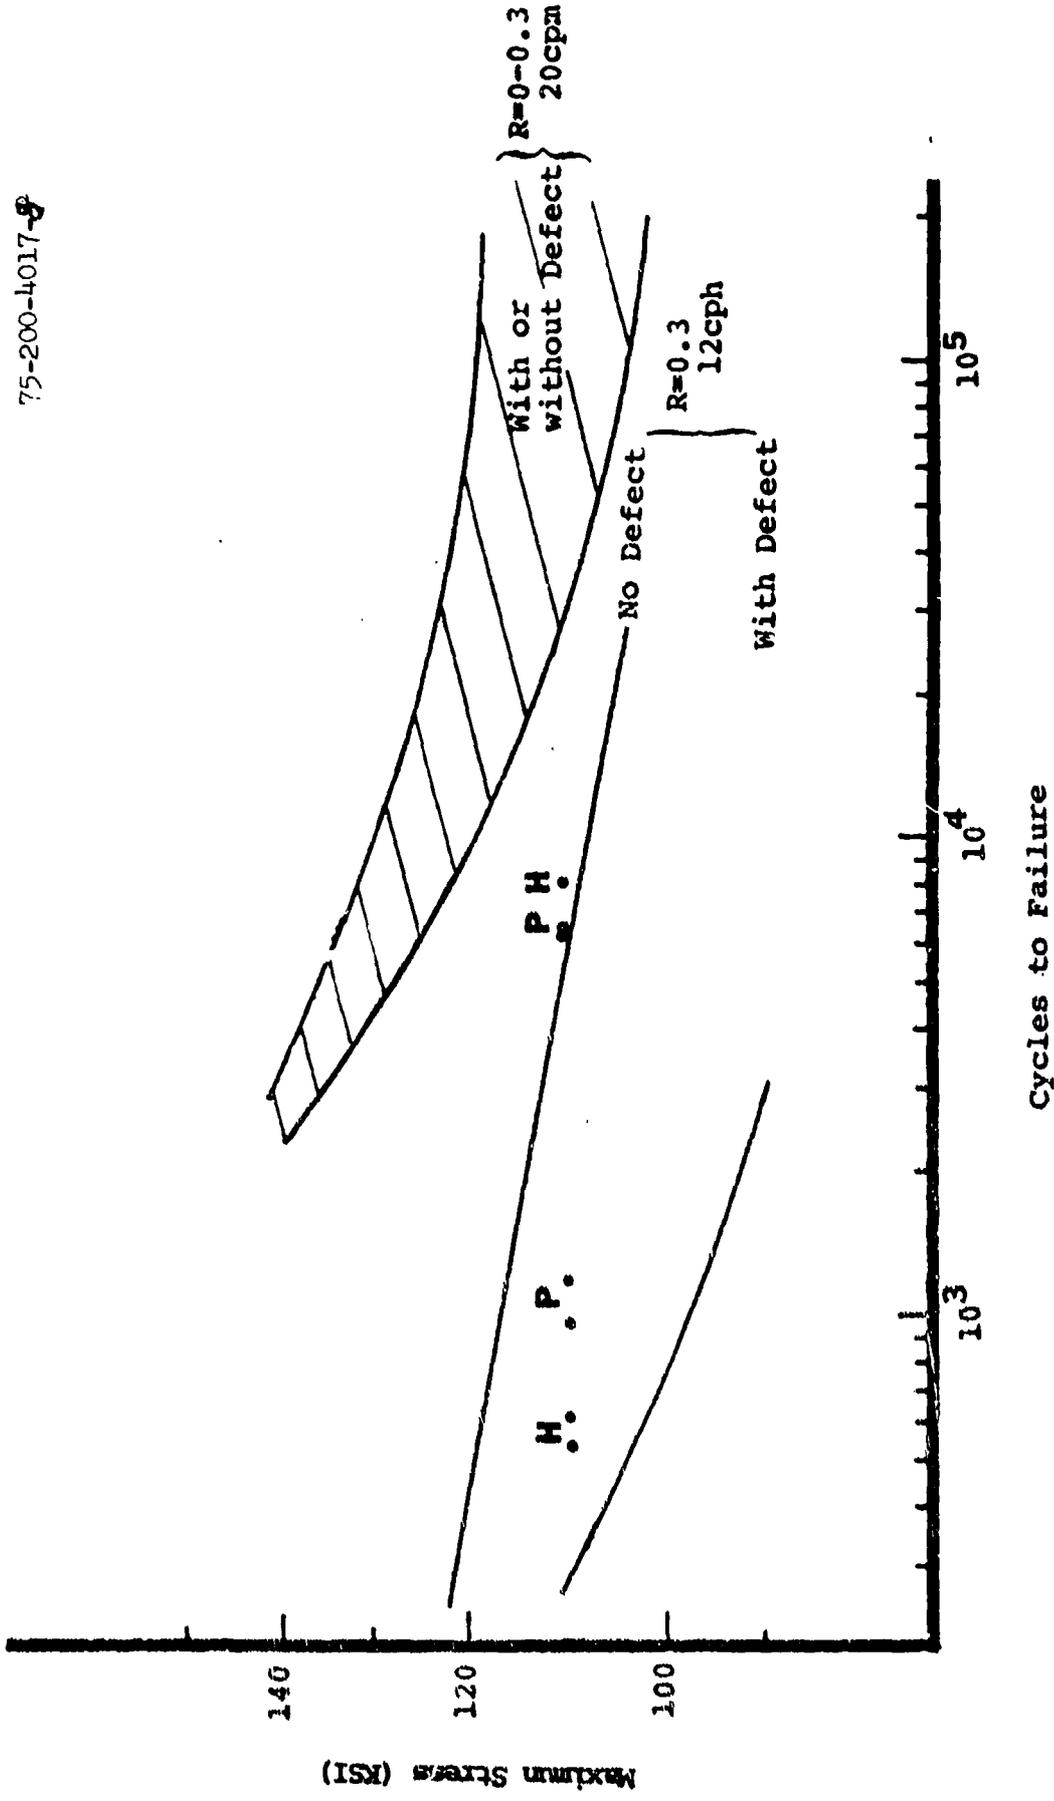
Figure 8

The LCF results of seeded IMI 685 specimens relative to those of the defect-free and rosette-containing specimens are illustrated in Figure 8. The data points from specimens seeded with hydride are indicated by H, while those seeded with clean pores are indicated by P. The frequency effect on fatigue life is again obvious. Specimens tested at the lower frequency of 12 cph (filled circles) have fatigue lives about one order of magnitude lower than those tested at the higher frequency of 20 cpm (pen circles). Relative to the 20 cpm LCF lives of defect-free and rosette-

8. The LCF lives of seeded IMI 685 specimens relative to those with and without rosette defects. The data points from specimens seeded with Ti-6Al-4V hydride are indicated by H and those from specimens seeded with clean pores, by P. The open circles indicate tests without dwell (i.e. at 20 cpm) and the filled circles indicate tests with dwell (i.e. at 12 cph).

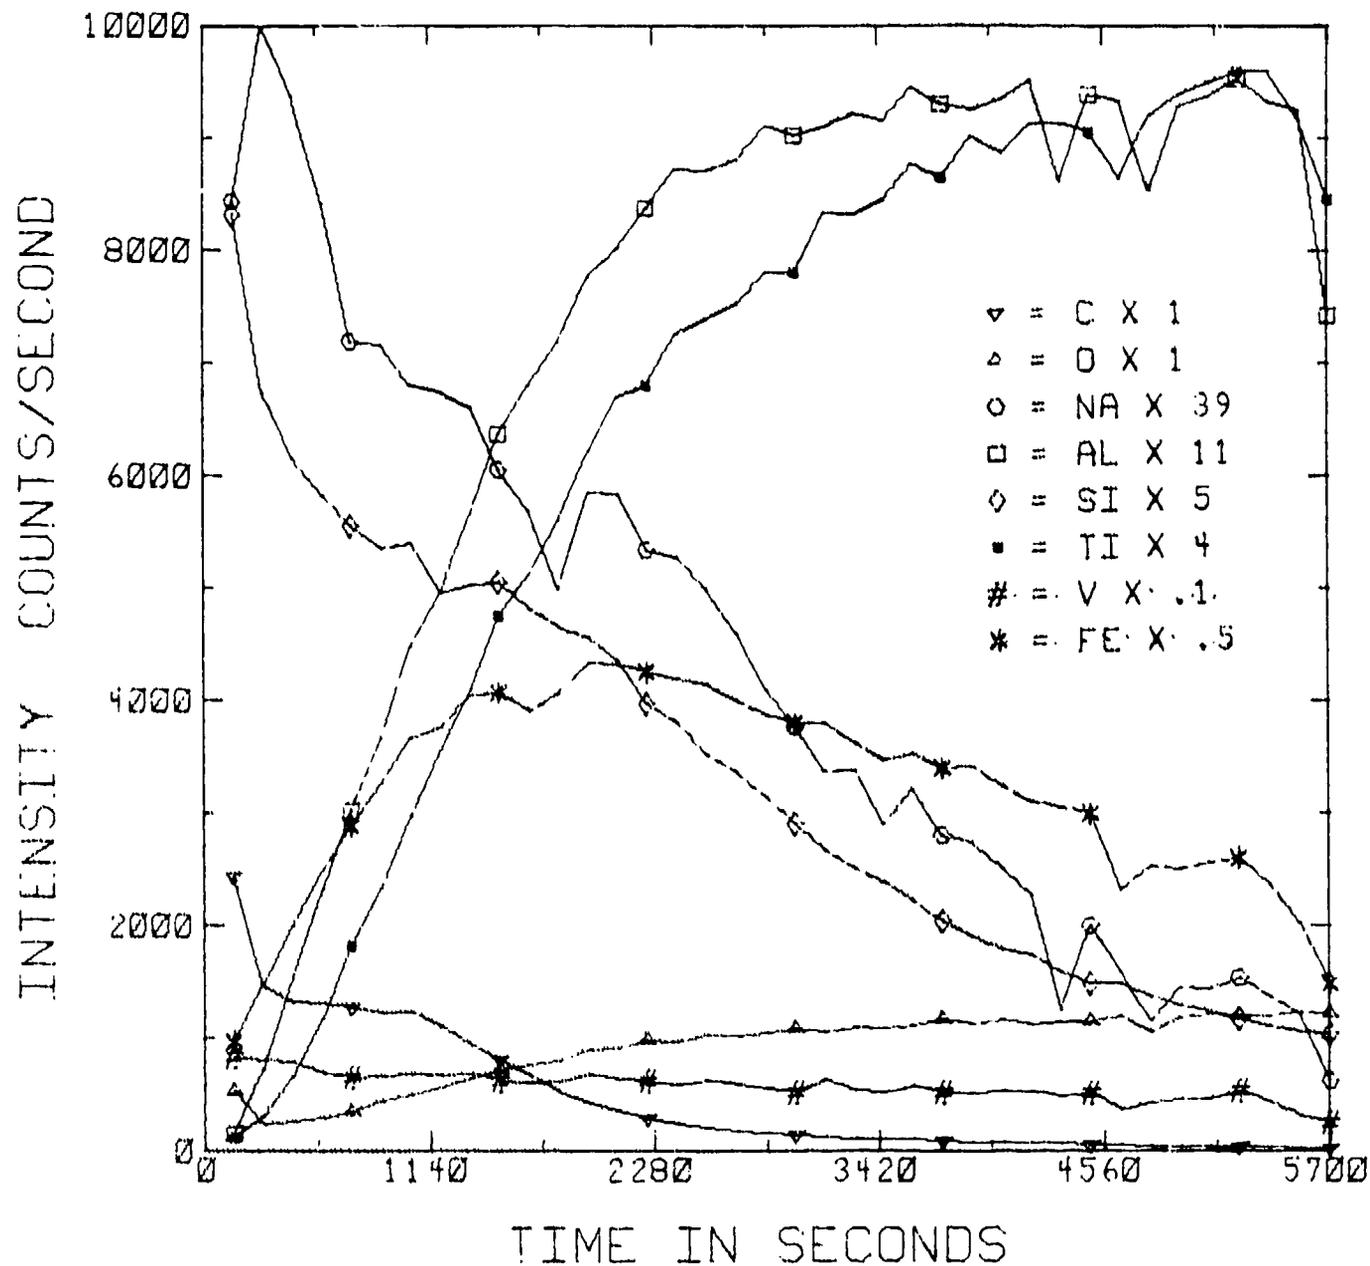
Figure 9

9. Change in intensities of several elements as a function of sputtering time. Determination of compositions at the 'fish eye' fracture origin and the bulk commenced after steady levels of major elements were observed.

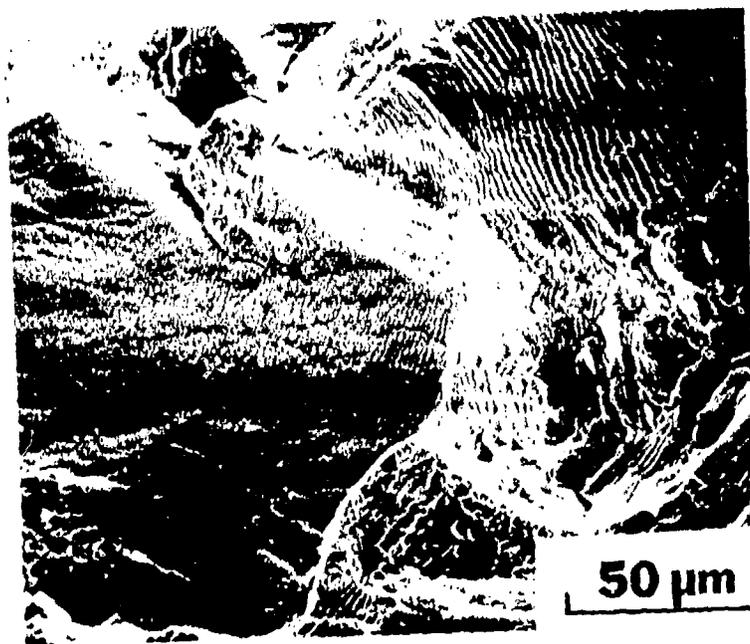
Figure 14

14. (a) Striations observed on facet A of the fracture surface shown in Figure 13(a).
  - (b) Striations observed on facet B of the fracture surface shown in Figure 13(b).

is illustrated in Figure 14b. The appearance of the fracture shown in Figure 13a and b are similar to those of the IMI 685 (Figures 5 and 3 respectively) except in the scale of the fracture surface topography, being relatively finer in the seeded Ti-6Al-4V specimens. This difference can be directly related to the scale of the microstructures, specifically the beta grain size and colony dimensions, in these materials.

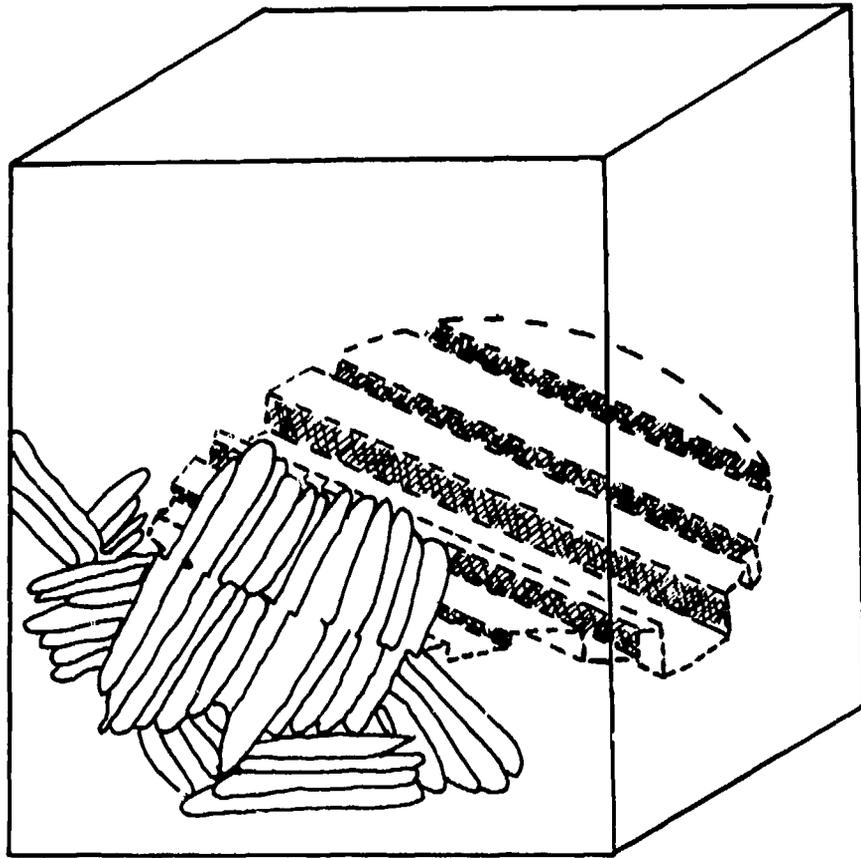
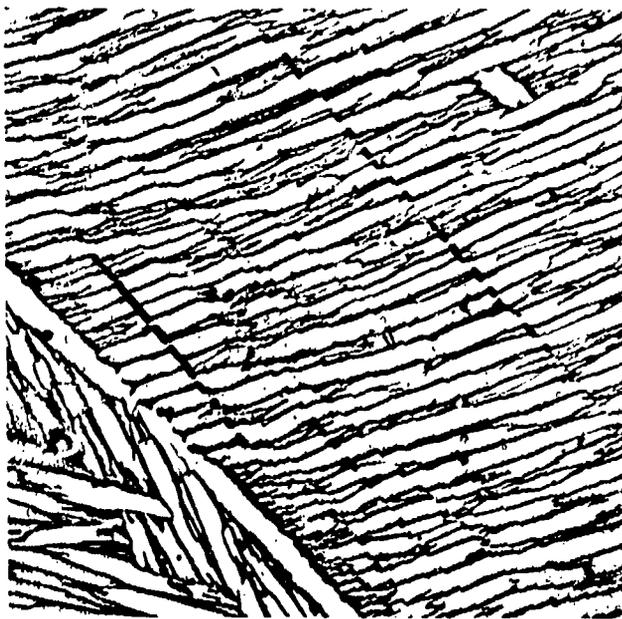
Figure 15

15. Mechanism of brittle-striation formation on the 'fish eye' of the rosette-fracture in IMI 685 alloy.
16. Schematic diagram showing the 'dwell debit' and the 'rosette debit' in IMI 685 alloy.

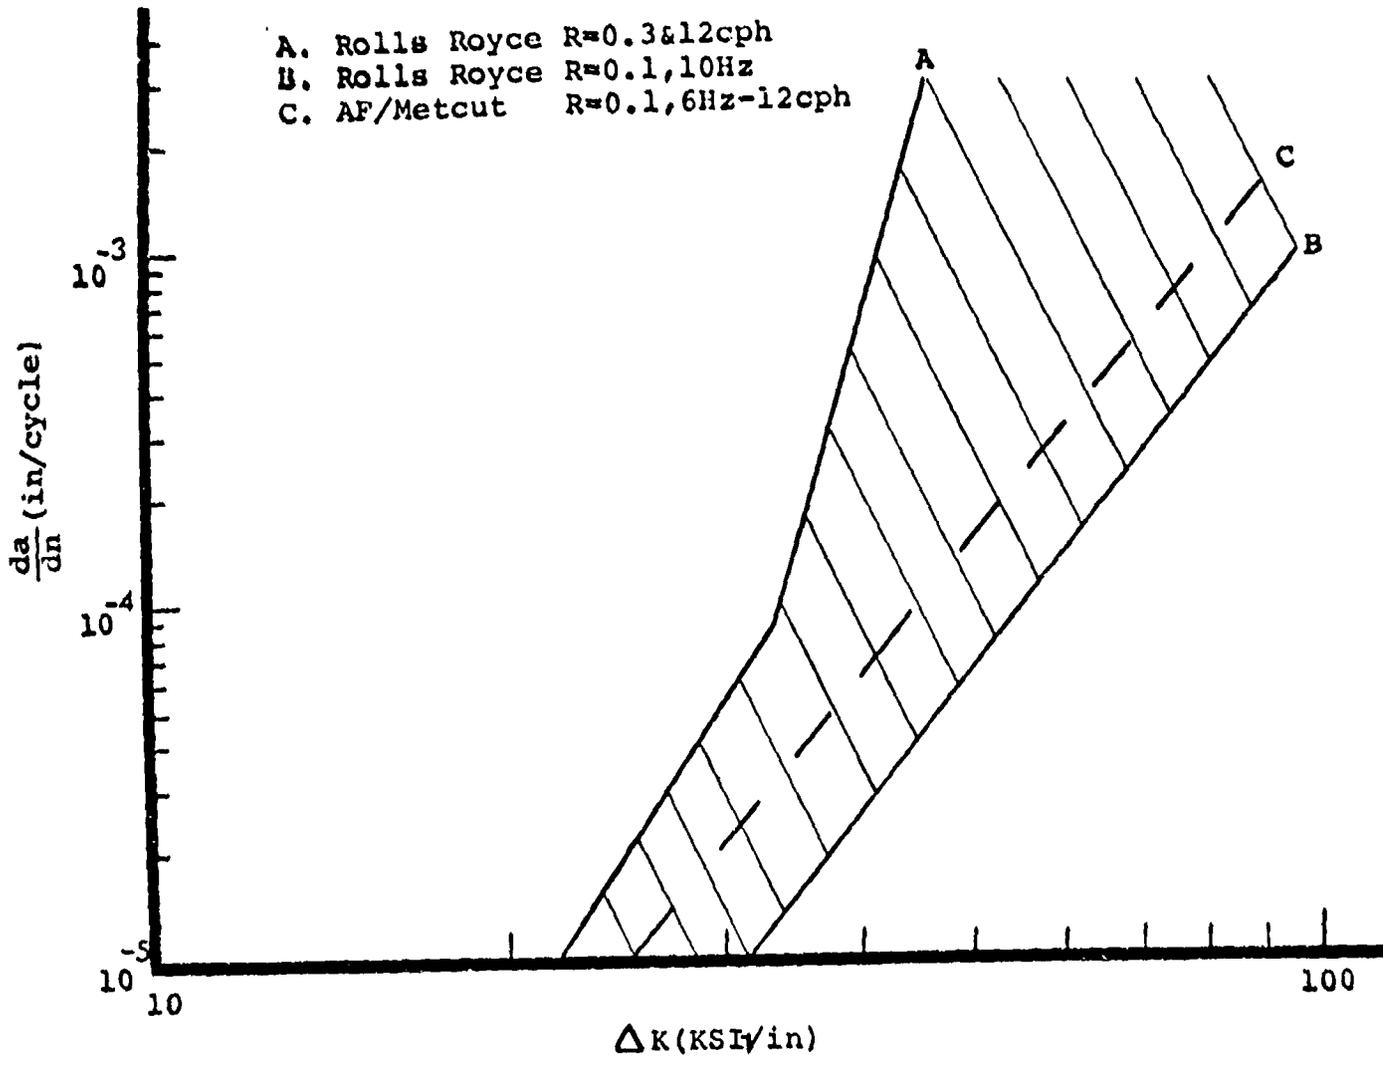
Figure 17

of frequency on fatigue crack propagation rate\*. Their results are shown in Figure 17. According to the AF/Metcut data the 'dwell debit' may be explainable in terms of the possible difference in crack nucleation life which is assumed to be much shorter when tested with a dwell than that without a dwell. This difference has not been demonstrated, however.

17. Crack propagation data on IMI 685 alloy.
18. Comparison of the calculated fatigue lives with those of IMI 685 specimens which failed with rosette-type fracture with a dwell (filled circles) without a dwell (open circles). The calculations were made using penny-shaped crack radii of 0.01" and 0.02" with either the Rolls Royce crack propagation data (band A) or the AF/Metcut data (band C).

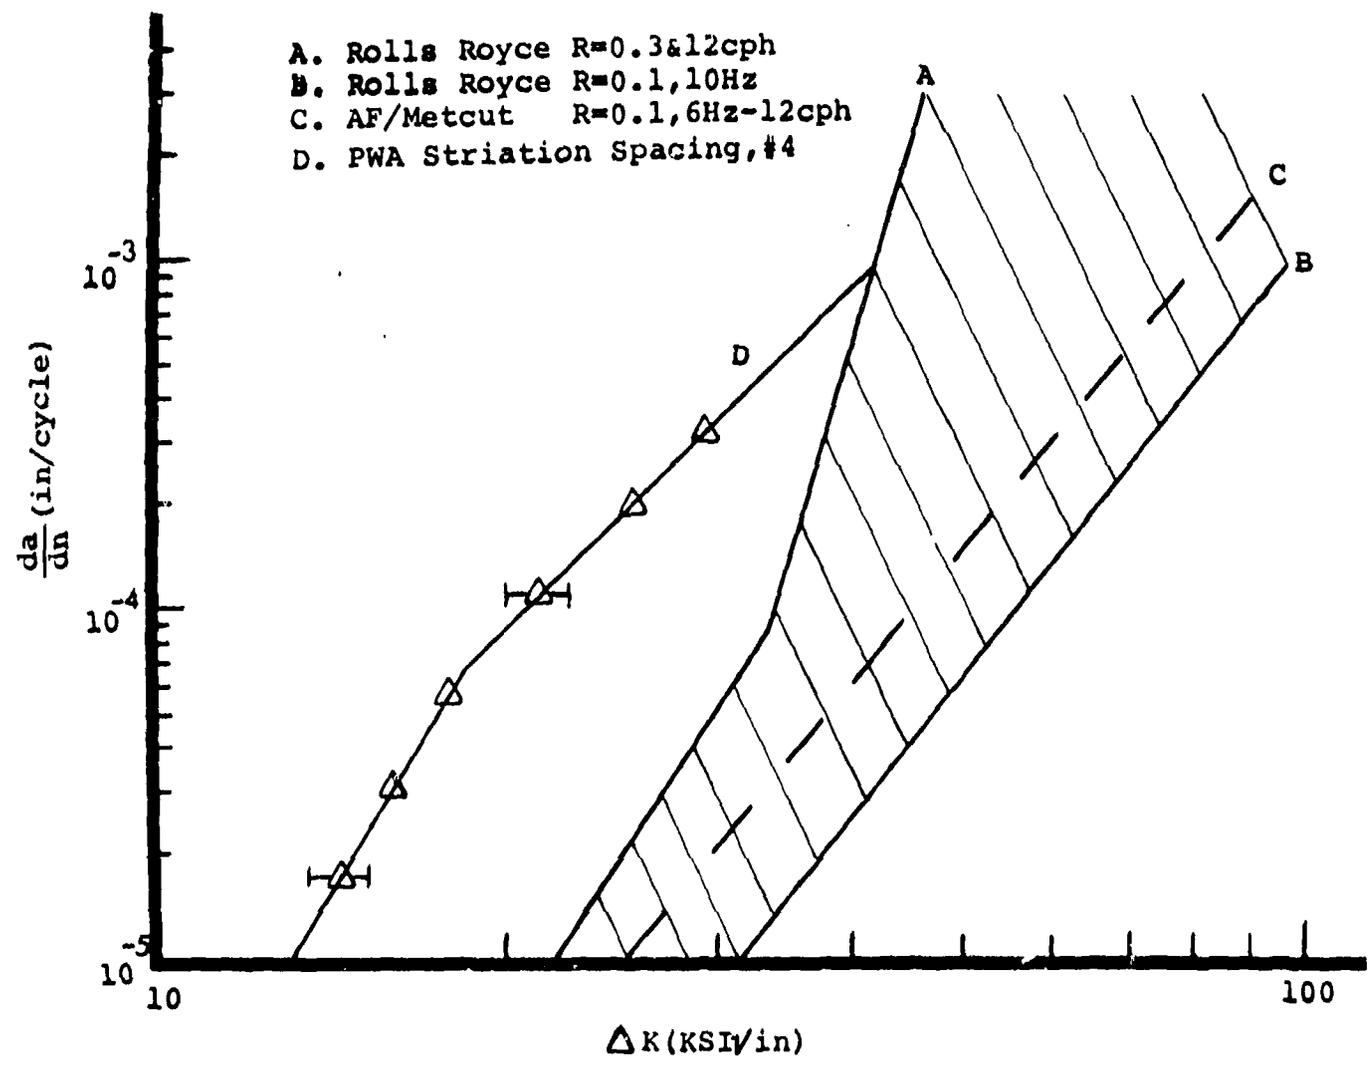
Figure 19

19. Striation spacings measured from IMI 685 specimen #4 (Figures 5 and 7) plotted as a function of  $\Delta K$  which are calculated using the central penny-shaped crack model<sup>6</sup>.

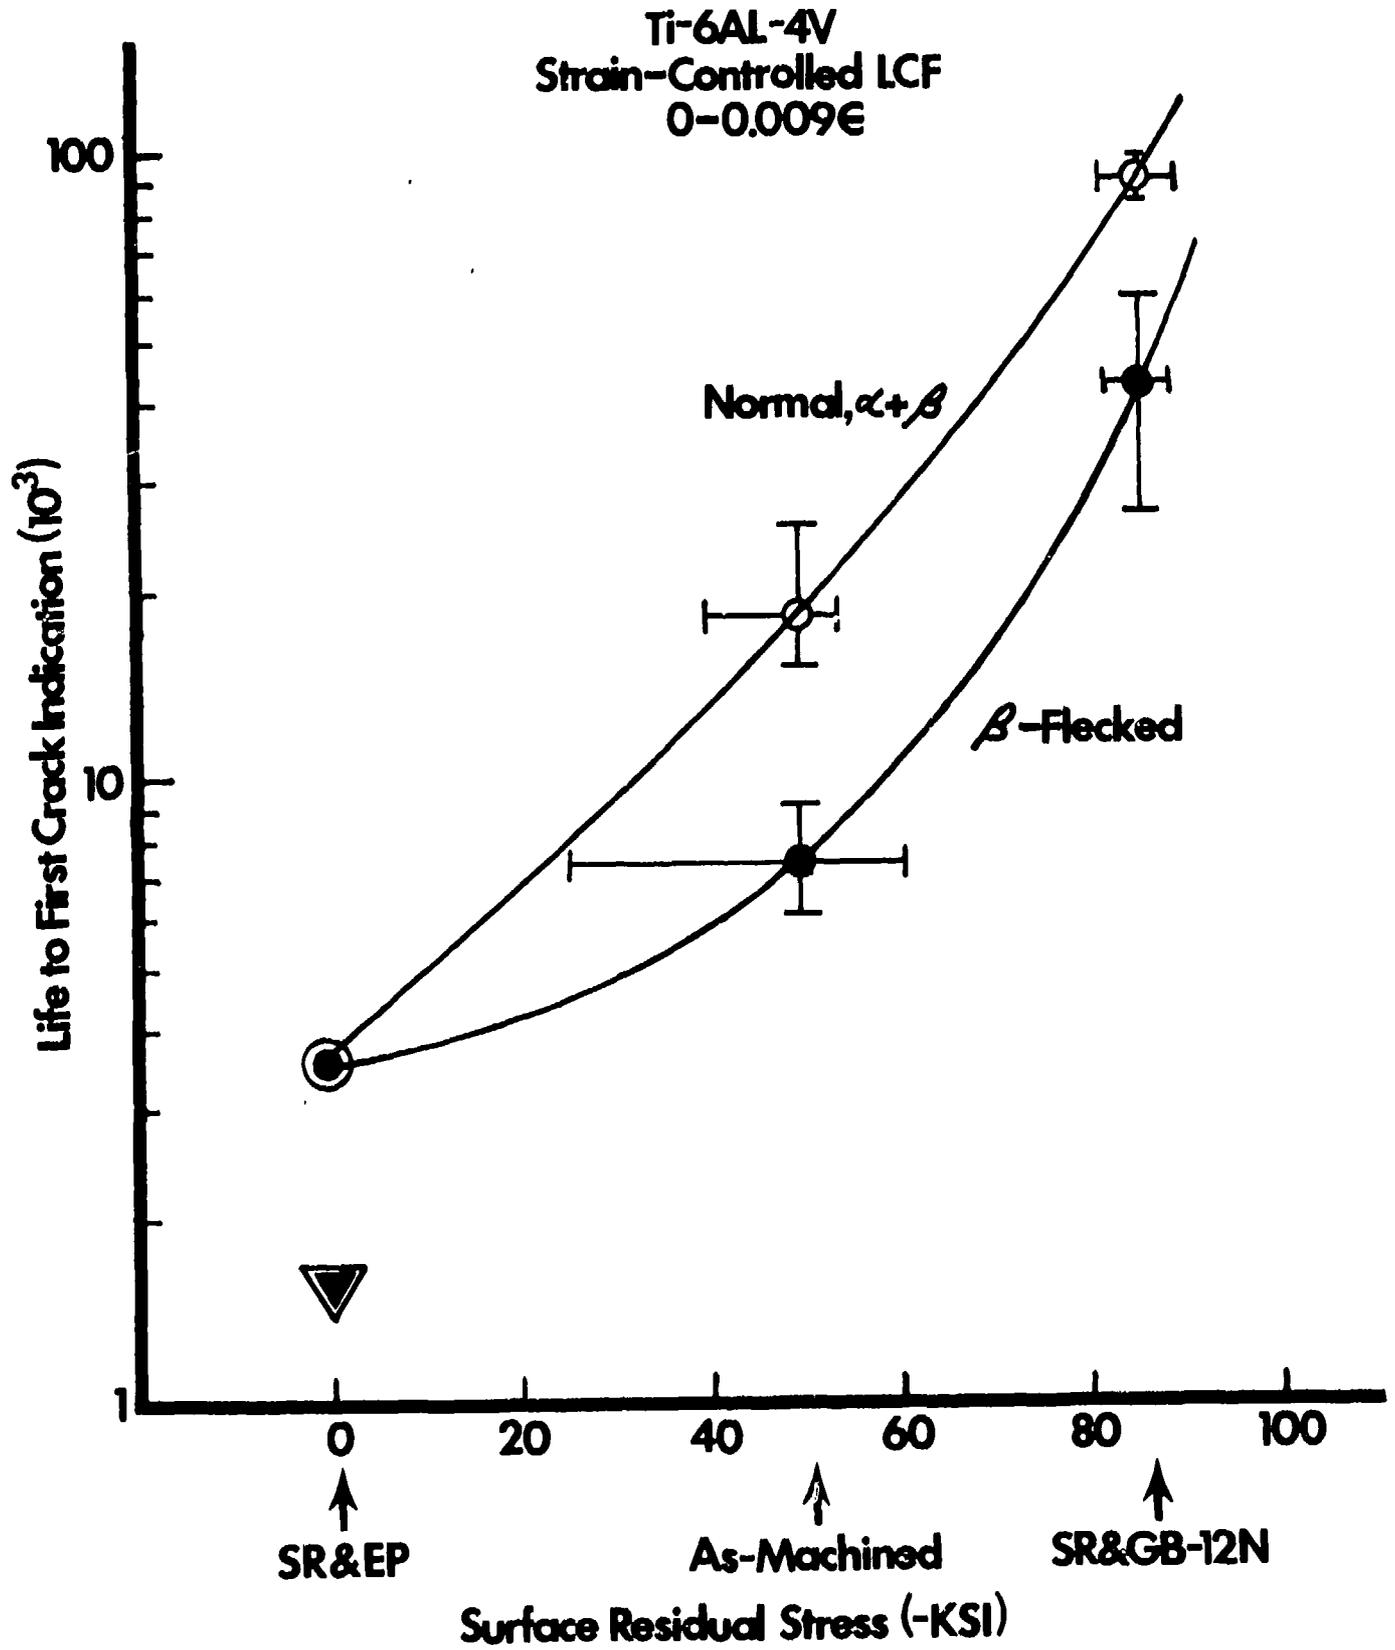
Figure 1

1. Fatigue crack initiation lives of normal and  $\beta$ -flecked Ti-6Al-4V as a function of surface preparations. The specimens were tested in strain-controlled LCF at 0.9% $\epsilon$
2. Fatigue live of normal and  $\beta$ -flecked Ti-6Al-4V as a function of surface preparations. The specimens were tested in stress-controlled fatigue at 110 KSI.
3. S-N curves of normal and  $\beta$ -flecked Ti-6Al-4V specimens which were stress-relieved and then electropolished prior to testing
4. (a) 51 V image of a normal area  
(b) 51 V image of a  $\beta$ -flecked area  
(c) 56 Fe image of a  $\beta$ -flecked area
