COMPARATIVE PERFORMANCE OF STRUCTURAL LAYERS IN PAVEMENT SYSTEMS

VOLUME IV

Analysis Of Insulating Layers In Pavement Test Sections

Walter R. Barker and Frazier Parker, Jr.

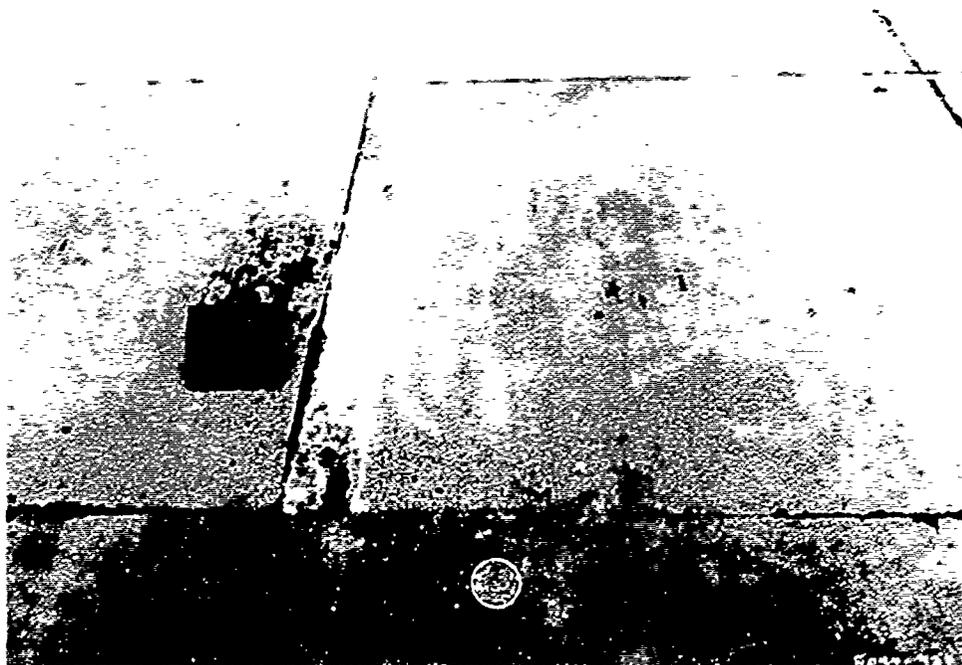
Figure 51. Condition of subitem 5a, lane 1, at completion of traffic, 3000 coverages, rigid pavement test section

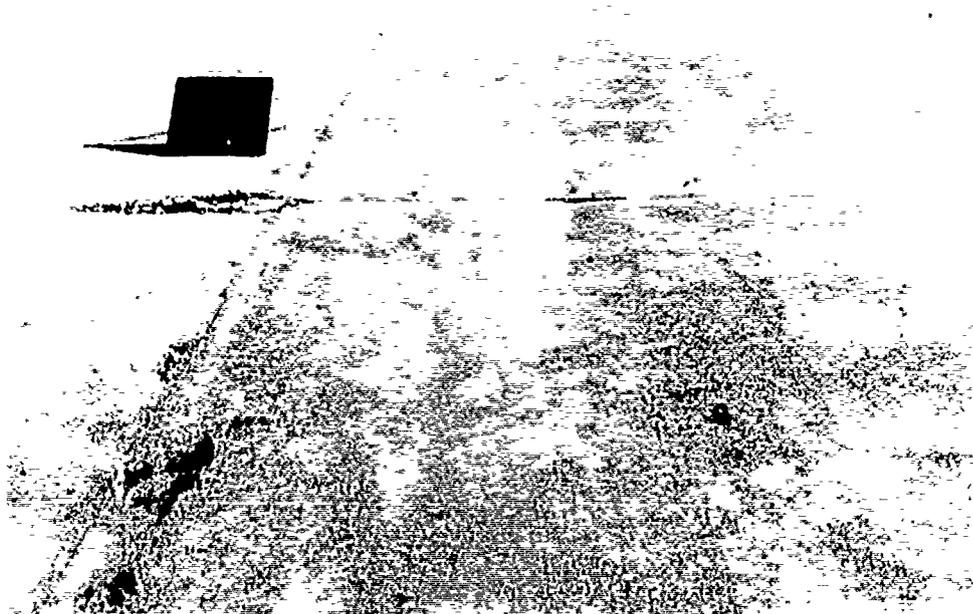
Figure 58. Condition of subitem 5c, lane 1, 1000 coverages, rigid pavement test section

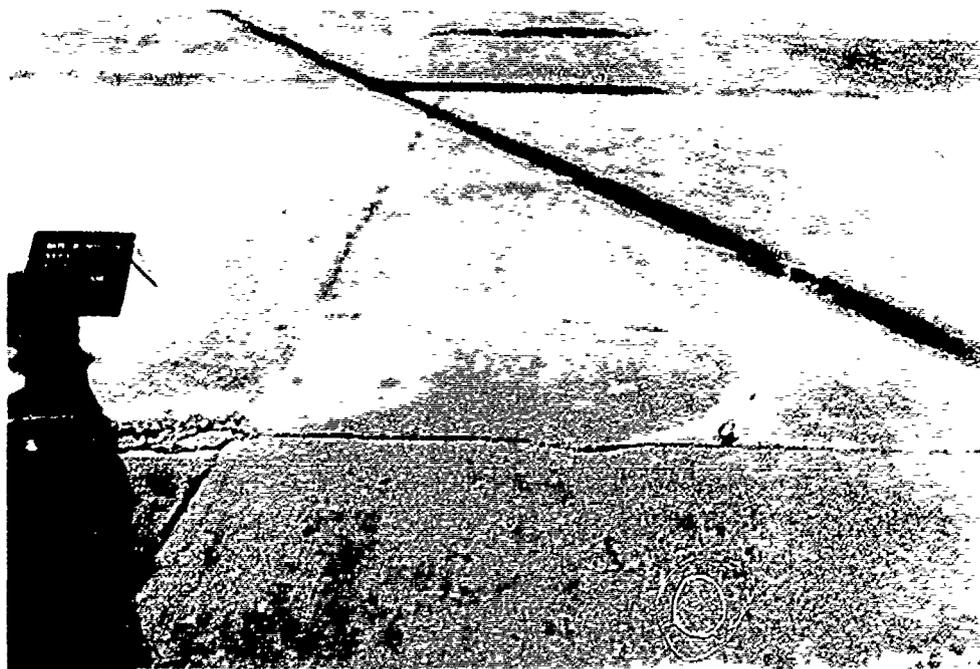
Figure 59. Condition of subitem 5c, lane 1, 1230 coverages, rigid pavement test section

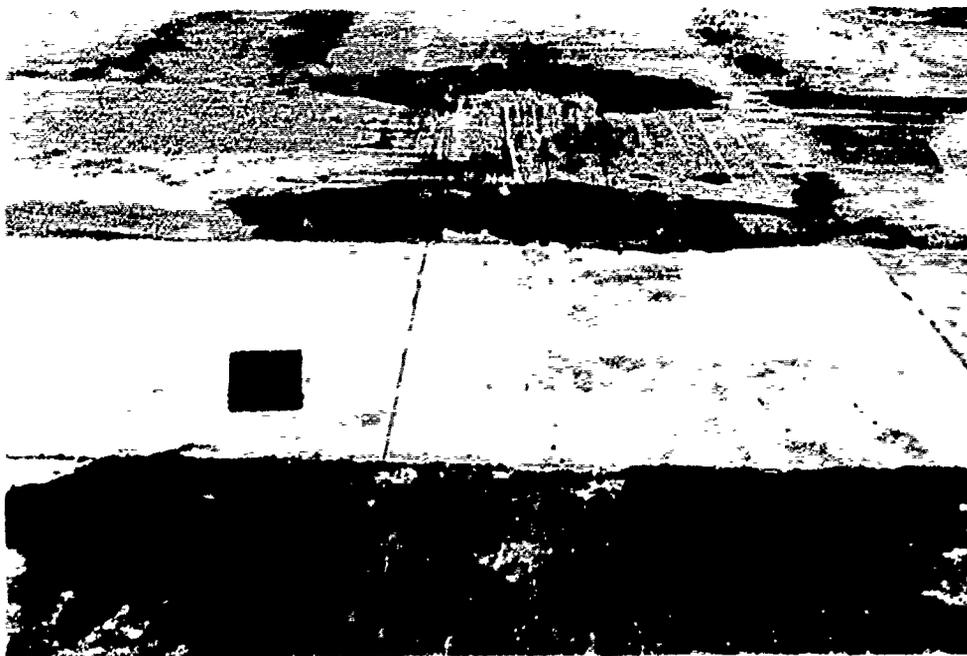
Figure 61. Condition of subitem 5d, lane 1, 1770 coverages, rigid pavement test section

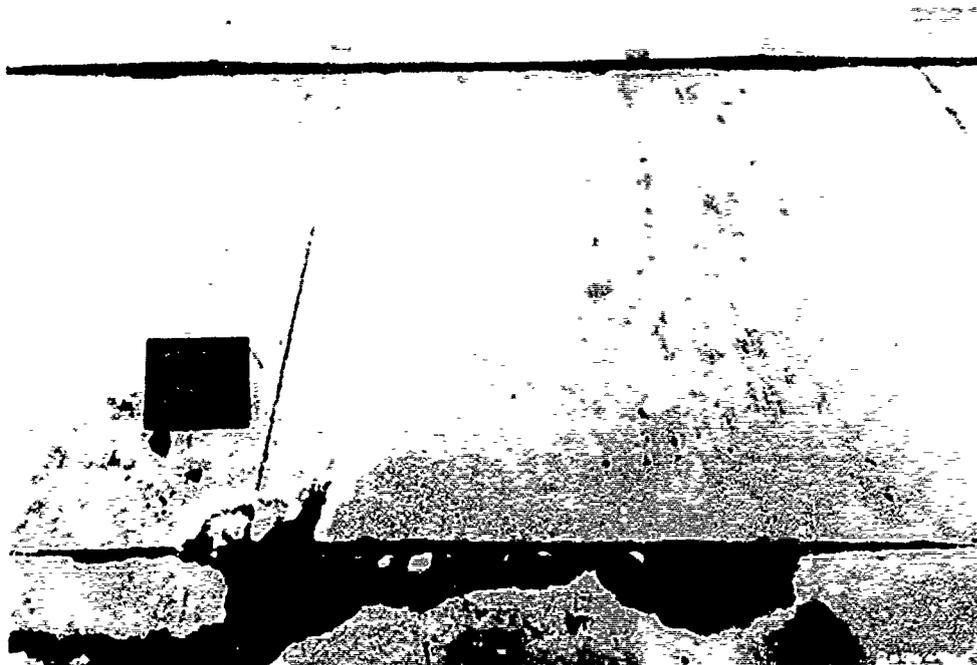
Figure 62. Condition of subitem 5d, lane 1, 3000 coverages, rigid pavement test section

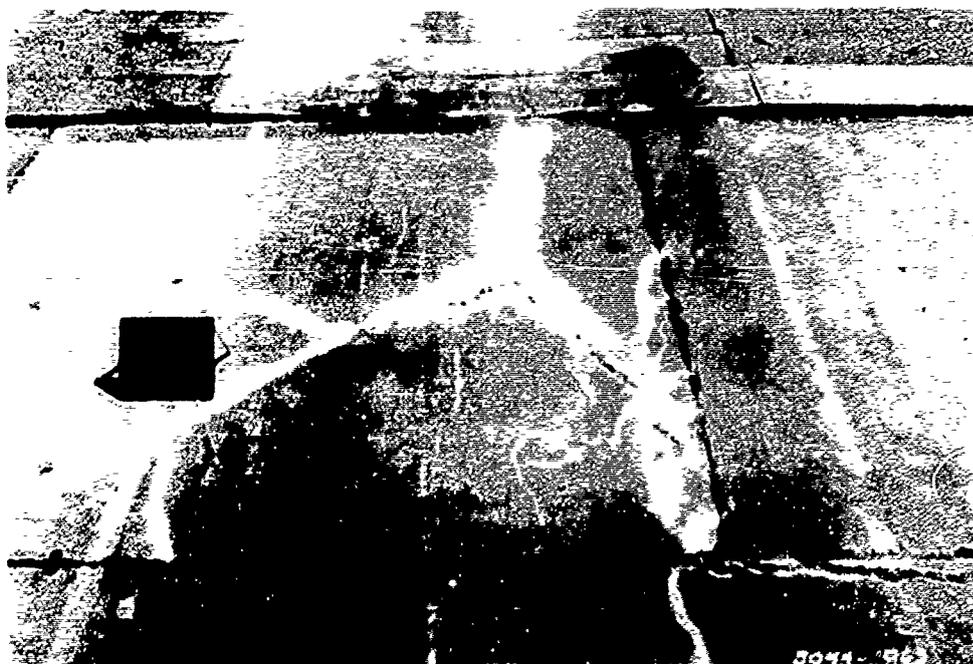
Figure 63. Condition of subitem 5d, lane 2, 200 coverages, rigid pavement test section

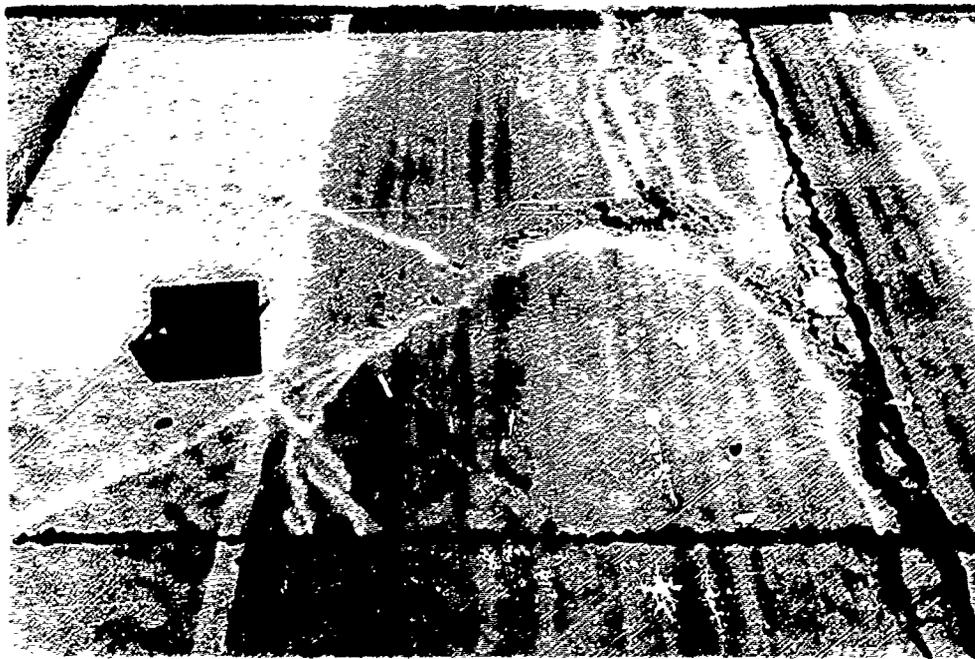
Figure 64. Condition of subitem 5d, lane 2, 350 coverages, rigid pavement test section

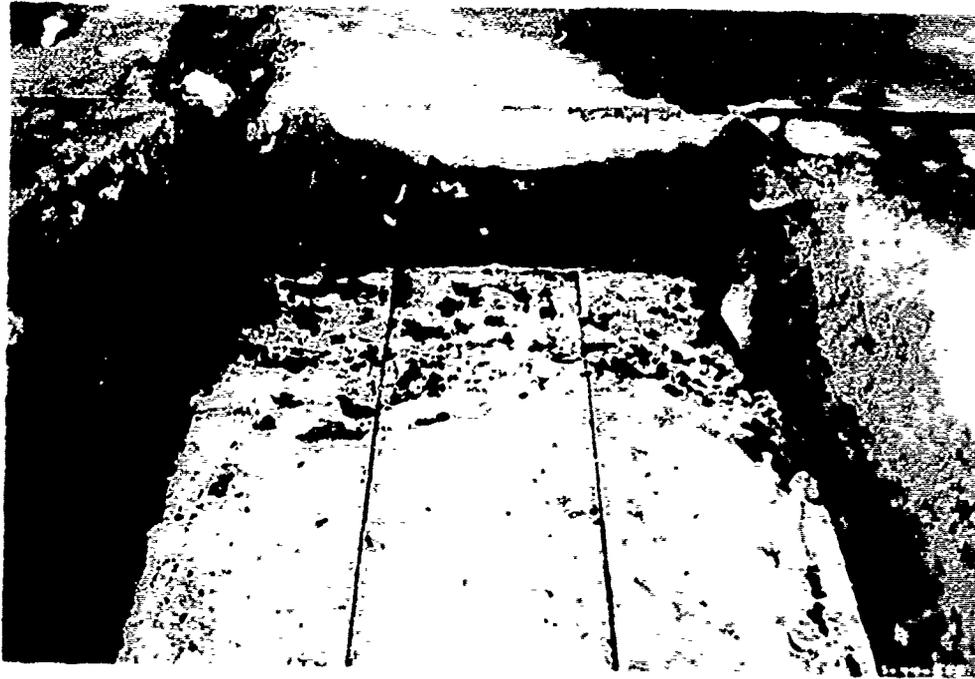
Figure 68. Condition of 120-psi polystyrene panels along longitudinal construction joint in subitem 5c, lane 1, rigid pavement test section
