**EXPLORATORY DEVELOPMENT ON DURABILITY OF
ADHESIVE BONDED JOINTS**

**BOEING COMMERCIAL AIRPLANE COMPANY
P.O. BOX 3707
SEATTLE, WASHINGTON 98124**

**TECHNICAL REPORT AFML-TR-76-173
FINAL REPORT FOR PERIOD FEBRUARY 1974 - OCTOBER 1976**

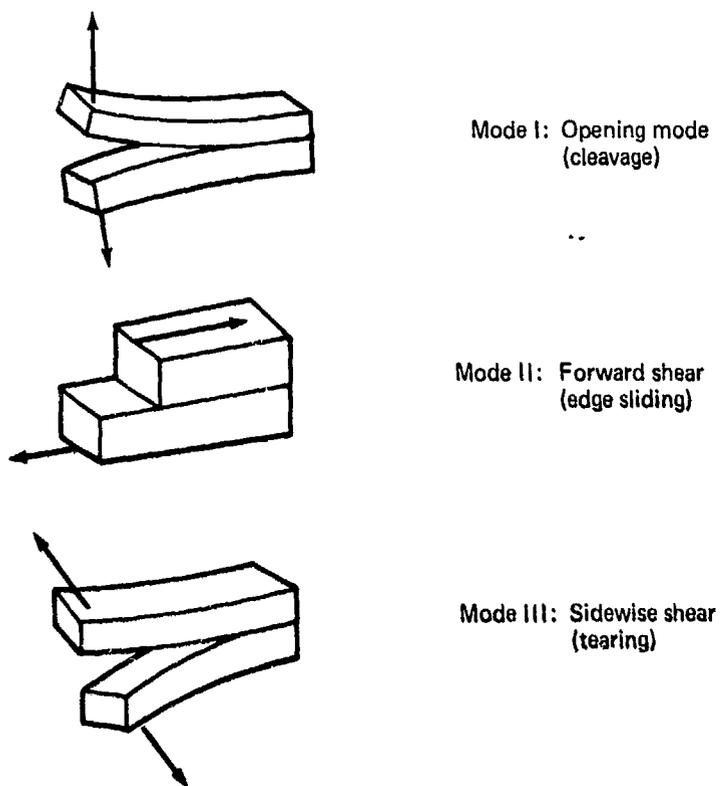
Figure 1.—Loading Modes Possible in Bonded Materials

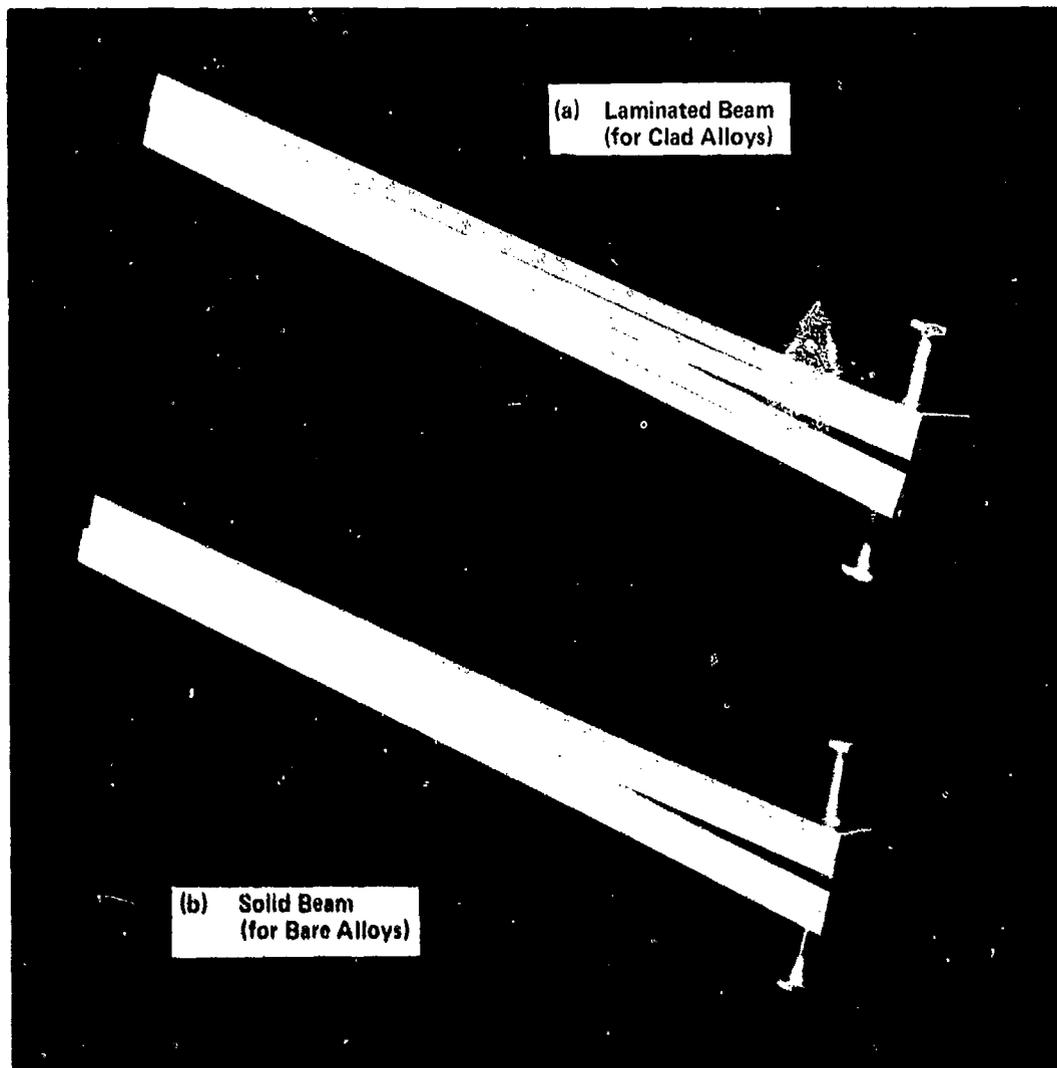
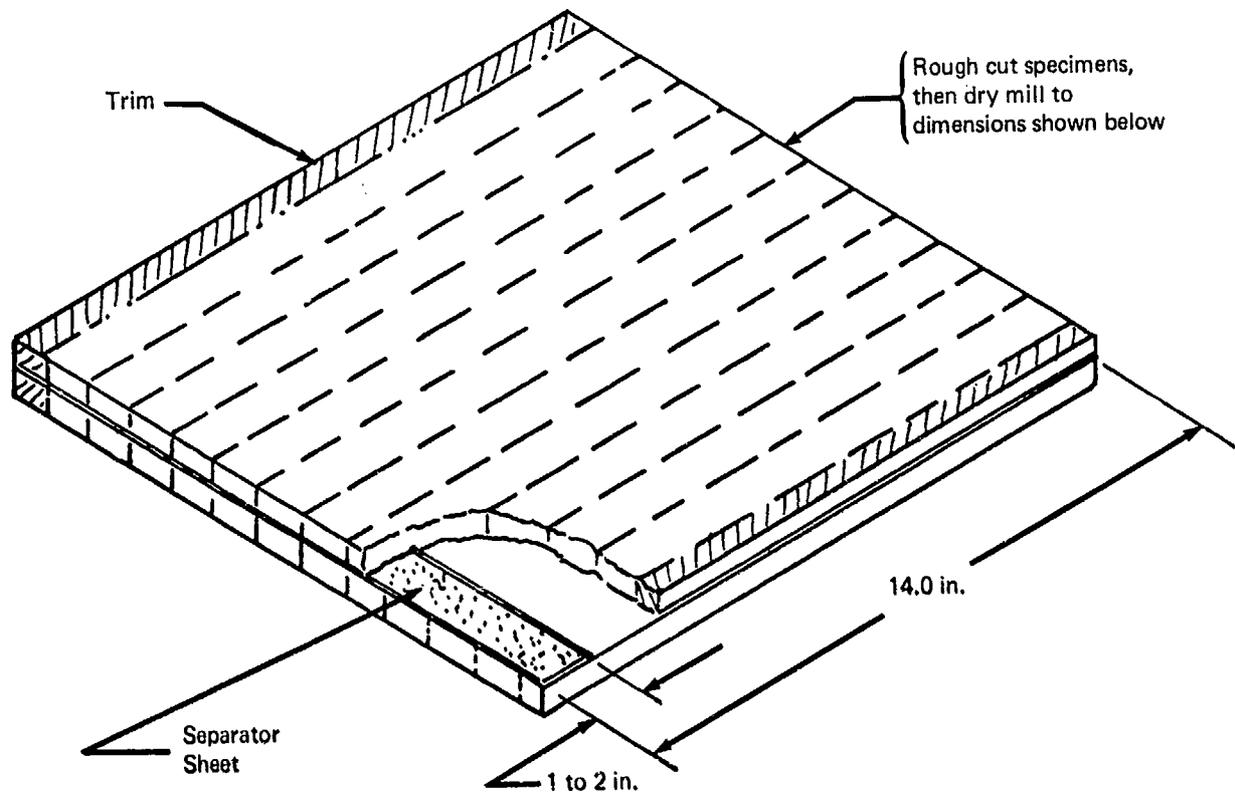
Figure 3.—Thick-Adherend DCB Specimens

(c) Typical DCB Specimen Bonded Assembly

Thick-adherend DCB specimens for each of the four alloys, four adhesives, three surface treatment processes, and three corrosion-inhibiting primers were fabricated by cutting specimens from large bonded assemblies and milling the cut sides to produce smooth surfaces (fig. 3). DCB specimens for each of the clad alloys were fabricated by bonding four 1/4-in.-thick plates to make up the 1-in.-thick specimen. This was necessary since 1/2-in.-thick clad plate could not be purchased at an acceptable cost. The specimens were stressed by tightening two 1/4-28 bolts into one end until a displacement of 0.10 in. was obtained (fig. 3). This displacement was chosen for convenience to standardize specimen configuration. After waiting 1 day for equilibrium to be established, the tip of the crack front created in the bondline was marked.

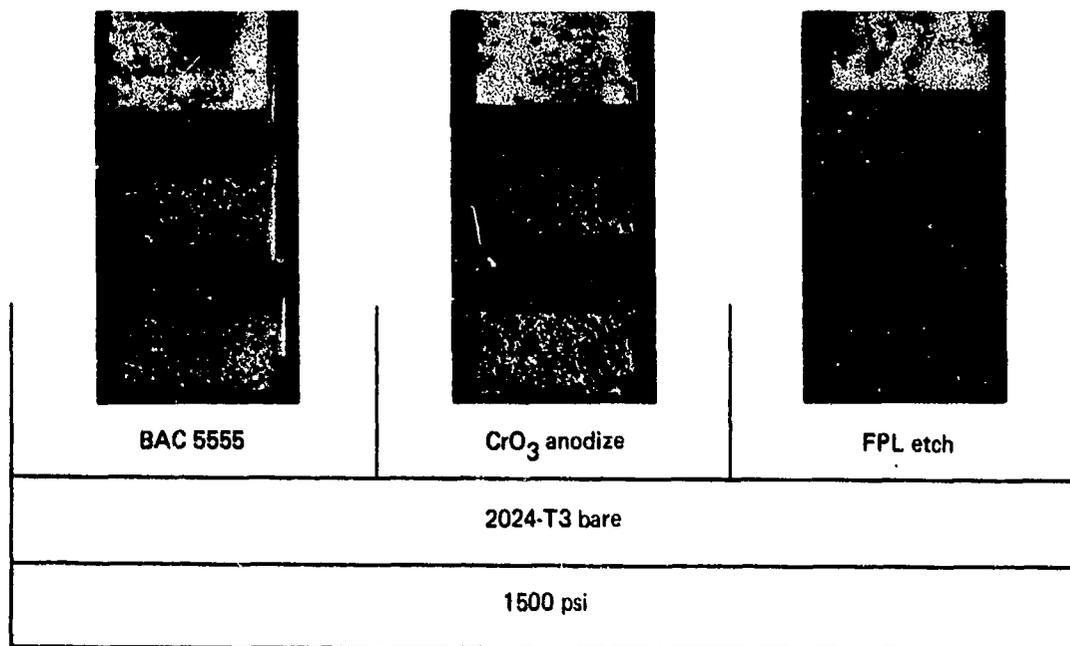
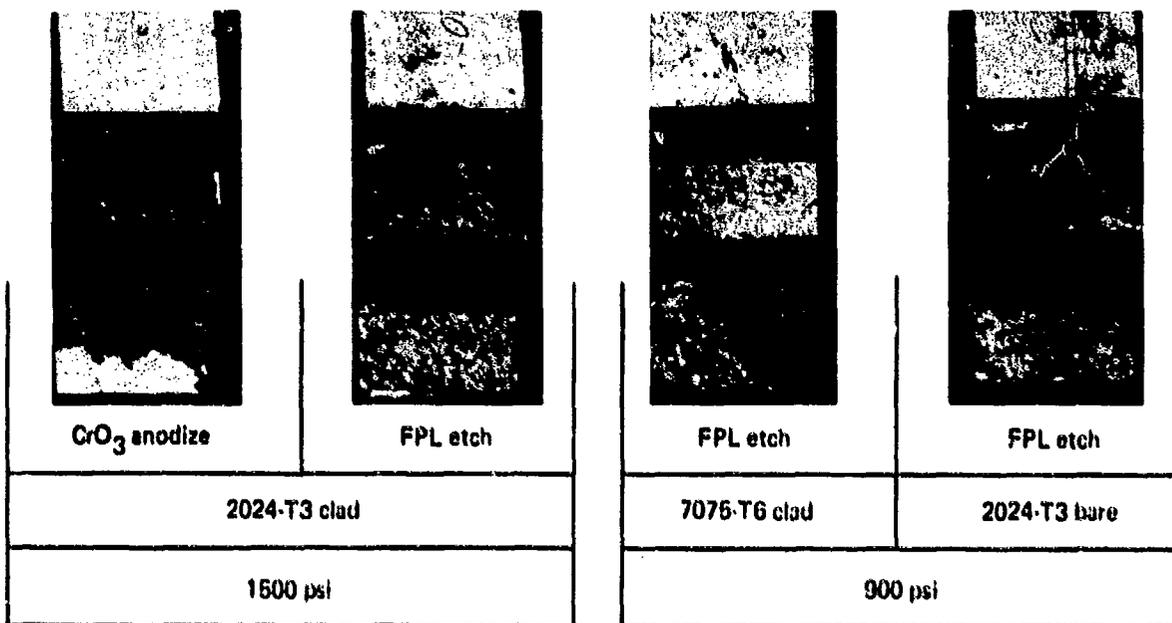
Adhesive System: FM 123-2/BR 127

Figure 8.—Typical Thick-Adherend Lap-Shear Specimen Failures for Sustained-Stress Tests Exposed to 140° F/Condensing Humidity

This test method discriminates between adhesive systems; i.e., most of the failures occurred with the FM 123-2/BR 127 adhesive/primer system, some failures occurred with the new technology adhesive/primer system EA 9628/BR 127, but no failures occurred with either of the two 350° F cure adhesive/primer systems. Surface treatments and alloys did not have a significant effect on the time to failure or the failure modes. Typical failure modes are shown in figure 8.

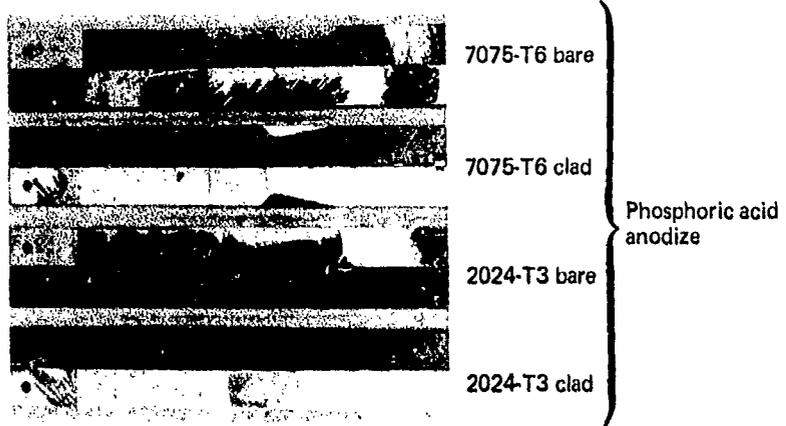
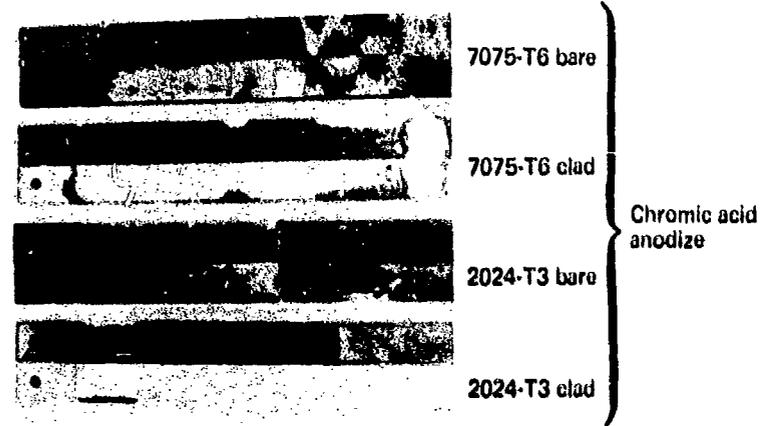
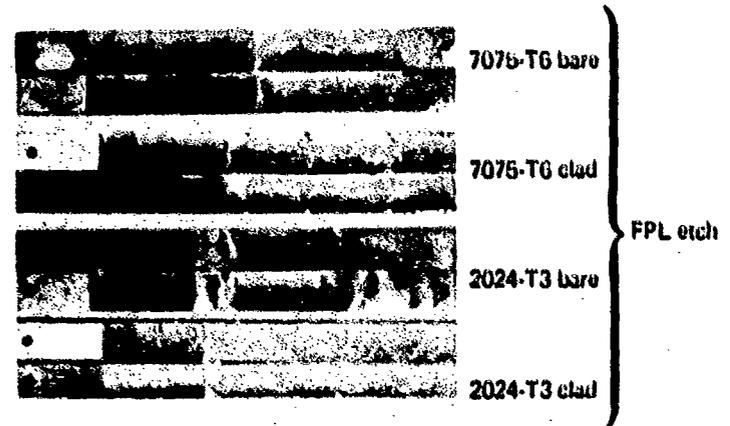
→ Crack growth

(a) With 20 Weeks' Exposure to 140°F/Condensing Humidity

Figure 10.—Opened DCB Specimens Bonded with PL 729-3/PL 728

Plots of G_I vs exposure time for each bonded system are shown in figure 9. There is no significant difference in durability behavior between surface treatments and alloys in terms of crack growth equilibrium resulting from the environmental exposure, i.e., the stress corrosion cracking threshold, G_{ISCC} , except for the failure modes within the stressed zone. After opening one set of specimens for each bonded system, it was observed that the FPL-etched specimens had a higher frequency of adhesive failures within the stressed zone than did the two anodized treatment specimens, primarily with the 250°F cure epoxy systems. This was not reflected in the crack growth data. For instance, the G_I vs time data in figure 9g show no significant difference between surface treatments, but the FPL-etched specimens had at least 50% adhesive-type failure in the area of crack growth while the two anodized surfaces had less than 5% adhesive failure. The apparent variations in G_I vs time between the three surface preparations are within the normal variations one would expect of this test method. Typical failure modes are shown in figures 10 through 13.

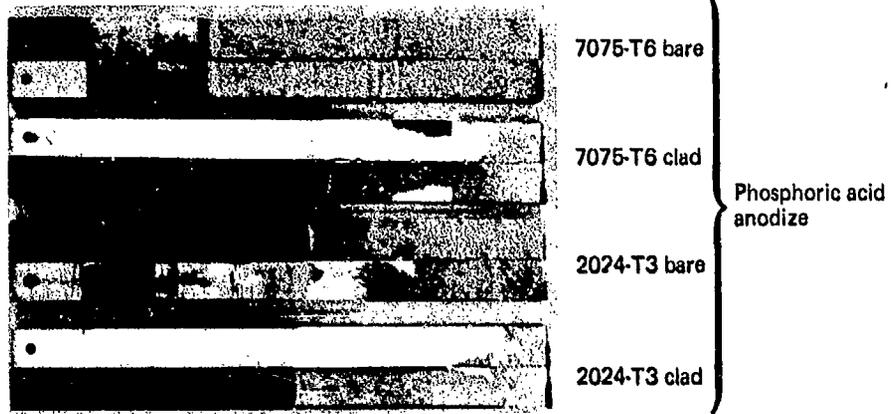
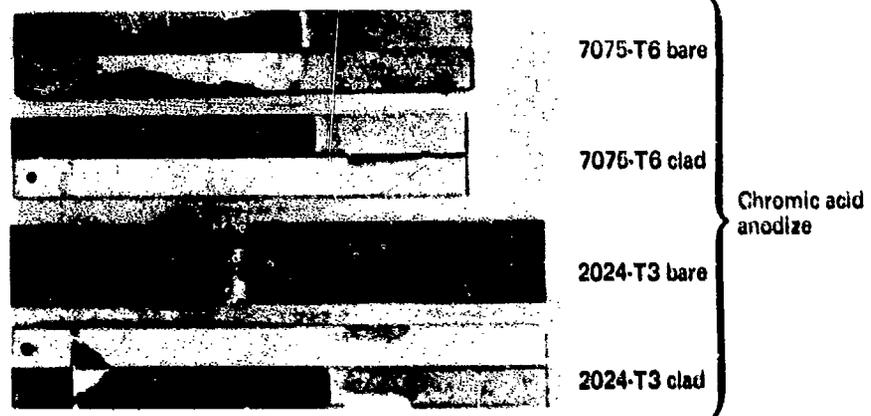
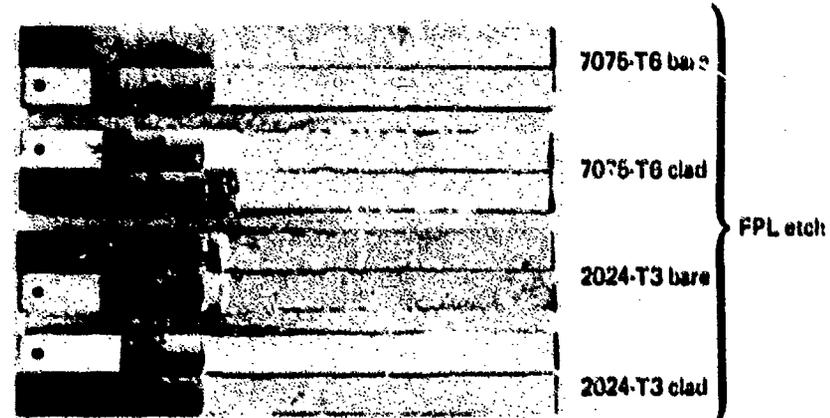
(b) With 77 Weeks' Exposure to 140°F/Condensing Humidity

Figure 10.--(Concluded)

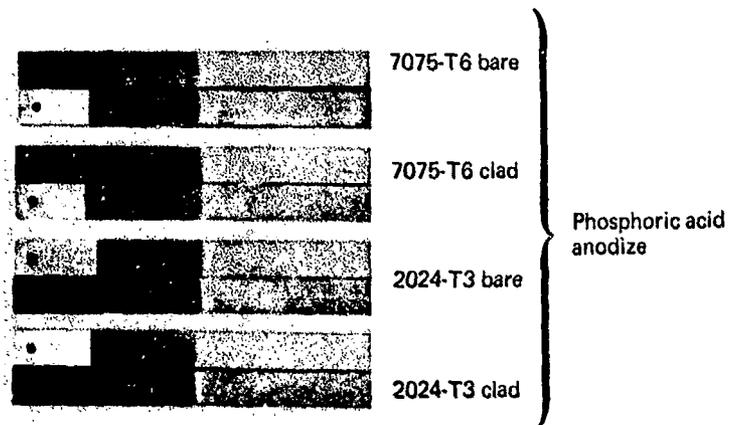
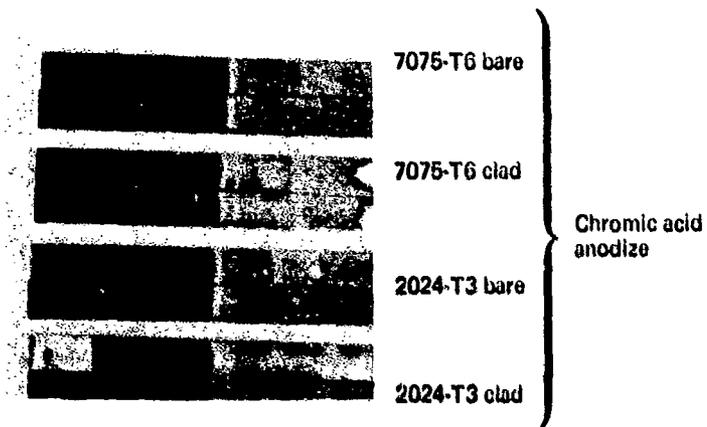
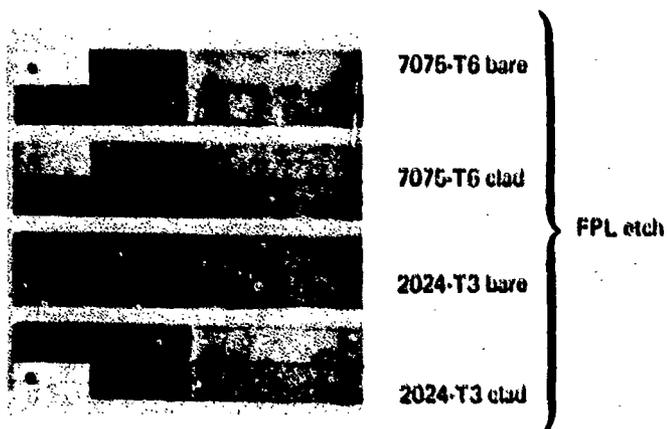
(a) With 20 Weeks' Exposure to 140°F/Condensing Humidity

Figure 11.—Opened DCB Specimens Bonded With AF 143/EC 3917 System

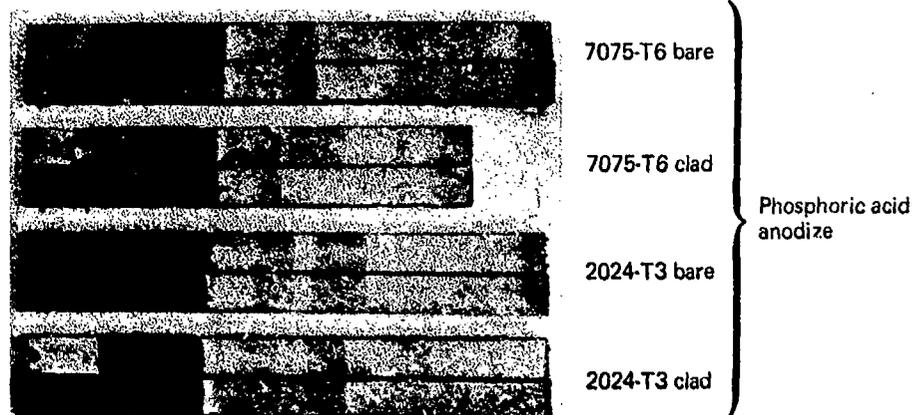
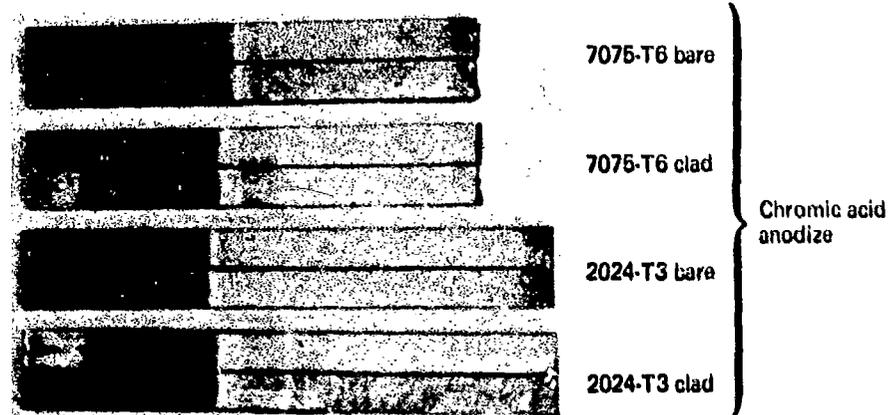
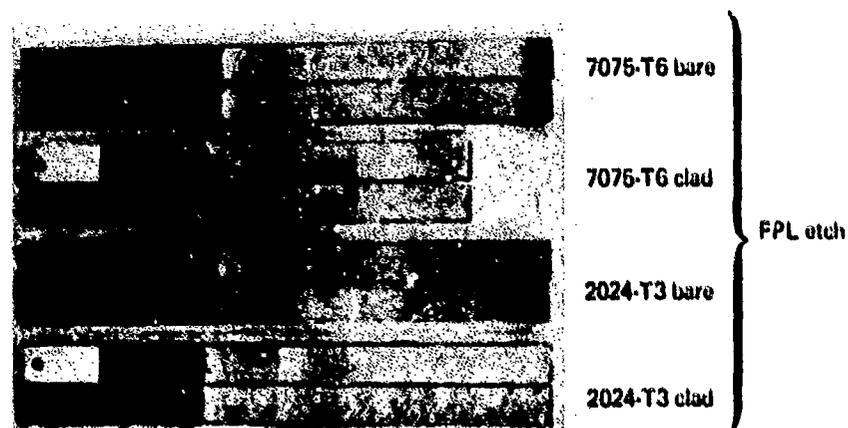
(b) With 77 Weeks' exposure to 140°F/Condensing Humidity

Figure 11.—(Concluded)

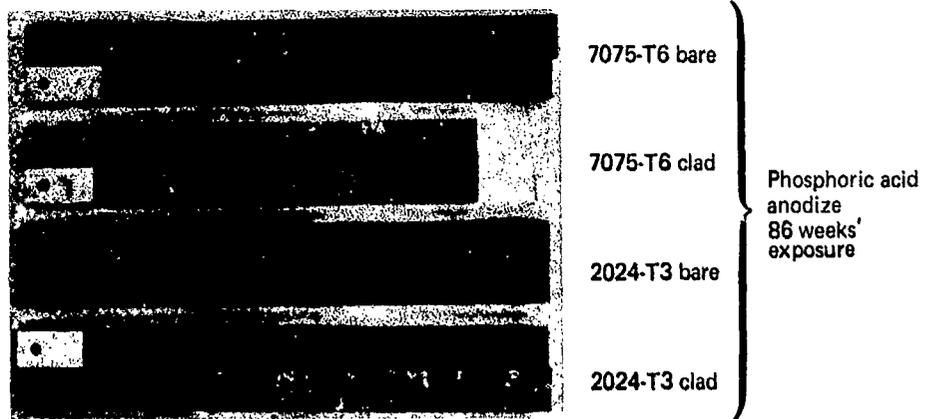
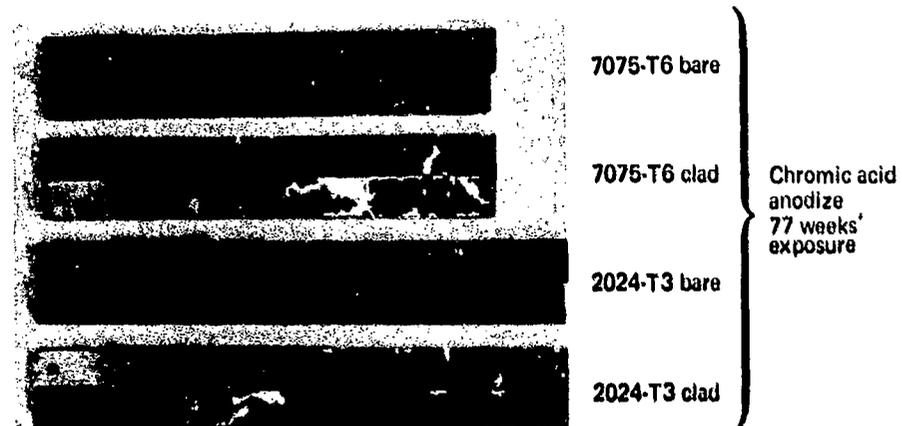
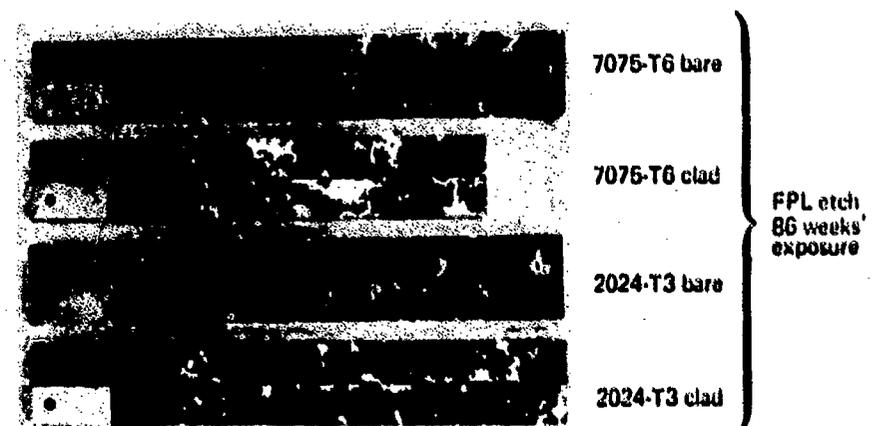
(b) With up to 86 Weeks' Exposure to 140°F/Condensing Humidity

Figure 12.—(Concluded)

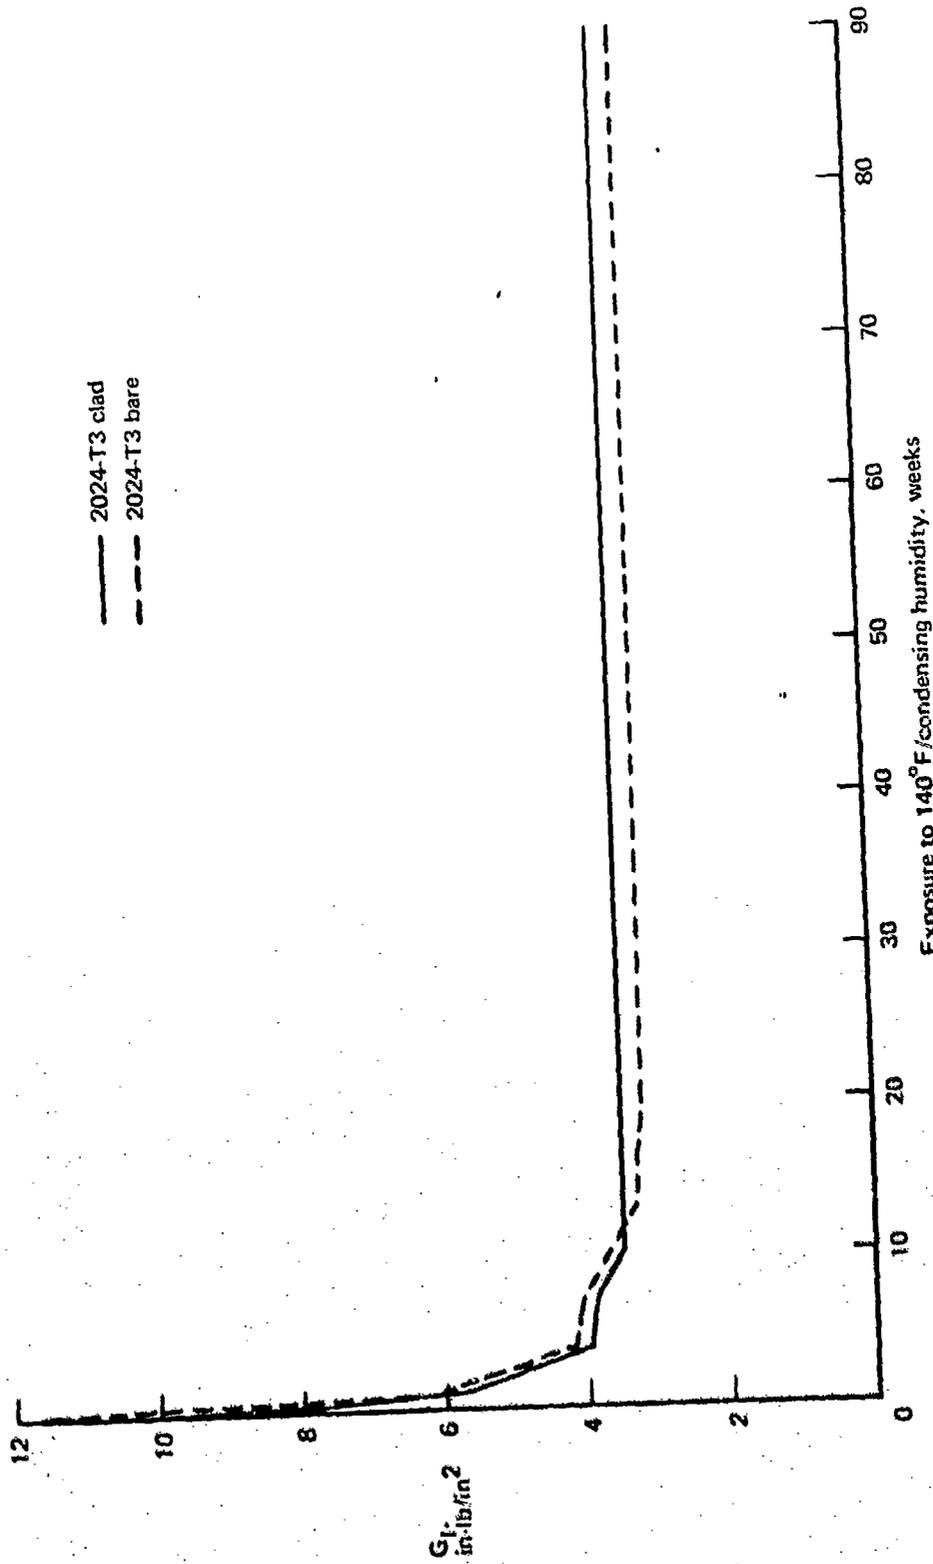
(a) Exposure Results: FM 123-2/BR 127, 2024-T3 Bare and Clad, Phosphoric Acid Anodize

Figure 15.—Influence of Long-Term Exposure on DCB Specimen

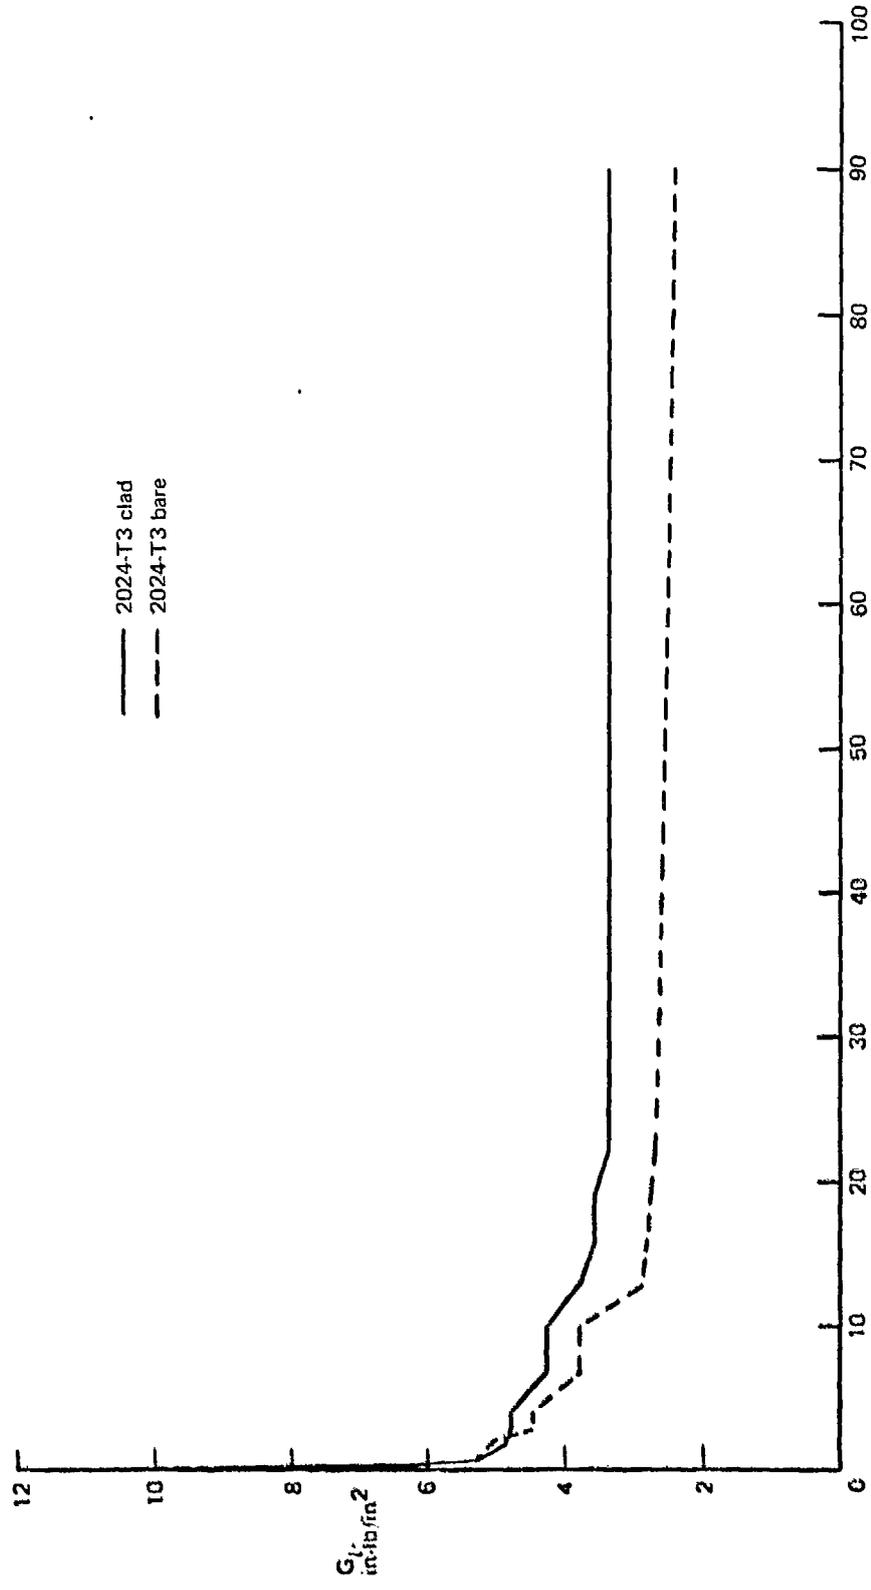
(b) Exposure Results: EA 9628/BR 127, 2024-T3 Bare and Clad, Phosphoric Acid Anodize
 Figure 15.—(Continued)

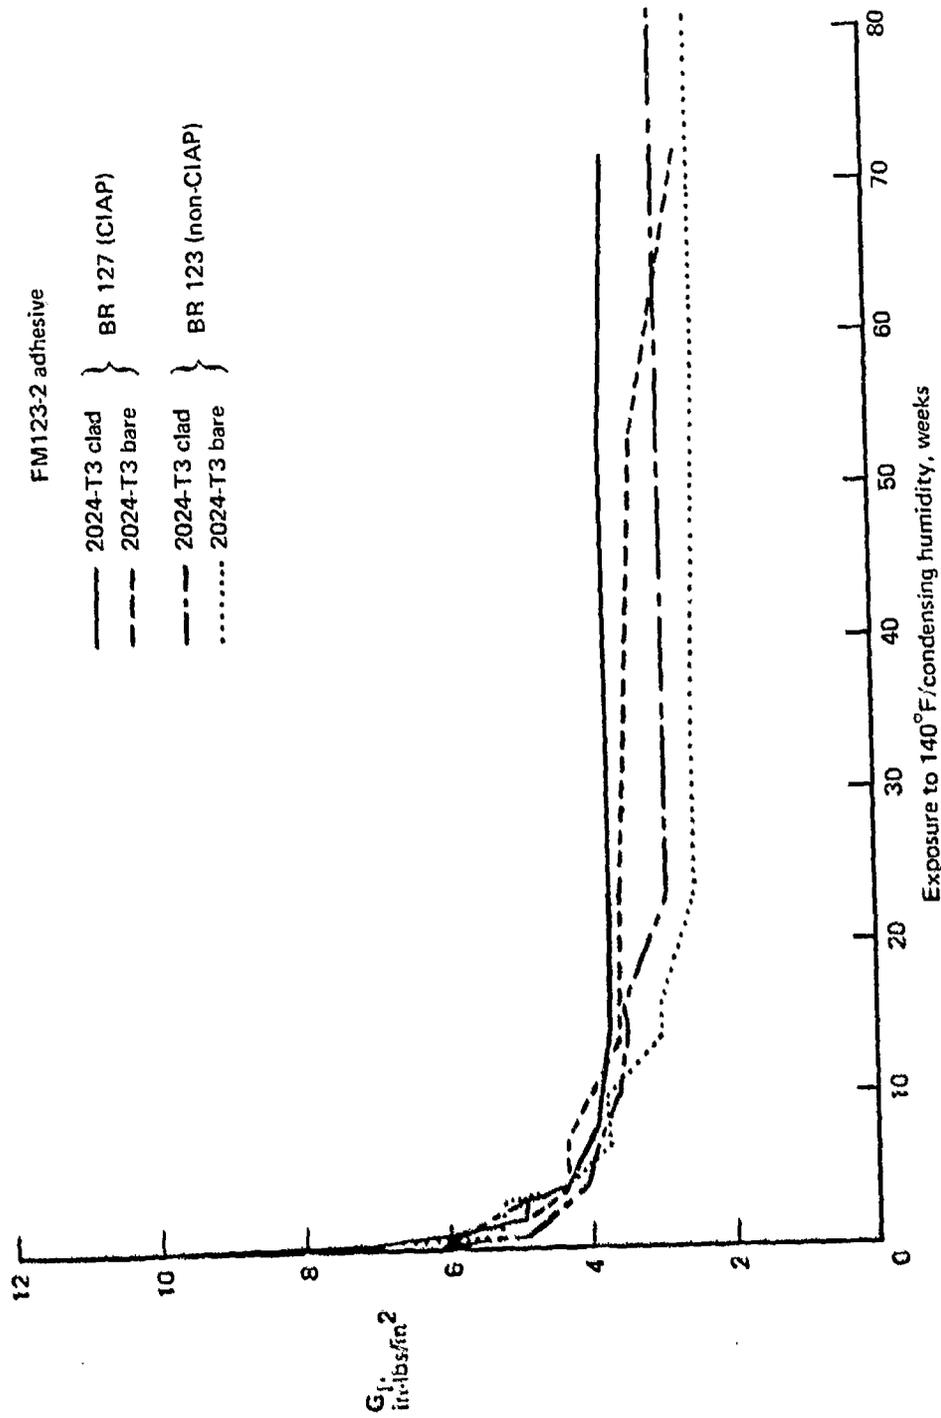
(a) Exposure Results, Phosphoric Acid Anodize Surface Preparation on 2024-T3 Bare and Clad with BR127(CIAP) and BR123(Non-CIAP) Primers

Figure 16.—Influence of Adhesive primers on DCB Specimen

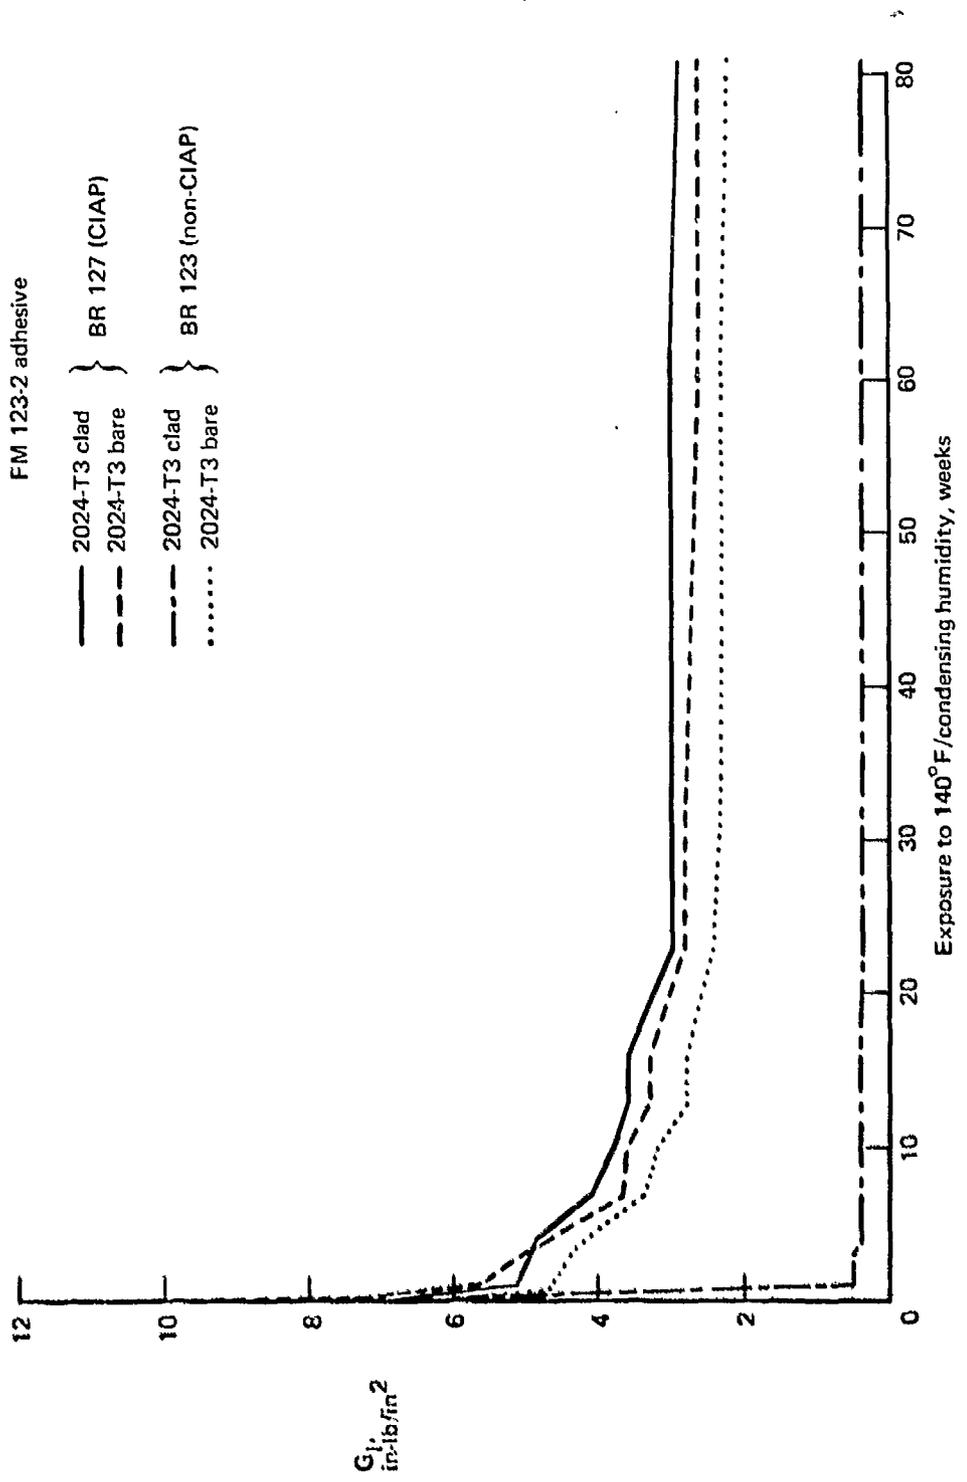
(b) Exposure Results—Chromic Acid Anodize Surface Preparation on 2024-T3 Bare and Clad with BR 127 (CIAP) and BR 123 (Non-CIAP) Primers

Figure 16.—(Concluded)

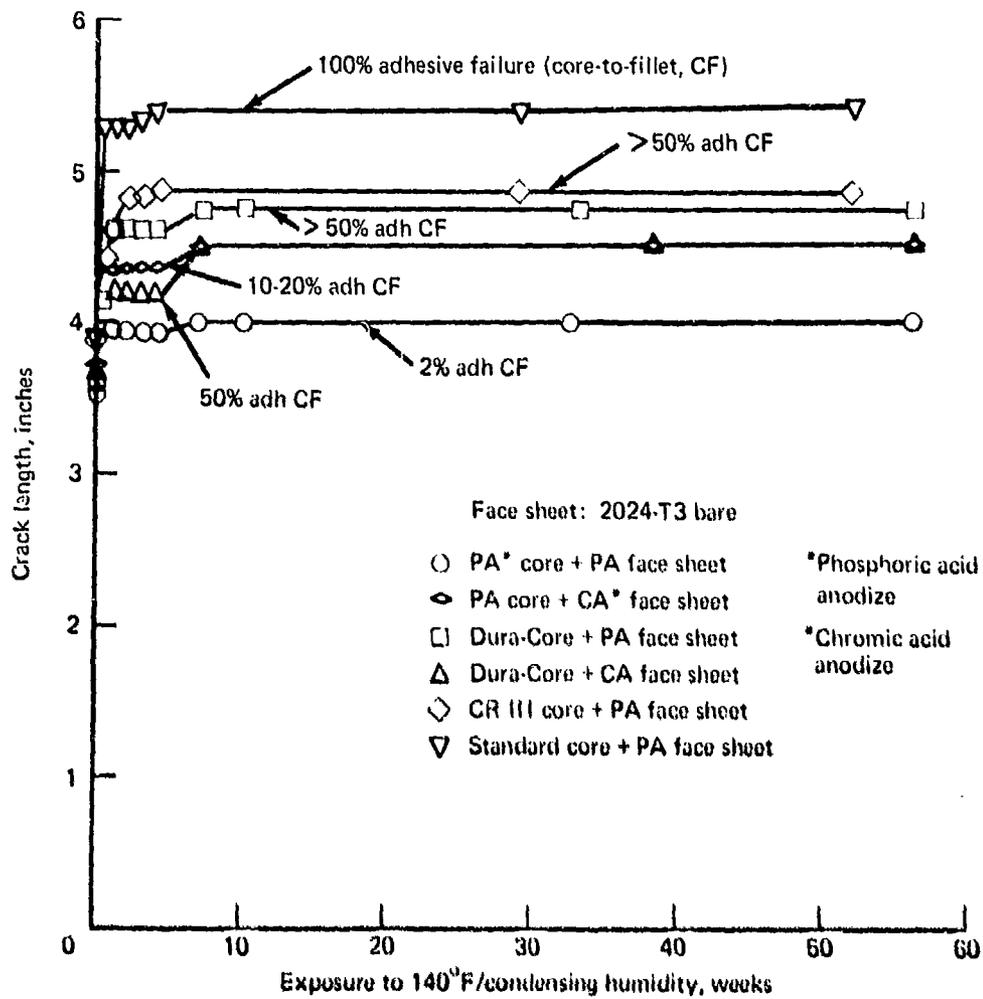
(a) SCB Specimens, EA 9628/BR 127

Figure 18.—Influence of Honeycomb Core and Face Sheet Surface Treatments on Environmental Durability

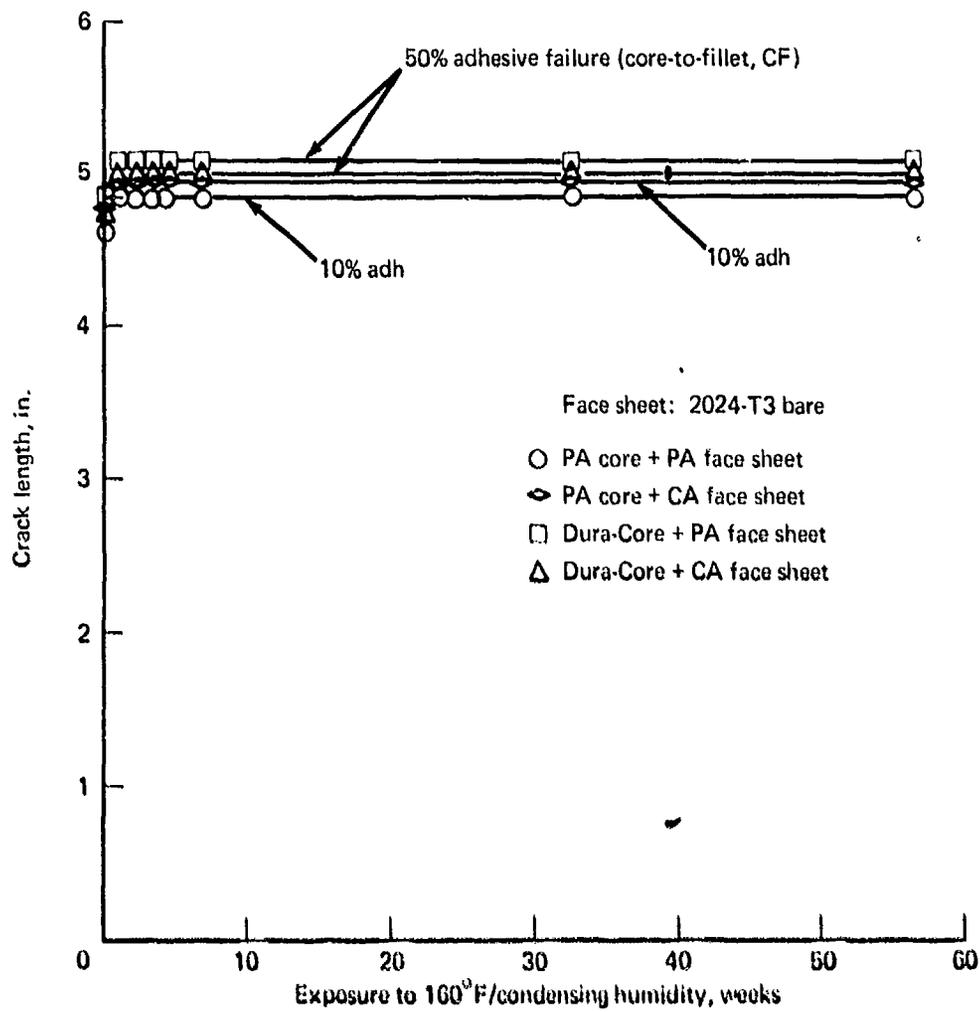
(c) SCB Specimens, AF 143/EC 3917

Figure 18.—(Concluded)

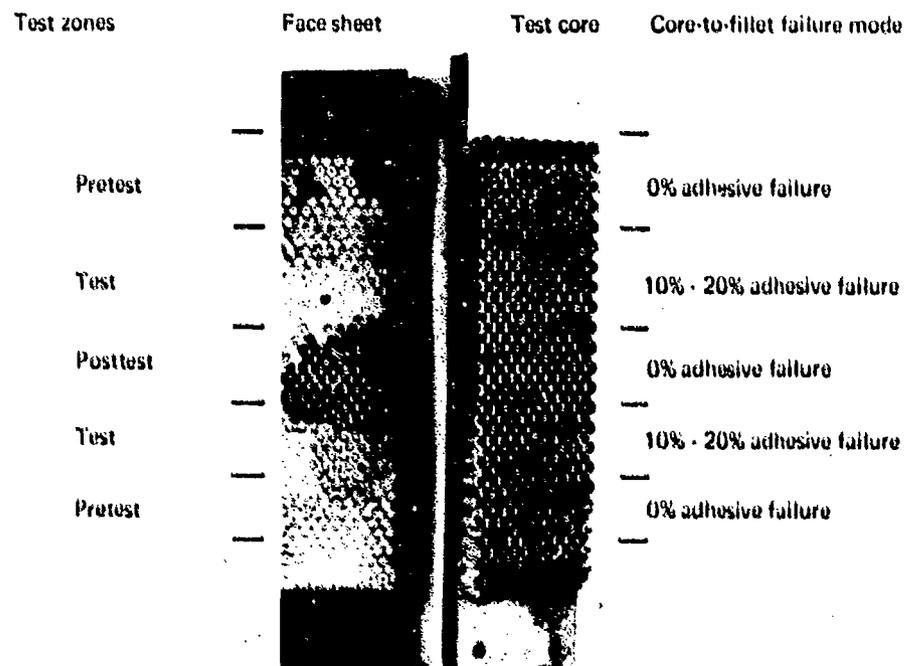
(b) Phosphoric Acid Anodize Core, Chromic Acid Anodize 2024-T3 Bare Face Sheet

Figure 19.—Failure Modes in the Pretest, Test, and Posttest Areas of SCB Specimens Bonded with EA 9628 and Exposed to 140° F/Condensing Humidity

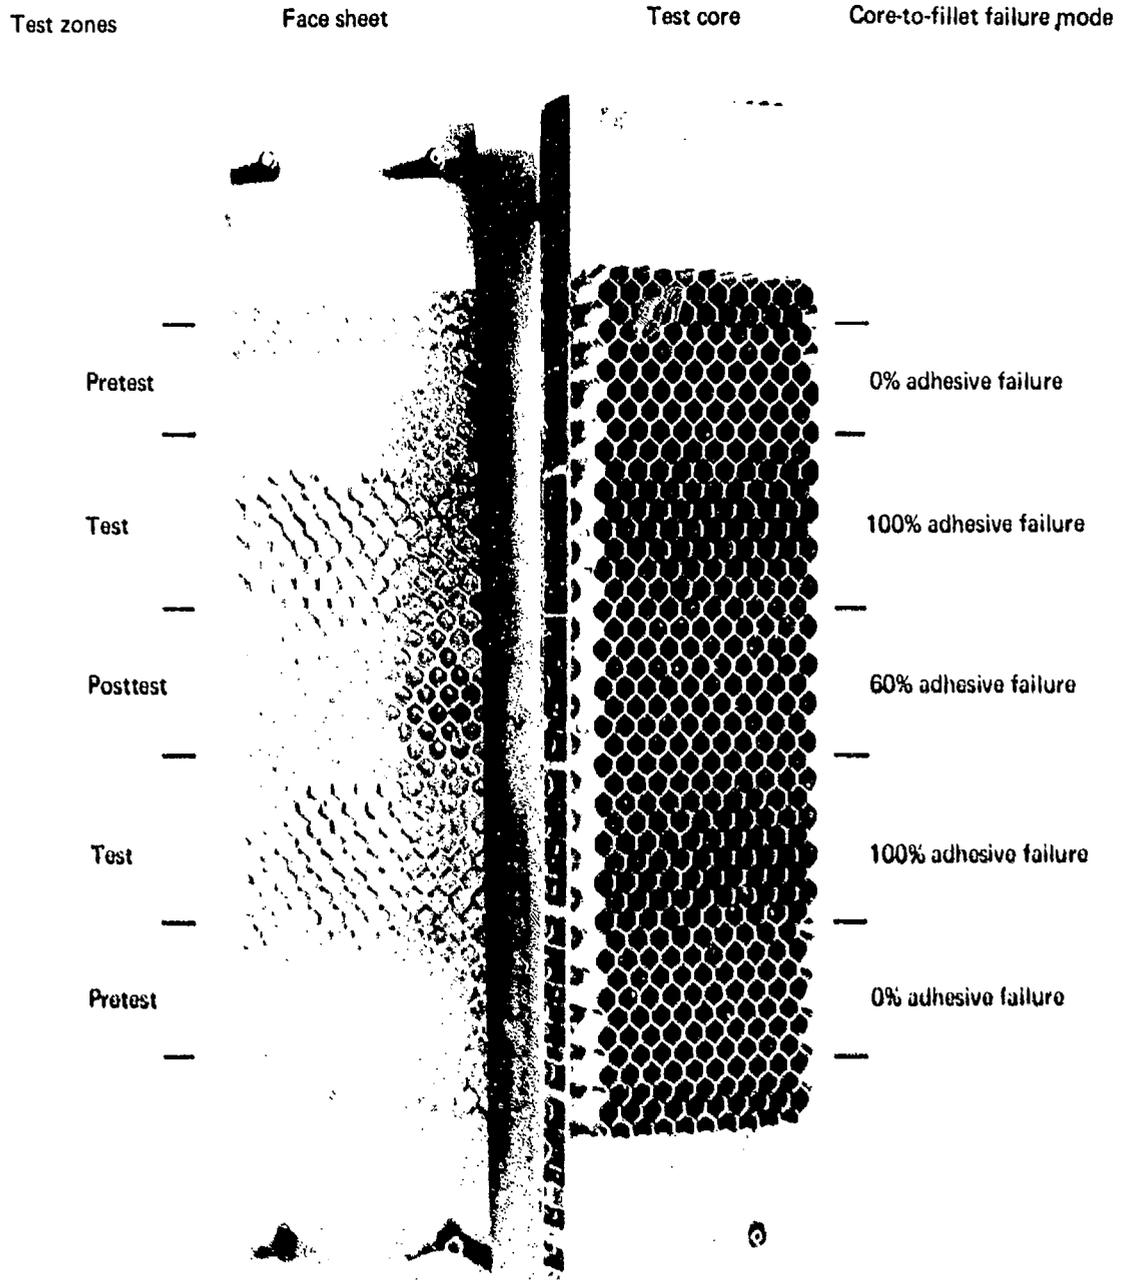
(c) Standard Core, Phosphoric Acid Anodize Face Sheet

Figure 19.—(Concluded)

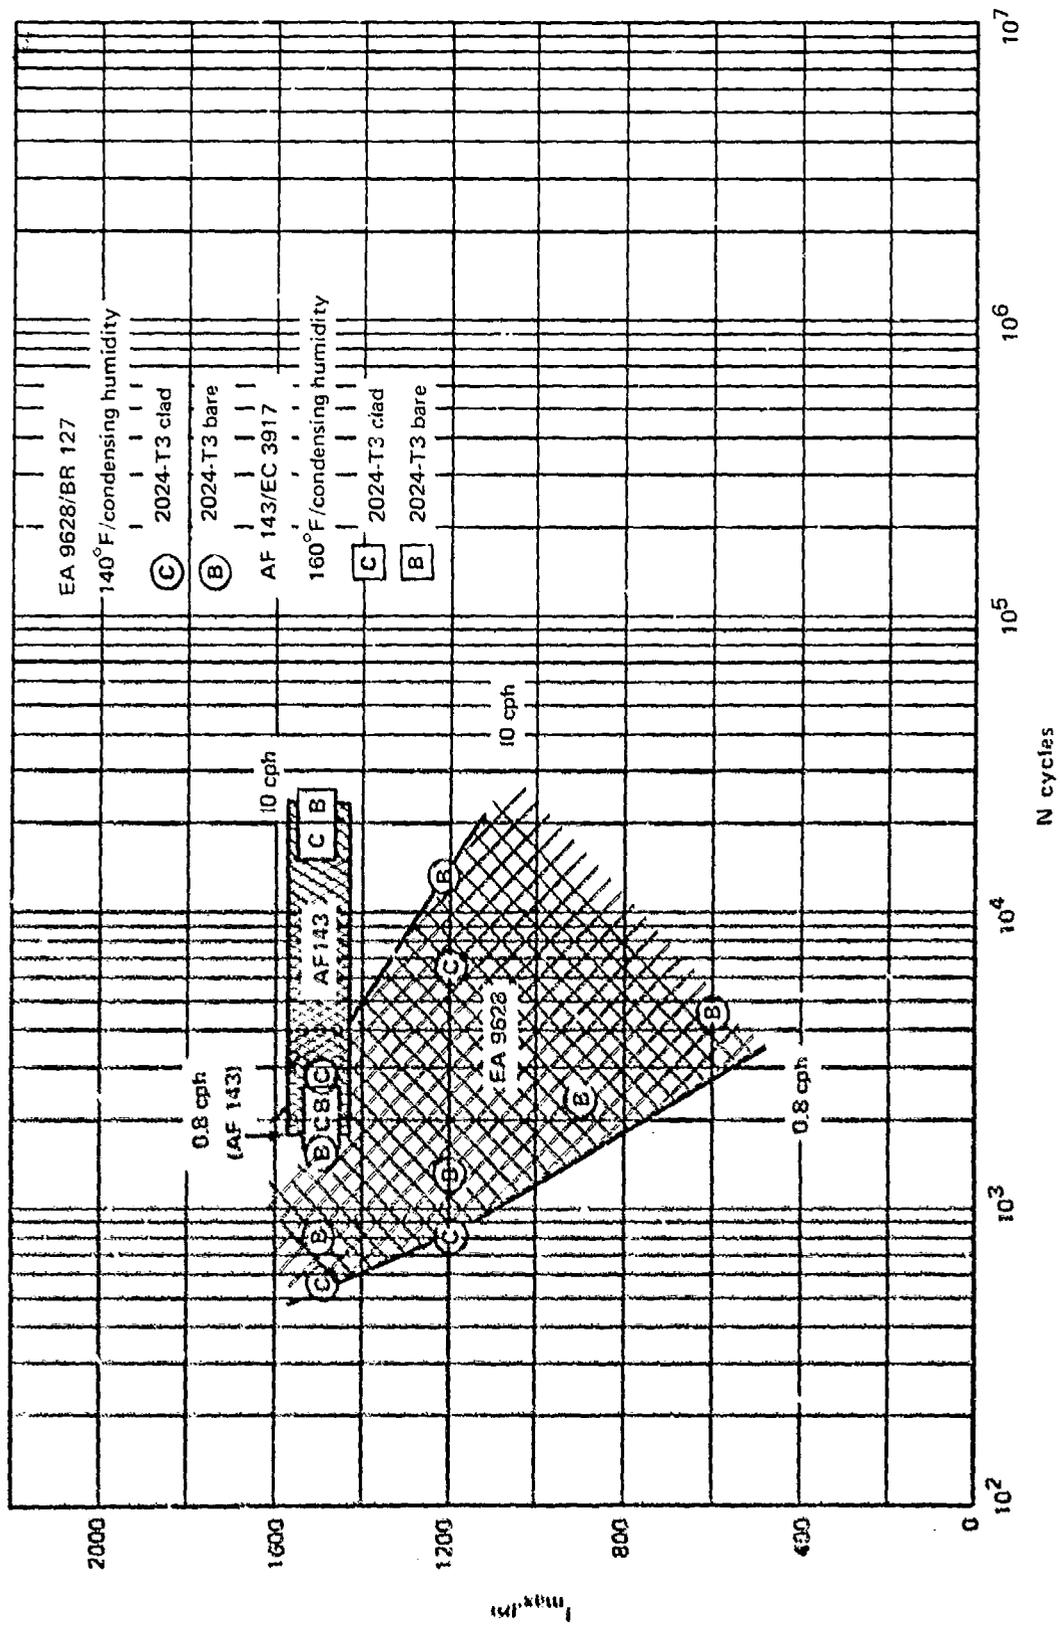
Figure 23.—Comparisons of Slow Cyclic Fatigue for 0.8 cph (Bell) and 10 cph for EA 9628/BR 127 and AF 143/EC 3917 Adhesive Systems
