**EXPLORATORY DEVELOPMENT ON DURABILITY OF
ADHESIVE BONDED JOINTS**

**BOEING COMMERCIAL AIRPLANE COMPANY
P.O. BOX 3707
SEATTLE, WASHINGTON 98124**

**TECHNICAL REPORT AFML-TR-76-173
FINAL REPORT FOR PERIOD FEBRUARY 1974 - OCTOBER 1976**

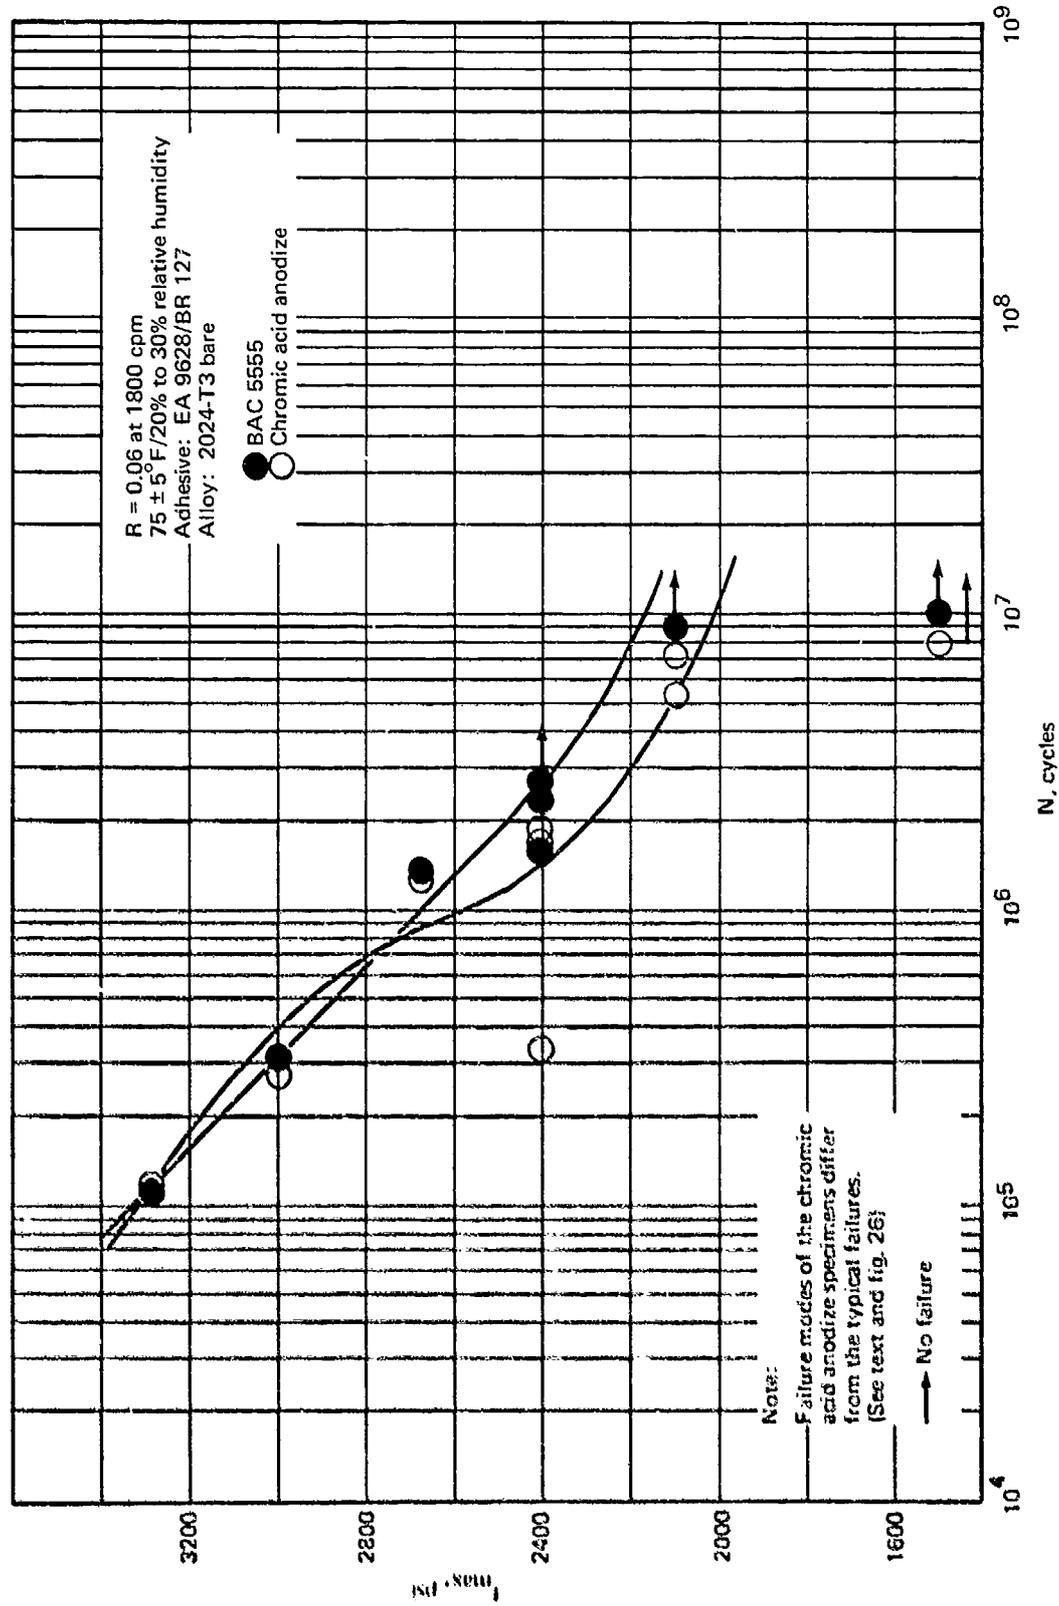
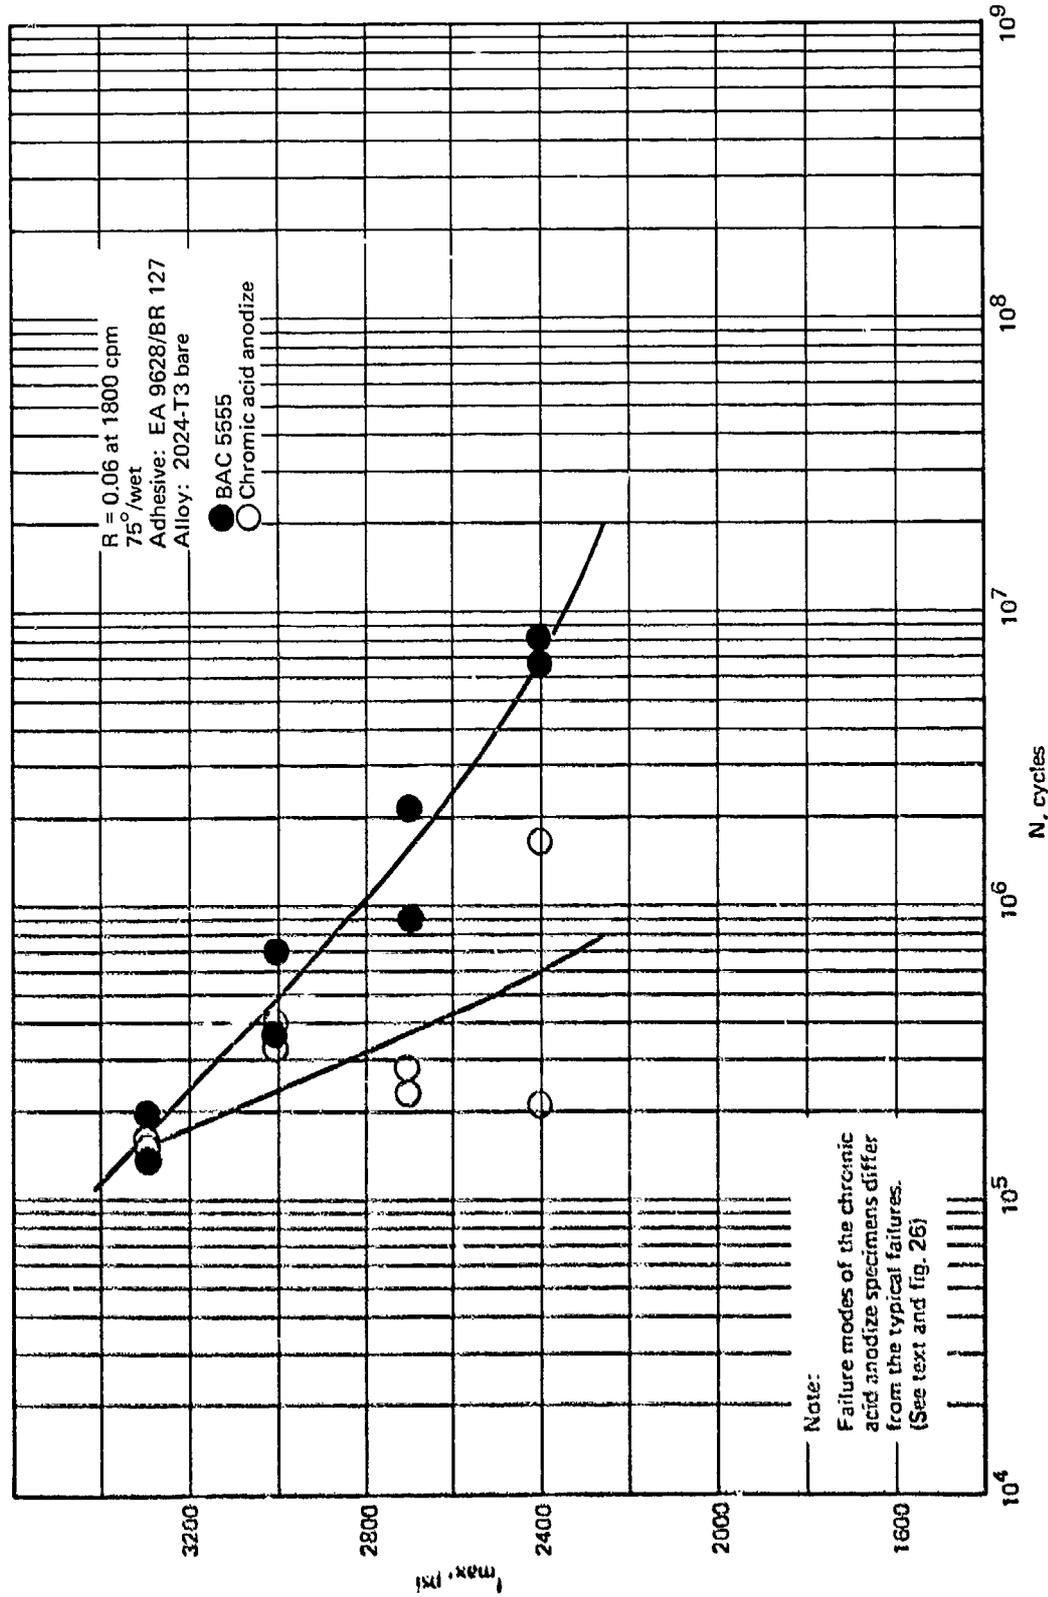
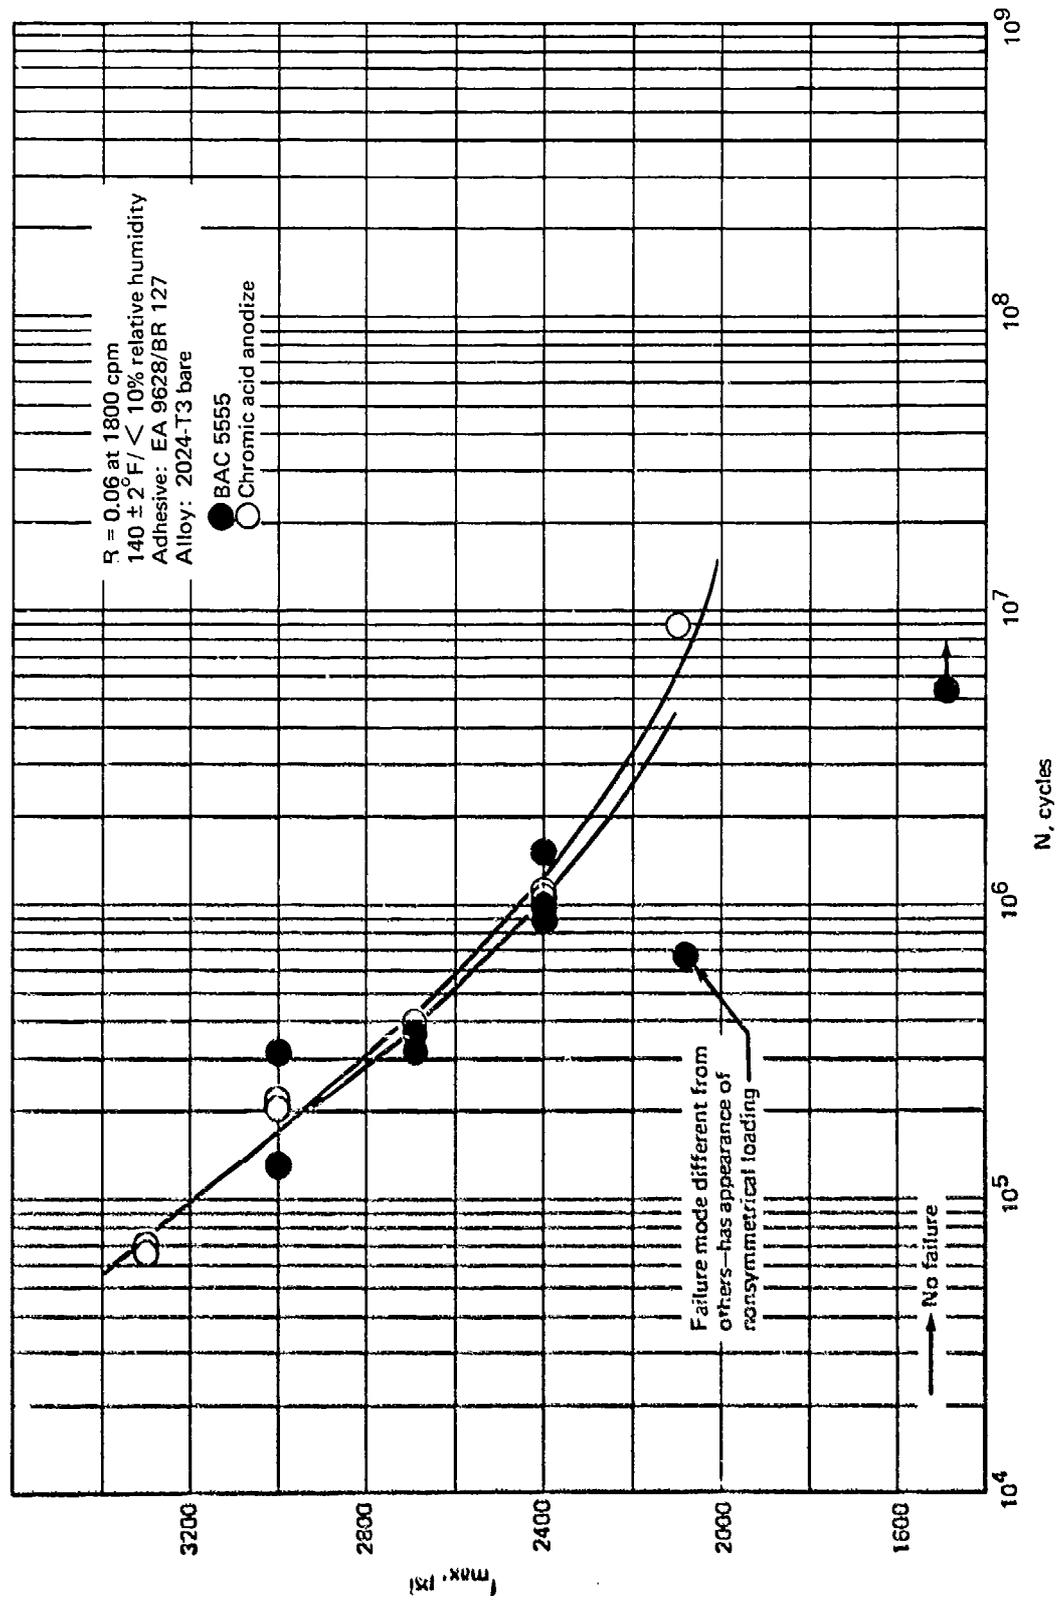
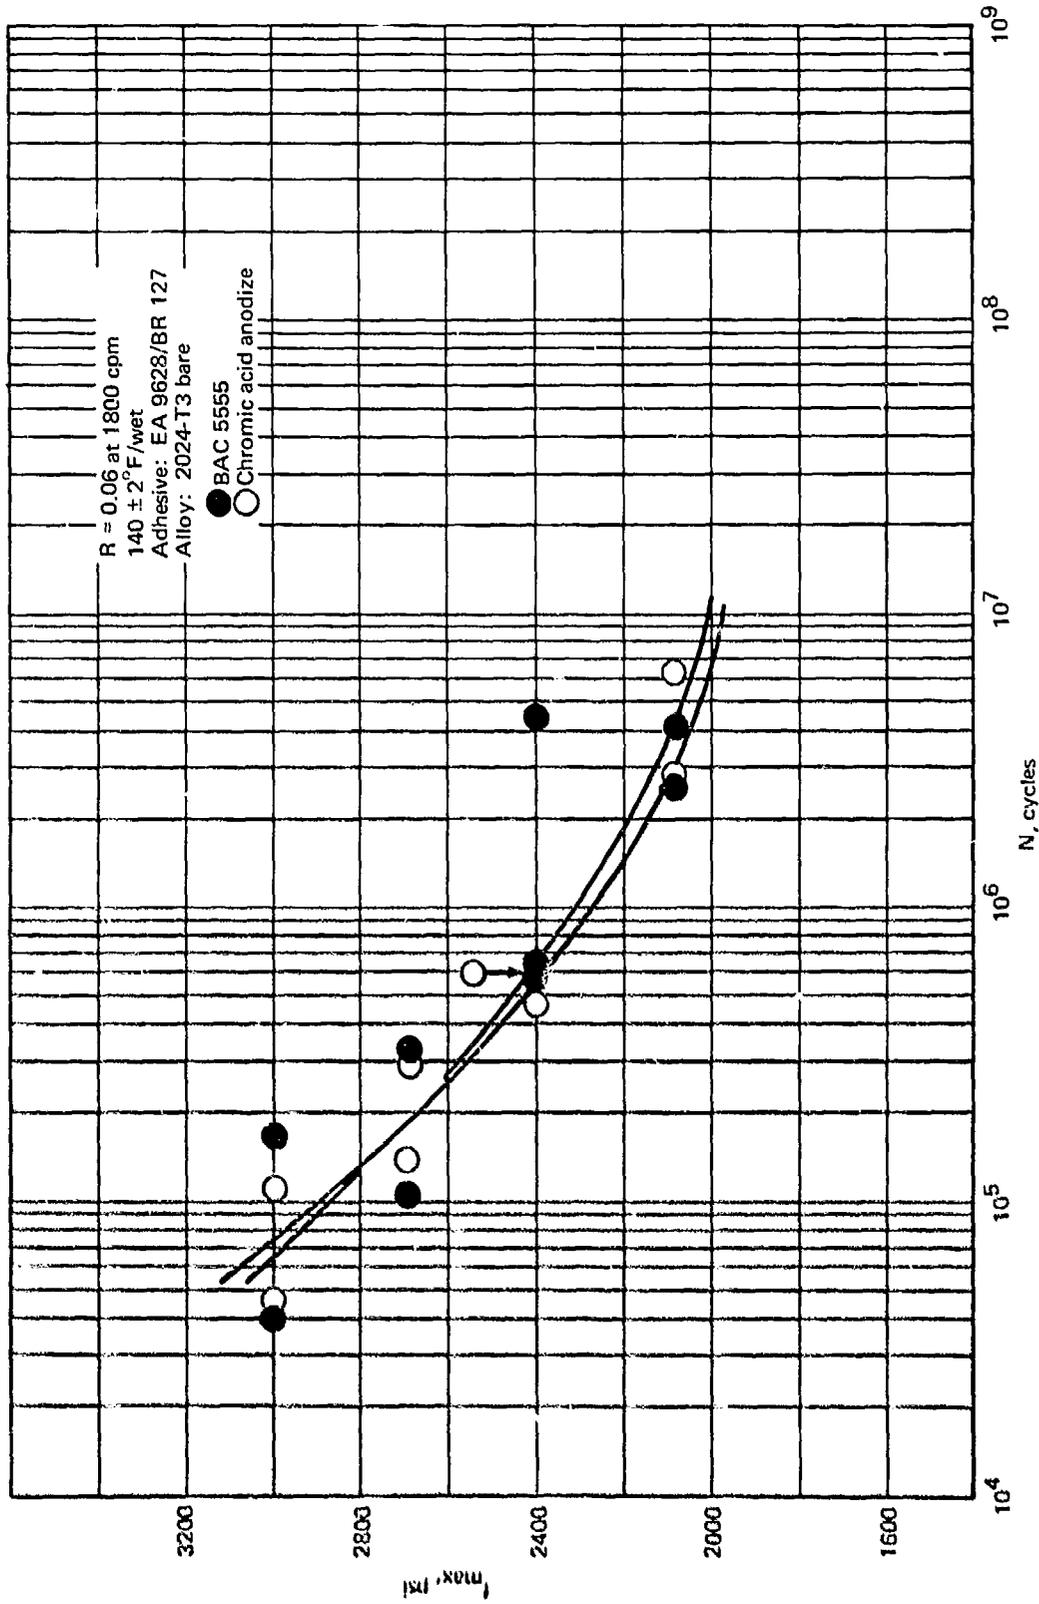
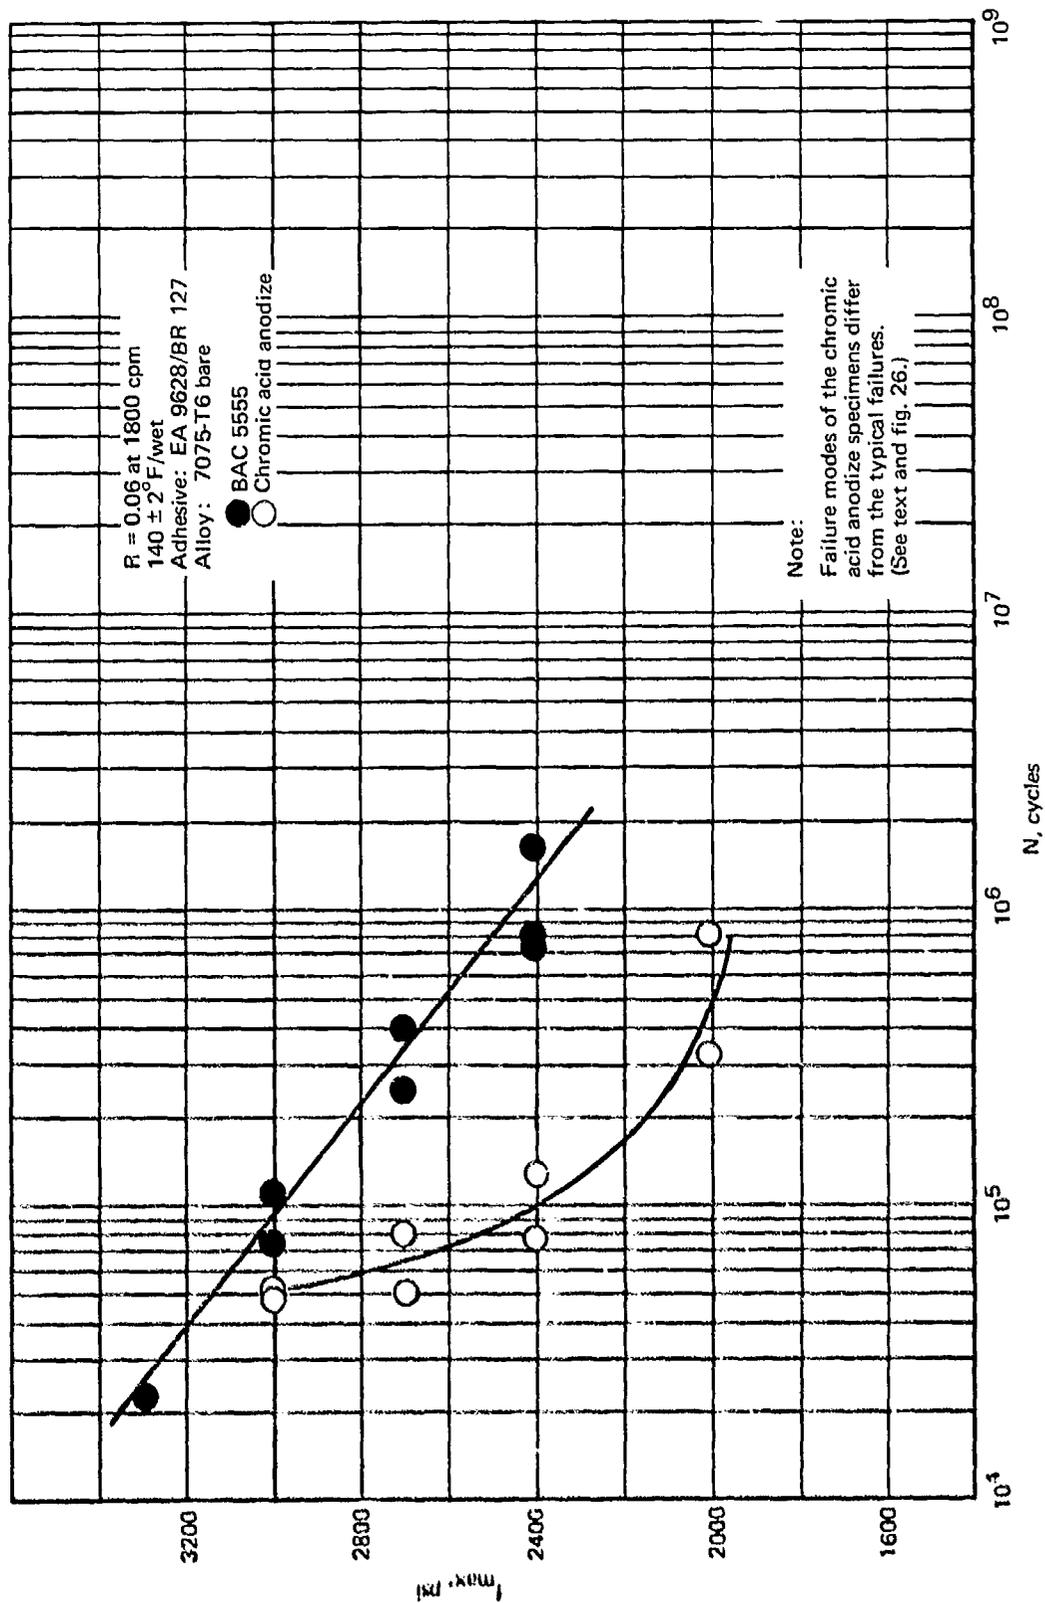
(a) 75°F Dry Environment

Figure 25.—Fast Cycle Stress Results

(b) 75°F Wet Environment
 Figure 25. — (Continued)

(c) 140° F Dry Environment
 Figure 25.—(Continued)

(d) 140° F Wet Environment
 Figure 25.—(Continued)

(e) 140°F Wet Environment, 7075-T6 bare

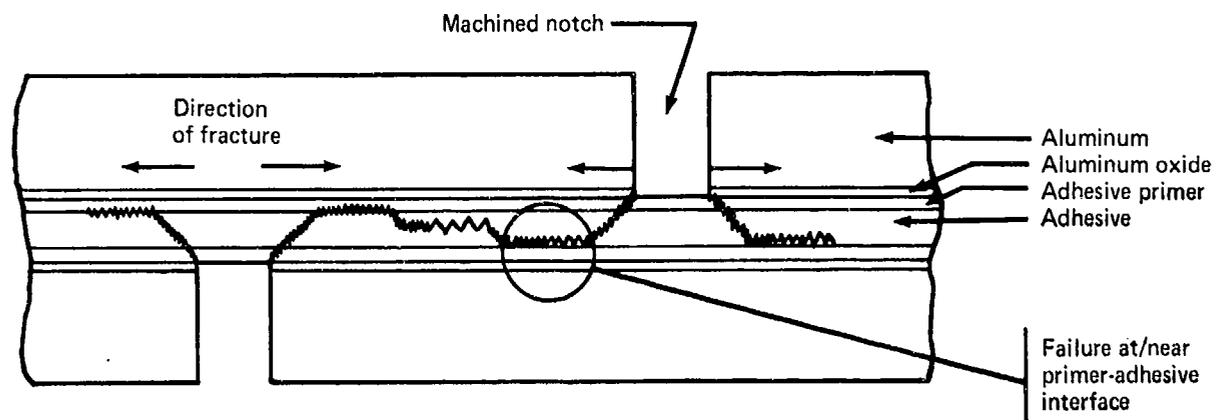
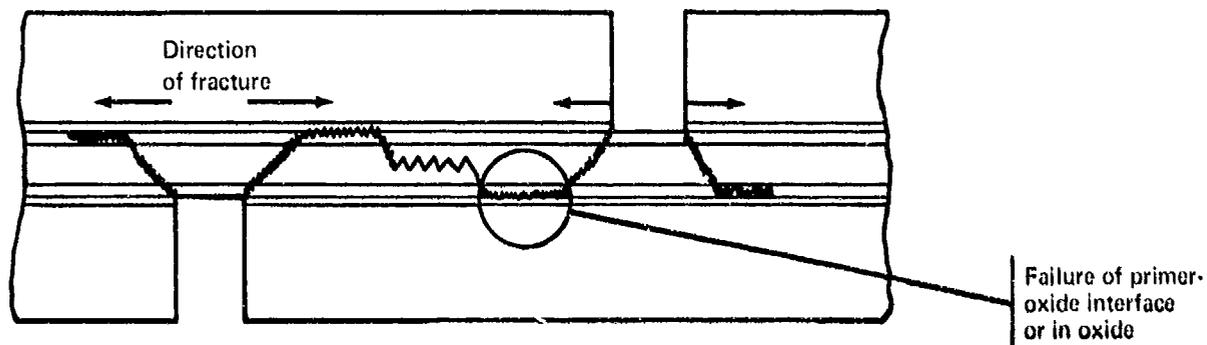
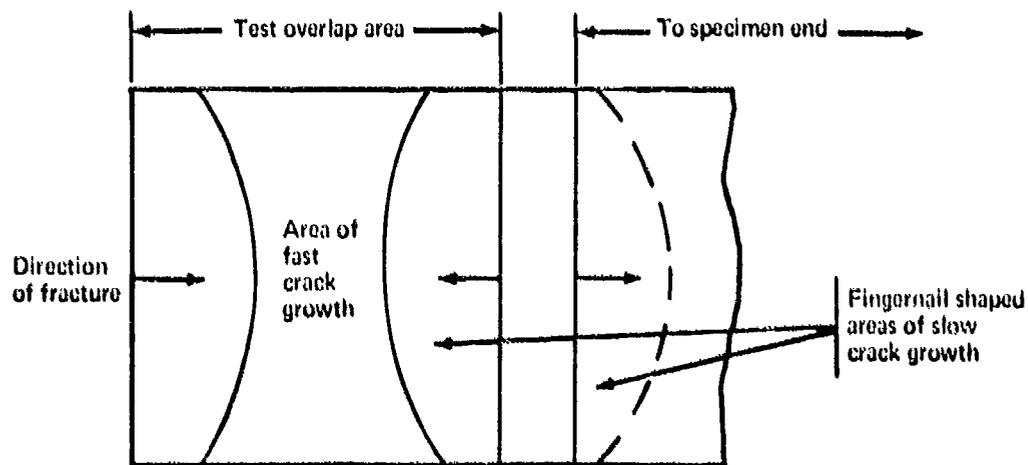
(a) Side View of "Typical" Failure

(b) Side View of "Adhesive" Failure

(c) Top View of Fracture Surfaces

Figure 26.—Failure Mode Characteristics of Thick Adherend Lap Shear Specimens Tested at 1800 cpm, $R = 0.06$.

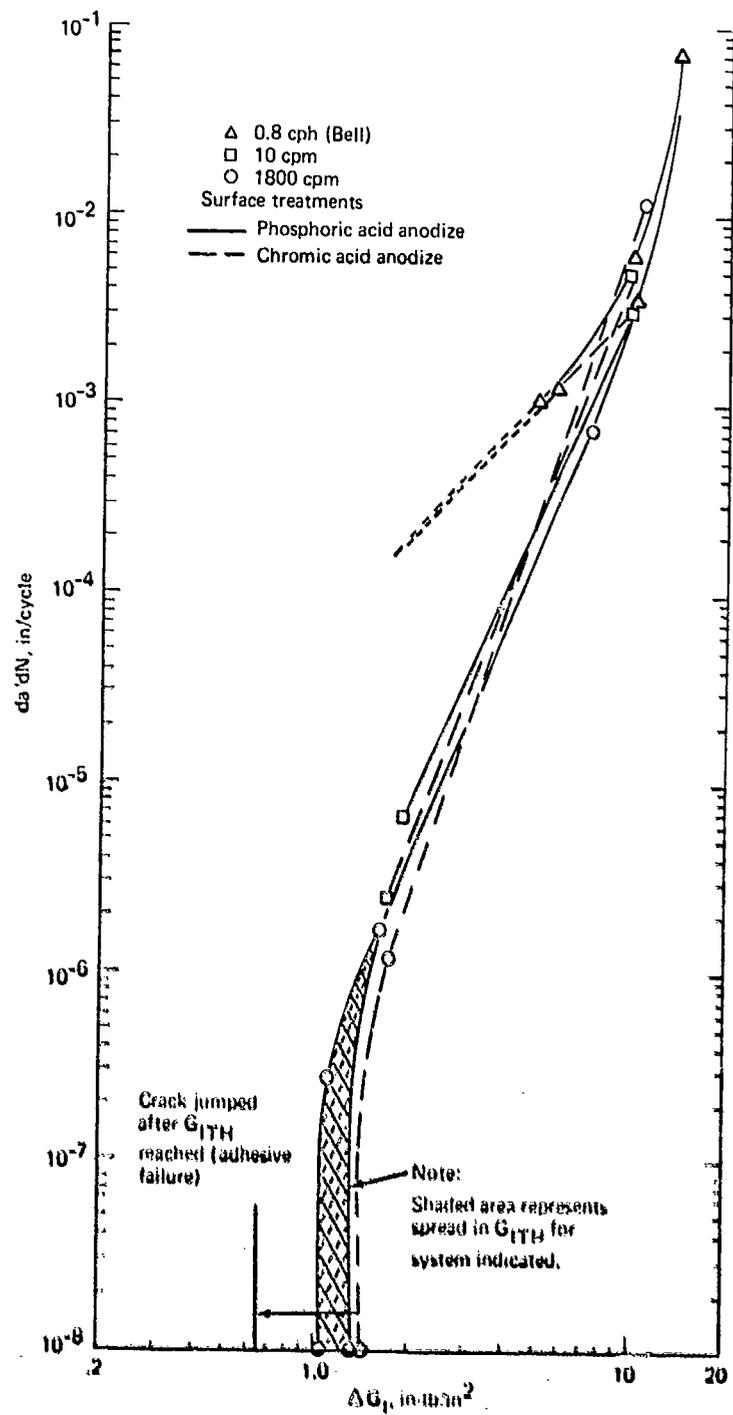
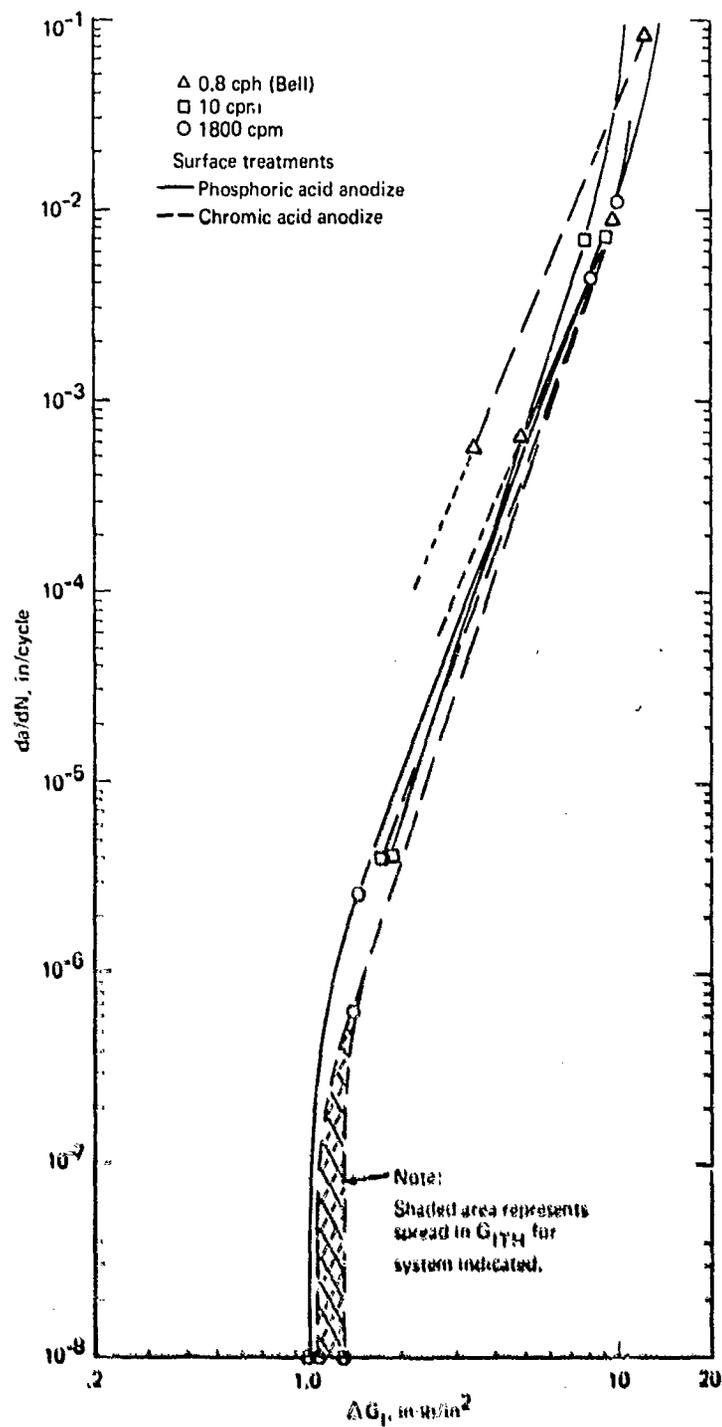
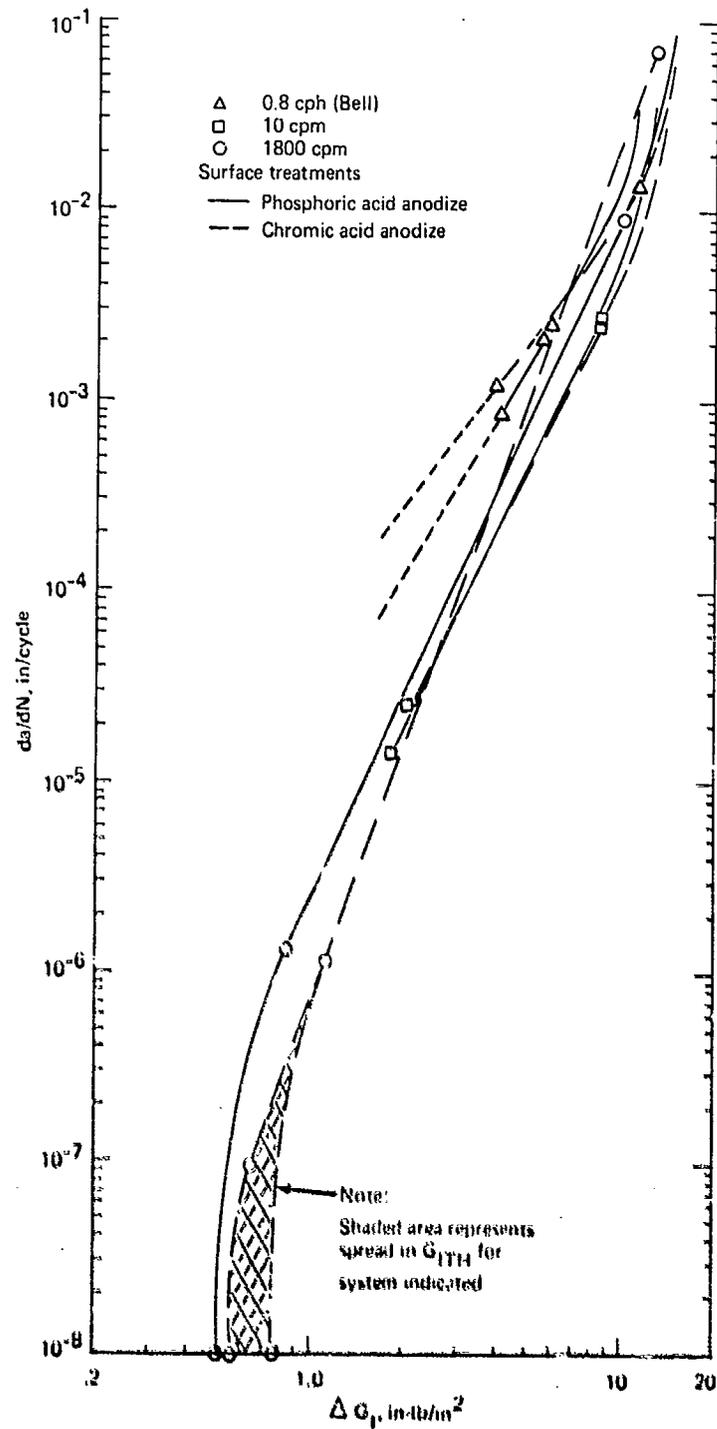
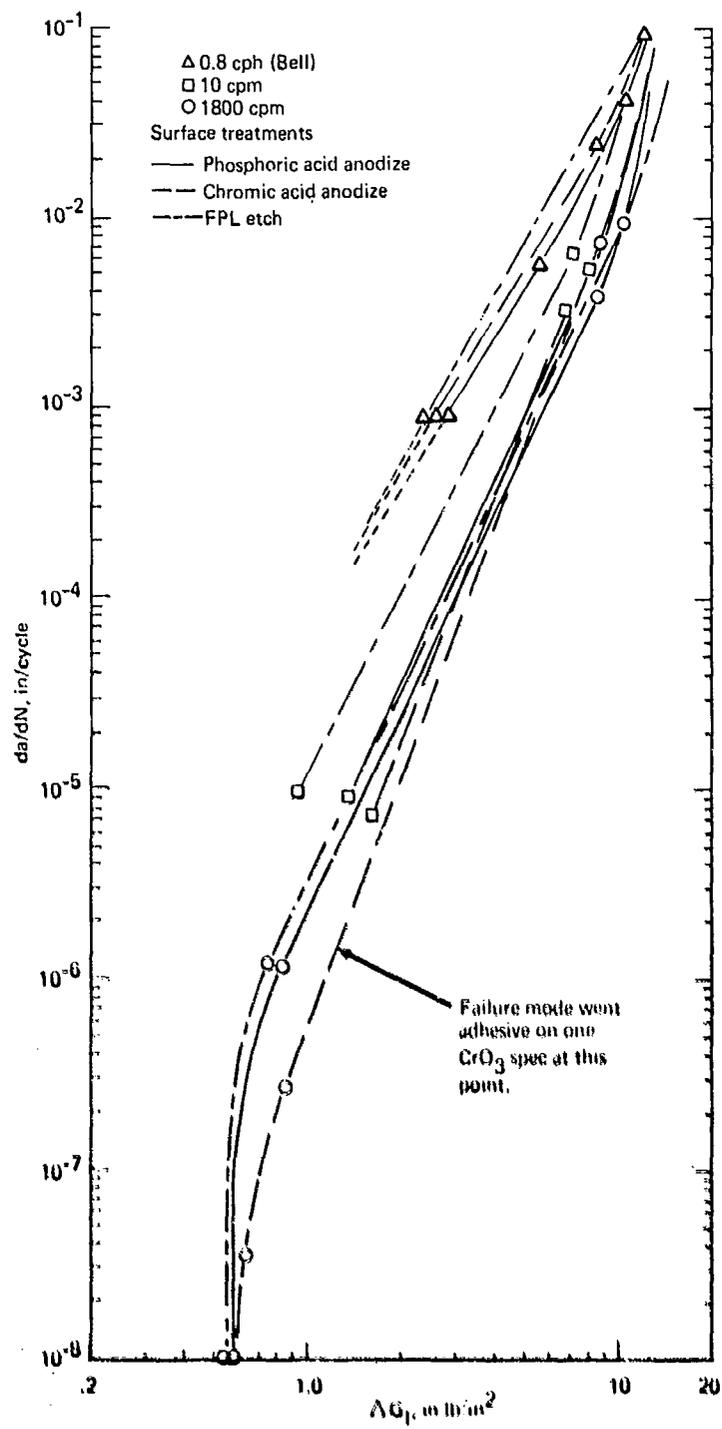
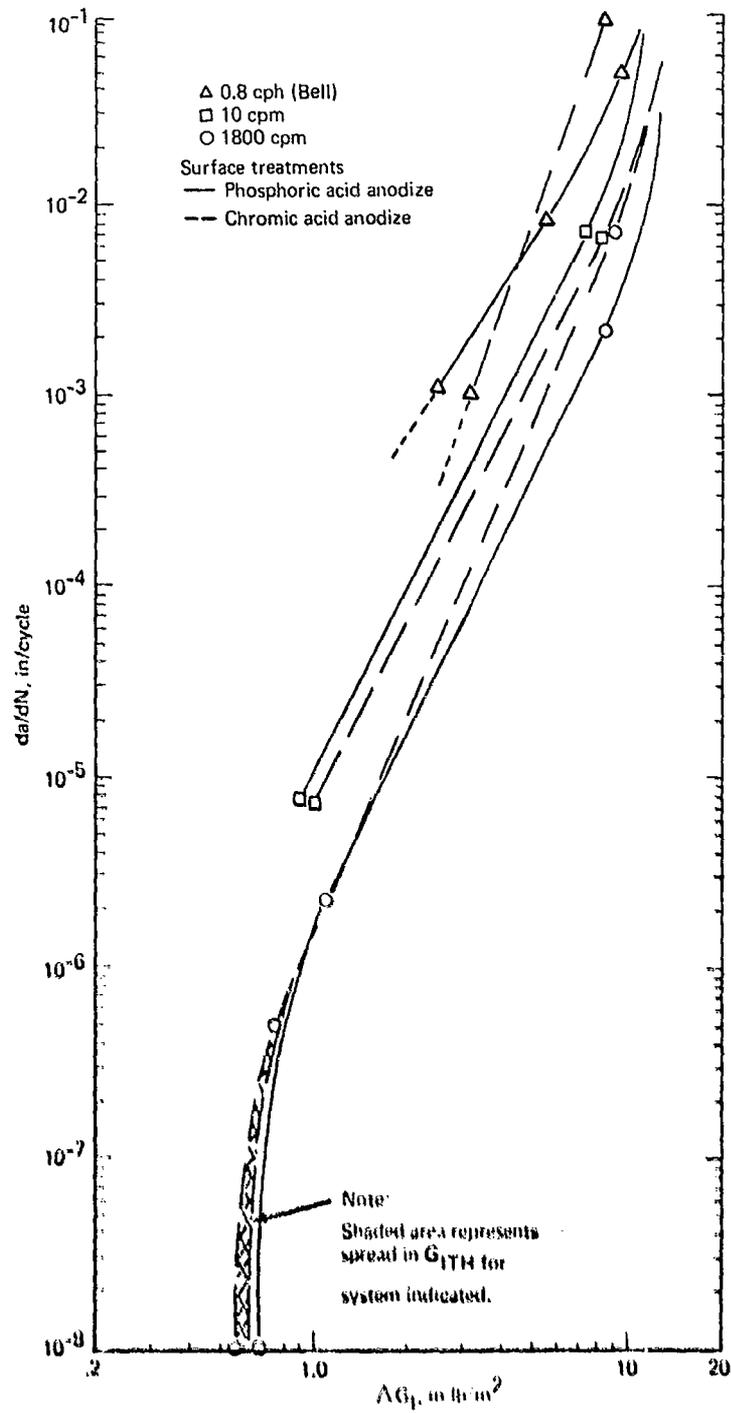
(a) Specimens Tested at Room Temperature, Humidity < 50%, EA 9628/BR 127, 2024-T3 Bare

Figure 31.—Cyclic Crack Growth Rate Data

(b) Specimens Tested at Room Temperature, Wet, EA 9628/BH 127, 2024-T3 Bars

(c) Specimens Tested at 140°F, Dry (<20% RH), EA 9628/BR 127, 2024-T3 Bare

(d) Specimens Tested at 140°F, Wat, EA 9628/BR 127, 2024-T3 Bars

(e) Specimens Tested at 140°F. Wet, EA 9628/BR 127, 2024-T3 Bare

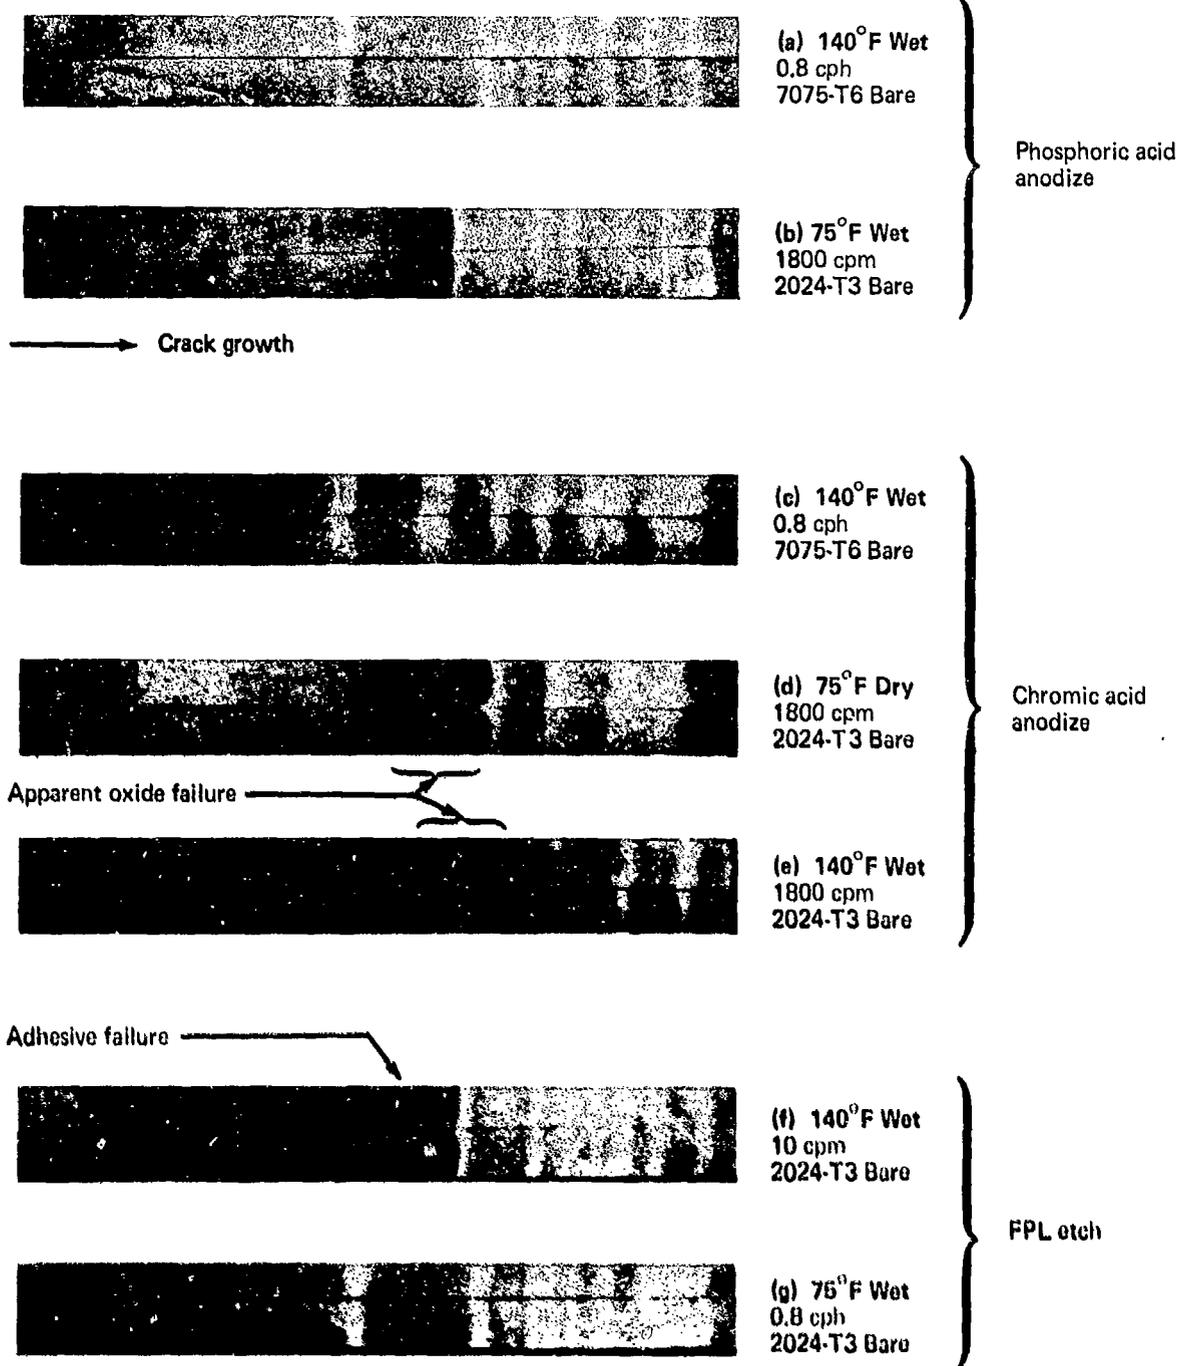
Figure 32.—Fracture Appearances From Cyclic Loading of DCB Specimens
EA 9628/BR 127 Adhesive Primer System.

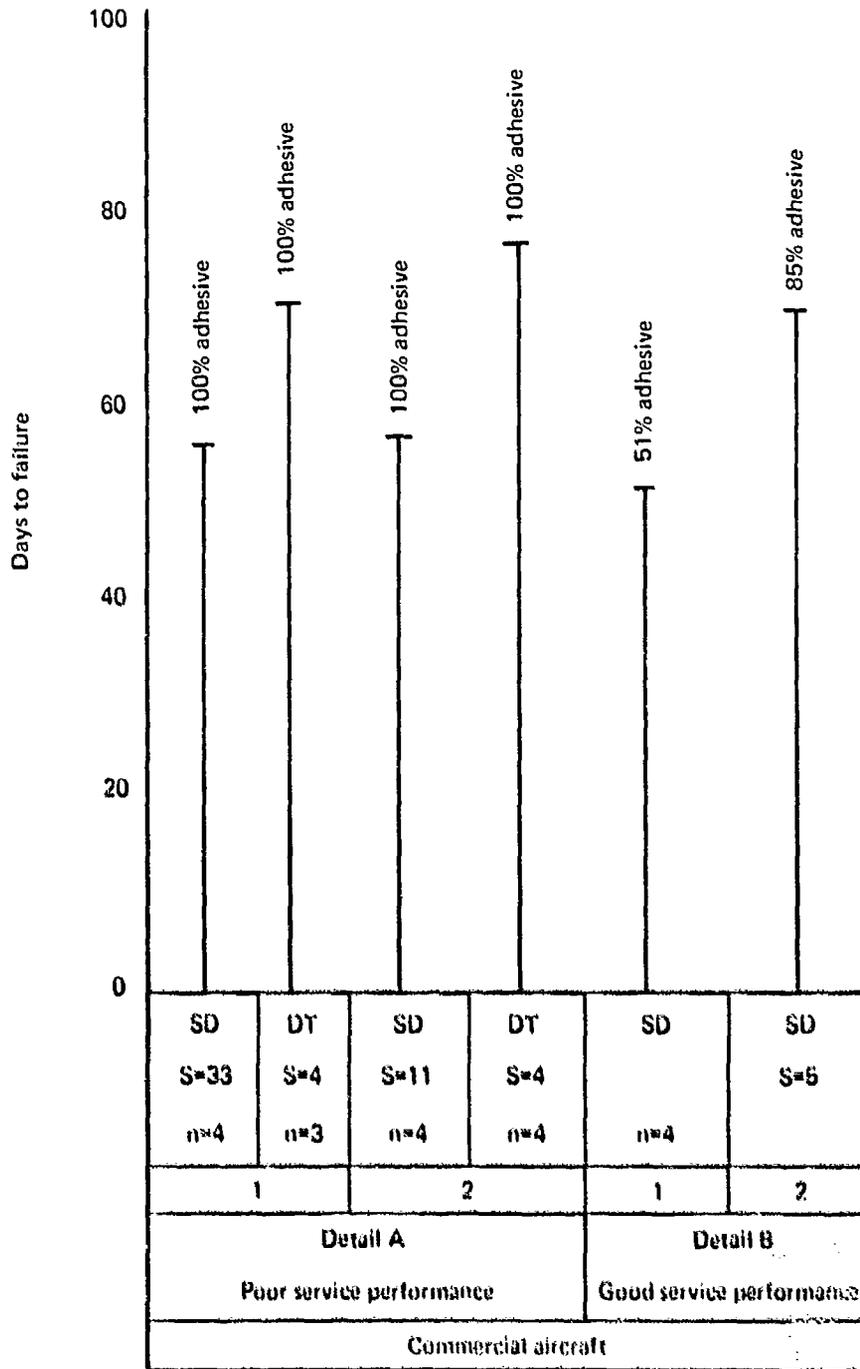
Figure 38.—Sustained-Stress Lap-Shear Results of Specimens Machined From Aircraft A and B Components

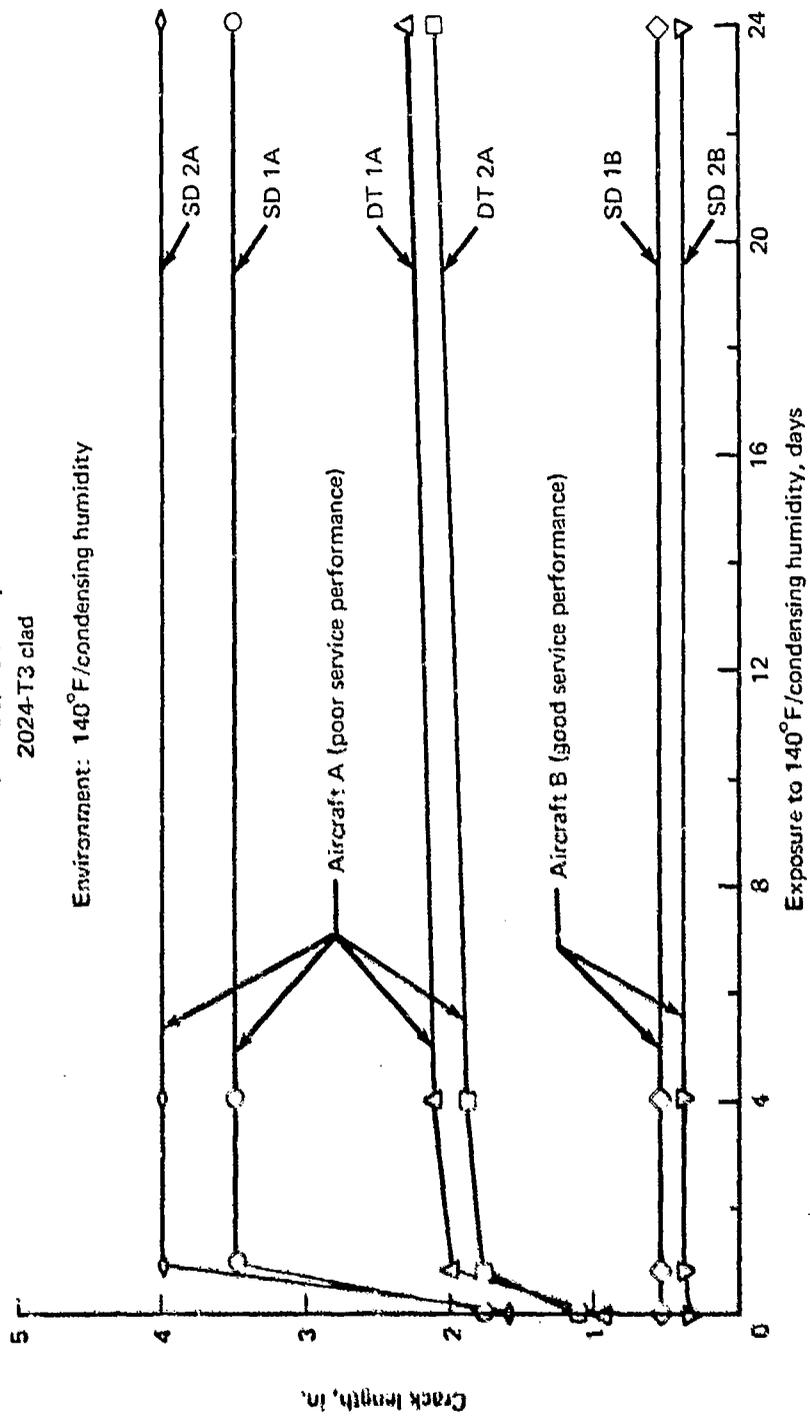
Figure 39.—Wedge Test Results of Specimens Machined From Aircraft A and B Components

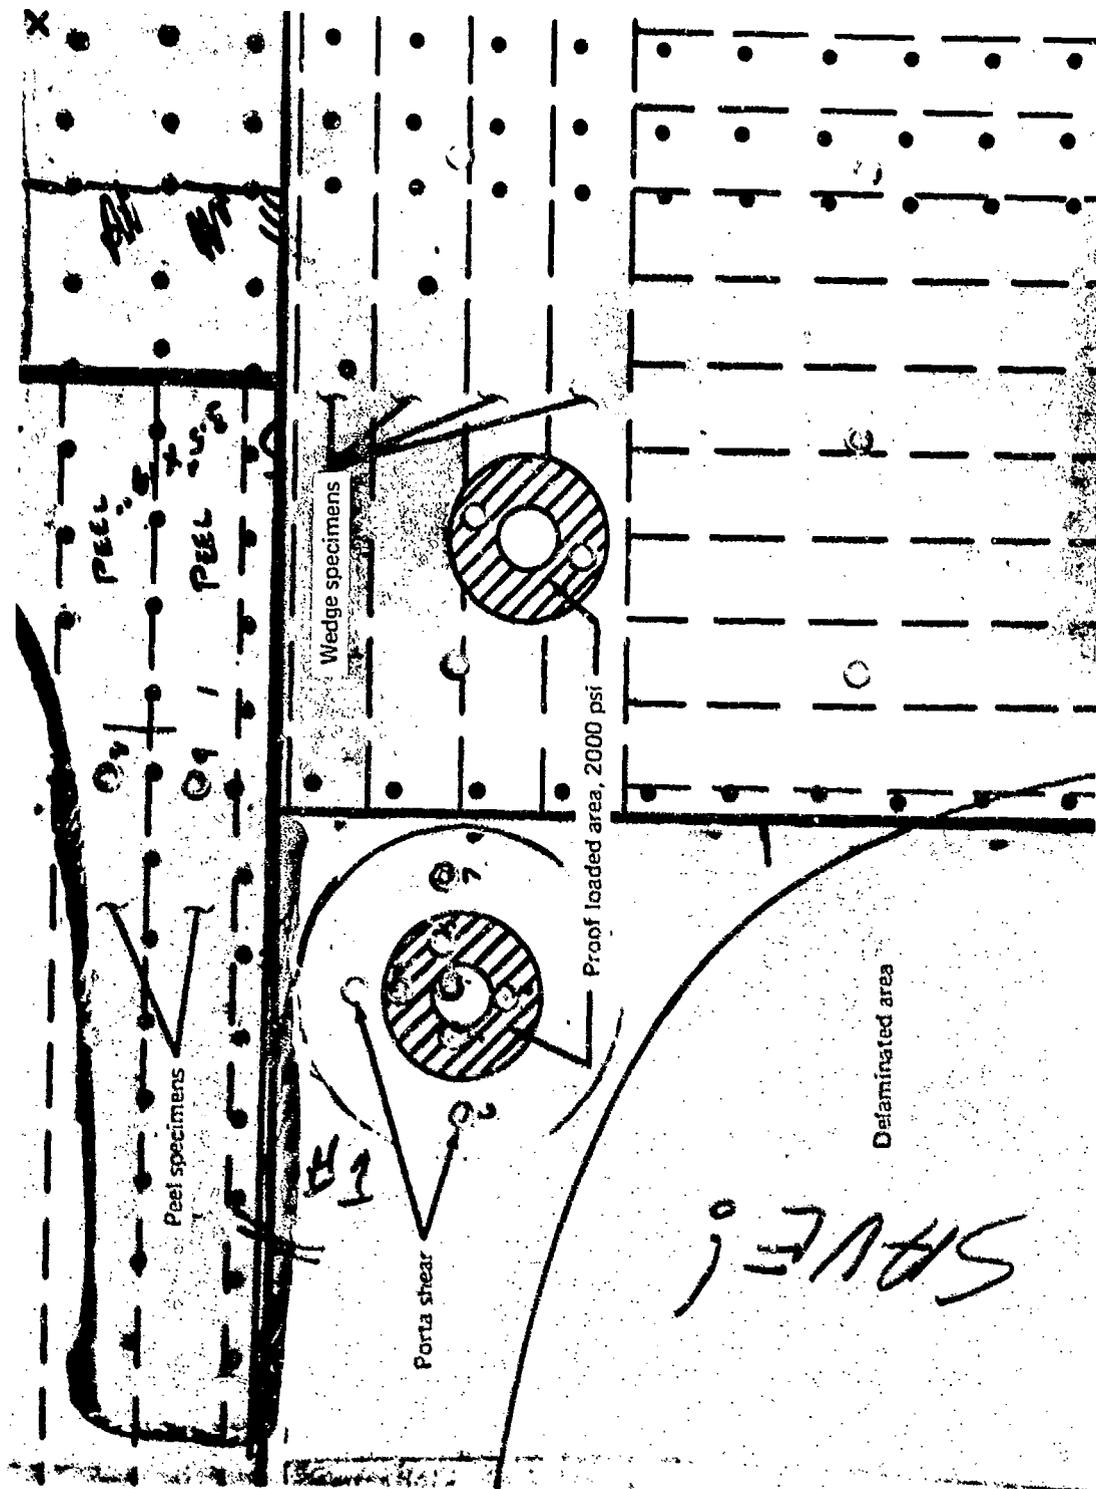
Figure 40.—Section of Aircraft C Component Showing Areas Where Test Specimens Were Taken

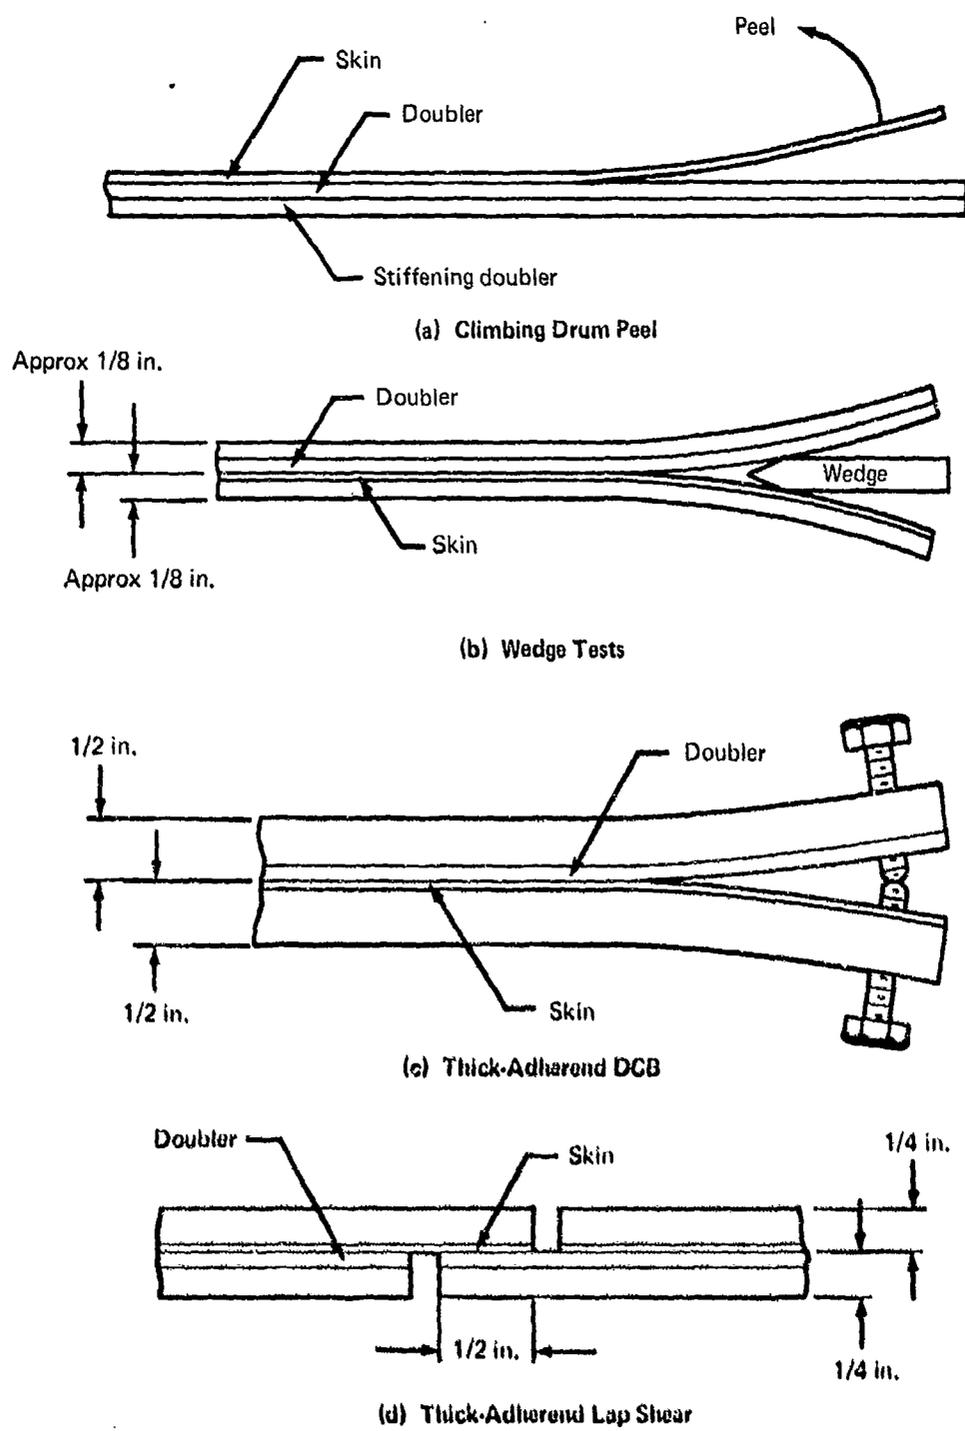
Figure 45.—Configurations of Specimens Fabricated From Air Force Aircraft Details

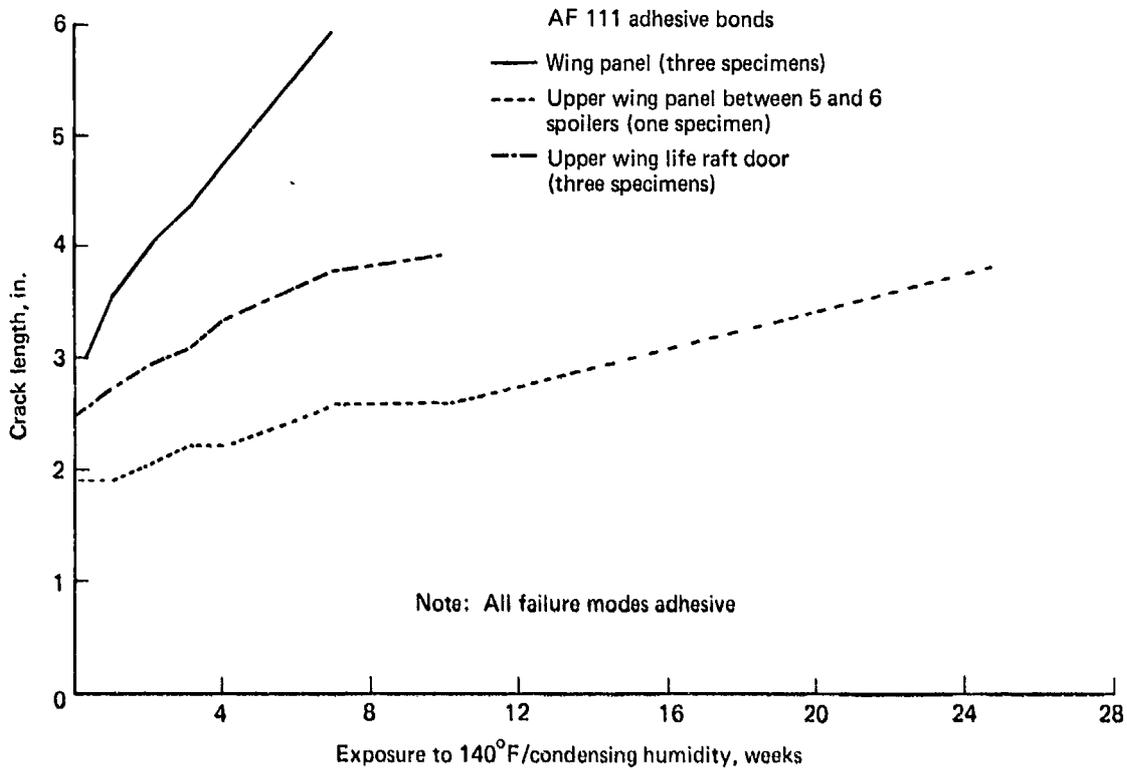
(a) C-141 Bonded Panels Which Were Not Obviously Delaminated
