**EXPLORATORY DEVELOPMENT ON DURABILITY OF
ADHESIVE BONDED JOINTS**

**BOEING COMMERCIAL AIRPLANE COMPANY
P.O. BOX 3707
SEATTLE, WASHINGTON 98124**

**TECHNICAL REPORT AFML-TR-76-173
FINAL REPORT FOR PERIOD FEBRUARY 1974 - OCTOBER 1976**

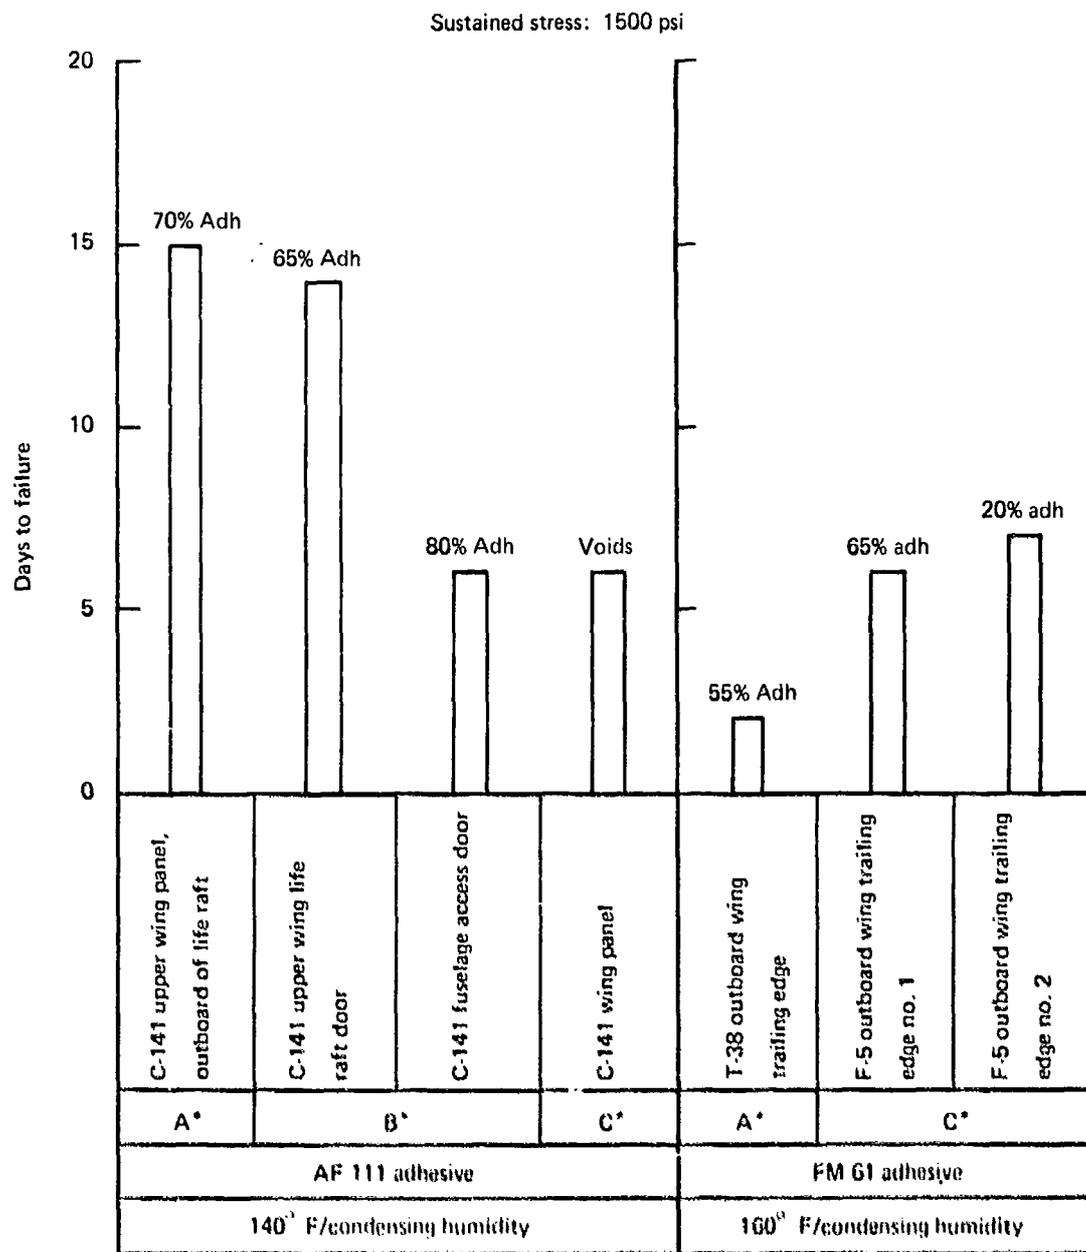
* Visual assessment of aircraft part condition:

A = poor bond, B = questionable bond, C = good bond

Figure 47.—Sustained-Stress Thick-Adherent Lap-Shear Time-to-Failure Results

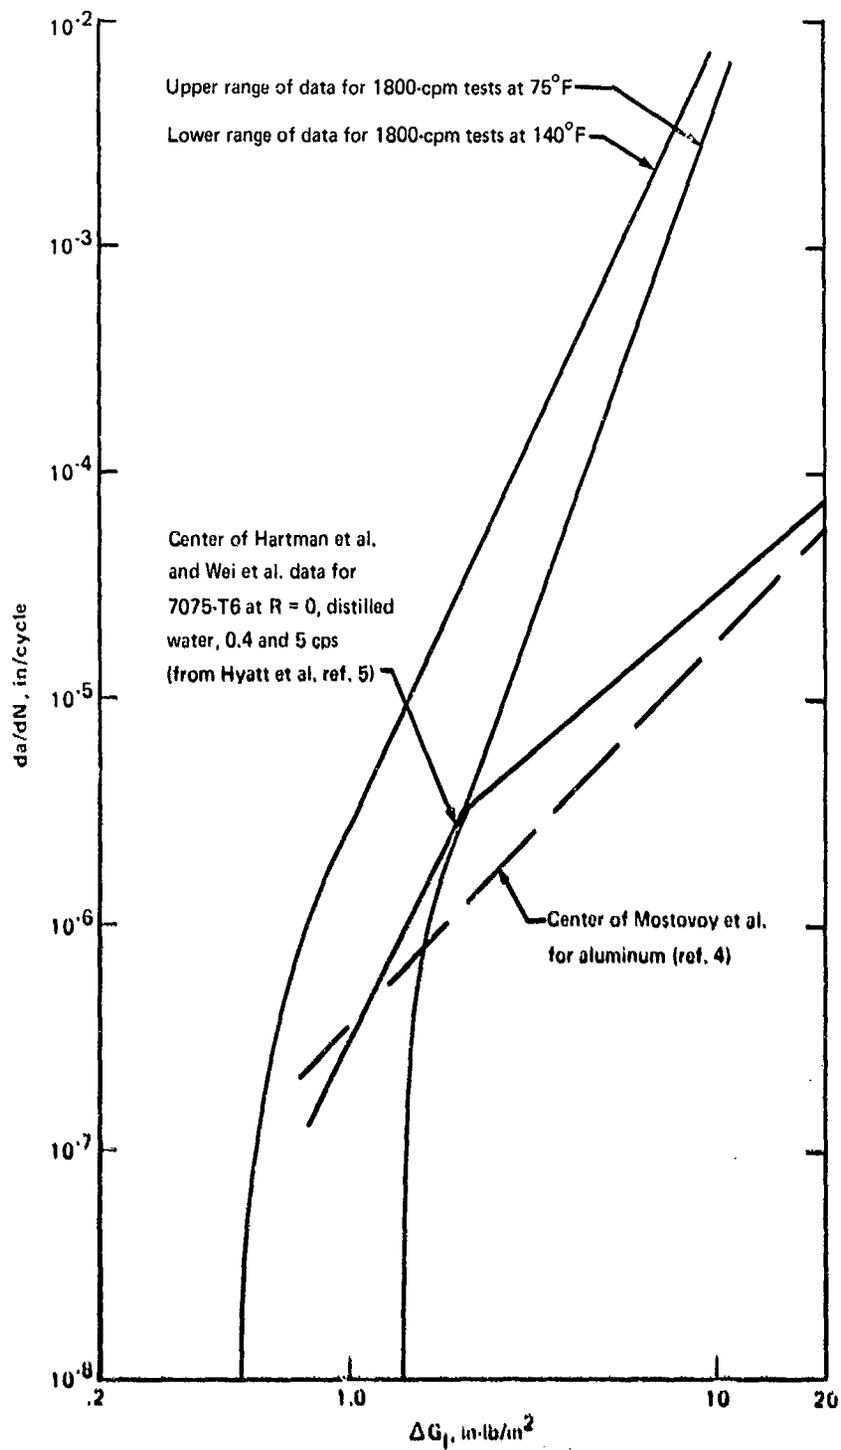
Figure 48.—Comparison of Bonded Aluminum Fatigue Crack Growth Data With Published Data for Fatigue Crack Growth in Aluminum Alloys

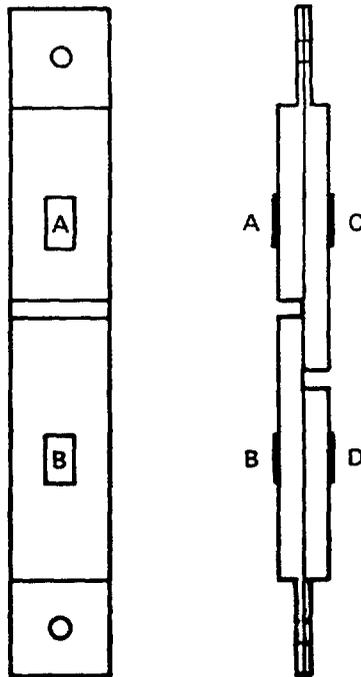
Figure B-2.—Strain Gage Location on Thick-Adherend Lap-Shear Specimen

Each of the four specimens was tested on two different tensile test machines to determine strain behavior under conditions of known uniaxial loading. These two machines were a Timius Olsen 30 000-lb tensile tester and a 20 000-lb Instron Universal. Tests were made by incorporating the clevis tie rods from the jig into the test fixture and substituting wider clevises requiring a longer pin for the jig clevis tie rod.

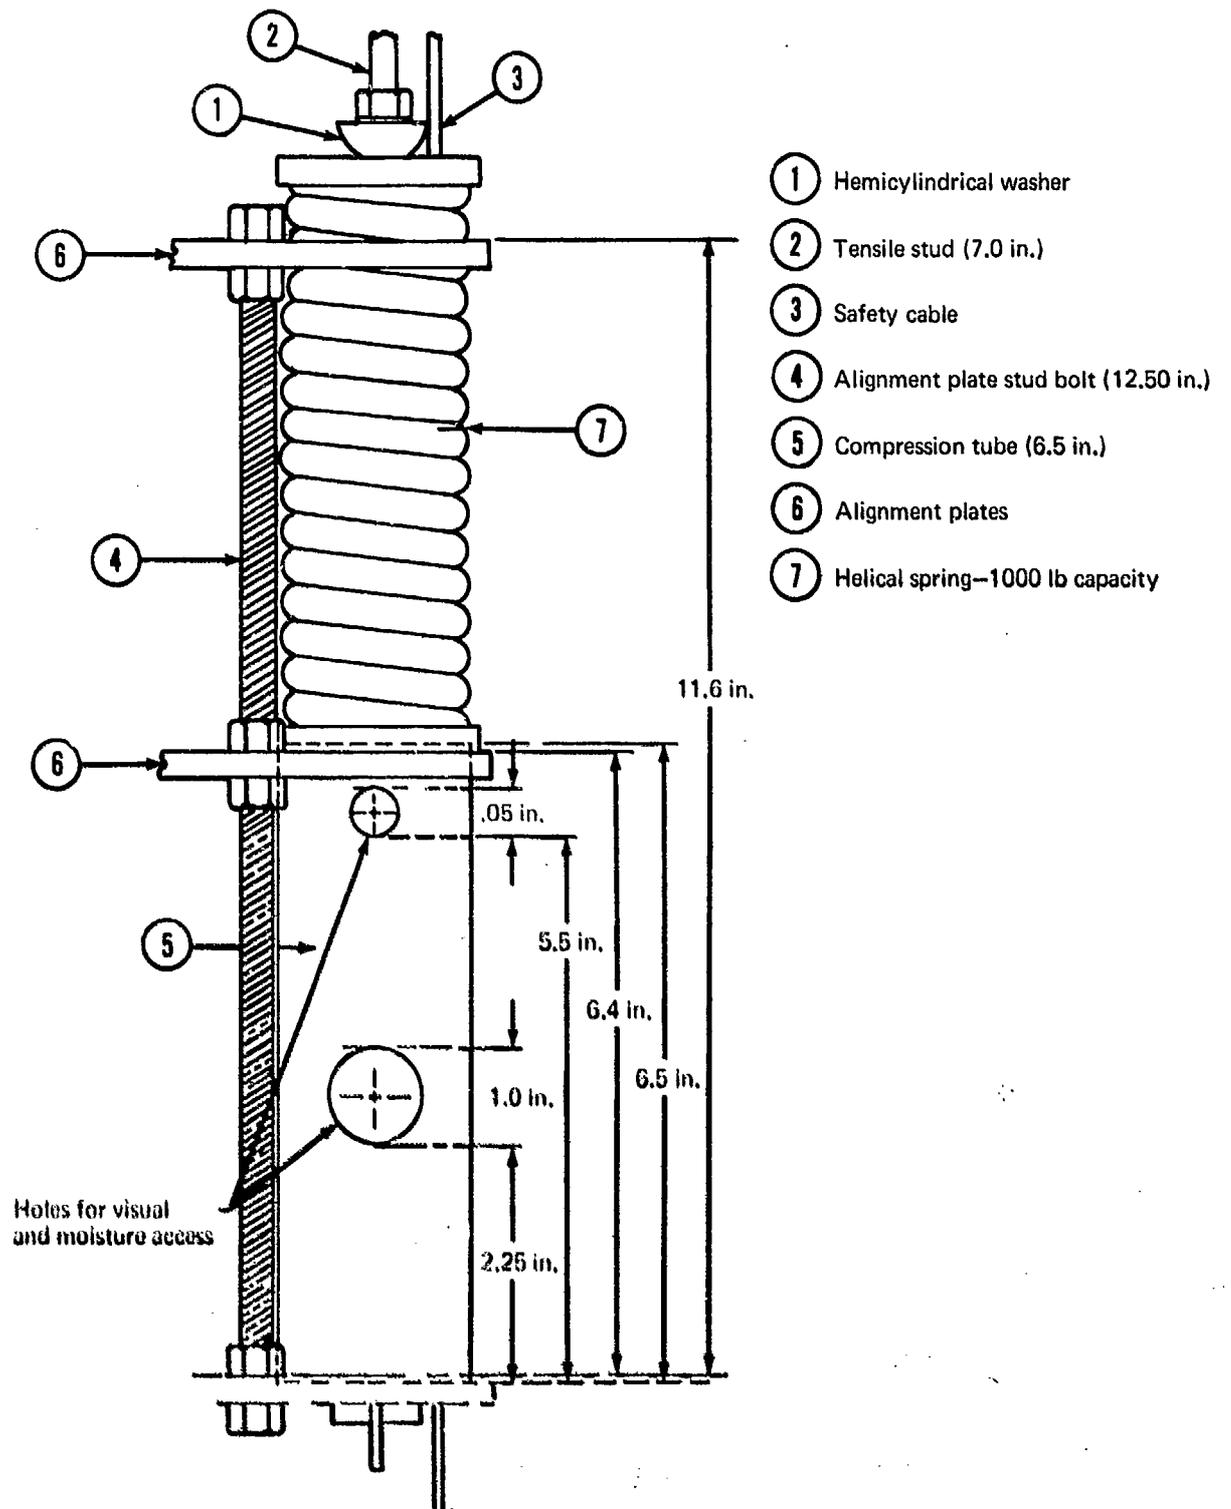
Figure B-3.—Thick-Adherend Lap-Shear Modified Loading Fixture

In keeping with these objectives, the tube was lengthened to contain the entire specimen, a second alignment plate was added and the distance between the two alignment plates was set to maintain both ends of the spring, a hemicylindrical washer was installed between the nut and bottom plate, and the safety bolt was replaced by a cable. The modified fixture is shown in figure B-3.

A prototype of this modified fixture was made as shown in figure B-3 except that two existing tubes were stacked together with a separator plate between in place of the single 6.5-in. tube shown. The gaged specimens were tested in this modified jig, and their orientation within the fixture was equivalent to that shown in figure B1, except for the specimen being contained within the tube. Strains indicated from four separate loadings to a nominal 750 lb in the modified jig are shown in table B-2. Loads 1 through 4 represent loadings of the modified fixture in a manner equivalent to the usual method of loading the fixture.

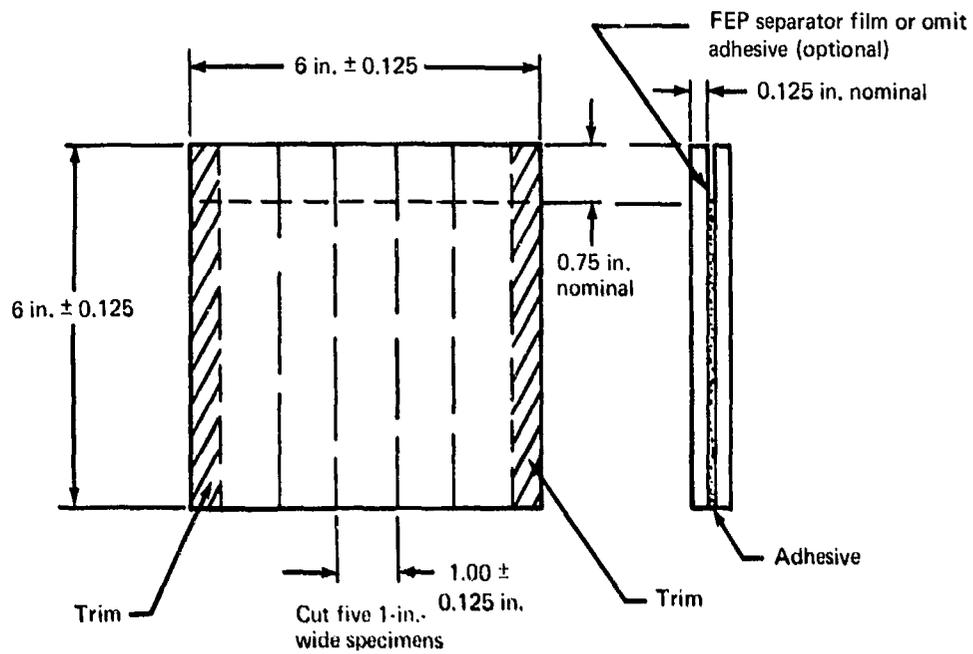
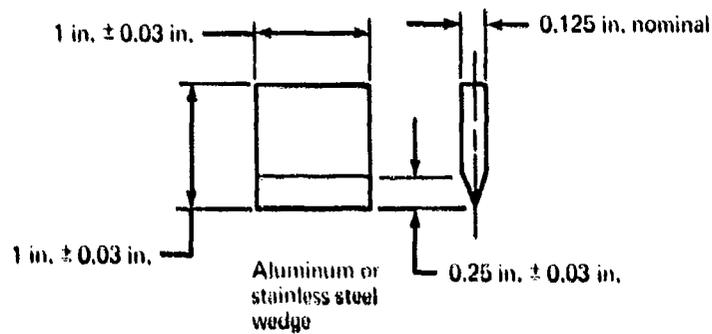
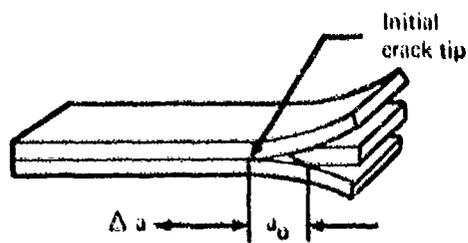
Wedge Crack Extension Specimen (The end and sides of the wedge shall be approximately flush with specimen end and sides.)

Figure C-1.—Crack Extension Specimen Configuration

5. Crack one end of each test specimen by inserting a wedge as shown in figure C-1. Insert the wedge by using a pushing force or several relatively light taps with a hammering device. *DO NOT* insert the wedge with a single striking blow. When inserting wedge, *DO NOT* hold specimen in any way that will restrain the initial cracking. Position the wedge so that the blunt end and sides are approximately flush with those of the specimen. (In any use of an auxiliary tool to precrack a test specimen to facilitate insertion of a wedge, the extent of precracking must be less than that which is caused by insertion of the wedge.)
