SECOND INTERIM TECHNICAL REPORT
ON USAFA SOLAR TEST HOUSE

**CIVIL AND ENVIRONMENTAL
ENGINEERING DEVELOPMENT OFFICE**

SECOND INTERIM
TECHNICAL REPORT ON
USAFA SOLAR TEST HOUSE

by
Captain Anthony Eden
Captain John T. Tinsley

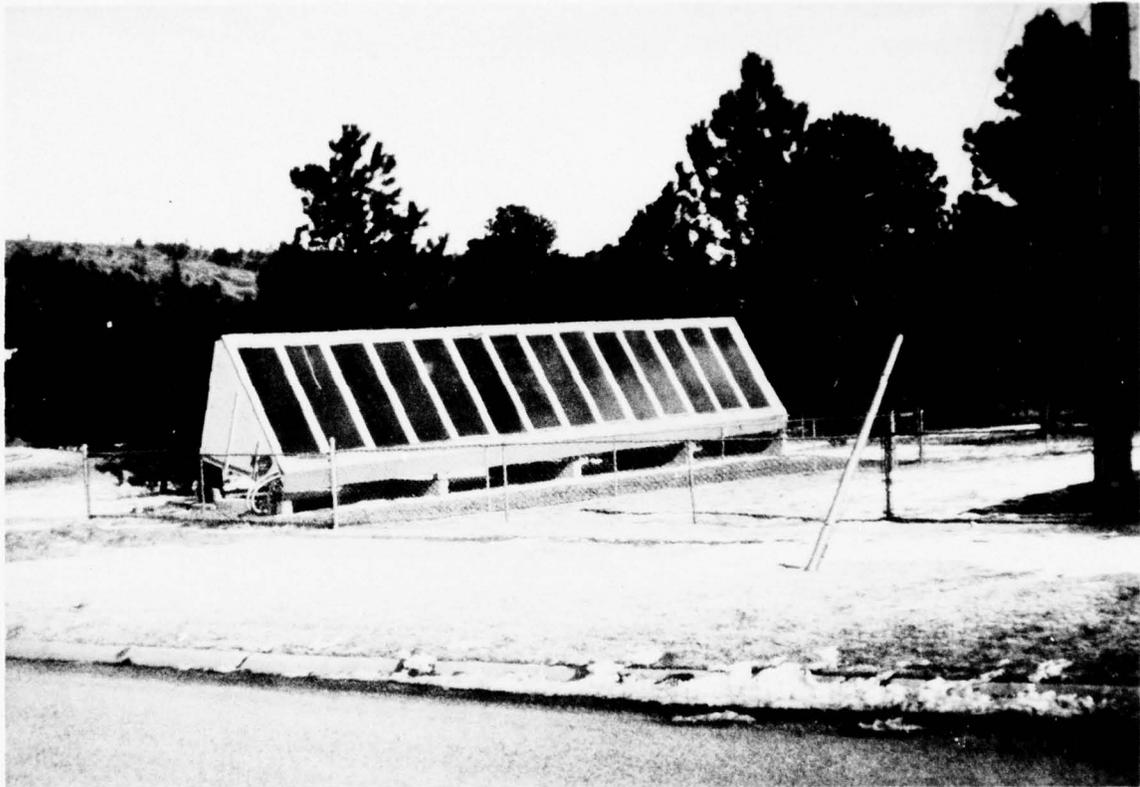
Figure 2-1
Ground Array

The ground array (Fig. 2-1) was chosen as a test bed for the modifications to be made to the collector loops. The ground array's location allowed quick and easy access for making these changes without the safety hazards and multiple trusses encountered when working on the roof array. The changes made on the ground array were the addition of a heat exchanger to the collection fluid loop, the addition of a bleed air line to the collectors, the variation of the slope of the array itself, the addition of air pressure gauges, and the insulation of the plumbing raceways.

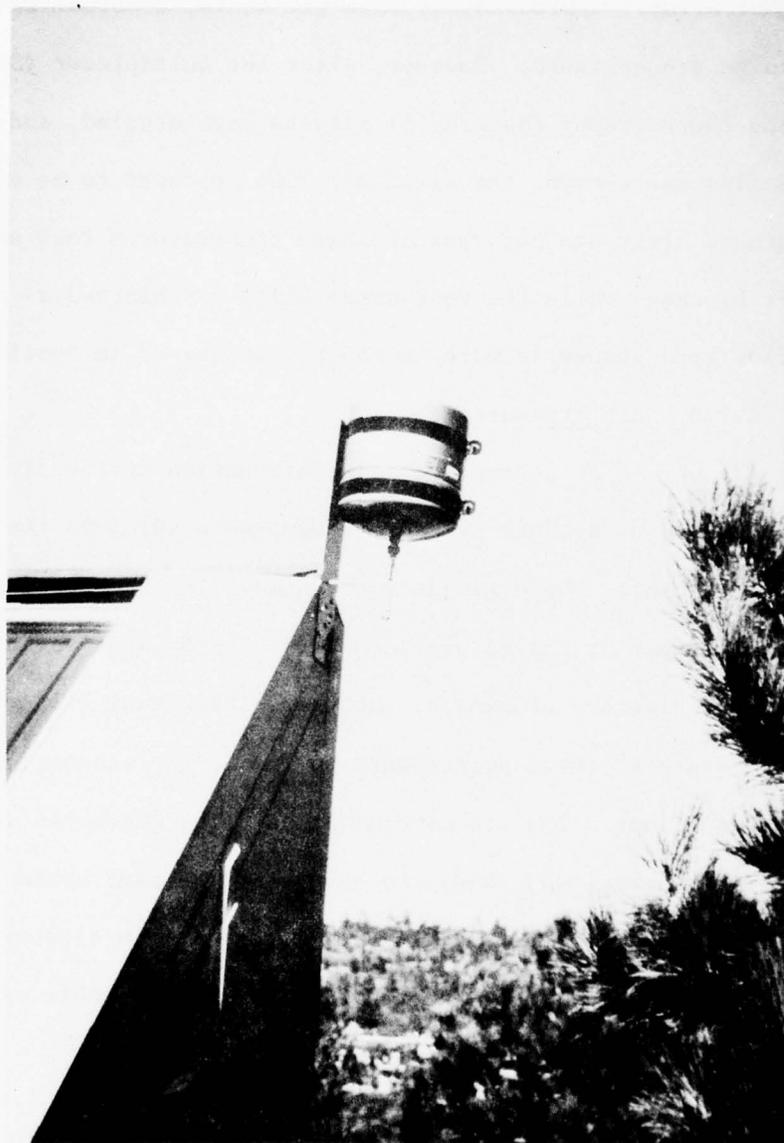
Figure 2-5

The bleed air line was also used for the initial charging of the array. A small submersible pump was attached to the end of the return water line and turned on while in a bucket containing a mixture of water and ethylene-glycol. The petcocks were opened one by one until all the air was forced out. However, minute leaks were always present and the air would eventually get back into the system.

Ground Array Expansion Tank/Bleed Air System

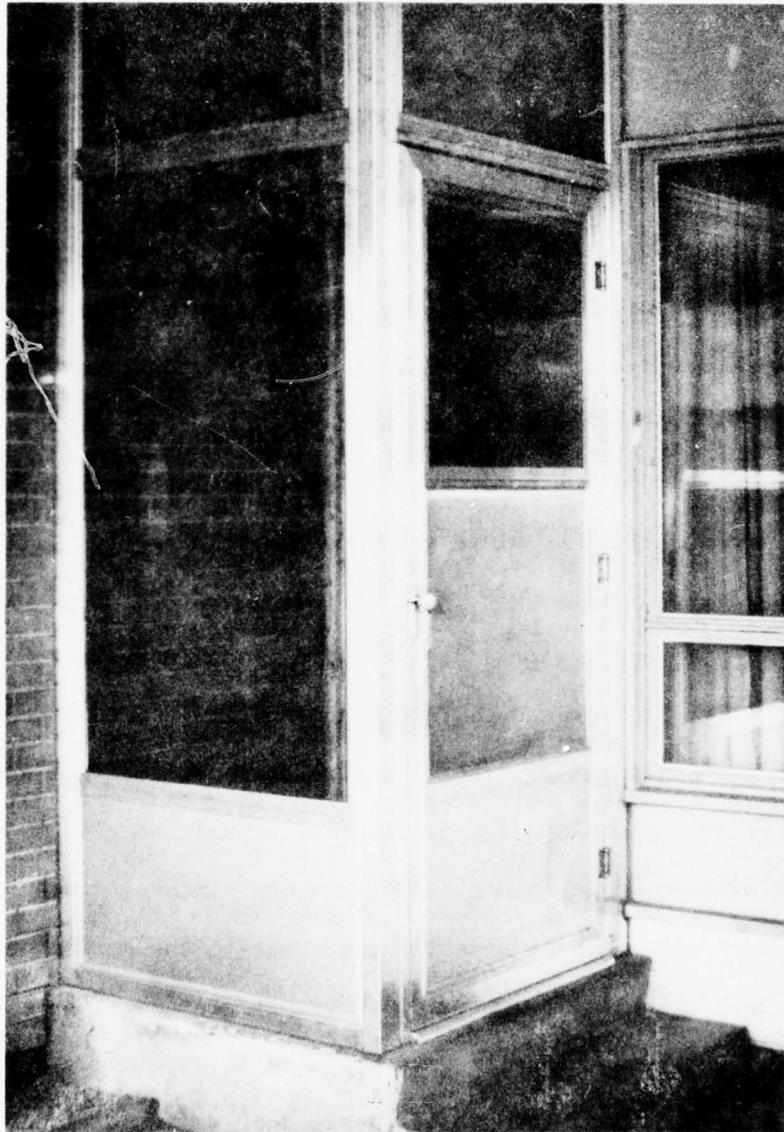
Figure 3-1. Vestibule

Vestibules are air lock-type structures that can be built around a door to decrease the air flow through it during use. These small chambers allow entrance to the structure while not allowing direct exposure of the inside to the outside ambient air. The use of vestibules was considered on the Solar Test House to decrease the air infiltration load. This was especially important considering the many tours and visitors that frequent the structure. Two vestibules (Fig. 3-1) were built over the doors. The vestibule door was designed to swing out so that it was very difficult to have both it and the main house door open simultaneously. This construction was accomplished during March 1977 and its exact effect has yet to be

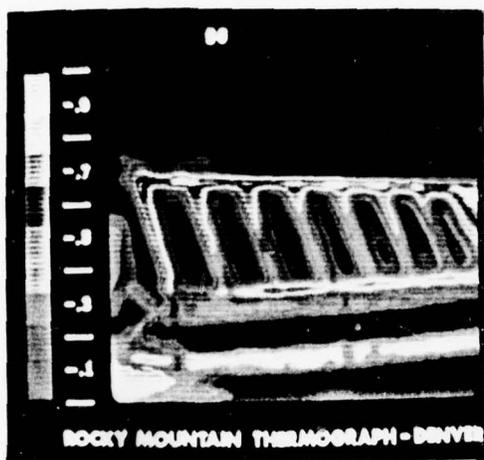
Figure 5-1 Thermography Studies

Initially, there appeared to be a large air blockage in cluster three, the second group of four panels in series. This air blockage had stopped the flow of fluid through the entire cluster and allowed the temperature to rise well above the neighboring panels. The thermograph indicated a temperature difference of at least 50^oC (90^oF) and the sensor readings indicated a difference of at least 75^oF. The reading of 255^oF was the highest the microprocessor could indicate. The correlation of the thermograph and the sensors, therefore, was limited to qualitative in that a picture showing hotter panels actually does reflect that condition on the surfaces.

The second indication noted from the data and pictures was the apparent reversed flow in the last cluster. The temperature readings
