AMMRC MS 77-5

CASE STUDIES IN FRACTURE MECHANICS

THOMAS P. RICH and DAVID J. CARTWRIGHT
MECHANICS OF MATERIALS DIVISION

June 1977

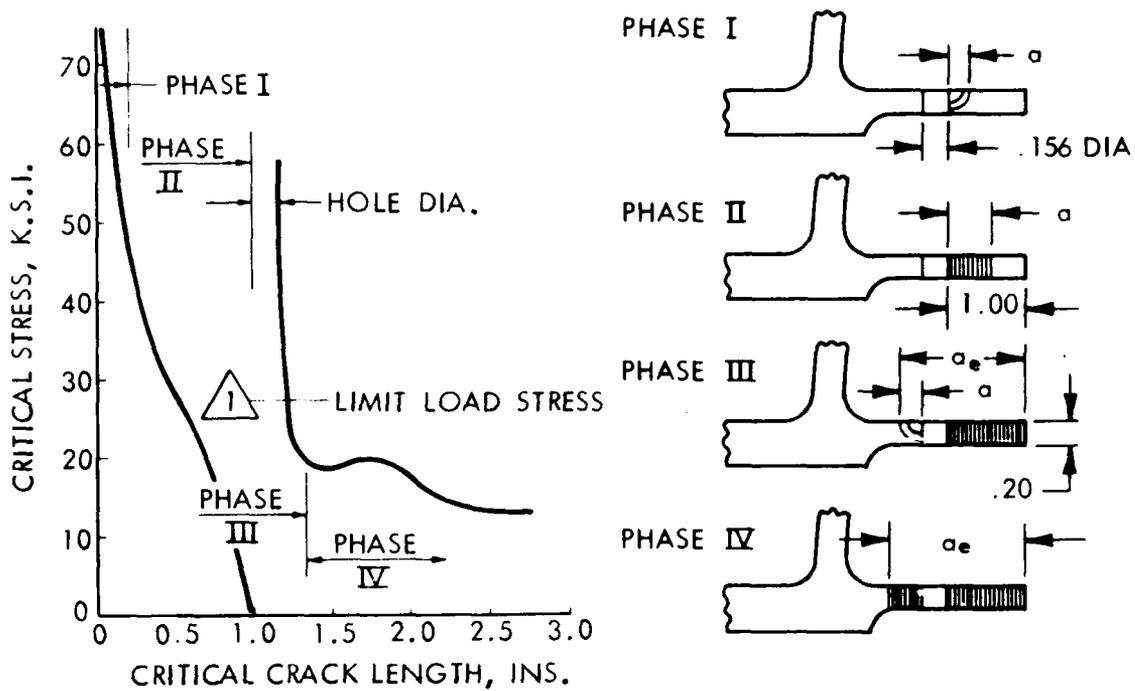
FIG. 6 CRITICAL STRESS AS A FUNCTION OF CRITICAL CRACK LENGTH

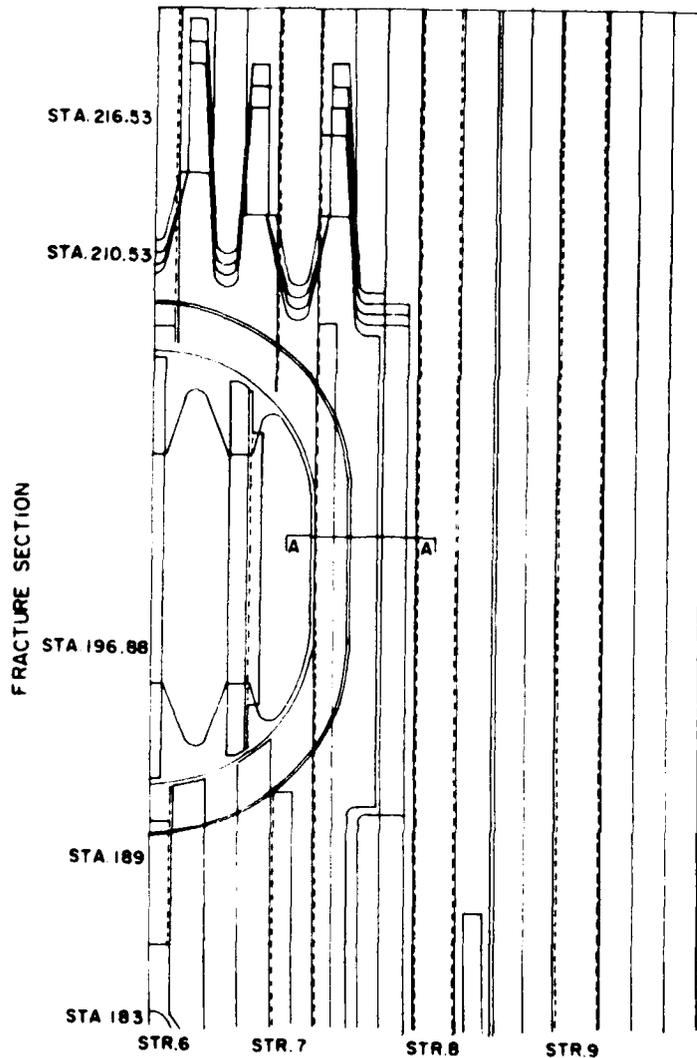
Figure 9 Plan View of Lower Wing Panel in the Vicinity of the Access Door

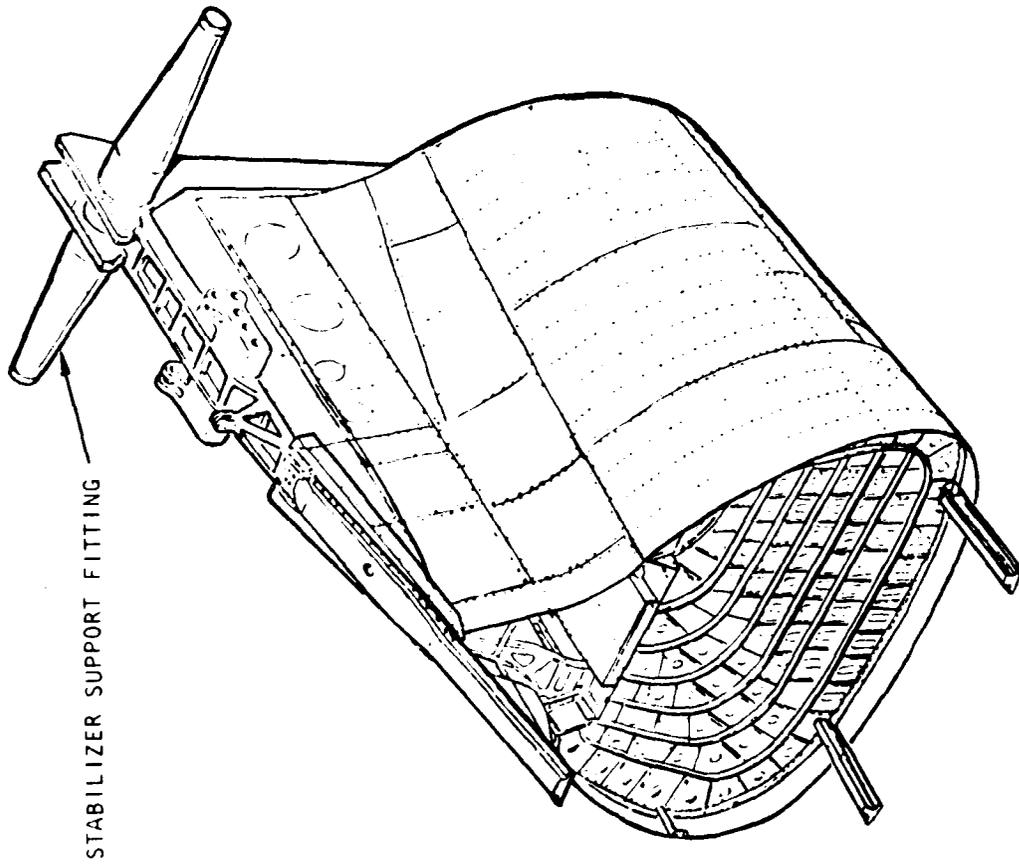
Figure 1. DWT-2 Aft Fuselage/Impennage Test Specimen

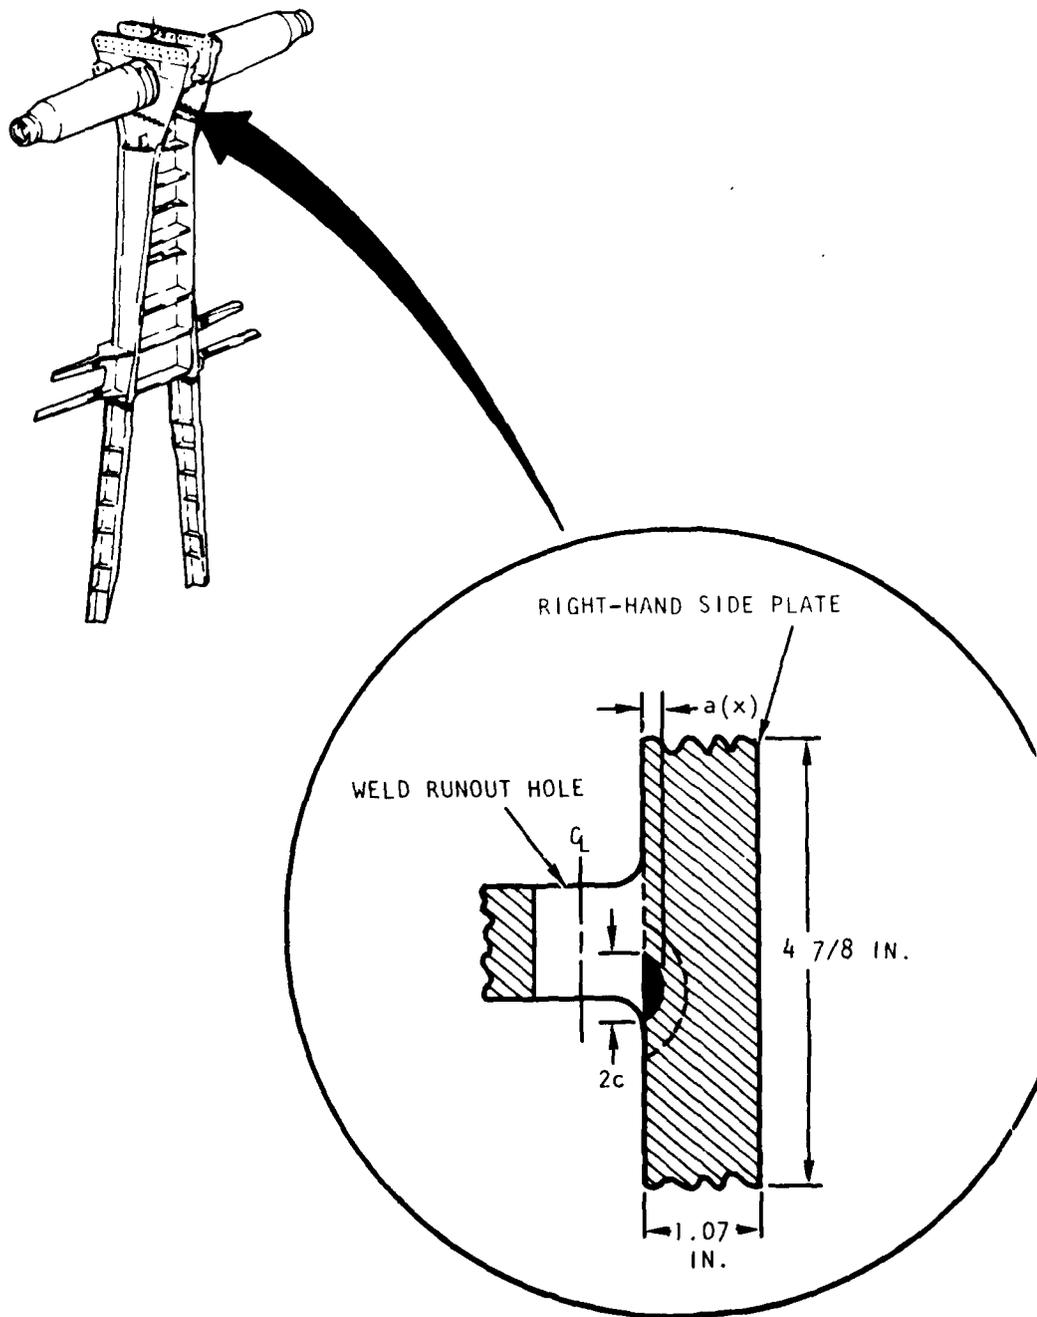
Figure 2. Spindle Support Fitting and Its Cracked Region

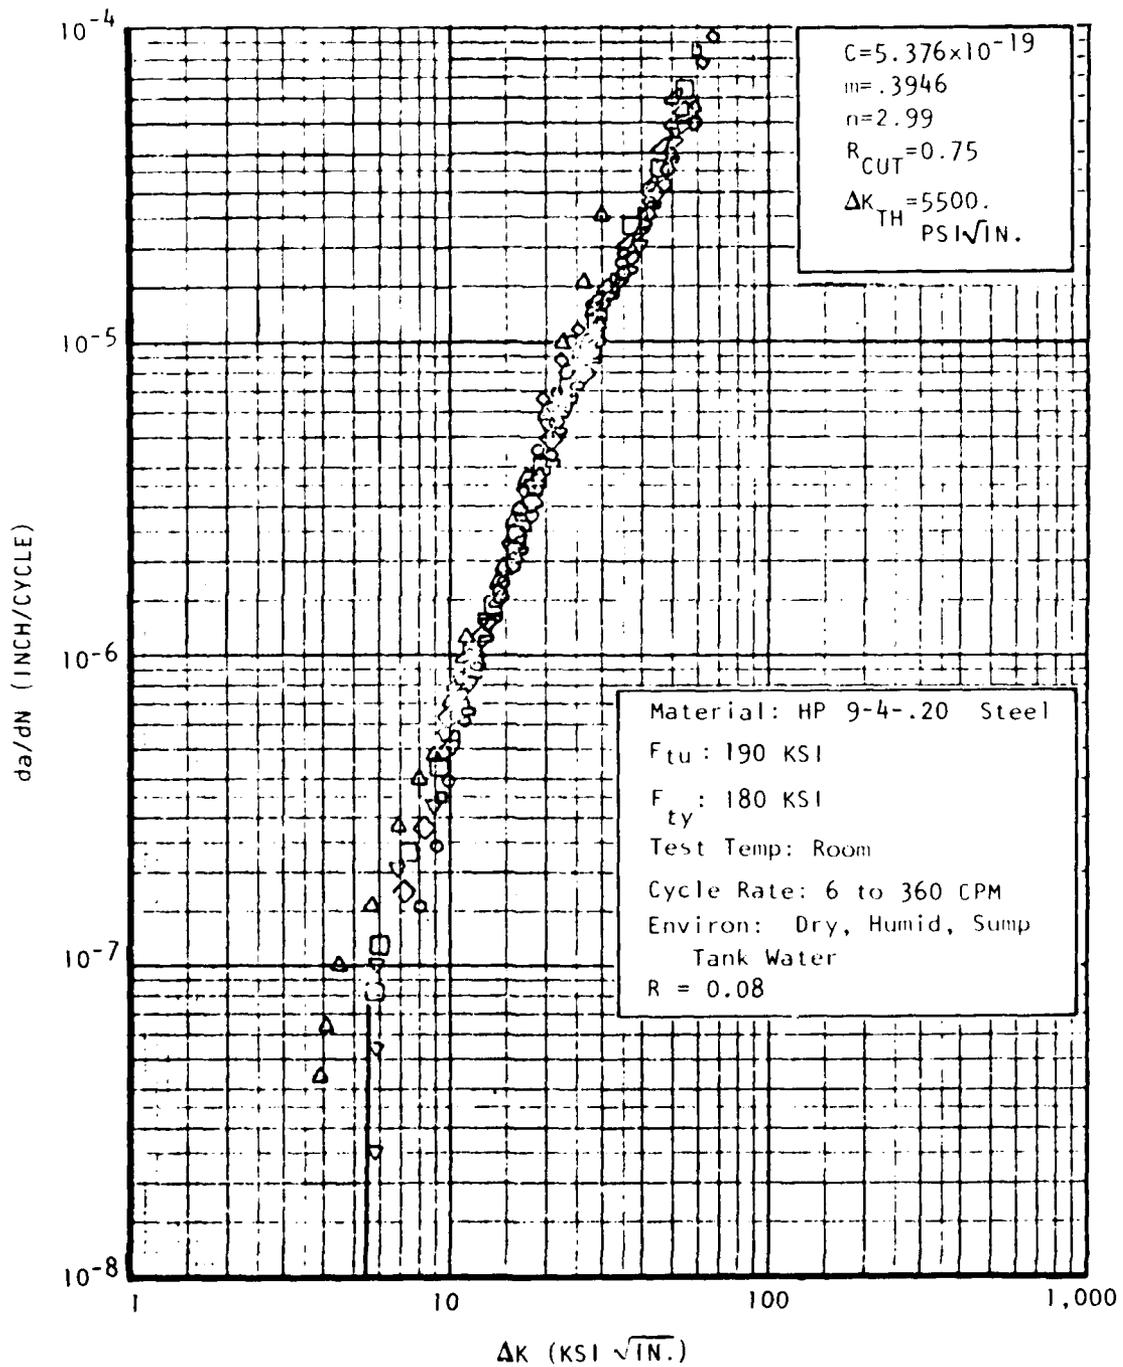
Figure 4. Material Properties, HP 9Ni-4Co-.2c Steel

The crack growth rate constants of the HP 9Ni-4Co-.2C steel employed in the predictions are as shown in figure 4. The growth rate data were generated from the compact type (CT) specimens under constant amplitude loading. The

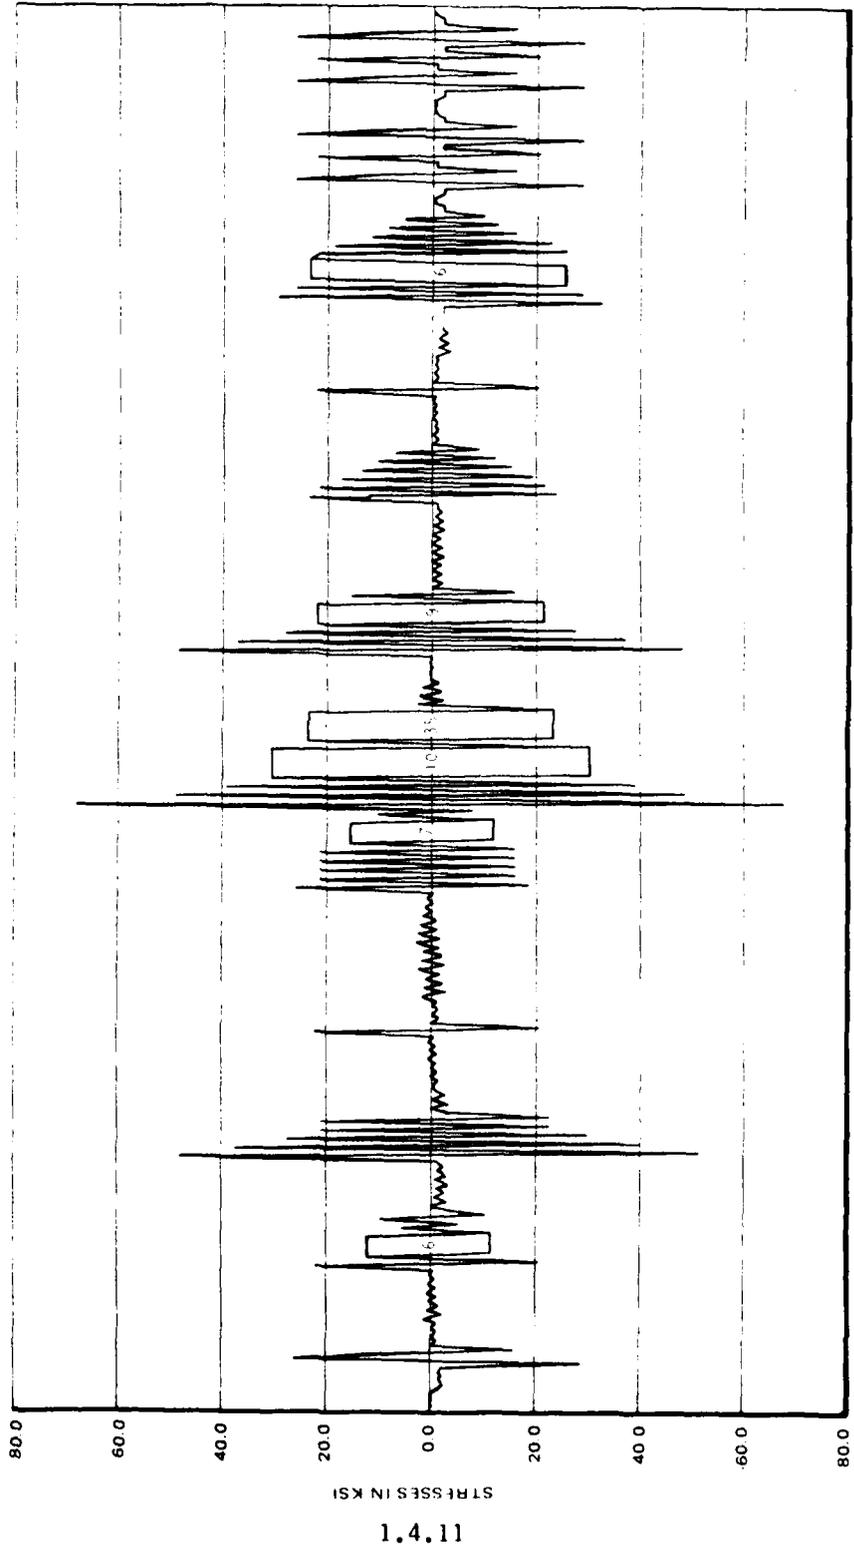
Figure 5. Stress Spectrum Chart, Spindle Support Fitting, one Flight

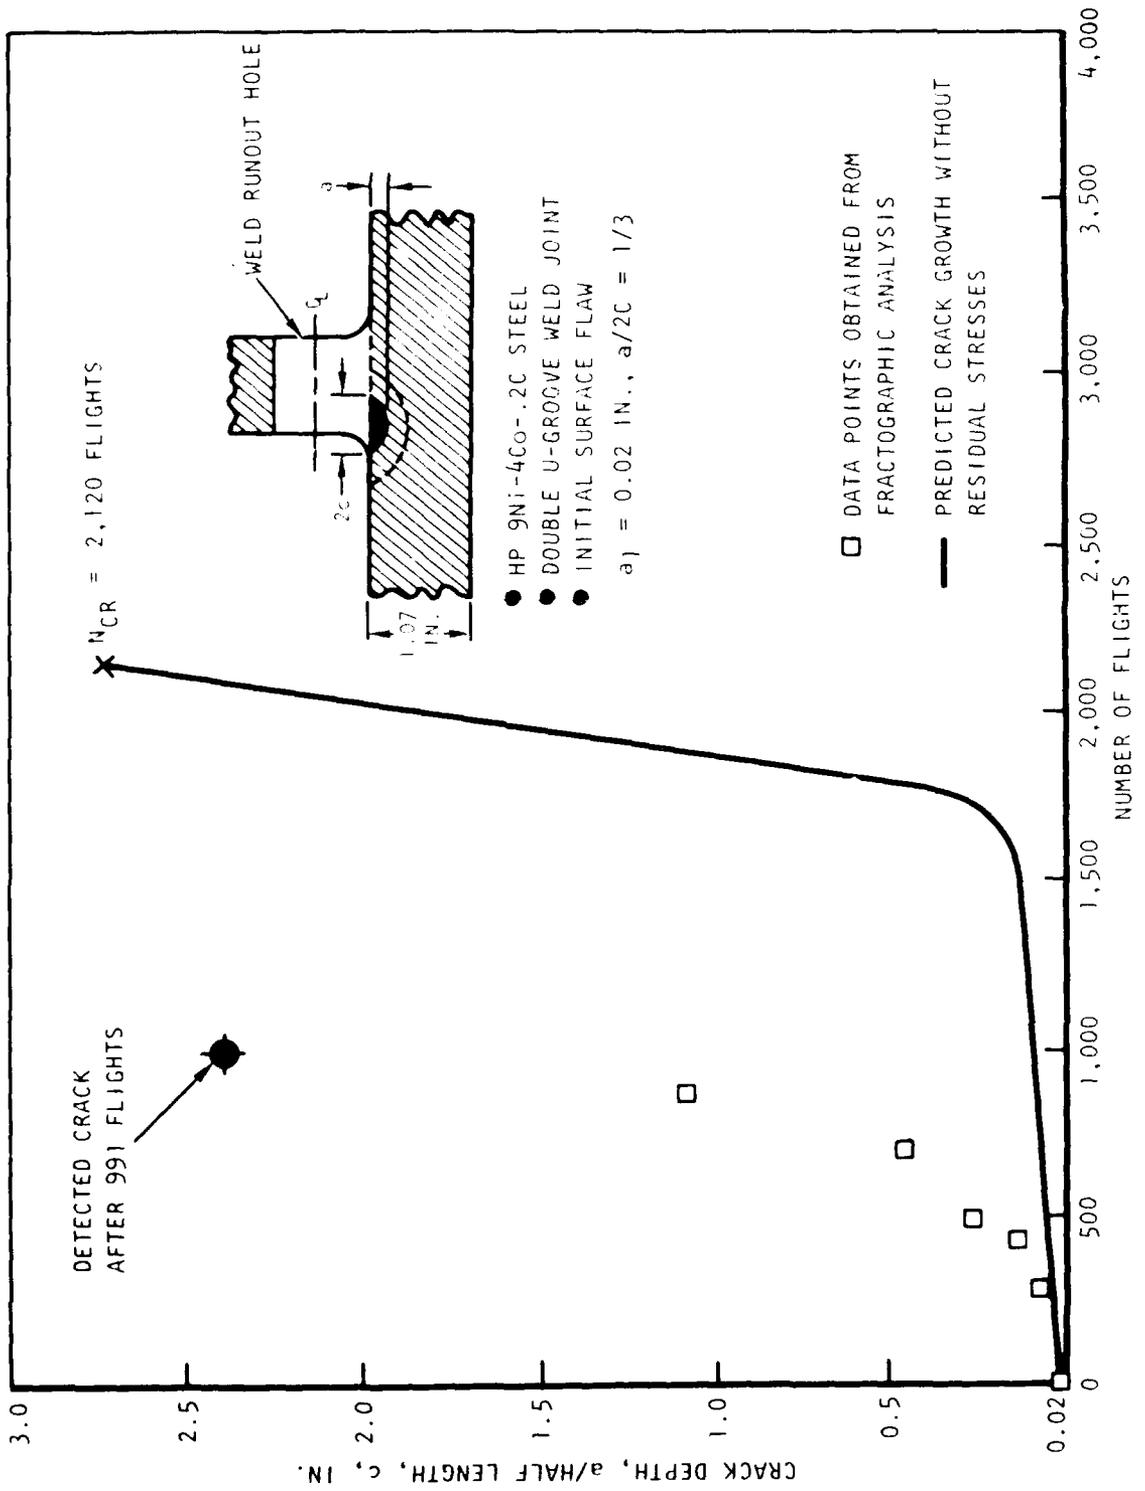
Figure 6. Test Data/Predicted Crack Growth Correlation, No Residual Stresses Assumed in Analysis

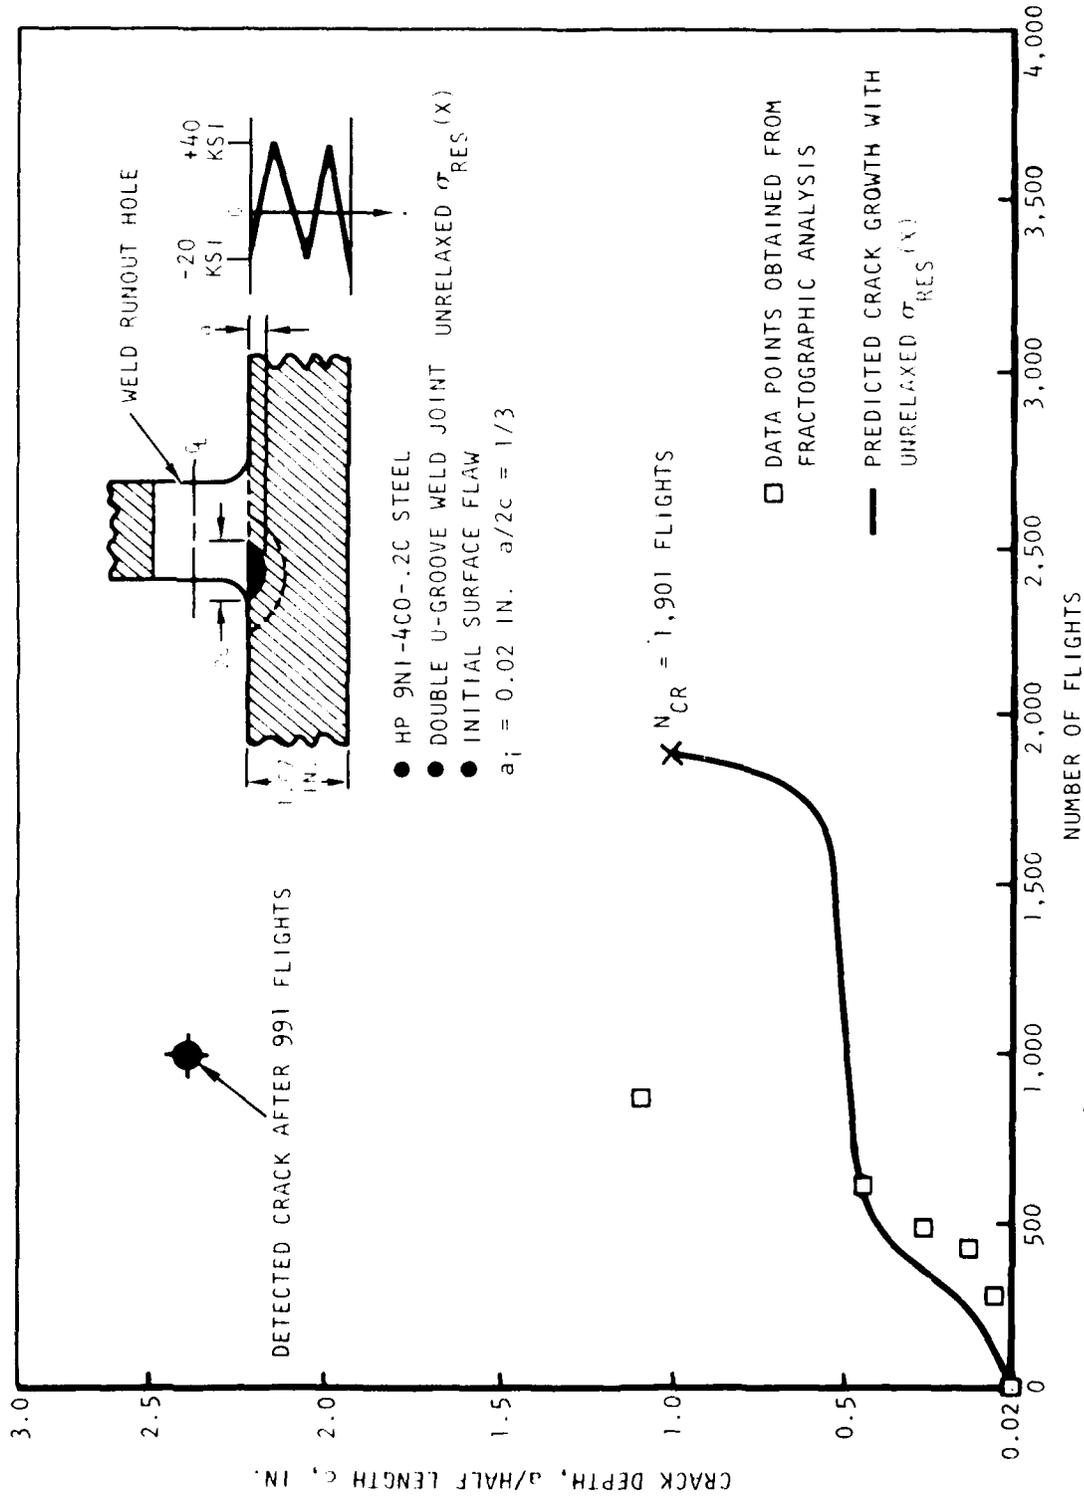
Figure 7. Test Data Predicted Crack Growth Correlation, Unrelaxed Residual Stresses Assumed in Analysis

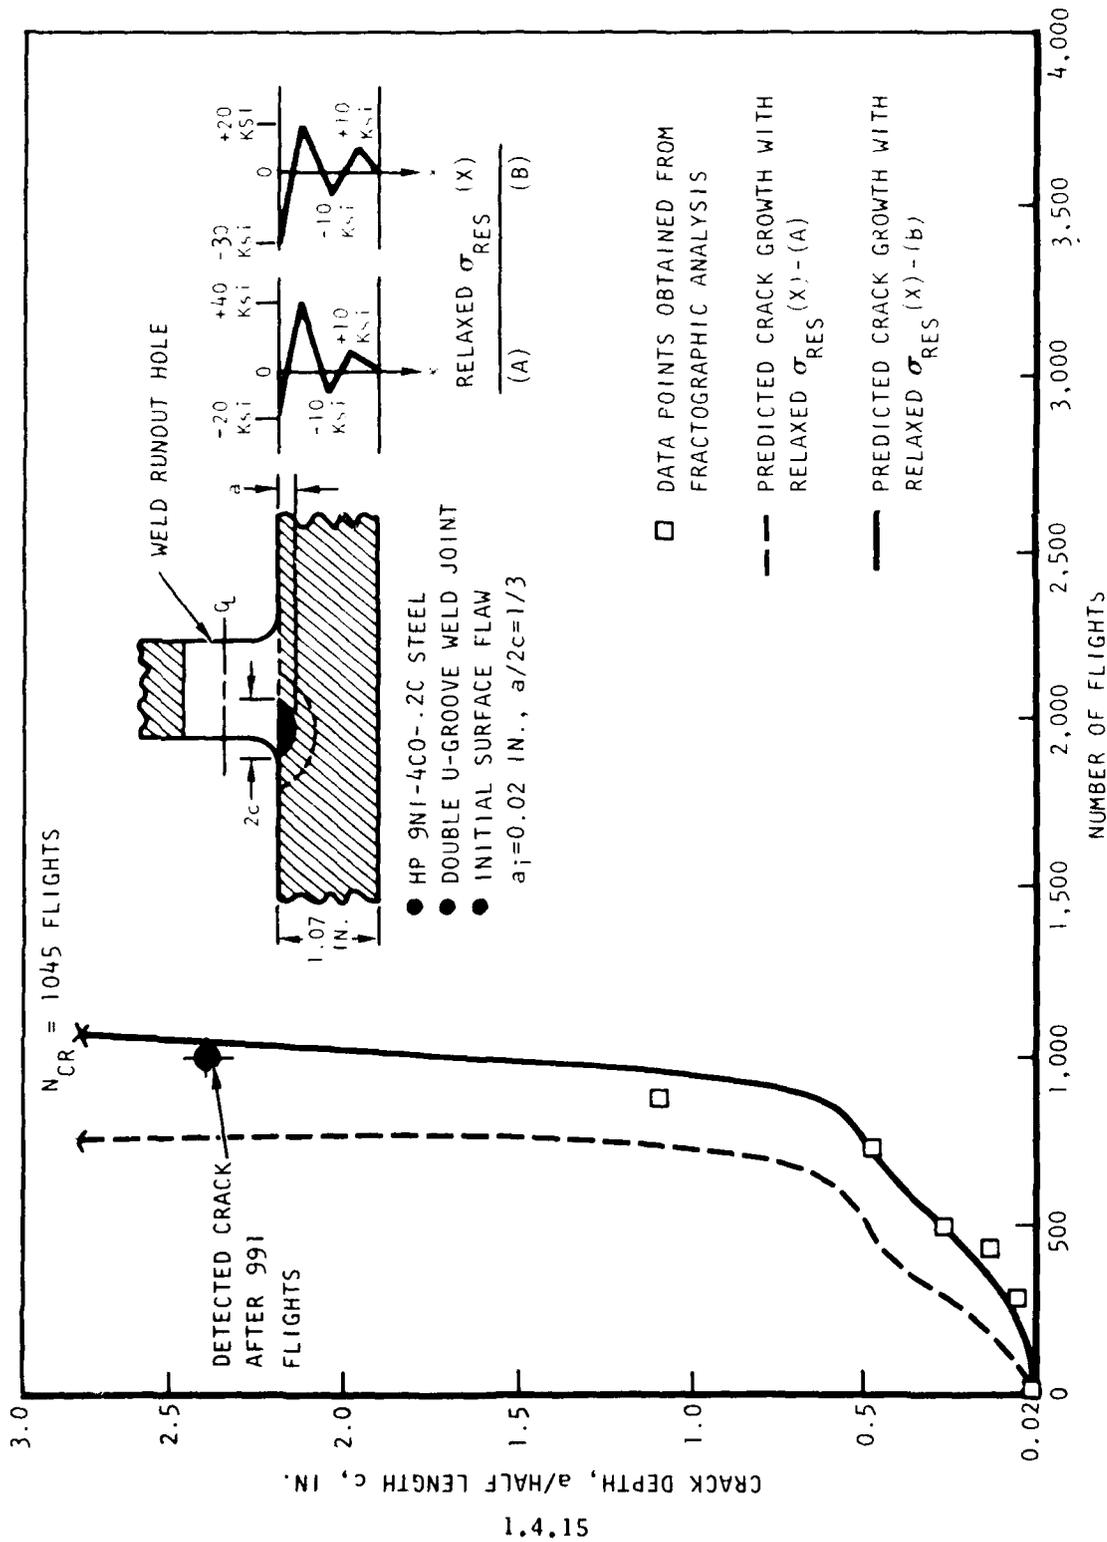
Figure 9. Test Data/Predicted Crack Growth Correlation, Released and Redistributed Residual Stresses Assumed in Analysis

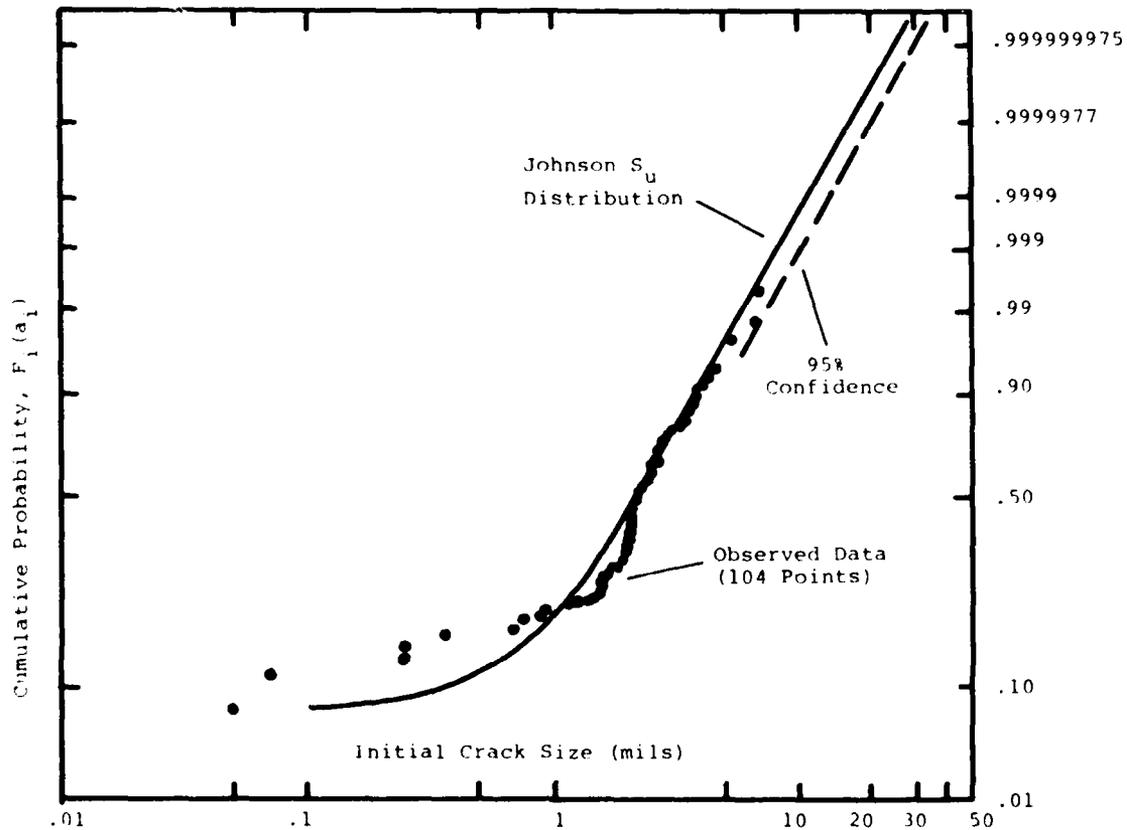
FIGURE 1. INITIAL CRACK SIZE DISTRIBUTION

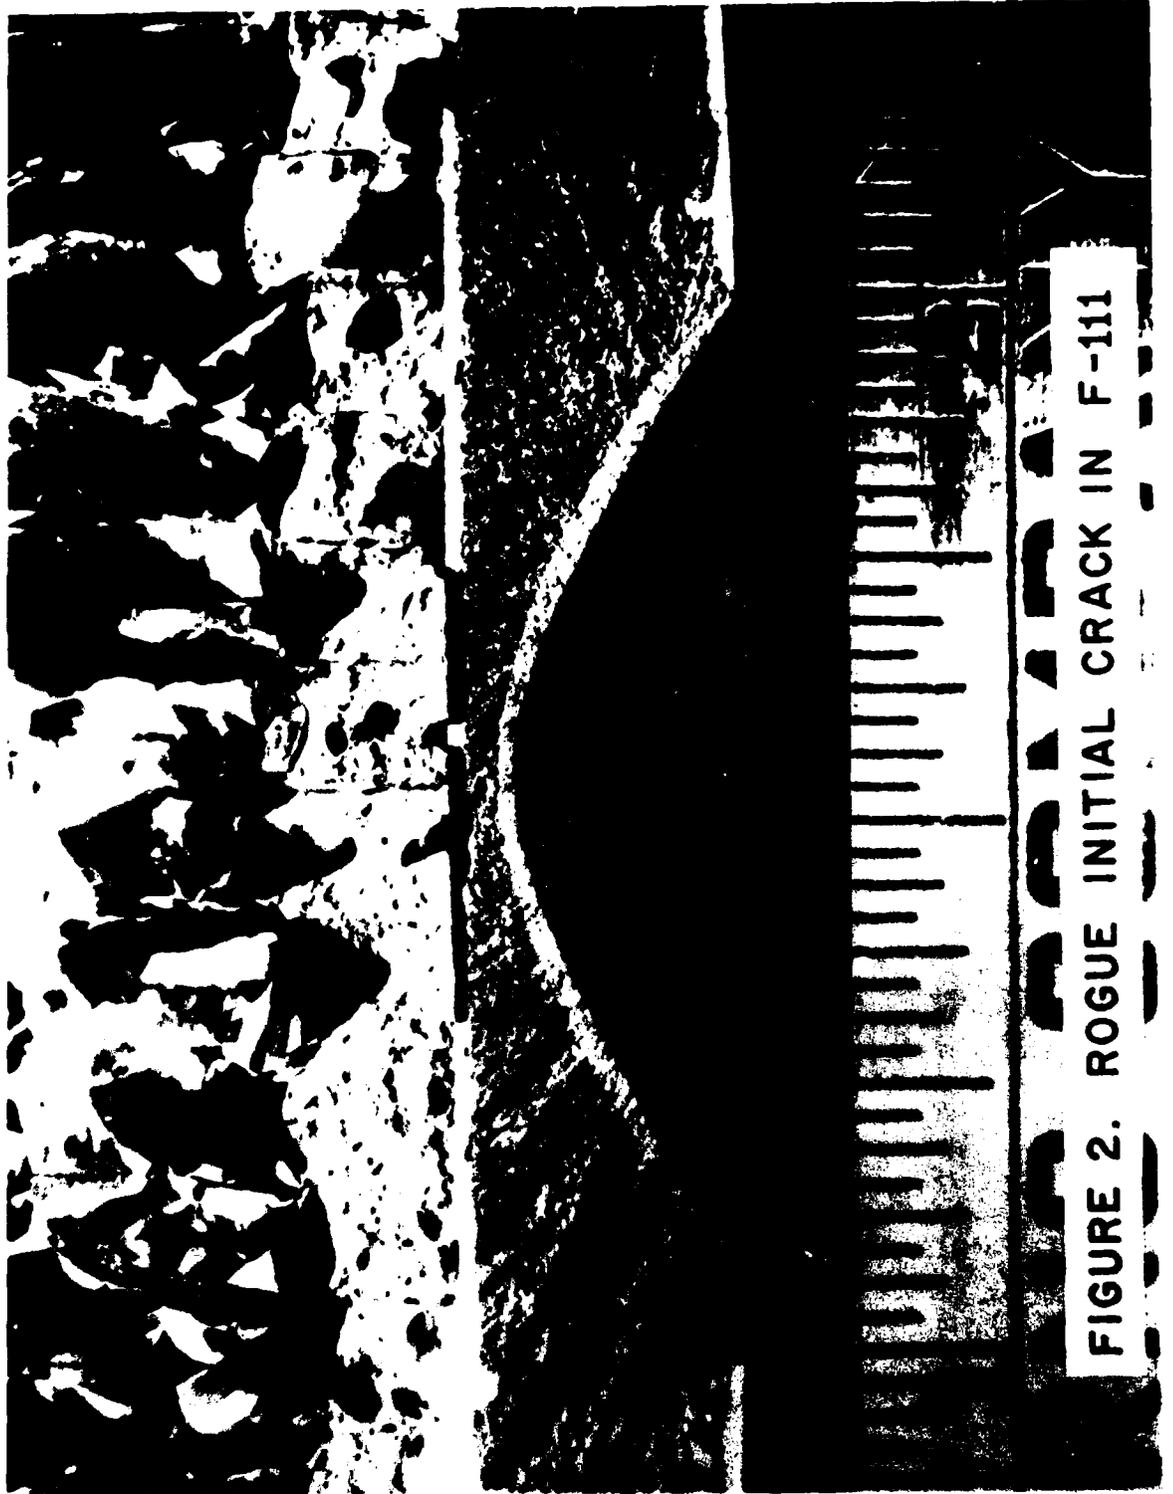
FIGURE 2. ROGUE INITIAL CRACK IN F-111

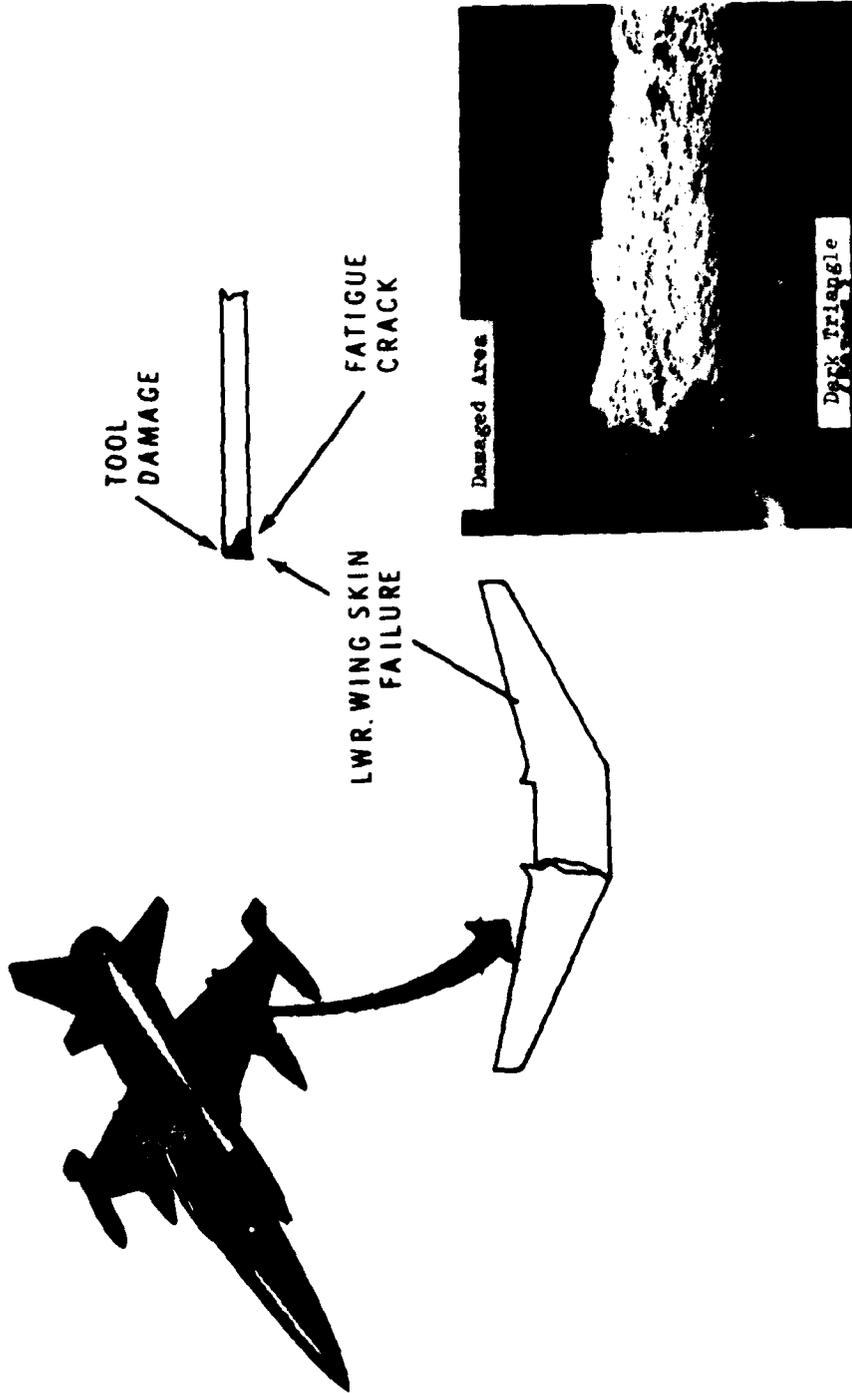
FIGURE 3. TOOL DAMAGE WHICH CAUSED F-5 LOSS

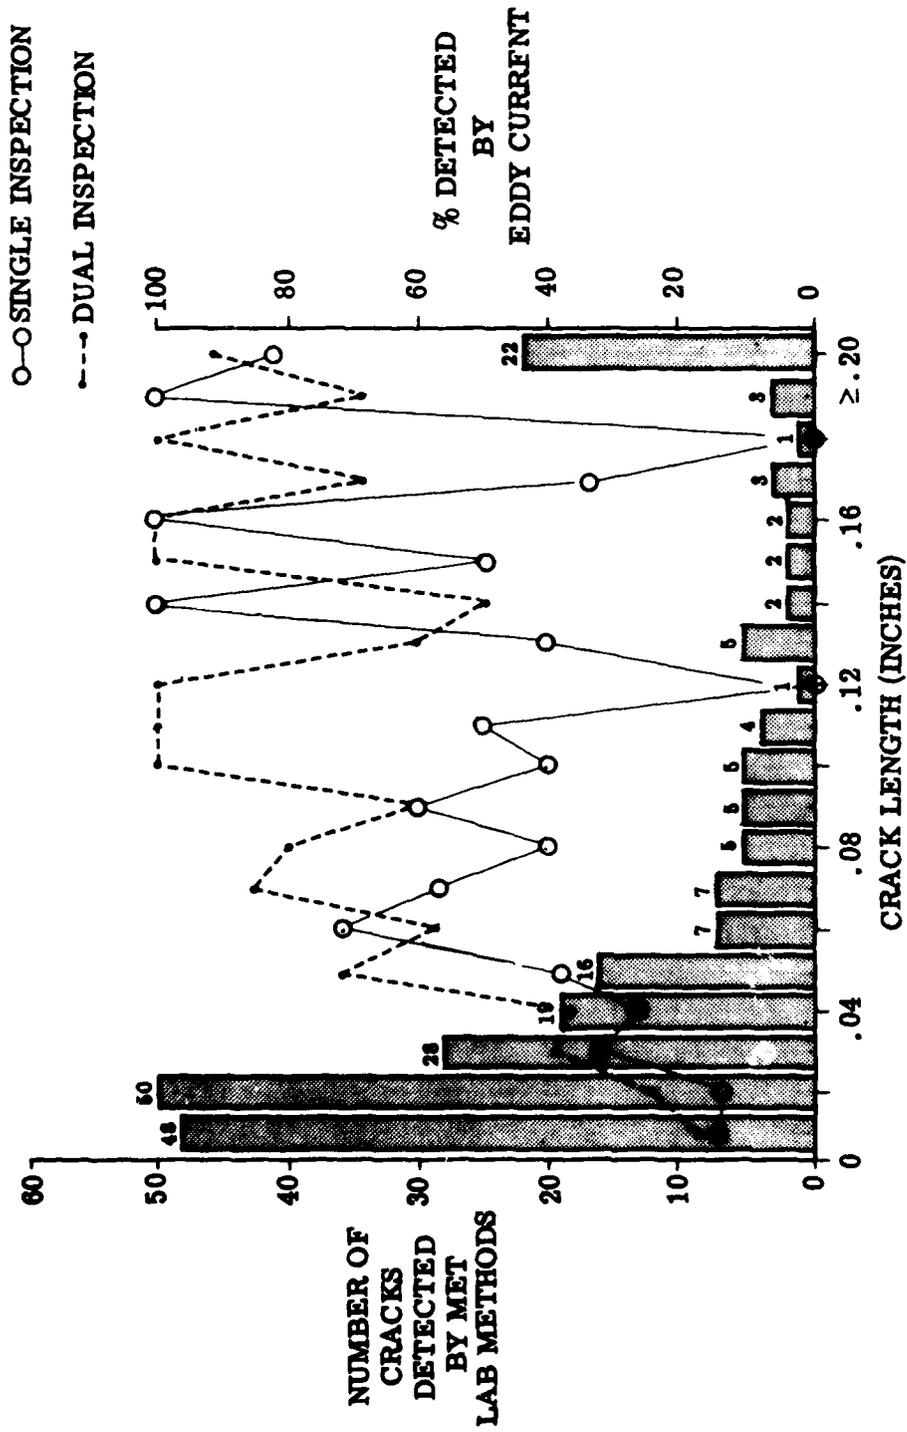
FIGURE 9. CRACK DETECTION RELIABILITY

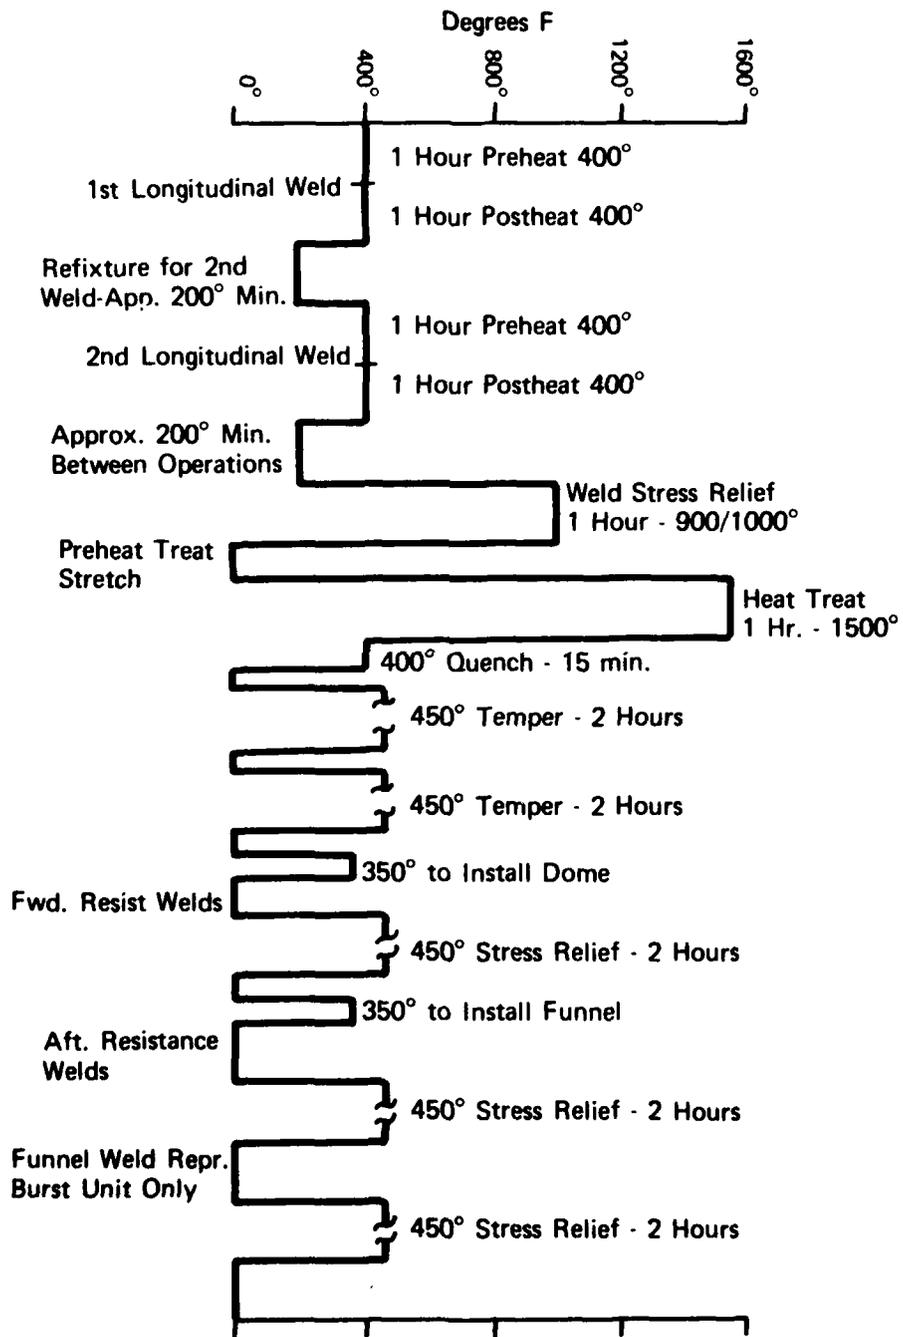
Figure 1. Processing history of second stage motor case

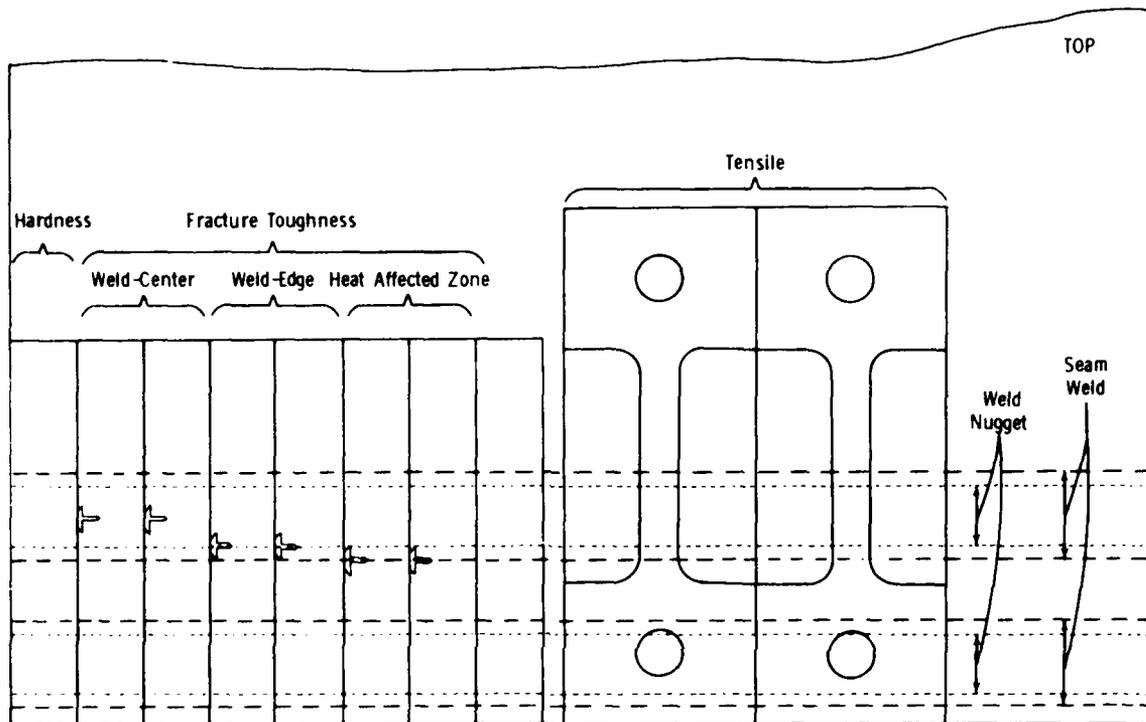
Figure 7. Layout of test specimens from dome section of motor case

Hardness, fracture toughness, and tension specimens were cut from the dome section containing the seam welds. In each case, the specimen included material from both the case and the dome. The 0.308 inch total thickness tension specimens in the dome section were a non-standard 3/8 inch wide, with a 1.5 inch gage length. They were located so that fracture could occur any place in the weld or heat-affected zone. For fracture toughness testing standard ASTM bend specimens were used [1]. The specimen width was 0.616 inch, with a 0.227 inch deep, 0.030 inch wide machined notch. The initial 0.003 inch radius at the crack tip was sharpened by fatigue cracking. As shown in Figure 7, the notches were located in the center of the weld, near the edge of the weld nugget, and in the heat-affected zone.

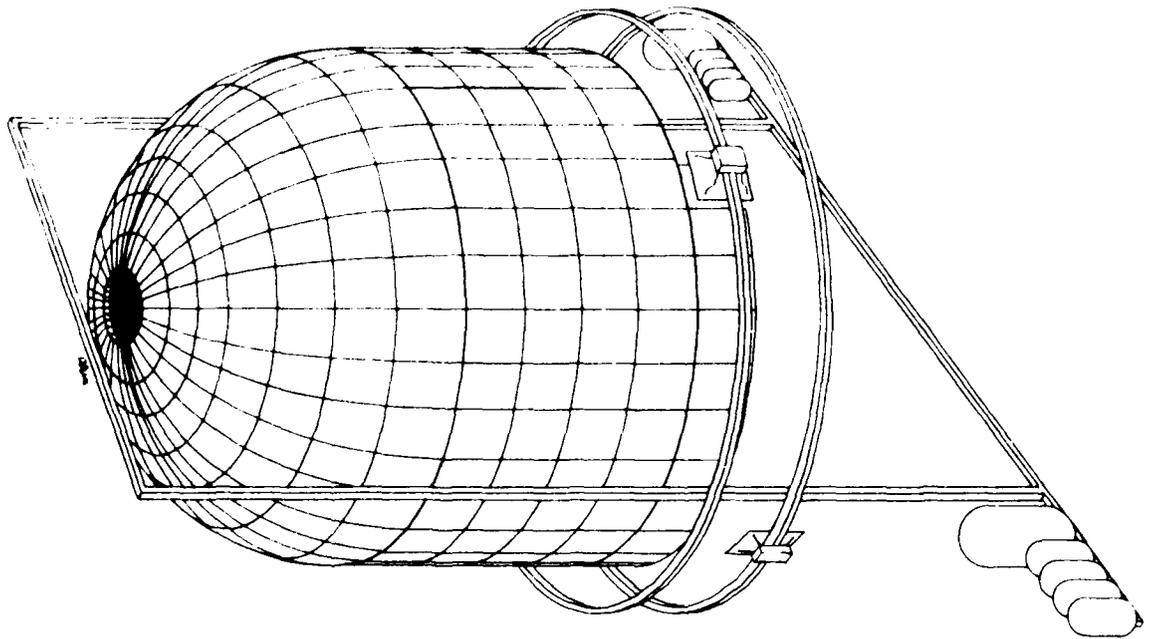
Fig. 1 Habitat Fabrication Scenario

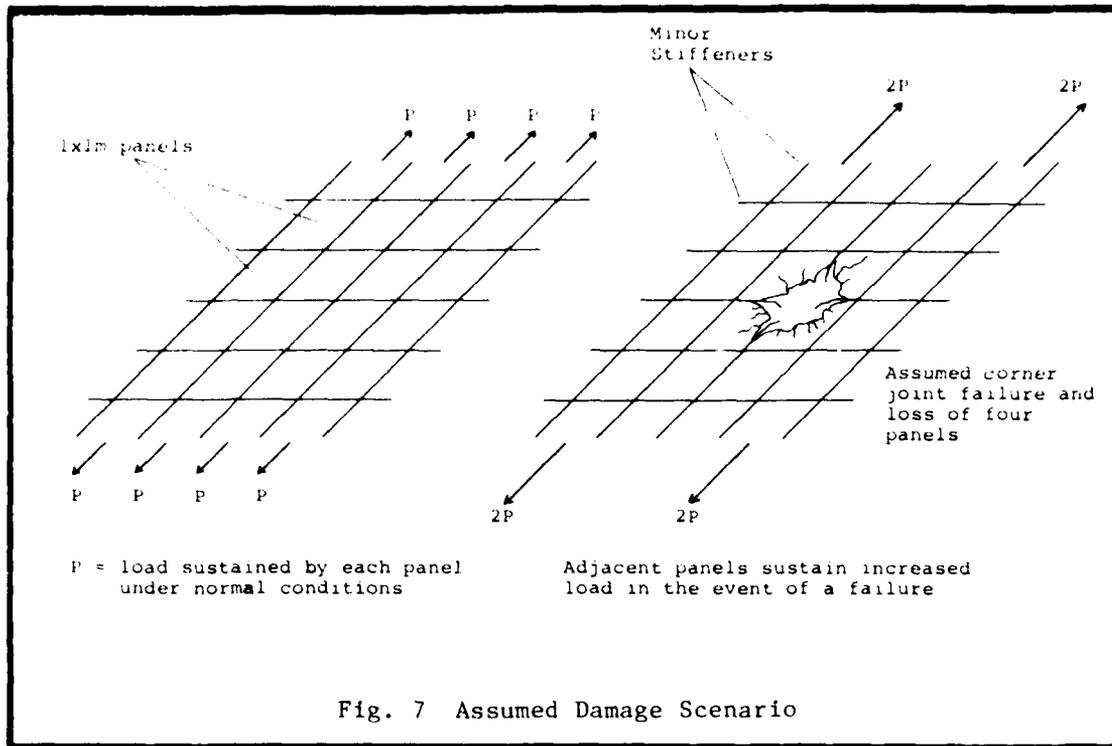
Fig. 7 Assumed Damage Scenario

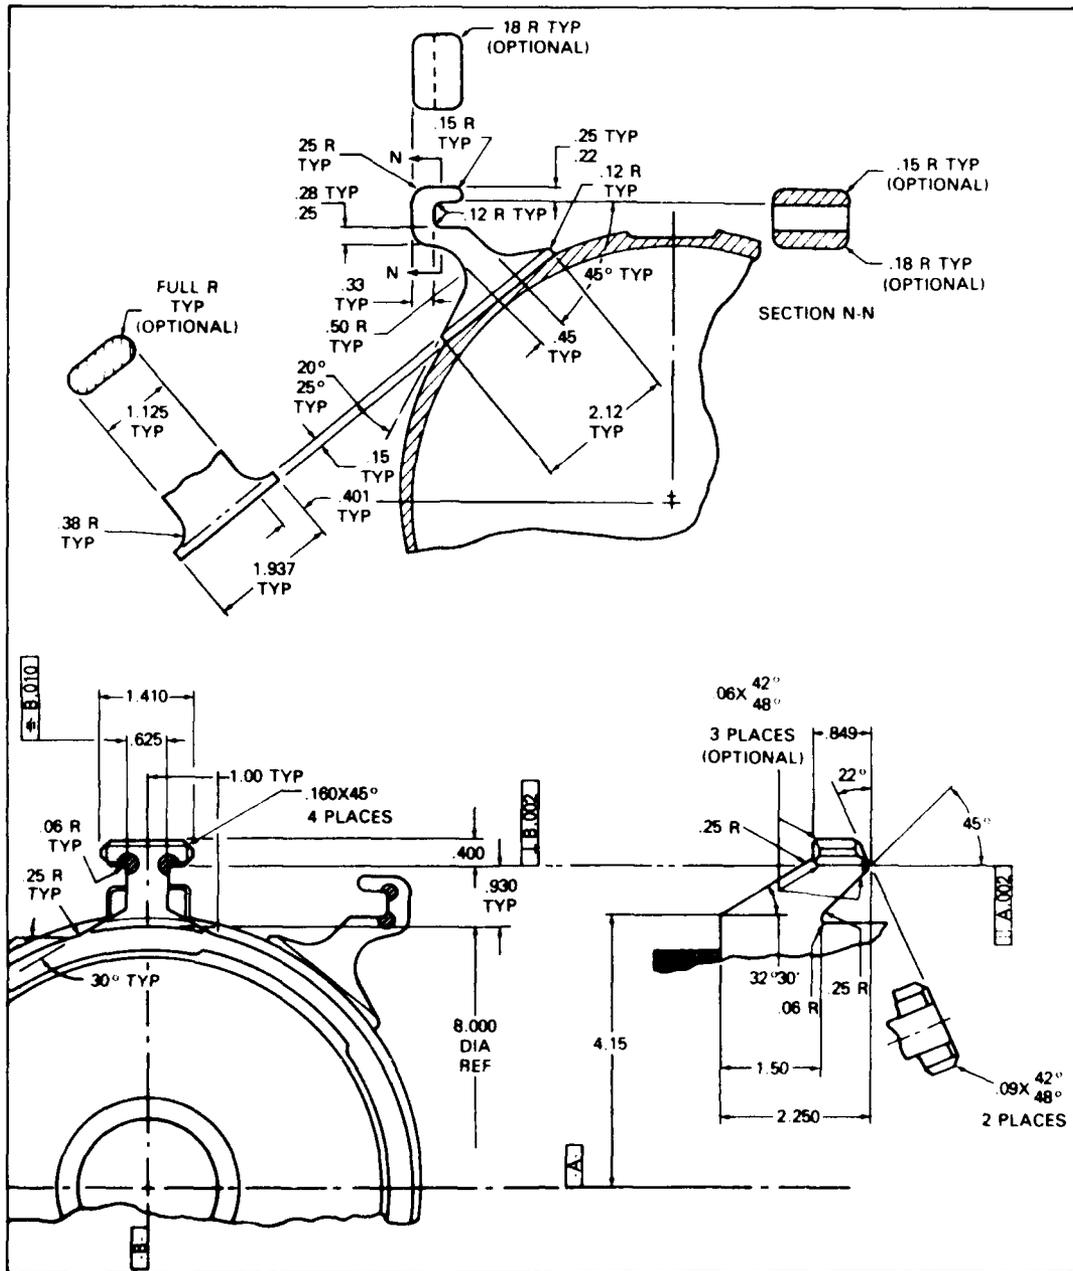
Figure 1(b): Dimensional details of the mounting lugs. Radii and bevels shown as optional were omitted for the Ex 53 model. The crack initiation zones are indicated by the shaded areas in the lower left-hand drawing.

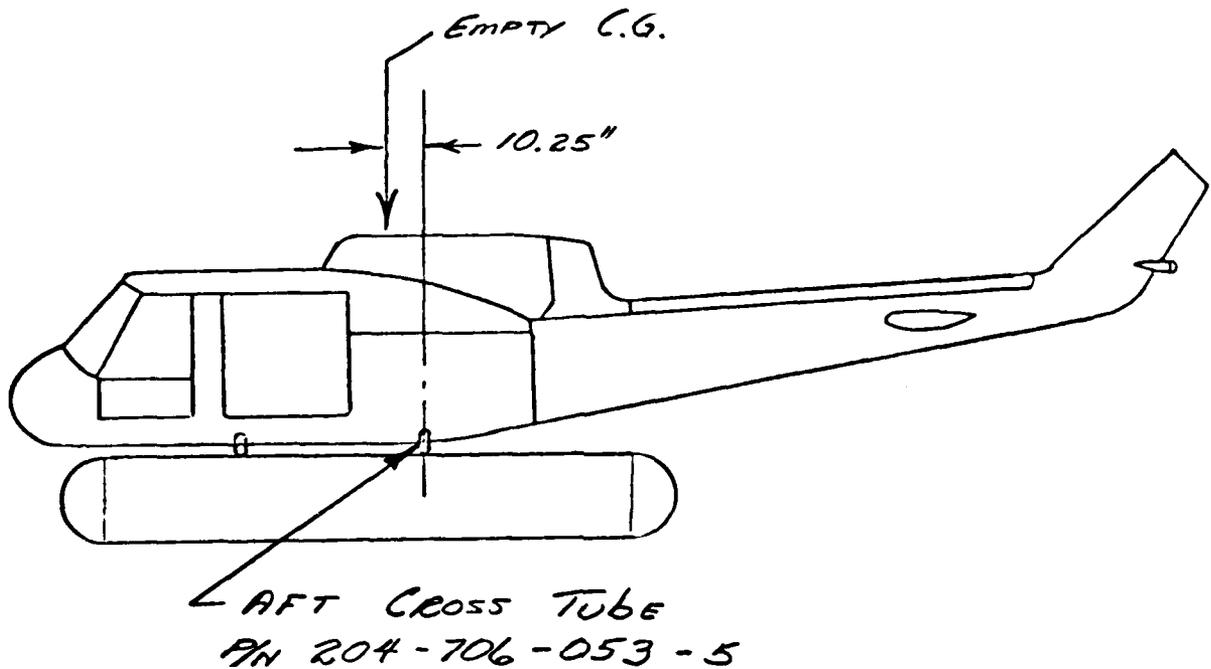
Fig. 1 -- General Position of Fracture
