AMMRC MS 77-5

CASE STUDIES IN FRACTURE MECHANICS

THOMAS P. RICH and DAVID J. CARTWRIGHT
MECHANICS OF MATERIALS DIVISION

June 1977

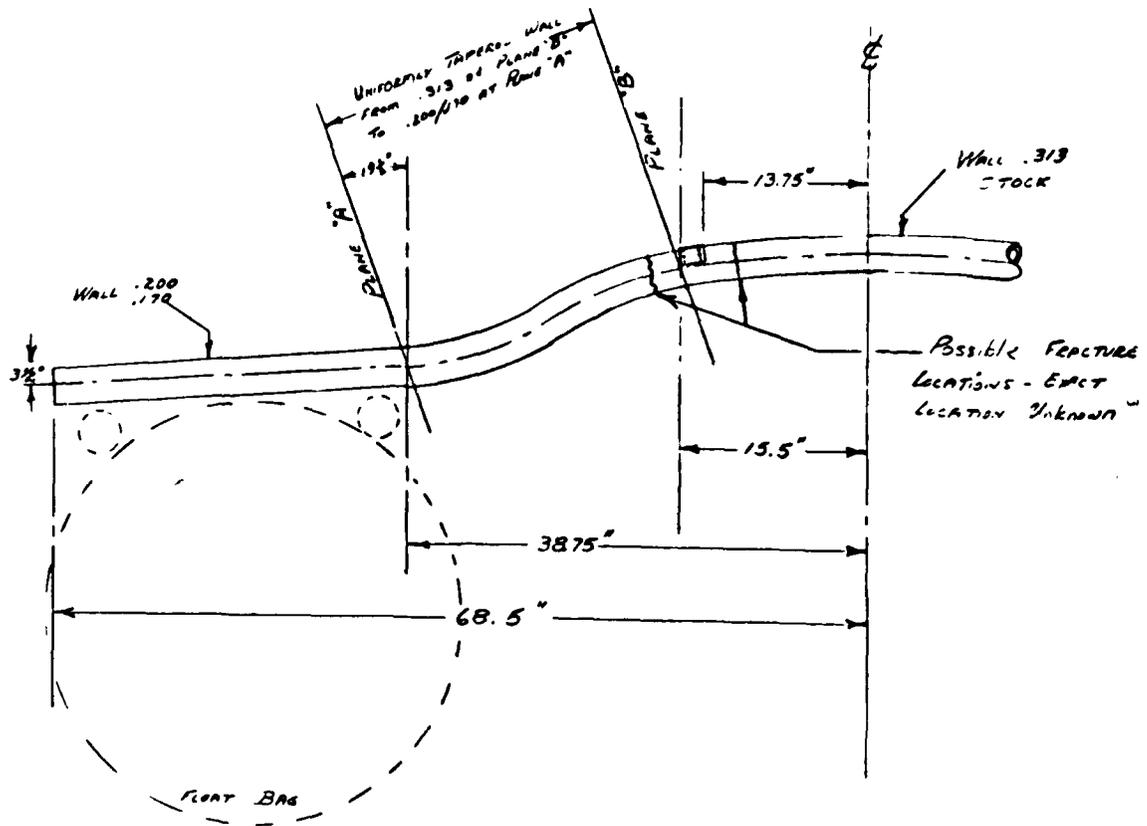
Fig. 2 -- Detailed Location of Fracture

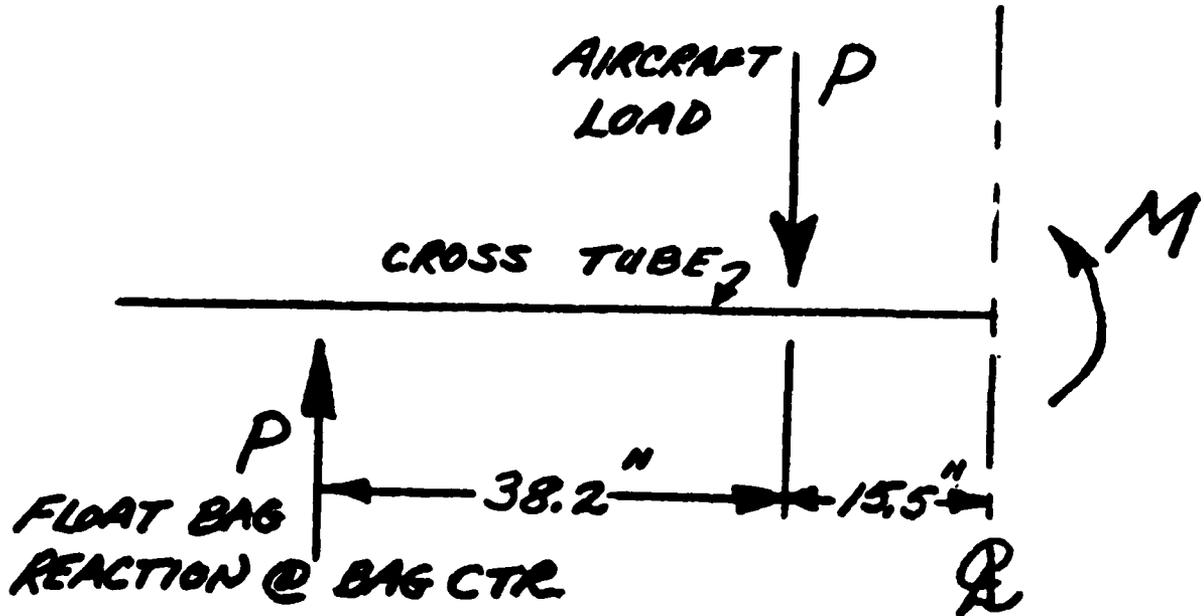
Fig. 8 -- Sketch of Loading Geometry in Float Cross Tube

Stress levels calculated for various possible loading conditions were then calculated and are listed at the bottom of Figure 8 in Table 1.

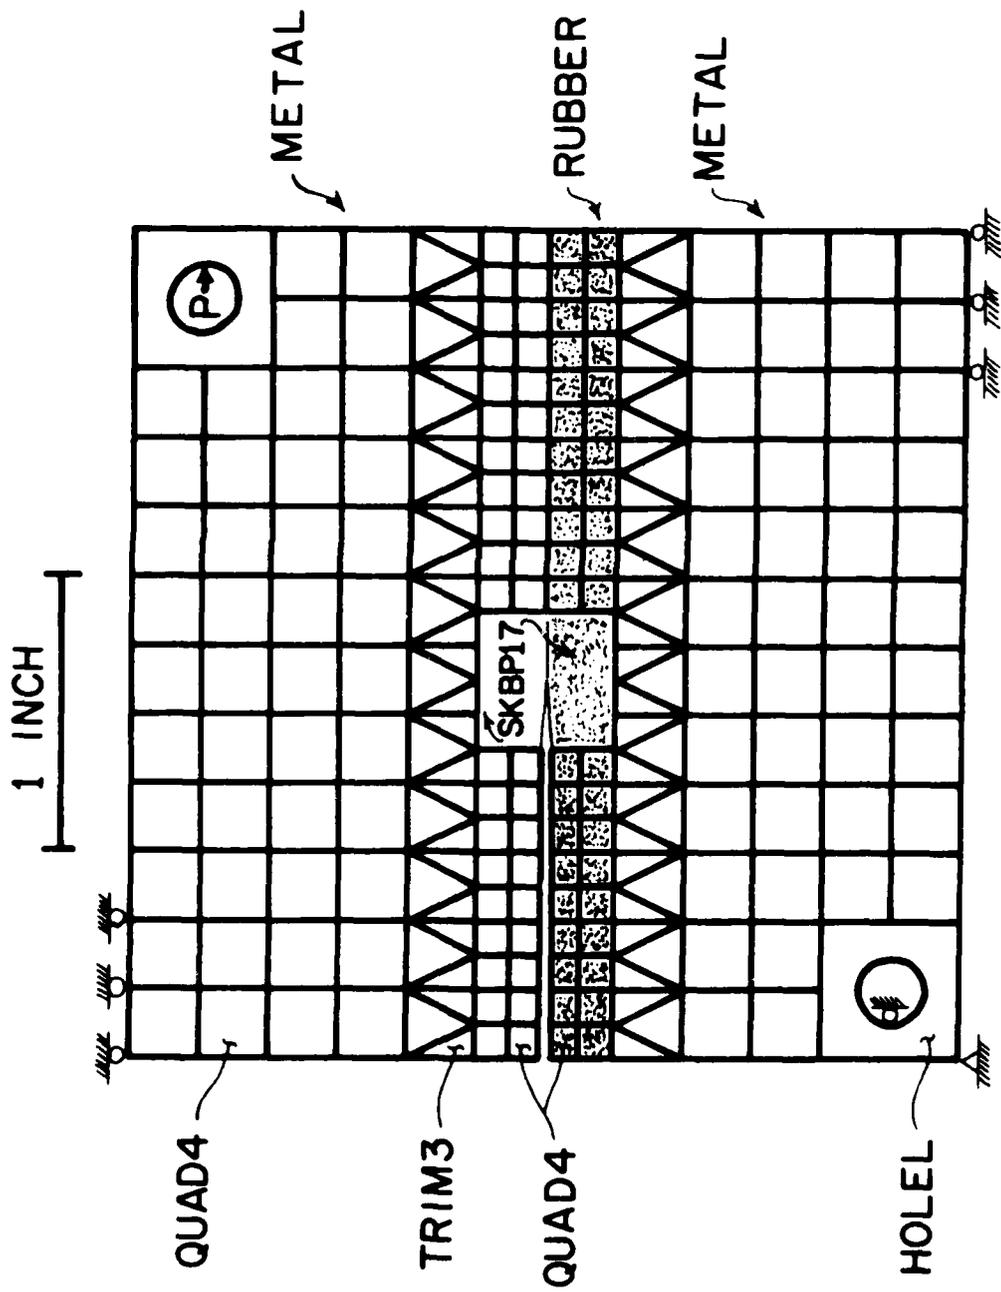
FIGURE 3. FINITE-ELEMENT MODEL

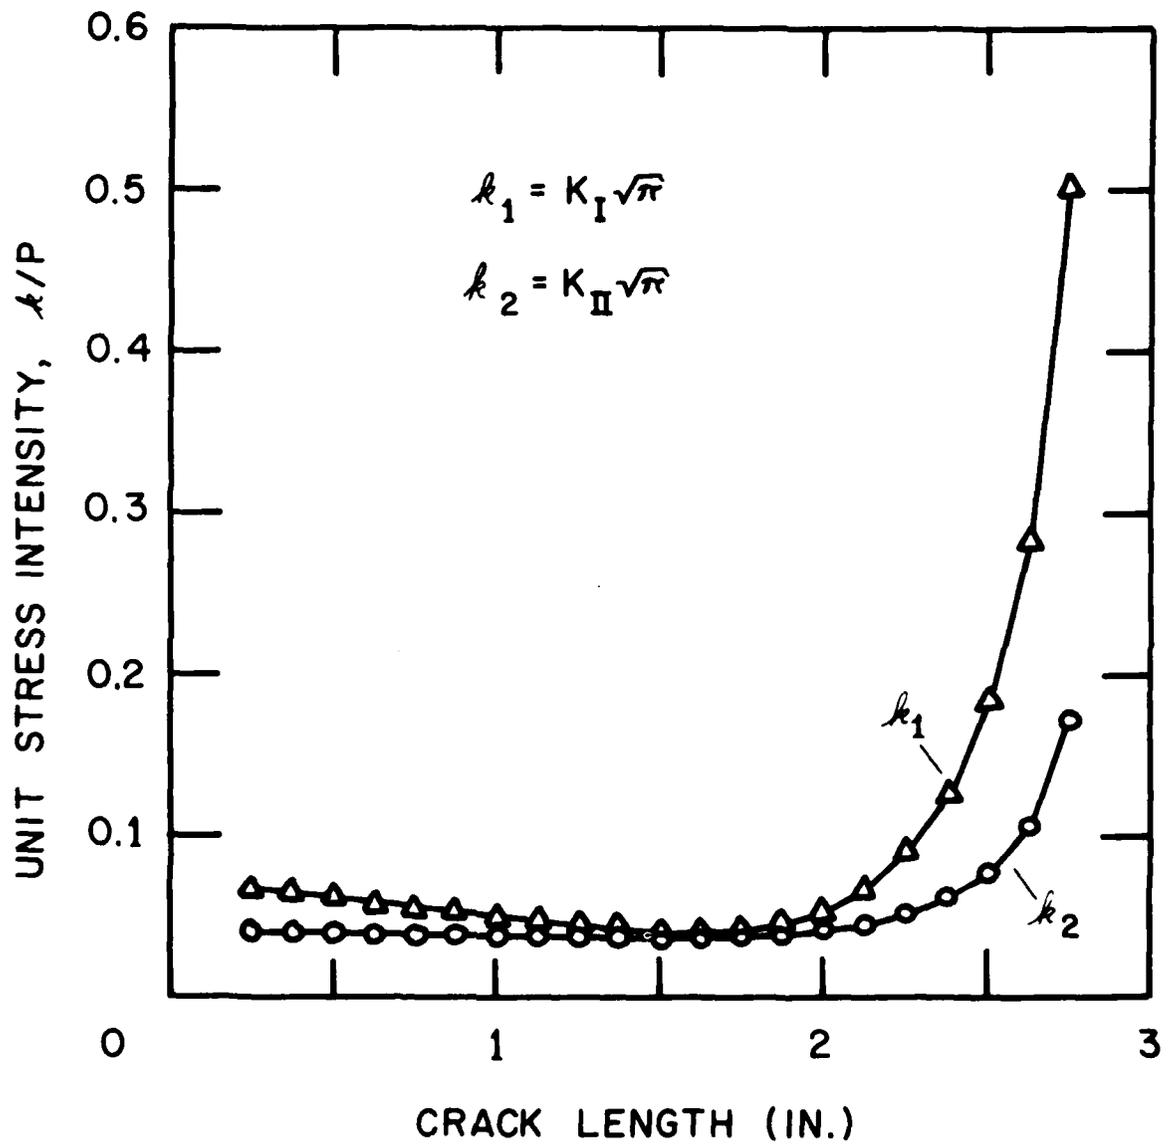
FIGURE 4. COMPUTED RESULTS

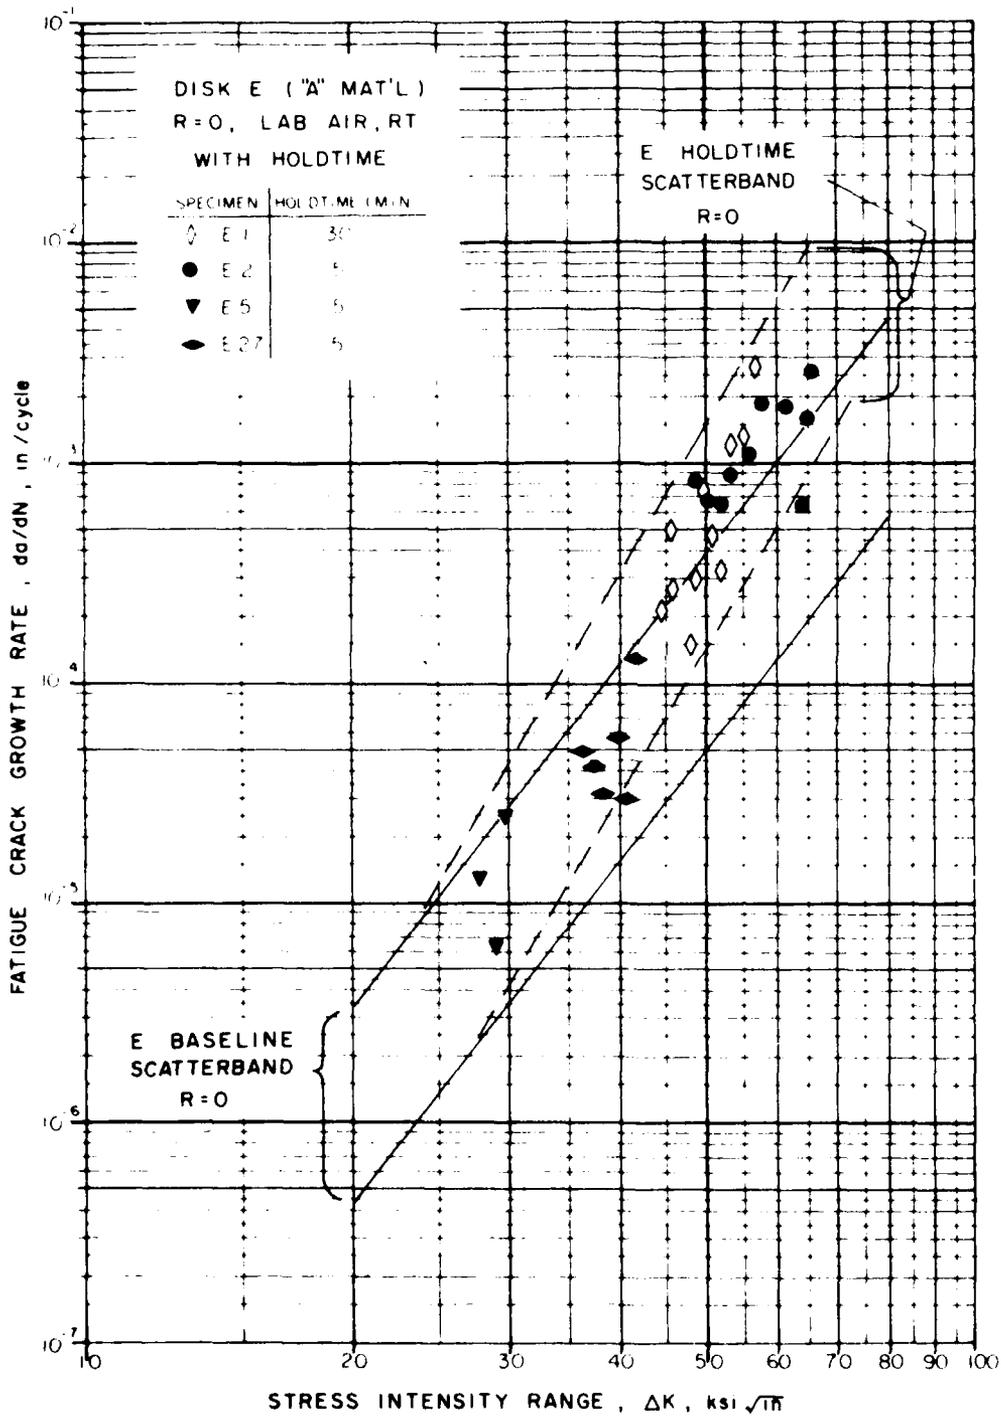
Figure 7 Effect of 5 and 30 minute hold times on fatigue-crack propagation in laboratory air

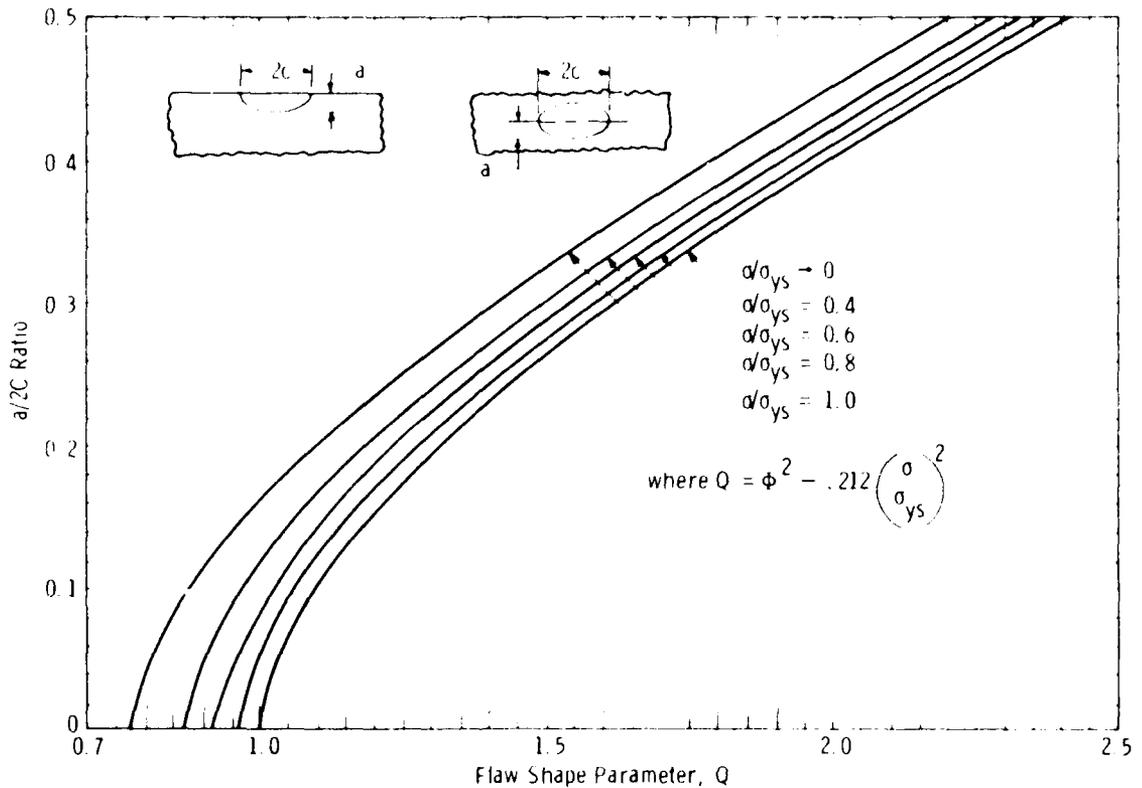
Figure 3 - Flaw shape parameter curves for surface and internal cracks [4]

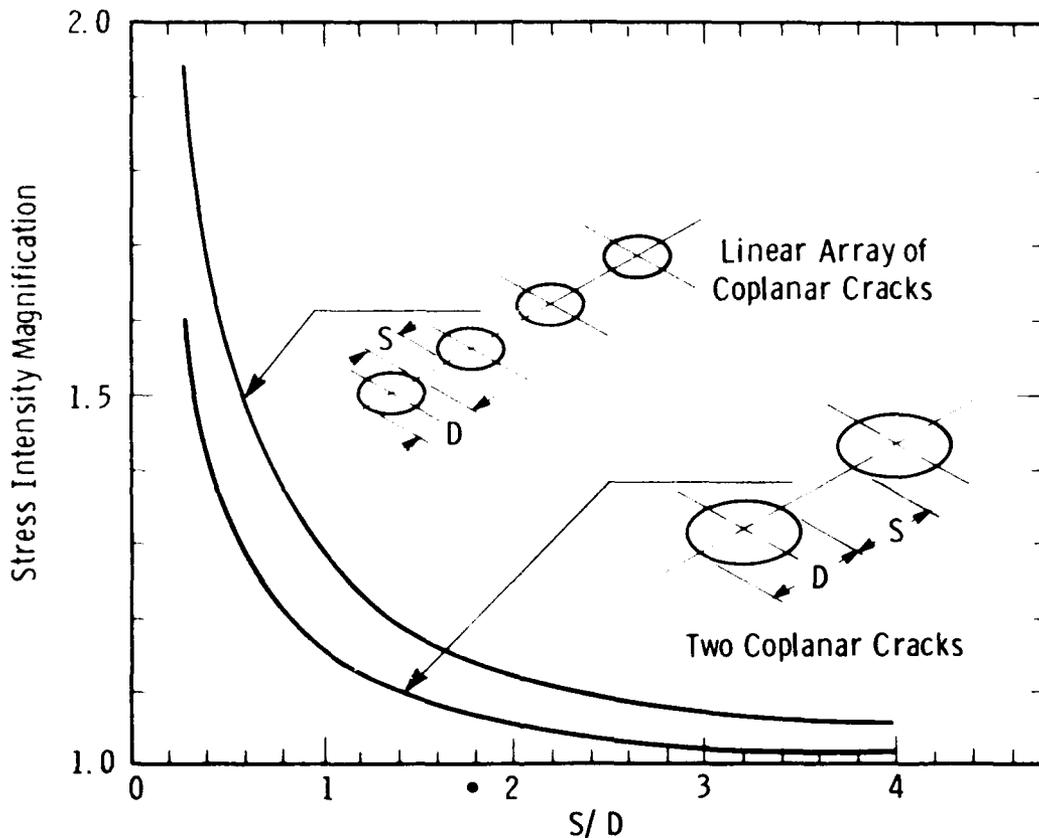
Figure 4—Stress intensity magnification at the approaching edge between adjacent circular defects in a tension stress field [5]

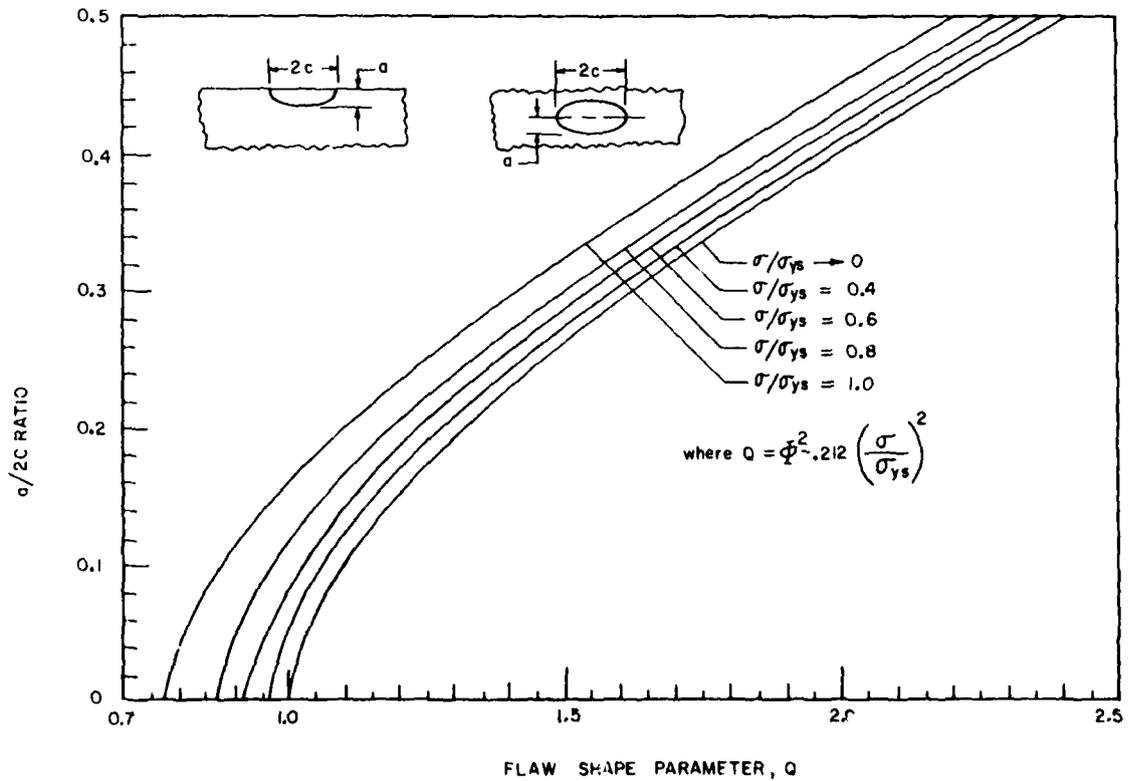
FIGURE 3 FLAW SHAPE PARAMETER CURVES FOR SURFACE AND INTERNAL CRACKS

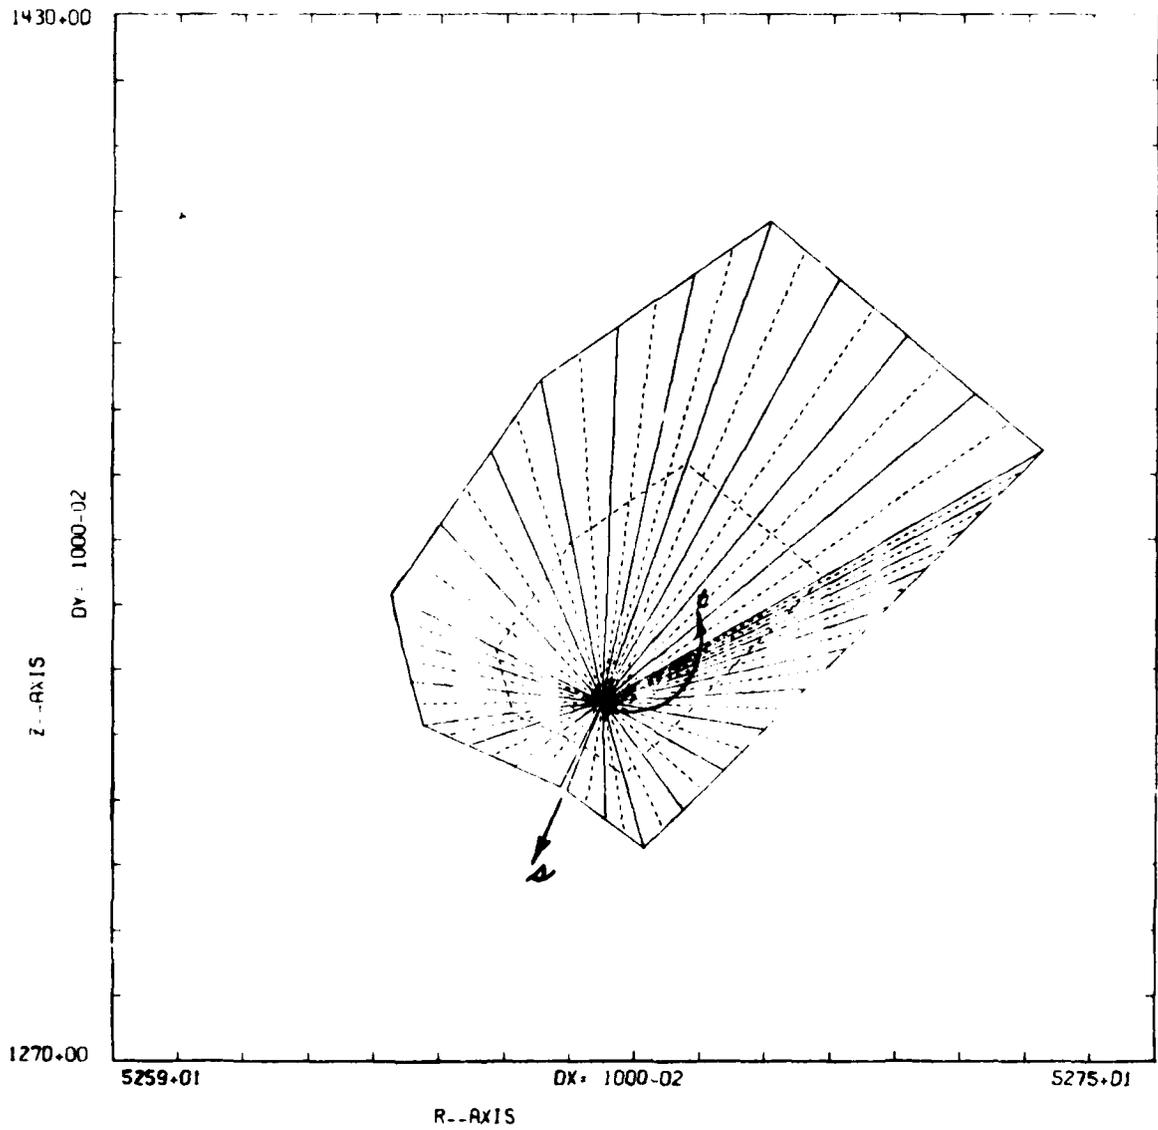
Figure 4 Free Body CRAKTIP (Crack-Tip Region)

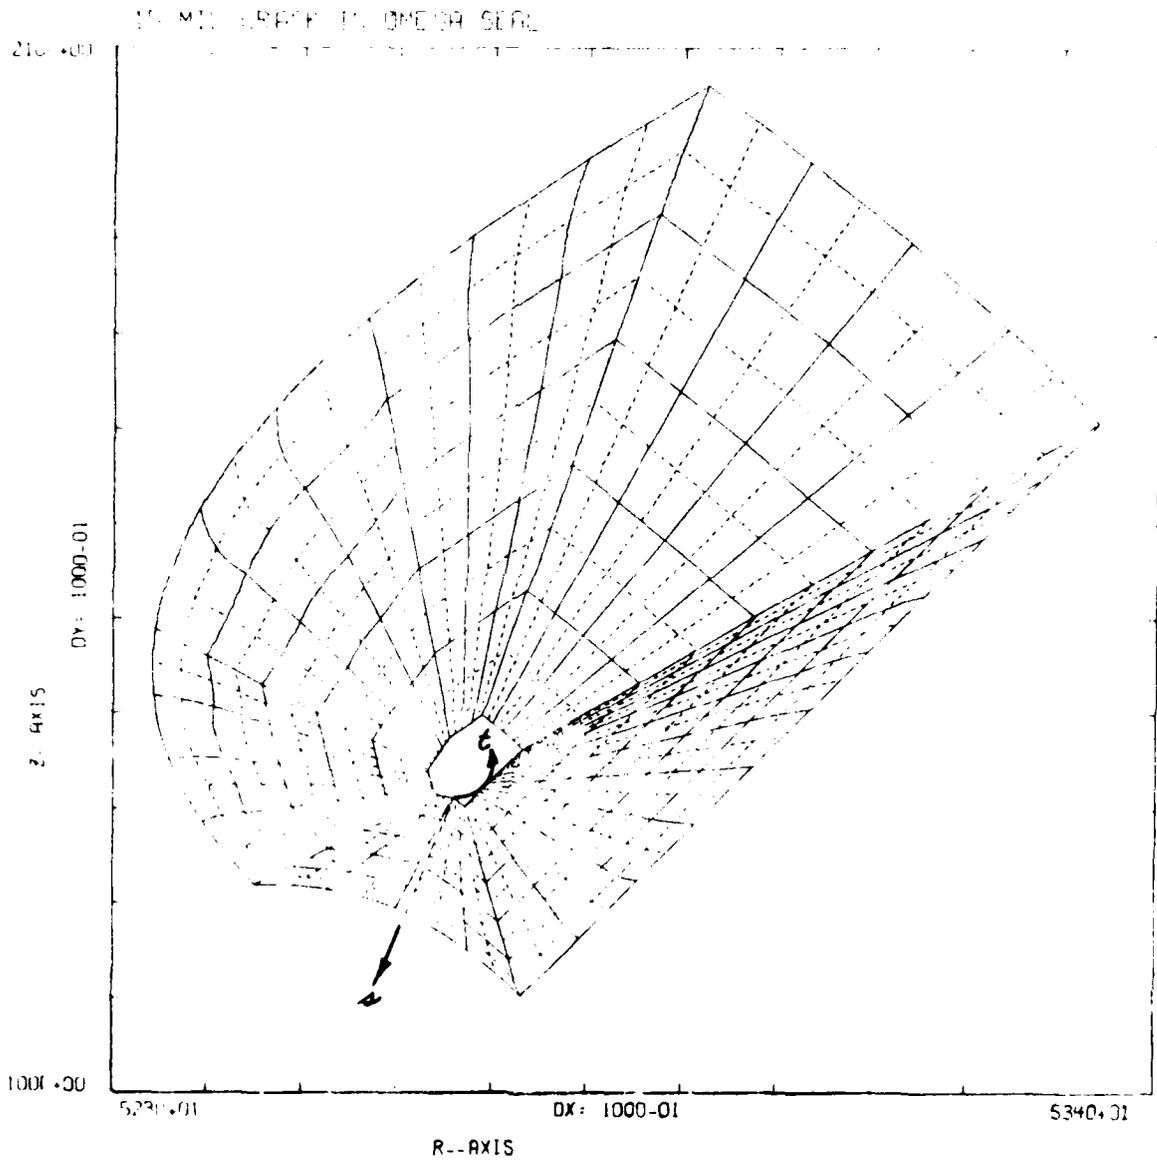
Figure 5 Revised Free Body CRAKEL

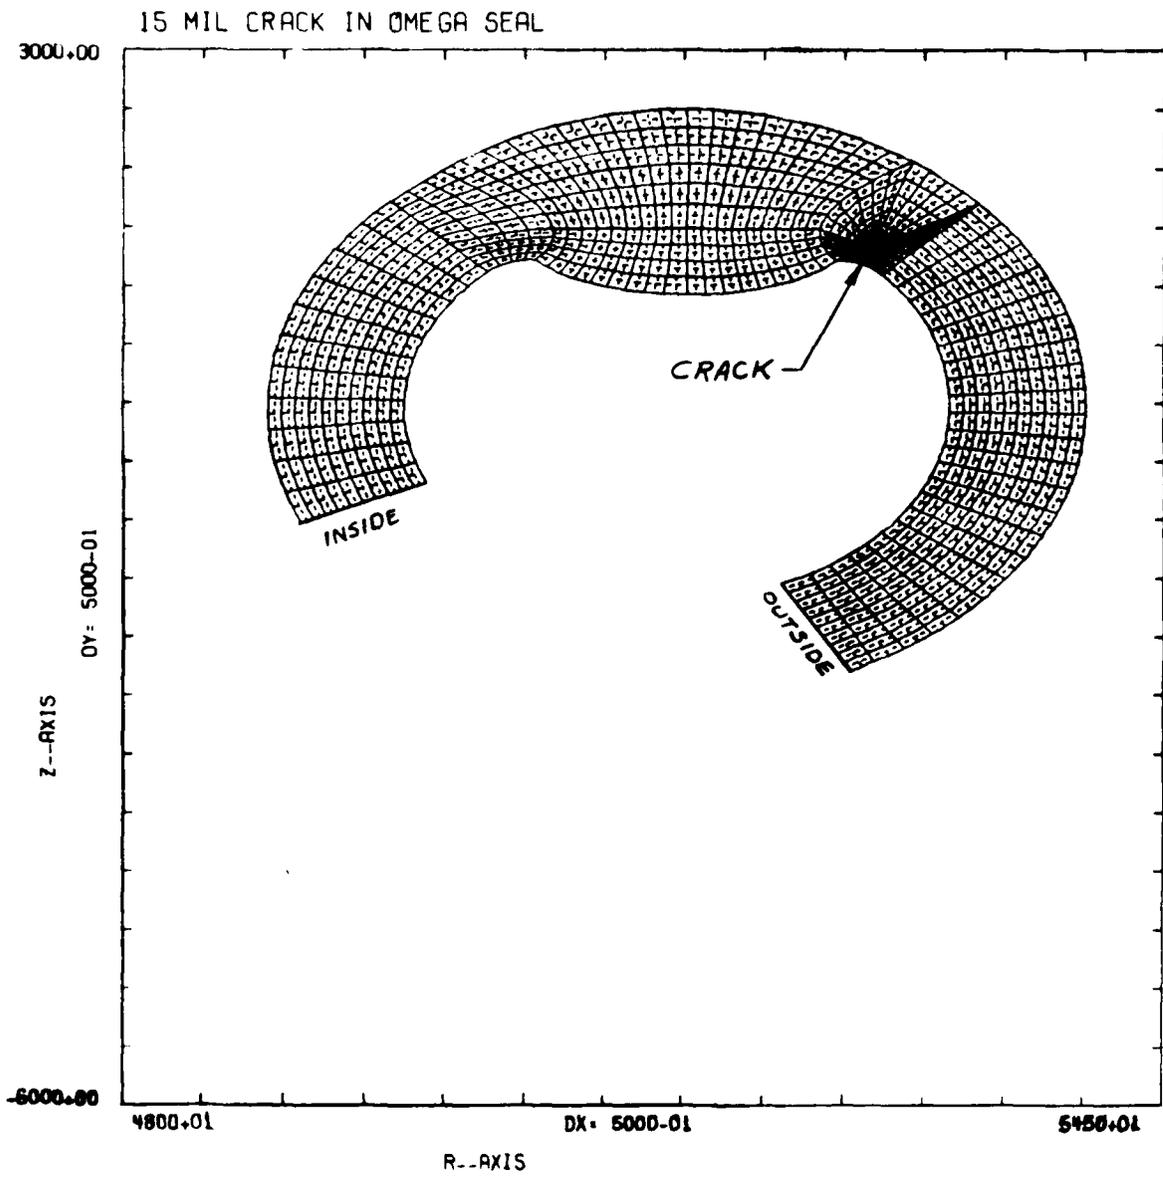
Figure 7 Cross Section of Omega Seal with Crack

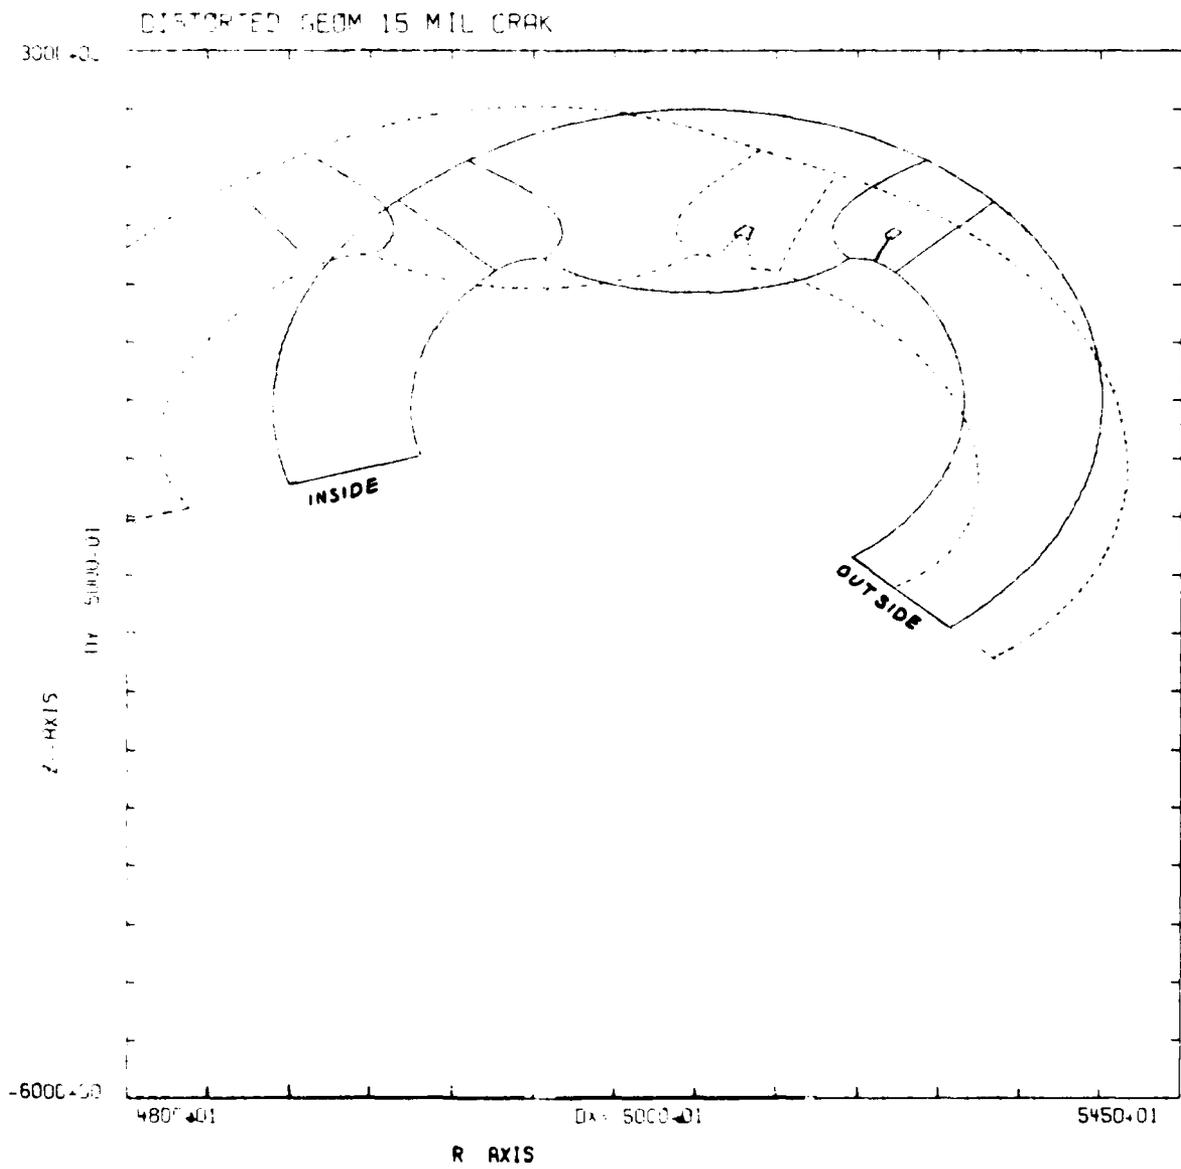
Figure 8 Distorted Geometry - Displacements Magnified 100 times
Steady State Boundary Conditions

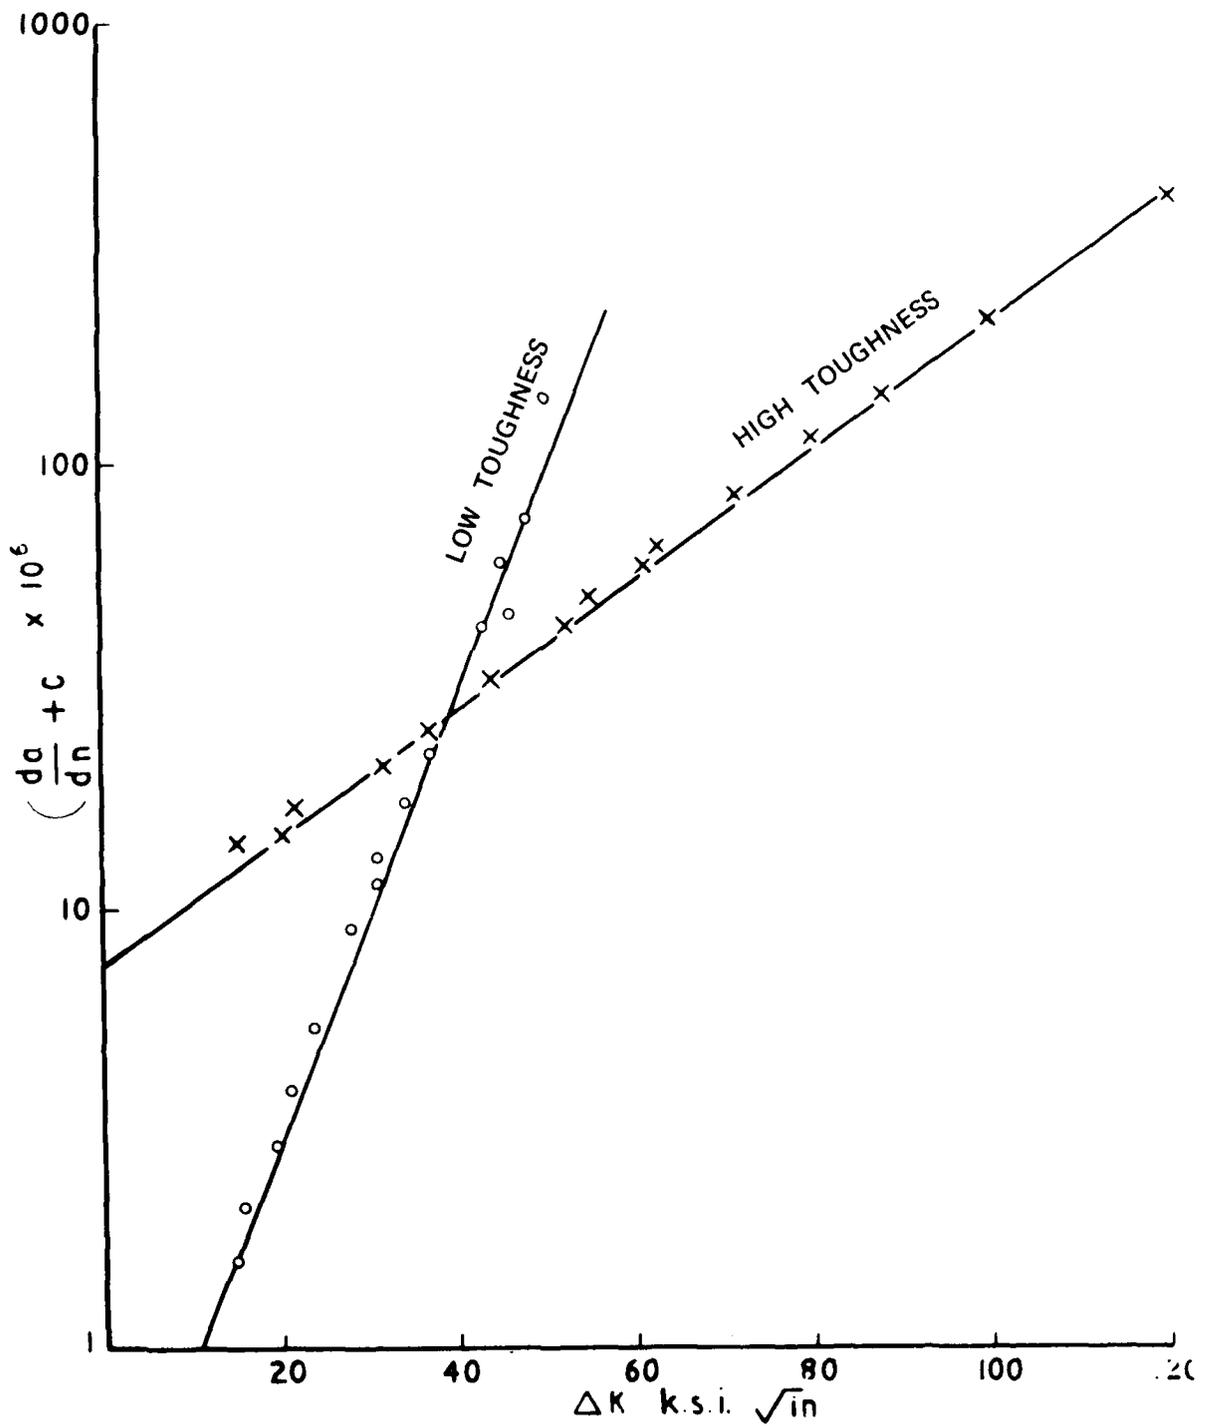
FIG. 4 FATIGUE CRACK GROWTH DATA FOR TWO STEELS

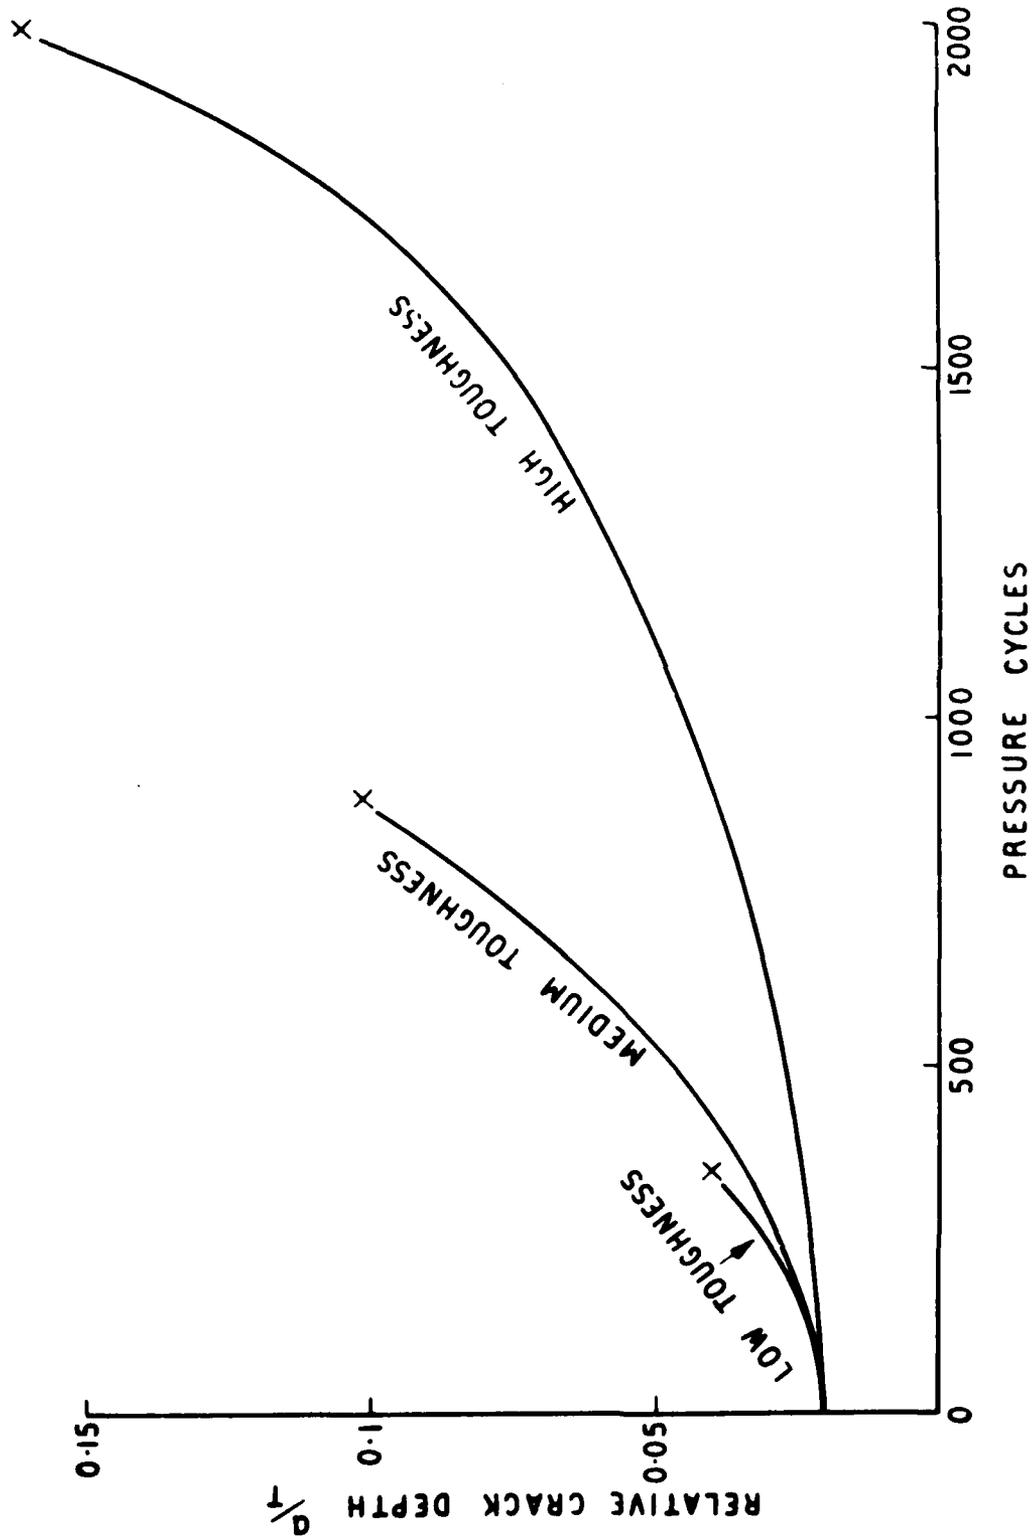
FIG. 5 PREDICTED FATIGUE CRACK GROWTH CURVES — SINGLE CRACK

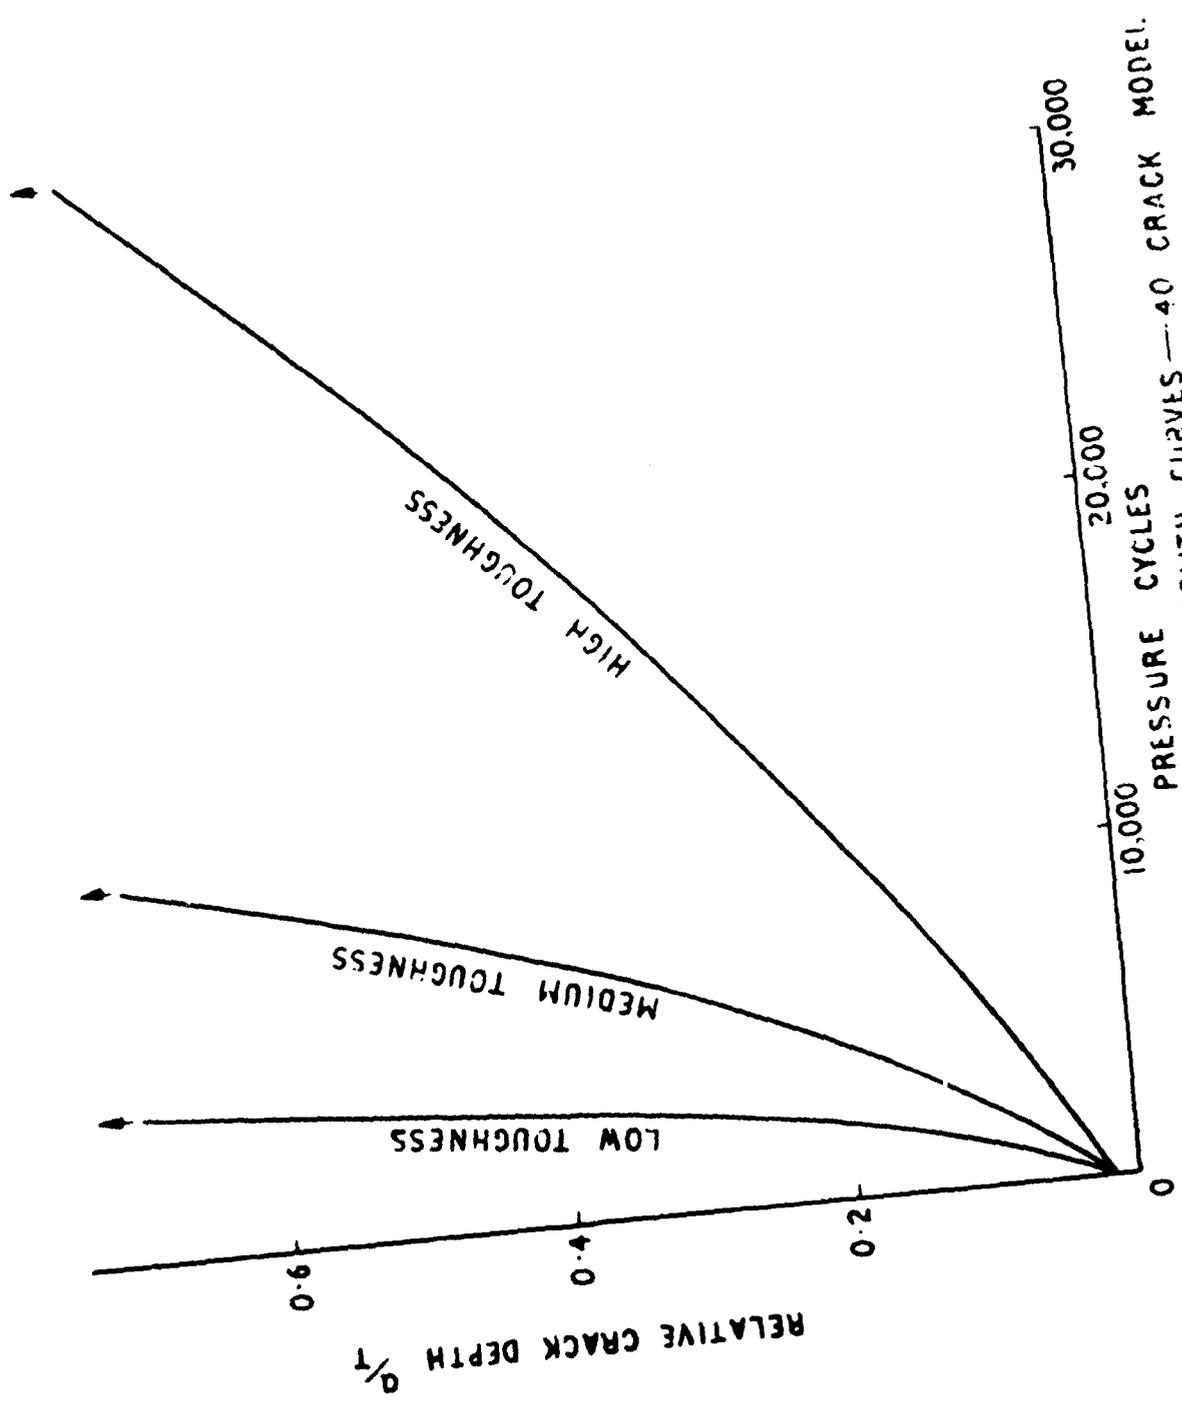
FIG. 6 PREDICTED FATIGUE CRACK GROWTH CURVES — 40 CRACK MODEL.

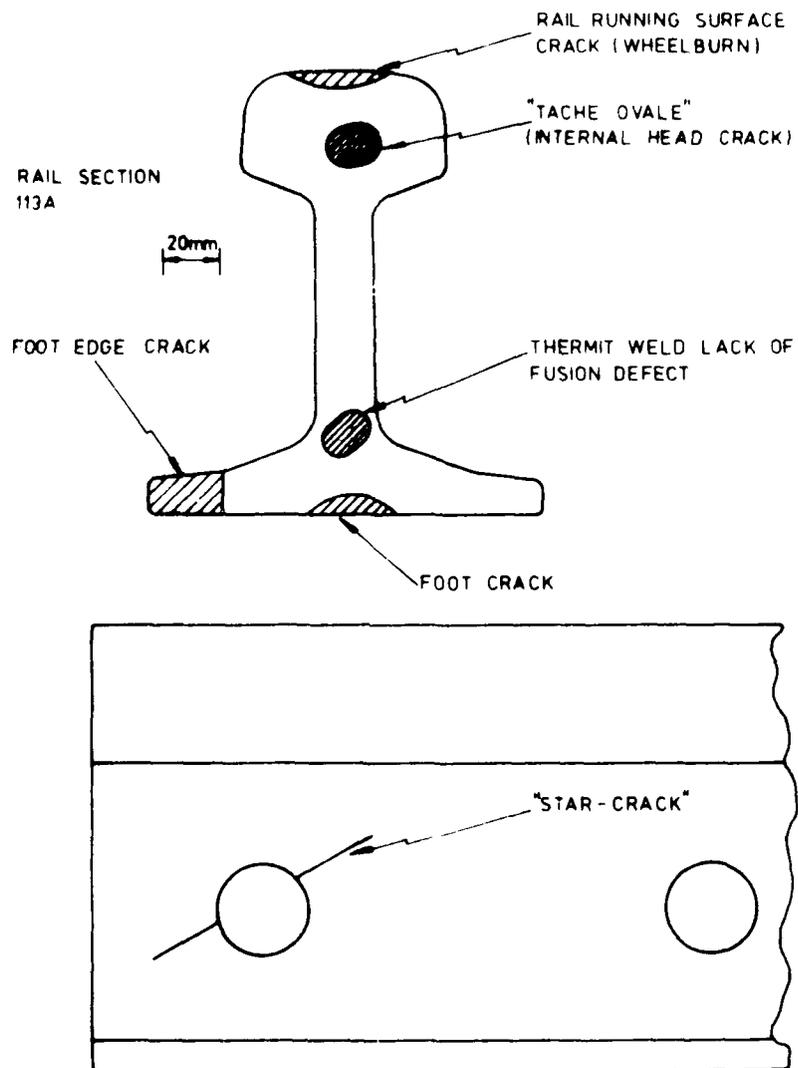
FIG. 1. SOME COMMON CRACK LOCATIONS IN THE RAIL SECTION.

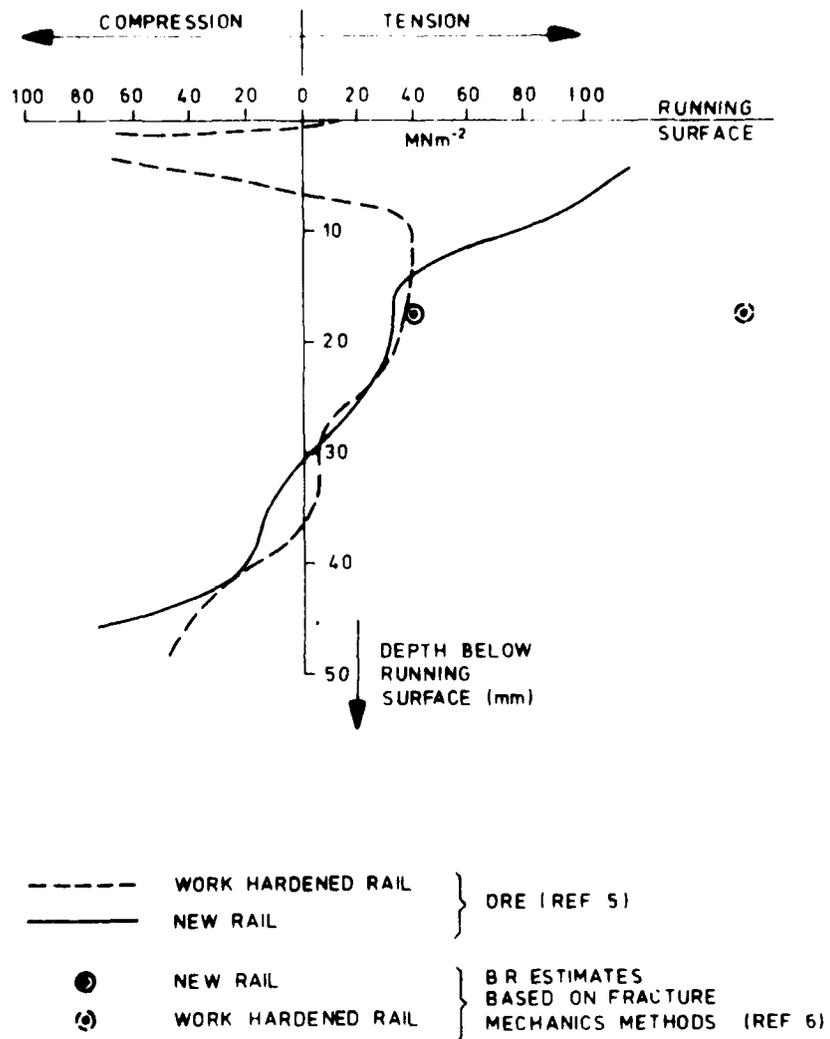
FIG. 2. VARIATION OF LONGITUDINAL RESIDUAL STRESS WITH
DEPTH BELOW RUNNING SURFACE ON THE AXIS
OF SYMMETRY.

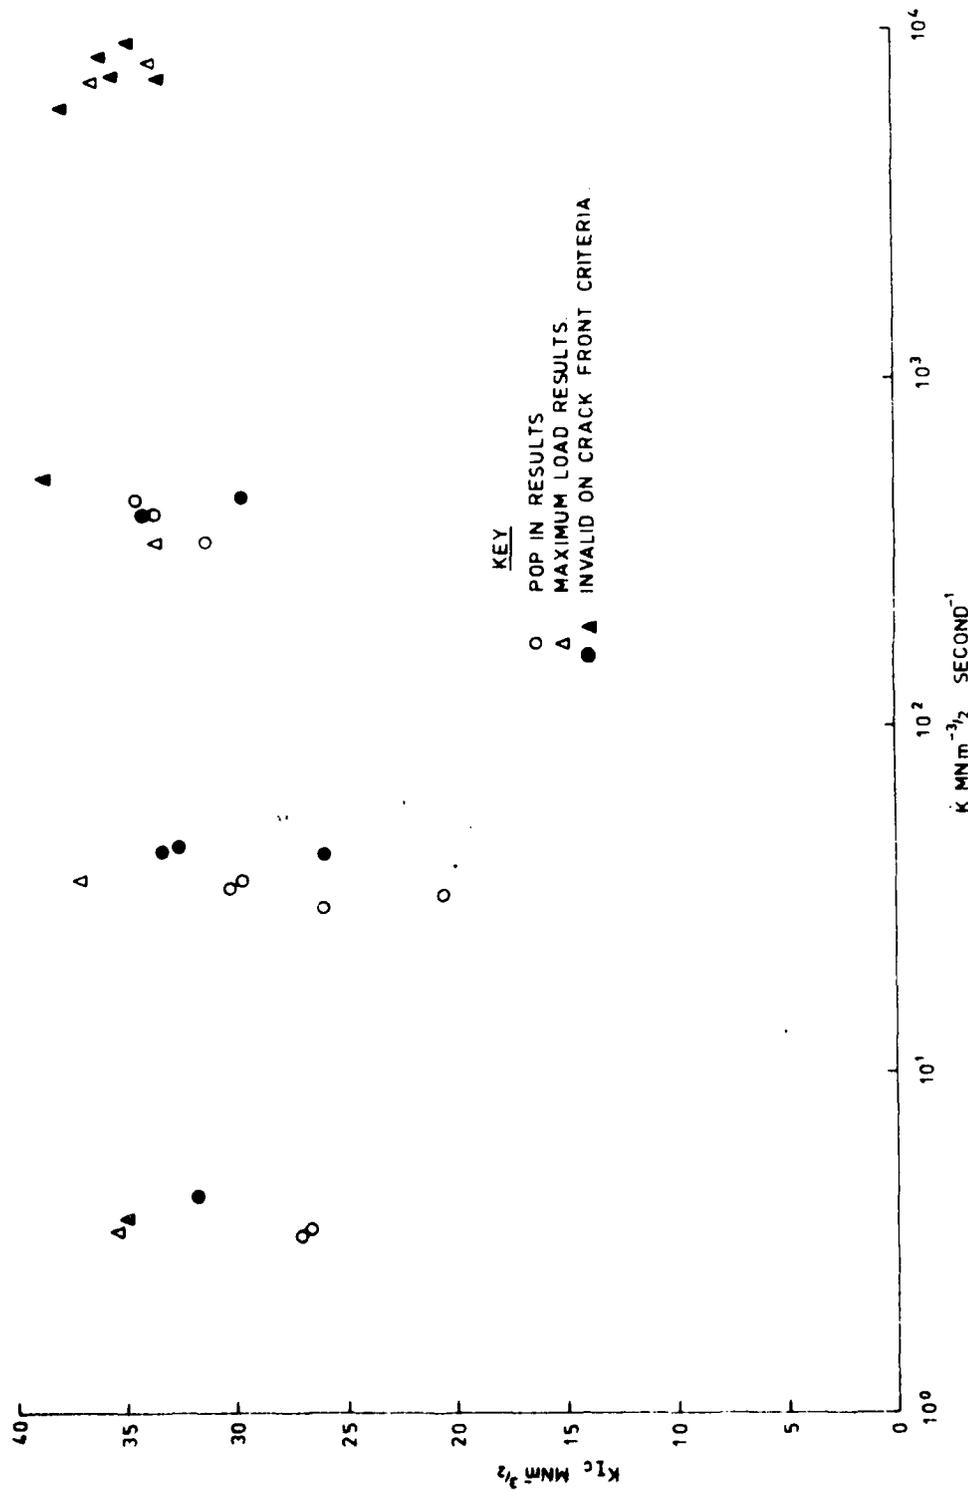
FIG. 4. THE EFFECT OF STRESS INTENSIFICATION RATE \dot{K} ON THE PLANE STRAIN
 FRACTURE TOUGHNESS K_{Ic} OF B.S.11 RAIL STEEL.
