AMMRC MS 77-5

CASE STUDIES IN FRACTURE MECHANICS

THOMAS P. RICH and DAVID J. CARTWRIGHT
MECHANICS OF MATERIALS DIVISION

June 1977

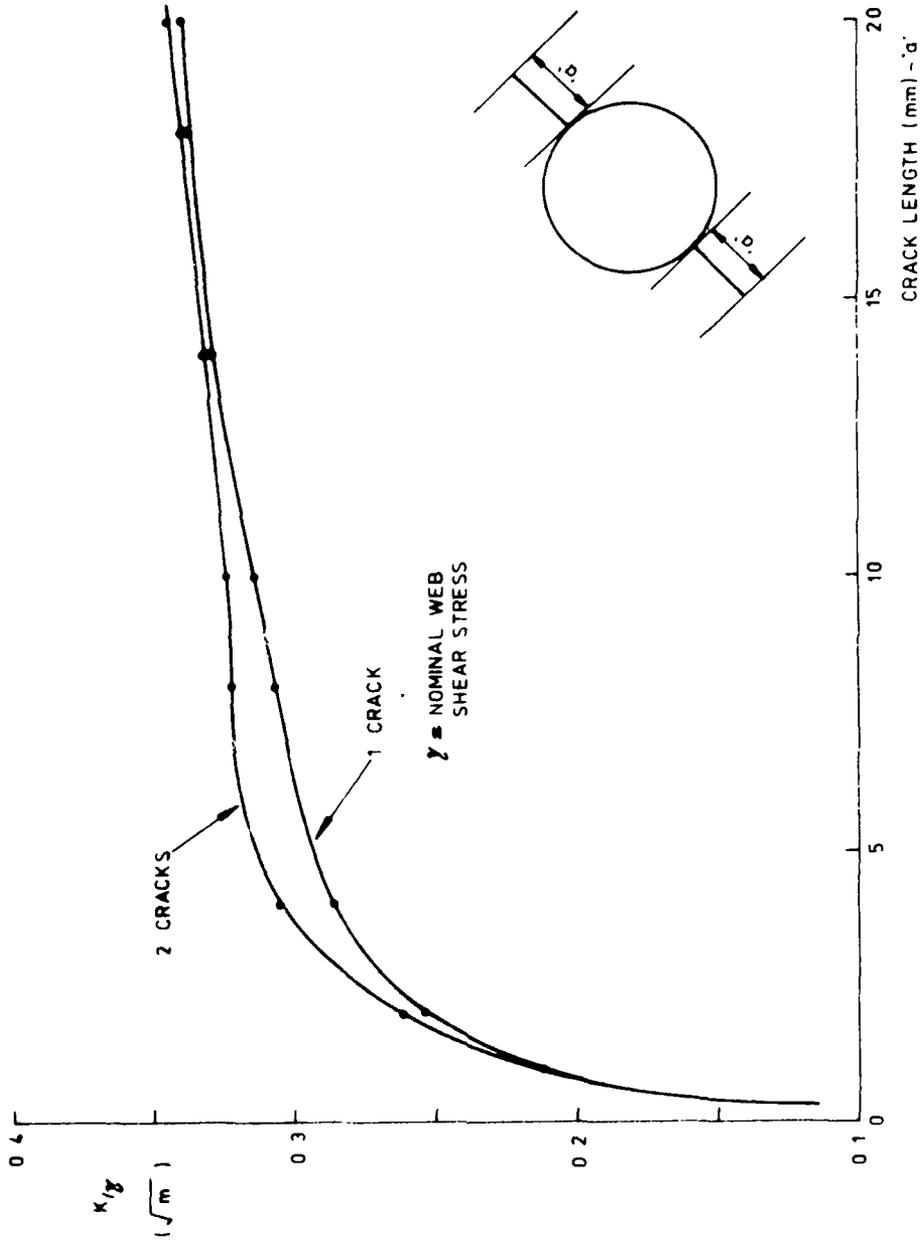
FIG 6. WELLS-BOWIE K-CALIBRATION FOR BOLT-HOLE CRACKS

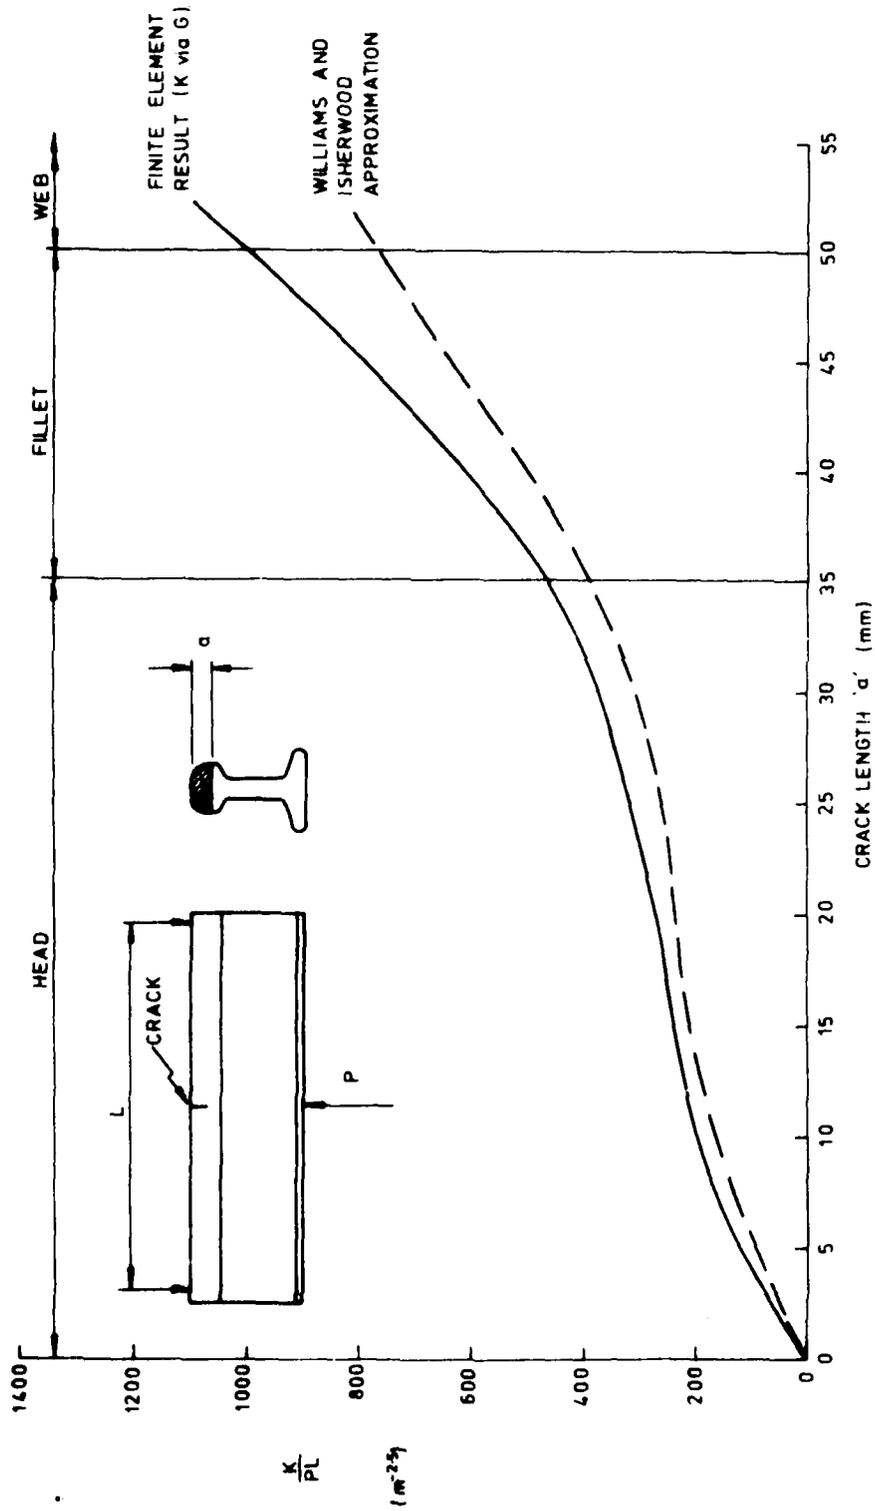
FIG. 7 'K' CALIBRATION RAIL HEAD CRACK IN B.S. 113A.

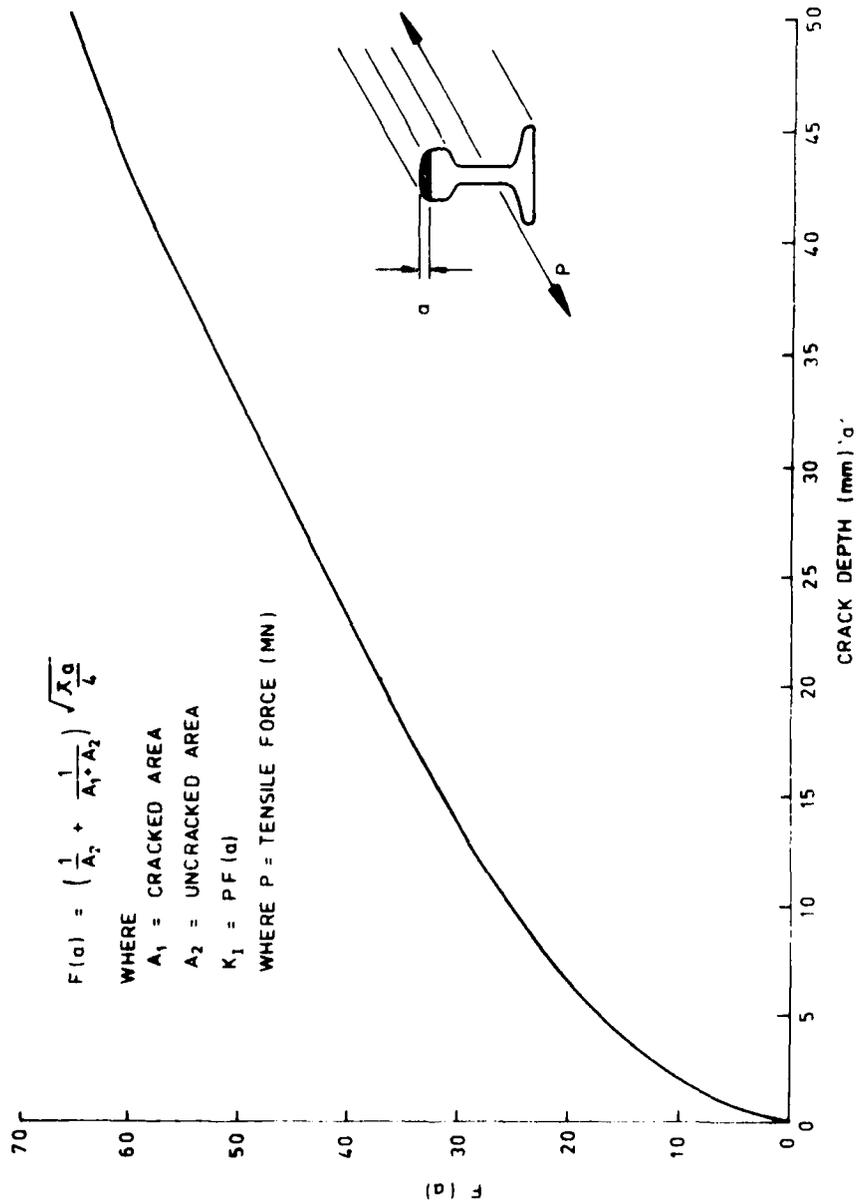
FIG. 8 K - CALIBRATION FOR THROUGH THICKNESS DEFECT IN RAIL HEAD SUBJECT TO UNIFORM TENSION (WILLIAMS AND ISHERWOOD METHOD).

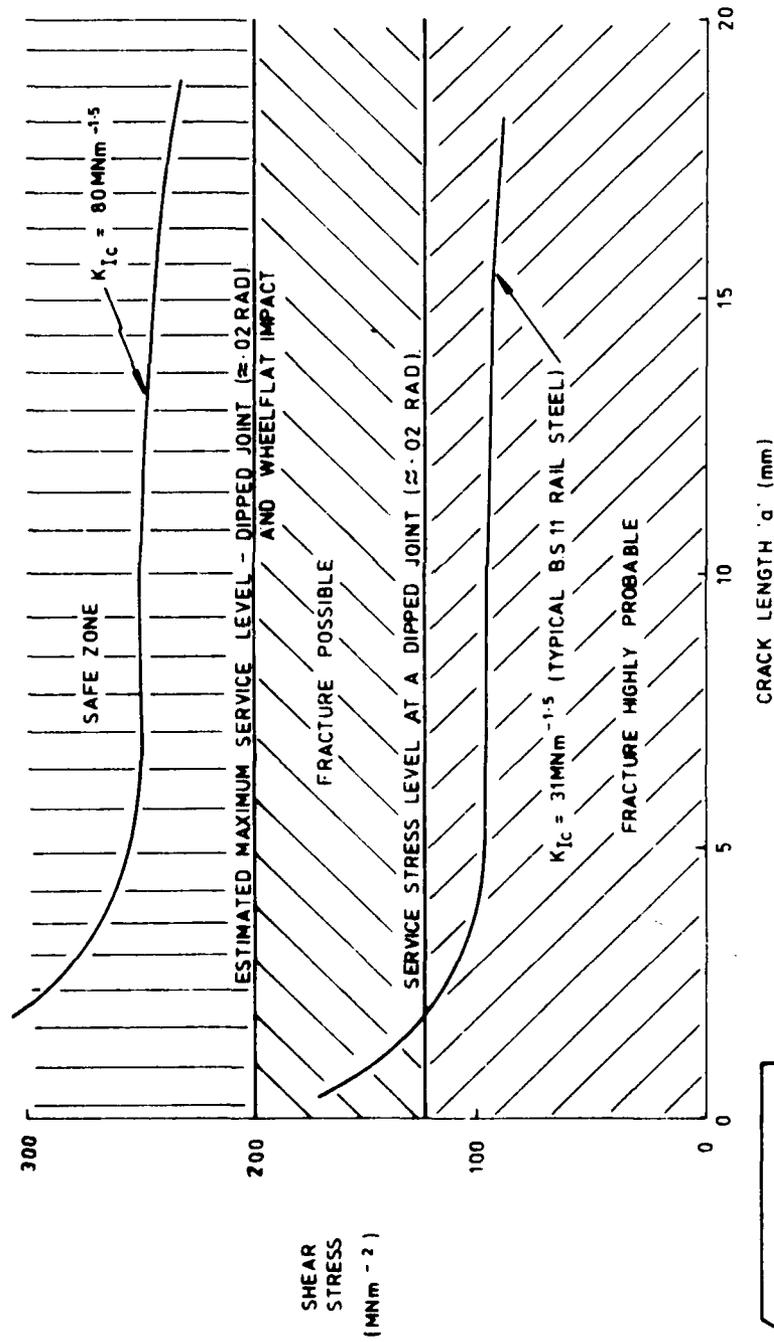
FIG. 10. EFFECT OF FRACTURE TOUGHNESS ON BOLTED RAIL JOINT CRITICAL CRACK LENGTH.

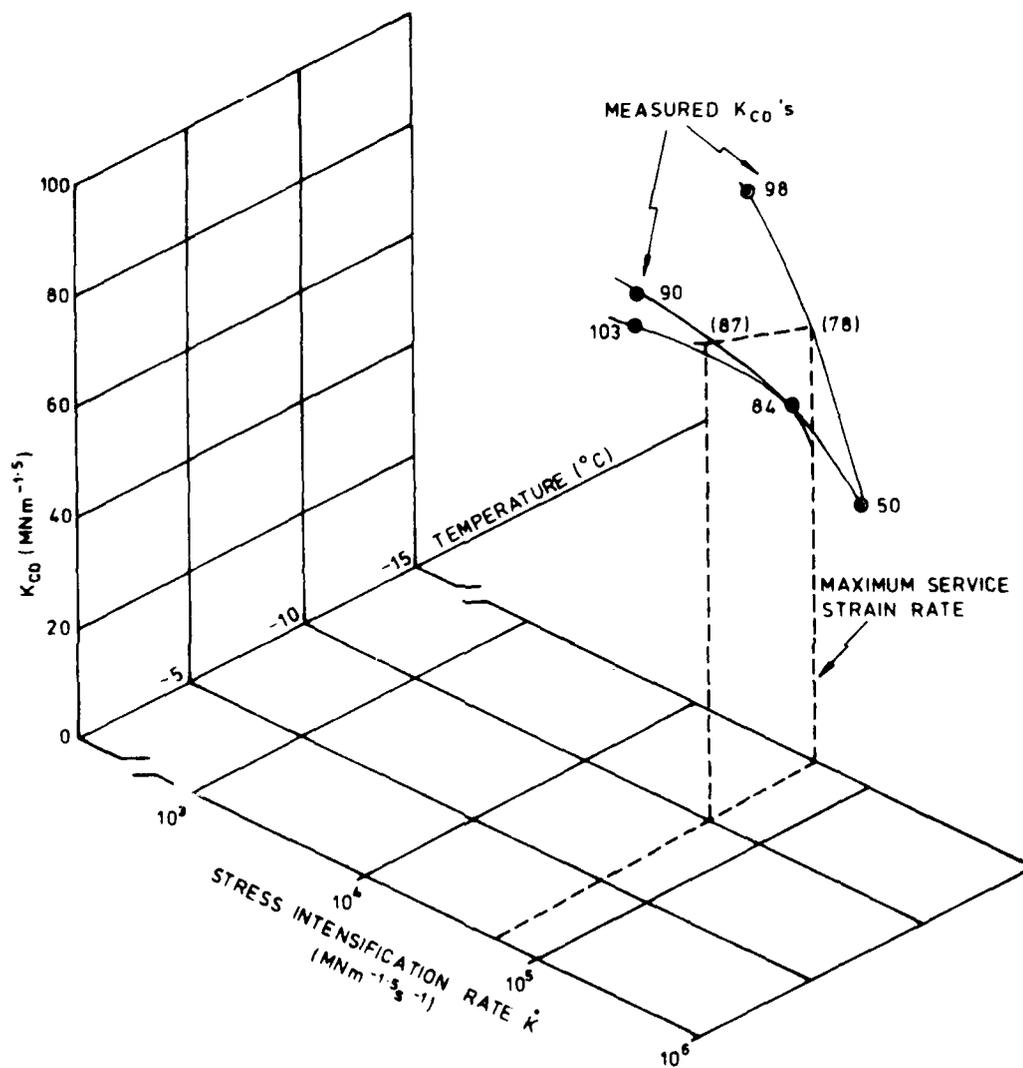
FIG. 11. EFFECT OF TEMPERATURE AND STRAIN RATE ON THE FRACTURE TOUGHNESS OF AN EXPERIMENTAL RAIL STEEL (CAST 4287).

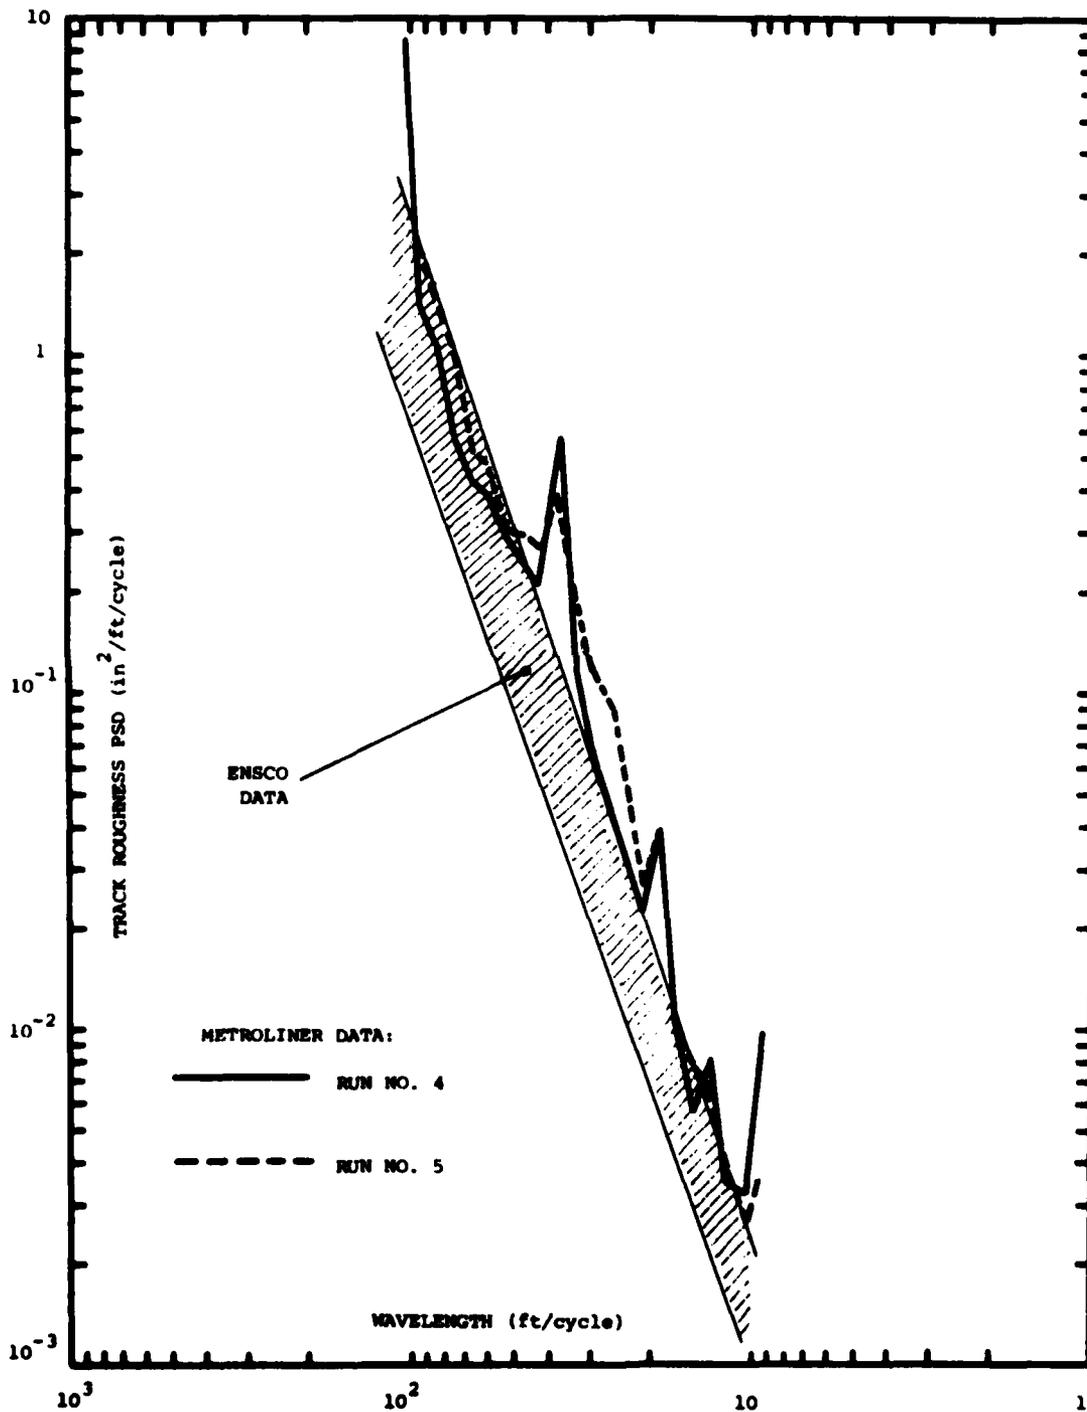
**FIGURE 3. NORTHEAST CORRIDOR
TRACK CONDITIONS (1971-75)**

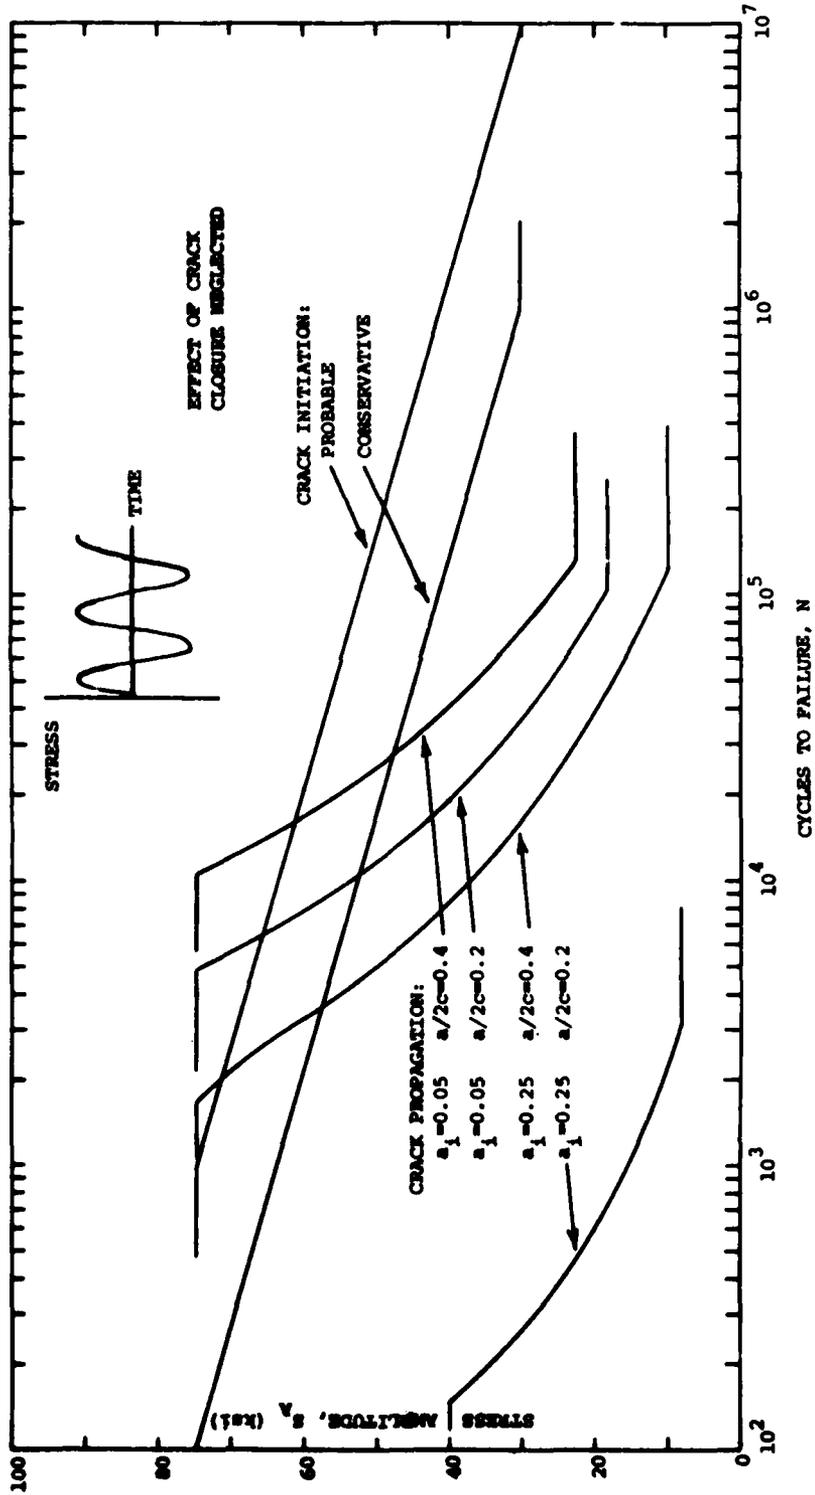
FIGURE 4. FATIGUE ENDURANCE VS. DAMAGE TOLERANCE (AISI-2330)

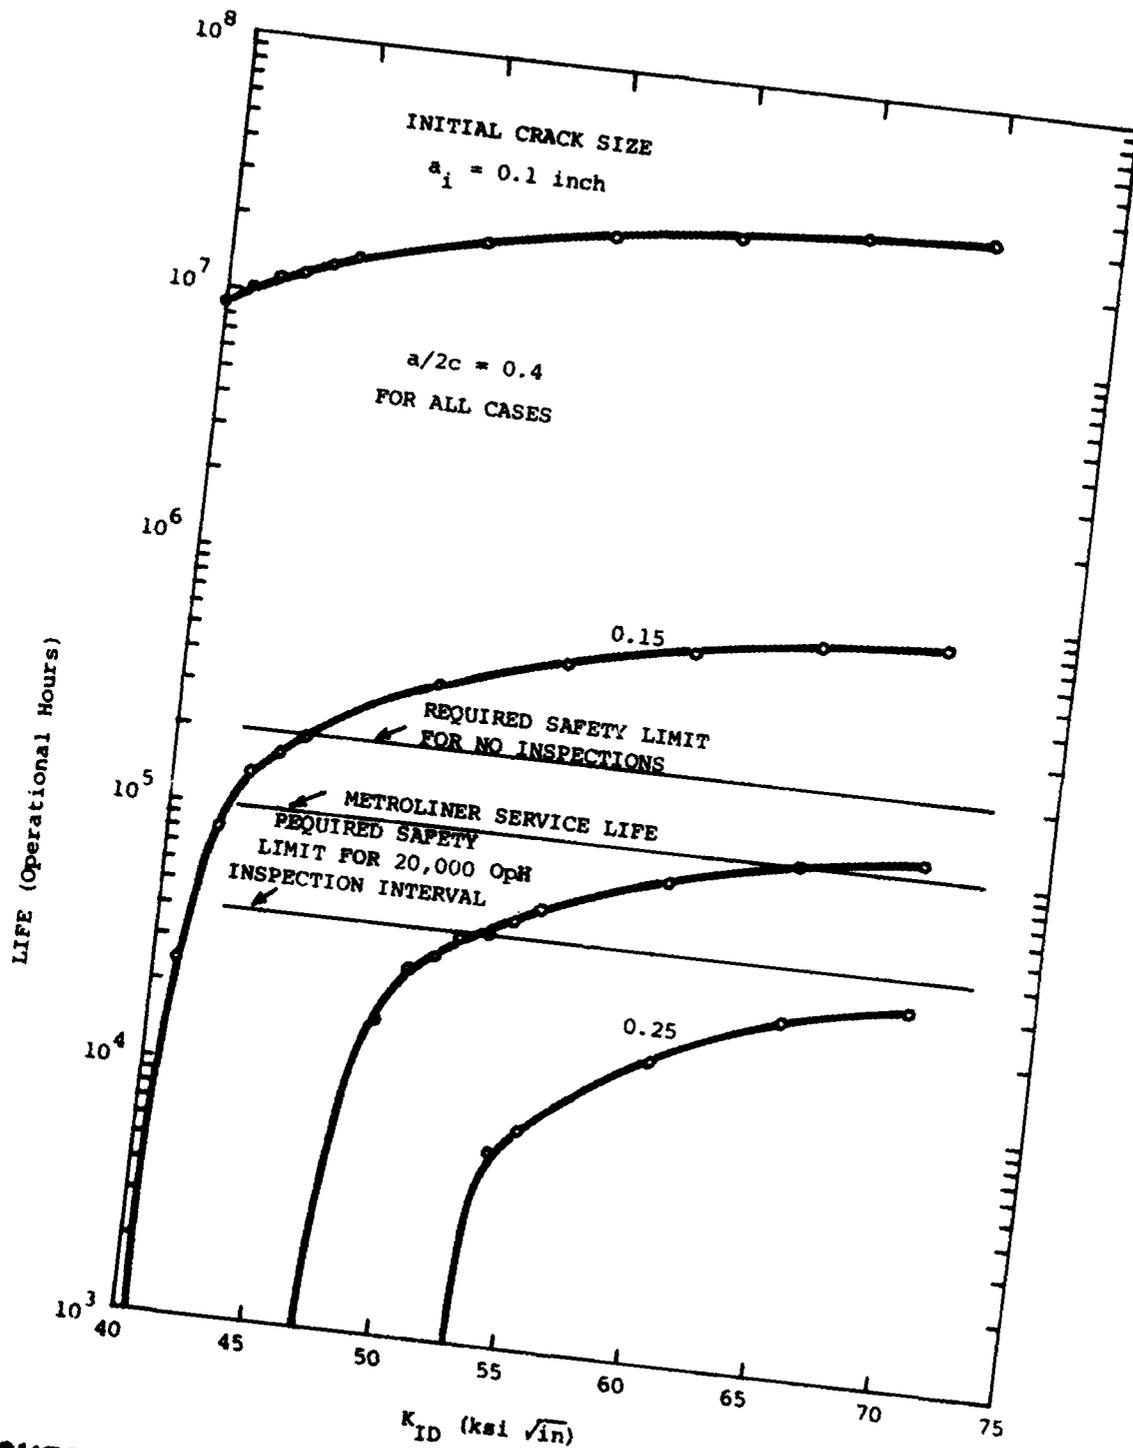
FIGURE 5. DEPENDENCE OF SAFETY LIMIT ON FRACTURE TOUGHNESS AND INSPECTION RELIABILITY

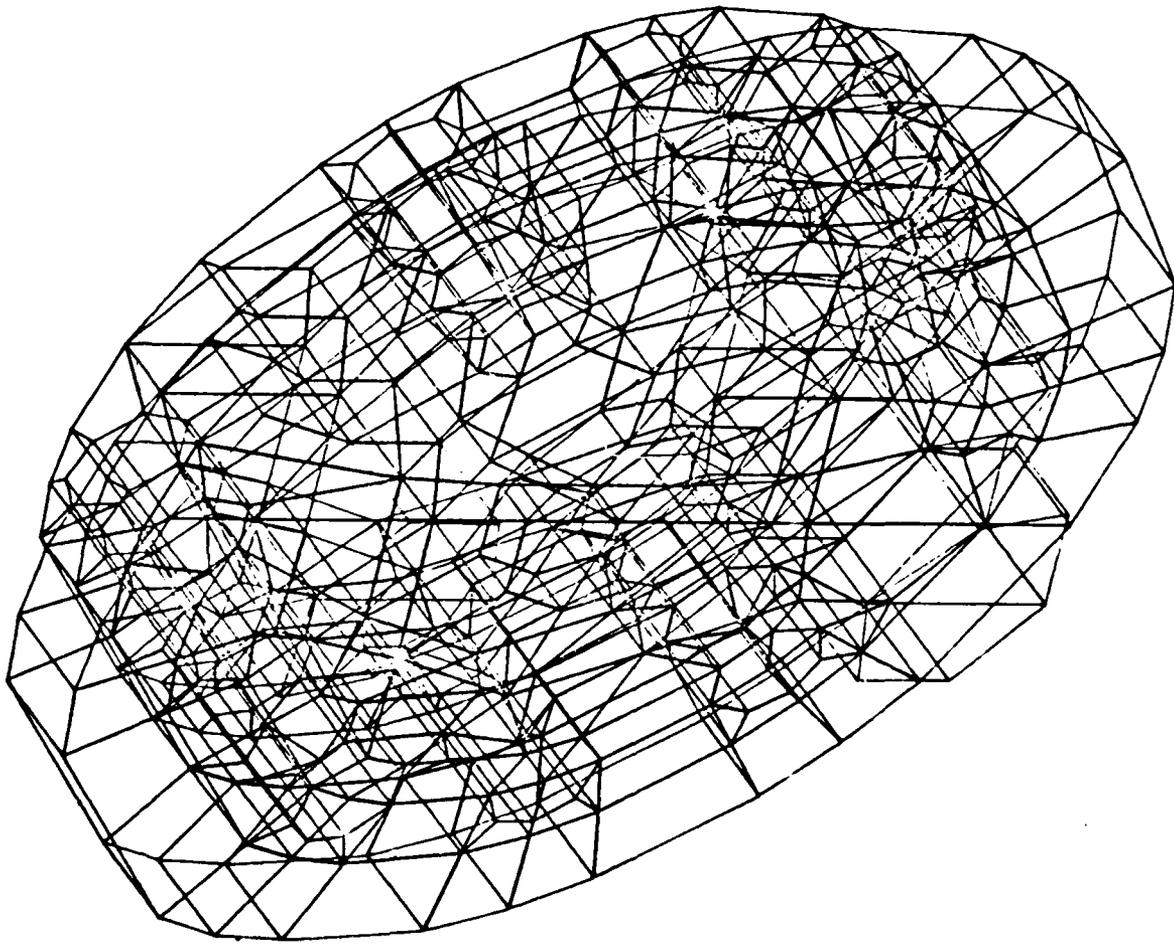
**FIGURE 5. USS BARBEY CRANK RING
FINITE-ELEMENT MODEL**

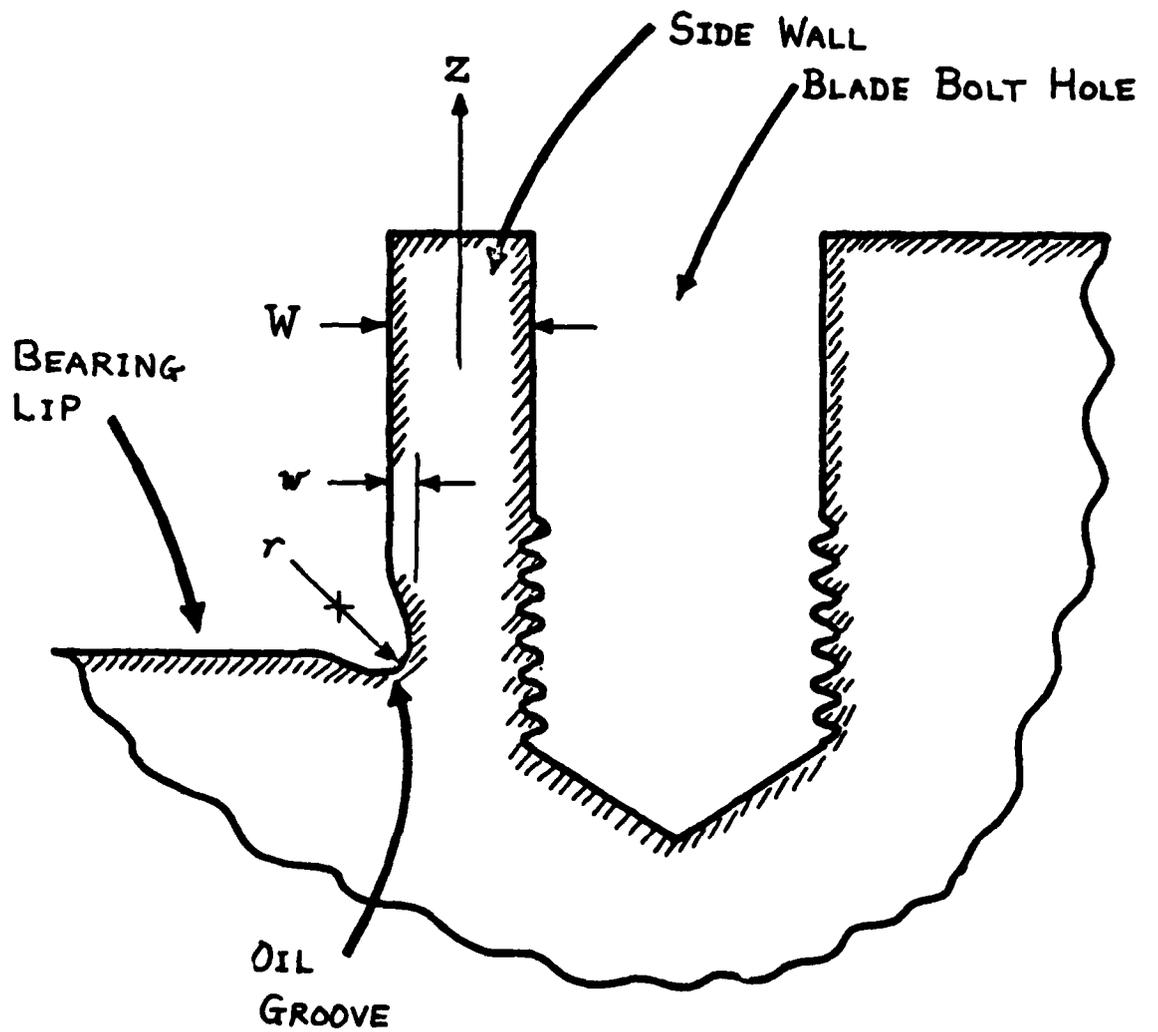
FIGURE 6. CRITICAL AREAS IN TYPICAL CRANK RING

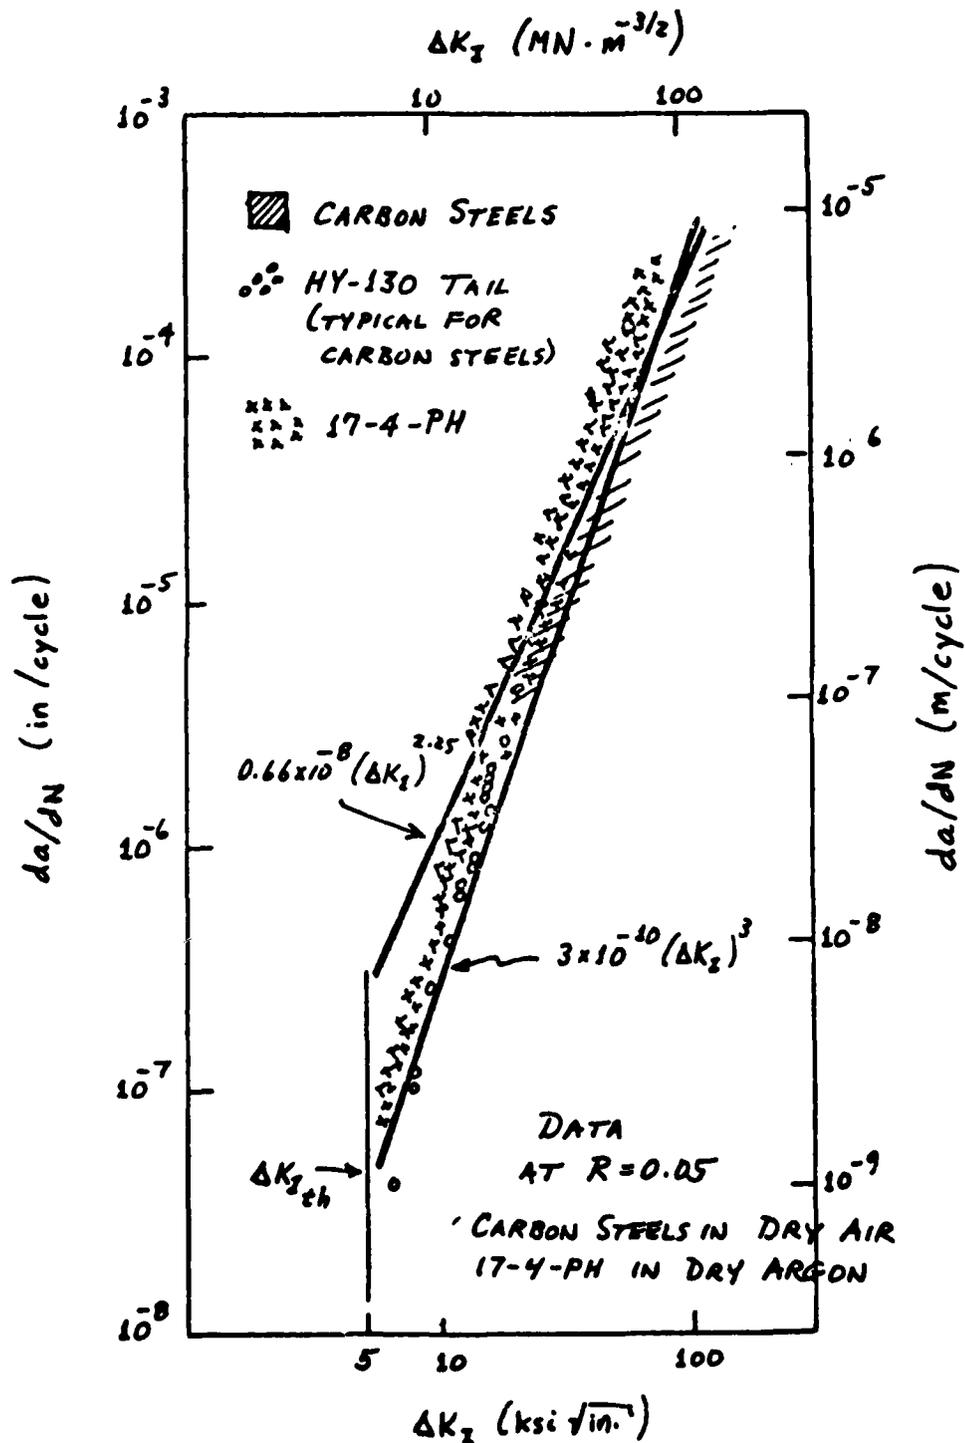
FIGURE 8. CRACK GROWTH RATE DATA [16,17,18] AND EMPIRICAL FITS

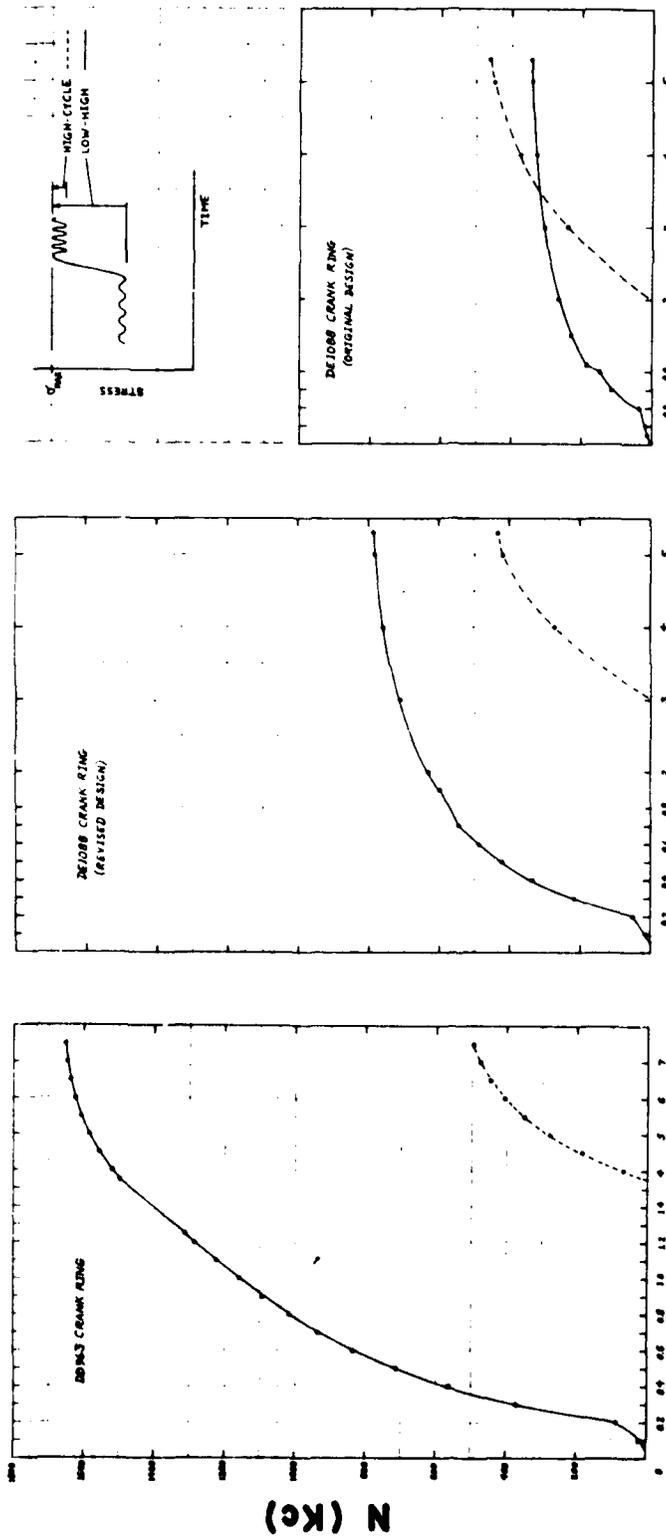
CRACK SIZE VERSUS CYCLES FOR CRANK RINGS

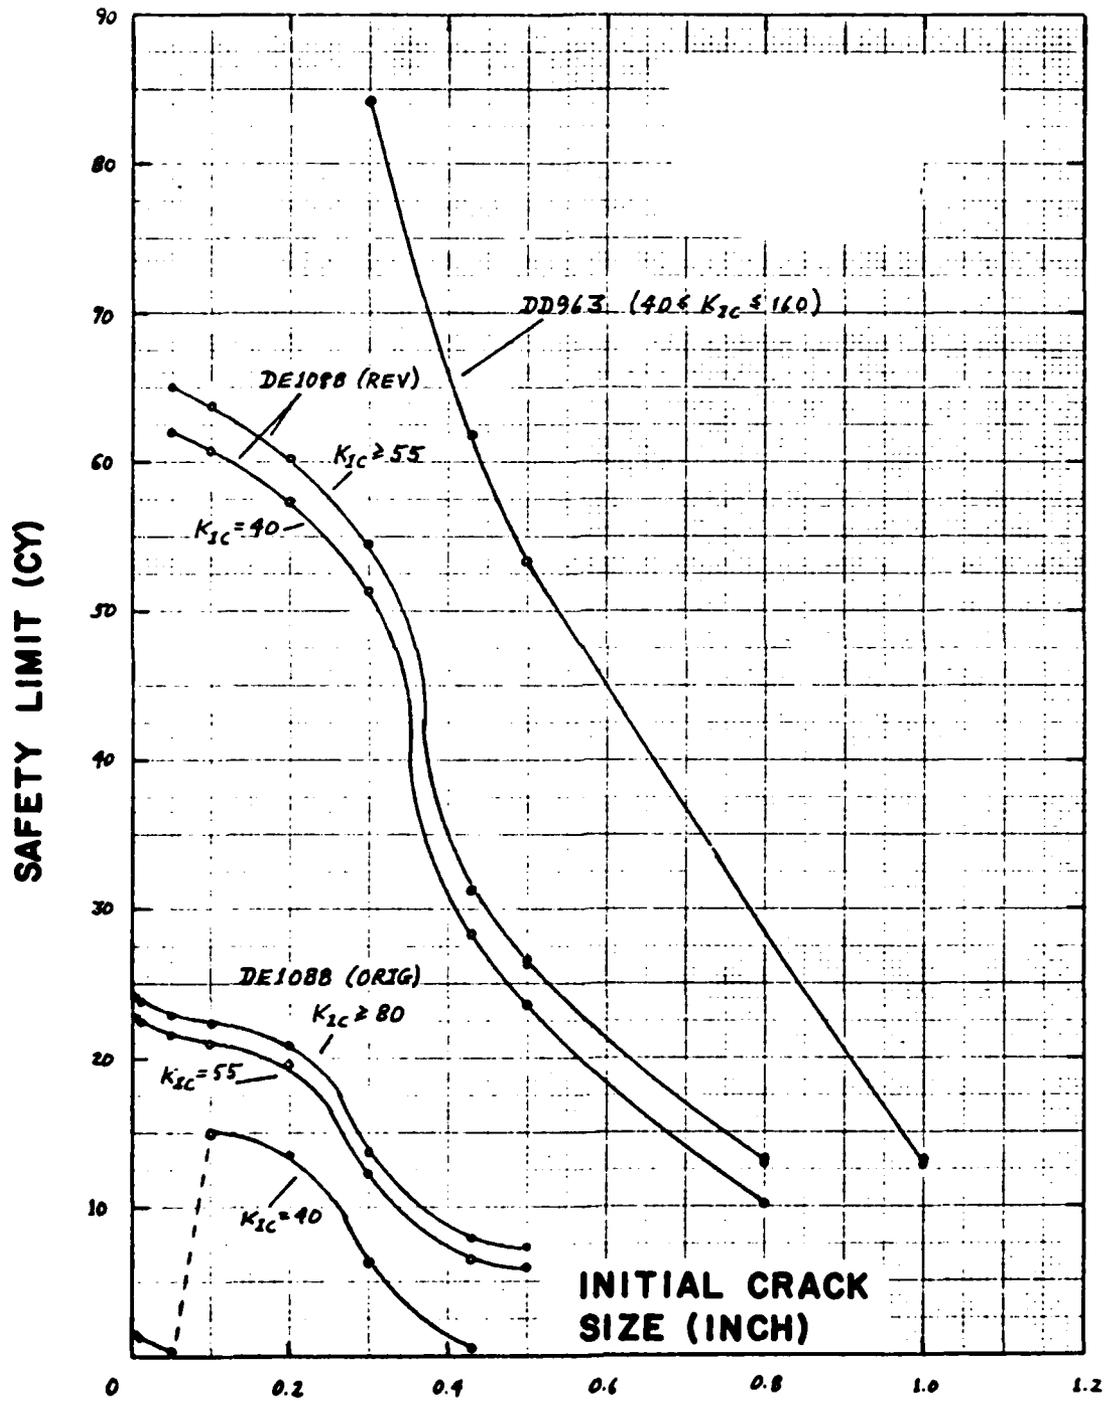
FIGURE 10. CRANK RING SAFETY LIMIT ESTIMATES

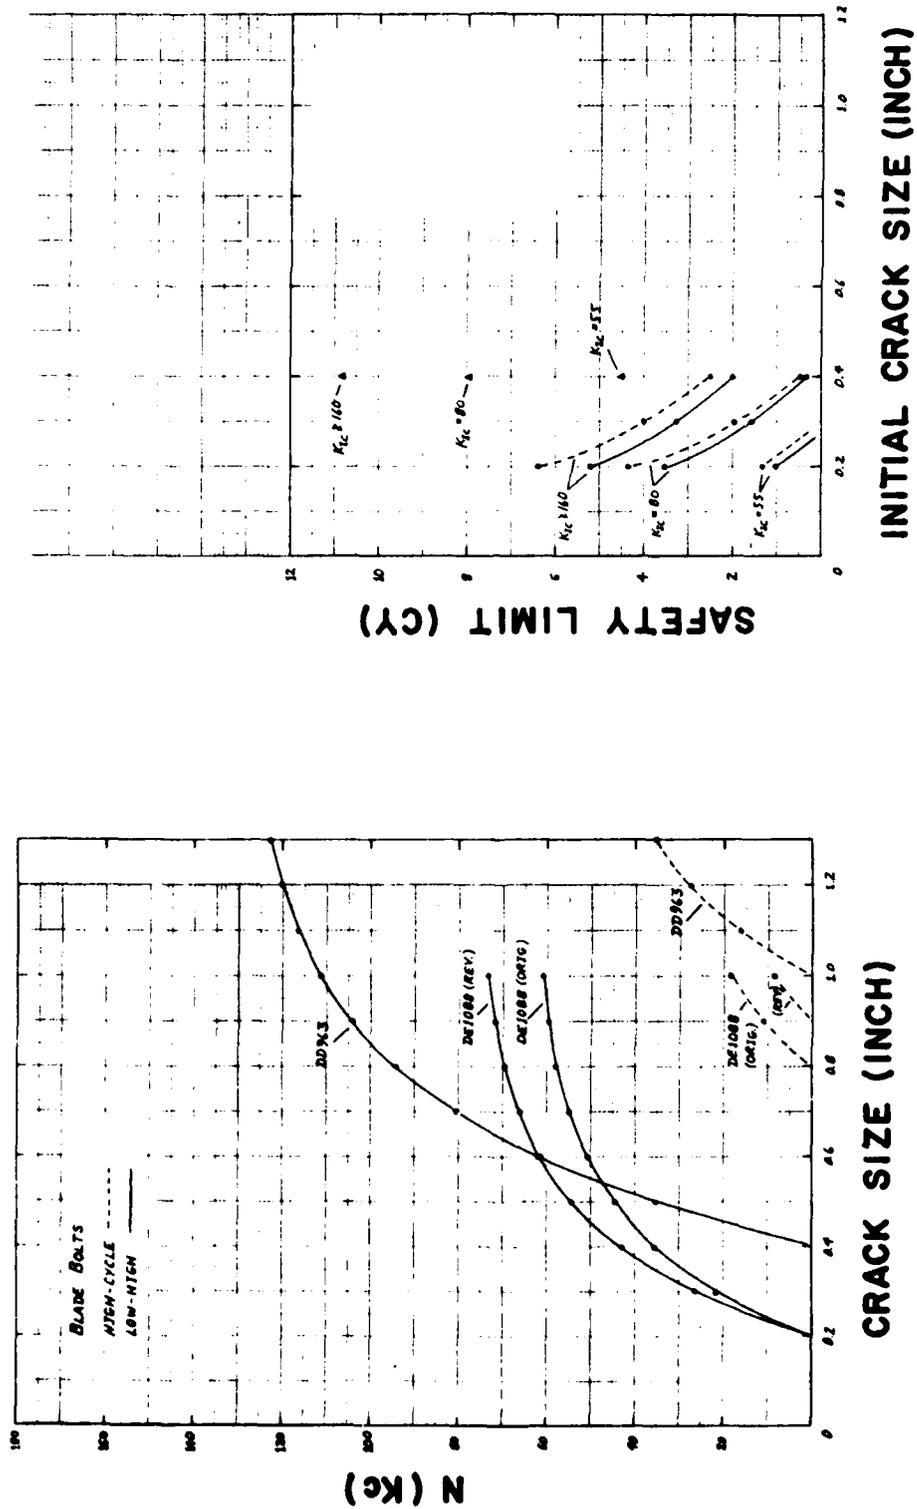
FIGURE 11. DAMAGE TOLERANCE OF BLADE BOLTS

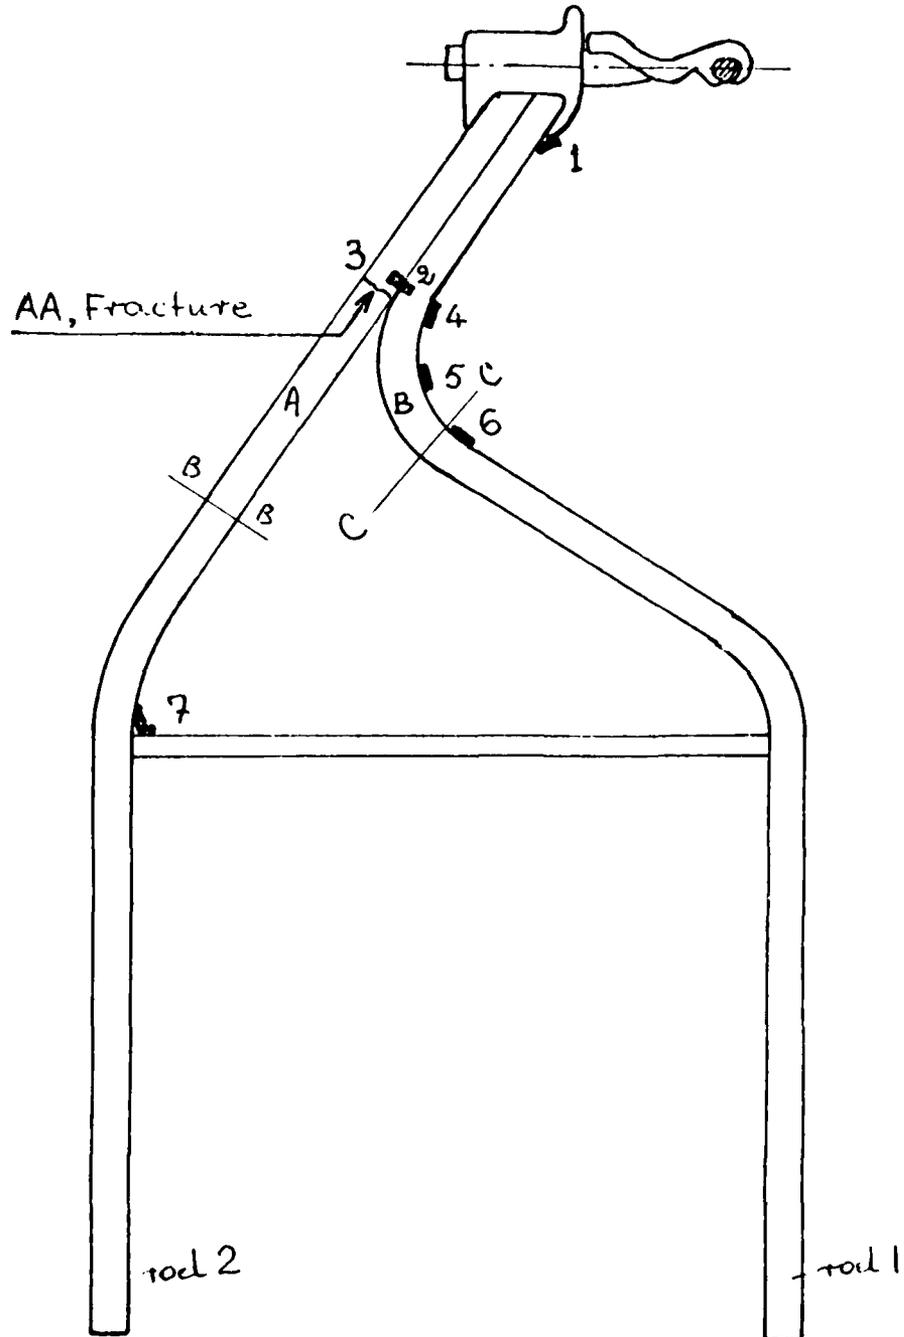
Fig.1 Sketch of the structural component subject to investigation. Numbers indicate location of the strain gages, while letters denote the cross-sections single-out for stress and fatigue fracture analysis.

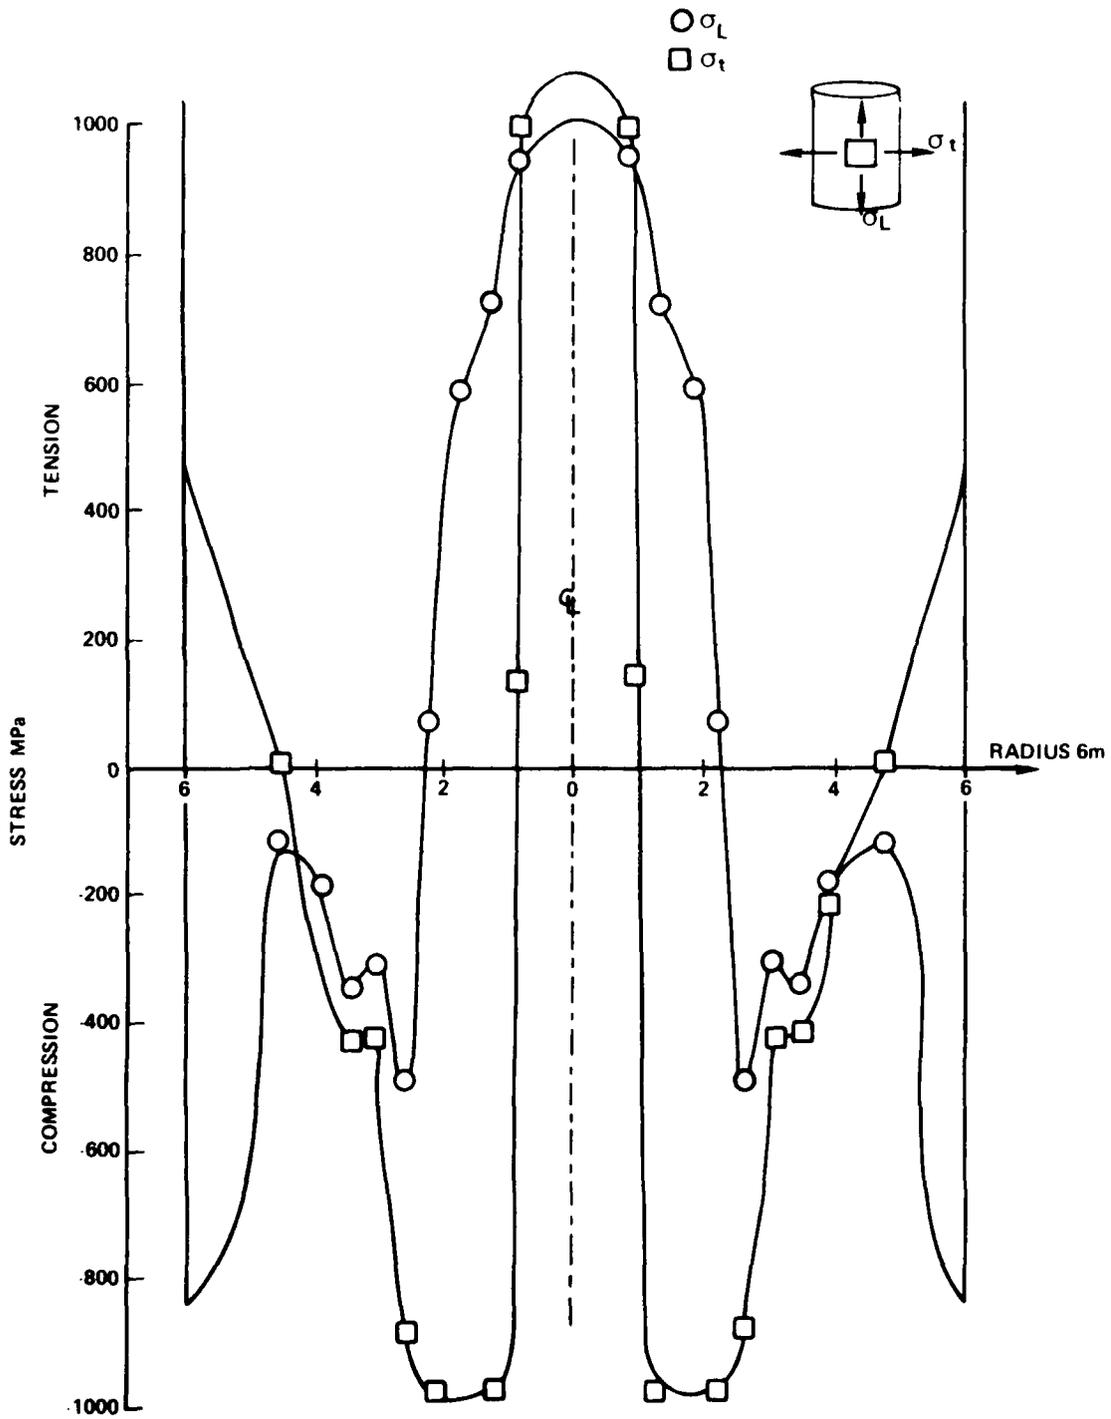
Fig. 3. Internal stress distribution in a penetrator

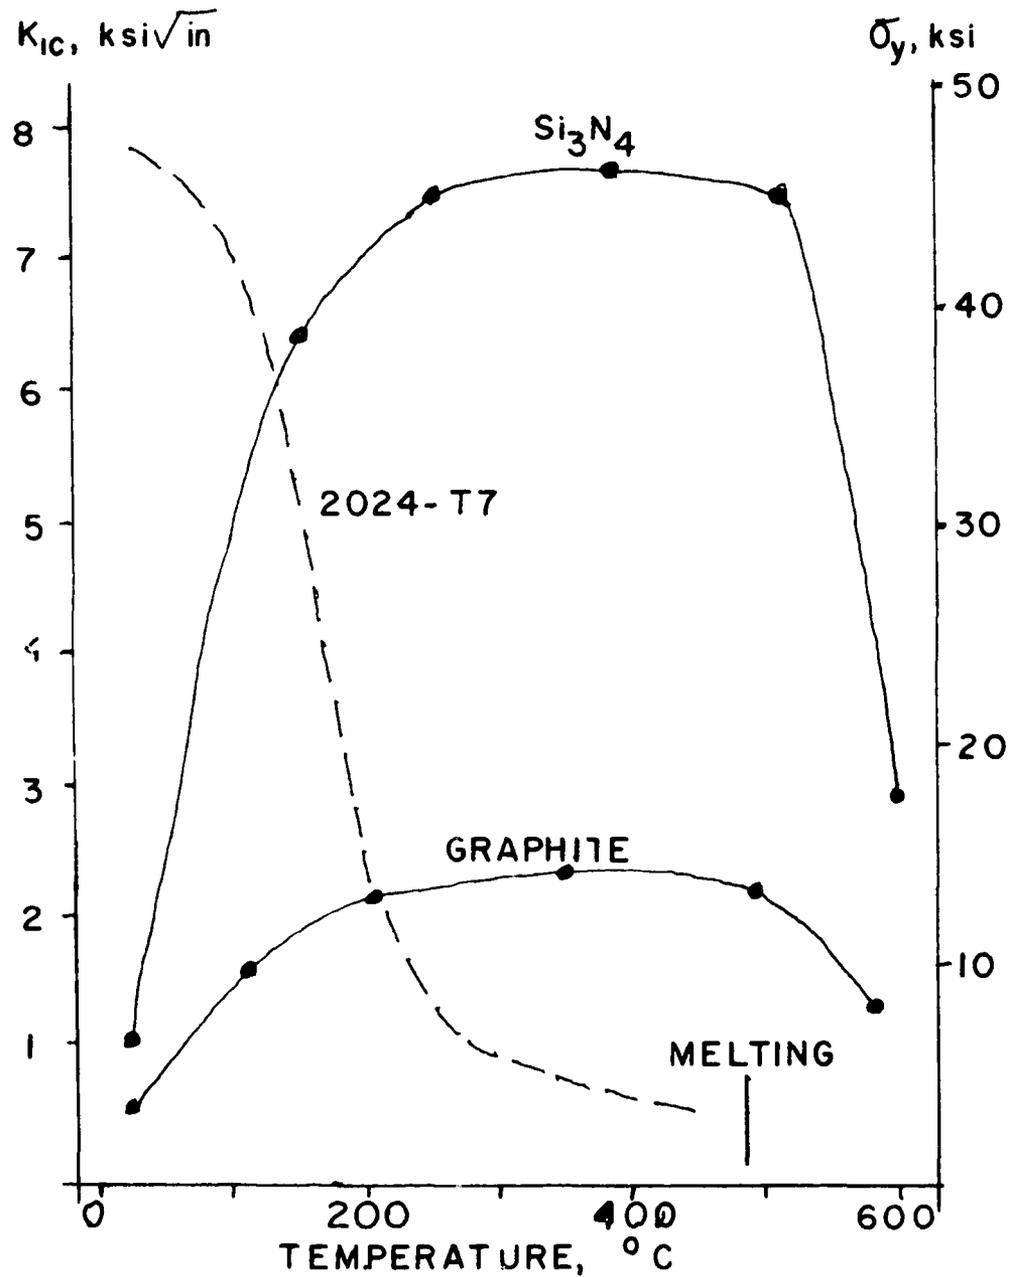
Figure 2. Measured Fracture Toughness (K_{1C}) Values and Infiltrant Yield Strength vs. Temperature for Two Infiltrated Ceramics.
