POSTCRASH FUEL FIRE HAZARD MEASUREMENTS IN A WIDE-BODY AIRCRAFT CABIN

FINAL REPORT

1. Report No. 144 FAA-NA-79-42		2. Government Accession No.		3. Recipient's Catalog No.	
4. Title and Subtitle 6 POSTCRASH FUEL FIRE HAZARD MEASUREMENTS IN A WIDE-BODY AIRCRAFT CABIN				5. Report Date 11 Dec 79

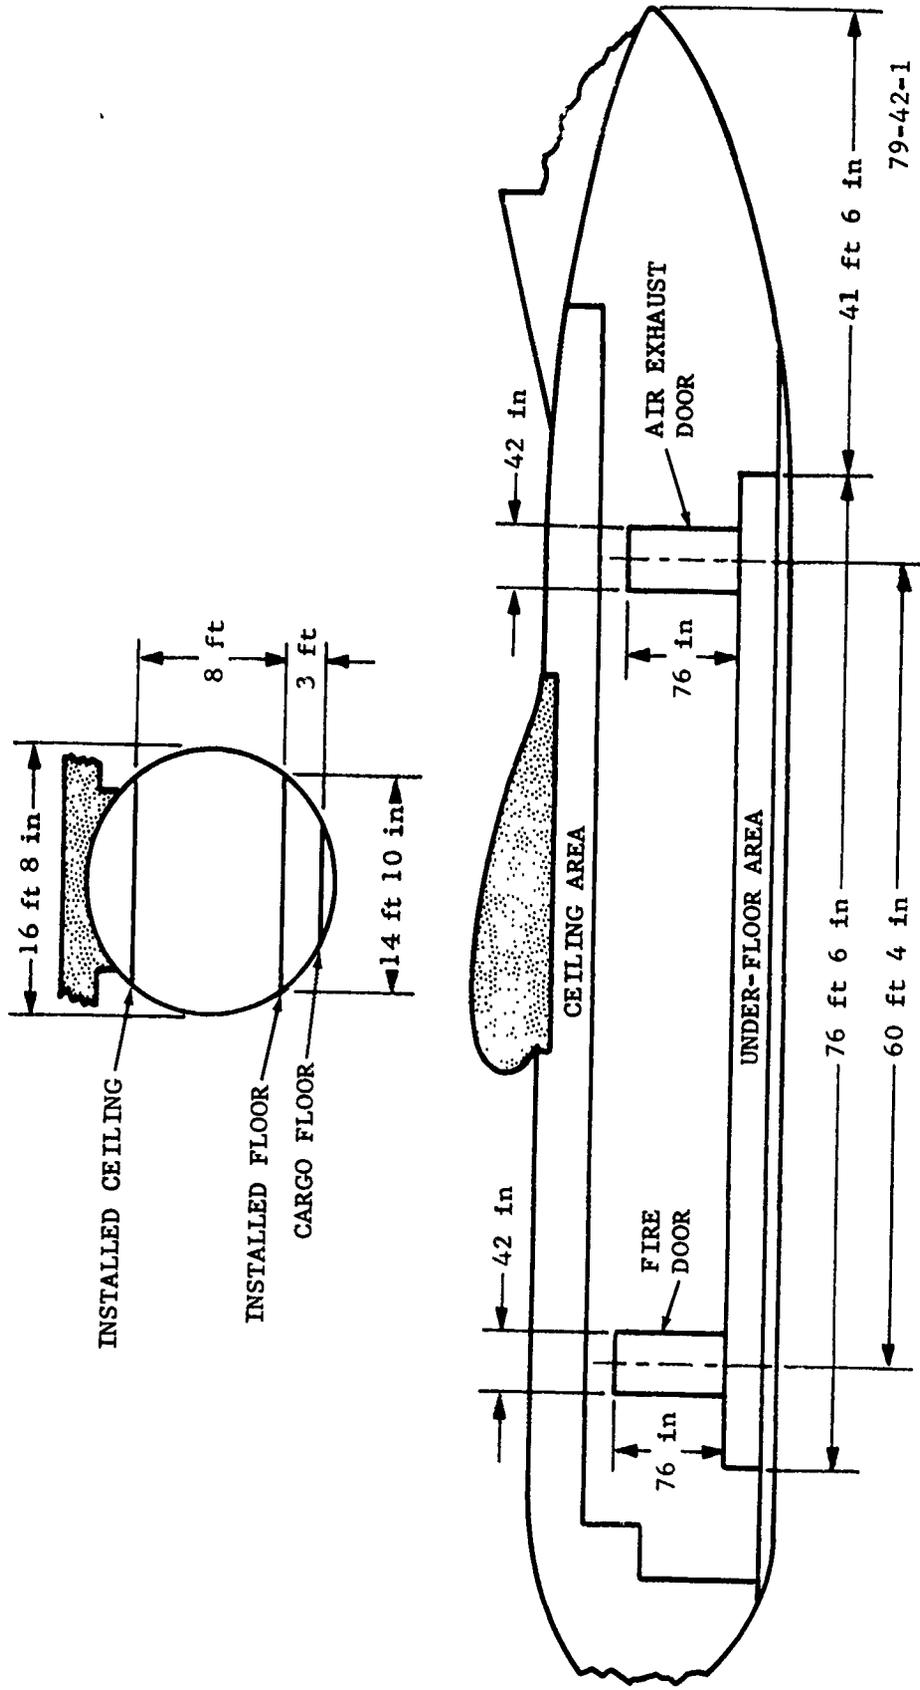
79-42-1

FIGURE 1. C133 WIDE-BODY CABIN FIRE TEST ARTICLE

A surplus United States (U.S.) Air Force C133A cargo aircraft, with the wings and tail surfaces removed, was utilized as the test article. This aircraft provided internal dimensions similar to those of wide-bodied jets currently in airline service. The C133 fuselage diameter is 200 inches, and internal usable length for test purposes is approximately 118 feet (figure 1). The fuselage cargo area was modified by the installation of a metal-covered plywood floor and a fire-resistant ceiling to provide an 8-foot floor-to-ceiling height. The cockpit area was sealed off and not used during the test program. The modification of the cargo area resulted in a calculated volume of interior airspace of 13,200 cubic feet (ft³).

The fuselage was further modified by the addition of two door openings on the right-hand side of the aircraft. The forward door opening was 76 inches high and 42 inches wide and was the location used for the external test fire penetration. The rear opening was a type A configuration and provided an exit point for smoke and gases to exhaust into the atmosphere. This opening had a hinged door that was normally open and a square wooden barrier external to the opening to prevent extraneous wind gusts from affecting flow characteristics through the fuselage. These openings were approximately 60 feet apart.

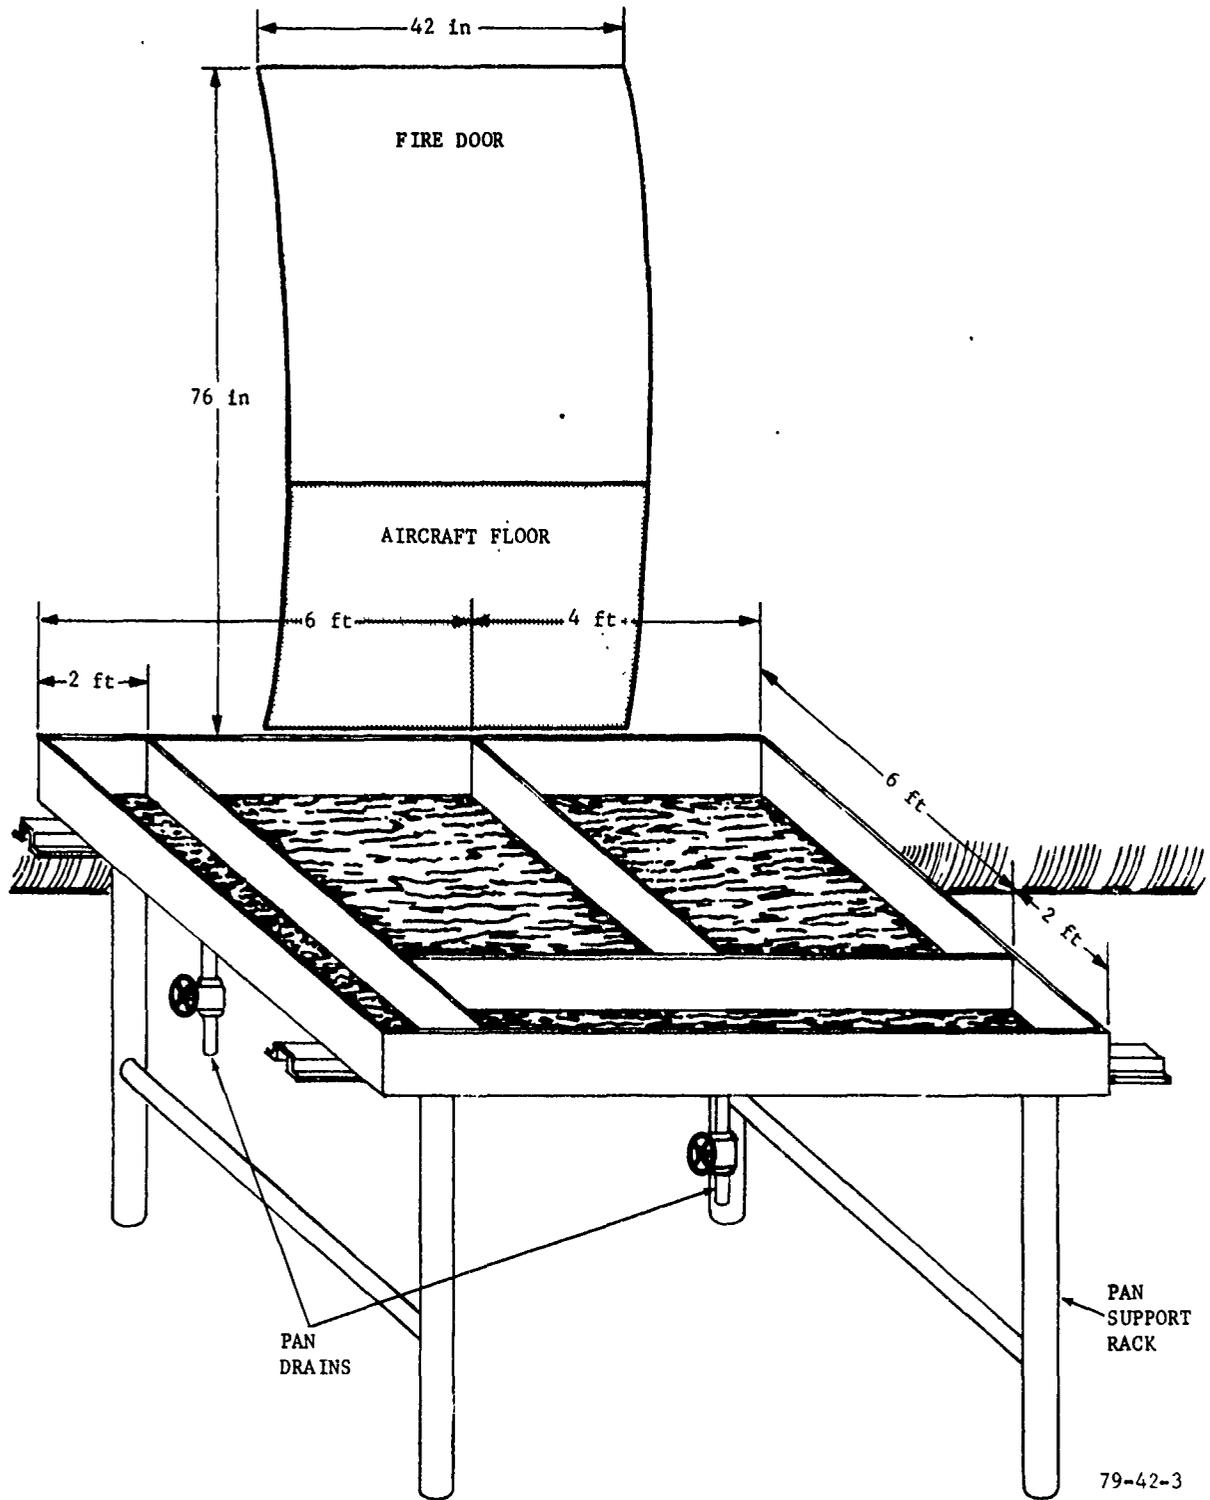
FIGURE 3. FIRE PAN INSTALLATION

The external fire was provided by a measured amount of jet fuel (JP-4) placed in steel pans of various sizes located on a framework adjacent to the fire door. The fire pan was located at the bottom edge of the door, rather than on the ground, in order to best assure that a solid sheet of flame would cover the entire door opening, as would result from a large ground fuel fire. There were four pans, all having a 4-inch-sidewall height. These pans were used singly or grouped together to provide the necessary area required for any particular test (figure 3). Pan sizes were as follows: two 6- by 4-foot pans and two 8- by 2-foot pans.

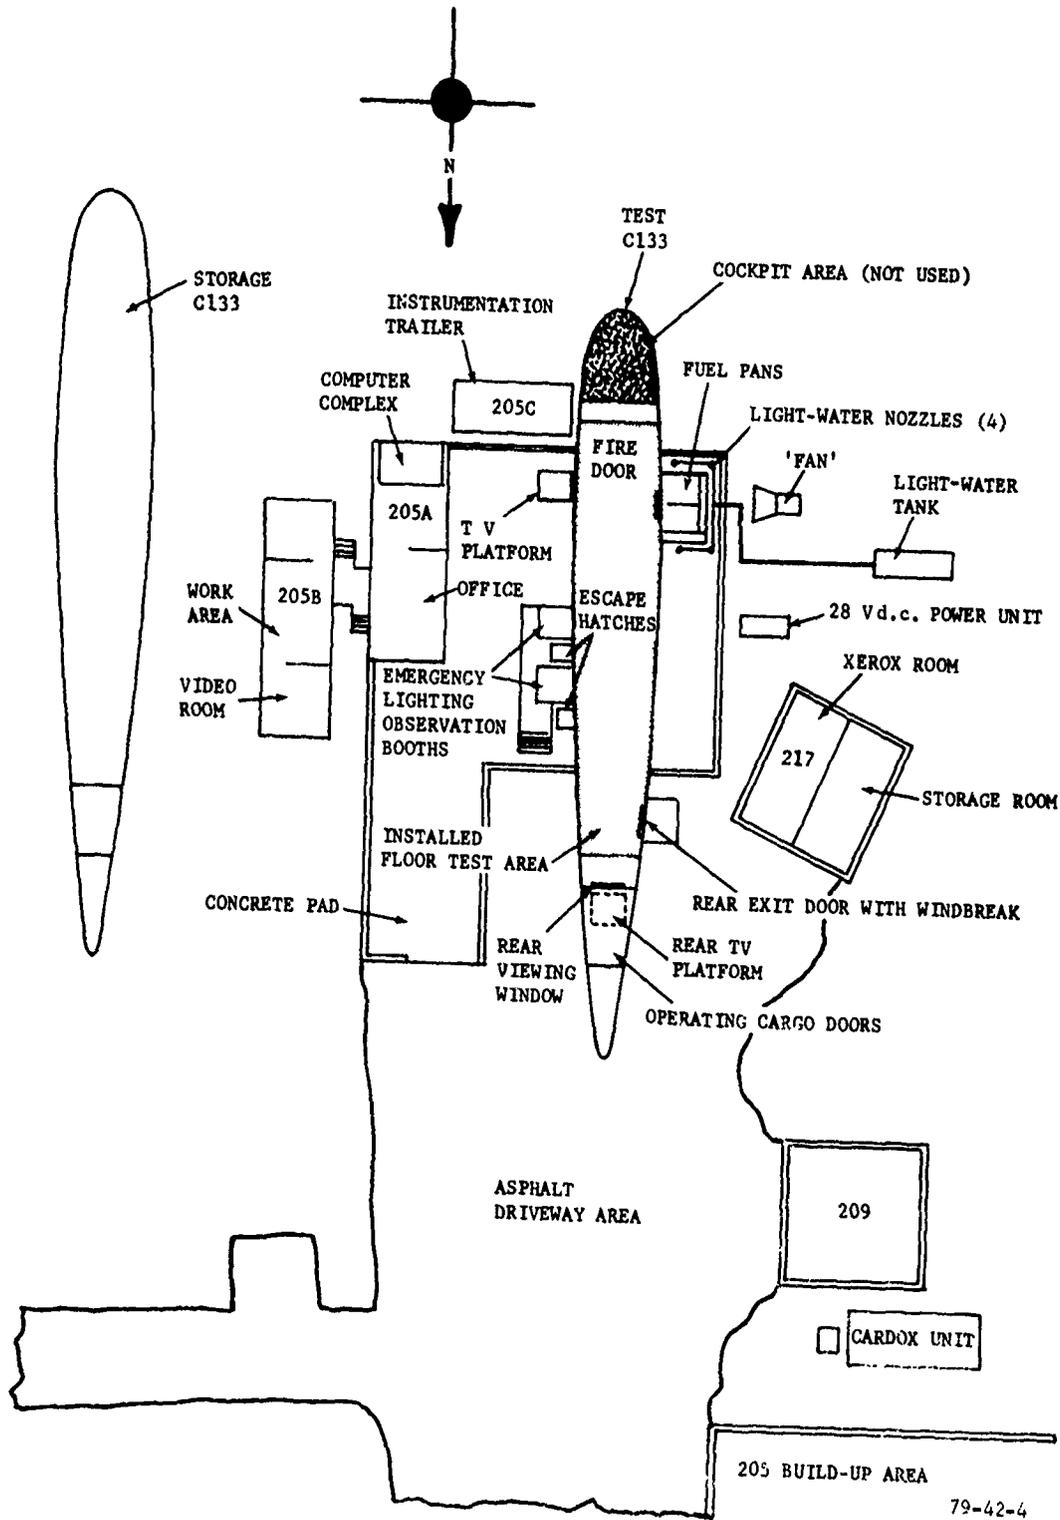
FIGURE 4. FULL-SCALE FIRE TEST FACILITY

The instrumentation trailer was positioned at the forward left-hand side of the fuselage. The trailer housed the visual readout faces of the CO and carbon dioxide (CO₂) concentration analyzers, the oxygen (O₂) concentration readout and amplifier, sample flow-control flowmeters and valves, various direct current (d.c.) voltage power units, the computer analog-to-digital converter, patch panels for the thermocouples, and other d.c. millivolt (mV) output instrumentation used during testing. Activation of fire-extinguishing components (both CO₂ and aqueous foam) along with the vacuum pump for the gas sampling lines were also controlled from the trailer. The test director and interested observers were able to view the fire area on closed-circuit video monitors installed in the trailer (figure 4).

When required, simulated ambient wind through the fuselage fire penetration opening was provided by a 36-inch-diameter fan mounted adjacent to the test article. A transition duct was attached to the fan outlet to distribute the air uniformly through the opening. The velocity of the simulated wind was controllable by the insertion of orifice plates in the fan outlet duct. Fan operation could be either continuous or intermittent (figure 4).

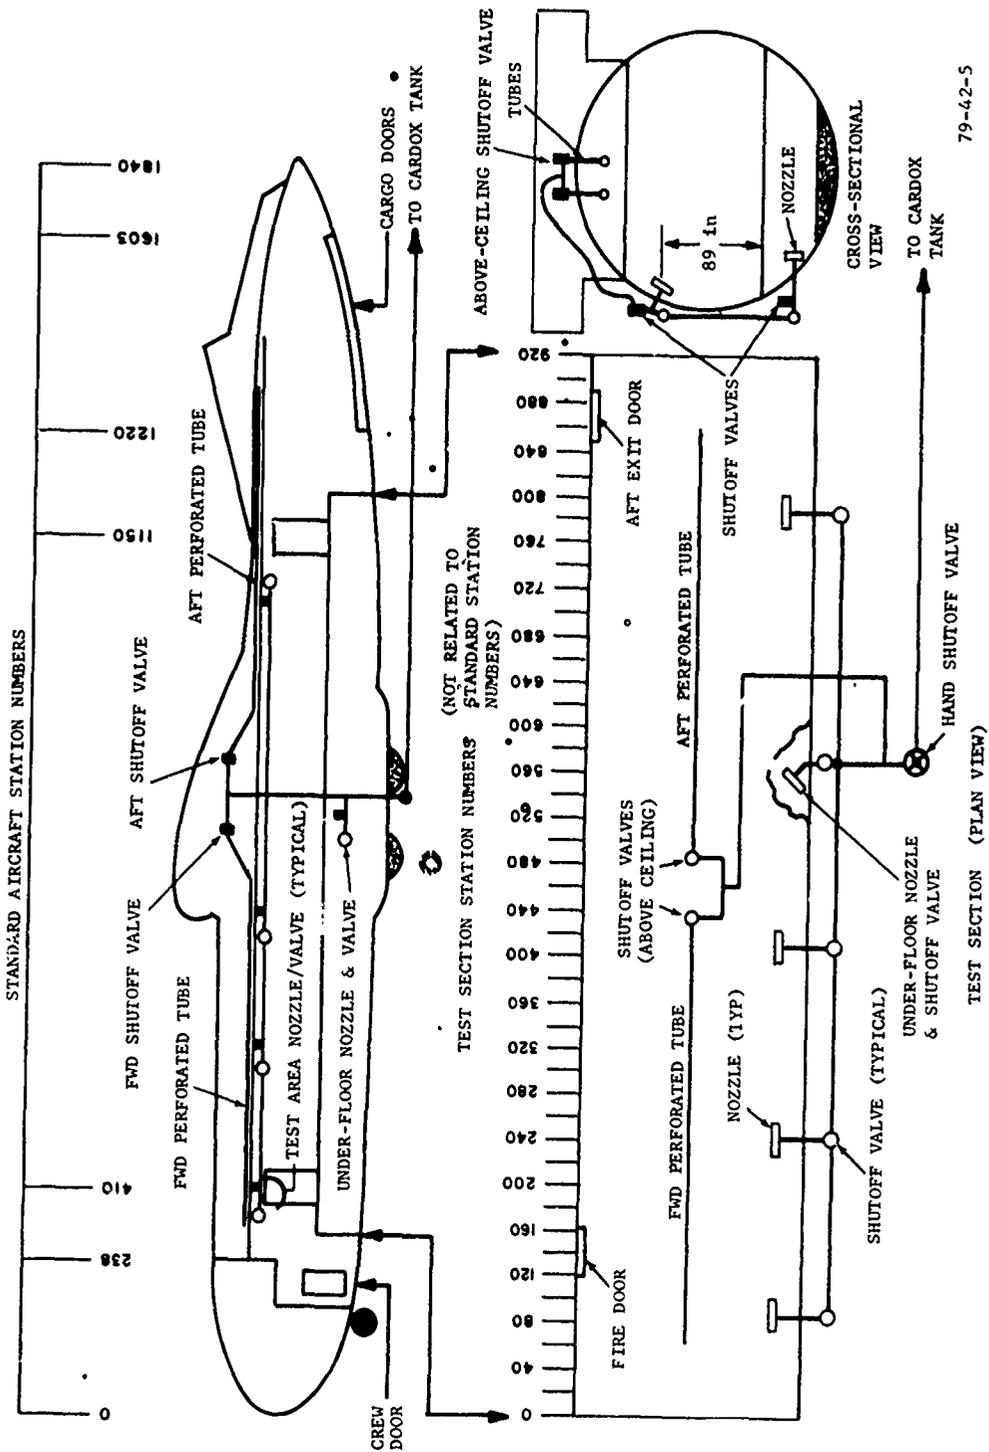
79-42-5

FIGURE 5. TEST ARTICLE FIRE PROTECTION SYSTEM

The fire-extinguishing capability on the test fuselage was provided by two different systems. The primary system was a CO₂ system that protected the

entire test article (figure 5). The fuselage was divided into four fire protection zones: (1) the fire pan area, (2) the above-test section ceiling, (3) the test section, and (4) below-test section floor. All zones utilized Atkomatic "DYMO"® 15,000 series solenoid valves to control agent discharge, which were mounted immediately upstream from discharge points and electrically controlled from the instrumentation trailer. The fire pan area had one discharge nozzle positioned to direct CO₂ toward the fire at an angle that would prevent burning fuel being blown out of the pans during agent discharge. The above ceiling system was a 0.75-inch-diameter perforated copper tube mounted on the aircraft structure with the agent discharge being directed downward toward the installed ceiling. Separate control was provided for the forward and aft sections, with the dividing point being the center wing section. Test section protection was provided by four discharge nozzles mounted on the upper left-hand interior wall, positioned to cover the floor area below. Each nozzle could be activated individually as required. Underfloor protection was from a single discharge nozzle mounted on the left-hand sidewall (figure 5). The second extinguishing system was used strictly to extinguish the external fire. The agent was a mixture of 6-percent aqueous film-forming foam (AFFF) mixed with water. This system proved more effective in extinguishing the pan fire than CO₂, since any slight ambient wind would blow the CO₂ away from the fire. The system consisted of a 1,000-gallon storage tank pressurized to 90 pounds per square inch (psi), an electric solenoid discharge valve, and four spray nozzles. A spray nozzle was positioned at each corner of the fire pan configuration and adjusted to cover the entire surface of the pans with foam upon actuation.

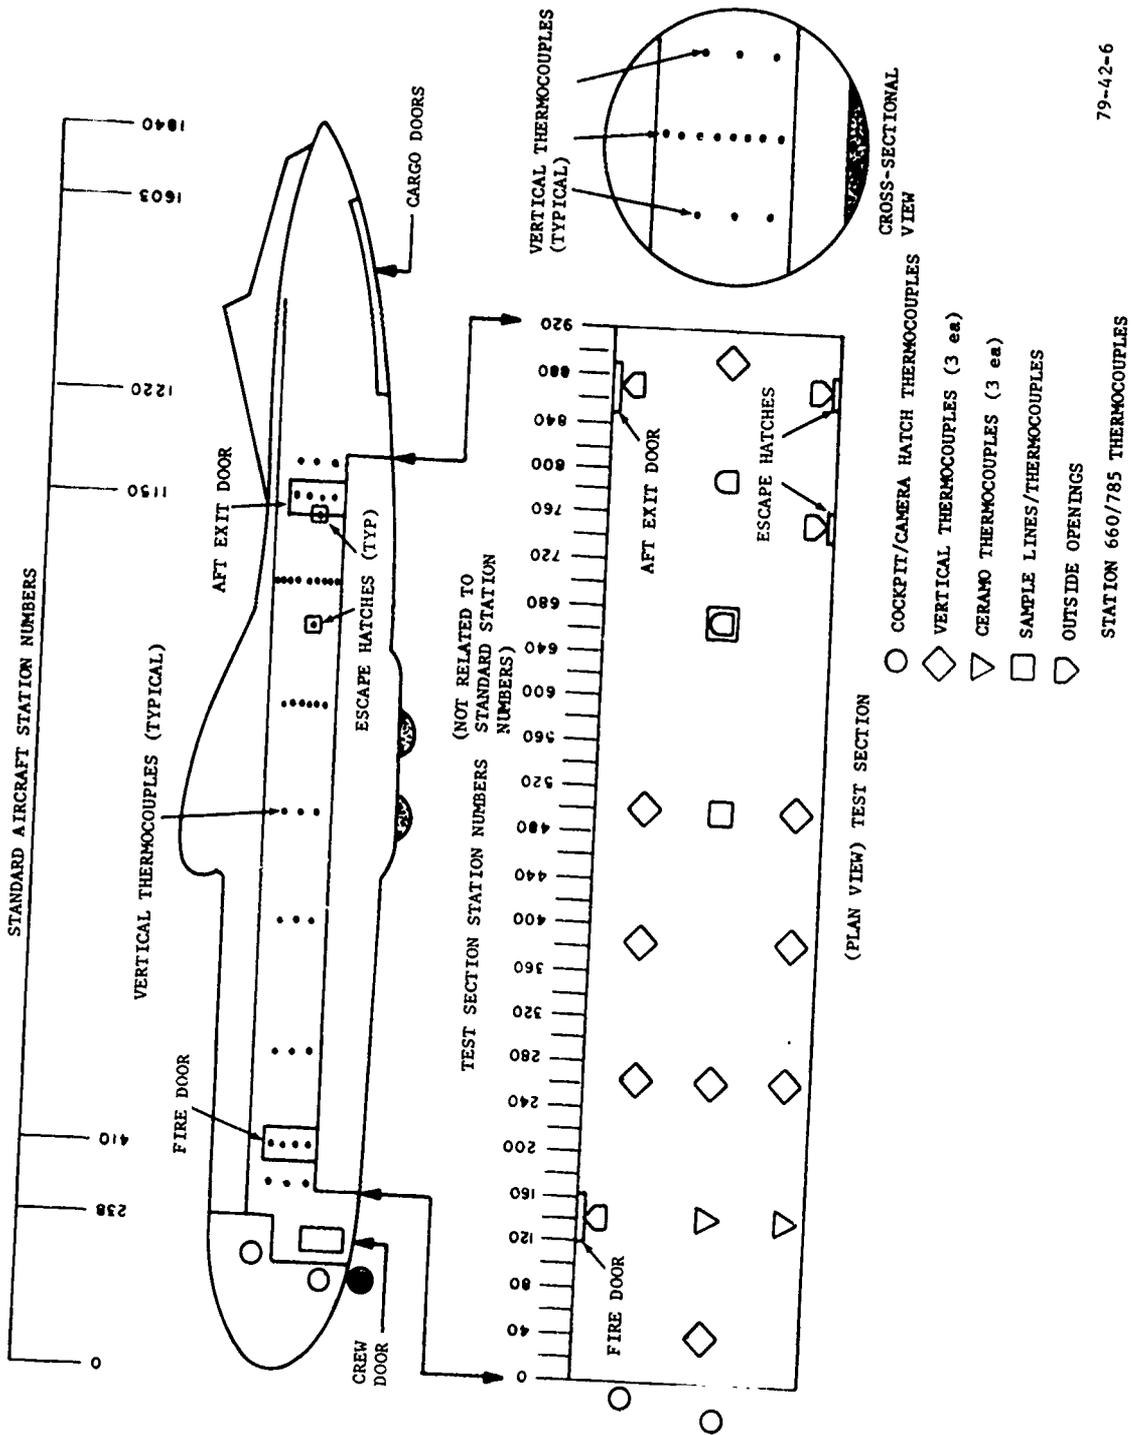
FIGURE 6. TEST ARTICLE AIR THERMOCOUPLE LOCATIONS

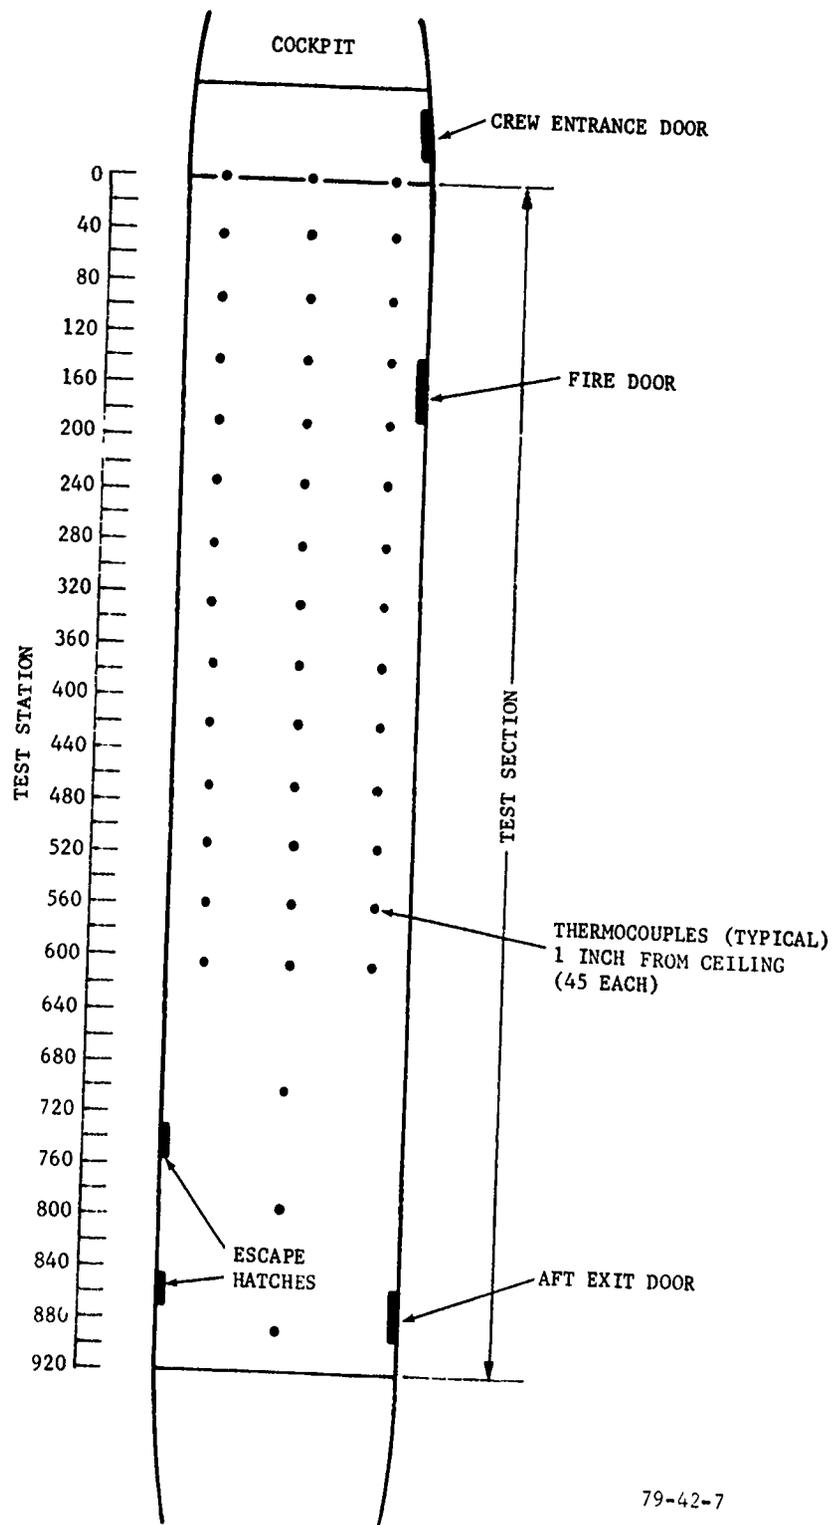
79-42-7

FIGURE 7. TEST ARTICLE CEILING THERMOCOUPLE LOCATIONS

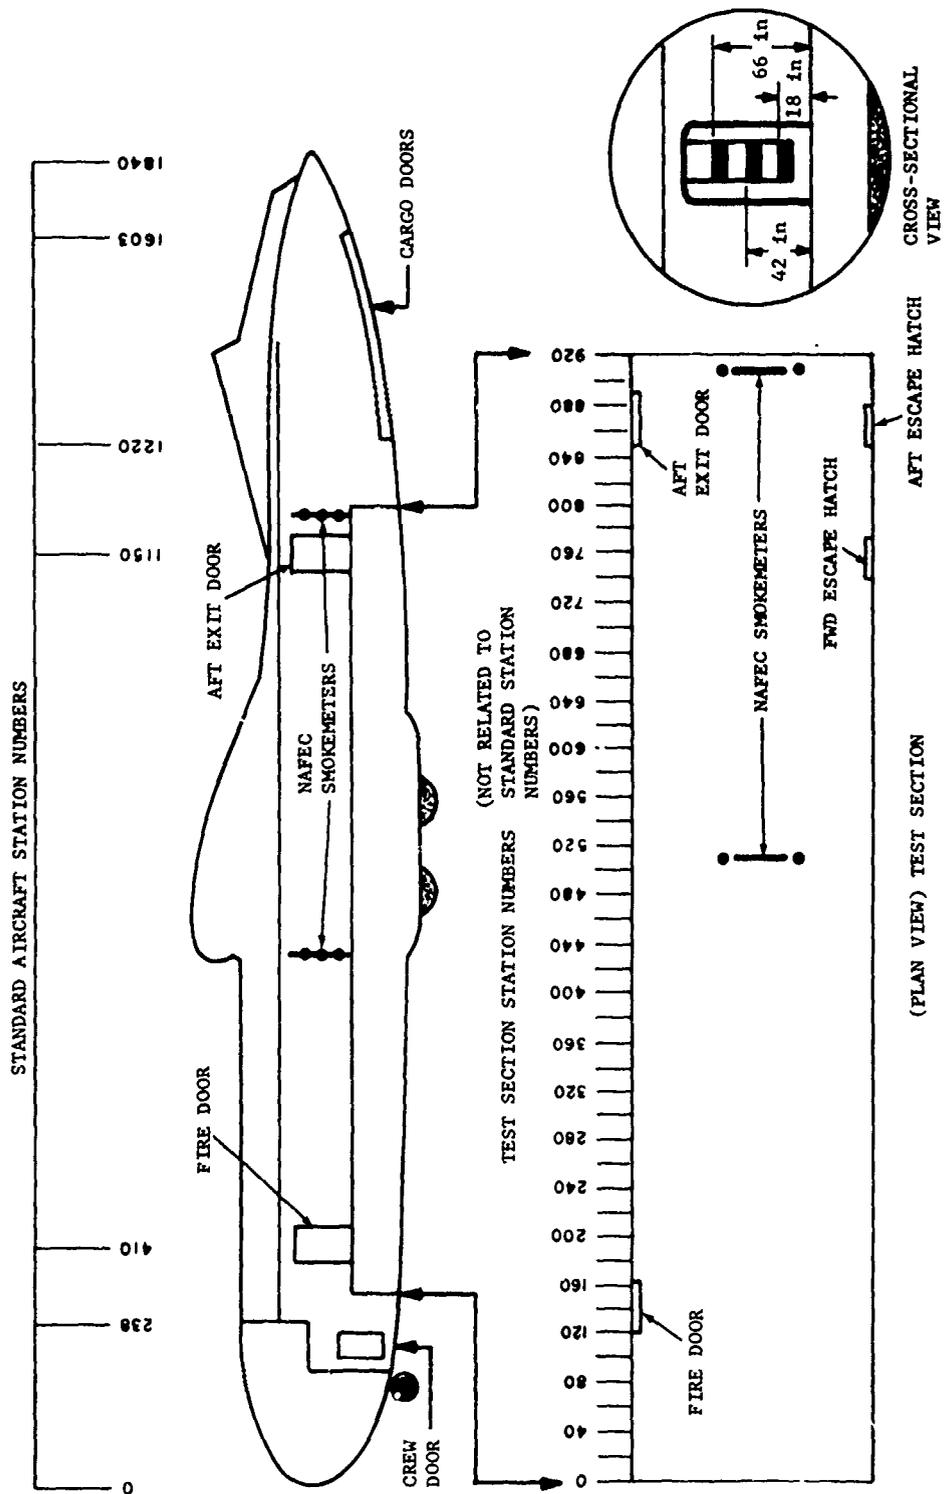
FIGURE 8. SMOKEMETER LOCATIONS

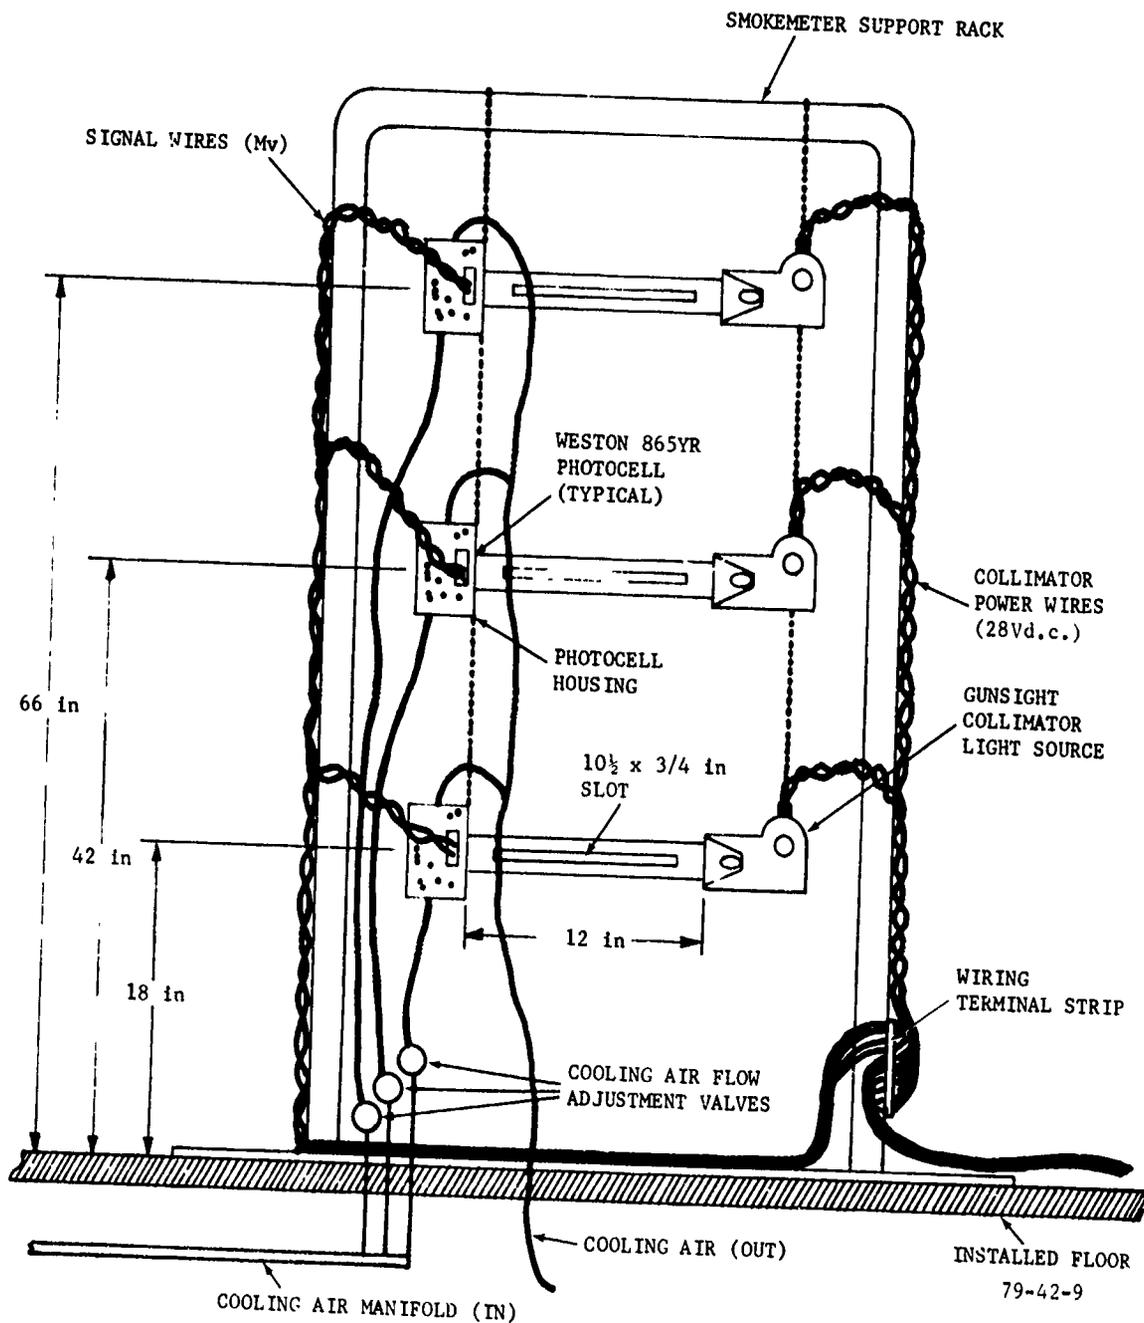
FIGURE 9. SMOKEMETER RACK INSTALLATION

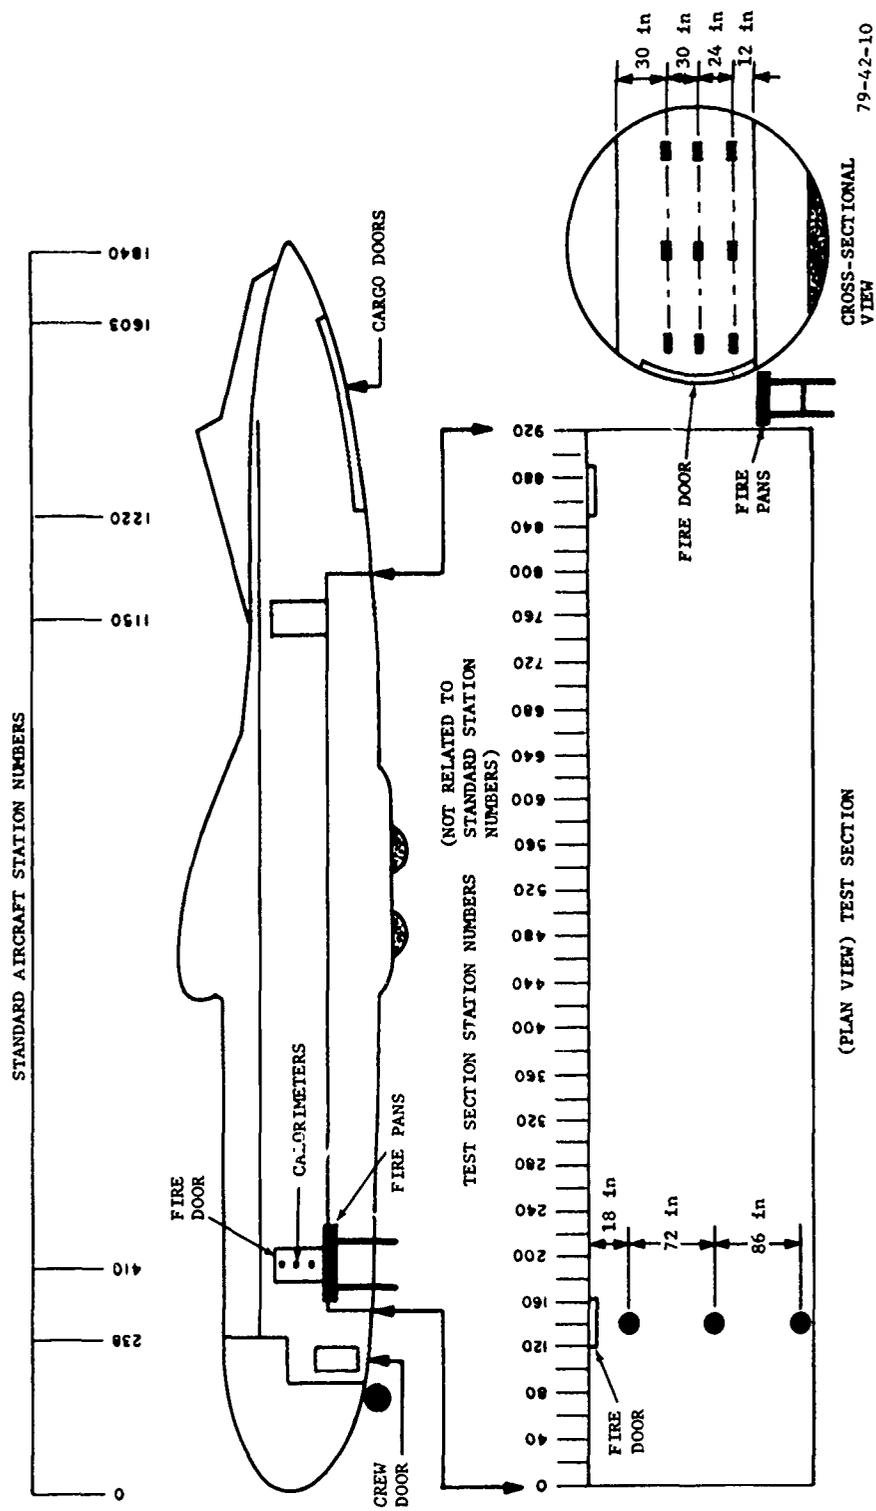
FIGURE 10. LOCATION OF ASYMPTOTIC RAPID-RESPONSE CALORIMETERS

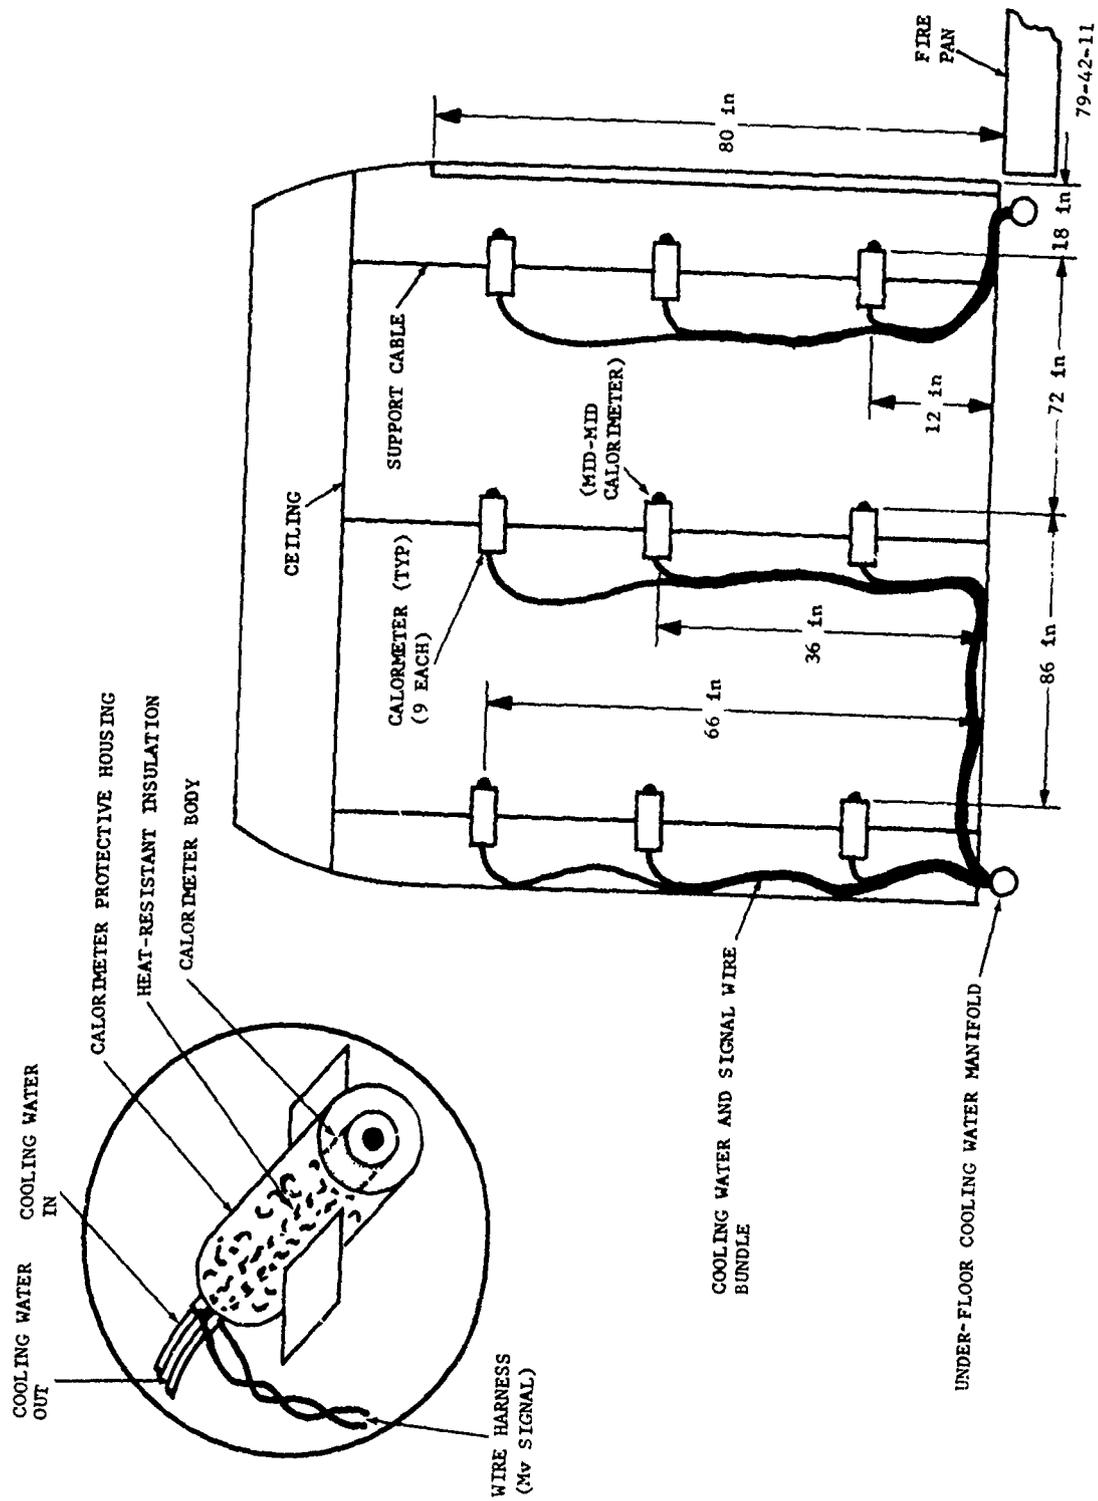
FIGURE 11. CALORIMETER INSTALLATION

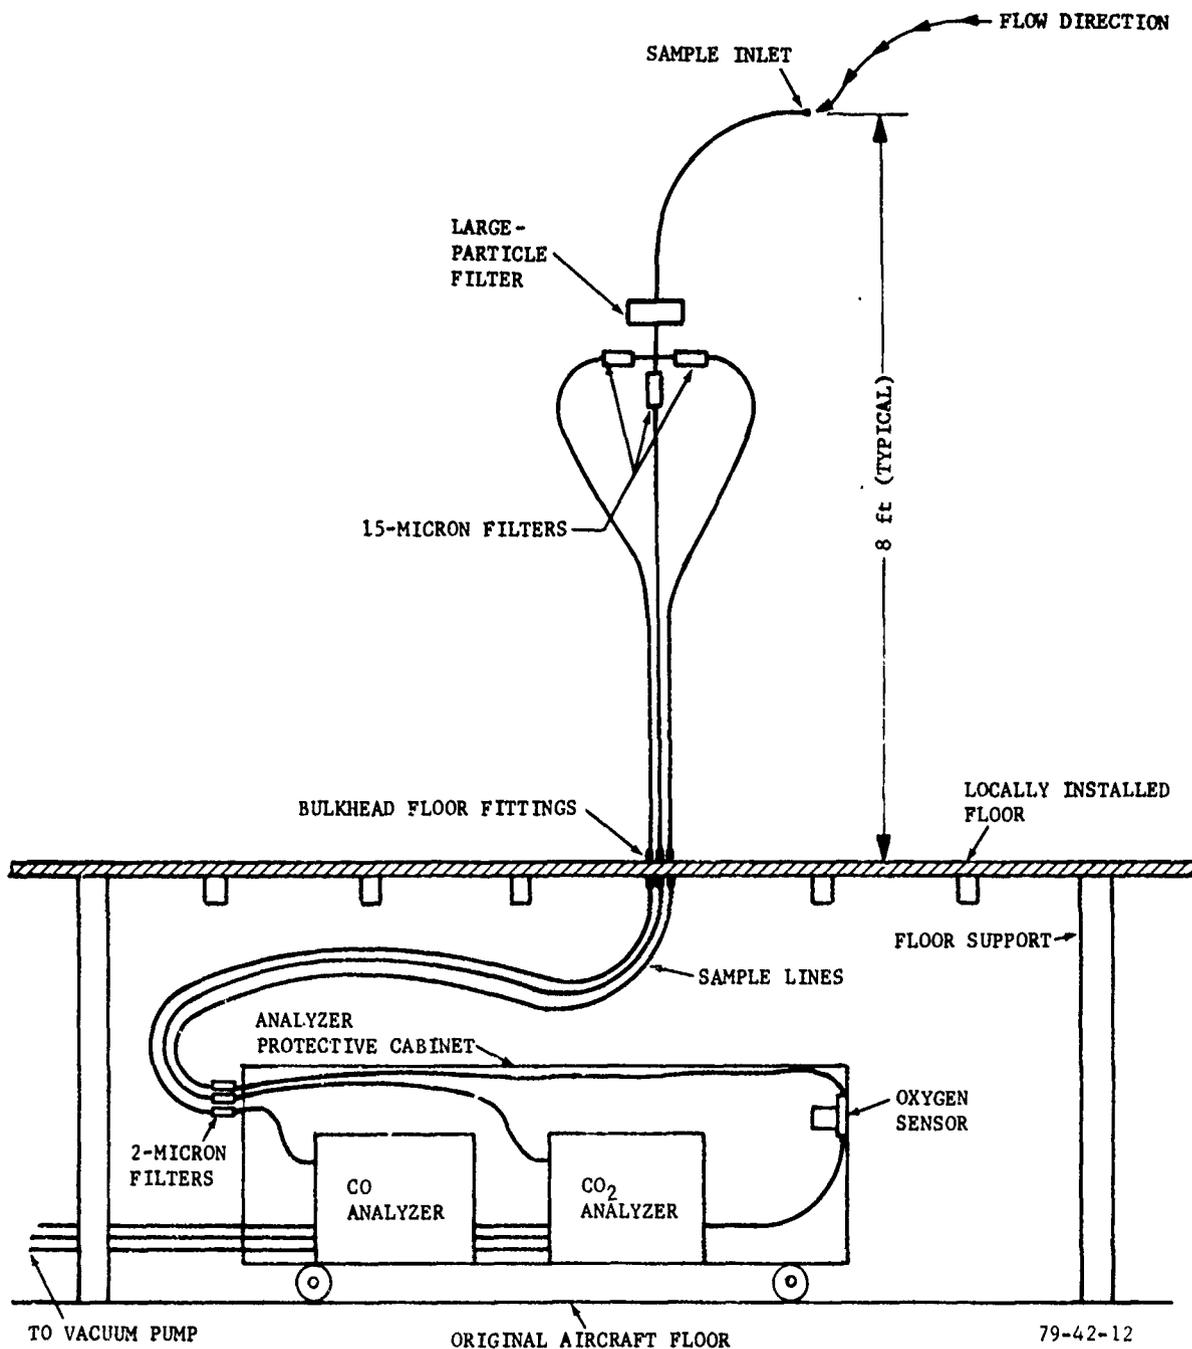
FIGURE 12. TYPICAL GAS SAMPLING LOCATION

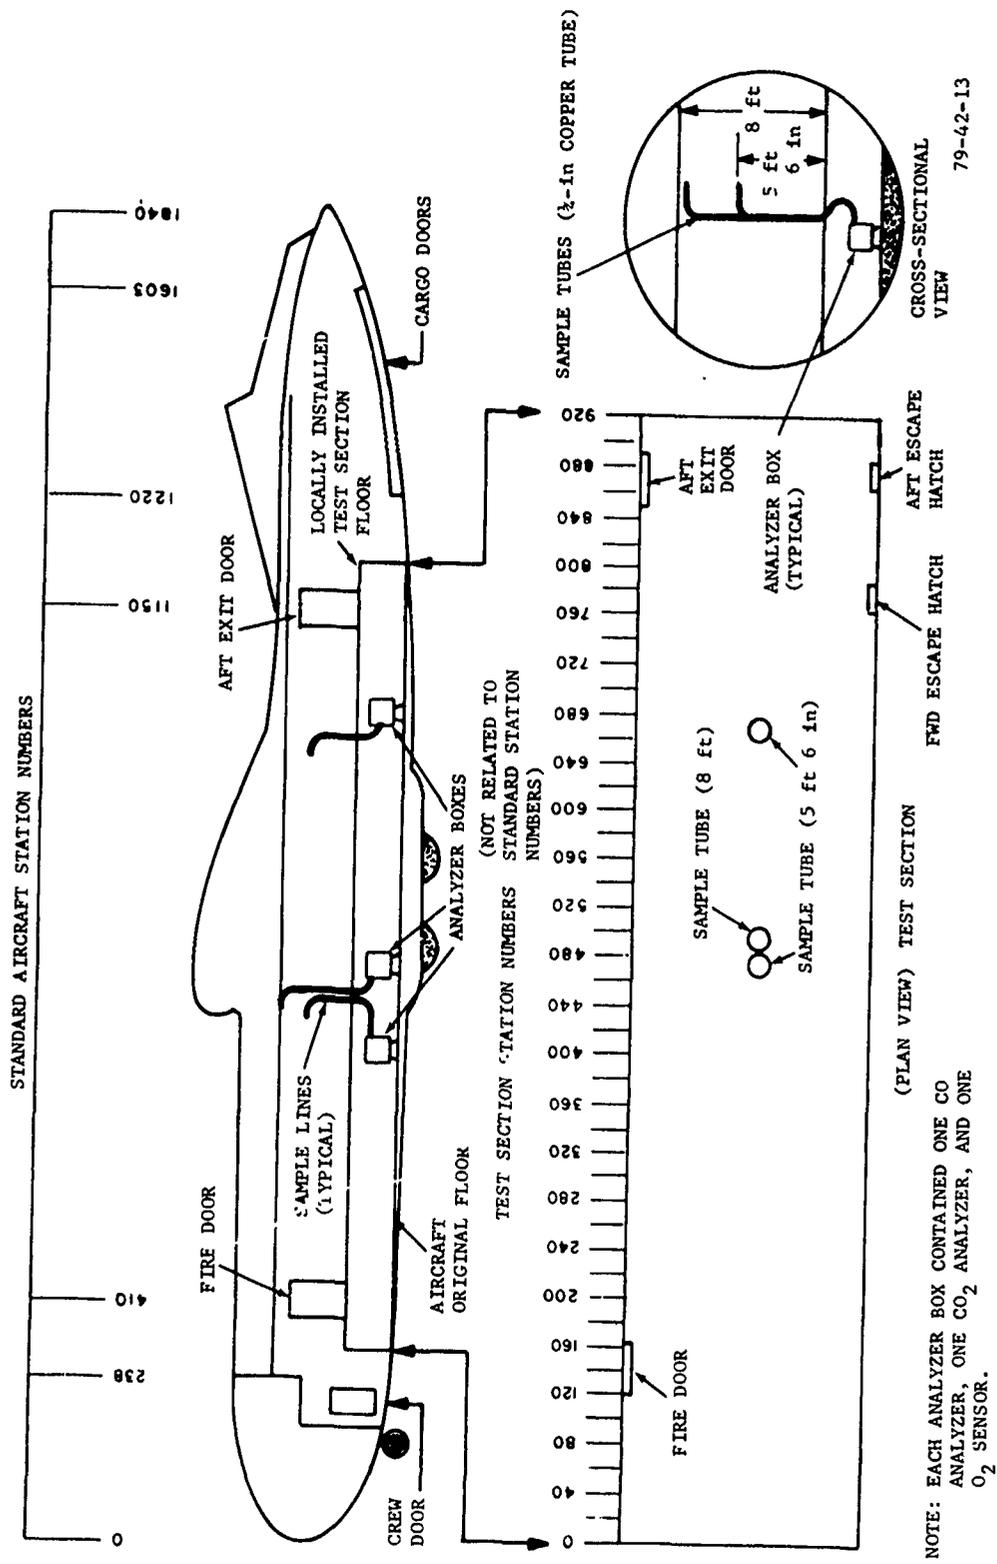
FIGURE 13. LOCATION OF GAS SAMPLE STATIONS

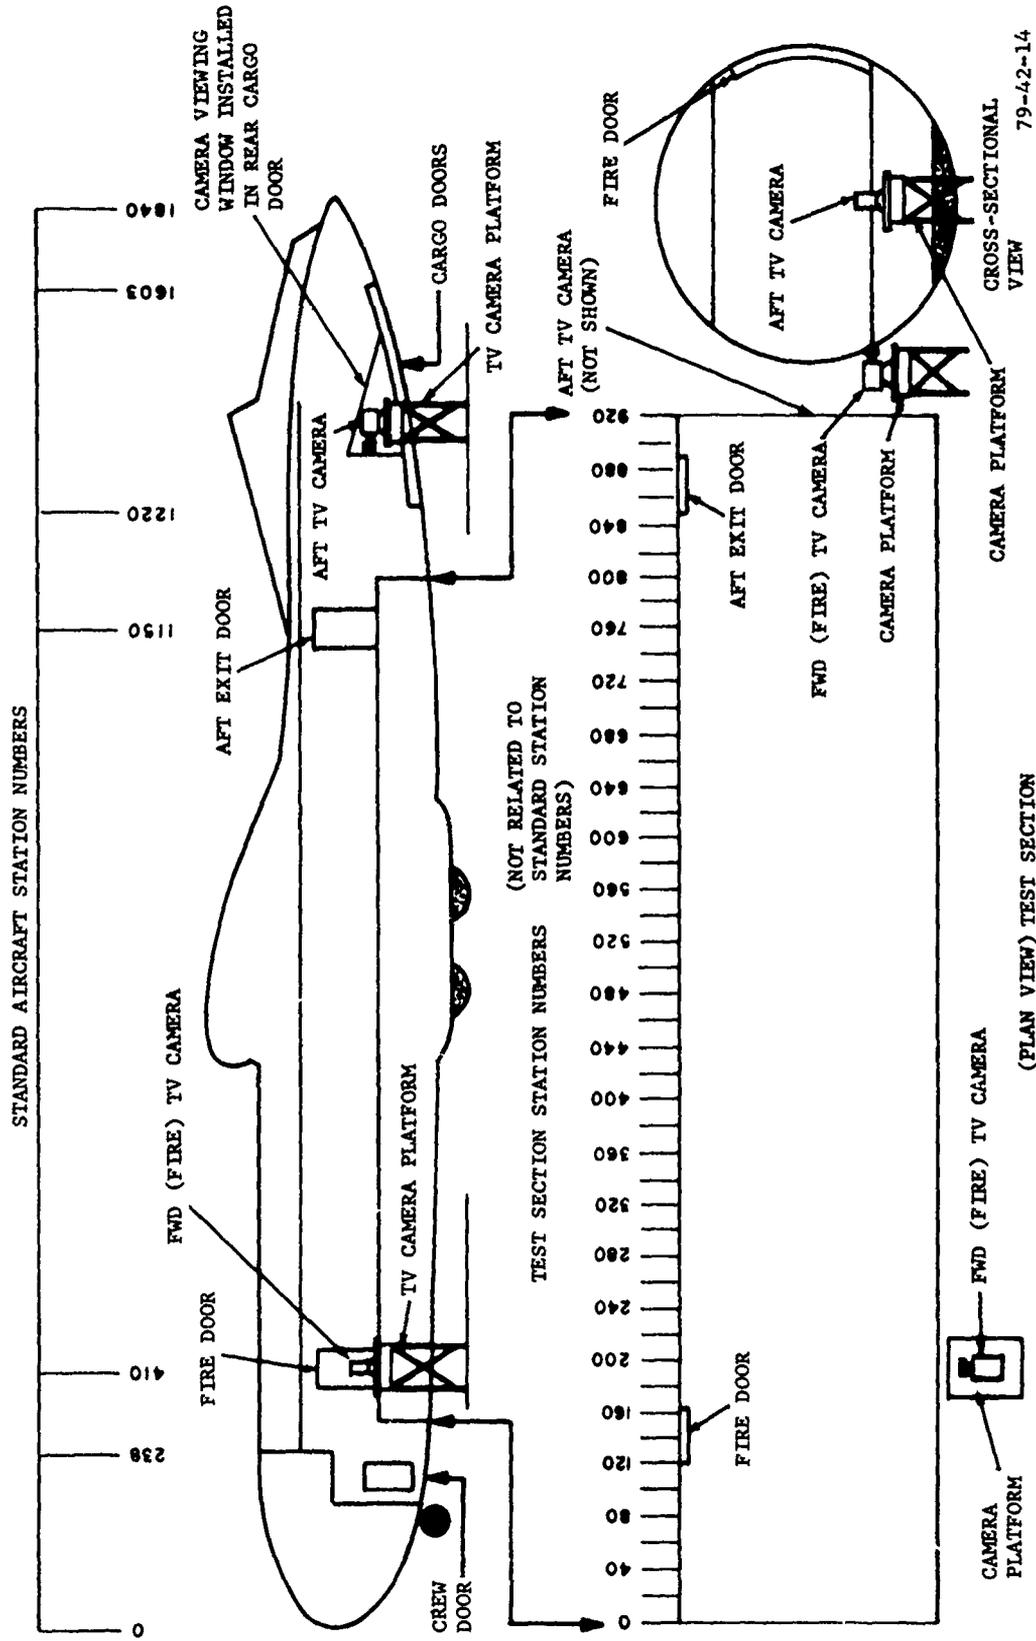
FIGURE 14. TELEVISION CAMERA LOCATIONS
