POSTCRASH FUEL FIRE HAZARD MEASUREMENTS IN A WIDE-BODY AIRCRAFT CABIN

FINAL REPORT

1. Report No. 144 FAA-NA-79-42		2. Government Accession No.		3. Recipient's Catalog No.	
4. Title and Subtitle 6 POSTCRASH FUEL FIRE HAZARD MEASUREMENTS IN A WIDE-BODY AIRCRAFT CABIN				5. Report Date 11 Dec 79

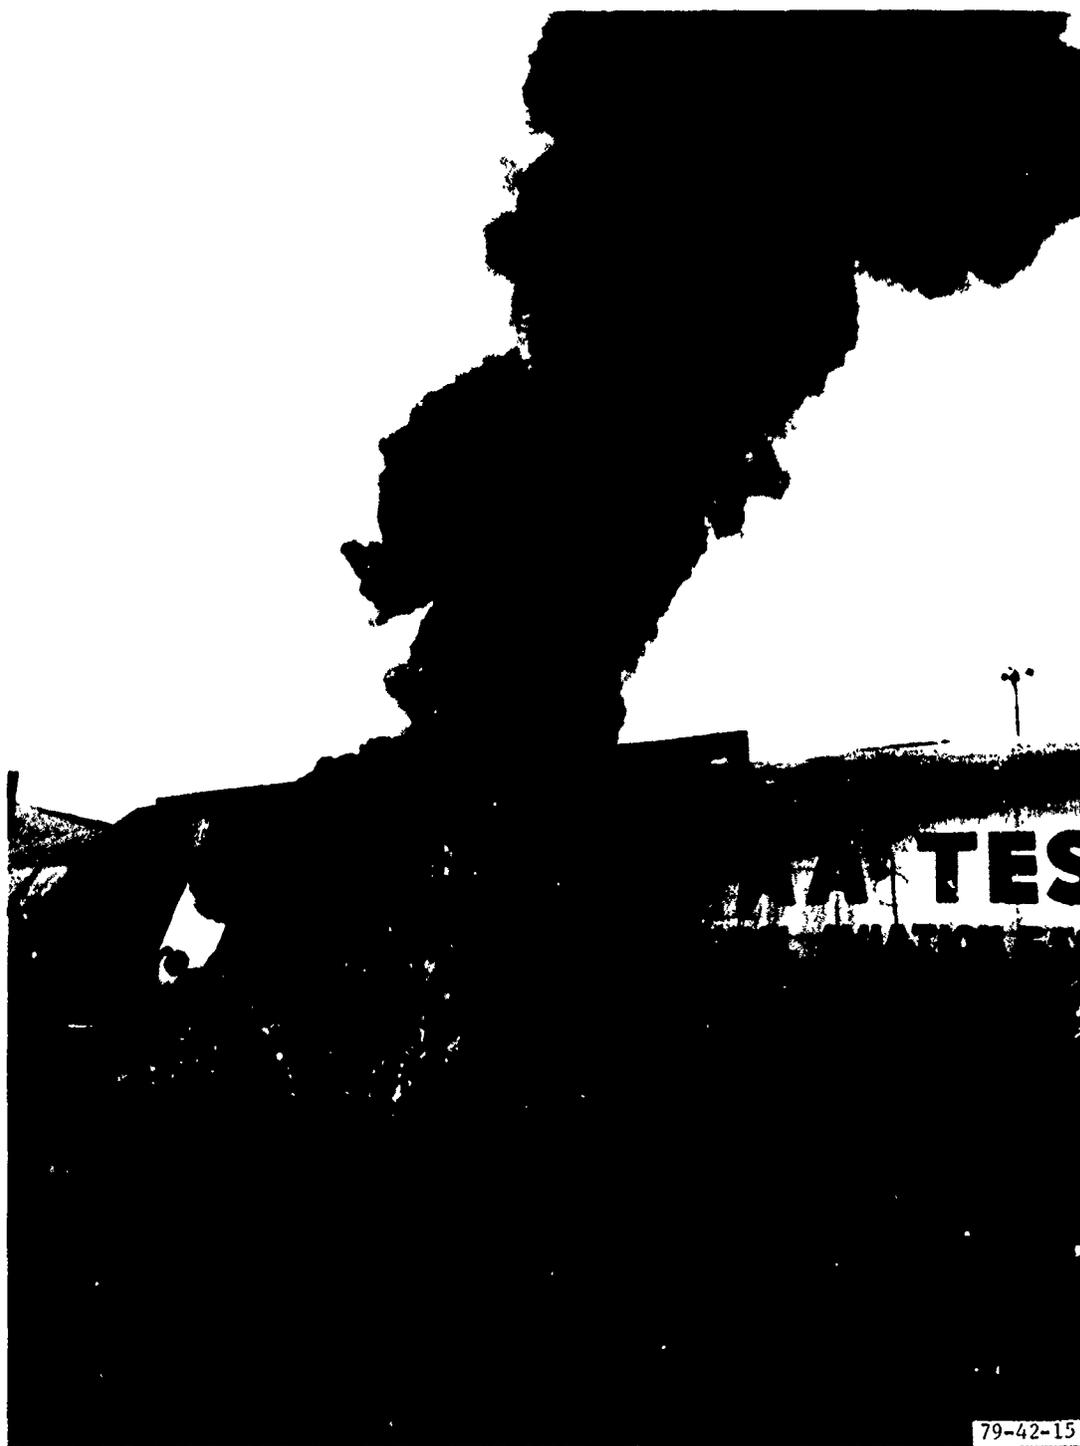
FIGURE 15. TYPICAL TEST FIRE

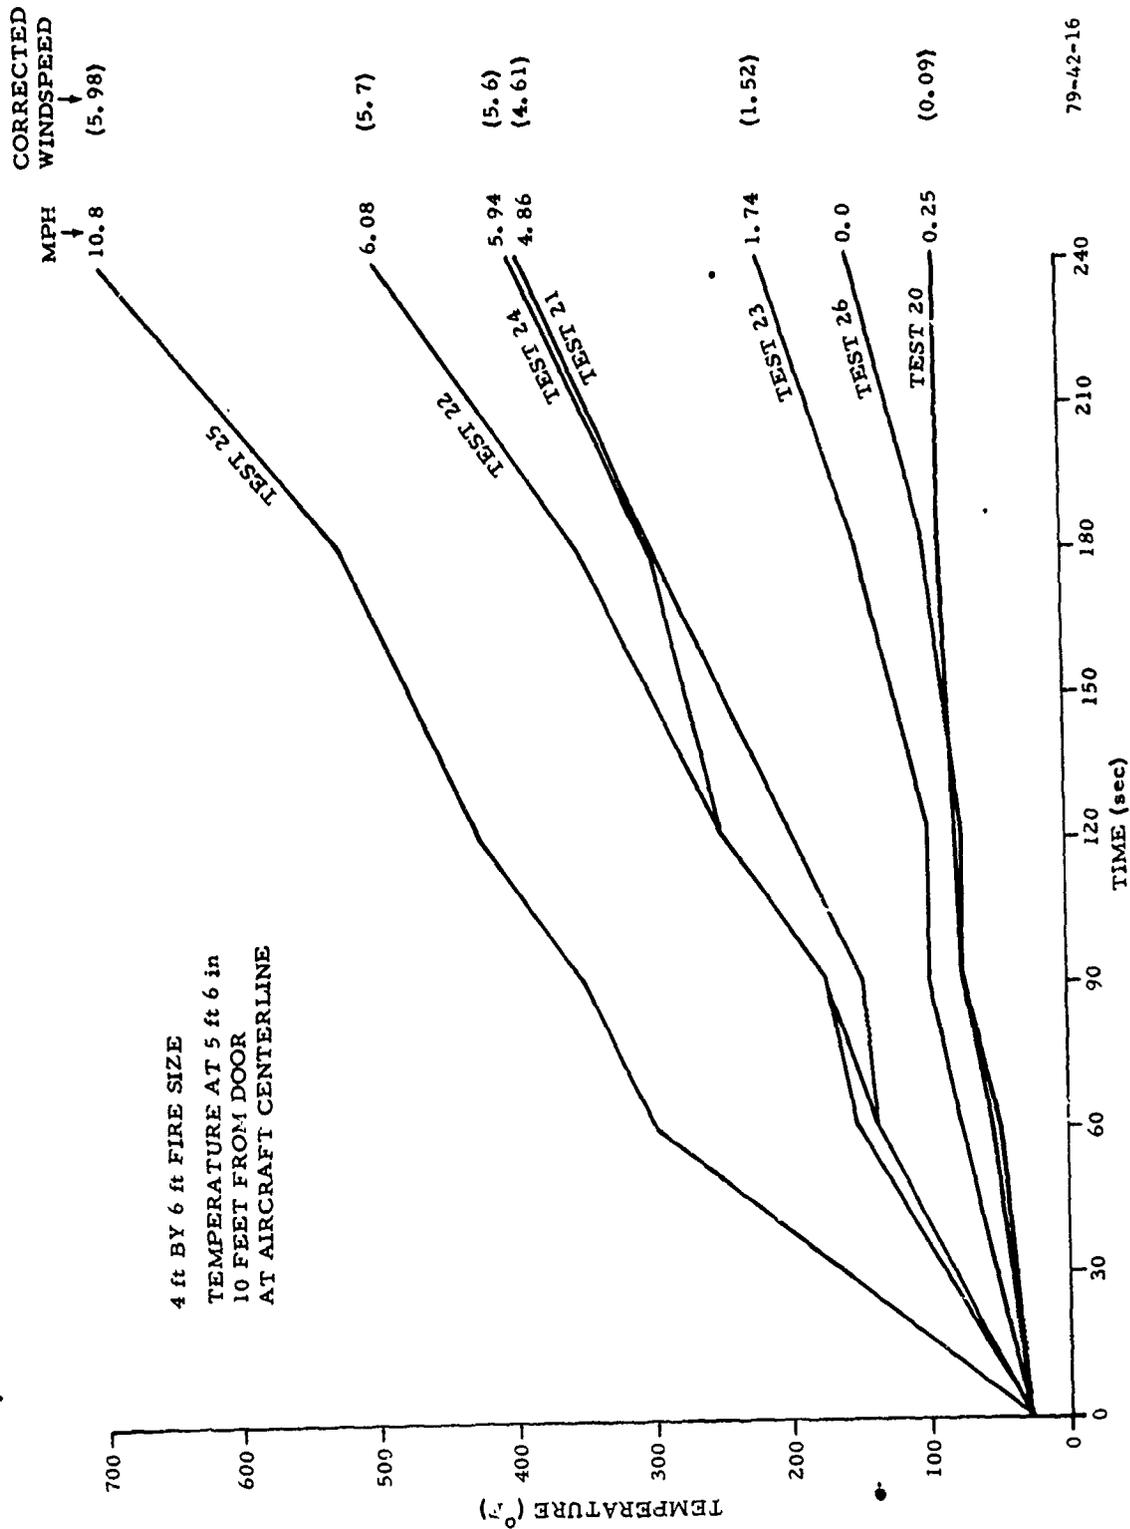
FIGURE 16. EFFECT OF WIND ON CABIN TEMPERATURES (4- BY 6-FOOT FIRE)

The wind was the single most important factor affecting the environmental conditions in the cabin during testing. Figures 16, 17, and 18 show the effect of wind on cabin air temperature using 4-by 6-foot, 6-by 8-foot, and 8-by 10-foot fires, respectively. The thermocouple plotted was 5 feet 6 inches high, 10 feet aft of the fire door and at the fuselage centerline. Windspeeds were averaged for the test duration. Windspeed listed in the parenthesis is the component of the windspeed entering the door perpendicular to the fuselage. Figure 19 shows the conversion for a typical test of the windspeed direction to the corrected windspeed perpendicular to the door.

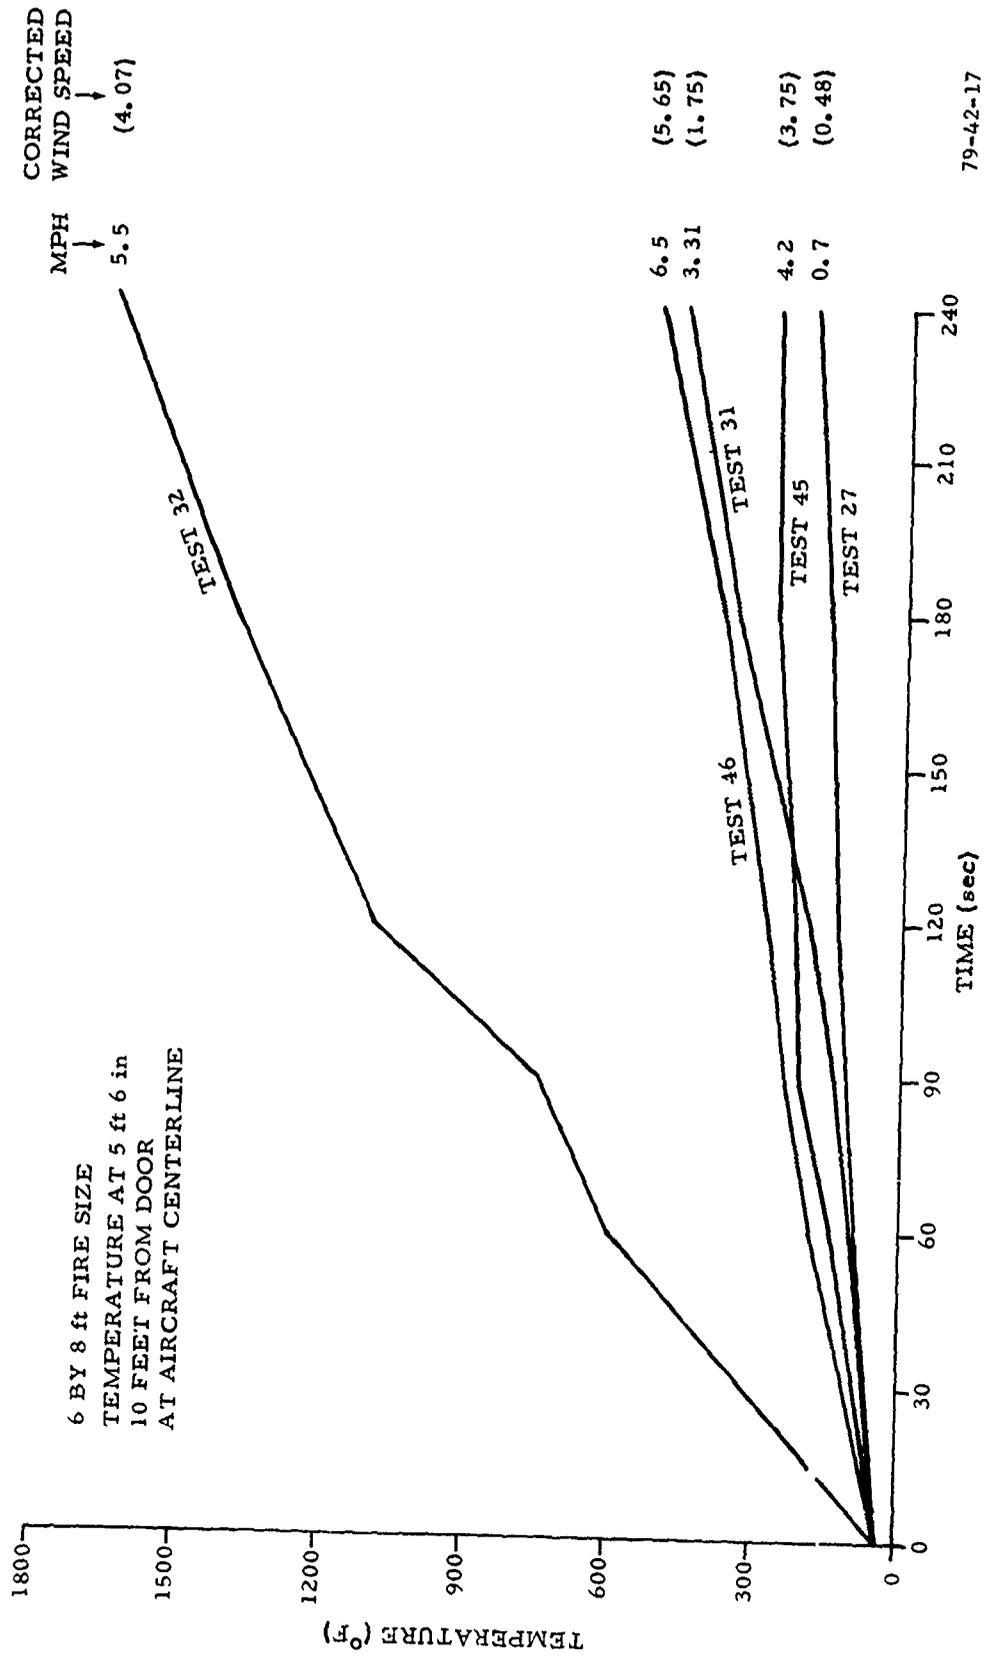
FIGURE 17. EFFECT OF WIND ON CABIN TEMPERATURES (6-- BY 8--FOOT FIRE)

Generally, the greater the wind towards the fuselage opening, the greater the hazard in the fuselage. However, exceptions to that rule were noted; one in particular, during test number 32, is seen in figure 17. Although the average windspeed and the corrected windspeed were lower than other tests, using the same size fire, the temperature at 5 feet 6 inches height, 10 feet from the fire door at the fuselage centerline was three to four times higher than those of the other tests.

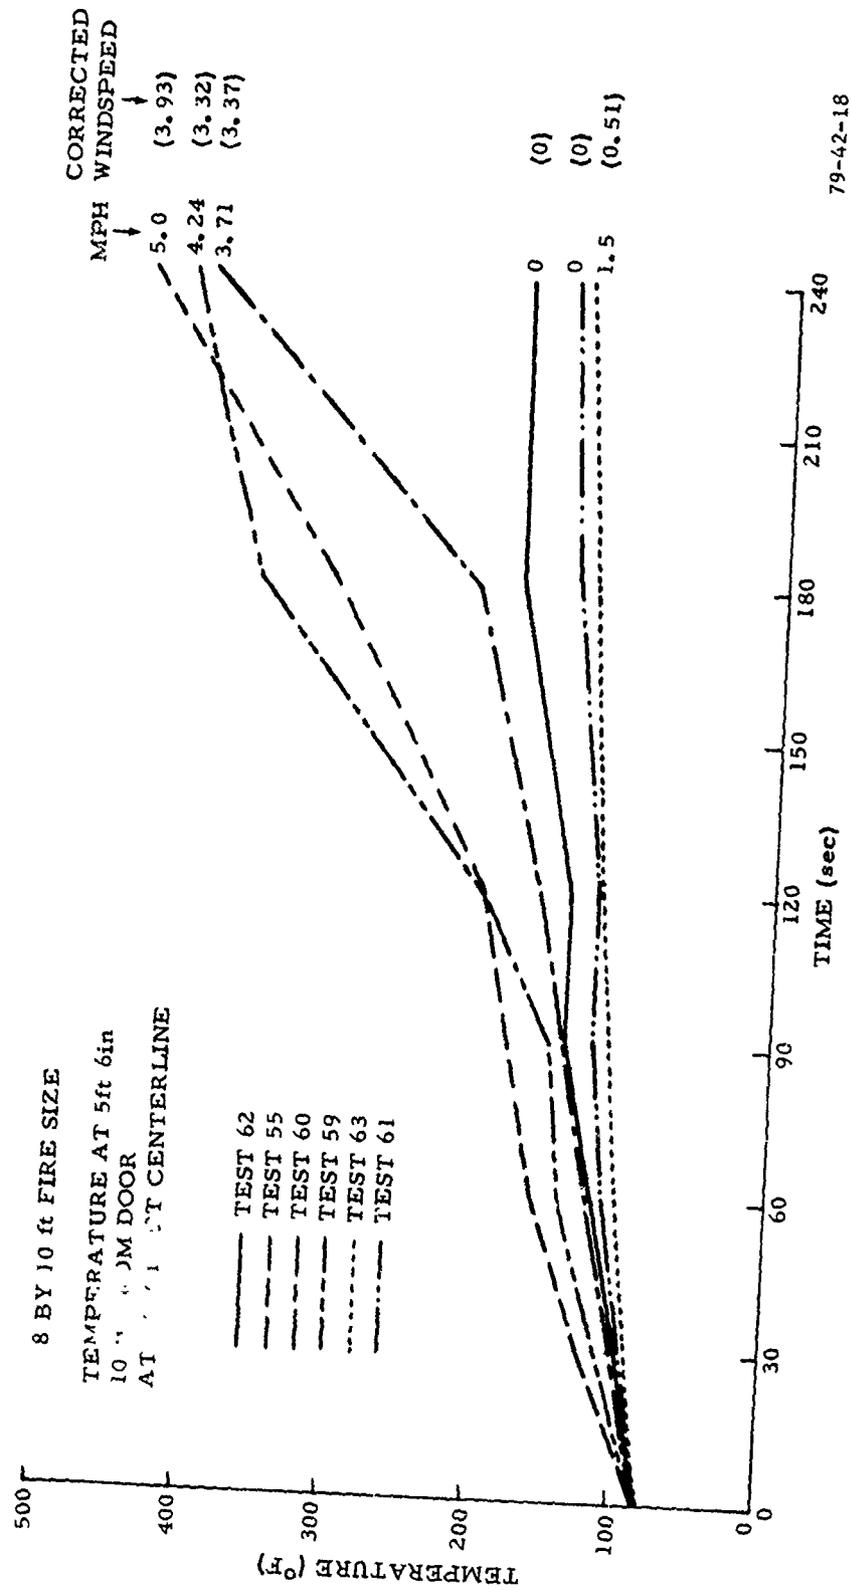
FIGURE 18. EFFECT OF WIND ON CABIN TEMPERATURES (8- BY 10-FOOT FIRE)

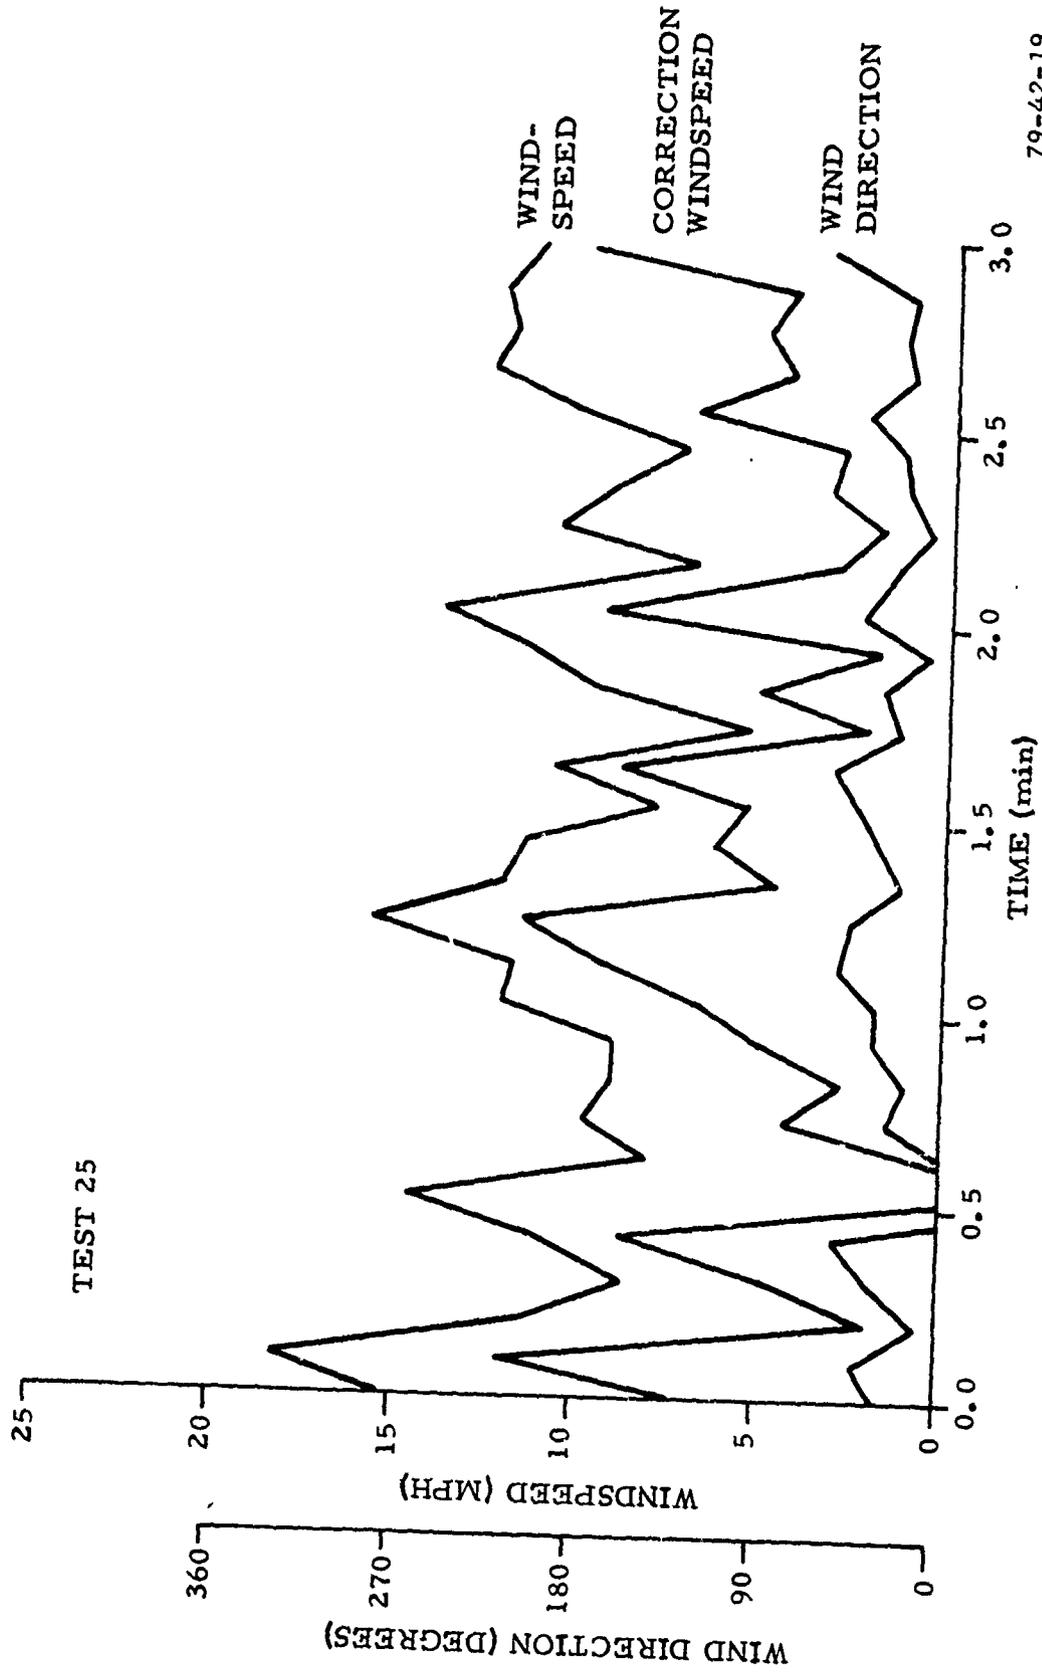
79-42-19

FIGURE 19. CORRECTED WINDSPEED DETERMINATION

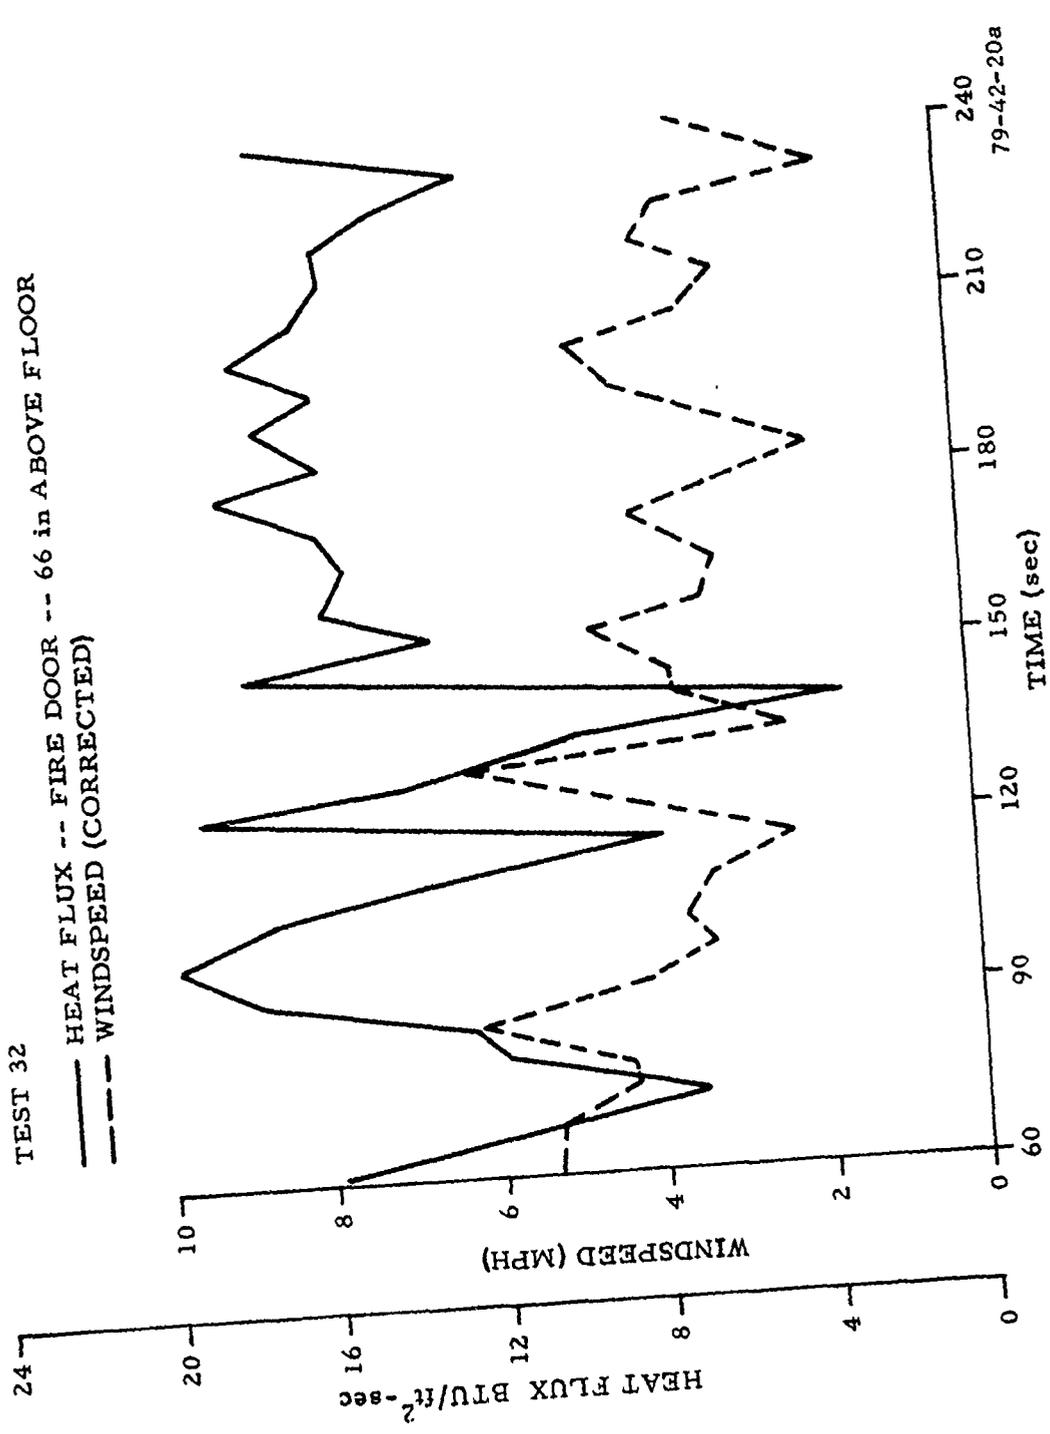
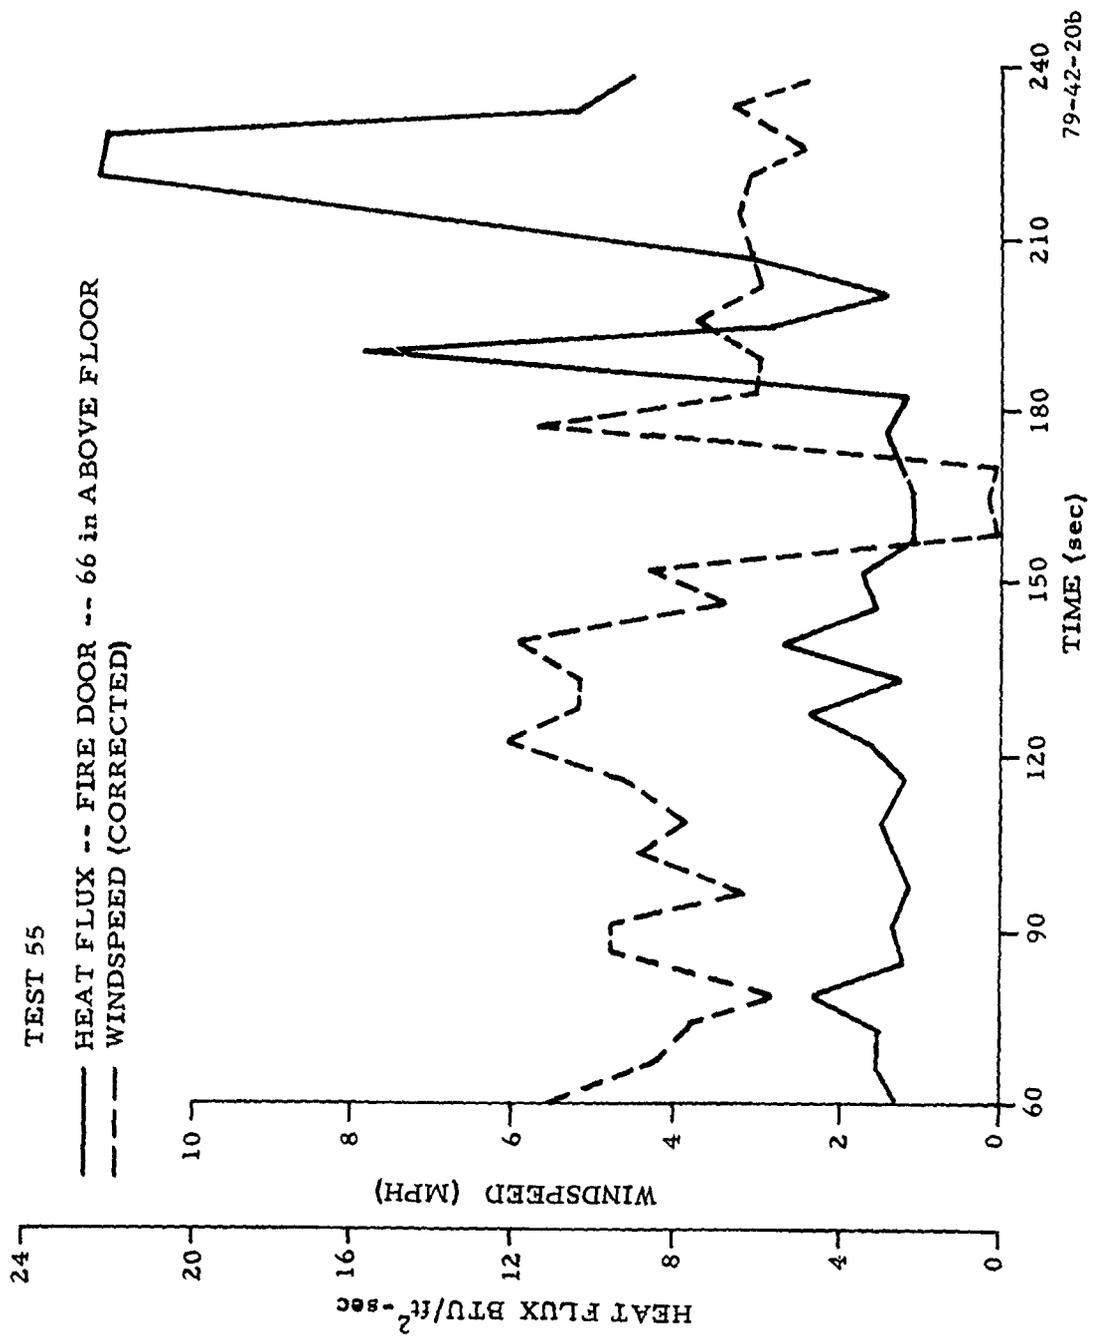
FIGURE 20. EFFECT OF WIND VARIATION ON WIND ENTERING FUSELAGE (Sheet 1 of 2)

FIGURE 20. EFFECT OF WIND VARIATION ON WIND ENTERING FUSELAGE (Sheet 2 of 2)

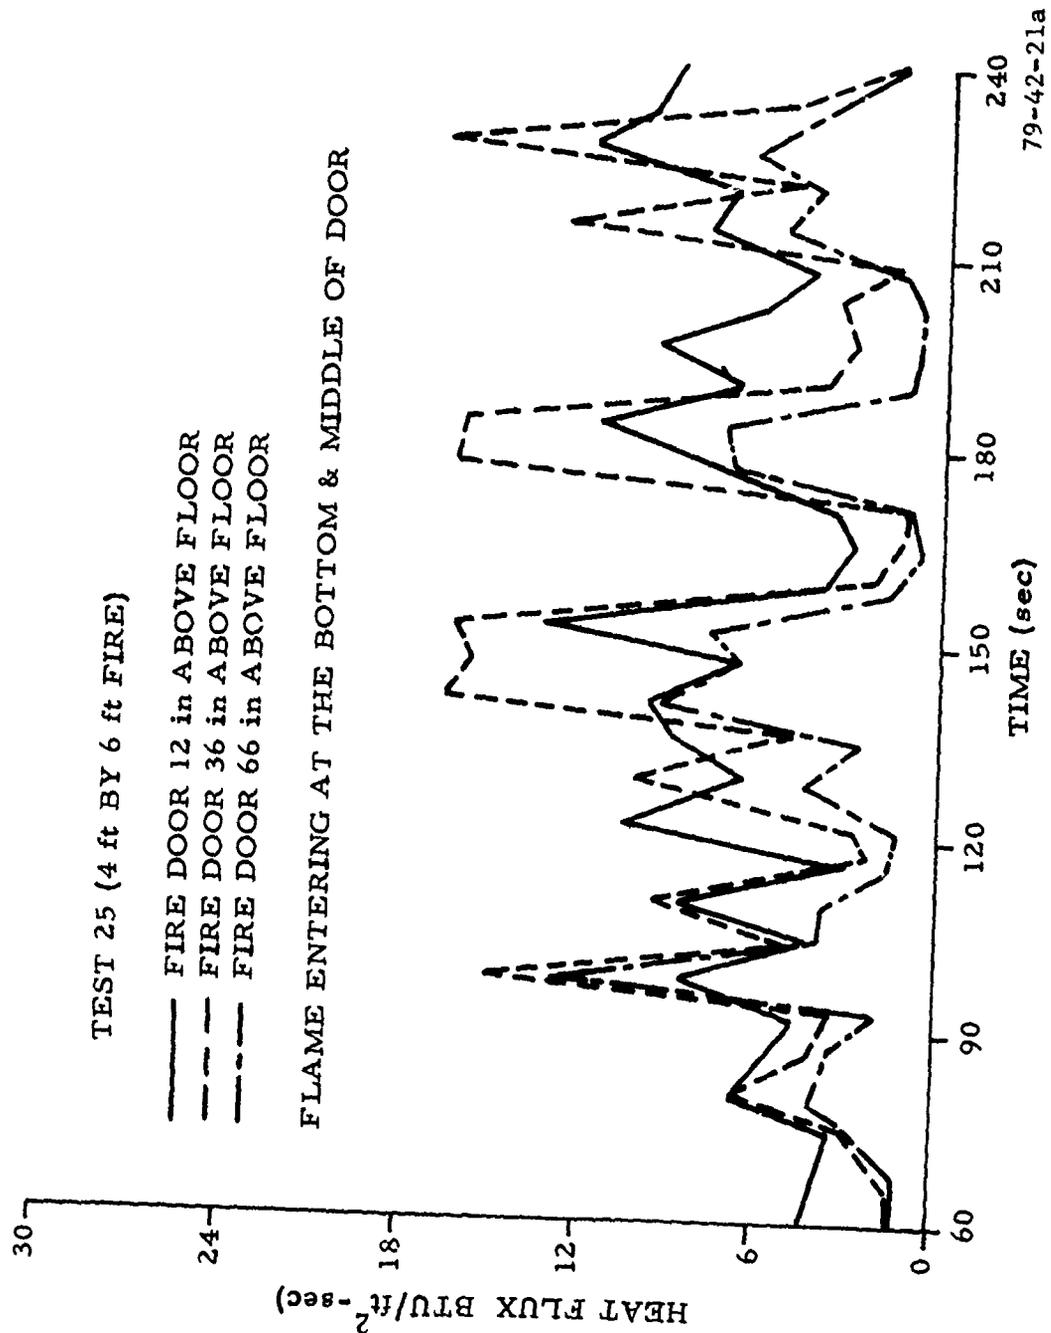
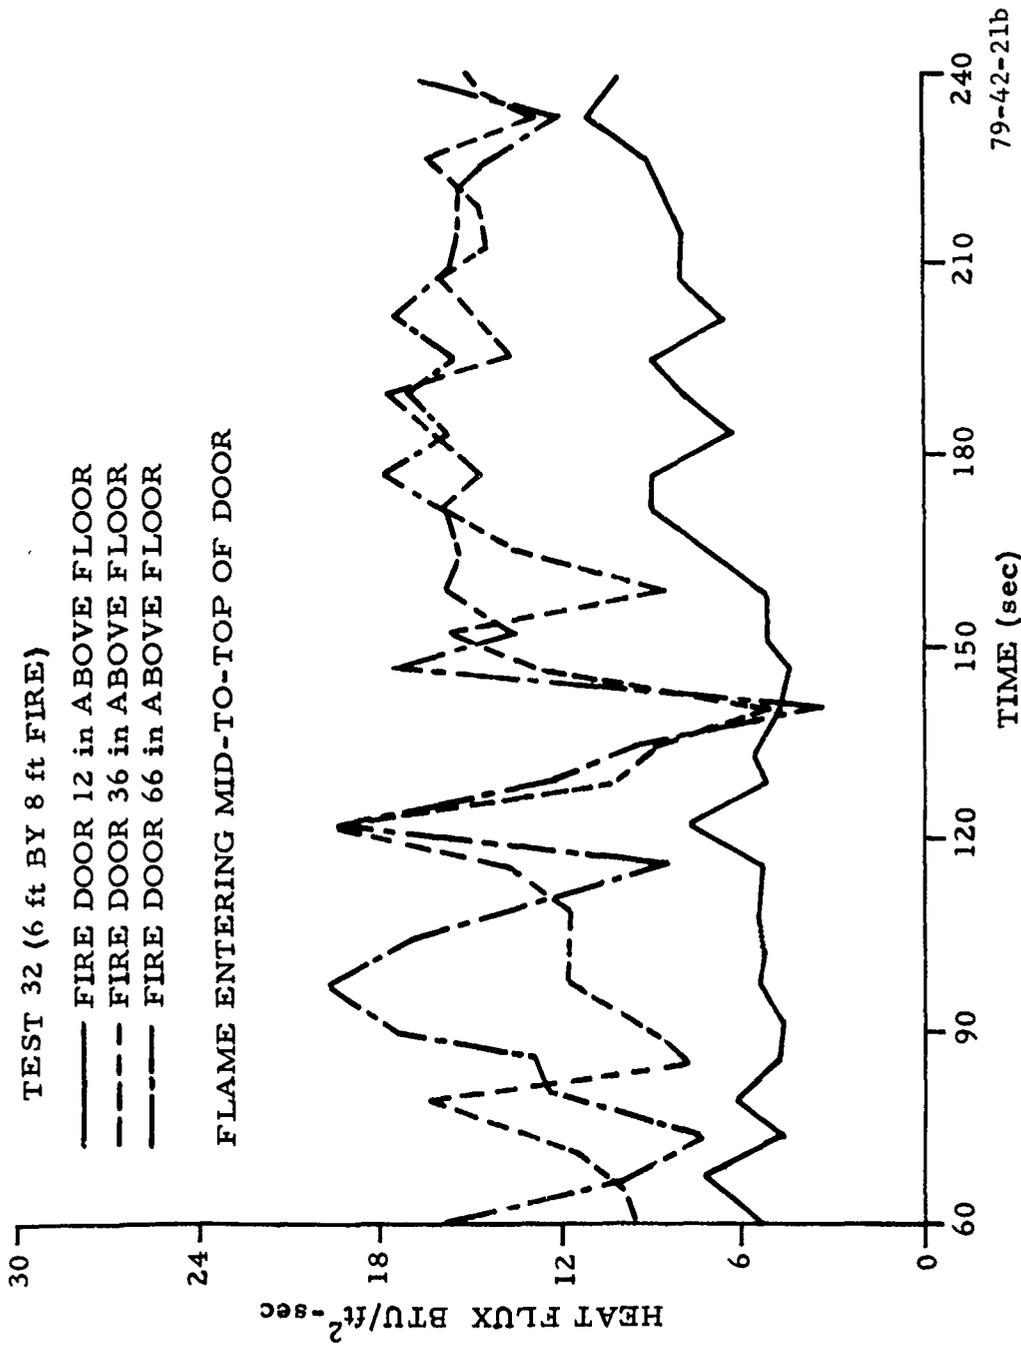
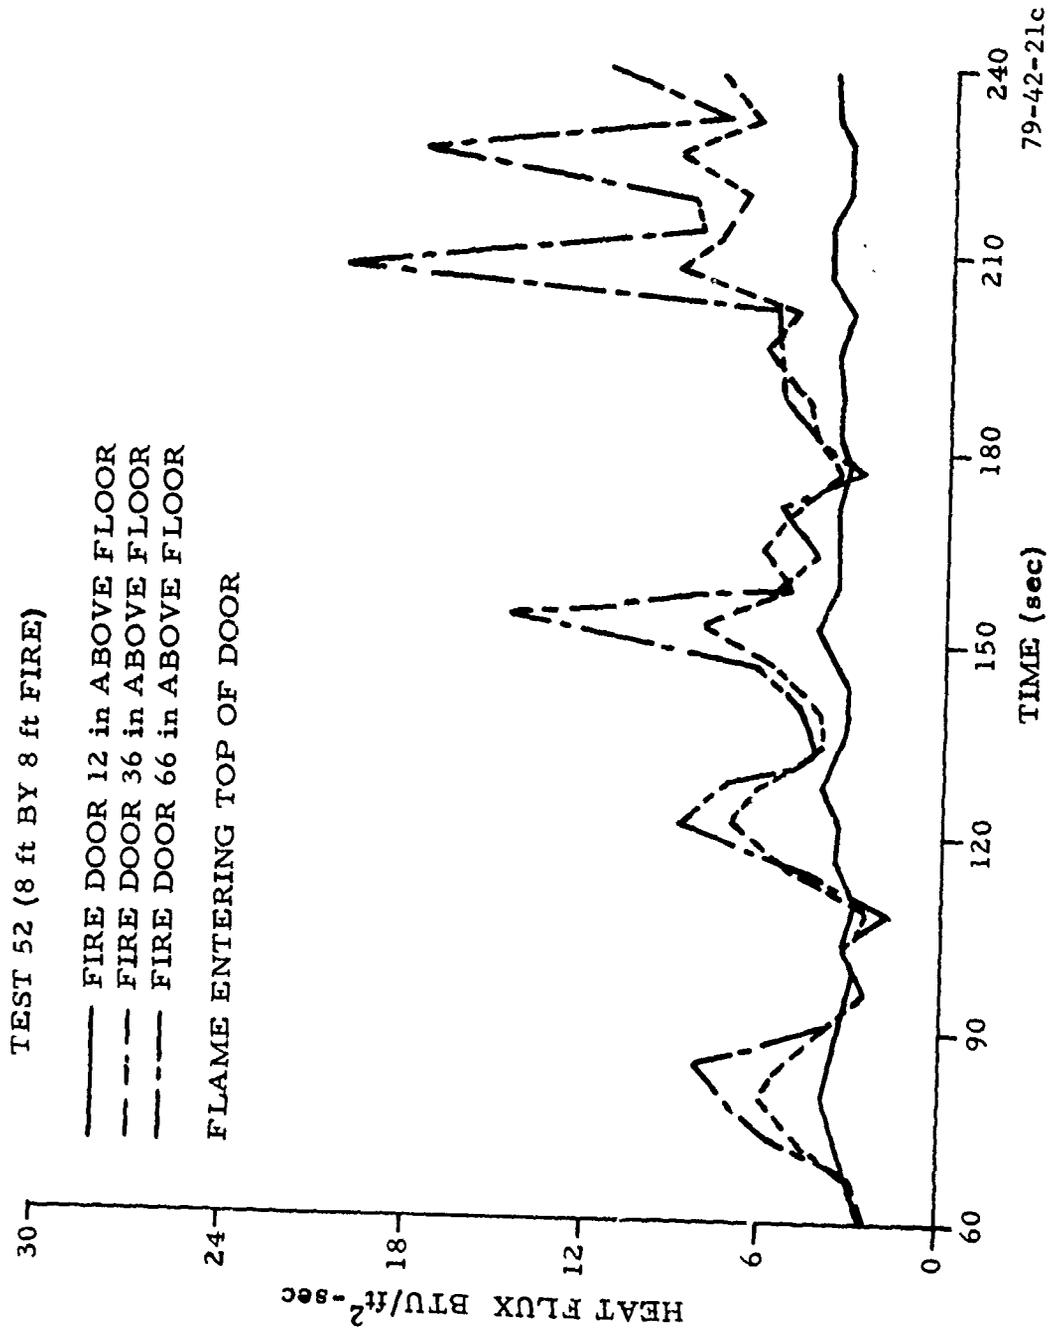
FIGURE 21. EFFECT OF FIRE SIZE ON FLAME PENETRATING FUSELAGE OPENING (Sheet 1 of 3)

FIGURE 21. EFFECT OF FIRE SIZE ON FLAME PENETRATING FUSELAGE OPENING (Sheet 2 of 3)

FIGURE 21. EFFECT OF FIRE SIZE ON FLAME PENETRATING FUSELAGE OPENING (Sheet 3 of 3)

By varying the fire size, the effect of the wind on the fire also varied. The smaller the fire, the greater the bending of the flame by the wind (figure 21). The heat flux in the doorway shows more penetration through the lower area of the door for the smaller fires, indicating a greater bending of the flame. Therefore, although a smaller fire puts out less heat, smoke, and toxic gases than a bigger fire, a larger portion of the smaller fire can penetrate a fuselage opening for a given wind condition.

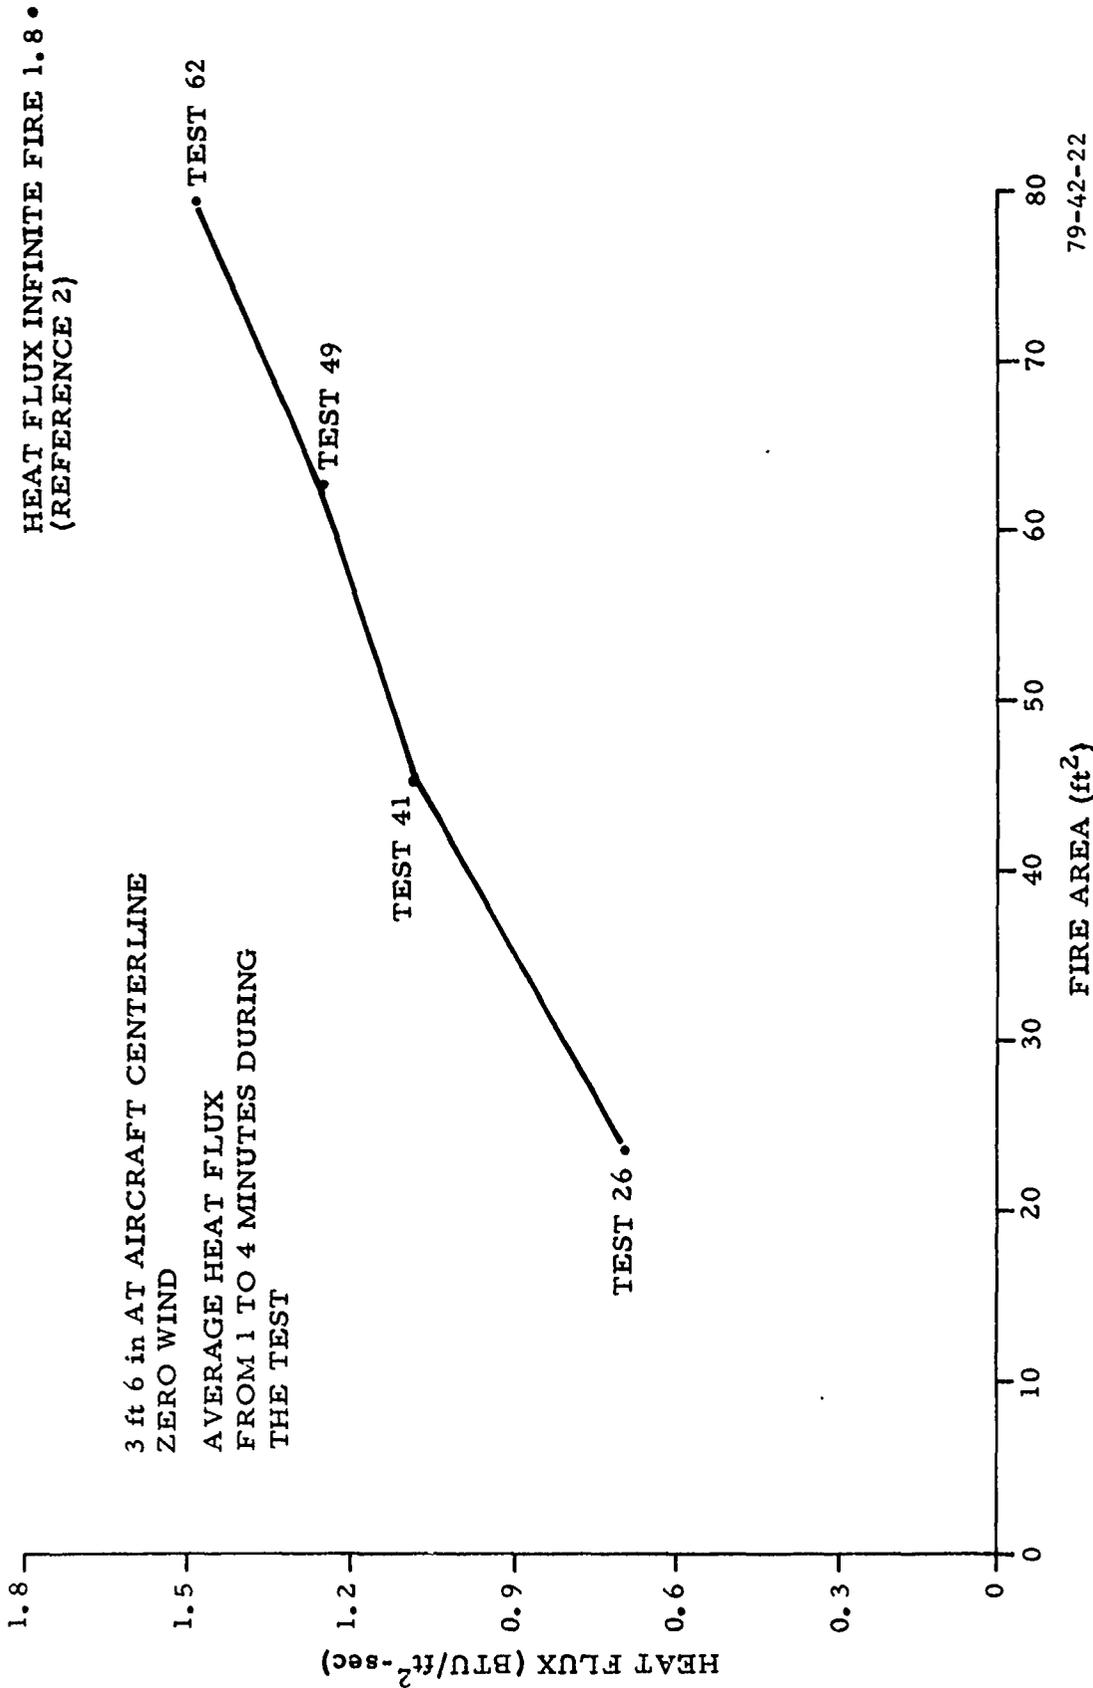
FIGURE 22. RADIANT HEAT IN CABIN RESULTING FROM ZERO-WIND FIRES

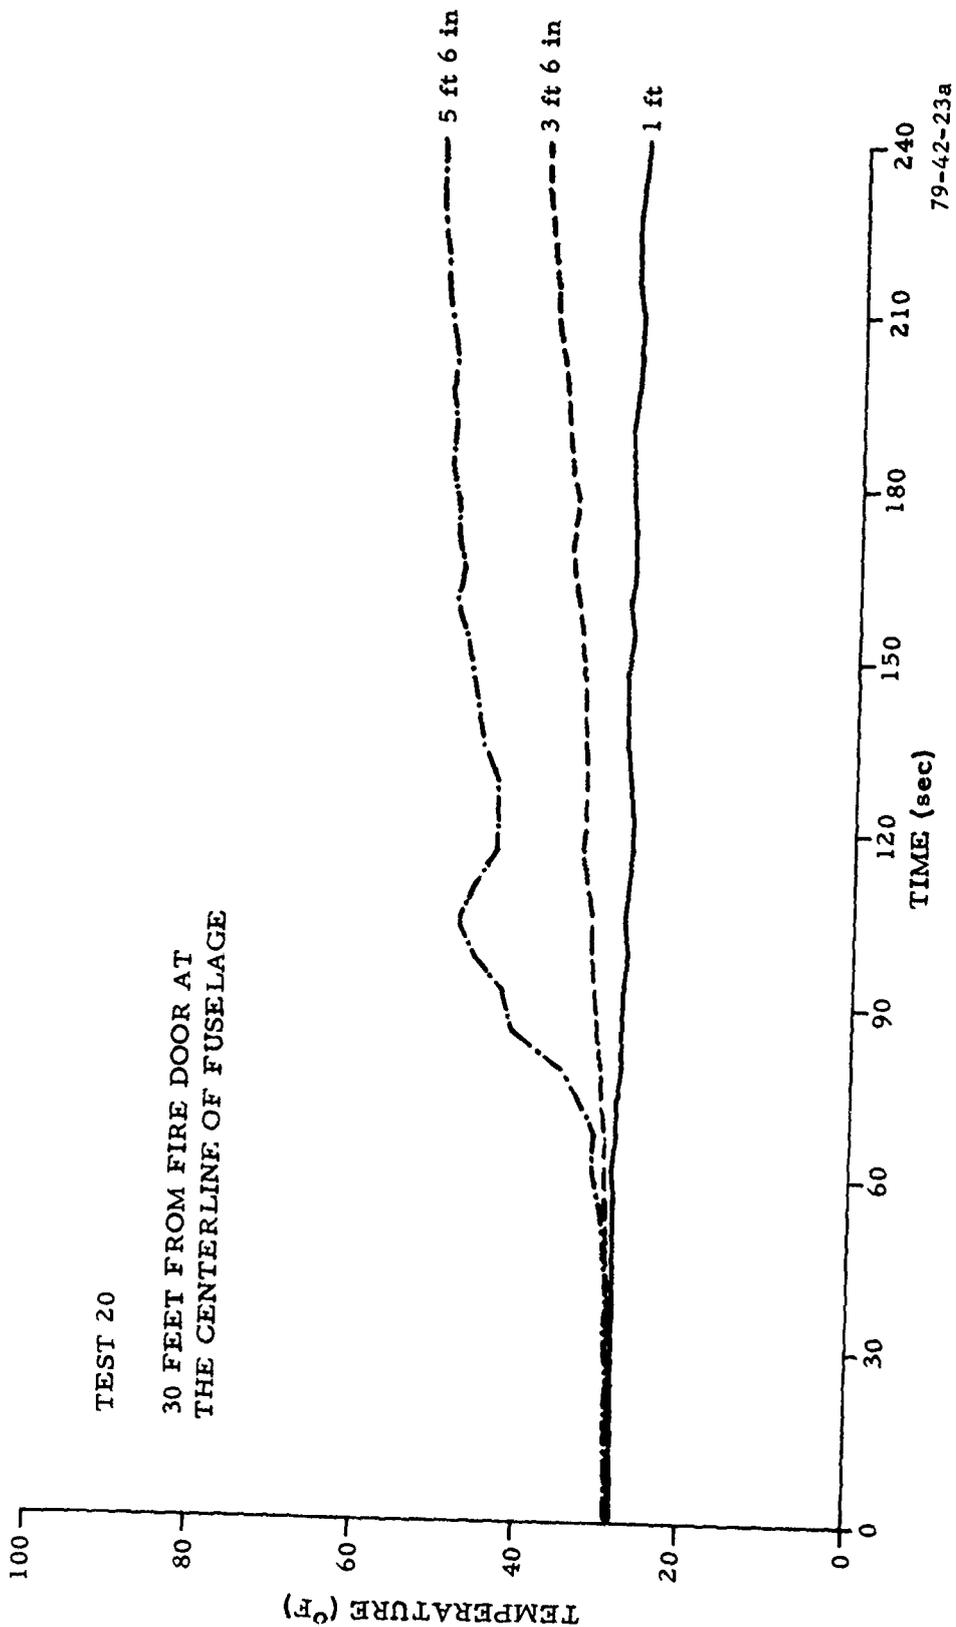
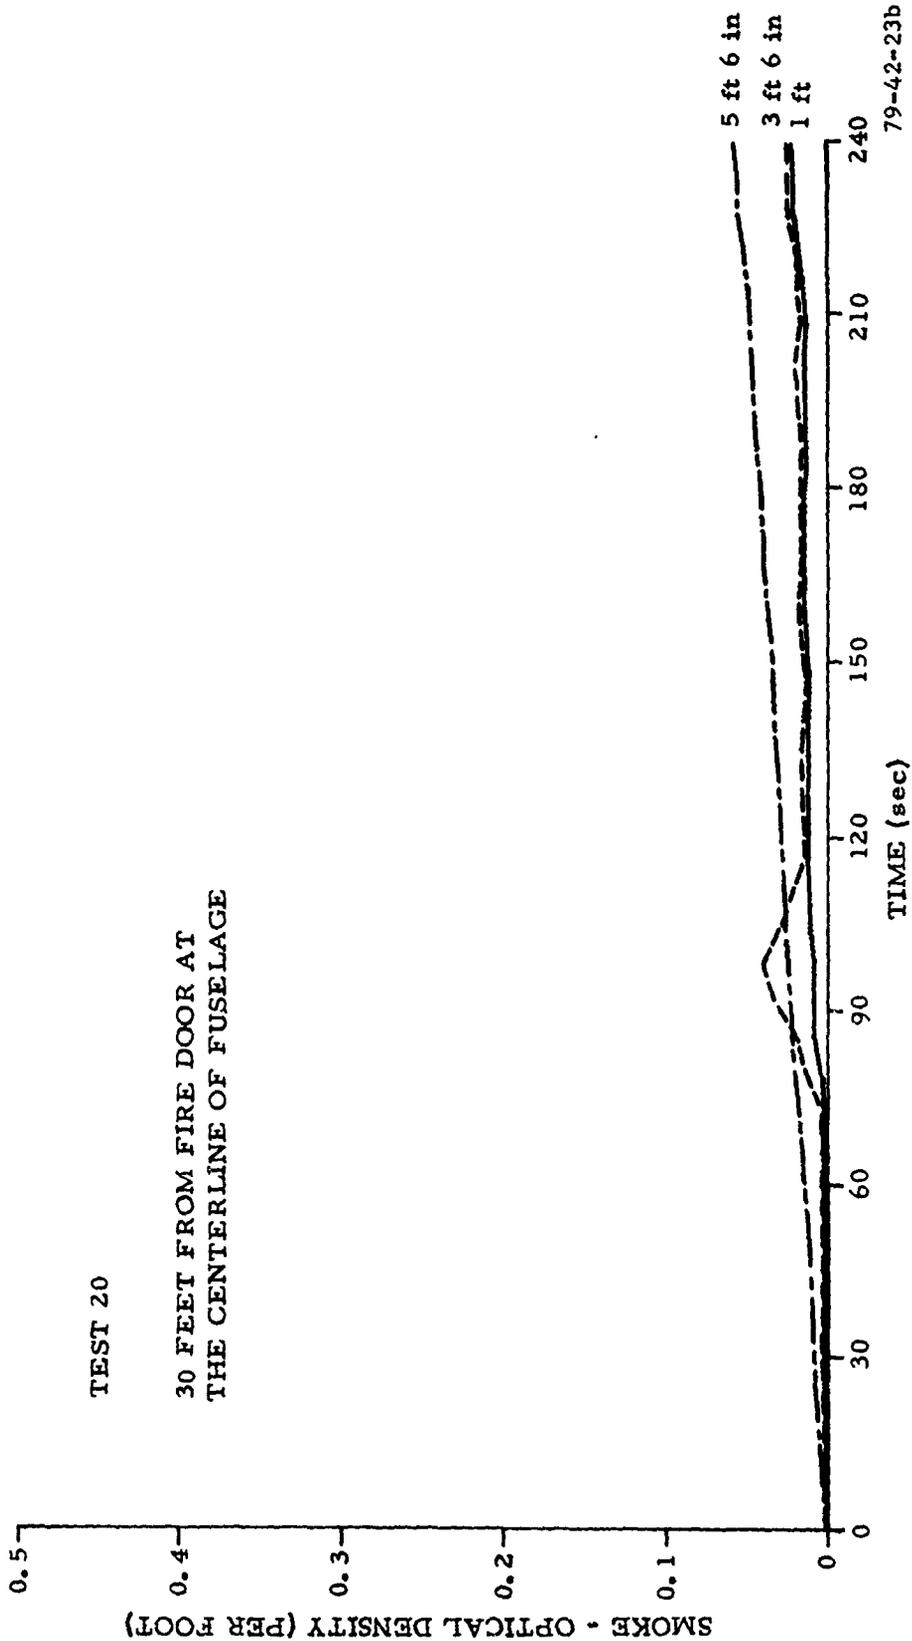
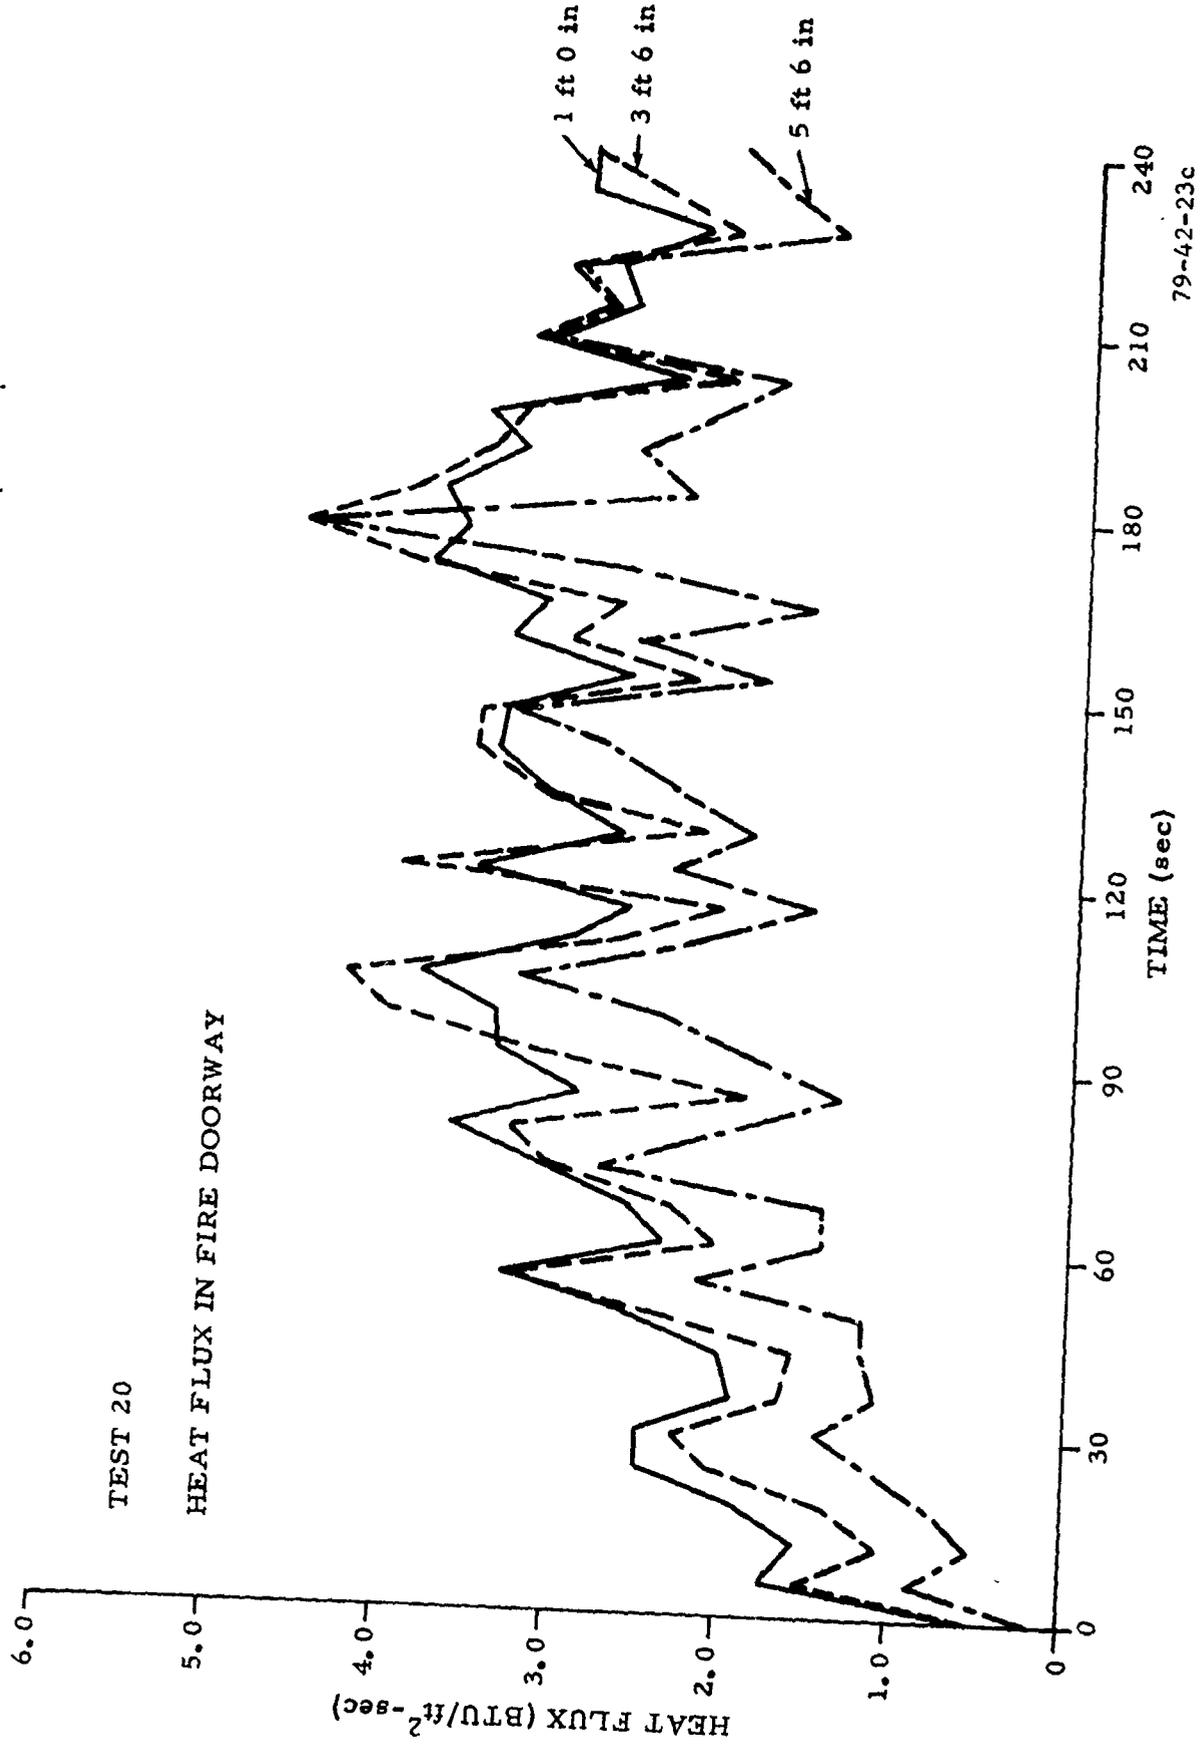
FIGURE 23. CABIN HAZARDS ASSOCIATED WITH CROSS-FUSELAGE WINDS (Sheet 1 of 3)

TEST 20

30 FEET FROM FIRE DOOR AT
THE CENTERLINE OF FUSELAGE

FIGURE 23. CABIN HAZARDS ASSOCIATED WITH CROSS-FUSELAGE WINDS (Sheet 2 of 3)

FIGURE 23. CABIN HAZARDS ASSOCIATED WITH CROSS-FUSELAGE WINDS (Sheet 3 of 3)

TEST 61

The cabin conditions resulting from that accident are similar to those found in the C133 under similar wind conditions (little temperature rise, little smoke, and radiant heat near any opening adjacent to the fire) (figure 23). Less smoke should be expected in the C133 tests, since no materials were present to char. Thus, smoking of some of the materials occurred during the DC10 fire. Zero-wind conditions created the same type of cabin environment as a wind blowing the fire away from the fuselage (figure 24). A wind blowing the flame toward the cabin can very quickly create a serious hazard in the cabin.
