POSTCRASH FUEL FIRE HAZARD MEASUREMENTS IN A WIDE-BODY AIRCRAFT CABIN

FINAL REPORT

1. Report No. 144 FAA-NA-79-42		2. Government Accession No.		3. Recipient's Catalog No.	
4. Title and Subtitle 6 POSTCRASH FUEL FIRE HAZARD MEASUREMENTS IN A WIDE-BODY AIRCRAFT CABIN				5. Report Date 11 Dec 79

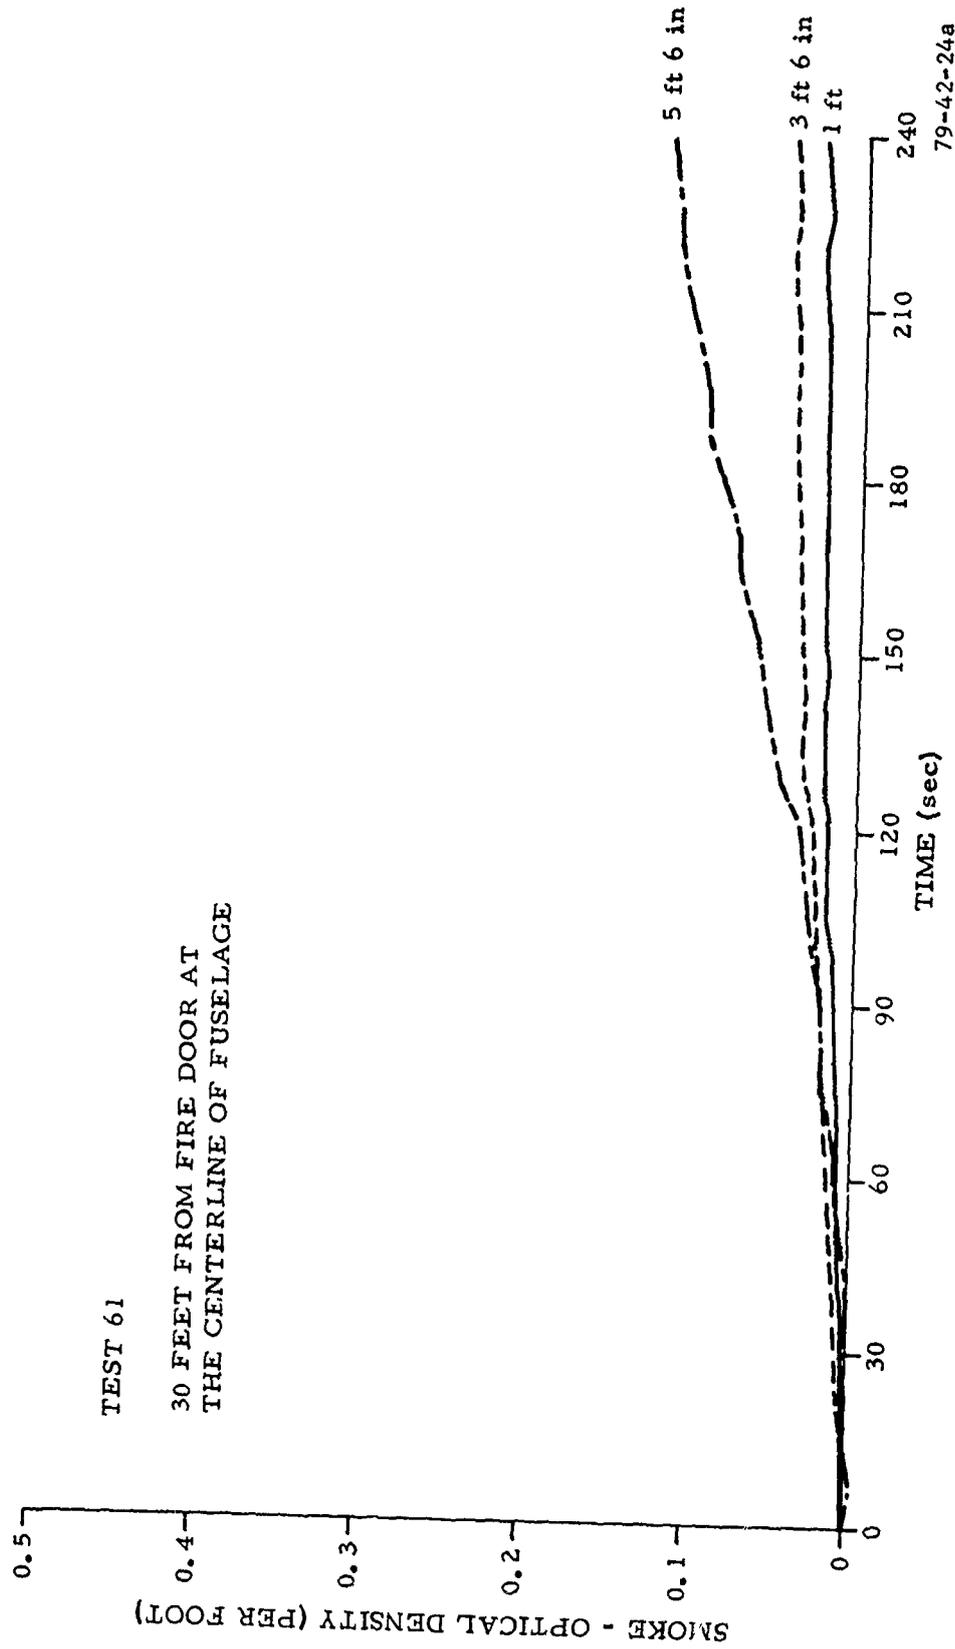
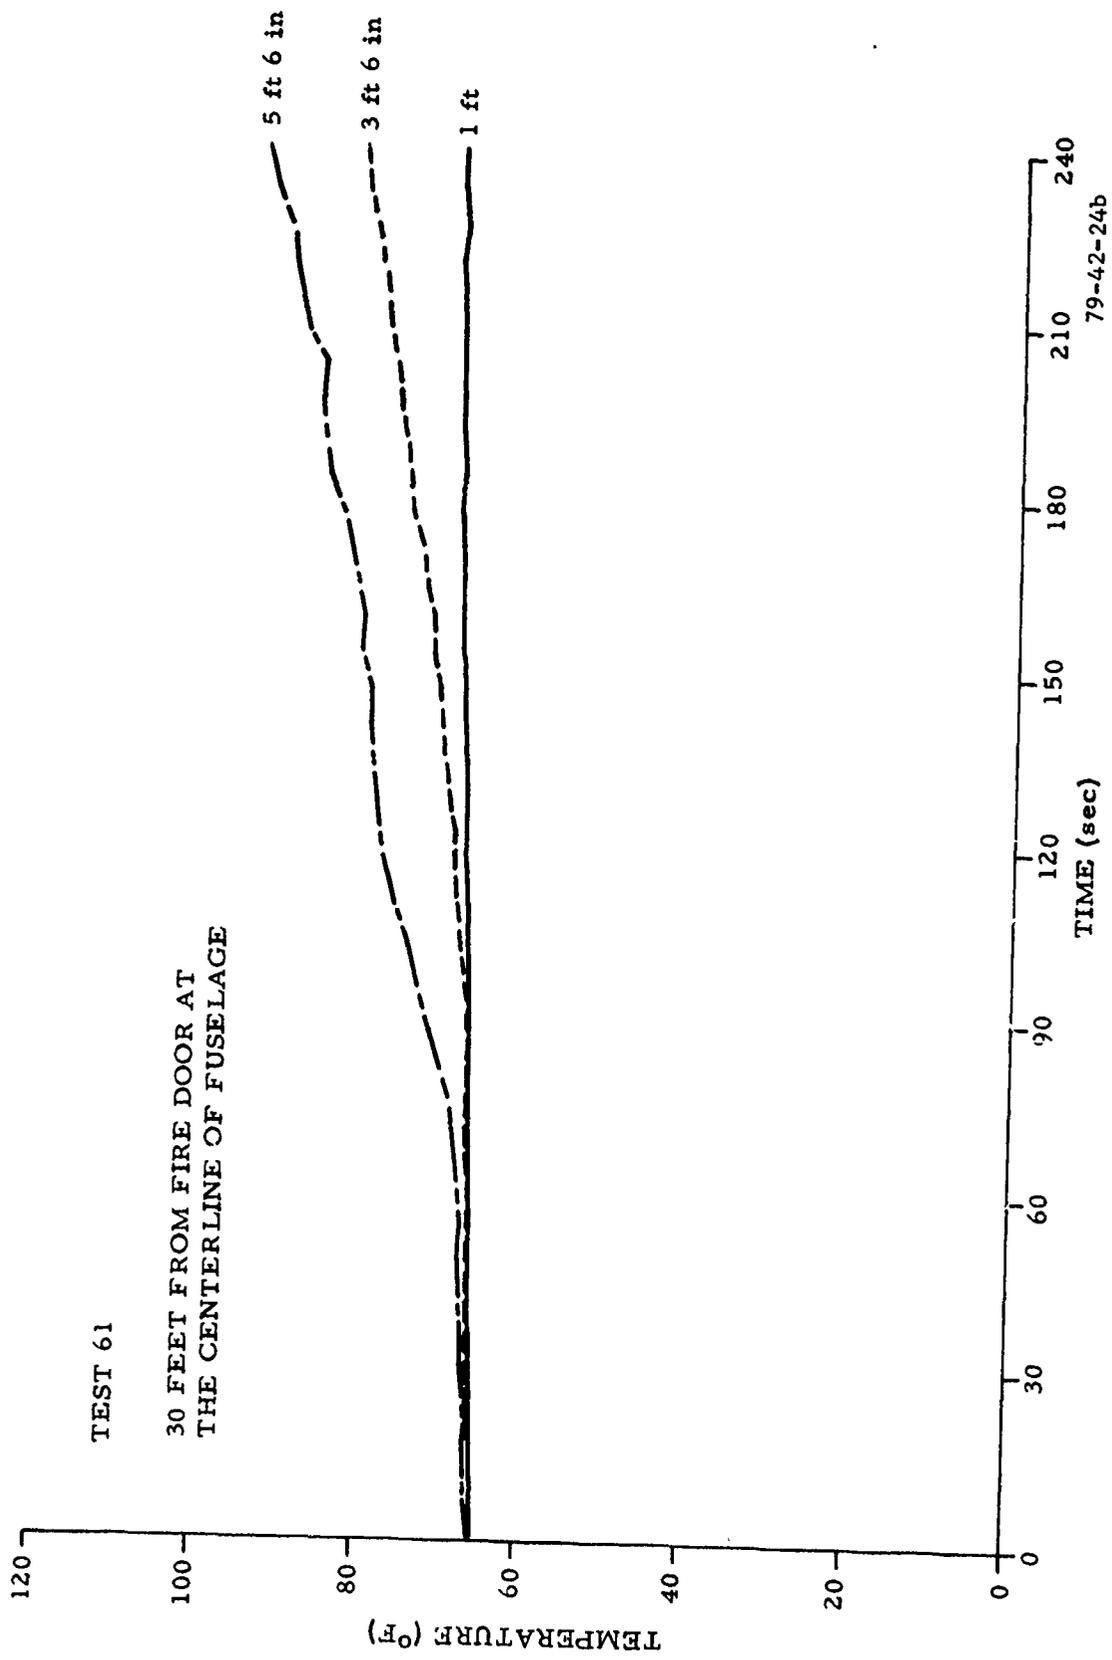
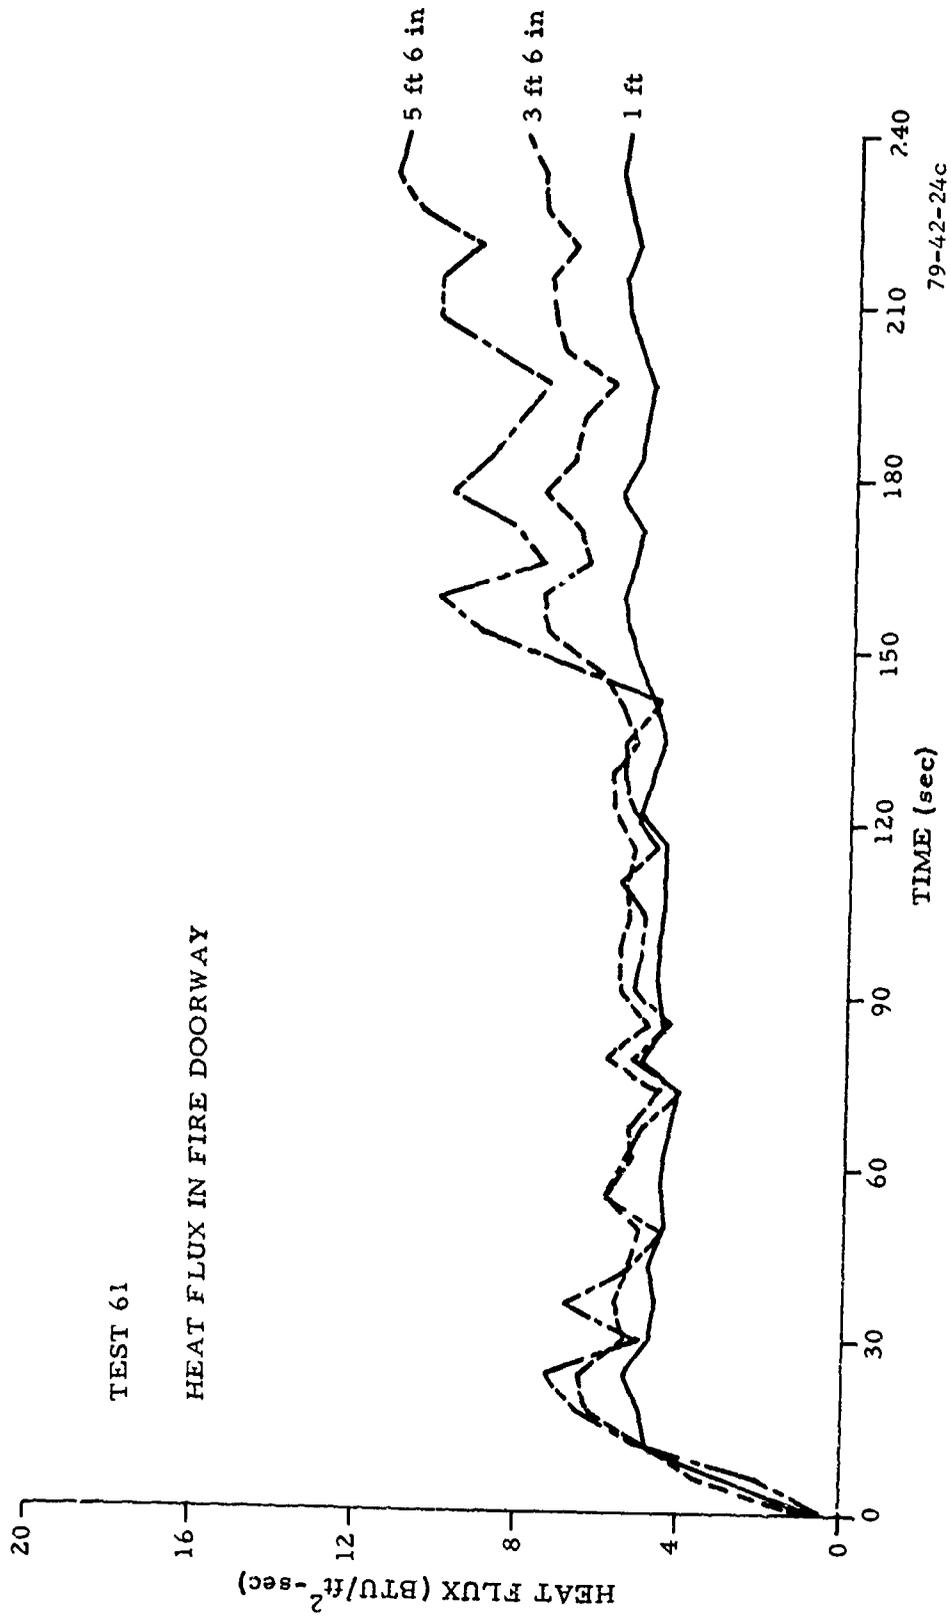
FIGURE 24. CABIN HAZARDS ASSOCIATED WITH ZERO WINDS (Sheet 1 of 3)

FIGURE 24. CABIN HAZARDS ASSOCIATED WITH ZERO WINDS (Sheet 2 of 3)

FIGURE 24. CABIN HAZARDS ASSOCIATED WITH ZERO WINDS (Sheet 3 of 3)

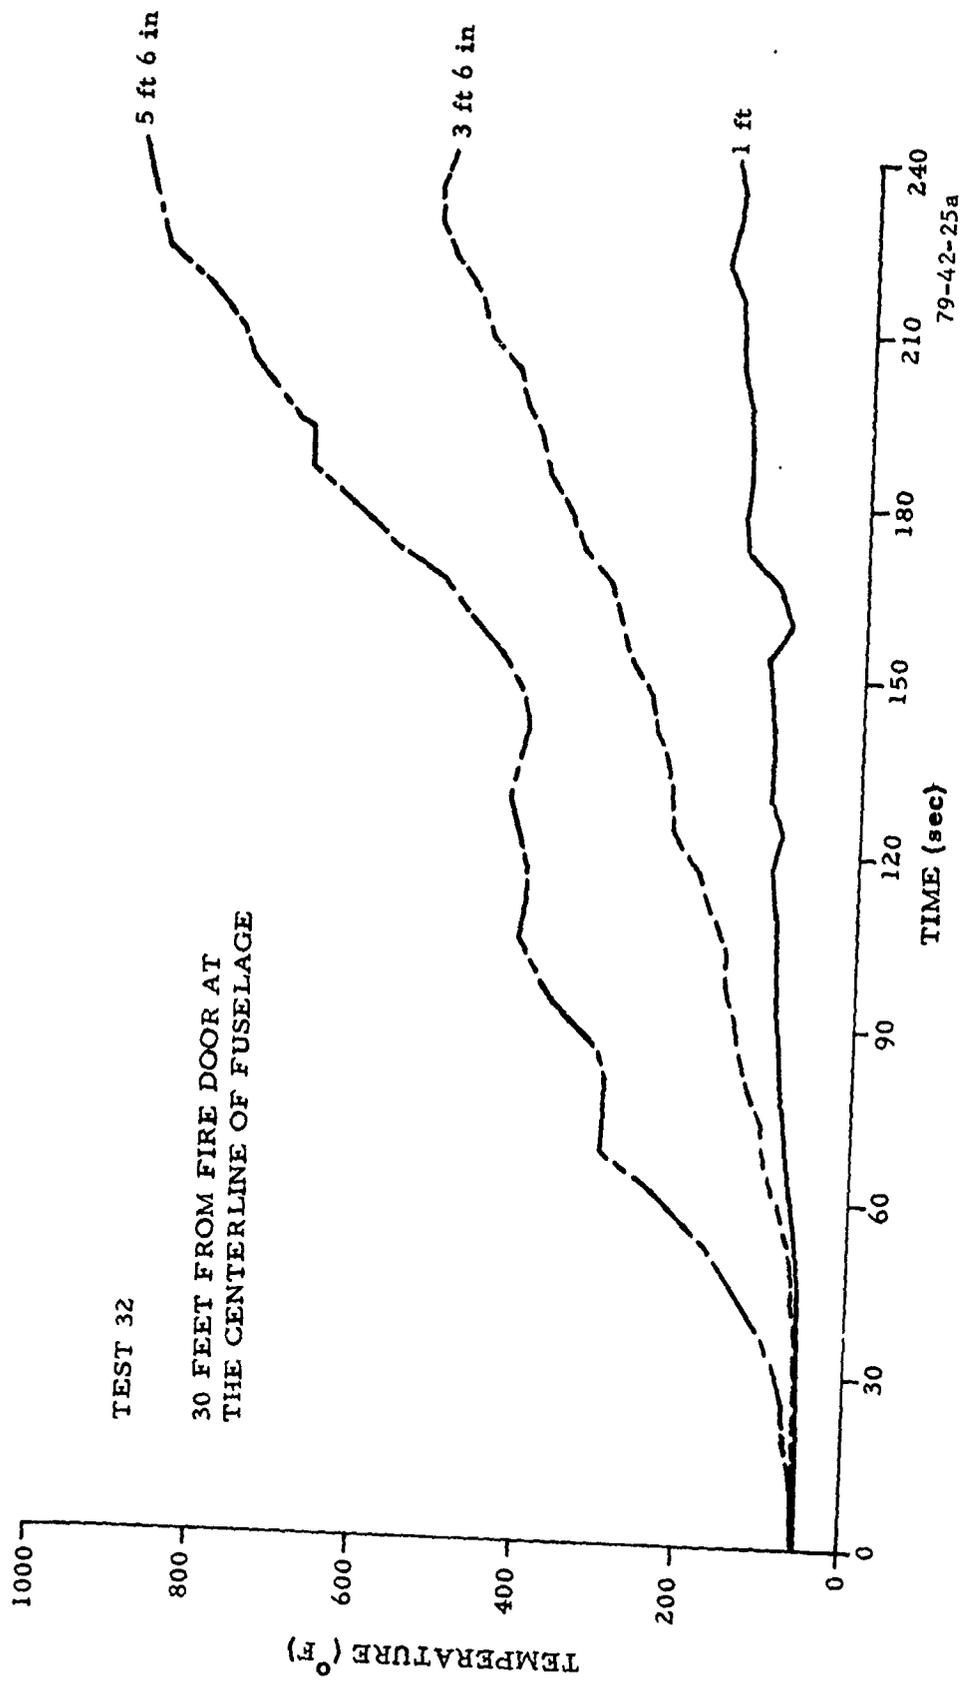
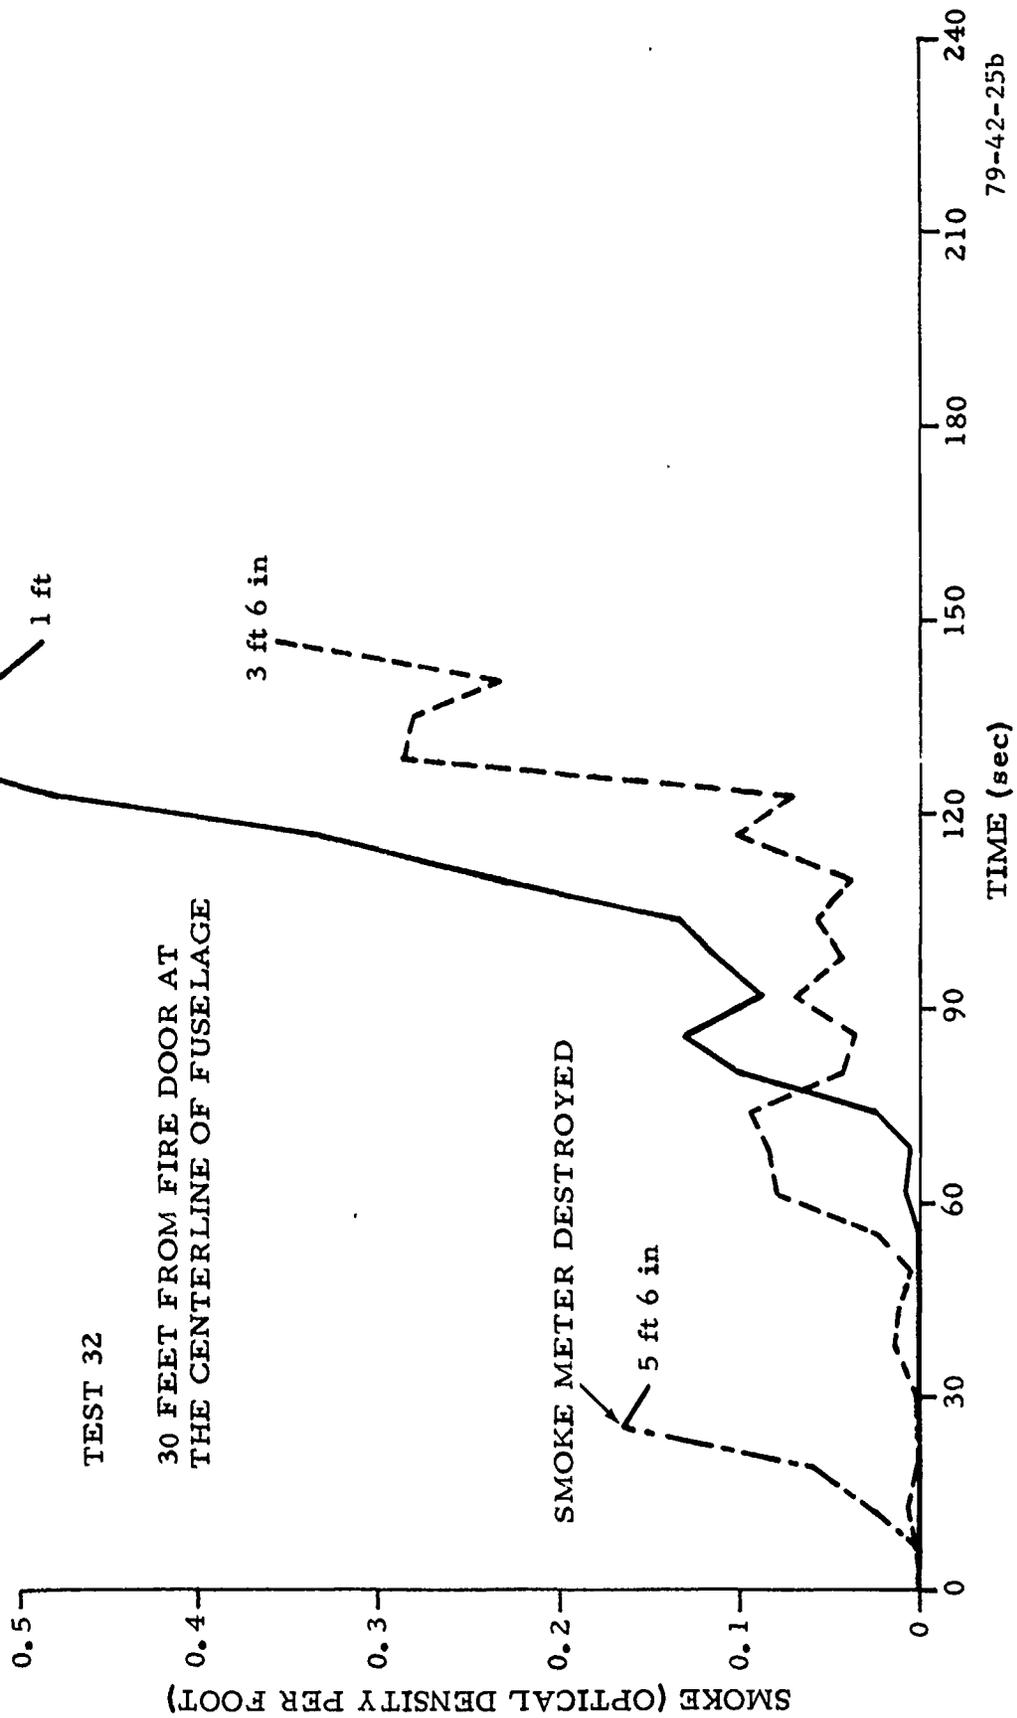
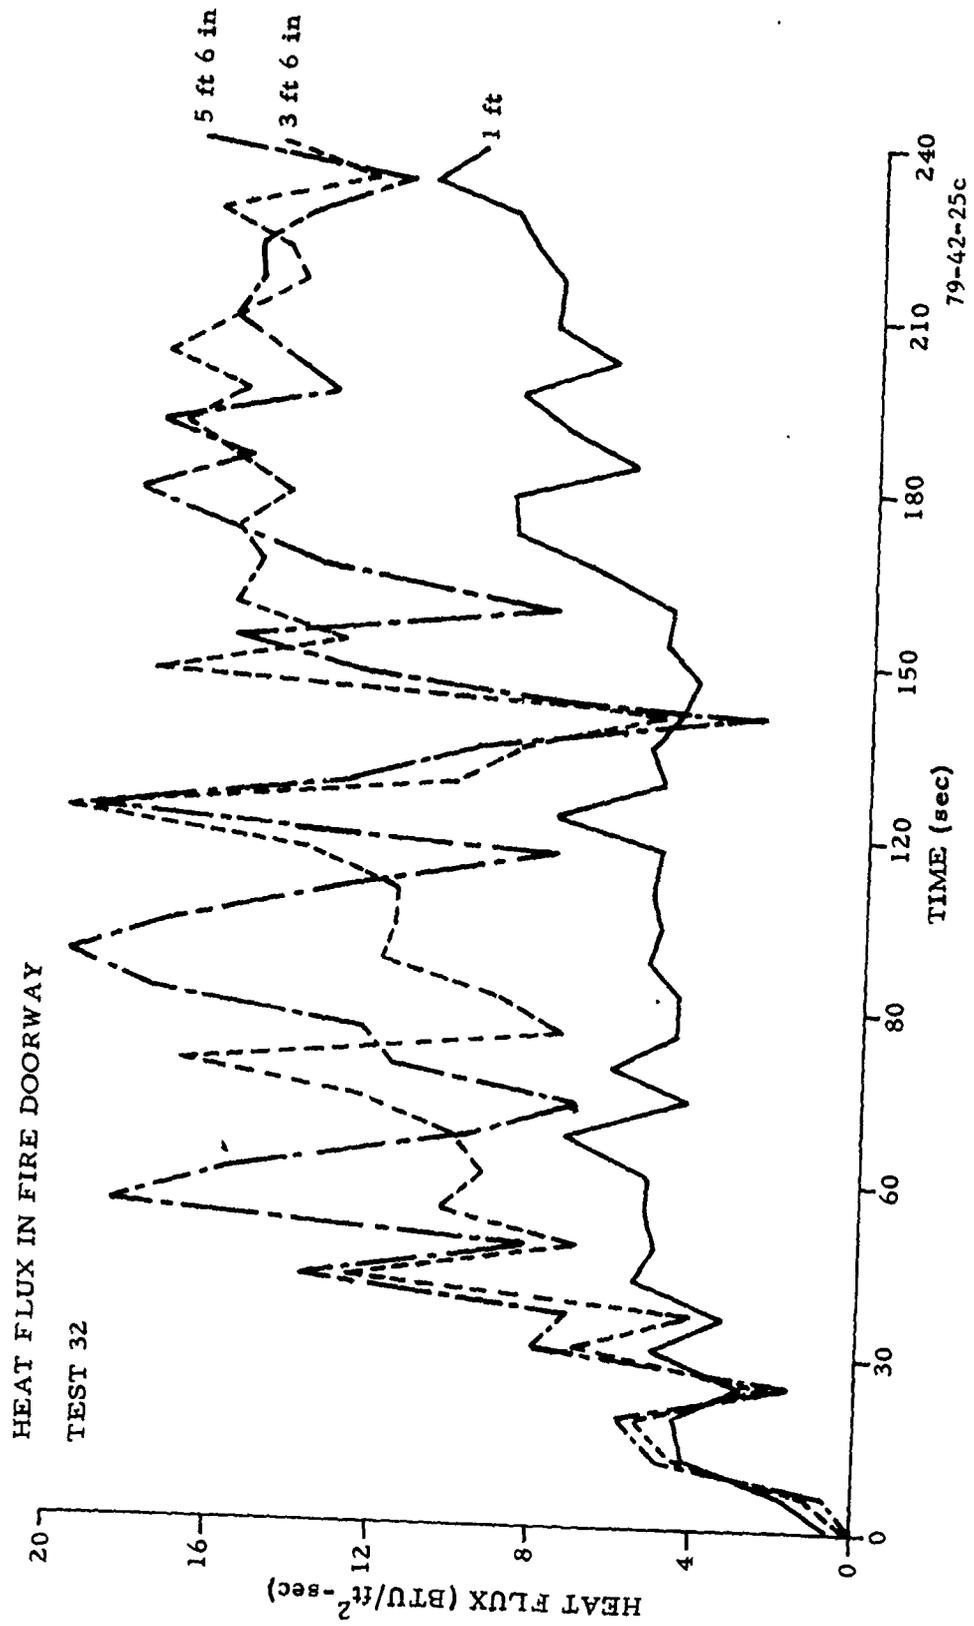
FIGURE 25. CABIN HAZARDS ASSOCIATED WITH WINDS INTO FUSELAGE OPENING (Sheet 1 of 3)

FIGURE 25. CABIN HAZARDS ASSOCIATED WITH WINDS INTO FUSELAGE OPENING (Sheet 2 of 3)

FIGURE 25. CABIN HAZARDS ASSOCIATED WITH WINDS INTO FUSELAGE OPENING (Sheet 3 of 3)

Figure 25 represents the temperature, smoke, and heat flux from the worst test conducted, test number 32. During this test, the windspeed was 5.5 miles per hour (mph) out of the southwest with a corrected windspeed of 4.07 mph. The fuel pan size was 4 by 6 feet. Since the fire scenario and fuselage configuration of these tests represent one of an infinite number of possibilities, the quantitative measurements mean only that they are obtainable levels dictated by the ambient wind and cabin draft conditions. An important study in these tests was that of the flow of hazards through the cabin, namely: heat, smoke, and gases.

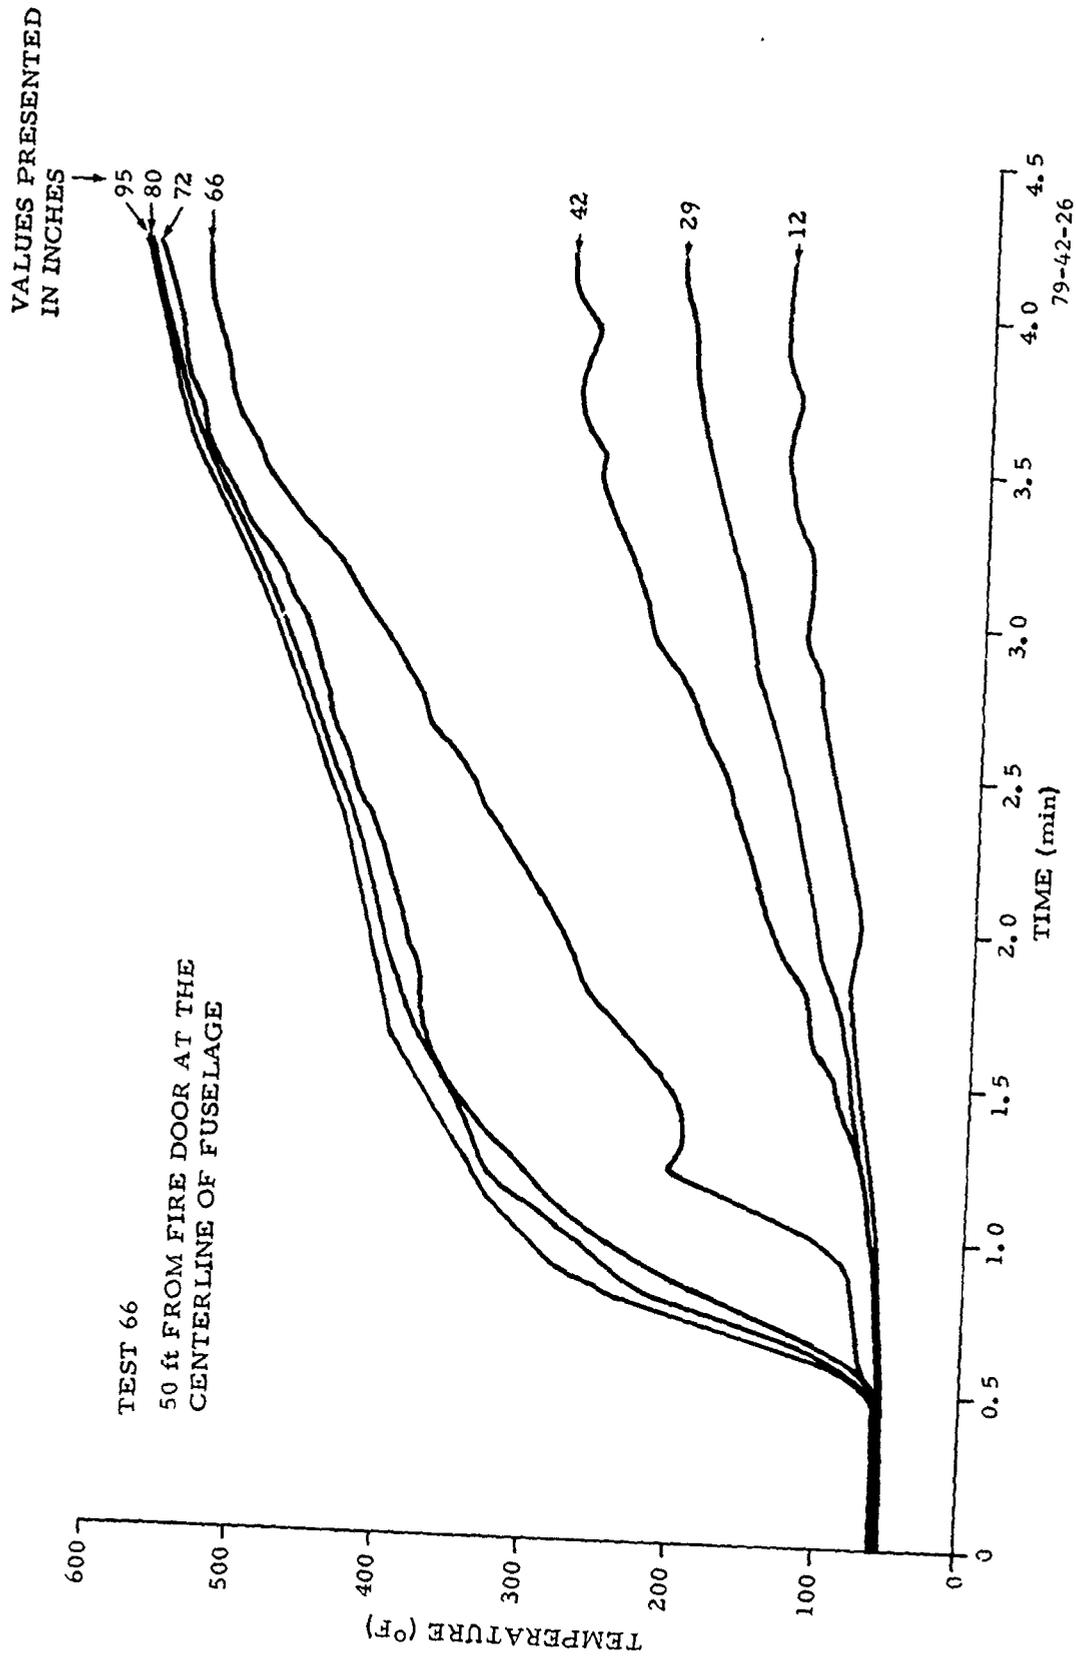
FIGURE 26. CABIN HEAT STRATIFICATION

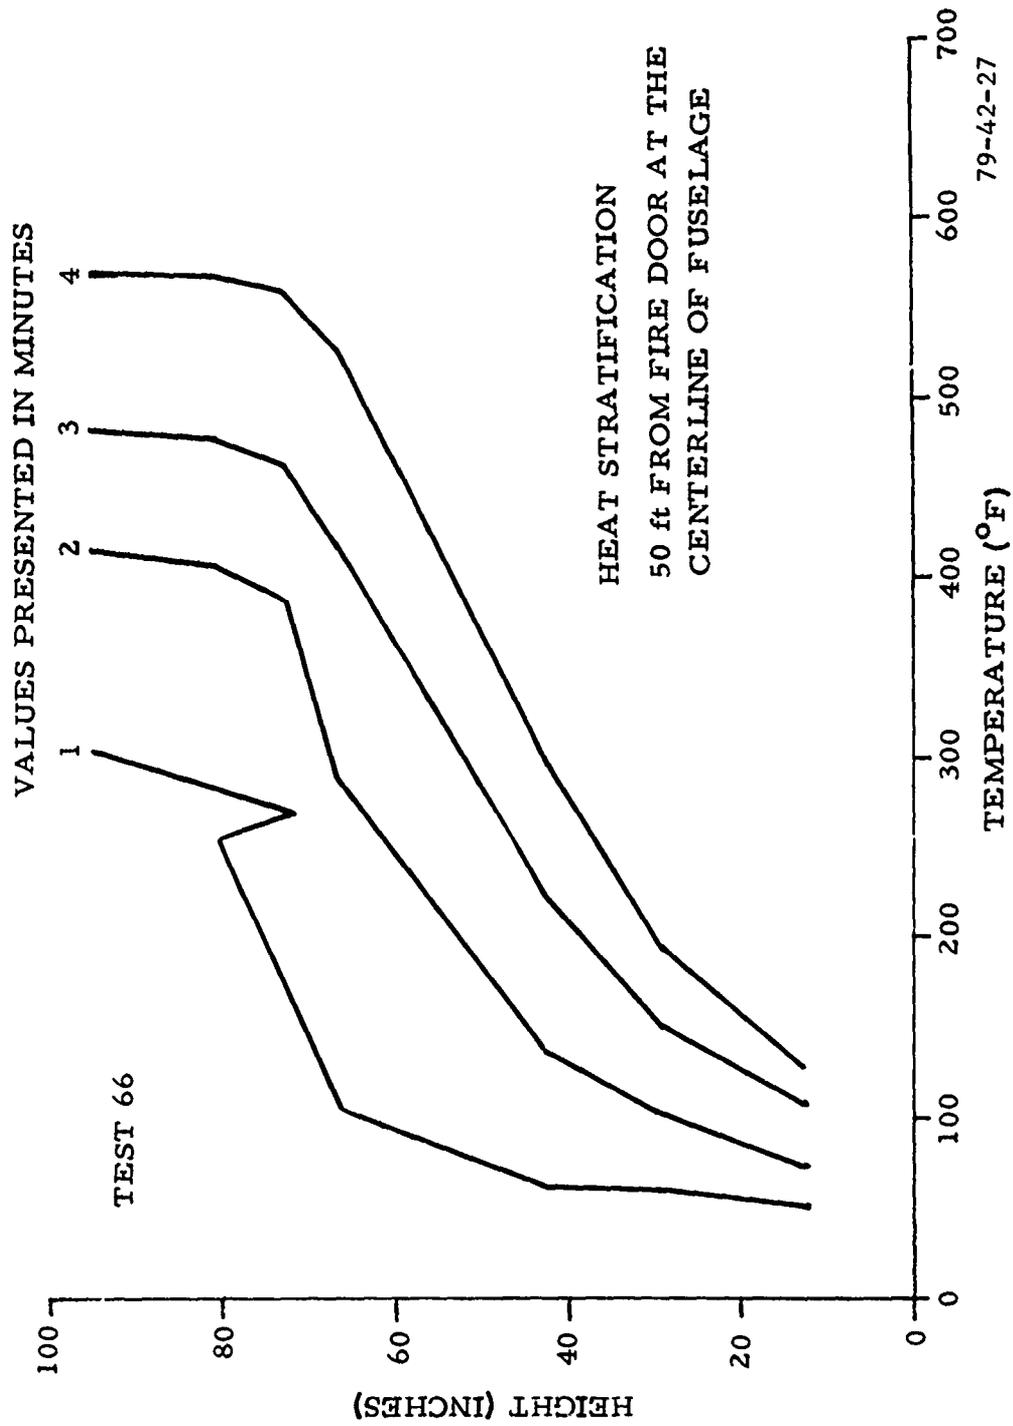
FIGURE 27. CABIN HEAT STRATIFICATION (REPLLOT)

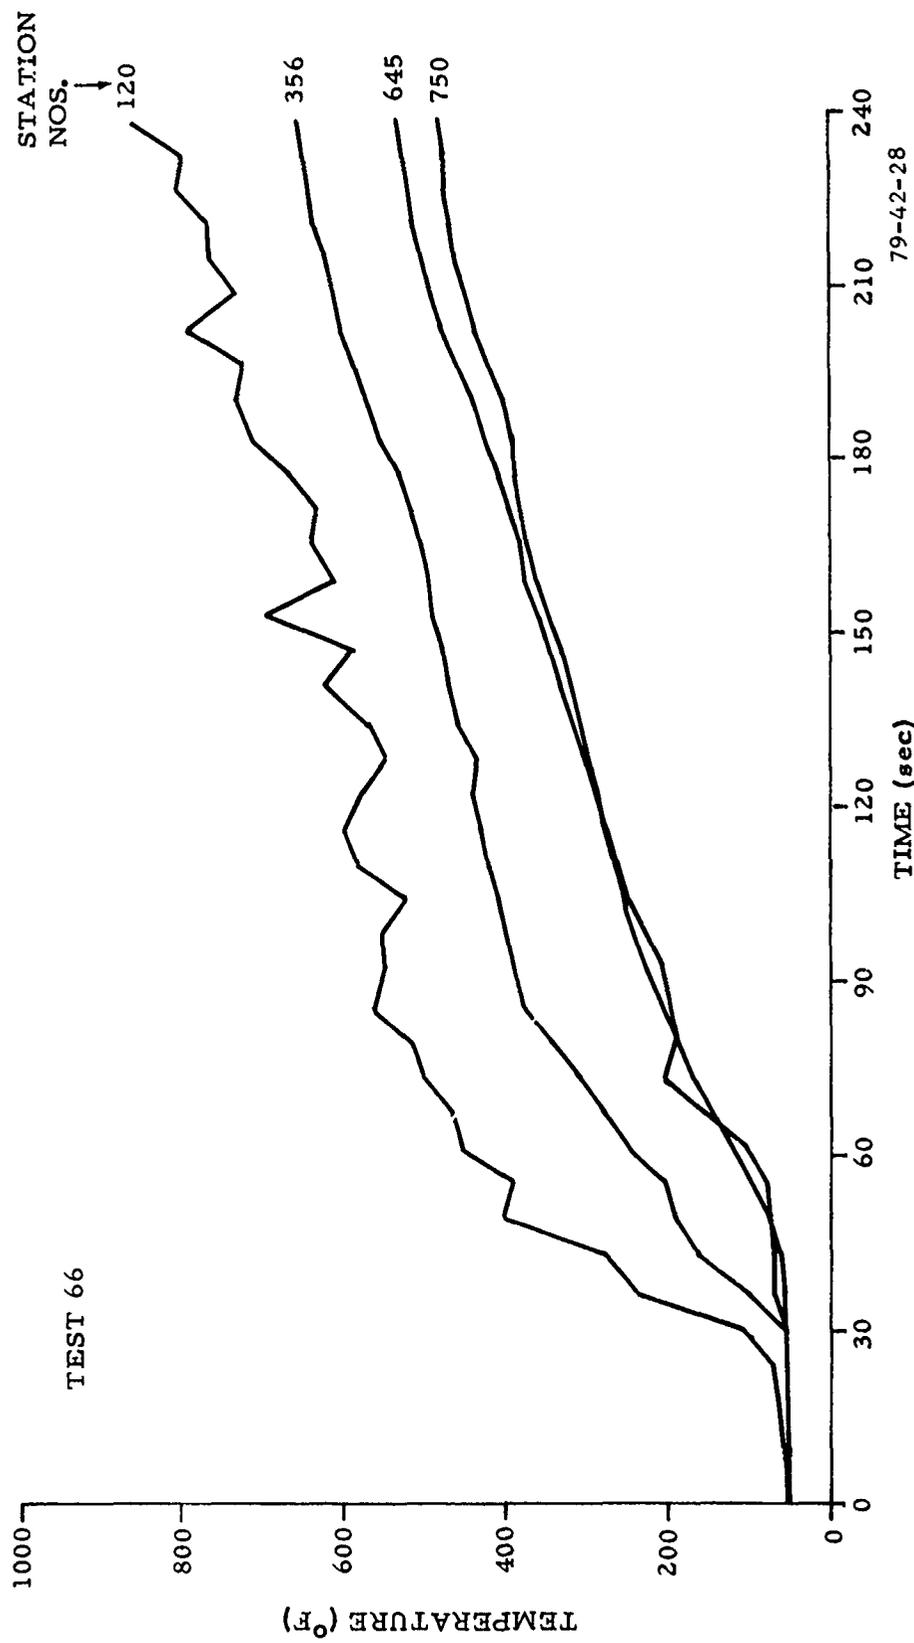
FIGURE 28. TEMPERATURES AT VARIOUS FUSELAGE STATIONS

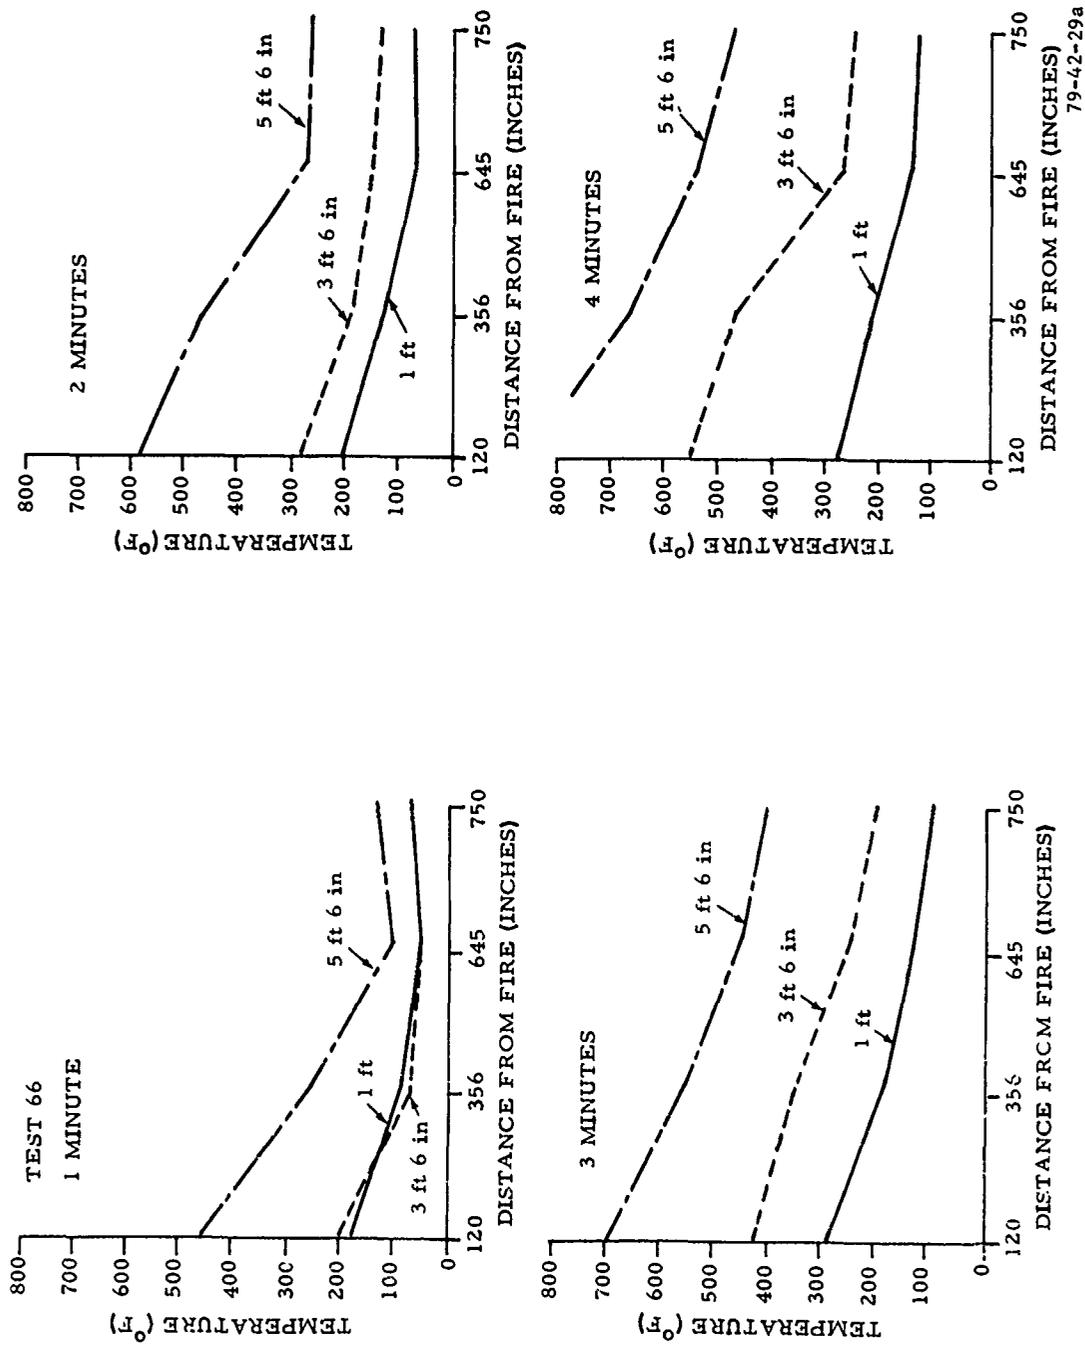
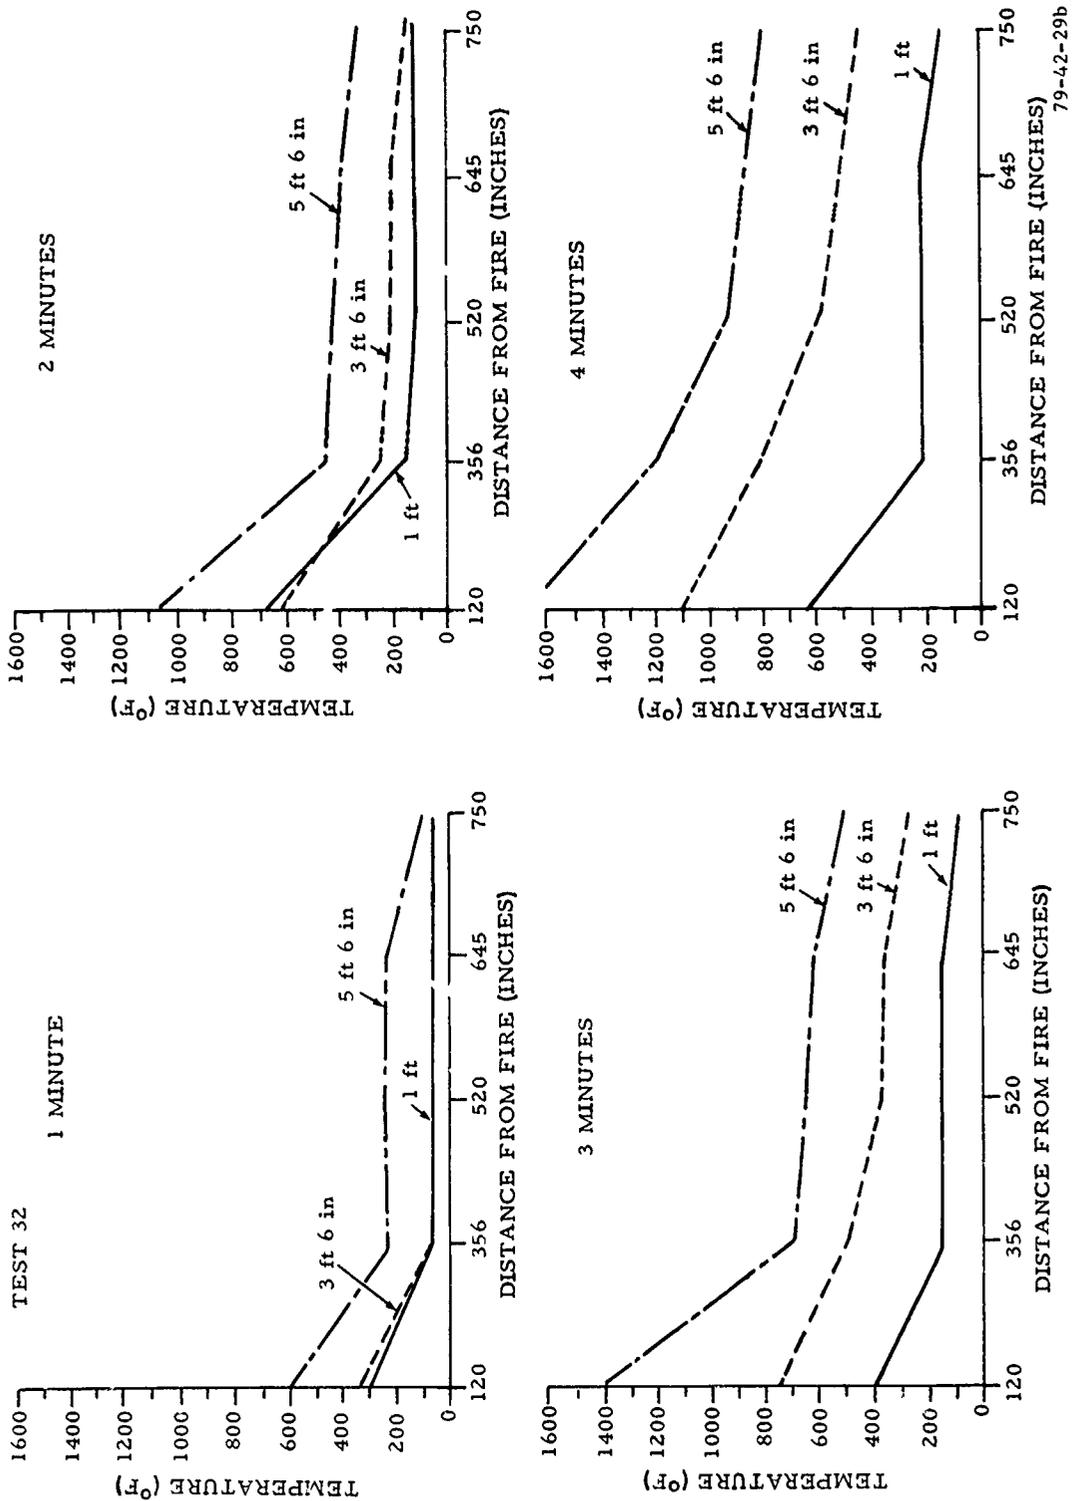
79-42-29a

FIGURE 29. CABIN TEMPERATURE PROFILES (Sheet 1 of 2)

FIGURE 29. CABIN TEMPERATURE PROFILES (Sheet 2 of 2)

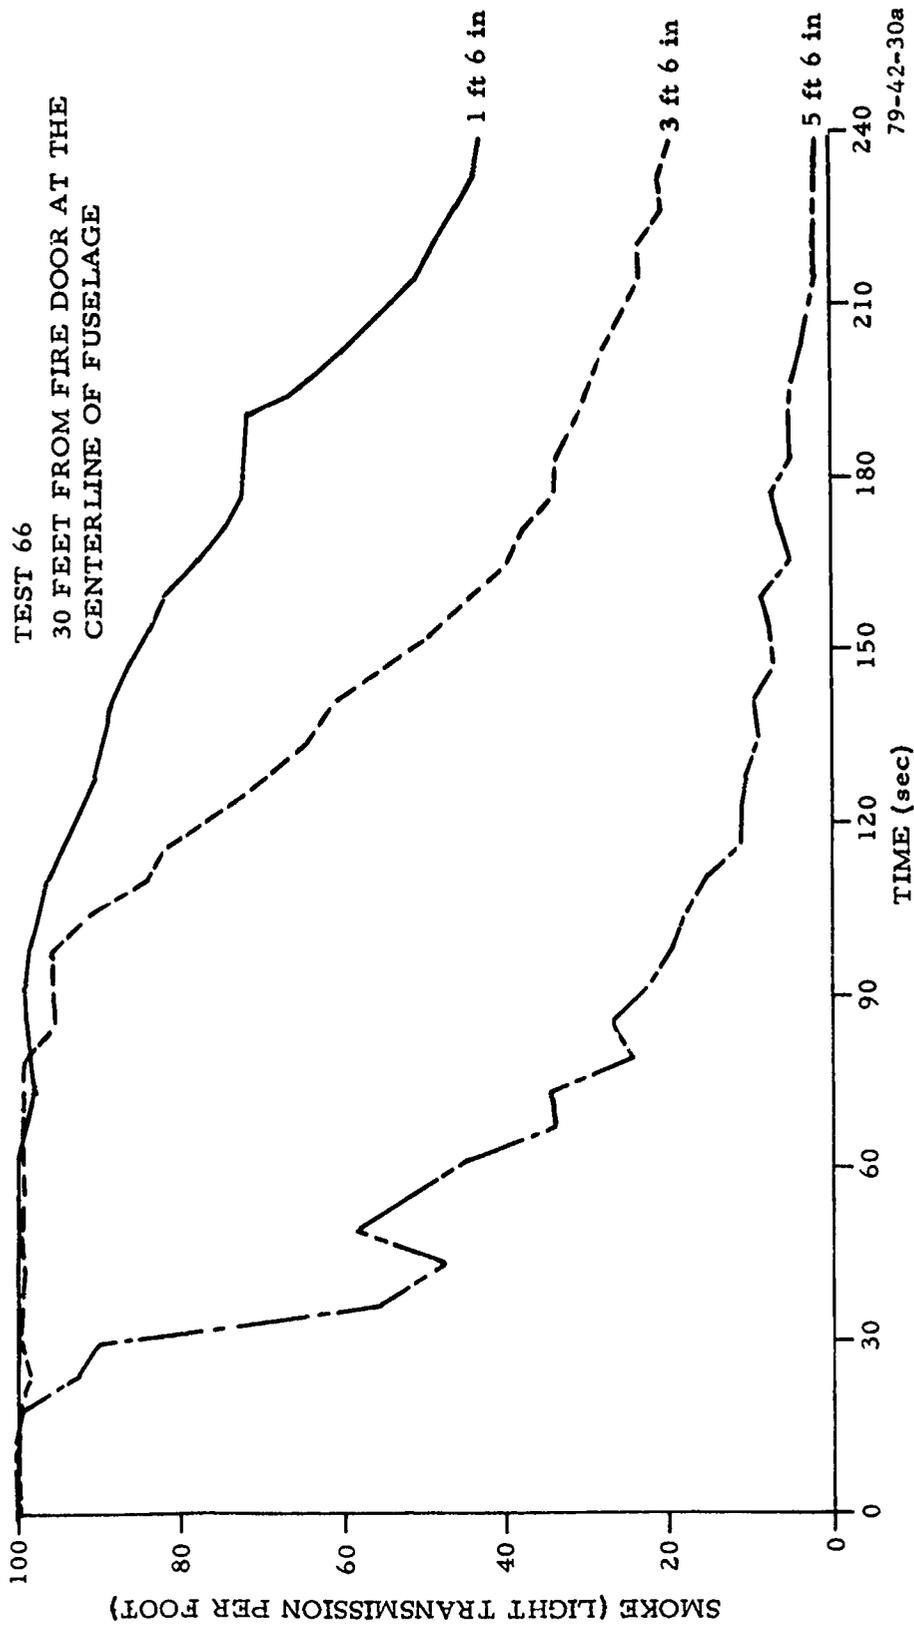
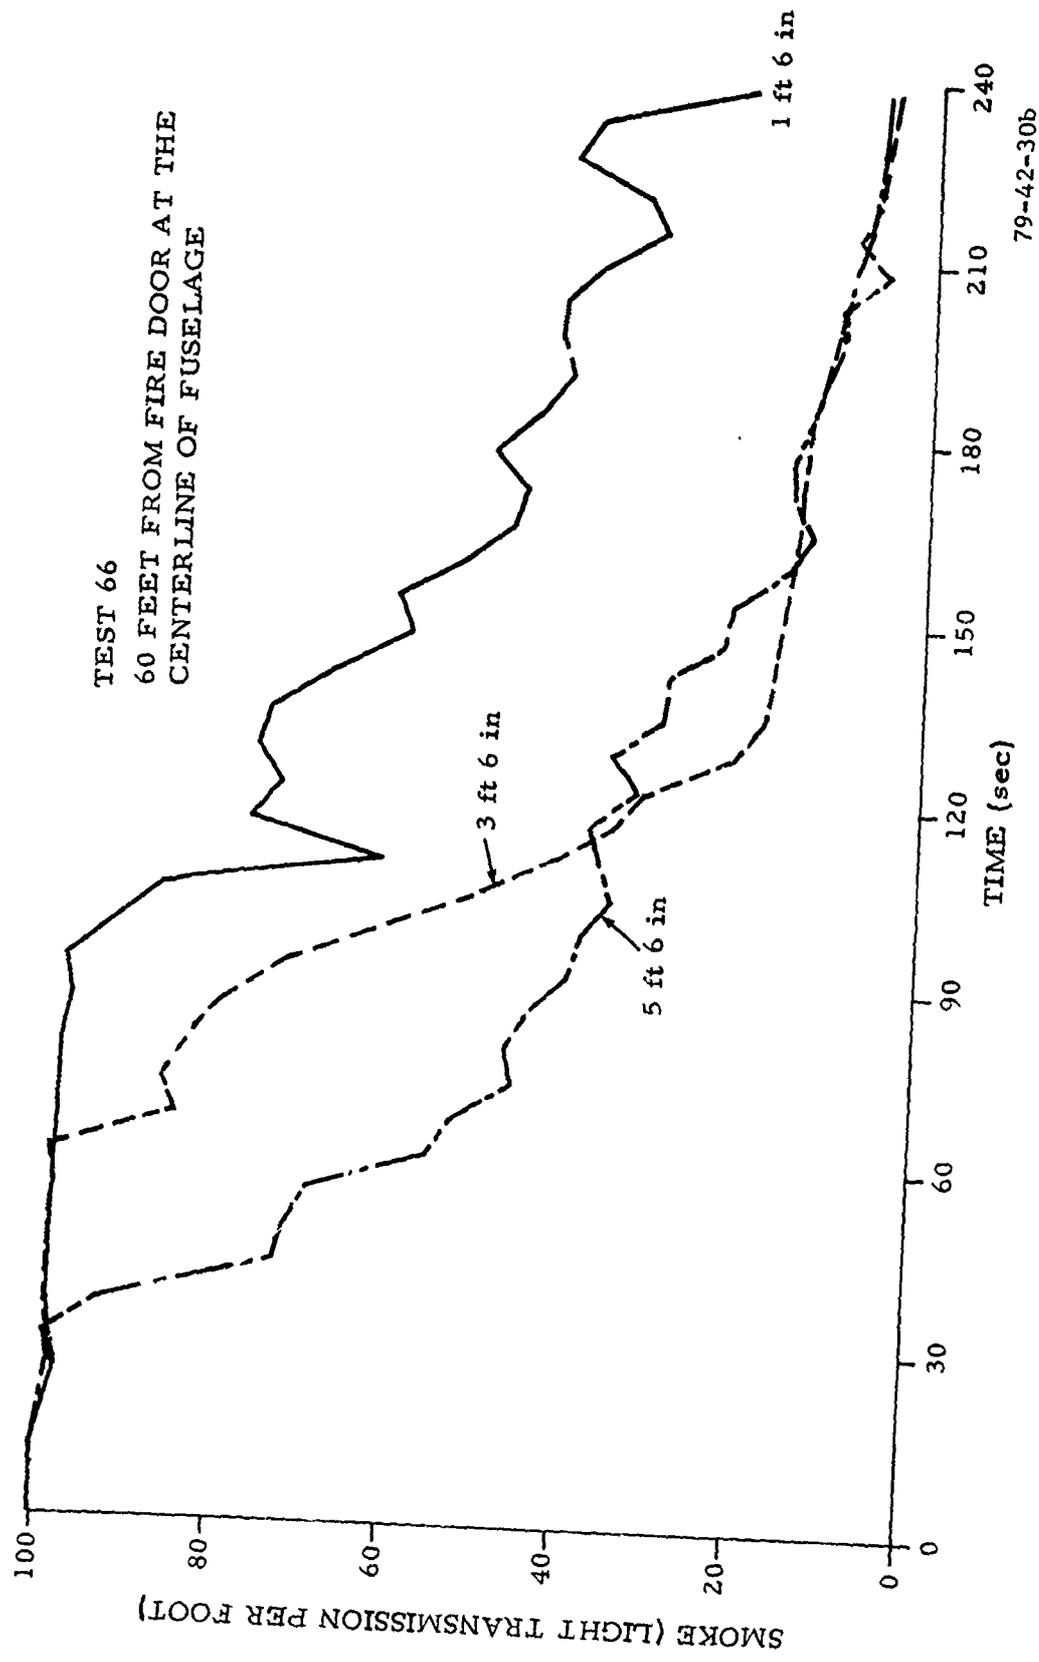
FIGURE 30. SMOKE STRATIFICATION (PERCENT LIGHT REDUCTION) (Sheet 1 of 2)

FIGURE 30. SMOKE STRATIFICATION (PERCENT LIGHT REDUCTION) (Sheet 2 of 2)
