POSTCRASH FUEL FIRE HAZARD MEASUREMENTS IN A WIDE-BODY AIRCRAFT CABIN

FINAL REPORT

1. Report No. 144 FAA-NA-79-42		2. Government Accession No.		3. Recipient's Catalog No.	
4. Title and Subtitle 6 POSTCRASH FUEL FIRE HAZARD MEASUREMENTS IN A WIDE-BODY AIRCRAFT CABIN				5. Report Date 11 Dec 79

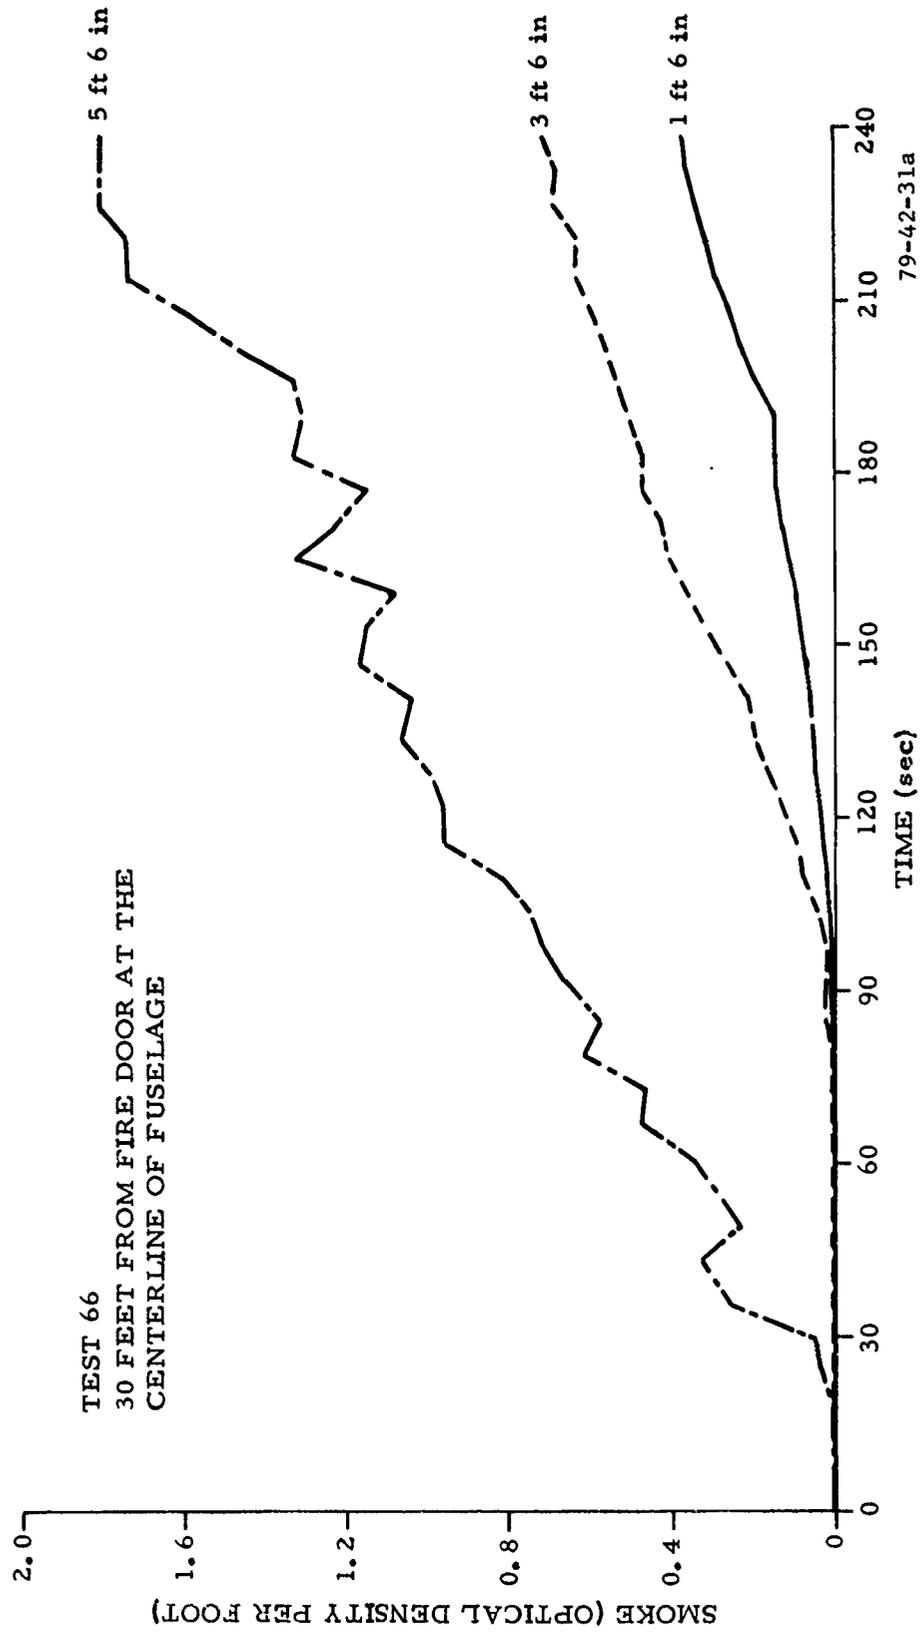
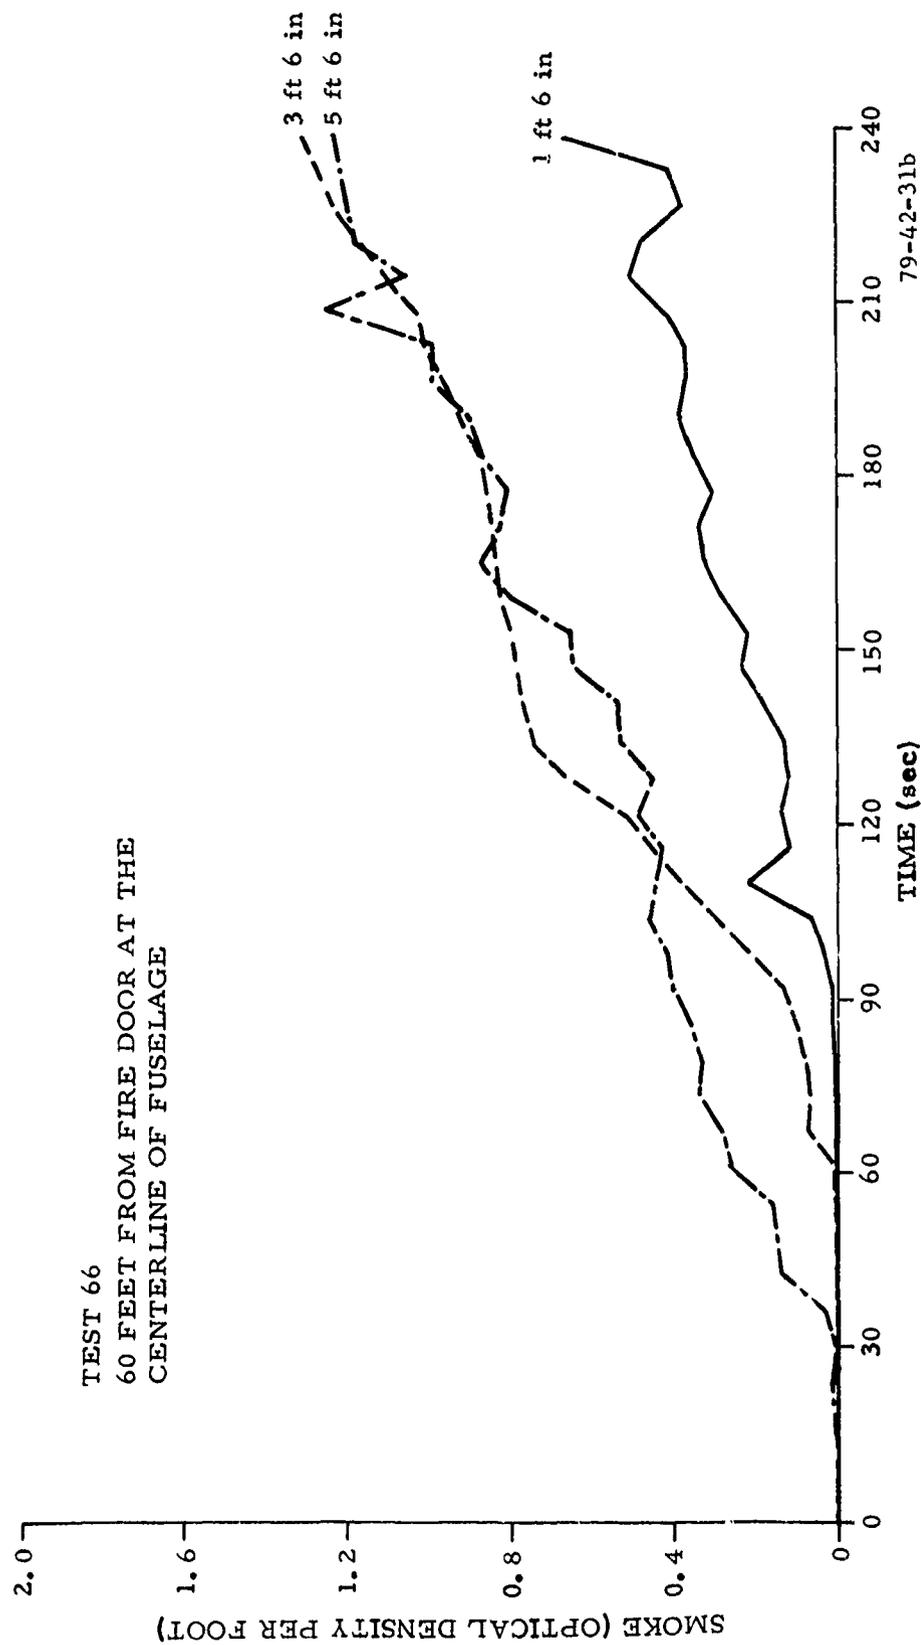
FIGURE 31. SMOKE STRATIFICATION (OPTICAL DENSITY) (Sheet 1 of 2)

FIGURE 31. SMOKE STRATIFICATION (OPTICAL DENSITY) (Sheet 2 of 2)

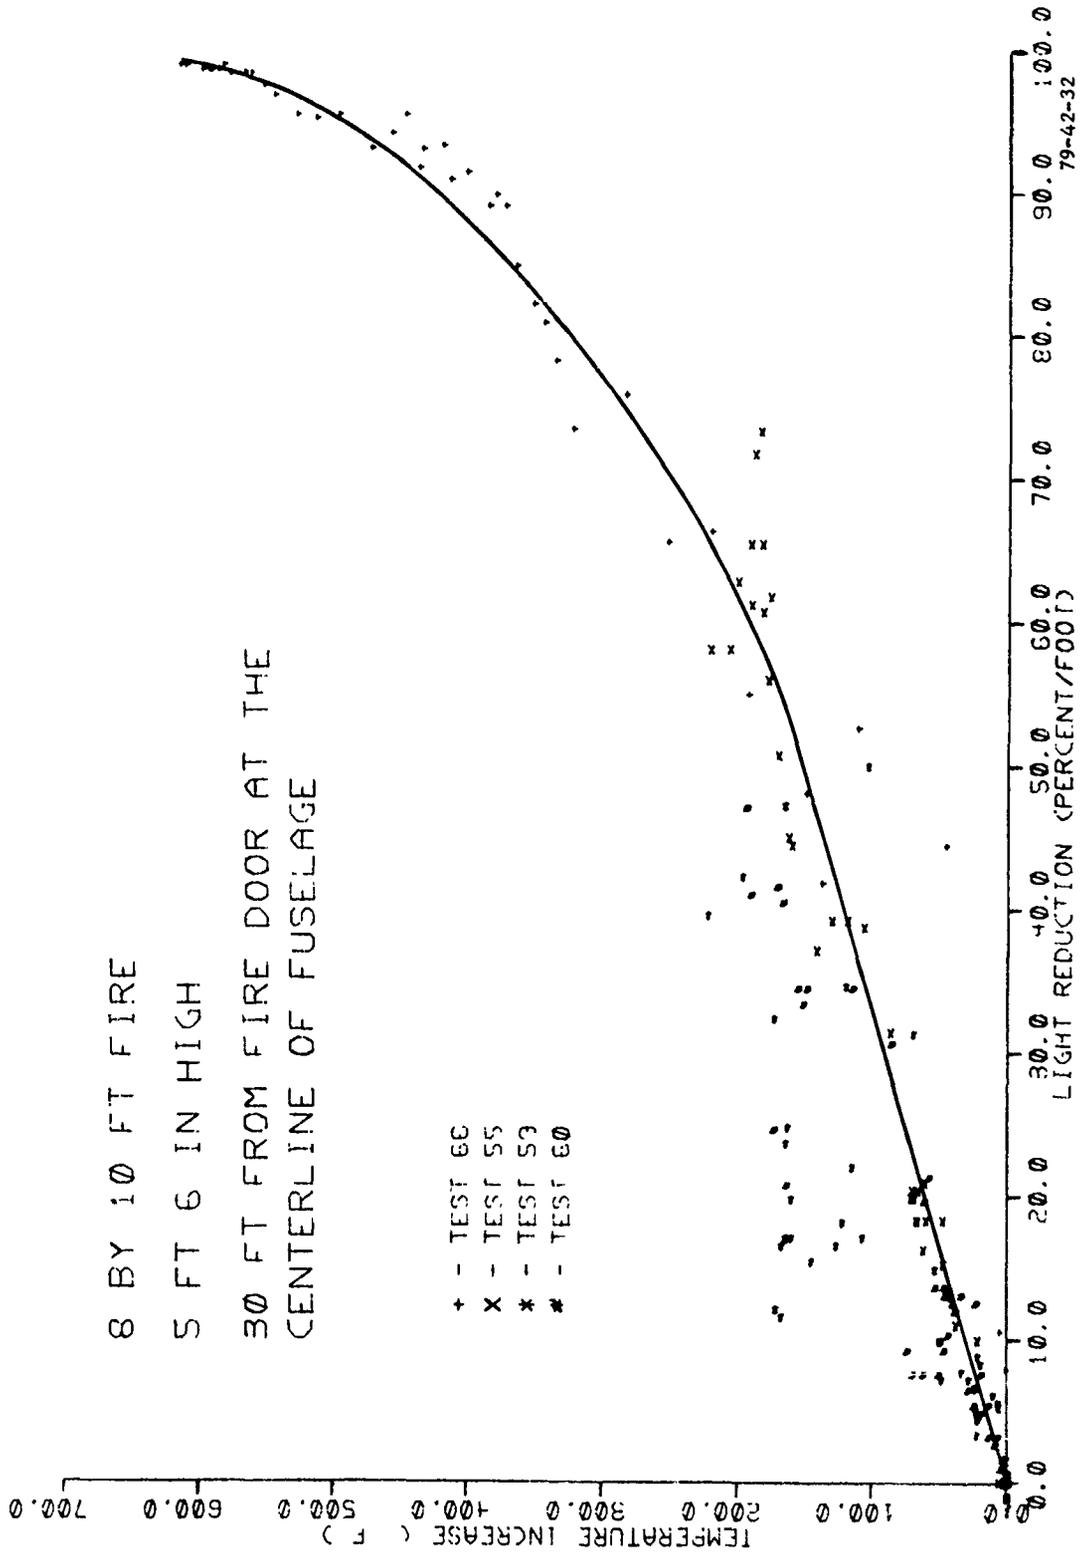
FIGURE 32. RELATION OF SMOKE-TO-TEMPERATURE INCREASE

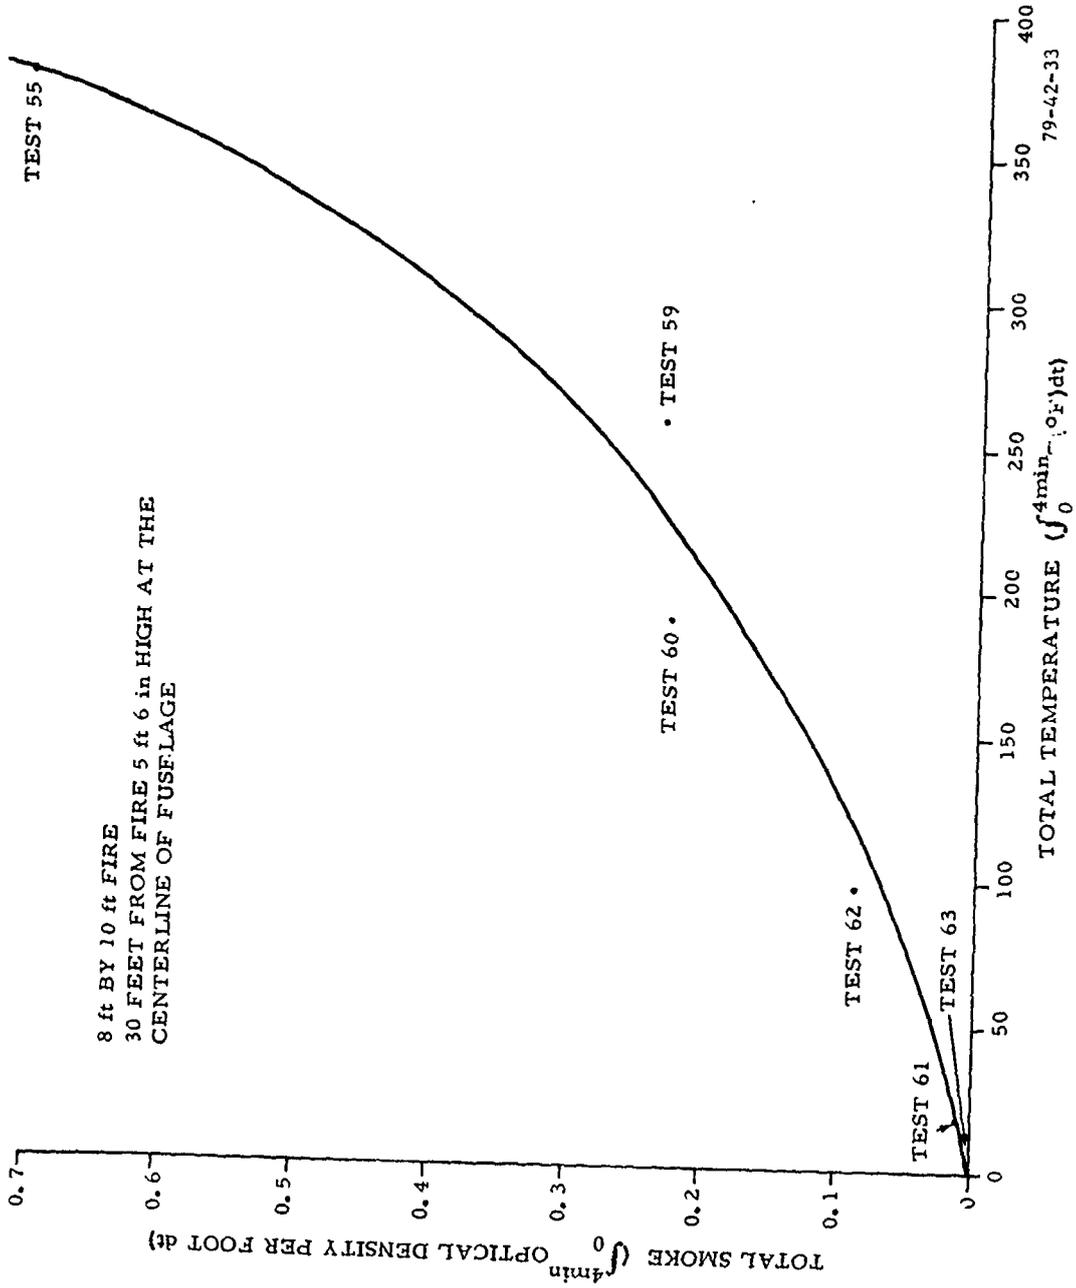
FIGURE 33. TOTAL HEAT VERSUS TOTAL SMOKE FOR 8- BY 10-FOOT FIRE

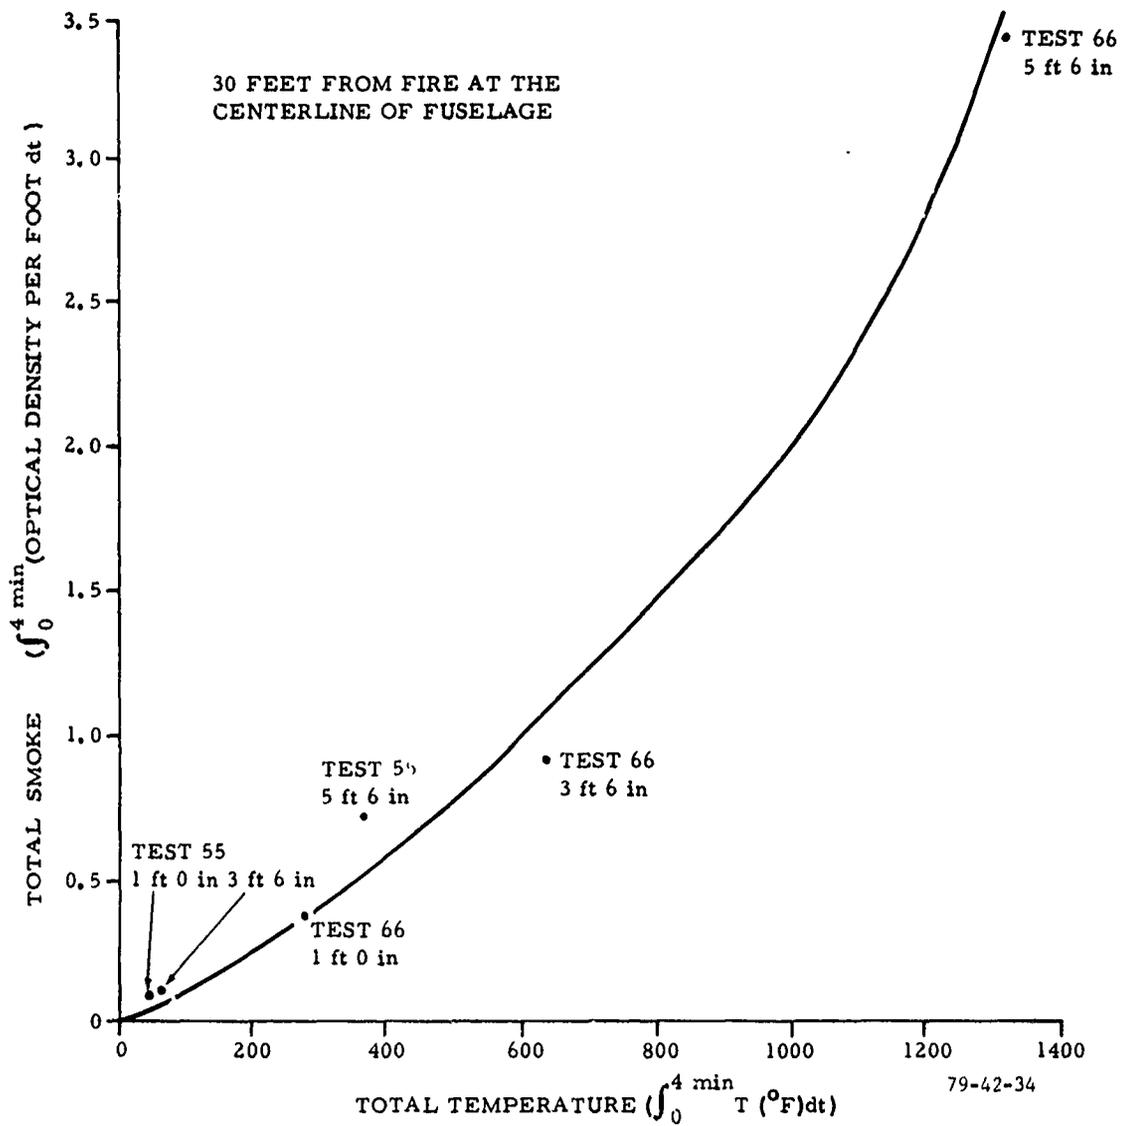
FIGURE 34. TOTAL SMOKE VERSUS TOTAL HEAT FOR VARIOUS FUSELAGE HEIGHTS

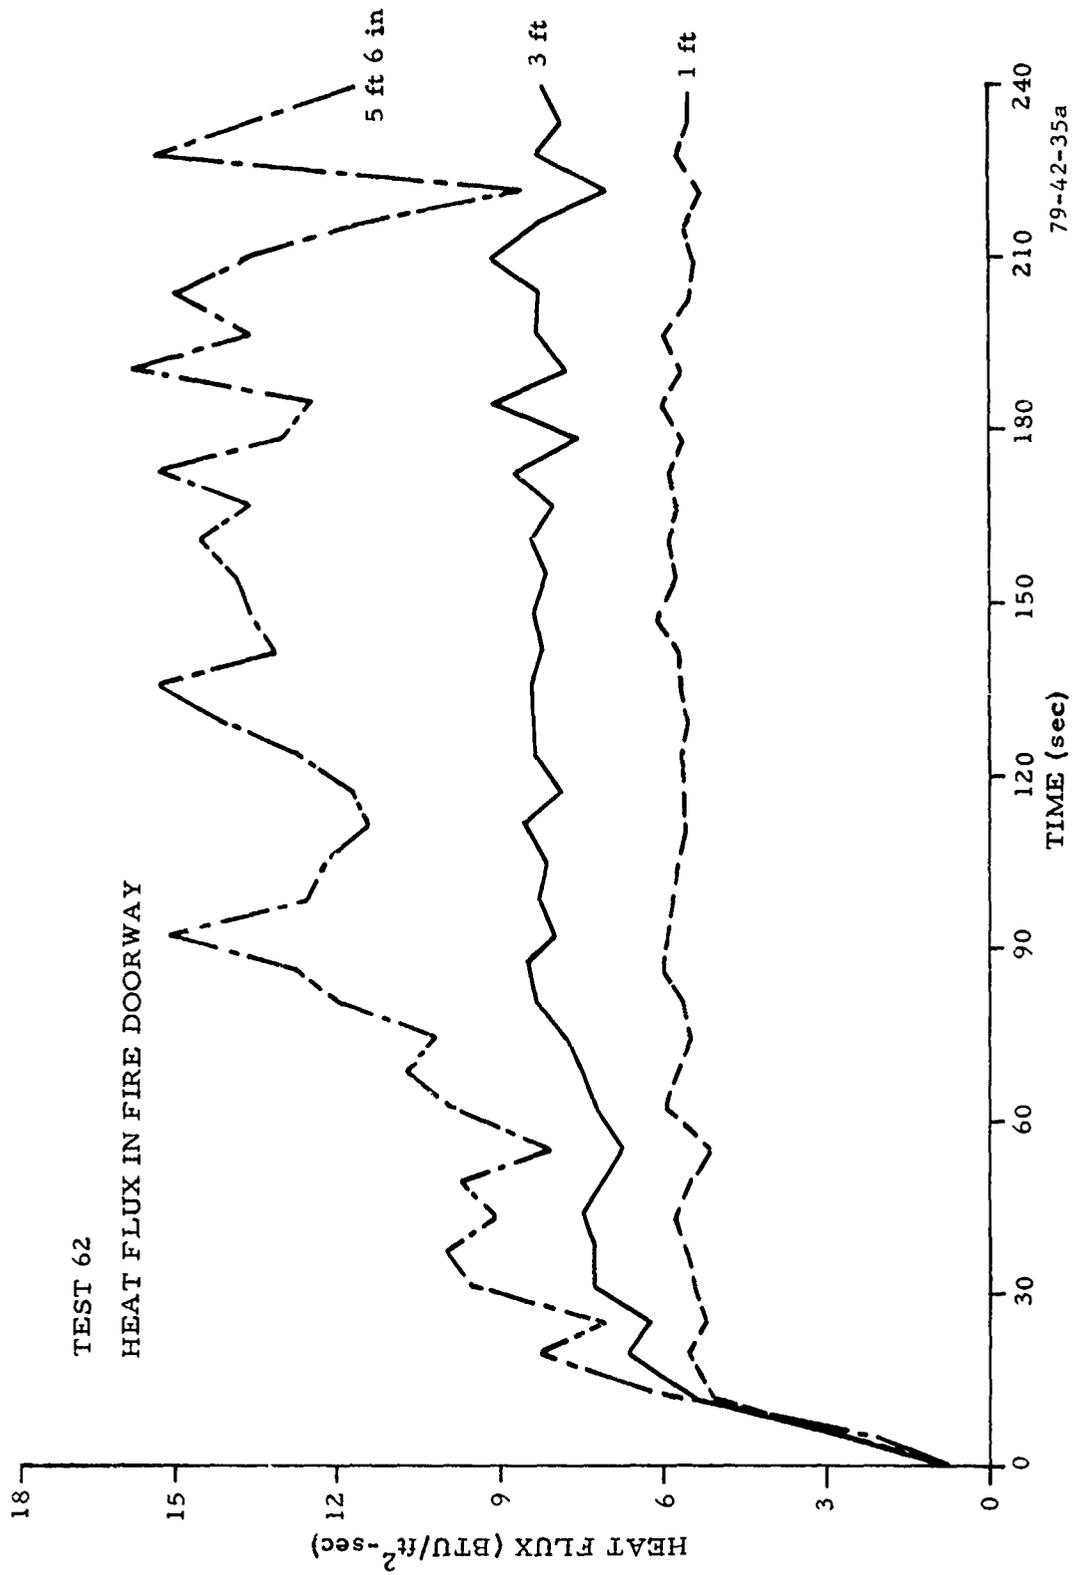
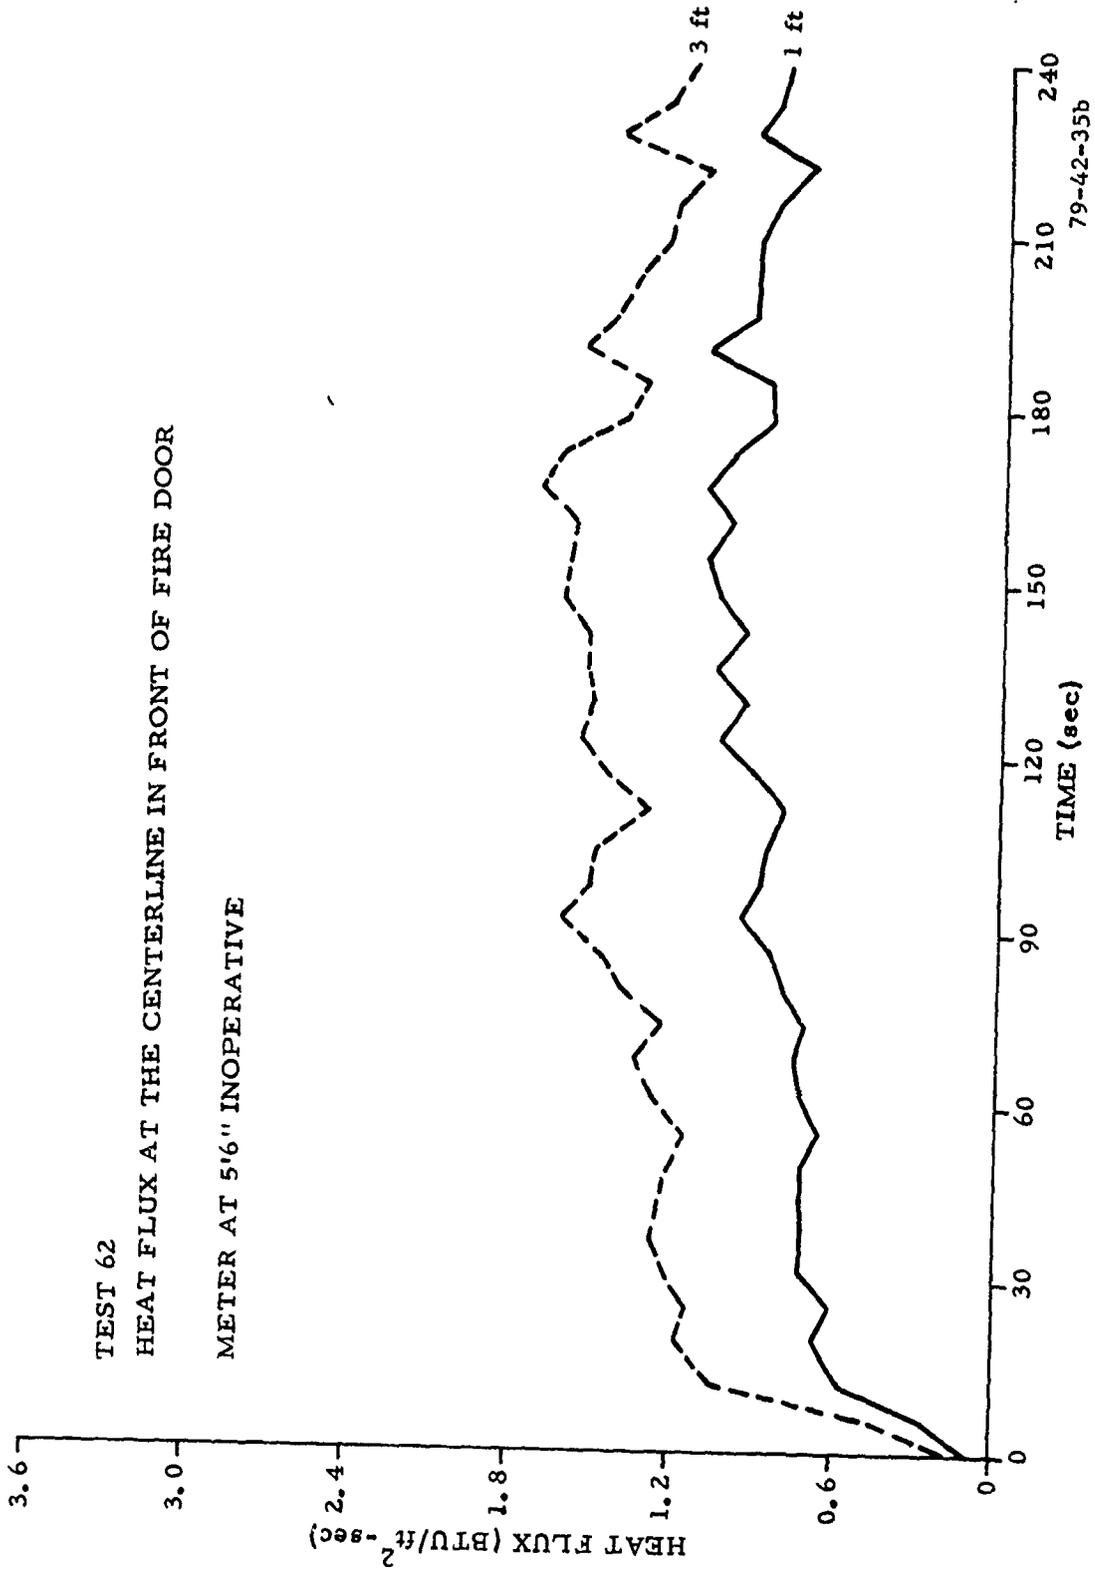
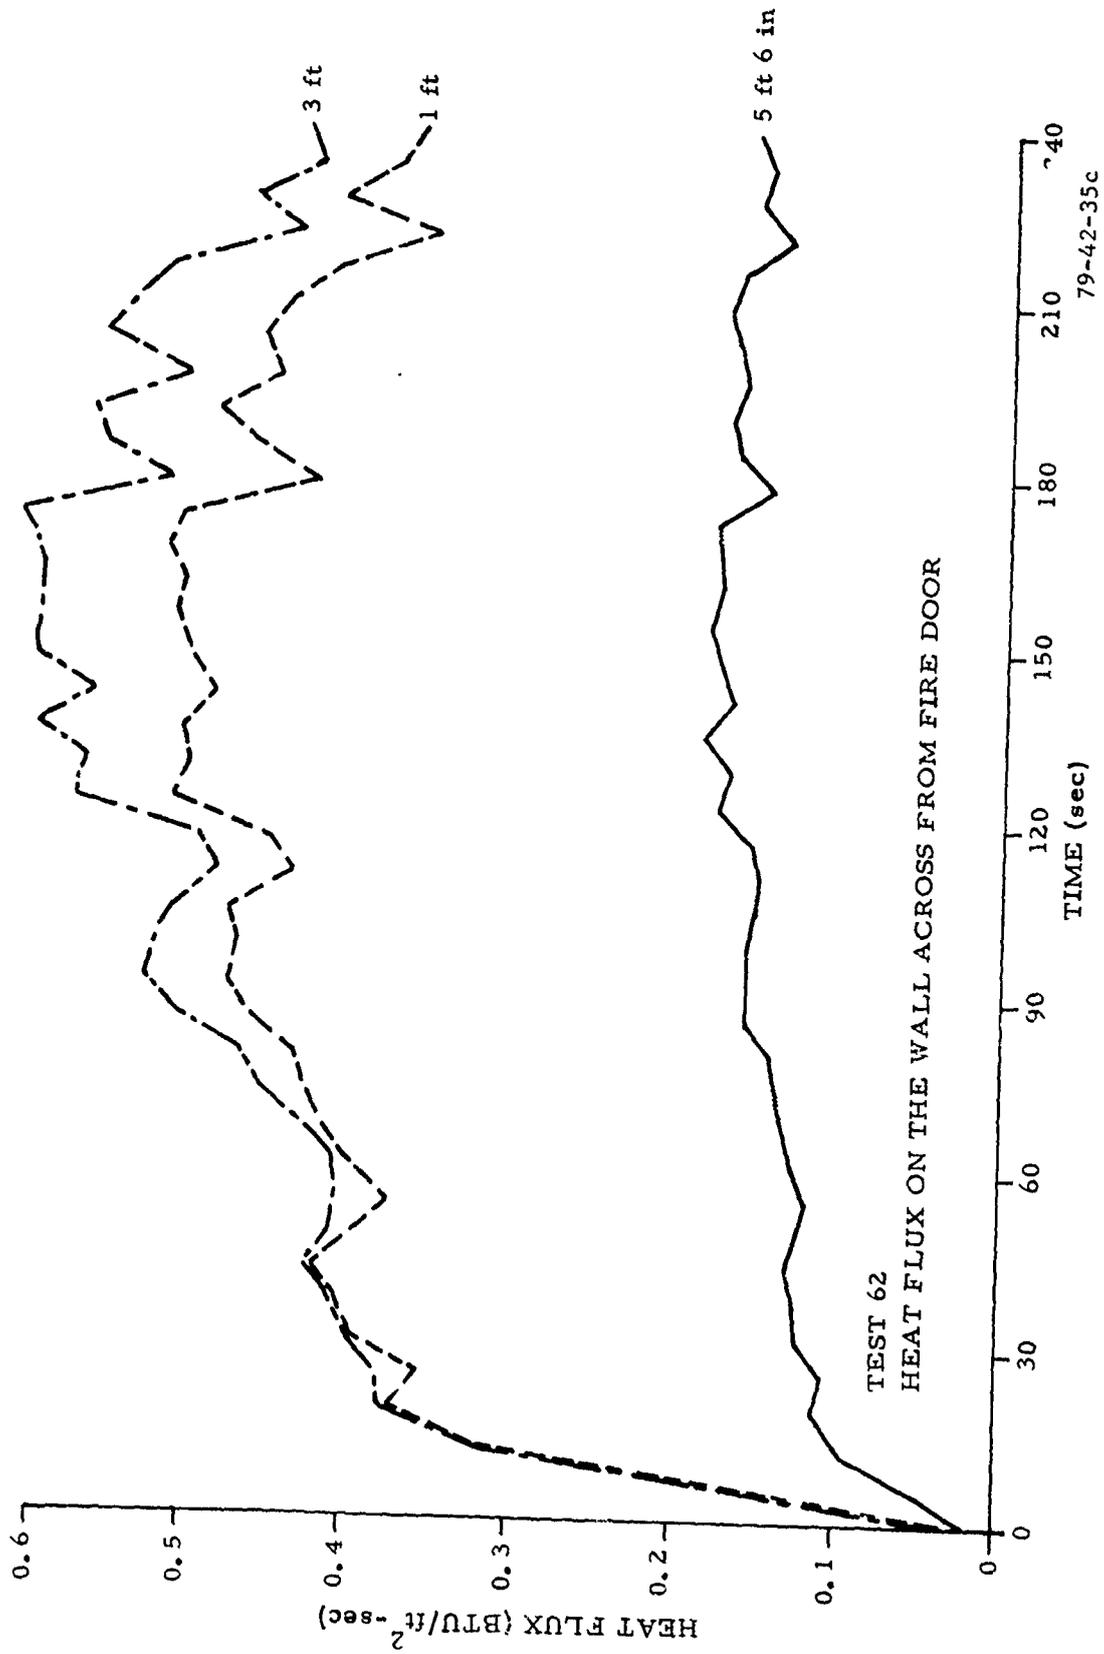
FIGURE 35. HEAT FLUX FOR ZERO-WIND TESTS (Sheet 1 of 3)

TEST 62
HEAT FLUX AT THE CENTERLINE IN FRONT OF FIRE DOOR
METER AT 5'6" INOPERATIVE

FIGURE 35. HEAT FLUX FOR ZERO-WIND TESTS (Sheet 2 of 3)

FIGURE 35. HEAT FLUX FOR ZERO-WIND TESTS (Sheet 3 of 3)

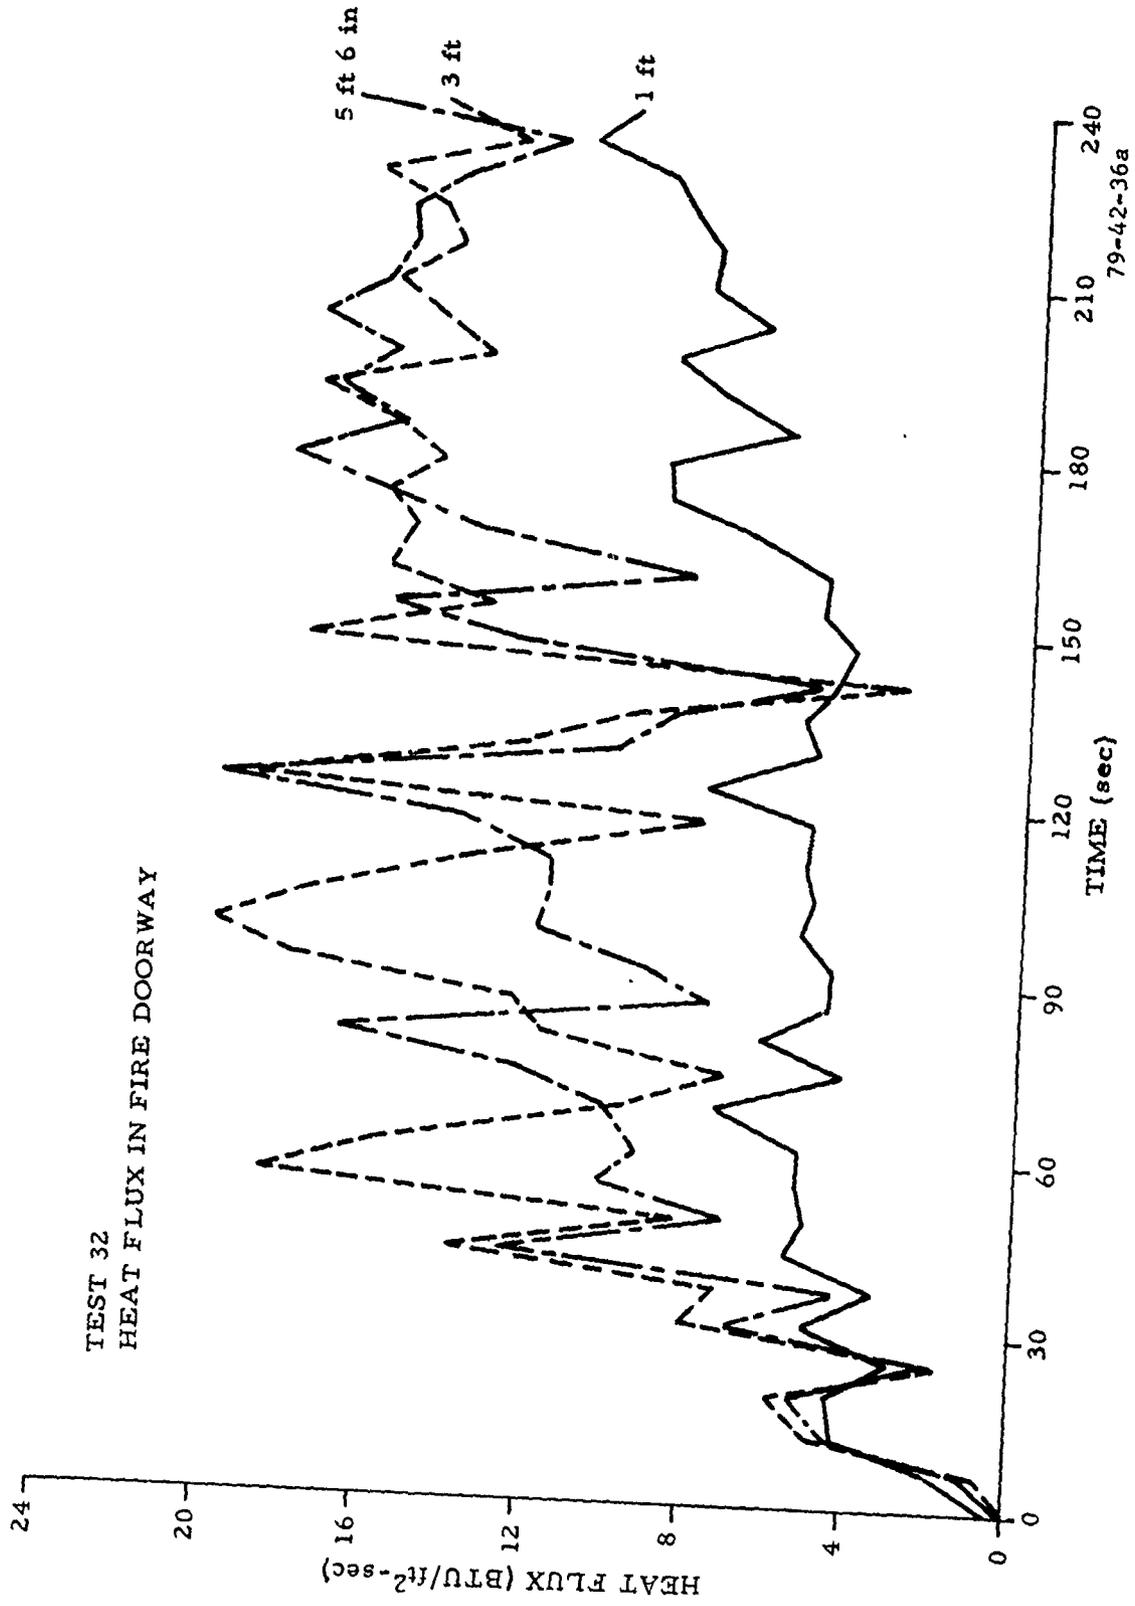
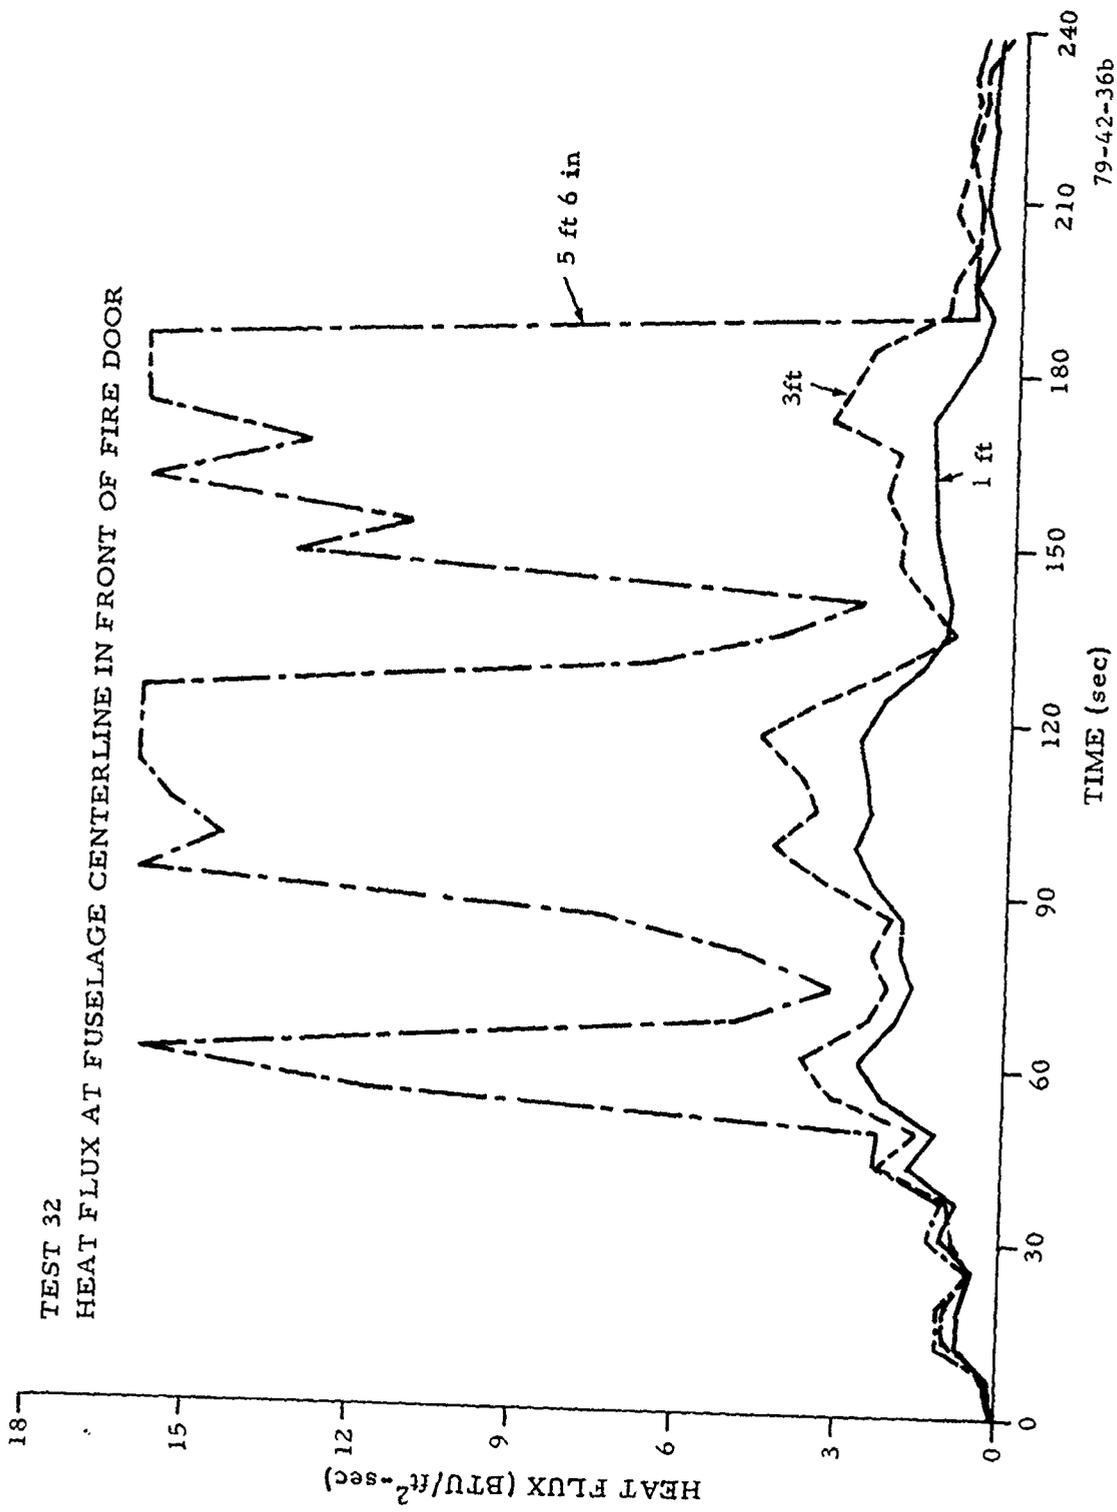
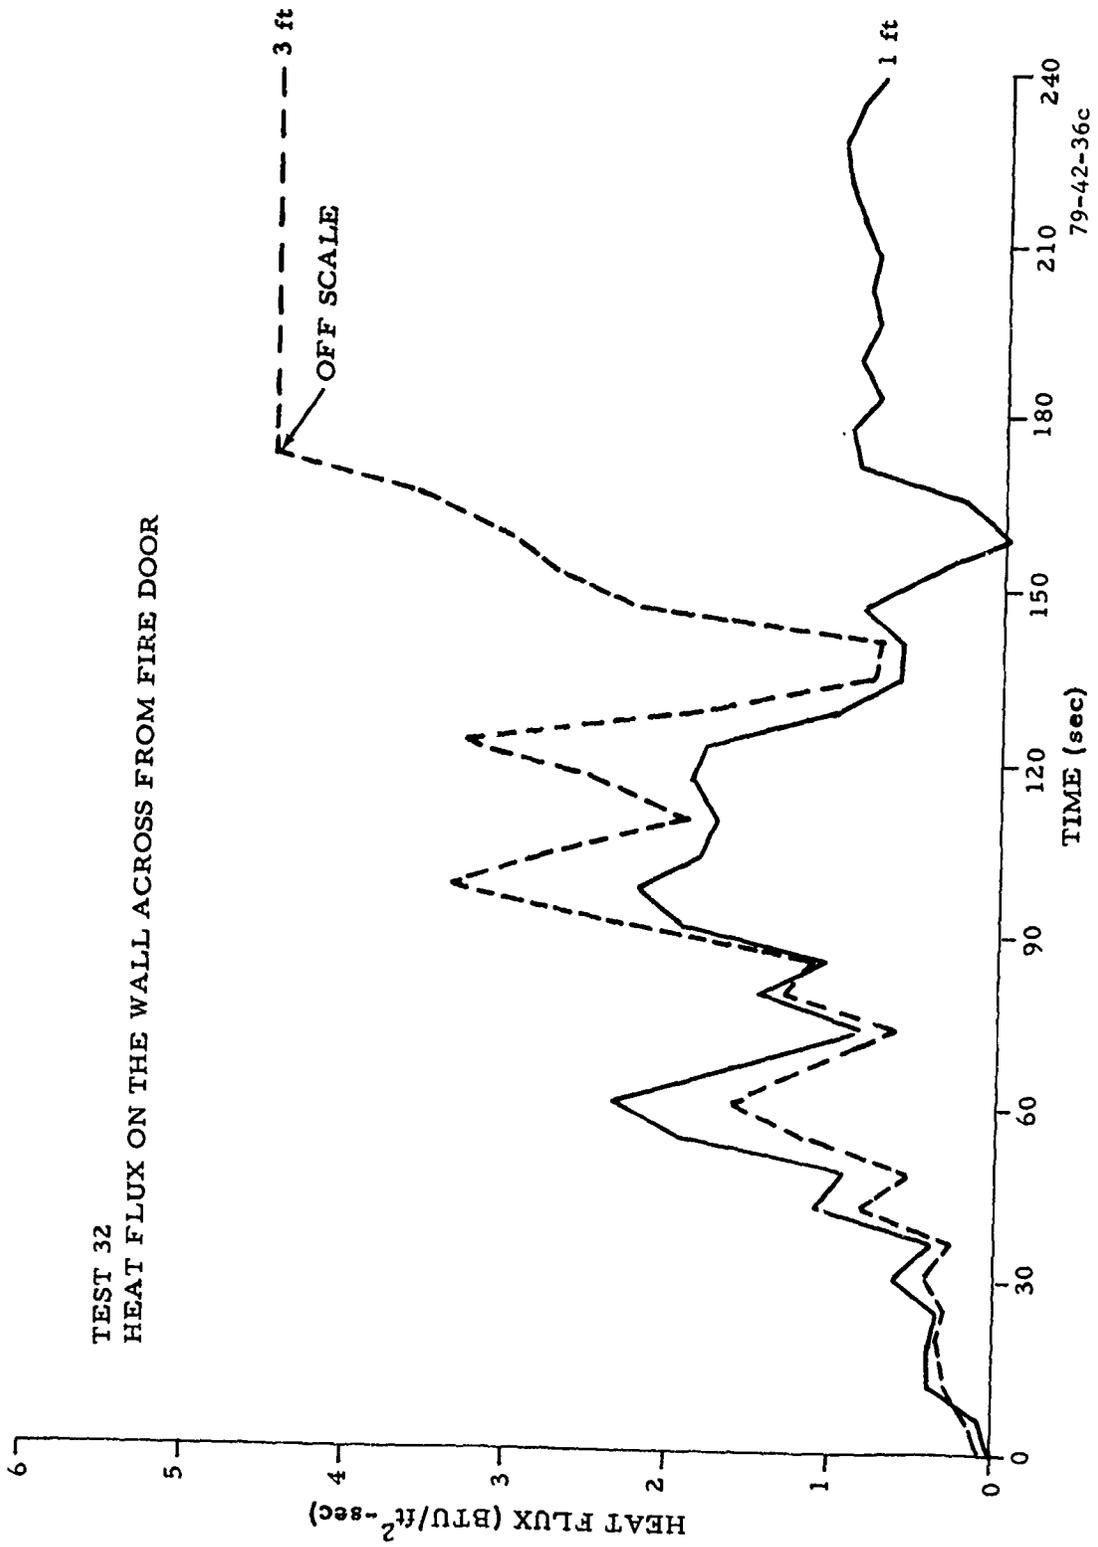
FIGURE 36. HEAT FLUX FOR MOST SEVERE TEST (Sheet 1 of 3)

FIGURE 36. HEAT FLUX FOR MOST SEVERE TEST (Sheet 2 of 3)

TEST 32
HEAT FLUX ON THE WALL ACROSS FROM FIRE DOOR

FIGURE 36. HEAT FLUX FOR MOST SEVERE TEST (Sheet 3 of 3)
