POSTCRASH FUEL FIRE HAZARD MEASUREMENTS IN A WIDE-BODY AIRCRAFT CABIN

FINAL REPORT

1. Report No. 144 FAA-NA-79-42		2. Government Accession No.		3. Recipient's Catalog No.	
4. Title and Subtitle 6 POSTCRASH FUEL FIRE HAZARD MEASUREMENTS IN A WIDE-BODY AIRCRAFT CABIN				5. Report Date 11 Dec 79

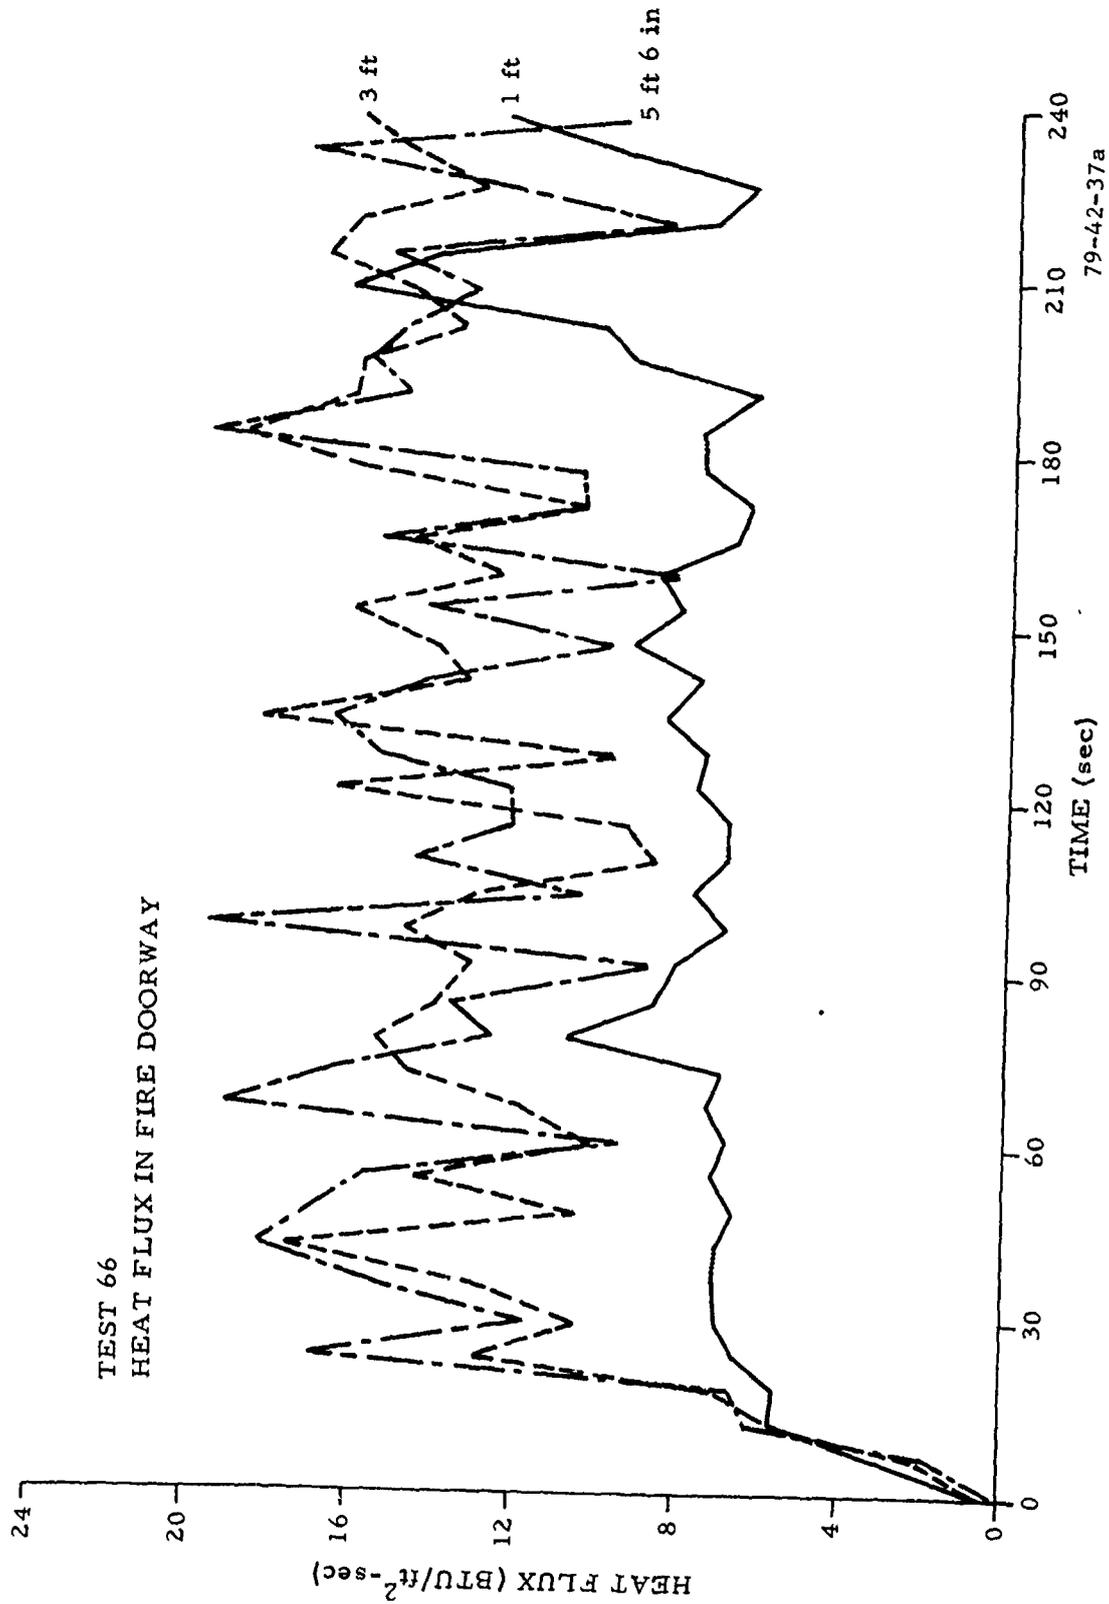
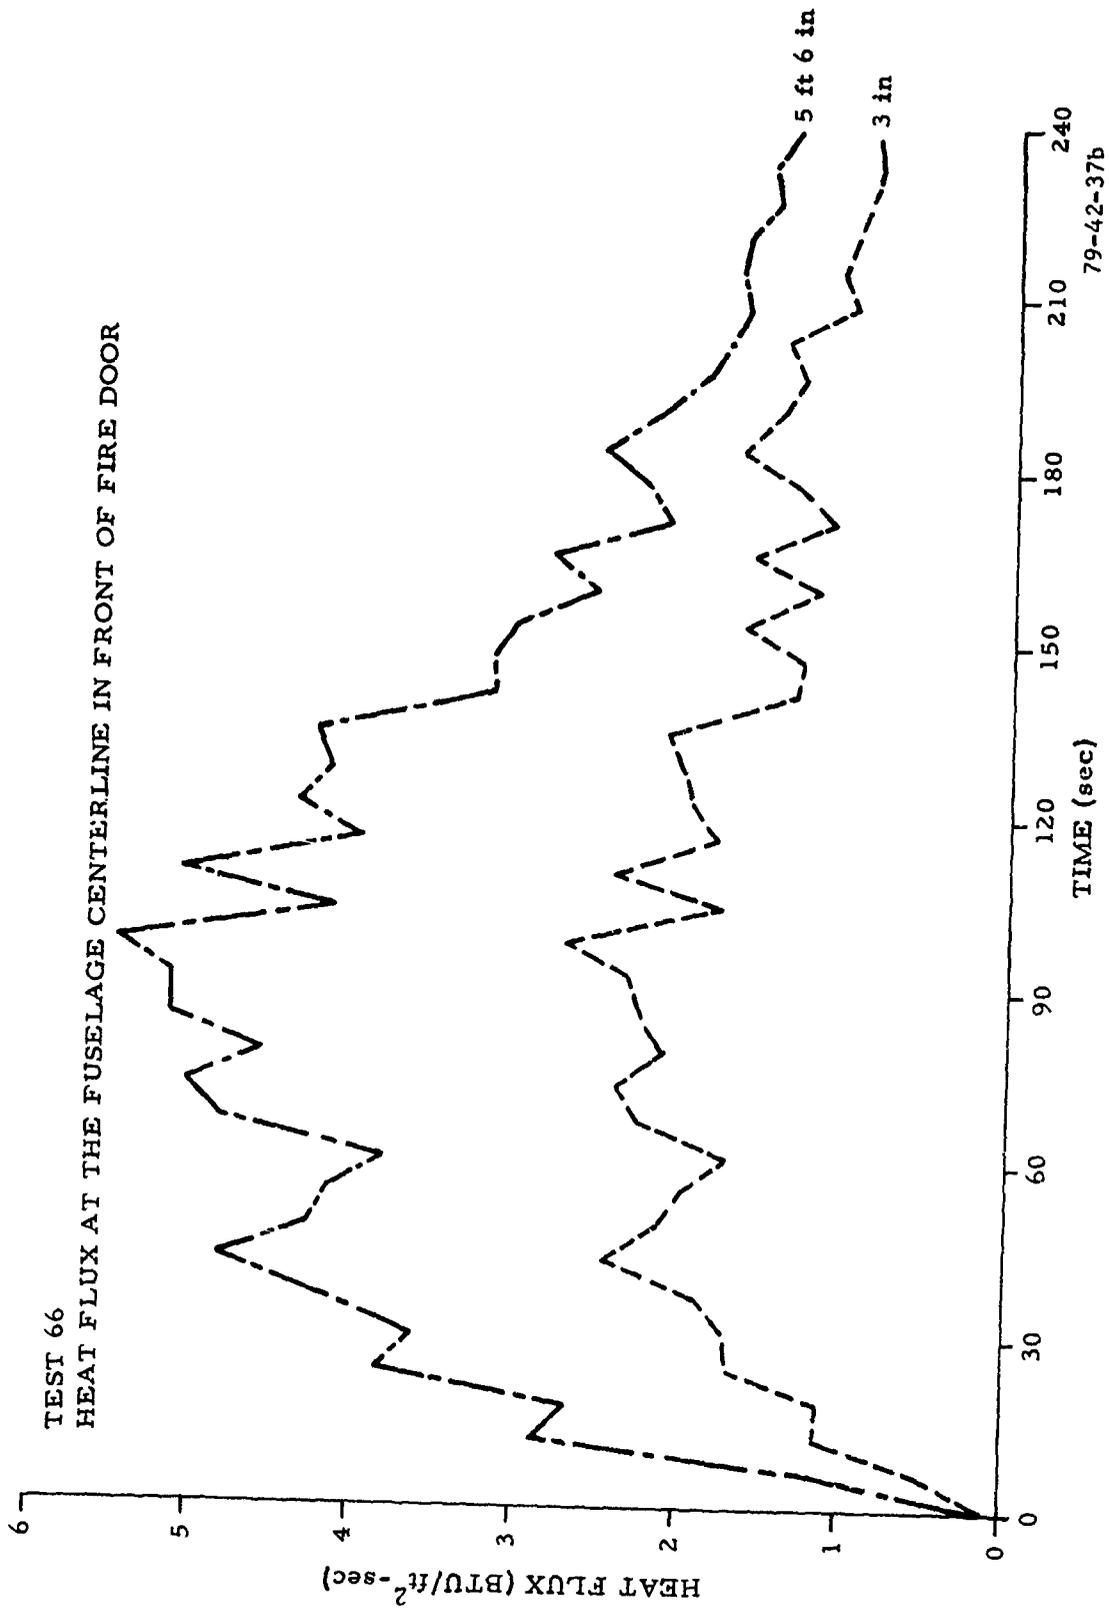
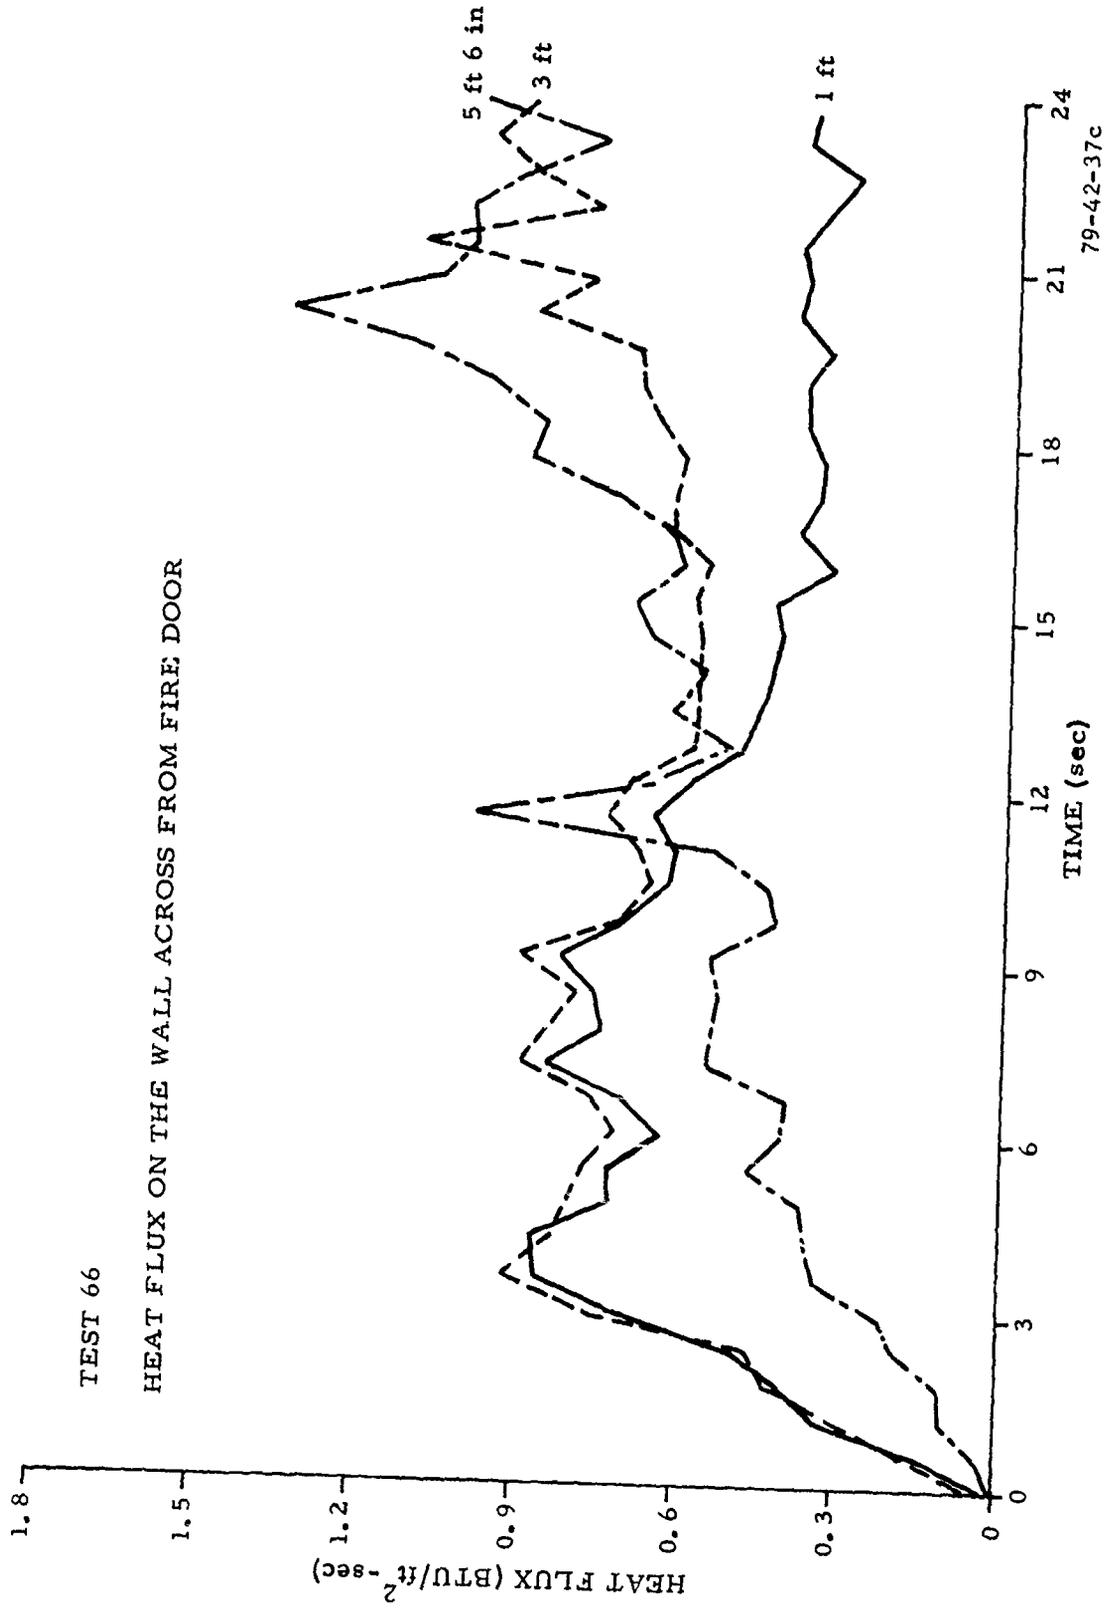
FIGURE 37. HEAT FLUX FOR MOST SEVERE 8- BY 10-FOOT TEST (Sheet 1 of 3)

FIGURE 37. HEAT FLUX FOR MOST SEVERE 8- BY 10-FOOT TEST (Sheet 2 of 3)

FIGURE 37. HEAT FLUX FOR MOST SEVERE 8- BY 10-FOOT TEST (Sheet 3 of 3)

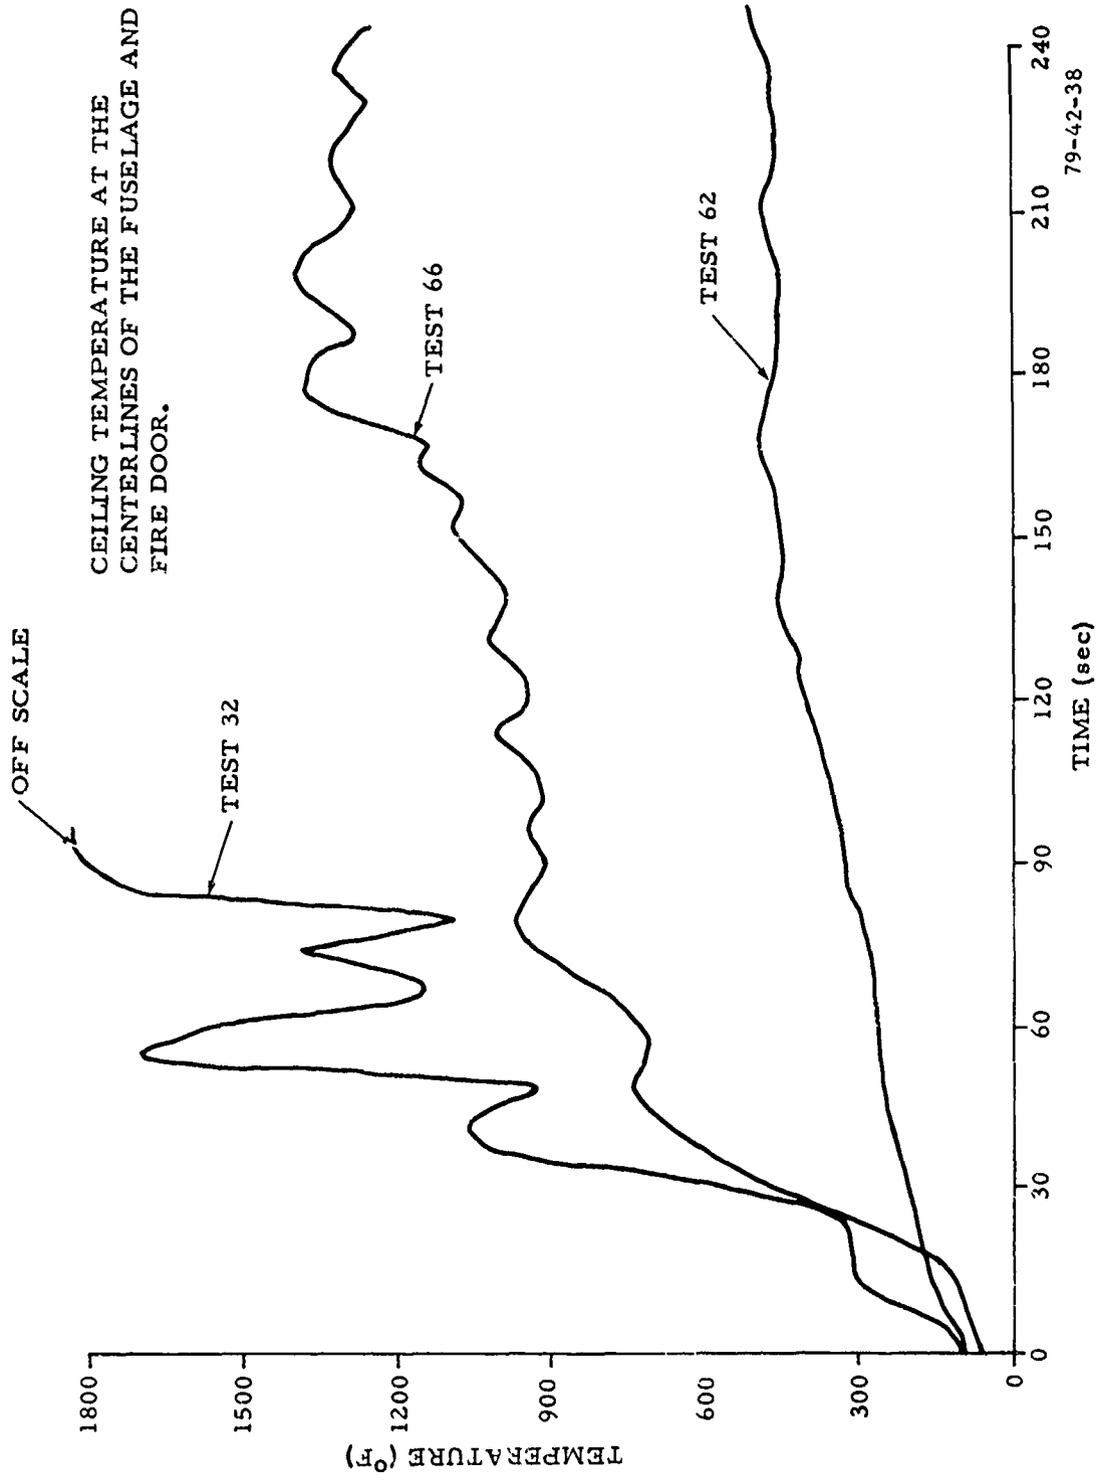
FIGURE 38. CEILING TEMPERATURES, FIRE DOOR AREA

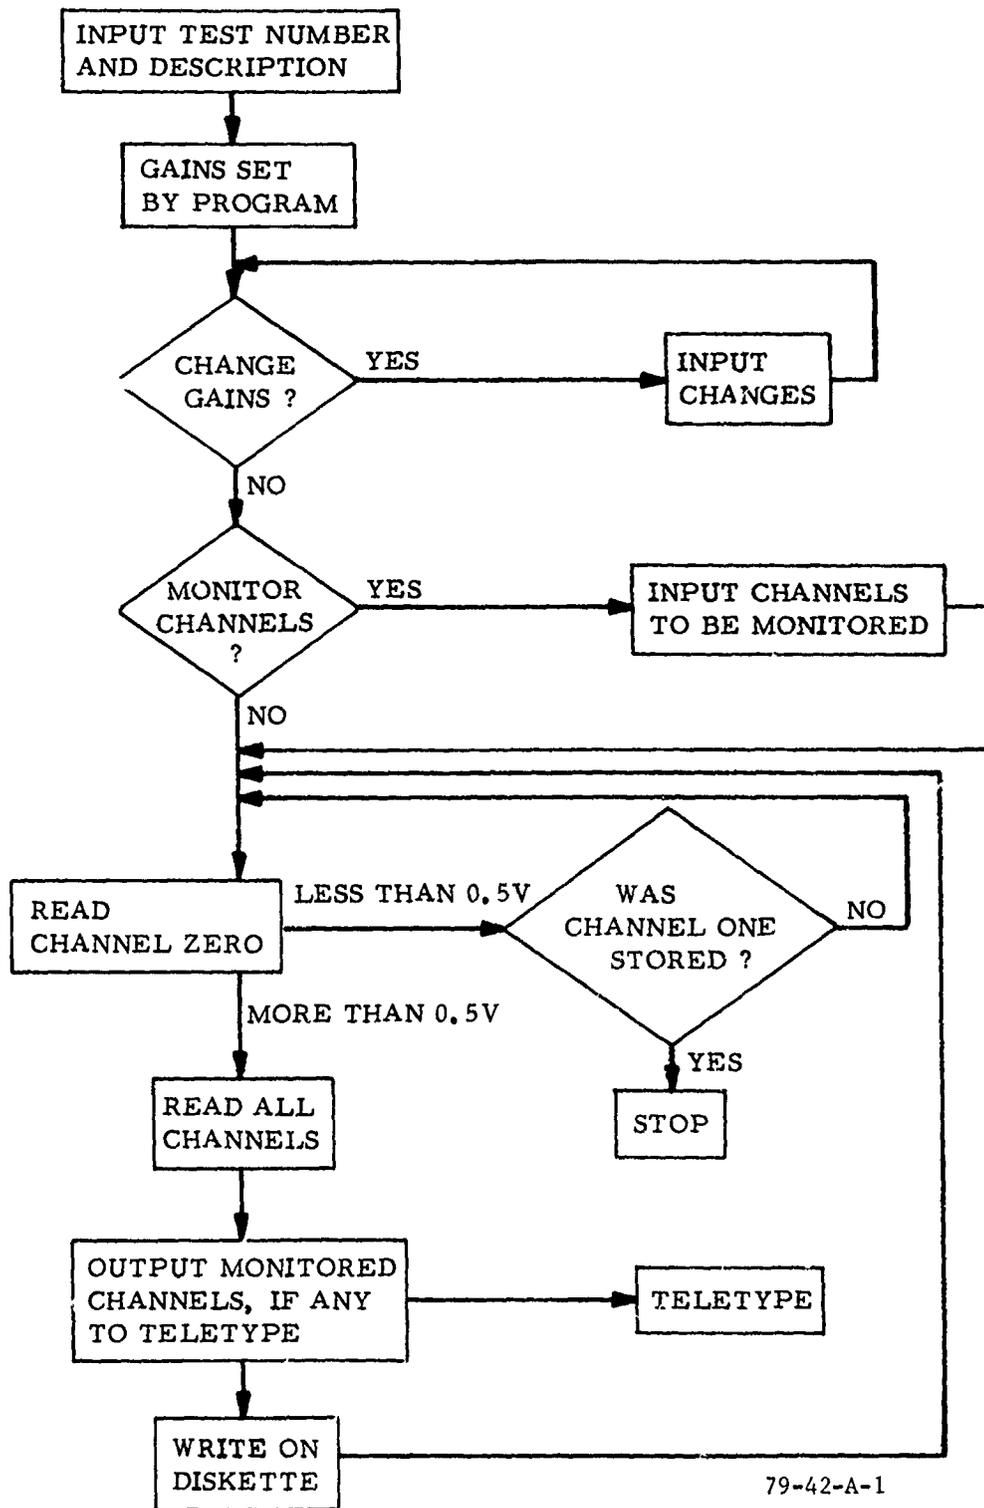
The acquisition and reduction of data were handled separately. Figure A-1 is a flow chart of the data acquisition program, and figure A-2 is a flow chart of the data reduction program.

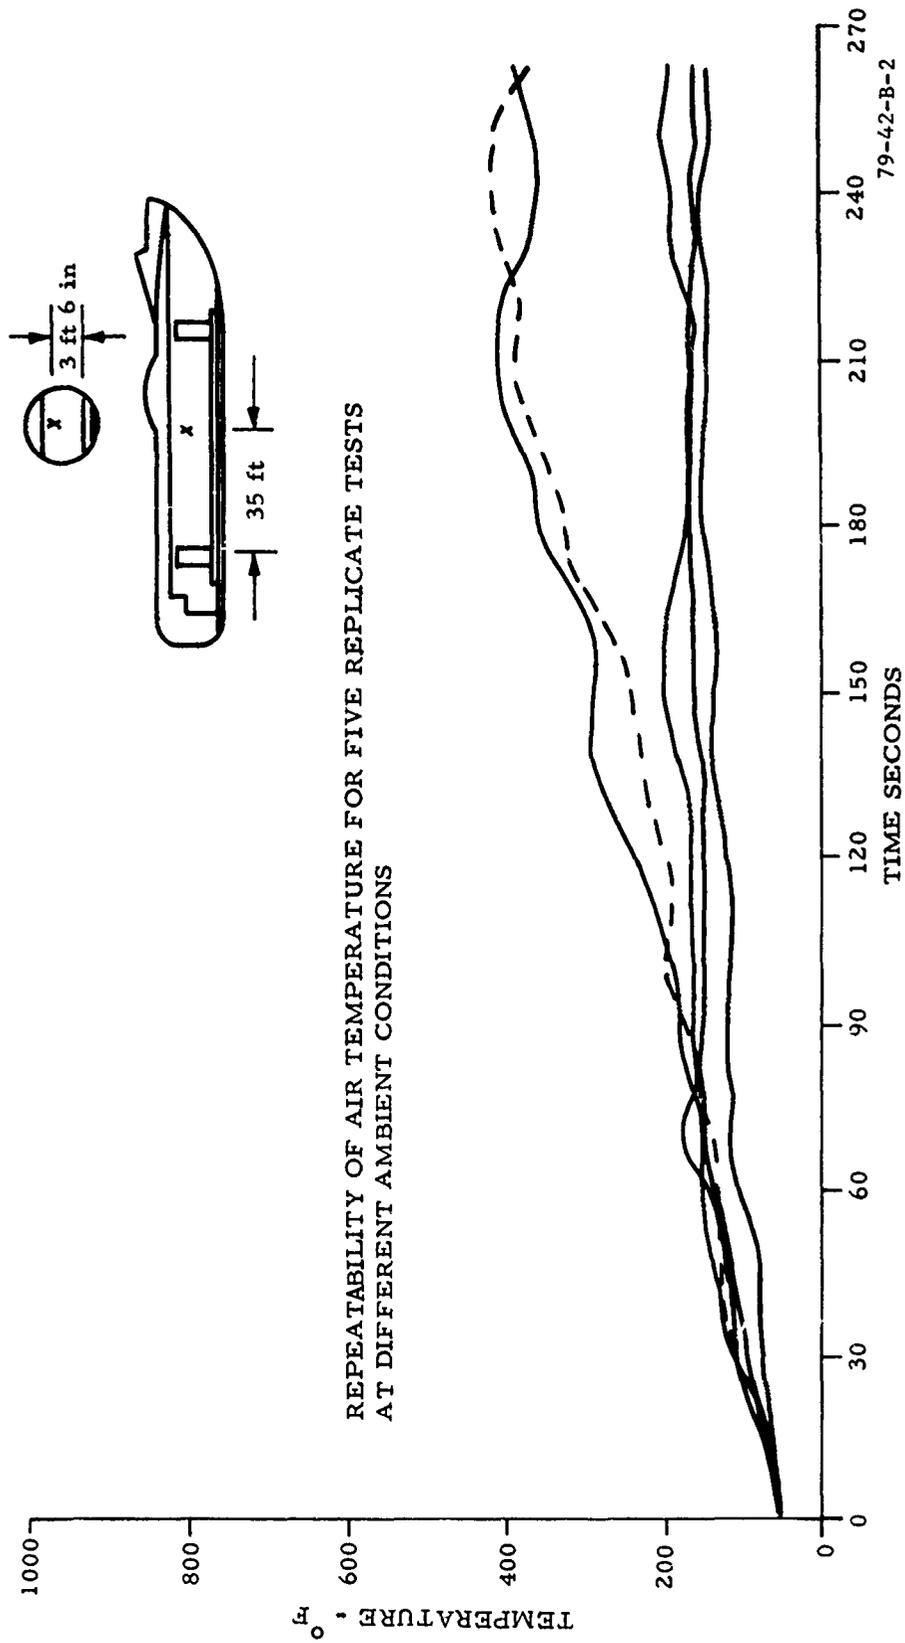
Figure B-2 shows data from five "identical" tests. Two families of curves are evident. For one family, the flames continuously penetrated into the cabin, resulting in an ever-increasing cabin temperature; however, for the other family, the flames penetrated for about a minute at the beginning of the test but later receded, and the resulting cabin temperature leveled off. The two-family behavior was probably related to the ambient conditions, possibly in combination with the steel-covered wind barrier. However, no correlation could be made with measurement taken during each test of ambient windspeed and direction, temperature, and relative humidity. Therefore, there was no apparent means of predicting which of the two family curves would exist under a given set of ambient conditions. For this reason, the wind barrier was removed for all subsequent testing.

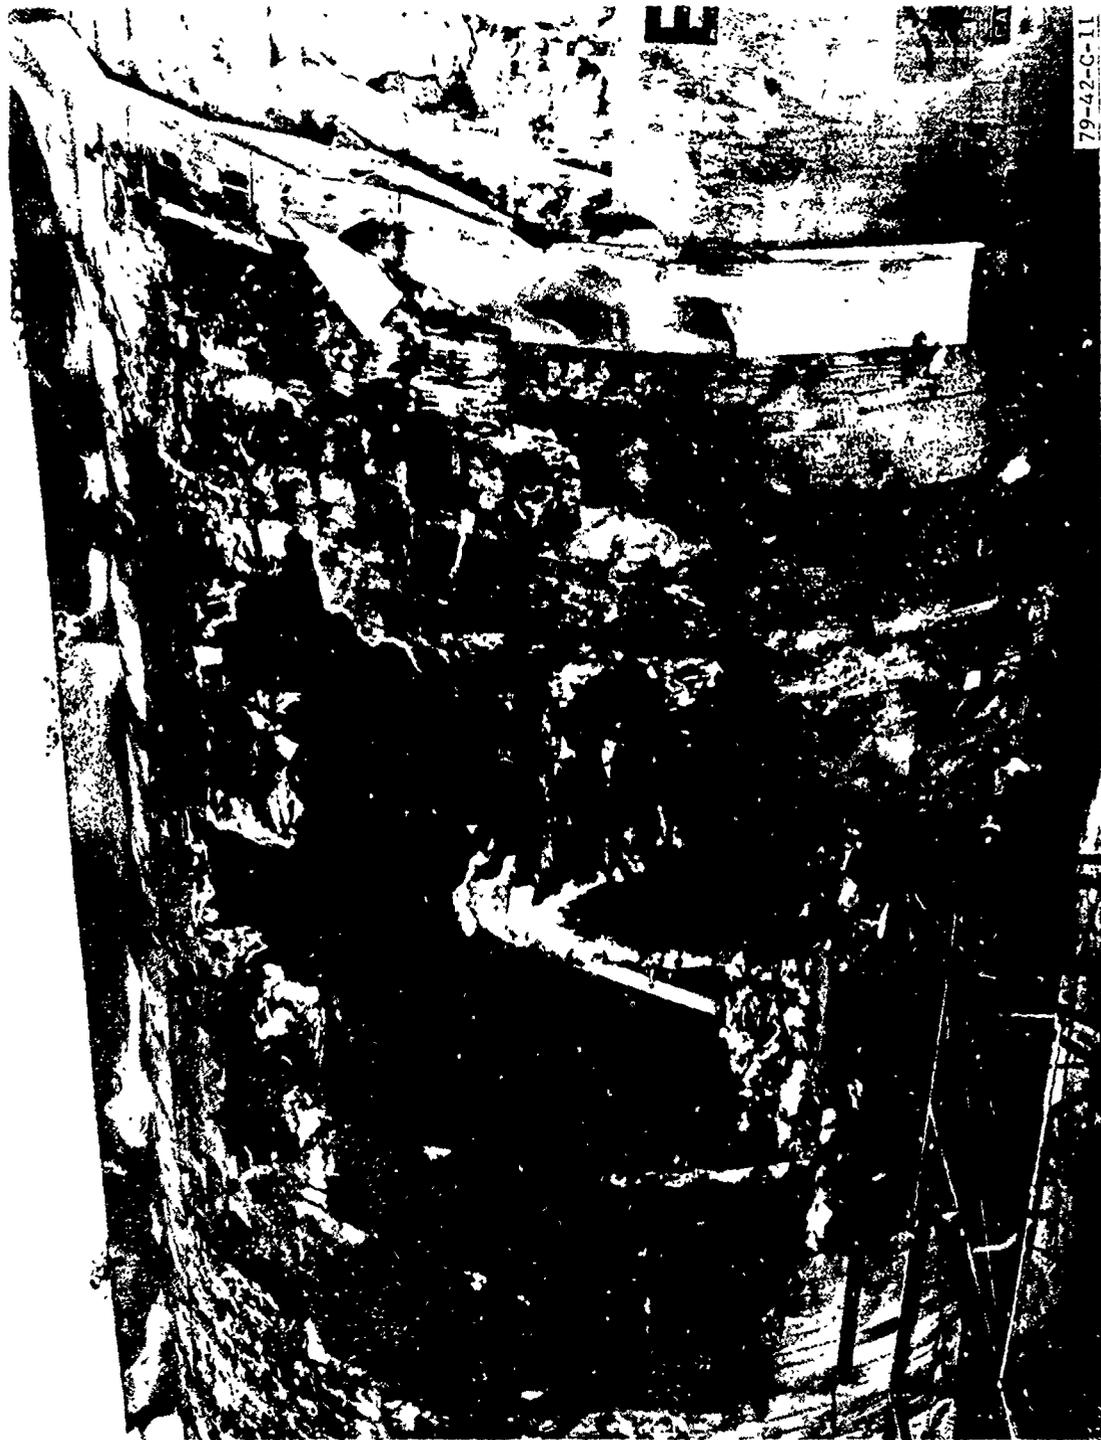
79-42-C-11

FIGURE C-11. POSTTEST FIRE DAMAGE (TEST 72)
