BELL HELICOPTER TEXTRON FORT WORTH TX
CONCEPTUAL DESIGN OF A HELICOPTER COMPOSITE TRUSS TAIL BOOM. (U)
APR 80 D A GALLIAN

USAAVRADCOM-TR-80-D-R

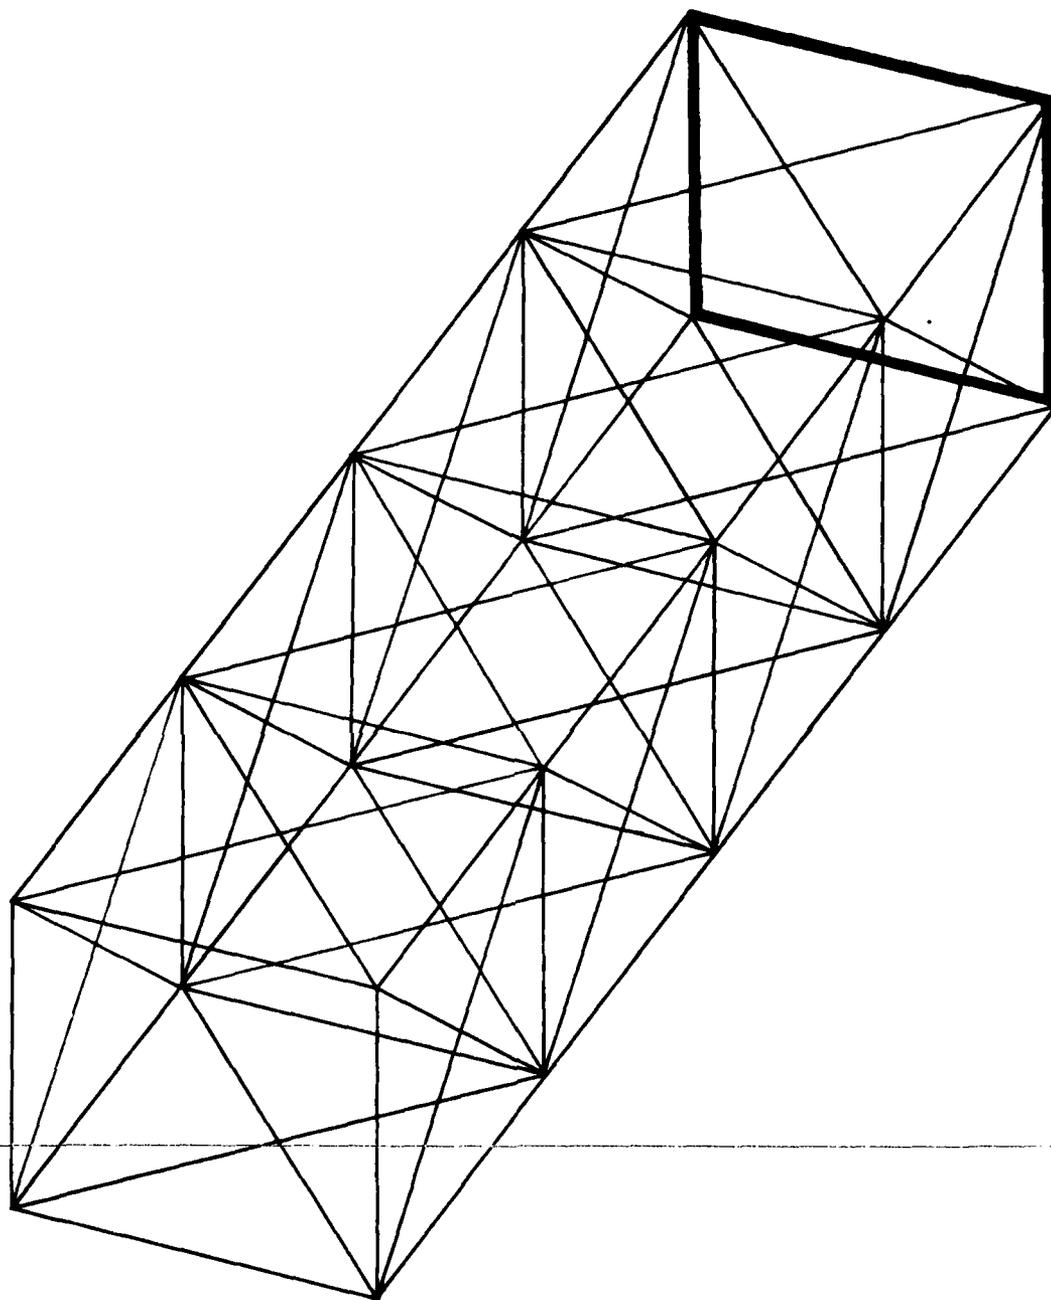
Figure 2. Truss Configurations 4T and 4T/C

Configuration I.D.
4 Longeron Truss	
- Diagonals capable of taking tension only	4T
- Diagonals capable of taking tension and compression	4T/C
5 Longeron Truss	
- Diagonals capable of taking tension only	5T
- Diagonals capable of taking tension and compression	5T/C
6 Longeron Truss	
- Diagonals capable of taking tension only	6T
- Diagonals capable of taking tension and compression	6T/C
7 Longeron Truss	
- Diagonals capable of taking tension only	7T
- Diagonals capable of taking tension and compression	7T/C
8 Longeron Truss	
- Diagonals capable of taking tension only	8T
- Diagonals capable of taking tension and compression	8T/C

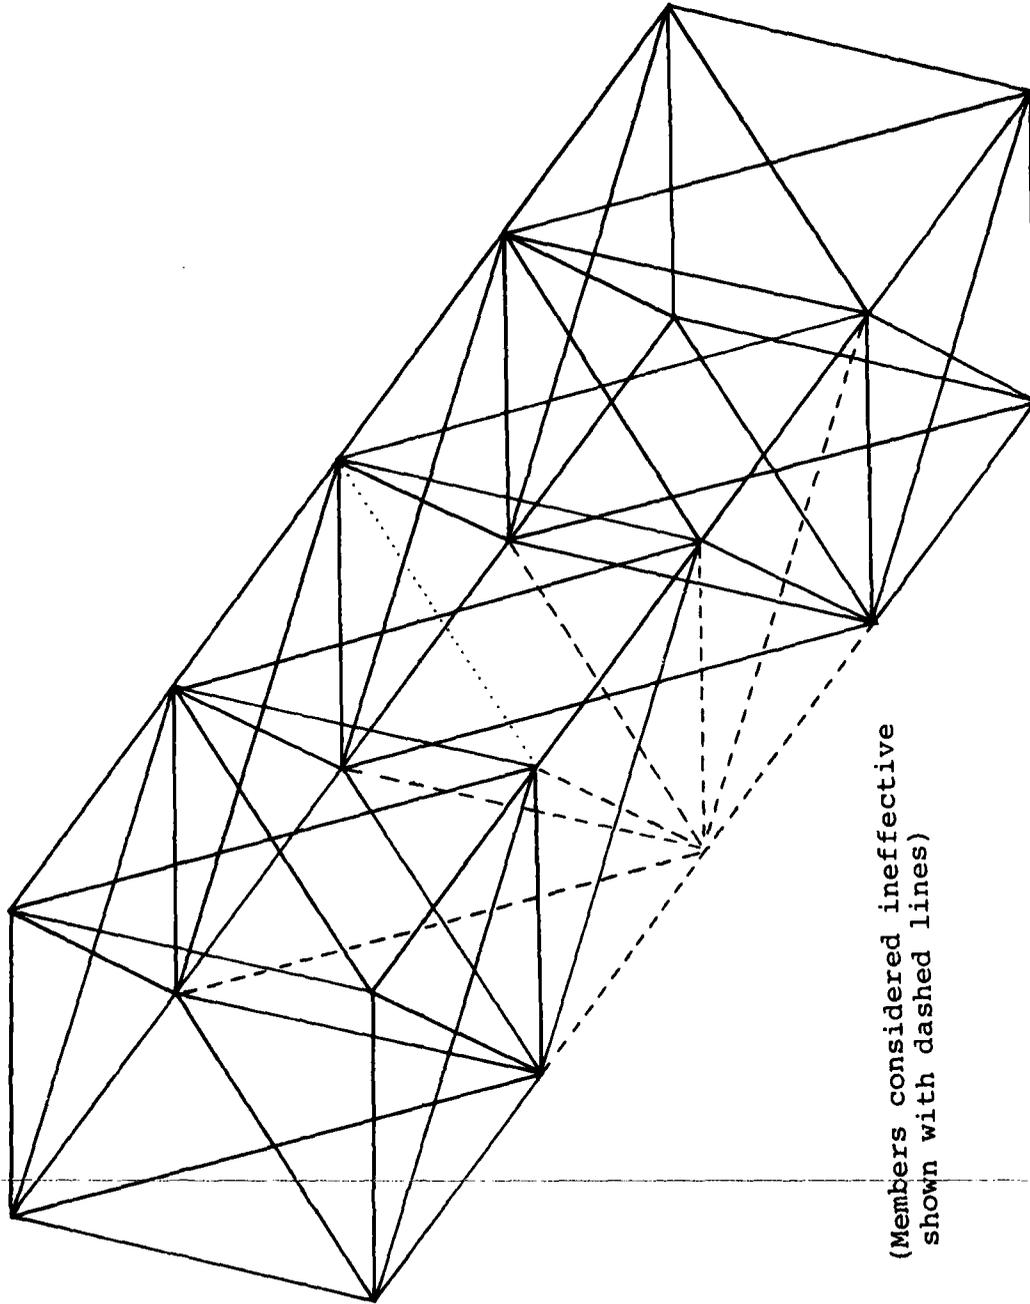
Figure 8. Typical Damage State 2

application of the two damage criteria. Damage state one refers to the loss of a single longeron and one opposite side diagonal member. Damage state two refers to the loss of a longeron joint and one opposite side diagonal member. Both the longeron and joint were removed from the compression side of the loaded truss model. A 1.5-degree slope line is also included on each graph. This line represents the maximum allowable tail rotor driveshaft coupling misalignment angle.

(Members considered ineffective
shown with dashed lines)

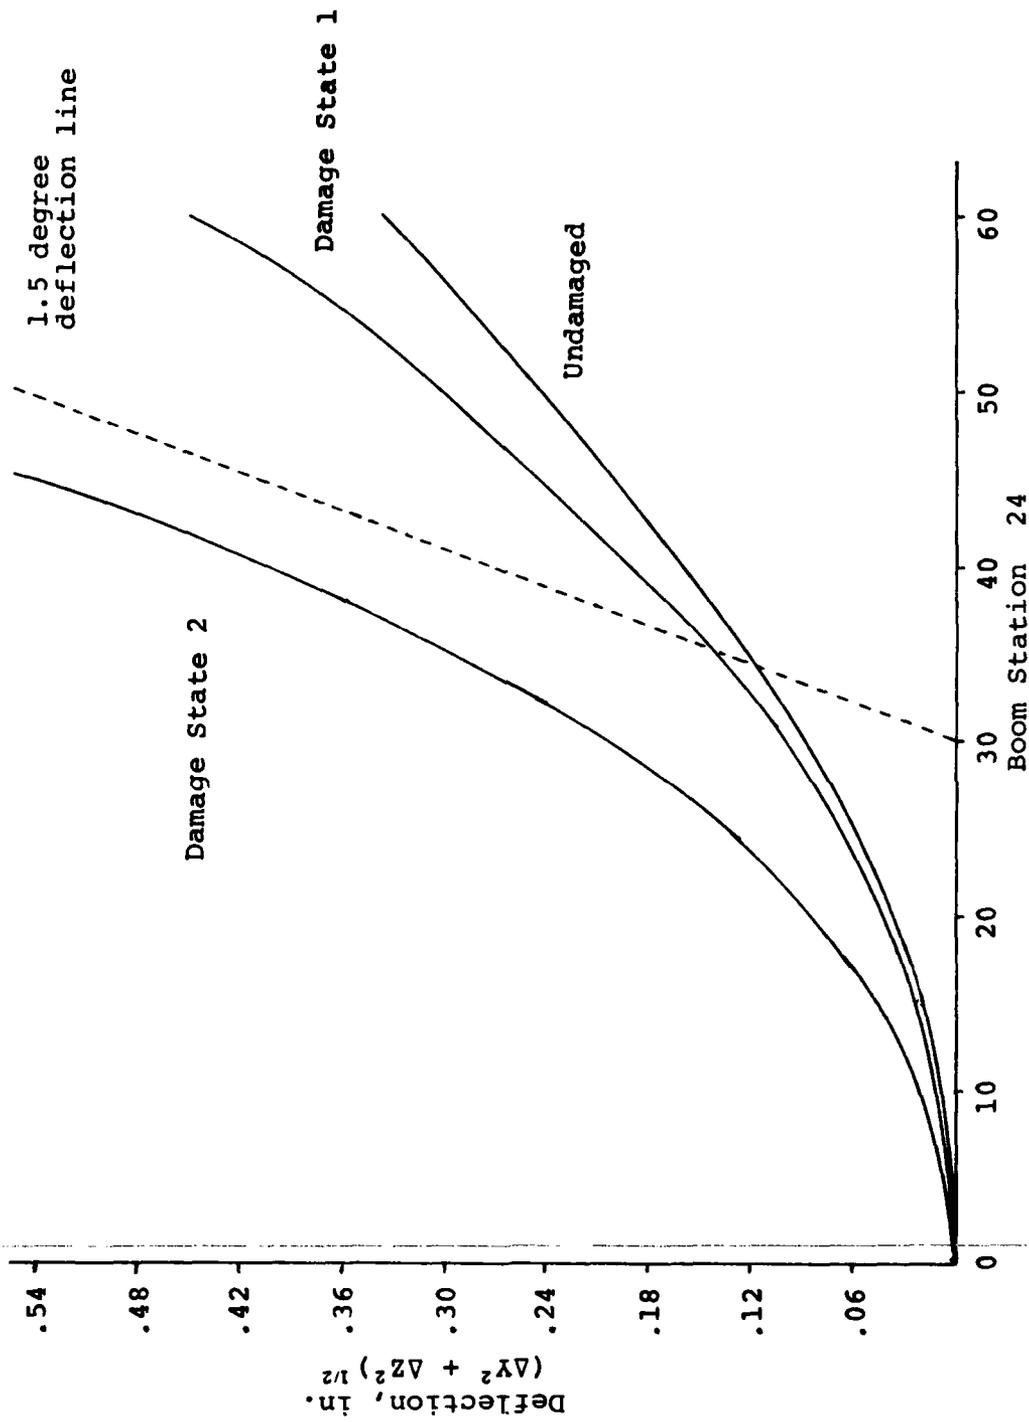
Figure 9. Deflection - Configuration 4T

As shown in Figure 9, truss configuration 4T exceeded the deflection criterion after damage. Configuration 7T was eliminated from further consideration because of an inability to converge on a tension-only solution. In order to match the stiffness of the existing Model OH-58 boom, both 8 longeron configurations required such a small diameter boom that they approached becoming a solid tube. Both of these configurations were eliminated from further consideration because of this condition. The results from the preliminary sizing study for the remaining six truss configurations are shown in Table 4.

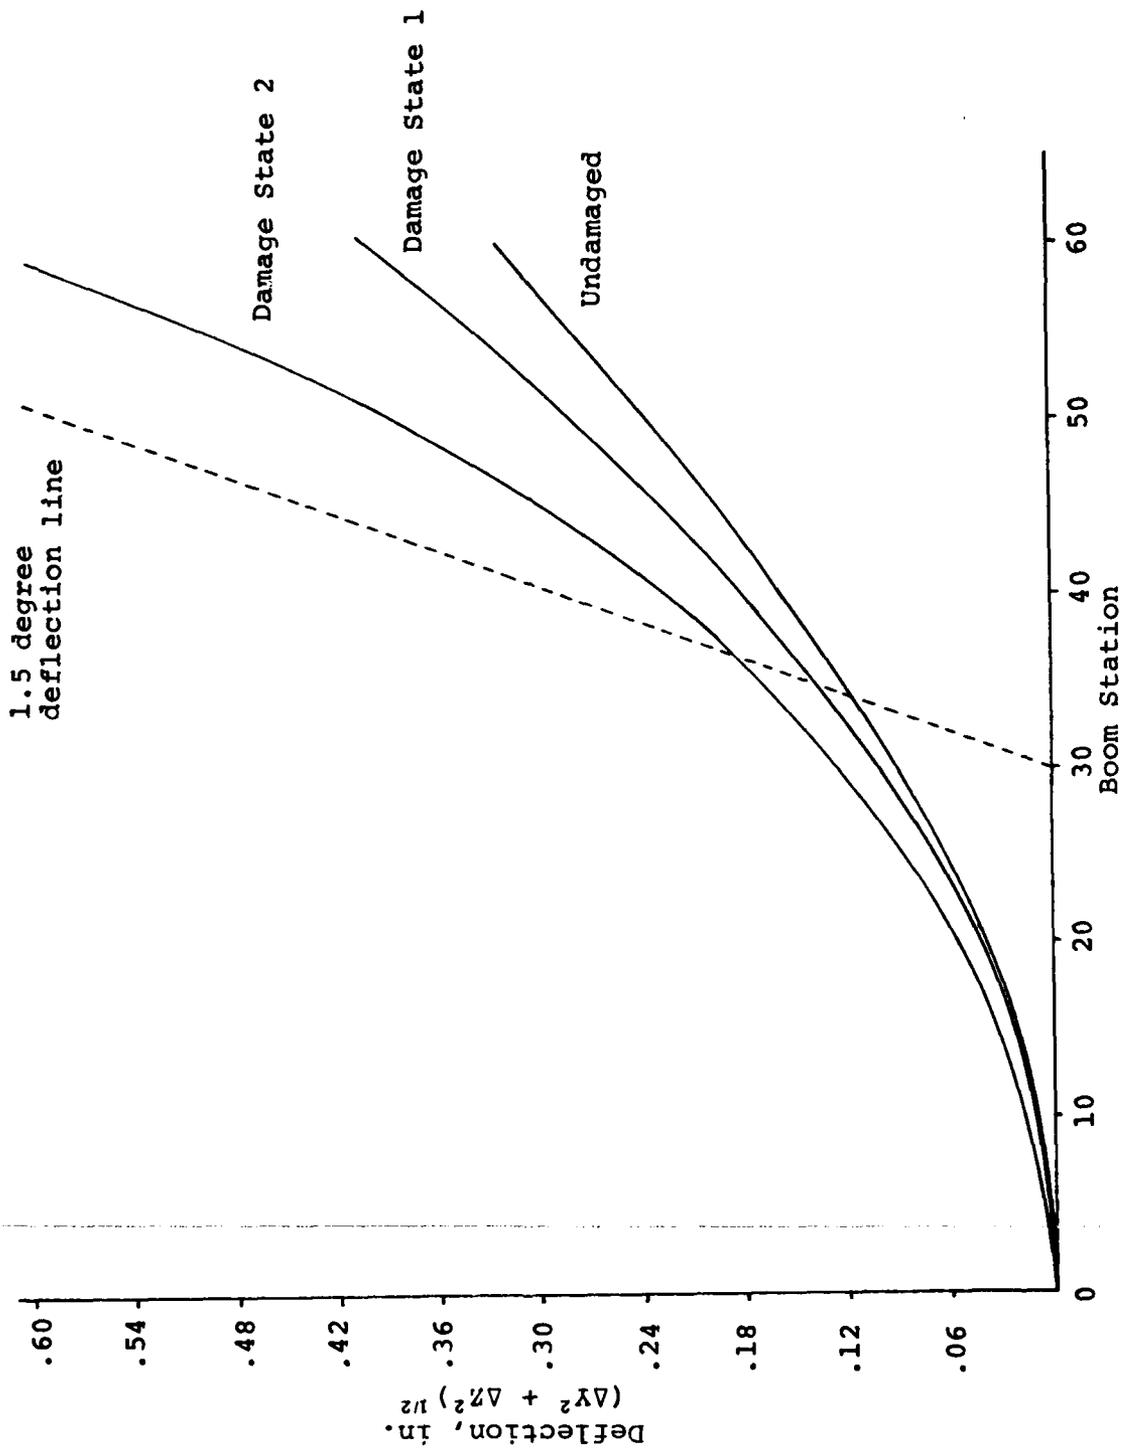
Figure 10. Deflection Damage - Configuration 4T/C

Configuration 4T/C exhibited a deflection pattern after the removal of a longeron joint that came very close to exceeding the 1.5-degree deflection limit. The remaining longerons also had the largest change in static load after damage. Even though configuration 4T/C was the lightest of the proposed designs and had the largest amount of open area, the potential for exceeding the tail rotor driveshaft bearing misalignment angle and the possible large dynamic impulse loads in the remaining longeron members eliminated configuration 4T/C from consideration.

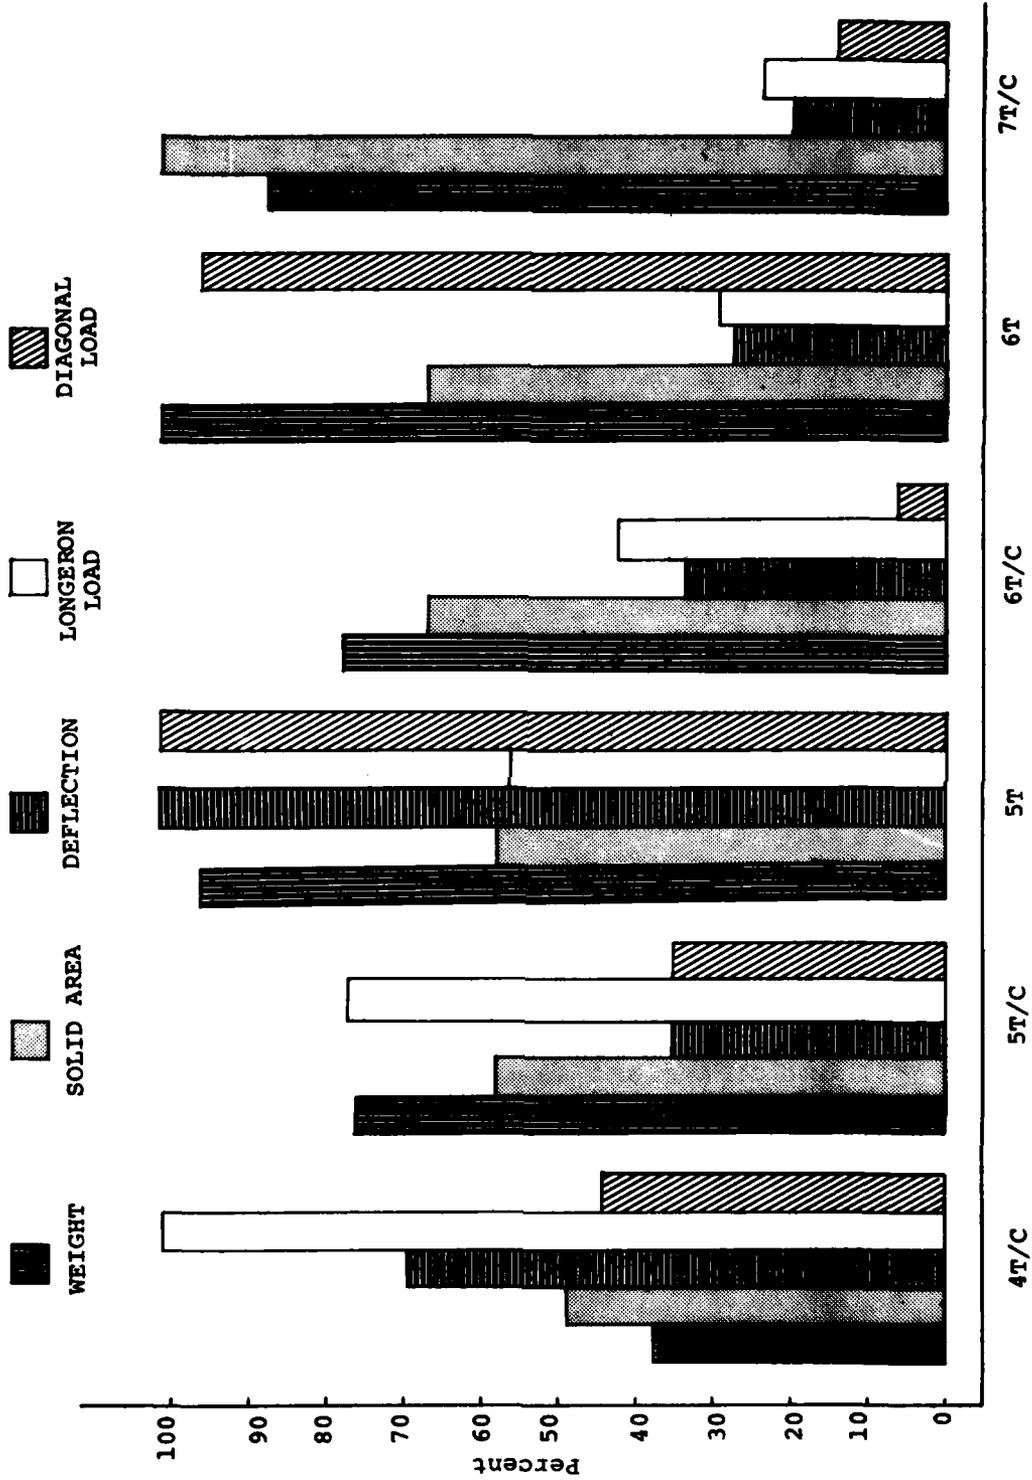
Figure 19. Configuration Characteristics

The key parameters of weight, amount of solid area, deflection after ballistic damage, and increase in longeron and diagonal load after damage are graphically compared in Figure 19. In this chart, the maximum values in each category are plotted as 100 percent. Lesser values are then shown as a percentage of the maximum values. As would be expected, the amount of solid (or presented) area is greater for those configurations having a larger number of longerons.

Likewise, the weight is generally less for those configurations having the fewer longerons.

The configurations that used diagonal members capable of taking only a tensile load were judged to be the worst overall designs. They were heavier than their tension/compression diagonal counterparts and exhibited a large increase in diagonal load after damage. During the initial sizing of these configurations, it became readily apparent that the stiffness of these two configurations was a function of the applied load. Since the stiffness of the existing Model OH-58 boom is constant throughout the range of design loads, any design that does not exhibit such a constant stiffness could possibly pass through a critical frequency as various flight loads were applied. For these reasons, truss configurations 5T and 6T were eliminated from the design selection.

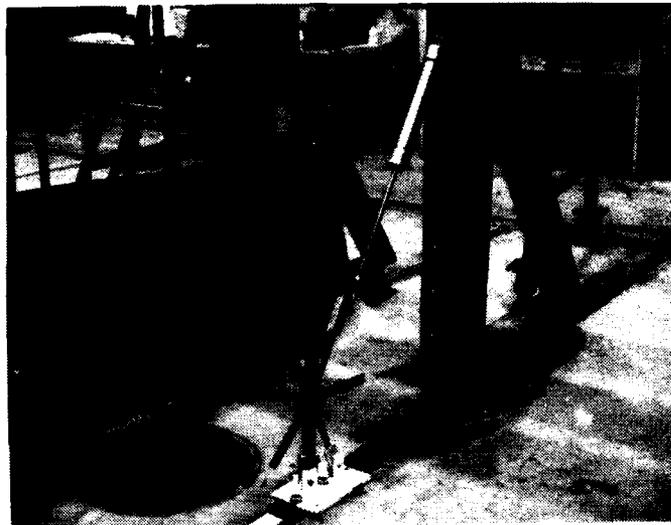
Figure 20. Member Joint Testing

Besides the individual member tests, member joint tests were performed to verify that sufficient capability exists to transfer loads among the members. The specimens were loaded in tension as shown in Figure 20.

Machined aluminum end fittings were attached to the constraint and load application members. These fittings were attached to the joint specimen members in double shear with a high strength epoxy bond. A single bolt hole was drilled in each fitting to provide for a pinned attachment. Before failure, the member joint was able to successfully transfer 150 percent of the maximum longeron load predicted by the design configuration study NASTRAN model (see Table 6). Failure of all specimens was a result of a compression failure in diagonal member 3 (see Figure 21). No spreading or ply delamination took place at the member joint of either specimen (Reference Figure 22).

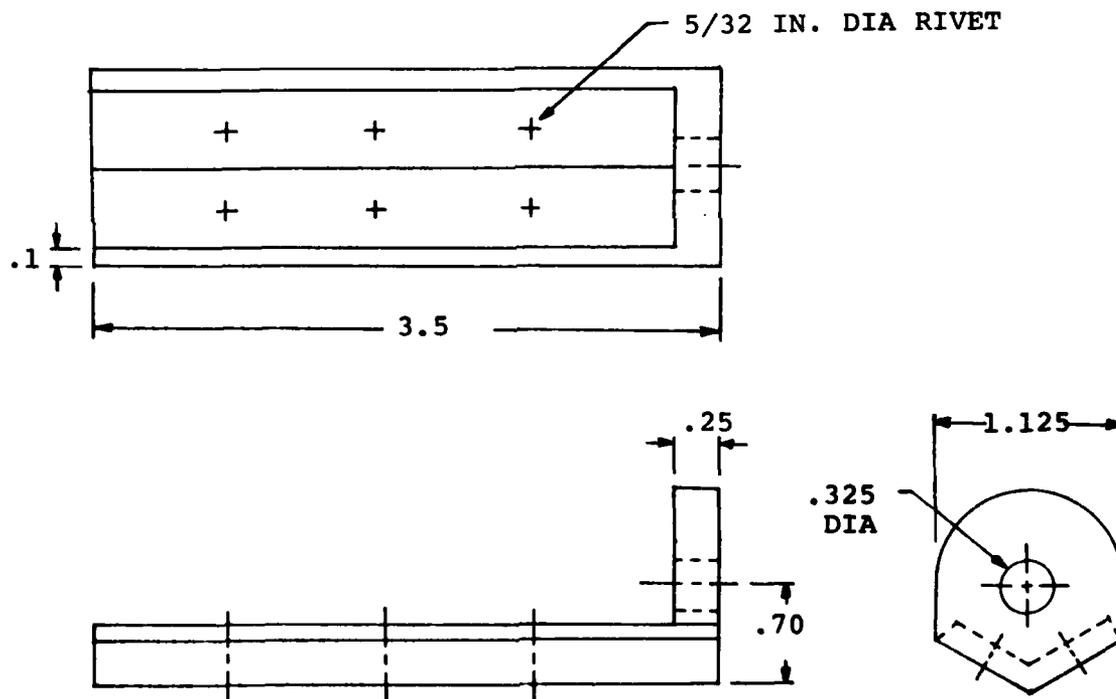
Figure 23. Machined Attachment Fitting

A 5/16-inch-diameter bolt was used to apply loading to the fitting. A fiberglass grip pad was built up on the other end of the longeron section. A tensile load was applied to the fitting. Test results are shown in Table 7.

Both specimens failed due to shear tearout at the bolt hole. This failure was directly related to the marginal e/D ratio provided by this design.

Although this fitting design and attachment procedure provided a 13-percent margin of safety, it proved to be costly both in terms of manufacturing cost and in the calendar time required for fabrication. While the use of rivets and adhesive to secure the fitting to the longeron was a working solution, it was not altogether satisfactory. The single shear bond failed at 2120 pounds for specimen 1, and 2640 pounds for specimen 2. Careful examination of the specimens after failure revealed that a slight (<.01 inch) amount of movement in the fitting relative to the longeron was noticeable. This movement was due to a bearing failure around the rivet holes in the longeron member.

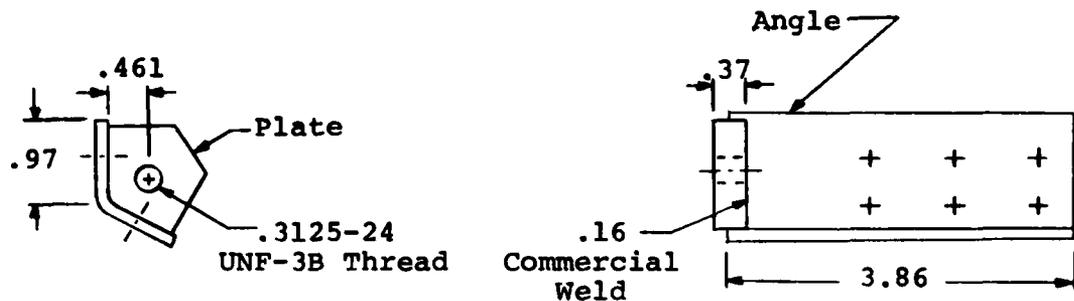
Figure 24. Welded Attachment Fitting

The angle was cold formed to fit the outside longeron contour. The face plate was cut from the same steel plate and welded to the angle. A 5/16-inch-diameter hole was drilled and tapped into the face plate. This allowed the attachment bolt to be positioned nearer the angle centroid since a nut bearing diameter and weld radius clearance did not have to be incorporated into the design.

Two additional attachment joint specimens were built and tested in order to verify the structural integrity of the welded endplate. Both specimens were loaded in excess of 200 percent of design load. No failure or material yielding was observed at this load level.

Two design changes were incorporated to alleviate the rivet bearing. First, the rivet diameter was increased from 5/32 inch to 3/16 inch. Second, two layers of fiberglass cloth were included in the longeron stacking sequence in the area of the attachment fittings. It was felt that the glass would provide a superior bearing surface than would the graphite by itself.

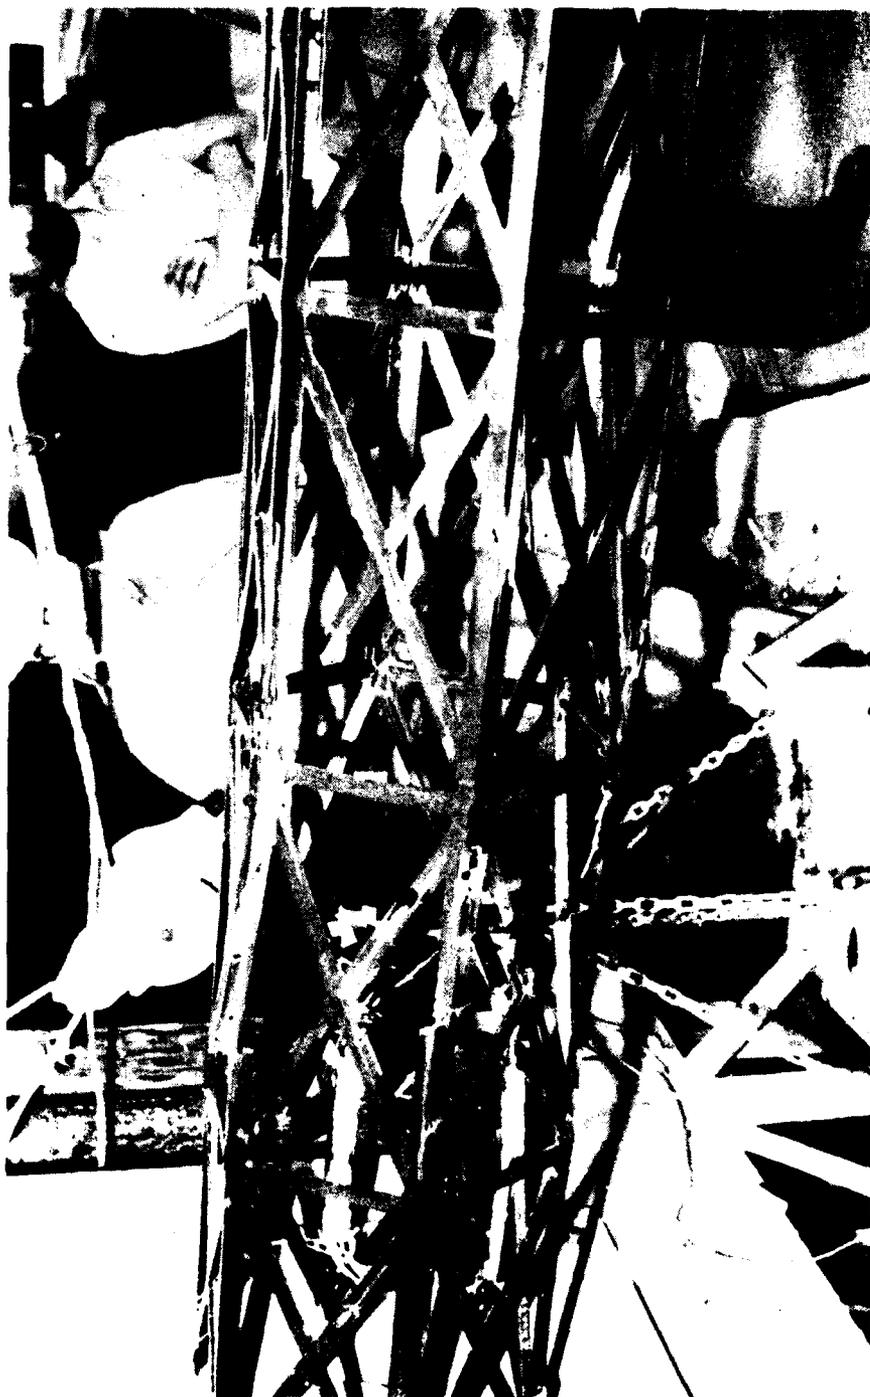
Figure 35. Exit Side Damage, Specimen 1

Fragments destroyed the three tension side longerons and numerous diagonal members on the upper, lower, and exit sides of the truss. Figure 35, view looking inboard at the exit side of the truss, shows the fragment damage. Figure 36 shows the approximate amount of damage done to each member. The fraction shown by each member is the percentage of area damaged by the shell fragments.

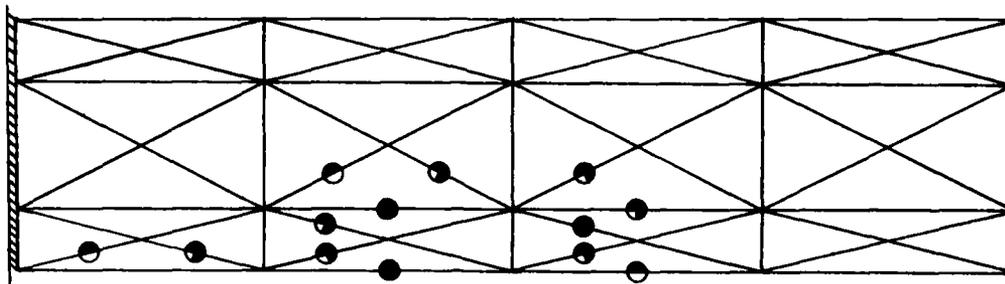
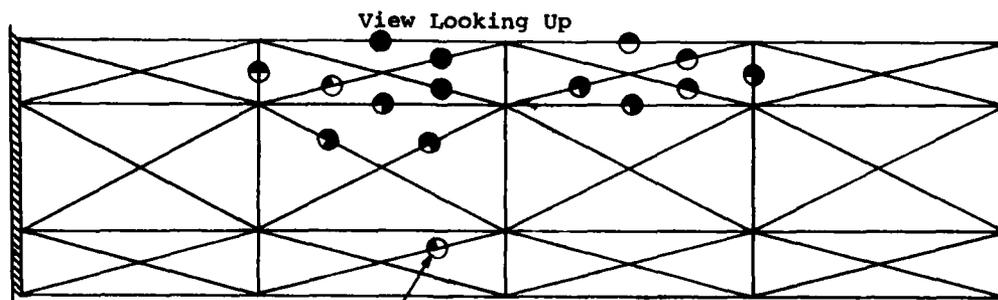
Figure 36. Individual Member Damage, Specimen

● Darkened area represents amount of damaged material

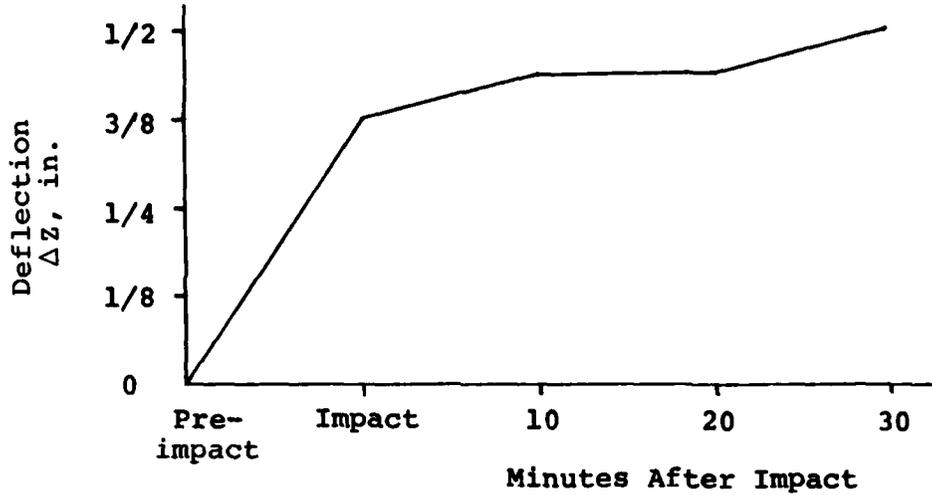
Figure 37. Boom Deflection After Impact

$$[\tan^{-1} (.375)/B.S. 60.00 - B.S. 25.00)] = .61 \text{ degree}$$

Even when the additional 1/8-inch creep deflection is included, the angle $[\tan^{-1} .5/35]$ of .82 degree is within the tail rotor driveshaft misalignment angle allowable of 1.5 degrees.

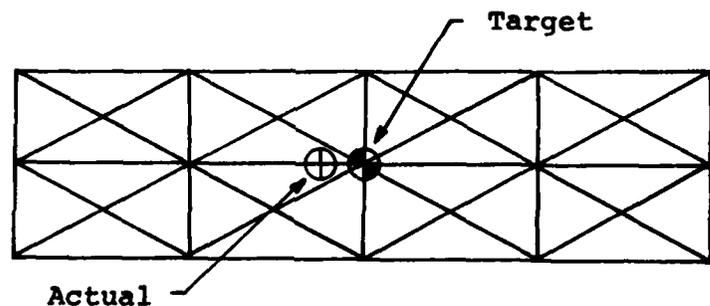
Figure 38. Targeted Impact Area, Specimen 2

The round impacted a point on the outermost compression longeron slightly aft of the targeted joint (Figure 38).

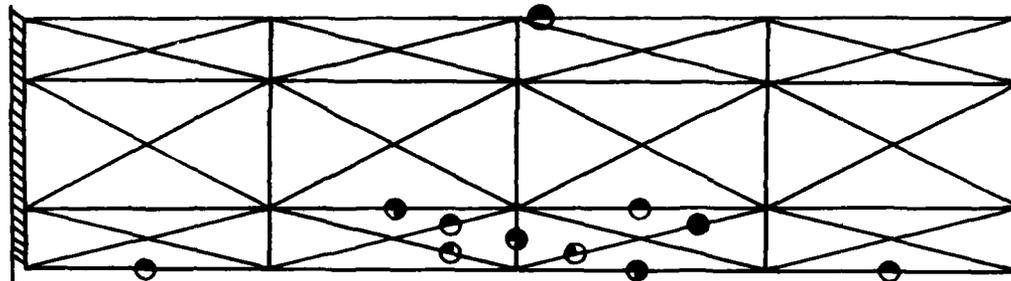
Figure 42. Individual Member Damage, Specimen 2

● Colored portion represents percent of damaged fibers

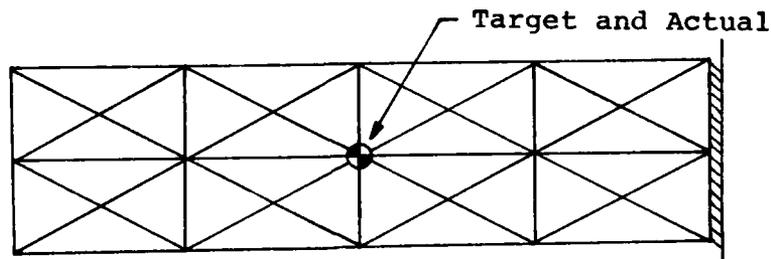
Figure 44. Targeted Impact Area, Specimen 3

The test plan for specimen number 3 called for the ballistic impact to be at the most outboard compression longeron/ frame joint at B.S. 30.0 (Figure 44).

The round impacted the target area, completely destroying continuity between the frame, diagonal, and longeron members. The base fragment destroyed the majority of the outboard tension longeron/frame joint (Figure 45). Other longeron and diagonal members were blown away, indicating that multiple fragment hits may have detached some members from the structure. The most outboard tension longeron between B.S. 30.0 and B.S. 45.0 and part of the exit side frame at B.S. 30.0 appears to have been severed at both ends. These members were among those found several feet away from the test specimen. Both the upper and lower tension longerons were subjected to fragment damage. Figure 46 shows the upper tension longeron. The upper half appears to have been cut with a fragment, leaving the lower leg to fail under a tensile load.

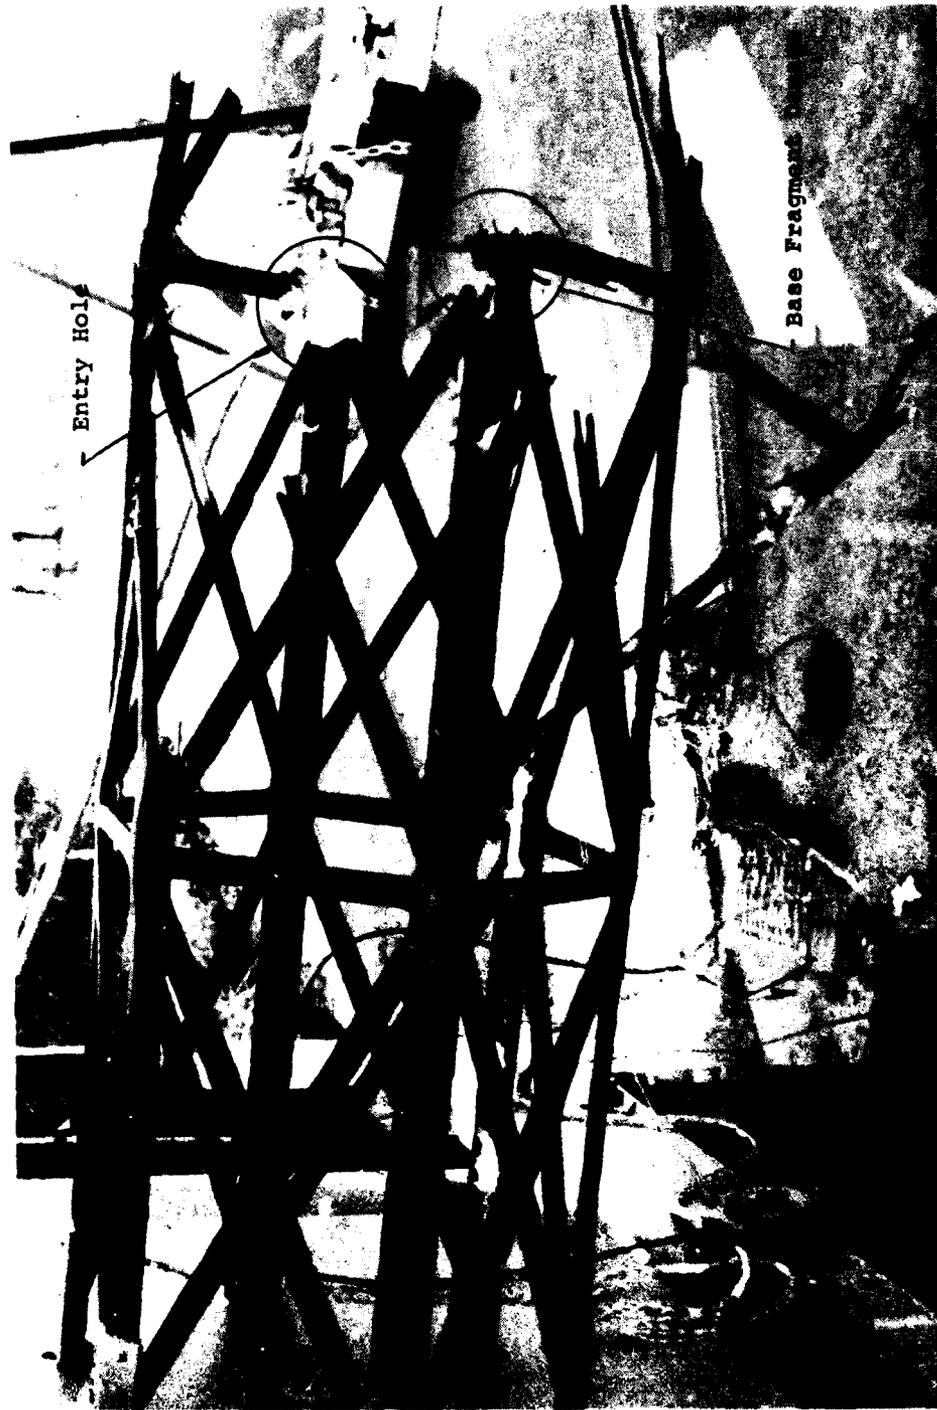
Figure 45. Fragment Damage, Specimen 3

Only the upper and lower compression longerons survived and retained the majority of their structural integrity after impact. These members could not support the applied loads and the truss collapsed immediately after impact.

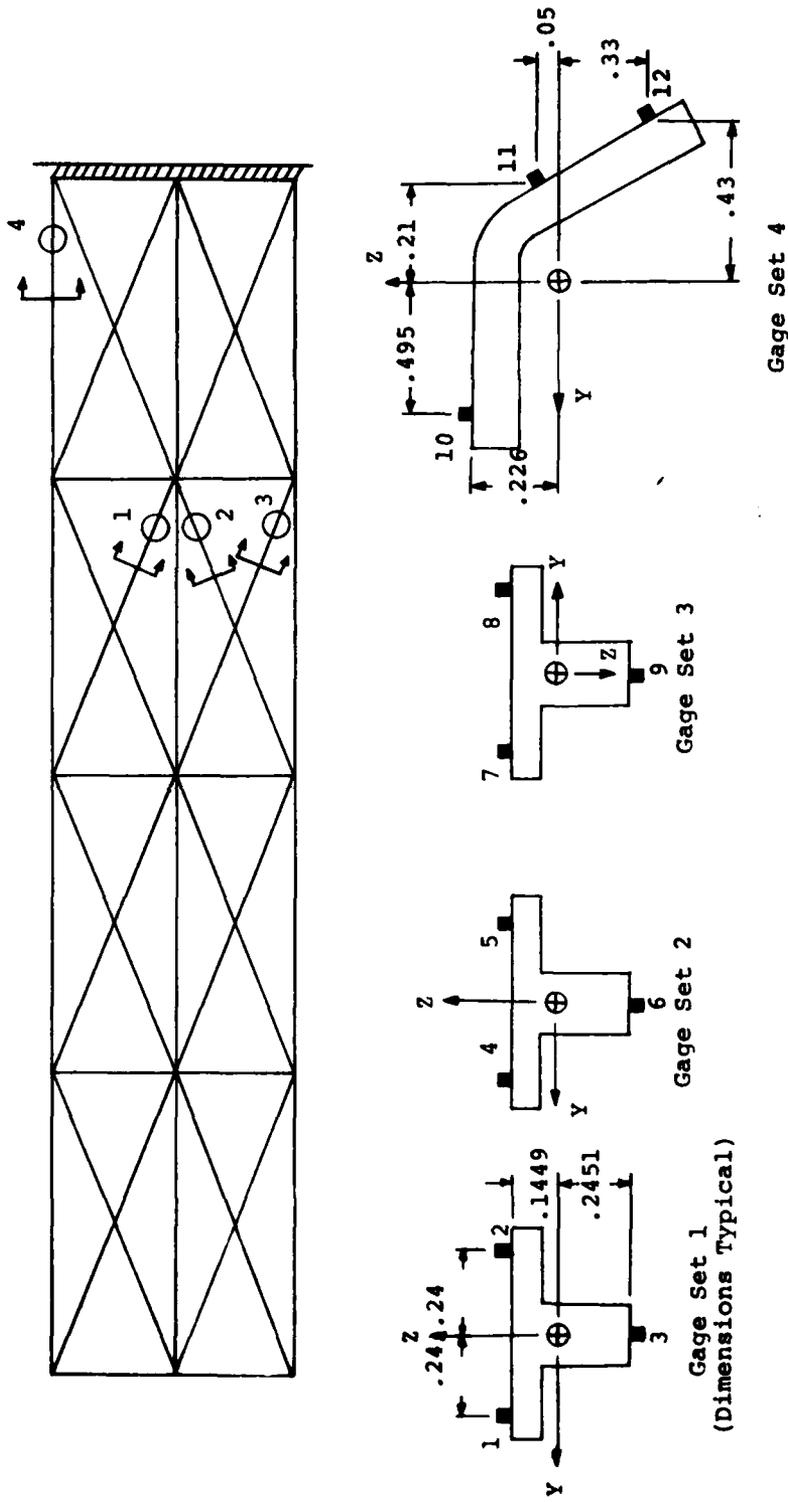
Figure 48. Strain Gage Locations, Specimen 1

Predicted strains at the gage locations were obtained by reducing the NASTRAN force and moment output data for the members of interest.

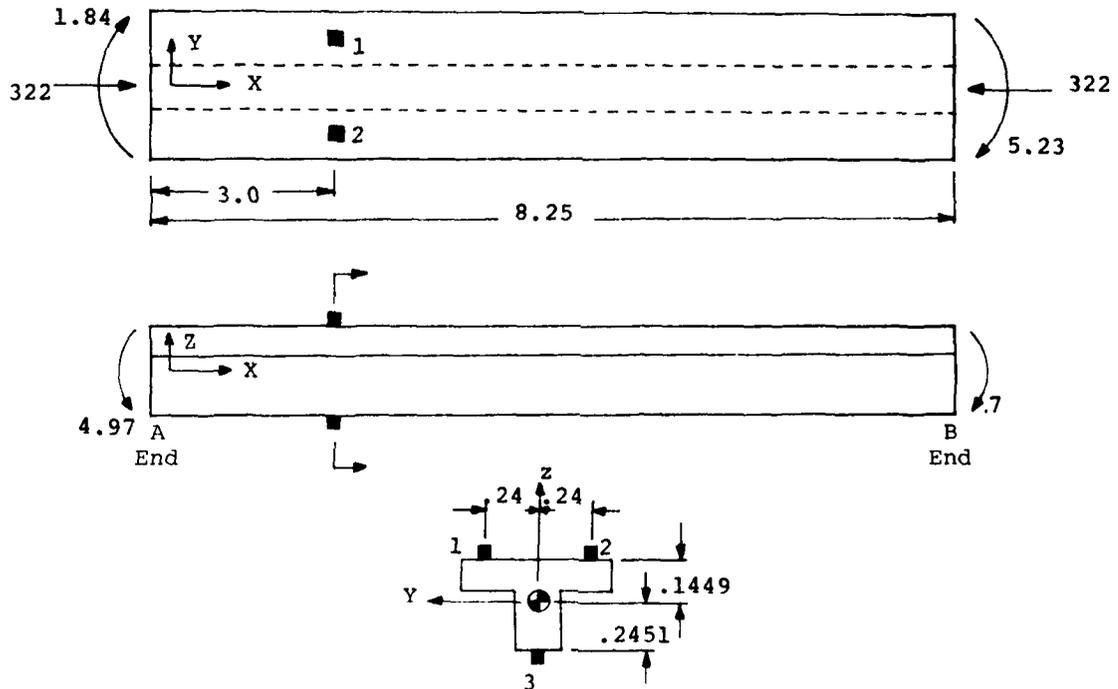
Figure 49. NASTRAN LOADS, Member 1, Specimen 1

Forces and moments are output from NASTRAN at the member end points. The gages were located approximately three inches from the 'A' end of the NASTRAN element. A straight line moment distribution was used to calculate the stress at the gage location. Axial force is considered to be constant throughout the length of the member (Figure 49).

Looking at gage 2 (located on the outboard flange) the stress due to bending at the 'A' end is $f_b = \frac{M_C}{I_2} + \frac{M_C}{I_1}$

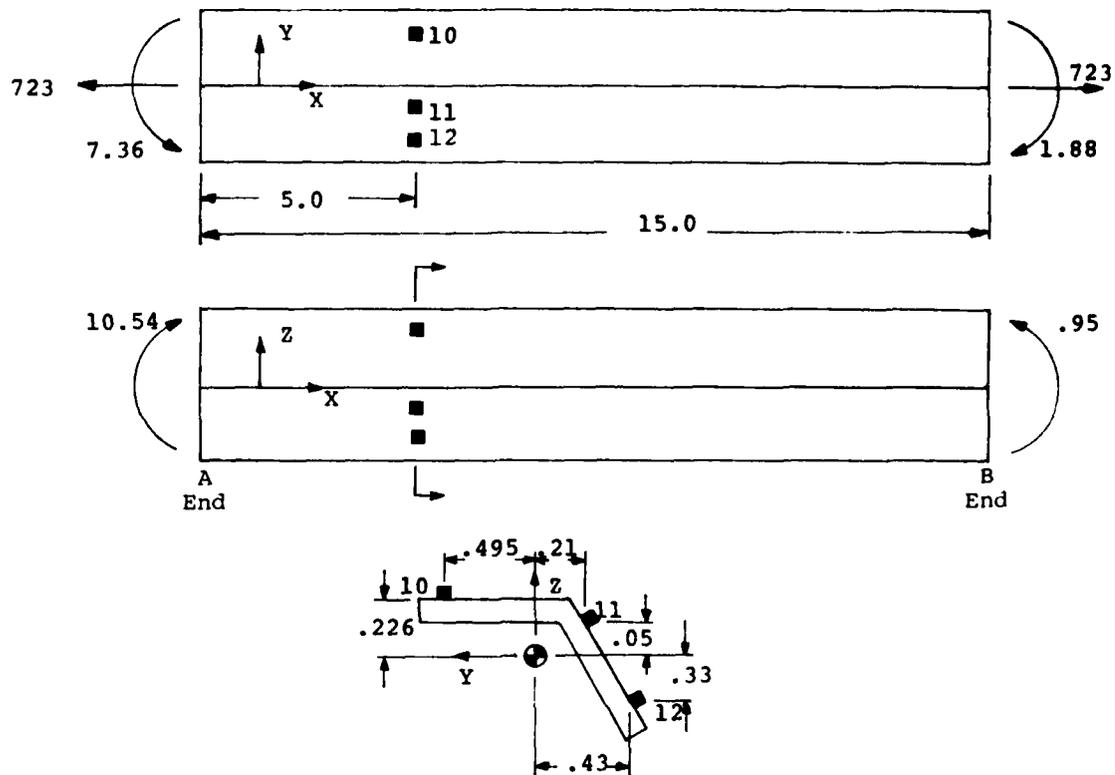
Figure 50. NASTRAN LOADS, Member 4, Specimen 1

Predicted strain values for the longeron members were obtained as follows (Figure 50):

At gage 10 (level leg, inboard), the bending stress at the 'A' end is
