FINAL REPORT
DRY LUBRICATION OF HIGH TEMPERATURE
SILICON NITRIDE ROLLING CONTACTS
N00019-79-C-0612

T. M. YONUSHONIS

NOVEMBER 17, 1980

U.S. DEPARTMENT OF THE NAVY
NAVAL AIR SYSTEMS COMMAND (AIR-5163D4)
WASHINGTON, D.C. 20361

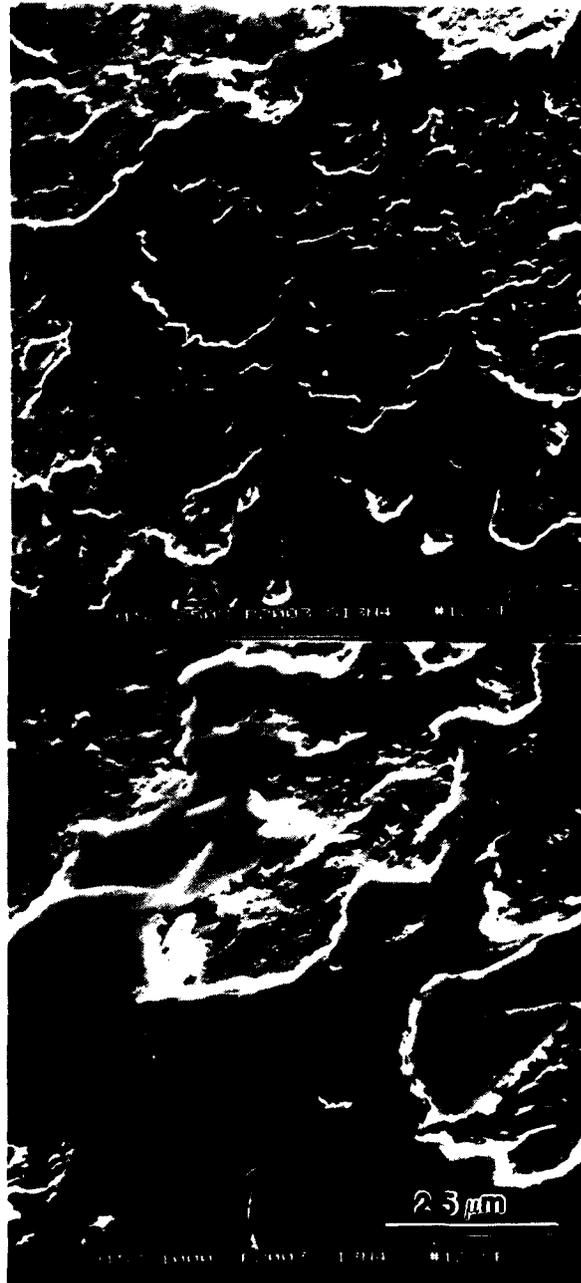
Scanning electron photomicrographs of solid lubricant coating on support ball. Lubricant was supplied by a Pure Carbon P2003 graphite cage. Test Conditions: 1000°F (538°C) for 139 hours (187 million stress cycles).

Support balls were also examined by optical and SEM methods. Figure 12 shows SEM photomicrographs of a partial solid lubricant coating on the support ball surface. X-ray wavelength spectroscopy was unsuccessfully used in an attempt to determine the solid lubricant film composition. This result was not totally

unexpected since thin carbon films are very difficult to detect by this technique. Scanning auger microscopy would probably be successful at positively identifying the film composition.

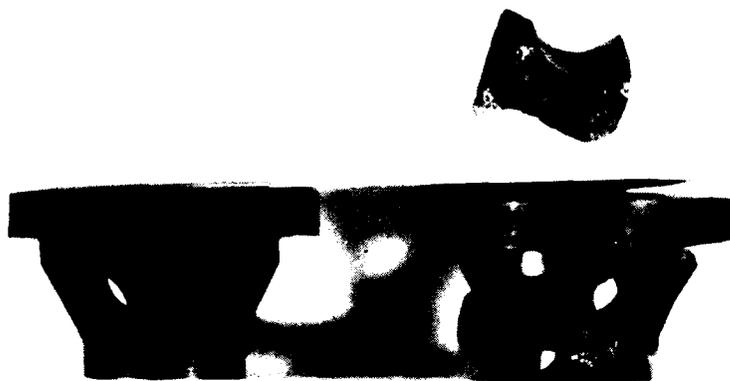
Figure 22 Photographs of L-23745 cage manufactured from POCO Graphite, Inc. AFX-5QE graphite and Union Carbide Co. CJPS graphite-carbon before and after test.

POCO GRAPHITE
AFX-5QE
(NEW)

POCO GRAPHITE
AFX-5QE
(71 HOURS, 1000°F)

UNION CARBIDE
CJPS
(NEW)

UNION CARBIDE
CJPS
(25 HOURS, 1000°F)
