COMBAT DAMAGE ASSESSMENT TEAM,
A-10/GAU-8 LOW ANGLE FIRINGS
VERSUS
SIMULATED SOVIET TANK COMPANY (ARRAY 20)
(AEROJET LOT NUMBER AJD 79A181-001)
(19 SEPTEMBER 1979)
10 Kussel D.H.S. STOLFI
Raymond B.R. MCEACHIN
11 MAY 1980

4. TITLE (and Subtitle) A-10/GAU-8 Low Angle Firing versus Simulated Soviet Tank Company (Array 20) (19 September 1979) (Aerojet Lot Number AJD 79A181-001)		5. TYPE OF REPORT & PERIOD COVERED Special report for Array Firings of 19 Sep 1979

20. ABSTRACT (Continue on reverse side if necessary and identify by block number) This report describes firings of the A-10/GAU-8 weapon system on 19 September 1979 against a Soviet tank company simulated by 10 combat loaded M-47 tanks. The pilots making the firing passes attacked at low altitude and used correspondingly low dive angles in order to simulate movement through a hostile air defense system. Ammunition used in the attacks comprised Aerojet Lot Number AJD 79A181-001 30mm armor piercing incendiary (API) rounds, which proved to be effective damage agents against substantial areas of

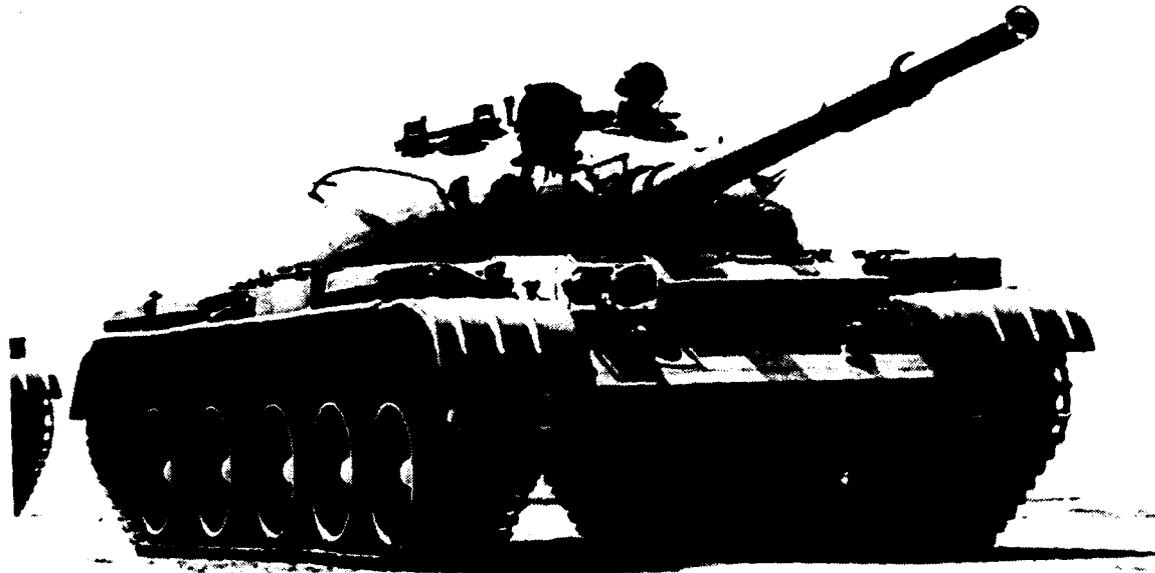
FIGURE 1. Russian T62 Medium Tank

Russian T62 Medium Tank

The most effective tanks available in sufficient numbers to simulate Soviet T-55 and T-62 (Figure 1) tanks were the US M-47 tanks. Both of the Soviet tank models are similar in armor protection to the M-47. With the appropriate purging of the gasoline fuel system of the US tanks, the CDAT managed to field a tank similar in survivability to the T-55 and T-62 tanks from the viewpoint of ignitable internal material. Few data are available on the Soviet T-64 and later model tanks from the viewpoints of armor protection and the arrangement of internal components. The decision was made, accordingly, to simulate the earlier model Soviet tanks with the readily available US tanks.

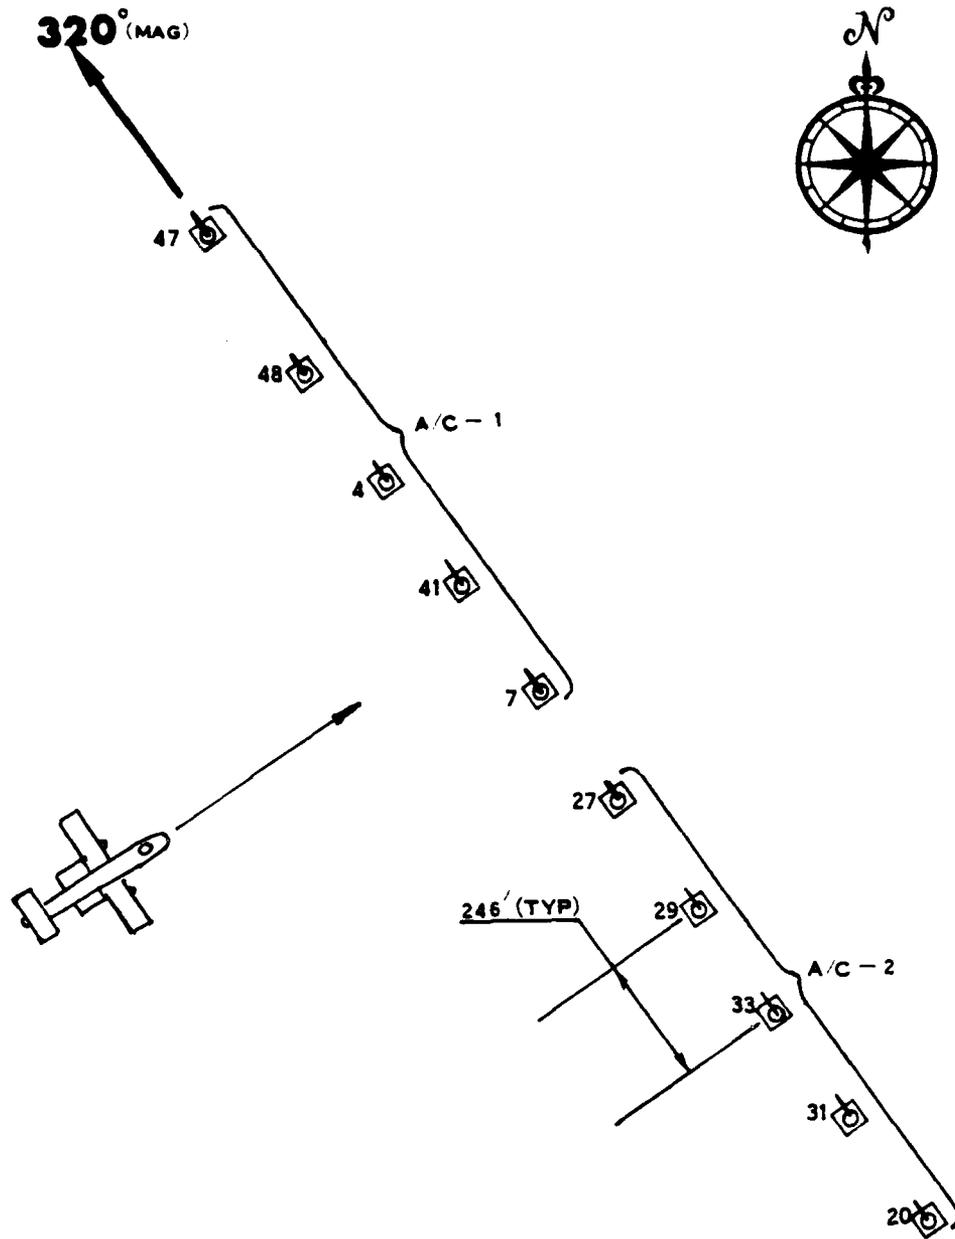
FIGURE 6. Approximate Target Layout.

The data noted immediately above were collected through the combined efforts of the CDAT and range support personnel at Nellis AFB, working together and using TSPI equipment, motion picture and still cameras, the industrial efforts required to repair, refurbish, and field the tank targets, and various systematic research techniques used to describe weapon effects and combat damage. The most basic materiel used in the test; i.e., the aircraft, gun, and projectile are illustrated in Figures 2, 3, 4, and 5. The tanks were arrayed in the tactical formation of a column of Soviet tanks as shown in Figure 6.

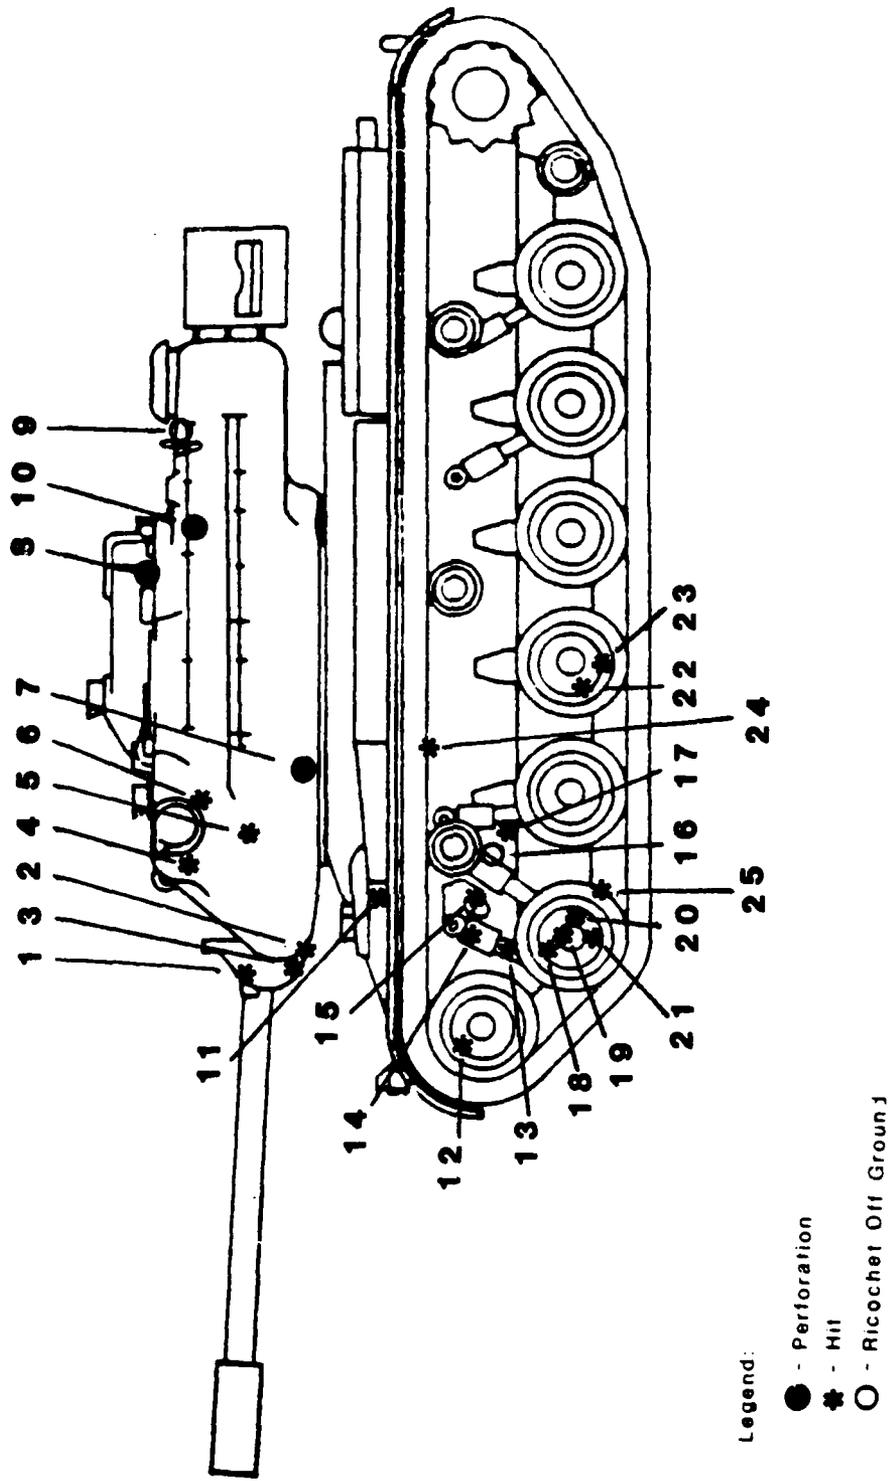
FIGURE 7. Impact Diagram, Tank 47.

100% M-Kill and 100% F-Kill resulting from the following observed projectile effects (Figure 7):

- a. M-Kill: The assessment of 100% M-Kill was based on impacts 7, 8, and 10 which perforated the left side of the turret killing the commander (Figure 8) and gunner and wounding the loader, driver, and bow gunner (Figure 9), impact 19 which destroyed the left number 1 road wheel hub, and impacts 13, 14, 15, 24, and 25 (Figure 10) which cumulatively damaged the track and suspension system.
- b. F-Kill: The assessment of 100% F-Kill is based on crew casualties to all five crew members.

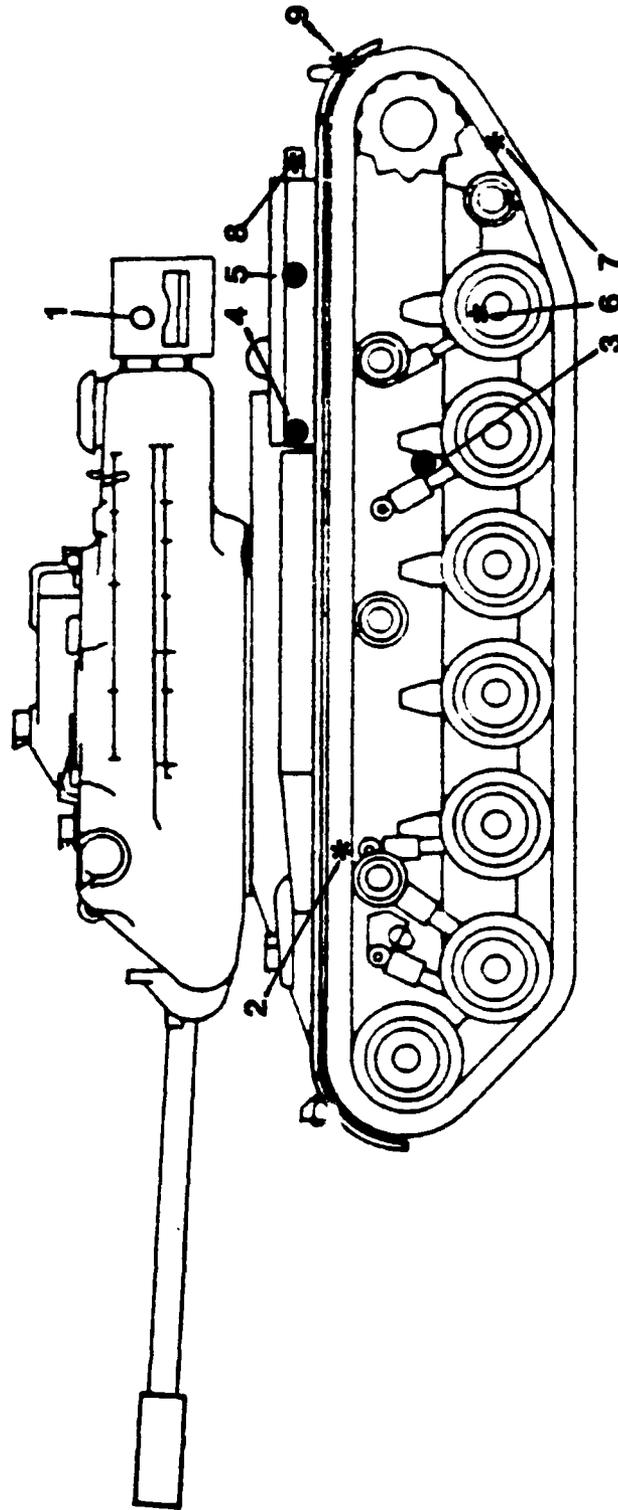
FIGURE 11. Impact Diagram, Tank 48.

100% M-Kill based on the following observed effects (Figure 11):

The assessment of 100% M-Kill is based on impact 3, which perforated the left hull and penetrated into the left fuel cell, and impact 5, which perforated the left hull into the engine compartment destroying the coupling on the oil cooler inlet line from the transmission (Figure 12).

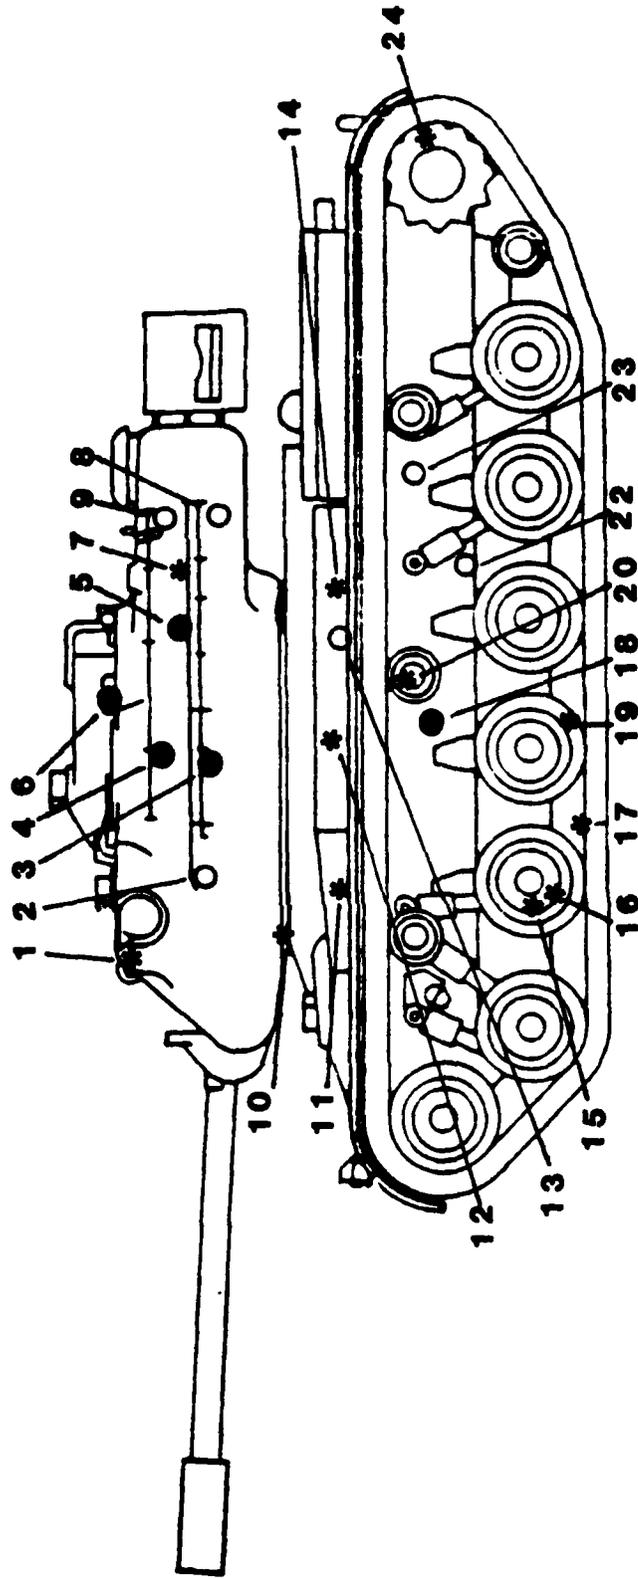
FIGURE 13. Impact Diagram, Tank 4.

90% M-Kill and 95% F-Kill resulting from the following observed effects (Figures 13):

NOTE: Number 21 not depicted.

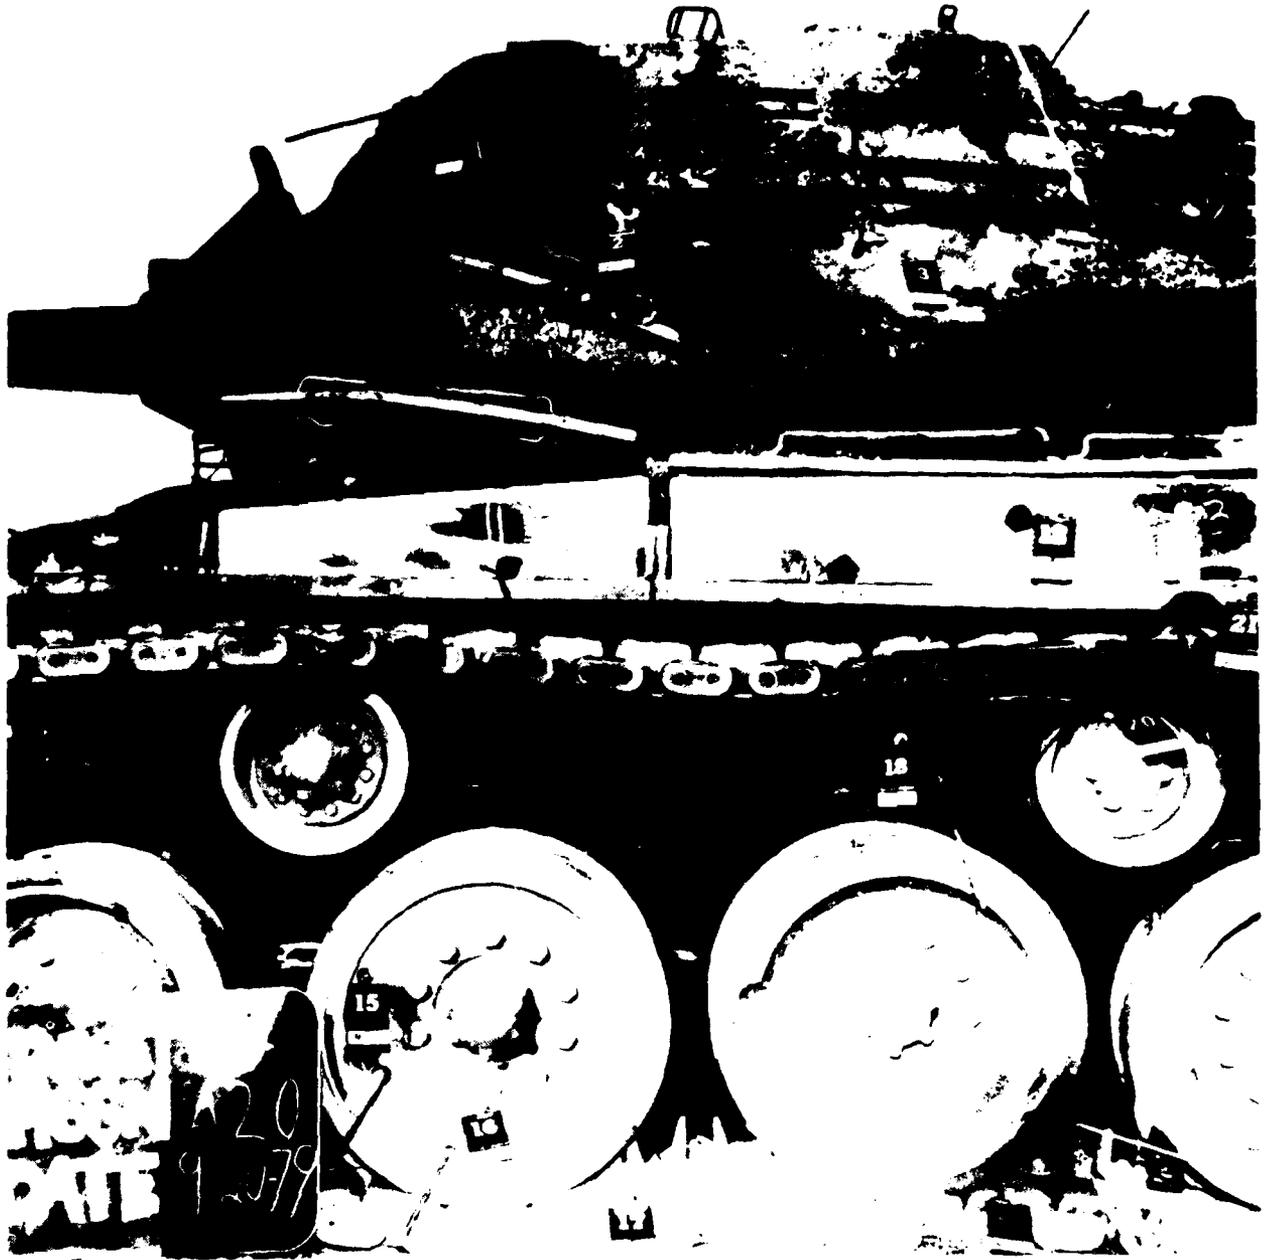
FIGURE 14. Crew Casualties Resulting from Impacts 3, 4, 5, and 6; Tank 4.

a. M-Kill: The assessment of a 90% M-Kill is based on casualty criteria resulting from impacts 3, 4, 5, and 6 (Figure 14) which caused casualties to all crewmen in the fighting compartment. The tank could continue its mission after replacement of the wounded crewmen.

b. F-Kill: The assessment of a 95% F-Kill is also based on casualty criteria. The tank could continue its mission after replacement of the wounded crewmen.

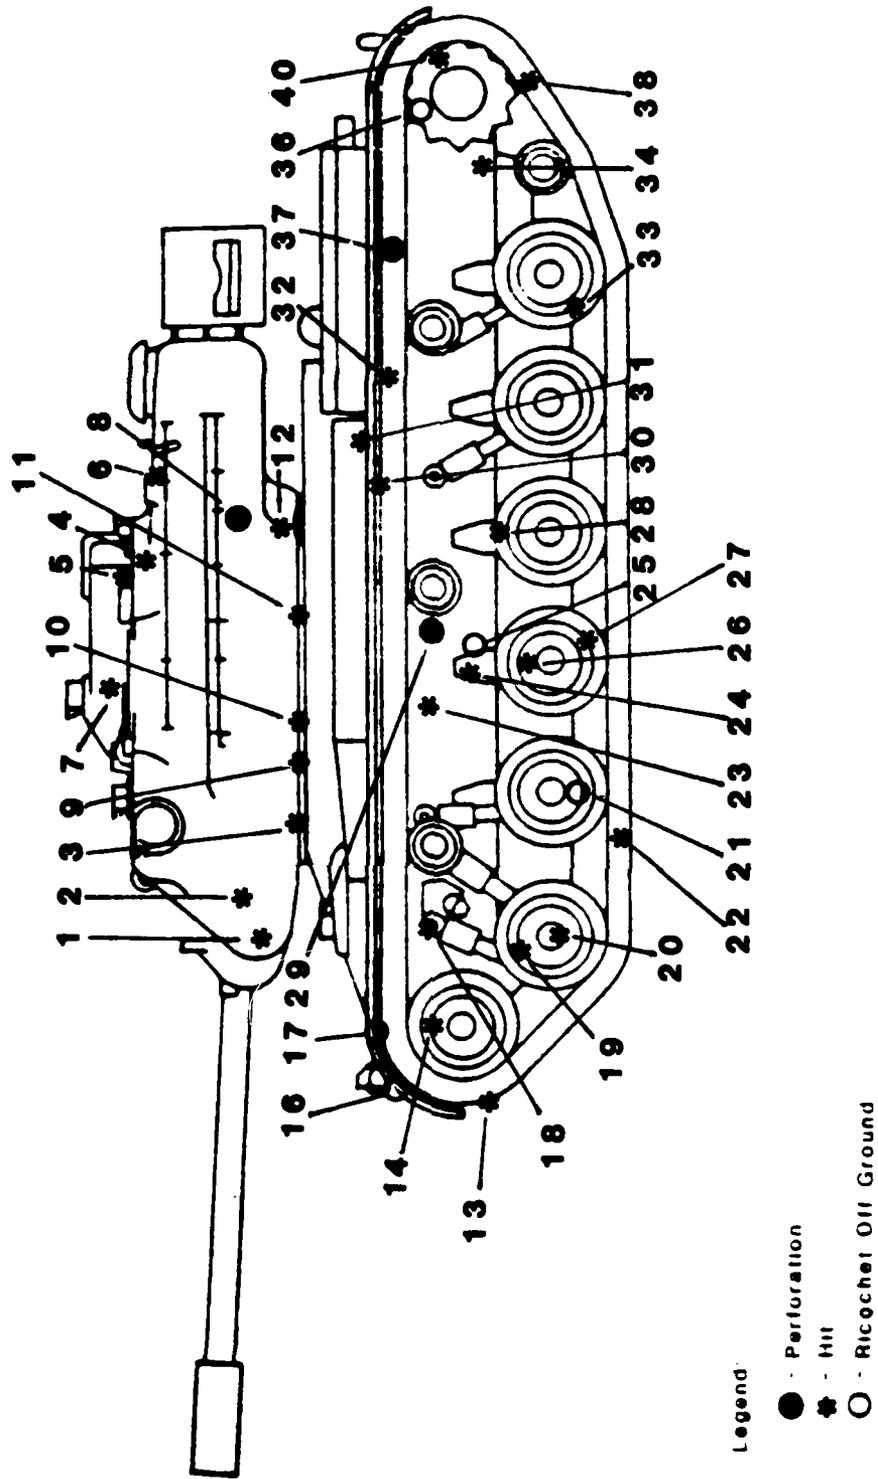
FIGURE 15. Impact Diagram, Tank 41, Left Side.

100% M-Kill and 100% F-Kill resulting from the following observed effects (Figures 15 and 16):

- a. M-Kill: The assessment of a 100% M-Kill is based on impact 29 which perforated the left hull armor and penetrated the fuel tank; to impact 8 (Figure 17) which wounded all personnel in the fighting compartment; and to cumulative damage to the track and suspension system resulting from impacts 13, 15, 20, 22, and 33 (see Figure 18 for impacts 13, 20, and 22).
- b. F-Kill: The assessment of 100% F-Kill is based on impacts 9, 10, and 11, which jammed the turret and prevented it from traversing (Figure 19); and impact 8 which incapacitated the tank commander, gunner and loader.

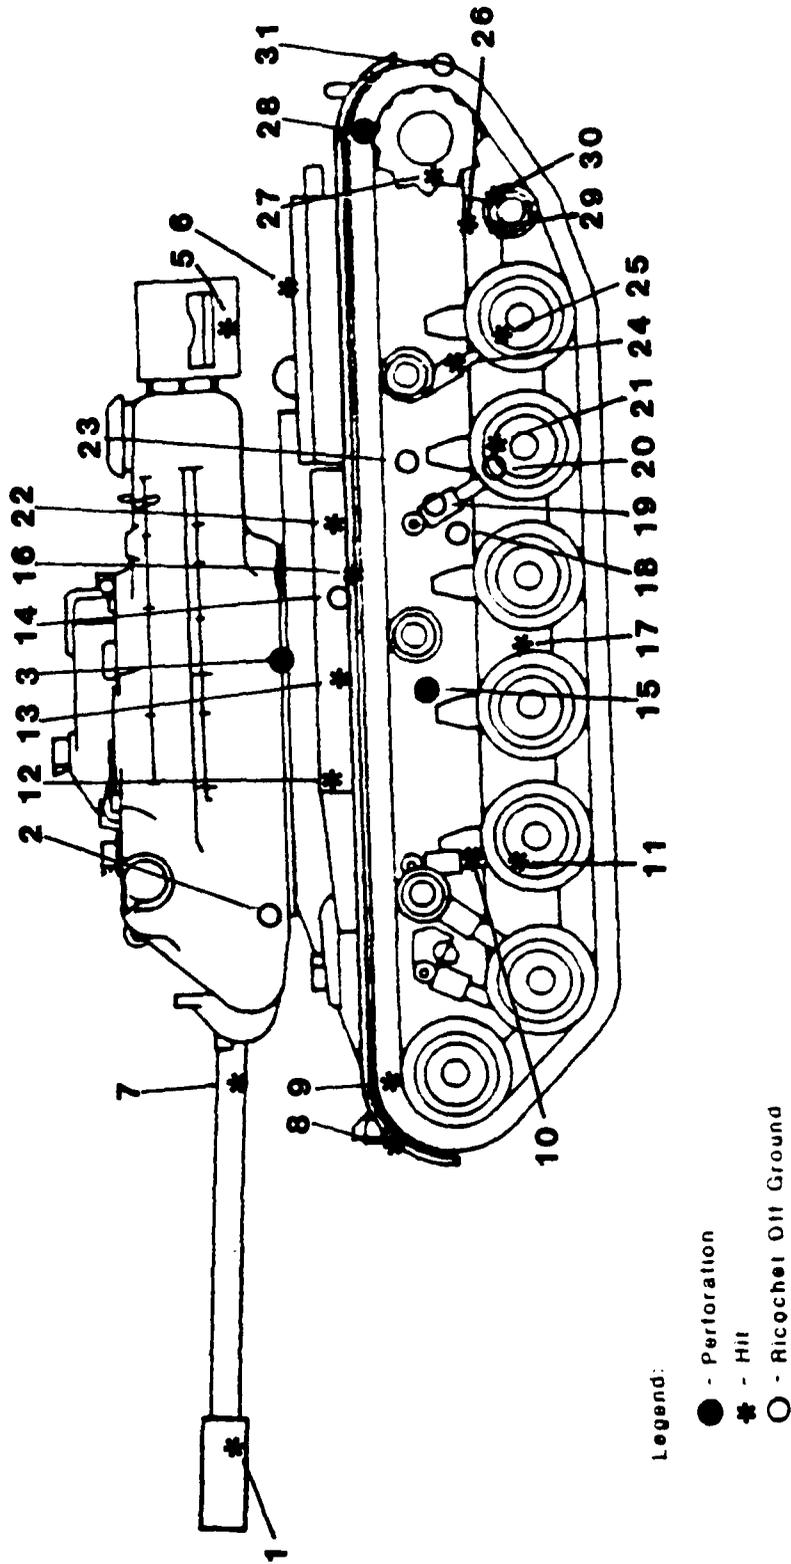
FIGURE 20. Impact Diagram, Tank 7.

100% (interdiction type) M-Kill and 20% F-Kill resulting from the following observed effects (Figure 20):

NOTE: Impact number 4 did insignificant damage to the storage box, and is not depicted.

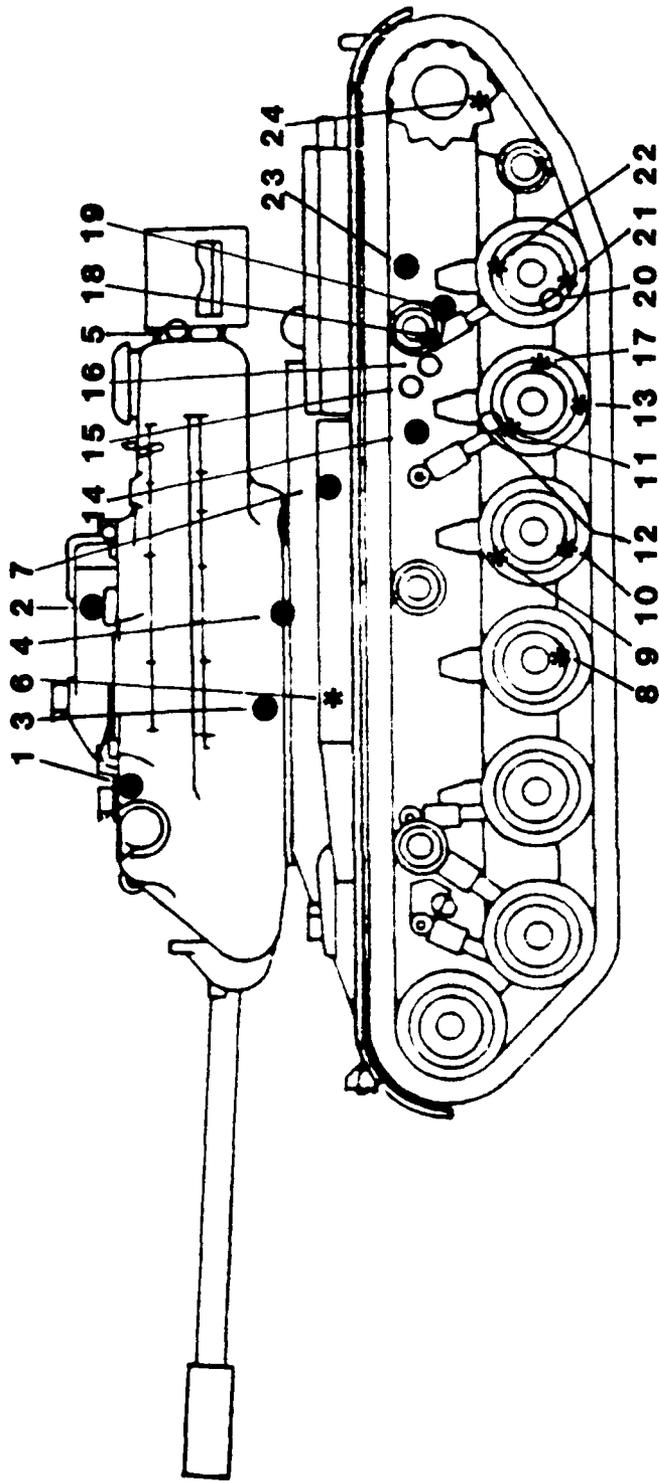
FIGURE 23. Impact Diagram, Tank 27.

100% K-Kill resulting from the following observed effects (Figure 23):

**Omitted - catastrophic fire and explosions overrode other damage.

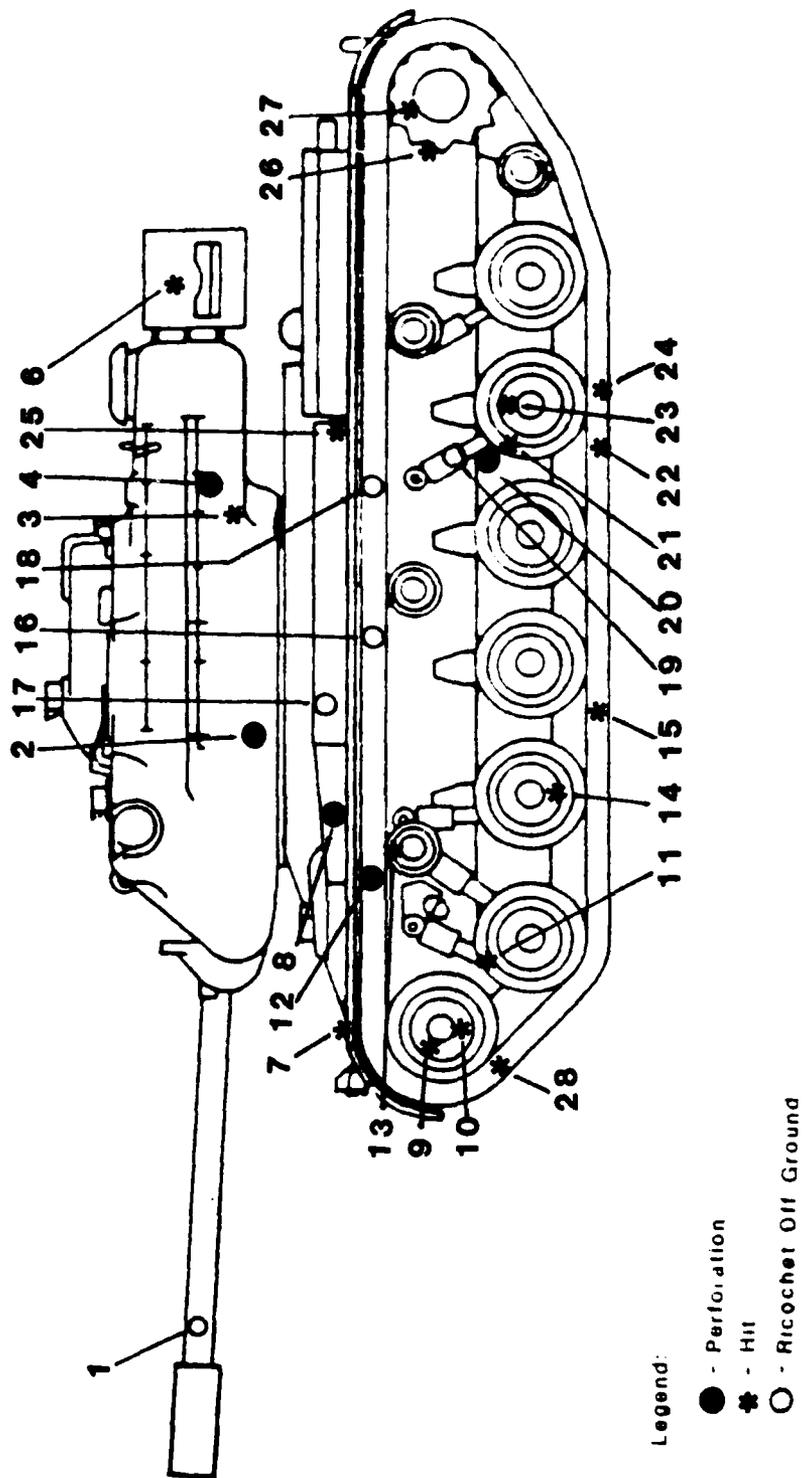
FIGURE 26. Impact Diagram, Tank 29.

100% K-Kill resulting from the following observed effects (Figure 26):

NOTE: Impact number 5 was a ricochet hit on left turret, not shown.

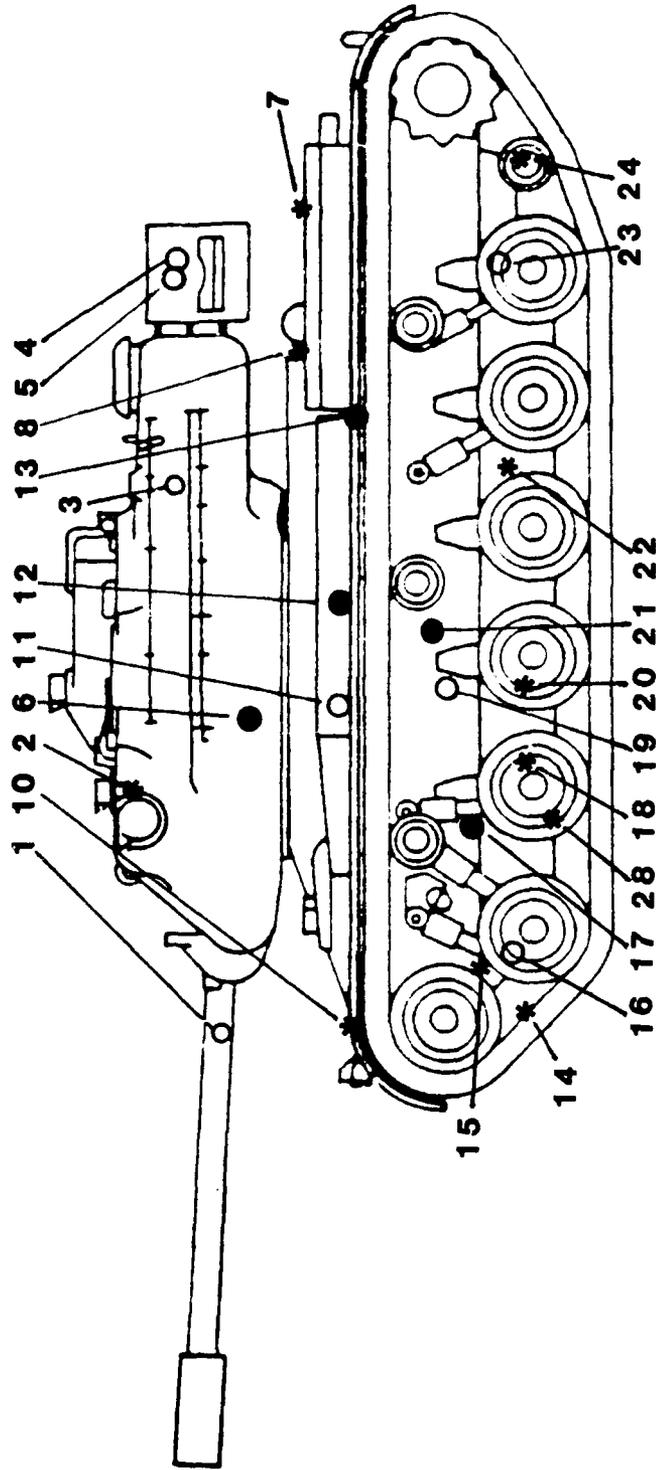
FIGURE 29. Impact Diagram, Tank 33, Left Side.

10% M-Kill and 30% F-Kill from the following observed effects (Figures 29 and 30):

NOTE: Impact number 9 was a simple hit which is not depicted.

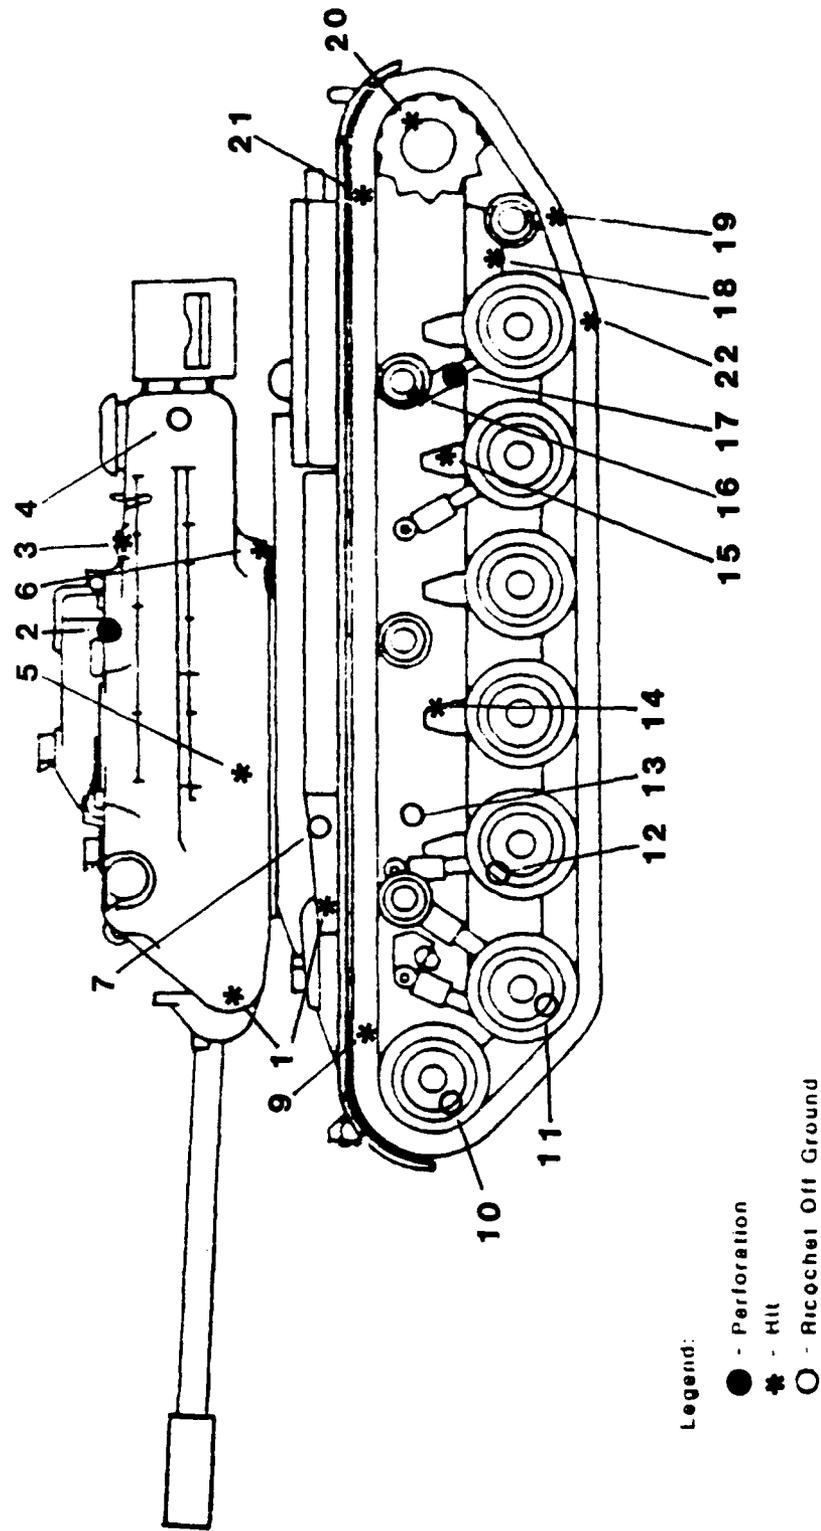
FIGURE 33. Impact Diagram, Tank 31.

100% M-Kill and 95% F-Kill resulting from the following observed effects (Figure 33):

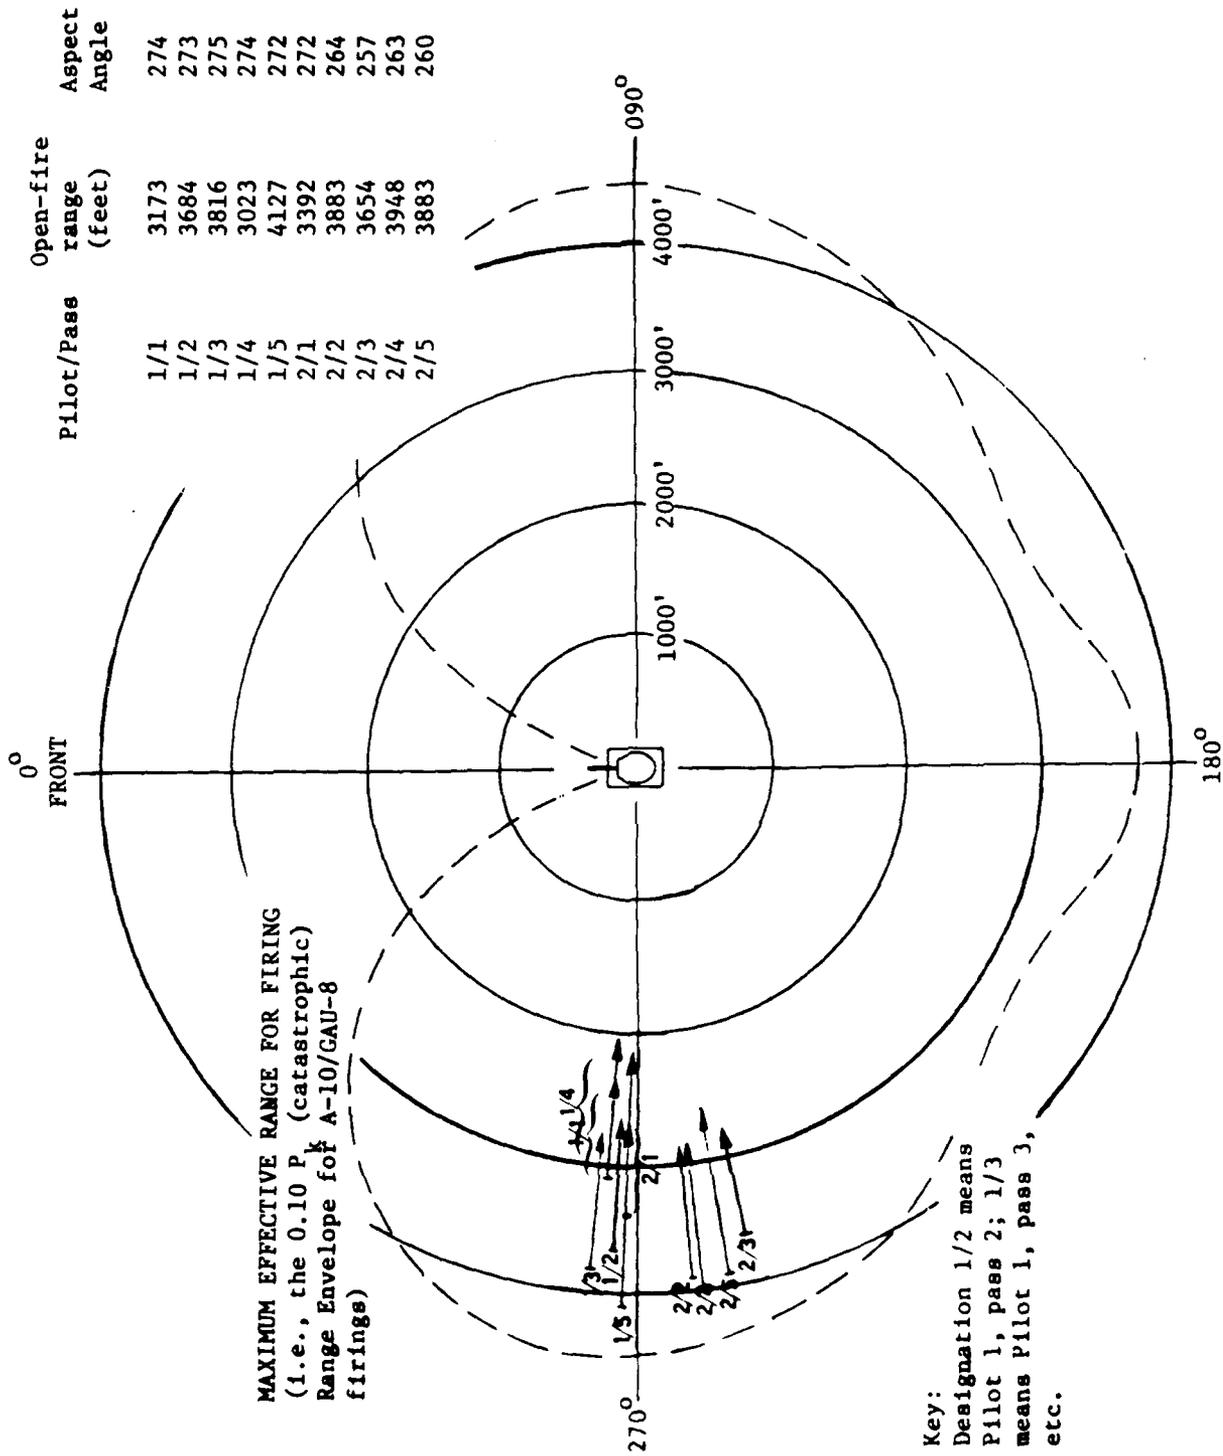
FIGURE A-1. Aircraft Attack Aspect.

Table A-I contains a summary of the results of Mission 20 of 19 September, 1979. Table A-II contains a summary of damage assessment based on perforation locations. Table A-III contains a summary of aircraft attack parameters. Figure A-1 depicts aircraft attack aspect by pilot as a function of open-fire range.
