FIELD INSPECTION OF THE FISHER RIVER  
CHANNEL REALIGNMENT PROJECT NEAR  
LIBBY, MONTANA,

11 Apr 81  
Inspection Report II

SECTION 32 PROGRAM  
STREAMBANK EROSION CONTROL EVALUATION AND DEMONSTRATION  
WORK UNIT 2 - EVALUATION OF EXISTING BANK PROTECTION

FIELD INSPECTION OF THE FISHER RIVER CHANNEL  
REALIGNMENT PROJECT NEAR LIBBY, MONTANA

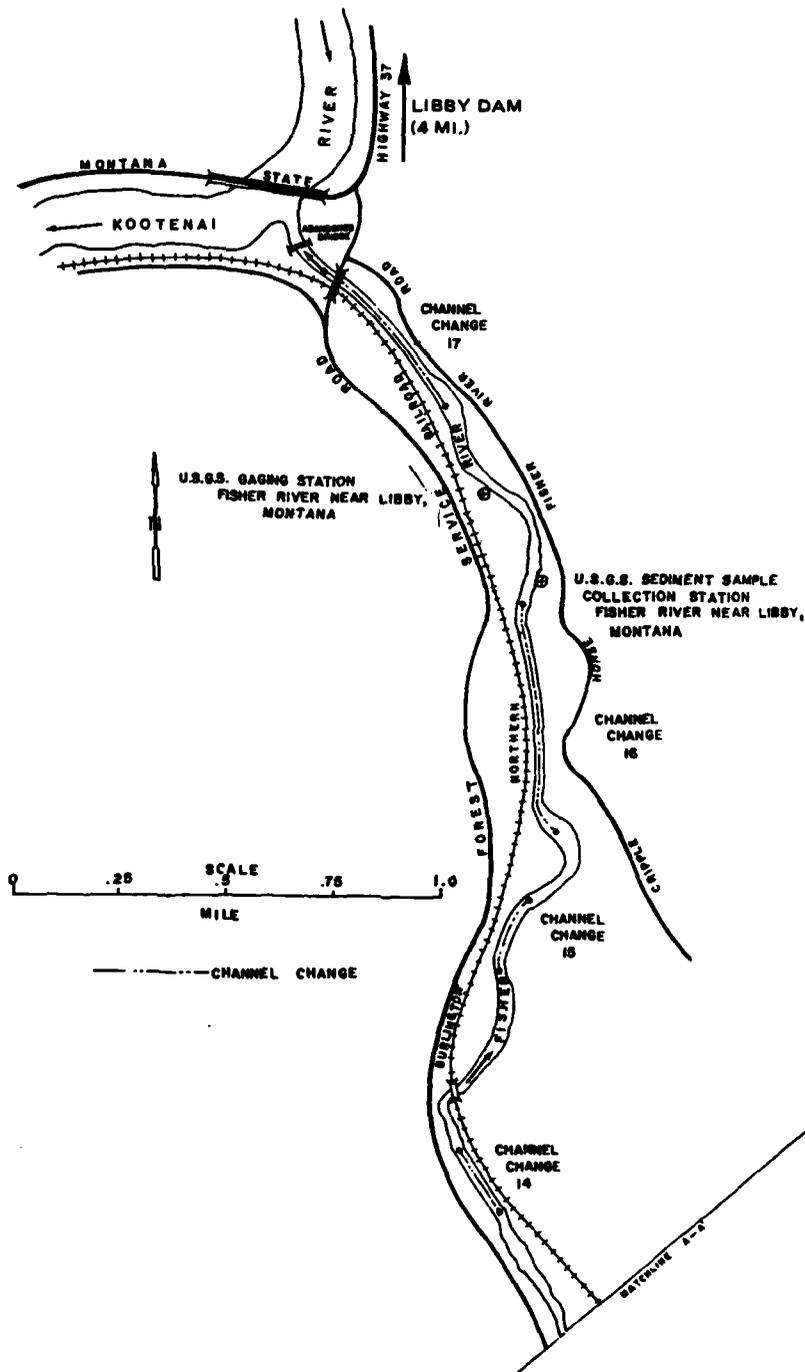
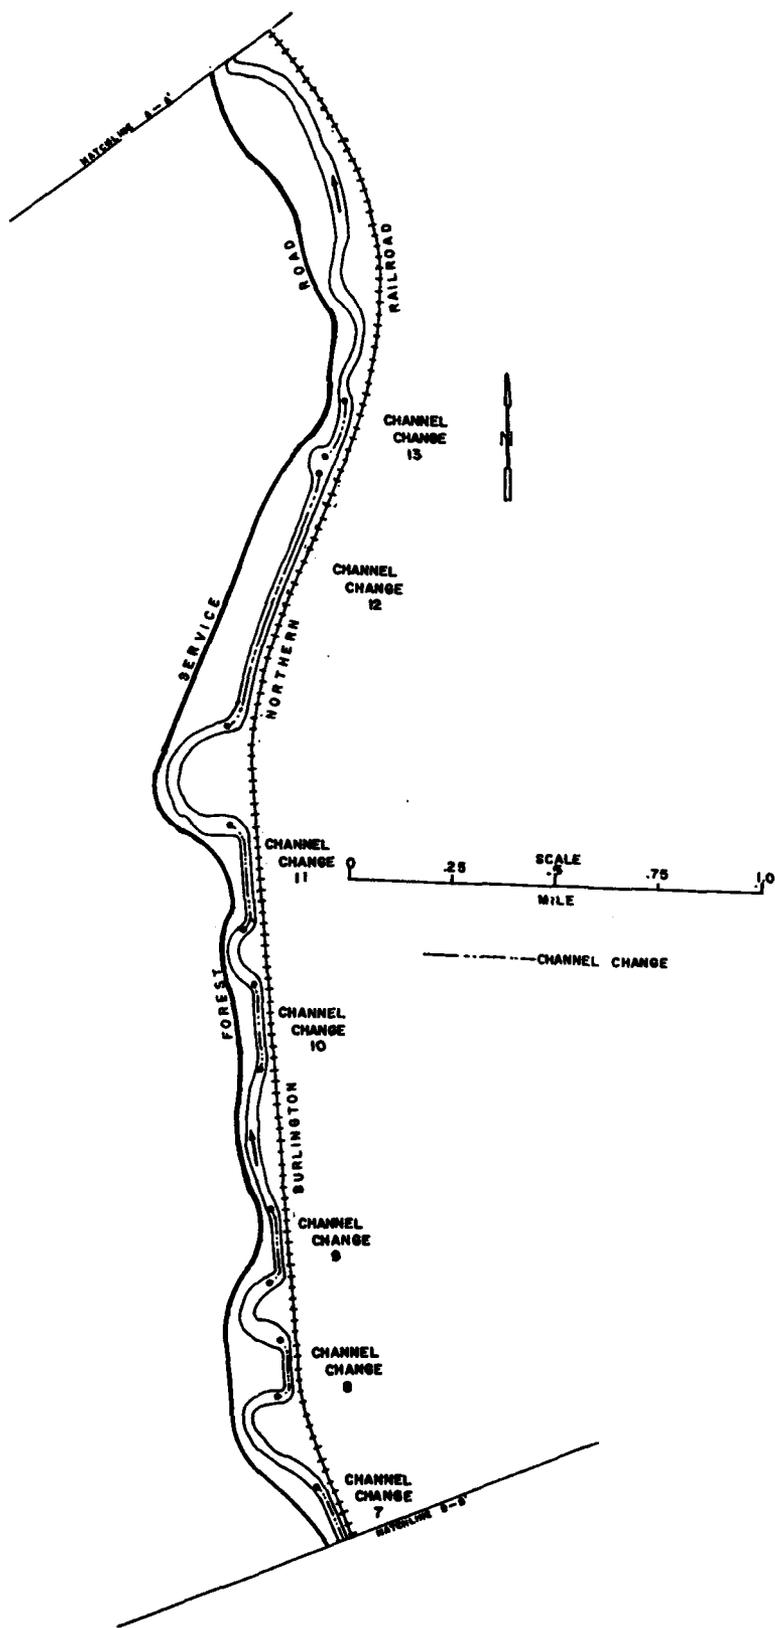
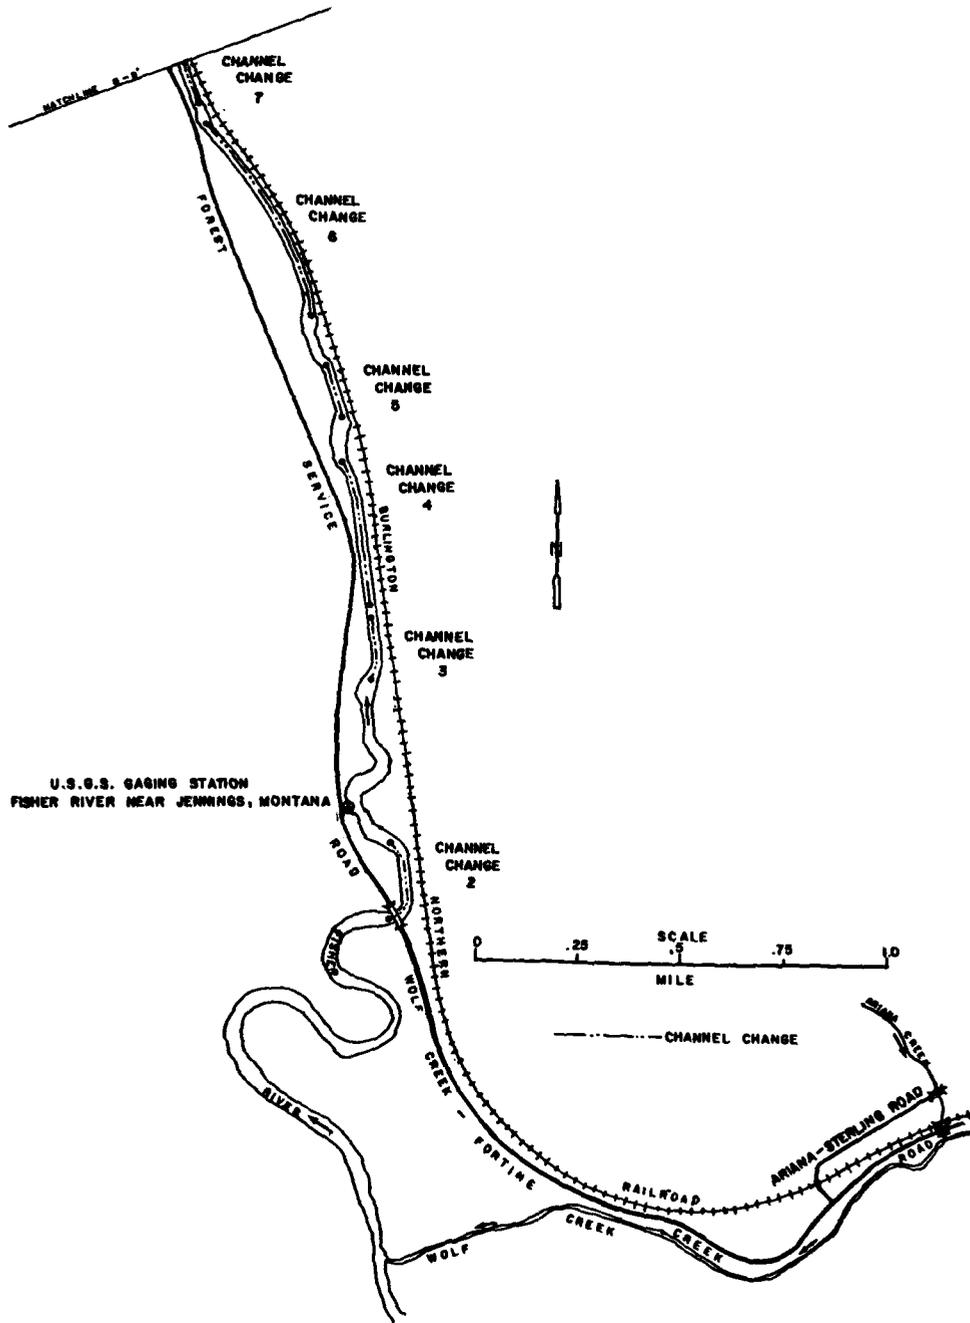
Figure 2a. Fisher River Realignment Project

Figure 2b. Fisher River Realignment Project

Figure 2c. Fisher River Realignment Project

7. A gaging station was operated on the Fisher River at mile 8.6\* (published as Fisher River near Jennings, Mont., Reference 4) from December 1950 through September 1969 (abandoned due to construction) (Figure 2c). The drainage area upstream from this location is 780 square miles. Daily discharges of record were: maximum 6,320 cfs, mean 531 cfs, and minimum 50 cfs. An additional gaging station was established at mile 0.8 (published as Fisher River near Libby, Mont., Reference 4) in 1967 and continues to operate through the present (Figure 2a) (the drainage area upstream from this station is 838 square miles). Daily discharges of record are: maximum 7,280 cfs, mean 522 cfs, and minimum 35 cfs (Table 1). A suspended-sediment sample collection station was established in 1967 at mile 1.0 (published as Fisher River near Libby, Mont.) and was operated through January 1976. Daily suspended-sediment loads for the period of record were: maximum 91,200 tons, mean 266 tons, and minimum 0.2 tons (Table 1). Annual suspended-sediment loads of record were: maximum 347,409 tons, mean 97,090 tons, and minimum 8,353 tons.

\* Channel change 1 was on Wolf Creek. Locations of the channel changes on Fisher River are shown in Figure 2, and are listed in this table in a downstream to upstream order. Channel change 14A consisted only of re-moving bedrock material along part of a 100-ft reach and thus is not listed in this table.

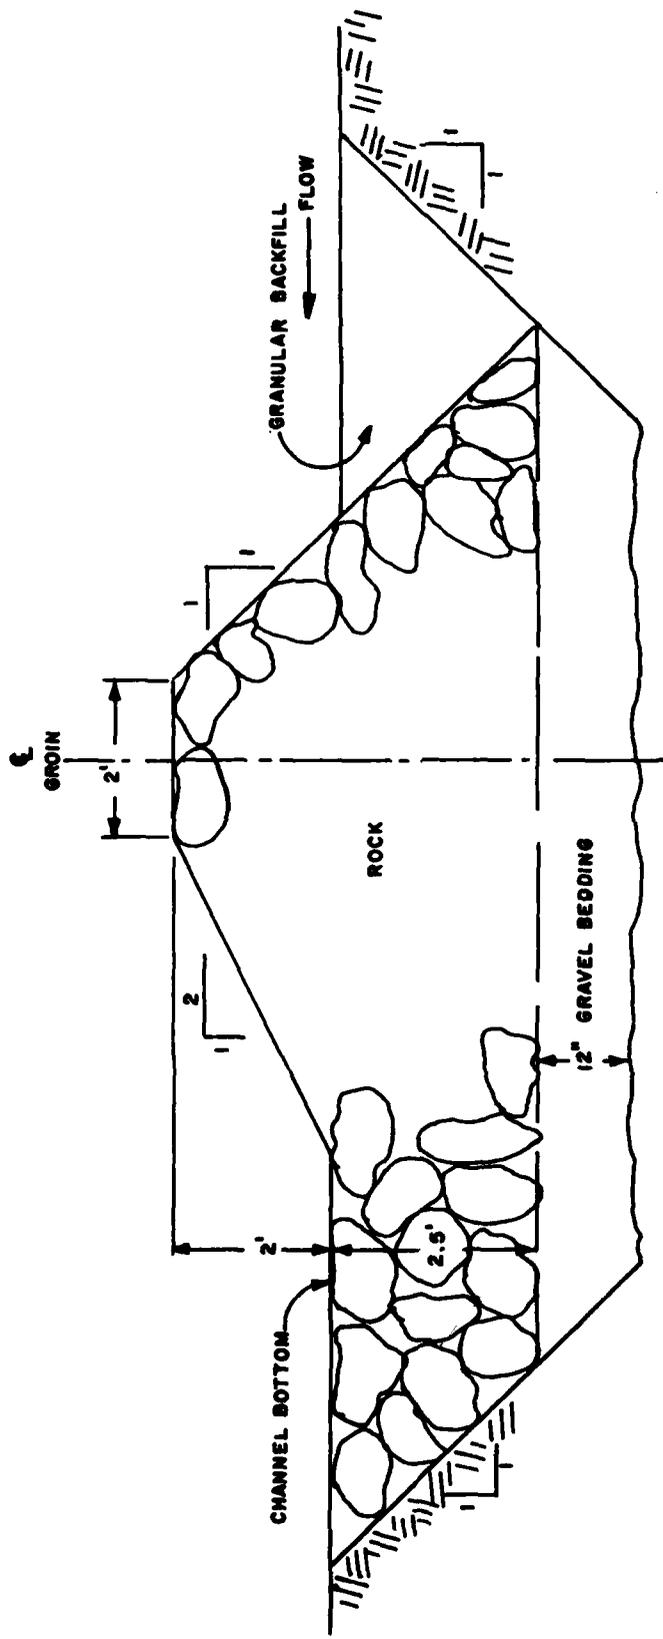
Figure 3. Cross-sectional view of groins (adapted from Great Northern Line Change, Ariana Creek to Jennings, Groins, Drawing E-53-33-81, December 1965, NPS)

12. Groins were constructed of rock placed over a 12-in.-thick layer of gravel bedding (Figures 3-5). Rock extended to a depth of 2.5 ft below channel grade to prevent undercutting and 2 ft above channel grade to provide fish resting pools and reduce stream velocities (Figures 6 and 7). The highest predicted average velocity in the channel changes was estimated to range from 10 to 14 fps. Rock for groins was sized to remain stable against these velocities with some provision for debris loads (Reference 5). Rock weight ranged from 25 to 1,000 lb with at least 75 percent of the stone weighing from 100 to 1,000 lb, and at least 40 percent weighing more than 400 lb. Quarry spalls less than 25 lb were

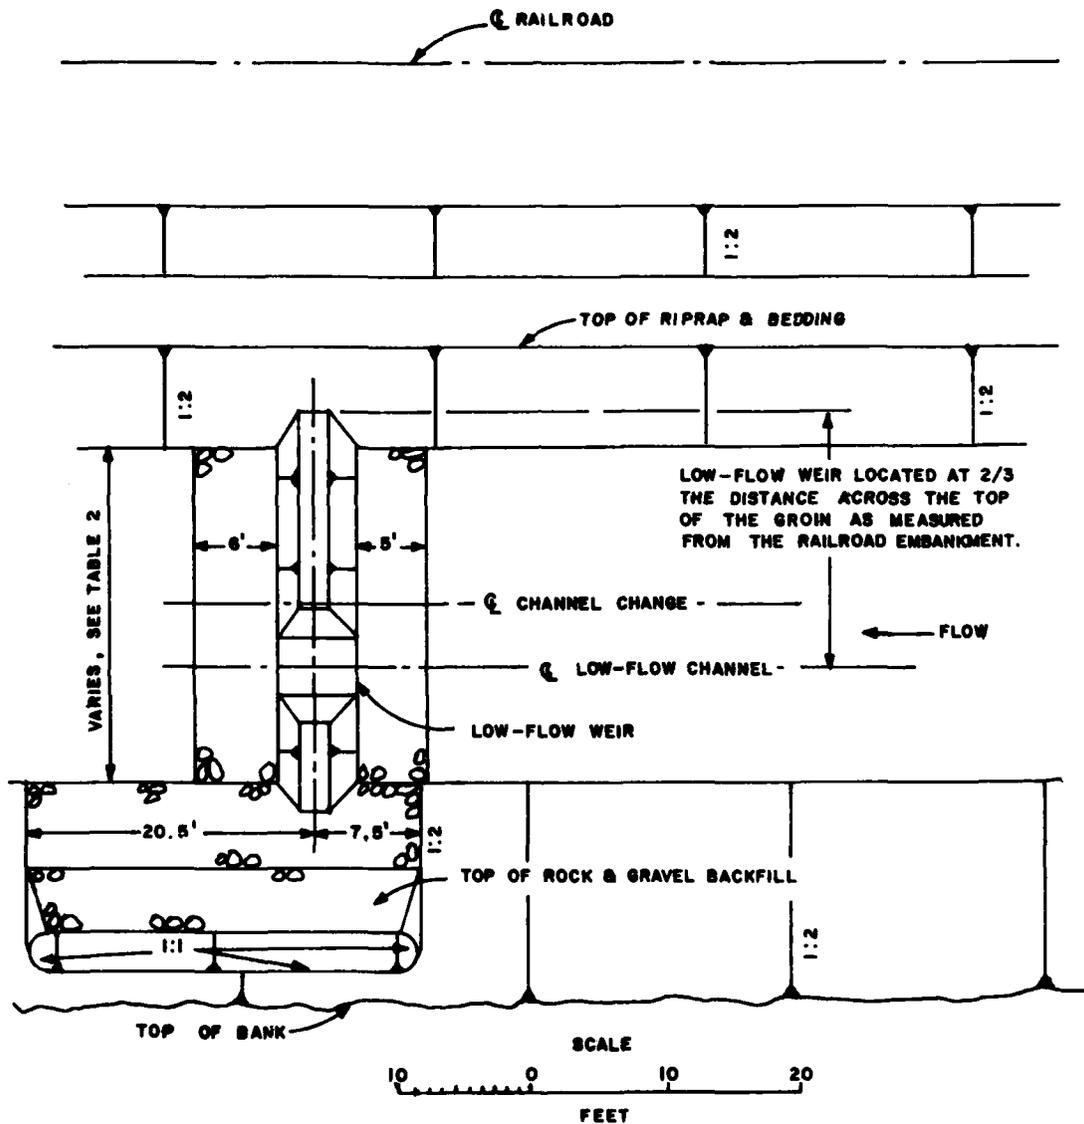
Figure 5. Typical plan view of groin and railroad embankment (adapted from Great Northern Line Change, Ariana Creek to Jennings, Groins, Drawing E-53-33-81, December 1965, NPS

A groin was placed at the downstream end of all channel changes to minimize the stream velocity before reentering the natural channel. The groins were designed so that during periods of low flow, the water would be concentrated at a weir to provide adequate depth for fish movement. The low-flow weir was located at a position two thirds of the distance across the top of the groin as measured from the railroad embankment to keep the current from being deflected against the embankment (Figures 4, 5, 9).
