CORPS OF ENGINEERS BUFFALO N Y BUFFALO DISTRICT  
FLOOD PLAIN INFORMATION, CUYAHOGA RIVER, MANTUA AND MIRAM, PORT--ETC(U)  
APR 72

This flood plain information report on the Cuyahoga River through the Village of Mantua and Townships of Mantua and Hiram has been prepared at the request of the Tri-County Regional Planning Commission through the Ohio Department of Natural Resources. It will be distributed to local interests through both of the above agencies.

CUYAHOGA RIVER  
MANTUA AND HIRAM  
PORTAGE COUNTY, OHIO  
FLOOD PLAIN INFORMATION REPORT  
INDEX MAP  
FOR FLOODED AREAS  
U.S. ARMY ENGINEER DISTRICT, BUFFALO  
APRIL 1972

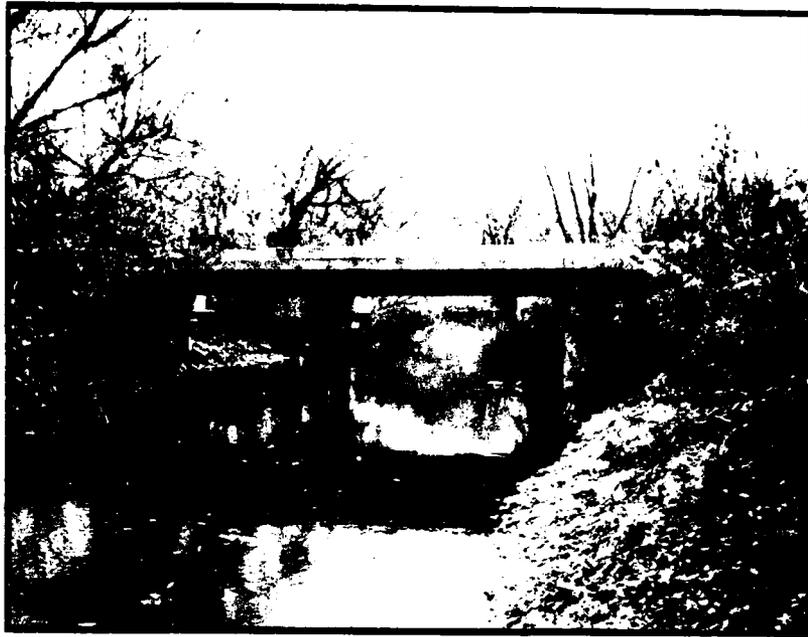
Figure 2 - Looking downstream at Gravel Road bridge,  
stream mile 69.25.

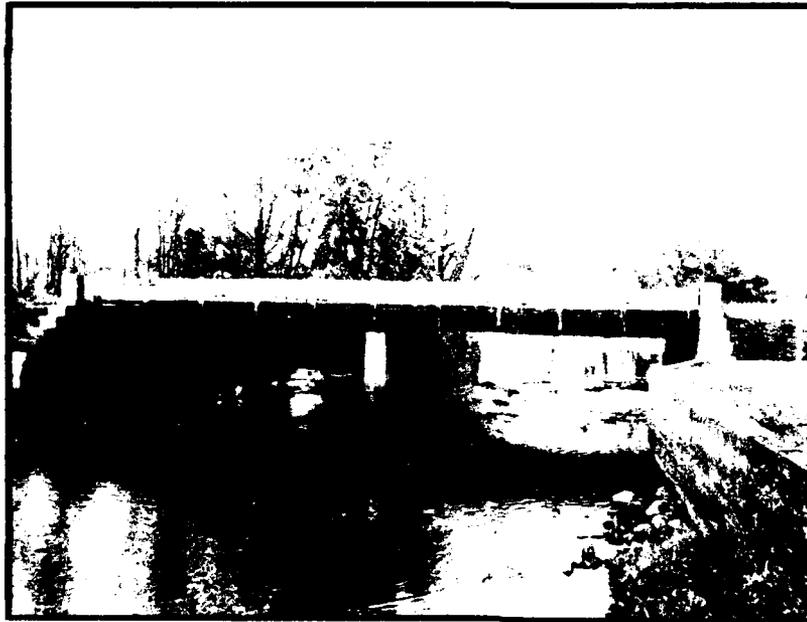
Figure 5 - Looking upstream at Mennonite Road bridge,  
stream mile 70.19.

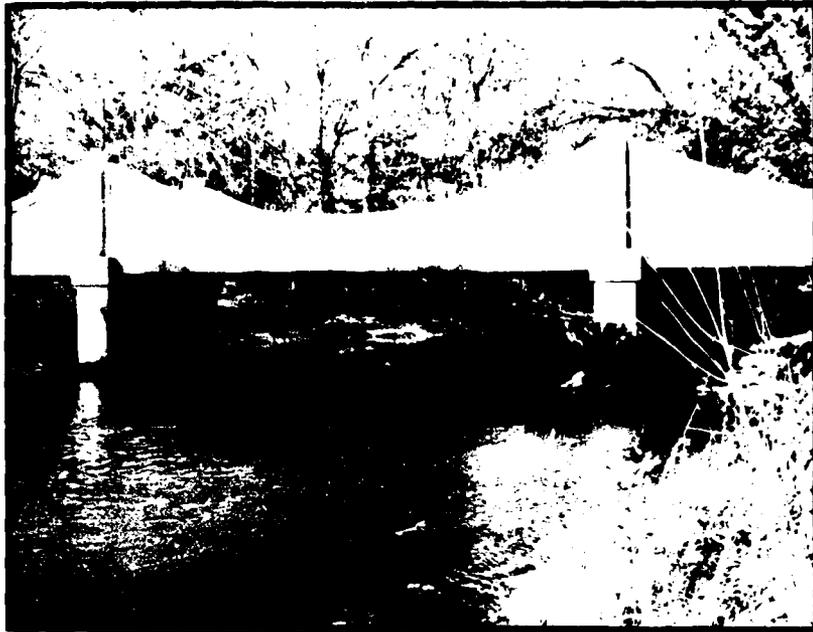
Figure 6 - Looking upstream at Pioneer Trail bridge, stream mile 71.71.

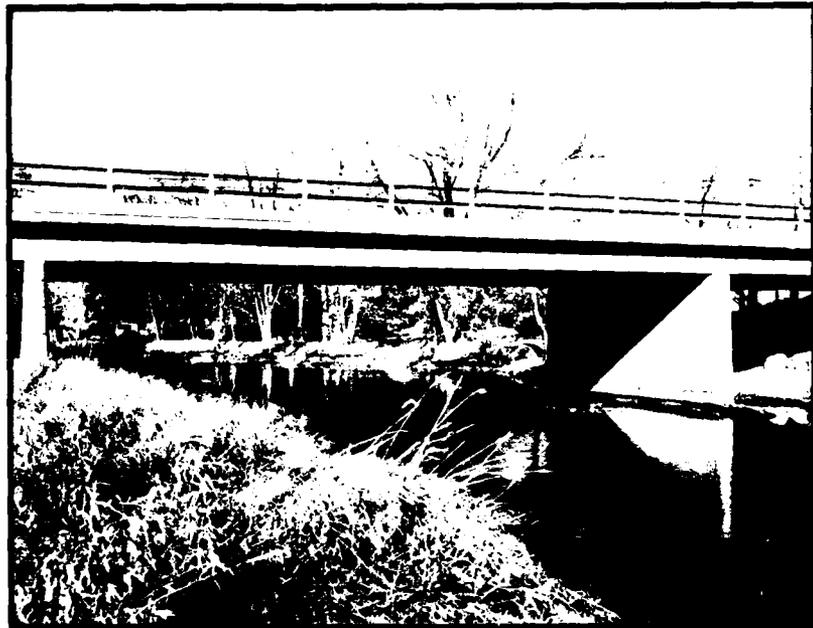
Figure 7 - Looking upstream at Ohio State Route 82 bridge, stream mile 72.63.

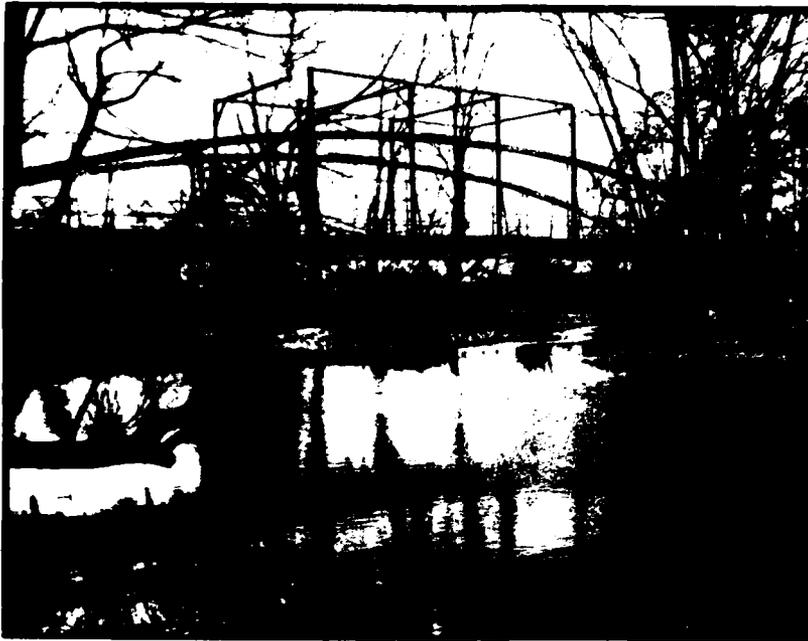
Figure 8 - Looking upstream at Allyn Road bridge,  
stream mile 75.63.

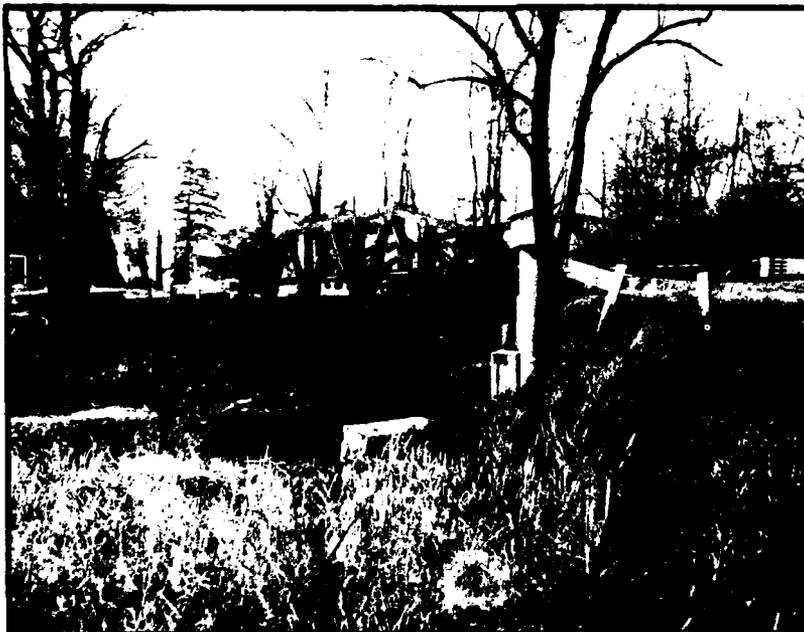
Figure 9 - Looking upstream at Winchell Road bridge,  
stream mile 75.80.

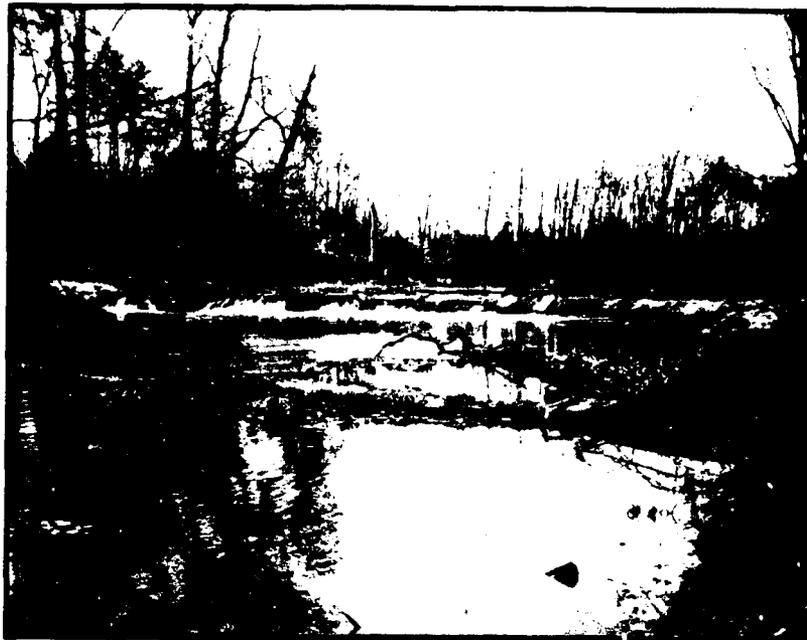
Figure 10 - Looking upstream at the dam at stream mile 74.72.

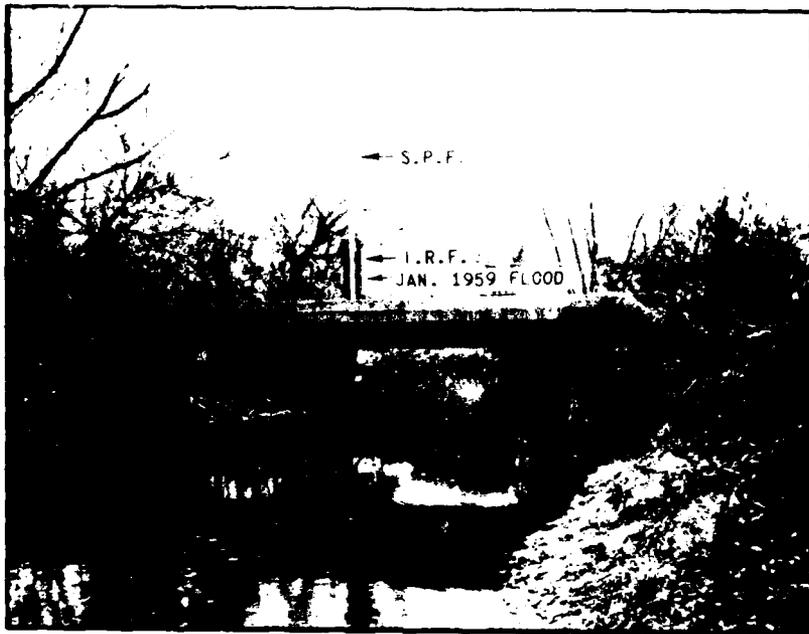
Figure 17 - Arrows indicate the heights of the Standard Project, Intermediate Regional, and January 1959 floods at the gravel road bridge, stream mile 69.25.

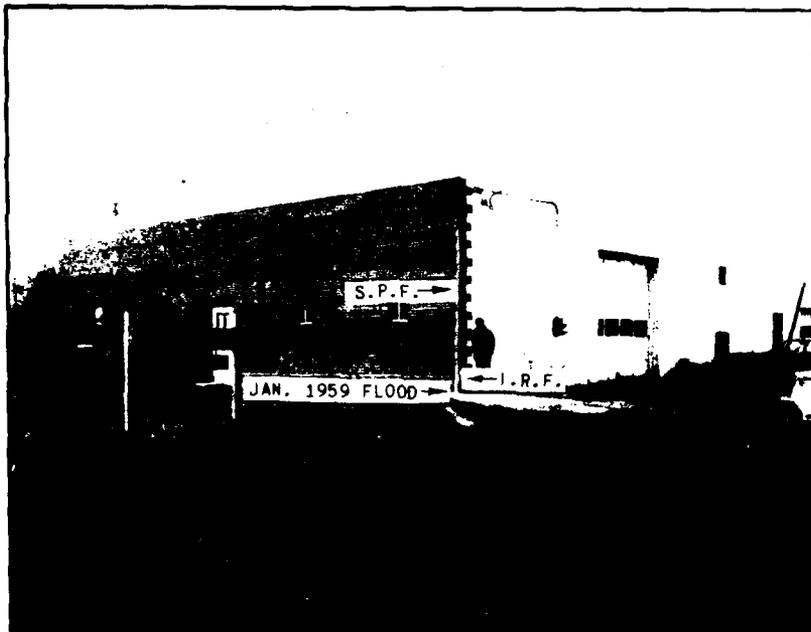
Figure 18 - Arrows indicate the heights of the Standard Project, Intermediate Regional, and January 1959 floods at Tummonds Corporation on State Route 44, stream mile 69.30

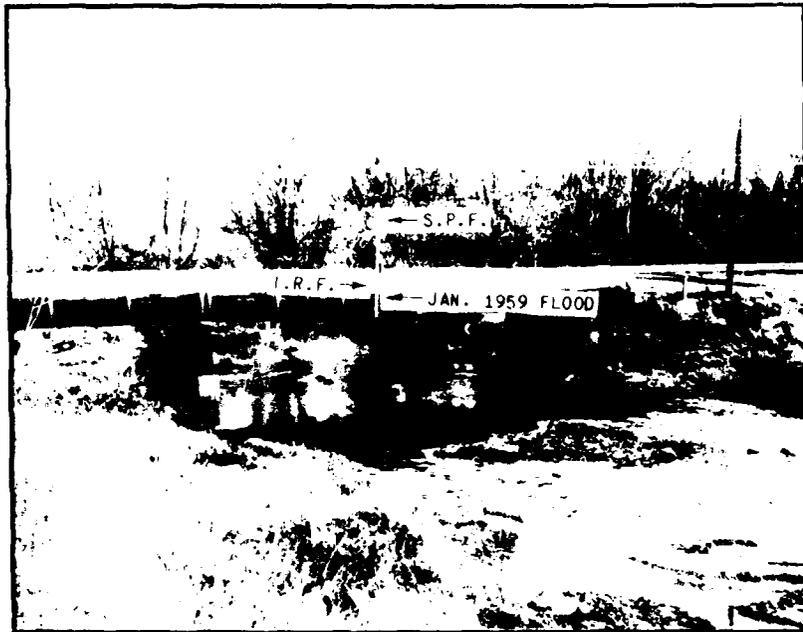
Figure 21 - Arrows indicate the heights of the Standard Project, Intermediate Regional, and January 1959 floods on the downstream side of State Route 44 bridge, stream mile 69.40.

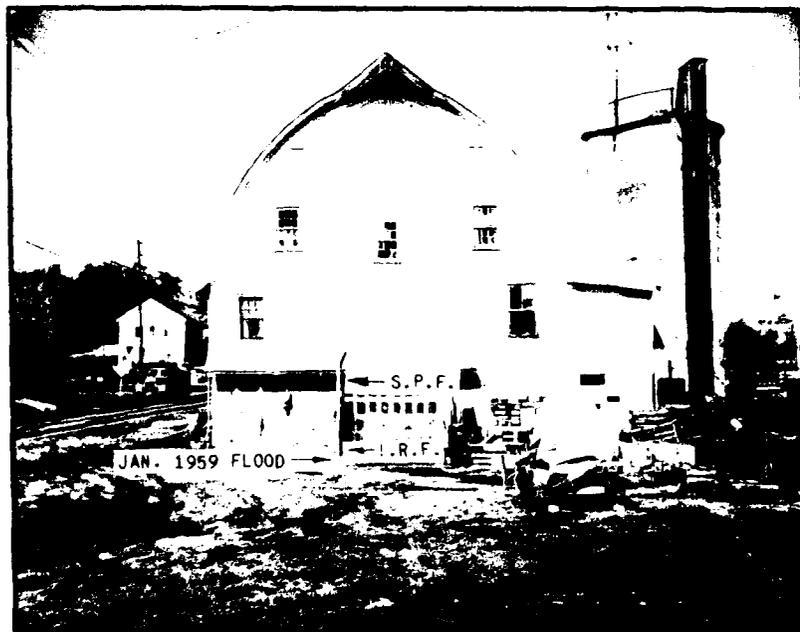
Figure 22 - Arrows indicate the heights of the Standard Project, Intermediate Regional, and January 1959 floods on the Modern Cement Company building upstream of State Route 44, stream mile 69.43.

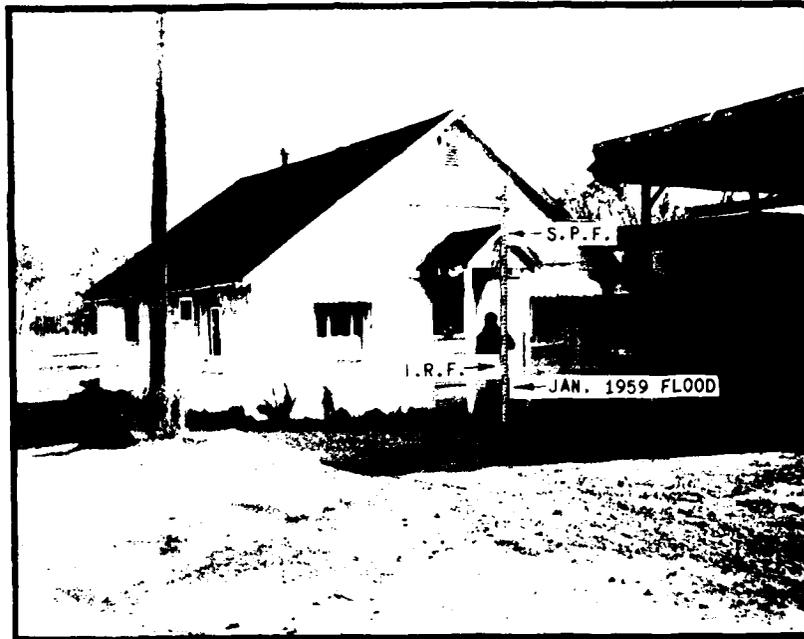
Figure 23 - Arrows indicate the heights of the Standard Project, Intermediate Regional, and January 1959 floods on the Wells Truck Lines office building, upstream of State Route 44, stream mile 69.45.

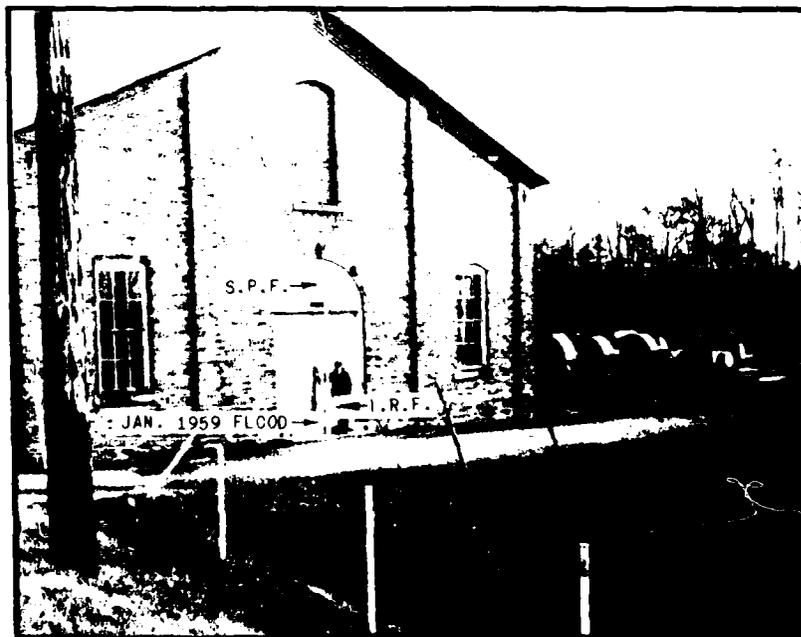
Figure 24 - Arrows indicate the heights of the Standard Project, Intermediate Regional, and January 1959 floods on a building located just downstream of Mennonite Road bridge, stream mile 70.15.

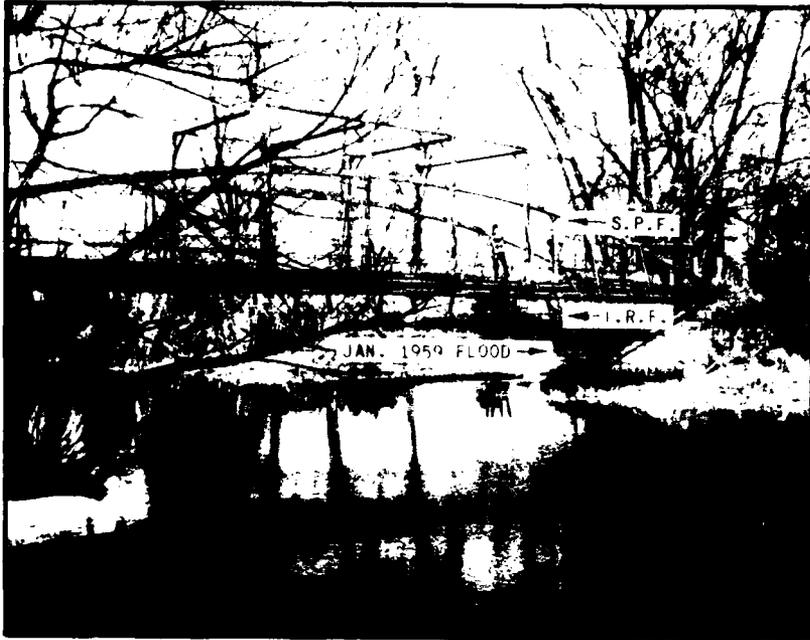
Figure 25 - Arrows indicate the heights of the Standard Project, Intermediate Regional, and January 1959 floods at Allyn Road bridge, stream mile 75.63.

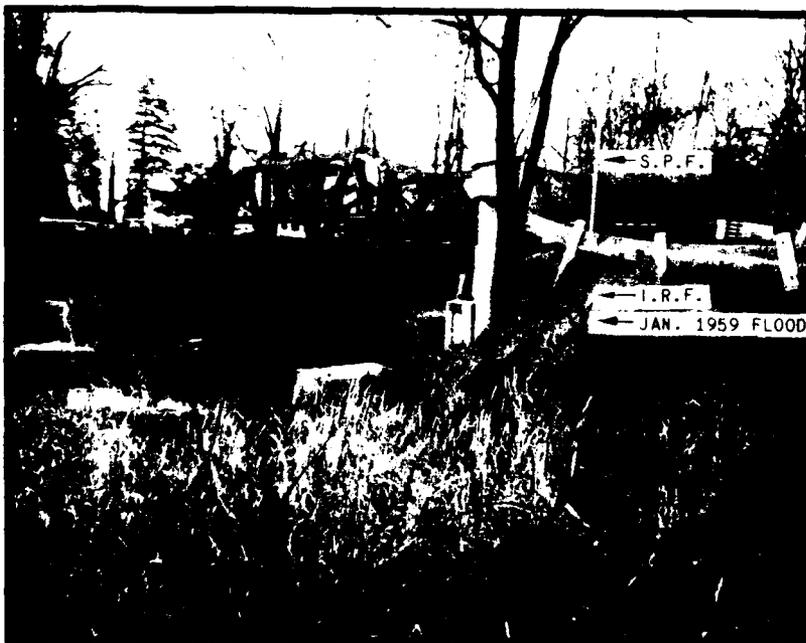
Figure 26 - Arrows indicate the heights of the Standard Project, Intermediate Regional, and January 1959 floods at Winchell Road bridge, stream mile 75.80.
