FLOOD PLAIN INFORMATION  
GRAND RIVER  
TRUMBULL COUNTY  
OHIO

PREPARED FOR  
OHIO DEPARTMENT OF NATURAL RESOURCES  
DIVISION OF PLANNING, FLOOD PLAIN MANAGEMENT SECTION  
AND THE TRUMBULL COUNTY PLANNING COMMISSION

BY  
CORPS OF ENGINEERS, U.S. ARMY  
BUFFALO DISTRICT  
JULY 1975

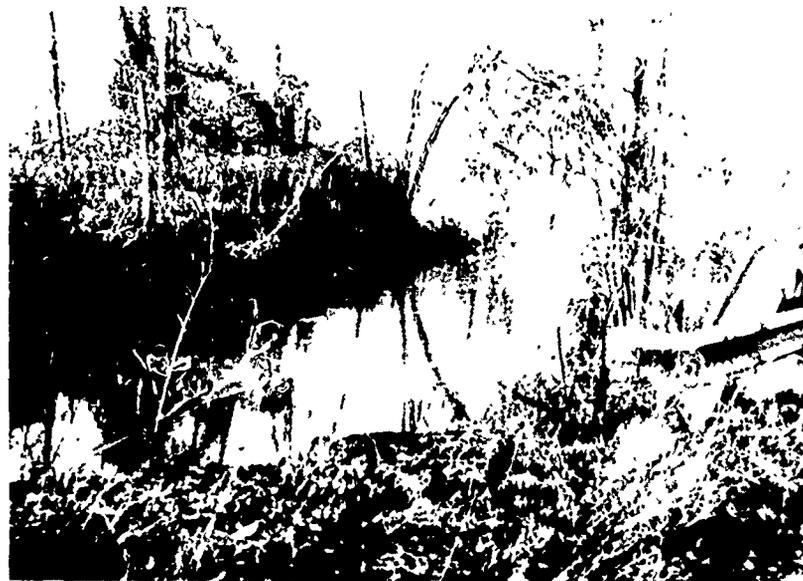
Figure 2—View of channel and banks looking upstream from Hoffman Norton Road, at river mile 85.51.

**Channel Conditions and Development** - The channel, banks, and immediate overbanks of the Grand River are similar throughout most of the study reach. The channel itself resembles a snake writhing back and forth across the flood plain as shown on Plate 2. River banks and immediate overbank areas are heavily wooded with only a few clearings near road crossings. Typical conditions along the banks are shown on Figures 1 and 2. The flood plain areas farther away from the river are more varied in that they are either wooded or used for agricultural purposes. Figures 3 and 4 show the distinction between the wooded areas and farmlands.

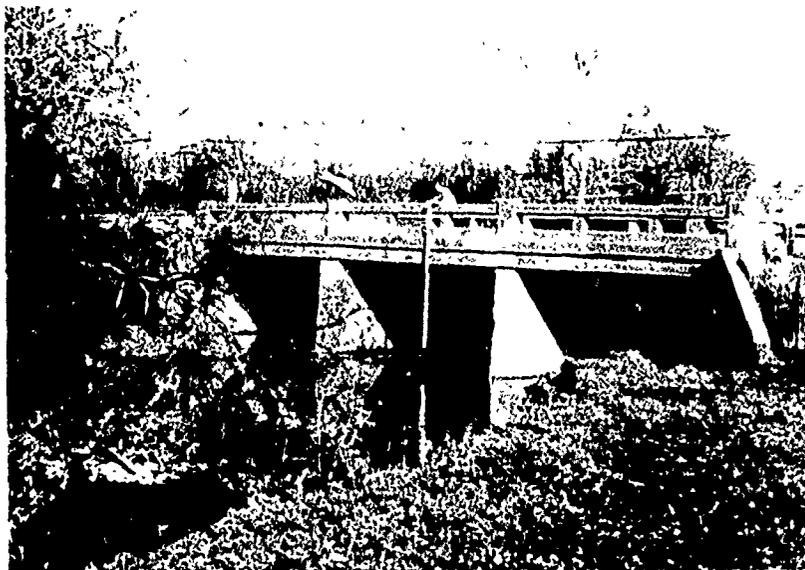
**Figure 7**—View of upstream face of State Route 534 bridge, looking downstream, at river mile 90.17.

There are ten bridges which cross the Grand River within the study limits. Figures 5 through 8 show some of the bridges and their waterway openings. Table 2 compares elevations of the bridges with the Intermediate Regional and Standard Project Flood elevations. If, during either the IRF or SPF, bridge openings become clogged with brush and fallen trees, then such obstructions would cause higher flood elevations upstream than normally would have occurred.

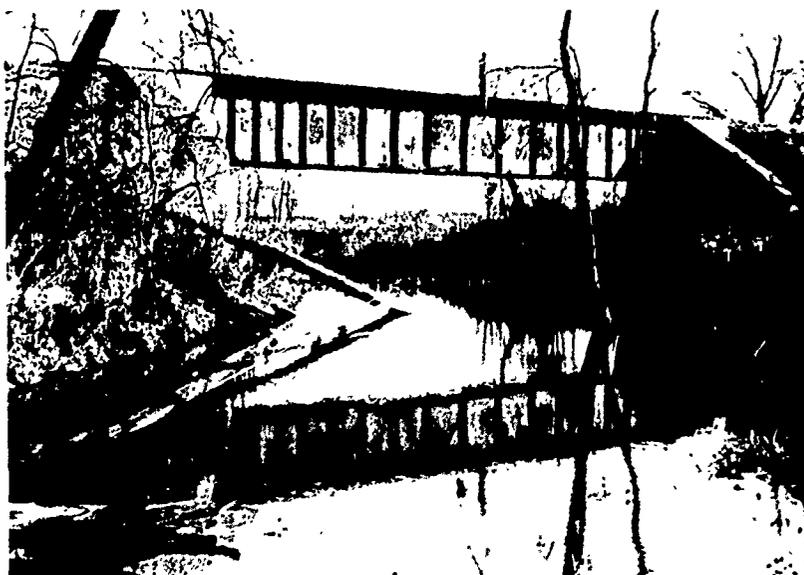
**Figure 8**—View of downstream face of Baltimore & Ohio Railroad bridge, looking upstream, at river mile 90.98.

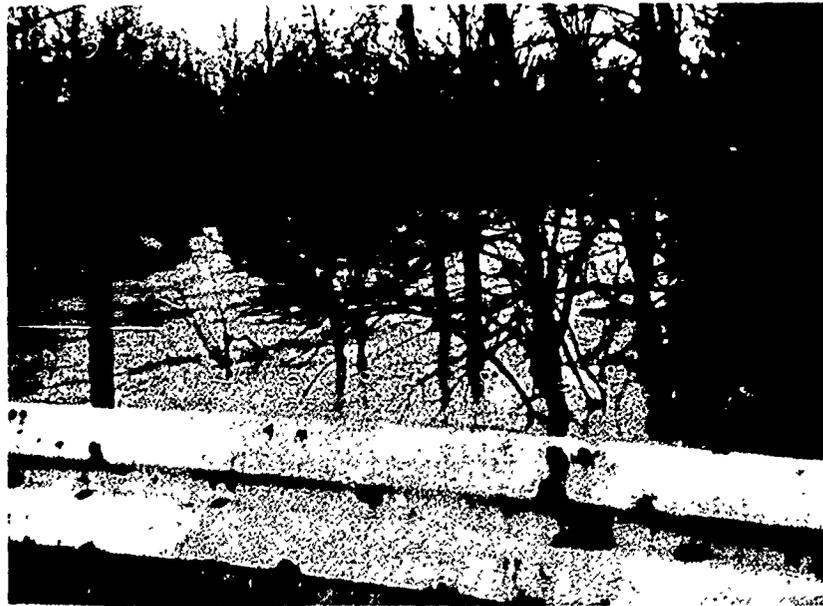
**Figure 9**—View of Grand River looking upstream from State Route 87 bridge during March, 1970 flood, at river mile 80.03.

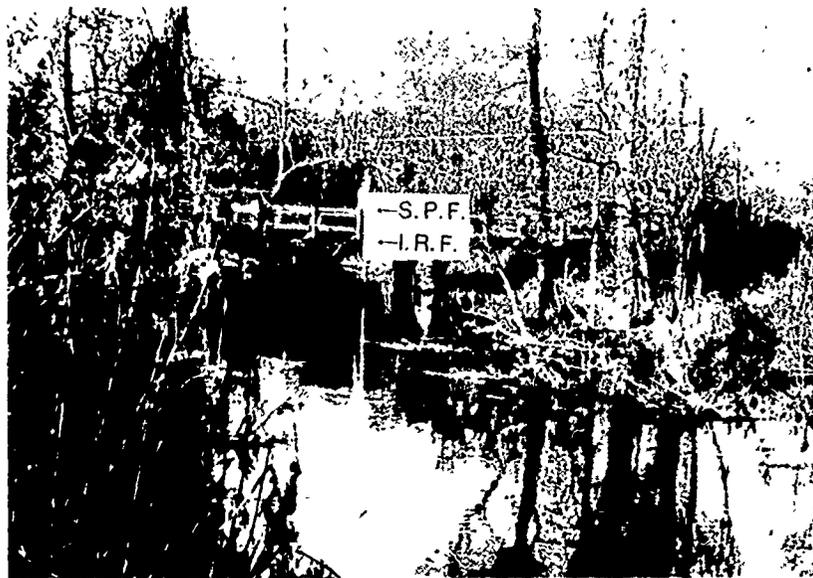
Figure 12—Heights of the Standard Project and Intermediate Regional Floods are shown by the arrows on the County Line Donley Road bridge at river mile 77.04

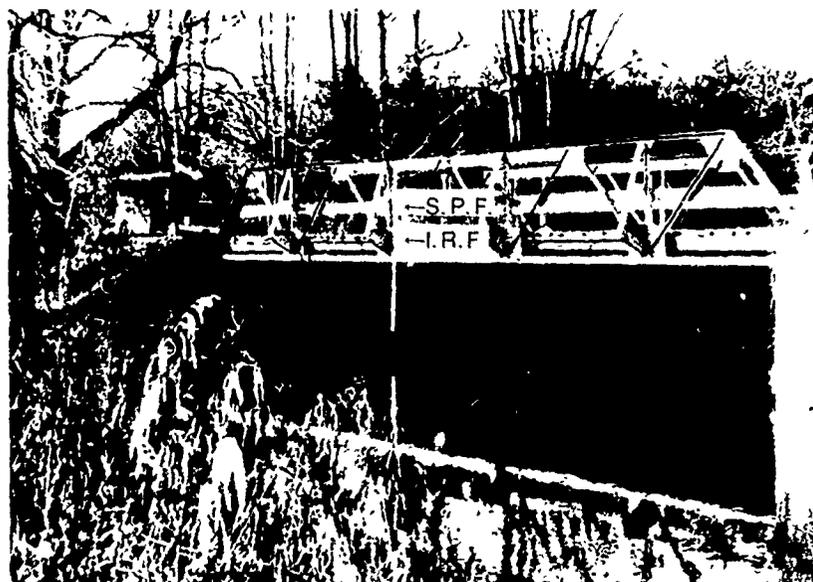
Figure 13—Heights of the Standard Project and Intermediate Regional Floods are shown by the arrows on the Hyde Oakfield Road bridge at river mile 85.31.

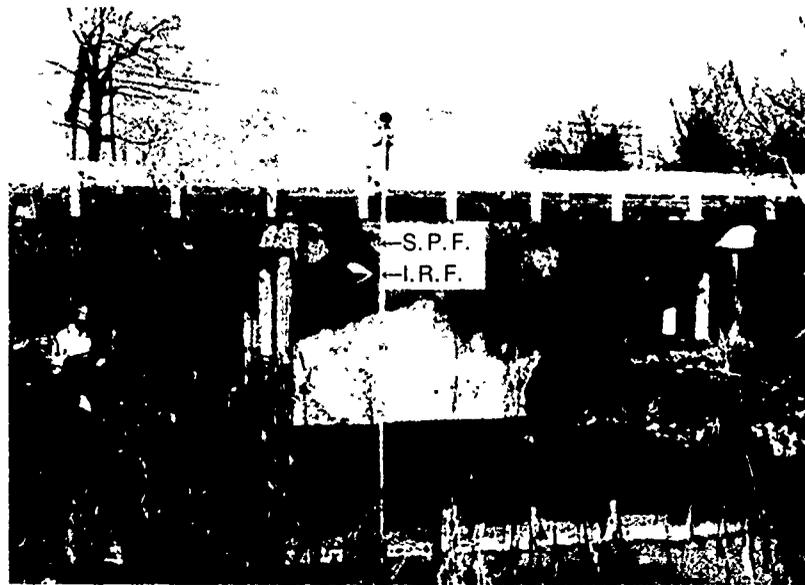
**Figure 14**—Heights of the Standard Project and Intermediate Regional Floods are shown by the arrows on the State Route 88 bridge at river mile 89.67

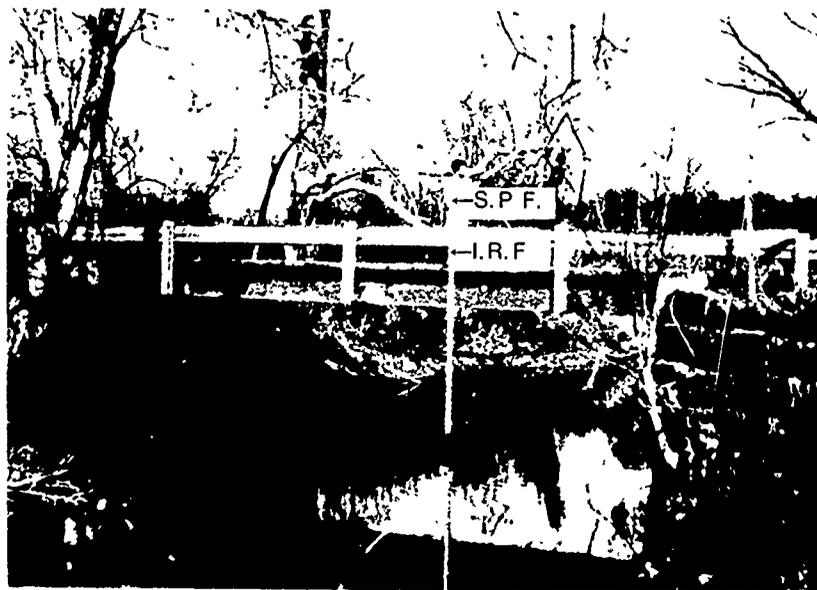
**Figure 15**—Heights of the Standard Project and Intermediate Regional Floods are shown by the arrows on the Wood Curtis Road bridge at river mile 90.56.
