REPORT DOCUMENTATION PAGE		READ INSTRUCTIONS BEFORE COMPLETING FORM
1. REPORT NUMBER	2. GOVT ACCESSION NO. AD-A100839	3. RECIPIENT'S CATALOG NUMBER
4. TITLE (and Subtitle) Flood Plain Information, Cuyahoga River, Akron to Summit-Portage County Line, Ohio.	5. TYPE OF REPORT & PERIOD COVERED Final	6. PERFORMING ORG. REPORT NUMBER

CUYAHOGA RIVER
 AKRON TO SUMMIT-PORTAGE
 COUNTY LINE, OHIO
 FLOOD PLAIN INFORMATION REPORT
 FLOODS ABOVE
 BANKFULL STAGE
 U. S. ARMY ENGINEER DISTRICT, BUFFALO
 MAY 1971

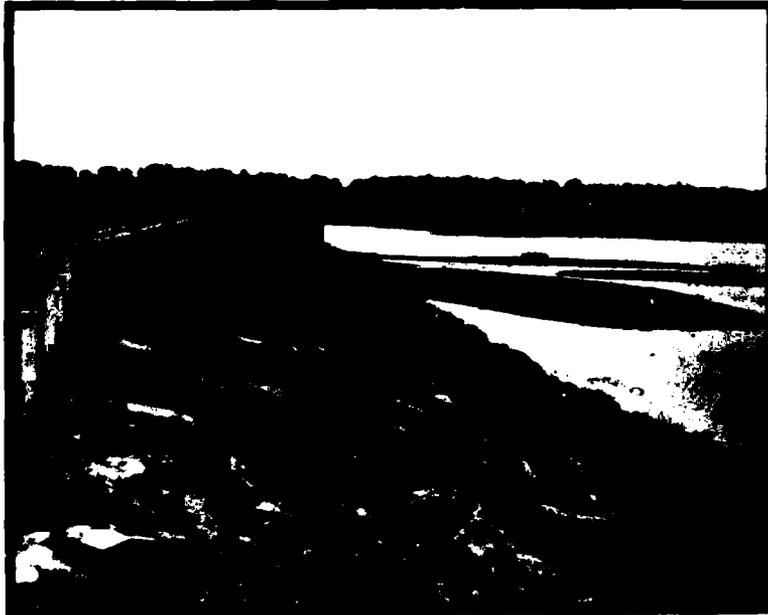
Figure 3 - Upstream face of dam at LaDue Reservoir
in Geauga County.

(d) LaDue Reservoir - is located just north of Hiram Rapids and controls about 30 square miles of drainage area. This reservoir was also constructed by the City of Akron for water supply. (See figure 3).

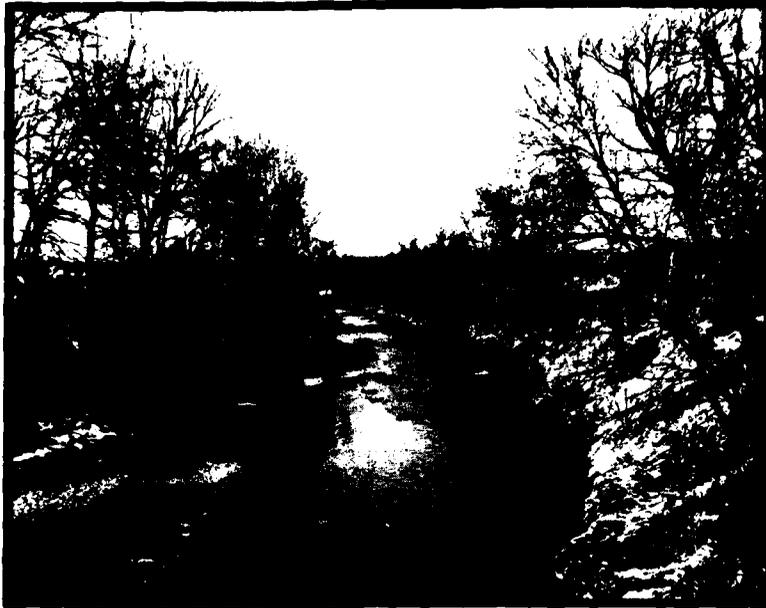
Figure 4 - Little Cuyahoga River, one of the major tributaries in study area.

The watershed consists of rolling hills except for the gently sloping area about three miles wide bordering Lake Erie. The Cuyahoga River rises at about elevation 1,300 feet above mean sea level and discharges into Lake Erie at about elevation 570.0. Upstream of Cuyahoga Falls, the Cuyahoga River cuts through glacial drift and is relatively flat with a fall of about four feet per mile. At Cuyahoga Falls the river cuts through Pennsylvania sandstone and drops 220 feet in 1.5 miles. In the lower northward course, the river flows in a pre-glacial valley with a fall of about five feet per mile. In the reach between the mouth of Tinkers Creek and the head of navigation in Cleveland, the channel falls 25 feet in 10 miles. Most of the residential, commercial, and industrial development in the study area is located on ground lying above the flood plain. Various channel conditions in the study area are shown on figures 4 through 8. Table 2 shows various drainage areas within the Cuyahoga River basin.

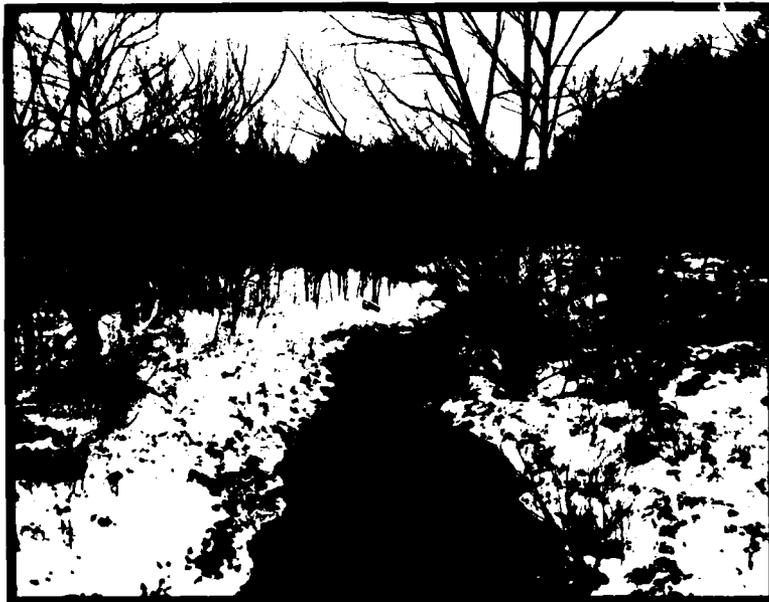
Figure 7 - Fish Creek, a tributary in study area.

Photograph was taken in December 1970.

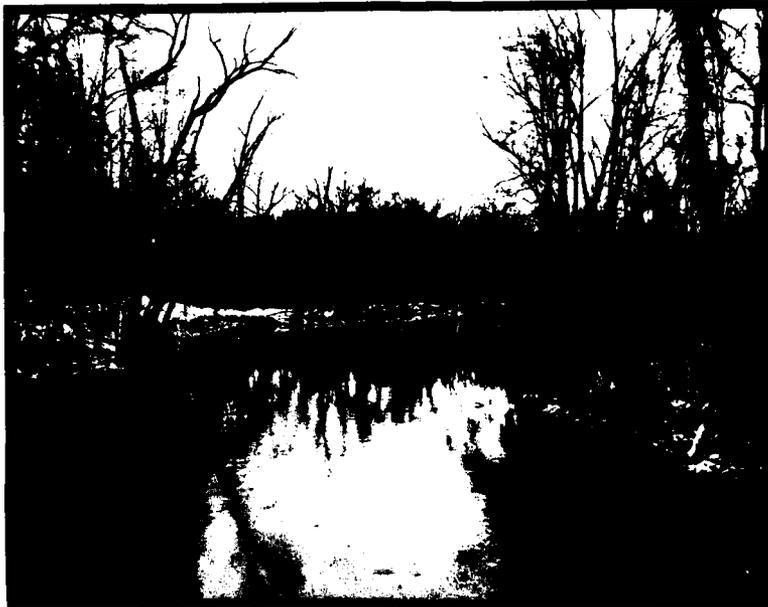
Figure 8 - Looking downstream along the Cuyahoga River, stream mile 52.7.

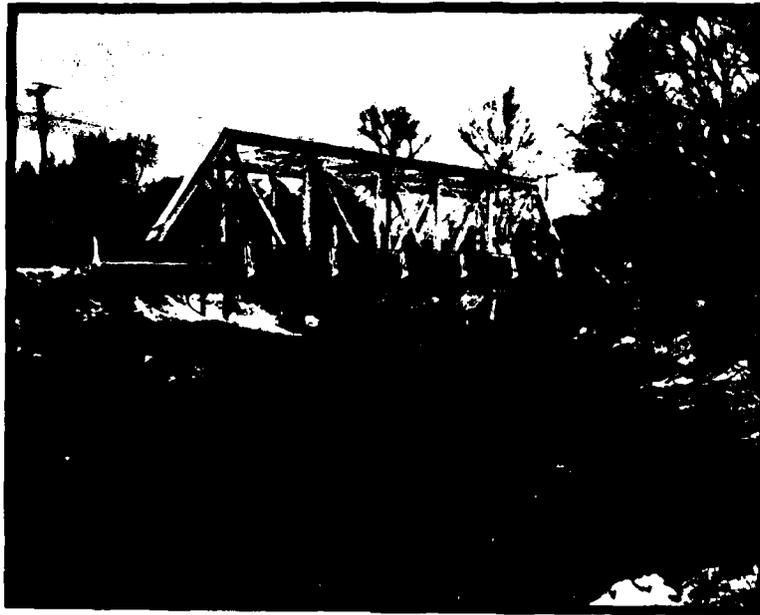
Figure 10 - Upstream face of the Akron-Peninsula Road bridge, stream mile 40.25.

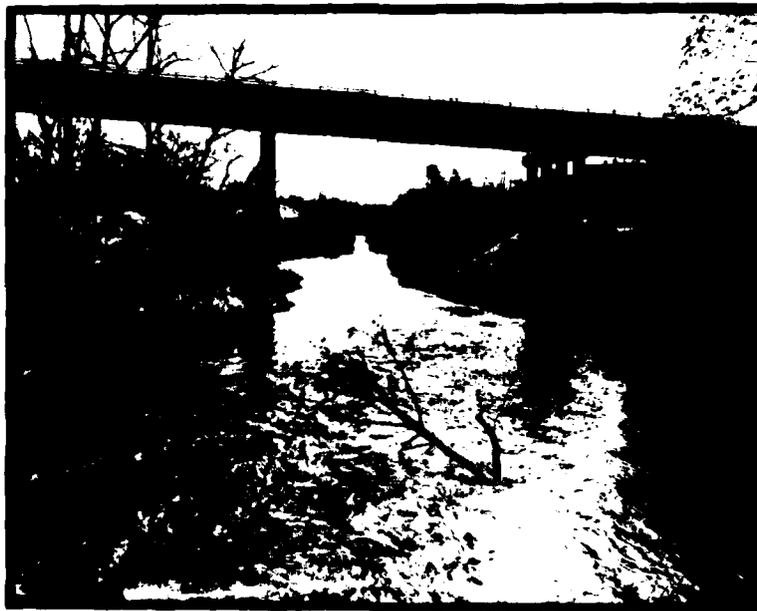
Figure 11 - Upstream face of the new Portage Trail bridge, stream mile 46.58.

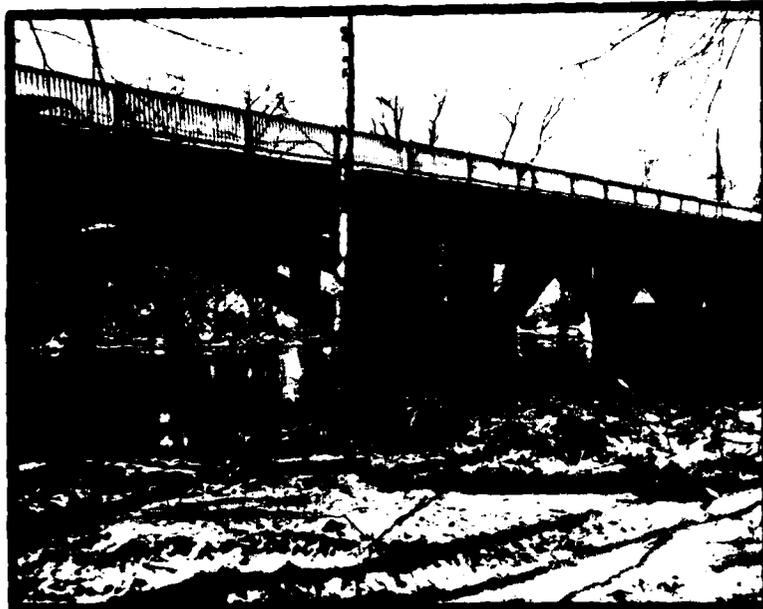
Figure 12 - Upstream face of the Oak Park Boulevard bridge, stream mile 47.72.

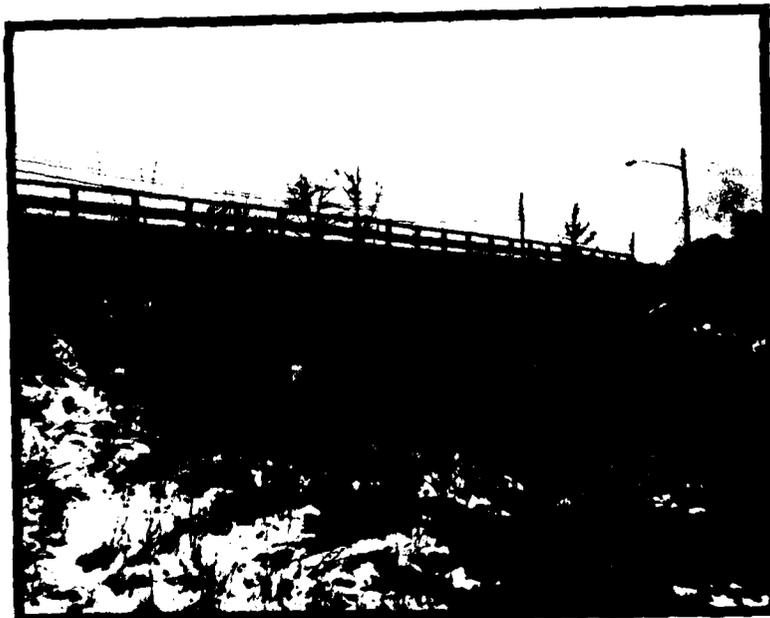
Figure 13 - Upstream face of the Darrow Road bridge, stream mile 49.96.

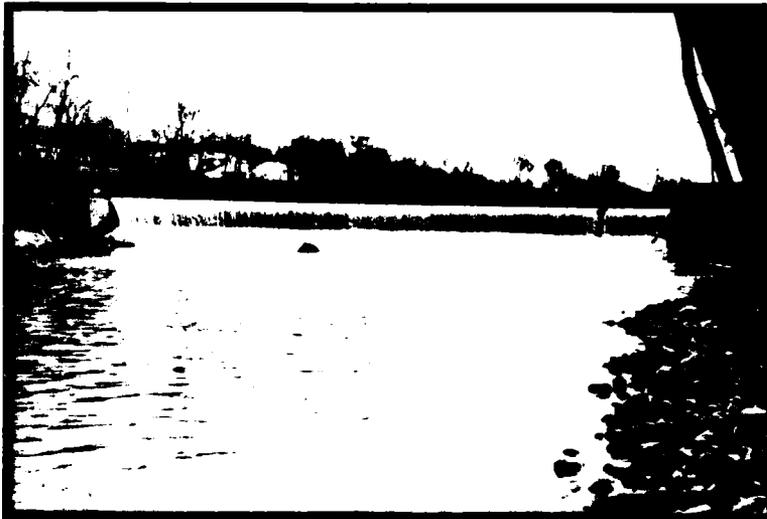
Figure 15 - Downstream face of dam in Munroe Falls,
stream mile 50.09.

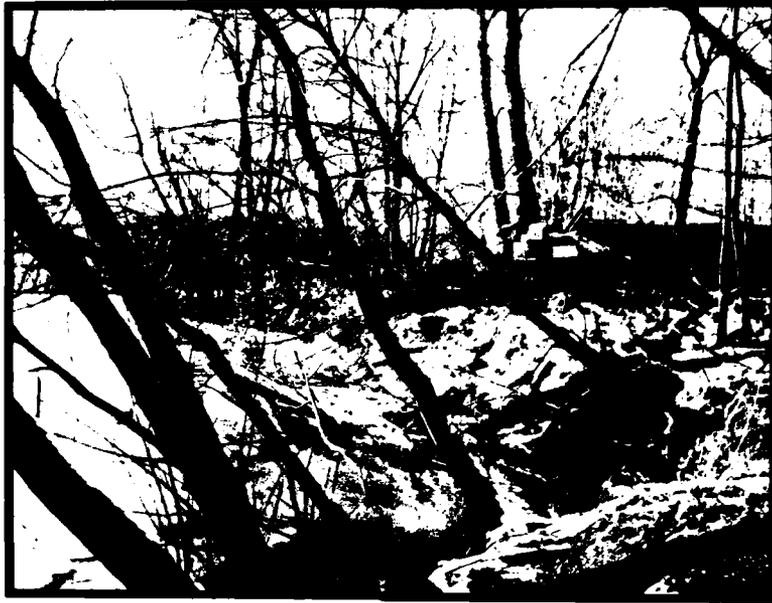
Figure 16 - Dumping along right bank downstream of the Akron-Peninsula Road bridge, stream mile 40.2.

OBSTRUCTIONS TO FLOOD FLOWS - Inadequate bridge areas, abandoned dams, encroachments, and fills are some of the obstructions to flood flows. Other serious obstructions are bends in the stream, irregularity of channel section, and heavy brush, weeds, and large trees growing on the channel banks and extending into the stream. Figures 16 through 19 show obstructions which tend to reduce floodway capacity and increase river stages.

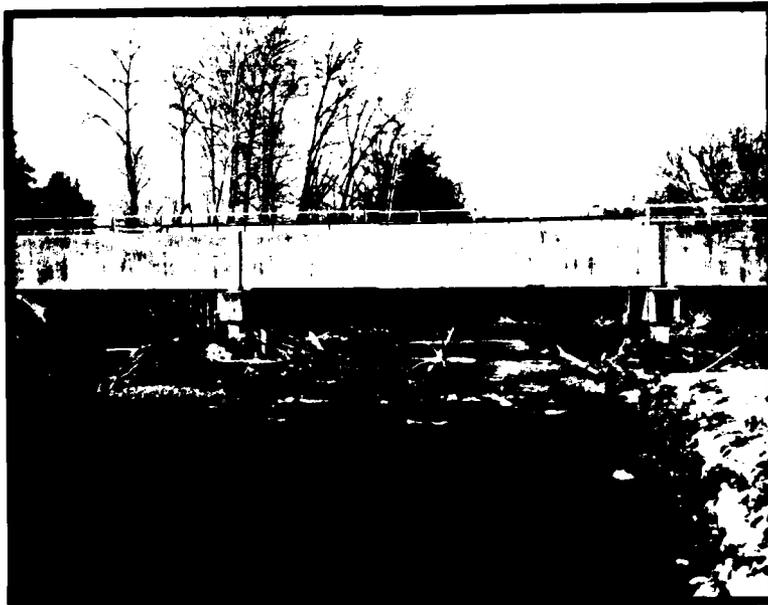
Figure 17 - Debris at bridge on Little Cuyahoga River.

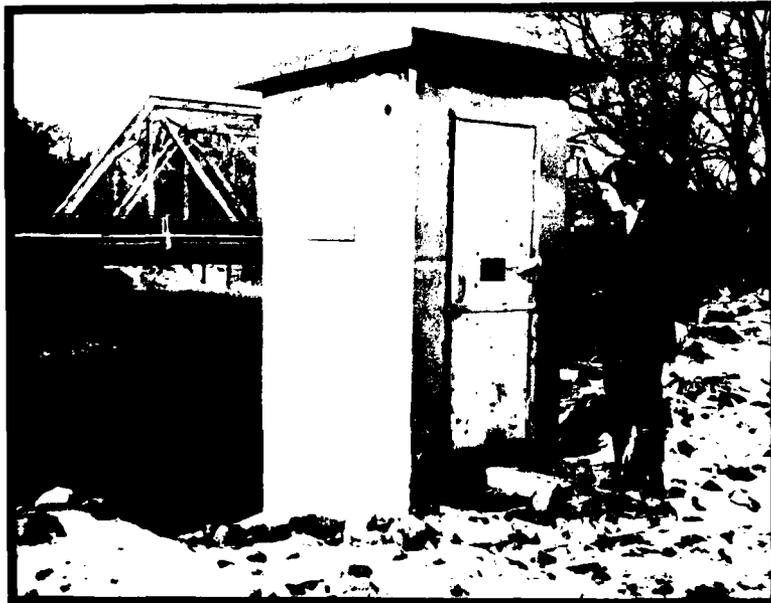
Figure 20 - U.S.G.S. gaging station at Old Portage, which is located on right bank upstream of the Akron-Peninsula Road bridge, stream mile 40.27.

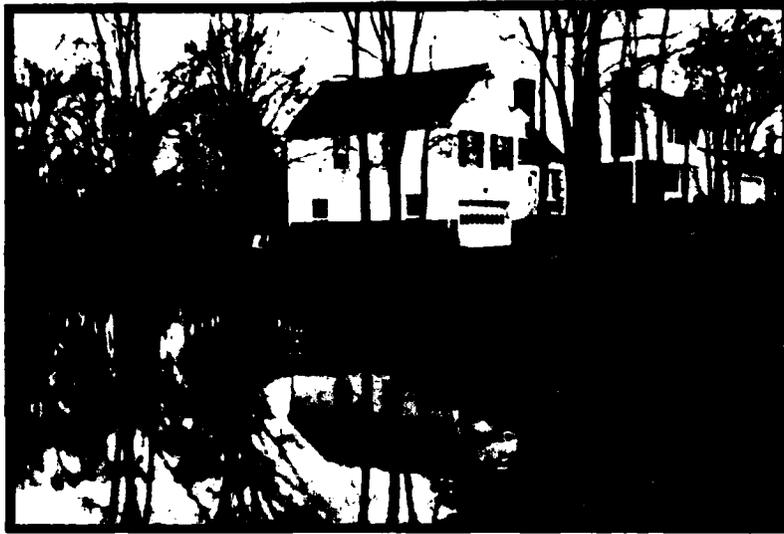
Figure 21 - Flooding conditions in January 1959
near South Park Drive in Silver Lake, stream
mile 48.0.

and snow melt averaged 2.94 inches. Three of the five Cuyahoga Falls' water pumping stations were surrounded by swirling water. The Cuyahoga River swelled 700 feet beyond its banks at the Waterworks Park and surrounded three picnic shelter houses. The swollen river carried away 20 picnic tables from the park. At the Old Portage gage the January 1959 flood reached elevation 751.6, U.S.C. & G.S. datum, which is approximately 2.5 feet above bankfull stage. Flooding conditions in January 1959 are shown on figures 21 and 22.

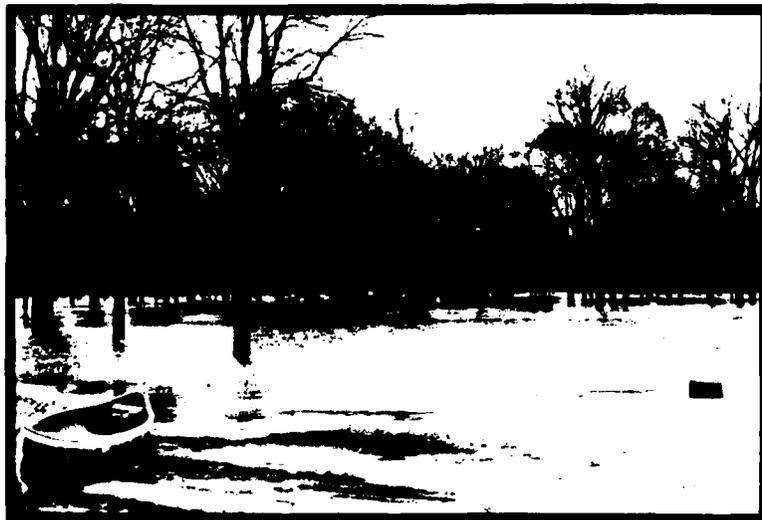
Figure 22 - Flooding conditions in January 1959 at
Waterworks Park, stream mile 48.6.

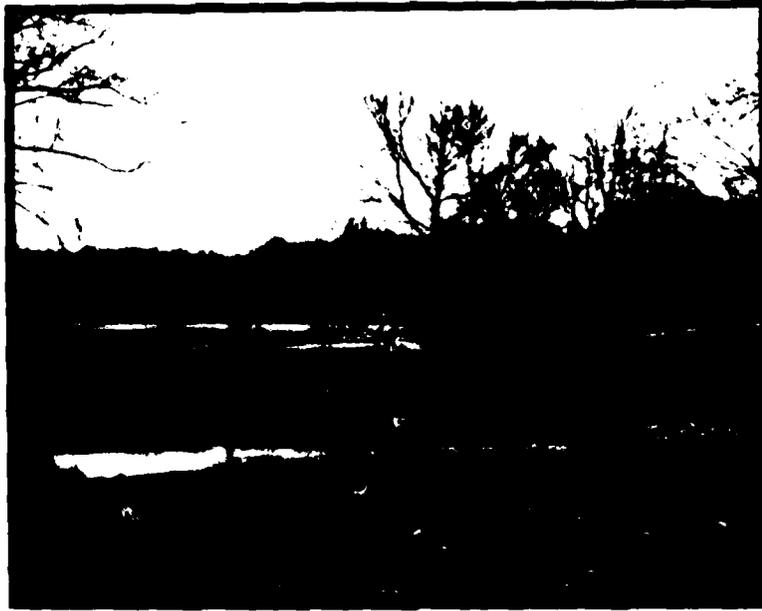
Figure 24 - Valley View Golf Course, stream mile 41.9.

Examples of wise flood plain use
Photographs were taken in December 1970.

of Engineers has prepared and is distributing to state, county and local governments for public dissemination two pamphlets, "Guidelines for Reducing Flood Damages" and "Introduction to Flood Proofing." The combination of data presented in this report and in the pamphlets will provide general guidelines for flood damage reduction in future development within the Cuyahoga River flood plain. Figure 23 lists the corrective and preventive measures described in the above mentioned pamphlets. The U. S. Army Corps of Engineers will distribute to State, county and local governments other helpful pamphlets as well as additions to existing pamphlets when they are developed. Figures 24 through 27 are examples of wise flood plain use.

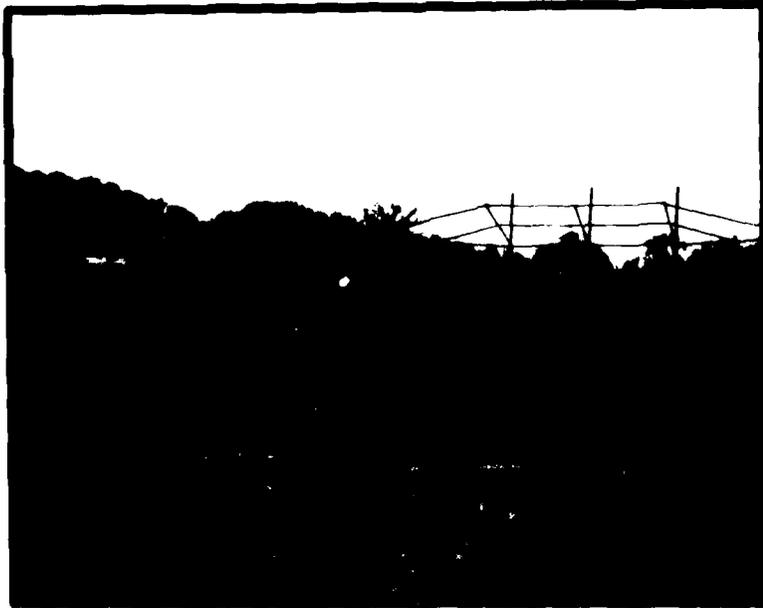
Figure 25 - Athletic field, stream mile 42.8.

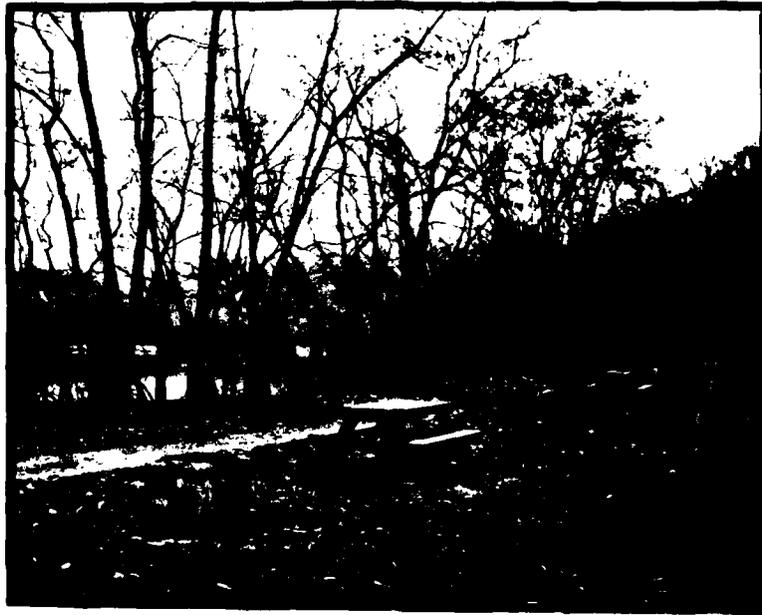
Figure 26 - Akron Metropolitan Park, stream mile 44.9.

Examples of wise flood plain use
Photographs were taken in December 1970.

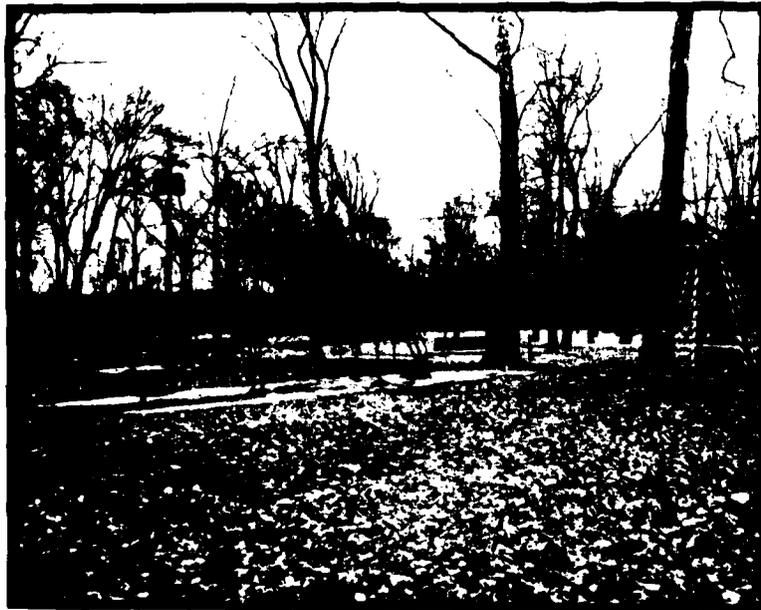
Figure 27 - Waterworks Park, stream mile 48.6.

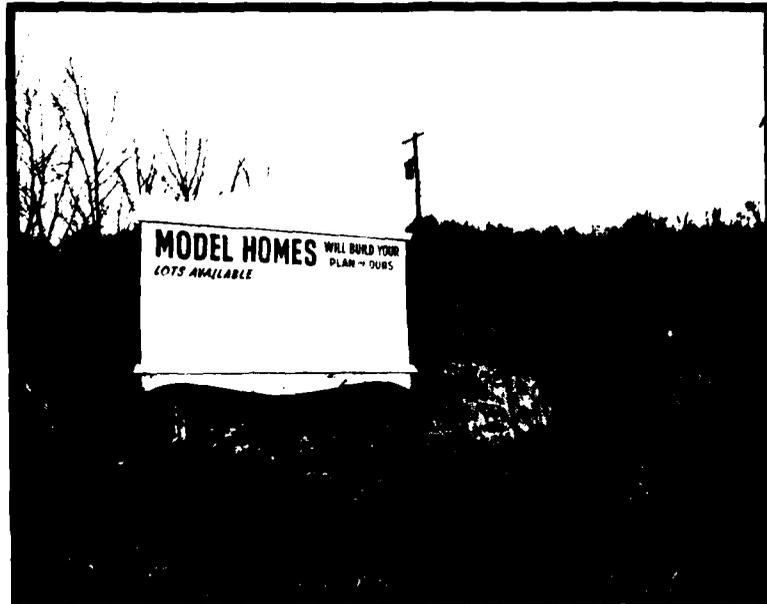
Figure 28 - Available lots along Kent Road in Silver Lake, stream mile 49.0.

Example of poor flood plain use
Photograph was taken in December 1970.

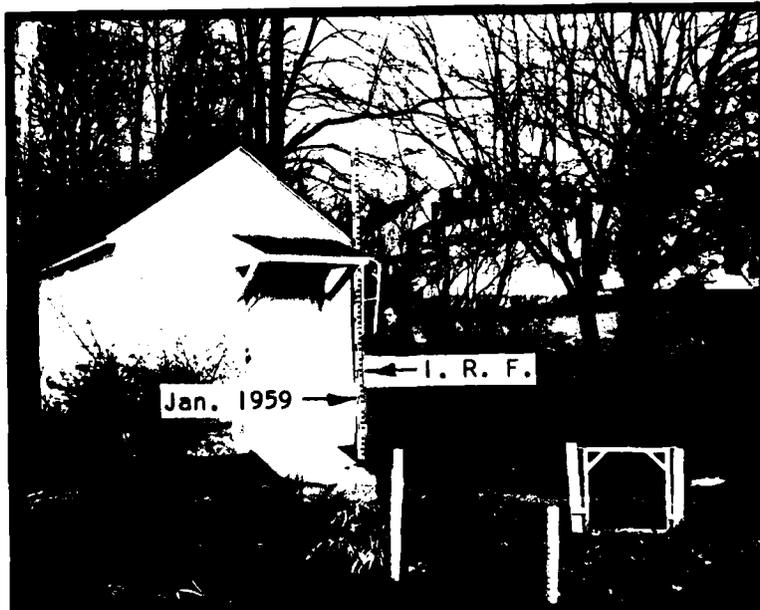
Figure 34 - Arrows indicate the heights of the Intermediate Regional and the January 1959 floods along South Park Drive in the Village of Silver Lake, stream mile 47.95.

The approximate heights of the Standard Project Flood, the Intermediate Regional Flood, and the January 1959 flood at selected sites are shown in figures 29 through 35.

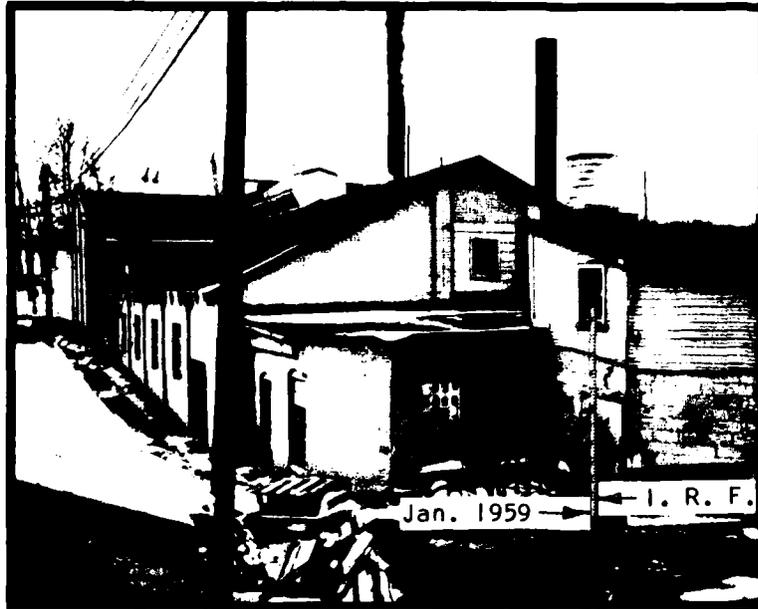
Figure 35 - Arrows indicate the heights of the Intermediate Regional and the January 1959 floods at the Sonoco Products Company, 59 N. Main St., Munroe Falls, stream mile 49.95.
