## HOT ISOSTATIC PRESSING OF ALUMINUM ALLOY CASTINGS

S.J. Vonk, G.S. Hoppin and K.W. Benn  
Garrett Turbine Engine Company  
A Division of the Garrett Corporation

February 1981

Final Technical Report for Period  
October 1979 - January 1981

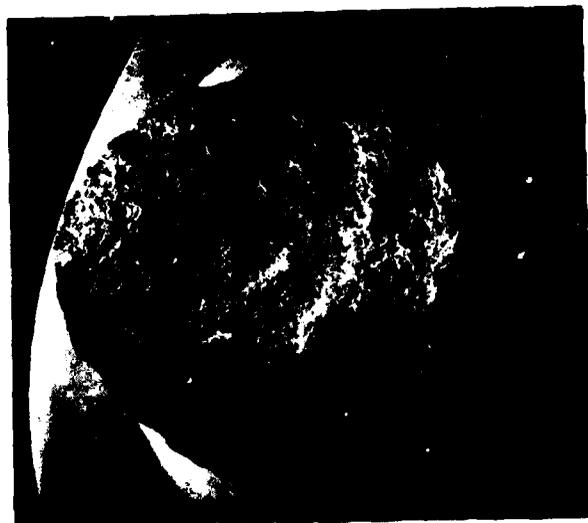
A comparison of Figures 14, 15 and 16 shows the impact of eutectic melting. Figure 14 depicts the fracture surface associated with a high-strength fracture. The failure mode is essentially 100-percent ductile-rupture. However, a second test on an identical tensile bar from the same rim section shows a completely different failure (Figure 15). Much of the fracture surface is

Figure 14. SEM fractographs of A201-T7 tensile bar that failed at 60.0 ksi. Material was HIPed at 980°F/10 ksi/6 hr. Initial radiographic Grade B, post-HIP Grade B+/A-.

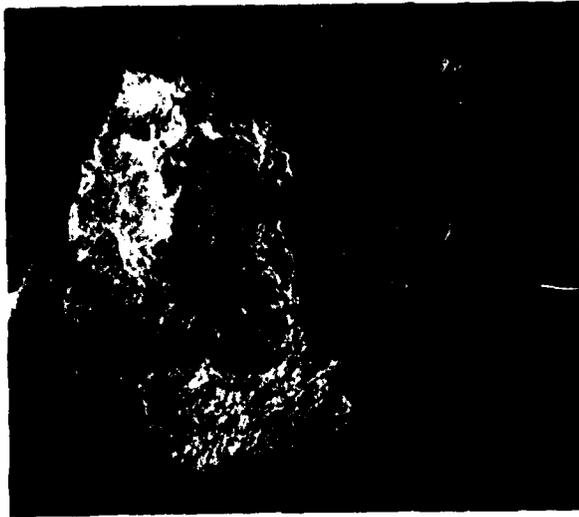
Figure 19. SEM fractographs of A201-T7 tensile bar that failed at 54.8 ksi. Material was HIPed at 950°F/10 ksi/12 hr. Initial radiographic Grade C, post-HIP Grade B/B+.

Fractography, utilizing a scanning electron microscope (SEM), was conducted on selected tensile fractures. Fractographs of particular interest are shown in Figures 12 through 19. The fracture modes vary greatly from ductile-rupture, to cleavage, to intergranular. Data from this evaluation are difficult to analyze as a result of the mixed-mode failures, but some trends are apparent.

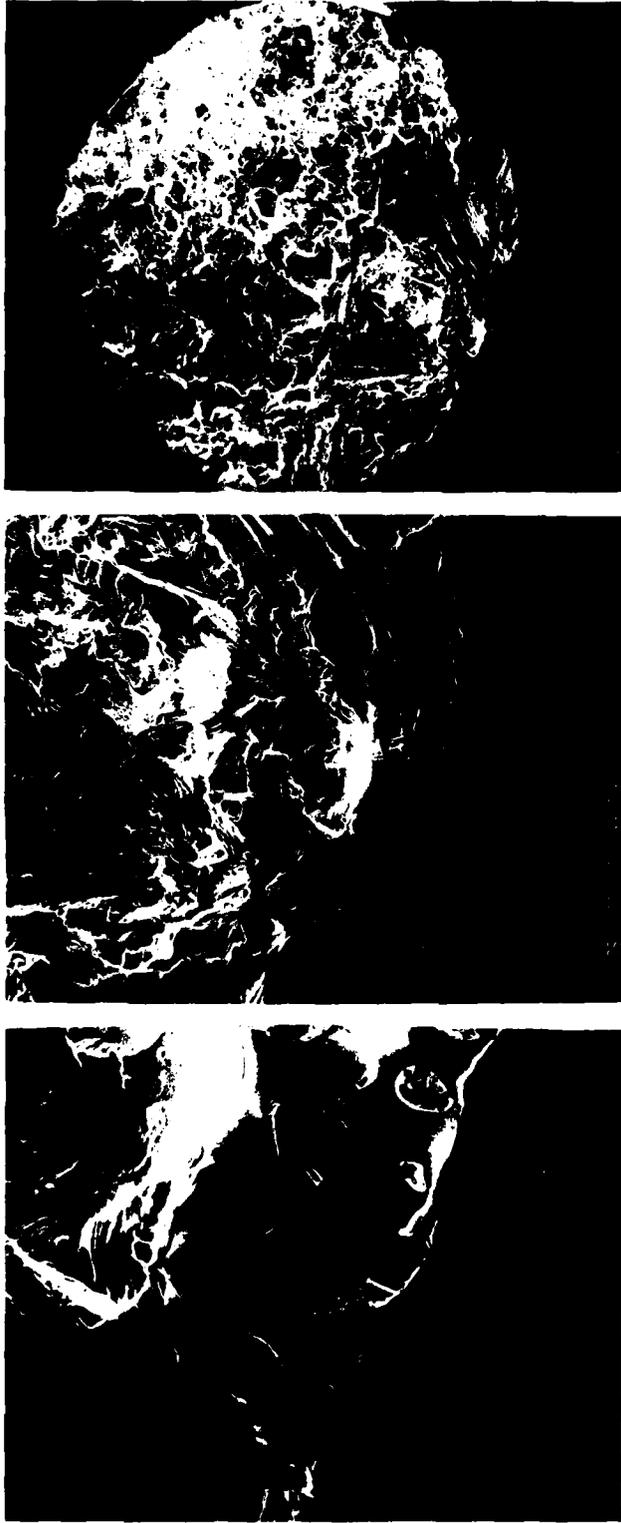
Figures 20 and 21 show the influence of porosity on fatigue properties of HCF test bars. The fatigue failure shown in Figure 20 clearly originates at a pore in the sample. The presence of this pore significantly reduced the fatigue life. In contrast, the sample in Figure 19, shows no porosity. Initiation of this fatigue crack required a great deal of energy, as evidenced by the ductile region at the initiation site, and the absorption of this energy greatly retarded fatigue crack initiation.

Figure 20. SEM fractographs of a typical HCF failure initiating at internal porosity remaining after HIP cycle. The material HIPed at 950°F/10 ksi/12 hr. The sample failed after 258,000 cycles at a 20-ksi stress level. Initial radiographic, Grade C, post-HIP Grade B/B+.

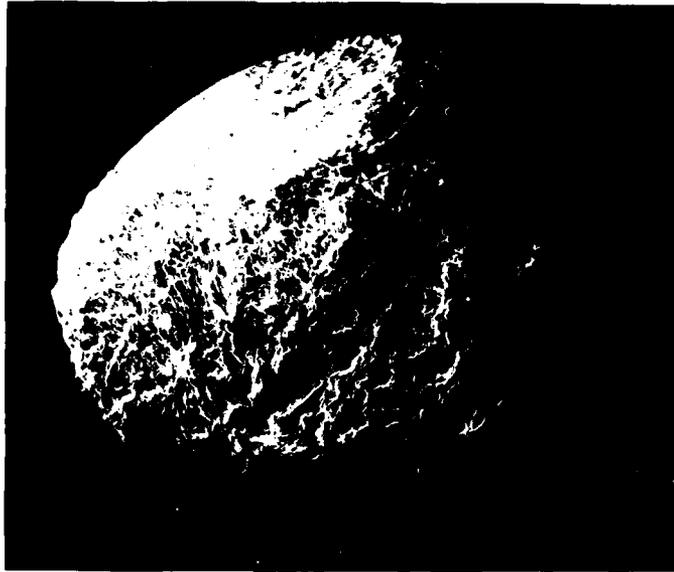
Figure 21. SEM fractographs of a typical HCF failure in a test sample exhibiting no internal porosity after HIP. The material was HIPed at 950°F/15 ksi/6 hr. The sample failed after 290,000 cycles at a 25-ksi stress level. Initial radiographic Grade B, post-HIP Grade A.
