MISCELLANEOUS PAPER SL-81-31

STRUCTURAL STABILITY EVALUATION PINE RIVER DAM

October 1981
Final Report

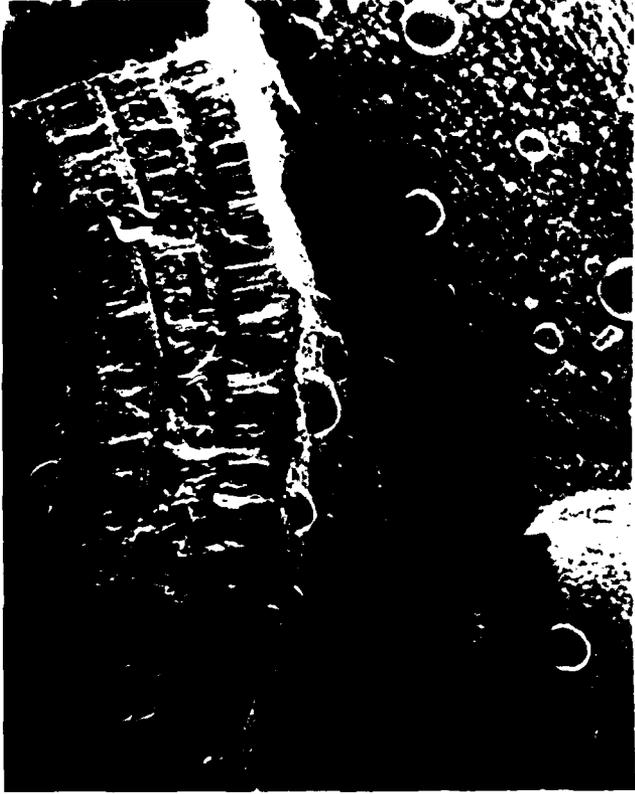
Figure 13. Enlarged view of gel from upper portion of previous SEM micrograph (magnified 250 times). The layered structure of some of the gel can be seen in the fractured surface of the ridge extending across the top of the micrograph
