ADVANCED MACHINERY LIQUID METAL WETTING,
CLEANING AND MATERIALS
COMPATIBILITY STUDY

W. R. Gass, G. C. Burrow,
and R. E. Witkowski

Westinghouse Research Laboratories
Pittsburgh, PA 15235

March 1982

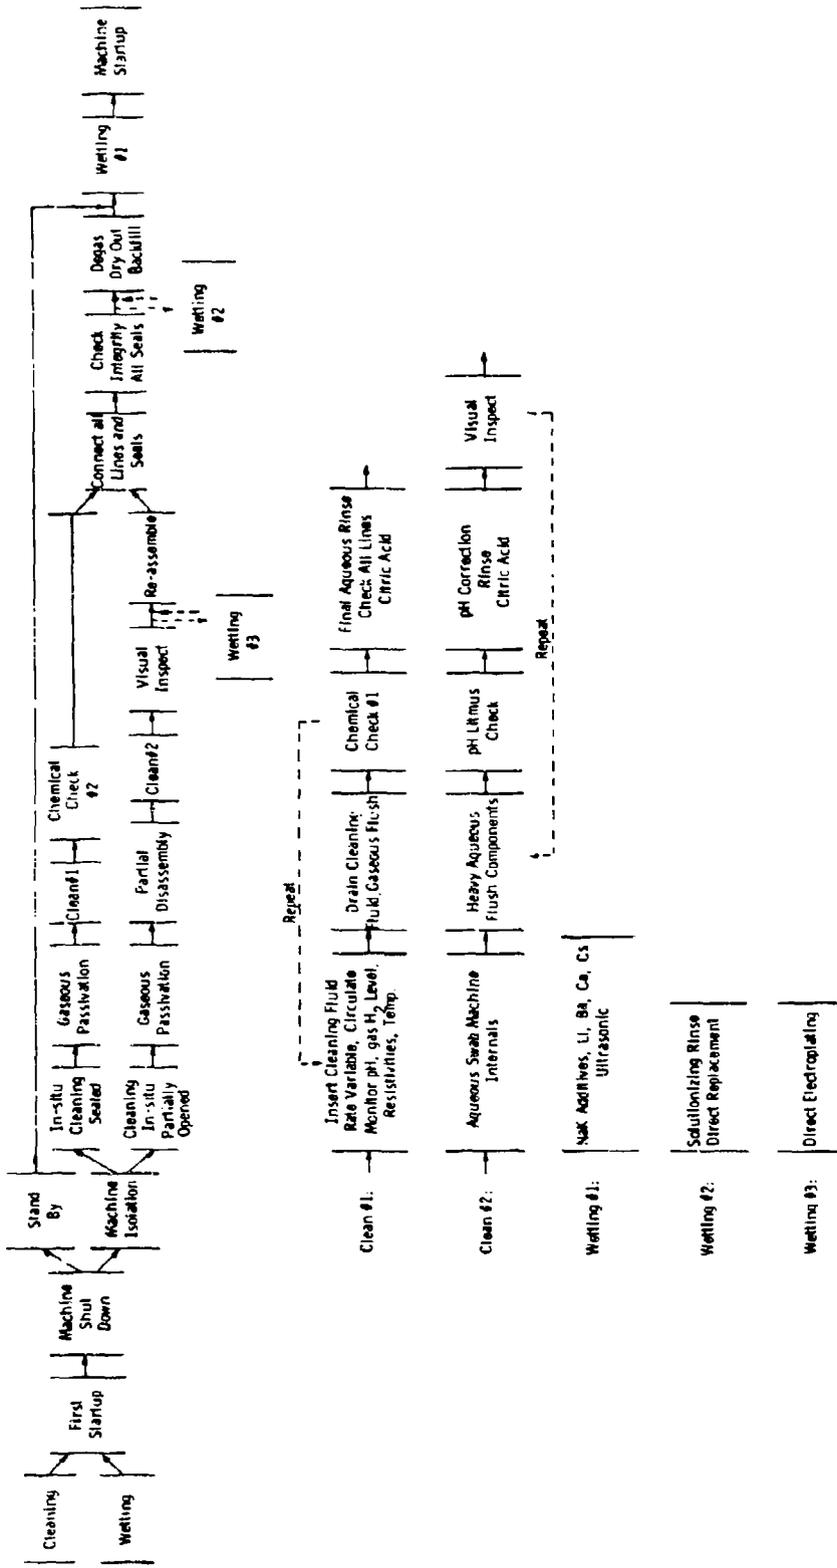
Dwg. 4246827

Fig. 1—Defining sequencing and interfaces

During this investigation the problems associated with wetting, cleaning and their interfacing were significantly simplified. Figure 2 is an updated version of the flow diagram presented in Figure 1. A foam cleaning procedure was developed which effectively replaced the various cleaning procedures referred to in Figure 1. Wetting was obtained by tin metallizing collector surfaces, by additions of barium metal to the

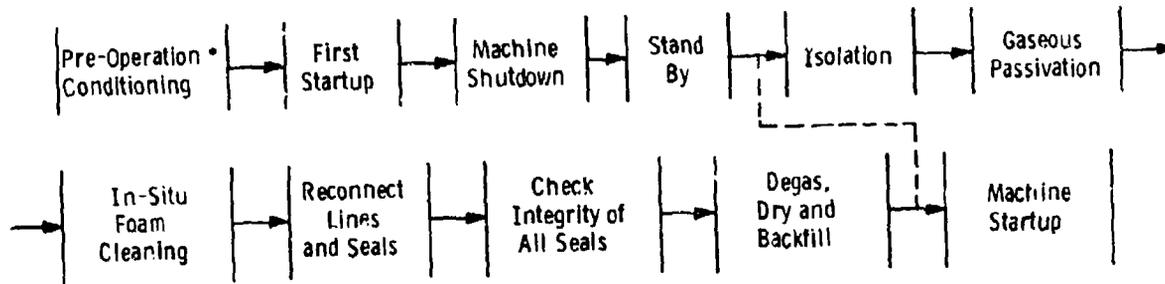
Dwg. 6376A79

- Pre-Operation Conditioning: 1) Tin Plating of Collectors
- 2) Barium Doping of Liquid Metal
- 3) Installation of Stator Braid

Fig. 2--Updated flowchart defining sequencing and interfaces

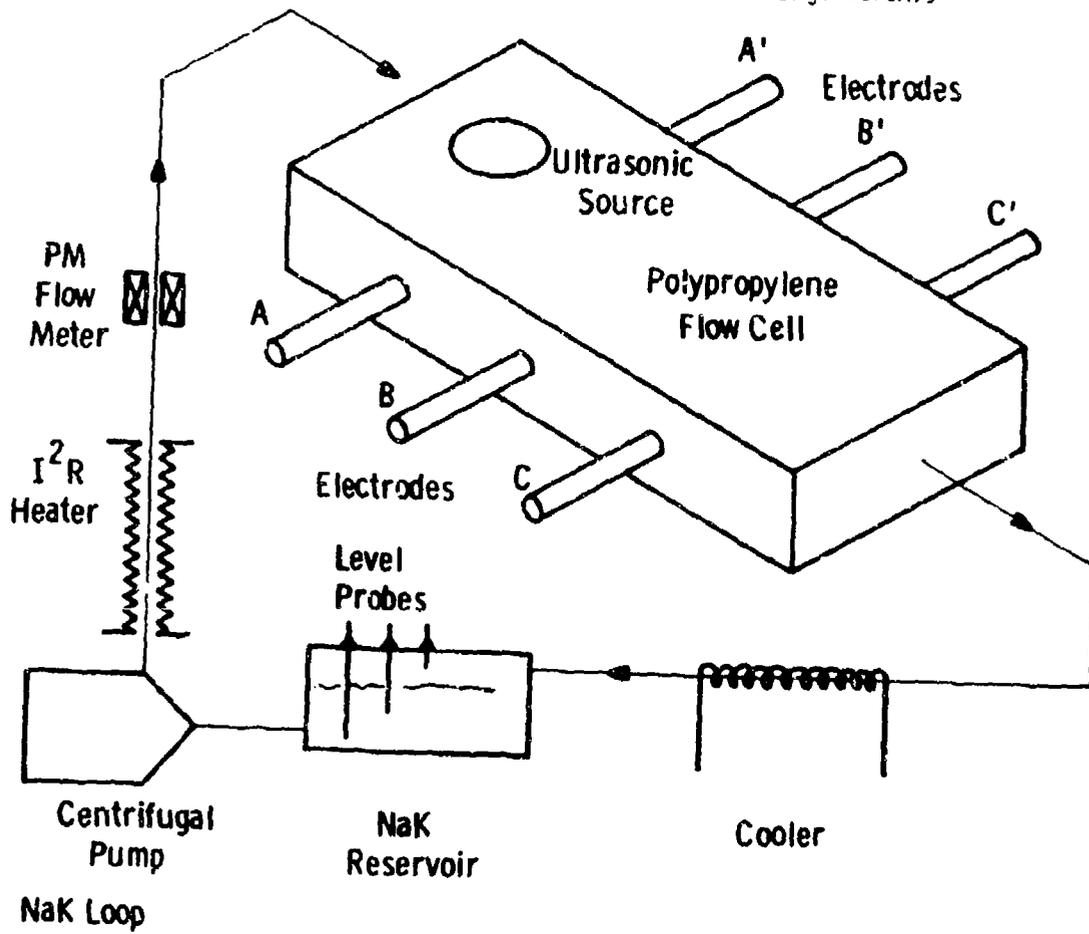
Fig. 3—Flow-cell test apparatus for the evaluation of specific contact resistance

A flowcell test apparatus (Figure 3) was designed and constructed into a flowcell loop (Figure 4) to simultaneously evaluate several wetting methods at various experimental conditions including: solid/liquid metal interface current density, liquid metal flowrate,

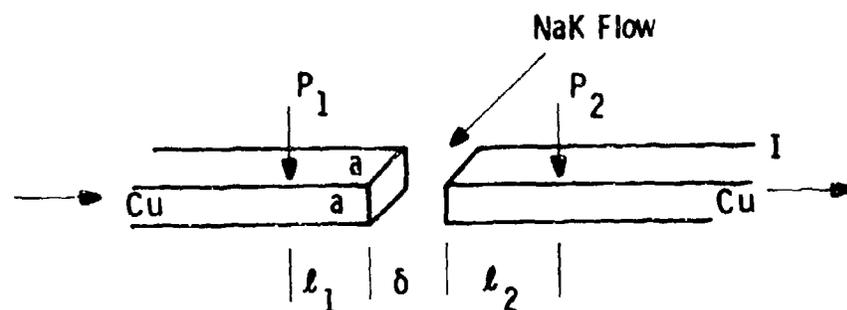
DC Current (Amps)	I
Current Density (I/a^2)	J
NaK Gap Width	δ
Copper Electrode Area	a^2
Couple Potential Drop	$P_1 - P_2$
Specific Contact Potential	ϵ_k

$$\epsilon_k = \frac{(P_1 - P_2)_{\text{meas}} - (V_{SM} + V_{LM})}{J}$$

$$= \frac{I \delta}{\sigma_{LM} a^2}$$

Fig. 5—Flow-cell schematic for measurement of specific contact resistance ϵ_k

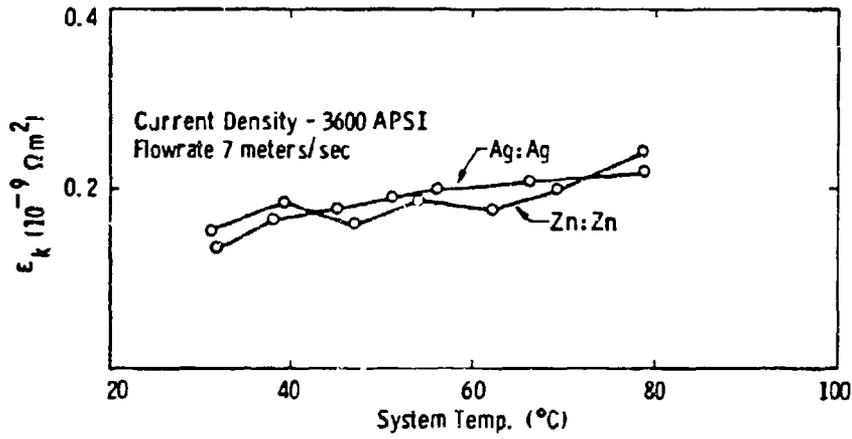
Curve 728142-B

Fig. 9 - ϵ_k vs. liquid metal temperature

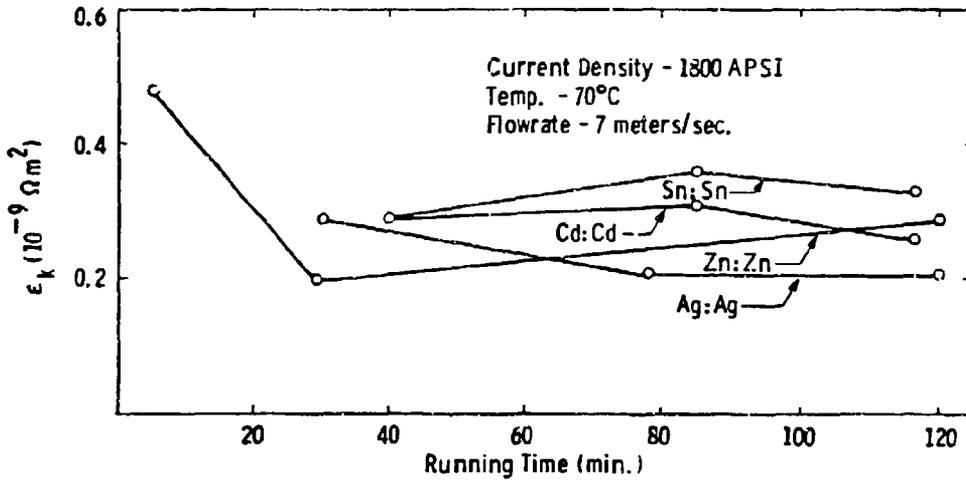
Fig. 10 - ϵ_k vs. running time

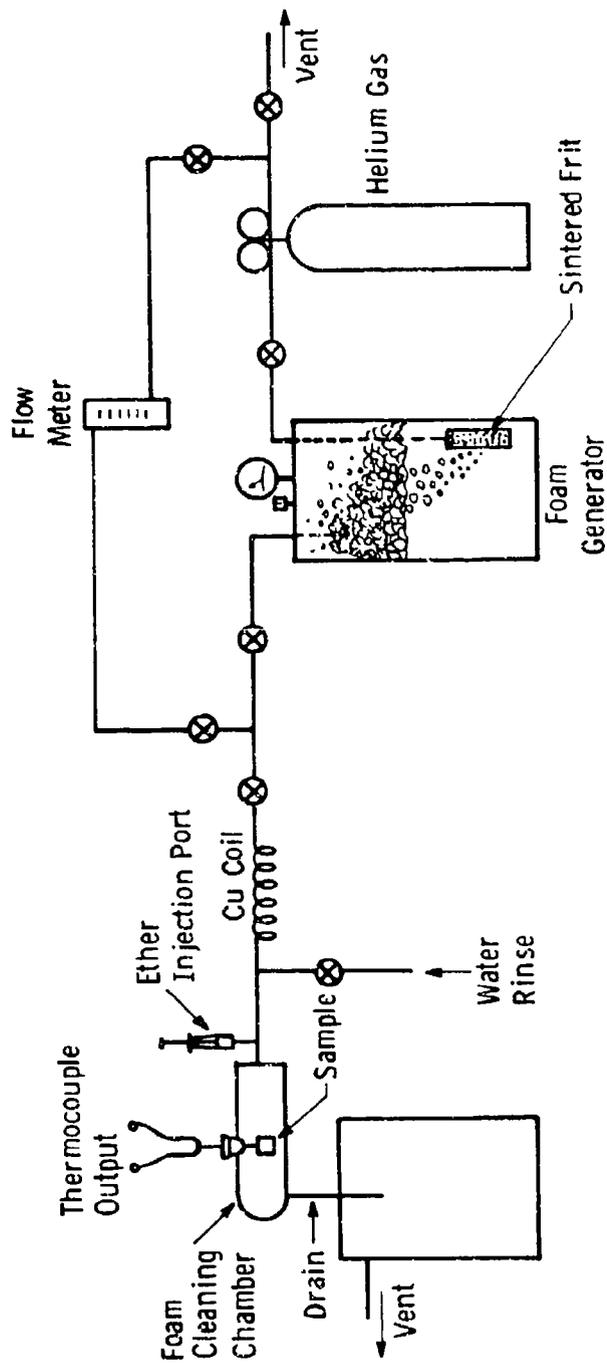
Dwg. 6.399A73

Fig. 11- Foam generator and associated apparatus for studying the cleaning of NaK from materials using a 5% sodium lauryl sulfate aqueous foam

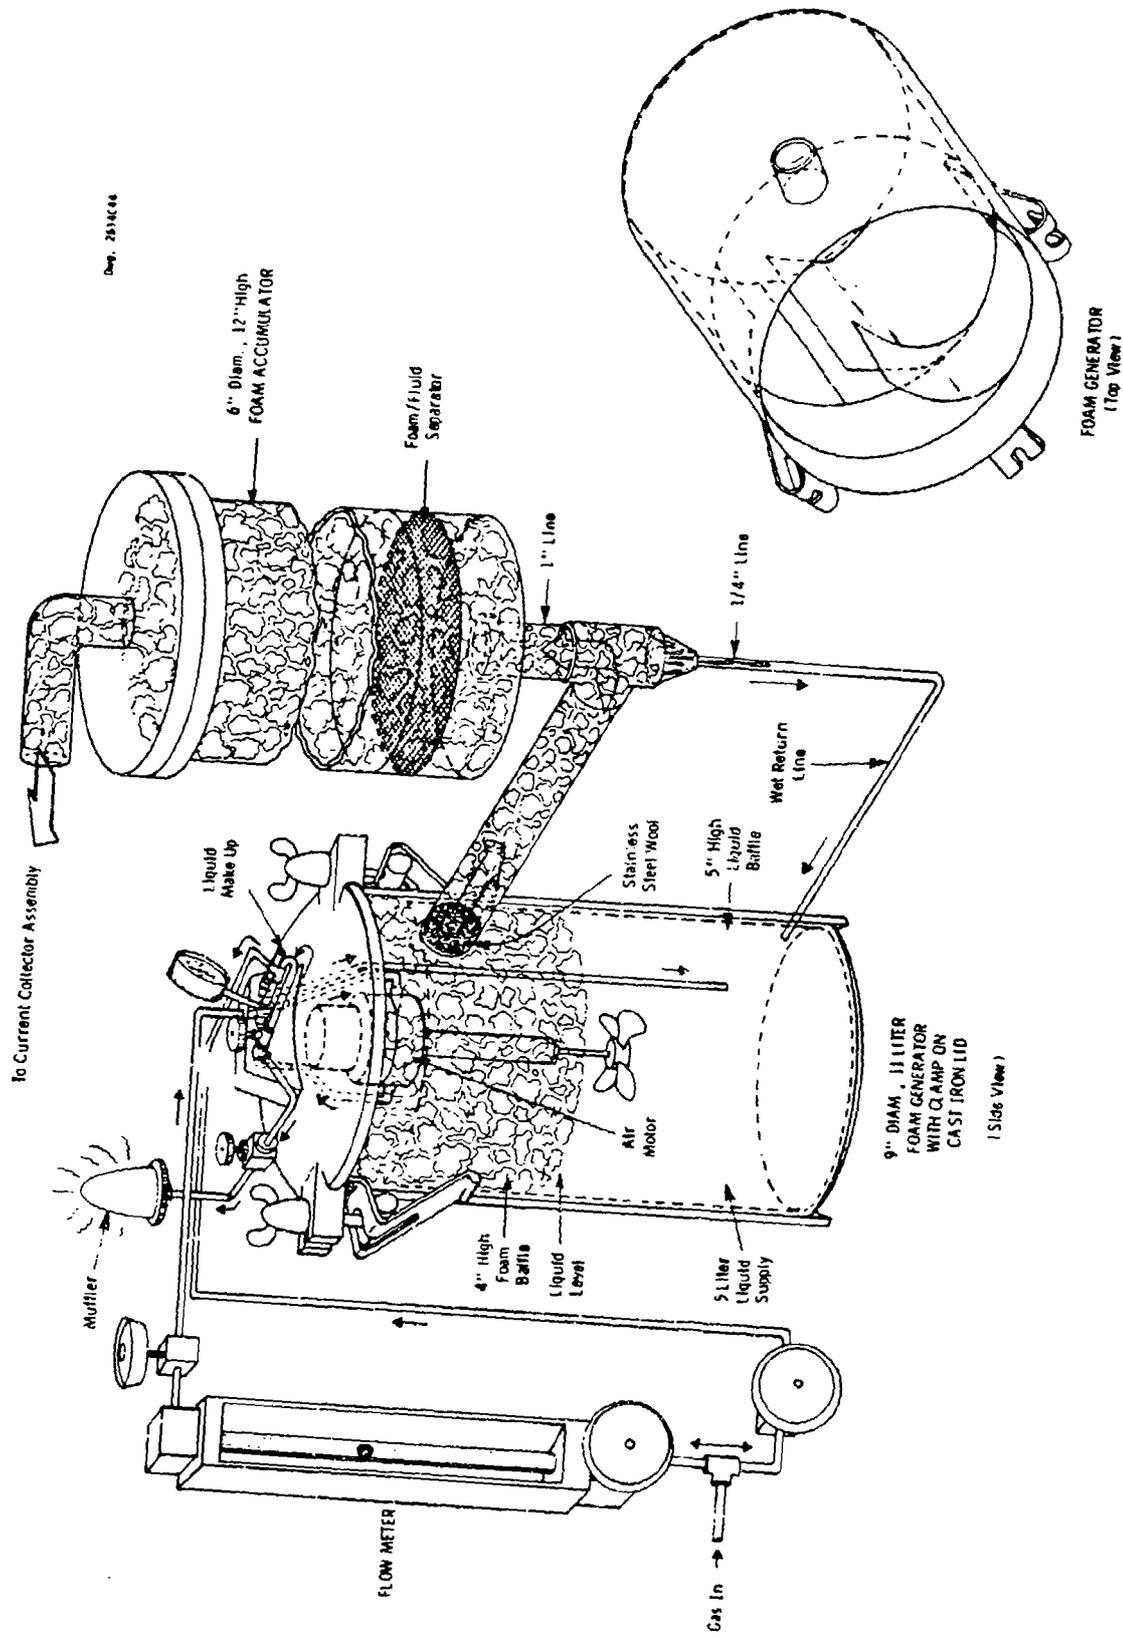
Fig. 12—foam generator for use in cleaning NAK from the internals of machines which utilize liquid metal current collectors

Several foam generator hybrids were designed, fabricated, and tested during this and previous studies.⁽³⁾ A detailed schematic of one generator design is pictured in Figure 12. As illustrated, a high density aqueous foam was generated by the mechanical agitation of the solution of 5 wt. % sodium lauryl sulfate. A helium driven, high speed stirrer was incorporated within the containment vessel. A suitable metal baffle arrangement, coupled with a stainless steel wool plug and foam accumulator, permitted the generation of "dry," compact foams which were injected directly into an in-house current collector test stand

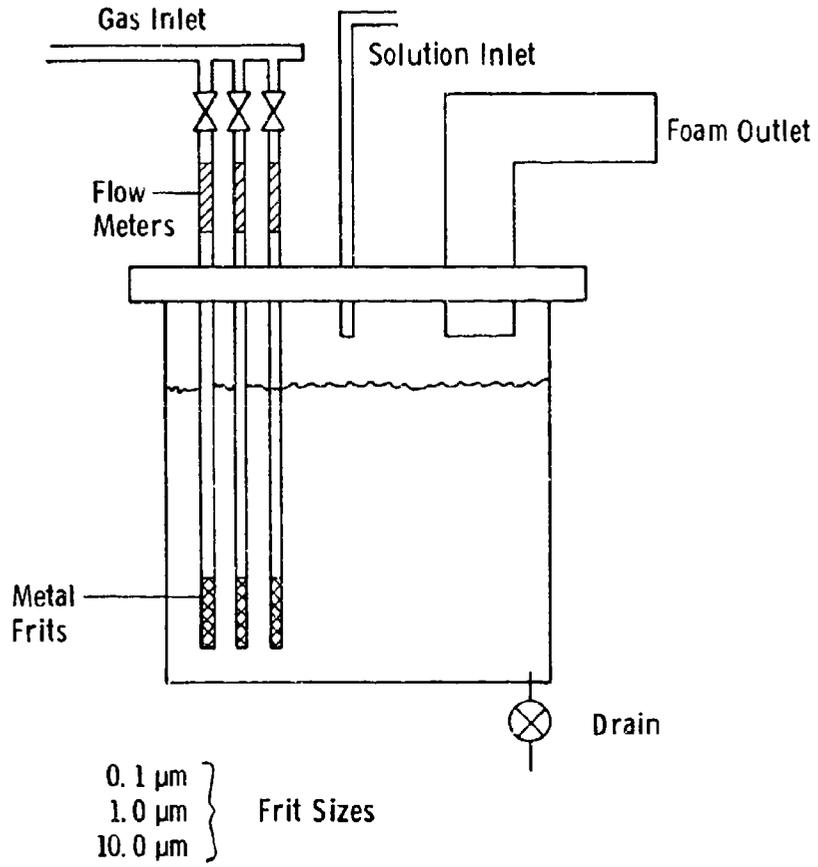
Dwg. 7701A21

Fig. 15- Foam generator

A foam generator as pictured in Figure 15 was fabricated. The mechanism of foam generation consisted of forcing inert gas under pressure through a metal frit into a sodium lauryl sulfate solution. The microscopic bubbles thus formed gathered at the head space above the solution level and were ejected from the foam generator under pressure in a continuous stream. The containment and cap were made of stainless steel to minimize corrosion from the sodium lauryl sulfate solution. The aqueous solution capacity was approximately 2 liters with an additional one liter head space for foam accumulation. With a metal frit size of 0.1 μm and a gas inlet pressure of 40 psi, foam was generated and delivered to and through an in-house collector prototype at rates varying from 0.25-1.0 liters/min. Foam densities as generated by the 0.1 μm frit were in the range of 0.05-0.10 g/cc. Ratios of foam generated to sodium lauryl sulfate solution were 10/1 to 20/1. The "dryness" of the foam, and presumably its reaction rate with NaK, was a function of its density. Tests indicated that foam density decreased with increasing gas inlet pressure.

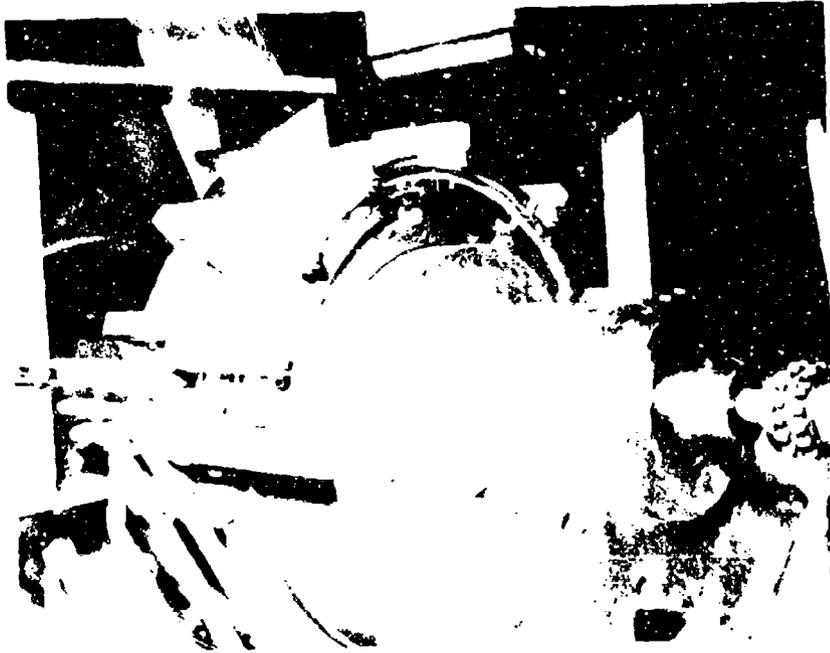
Figure 25. High current bus network.

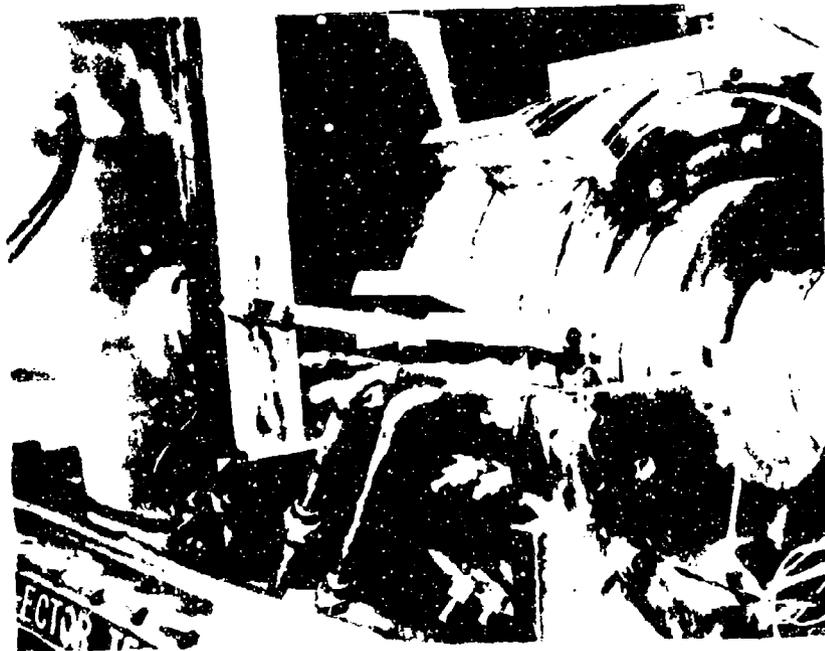
Figure 26. Upper and lower stator half conductors.

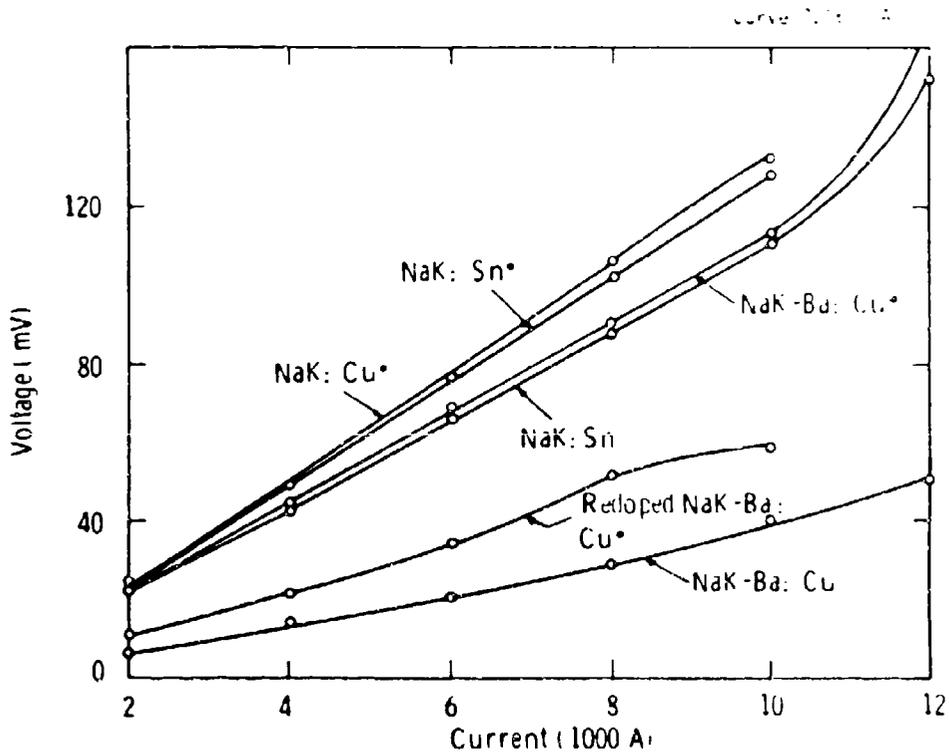
*Post-Cleaning Electrical Test

Fig. 27—In-house current collector prototype performance curves: before and after foam cleaning

Foam cleaning was compatible with subsequent collector operation. Cleaning of the in-house collector prototype produced minimal deterioration of electrical performance. The performance curves of Figure 27 show incremental increases in the slopes of the voltage/current curves for tests run after foam cleaning. For the NaK-Ba:Cu wetting system, the increase in slope was approximately 30%. For the NaK:Sn wetting system, the increase was approximately 12%. One might interpret that the increases in slopes reflect increases in liquid metal/solid metal interface resistances. Increases in interface resistances would suggest that the foam cleaning does slightly interfere with rewetting of the collector surfaces by the liquid metal. Previous testing⁽³⁾ had indicated that rewetting improved with running time and

Periodic redoping of NaK₇₈ with barium improved collector electrical performance. As indicated on Figure 27, severe deterioration of performance occurred with the NaK-Ba:Cu wetting method when the collector assembly was foam cleaned. It appeared that the foam cleaning operation was responsible for a substantial increase of >150% in apparent collector electrical resistance. The collector prototype was again foam cleaned and another series of performance tests was run with barium doped NaK, which was redoped with approximate 0.2 wt. % barium. Collector resistance decreased to almost the same value as before foam cleaning. The original charge of barium was apparently depleted during collector operation. Redoping promoted rewetting of foam cleaned collector surfaces. The collector performance study did not include an evaluation of barium depletion as a function of machine operating time, temperature, current density, etc. due to funding constraints.

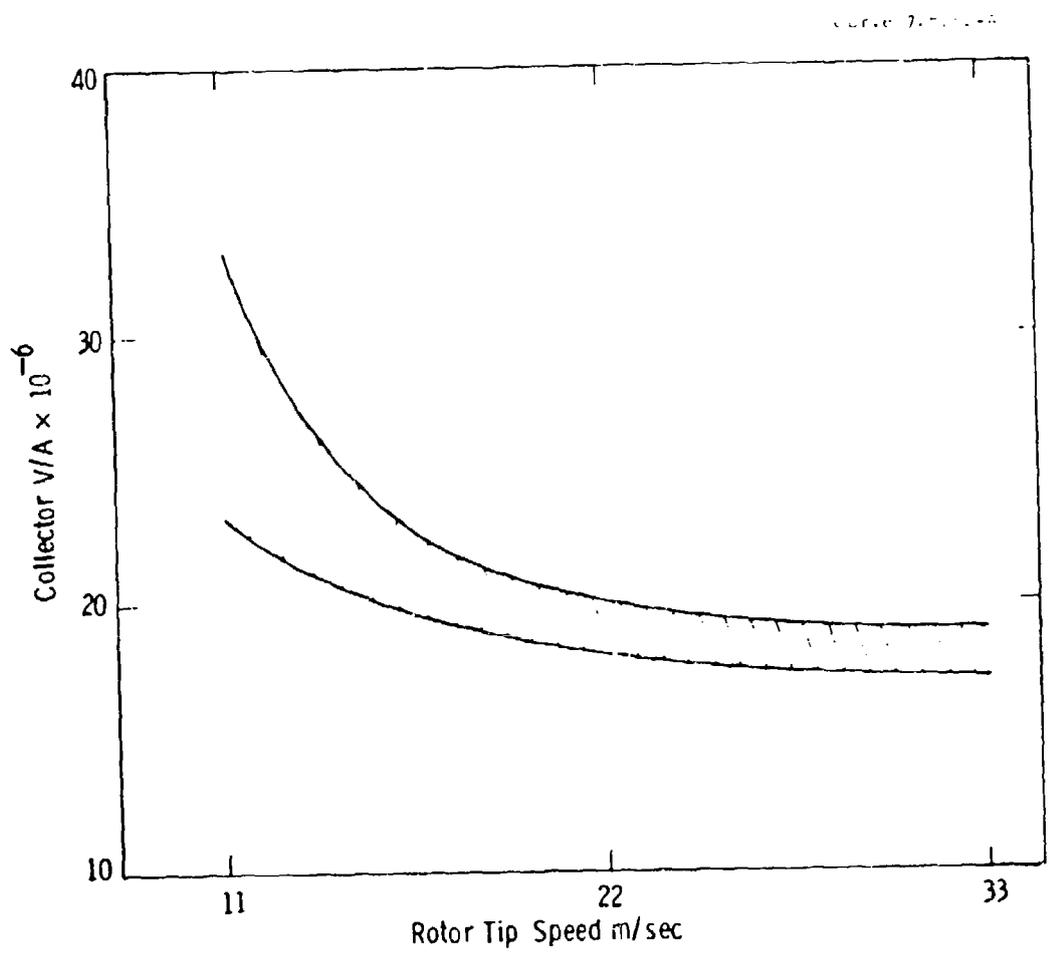
Fig. 28—Electrical performance as a function of rotor tip speed: In-house collector prototype

Operational stability of the in-house collector prototype increased with increasing rotor tip speed. Figure 28 shows that collector losses decreased substantially by increasing the rotor tip speed from 11 m/sec to 33 m/sec. Probable cause for the dependence of electrical performance on tip speed was improved filling of the liquid metal annuli from increased centrifical forces, resulting in better pumping action. The dependence of electrical performance on rotor tip speed would suggest that machines utilizing collectors of this particular design might be limited to some minimum rotor tip speed before electrical losses became too high. There might also be some serious limitations on crash-back operation.

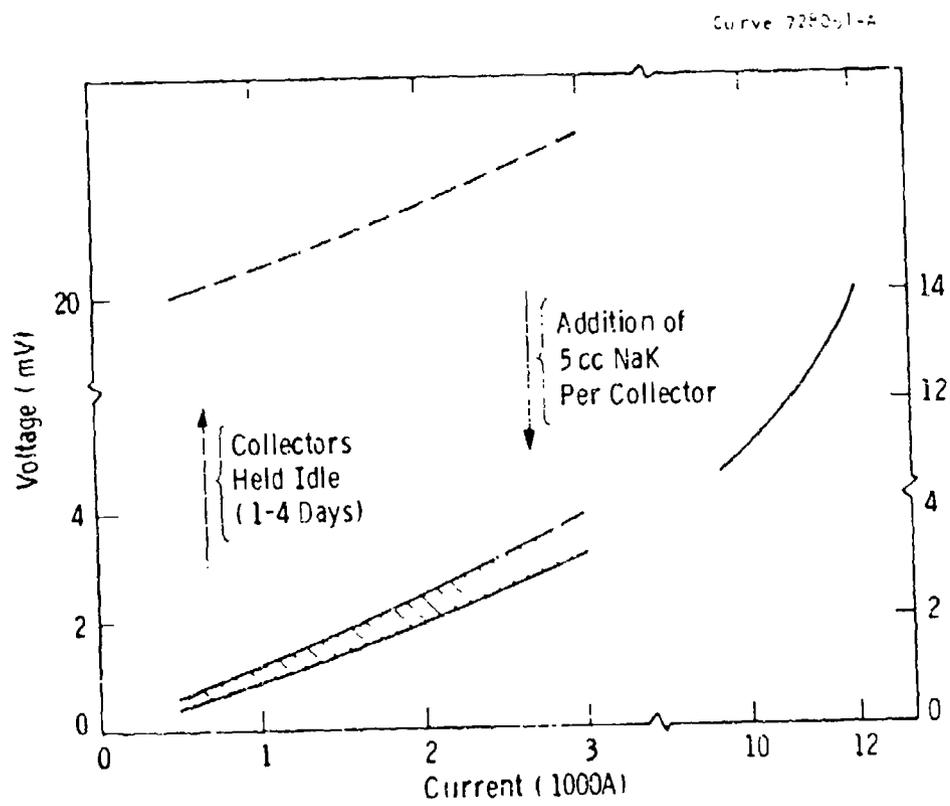
Fig. 29—Navy current collector prototype performance curves

Figure 29 shows performance curves for the Navy collector prototype. Experimental data for the two wetting methods tested (NaK:Sn and NaK-Ba:Sn) fell within a narrow range, regardless of whether the tests were conducted before or after foam cleaning. Foam cleaning did not contribute to measurable deterioration of subsequent collector electrical performance. Disassembly and inspection of collector internals after foam cleaning revealed no corrosion products on either rotor or stator current collecting surfaces. The collector braid was clean of any traces of NaK₇₈ or its salts.

Idling the collector assembly for one or more days with liquid metal within the collector reservoirs promoted severe deterioration of electrical performance on start-up. Figure 29 shows greater than an order of magnitude increase in voltage drop across the collector pair. Electrical performance was restored by the addition of 5 cm³ of liquid metal to each collector. The deterioration and subsequent restoration of performance was obtained with undoped and barium doped NaK₇₈, indicating that deterioration of performance was not caused by loss of wetting. Apparently not all the liquid metal returned to the reservoirs when the collector assembly was shut down. Sufficient quantities may have been retained within the stator braid and within the collector internals to deplete the supply and prevent complete filling of collector annuli on start-up. Although the problem was temporarily solved by the addition of more liquid metal, a more permanent solution might be to redesign the collector reservoirs to hold more liquid metal.

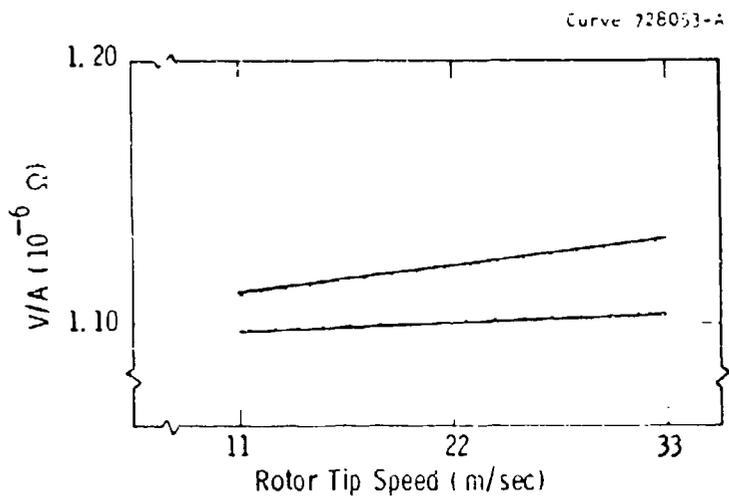
Fig. 30—Electrical performance vs rotor tip speed:
navy collector prototype

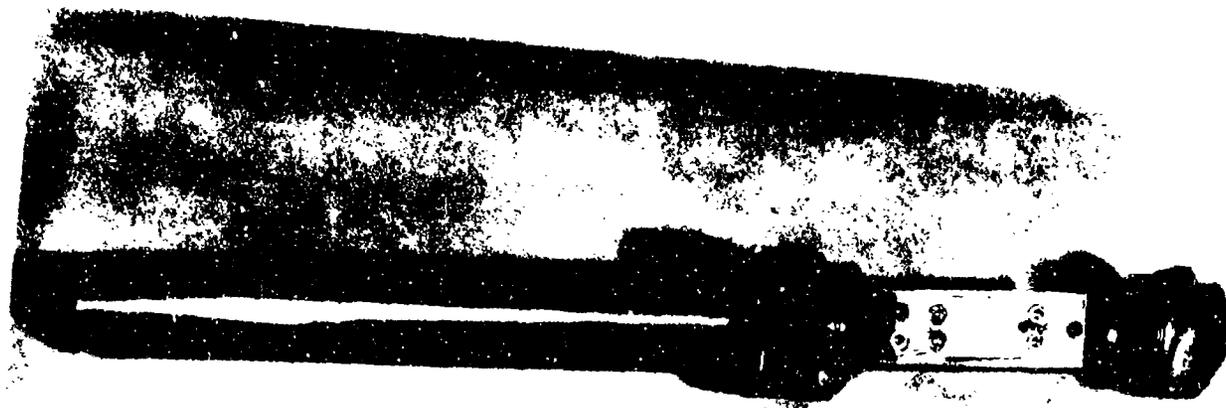
Figure 32. Example of the stainless steel exposure capsules and specimen trees.

The specimens were cleaned, weighed, mounted on specimen trees, Figure 31, and sealed in stainless steel capsules, Figure 32, containing barium doped NaK (saturated sol. at 100°C). A constant temperature oil bath maintained at 100°C was utilized for isothermal specimen exposure. The eight test conditions under which the materials were exposed are detailed in the test matrix in Table 6.

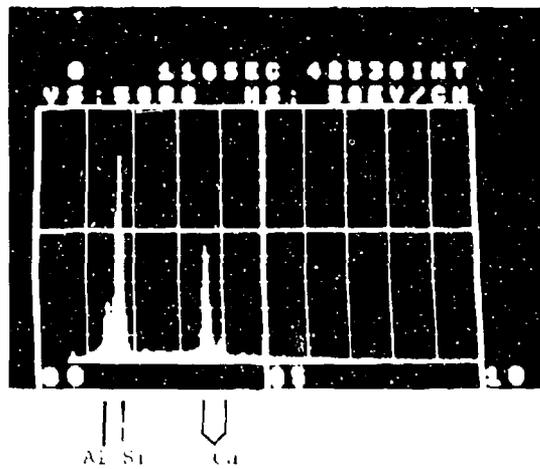
(c) Electron excited x-ray spectrum.
(100X rastered area)

Figure 33. Nema Grade G-10 Fiberglass Laminator. Surface features and composition. (100X rastered area). (48A) (exposed)

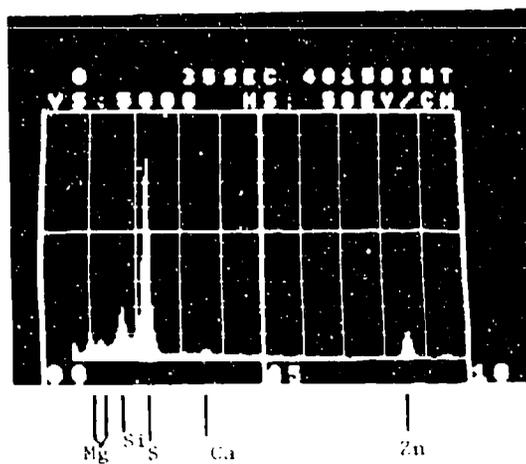
(c) Electron excited x-ray spectrum
(100X rastered area)

Figure 36. Buna N Rubber: Surface features and composition before NaK₇₈ (EB) exposure.

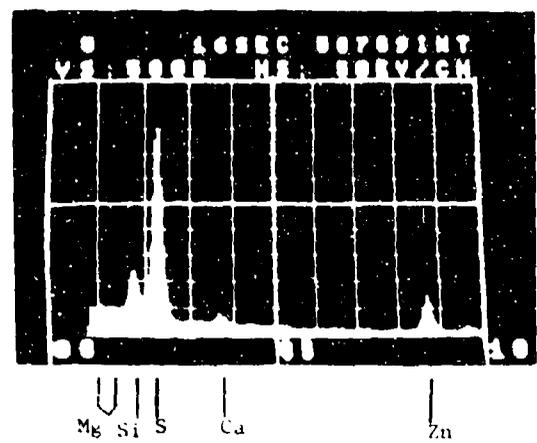
(c) Electron excited x-ray spectrum
(100X rastered area)

Figure 38. Buna X Rubber: Surface features and composition after thermal exposure.

- The cleaning environment was more harsh and resulted in more degradation of the materials than the NaK exposure conditions, particularly in the case of the Buna N Rubber.

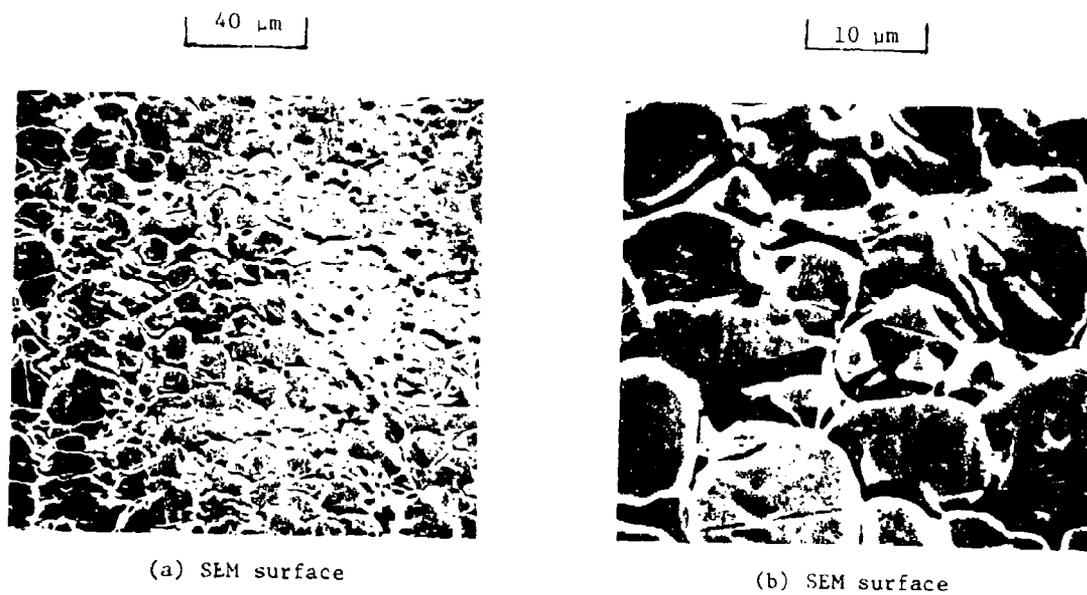
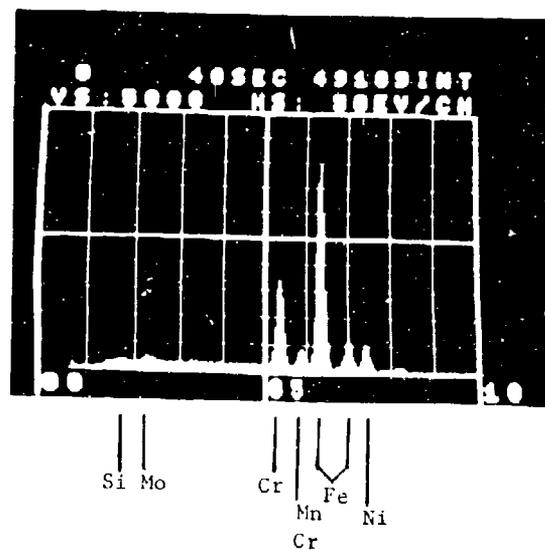
(c) Electron excited x-ray spectrum
(100X rastered area)

Figure 39. 316 Stainless Steel: Surface features and composition before
NaK₇₈ (+Ba) exposure.

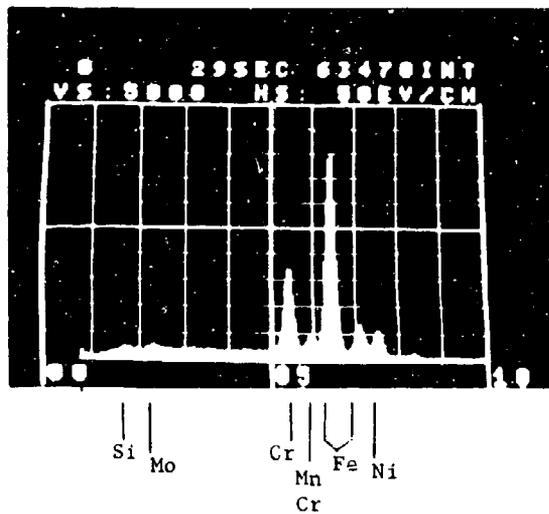
(c) Electron excited x-ray spectrum
(100X rastered area)

Figure 40. 316 Stainless Steel: Surface features and composition after NaK₇₈ (+Ba) exposure.

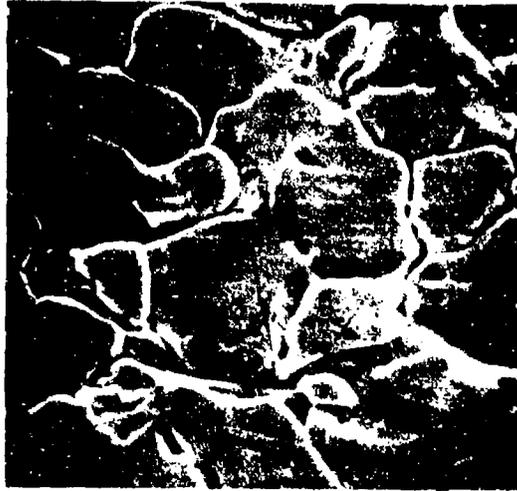
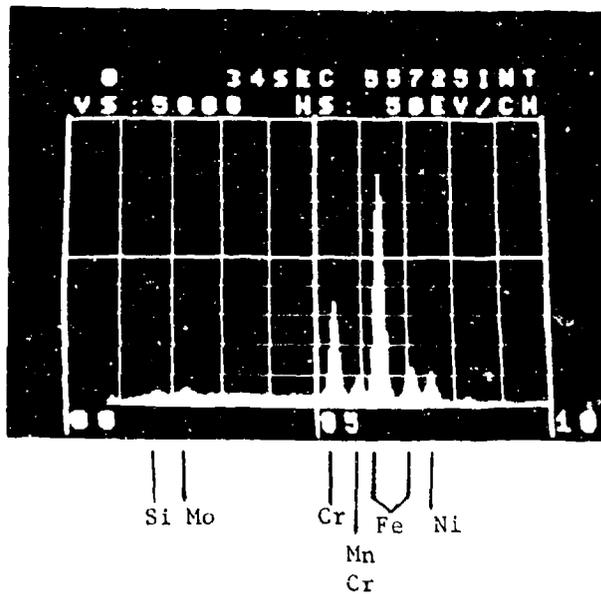
Figure 41. 316 Stainless Steel: Surface features and composition after thermal exposure.

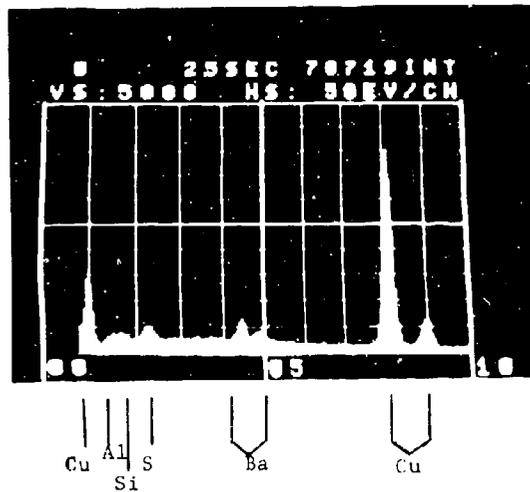
(c) Electron excited x-ray spectrum
(200X rastered area)

Figure 43. OFHC Copper: Surface features and composition after NaK₇₈ (+Ba) exposure.

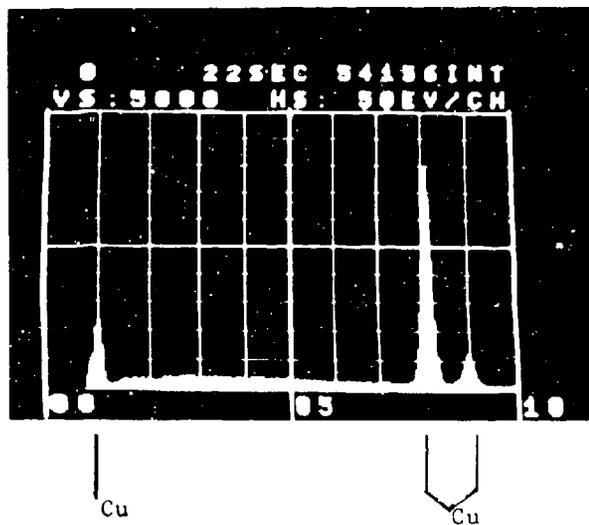
(b) Electron excited x-ray spectrum
(2000X rastered area)

Figure 44. OFHC Copper: Surface features and composition after thermal exposure.

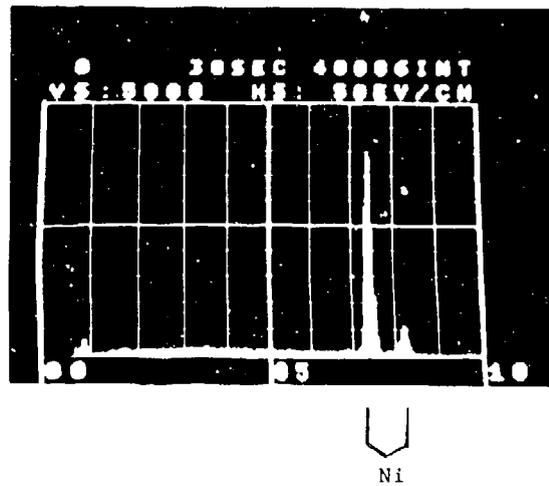
(c) Electron excited x-ray spectrum
(100X rastered area)

Figure 45. Nickel plated OFHC Copper: Surface features and composition before NaK_{78} (+Ba) exposure.

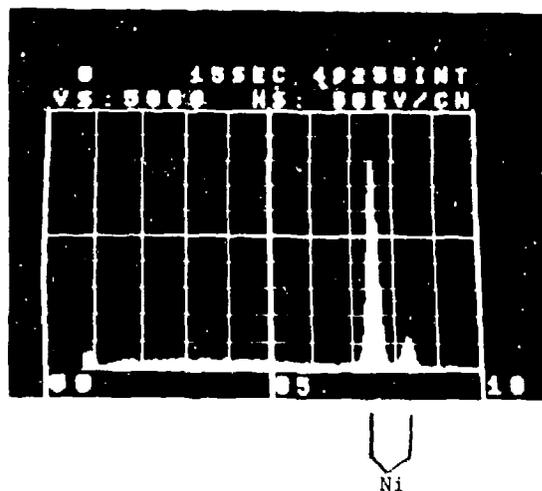
(c) Electron excited x-ray spectrum
(100X rastered area)

Figure 46. Nickel plated OFHC Copper; Surface features and composition after NaK₇₈ (+Ba) exposure.

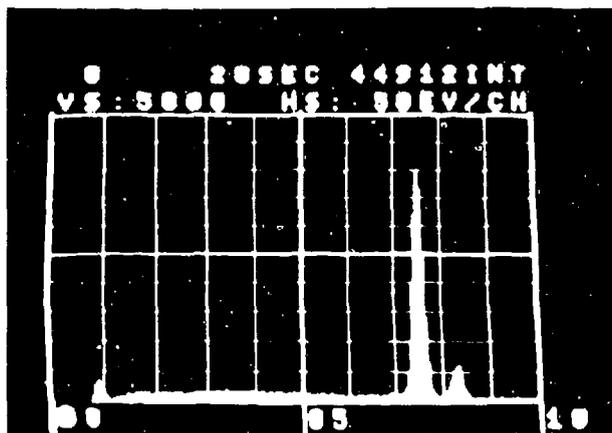
(b) Electron excited x-ray spectrum
(100X rastered area)

Figure 47. Nickel plated OFHC Copper; Surface features and composition after thermal exposure.

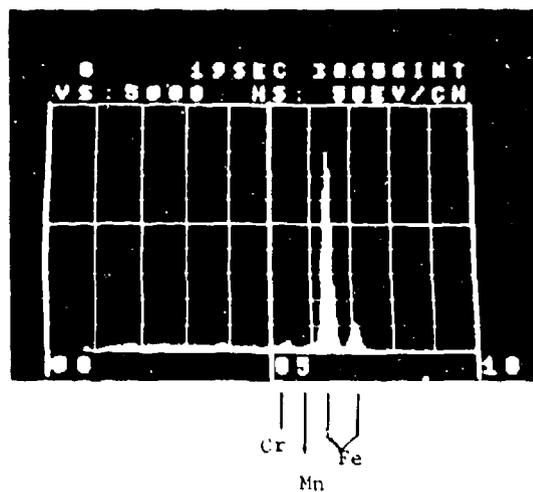
(c) Electron excited x-ray spectrum
(100X rastered area)

Figure 49. Ball Bearing Steel: Surface features and composition after NaK₇₈ (+Ba) exposure.

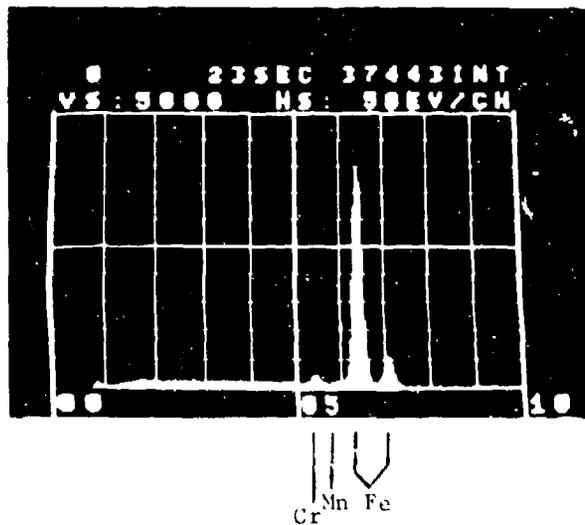
(b) Electron excited x-ray spectrum
(100X rastered area)

Figure 50. Ball Bearing Steel: Surface features and composition after thermal exposure.

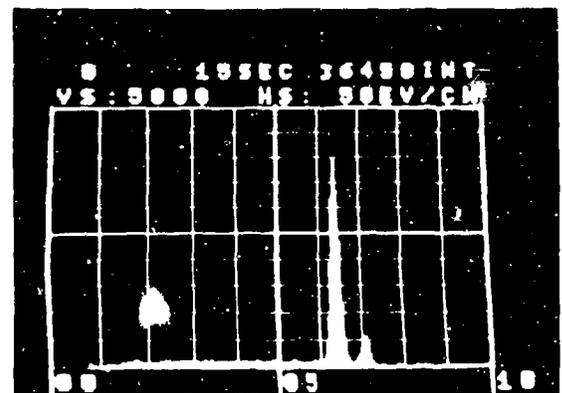
(c) Electron excited x-ray spectrum
(100X rastered area)

Figure 52. Mild Magnetic Steel: Surface features and composition after NaK₇₈ (+Ba) exposure.

- Complete wetting was observed for all of the materials (except the mild steel) exposed to the barium doped NaK. This infers that barium does enhance wetting by NaK.

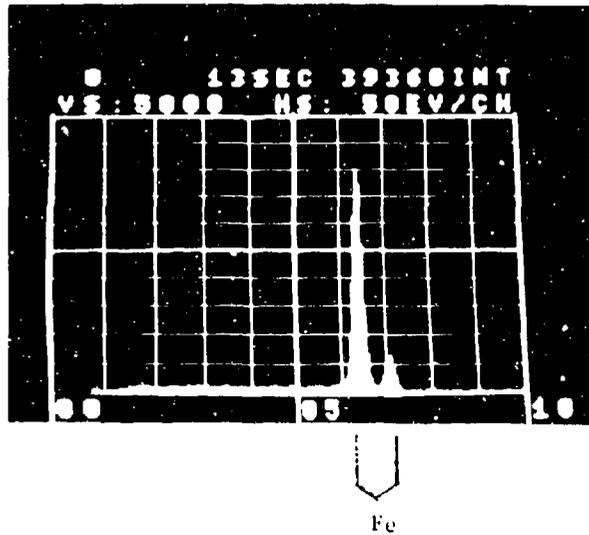
(b) Electron excited x-ray spectrum
(100X rastered area)

Figure 53. Mild Magnetic Steel: Surface features and composition after thermal exposure.

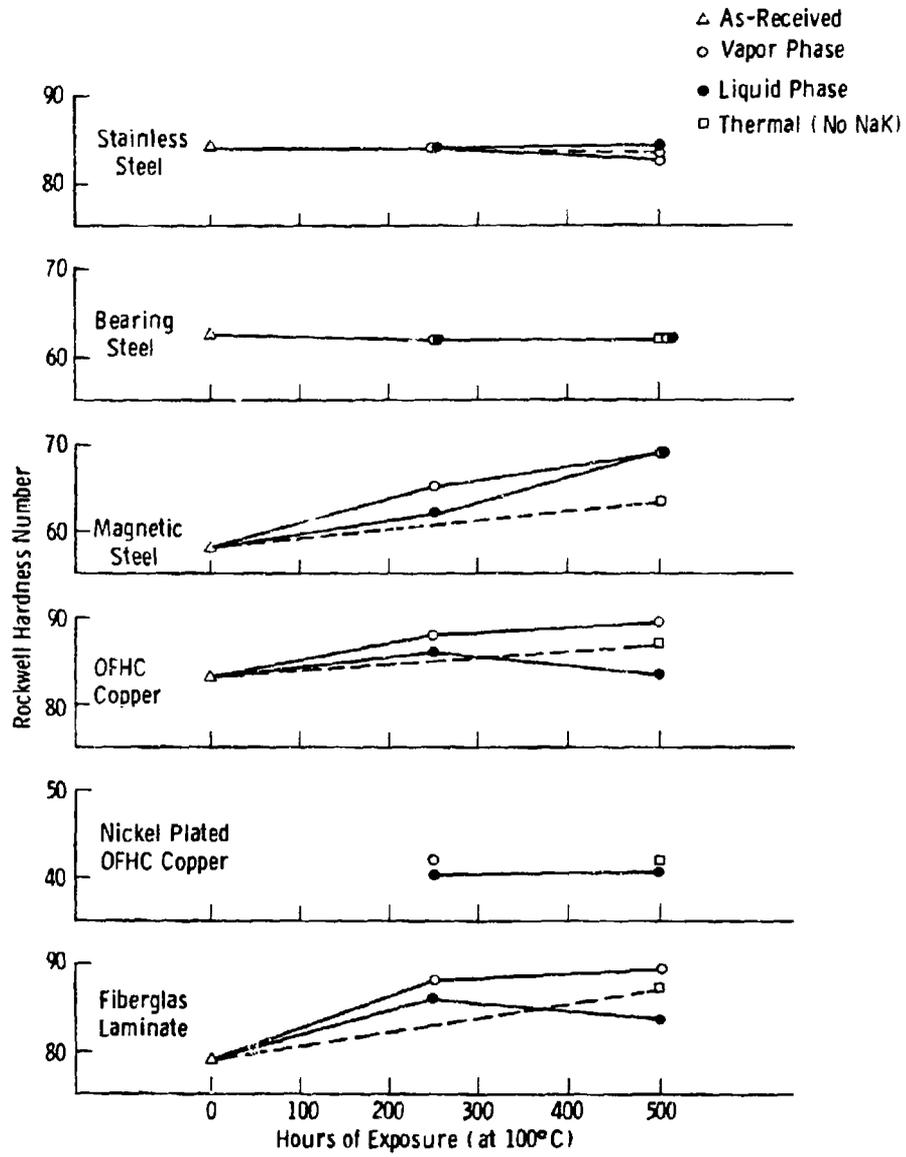
Curve 72805-1-1

Fig. 54—Hardness profiles of machine materials after exposure to Nak (liquid and vapor) and thermal exposure
