Technical Report 690

REMOTE MEDICAL DIAGNOSIS SYSTEM (RMDS) ADVANCED DEVELOPMENT MODEL (ADM) AT-SEA TEST RESULTS

January 1982

Prepared for
Naval Medical Research and Development Command
Code 45
Bethesda, MD

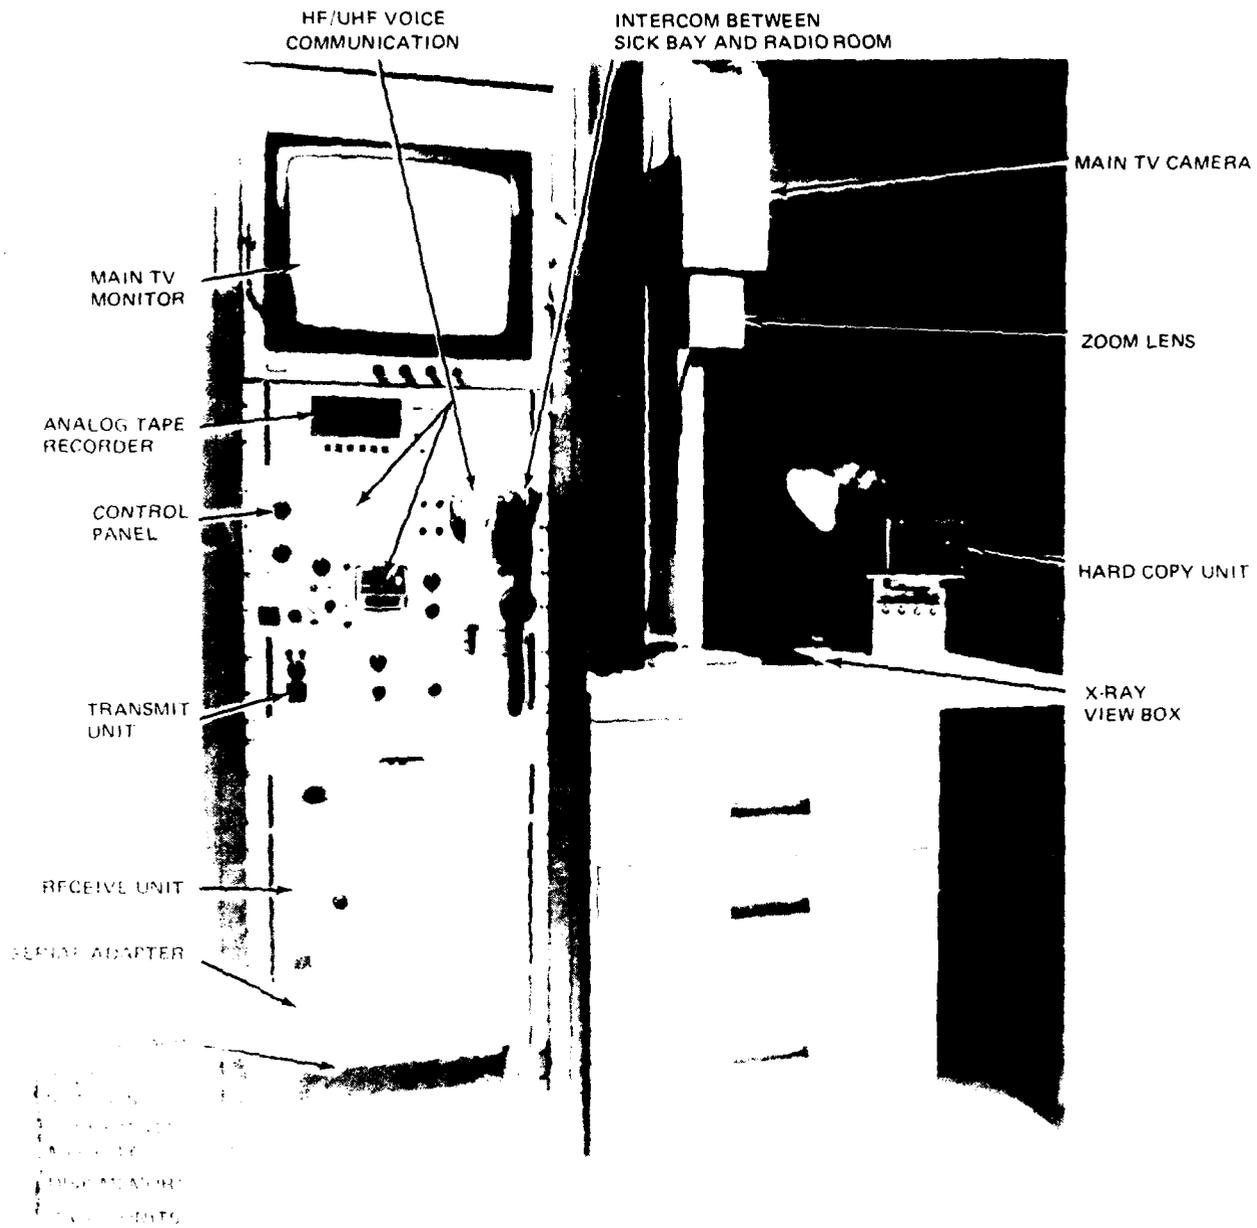
Figure 1 Advanced Development Model (ADM) RMDS terminal and related components.

- Video receive unit, including solid-state memory for up to 525 x 256 picture elements at 6 bits per picture element (Modified CVI Model 275)
- Hard-copy unit, consisting of 5" auxiliary TV monitor and Polaroid camera
- ECG strip chart recorder (MFE Corp. Model M-21) (not shown)
- Serial adapter
- Modem (Model ICC 24) 2400 bps
- Two radio control units (C1138B/UR)
- Remote TV camera, including monitor, tripod, zoom lens, 50 feet of cable, and padded carrying case (not shown)
- Stethoscope pickup unit (not shown)
- ECG machine (Model HP 1500B) (not shown)
- Mounting racks and miscellaneous hardware

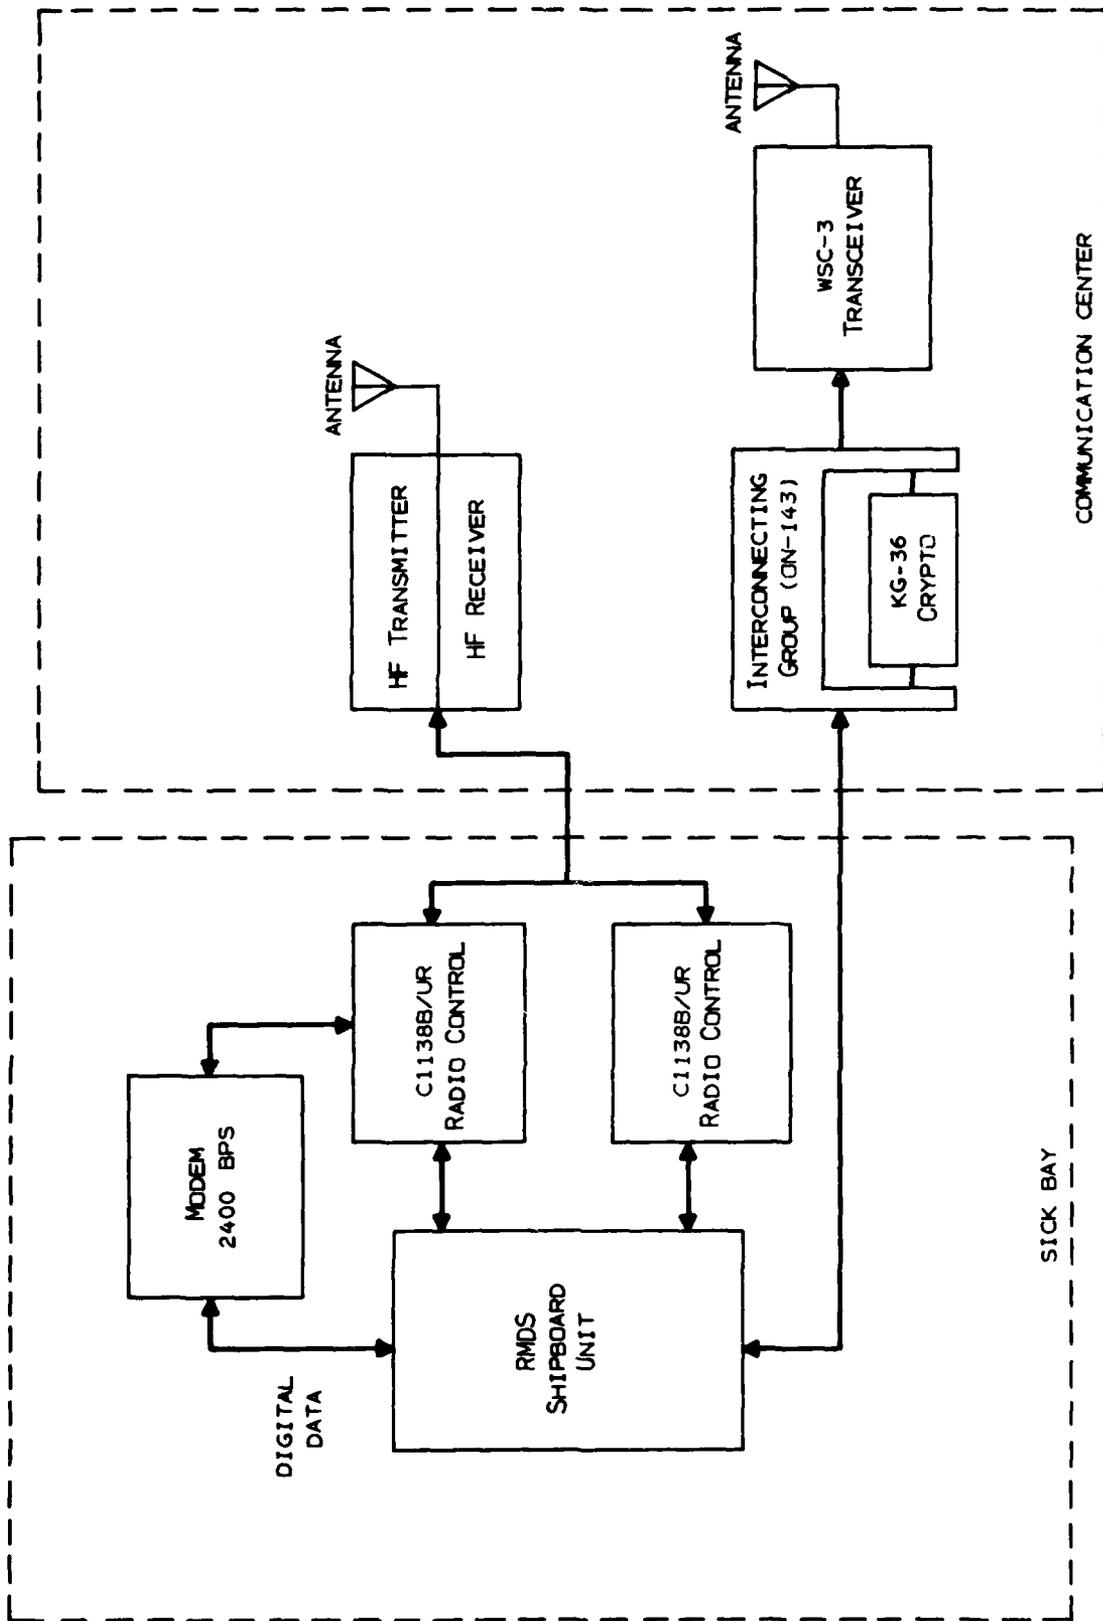
Figure 2. RMDS equipment interface aboard USS ENTERPRISE.

The RMDS terminal was located in the sick bay aboard USS ENTERPRISE. Figure 2 illustrates the equipment interface used for RMDS testing aboard ship. Digital data from the RMDS terminal passed through a 2400 bps modulator-demodulator (modem) integral to the RMDS terminal; the data were routed to the communications center via C1138B/UR radio control units and communications lines especially installed for these tests. Shipboard environmental conditions were less than optimal in the following respects:

The first two types of interference were reduced at the RMDS phone jack outputs with the addition of a 1000 pF capacitor.

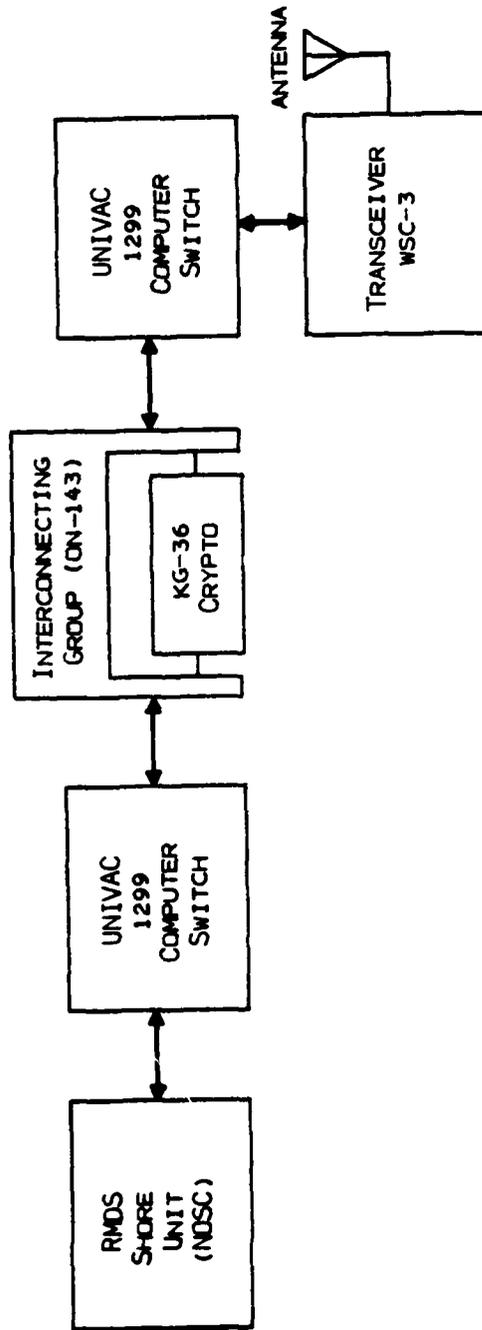
Figure 5. RMDS equipment interface for satellite communication on shore.

The satellite communication link tests required that the RMDS terminal be located in a secure area near the encryption/decryption devices at NOSC. Figure 5 illustrates the equipment configuration for satellite communications needed in support of RMDS testing at NOSC.

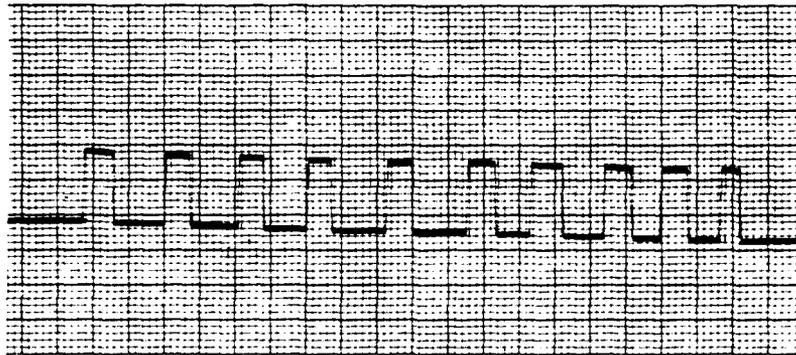
(a) Transmitted calibration pulse

Overshoot of about 10% was measured on the received calibration pulses (figure 6). This overshoot accounted for the difference in attenuation for high- and low-frequency pulses (points B and C of figure 7, respectively), since overshoot would decrease the amount of attenuation observed on high frequency pulses. A 1% increase in the distance between pulses, ie between points A and D of figure 7, was observed for the received signals. The increase was proportional for all elements of the received signal and did not represent significant signal distortion. In general, it was felt that the quality of the received ECG data was good and of a level sufficient for diagnostic purposes.

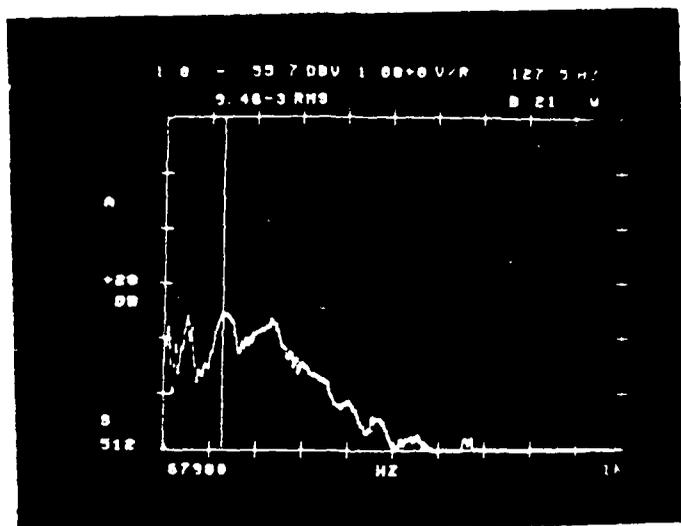
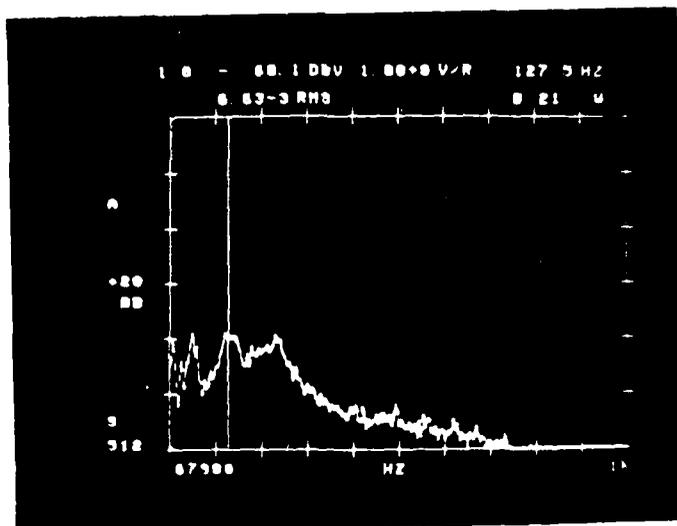
Figure 9. Photographs of spectral analysis (linear scale) for transmitted/received recordings of stethoscopic testing, severe constrictive pericarditis.

Figures 9 through 12 show representative photographs of the spectral analysis for transmitted and received heart sound recordings. Appendix A identifies the alphanumeric symbols present on the spectral analysis photographs. In general, the received heart sounds were similar in amplitude and frequency to the transmitted sounds, as indicated in figures 9 through 12. Figures 10 and 12 (spectral analysis, log scale) show good frequency response for the lower frequencies (1 to 100 Hz). A general increase in noise that was observed on the received recording was attributable to the RMDS terminals and the communication link. In addition to this increase in noise, a number of the received signals possessed distinct noise spikes at approximately 60 Hz intervals, as seen in figure 11.

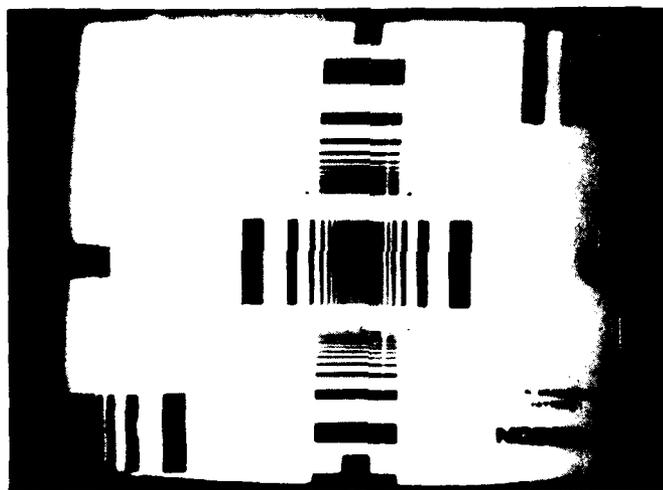
Figure 13. Transmitted image of test patterns for figures 14 through 17.

In general, the quality of both analog and digital video transmission was good. Figures 13 through 17 show representative photographs of transmitted/received images of test patterns for the various test conditions over an hf communication link. These reproductions of the photographed images do not show all the slight differences between test conditions, but those irregularities are discussed herein. The photos do demonstrate, however, the nature of the subject material and the qualitative bounds of the differences.

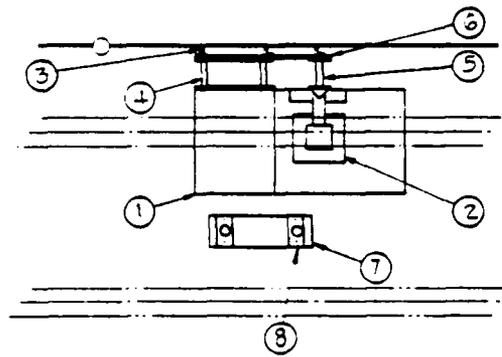
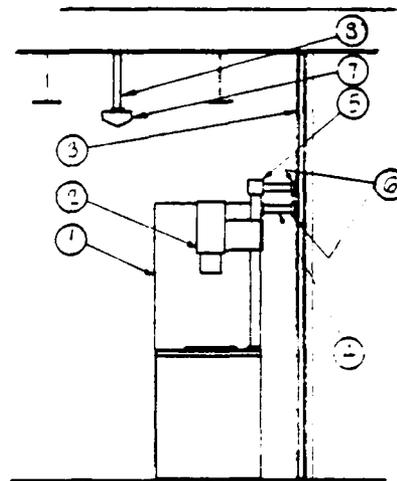
Figure 18. RMDS shipboard equipment configuration.

1. Equipment Cabinet
2. Camera
3. Floor-to-Ceiling Beams
4. Cabinet Back Sway Braces
5. Camera Support Sway Braces
6. Crossmember Between Floor-to-Ceiling Beams
7. Overhead Light
8. Light Foundation

To reduce vibrational distortion, the TV camera must remain as stationary as possible with respect to the viewing table. This might be accomplished by the use of sway braces from the top of the camera support pole to the RMDS equipment cabinet. Two additional approaches which may reduce camera vibration are 1) the use of shock/vibration mounts under the RMDS terminal and between horizontal securing braces and 2) a decrease in camera mass. With the TV camera stationary with respect to the RMDS equipment cabinet and viewing table, vibration mounts should result in equal displacement of camera and table, ie no vibrational distortion. The mass of the TV camera contributes to vibration in a fashion similar to a pendulum; thus a reduction in mass should decrease vibration. This could be achieved by the use of a solid-state camera or a conventional camera with separate control panels. In order for the RMDS terminals to meet military specifications, special attention should be directed toward such camera vibration. It should be noted that camera vibration distortion was reduced

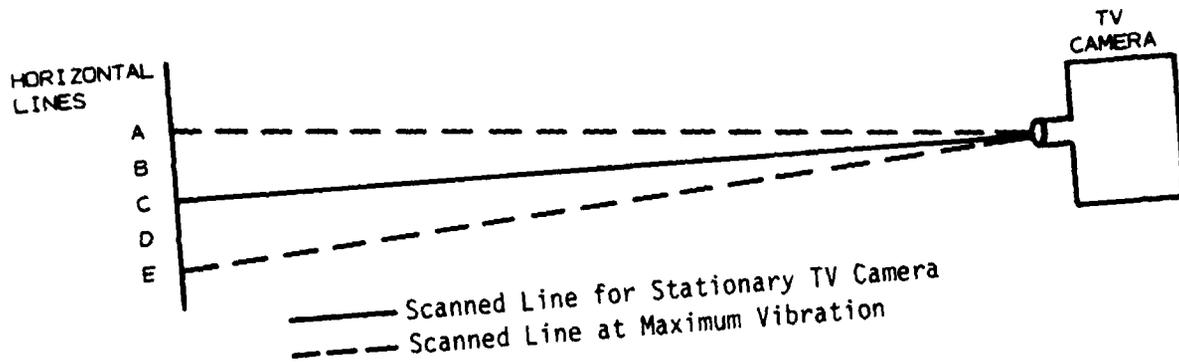
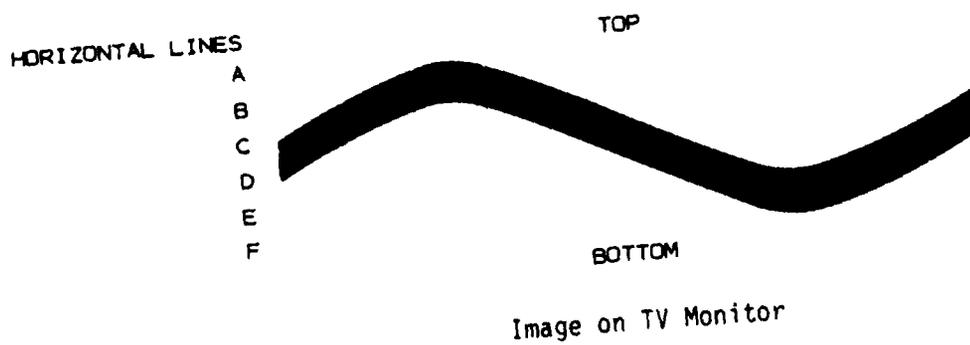
Figure 19. Effects of camera vibration in vertical axis.

The maximum vibration observed was approximately 1% of the camera's vertical field of view, representing a distortion of approximately two horizontal lines both above and below the desired scanning position. Figure 19 graphically depicts the horizontal waviness effect of camera vibration along the vertical axis. Reducing camera vibration by 75%, ie to 0.25% of the camera's vertical field of view, would have eliminated waviness by restricting camera scanning to one horizontal line.

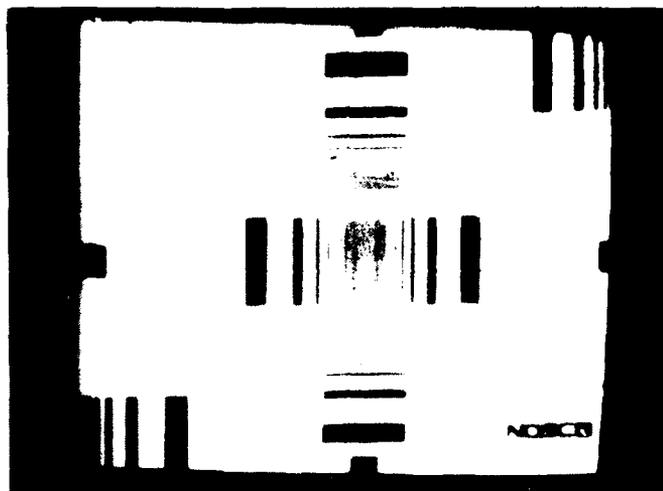
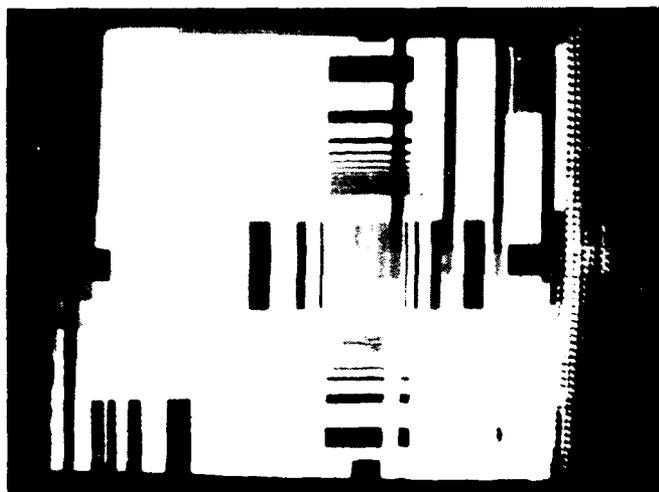
Figure 20. Received image of Horizontal Resolution Test Pattern, live, fine, digital transmission mode, uhf/satellite.

Vibrations aboard ship caused horizontal waviness in the received images when the TV camera was used as a live image source (see figures 20 and 21, received images). This was similar to the waviness seen via the hf communication link. Figure 21 shows transmitted and received images of a gray scale test pattern. Ten distinct gray levels could be observed for the transmitted and received images, meeting the gray scale specifications called for in the Remote Medical Diagnosis System ADM specification.

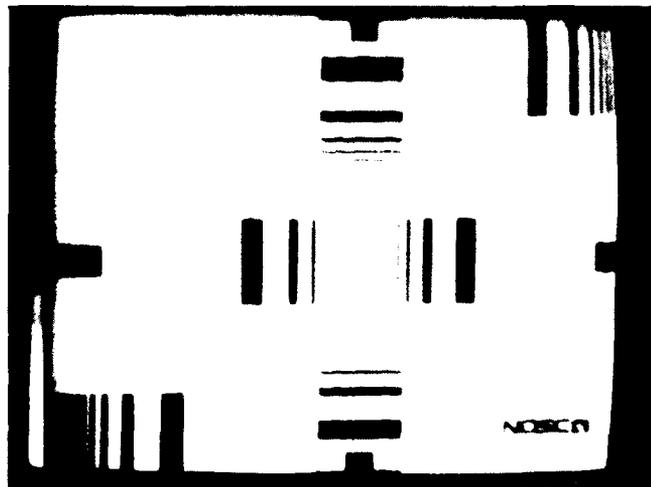
Figure 25. Transmitted/received image of Horizontal Resolution Test Pattern, main camera far field, fine, digital transmission mode, hf.

The ability to image the Horizontal Resolution Test Pattern (figure 24) was examined at the two zoom settings, ie far and close fields of view. Images were transmitted and received using an hf communication link. Transmission occurred via the digital, fine transmission mode; the main camera was used to view the test pattern. Figures 25 and 26 show photographs of the transmitted and received images. The received images clearly demonstrated the ability of the zoom lens to magnify areas of an image with good quality. Waviness, similar to that mentioned in section 3.3.1 (figures 14 and 15, live image), was observed in the received images. It was attributable to camera vibration aboard ship.

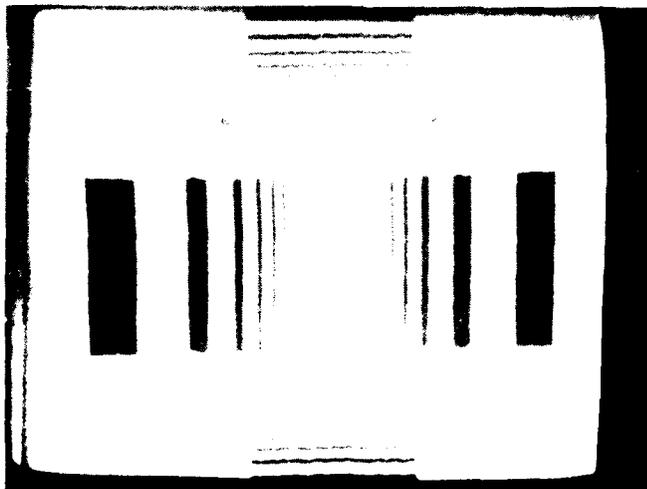
Figure 26. Transmitted/received image of Horizontal Resolution Test Pattern, main camera close field, fine, digital transmission mode, hf.

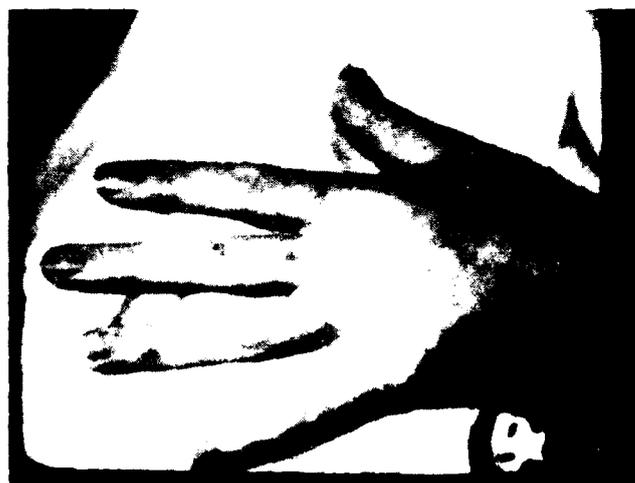
Figure 29. Transmitted/received image of hand, video disc recorder, remote camera, digital transmission mode, hf.

A human subject was employed during tests of image transmission for the remote camera. Images were transmitted and received via an hf communication link. Prior to transmission, all images viewed by the remote camera were stored on the video disc recorder. Figures 27 through 30 are representative photographs of transmitted and received images of the subject. A comparison of the transmitted versus received images demonstrated good quality for image transmission via the remote camera. As stated in section 3.3.1 for figures 21 and 22, the use of the video recorder reduced the effect of camera vibration in the horizontal direction. Similarly, no horizontal waviness was observed in the received images of the remote camera.

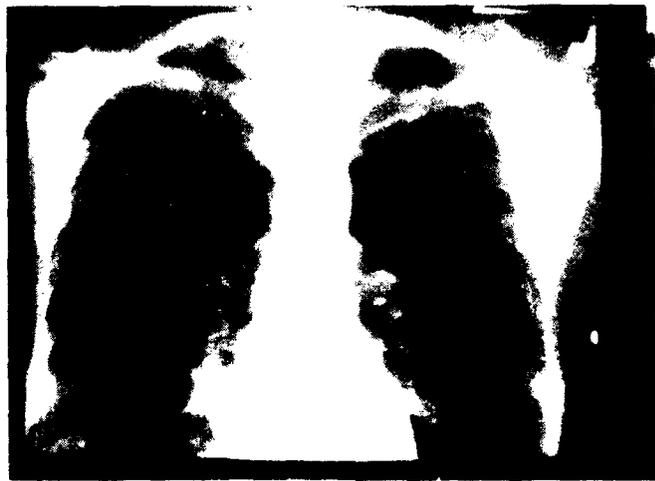
Figure 33. Transmitted/received image of radiograph Case Three (chest - normal).

Case Three (Chest - Normal), figure 33. Dr Gerber: This film was of a normal female chest with no significant visual clues which could have been mistaken for any of the diagnoses to be evaluated.

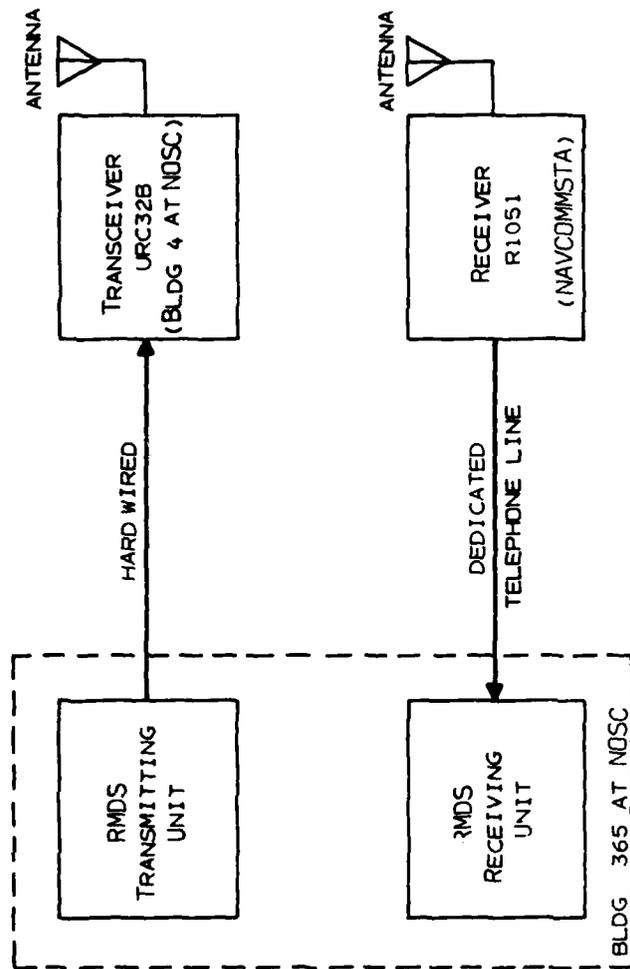
Figure 36. RMDS equipment interface for hf back-to-back testing.

Prior to the at-sea tests, NOSC participated in qualitative testing of the RMDS video system via hf and uhf/satellite communication links. For these tests, the RMDS transmitting and receiving terminals were located at the NOSC facilities, wired in a back-to-back configuration. Figures 36 and 37 illustrate the equipment setup used for the hf and uhf/satellite communication links, respectively. The RMDS terminals were operated in the live, fine resolution, digital (2400 bps) transmission mode for the testing of both communication links. The main camera was used for all hf testing; both

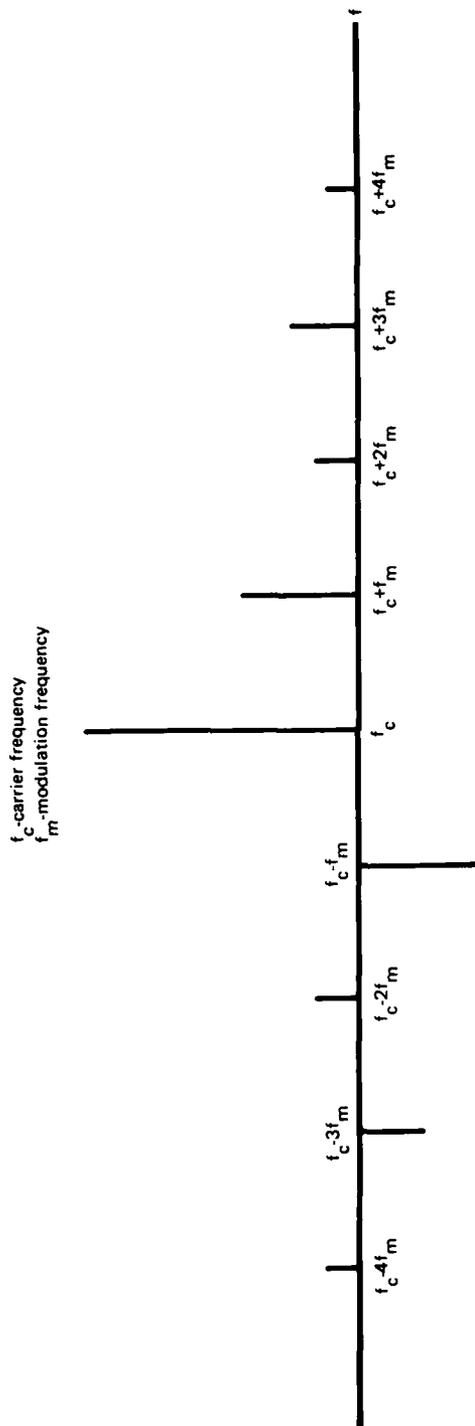
Figure 46. Typical FM line spectrum.

Figure 46 illustrates a typical frequency modulation (FM) energy spectrum, where signal information is contained in discrete sideband spectral lines. The odd-order lower spectrum lines are equal in amplitude but reversed in phase from the upper

spectral lines. These sideband spectral lines are located above and below the carrier frequency (f_c) at intervals equal to the modulation frequency (f_m). Elimination of the more distant sidebands, due to bandwidth limitations, will result in a loss of signal information.

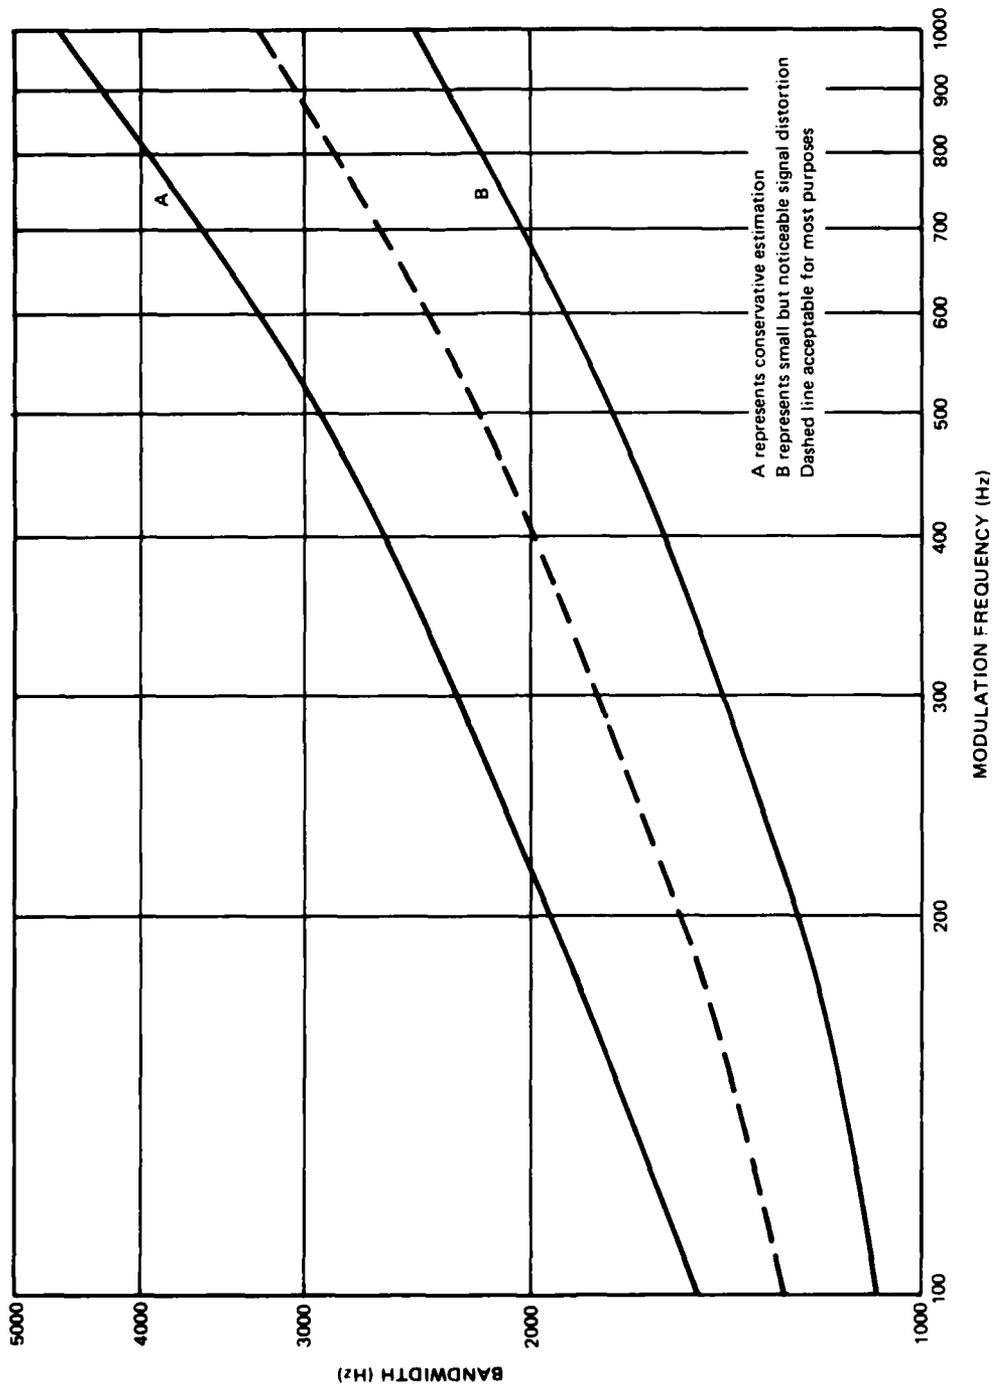
Figure 47. FM bandwidth requirements versus modulation frequency.

The amplitude of input signal during testing was less than the maximum obtainable for stethoscopic transmission, and an increase in frequency response distortion would be expected with increases in signal amplitude.
