USAAEFA PROJECT NO. 80-17-1

**AIRWORTHINESS AND FLIGHT CHARACTERISTICS TEST
PART I
YAH-64¹ ATTACK HELICOPTER
Advanced
FINAL REPORT**

SEPTEMBER 1981

UNITED STATES ARMY AVIATION ENGINEERING FLIGHT ACTIVITY
EDWARDS AIR FORCE BASE, CALIFORNIA 93523

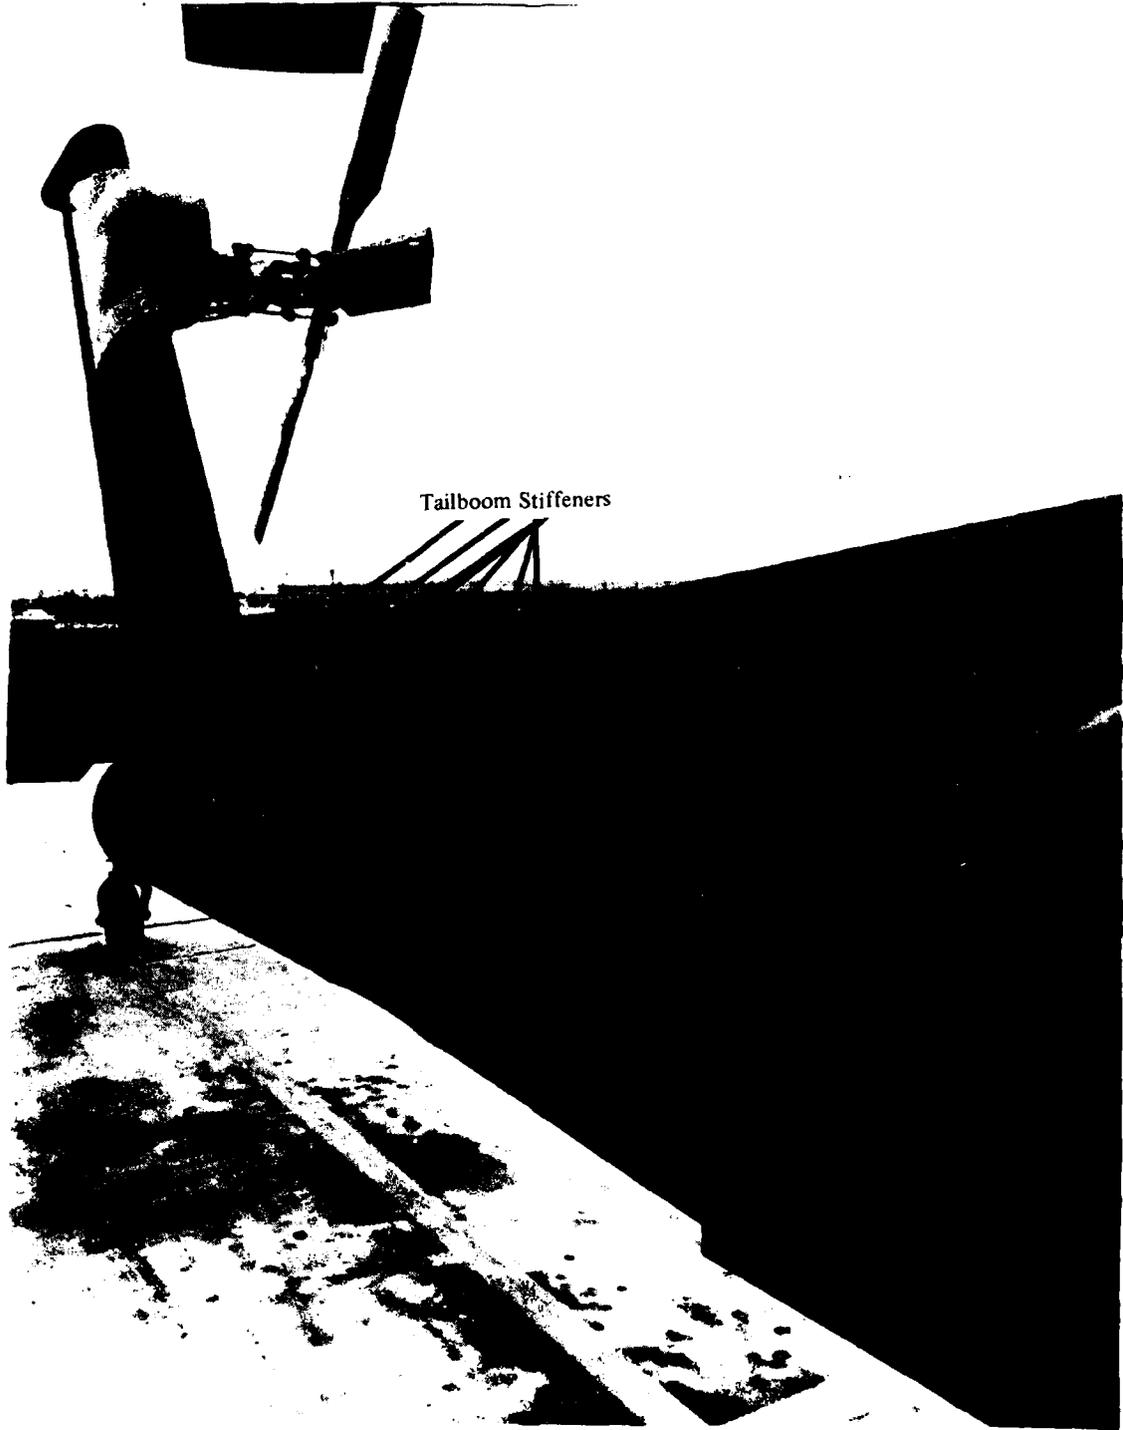
Photo 11. Tailboom Stiffeners

1. Removal of wing tip light fairing, Engineering Change Request and Record (ECRR) Number 39322, dated 7 August 1980
2. Installation of one instrumented main rotor blade and two instrumented tail rotor blades
3. Installation of rotating PCM Canister (photo 10)
4. Installation of rotating PCM antenna brackets (photo 10)
5. Installation of one instrumented main rotor pitch change link (photo 10)
6. Installation of tail boom stiffeners (photo 11)
7. Installation of wing stiffening (photo 12).
