NWC TP 6343

# Hydrogen Embrittlement in 17-4PH Stainless Steel

by  
Kenneth R. Hayes  
*Engineering Department*

**AUGUST 1982**

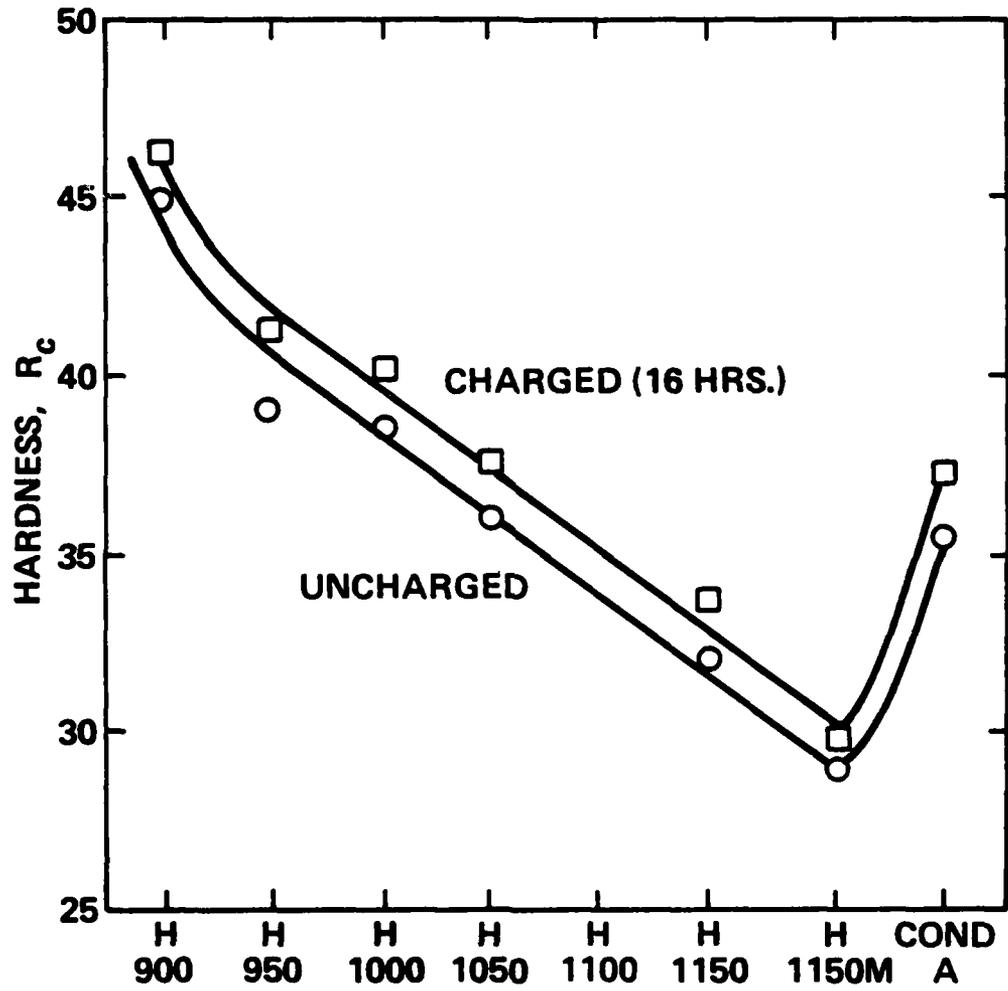
FIGURE 2. The Influence of Hydrogen Charging on the Hardness of 17-4PH in Various Aged Conditions.

The hardness data (Figure 2) showed that hydrogen charged specimens exhibited a consistent increase in hardness of from one to three Rockwell C points when compared to the values for uncharged specimens. Although the effect was small, it appears real in that it was observed for all aging conditions. Each data point represents an average of at least three independent hardness measurements.

The results of this investigation show a small but consistent increase in hardness in all heat-treated conditions after hydrogen charging. This behavior implies some kind of hydrogen atom-dislocation interaction taking place, probably causing dislocation pinning to occur. This investigation also presents data indicating that at intermediate strain rates,

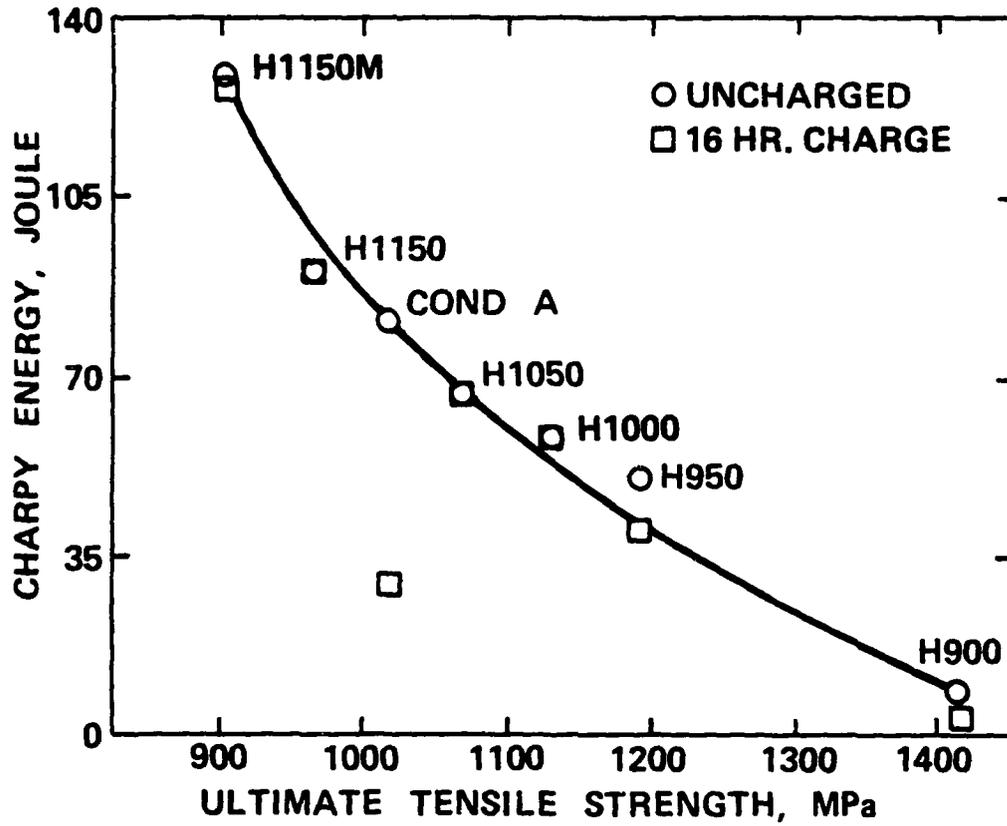
FIGURE 3. Charpy Impact Energy of Hydrogen Charged and Uncharged Specimens of Varying Ultimate Tensile Strength.

Charpy impact tests were performed and it was found that in general, hydrogen charged specimens had comparable impact properties to uncharged specimens. The one exception was that in the solution treated condition which showed a significant loss of impact energy when charged. This is not surprising since it is generally agreed that untempered martensite is the most susceptible microstructure to HE (Reference 9). Figure 3 is a plot of charpy energy versus ultimate tensile strength of 17-4PH, and shows the decrease in impact energy associated with the strength increase, as well as the charged versus uncharged impact energy results.

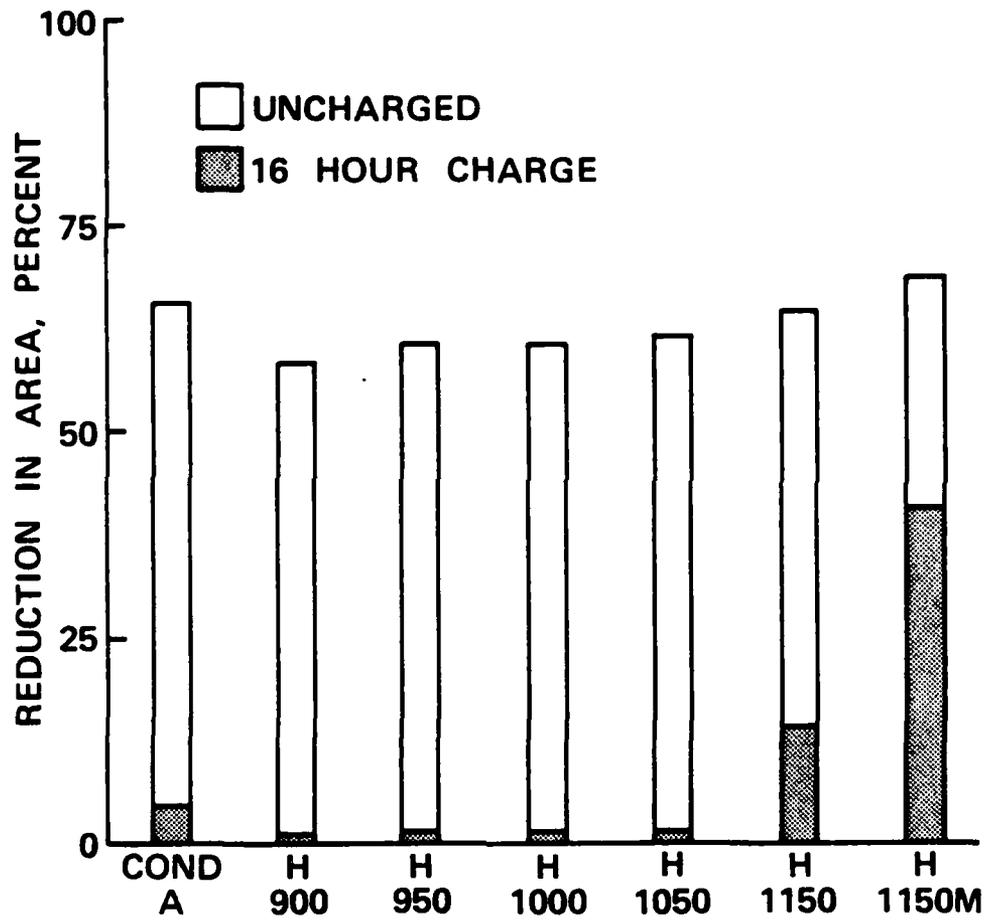
FIGURE 4. Influence of Hydrogen Charging % RA of 17-4PH in Various Aged Conditions.

It was observed that ductility as measured by % RA was affected in all aging treatments of the 17-4PH stainless steel when charged with hydrogen. Figure 4 illustrates that the heat-treated condition of the specimen had some influence on the degree to which specimens were embrittled. For example, the H900 specimen decreased in ductility from 57.9% RA to 0.4% RA upon charging while the double overaged H1150M tensile bar only decreased from 68.4% RA to 40% RA.

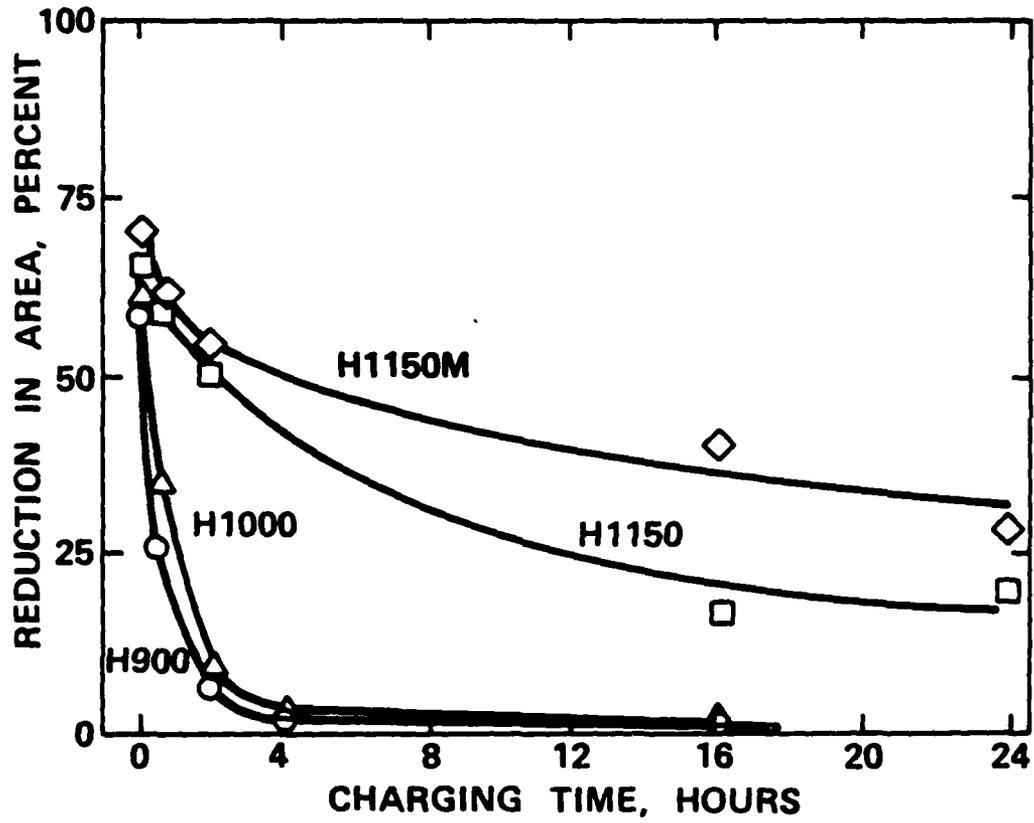
FIGURE 5. The Effect of Hydrogen Charging Time on % RA of Heat-Treated 17-4PH.

The effect of hydrogen charging time on HE was studied by varying this time from 0.5 hour to 24 hours. The results of the four aging treatments investigated are plotted in Figure 5 as % RA versus charging time. It is apparent that higher aging temperatures lead to less severe HE. In 0.5 hour of charging, the H900 and H1000 specimens lost approximately 50% of their ductility. The lower strength H1150 and H1150M specimens required approximately 16 hours of charging to incur an equivalent loss.

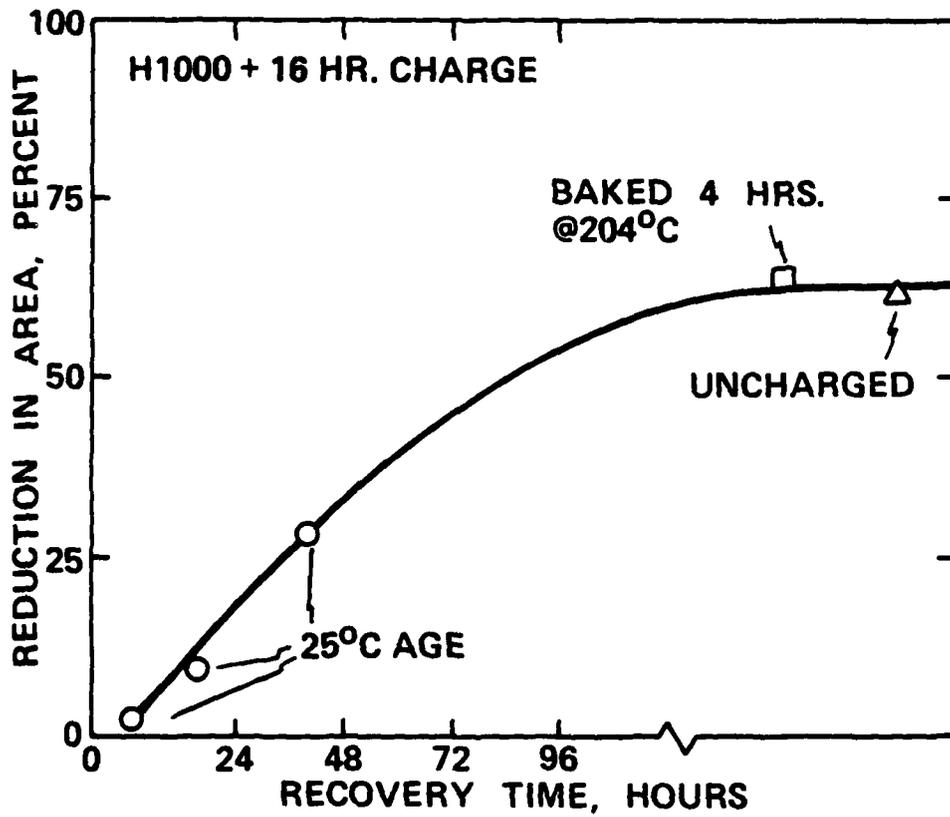
FIGURE 6. Recovery of % RA in Hydrogen Charged 17-4PH in Condition H1000.

Three specimens in condition H1000 were charged for 16 hours. Two of the specimens were allowed to stand at room temperature for 16 hours and 40 hours respectively. The third specimen was baked at 204°C for 4 hours. At the end of the recovery treatment, tensile test data indicated that significant ductility was recovered, going from 0.4% RA for a 16-hour charge with no recovery to 29.4% RA for a 16-hour charge followed by a 40-hour recovery. The baked specimen completely regained its ductility, showing 63.4% RA compared to 61.2% RA for an uncharged specimen (Figure 6).

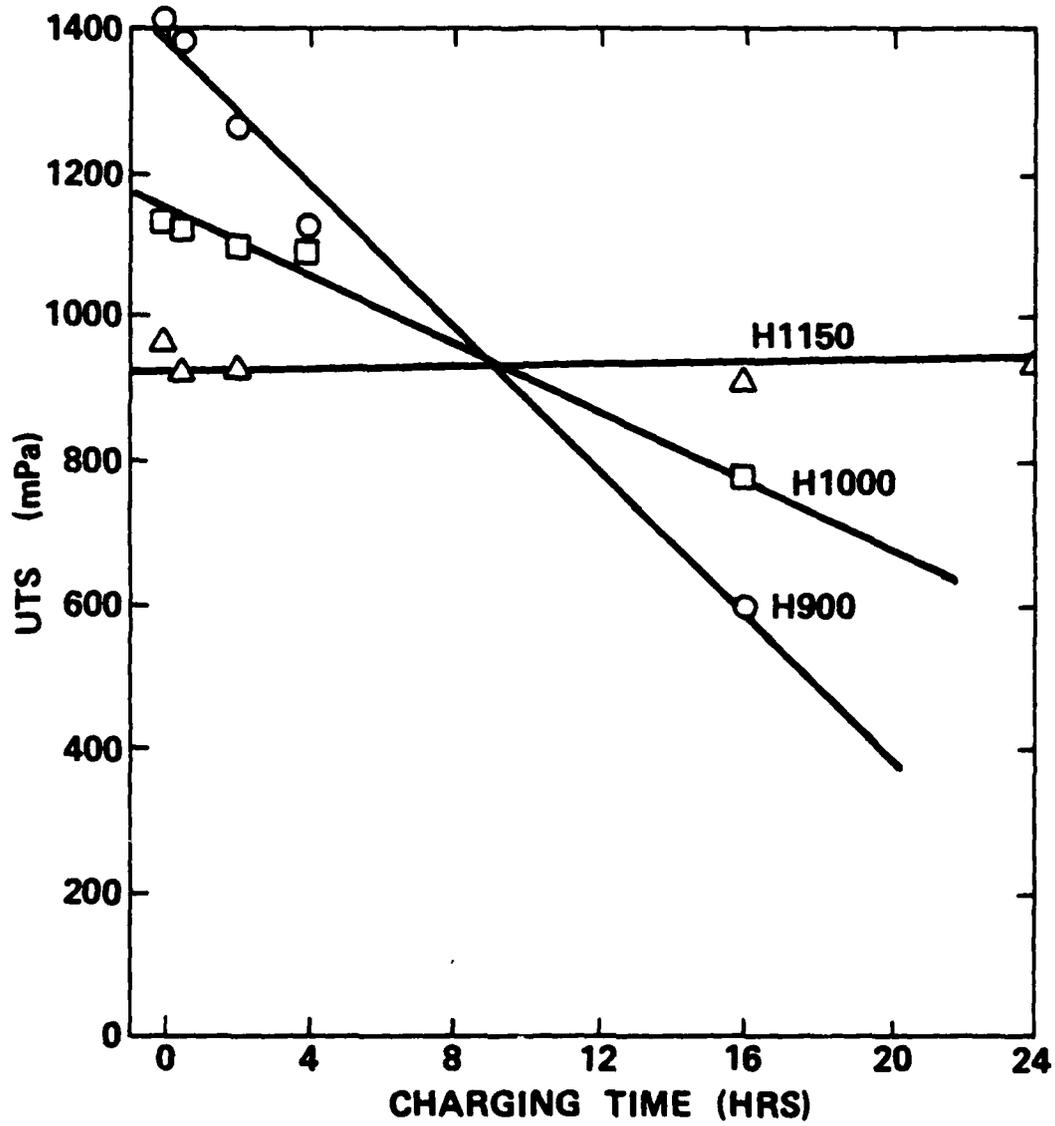
FIGURE 7. Variation in Ultimate Tensile Strength with Hydrogen Charging Time for 17-4PH in Various Aged Conditions.

The effect that charging time had on the ultimate tensile strength (UTS) can be seen in Figure 7. It is apparent that the high strength H900 condition lost considerable UTS with increasing charging time while the more ductile, low strength H1150 condition was not significantly affected. This is consistent with the results of other investigations (References 10, 11) which explain that hydrogen decreases ductility, leading to less workhardening, thus decreasing the UTS. However, in the case of 17-4PH very little workhardening occurs. Consequently the reason for the decrease in UTS of high strength 17-4PH after hydrogen charging may be related to relative resistance to crack propagation. In the high strength, low fracture toughness condition, hydrogen assisted crack propagation is not readily arrested and failure occurs at lower UTS than in the uncharged condition. In the lower strength conditions, hydrogen assisted crack propagation is more readily arrested by the tougher material, and UTS is affected to a lesser degree.

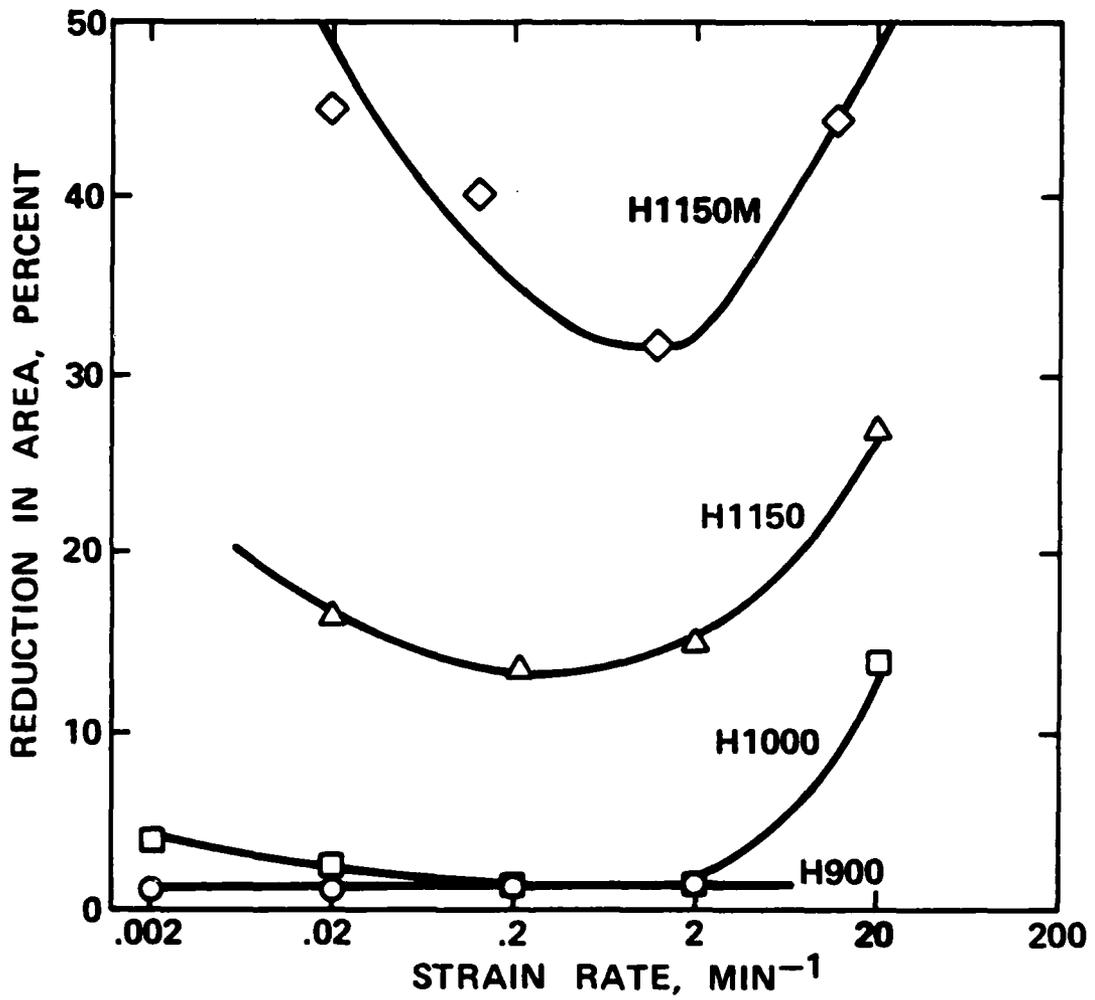
FIGURE 8. The Influence of Strain Rate on % RA of Hydrogen Charged 17-4PH in Various Aged Conditions.

The final variable investigated in this study was that of strain rate. As described earlier, a series of tensile specimens that were charged 16 hours were tested with strain rates varying from 0.002  $\text{min}^{-1}$  to 20.0  $\text{min}^{-1}$ . This was performed for each of the following heat treatments: H900, H1000, H1150, and H1150M. Percent RA plotted versus strain rate for the four treatments is presented in Figure 8. While the H900 condition seemed unaffected by loading rate, the other three treatments showed varying degrees of sensitivity to the strain rate. All three exhibited minimum values of % RA for strain rates in the vicinity of 0.2  $\text{min}^{-1}$  to 2.0  $\text{min}^{-1}$ . At the same time, some loss of % RA was observed no matter what strain rate was employed. Typical of the three treatments was that for condition H1150. At a strain rate of 0.02  $\text{min}^{-1}$  the RA was measured to be 16.4%. This decreased to a minimum value of 13.7% RA at 0.2  $\text{min}^{-1}$ . At a strain rate of 20  $\text{min}^{-1}$  the RA increased to 27.0%.

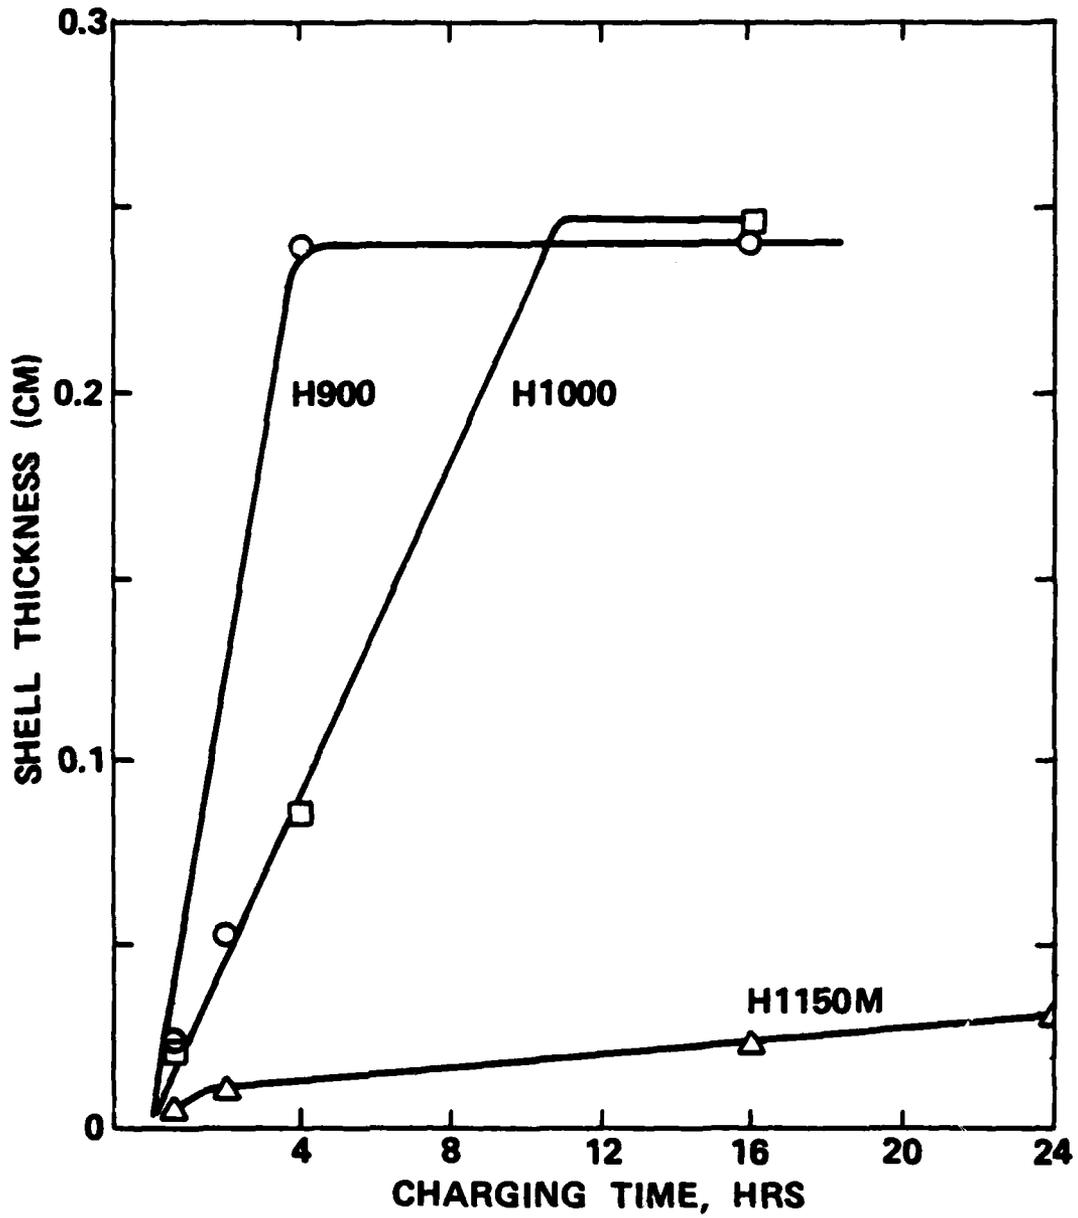
FIGURE 10. Relationship Between Shell Thickness and Hydrogen Charging Time for 17-4PH in Various Aged Conditions.

In most cases, visual examination of the fracture surfaces showed a distinct shell near the exterior of the hydrogen charged specimens. Figure 9 is a series of fractographs of specimens aged to condition H1000 and hydrogen charged for varying times. It can be seen that as the charging time increases, the shell thickness also increases. The thickness of the shell plotted against the hydrogen charging time is shown in Figure 10.

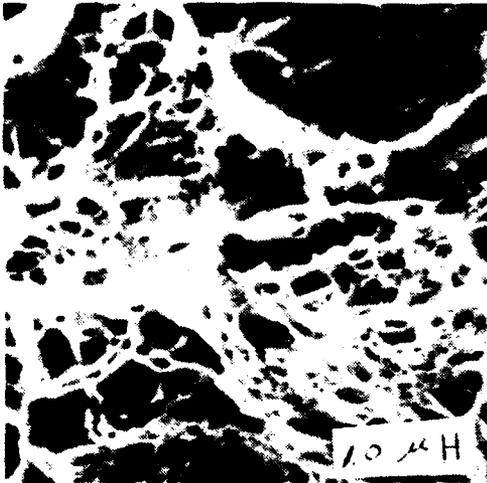
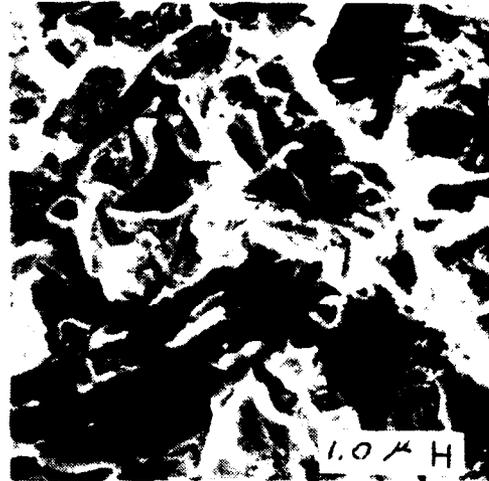
FIGURE 11. SEM Fractography of 17-4PH in Condition H900 Hydrogen Charged for 2 hours, (a) Central Region Showing Mixture at Dimpled Rupture and Quasi-Cleavage, and (b) Shell Region Near Edge Exhibiting Quasi-Cleavage.

SEM fractography was employed to characterize the fracture behavior of the embrittled material. The specimens observed were in the H900, H1000, H1150, and H1150M conditions with a common charging time of 2 hours. In each specimen (Figures 11-14) it can be observed that the structure ranges from dimpled rupture in the center to a type of brittle fracture at the edge. In the H900 (Figure 11) and the H1000 conditions (Figure 12), the central region is a mixture of dimpled rupture and quasi-cleavage, while the edge is almost exclusively quasi-cleavage. In the H1150 (Figure 13) and the H1150M conditions (Figure 14), the central region is composed almost completely of dimpled rupture, while the structure at the edge is observed to exhibit microplastic tearing mixed with some quasi-cleavage. When exposed to longer hydrogen charging times, specimens in the higher strength conditions exhibited instances of intergranular fracture like that observed in Figure 15 (H1000 condition, 16-hour charge).

The changes in fracture mode seen in this investigation are commonly observed in hydrogen embrittled alloys. The fracture mode of the specimens whose treatments yielded high strength behavior (H900, H1000 conditions) changed from primarily dimpled rupture to quasi-cleavage after hydrogen charging. The high temperature aging treatments (H1050, H1150) caused the structure to change from pure dimpled rupture to a combination of quasi-cleavage and what Thompson and Chesnutt (Reference 15) termed "tearing topography surface" (TTS).

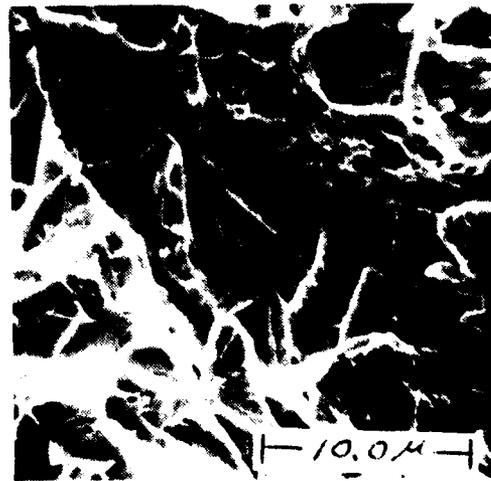
FIGURE 12. SEM Fractography of 17-4PH in Condition H1000 Hydrogen Charged for 2 hours, (a) Central Region Showing Mixture at Dimpled Rupture and Quasi-Cleavage, and (b) Shell Region Near Edge Exhibiting Quasi-Cleavage.

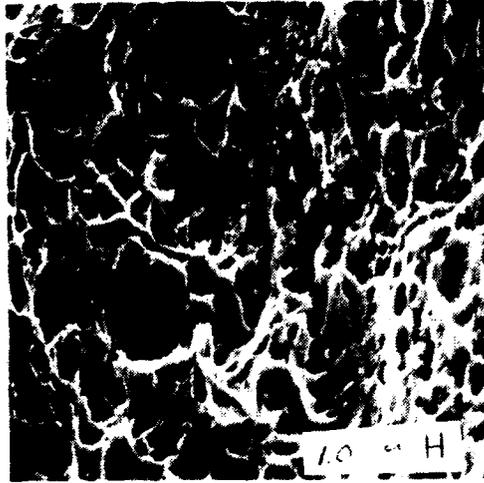
FIGURE 13. SEM Fractography of 17-4PH in Condition H1150 Hydrogen Charged for 2 Hours, (a) Central Region Illustrating Dimpled Rupture, (b) and (c) Shell Region Near Edge Exhibiting Microplastic Tearing.

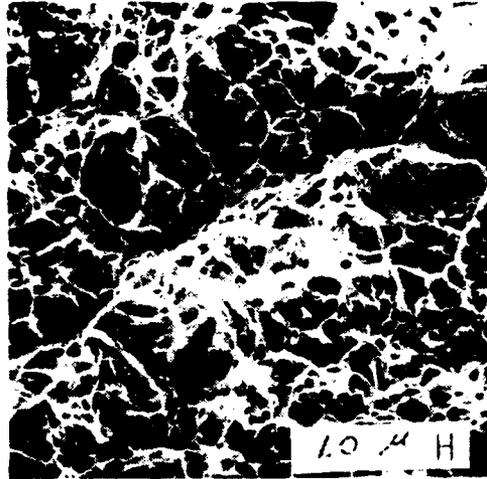
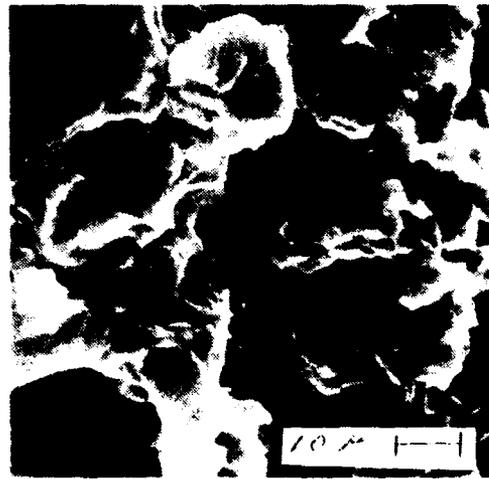
FIGURE 14. SEM Fractography of 17-4PH in Condition H1150M Hydrogen Charged for 2 Hours, (a) Central Region Illustrating Dimpled Rupture, (b) and (c) Shell Region Near Edge Exhibiting Microplastic Tearing.

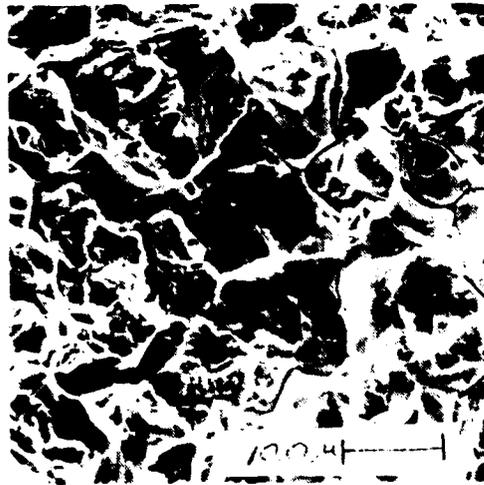
FIGURE 15. SEM Fractography Showing Intergranular Fracture of 17-4PH in Condition H1000 After 16 Hours Hydrogen Charge.
