TECHNICAL REPORT GL-82-7

MEMBRANE-SOIL COMPOSITE LAYERS IN THE DESIGN, CONSTRUCTION, AND PERFORMANCE OF AN EXPEDIENT BRIDGE AND APPROACH

George L. Regan

September 1982

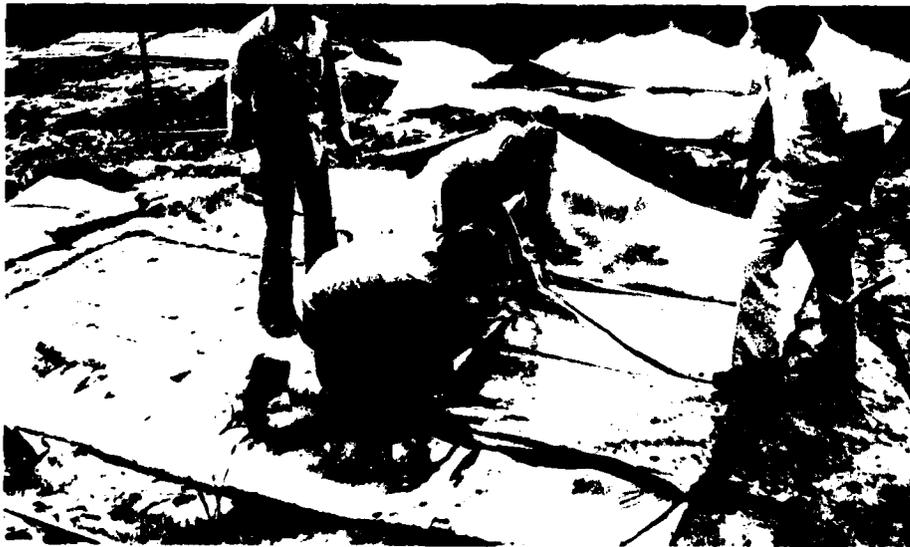
Photo 10. Closing flaps of membrane layer
(nailing membrane to plywood)

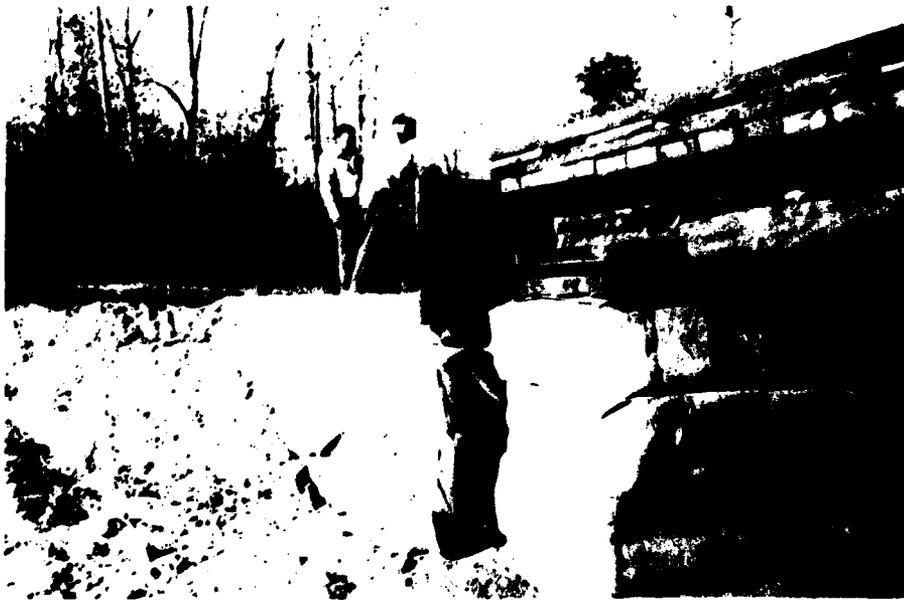
Photo 24. Layered approach construction
north of support 4

43. The preceding general steps were followed; however, construction problems led to the use of two building techniques on the north approach. In the first technique, shown in Figure 14, facing sandbags were stacked three layers high, membrane was not overlapped at the interior, and inner sandbags were placed adjacent to facing sandbags to hold membrane in place. This technique was used on the lower three layers. As the approach was built higher by filling and compacting the lean clay soil, more outward leaning and lateral movement of the wall faces was observed. Technique 1 and the effect of using Technique 1 can be seen in Photos 23 and 24, respectively.
