1. Report No. CG-D-77-79		2. Government Accession No. AD-A123286		3. Recipient's Catalog No.	
4. Title and Subtitle LIGHTWEIGHT FIRE FIGHTING MODULE EVALUATION				5. Report Date January 1983

16. Abstract An operational test and evaluation was conducted on a lightweight, modularized 2000 gpm, self-contained, gas turbine driven fire fighting pump. The NASA/U.S. Coast Guard jointly developed firefighting module is intended to remain in long term unattended, unprotected storage ready for immediate deployment to a fire scene over the road by trailer, by helicopter or on board Coast Guard vessels. It could be used for fighting fires in and around the waterfront, on ships at sea or in port and on offshore structures. Following performance, endurance and shock tests, it was operated on board a 32 foot ports and waterways boat, and an 82 foot patrol boat. Air Transportability was evaluated with an HH-3 helicopter. It was concluded that the module in its present configuration is not suitable for Coast Guard servicewide use.

This report describes the field test and evaluation of a prototype Lightweight Fire Fighting Module, designed and built by Northern Research Engineering Corp. (NREC) of

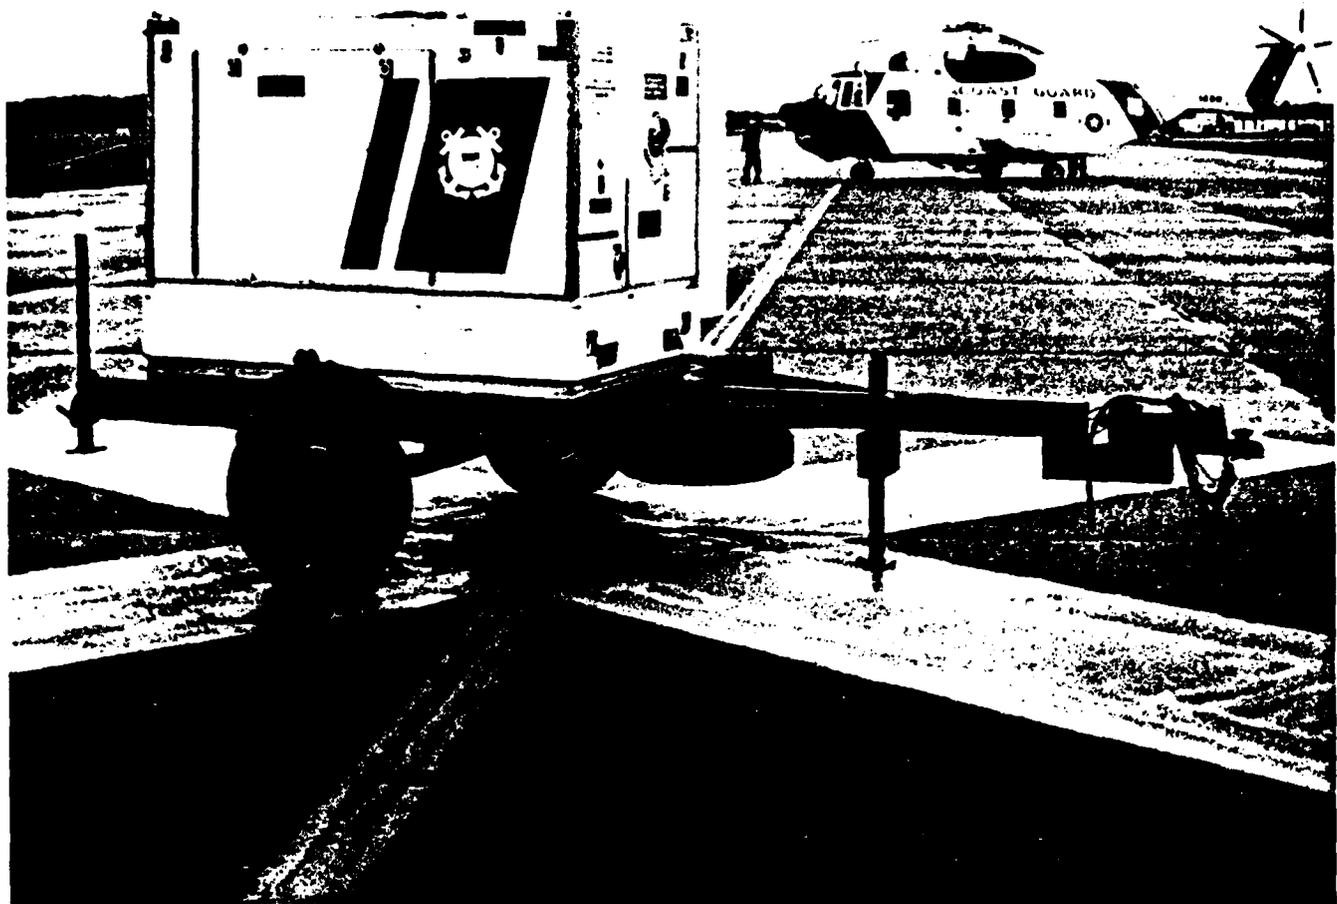
FIGURE 1. 2,000 GPM LIGHTWEIGHT FIRE FIGHTING MODULE AND TRAILER

The module is intended to remain in long-term unattended and unprotected storage ready for immediate deployment to a fire scene over the road by trailer, onboard Coast Guard vessels and by helicopter. It could be used for fighting fires in and around the waterfront, ships at sea or in port, and on offshore platforms. Figure 1.

Module	Fiberglass reinforced plastic housing with stainless steel lifting straps down each corner. Overall dimensions are 72" long x 60" wide x 48" high.
Fuel Tank	100 gallons diesel oil in base of module.
Engine	349 HP gas turbine Allison Model 250-C20
Pump	Two stage aluminum housing with aluminum impellers and inducer 2000 GPM rated discharge at 150 psig
Suction Hose	10" dia. fiberglass reinforced plastic
Discharge Hose	4" dia. fire hose 25' in length
Monitors	Two 3.5" in diameter with 1 1/2" and 2" nozzles
Trailer	Two wheel flat bed rated up to 50 mph highway speed

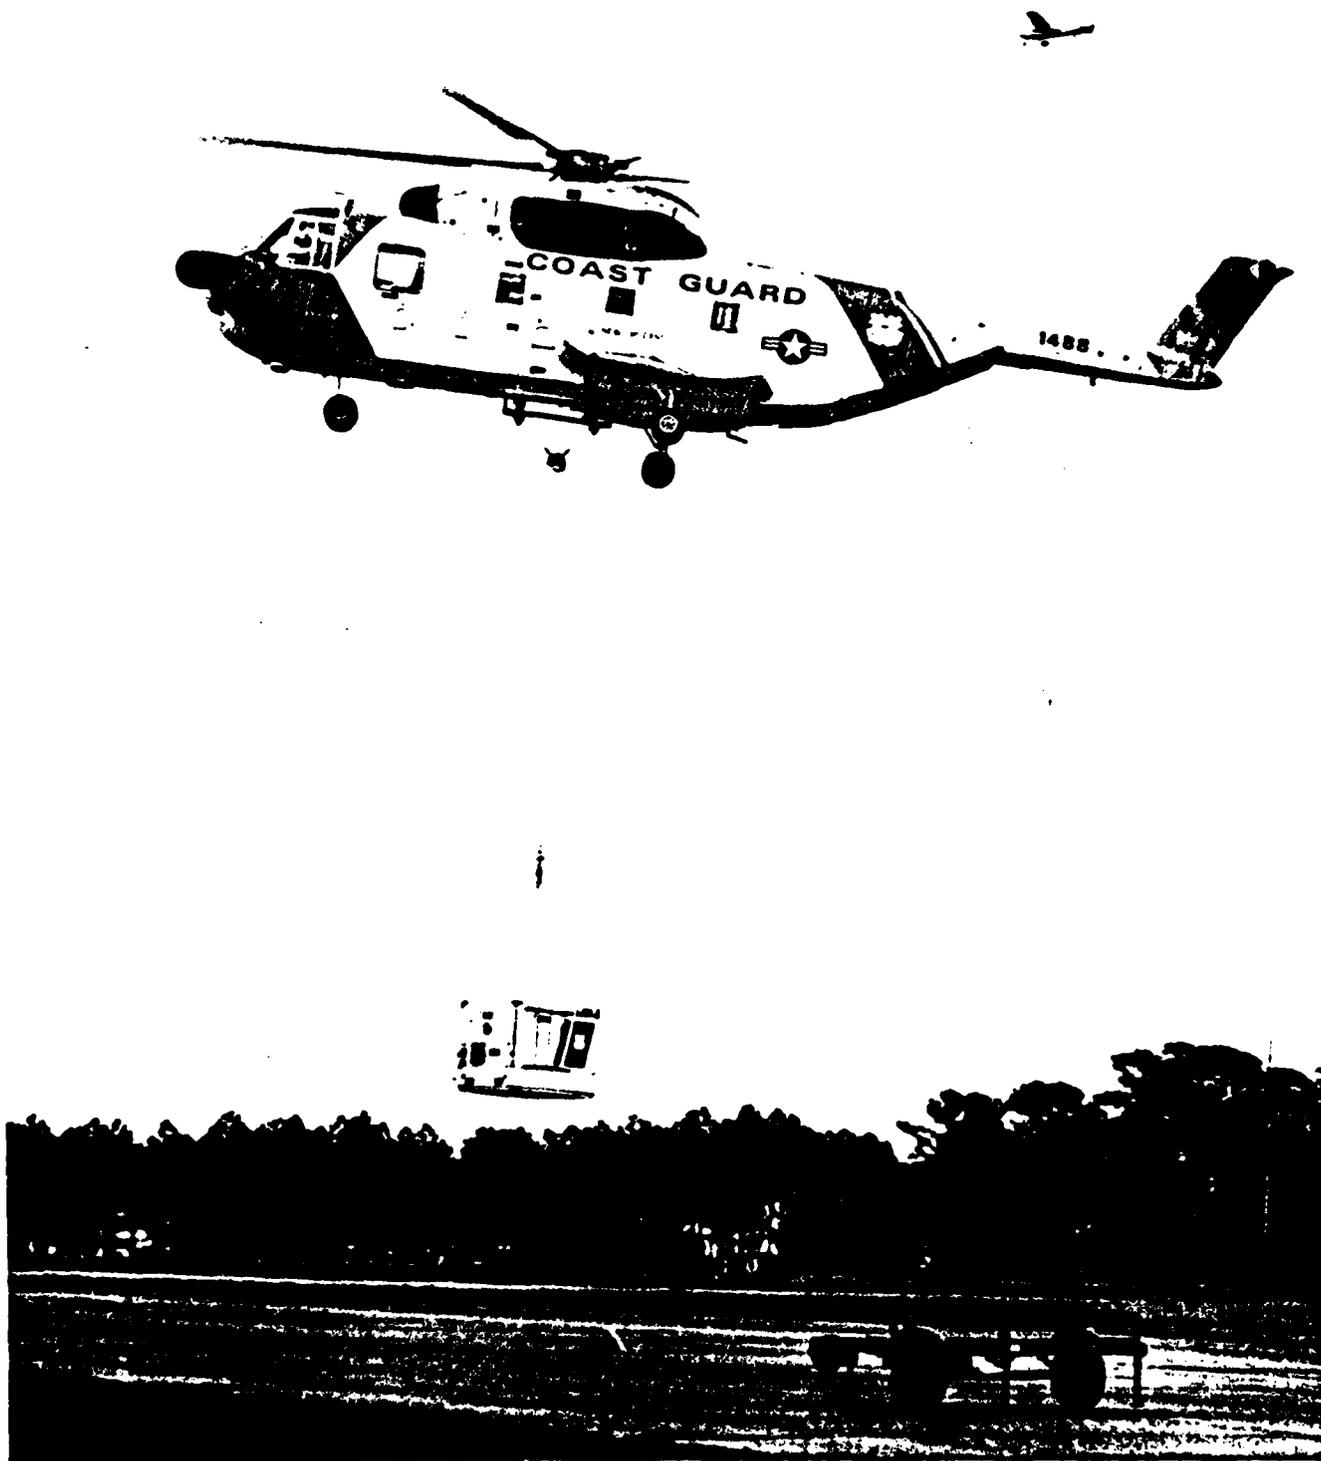
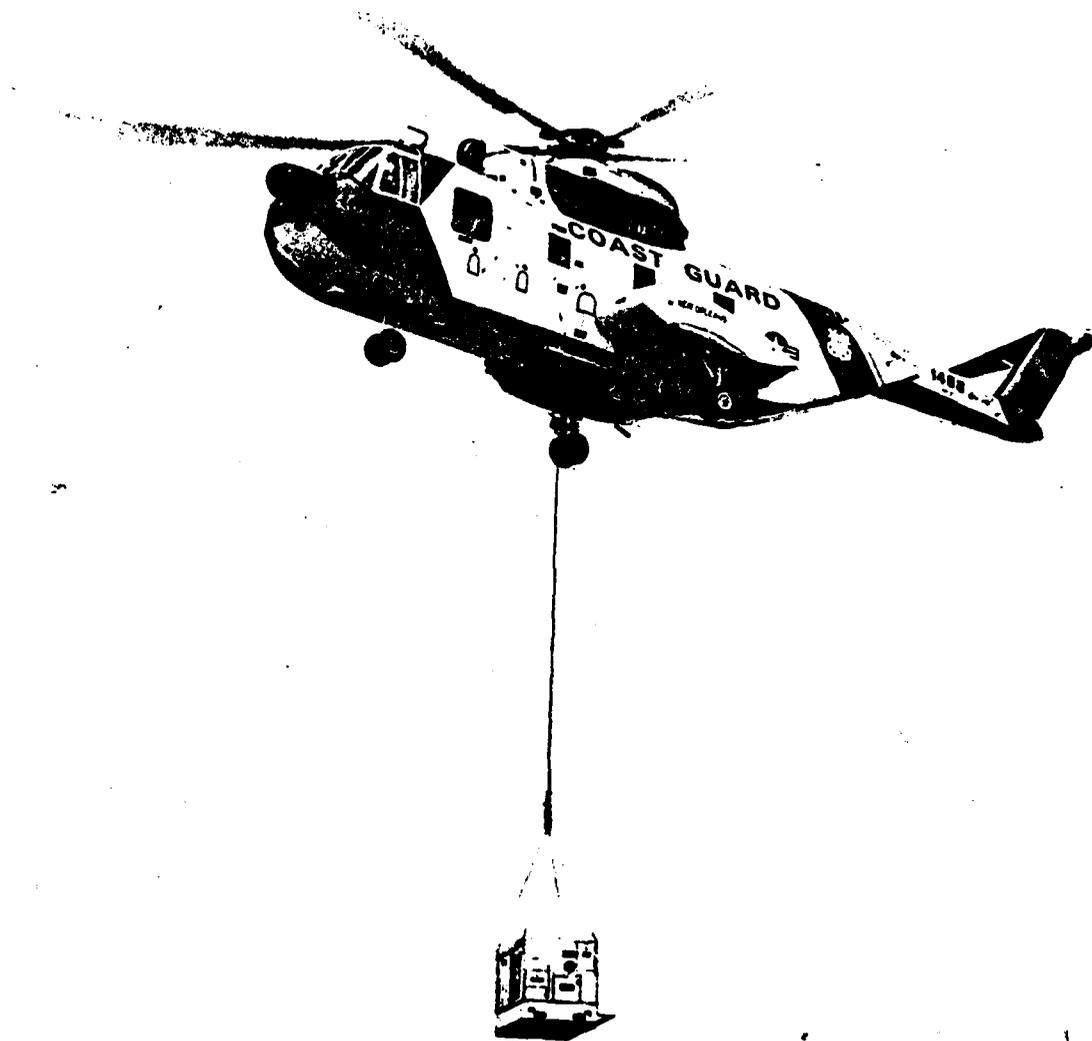
- a. The pennant was too long (20 feet),
- b. In flight the module rotated approximately fifteen times a minute, with a jerking motion
- c. The weight of the module and its equipment was of concern because the aircraft had to be lightened by 1 1/2 hours of fuel weight in order to carry the module. This would leave only 30 minutes of fuel for transporting, delivering, and returning. Figures 5 and 6 show the module during the helicopter transport trials.

FIGURE 5. HH HELICOPTER LIFTING MODULE FROM ITS TRAILER

FIGURE 6. IN FLIGHT TRANSPORT OF THE MODULE BY HH-3 HELICOPTER

steel wire pennant of at least ten feet and a ball bearing swivel was needed for lifting the module. The suction pipe support bracket had to be removed, and the securing devices for the suction pipe and the suction pipe bracket were not considered adequate for flight operations. On the second day, the module was ready for flight operations. The module was lifted and transported over Mobile Bay, and returned to the pickup point. The helicopter could not place the module back on its trailer. Following the flight the pilot was debriefed. He made the following comments:
