AFWAL-TR-82-2119

RESTARTABLE HIGH POWER GAS GENERATOR

ROCKETDYNE DIVISION/ROCKWELL INTERNATIONAL
6633 CANOGA AVENUE
CANOGA PARK, CALIFORNIA 91304

FINAL REPORT FOR PERIOD MAY 1979 - AUGUST 1982

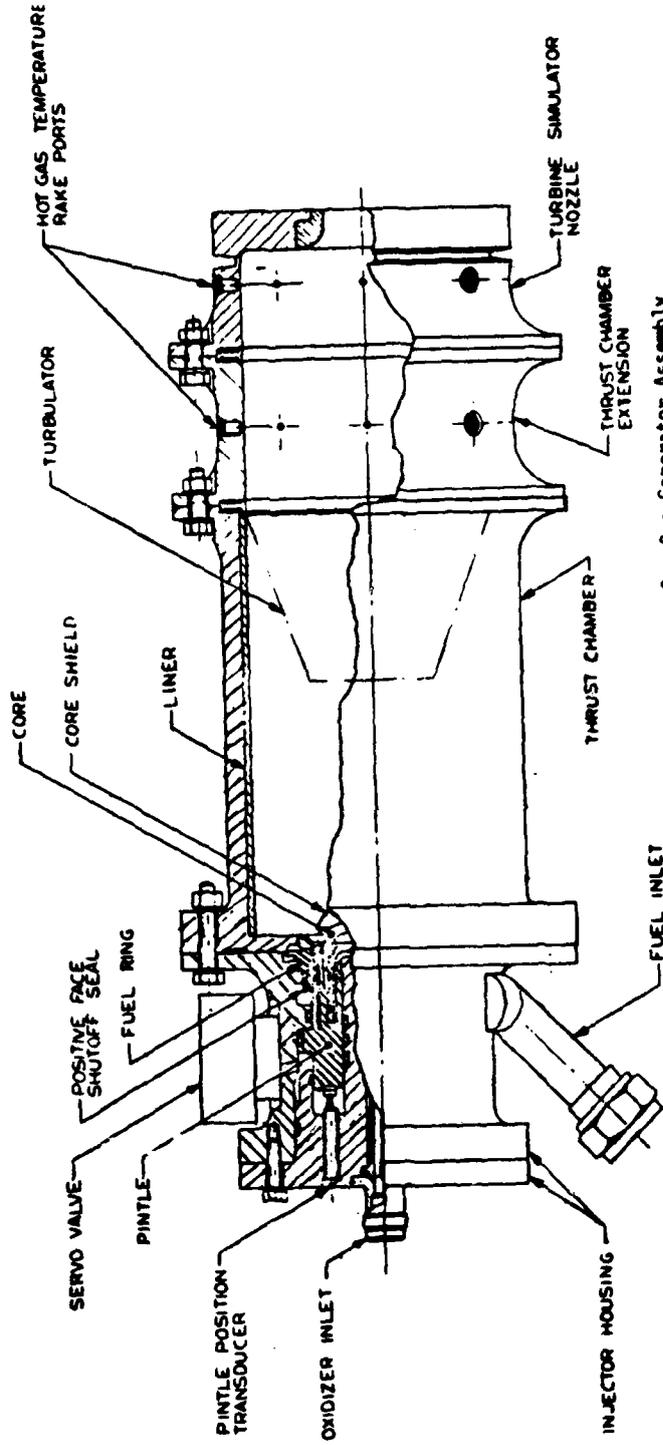
1. Pintle-type throttling injector using a hydraulic servo valve to control throttling;
2. Two injector face-mounted spark plugs for ignition;
3. Combustion chamber equipped with a nickel liner to dissipate localized chamber wall streaks;
4. Hot gas turbulator to enhance hot gas mixing;
5. Chamber extension equipped with a hot gas temperature rake;
6. Hot gas nozzle, simulating turbine inlet area.

Figure 2. Gas Generator Assembly

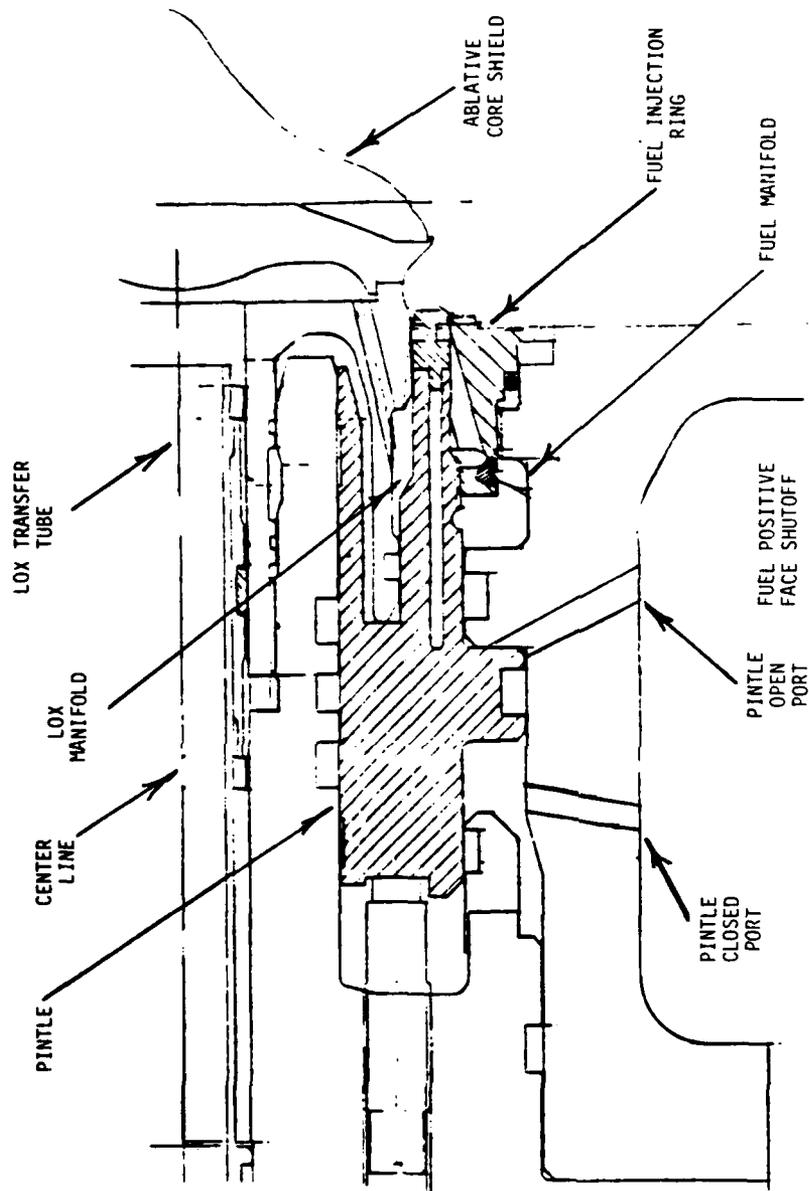
Liquid oxygen is introduced into the injector from the LOX shutoff valve through the centerline transfer tube. The tube is fitted with a thermal liner designed to minimize chilldown of the hardware by the cryogenic oxidizer. The original thermal liner was a teflon tube. During the initial tests, a structural failure of the tube was encountered (see Test Section). The liner was redesigned using a concentric Cres tube providing a static oxygen barrier to minimize heat transfer.

The liquid oxygen is injected into the oxidizer manifold through the core assembly. The liquid oxygen system relies on the metering rings to provide a seal. Metering ring leakage is in the order of 1000 cc/min at 400 psid. This minor leakage provides a means of preventing cryogenic lock-up following test termination.

FIGURE 3. INJECTOR INTERNAL CONFIGURATION

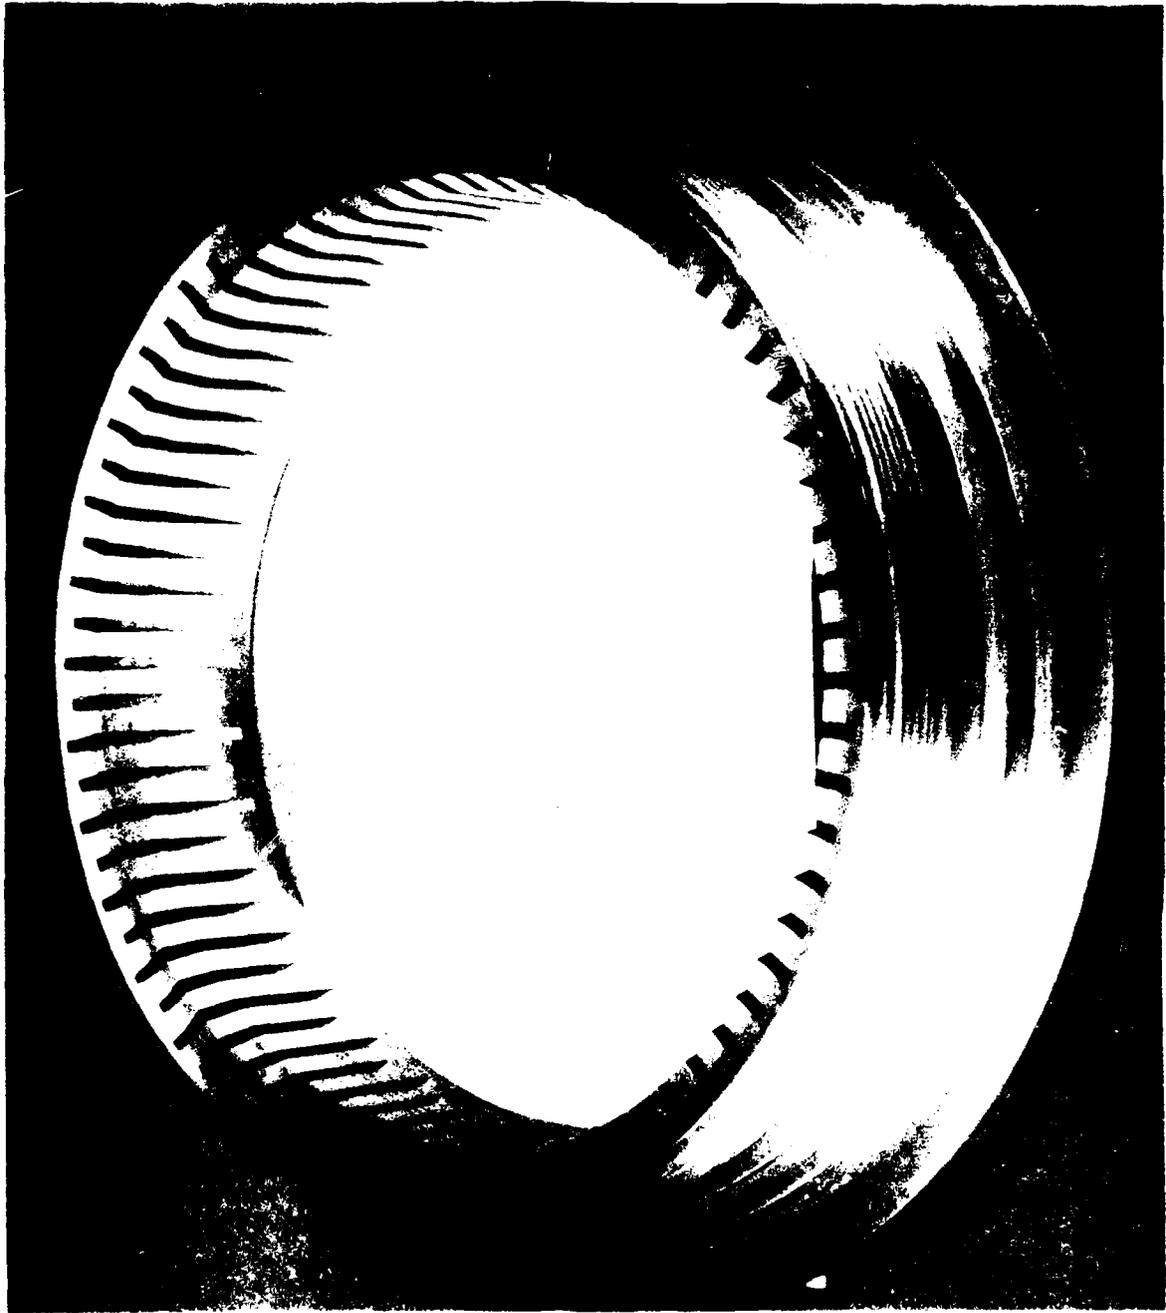
Figure 8. Fuel Injection Ring

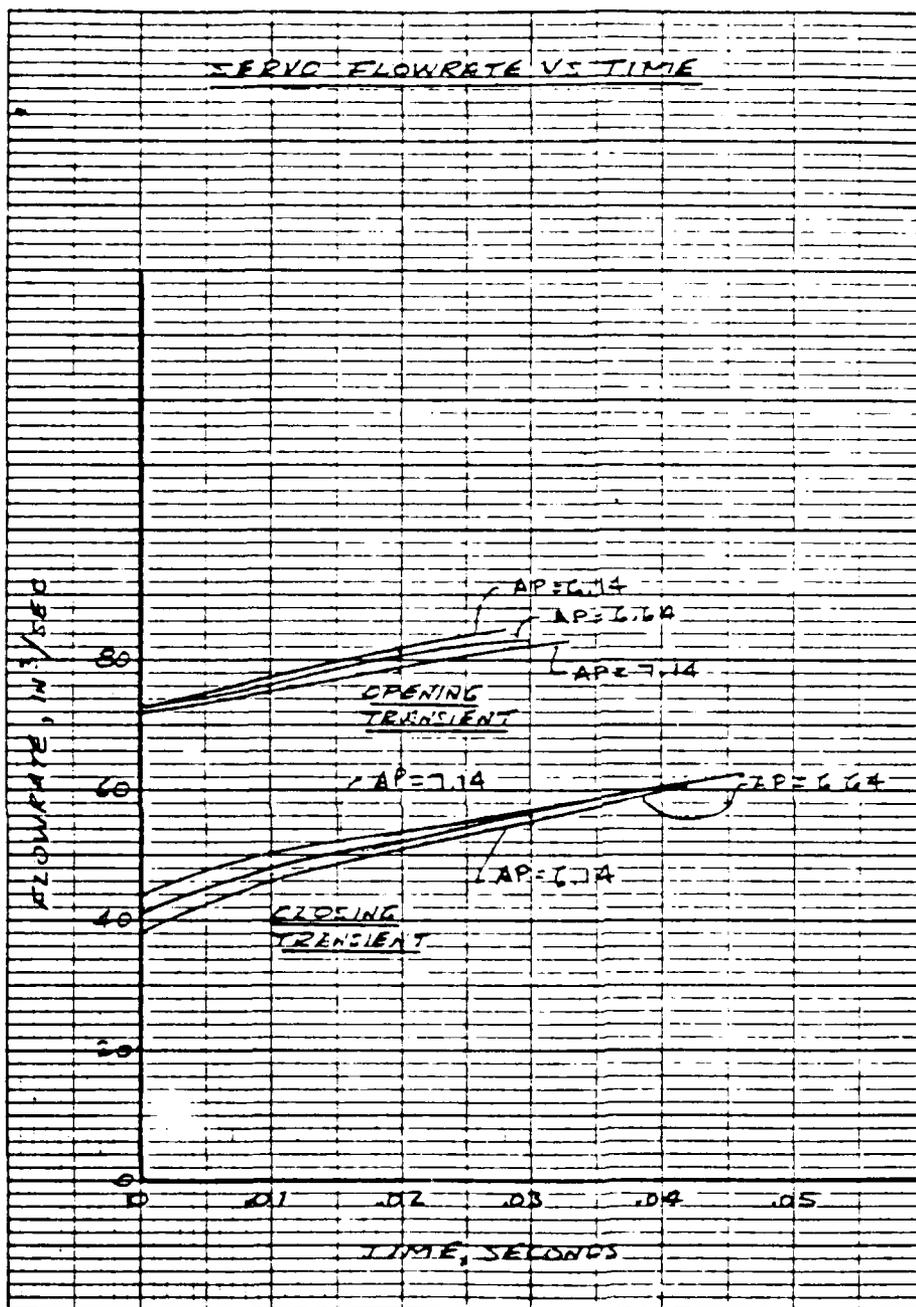
FIGURE 17. CONTROL SYSTEM FLOWRATE vs. TIME

Curves of control system flowrate, differential pressure, and stroke versus time are shown in Figures 17 through 19. Three curves for each parameter are shown, representing three different piston areas: 6.64, 6.14, and 7.14 square inches. The curves in Figure 17 indicate that a decrease in piston area slightly increases the pintle velocity, thus reducing the opening and closing times. This, however, is accompanied by an increase in required ΔP across the actuator piston, as shown in Figure 18. The design was finalized using a 6.640 square inch piston area, and it is concluded that this is satisfactory from the standpoint of opening and closing force margins and will open within .050 seconds (opening travel time = .030 seconds). The closing response will be less than .065 seconds (travel time = .044 seconds).

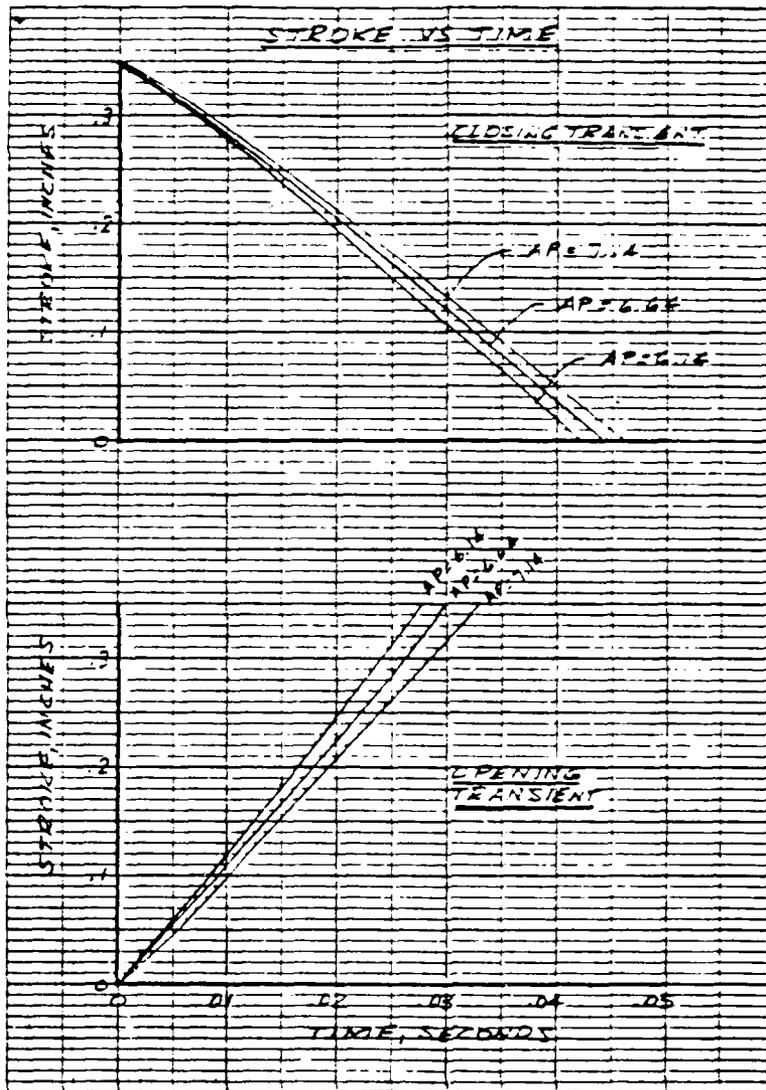
FIGURE 19. PINTLE STROKE vs. TIME

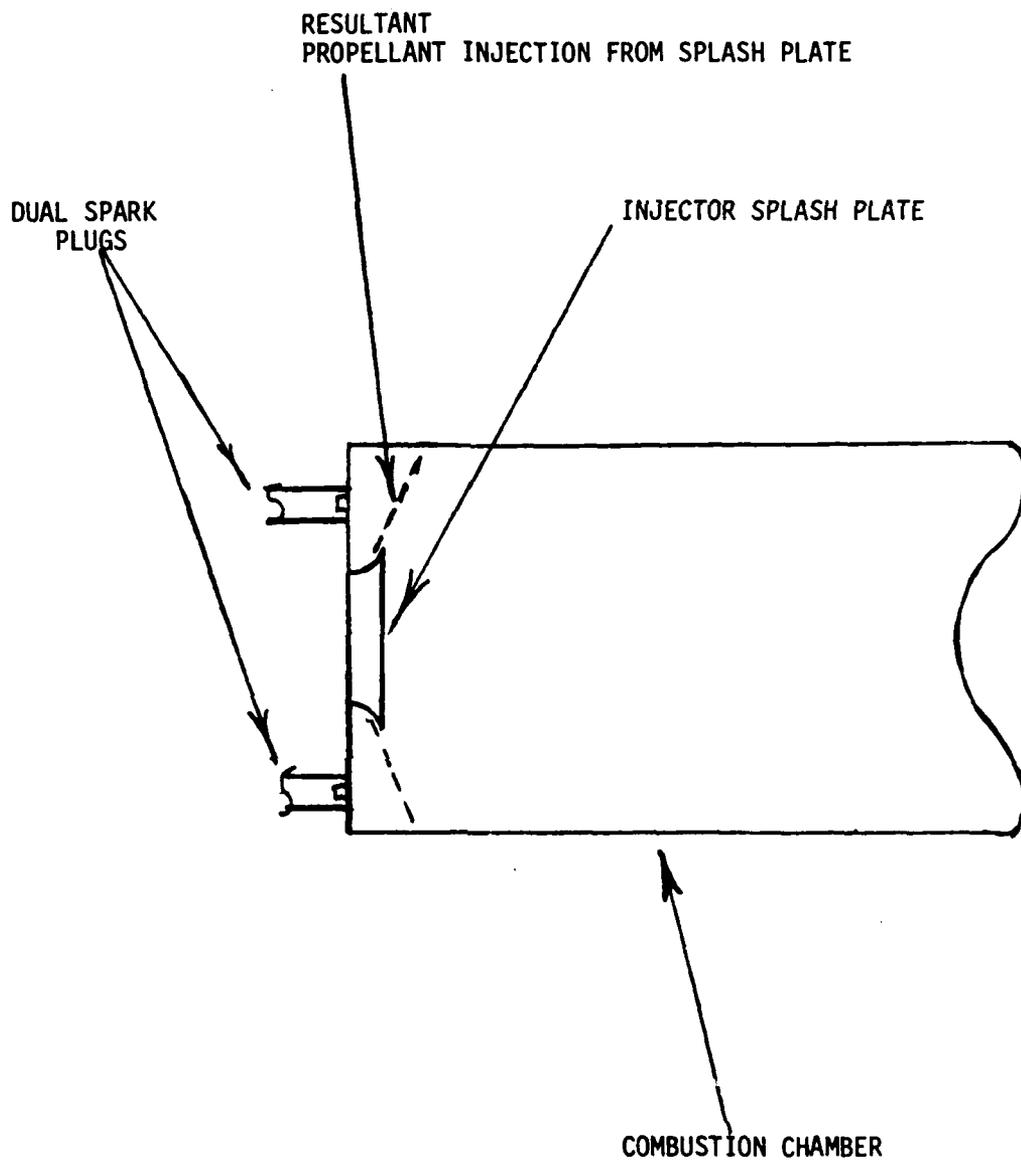
FIGURE 23 SPARK PLUG LOCATION

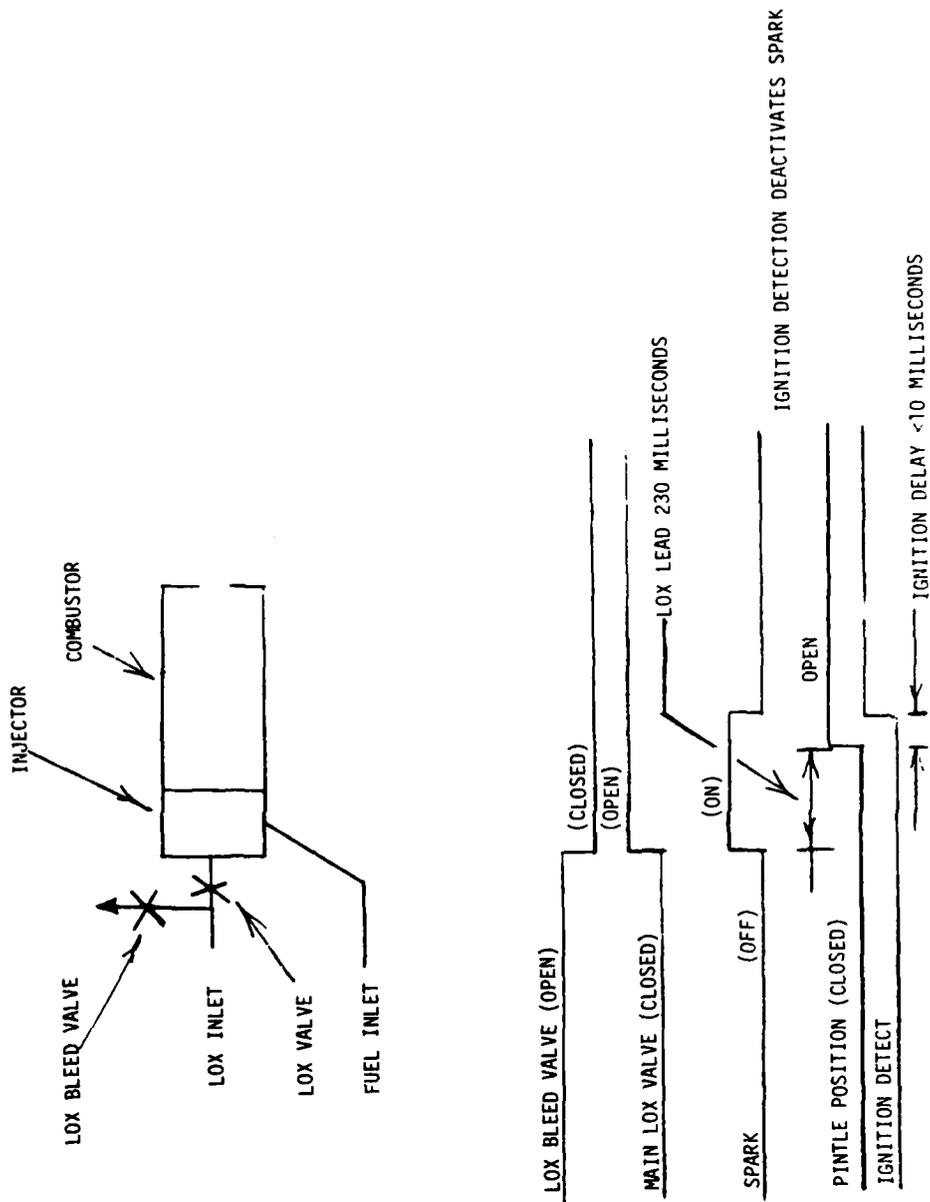
FIGURE 24 IGNITION TEST START SEQUENCE

1. With the pintle closed and fuel system pressurized, chill the LOX system to achieve quality LOX at the main LOX valve in the closed position by using the LOX bleed.
2. Sequence the LOX bleed closed and the LOX main valve open. The injector manifold is pressurized with oxygen and a small LOX flow into the chamber initiated due to the LOX metering ring leakage.

3. The pintle is commanded open 230 milliseconds after the main LOX valve is opened and the main fuel flow starts.

Approximately ten milliseconds after the initiation of the pintle movement, ignition occurs. This start sequence was used for all tests, with no anomalies noted with respect to ignition or start transient.

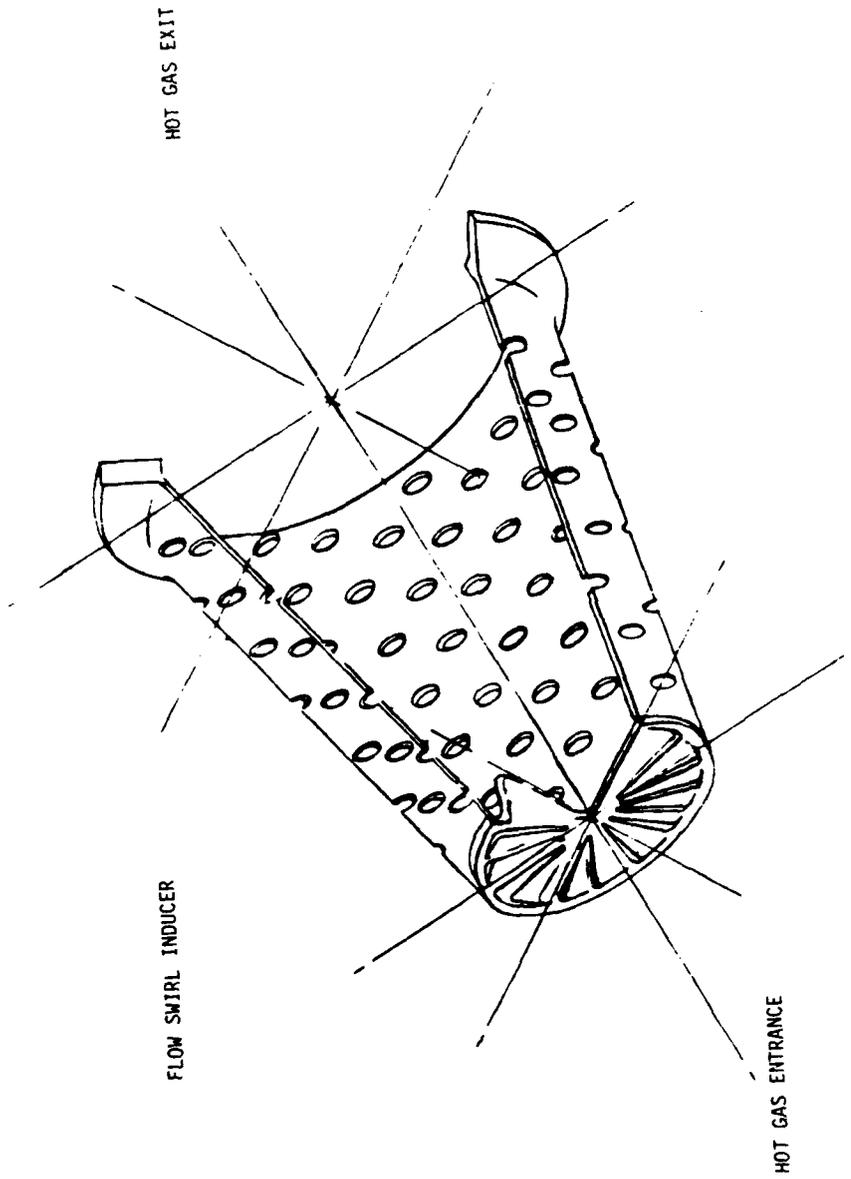
The turbulator is shown in Figure 25. Hot fire tests indicated that the turbulator was not effective in mixing the hot gas at the maximum power level.

FIGURE 2.5, ORIGINAL TURBULATOR DESIGN

Also, the vane plate was eroded as a result of the initial full power level test. Replacement of the vane plate with a solid nickel nose section, Figure 26, did not improve the hot gas temperature distribution (Reference Test 9). Due to the hot gas temperature distribution problem, injector cold flow tests and combustion modeling effort was accomplished. The results of this effort are discussed in Appendix A.

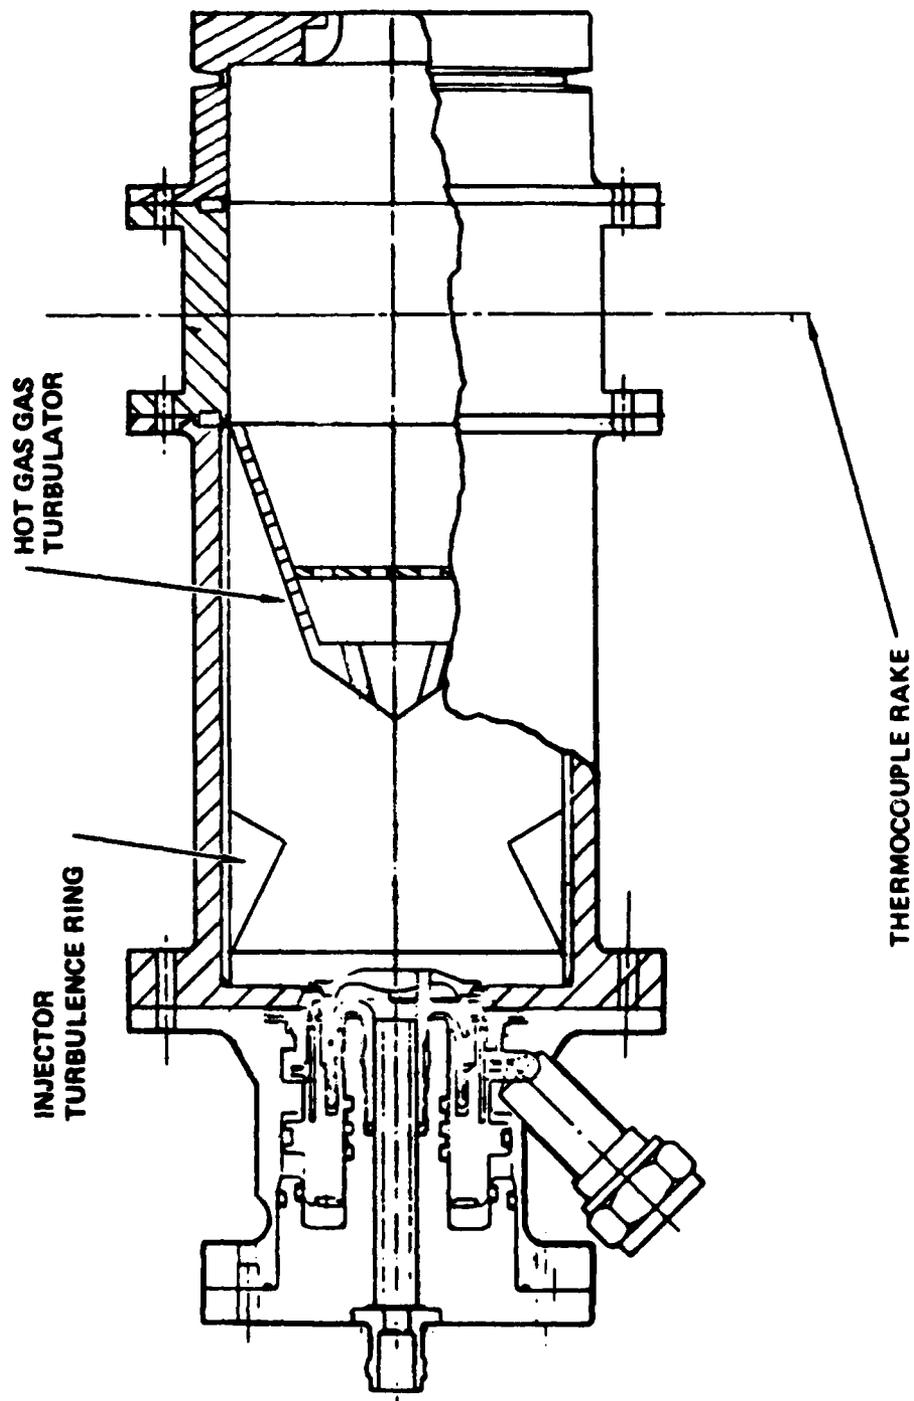
Figure 26. Modified Hot Gas Turbulator With Injector Turbulence Ring

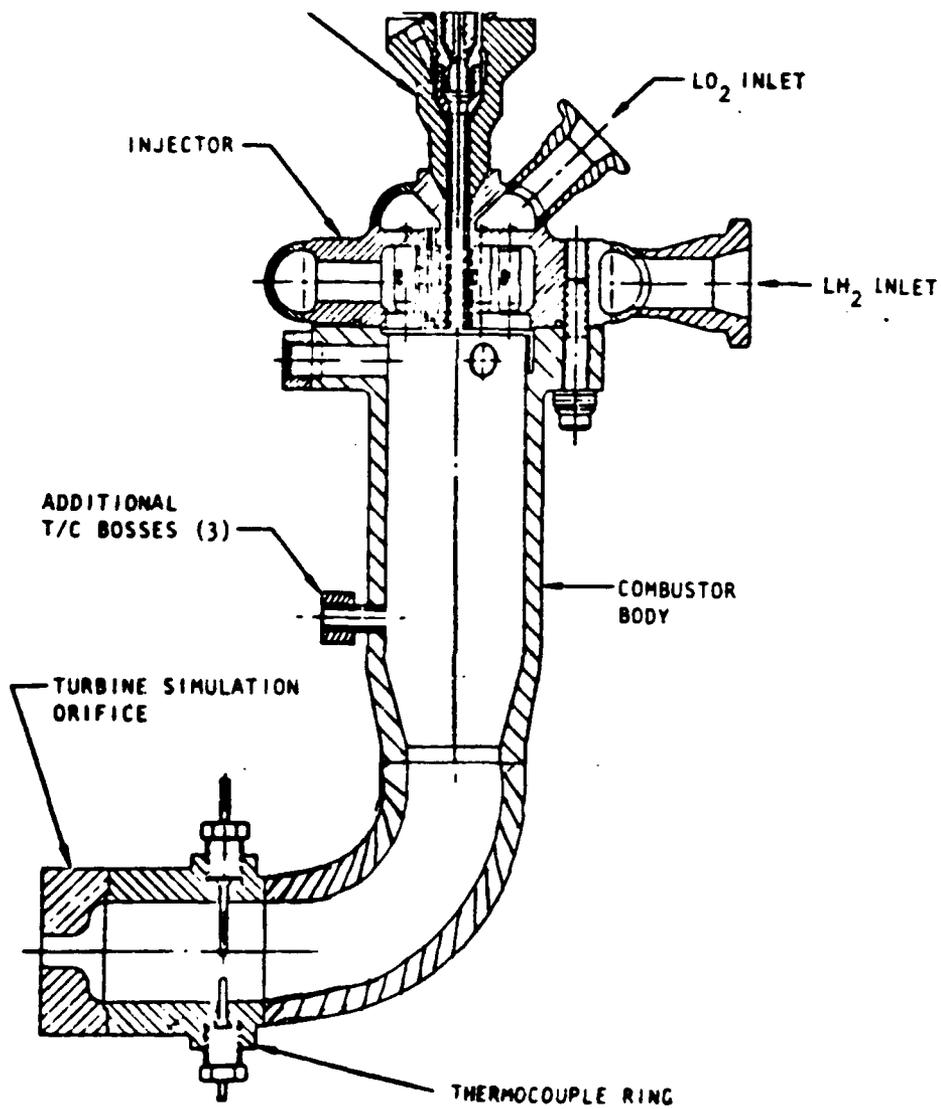
Figure 27 . Small, High-Pressure Gas Generator Combustor with well-rounded 90° bend

Review of other gas generators exhibiting a hot gas temperature distribution problem indicated that a right angle mitered bend combustion chamber produced a marked improvement. Figures 27 and 28 indicate a cross section view of a high pressure gas generator equipped with smooth well rounded 90 degree bend and the same gas generator with a 90 degree miter bend. The hot gas temperature data produced by both configurations is presented in Figure 29. The well rounded bend produced a 500 degree temperature differential from the chamber wall to the centerline whereas the miter bend produced a 100 degree temperature differential. Based on this data, a miter bend turbulator was designed and fabricated. The final configuration is shown in Figure 30. The significant operating parameters of the LOX/H₂ gas generator configuration and the Restartable Gas Generator are presented in Figure 31a. The key design parameter was the turbulator Mach number. A Mach number of 0.2 is considered near the upper limit for turbine inlet considerations. It is recognized that turbulator gas velocity is a key parameter in mixing; however, matching the turbulator velocity of the LOX/H₂ gas generator would have resulted in a Mach number of 0.31 and considerable increase in differential pressure.

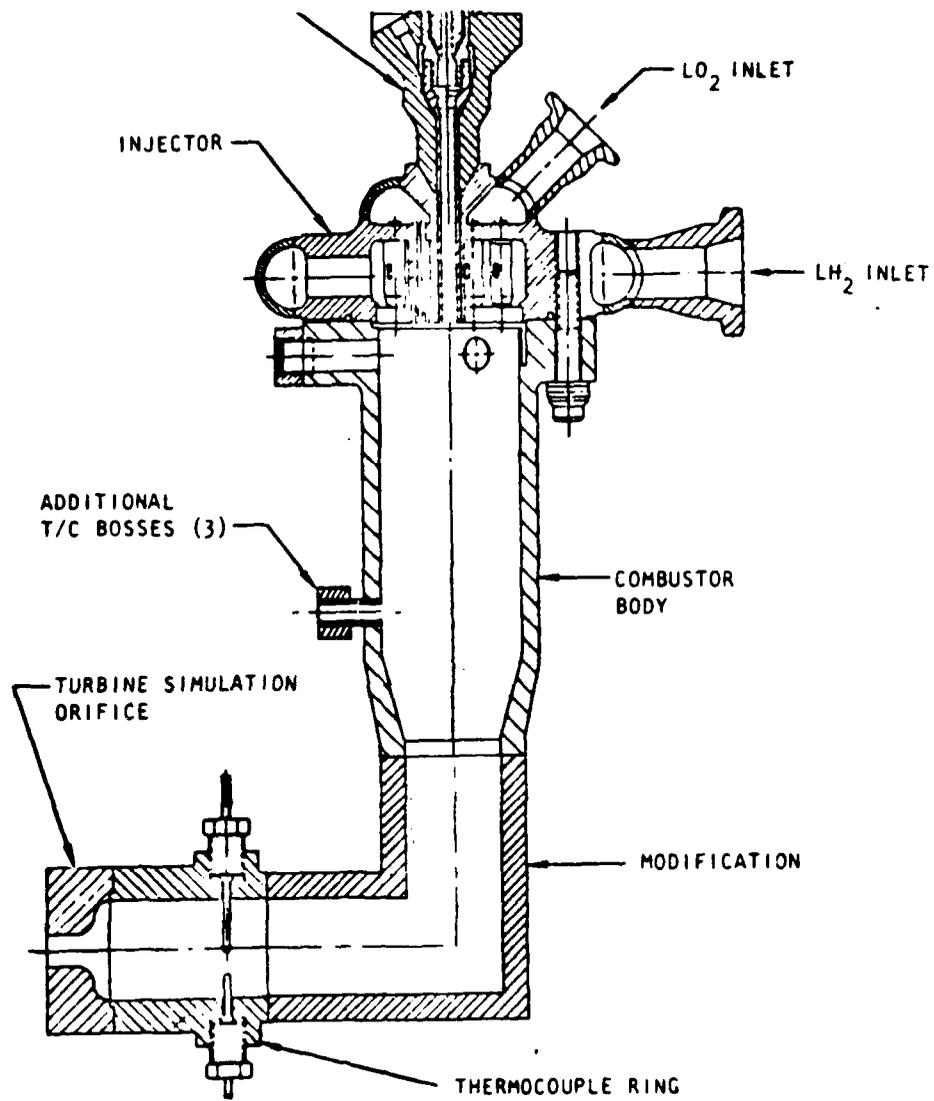
Figure 28. Small, High-Pressure Gas Generator Combustor with 90° Miter Combustion Chamber

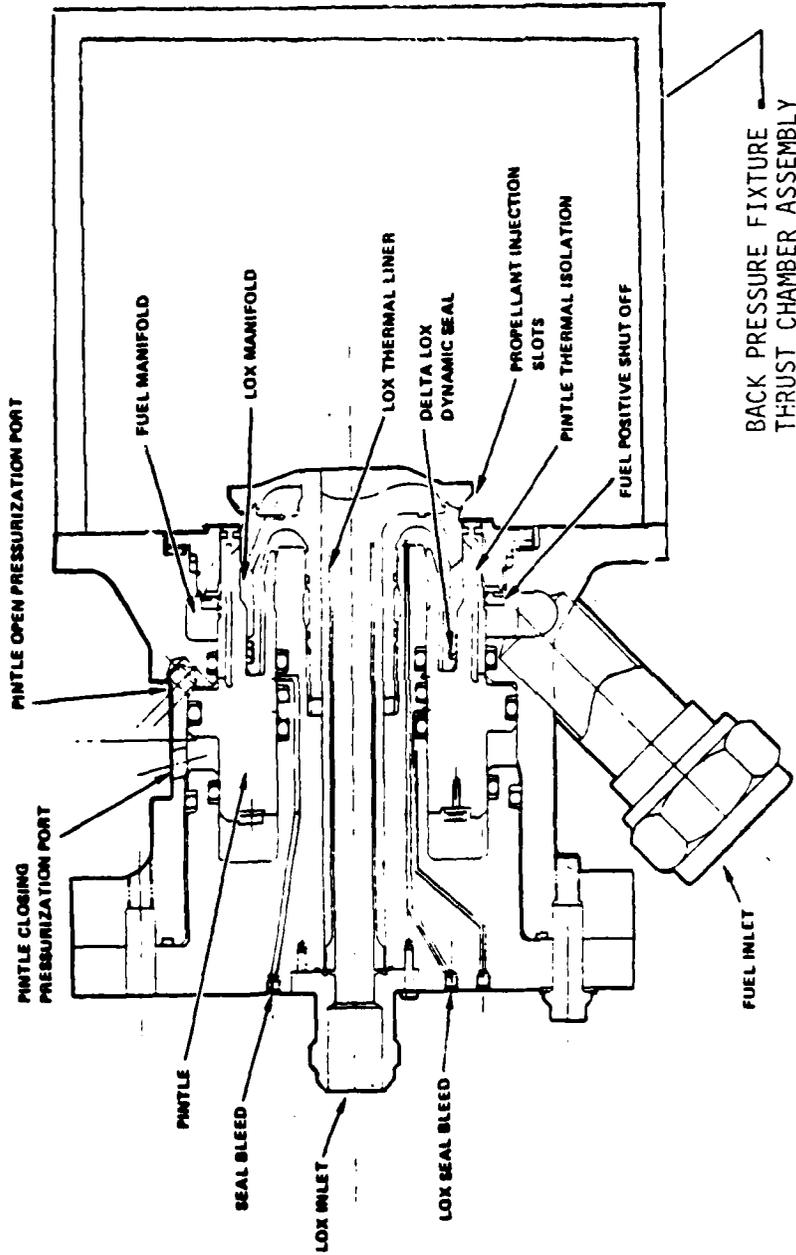
Figure 31 b . Ignition Leak Check Setup

Following assembly of the injector, the unit was subjected to a rigorous leak and proof pressure test to assure the integrity of the unit prior to hot fire. All tests were accomplished with clean dry Mil spec gaseous nitrogen to assure maintenance of LOX clean conditions. A section view of the injector showing the internal seal leak check ports and the general test setup are shown in Figure 31 b.

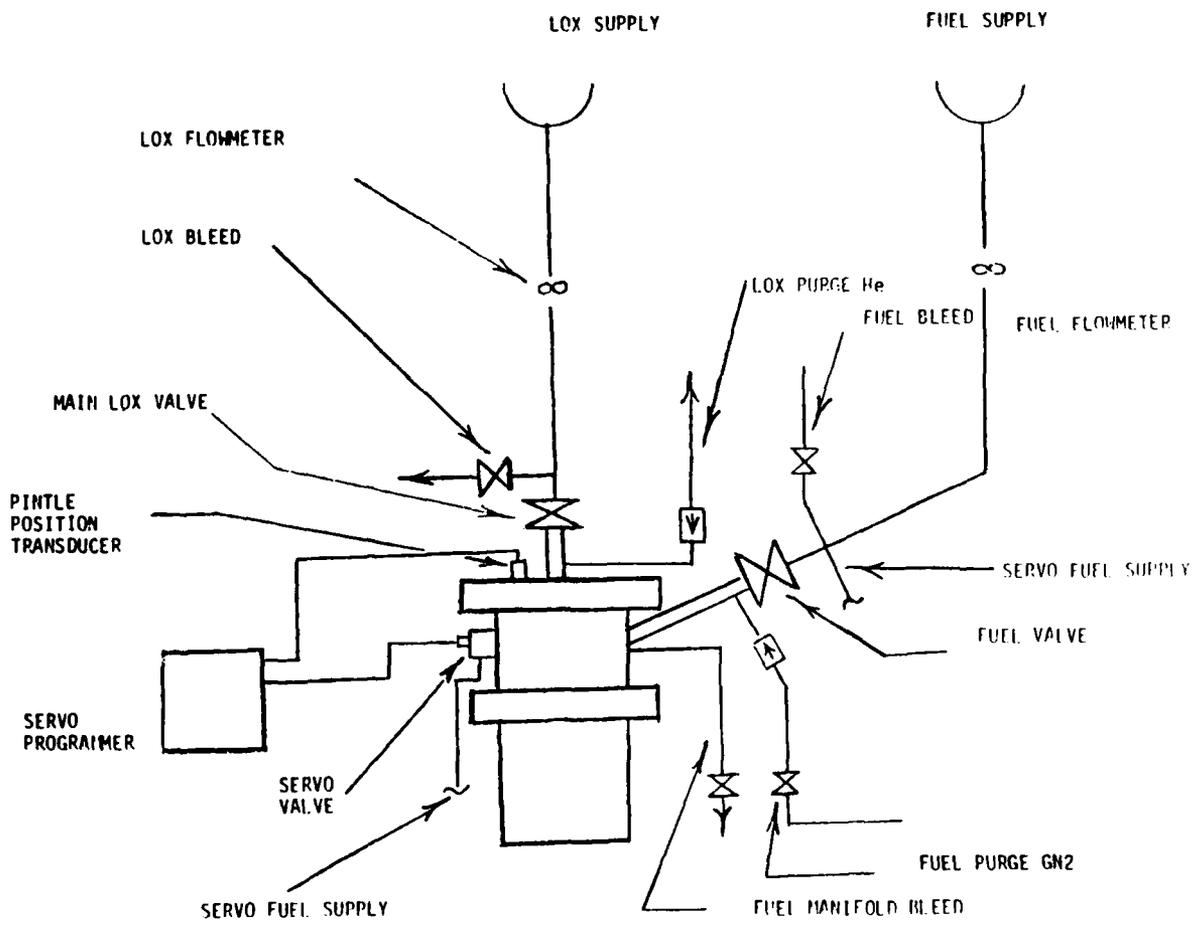
Figure 35. Restartable High Power Gas Generator Test Setup

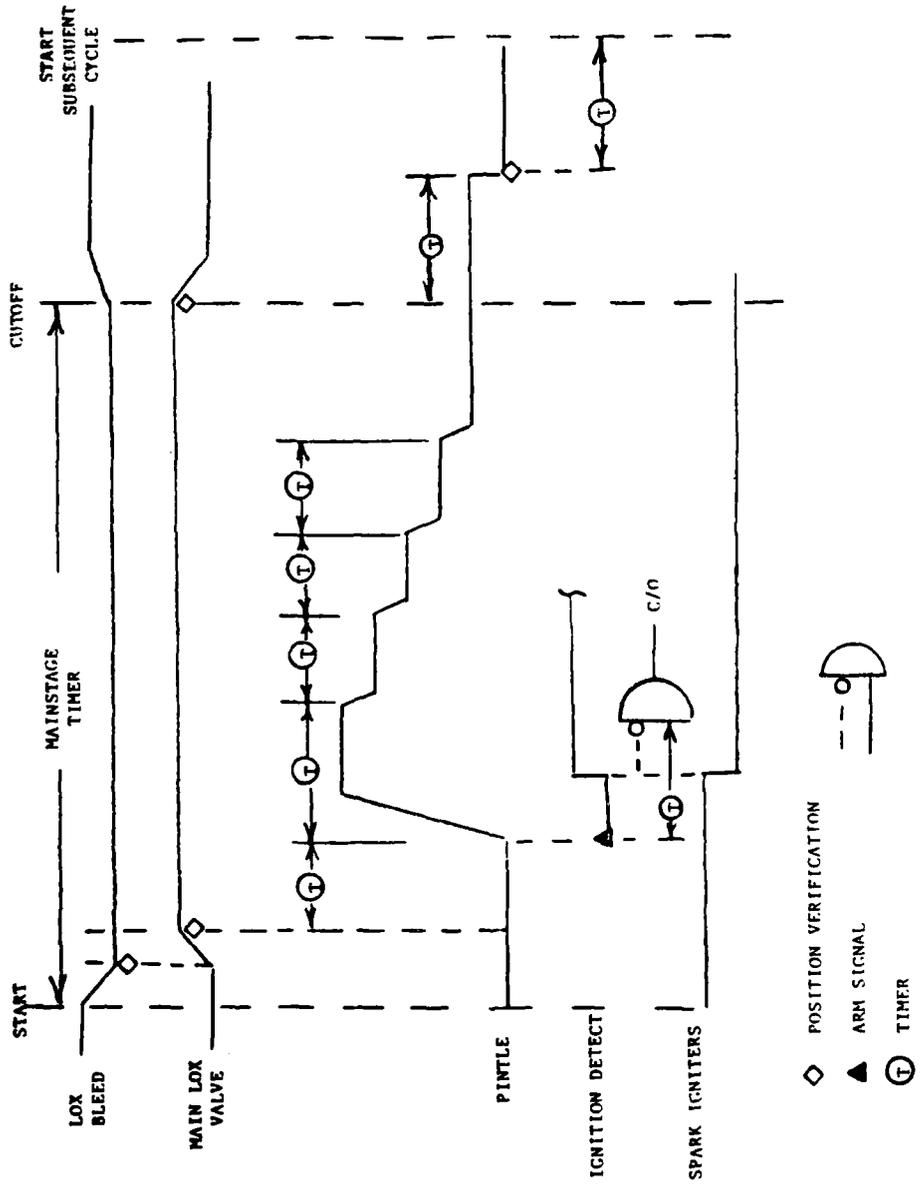
FIGURE 36. START AND CUTOFF SEQUENCE

1. Test cutoff initiated by the mainstage timer or failure to detect ignition shall close the main oxidizer valve, open the LOX bleed valve and start the pintle open override timer.
2. At the expiration of the pintle override timer, the pintle is commanded closed and starts the timer delay prior to the start of the next mainstage test.

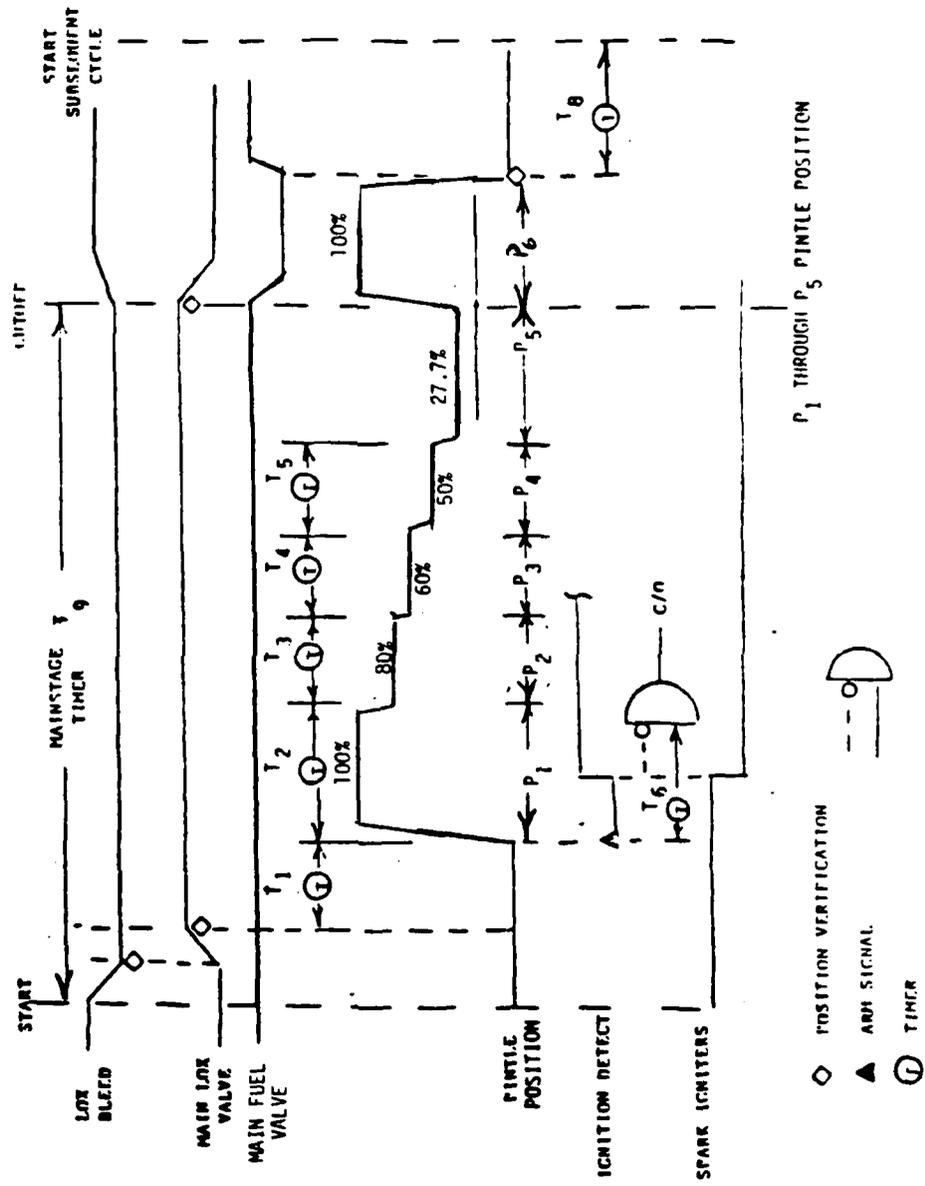
Figure 37. Revised Test Sequence

As a result of test termination and hot gas temperature spikes noted during the early hot fire tests, the test termination phase was modified. The sequence was modified to include a low flow fuel bypass and opening the pintle to the 100% position immediately after closing the LOX shutoff valve. This allowed expulsion of the residual oxidizer in the injector concurrent with a low fuel flowrate to react with the residual at a relatively low mixture ratio. The revised sequence is shown in Figure 37.

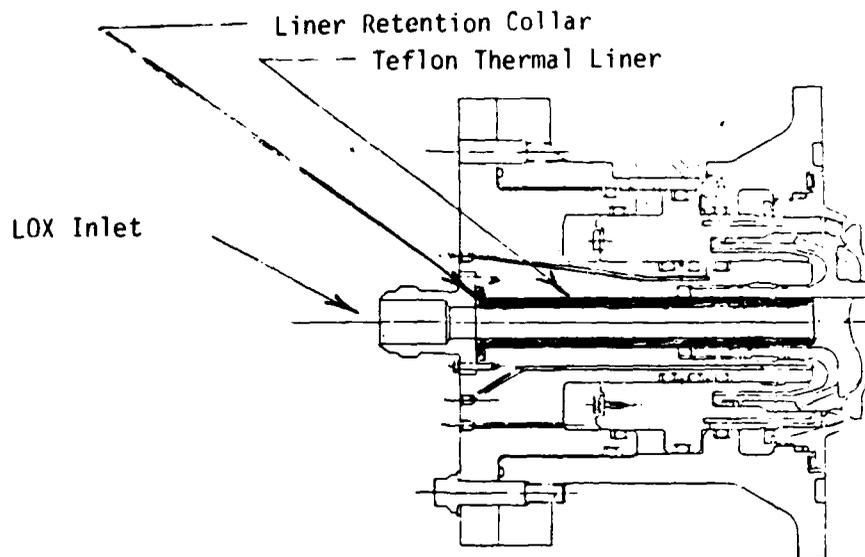
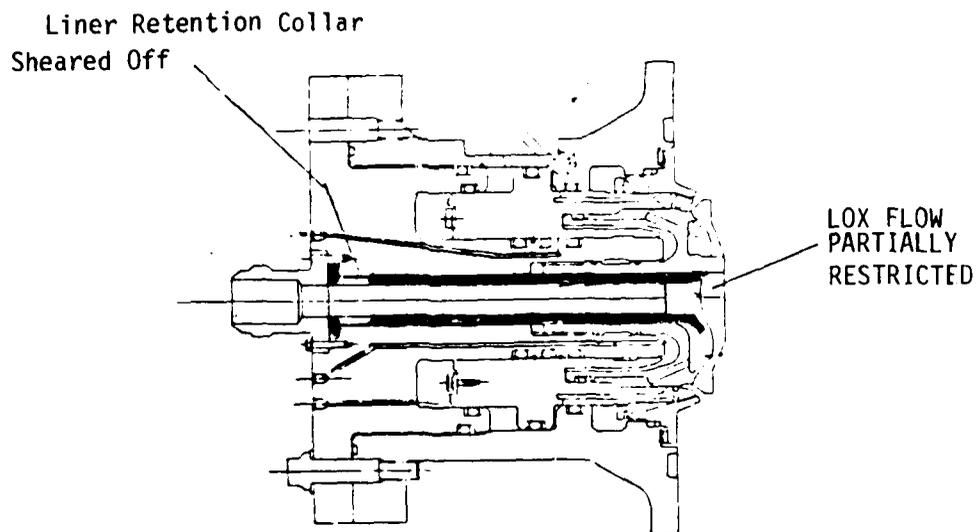
Test Results. The liquid oxygen thermal liner retainer sheared off at test start, resulting in the liner being driven aft into the core, producing a restriction in LOX flow, as shown in Figure 38. The resulting increased LOX injector differential pressure decreased the LOX flow, resulting in a mixture ratio of 0.326; target was 0.466. The measured hot gas temperature pattern was excellent, even though the LOX manifold was partially restricted by the failed thermal liner.

FIGURE 38. TEFLON THERMAL LINER FOLLOWING TEST 003

Hardware Configuration. The injector was rebuilt, incorporating a new fuel injector ring and forward section of the injector housing. Both were severely eroded as a result of Test 003. The injector teflon LOX thermal liner was replaced with a Cres tube (Figure 40), concentric with the LOX inlet passage. The design provided a gap between the liner flowing LOX and the injector housing. During operation the gap was filled with static LOX or GOX (no flow velocity).

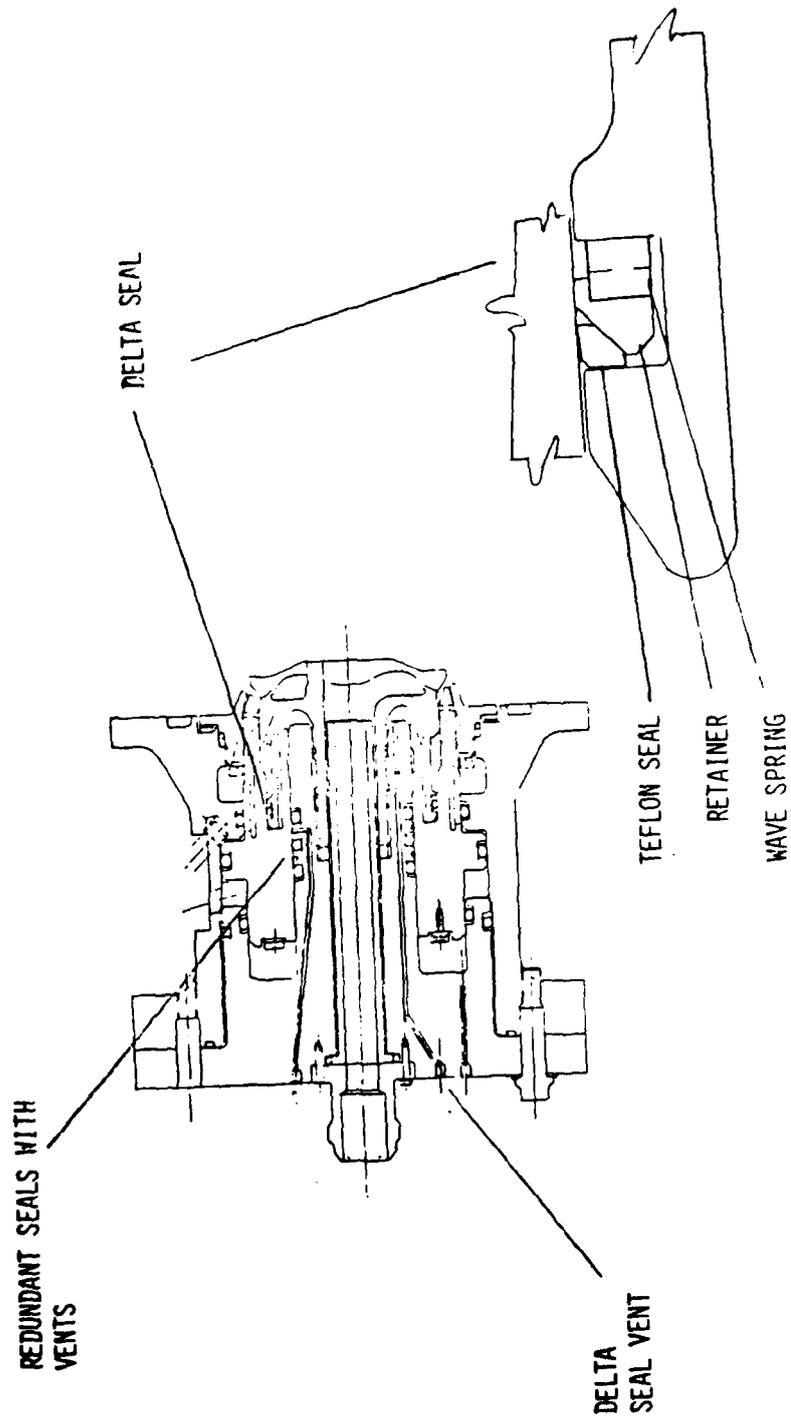
Figure 44 LOX Dynamic Delta Seal Vent

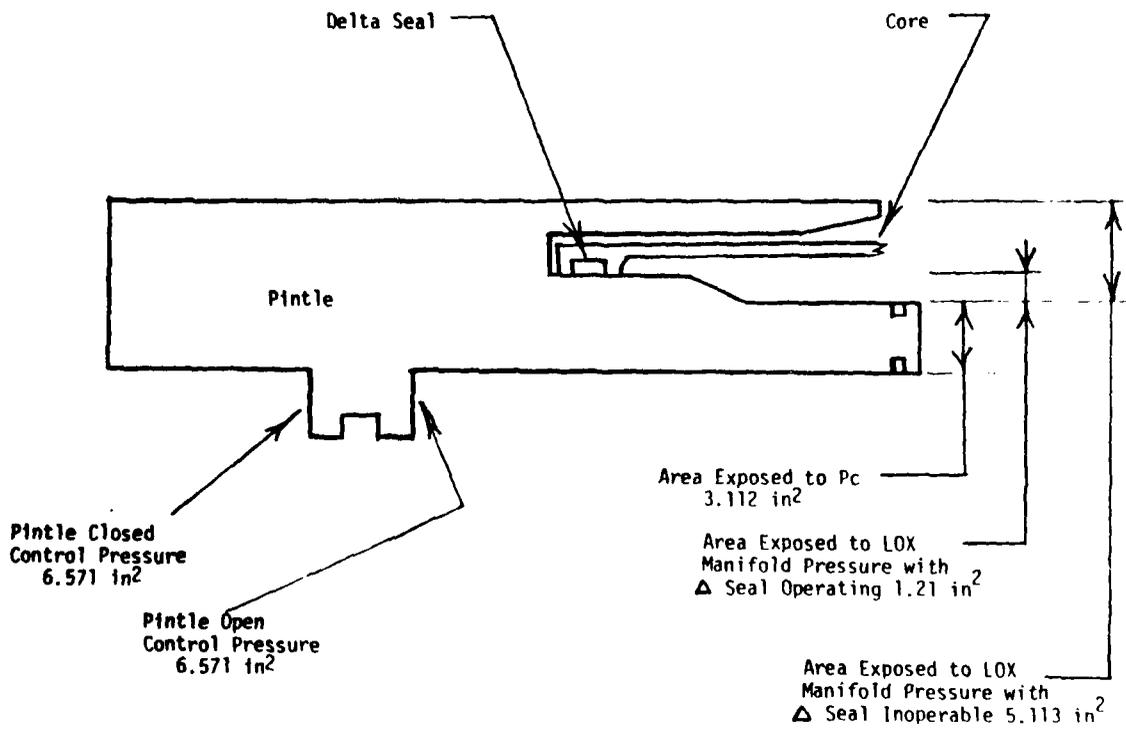
Figure 45 Pintle Area Balance

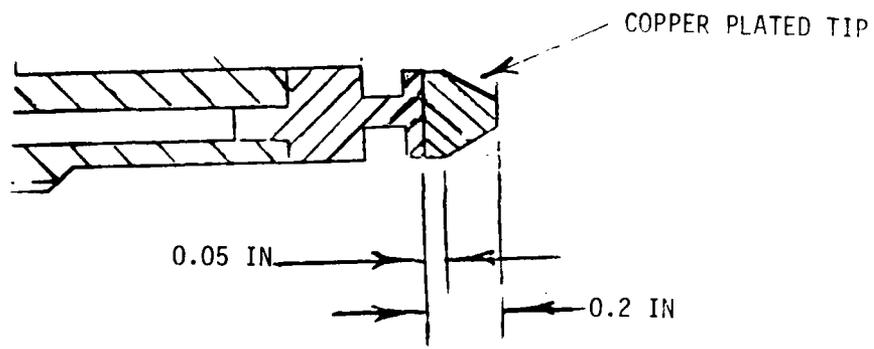
FIGURE 47. COPPER PINTLE TIP

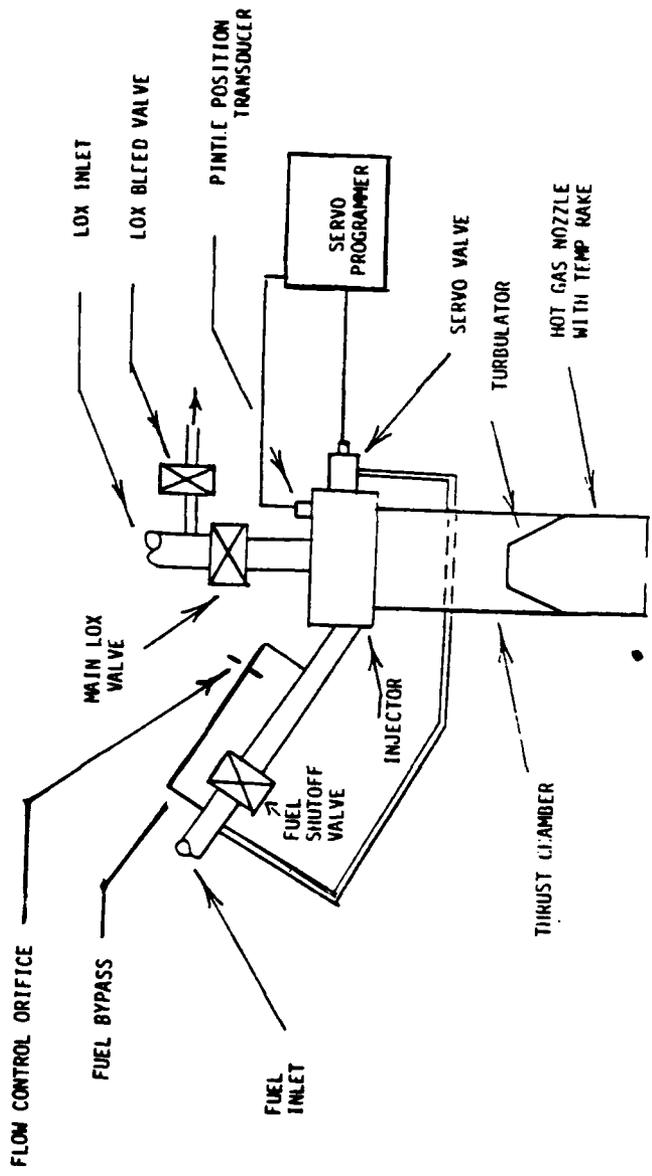
Figure 49. Test Termination Fuel Bypass System
